Your Ref: Porsche Taycan  
(chassis number WP0ZZZY1ZMSA31028)  
Our Ref : CI/TP22012961/D

**INSPECTION REPORT OF AN UNREGISTERED PORSCHE TAYCAN MOTOR CAR WITH CHASSIS NUMBER WP0ZZZY1ZMSA31028**

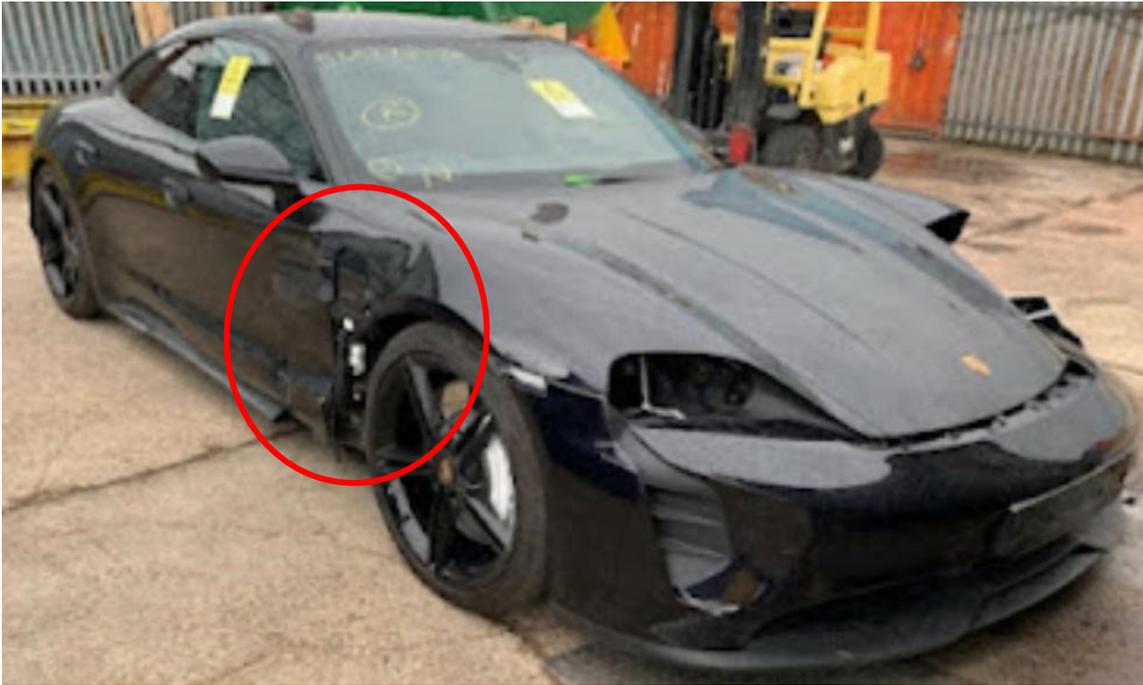
**Photo 1** shows the front right body of the Motor Car (photograph provided to me). The Motor Car was observed to have sustained damage at its right side portion (circled). The front right fender, front right door and right side rocker panel garnish were amongst the body parts that were observed to have been damaged. The front right headlamp was also observed to be missing/dislodged/damaged.

23. The body parts at the right side portion and left side front portion of the Motor Car were visually examined, and it was noted that the repair/restoration works carried out to the damaged area of the Motor Car (refer to photograph 1 & 2 above) were reasonably adequate and in order.

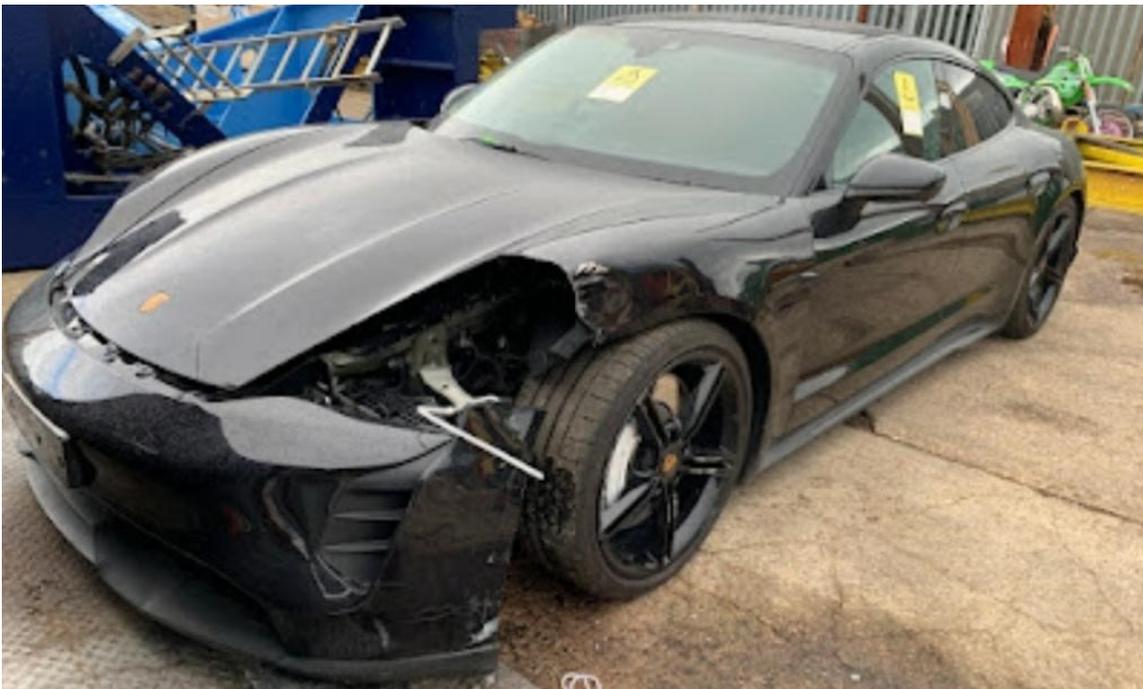
**Photo 2** shows the front left body of the Motor Car (photograph provided to me). Apart for the right side portion, I had also observed damage to the left side front portion of the Motor Car. The front bumper, front left signal lamp, front left fender and front left fender inner shield were amongst the body parts that were observed to have been damaged. The front left headlamp was also observed to be missing/dislodged/damaged.

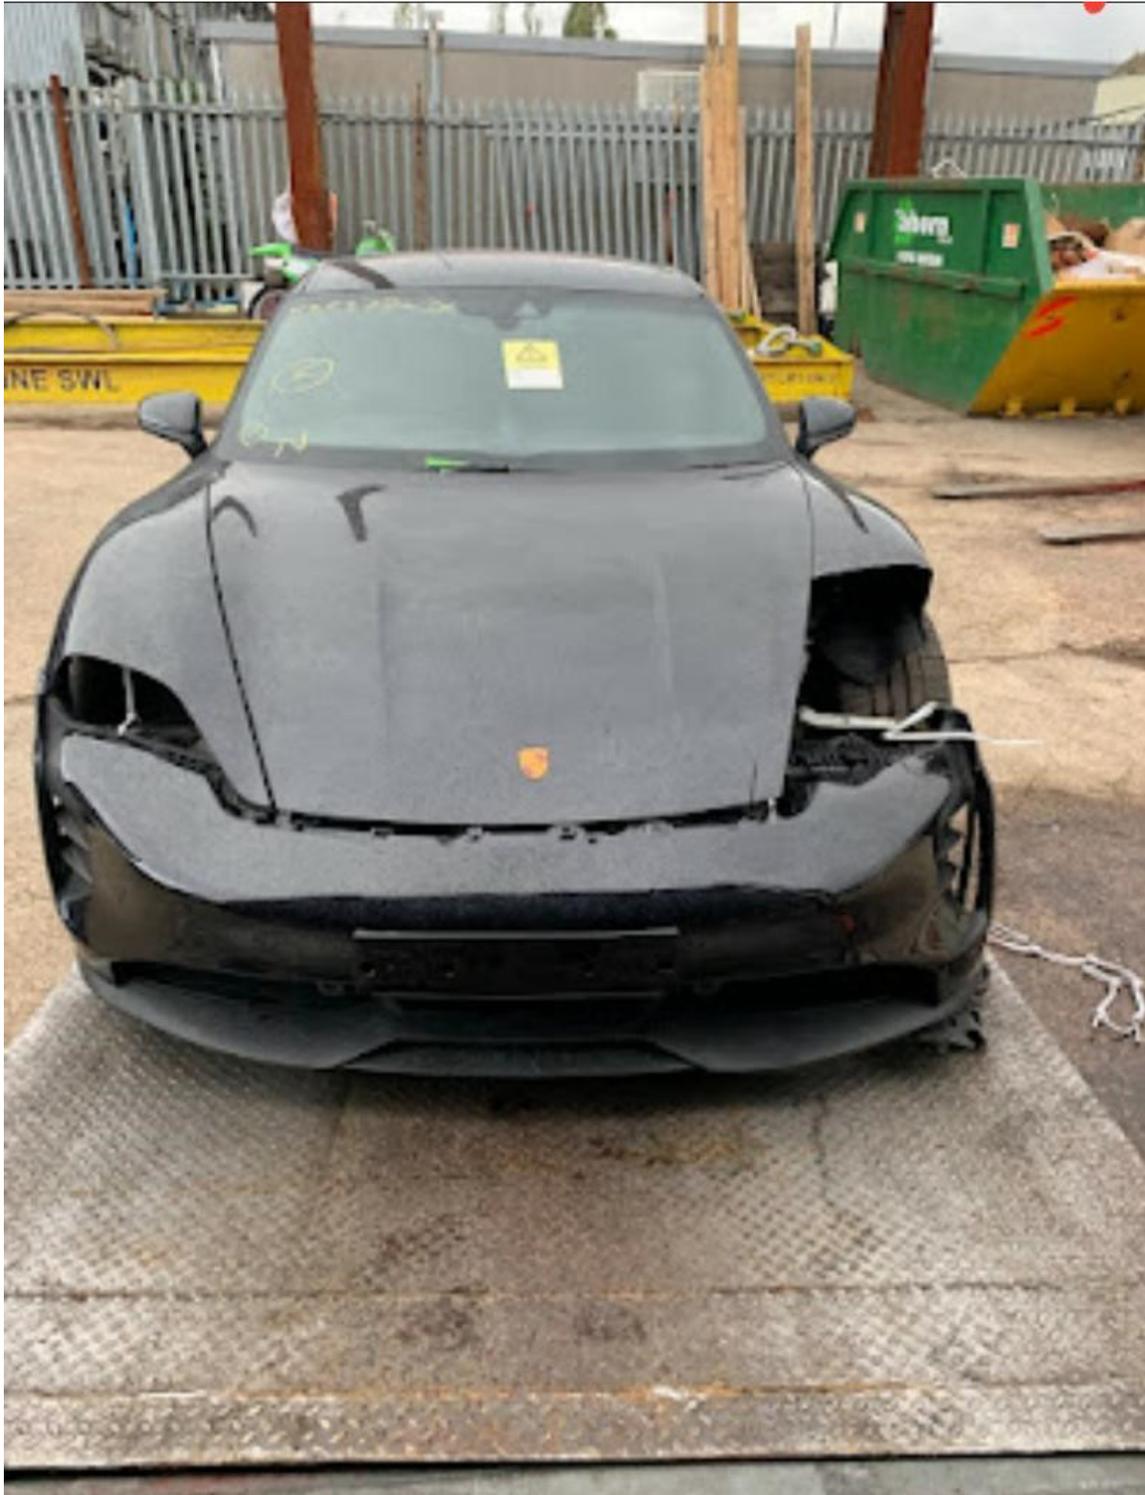
**Photo 3** shows the frontal body of the Motor Car (photograph provided to me). No physical damage was observed to the frontal portion of the Motor Car. I did however observe that the front left headlamp and front right headlamp were missing/dislodged/damaged.

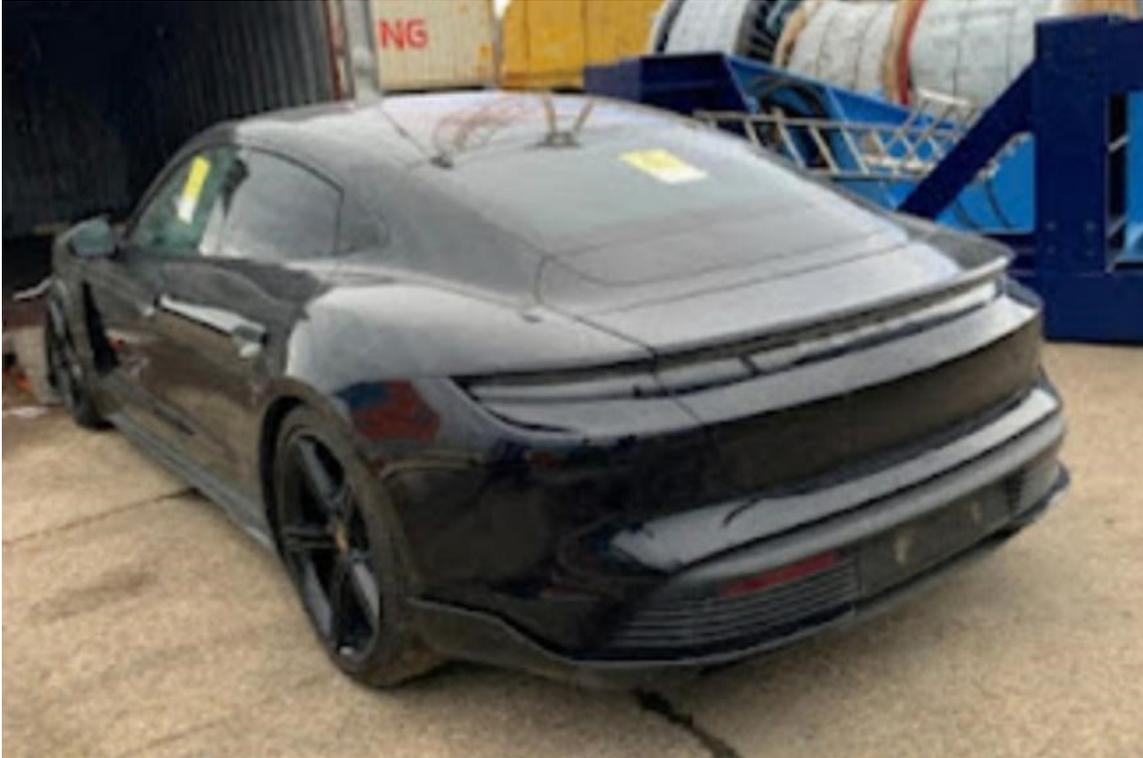
**Photo 4** shows the rear left body of the Motor Car (photograph provided to me). Apart for the right side portion and left side front portion, there was no physical damage observed to other areas of the Motor Car.

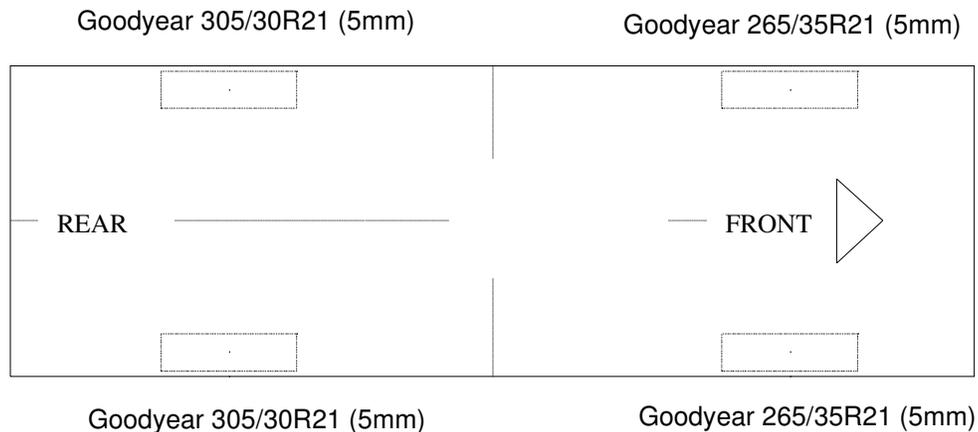
9. The Motor Car was fitted with 21inch sport wheel rims that were wrapped with tyres that were observed to be of serviceable condition. The tyres were also sufficiently inflated for vehicular operation. The tyre brand, tyre size and approximate remaining tread depth of the 4 tyres of the Motor Car were recorded as follows: -

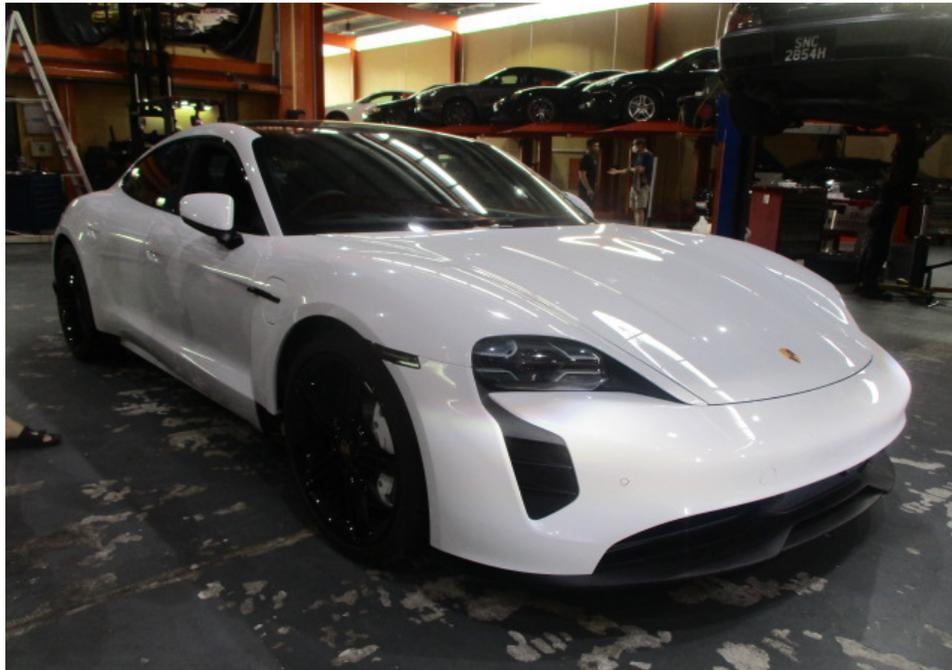
**Photo 5** shows a general view of the front right body of the Motor Car at the time of my inspection. The Motor Car was observed to be in a relatively good general condition with no loose exterior fittings observed. The body parts at the right side portion of the Motor Car were visually examined and it was observed that the repair/restoration works carried out to the damaged area of the Motor Car (refer to photograph 1 above) were reasonably adequate and in order.

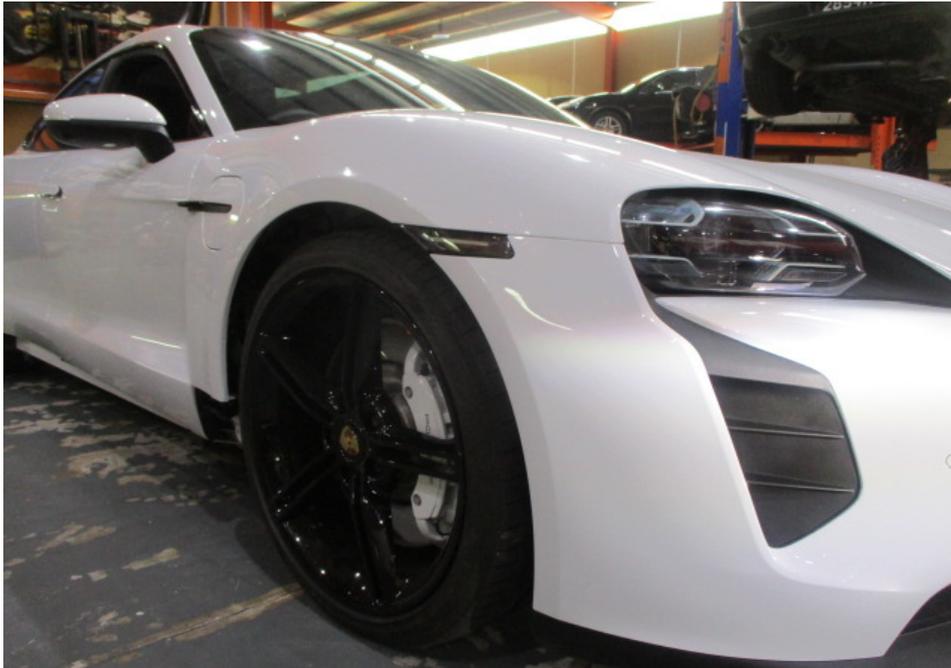
**Photo 6** shows a closer view of the Motor Car's front right headlamp, front right signal lamp, front right fender, front right wheel rim and front right door. The body parts at the right side portion of the Motor Car were visually examined and it was observed that the repair/restoration works carried out to the damaged area of the Motor Car (refer to photograph 1 above) were reasonably adequate and in order.

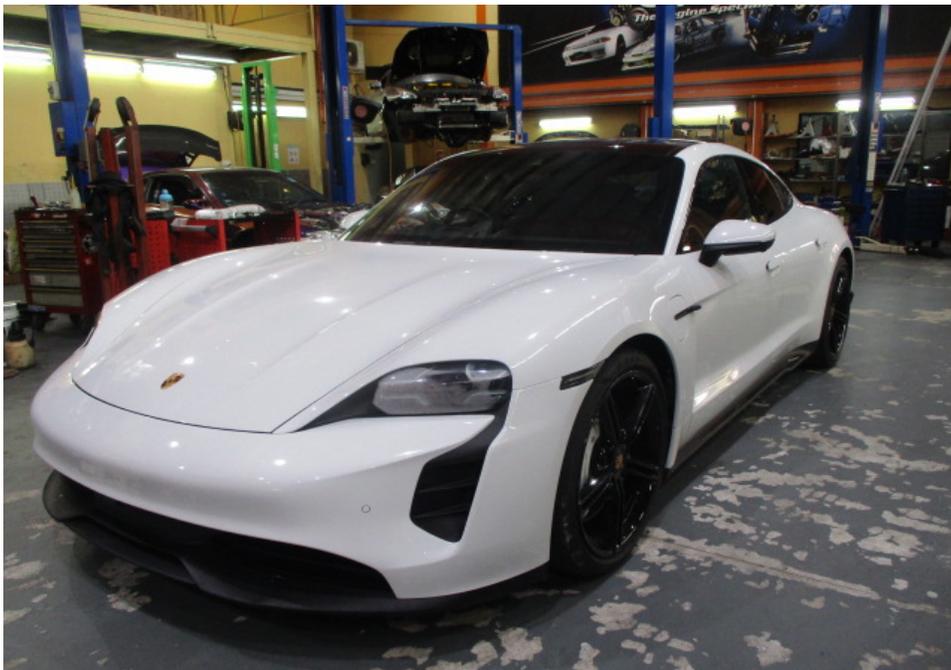
**Photo 7** shows a general view of the front left body of the Motor Car at the time of my inspection. The Motor Car was observed to be in a relatively good general condition with no loose exterior fittings observed. The body parts at the left side front portion of the Motor Car were visually examined and it was observed that the repair/restoration works carried out to the damaged area of the Motor Car (refer to photograph 2 above) were reasonably adequate and in order.

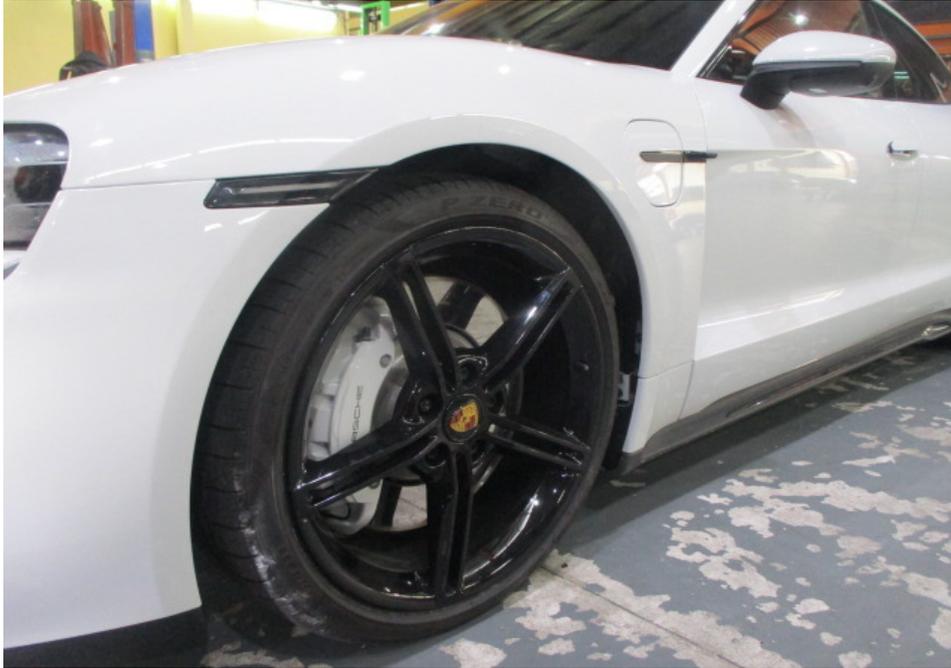
**Photo 8** shows a closer view of the Motor Car's front bumper, front left signal lamp, front left fender, front left wheel rim and front left door. The body parts at the left side front portion of the Motor Car were visually examined and it was observed that the repair/restoration works carried out to the damaged area of the Motor Car (refer to photograph 2 above) were reasonably adequate and in order.

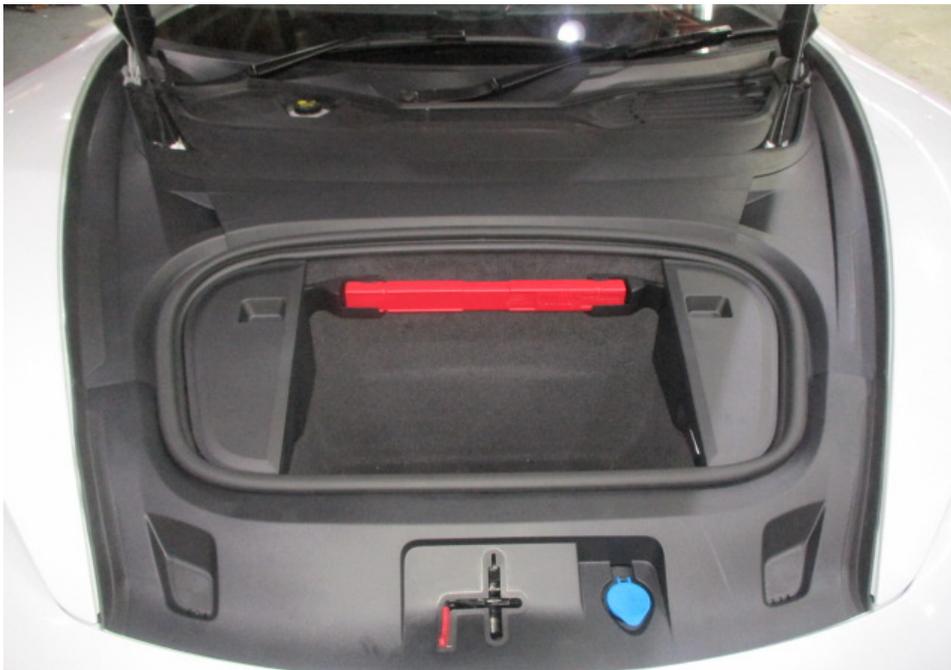
**Photo 9** shows a general view of the Motor Car's front bonnet compartment at the time of my inspection. All inner trims, garnishes and upholstery etc were observed to be properly fitted.

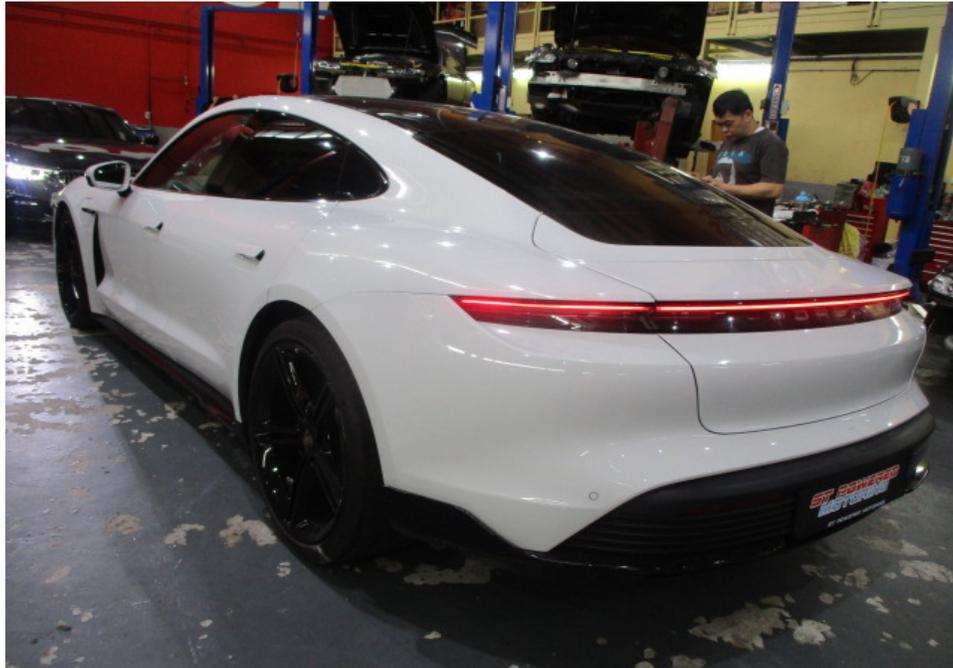
**Photo 10** shows a general view of the rear left body of the Motor Car at the time of my inspection. The Motor Car was observed to be in a relatively good general condition with no loose exterior fittings observed. The mileage of the Motor Car recorded at the time of my inspection was 18,435km.

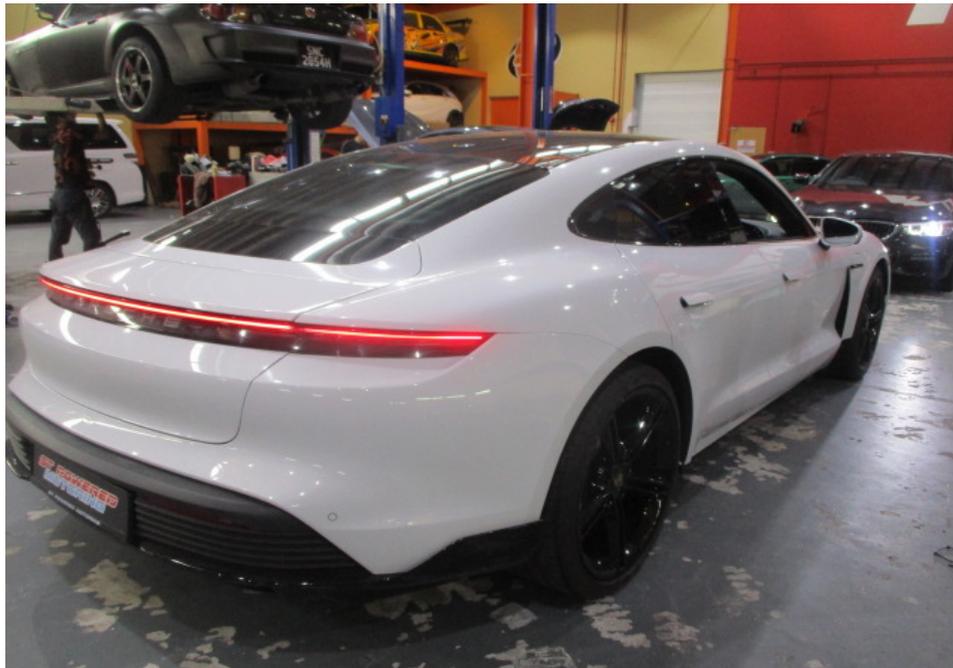
**Photo 11** shows a general view of the rear right body of the Motor Car at the time of my inspection. The Motor Car was observed to be in a relatively good general condition with no loose exterior fittings observed. The mileage of the Motor Car recorded at the time of my inspection was 18,435km.

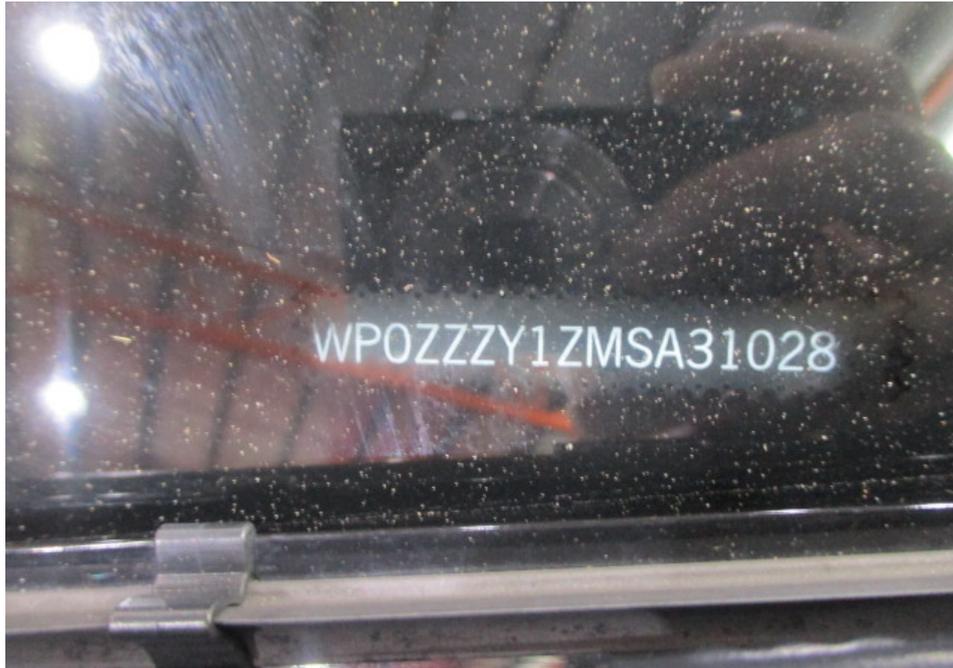
**Photo 12** shows the chassis number of the Motor Car. The chassis number recorded was WP0ZZZY1ZMSA31028.

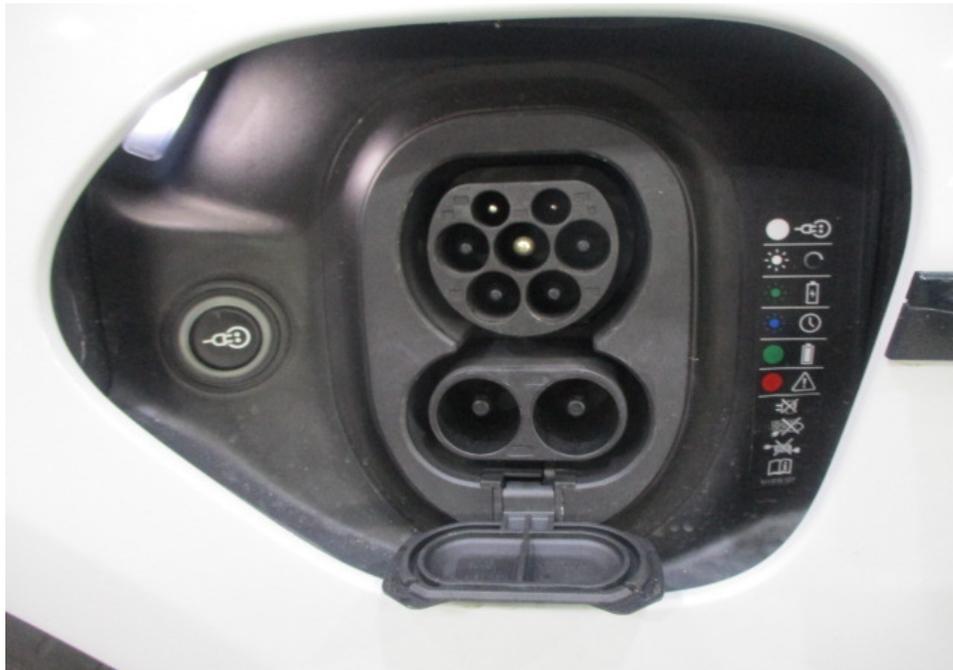
**Photo 13** shows the high voltage charging port located at the front left fender of the Motor Car at the time of my inspection. A Combined Charging Standard 2 (CCS 2) for direct current (DC) charging was fitted on the front left fender of the Motor Car. No physical damage was observed to the charging head.

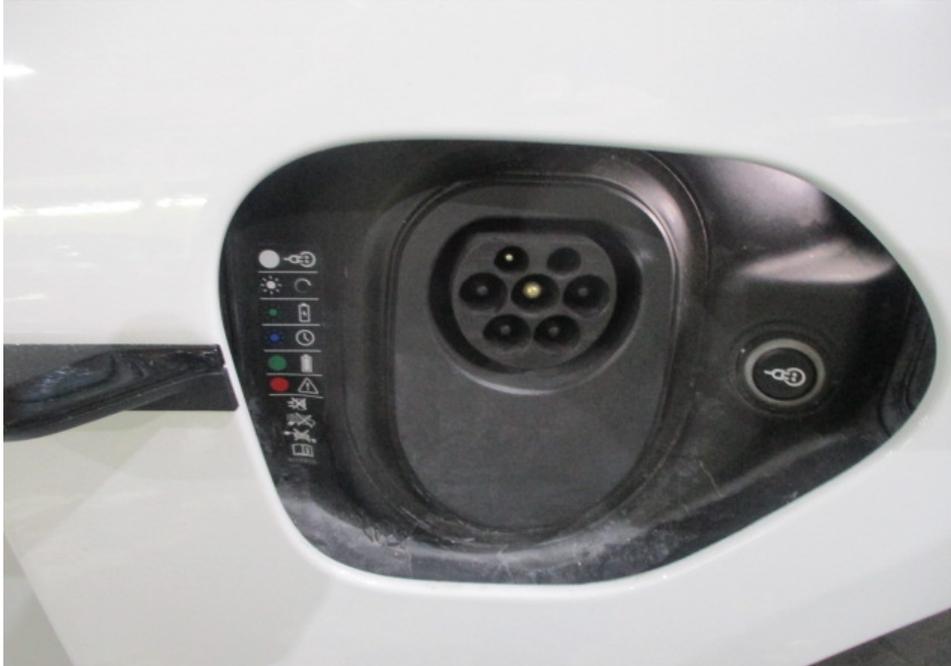
**Photo 14** shows the high voltage charging port located at the front right fender of the Motor Car at the time of my inspection. A JS 1772 (Type 2) for alternating current (AC) charging was fitted on the front right fender of the Motor Car. No physical damage was observed to the charging head.

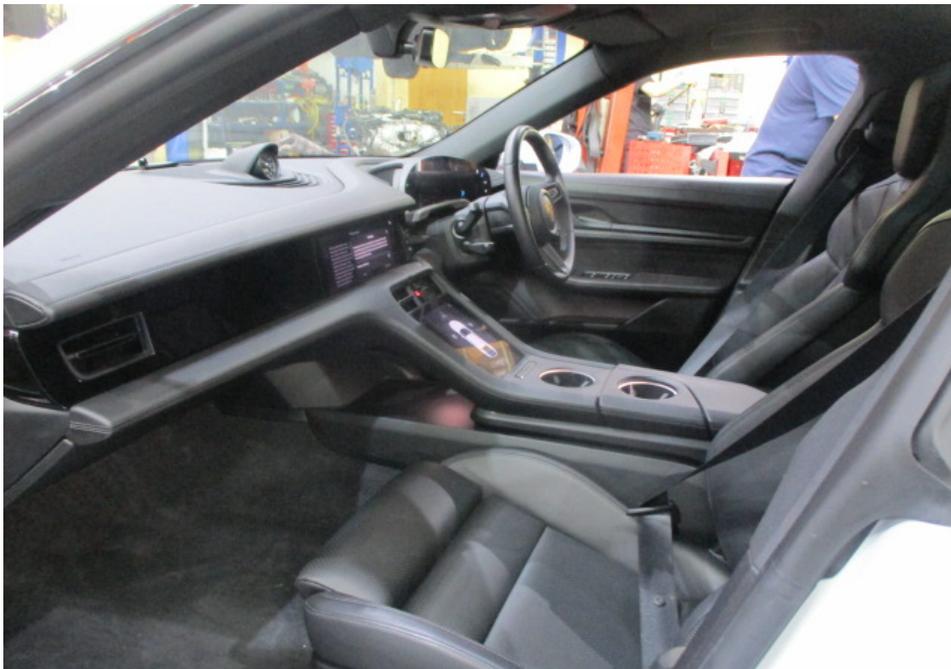
**Photo 15** shows the interior compartment of the Motor Car at the time of my inspection. The various parts and components, trims, carpet, and upholstery inside the interior compartment were all observed to be intact and properly fitted.

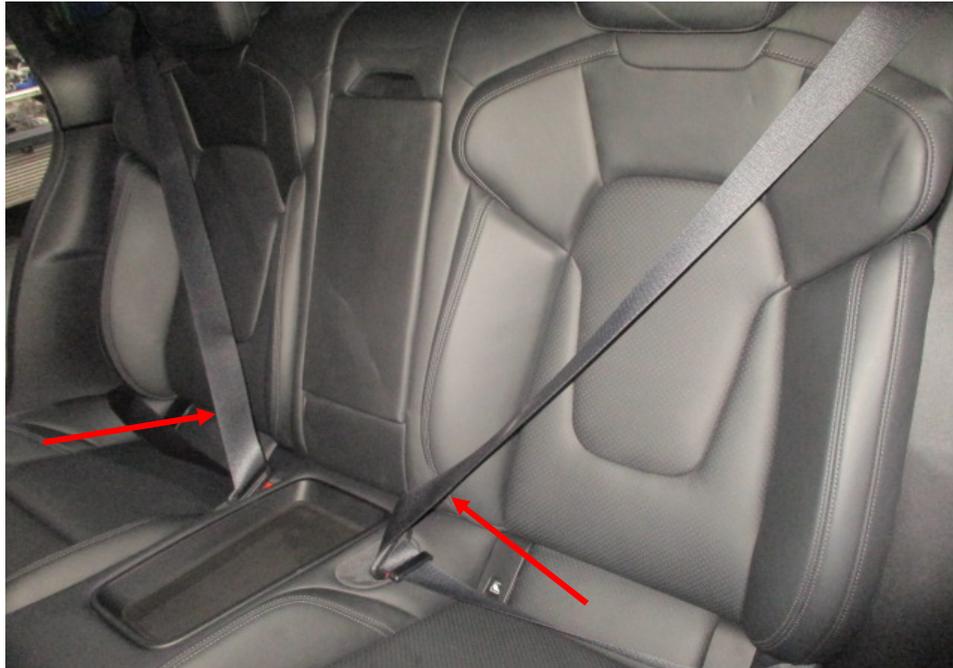
**Photo 16** shows the rear seats of the Motor Car. All the seats of the Motor Car were secured via seat rails to the floorboard. They were also fitted with a retractable seat belt reel and a pre-tensioner. The seat belts (arrowed) were tested and were able to be fastened into the respective pre-tensions that were fitted on the side of each individual seat.

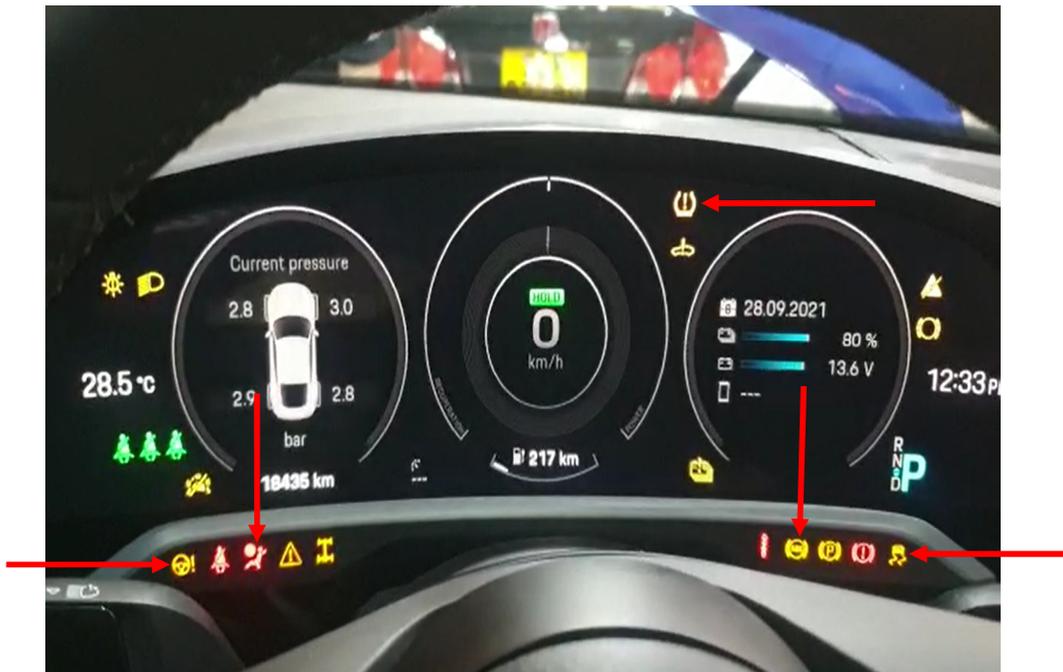
**Photo 17** shows the warning lights for the various electronic safety features appearing on the instrument panel of the Motor Car during its self-test when the engine is cranked, in particular the ABS, SRS, EPS, TPM and SCS lights (arrowed).

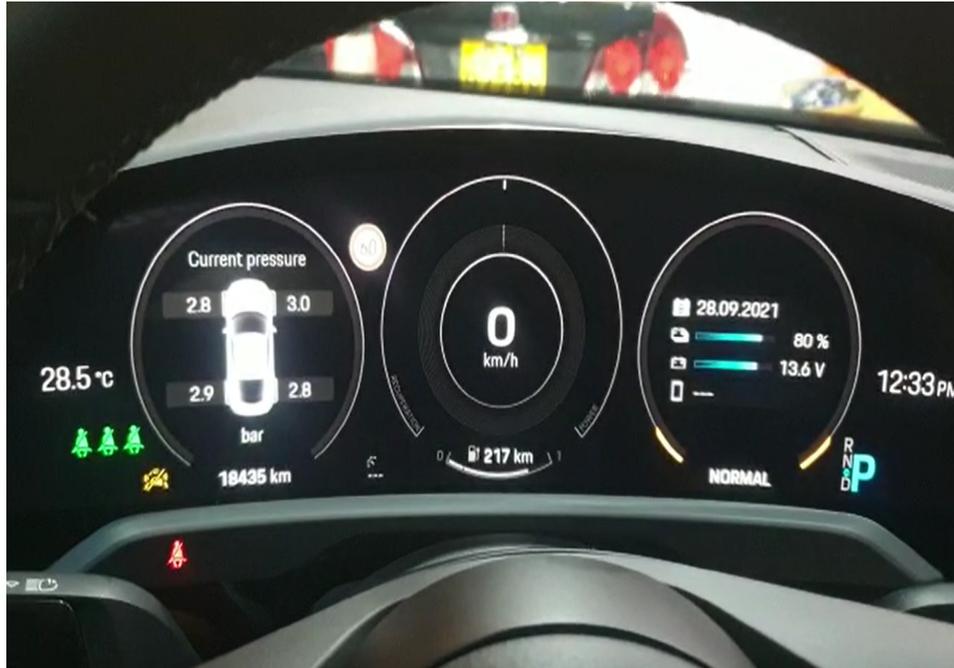
**Photo 18** shows the respective warning lights no longer illuminated, indicating that there is no fault detected to the ABS, SRS, EPS, TPM and SCS systems of the Motor Car during the self-test. These electronic systems were hence in working condition at the time of my inspection.

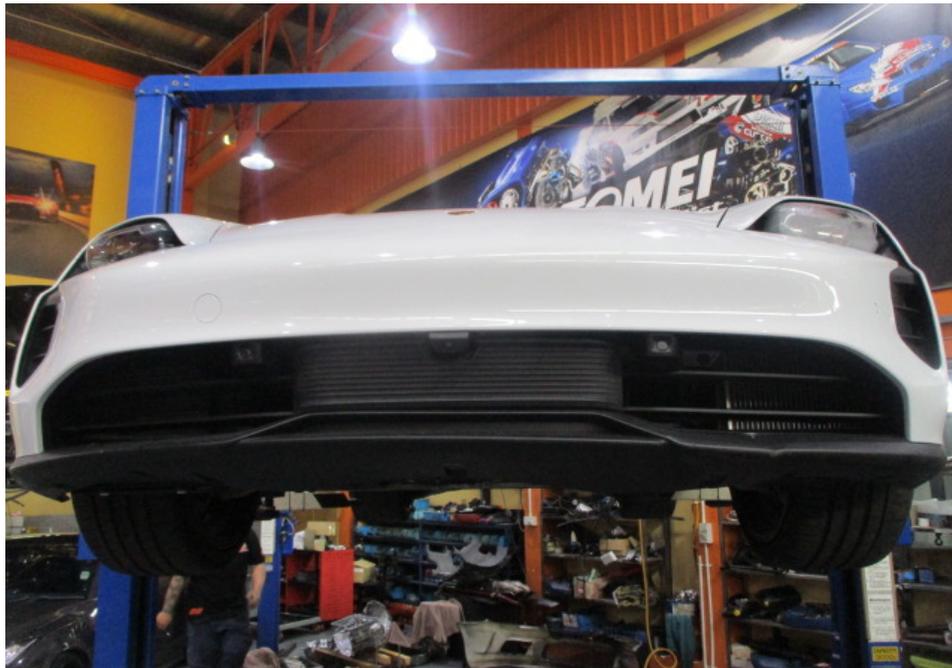
**Photo 19** shows the Motor Car hoisted up for checks on its undercarriage. There was no sign(s) or indication(s) of fluid leakage and/or fluid stain(s) on the underside of the Motor Car. The undercarriage components of the Motor Car were also all observed to be intact and secured in an appropriate manner.

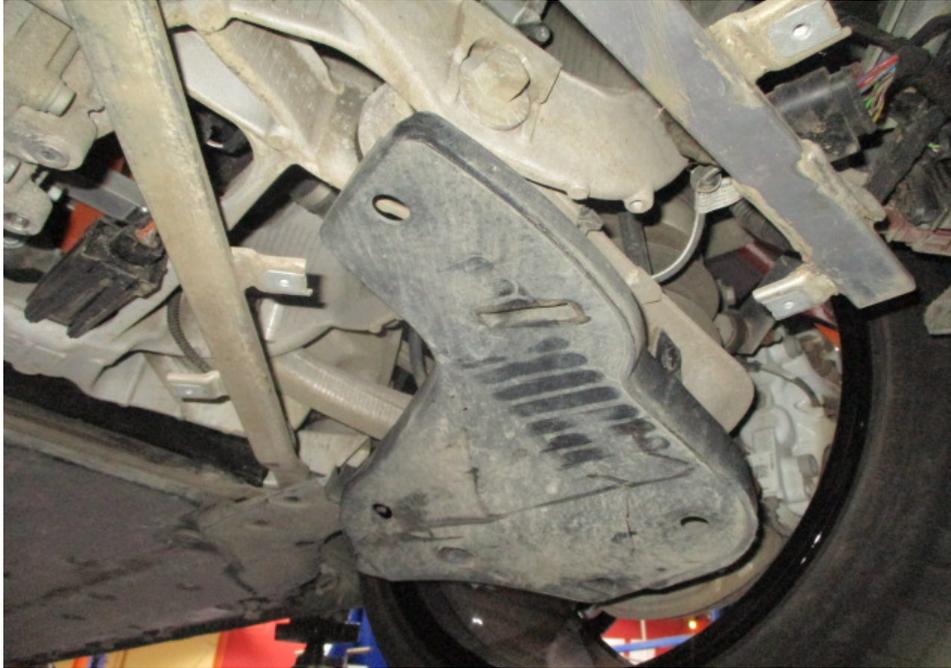
**Photo 20** shows a general view of the control arms and linkages at the rear right wheel of the Motor Car. I did not observe any fluid leak and/or fluid stain on the underside of the Motor Car. All of the Motor Car's undercarriage components were observed to be intact and secured in an appropriate manner.

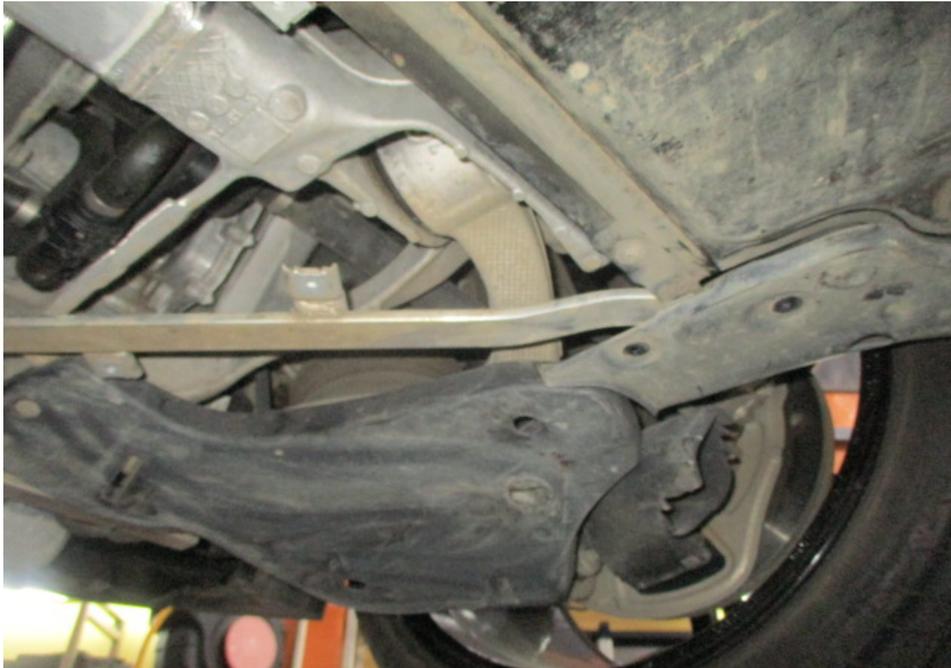
**Photo 21** shows a general view of the control arms and linkages at the rear left wheel of the Motor Car. I did not observe any fluid leak and/or fluid stain on the underside of the Motor Car. All of the Motor Car's undercarriage components were observed to be intact and secured in an appropriate manner.

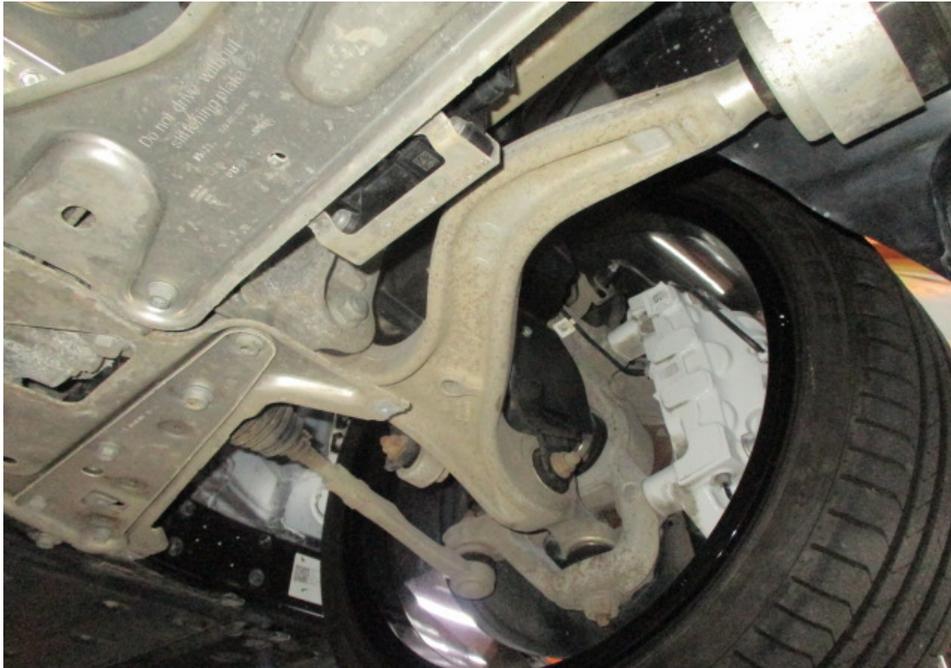
**Photo 22** shows the various undercarriage components at the front left wheel of the Motor Car. The mechanical components, control arms and linkages were all found to be intact and secured in an appropriate manner.

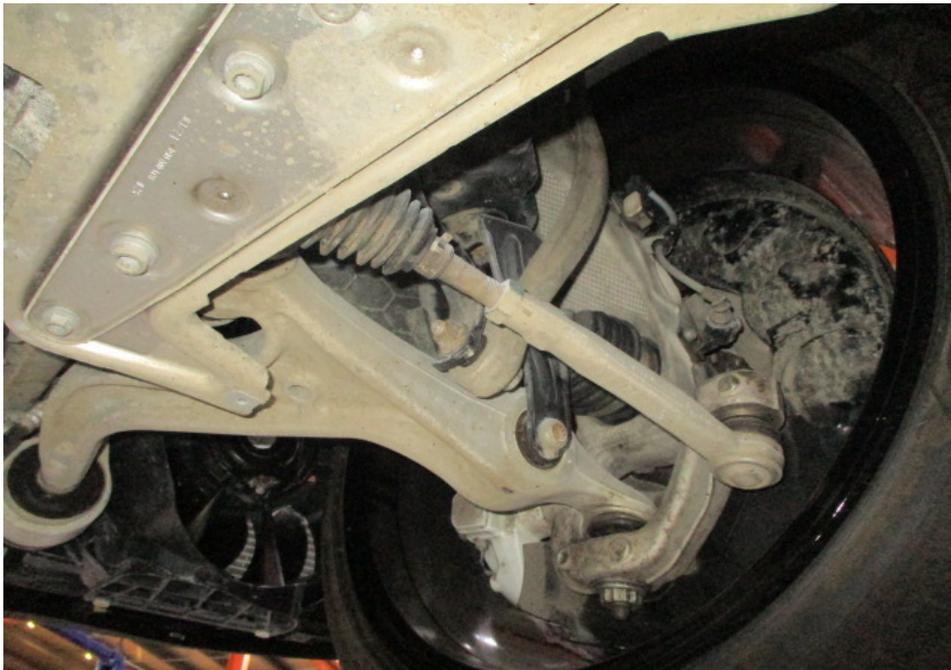
**Photo 23** shows the various undercarriage components at the front right wheel of the Motor Car. The mechanical components, control arms and linkages were all found to be intact and secured in an appropriate manner. I also did not observe any fluid leak and/or fluid stain on the underside of the Motor Car.

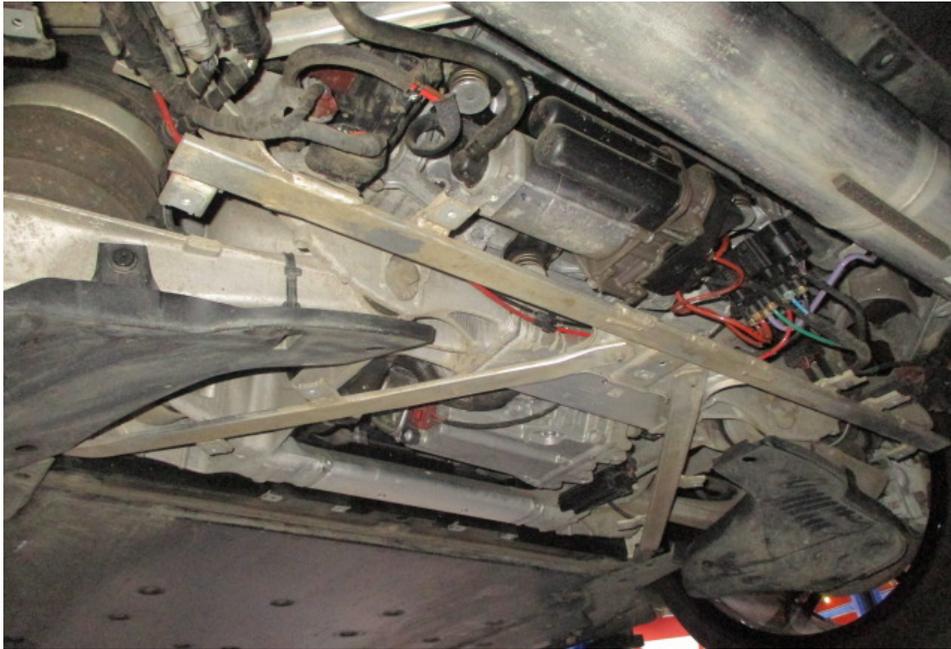
**Photo 24** shows the underside rear of the Motor Car, at the location where the rear electric motor is fitted. The high voltage system of the Motor Car was visually checked, and it was observed that the various high voltage parts and components like the high voltage battery, inverter unit, converter unit, high voltage cables, electric motors and electric aircon compressor amongst others, were properly secured and without any physical damage.

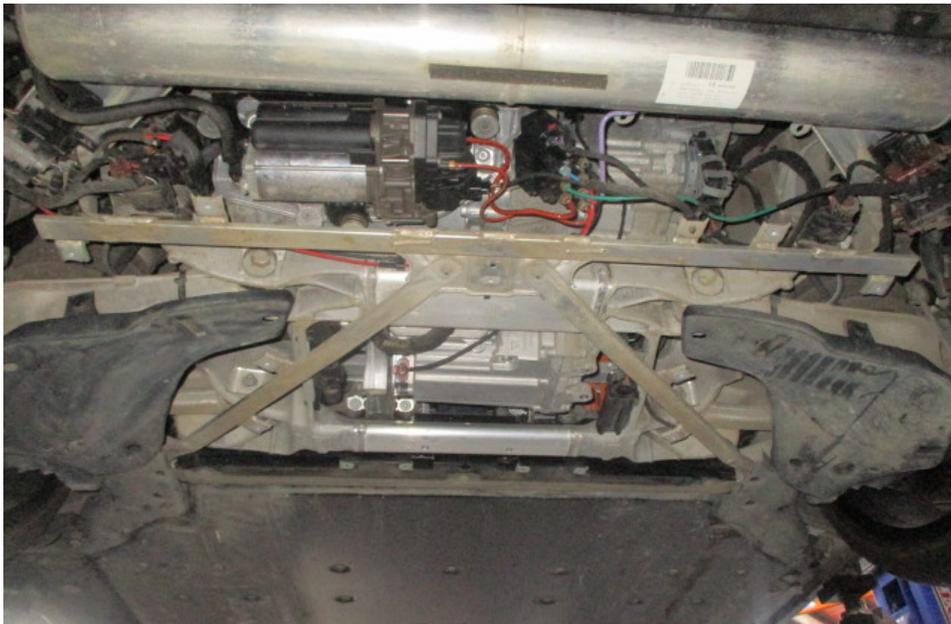
**Photo 25** shows another view of the underside rear of the Motor Car, at the location where the rear electric motor is fitted. The high voltage system of the Motor Car was visually checked, and it was observed that the various high voltage parts and components like the high voltage battery, inverter unit, converter unit, high voltage cables, electric motors and electric aircon compressor amongst others, were properly secured and without any physical damage.

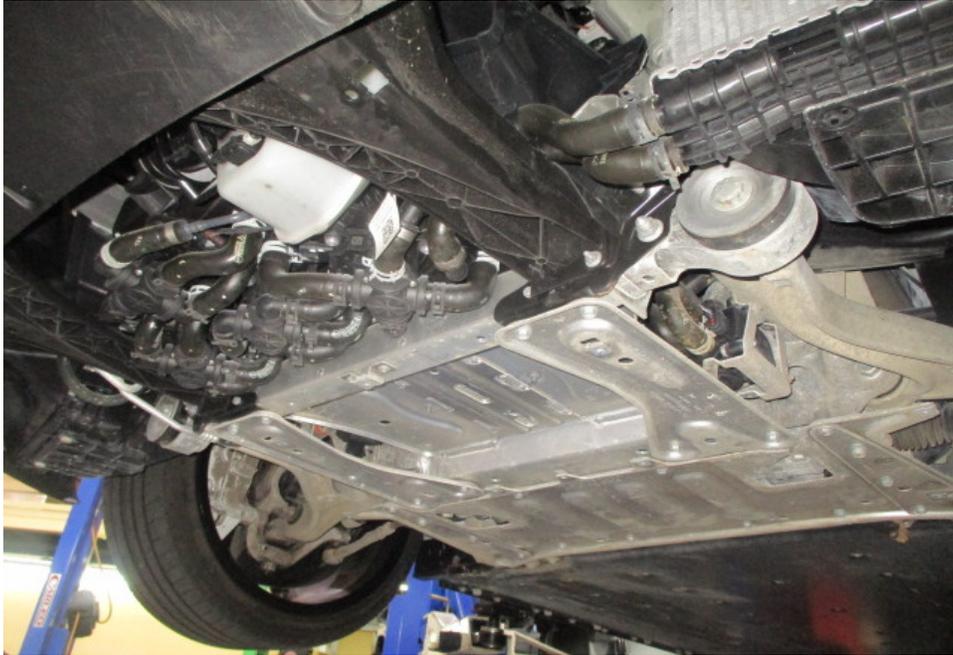
**Photo 26** shows the underside front of the Motor Car, at the location where the front electric motor, is fitted. The high voltage system of the Motor Car was visually checked, and it was observed that the various high voltage parts and components like the high voltage battery, inverter unit, converter unit, high voltage cables, electric motors and electric aircon compressor amongst others, were properly secured and without any physical damage.

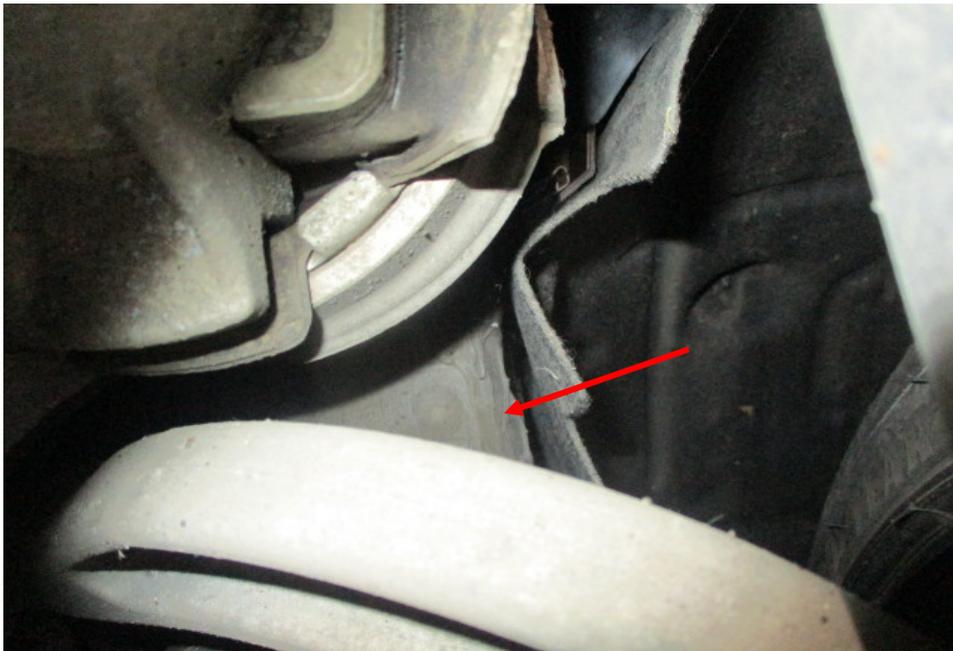
**Photo 27** shows the chassis/structural body at the underside rear right of the Motor Car. I did not find any weld marks other than original spot weld marks on the chassis/structural body of the Motor Car. The original factory sealant (arrowed) at the joints along the chassis/structural body was untouched, indicating no work was done on the chassis/structural body of the Motor Car and that the chassis/structural body was originally fitted.

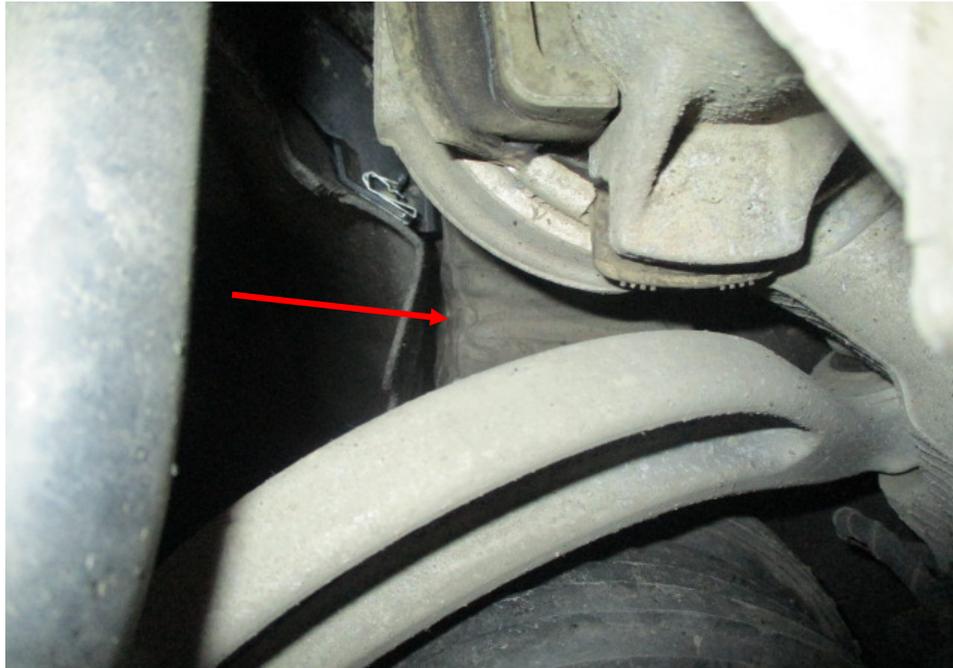
**Photo 28** shows the chassis/structural body at the underside rear left of the Motor Car. The original factory sealant (arrowed) at the joints along the chassis/structural body was observed to be untouched. In general, I had found no work was carried out on the chassis/structural body of the Motor Car. The chassis/structural body of the Motor Car was originally fitted.
