Your Ref: Porsche Taycan  
(chassis number WP0ZZZY1ZMSA31028)  
Our Ref : CI/TP22012961/D

**INSPECTION REPORT OF AN UNREGISTERED PORSCHE TAYCAN MOTOR CAR WITH CHASSIS NUMBER WP0ZZZY1ZMSA31028**

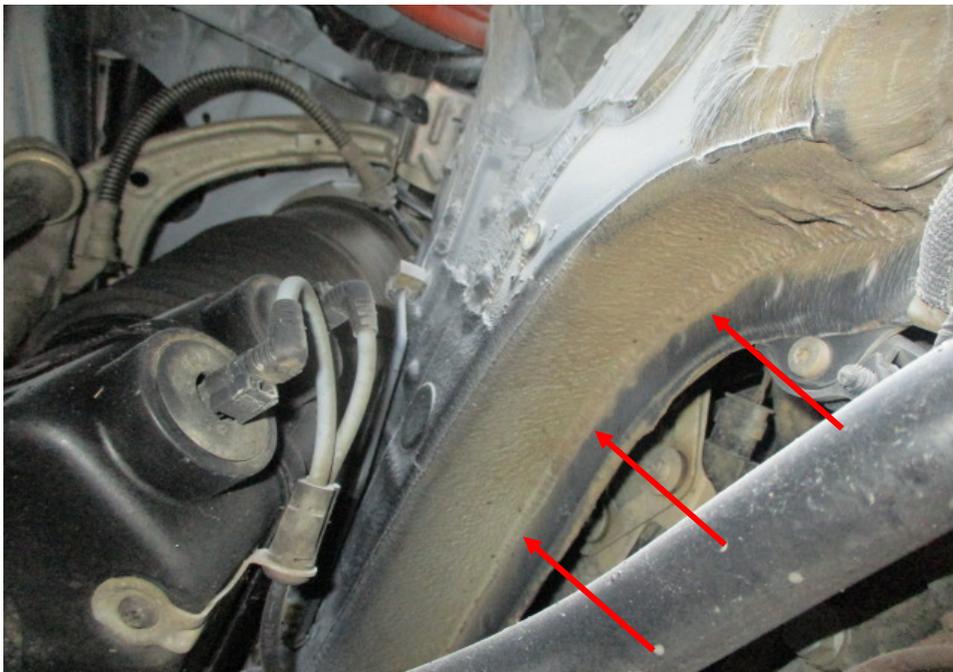
**Photo 29** shows the chassis/structural body at the underside front left of the Motor Car. I did not find any weld marks other than original spot weld marks on the chassis/structural body of the Motor Car. The original factory sealant (arrowed) at the joints along the chassis/structural body was untouched, indicating no work was done on the chassis/structural body of the Motor Car and that the chassis/structural body was originally fitted.

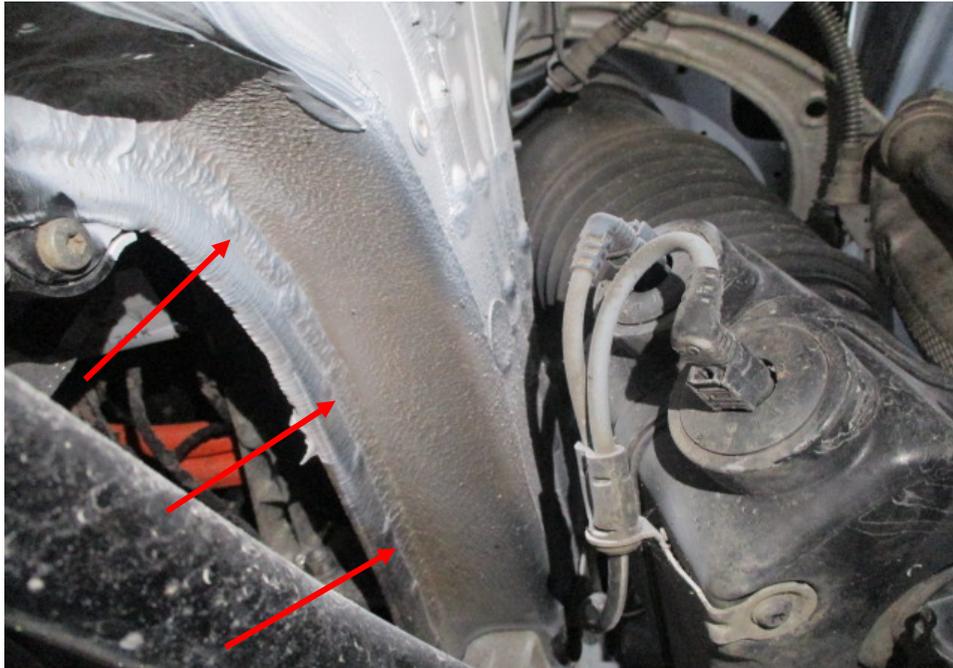
**Photo 30** shows the chassis/structural body at the underside front right of the Motor Car. The original factory sealant (arrowed) at the joints along the chassis/structural body was observed to be untouched. In general, I had found no work was carried out on the chassis/structural body of the Motor Car. The chassis/structural body of the Motor Car was originally fitted.
