Your Ref: TP/IP/28682/2022
Our Ref : CI/TPD22013007/P

18th January 2023

MECHANICAL INSPECTION REPORT OF MOTOR CAR SME 1055E

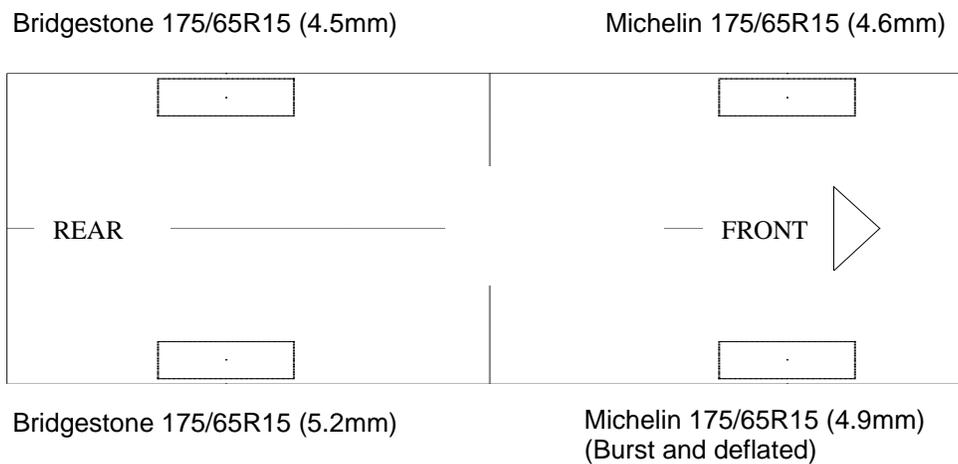
6. The front right tyre and wheel rim was damaged with a burst mark on the outer side wall of the tyre and a dent on the wheel rim due to the impact sustain as a result of the accident. However, during our inspection the front right tyre was replace with a serviceable tyre by the workshop to facilitate towing and vehicle testing. The condition of the other Motor Car's front left, both rear left and right tyres was observed to be in serviceable condition. I did not find any tear, cut or burst mark(s) on the outer and the inner sidewalls as well as across the tread of the Motor Car's front left, both rear left and right tyres. The Motor Car's front left, both rear left and right tyres were also observed to be sufficiently inflated for vehicular operation. The tyre brand, tyre size and remaining tread depth of the 4 tyres were recorded as follows:-

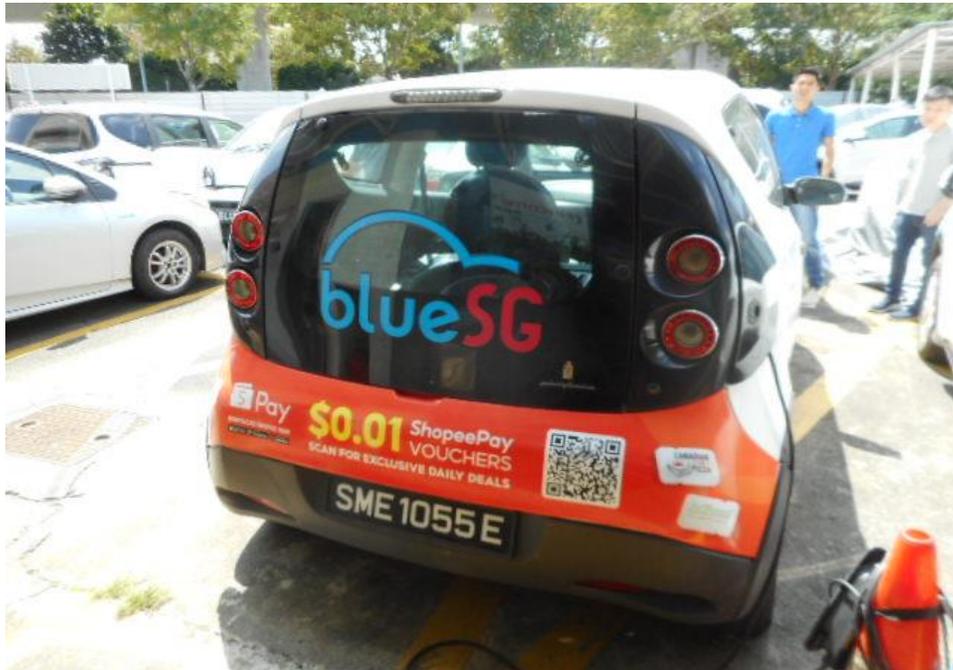
Photo 1 shows the general view of the Motor Car's rear body at the time of my inspection. The Motor Car rear was observed to be unaffected by the accident.

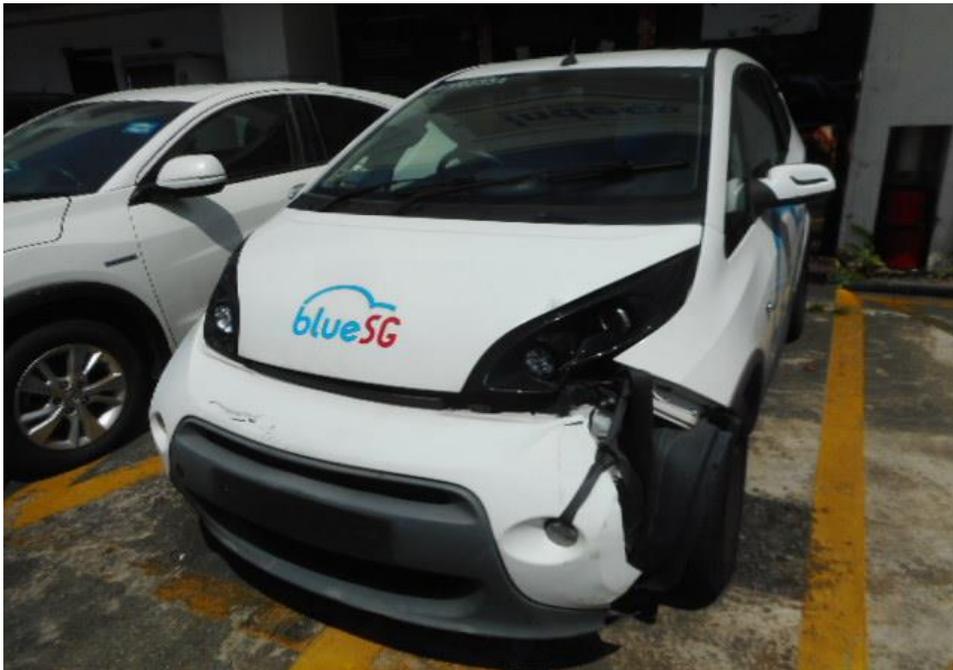
Photo 2 shows a general view of the Motor Car's front body at the time of my inspection. The Motor Car was observed to have sustained damage at its front portion. Its front bonnet, front left headlamp and front bumper were amongst the body parts were damaged as a result of the accident.

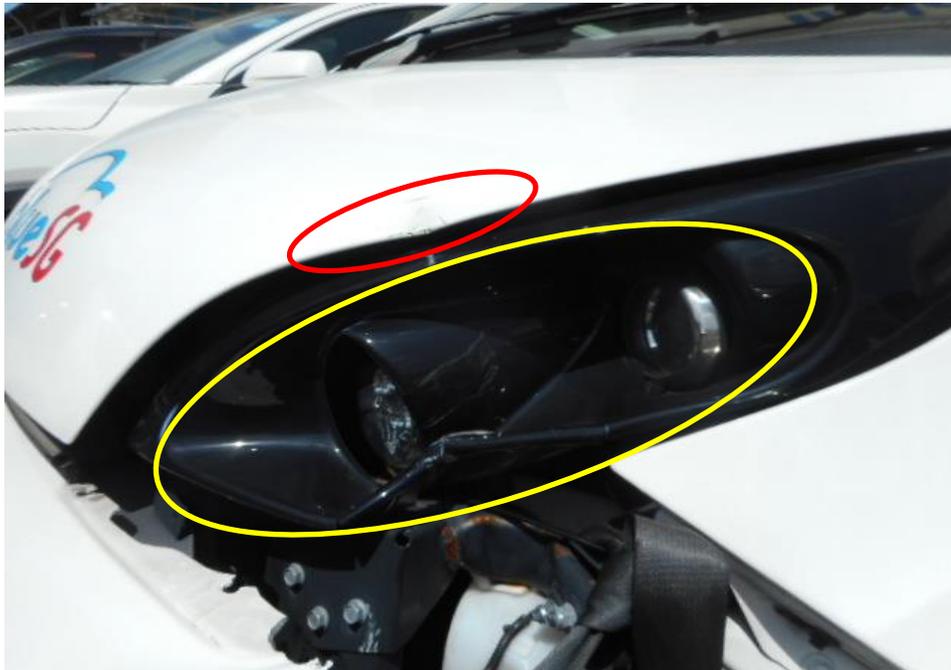
Photo 3 shows the close up view of the Motor Car's front body at the time of my inspection. The Motor Car was observed to have sustained damage at its front portion. Its front bonnet (red circle) and front left headlamp (yellow circle) were amongst the body parts that were damaged as a result of the accident.

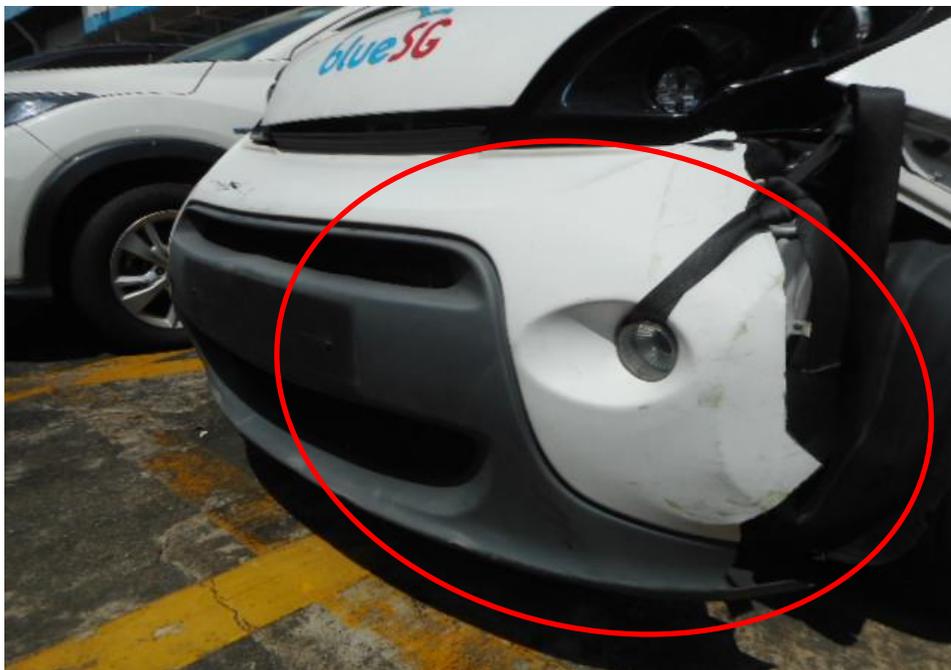
Photo 4 shows the close up view of the Motor Car's front body at the time of my inspection. The Motor Car was observed to have sustained damage at its front portion. Its front bumper (circled) were amongst the body parts that were damaged as a result of the accident.

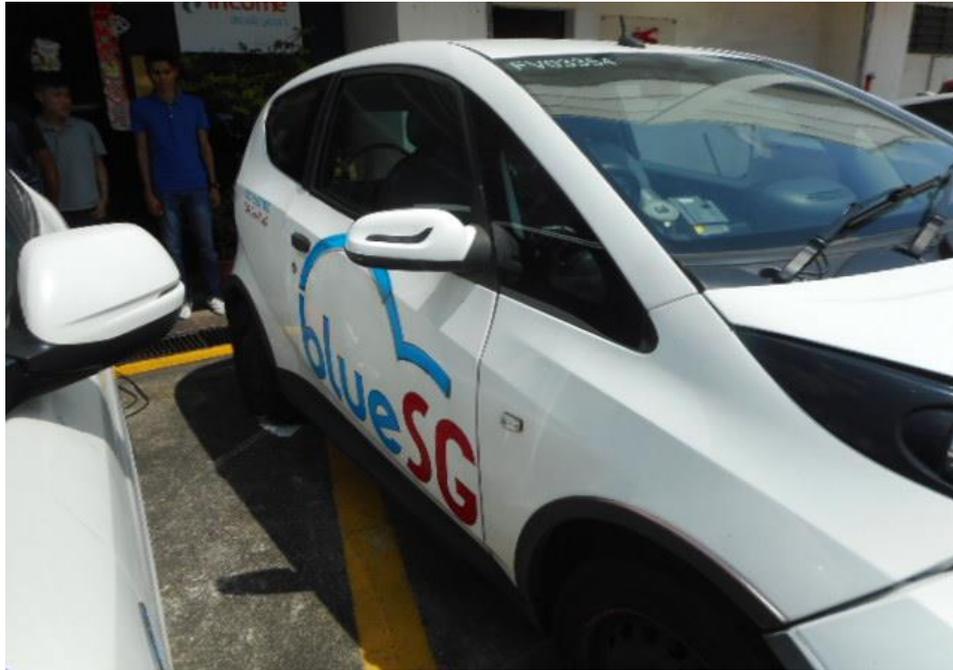
Photo 5 shows a general view of the Motor Car's right body at the time of my inspection. The Motor Car left was observed to be unaffected by the accident.

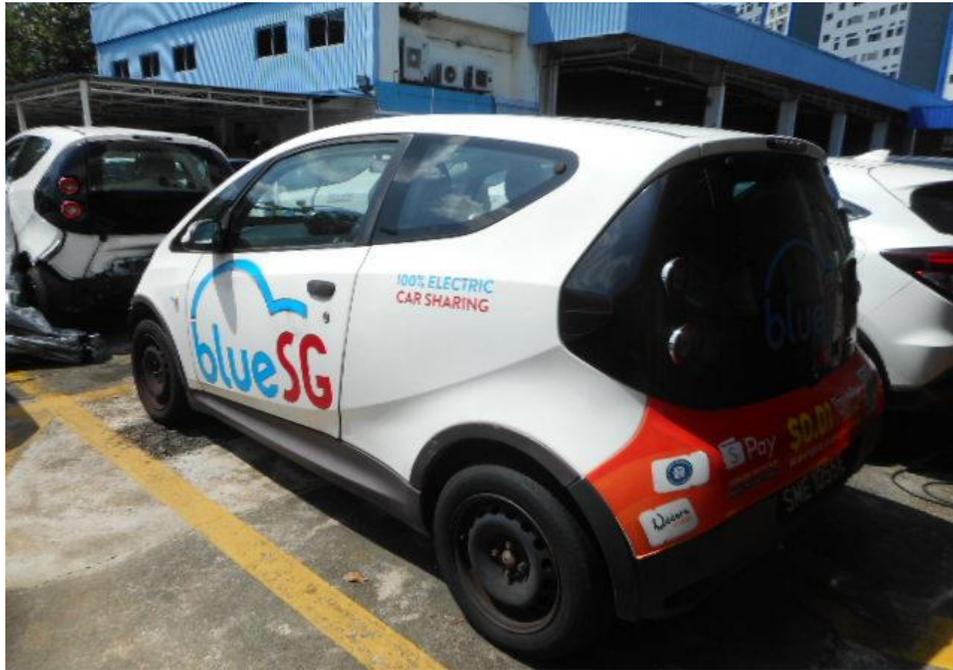
Photo 6 shows a general view of the Motor Car's left body at the time of my inspection. The Motor Car left was observed to be unaffected by the accident.

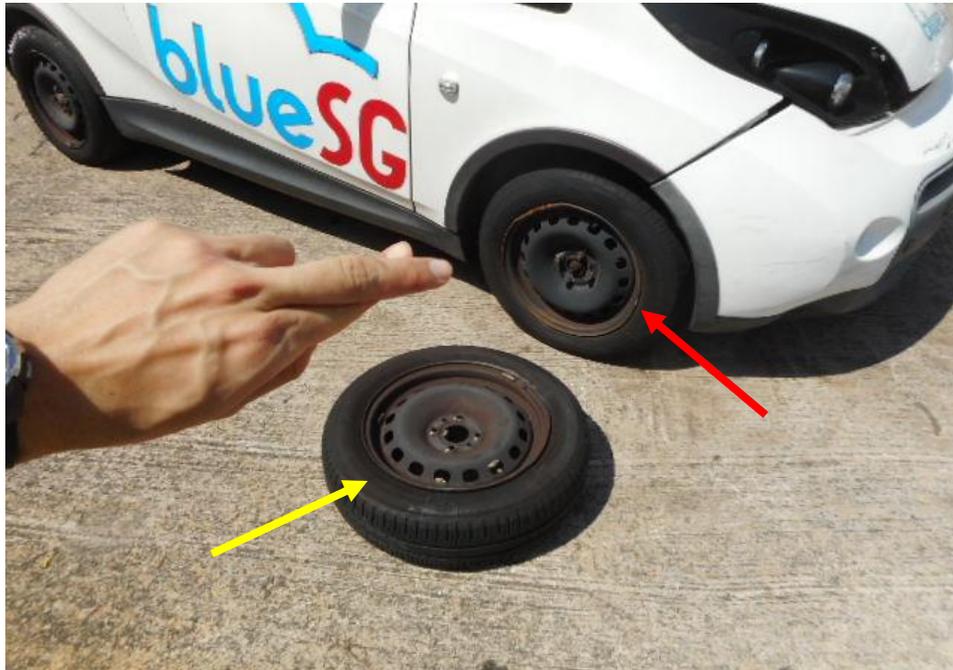
Photo 7 shows the damaged front right tyre and wheel rim (red arrow) and the replaced serviceable front right tyre and wheel rim (yellow arrow) of the Motor Car.

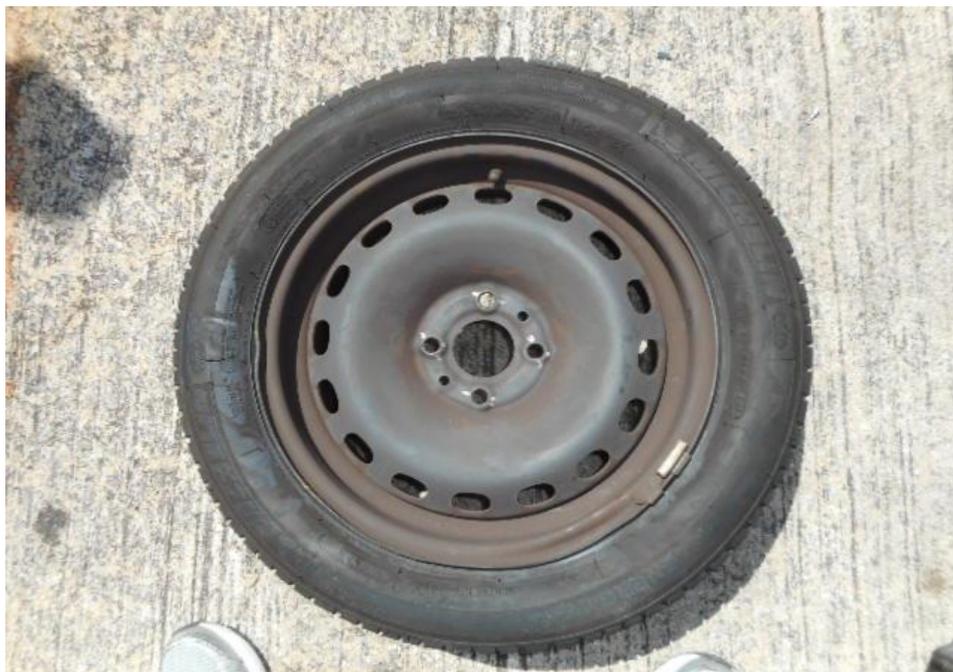
Photo 8 shows the general view of the front right tyre and wheel rim which was damaged with a burst mark on the outer side wall of the tyre and a dent on the wheel rim due to the impact sustain as a result of the accident. Its remaining tread depth was of approximately 4.9mm.

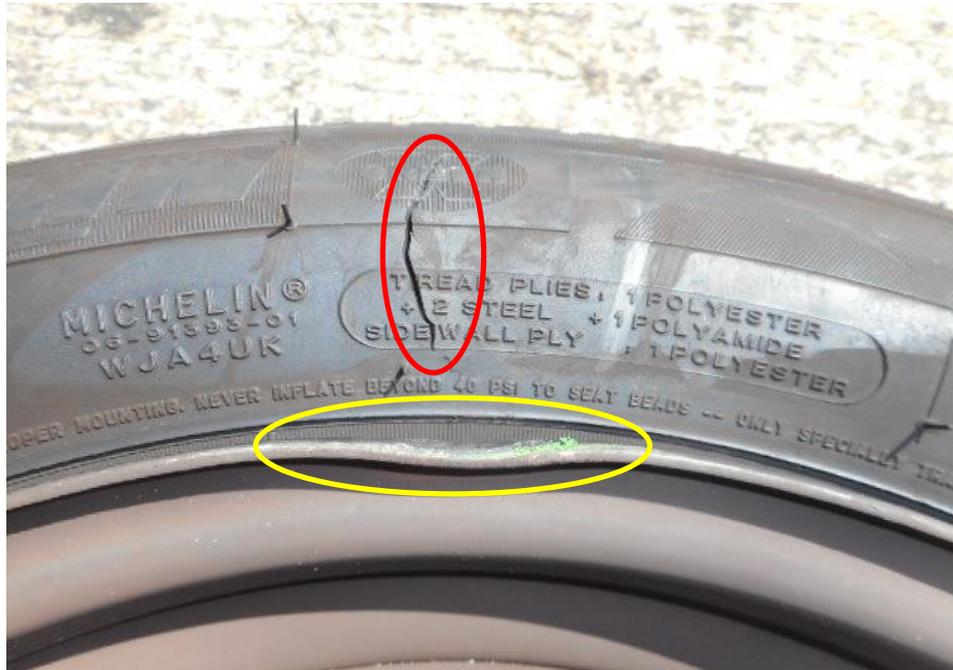
Photo 9 shows the close up view of the front right tyre and wheel rim which was damaged with a burst mark (red circle) on the outer side wall of the tyre and a dent (yellow circle) on the wheel rim due to the impact sustain as a result of the accident. Its remaining tread depth was of approximately 4.9mm.

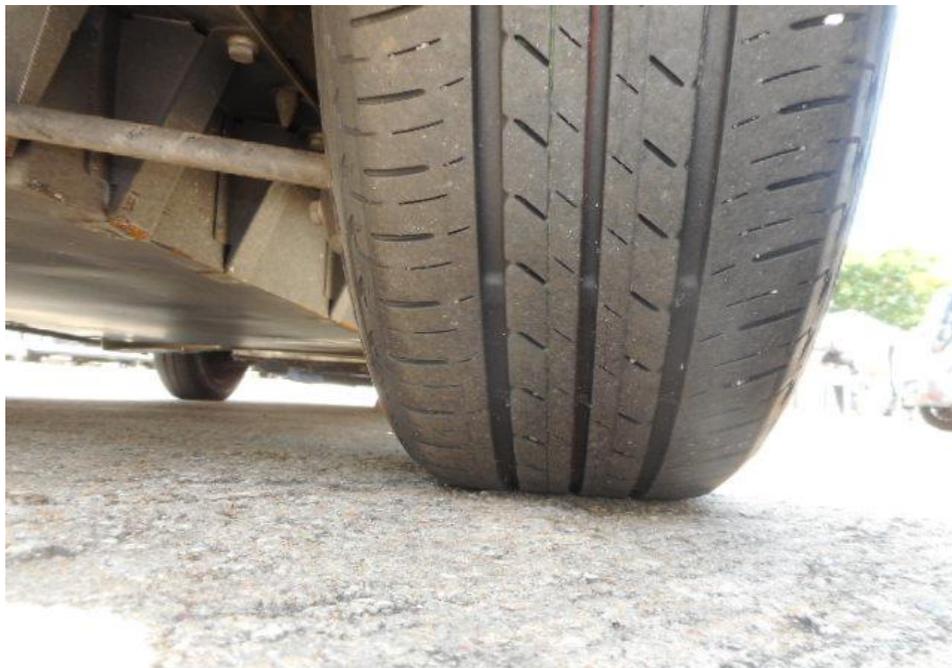
Photo 10 shows the condition of the rear right tyre of the Motor Car, which was observed to be in serviceable condition with remaining tread depth of approximately 5.2mm. The tyre, which was wrapped around standard steel wheel rim, was also observed to be sufficiently inflated for vehicular operation.

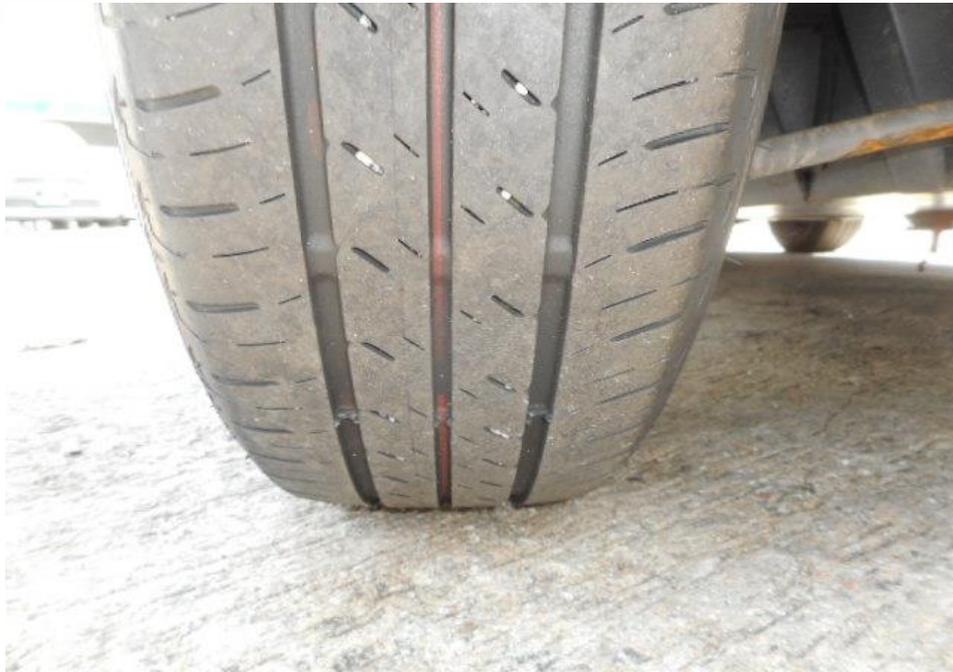
Photo 11 shows the condition of the rear left tyre of the Motor Car, which was observed to be in serviceable condition with remaining tread depth of approximately 4.5mm. The tyre, which was wrapped around standard steel wheel rim, was also observed to be sufficiently inflated for vehicular operation.

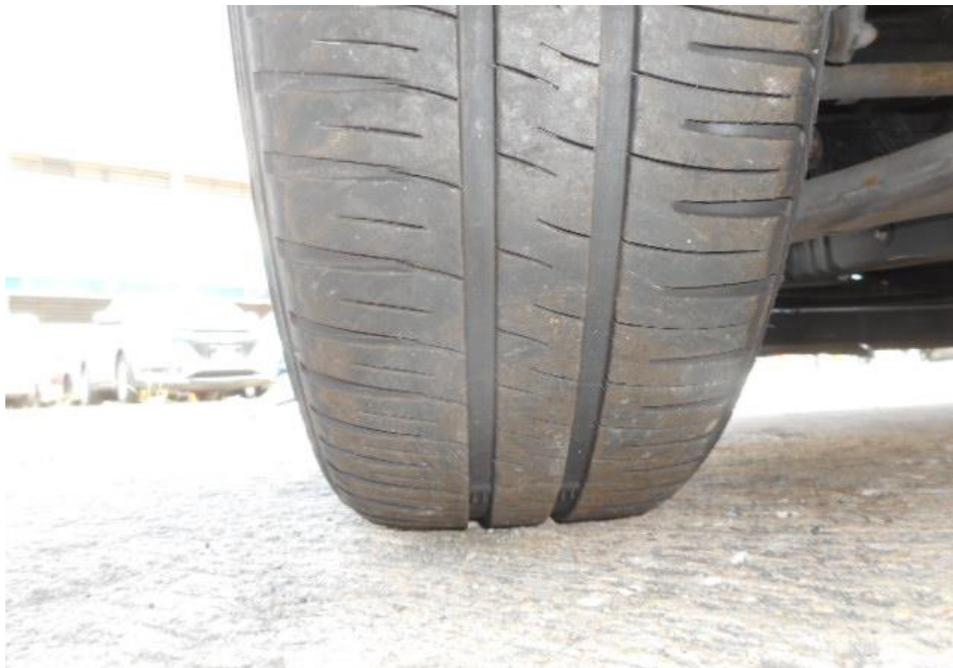
Photo 12 shows the condition of the front left tyre of the Motor Car, which was observed to be in serviceable condition with remaining tread depth of approximately 4.6mm. The tyre, which was wrapped around standard steel wheel rim, was also observed to be sufficiently inflated for vehicular operation.

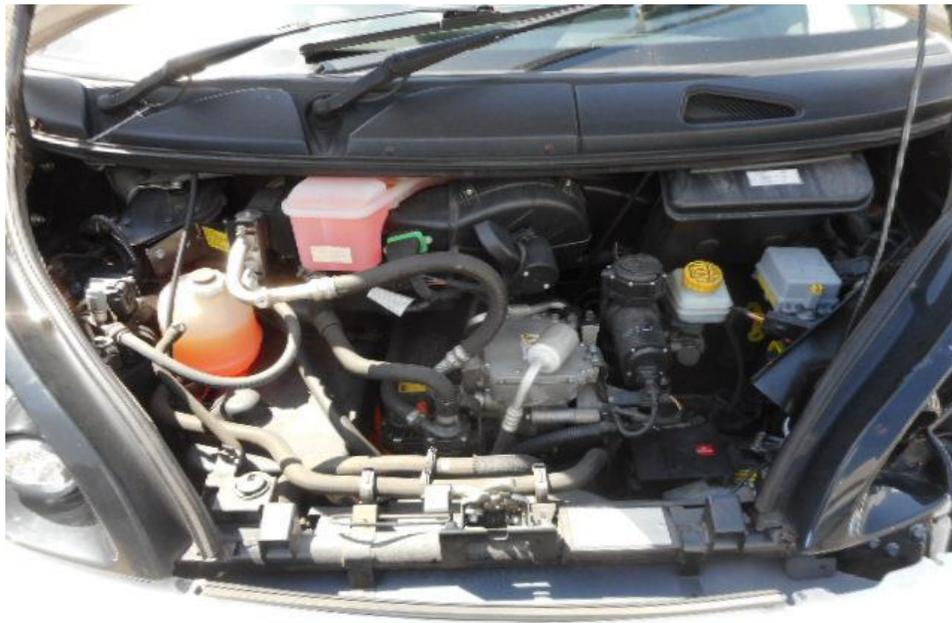
Photo 13 shows a general view of the Motor Car's electric motor compartment, which was accessed by lifting the front bonnet of the Motor Car. The various parts and components inside the electric motor compartment were unaffected by the accident. There was also no sign(s) or indication(s) of fresh fluid leakage and/or fluid stain within the electric motor compartment

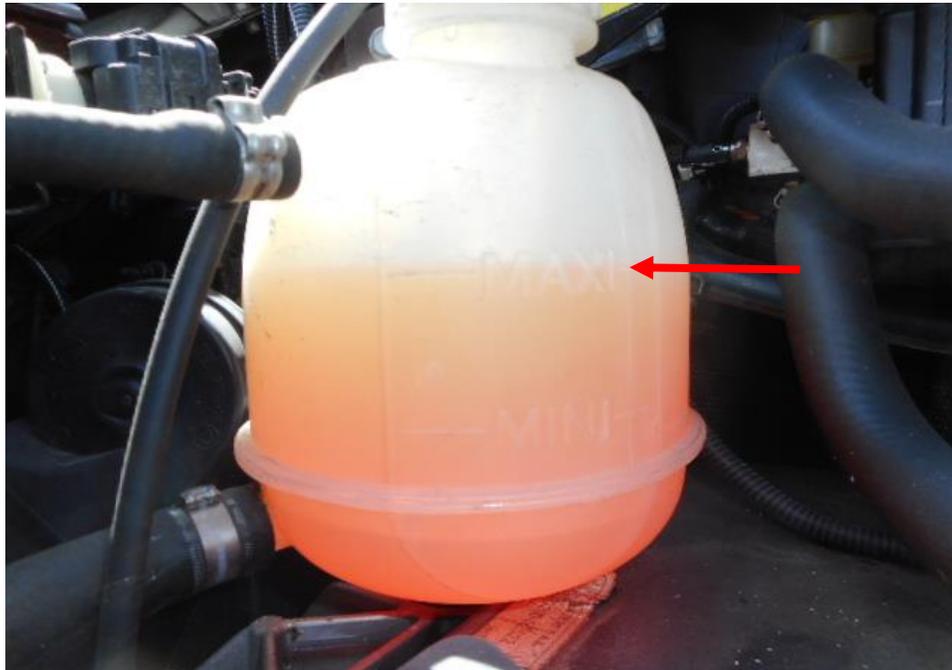
Photo 14 shows the electric motor coolant reservoir of the Motor Car at the time of my inspection. The electric motor coolant was observed to be of sufficient level (arrowed) and without any visible contamination.

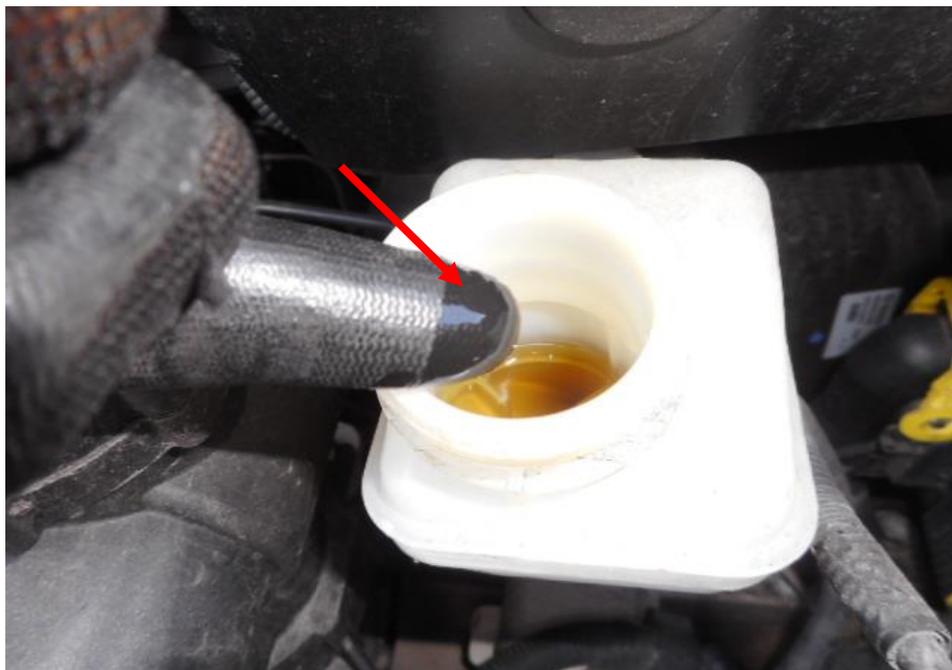
Photo 15 shows the brake fluid reservoir of the Motor Car at the time of my inspection. The brake fluid was observed to be of sufficient level (arrowed) and without any visible contamination.

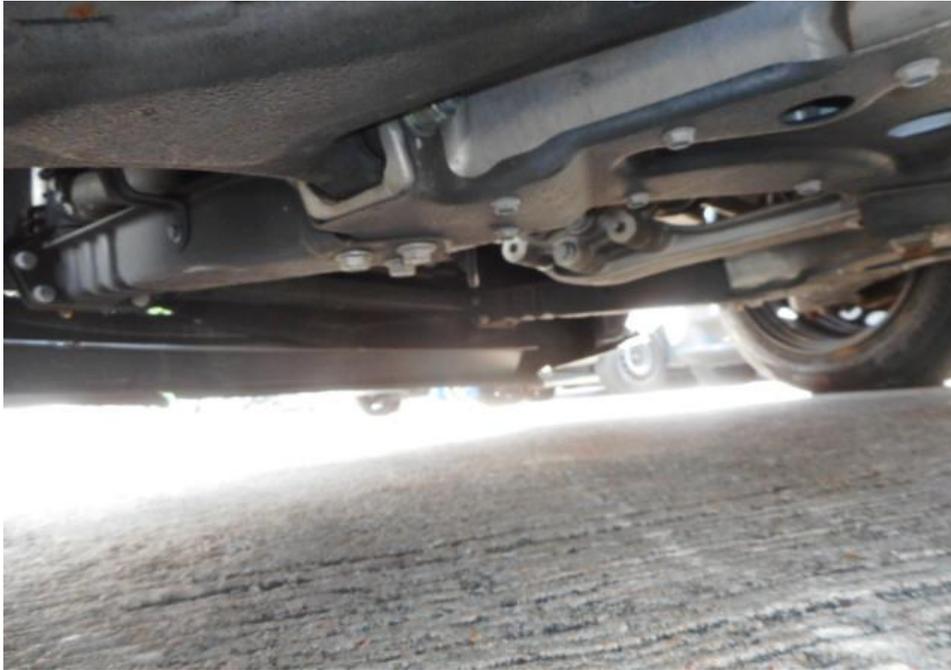
Photo 16 shows the undercarriage of the Motor Car, at the area where the electric motor housing and transmission housing are located. I did not find any sign(s) or indication(s) of fluid leak and/or fluid stain(s) on the underside of the Motor Car.

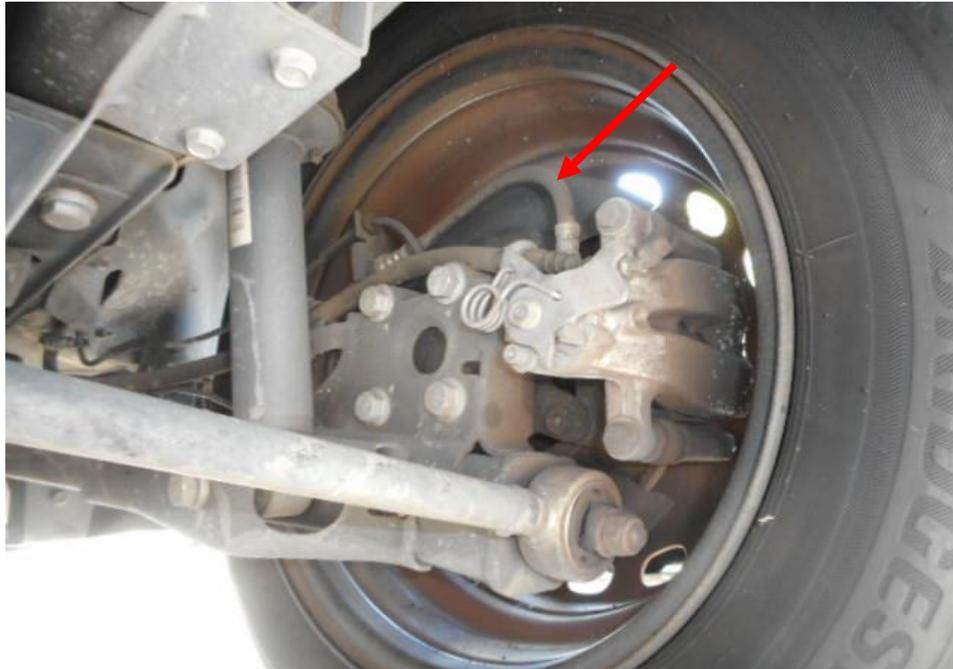
Photo 17 shows the brake hose/pipe (arrowed) at the rear right wheel of the Motor Car. No leakage of brake fluid was observed. Visual examination of the various components of the braking system like the drum brake, brake booster, brake pedal etc. had revealed all to be intact and without visible damage.

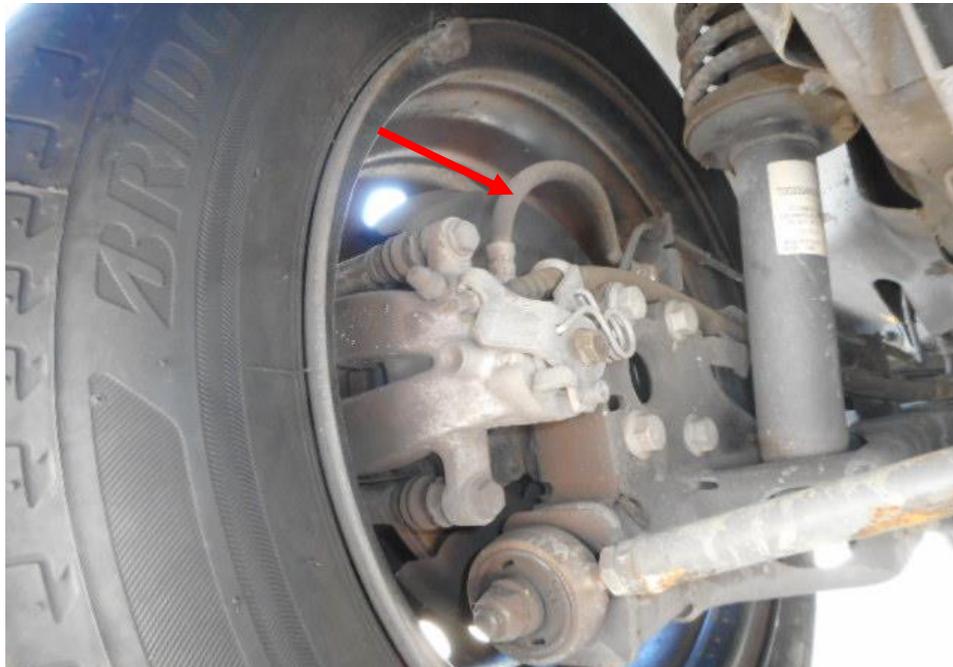
Photo 18 shows the brake hose/pipe (arrowed) at the rear left wheel of the Motor Car. I did not observe any leakage of brake fluid at the time of my inspection of the Motor Car. The undercarriage components of the Motor Car were also all found to be intact and without any visible damage.

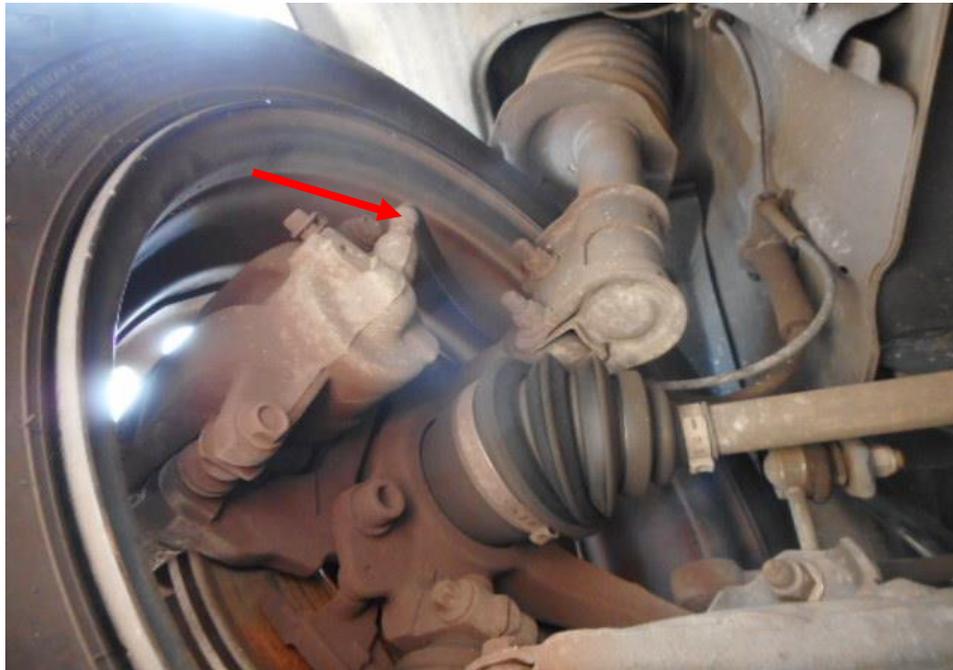
Photo 19 shows the brake hose/pipe (arrowed) at the front right wheel of the Motor Car. I did not observe any leakage of brake fluid at the time of my inspection of the Motor Car. The undercarriage components of the Motor Car were also all found to be intact and without any visible damage.

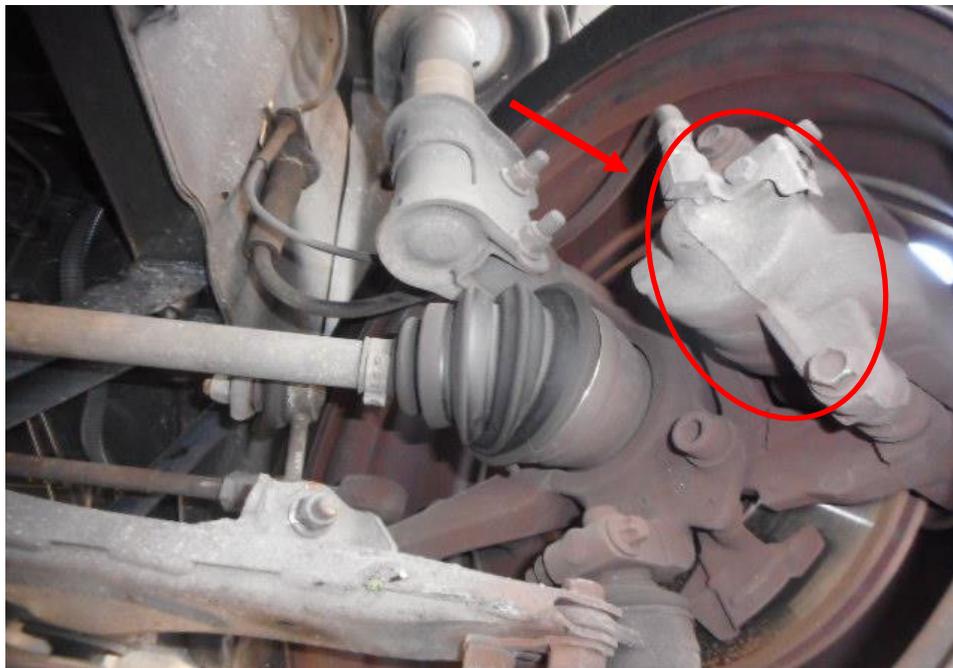
Photo 20 shows the brake hose/pipe (arrowed) at the front left wheel of the Motor Car. No leakage of brake fluid was observed. Visual examination of the various components of the braking system like the brake caliper (circled), brake booster, brake pedal etc had revealed all to be intact and without visible damage.

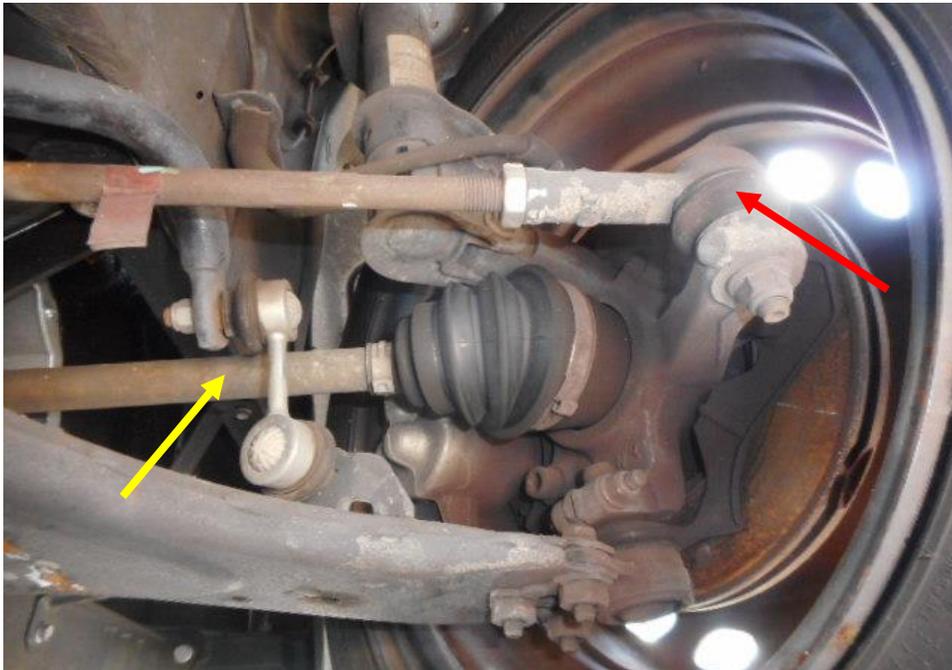
Photo 21 shows the various undercarriage components at the front right wheel of the Motor Car, in particular the steering tie rod (red arrow) and its driveshaft (yellow arrow). The various steering components were all found to be intact. There was also no sign of fluid stain observed on the various undercarriage components at the front right wheel of the Motor Car.

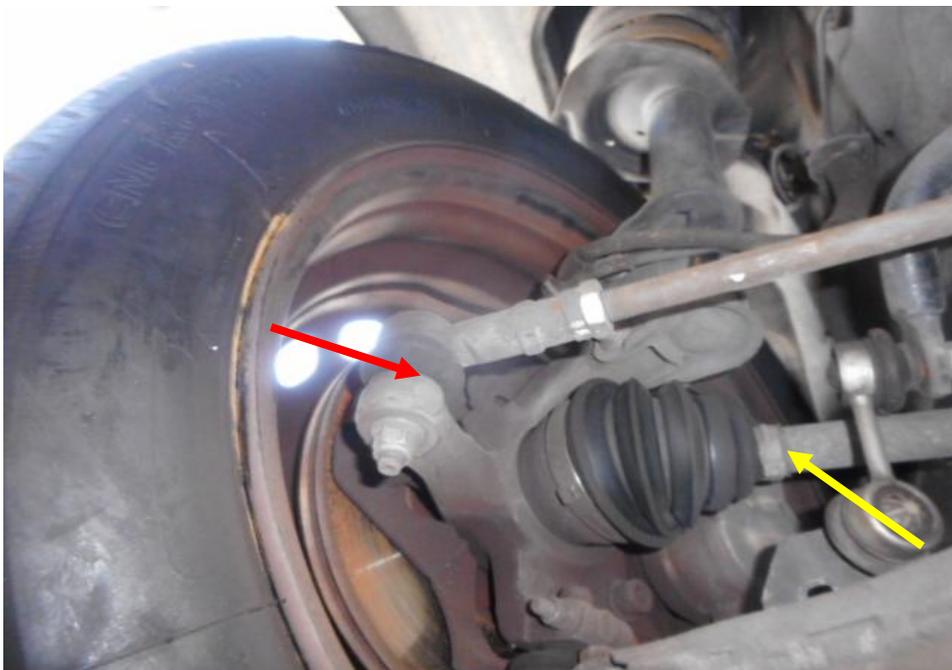
Photo 22 shows the various undercarriage components at the front right wheel of the Motor Car, in particular the steering tie rod (red arrow) and its driveshaft (yellow arrow). The various steering components were all found to be intact. There was also no sign of fluid stain observed on the various undercarriage components at the front right wheel of the Motor Car.

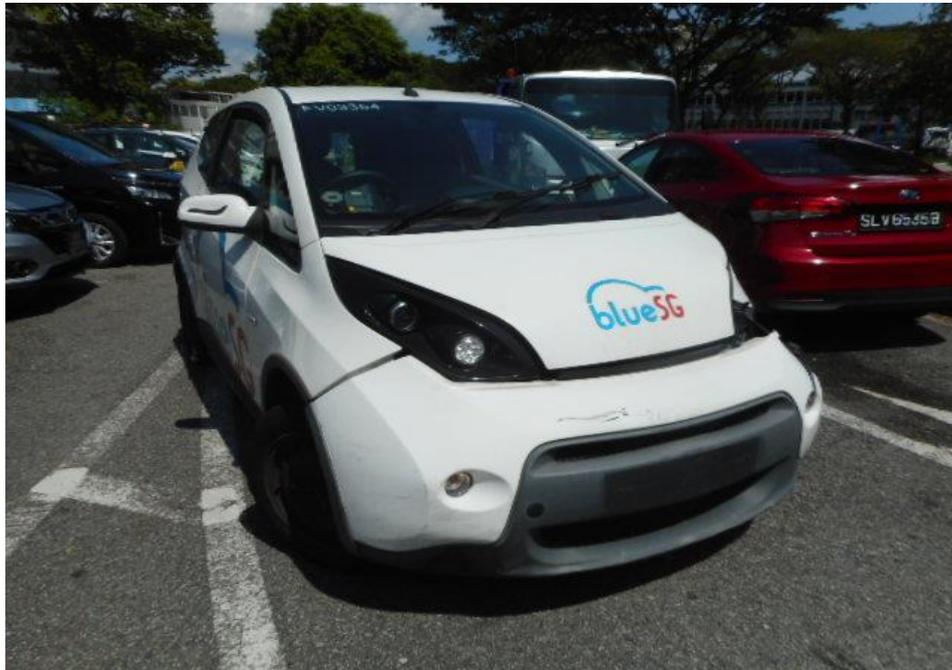
Photo 23 shows the front right wheel of the Motor Car turned to its full left. During my steering system test, I did not experience any abnormal free play and/or resistance when I had turned the steering wheel towards full left and full right. This would suggest that the steering system of the Motor Car was likely to be in serviceable condition at the material time of accident.

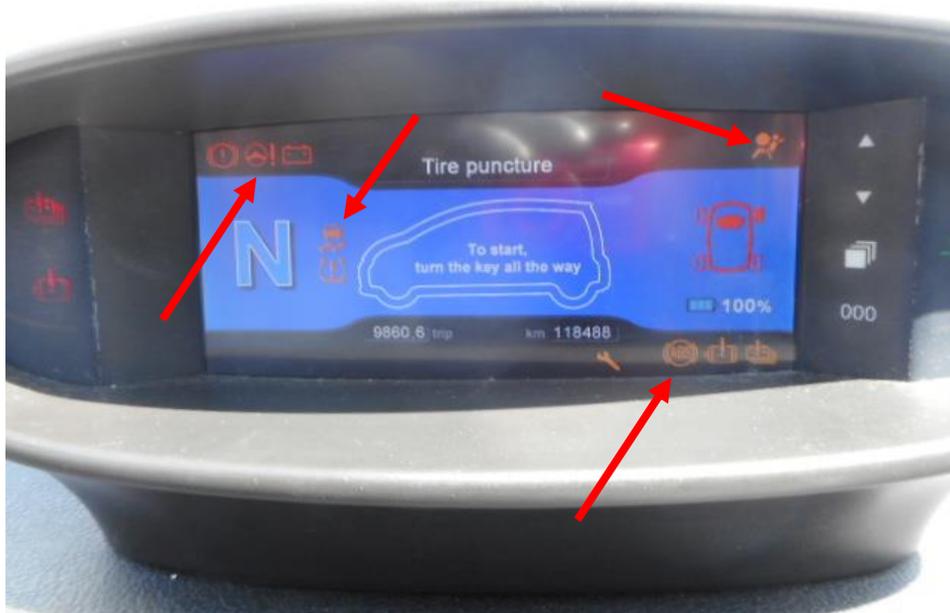
Photo 24 shows the warning light for Anti-Lock Brake System (ABS), Electronic Power Steering System (EPS), Traction Control System (TCS) and Supplemental Restraint System (SRS) (arrowed) appearing on the instrument panel of the Motor Car during the self-test of its various electronic operating systems when its electric motor was cranked.

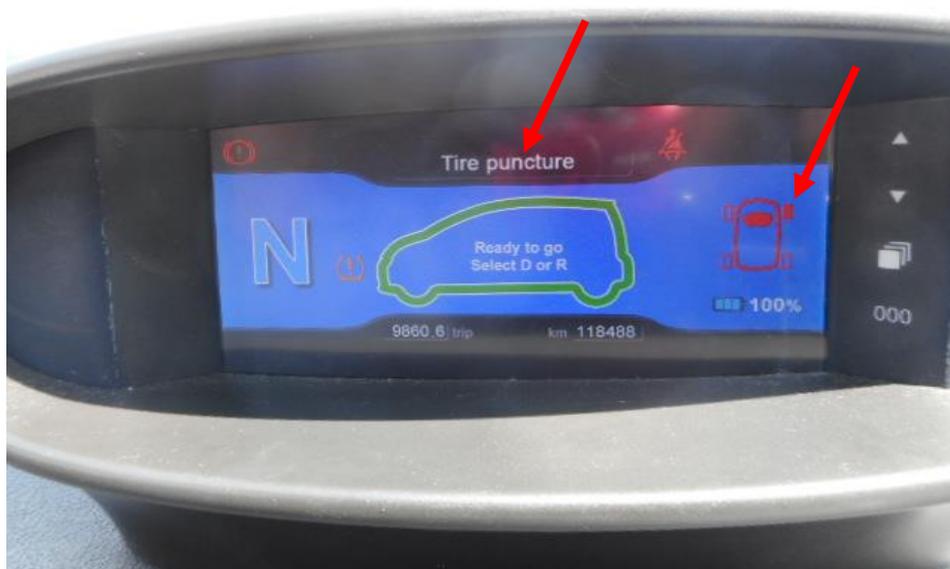
Photo 25 shows no warning lights illuminated on the instrument panel of the Motor Car after the electric motor was cranked. This would suggest that there was no abnormality to the electronic operating system of the Motor Car, like the ABS, EPS, TCS, SRS and etc.

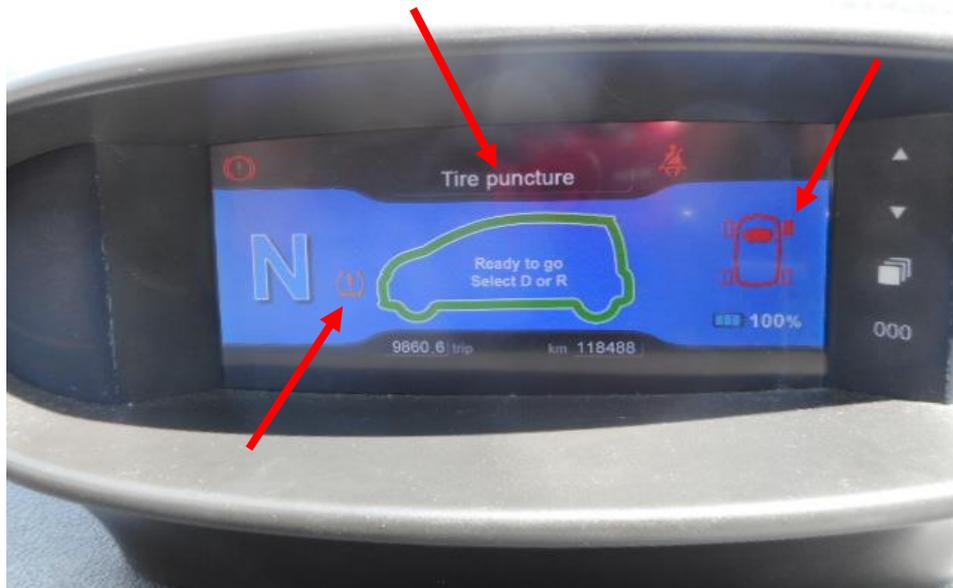
Photo 26 shows tyre puncture warning light (arrowed) remained illuminated on the instrument panel of the Motor Car after the electric motor was cranked. This was due to the saved data log of the deflated tyre as a result of the accident front right tyre.
