Your Ref: TP/IP/24186/2022
Our Ref : CI/TPD22013009/P

10th February 2023

MECHANICAL INSPECTION REPORT OF MOTOR LORRY YN 1461B

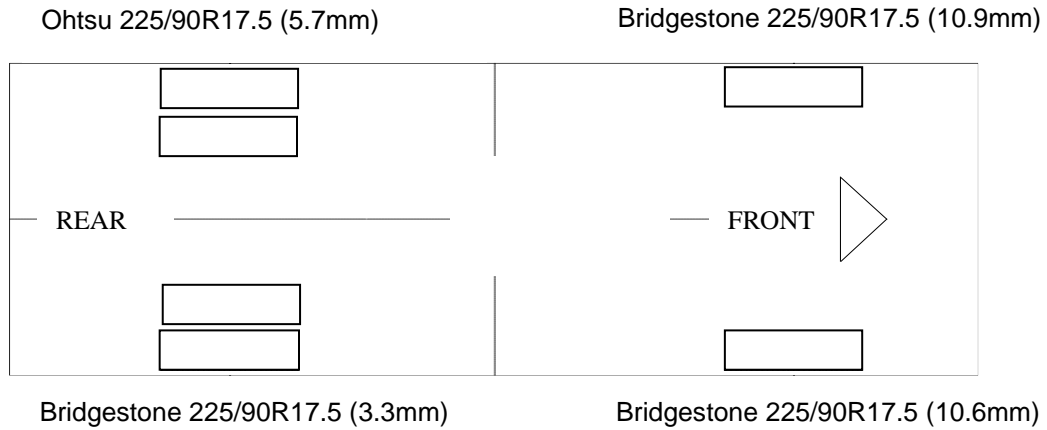
6. The 6 tyres of the Motor Lorry were observed to be in serviceable condition and sufficiently inflated for vehicular operation. I did not find any tear, cut or burst mark(s) on the outer and the inner sidewalls as well as across the tread of the 6 tyres. The tyre brand, tyre size and remaining tread depth of the 6 tyres of the Motor Lorry were recorded as follows:-

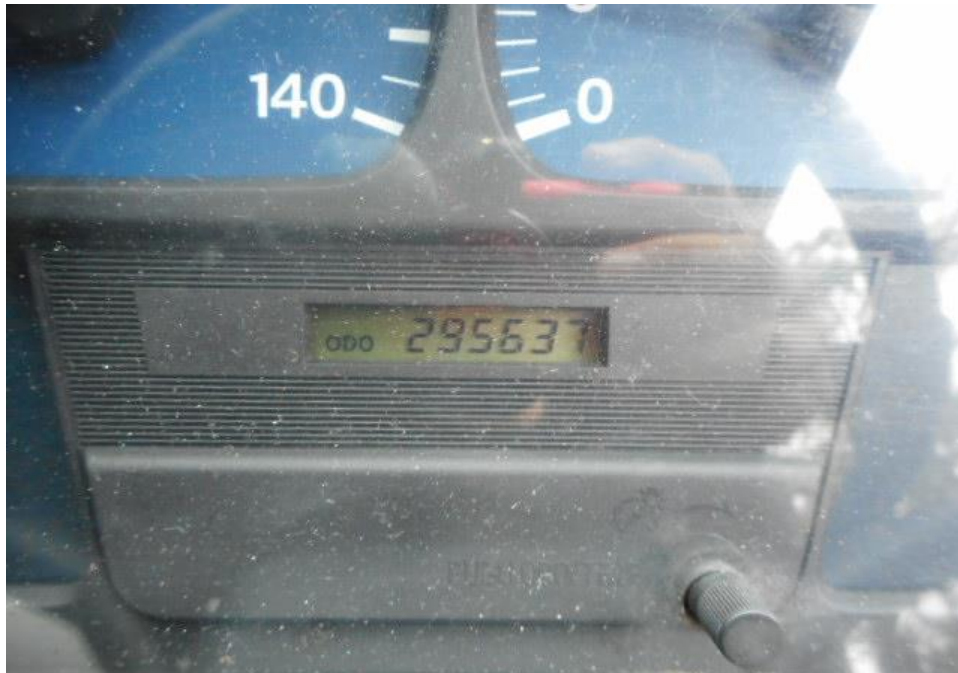
Photo 1 shows a general view of the instrument cluster of the Motor Lorry at the time of my inspection. The mileage of the Motor Lorry was 295,637km.

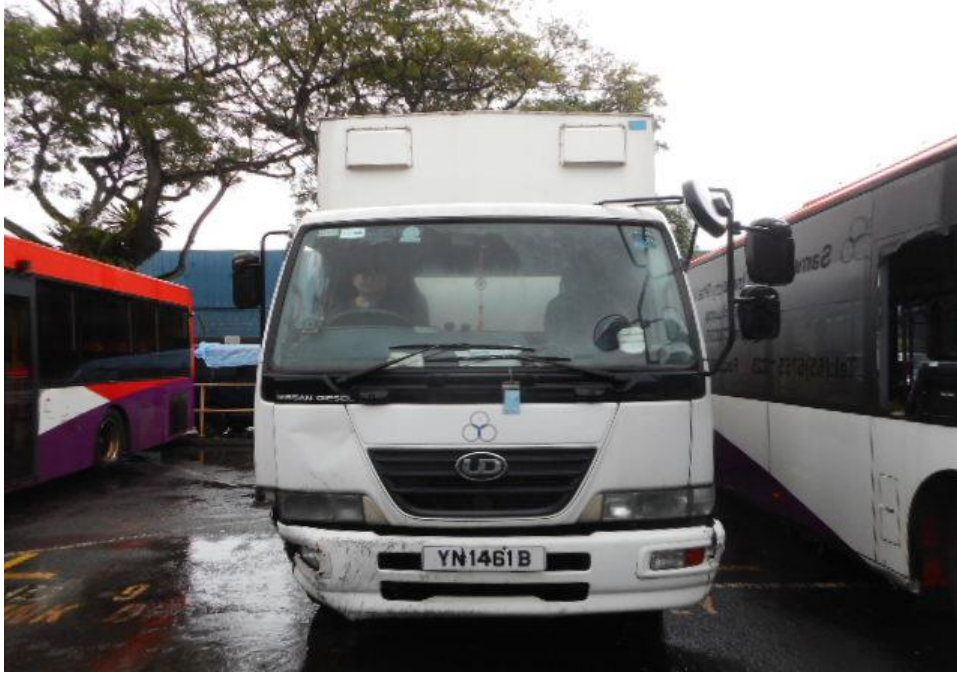
Photo 2 shows a general view of the front body of the Motor Lorry at the time of my inspection. It appeared to have sustained damage at its front portion. Its front bumper was damage at the time of my inspection as a result of the accident.

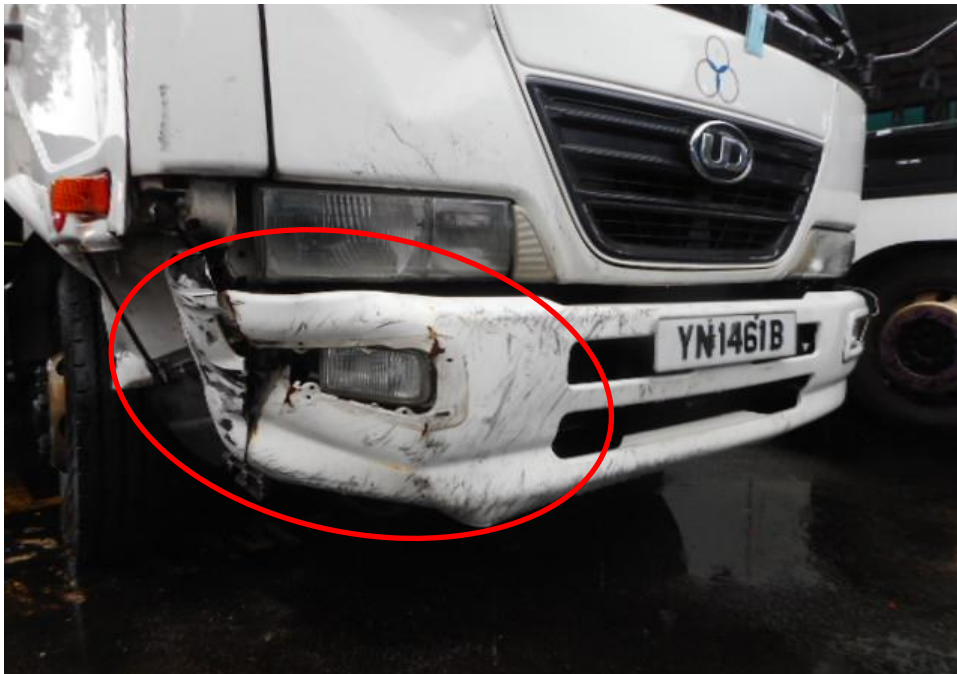
Photo 3 shows a close up view of the Motor Lorry's front portion at the time of my inspection. Its front bumper (circled) was damage at the time of my inspection as a result of the accident.

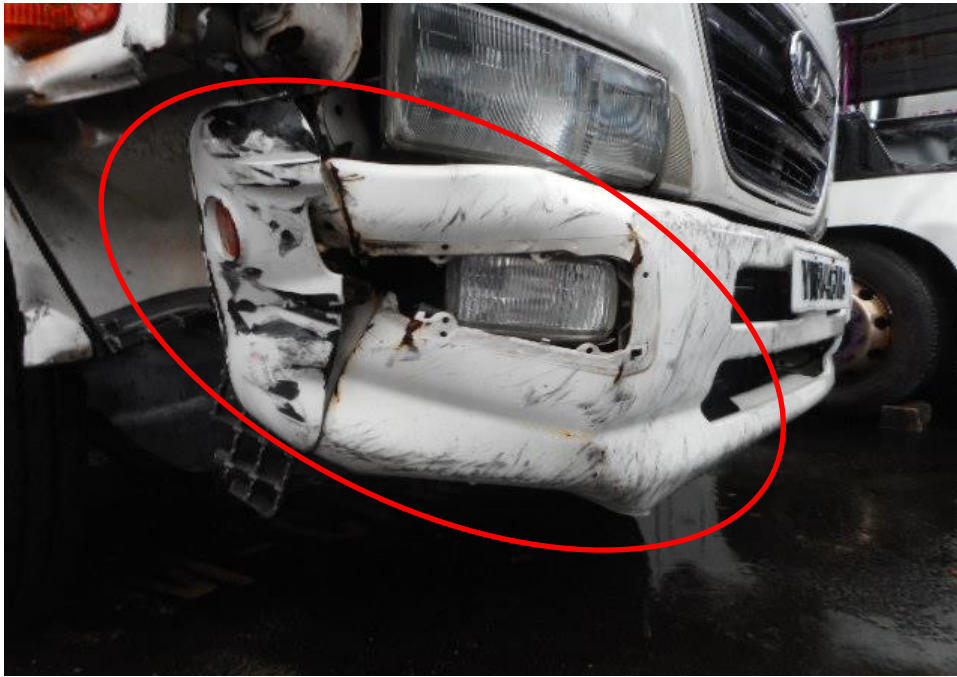
Photo 4 shows a close up view of the Motor Lorry's front portion at the time of my inspection. Its front bumper (circled) was damage at the time of my inspection as a result of the accident.

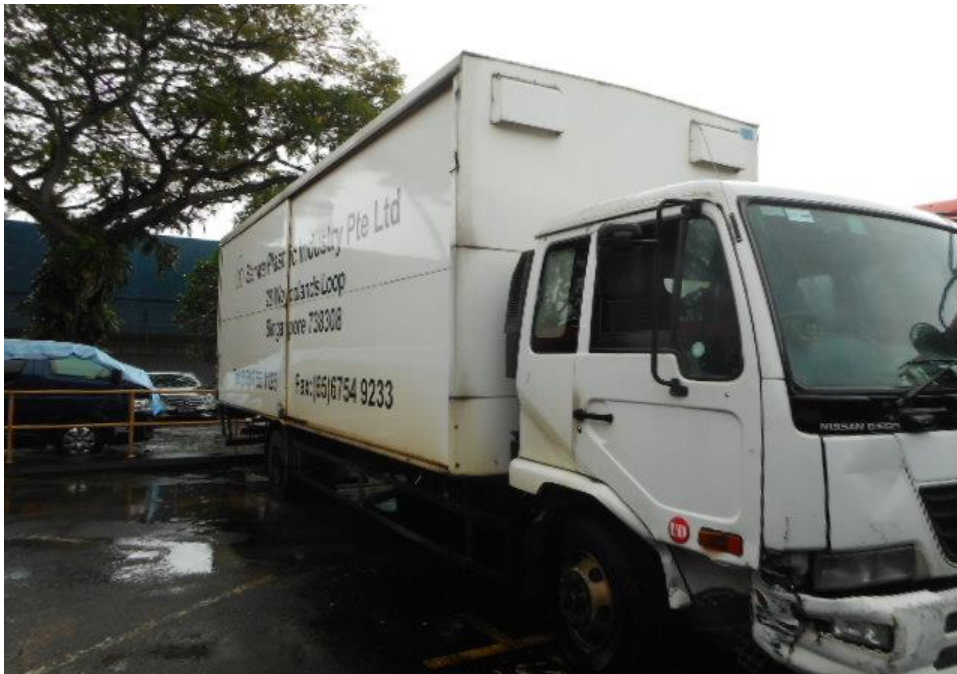
Photo 5 shows a general view of the Motor Lorry's right portion at the time of my inspection. The Motor Lorry was observed to be intact and unaffected by the accident.

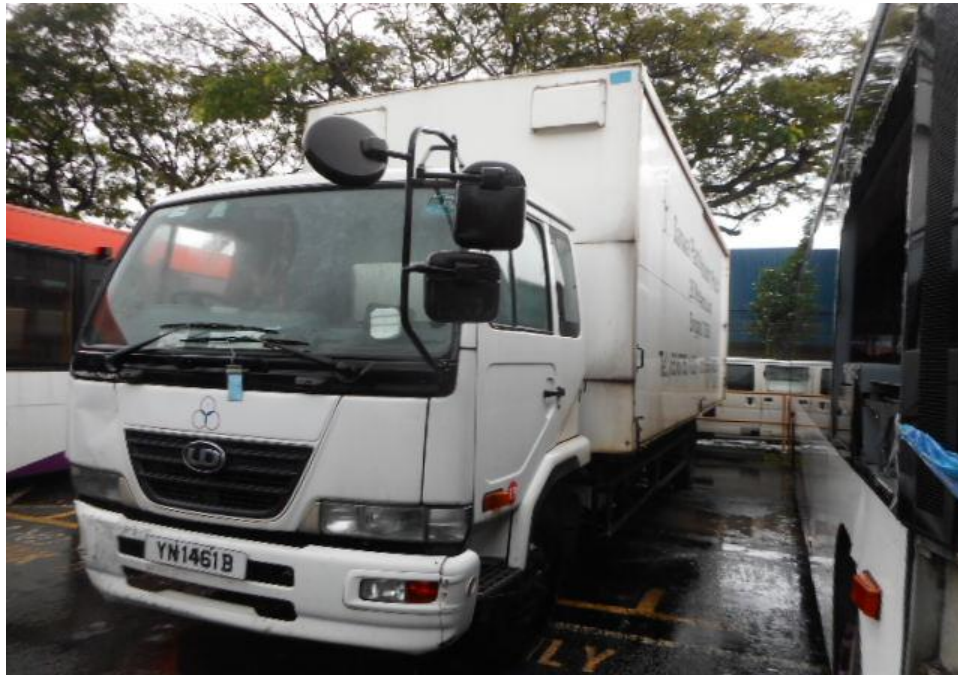
Photo 6 shows a general view of the right body of the Motor Lorry at the time of my inspection. The Motor Lorry was observed to be intact and unaffected by the accident.

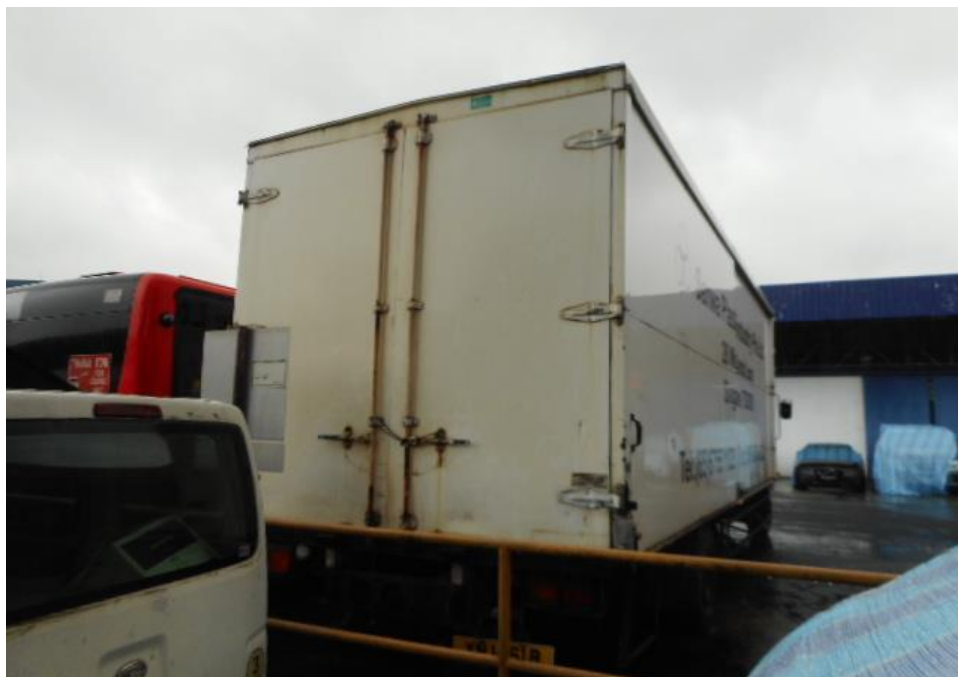
Photo 7 shows a general view of the left body of the Motor Lorry at the time of my inspection. The Motor Lorry was observed to be intact and unaffected by the accident.

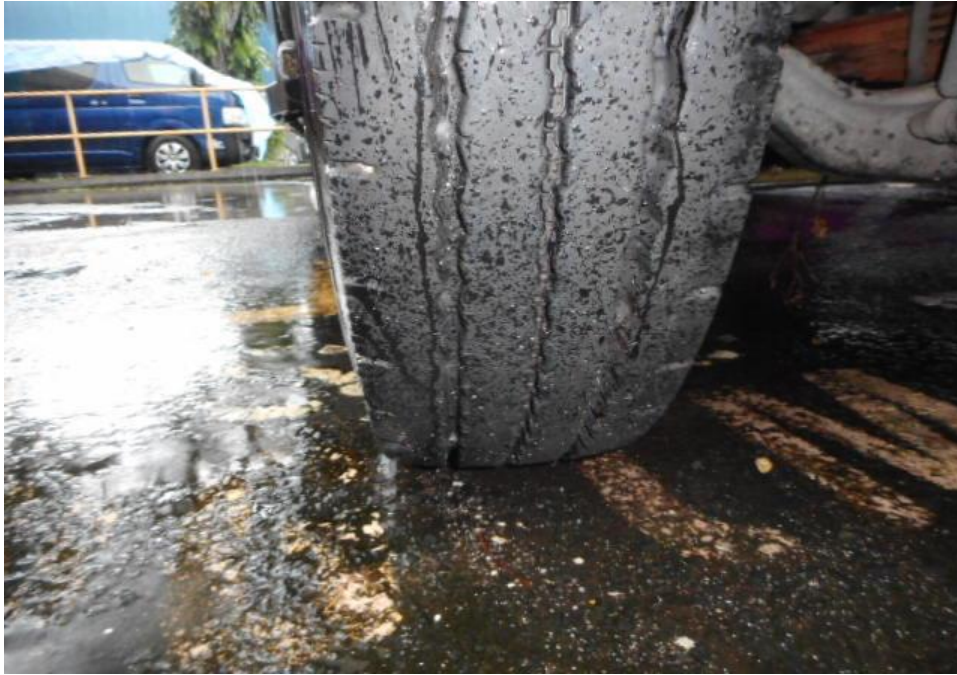
Photo 8 shows the condition of the front right tyre of the Motor Lorry, which was observed to be in serviceable condition with remaining tread depth of approximately 10.6mm. The tyre, which was wrapped around standard steel wheel rim, was also observed to be sufficiently inflated for vehicular operation. There was no tear, cut or burst mark(s) on the outer and the inner sidewalls as well as across the tread of the 6 tyres that were fitted on the Motor Lorry.

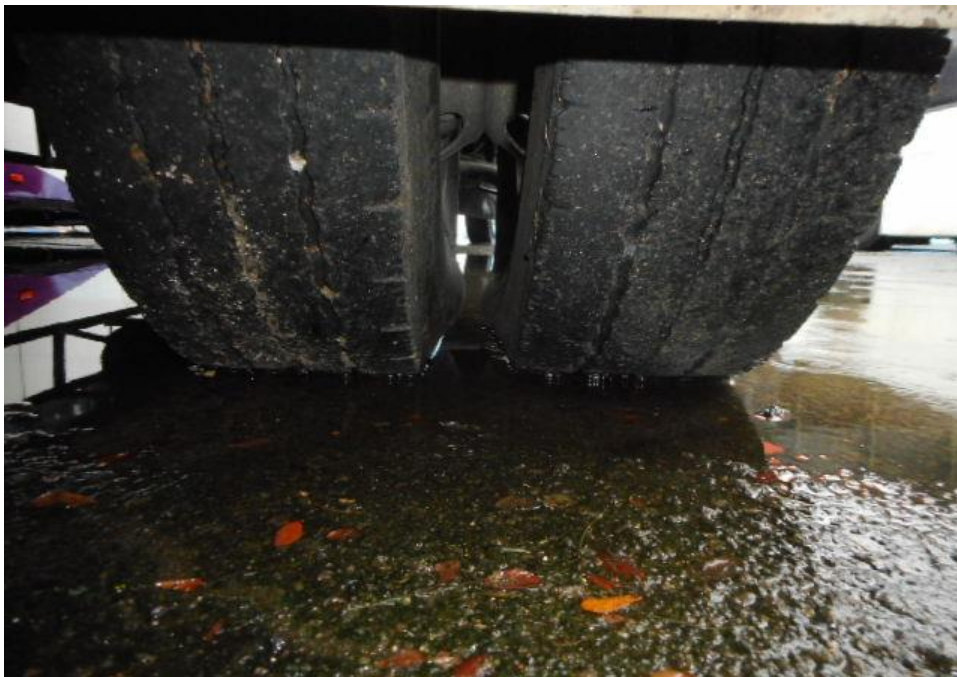
Photo 9 shows the condition of the rear right tyres of the Motor Lorry, which was observed to be in serviceable condition with remaining tread depth of approximately 3.3mm. The tyre, which was wrapped around standard steel wheel rim, it was observed to be sufficiently inflated for vehicular operation.

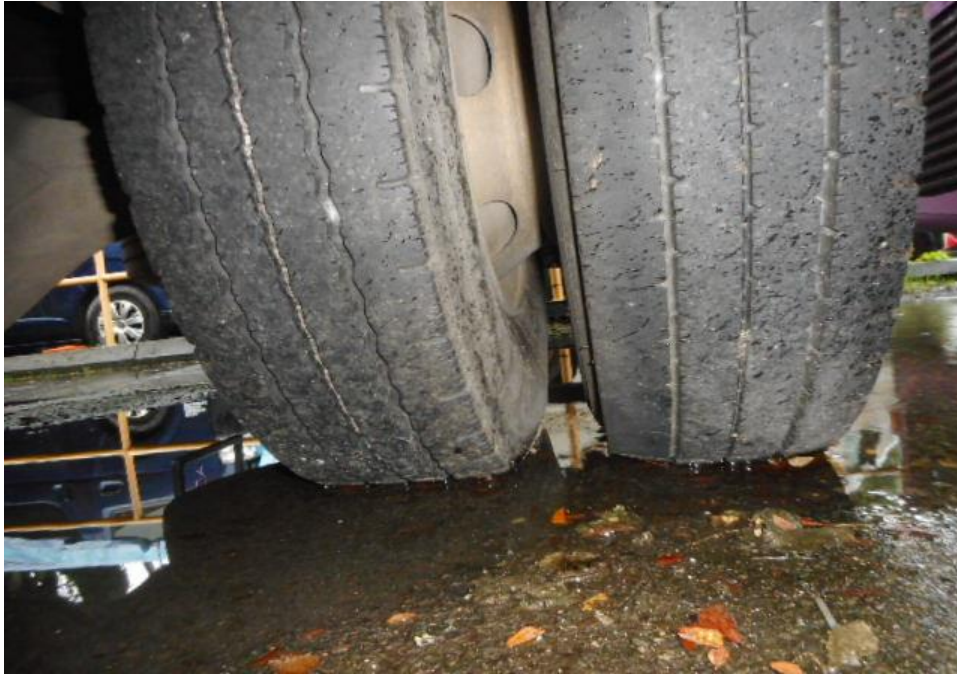
Photo 10 shows the condition of the rear left tyres of the Motor Lorry, which was observed to be in serviceable condition with remaining tread depth of approximately 5.7mm. The tyres, which were wrapped around standard steel wheel rim, were also observed to be sufficiently inflated for vehicular operation.

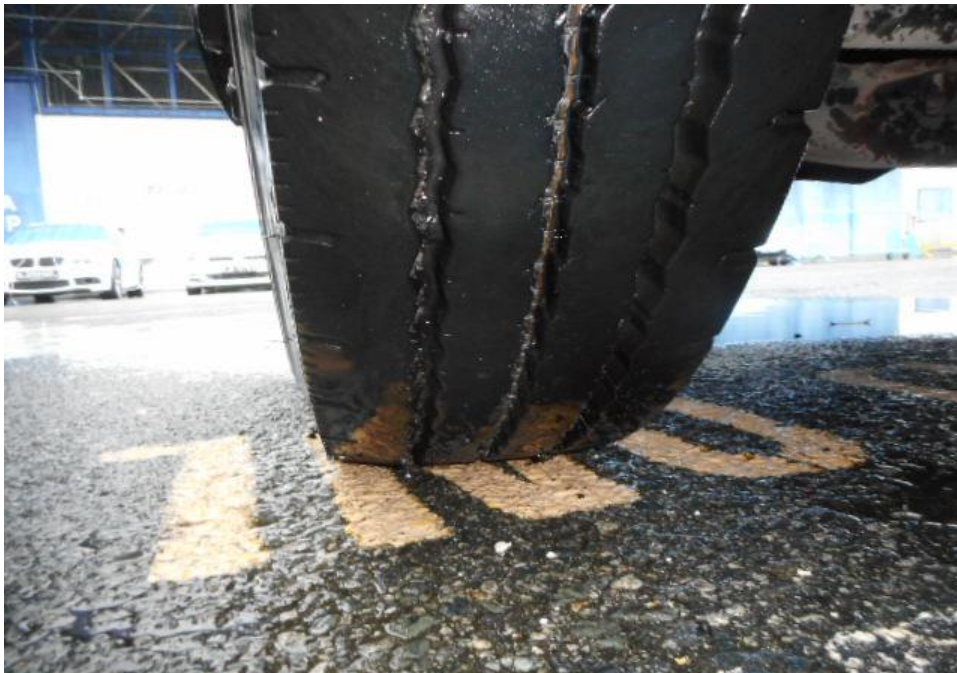
Photo 11 shows the condition of the front left tyre of the Motor Lorry, which were observed to be in serviceable condition with remaining, tread depth of approximately 10.9mm. There was also no tear, cut or burst mark(s) on the outer and the inner sidewalls as well as across the tread of the 6 tyres that were fitted on the Motor Lorry.

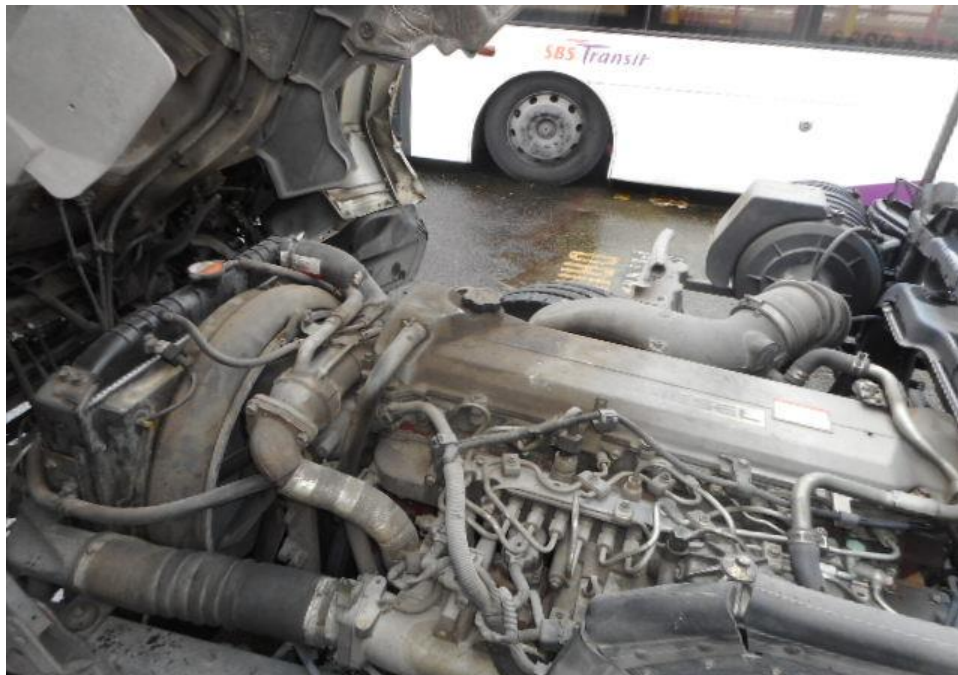
Photo 12 shows a general view of the Motor Lorry's engine compartment, which was accessed by lifting the front cabin of the Motor Lorry. The various parts and components inside the engine compartment were unaffected by the accident. There was also no sign(s) or indication(s) of fresh fluid leakage and/or fluid stain within the engine compartment.

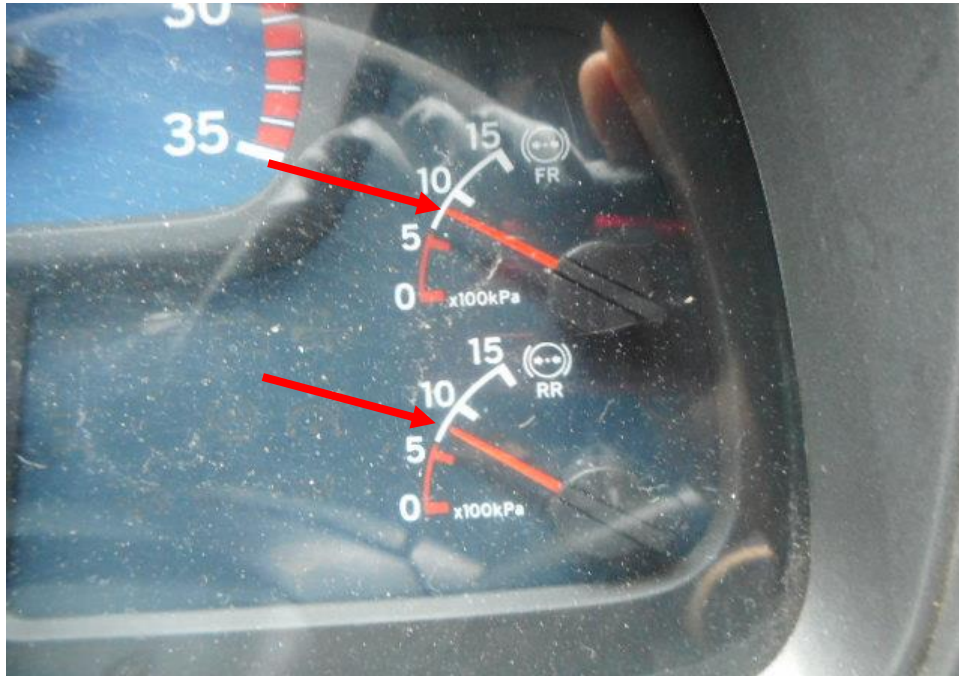
Photo 13 shows the air in the air brake cylinders of the Motor Lorry at the time of my inspection. The air in the cylinder was observed to be of sufficient level & serviceable at the time of the accident.

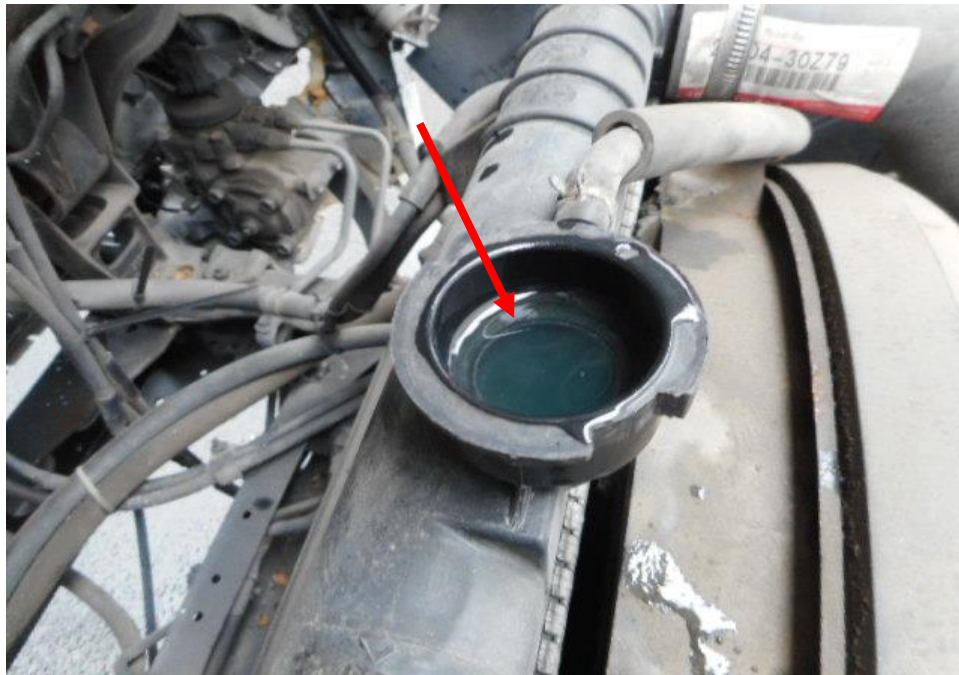
Photo 14 shows the engine coolant reservoir of the Motor Lorry at the time of my inspection. The engine coolant was observed to be of sufficient level (arrowed) and without any visible contamination.

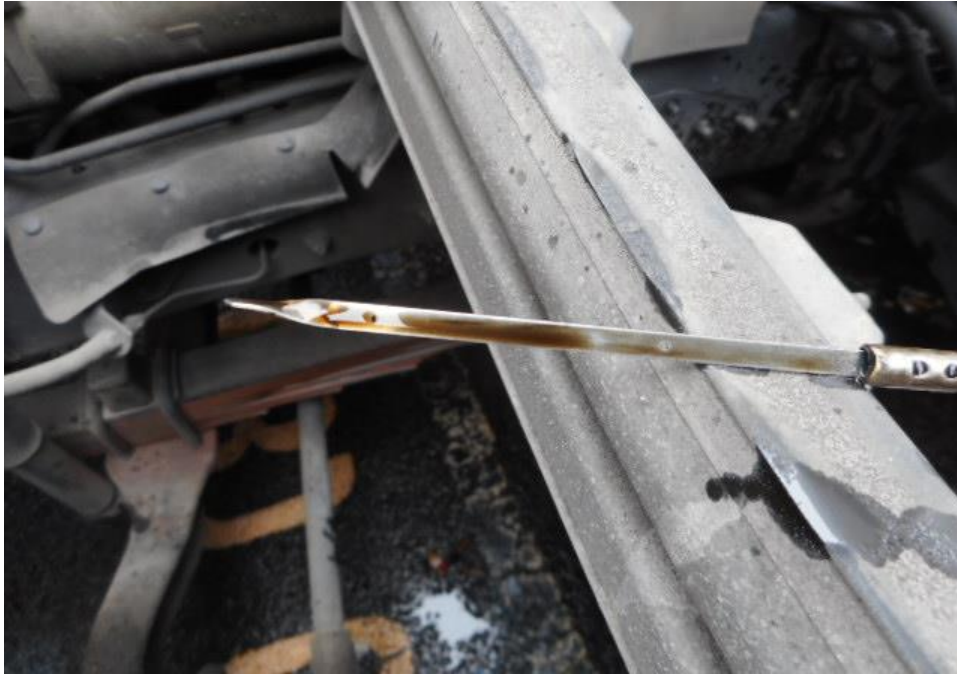
Photo 15 shows the engine oil dip stick of the Motor Lorry at the time of my inspection. The engine oil was observed to be of sufficient level and without any visible contamination.

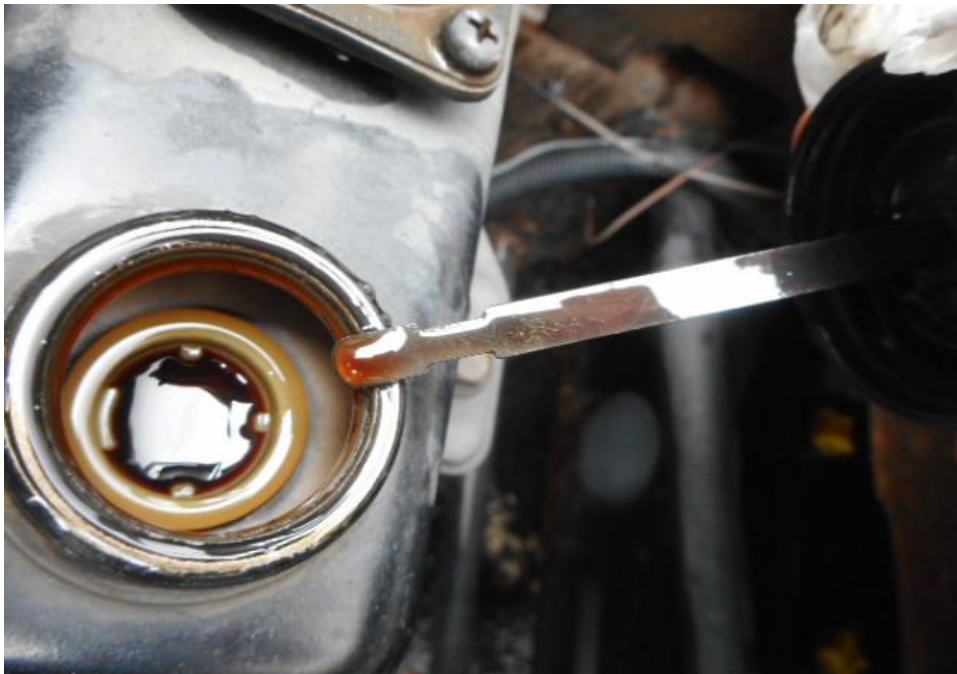
Photo 16 shows the power steering fluid reservoir of the Motor Lorry at the time of my inspection. The power steering fluid was observed to be of sufficient level and without any visible contamination.

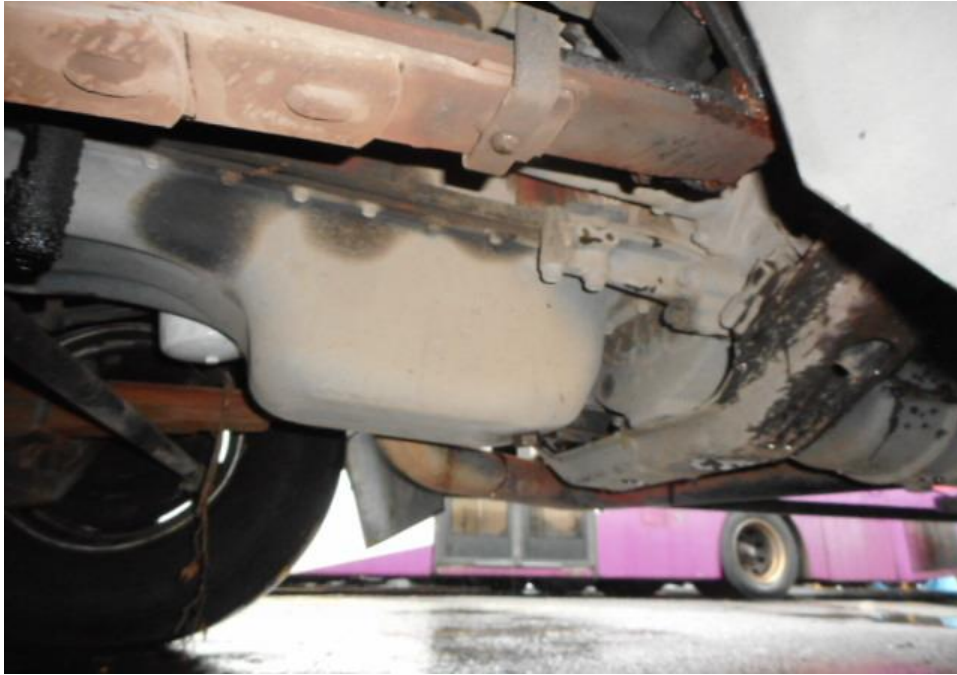
Photo 17 shows the undercarriage of the Motor Lorry, at the area where the engine housing and transmission housing are located. I did not find any sign(s) or indication(s) of fluid leak and/or fluid stain(s) on the underside of the Motor Lorry.

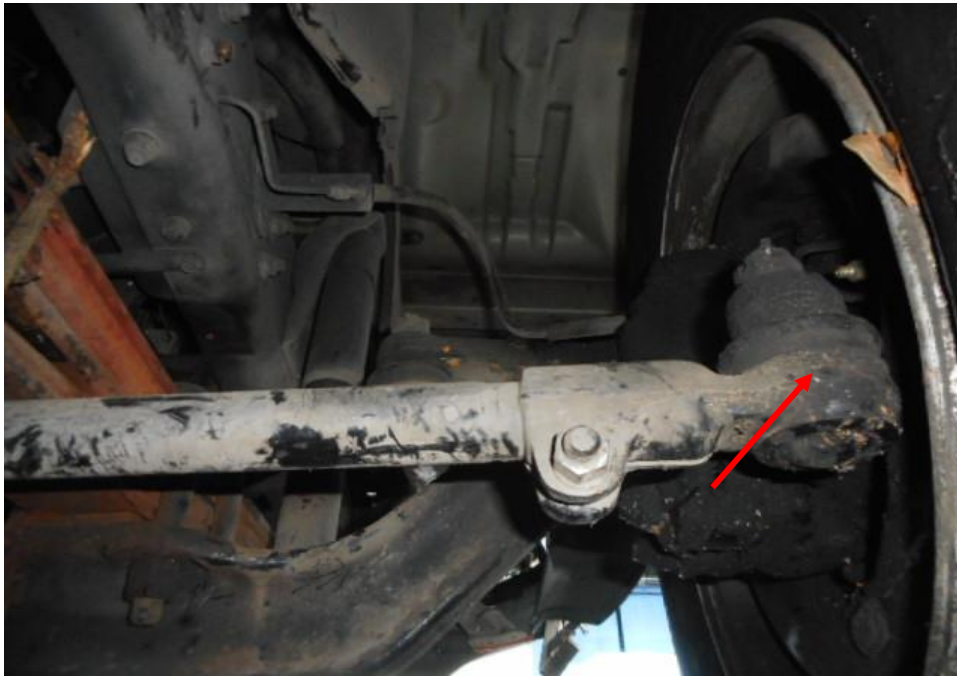
Photo 18 shows the various undercarriage components at the front right wheel of the Motor Lorry, in particular the steering tie rod end (arrowed). The various steering components were all found to be intact, suggesting that the steering system of the Motor Lorry was likely to be in serviceable condition at the material time of accident. There was also no sign of fluid stain(s) observed on the various undercarriage components.

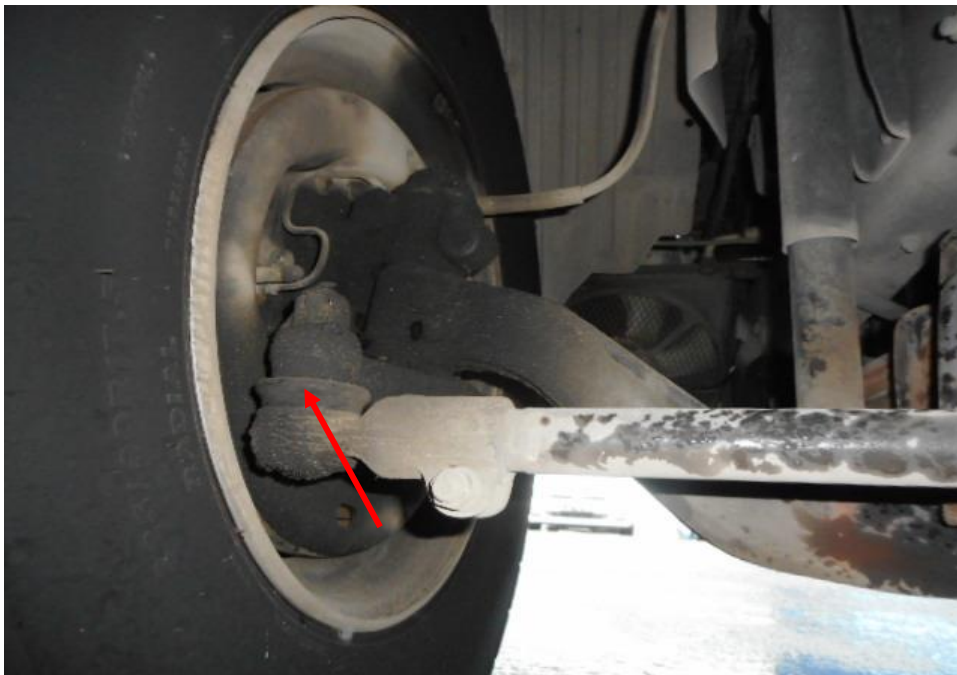
Photo 19 shows the various undercarriage components at the front left wheel of the Motor Lorry, in particular the steering tie rod end (arrowed). The various undercarriage components of the Motor Lorry were all found to be intact without any visible damage. There was also no sign of fluid stain(s) observed on the various undercarriage components.

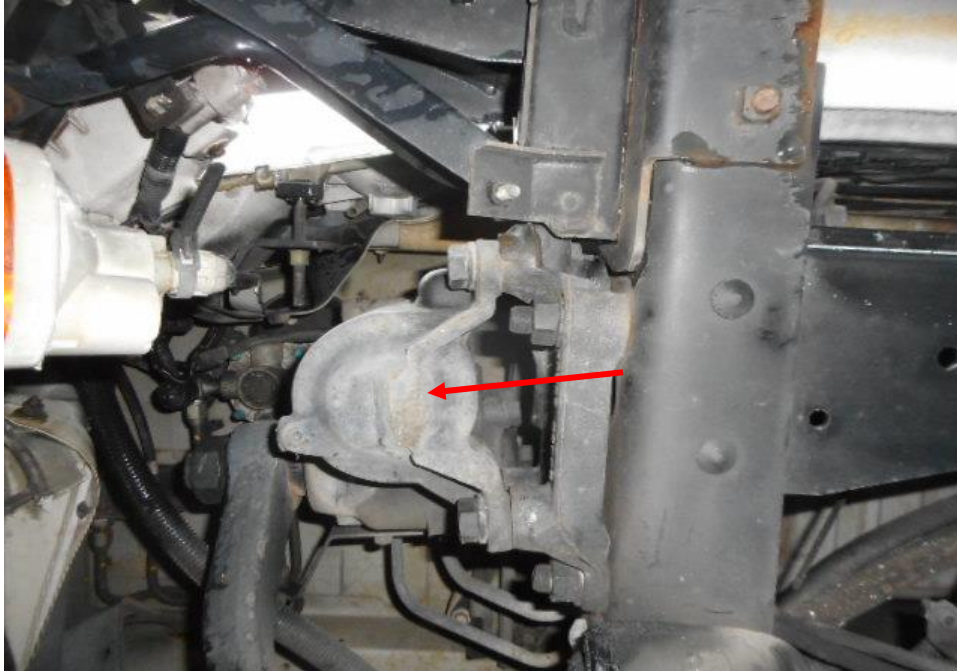
Photo 20 shows the various undercarriage components at the front right wheel of the Motor Lorry, in particular the steering box (arrowed). The various undercarriage components of the Motor Lorry were all found to be intact without any visible damage. There was also no sign of fluid stain(s) observed on the various undercarriage components.

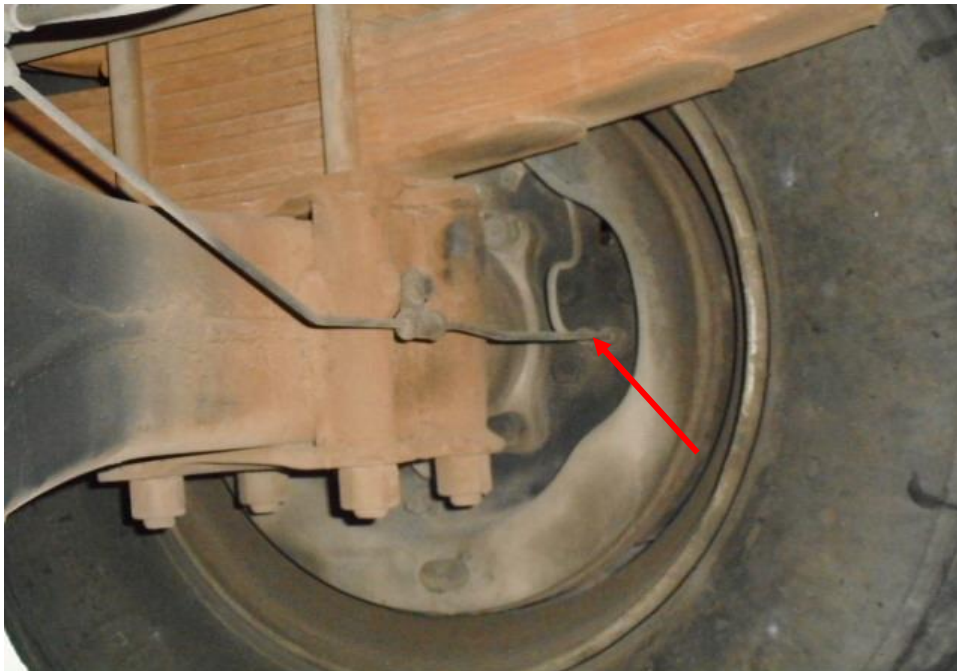
Photo 21 shows the brake pipe (arrowed) at the rear right wheel of the Motor Lorry. I did not observe any leakage of air brake at the time of my inspection of the Motor Lorry. My static tests of the Motor Lorry's braking system, along with my visual examination of the various mechanical components in the braking system, had indicated that there was no internal leakage of pressure/vacuum. Hence the braking system of the Motor Lorry was likely to be in serviceable condition at the material time of accident.

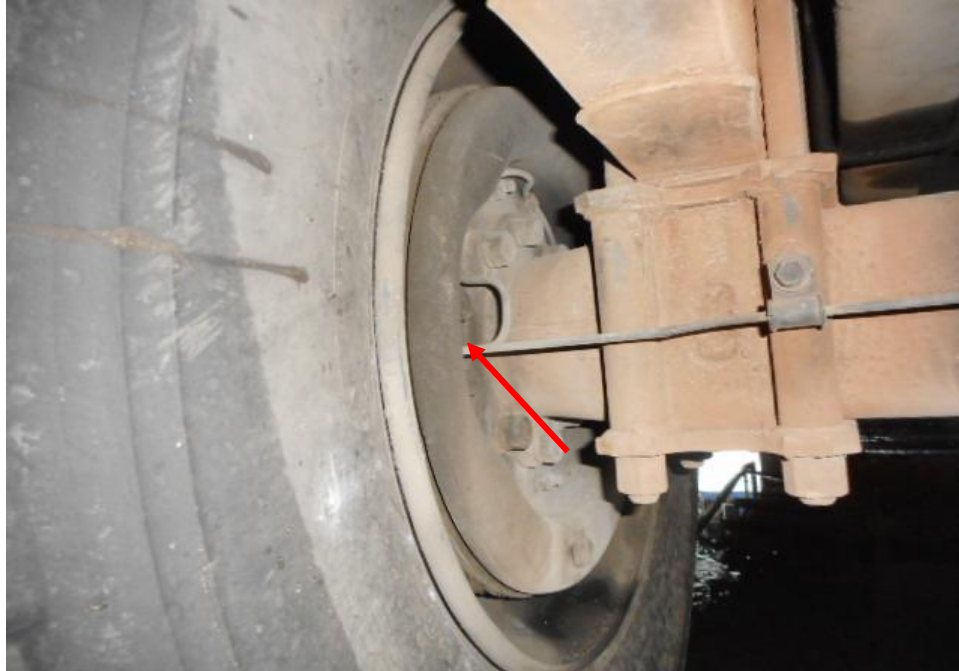
Photo 22 shows the brake pipe (arrowed) at the rear left wheel of the Motor Lorry. I did not observe any leakage of air brake at the time of my inspection of the Motor Lorry. My static tests of the Motor Lorry's braking system, along with my visual examination of the various mechanical components in the braking system, had indicated that there was no internal leakage of pressure/vacuum. Hence the braking system of the Motor Lorry was likely to be in serviceable condition at the material time of accident.

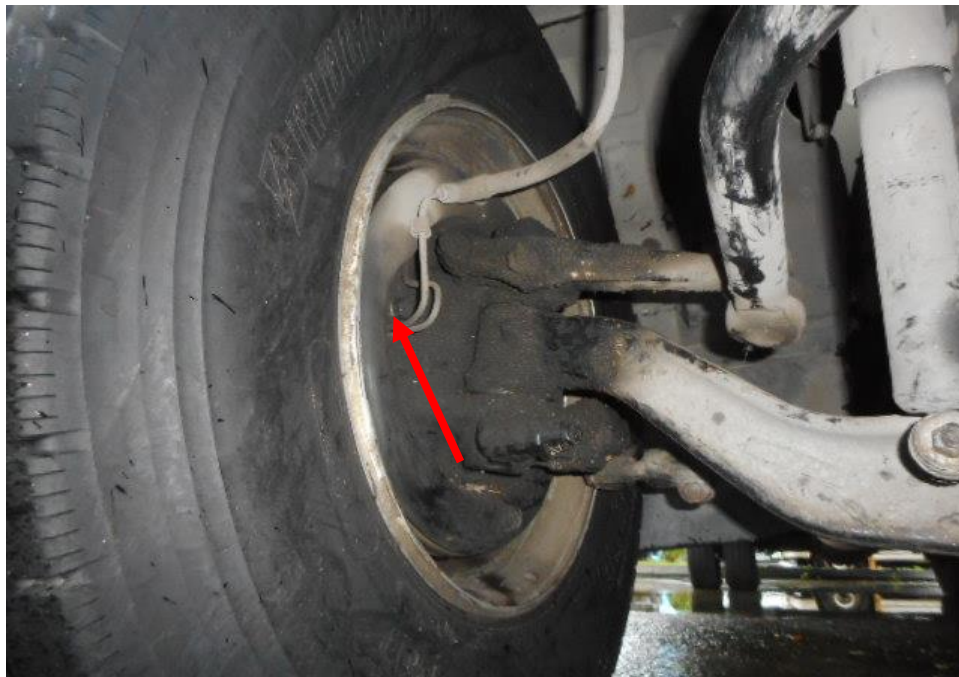
Photo 23 shows the brake hose/pipe (arrowed) at the front right wheel of the Motor Lorry. No leakage of air brake was observed. Visual examination of the various components of the braking system like the brake drum, brake booster, brake pedal etc had revealed all to be intact and without visible damage at the time of accident. There was also no sign of fluid stain(s) observed on the various undercarriage components.

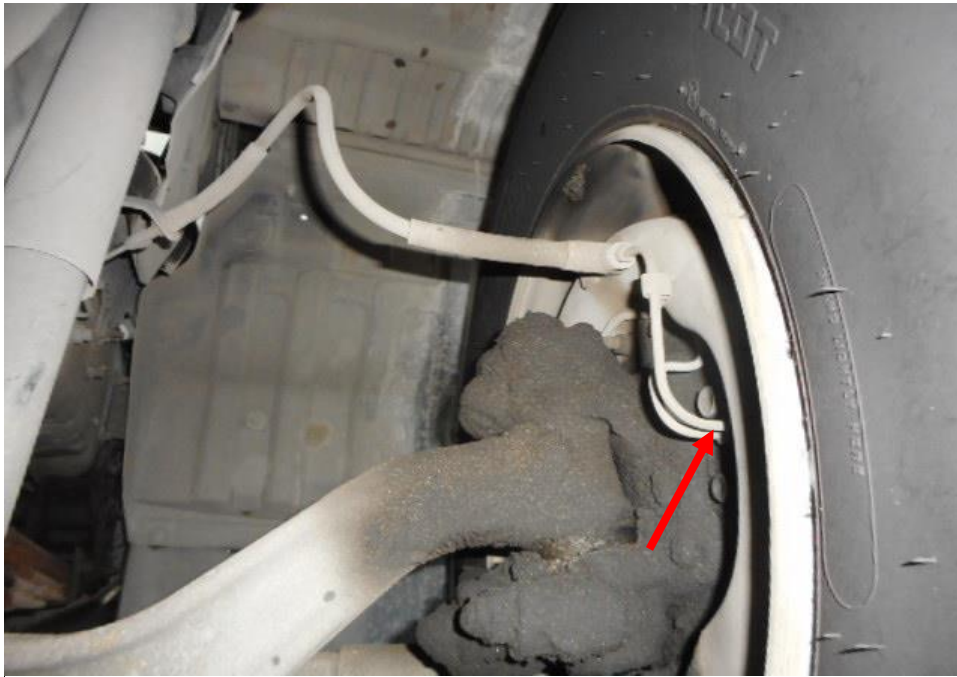
Photo 24 shows the brake hose/pipe (arrowed) at the front left wheel of the Motor Lorry. No leakage of air brake was observed. Visual examination of the various components of the braking system like the brake drum, brake booster, brake pedal etc had revealed all to be intact and without visible damage at the time of accident. There was also no sign of fluid stain(s) observed on the various undercarriage components.

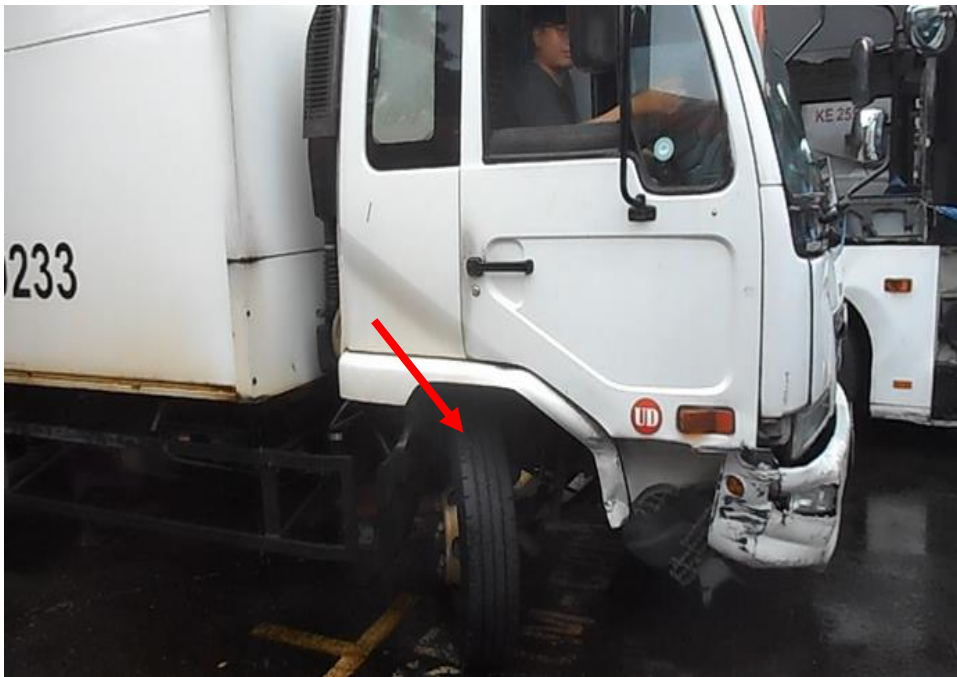
Photo 25 shows the front right wheel of the Motor Lorry turned to its full right (arrowed). During my steering system test, I did not experience any abnormal free play and/or resistance when I had turned the steering wheel towards full right.

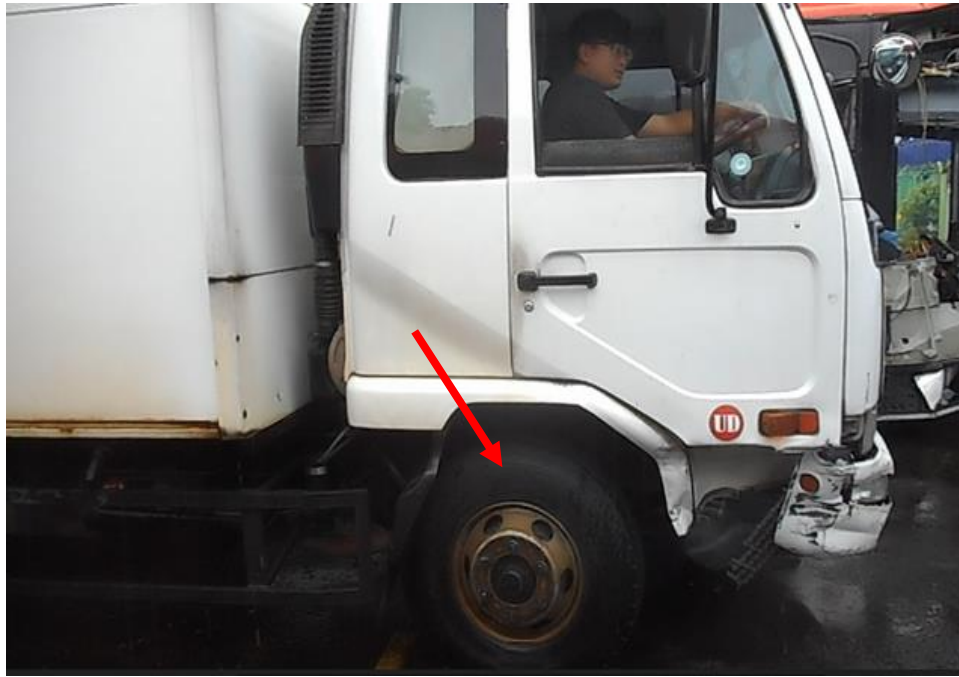
12. Static test on the steering system of the Motor Lorry also revealed abnormality to the steering system. I experience abnormal resistance when turning the steering wheel to the left full lock position. However, my visual examination of the various steering components which had included the steering box, tie rods, tie rod ends and ball joints had revealed that these components were all generally in good condition. See photo 18 - 26 below.

Photo 26 shows the front right wheel of the Motor Lorry turning to its left (arrowed) however, during my steering system test, I experience resistance when I turned the steering wheel towards the left and the steering would be jammed in the midst of turning towards the left.

16. For this particular case, I was able to determine that there was a mechanical failure to the steering system of the Motor Lorry that may have contributed to the accident. Although our visual check to the steering components but during our static test to the steering system the steering was able to turn fully to the right, however when the steering was turning to the left it had jammed in the midst. We are in view that the mechanical failure to the steering system had likely caused the accident to the Motor Lorry.
