You're Ref: TP/IP/30524/2022
Our Ref: CI/TPD22013011/P

5th April 2023

MECHANICAL INSPECTION REPORT OF MOTOR CAR SLD 962K

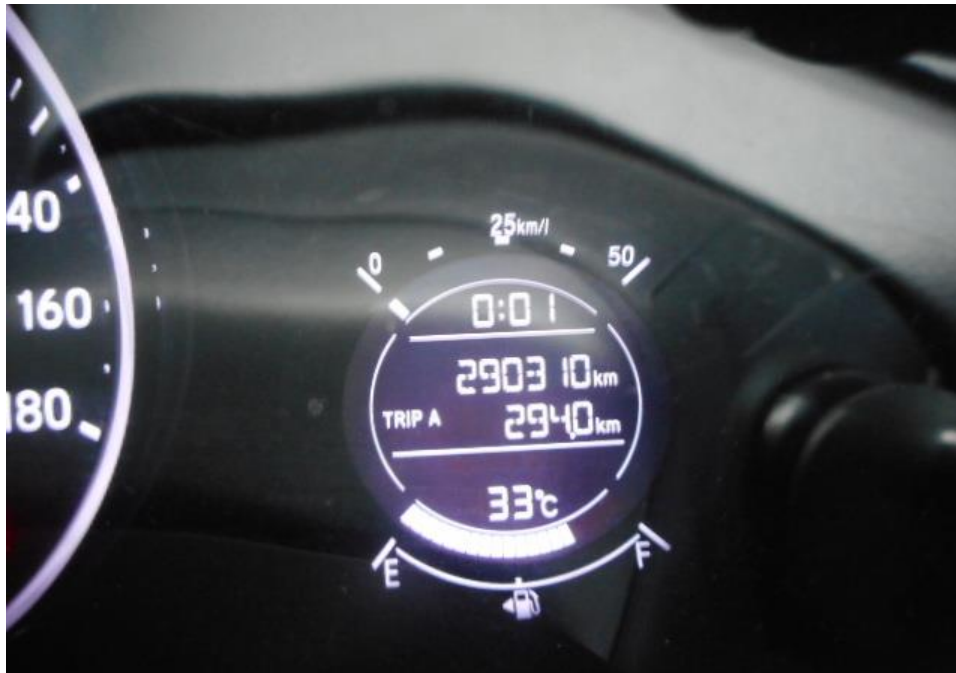
Photo 1 shows the mileage of the Motor Car at the time of my inspection. The mileage observed was 290,310km.

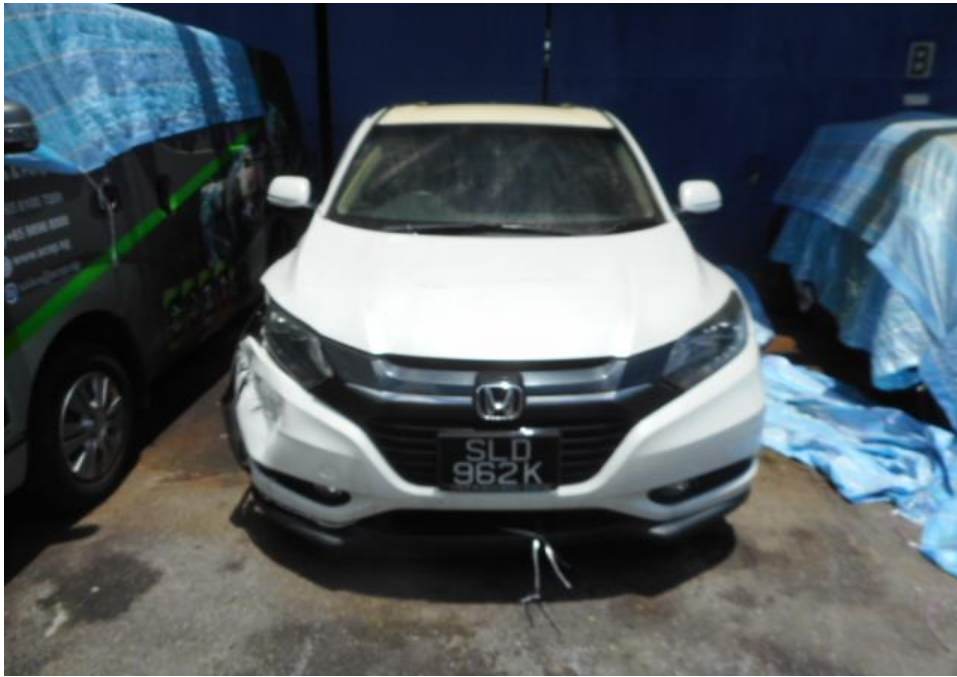
4. The mileage of the Motor Car at the time of my inspection was 290,310km.
5. The Motor Car was observed to have sustained damage at its front portion. Its front bonnet, front bumper, front right fender was amongst the body parts that were damaged as a result of the accident.

Photo 2 shows a general view of the Motor Car's front body at the time of my inspection. The front portion of the Motor Car was observed to have sustained damage. Its front bonnet, front bumper, front right fender was amongst the body parts that were damaged as a result of the accident.

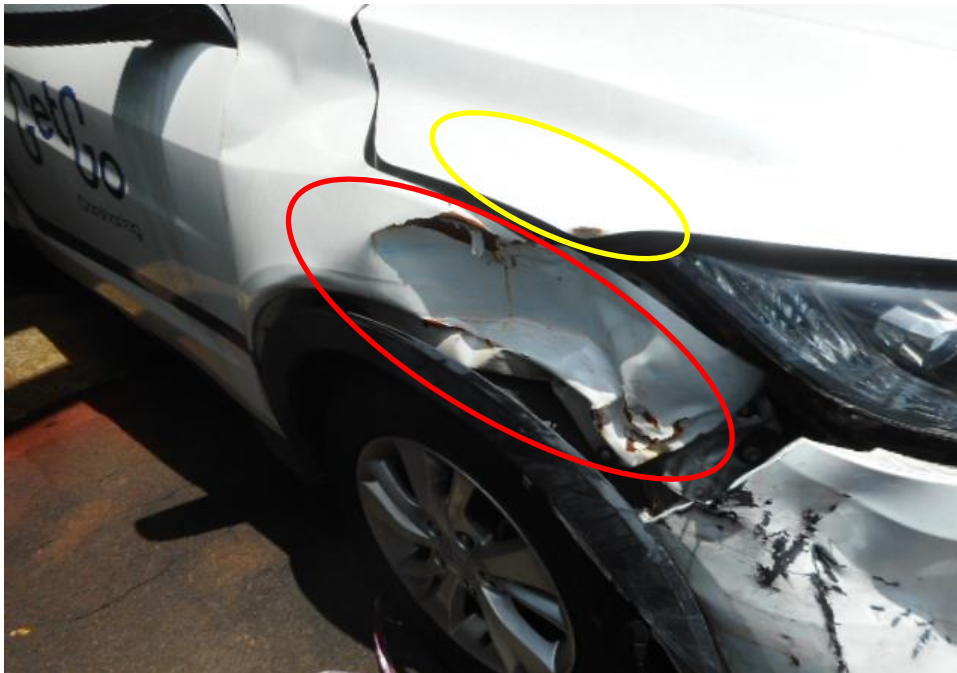
Photo 3 shows a close up view of the Motor Car's front body at the time of my inspection. The front portion of the Motor Car was observed to have sustained damage. Its front bonnet (yellow circle) and front right fender (red circle) was the body parts that were damaged as a result of the accident.

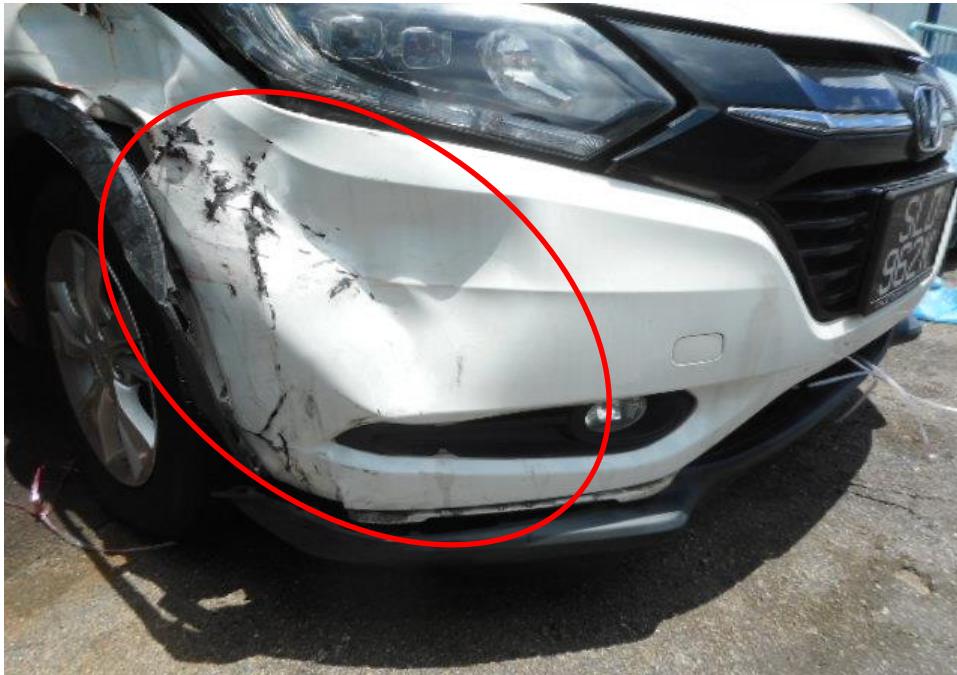
Photo 4 shows a close up view of the Motor Car's front body at the time of my inspection. The front portion of the Motor Car was observed to have sustained damage. Its front bumper (circled) was the body parts that were damaged as a result of the accident.

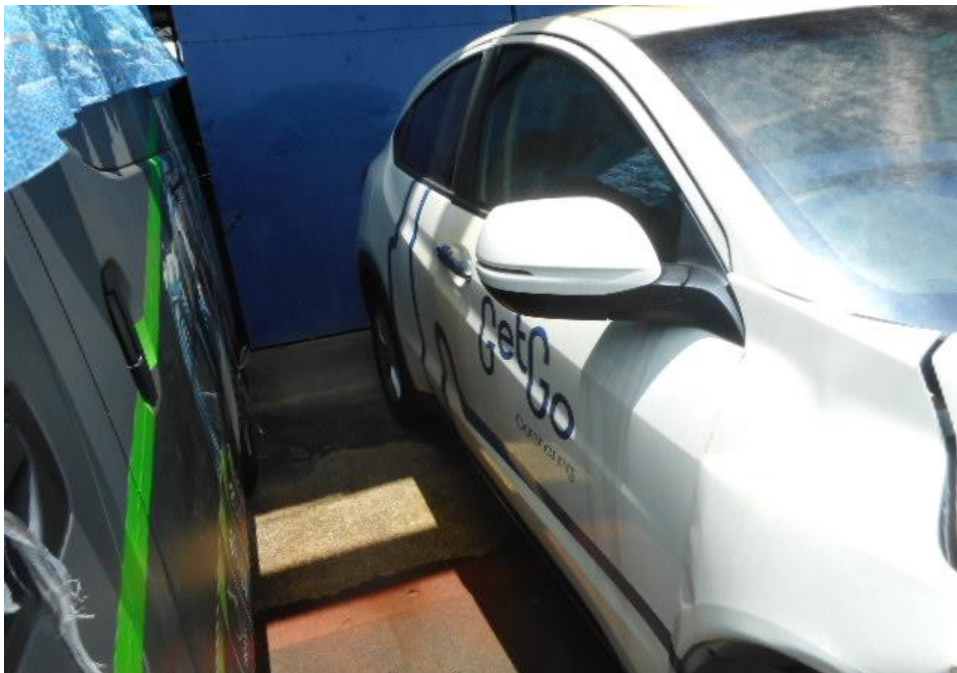
Photo 5 shows a general view of the Motor Car's right body at the time of my inspection. The right portion of the Motor Car was observed to have been unaffected by the accident.

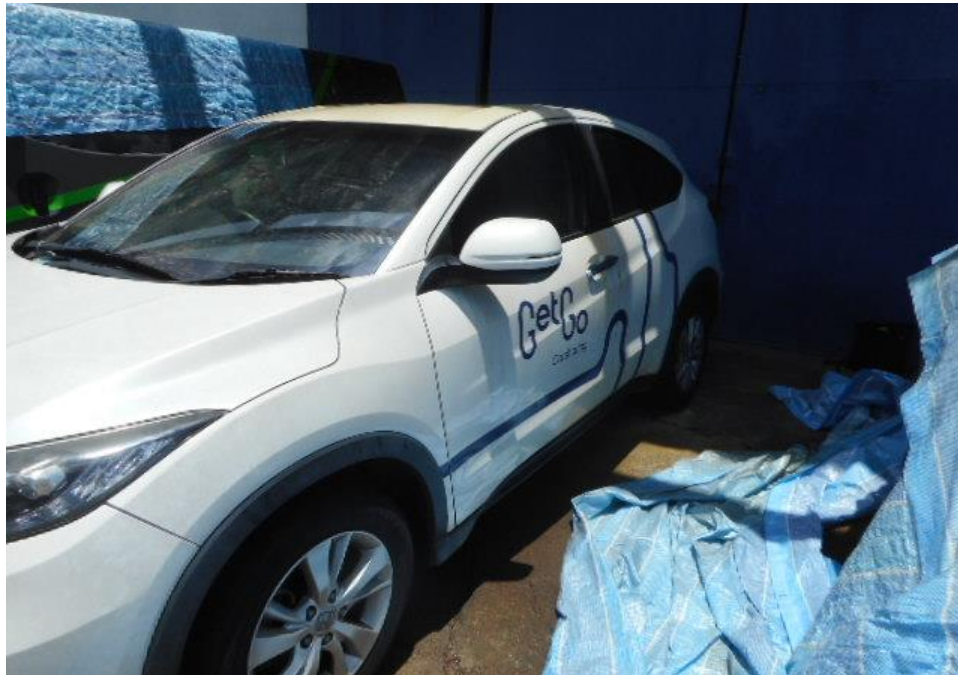
Photo 6 shows a general view of the Motor Car's left body at the time of my inspection. The left portion of the Motor Car was observed to have been unaffected by the accident.

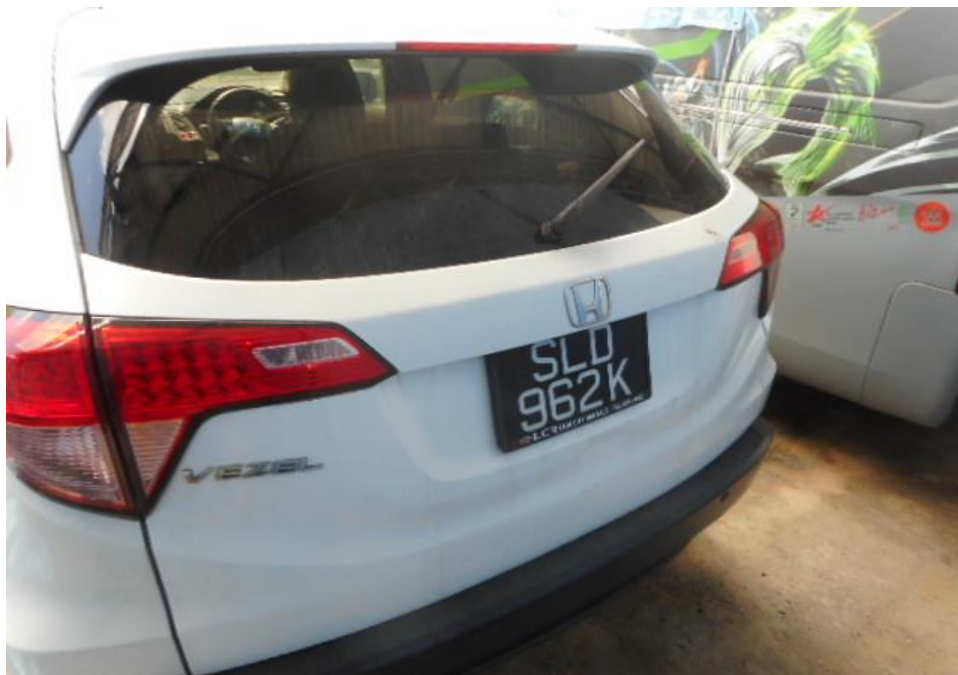
Photo 7 shows the general view of the Motor Car's rear body at the time of my inspection. The Motor Car rear was observed to be unaffected by the accident.

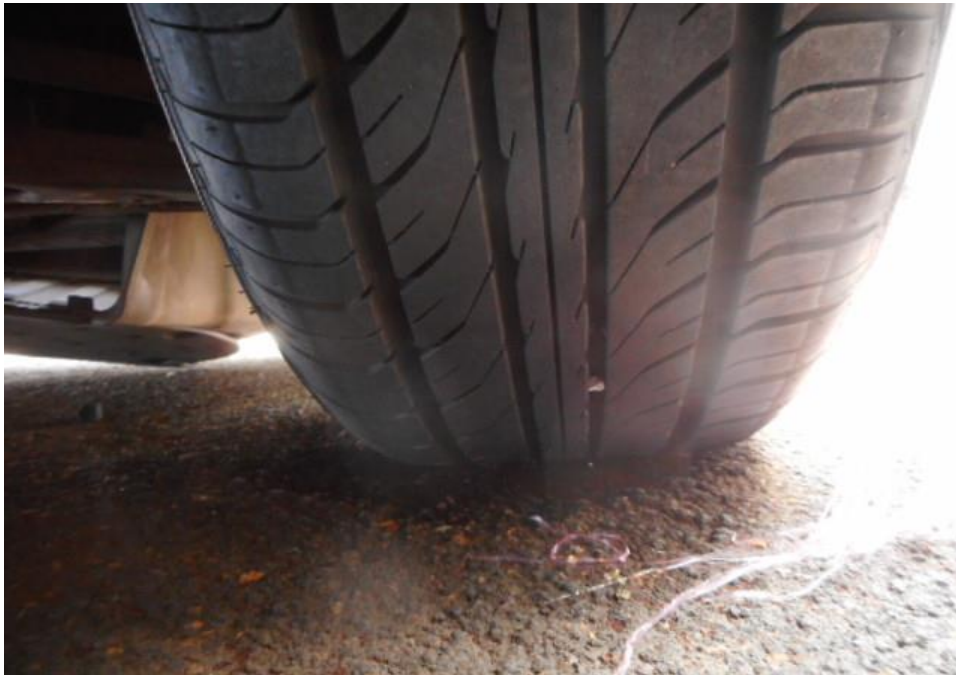
Photo 8 shows the condition of the front right tyre of the Motor Car, which was observed to be in serviceable condition with remaining tread depth of approximately 5.6mm. The tyre was sufficiently inflated for vehicular operation with no tear, cut or burst mark(s) on the outer and the inner sidewalls as well as across the tread. The 4 tyres of the Motor Car were wrapped around standard alloy wheel rims without any damage.

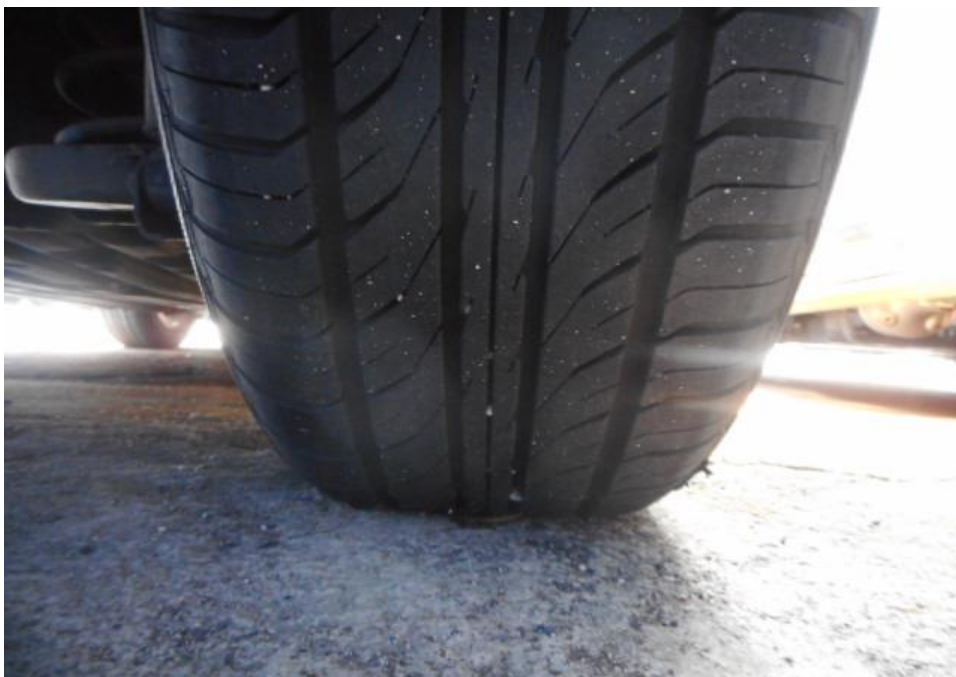
Photo 9 shows the condition of the rear right tyre of the Motor Car, which was observed to be in serviceable condition with remaining tread depth of approximately 6mm. The tyre was also observed to be sufficiently inflated for vehicular operation with no tear, cut or burst mark(s).

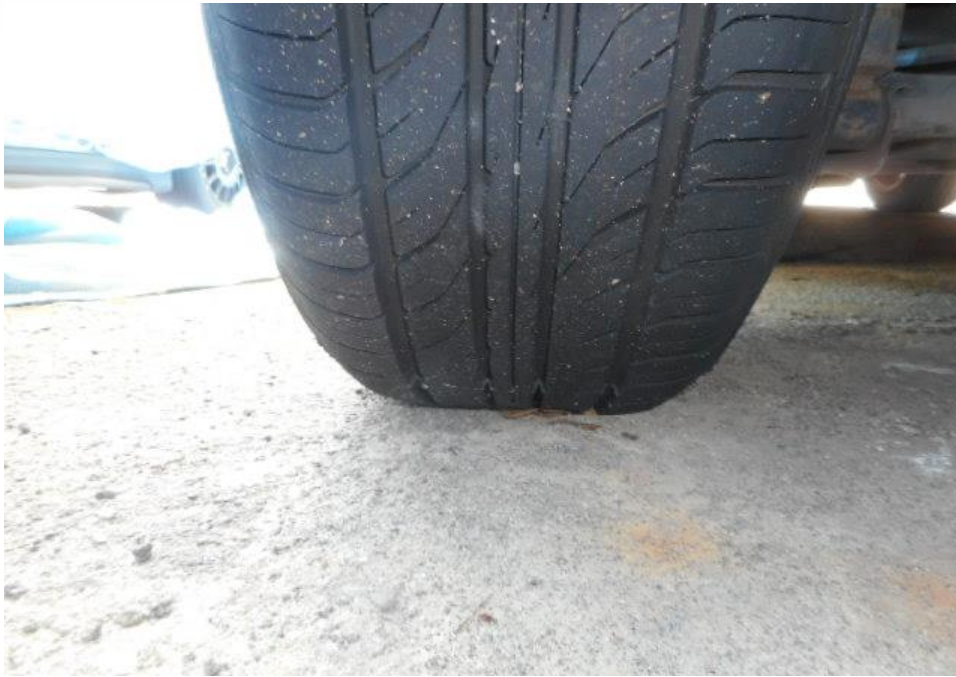
Photo 10 shows the condition of the rear left tyre of the Motor Car, which was observed to be in serviceable condition with remaining tread depth of approximately 4.4mm. The tyre, which was wrapped around alloy wheel rim, was also observed to be sufficiently inflated for vehicular operation. The 4 tyres of the Motor Car were wrapped around standard alloy wheel rims.

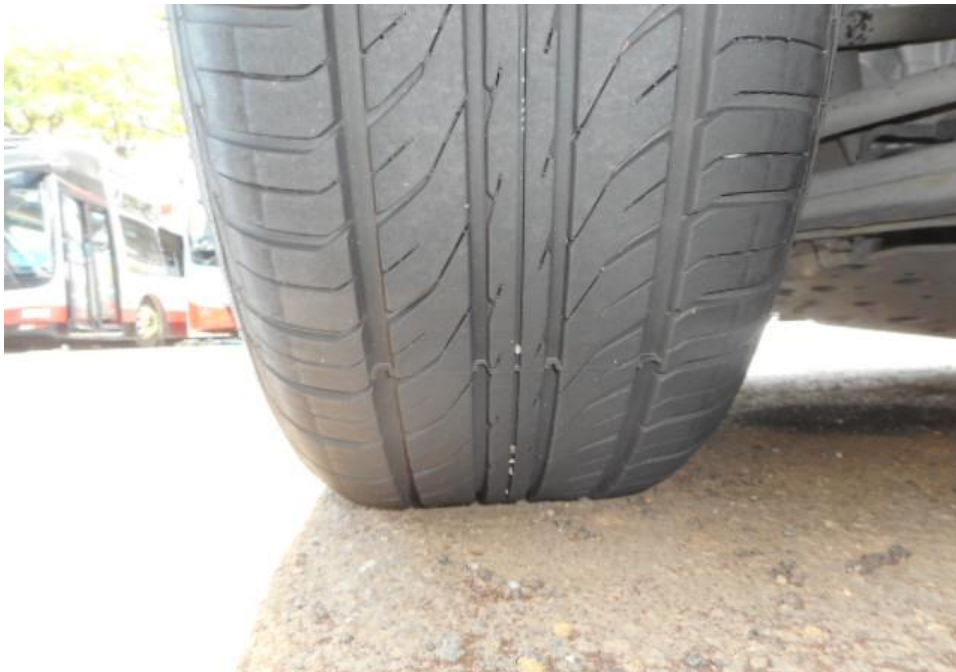
Photo 11 shows the condition of the front left tyre of the Motor Car, which was observed to be in serviceable condition with remaining tread depth of approximately 5.6mm. There was also no tear, cut or burst mark(s) on the outer and the inner sidewalls as well as across the tread of the Motor Car's 4 tyres.

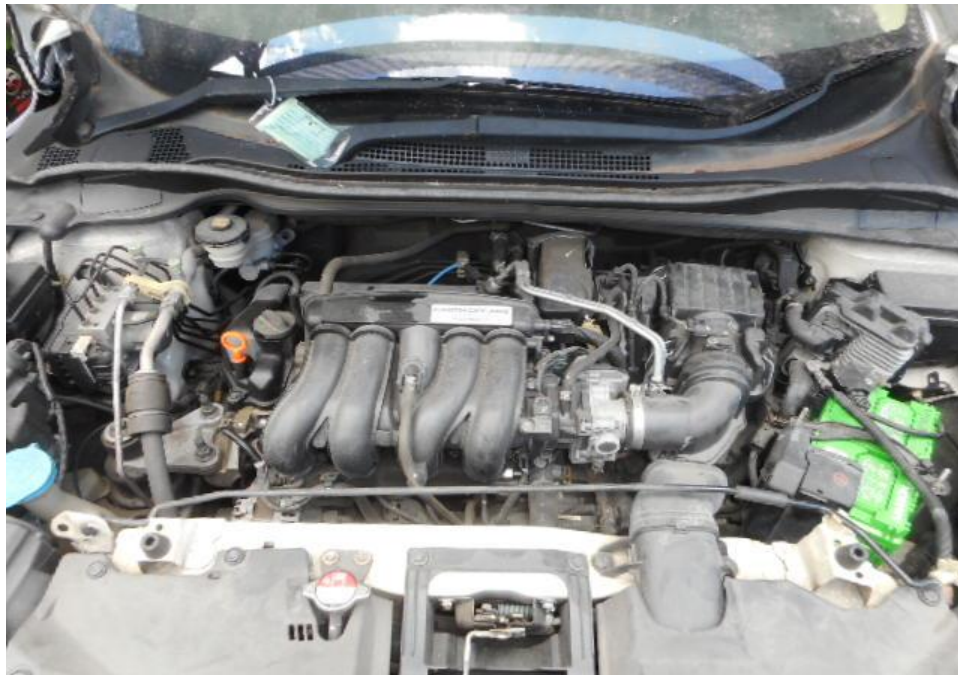
Photo 12 shows a general view of the Motor Car's engine compartment. The various parts and components inside the engine compartment were unaffected by the accident. There was also no sign(s) or indication(s) of fluid leakage and/or fluid stain within the engine compartment.

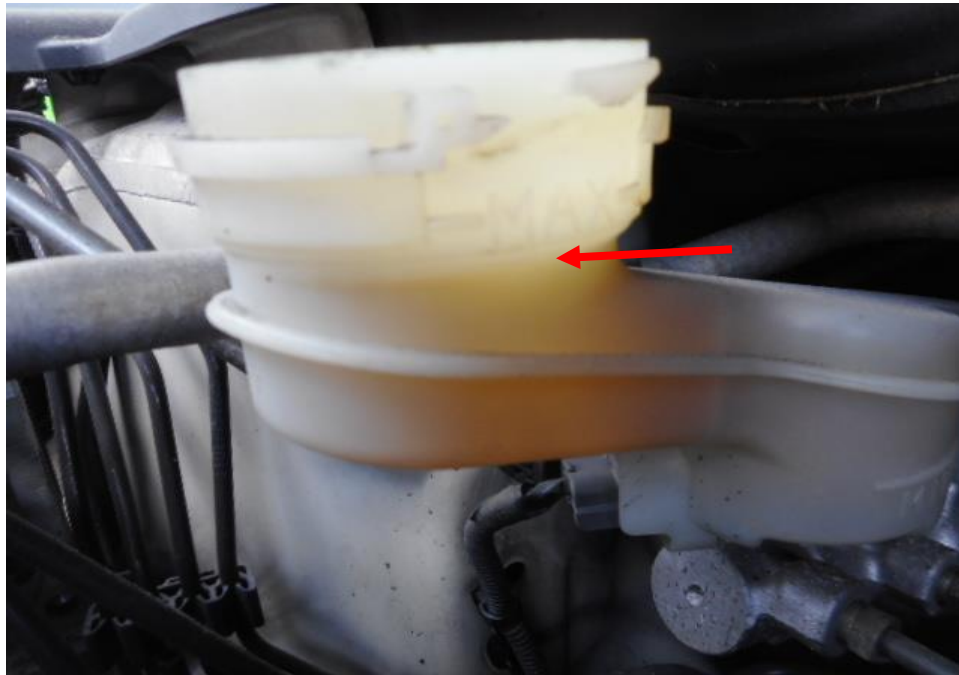
Photo 13 shows the brake fluid reservoir of the Motor Car at the time of my inspection. The brake fluid was observed to be of sufficient level (arrowed) and without any visible contamination.

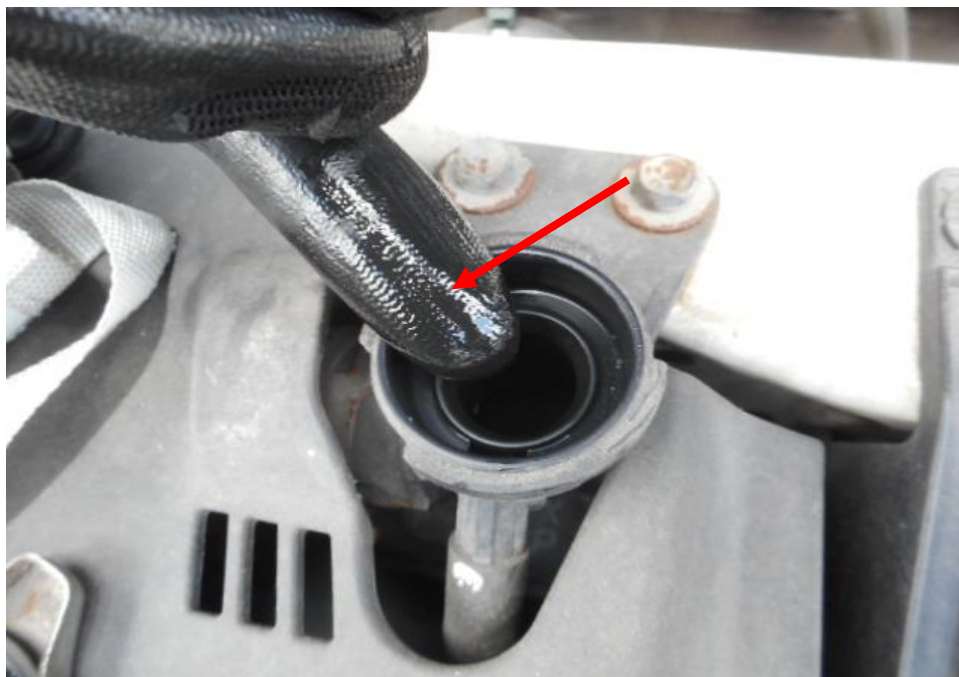
Photo 14 shows checks being carried out to the engine coolant of the Motor Car at the time of my inspection. The engine coolant was observed to be of sufficient level (arrowed) and without any visible contamination.

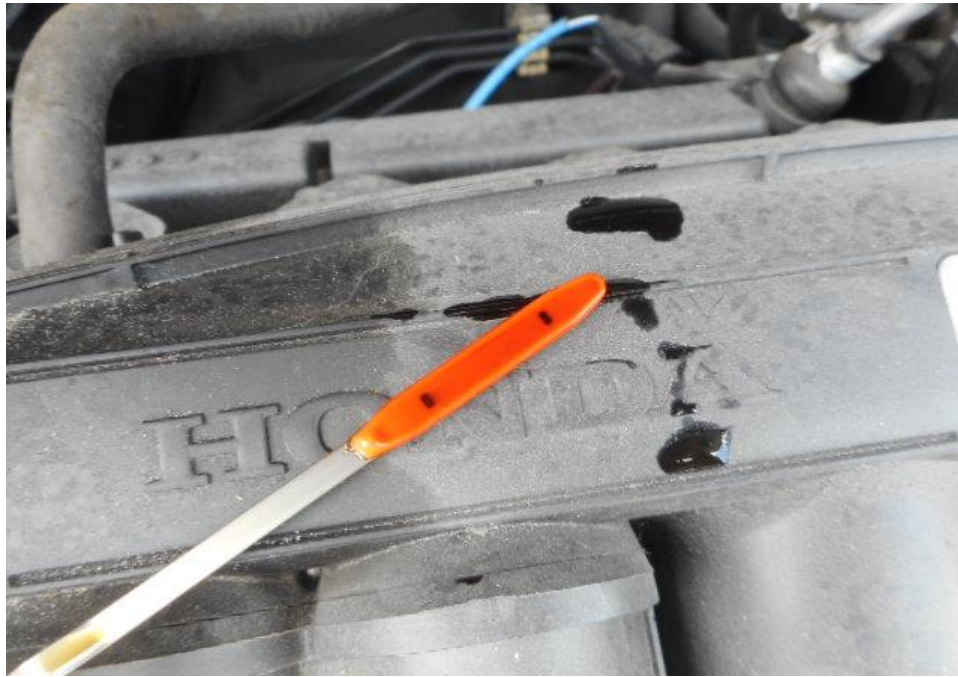
Photo 15 shows the engine oil dipstick of the Motor Car at the time of my inspection. The engine oil was observed to be of sufficient level and without any visible contamination.

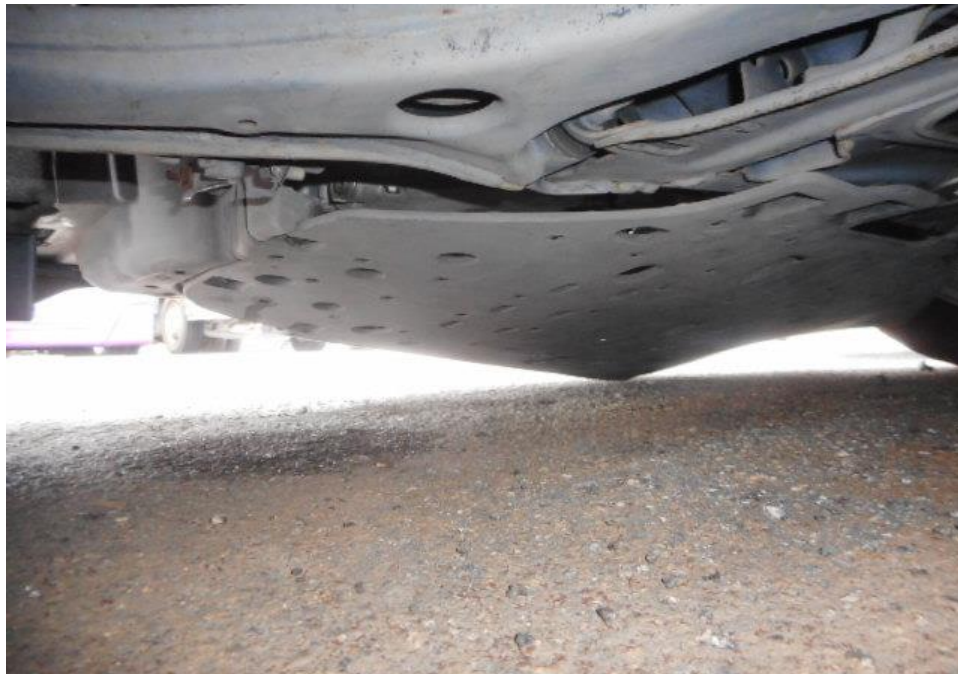
Photo 16 shows the undercarriage of the Motor Car, at the area where the engine housing and transmission housing are located. I did not find any sign(s) or indication(s) of fluid leak and/or fluid stain(s) on the underside of the Motor Car.

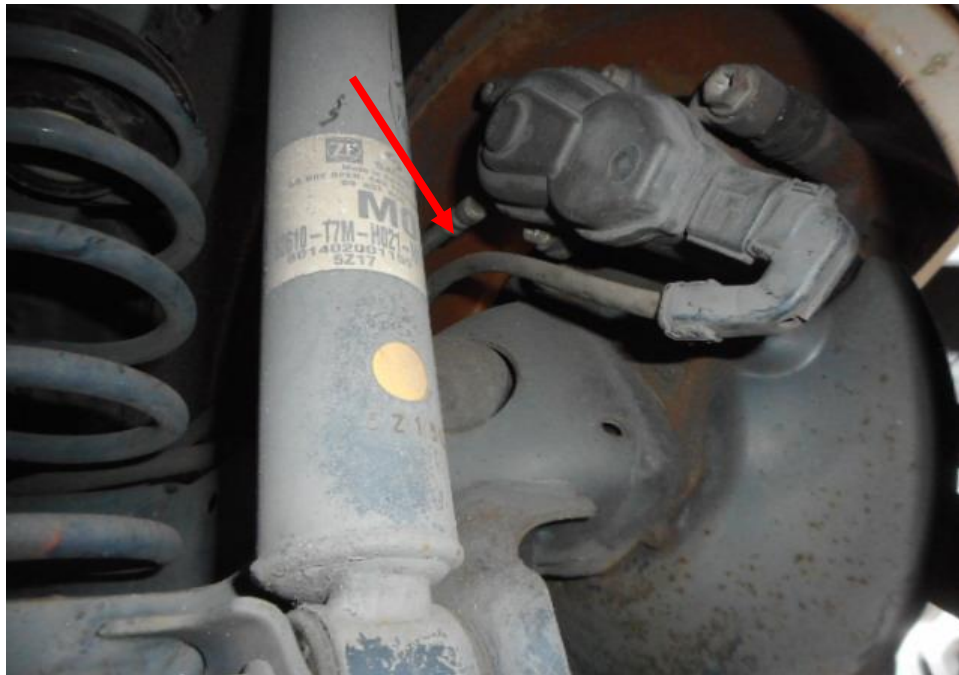
Photo 17 shows the brake hose/pipe (arrowed) at the rear right wheel of the Motor Car. No leakage of brake fluid was observed. Visual examination of the various components of the braking system like the drum brake, brake booster, brake pedal etc. had revealed all to be intact and without visible damage.

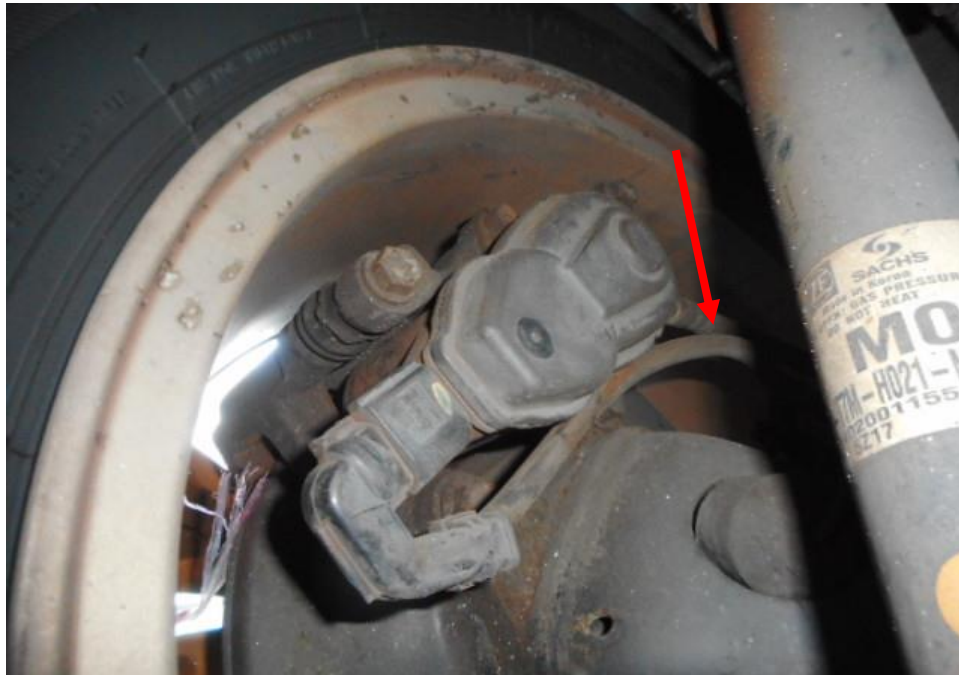
Photo 18 shows the brake hose/pipe (arrowed) at the rear left wheel of the Motor Car. I did not observe any leakage of brake fluid at the time of my inspection of the Motor Car. Static tests of the Motor Car's braking system had indicated that there was no internal leakage of pressure/vacuum. The undercarriage components of the Motor Car were also all found to be intact and without any visible damage.

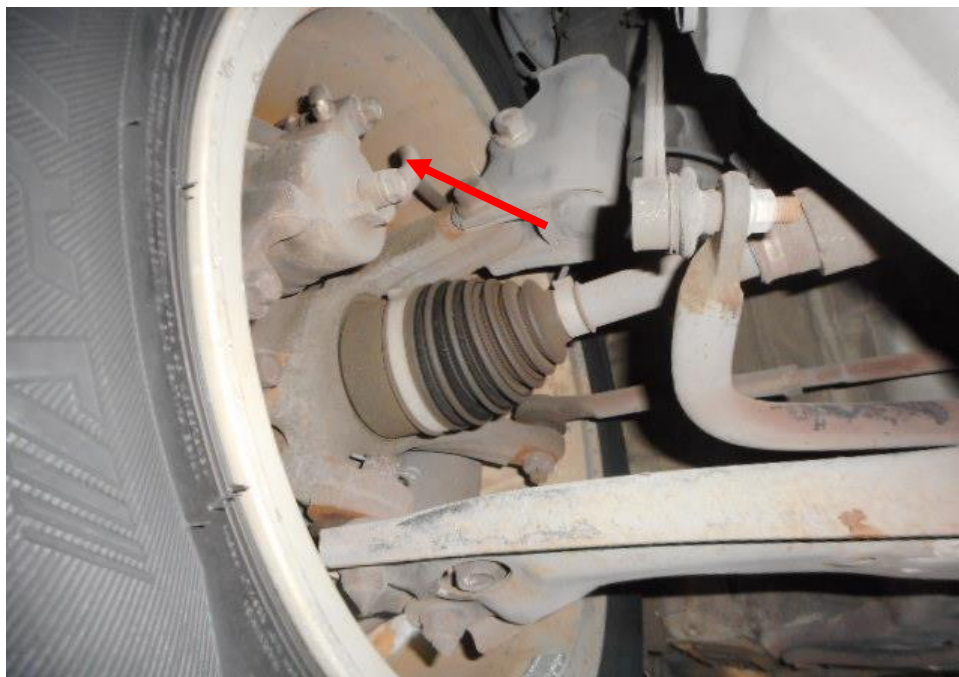
Photo 19 shows the brake hose/pipe (arrowed) at the front right wheel of the Motor Car. I did not observe any leakage of brake fluid at the time of my inspection of the Motor Car. Static tests of the Motor Car's braking system had indicated that there was no internal leakage of pressure/vacuum. The undercarriage components of the Motor Car were also all found to be intact and without any visible damage.

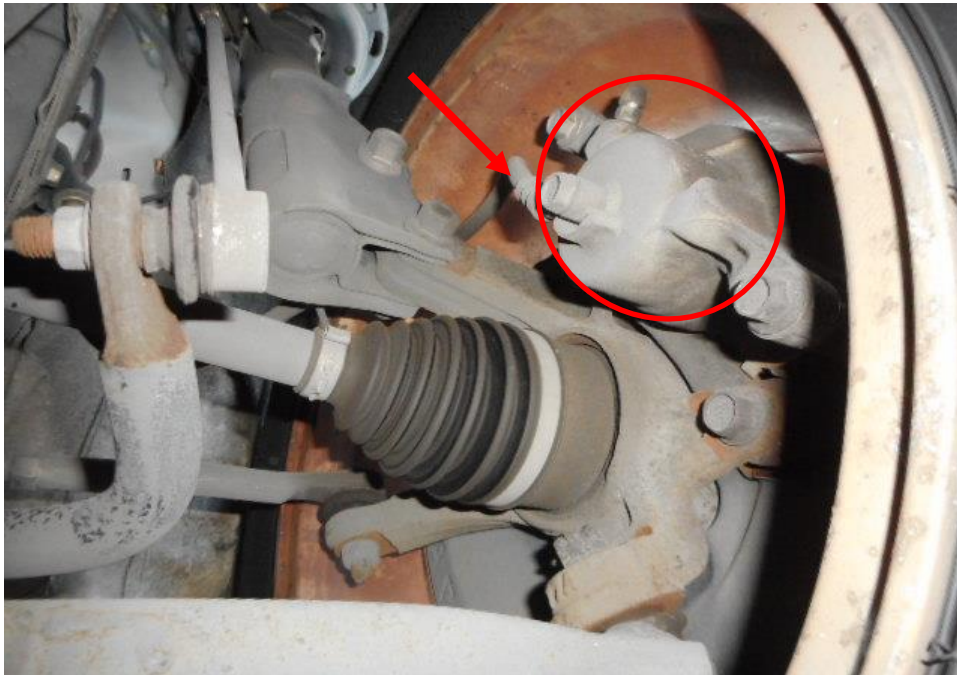
Photo 20 shows the brake hose/pipe (arrowed) at the front left wheel of the Motor Car. No leakage of brake fluid was observed. Visual examination of the various components of the braking system like the brake caliper (circled), brake booster, brake pedal etc had revealed all to be intact and without visible damage.

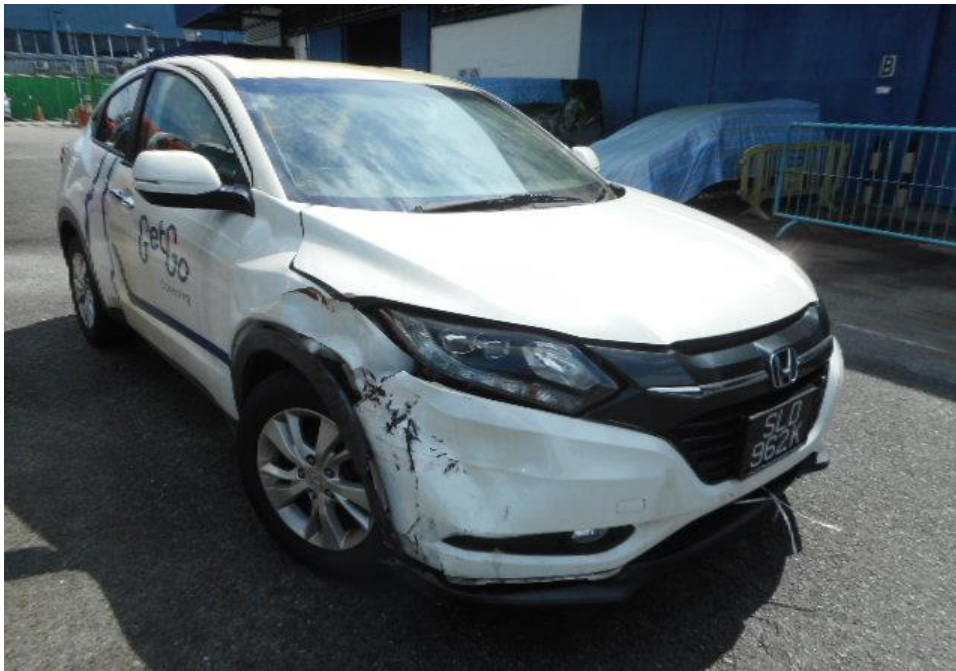
Photo 21 shows the front right wheel of the Motor Car turned to its full left. During my steering system test, I did not experience any abnormal free play and/or resistance when I had turned the steering wheel towards the left and right. This would suggest that the steering system of the Motor Car was likely to be in serviceable condition at the material time of accident.

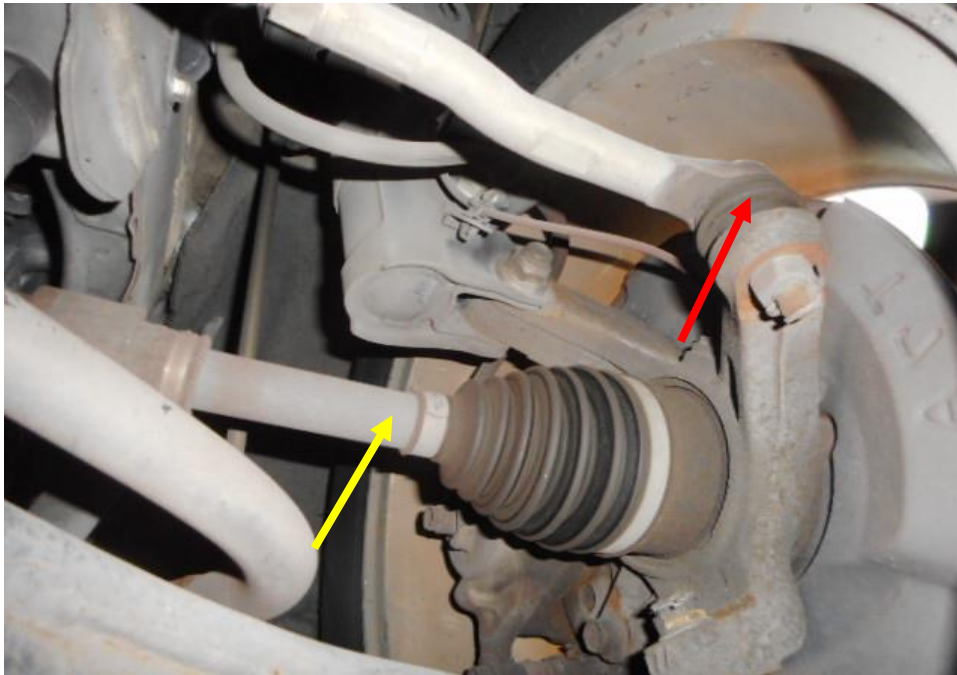
Photo 22 shows the various undercarriage components at the front right wheel of the Motor Car, in particular the steering tie rod (red arrow) and drive shaft (yellow arrow). The various steering components were all found to be intact, suggesting that the steering system of the Motor Car was likely to be in serviceable condition at the material time of accident. There was also no sign of fluid stain observed on the various undercarriage components at the front right wheel of the Motor Car.

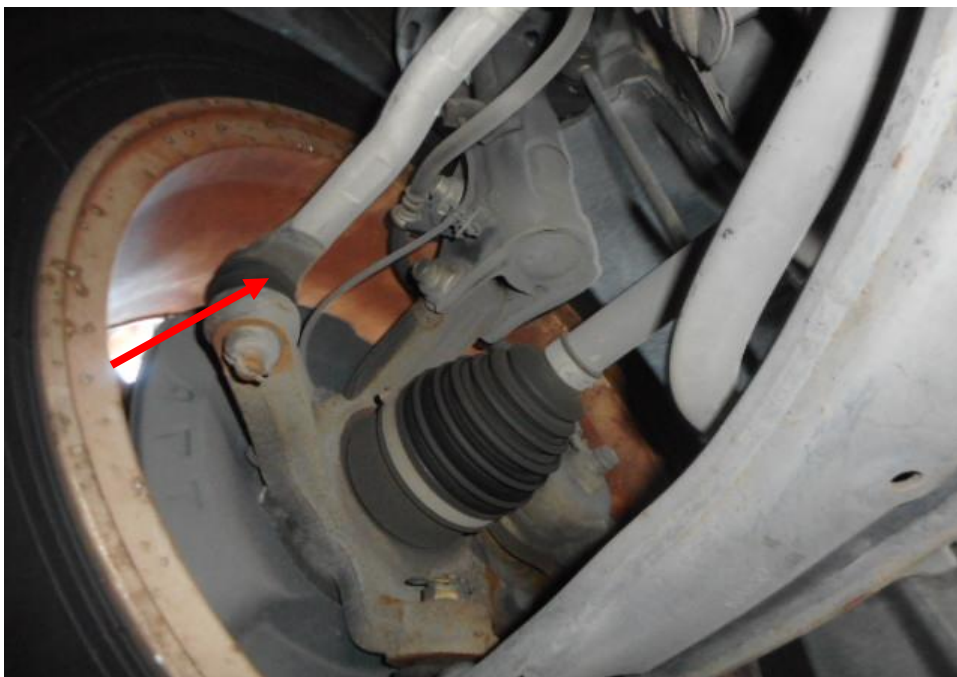
Photo 23 shows the various undercarriage components at the front left wheel of the Motor Car, which had included the steering tie rod (red arrow). The various undercarriage components of the Motor Car were all found to be intact without any visible damage.

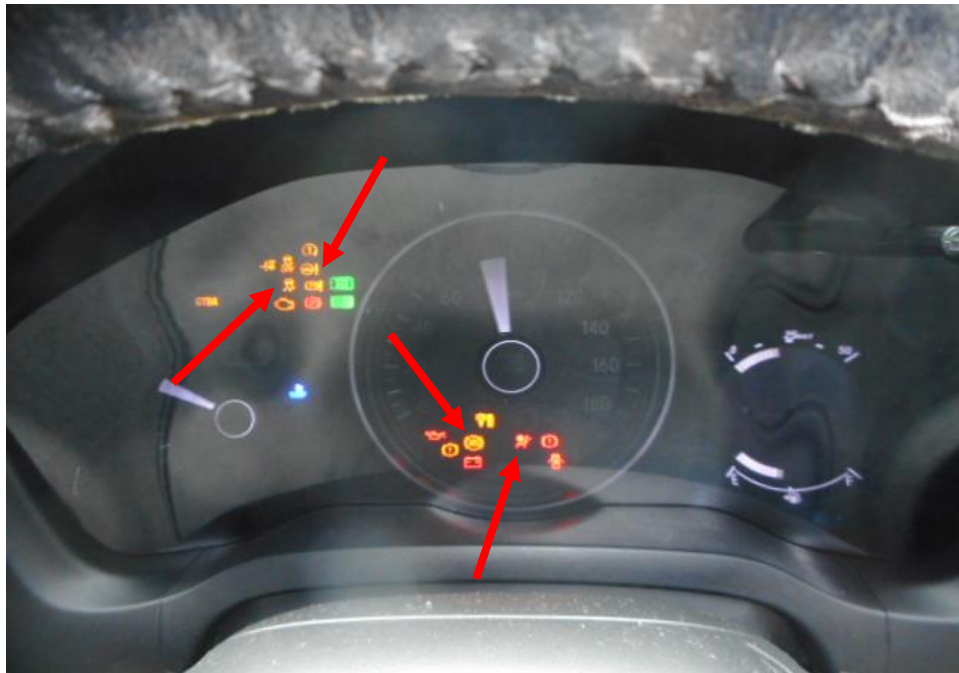
Photo 24 shows the warning light for Anti-Lock Brake System (ABS), Electric Power Steering System (EPS), Traction Control System (TCS) and Supplemental Restraint System (SRS) (arrowed) appearing on the instrument panel of the Motor Car during the self-test of its various electronic operating systems when its engine was cranked.

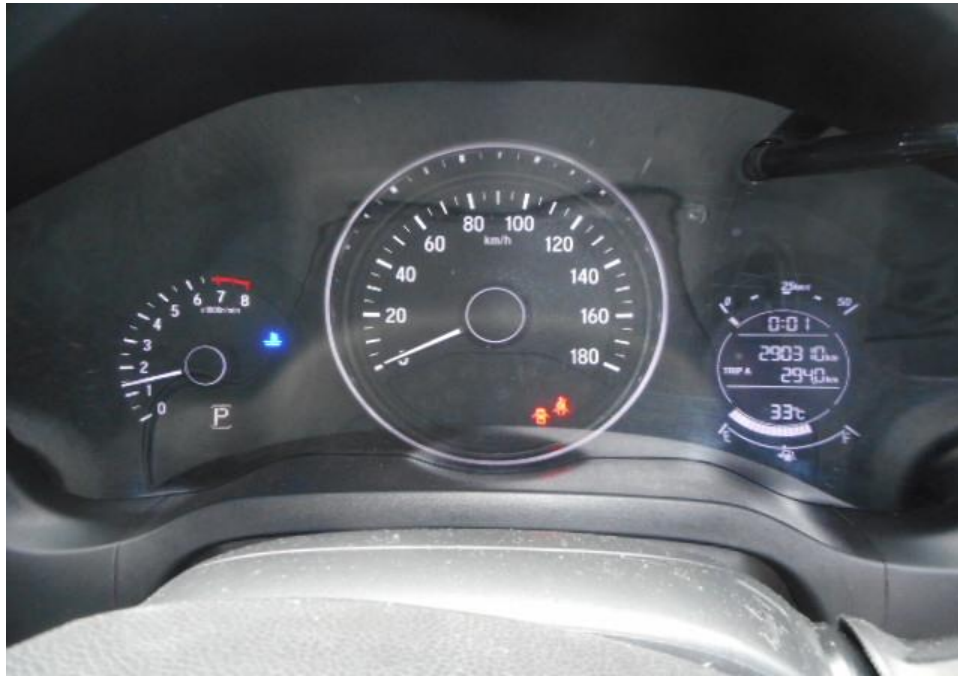
Photo 25 shows no warning lights illuminated on the instrument panel of the Motor Car after the engine was cranked. This would suggest that there was no abnormality to the electronic operating system of the Motor Car, like the ABS, EPS, TCS and SRS etc.
