You're Ref: TP/IP/31296/2022
Our Ref: CI/TPD22013012/P

4th April 2023

Fatal Accident Investigation Team

MECHANICAL INSPECTION REPORT OF POLICE CAR QX 505H

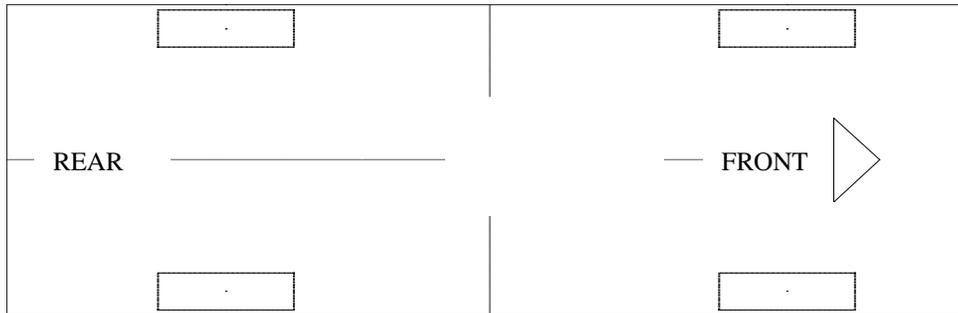
6. The condition of the Police Car's 4 tyres was observed to be in serviceable condition. I did not find any tear, cut or burst mark(s) on the outer and the inner sidewalls as well as across the tread of the 4 tyres. The 4 tyres were also observed to be sufficiently inflated for vehicular operation. The tyre brand, tyre size and remaining tread depth of the 4 tyres were recorded as follows:-

Falken 195/65R15 (4.3mm)

Falken 195/65R15 (5mm)

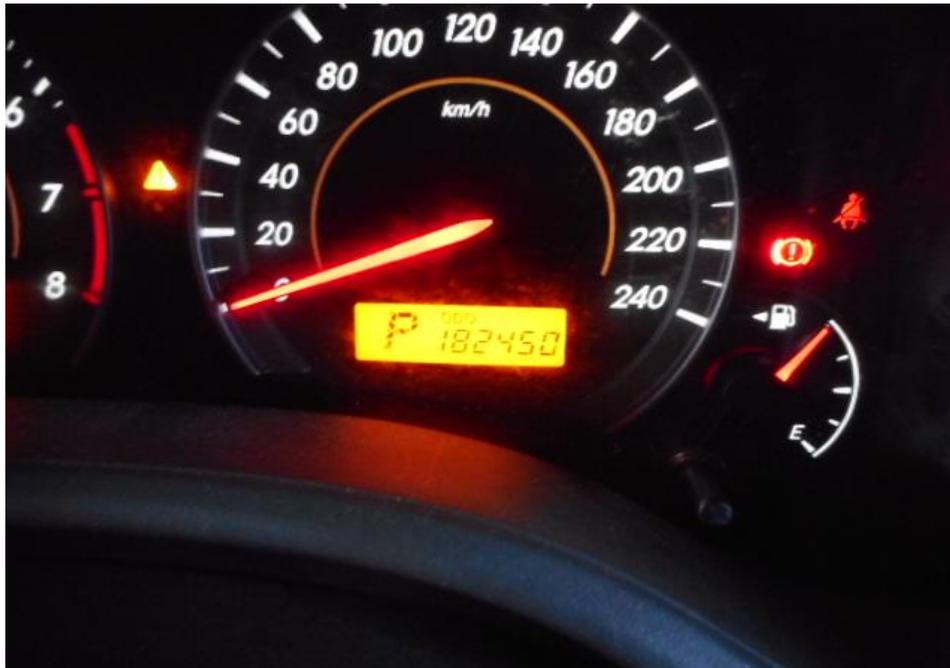
Photo 1 shows the mileage of the Police Car at the time of my inspection. The mileage observed was 182,450km.

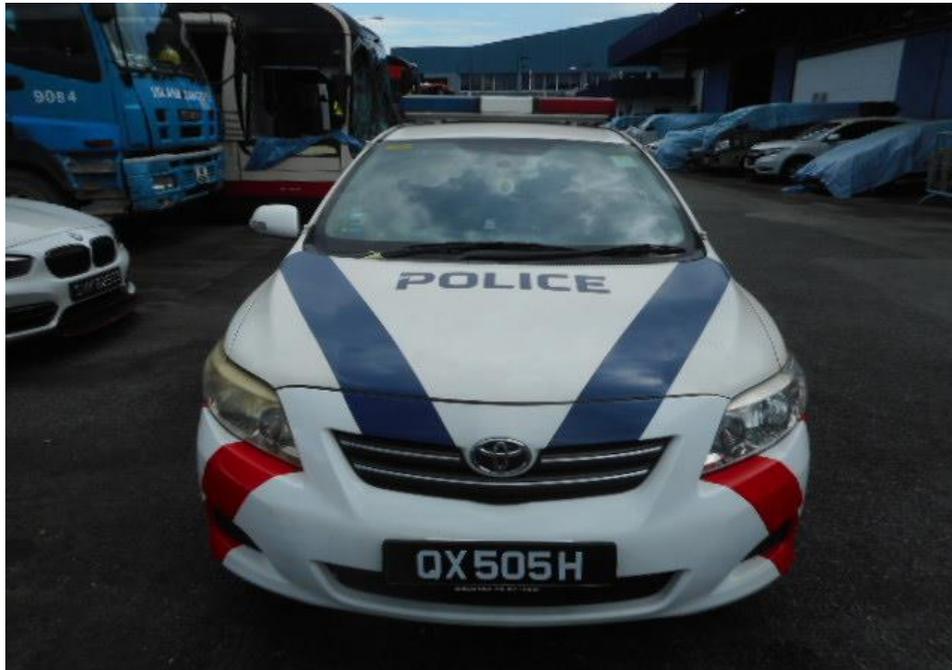
Photo 2 shows a general view of the Police Car's front body at the time of my inspection. The Police Car front body was observed to be unaffected by the accident.

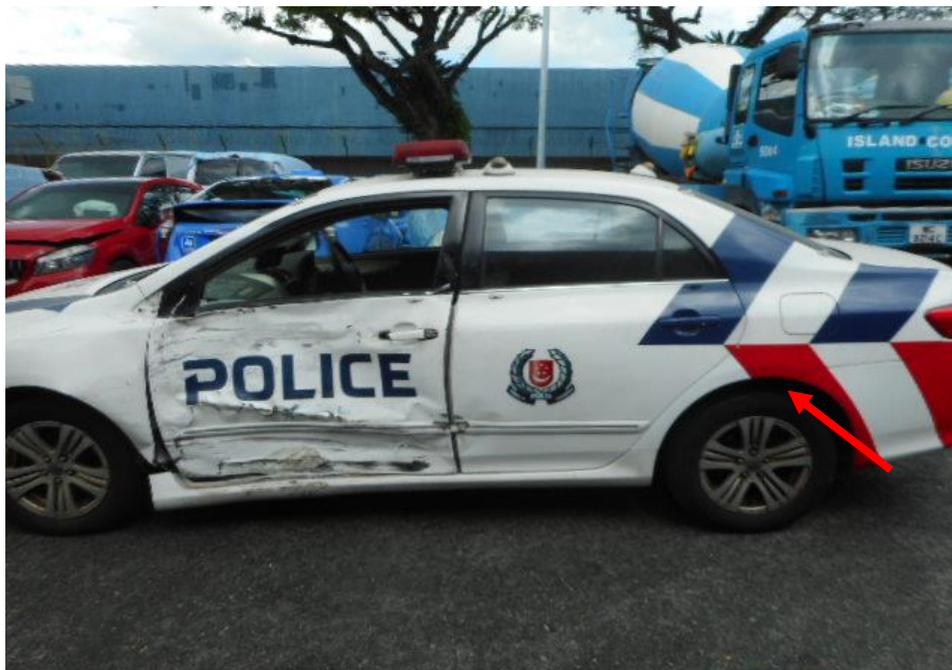
4. The mileage of the Police Car at the time of my inspection was 182,450km.
5. The Police Car was observed to have sustained damage at its left portion. Its left door, left rear view mirror and front left fender was the body parts that were damaged as a result of the accident.

Photo 3 shows a general view of the Police Car's left body at the time of my inspection. The left portion of the Police Car was observed to have sustained damage. Its left door, left rear view mirror and front left fender was the body parts that were damaged as a result of the accident.

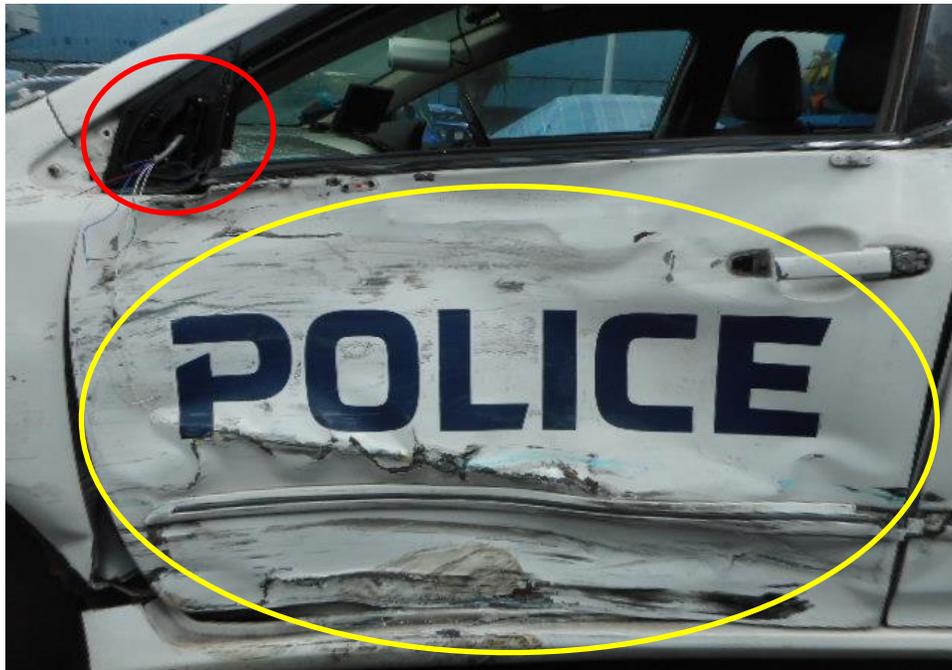
Photo 4 shows a close up view of the Police Car's left body at the time of my inspection. The left portion of the Police Car was observed to have sustained damage. Its left door (yellow circle) and left rear view mirror (red circle) was the body parts that were damaged as a result of the accident.

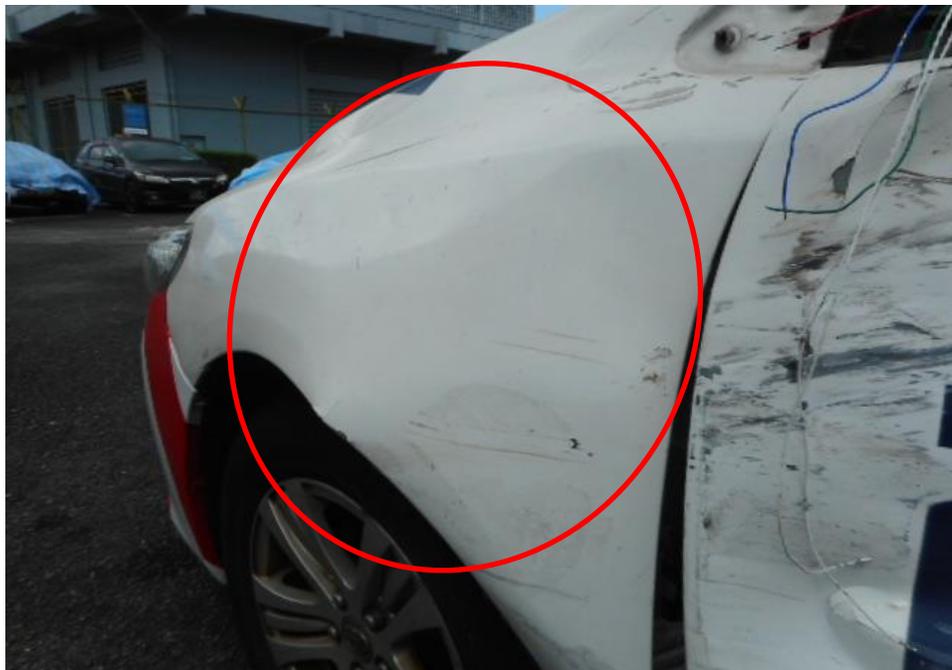
Photo 5 shows a close up view of the Police Car's left body at the time of my inspection. The left portion of the Police Car was observed to have sustained damage. Its front left fender (circled) was the body parts that were damaged as a result of the accident.

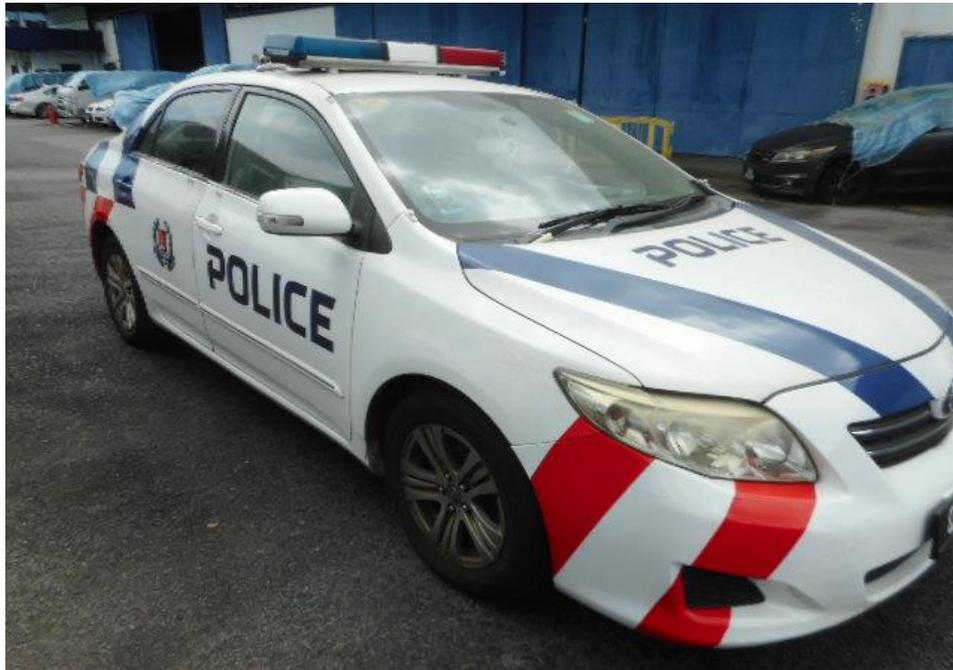
Photo 6 shows the general view of the Police Car's right body at the time of my inspection. The Police Car right body was observed to be unaffected by the accident.

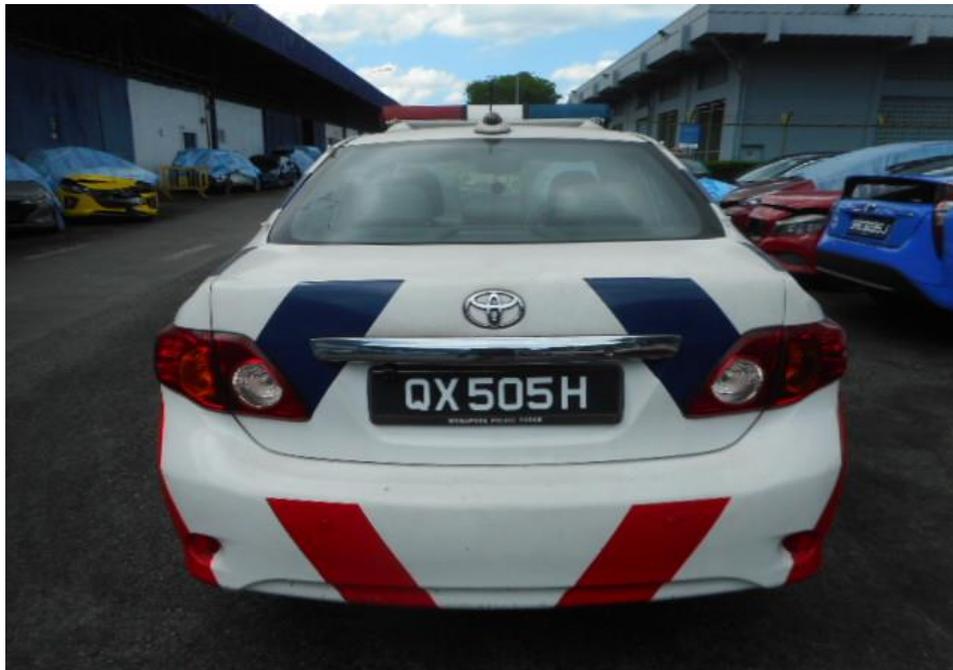
Photo 7 shows the general view of the Police Car's rear body at the time of my inspection. The Police Car rear was observed to be unaffected by the accident.

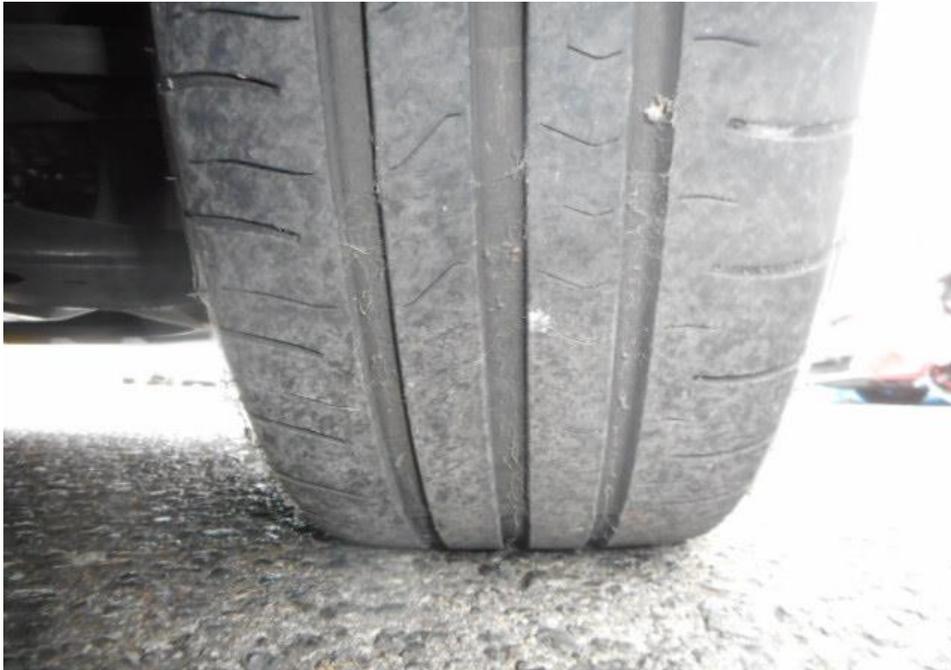
Photo 8 shows the condition of the front right tyre of the Police Car, which was observed to be in serviceable condition with remaining tread depth of approximately 5mm. The tyre was also observed to be sufficiently inflated for vehicular operation with no tear, cut or burst mark(s).

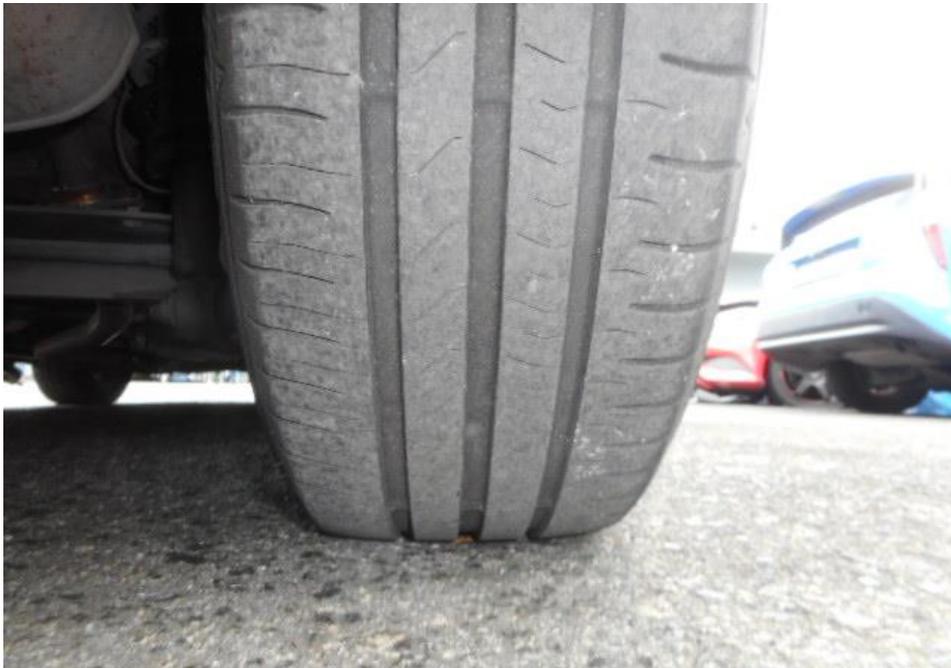
Photo 9 shows the condition of the rear right tyre of the Police Car, which was observed to be in serviceable condition with remaining tread depth of approximately 4.3mm. The tyre was also observed to be sufficiently inflated for vehicular operation with no tear, cut or burst mark(s).

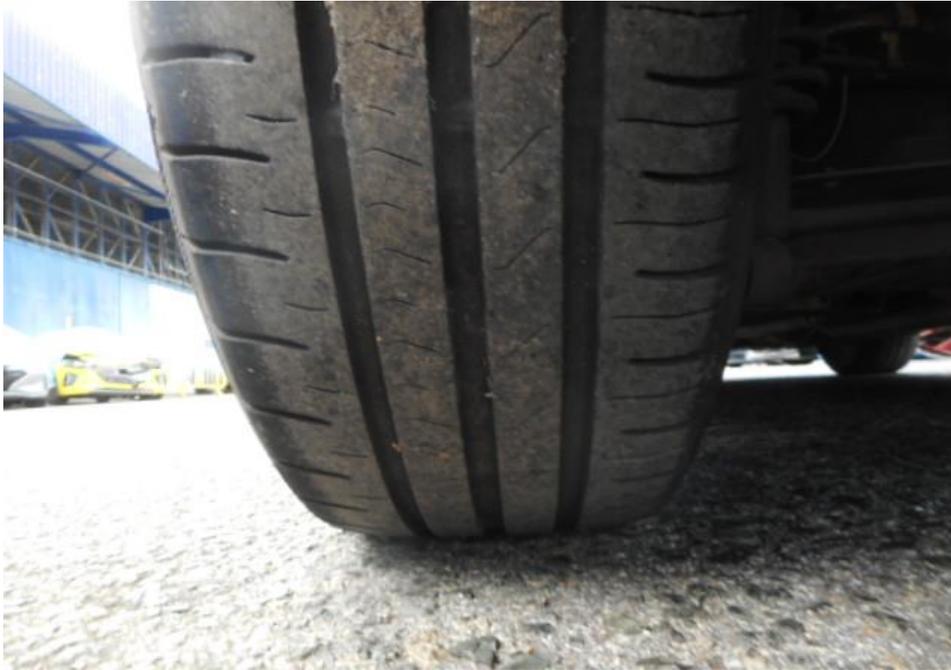
Photo 10 shows the condition of the rear left tyre of the Police Car, which was observed to be in serviceable condition with remaining tread depth of approximately 4.3mm. The tyre, which was wrapped around alloy wheel rim, was also observed to be sufficiently inflated for vehicular operation. The 4 tyres of the Police Car were wrapped around standard alloy wheel rims.

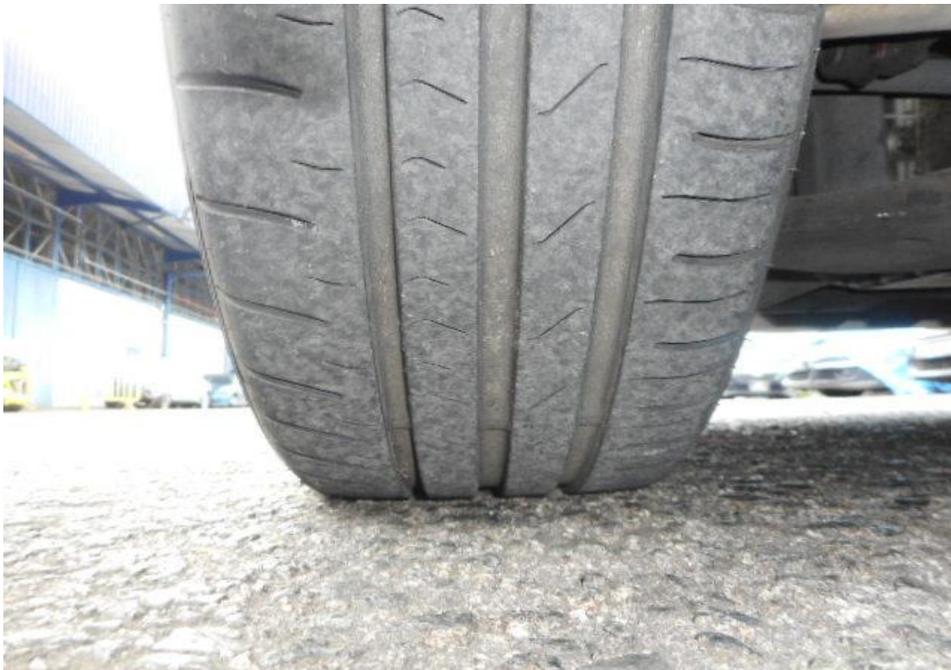
Photo 11 shows the condition of the front left tyre of the Police Car, which was observed to be in serviceable condition with remaining tread depth of approximately 4.3mm. There was also no tear, cut or burst mark(s) on the outer and the inner sidewalls as well as across the tread of the Police Car's 4 tyres.

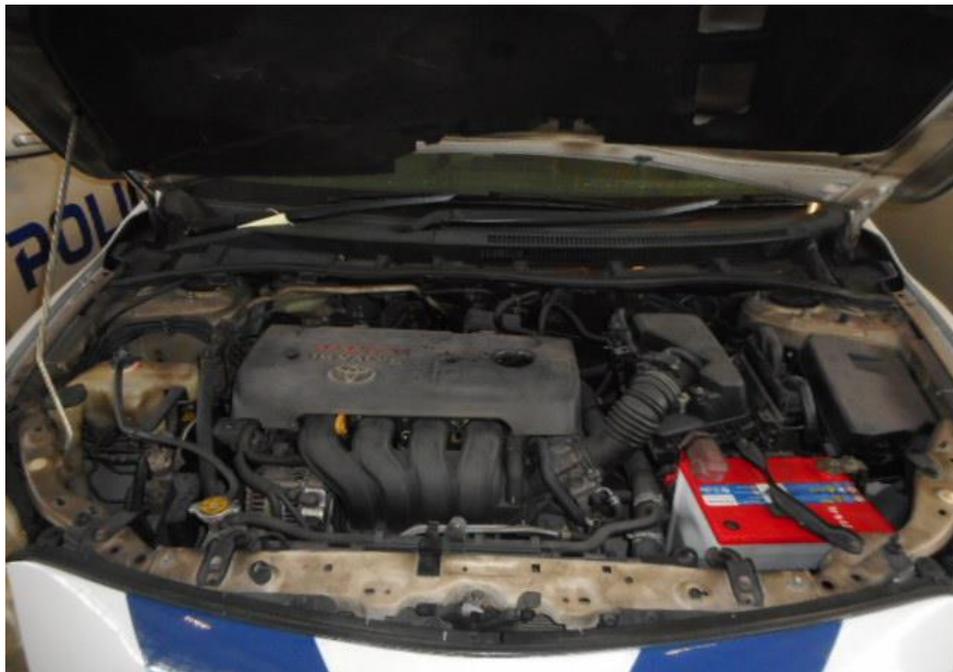
Photo 12 shows a general view of the Police Car's engine compartment. The various parts and components inside the engine compartment were unaffected by the accident. There was also no sign(s) or indication(s) of fluid leakage and/or fluid stain within the engine compartment.

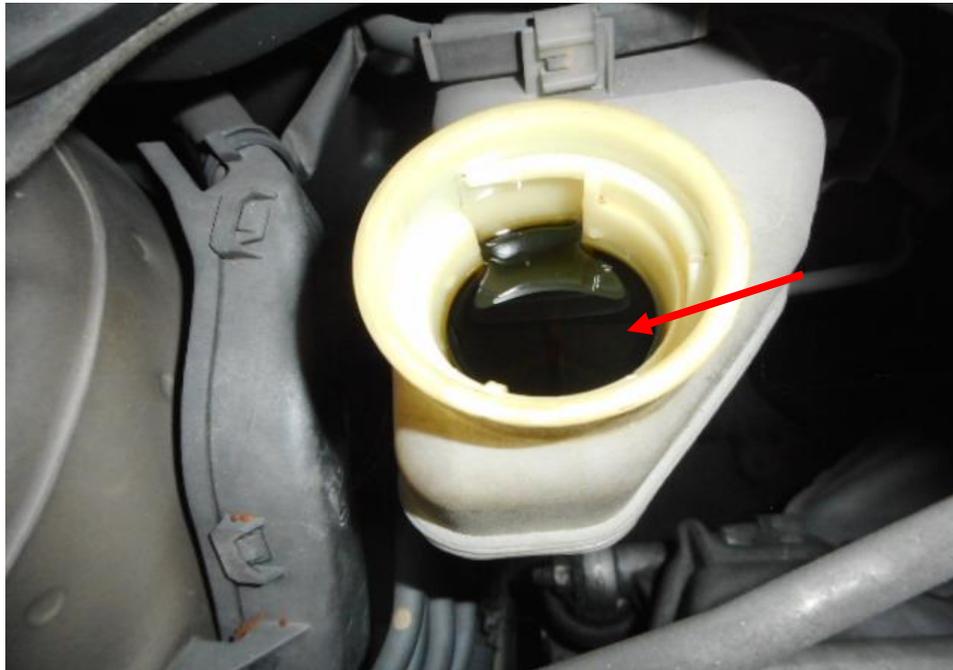
Photo 13 shows the brake fluid reservoir of the Police Car at the time of my inspection. The brake fluid was observed to be of sufficient level (arrowed) and without any visible contamination.

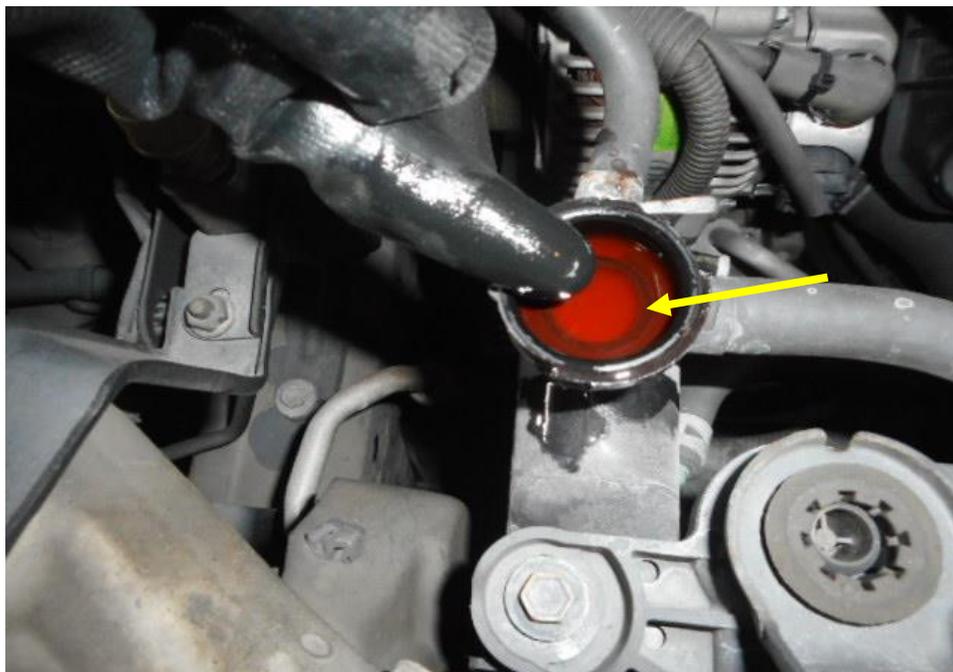
Photo 14 shows checks being carried out to the engine coolant of the Police Car at the time of my inspection. The engine coolant was observed to be of sufficient level (arrowed) and without any visible contamination.

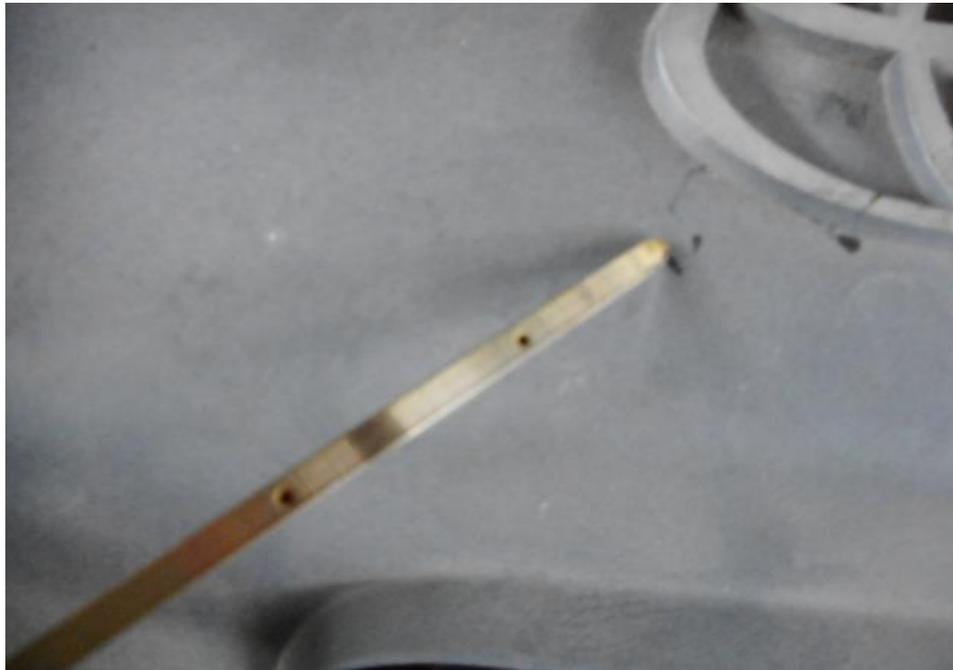
8. Upon examination of the engine compartment of the Police Car, I had observed all the parts and components inside the engine compartment to be intact and unaffected by the accident. The brake fluid and engine coolant were all found to be of sufficient level for operating purposes. Visually, there was also no contamination found to these fluids. However, the engine oil was observed to be insufficient level.

Photo 15 shows the engine oil level dipstick of the Police Car at the time of my inspection. The engine oil was observed to be of insufficient level.

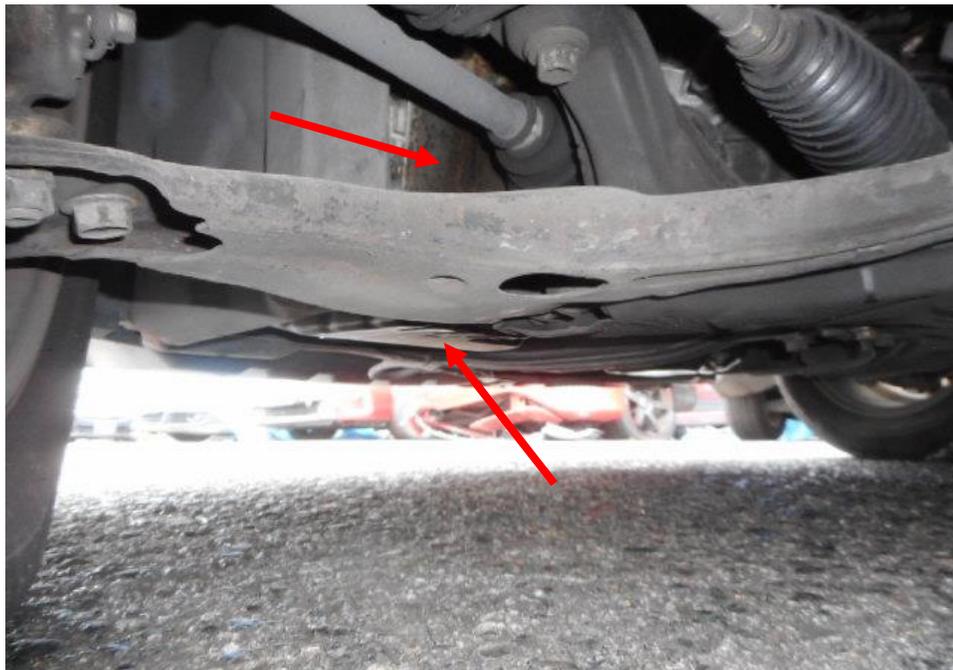
10. My subsequent checks on the underside of the Police Car had revealed engine oil leakage at the undercarriage of the Police Car which had contributed to the insufficient engine oil as shown on the engine oil dipstick. However, there no sign(s) or indication(s) of fluid leak and/or fluid stain(s) to other various undercarriage components of the Police Car and were all observed to be intact and without any visible damage. See photo 12 – 16 below.

Photo 16 shows the undercarriage of the Police Car, at the area where the engine housing and transmission housing are located. I noticed engine oil leak and fluid stain on the engine oil sump (arrowed) on the underside of the Police Car.

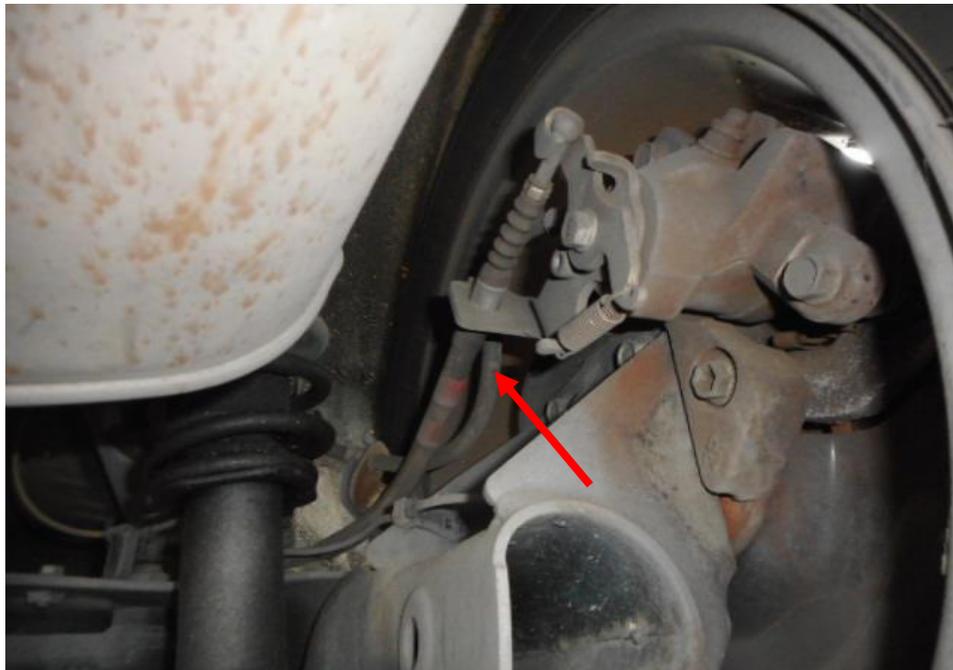
Photo 17 shows the brake hose/pipe (arrowed) at the rear right wheel of the Police Car. No leakage of brake fluid was observed. Visual examination of the various components of the braking system like the drum brake, brake booster, brake pedal etc. had revealed all to be intact and without visible damage.

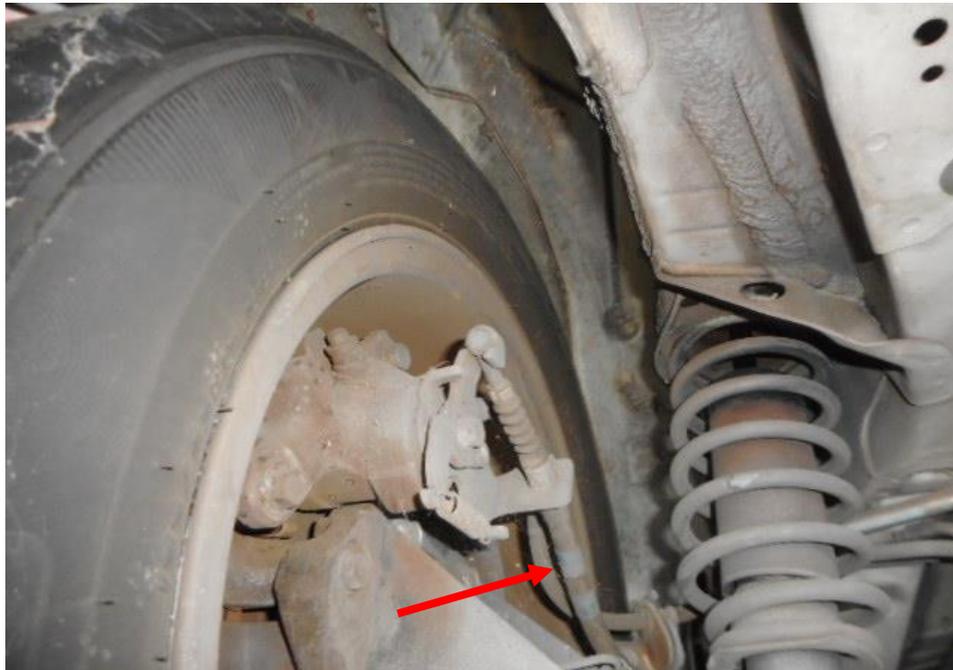
Photo 18 shows the brake hose/pipe (arrowed) at the rear left wheel of the Police Car. I did not observe any leakage of brake fluid at the time of my inspection of the Police Car. Static tests of the Police Car's braking system had indicated that there was no internal leakage of pressure/vacuum. The undercarriage components of the Police Car were also all found to be intact and without any visible damage.

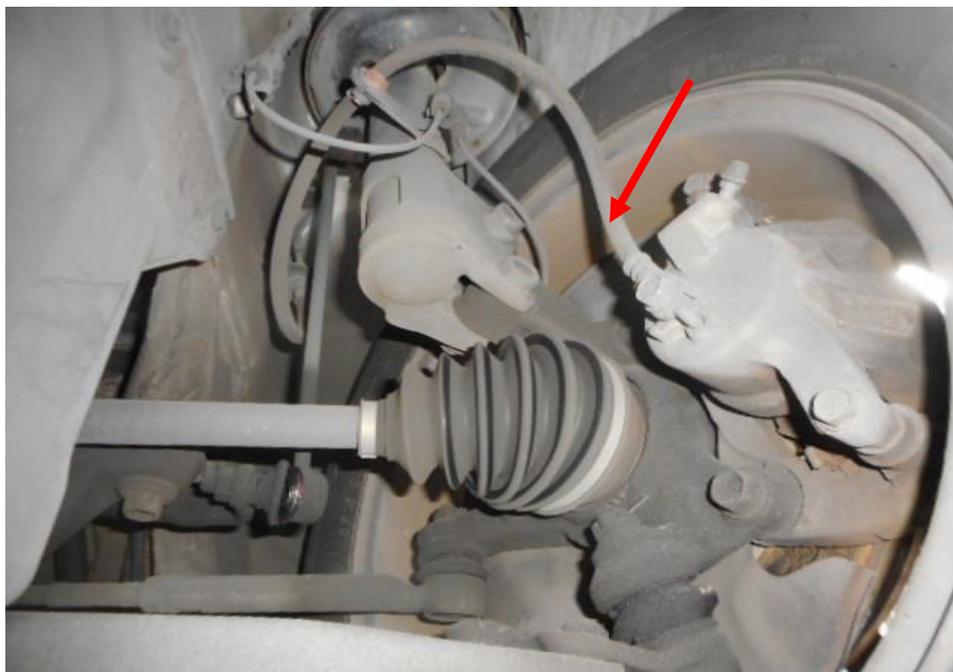
Photo 19 shows the brake hose/pipe (arrowed) at the front right wheel of the Police Car. I did not observe any leakage of brake fluid at the time of my inspection of the Police Car. Static tests of the Police Car's braking system had indicated that there was no internal leakage of pressure/vacuum.

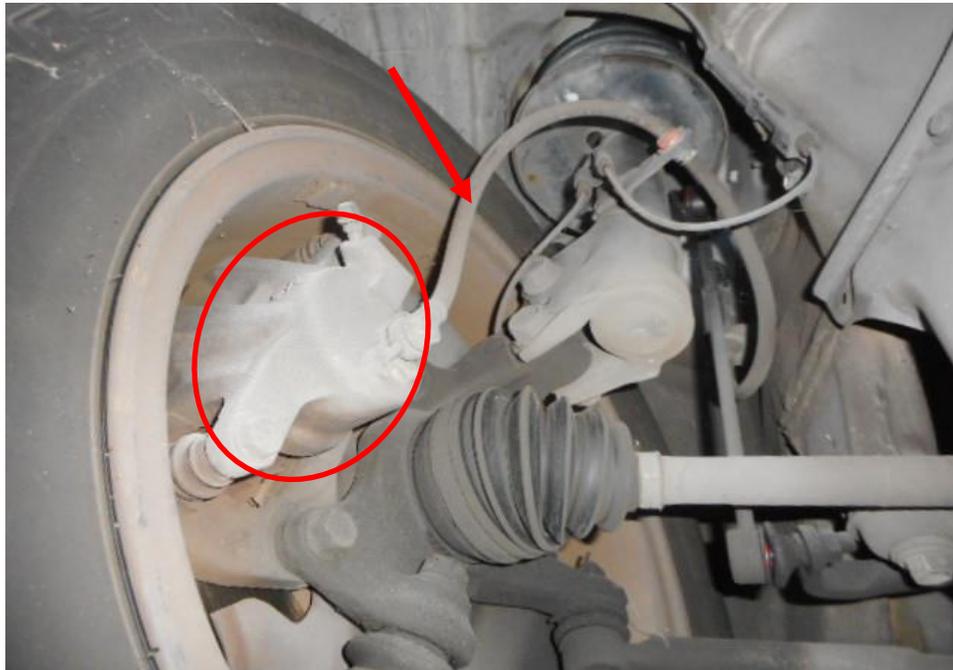
Photo 20 shows the brake hose/pipe (arrowed) at the front left wheel of the Police Car. No leakage of brake fluid was observed. Visual examination of the various components of the braking system like the brake caliper (circled), brake booster, brake pedal etc had revealed all to be intact and without visible damage.

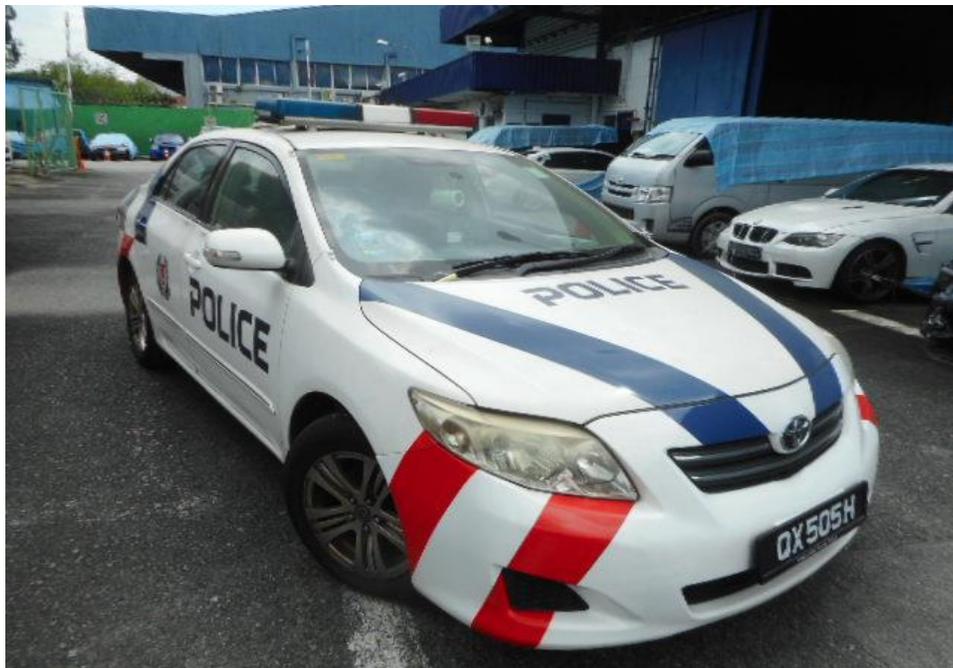
Photo 21 shows the front right wheel of the Police Car turned to its full left. During my steering system test, I did not experience any abnormal free play and/or resistance when I had turned the steering wheel towards the left and right. This would suggest that the steering system of the Police Car was likely to be in serviceable condition at the material time of accident.

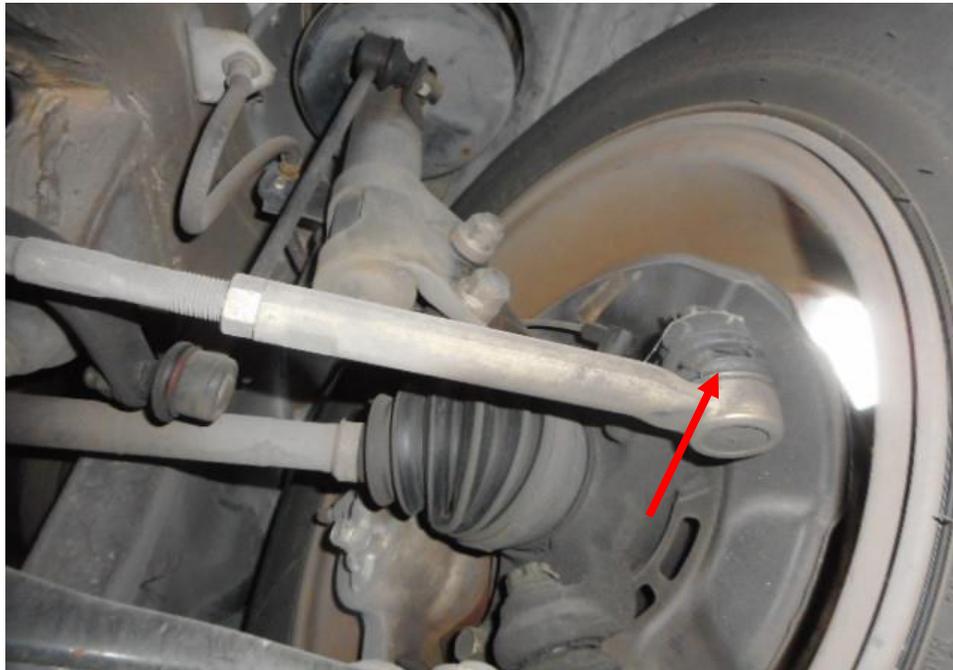
Photo 22 shows the various undercarriage components at the front right wheel of the Police Car, in particular the steering tie rod (red arrow). The various steering components were all found to be intact, suggesting that the steering system of the Police Car was likely to be in serviceable condition at the material time of accident. There was also no sign of fluid stain observed on the various undercarriage components at the front right wheel of the Police Car.

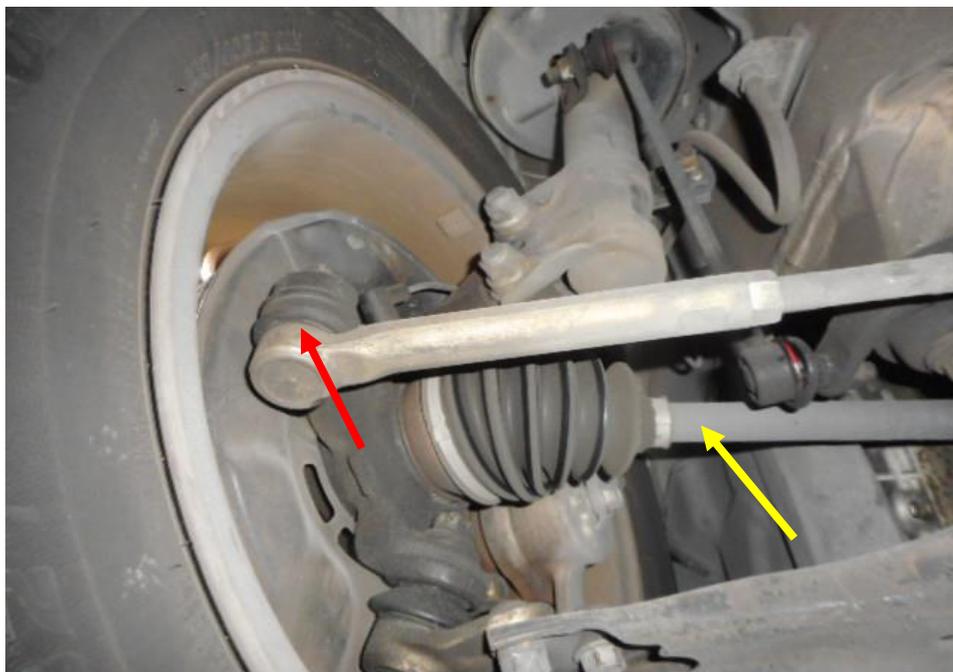
Photo 23 shows the various undercarriage components at the front left wheel of the Police Car, which had included the steering tie rod (arrowed) and in particular the drive shaft (yellow arrow). The various undercarriage components of the Police Car were all found to be intact without any visible damage.

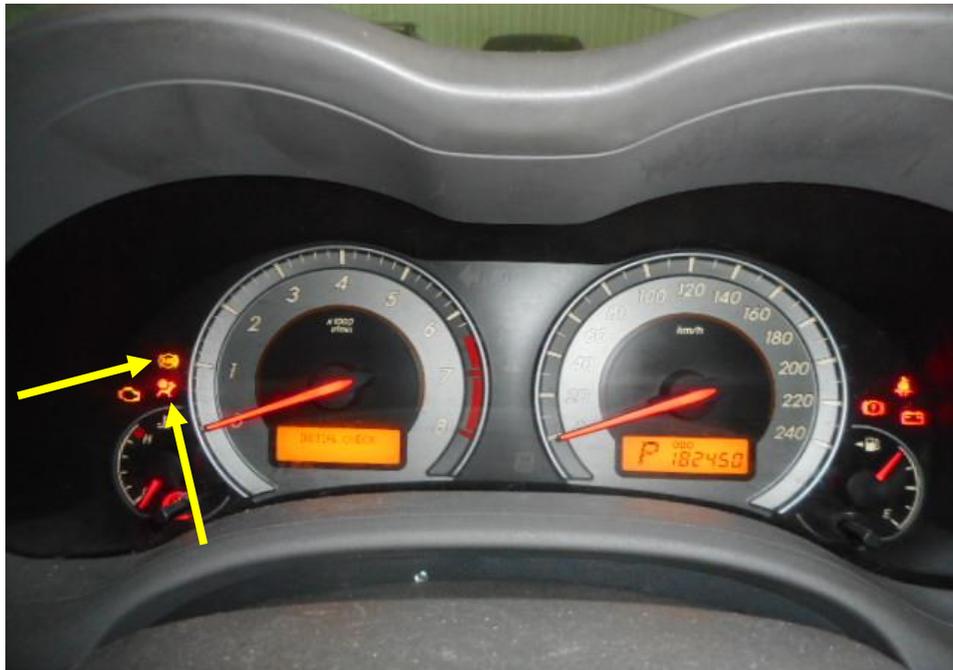
Photo 24 shows the warning light for Anti-Lock Brake System (ABS) and Supplemental Restraint System (SRS) (arrowed) appearing on the instrument panel of the Police Car during the self-test of its various electronic operating systems when its engine was cranked.

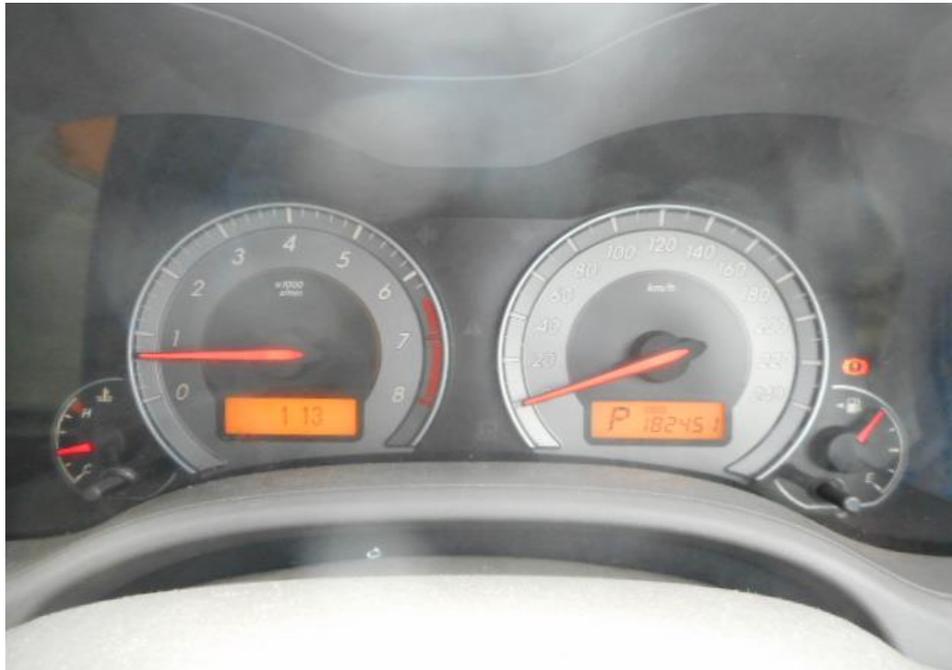
Photo 25 shows no warning lights illuminated on the instrument panel of the Police Car after the engine was cranked. This would suggest that there was no abnormality to the electronic operating system of the Police Car, like the ABS and SRS etc.
