You're Ref: TP/IP/32554/2022  
Our Ref: CI/TPD22013014/P

**Fatal Accident Investigation Team**

**MECHANICAL INSPECTION REPORT OF MOTOR TAXI SHA 9055H**

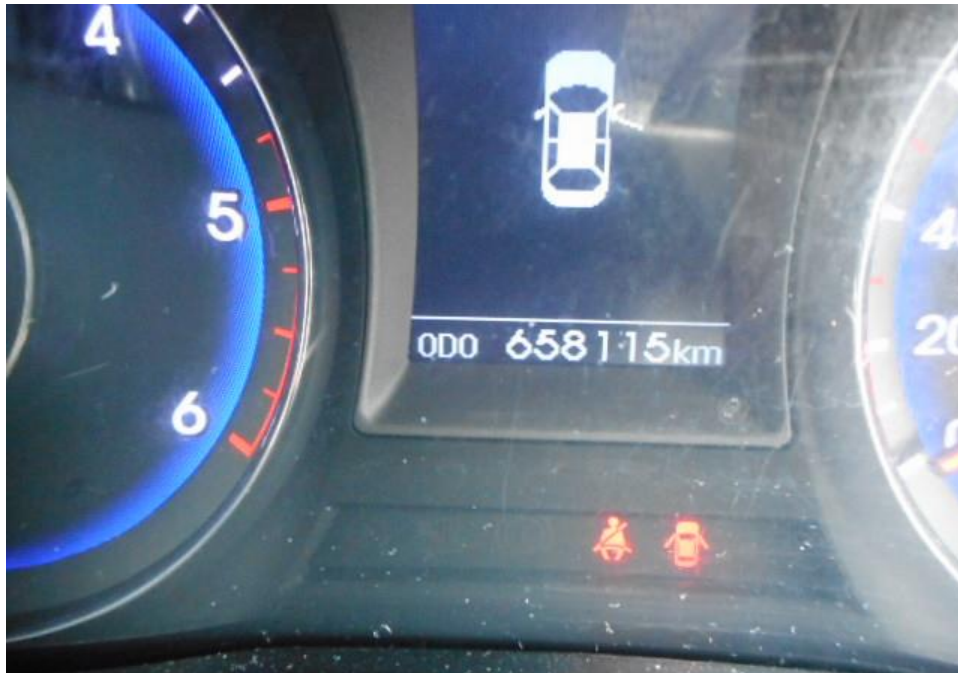
**Photo 1** shows the mileage of the Motor Taxi at the time of my inspection. The mileage observed was 658,115km.

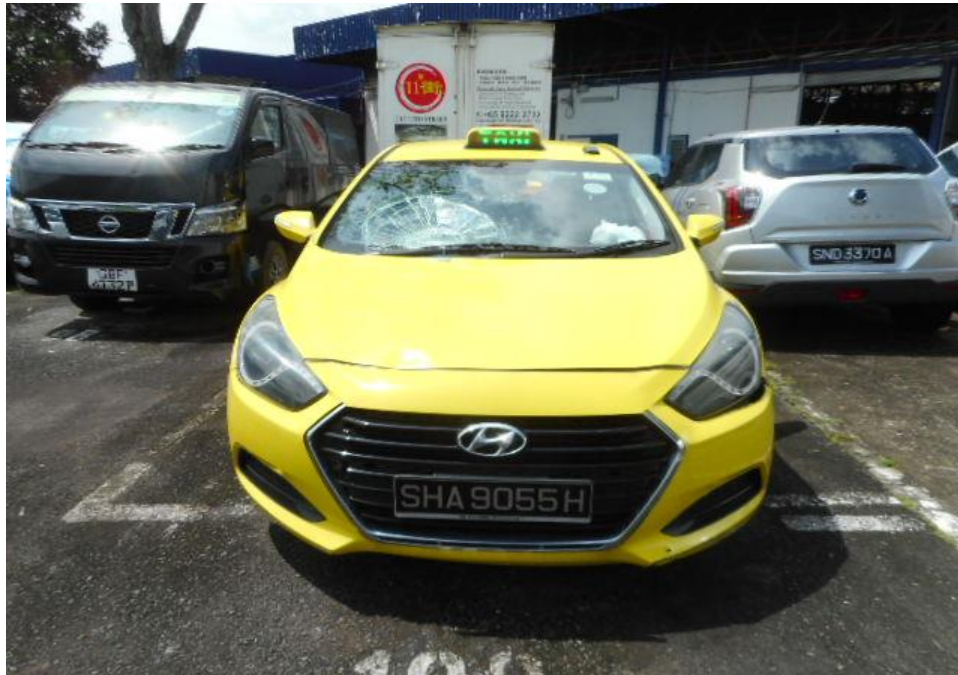
4. The mileage of the Motor Taxi at the time of my inspection was 658,115km.
5. The Motor Taxi was observed to have sustained damage at its front portion. Its front windscreen, front bonnet, front bumper and front grille was amongst the body parts that were damaged as a result of the accident.

**Photo 2** shows a general view of the Motor Taxi's front body at the time of my inspection. The front portion of the Motor Taxi was observed to have sustained damage. Its front windscreen, front bonnet, front bumper and front grille was amongst the body parts that were damaged as a result of the accident.

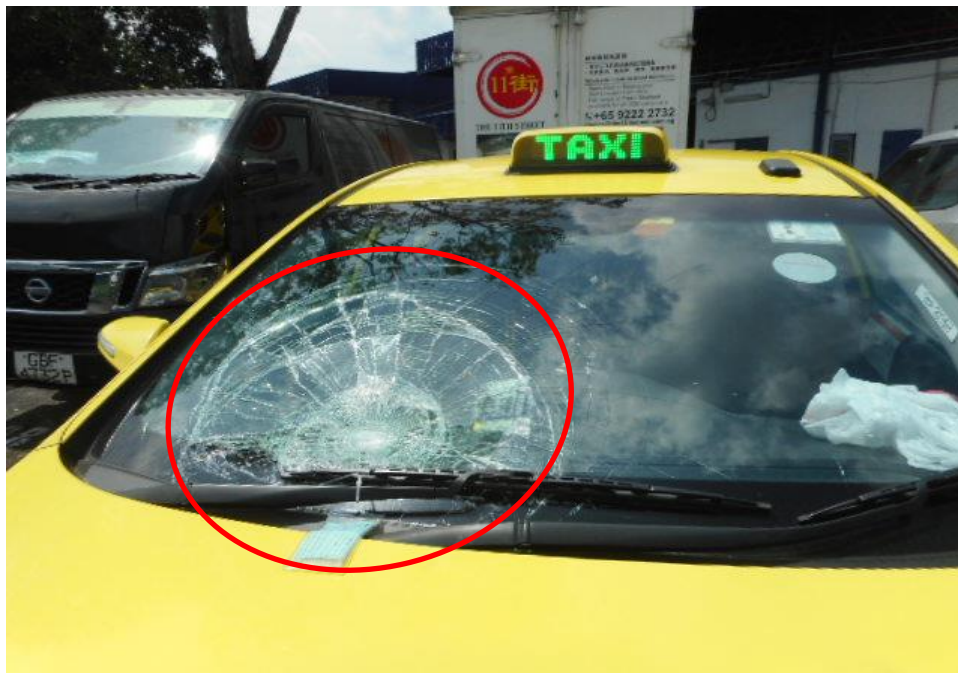
**Photo 3** shows a close up view of the Motor Taxi's front body at the time of my inspection. The front portion of the Motor Taxi was observed to have sustained damage. Its front windscreen (circled) was the body parts that were damaged as a result of the accident.

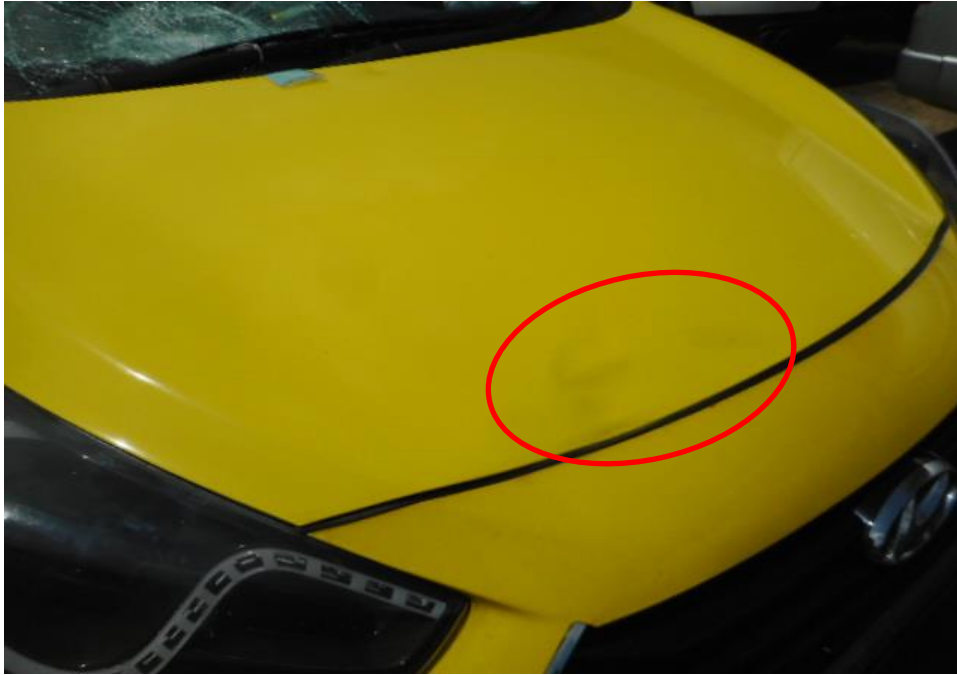
**Photo 4** shows a close up view of the Motor Taxi's front body at the time of my inspection. The front portion of the Motor Taxi was observed to have sustained damage. Its front bonnet (circled) was the body parts that were damaged as a result of the accident.

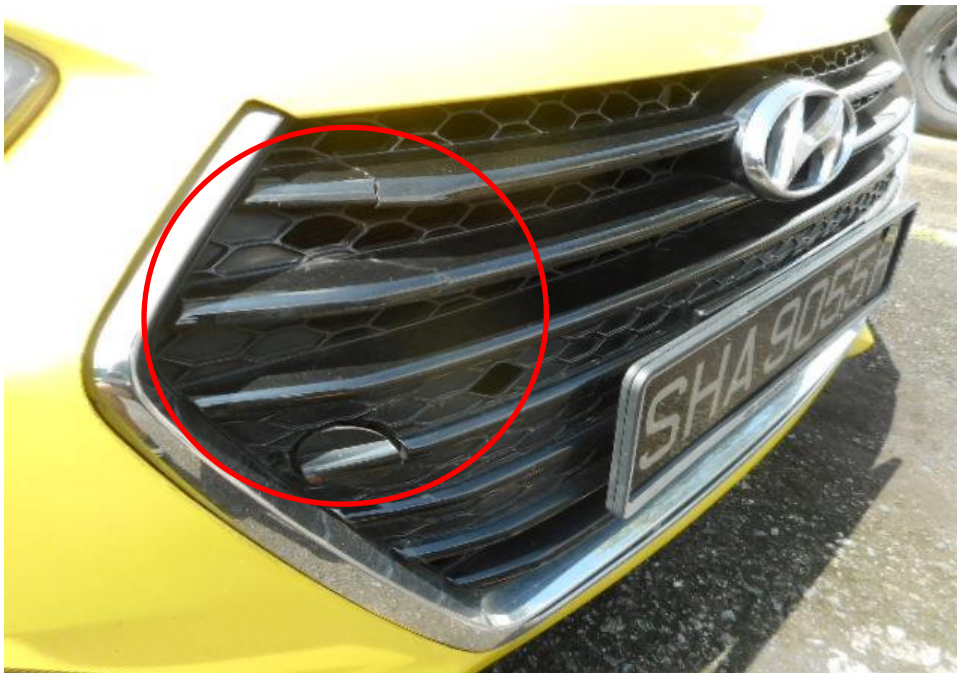
**Photo 5** shows a close up view of the Motor Taxi's front body at the time of my inspection. The front portion of the Motor Taxi was observed to have sustained damage. Its front grille (circled) was the body parts that were damaged as a result of the accident.

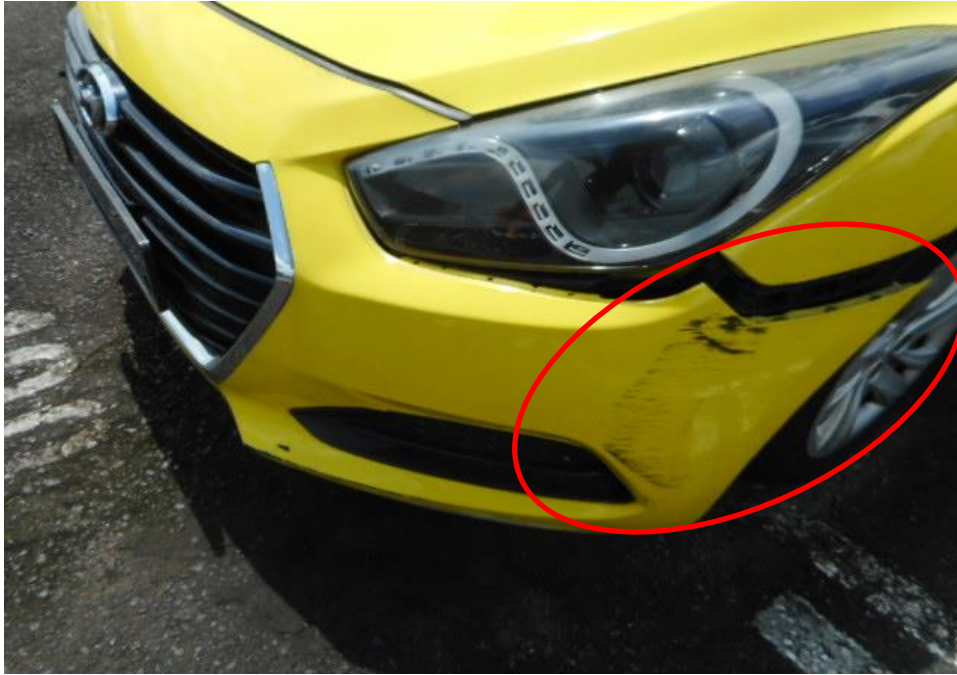
**Photo 6** shows a close up view of the Motor Taxi's front body at the time of my inspection. The front portion of the Motor Taxi was observed to have sustained damage. Its front bumper (circled) was the body parts that were damaged as a result of the accident.

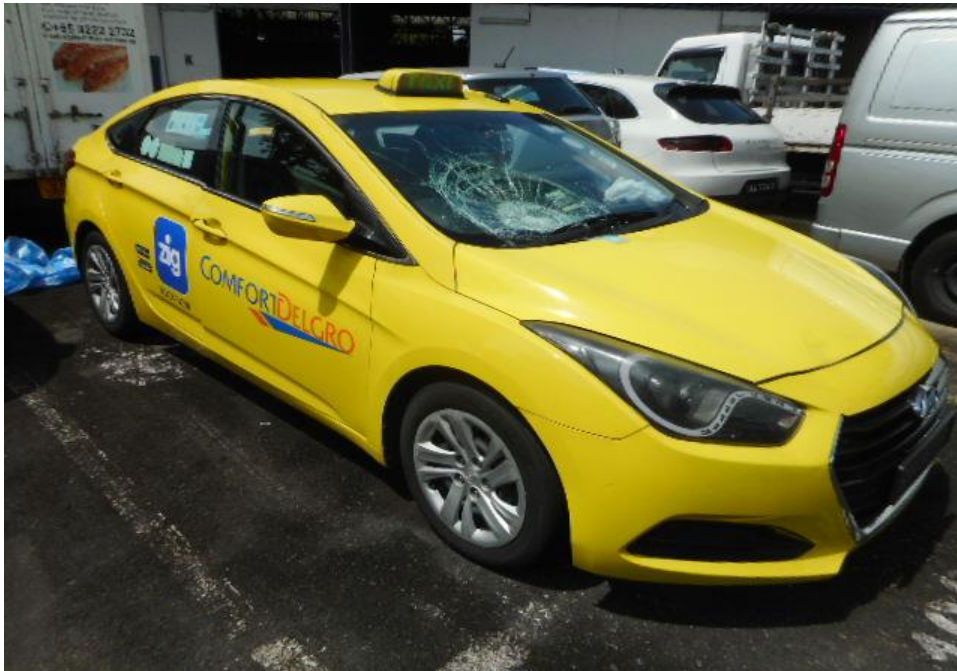
**Photo 7** shows a general view of the Motor Taxi's right body at the time of my inspection. The right portion of the Motor Taxi was observed to have been unaffected by the accident.

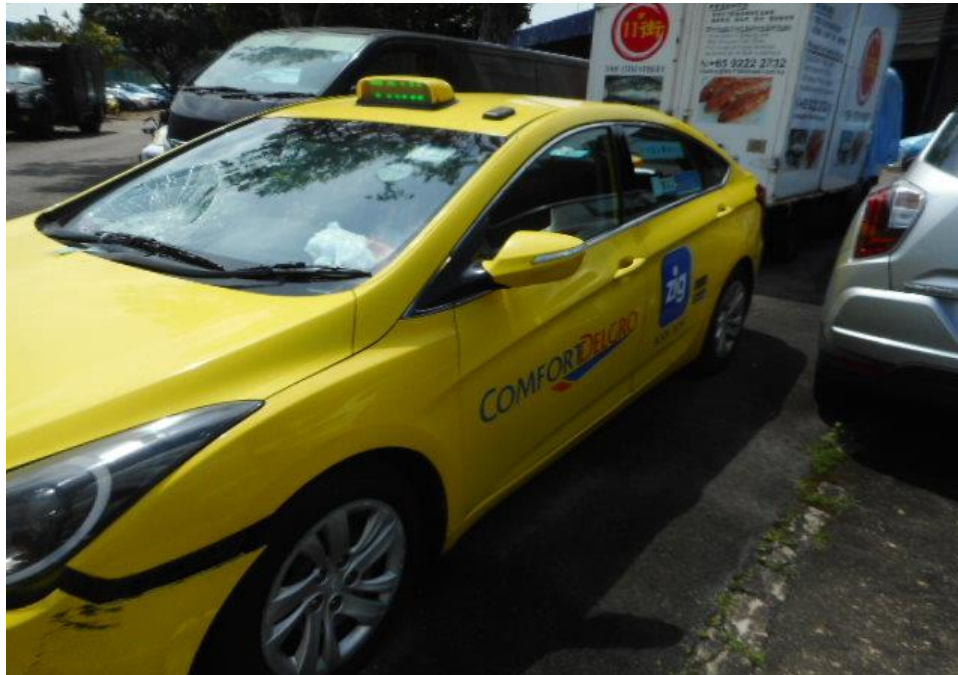
**Photo 8** shows a general view of the Motor Taxi's left body at the time of my inspection. The left portion of the Motor Taxi was observed to have been unaffected by the accident.

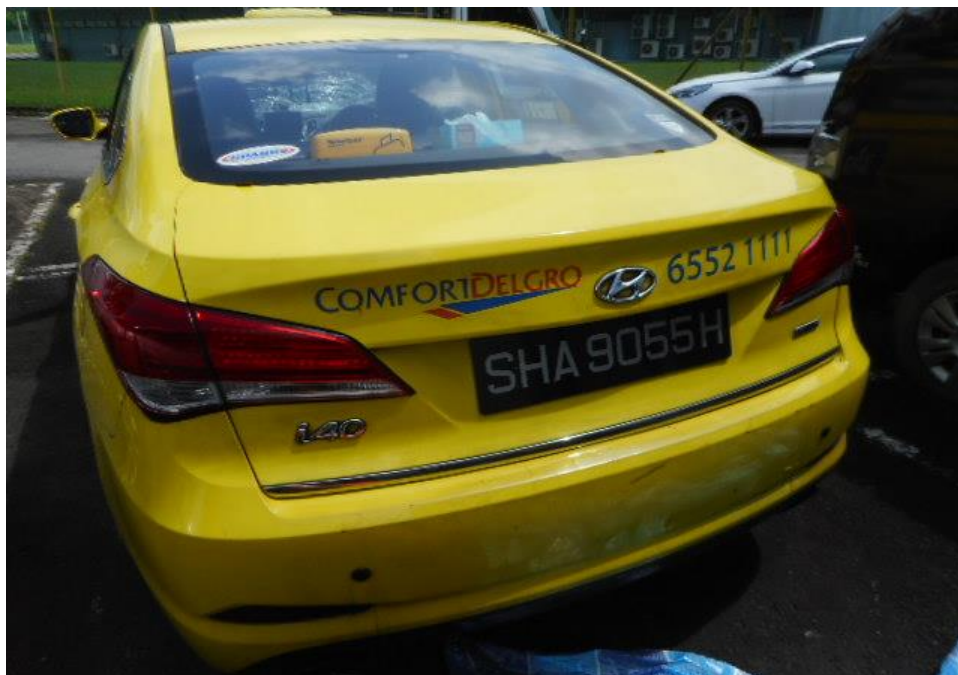
**Photo 9** shows the general view of the Motor Taxi's rear body at the time of my inspection. The Motor Taxi rear was observed to be unaffected by the accident.

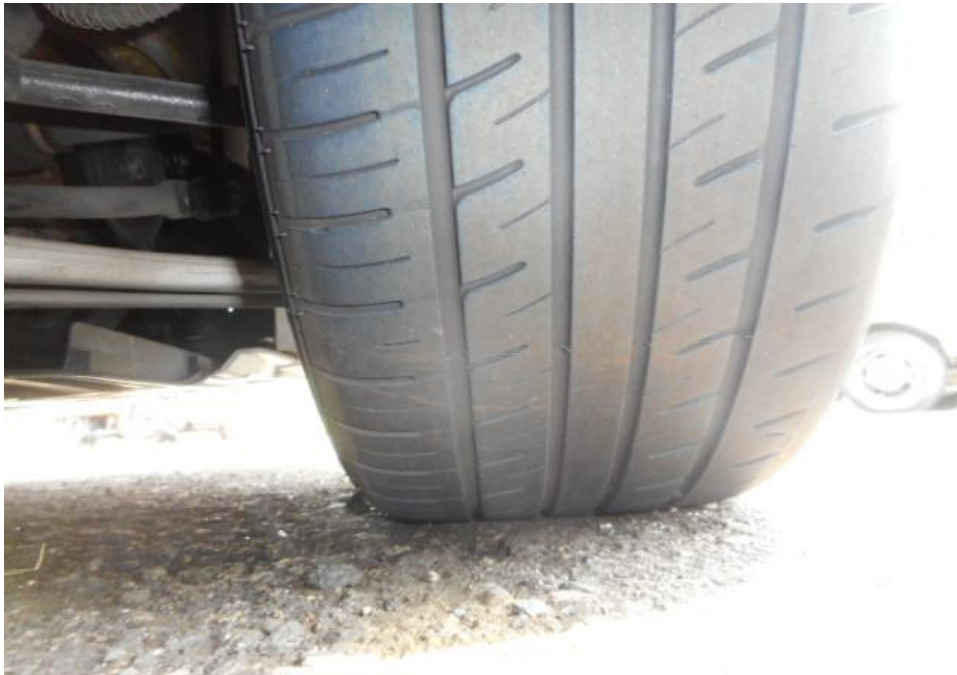
**Photo 10** shows the condition of the front right tyre of the Motor Taxi, which was observed to be in serviceable condition with remaining tread depth of approximately 3.2mm. The tyre was sufficiently inflated for vehicular operation with no tear, cut or burst mark(s) on the outer and the inner sidewalls as well as across the tread. The 4 tyres of the Motor Taxi were wrapped around standard steel wheel rims without any damage.

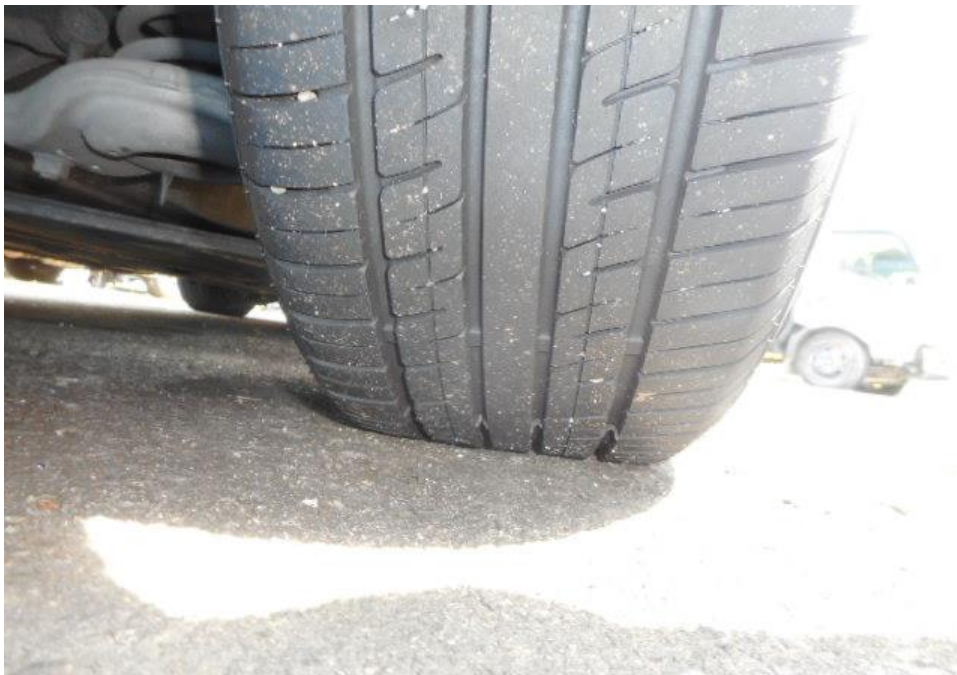
**Photo 11** shows the condition of the rear right tyre of the Motor Taxi, which was observed to be in serviceable condition with remaining tread depth of approximately 6.1mm. The tyre was also observed to be sufficiently inflated for vehicular operation with no tear, cut or burst mark(s).

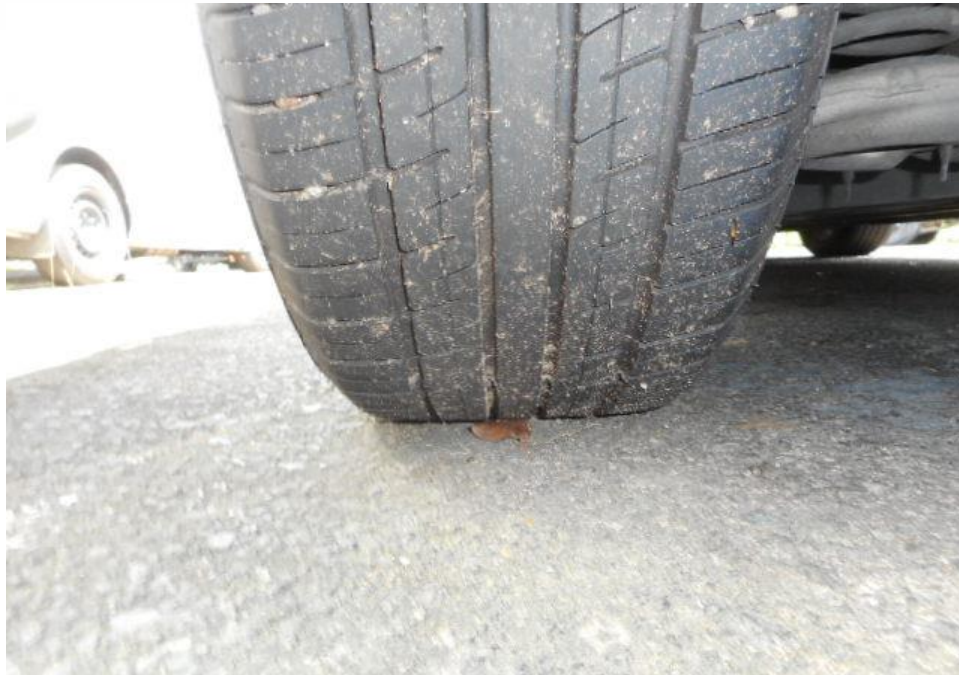
**Photo 12** shows the condition of the rear left tyre of the Motor Taxi, which was observed to be in serviceable condition with remaining tread depth of approximately 5.6mm. The tyre, which was wrapped around steel wheel rim, was also observed to be sufficiently inflated for vehicular operation. The 4 tyres of the Motor Taxi were wrapped around standard steel wheel rims.

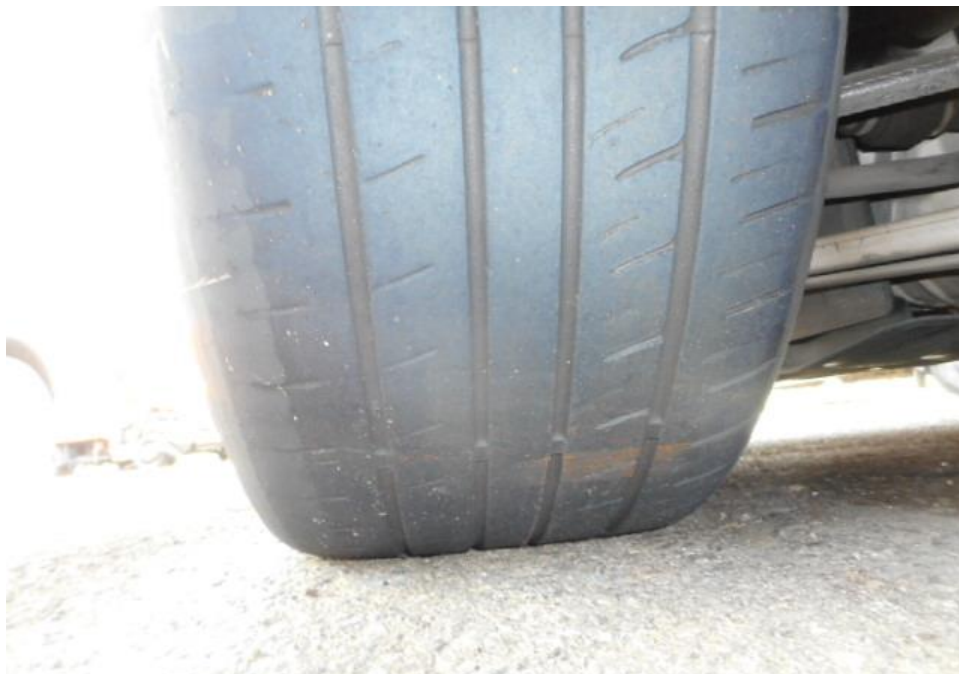
**Photo 13** shows the condition of the front left tyre of the Motor Taxi, which was observed to be in serviceable condition with remaining tread depth of approximately 2.4mm. There was also no tear, cut or burst mark(s) on the outer and the inner sidewalls as well as across the tread of the Motor Taxi's 4 tyres.

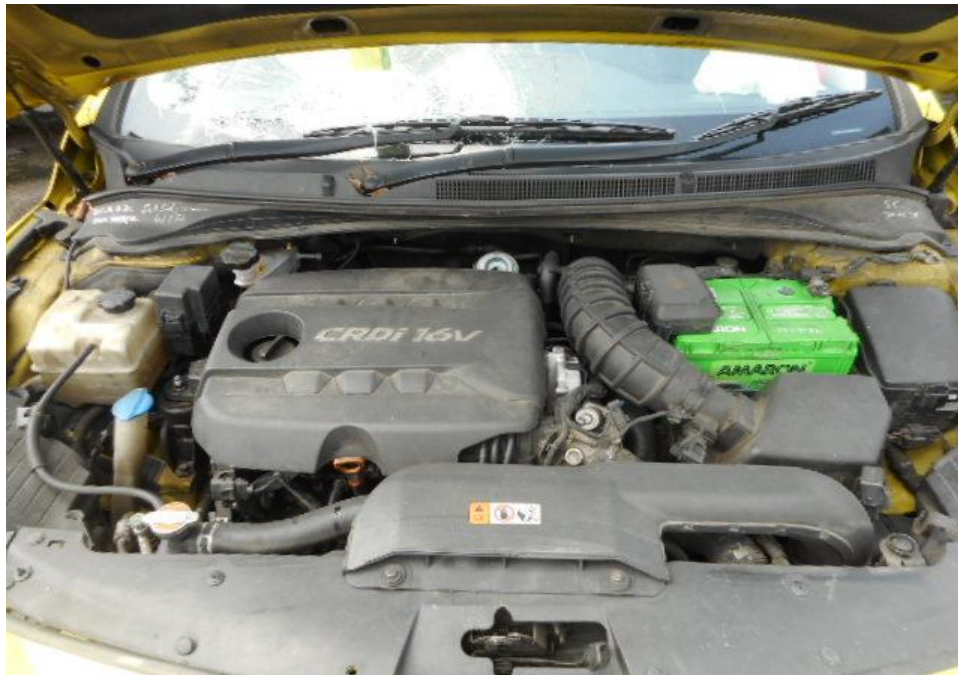
**Photo 14** shows a general view of the Motor Taxi's engine compartment. The various parts and components inside the engine compartment were unaffected by the accident. There was also no sign(s) or indication(s) of fluid leakage and/or fluid stain within the engine compartment.

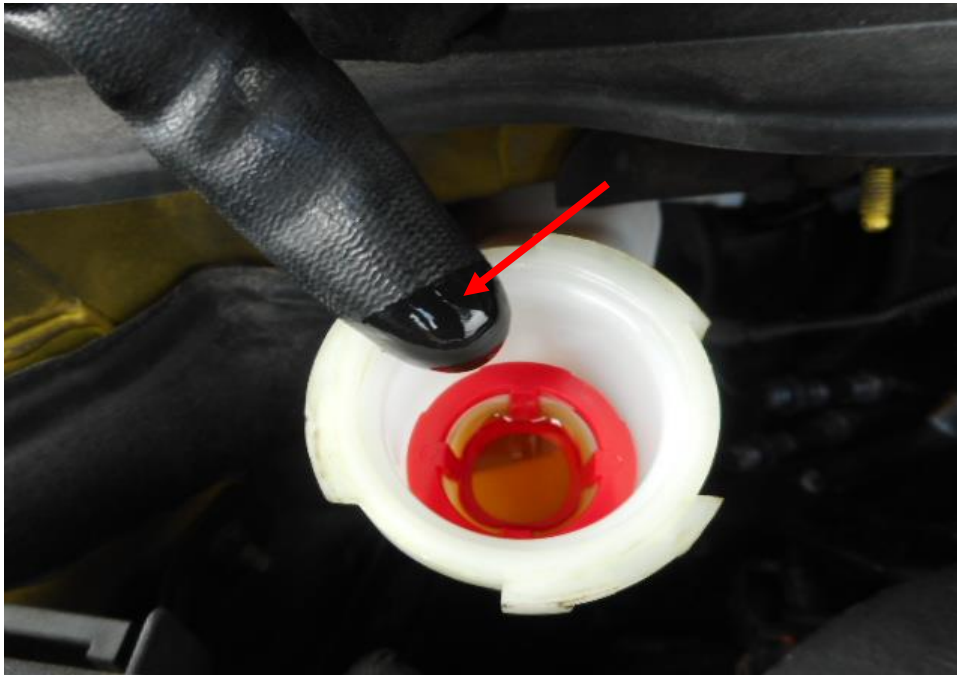
**Photo 15** shows the brake fluid reservoir of the Motor Taxi at the time of my inspection. The brake fluid was observed to be of sufficient level (arrowed) and without any visible contamination.

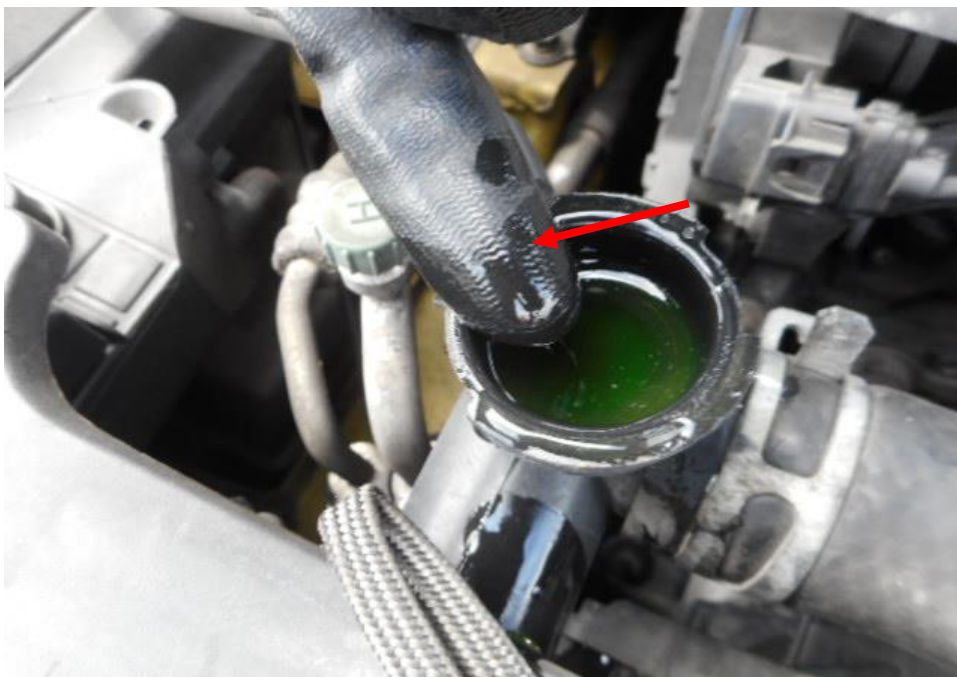
**Photo 16** shows checks being carried out to the engine coolant of the Motor Taxi at the time of my inspection. The engine coolant was observed to be of sufficient level (arrowed) and without any visible contamination.

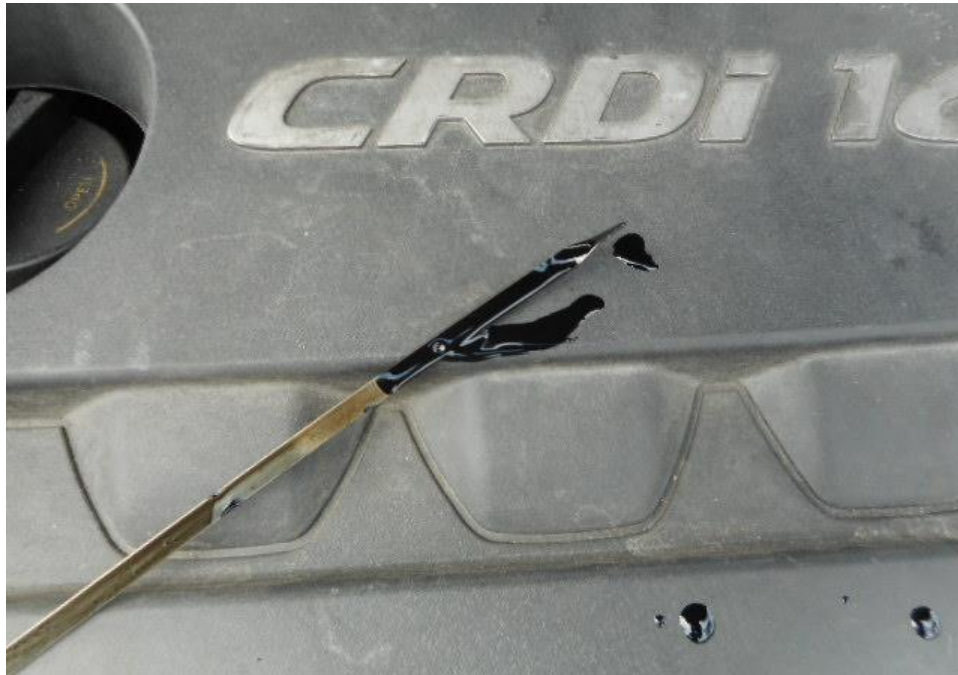
**Photo 17** shows the engine oil dipstick of the Motor Taxi at the time of my inspection. The engine oil was observed to be of sufficient level and without any visible contamination.

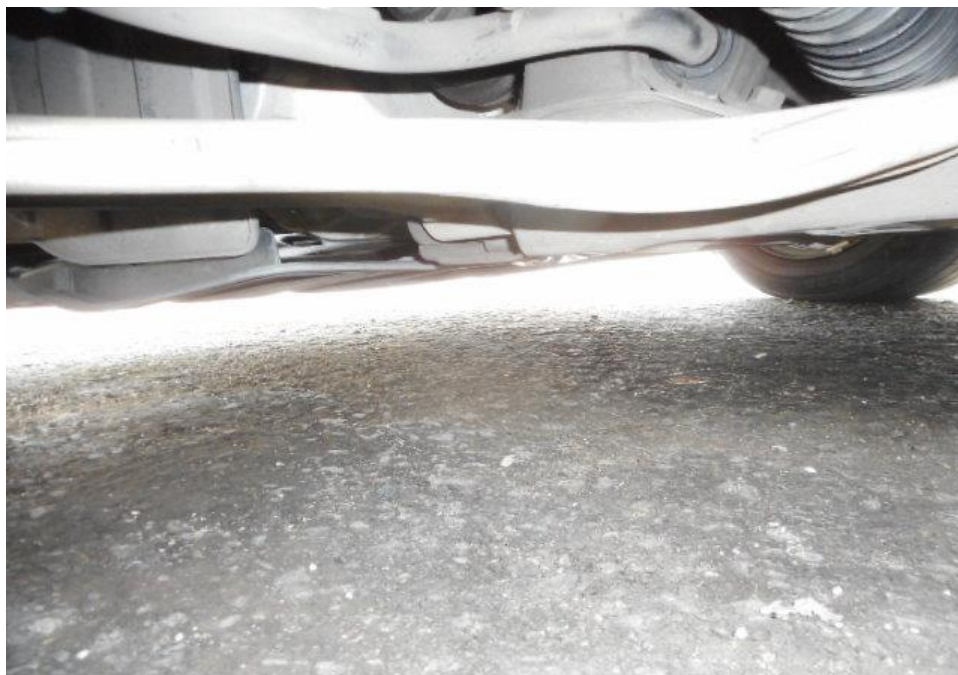
**Photo 18** shows the undercarriage of the Motor Taxi, at the area where the engine housing and transmission housing are located. I did not find any sign(s) or indication(s) of fluid leak and/or fluid stain(s) on the underside of the Motor Taxi.

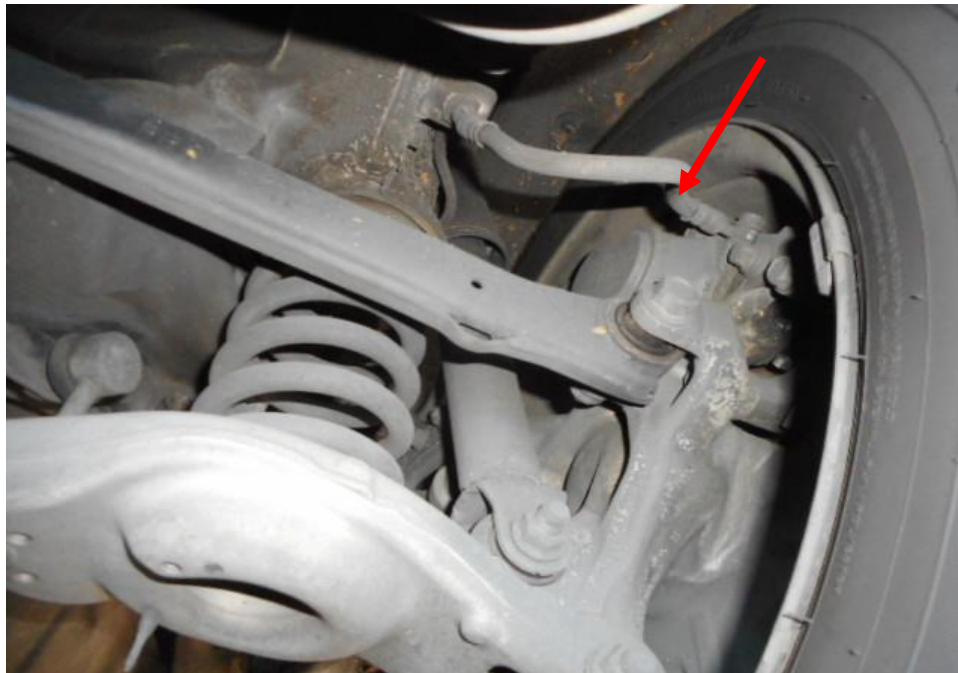
**Photo 19** shows the brake hose/pipe (arrowed) at the rear right wheel of the Motor Taxi. No leakage of brake fluid was observed. Visual examination of the various components of the braking system like the drum brake, brake booster, brake pedal etc. had revealed all to be intact and without visible damage.

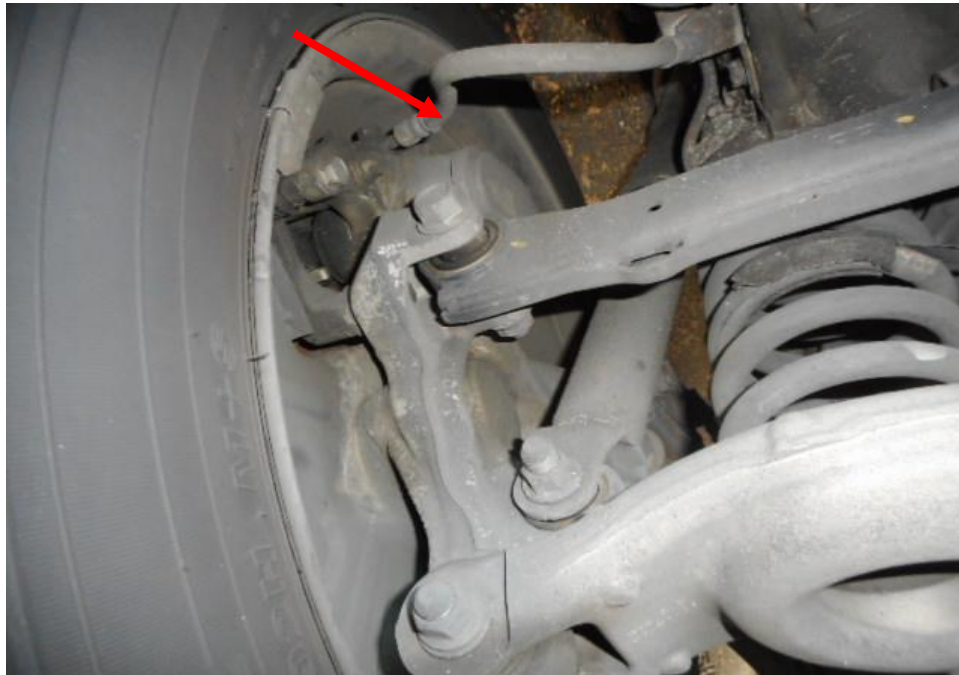
**Photo 20** shows the brake hose/pipe (arrowed) at the rear left wheel of the Motor Taxi. I did not observe any leakage of brake fluid at the time of my inspection of the Motor Taxi. Static tests of the Motor Taxi's braking system had indicated that there was no internal leakage of pressure/vacuum. The undercarriage components of the Motor Taxi were also all found to be intact and without any visible damage.

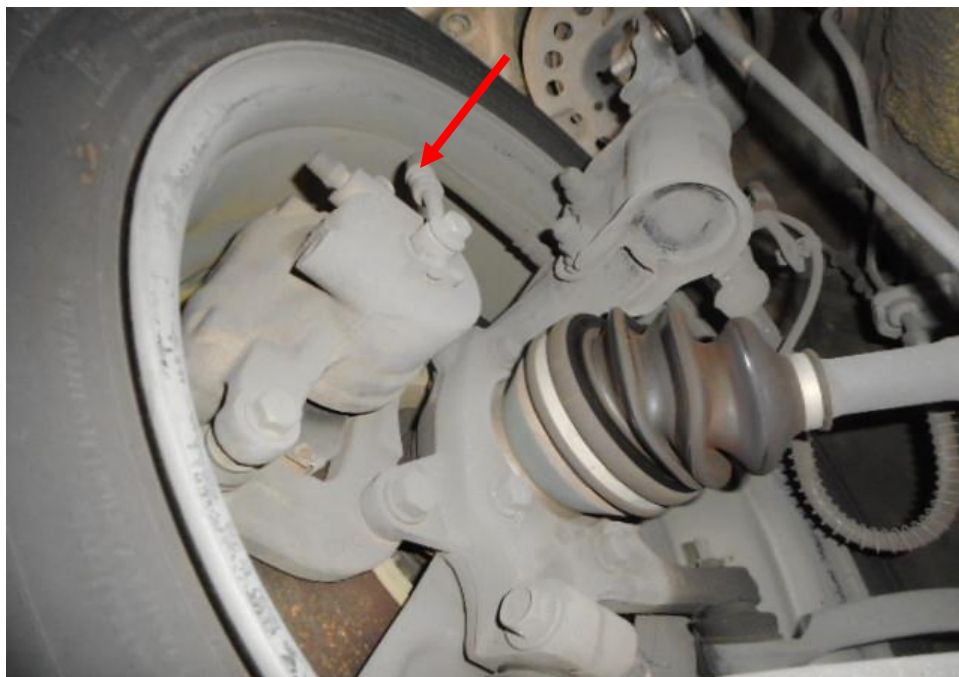
**Photo 21** shows the brake hose/pipe (arrowed) at the front right wheel of the Motor Taxi. I did not observe any leakage of brake fluid at the time of my inspection of the Motor Taxi. Static tests of the Motor Taxi's braking system had indicated that there was no internal leakage of pressure/vacuum. The undercarriage components of the Motor Taxi were also all found to be intact and without any visible damage.

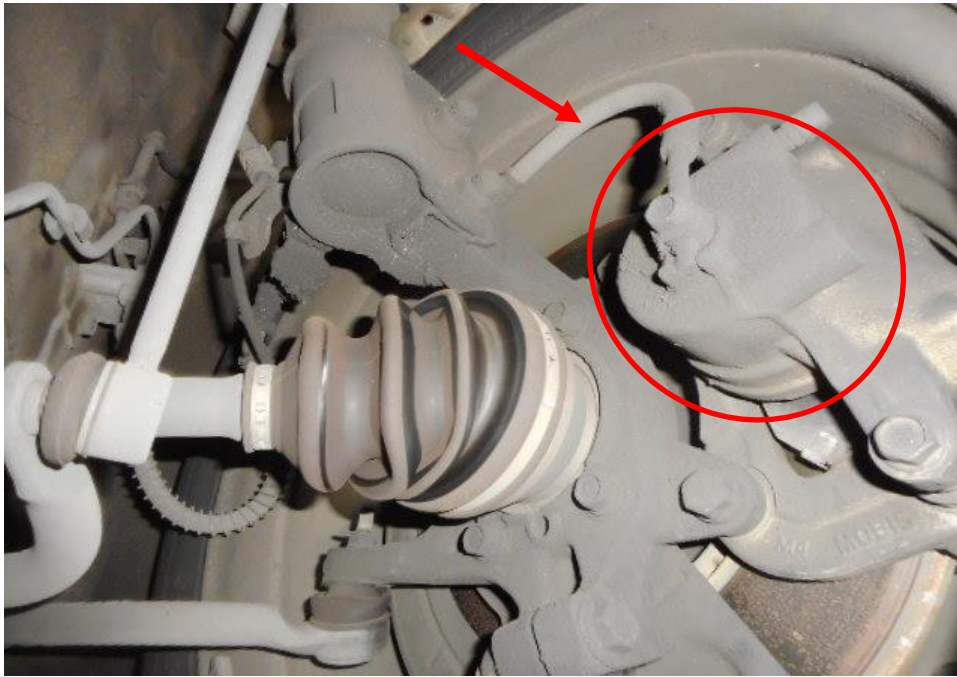
**Photo 22** shows the brake hose/pipe (arrowed) at the front left wheel of the Motor Taxi. No leakage of brake fluid was observed. Visual examination of the various components of the braking system like the brake caliper (circled), brake booster, brake pedal etc had revealed all to be intact and without visible damage.

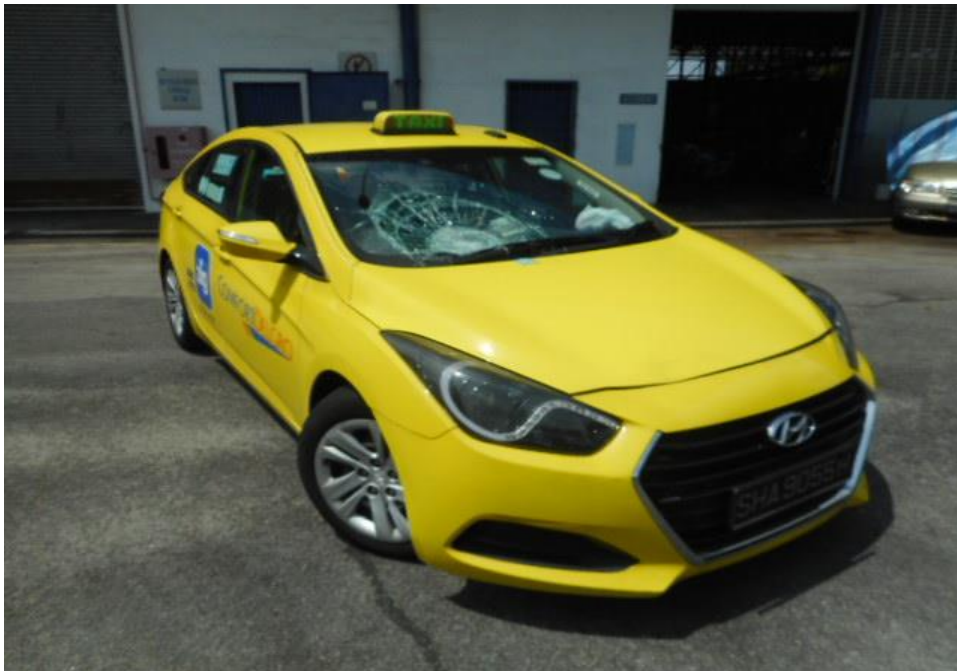
**Photo 23** shows the front right wheel of the Motor Taxi turned to its full left. During my steering system test, I did not experience any abnormal free play and/or resistance when I had turned the steering wheel towards the left and right. This would suggest that the steering system of the Motor Taxi was likely to be in serviceable condition at the material time of accident.

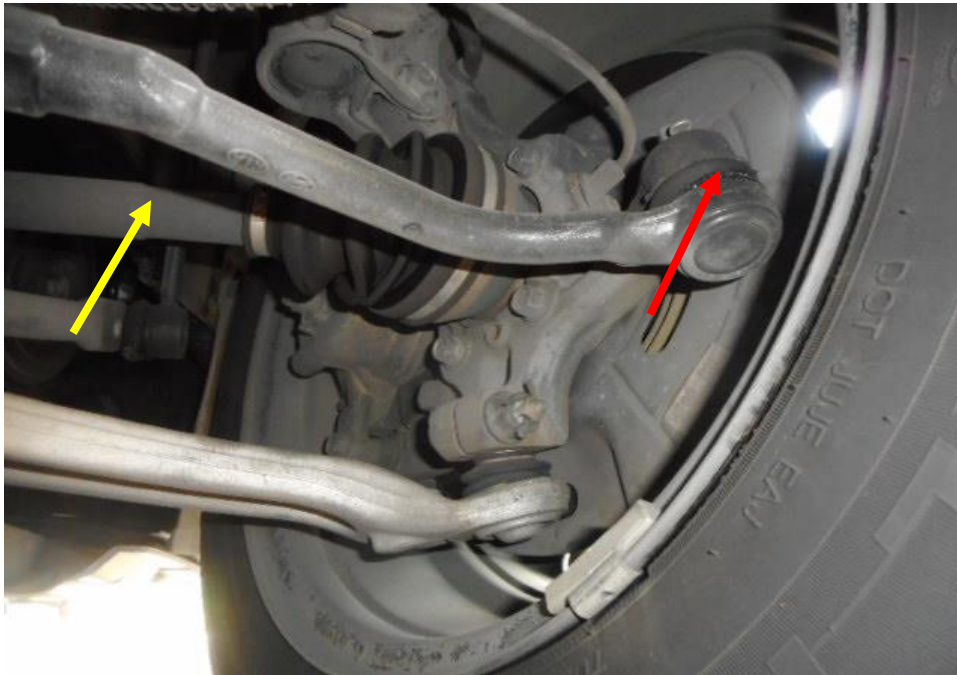
**Photo 24** shows the various undercarriage components at the front right wheel of the Motor Taxi, in particular the steering tie rod (red arrow) and drive shaft (yellow arrow). The various steering components were all found to be intact, suggesting that the steering system of the Motor Taxi was likely to be in serviceable condition at the material time of accident. There was also no sign of fluid stain observed on the various undercarriage components at the front right wheel of the Motor Taxi.

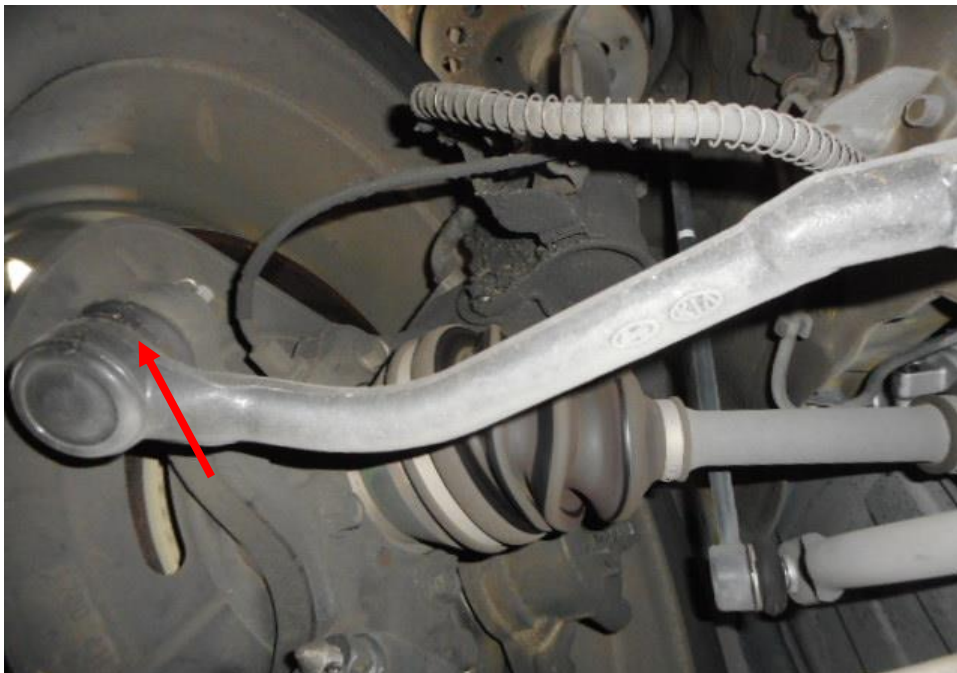
**Photo 25** shows the various undercarriage components at the front left wheel of the Motor Taxi, which had included the steering tie rod (red arrow). The various undercarriage components of the Motor Taxi were all found to be intact without any visible damage.

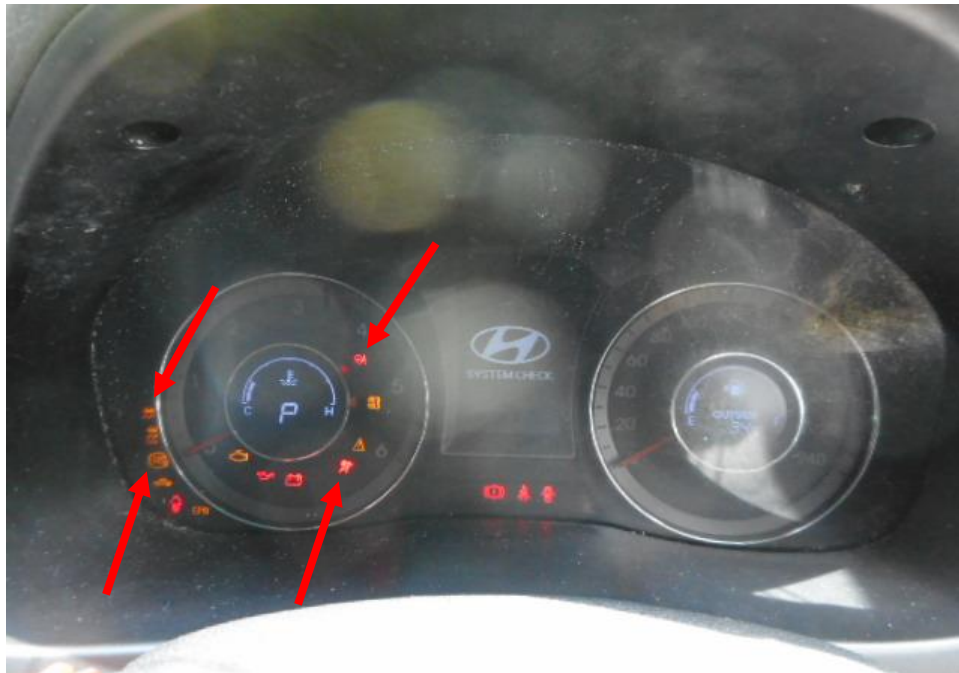
**Photo 26** shows the warning light for Anti-Lock Brake System (ABS), Electric Power Steering System (EPS), Traction Control System (TCS) and Supplemental Restraint System (SRS) (arrowed) appearing on the instrument panel of the Motor Taxi during the self-test of its various electronic operating systems when its engine was cranked.

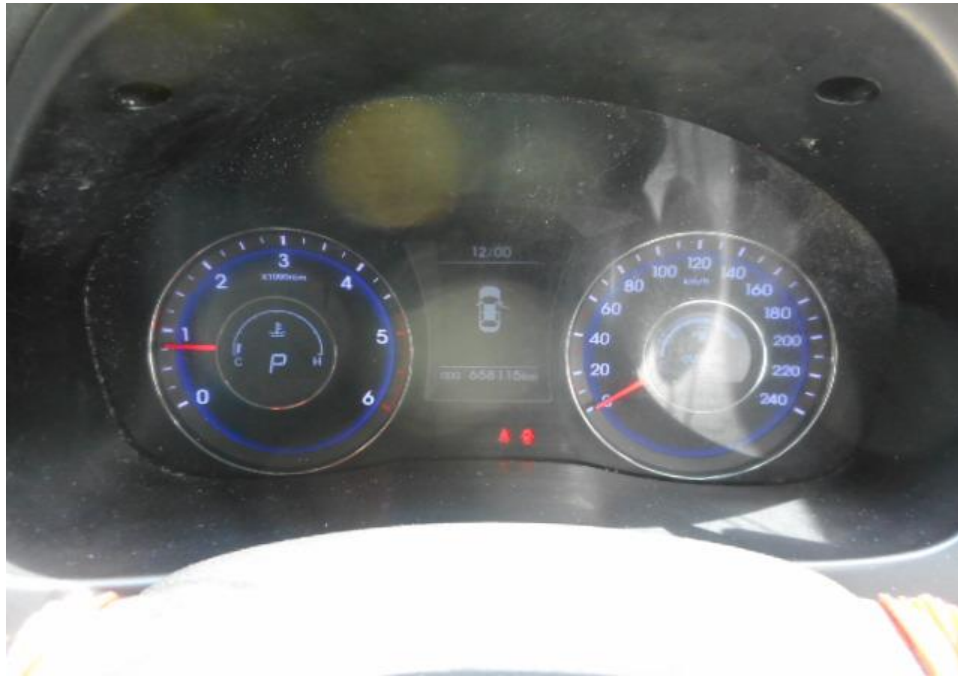
**Photo 27** shows no warning lights illuminated on the instrument panel of the Motor Taxi after the engine was cranked. This would suggest that there was no abnormality to the electronic operating system of the Motor Taxi, like the ABS, EPS, TCS and SRS etc.
