Your Ref: Rolls Royce Wraith  
(chassis number SCAXZ0200LUH25798)  
Our Ref : CI/TP22013016/D

**INSPECTION REPORT OF AN UNREGISTERED ROLLS ROYCE WRAITH  
MOTOR CAR WITH CHASSIS NUMBER SCAXZ0200LUH25798**

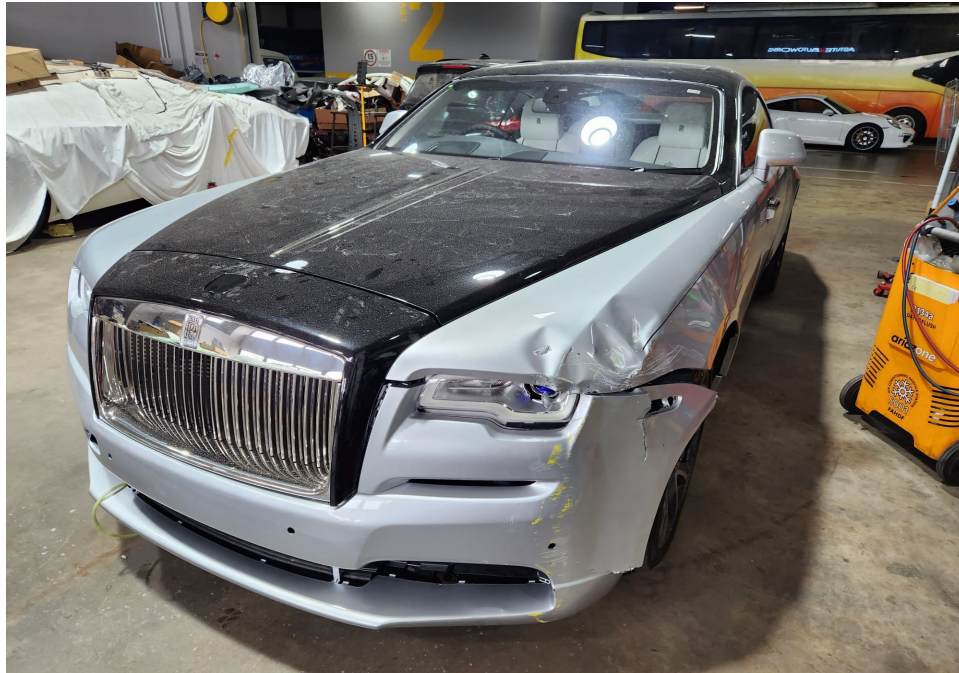
3. The photographs provided to me had showed damage to the front left portion of the Motor Car. Body parts damaged include the front bumper, front bumper left reflector, front left headlamp, front left fender and front bonnet amongst others.
4. The front bumper sensors, front bumper left lower chrome moulding, front bumper right lower chrome moulding, front bumper tow cover, front left day light, front right day light, front bonnet emblem and front left fender emblem were observed to be missing/dislodged/damaged.
5. Apart for the front left portion, there was no physical damage observed to other areas of the Motor Car. The airbag(s) of the Motor Car was not deployed as seen from the photographs that were provided to me. See photo 1 – 5 below.

**Photo 1** shows the front left body of the Motor Car (photograph provided to me). The photographs provided to me had showed damage to the front left portion of the Motor Car. The front bumper, front bumper left reflector, front left headlamp, front left fender and front bonnet were amongst the body parts that were observed to have been damaged. The front bumper sensors, front bumper left lower chrome moulding and front left day light were also observed to be missing/dislodged/damaged.

23. The body parts at the front left portion of the Motor Car were visually examined and it was noted that the repair/restoration works carried out to the damaged area of the Motor Car (refer to photograph 1 & 2 above) were reasonably adequate and in order.

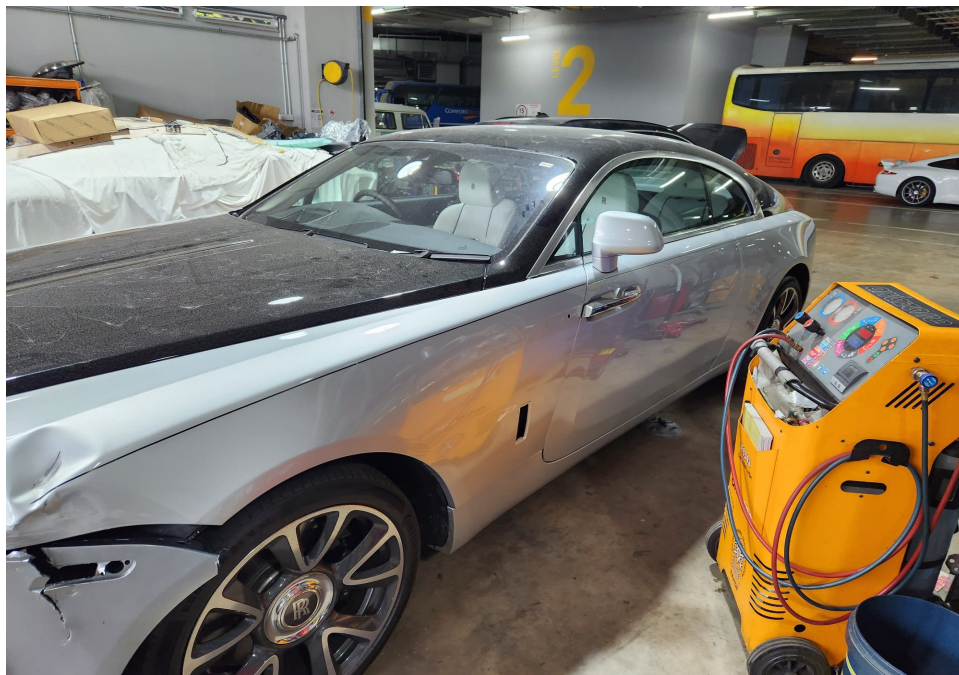
**Photo 2** shows the left side front portion of the Motor Car (photograph provided to me). The front bumper, front bumper left reflector and front left fender were amongst the body parts that were observed to have been damaged. The front left fender emblem was also observed to be missing/dislodged/damaged.

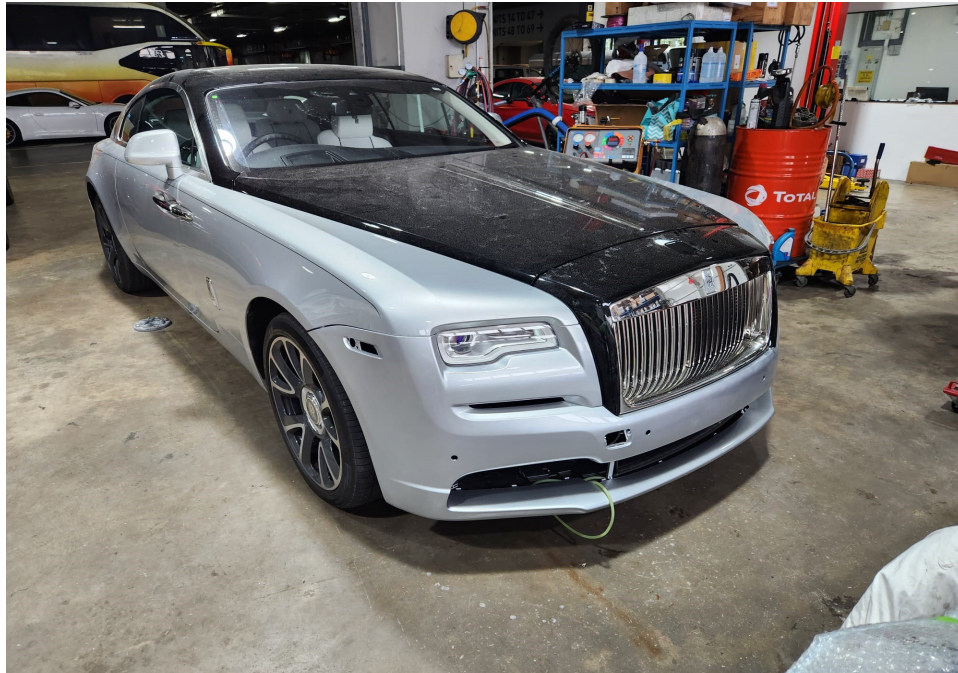
**Photo 3** shows the front right body of the Motor Car (photograph provided to me). Apart for the front left portion, there was no physical damage observed to other areas of the Motor Car. I did however observe that the front bumper sensors, front bumper tow cover, front bumper right lower chrome moulding, front right day light and front bonnet emblem were missing/dislodged/damaged. The Motor Car's airbag(s) was not deployed as seen from the photographs that were provided to me.

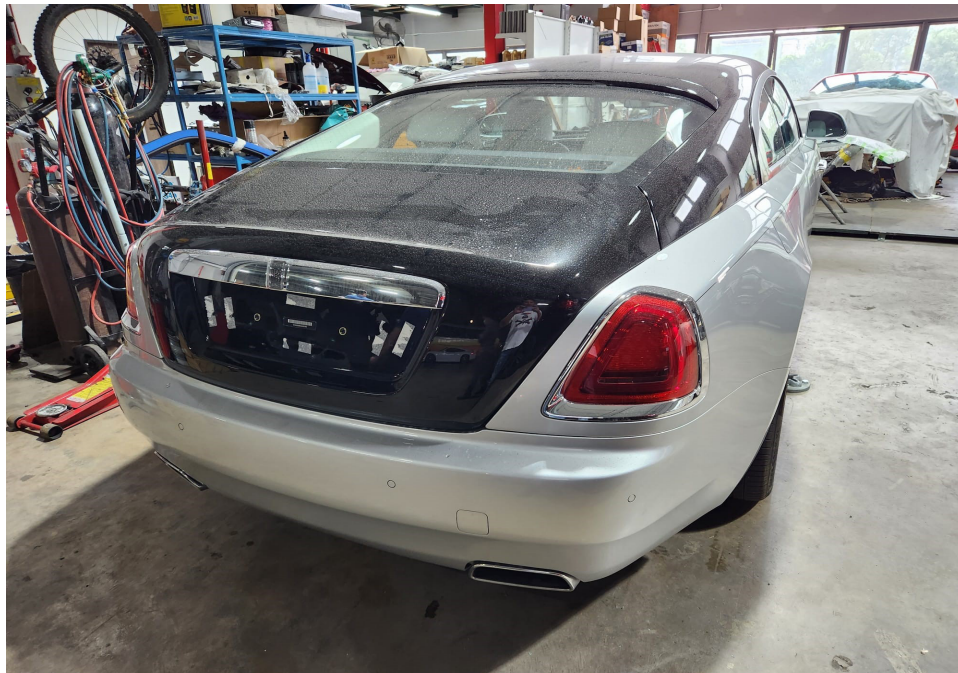
**Photo 4** shows the rear right body of the Motor Car (photograph provided to me). Apart for the front left portion, there was no physical damage observed to other areas of the Motor Car

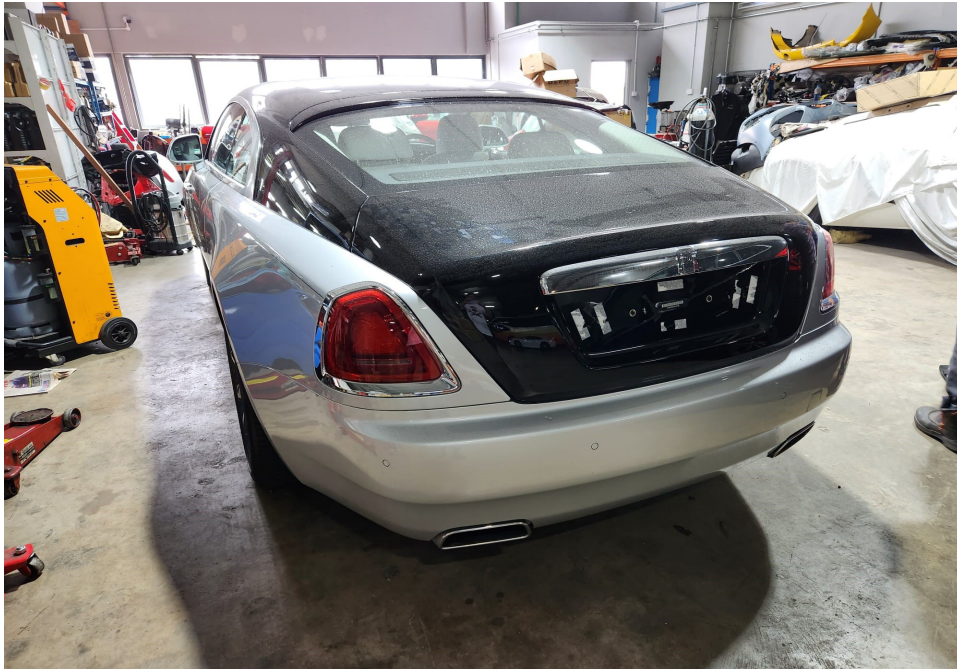
**Photo 5** shows the rear left body of the Motor Car (photograph provided to me). Apart for the front left portion, there was no physical damage observed to other areas of the Motor Car

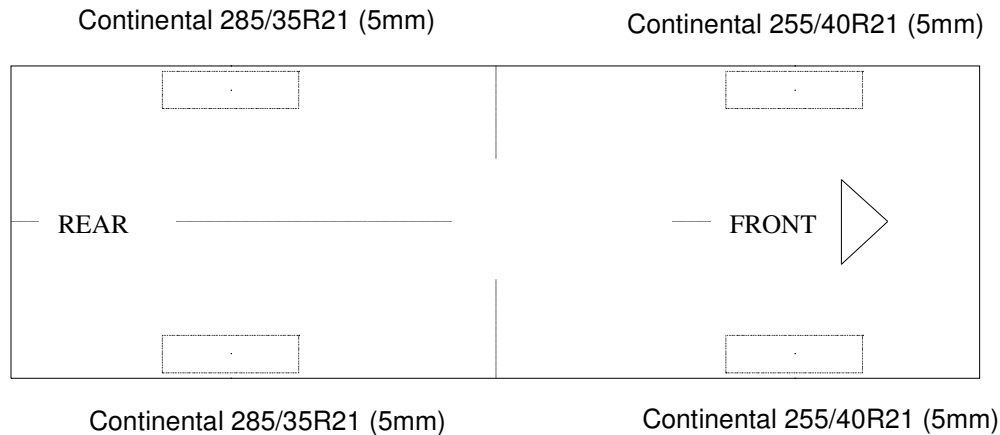
9. The Motor Car was fitted with 21inch sport wheel rims that were wrapped with tyres that were observed to be of serviceable condition. The tyres were also sufficiently inflated for vehicular operation. The tyre brand, tyre size and approximate remaining tread depth of the 4 tyres of the Motor Car were recorded as follows: -

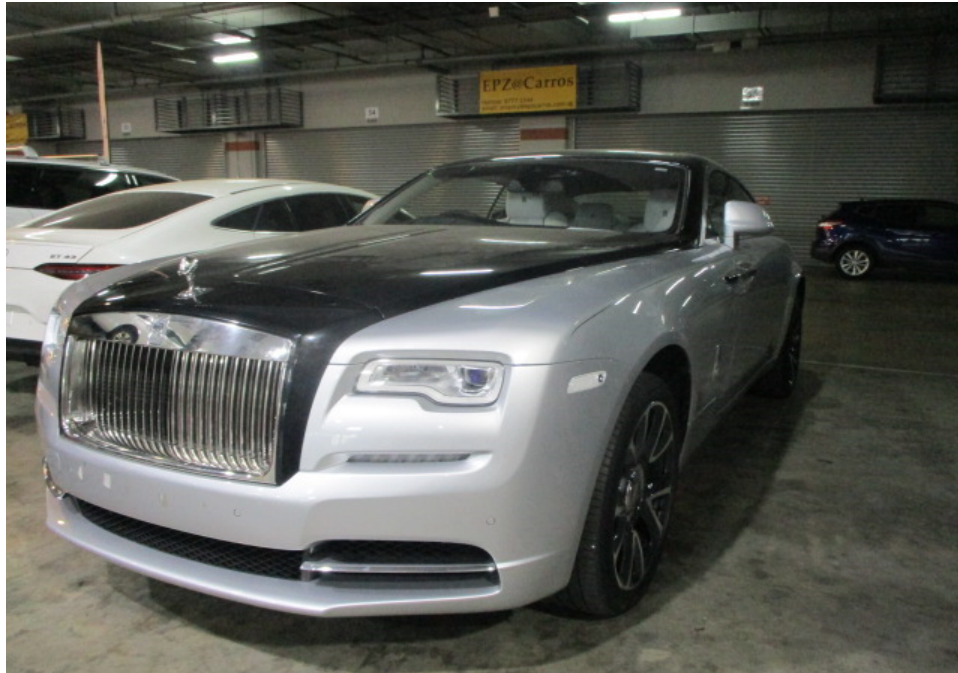
**Photo 6** shows a general view of the front left body of the Motor Car at the time of my inspection. The Motor Car was observed to be in a relatively good general condition with no loose exterior fittings observed. The body parts at the front left portion of the Motor Car were visually examined and it was observed that the repair/restoration works carried out to the damaged area of the Motor Car (refer to photograph 1 & 2 above) were reasonably adequate and in order.

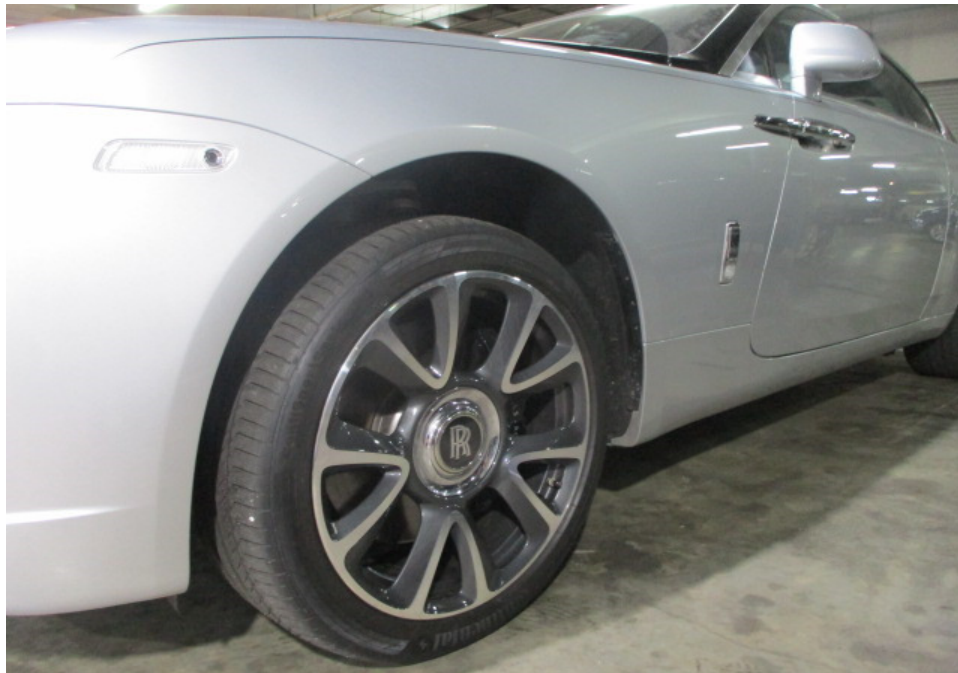
**Photo 7** shows a closer view of the Motor Car's front bumper, front bumper left reflector, front left fender and front left wheel rim. The body parts at the front left portion of the Motor Car were visually examined and it was observed that the repair/restoration works carried out to the damaged area of the Motor Car (refer to photograph 1 & 2 above) were reasonably adequate and in order.

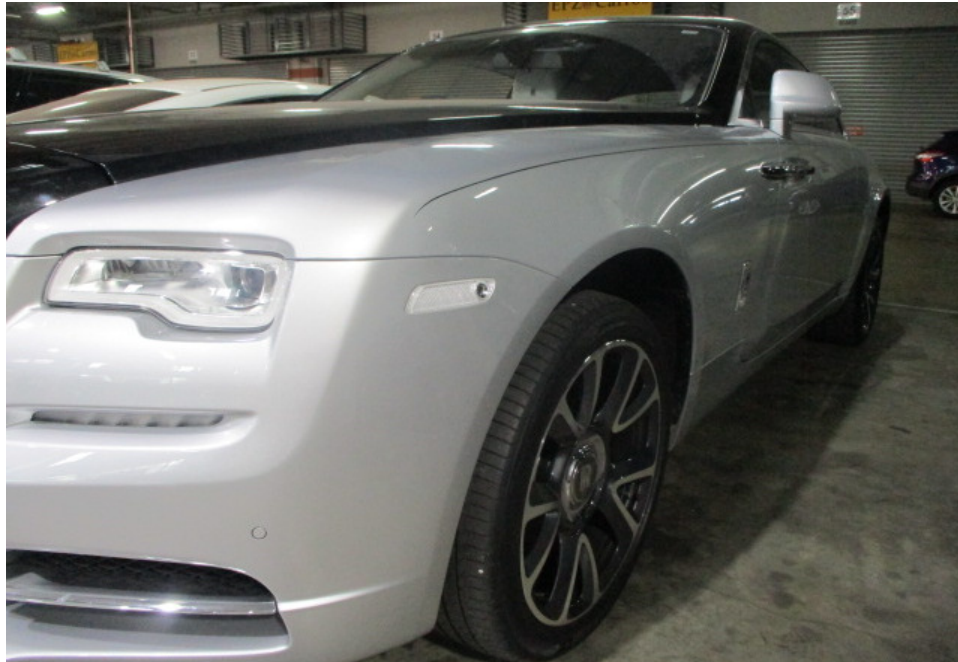
**Photo 8** shows a closer view of the Motor Car's front bumper, front bumper left reflector, front bumper left sensor, front bumper left lower chrome moulding, front left day light, front left headlamp and front bonnet. The body parts at the front left portion of the Motor Car were visually examined and it was observed that the repair/restoration works carried out to the damaged area of the Motor Car (refer to photograph 1 & 2 above) were reasonably adequate and in order.

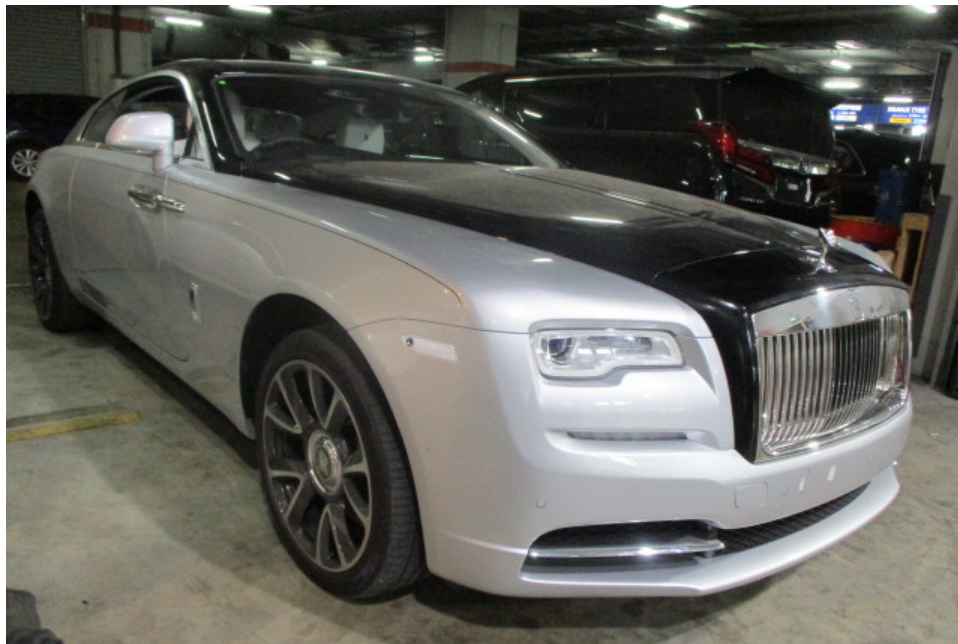
**Photo 9** shows a general view of the front right body of the Motor Car at the time of my inspection. The Motor Car was observed to be in a relatively good general condition with no loose exterior fittings observed. The body parts at the front right portion of the Motor Car were visually examined and it was observed that the repair/restoration works carried out to the damaged area of the Motor Car (refer to photograph 3 above) were reasonably adequate and in order.

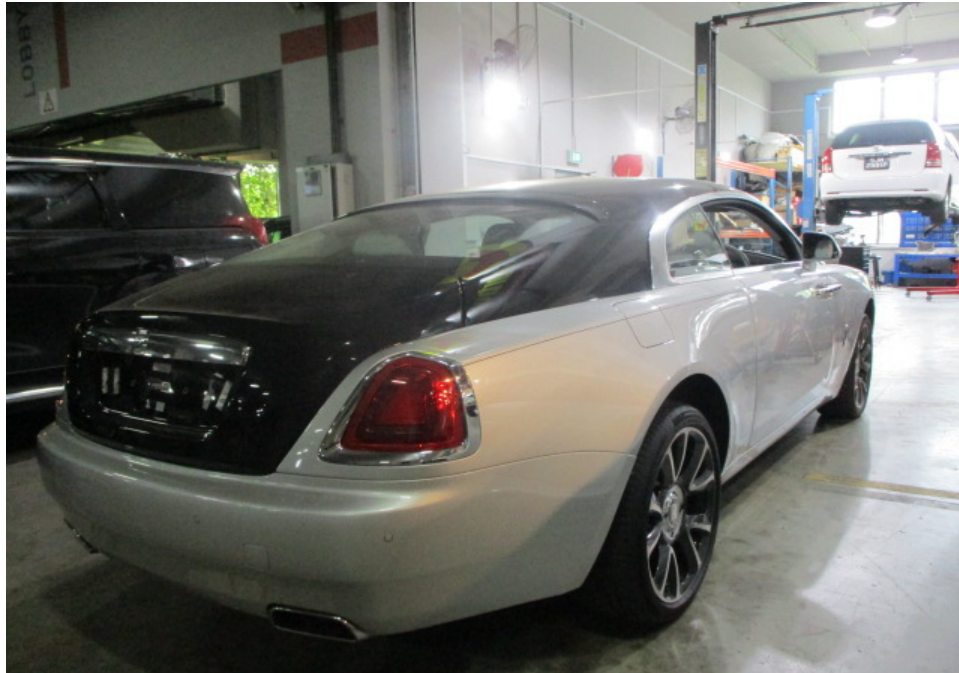
**Photo 10** shows a general view of the rear right body of the Motor Car at the time of my inspection. The Motor Car was observed to be in a relatively good general condition with no loose exterior fittings observed. The mileage of the Motor Car recorded at the time of my inspection was 5,724km.

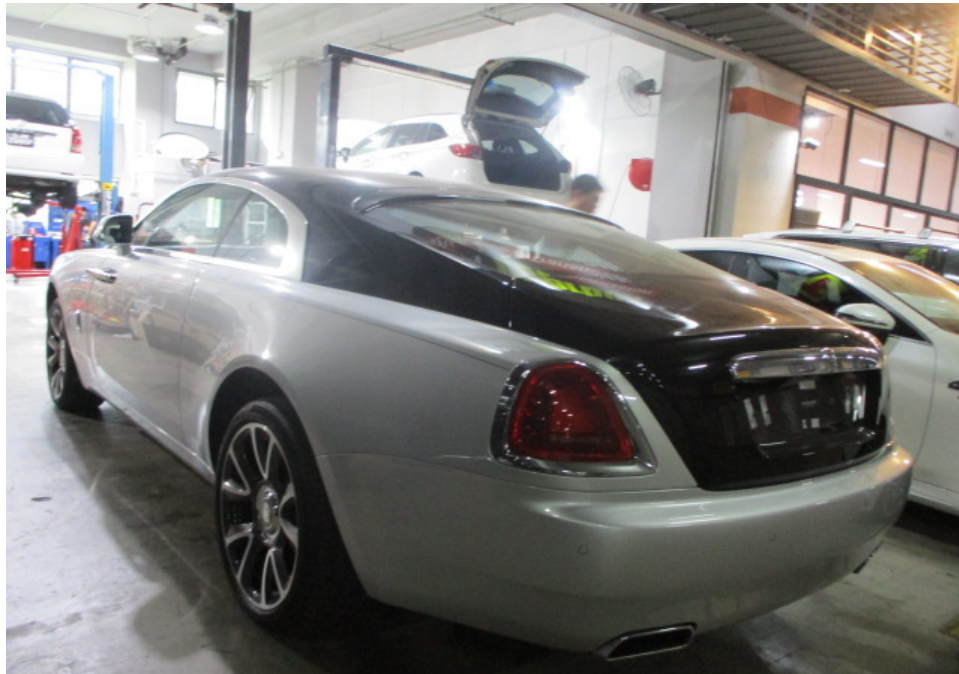
**Photo 11** shows a general view of the rear left body of the Motor Car at the time of my inspection. The Motor Car was observed to be in a relatively good general condition with no loose exterior fittings observed. The mileage of the Motor Car recorded at the time of my inspection was 5,724km.

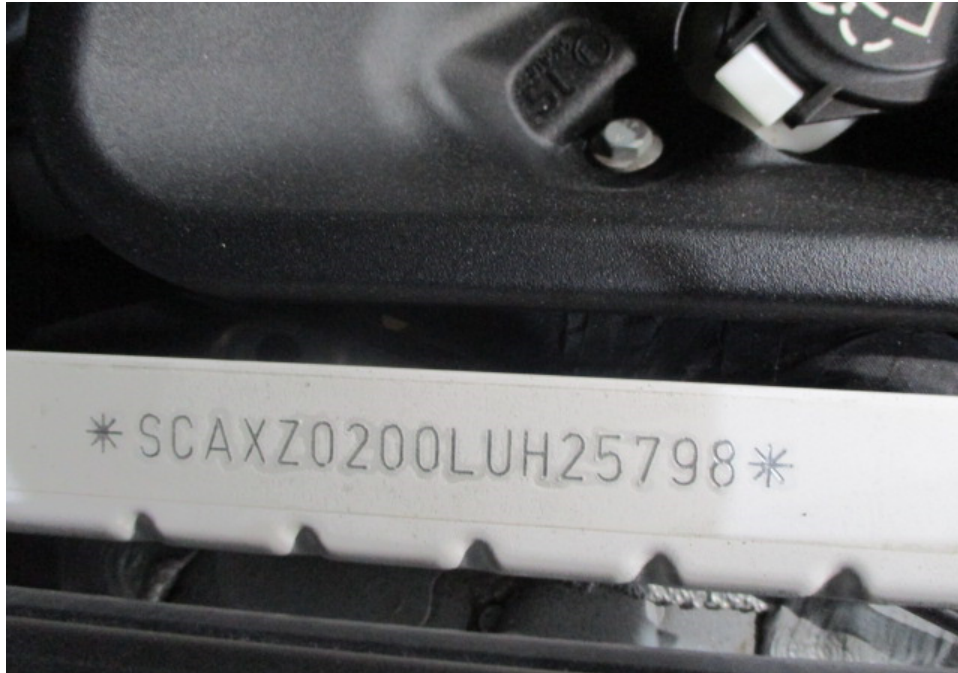
**Photo 12** shows the chassis number of the Motor Car. The chassis number recorded was SCAXZ0200LUH25798.

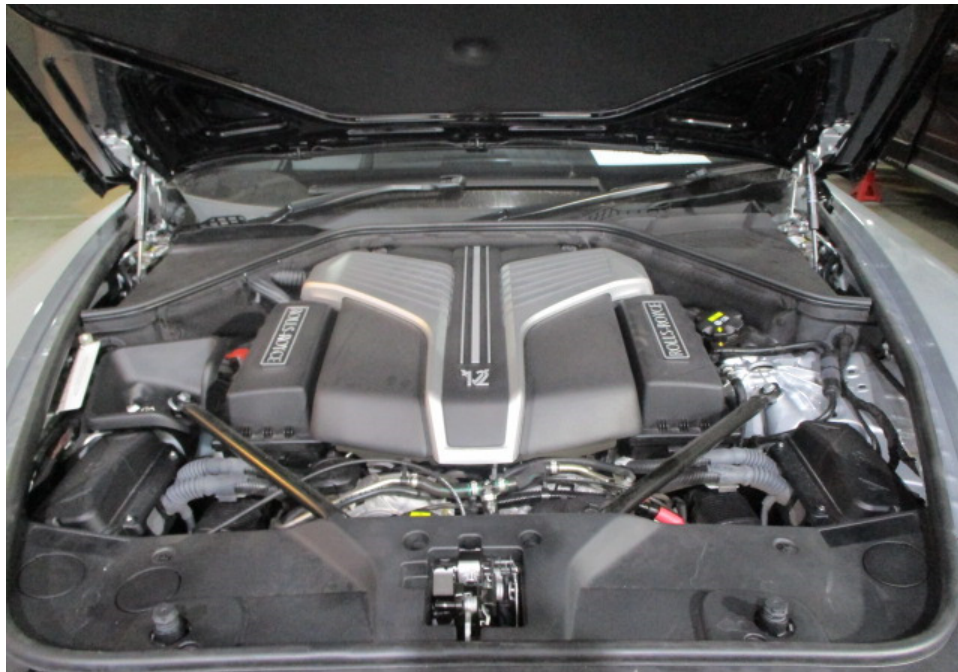
**Photo 13** shows a general view of the Motor Car's engine compartment at the time of my inspection. The various parts and components inside the engine compartment were all observed to be intact and properly fitted. There was also no sign(s) or indication(s) of fluid leak and/or fluid stain found inside the engine compartment.

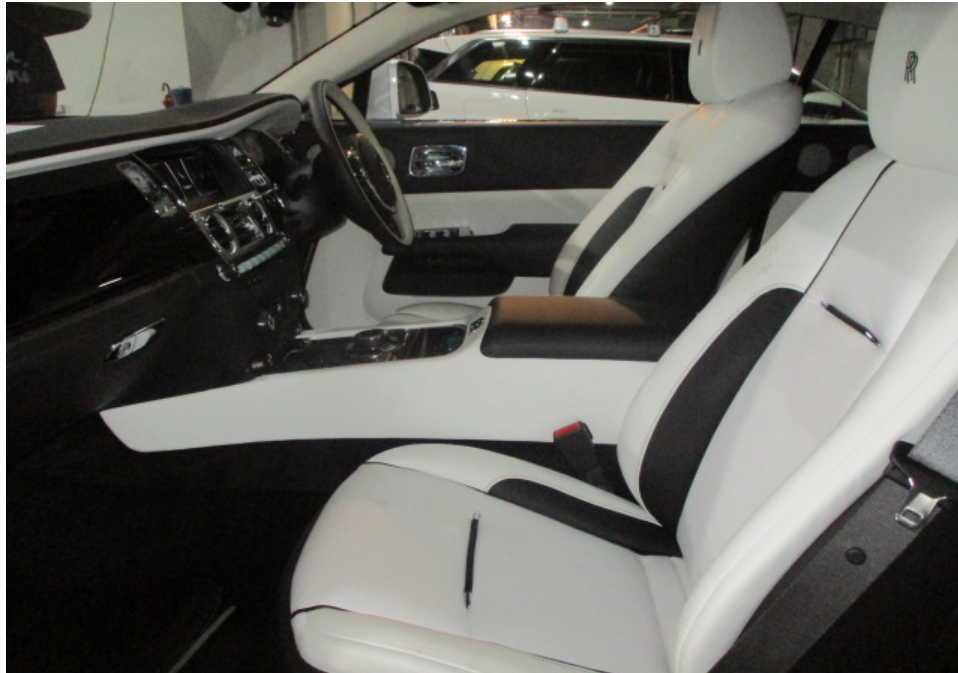
**Photo 14** shows the interior compartment of the Motor Car at the time of my inspection. The various parts and components, trims, carpet, and upholstery inside the interior compartment were all observed to be intact and properly fitted.

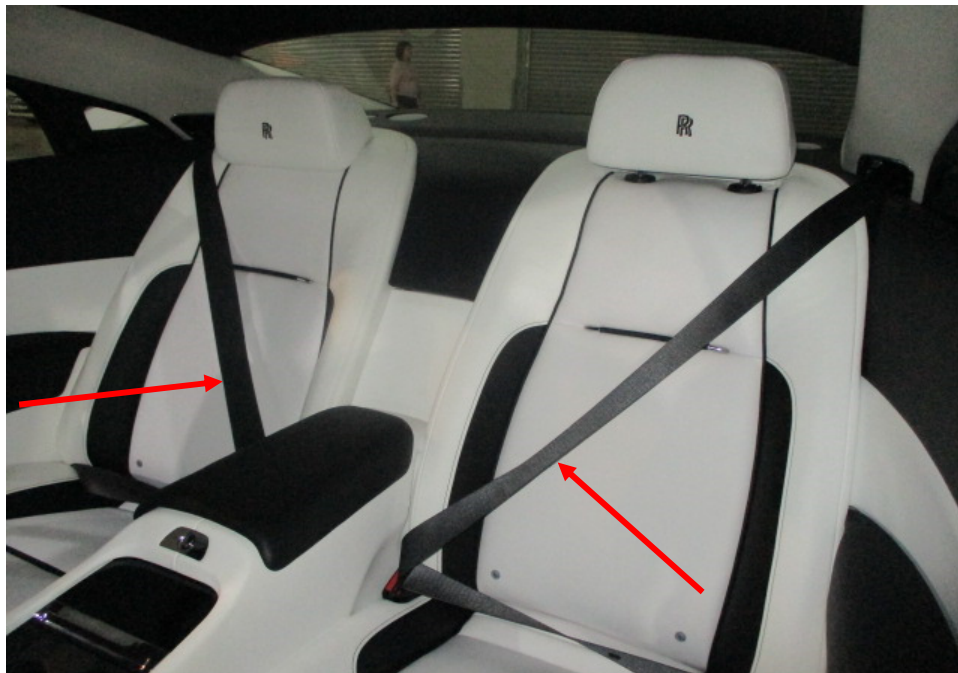
**Photo 15** shows the rear seats of the Motor Car. All the seats of the Motor Car were secured via seat rails to the floorboard. They were also fitted with a retractable seat belt reel and a pre-tensioner. The seat belts (arrowed) were tested and were able to be fastened into the respective pre-tensions that were fitted on the side of each individual seat.

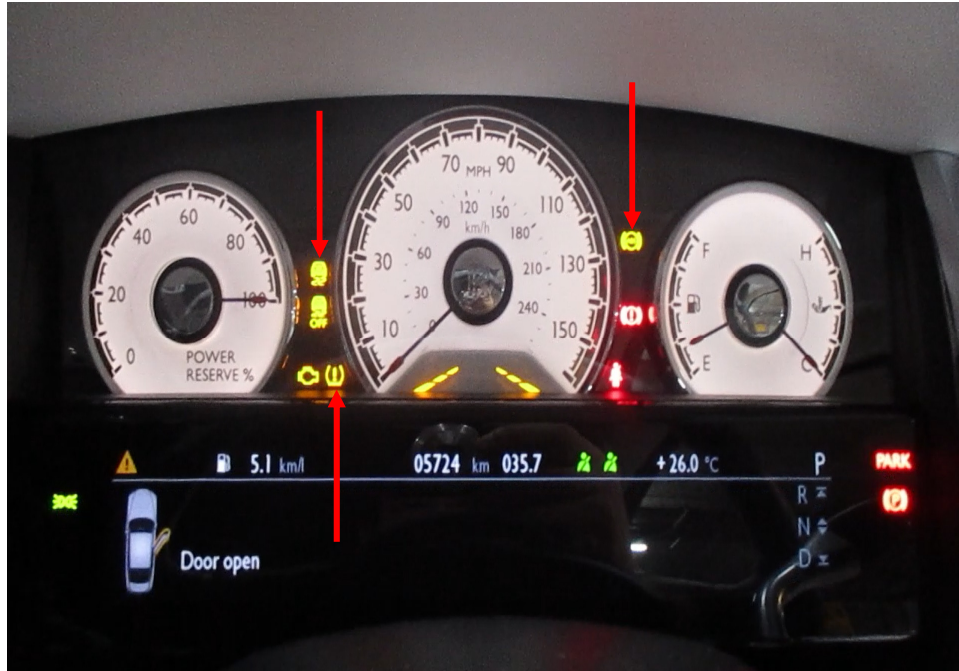
**Photo 16** shows the warning lights for the various electronic safety features appearing on the instrument panel of the Motor Car during its self-test when the engine is cranked, in particular the ABS, SRS, TPM and TCS lights (arrowed).

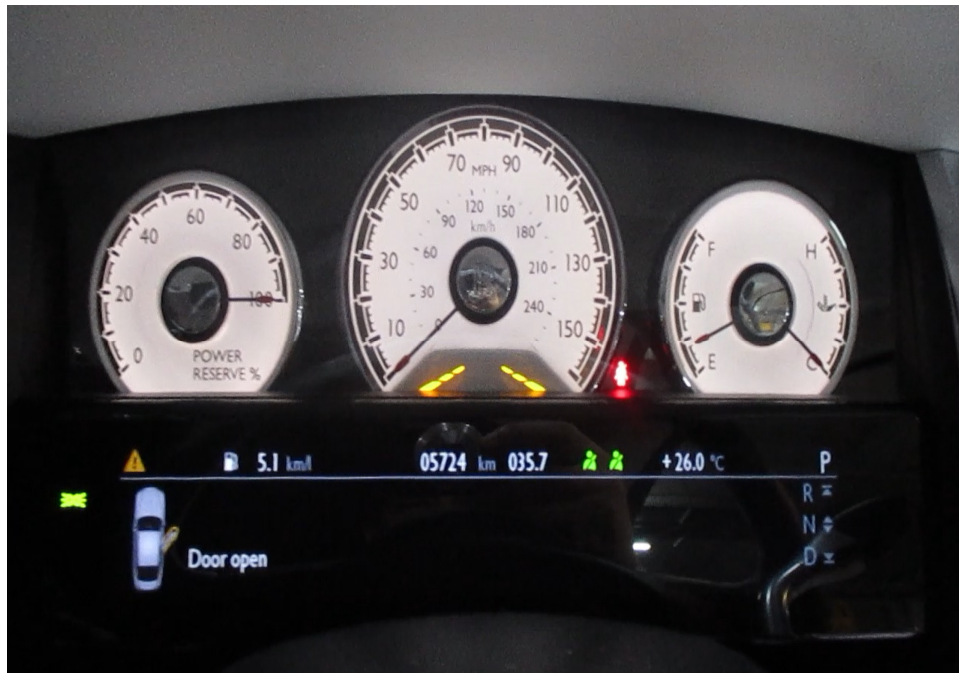
**Photo 17** shows the respective warning lights no longer illuminated, indicating that there is no fault detected to the ABS, SRS, TPM and TCS systems of the Motor Car during the self-test. These electronic systems were hence in working condition at the time of my inspection.

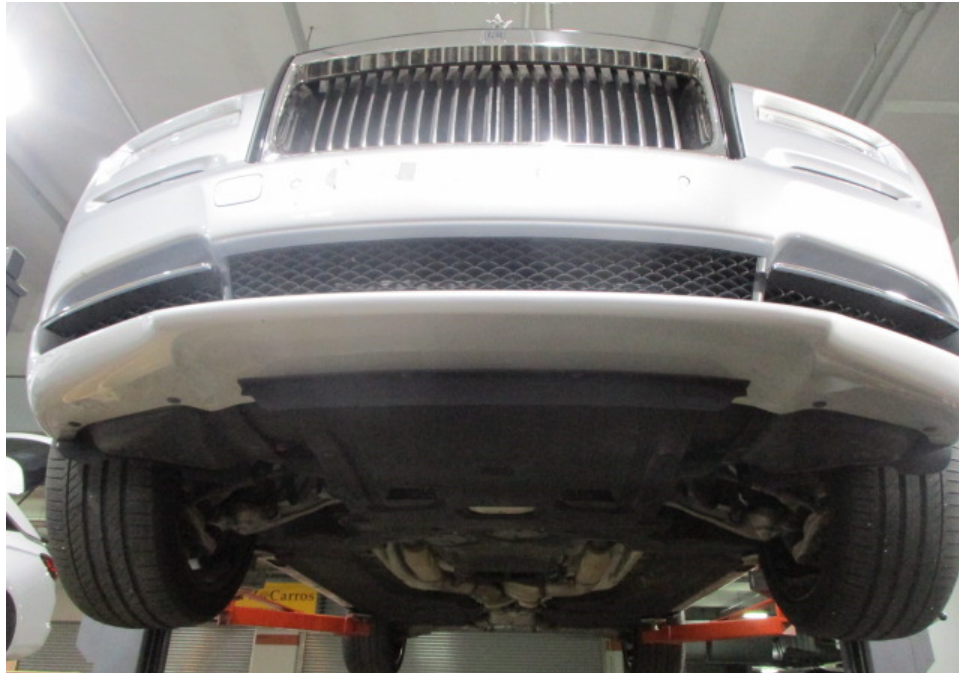
**Photo 18** shows the Motor Car hoisted up for checks on its undercarriage. There was no sign(s) or indication(s) of fluid leakage and/or fluid stain(s) on the underside of the Motor Car. The undercarriage components of the Motor Car were also all observed to be intact and secured in an appropriate manner.

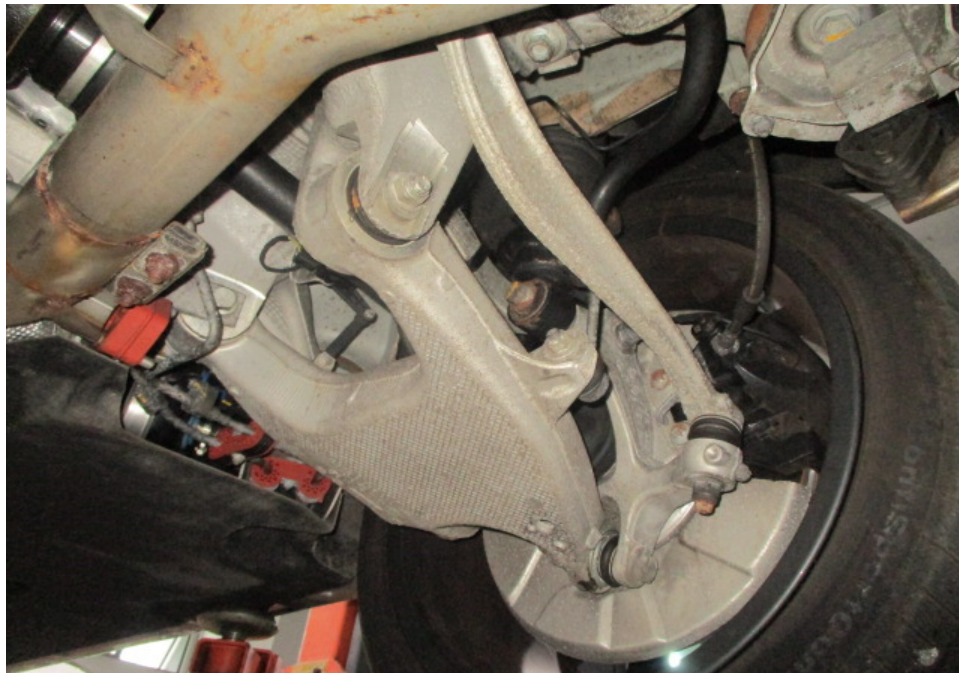
**Photo 19** shows a general view of the control arms and linkages at the rear right wheel of the Motor Car. I did not observe any fluid leak and/or fluid stain on the underside of the Motor Car. All of the Motor Car's undercarriage components were observed to be intact and secured in an appropriate manner.

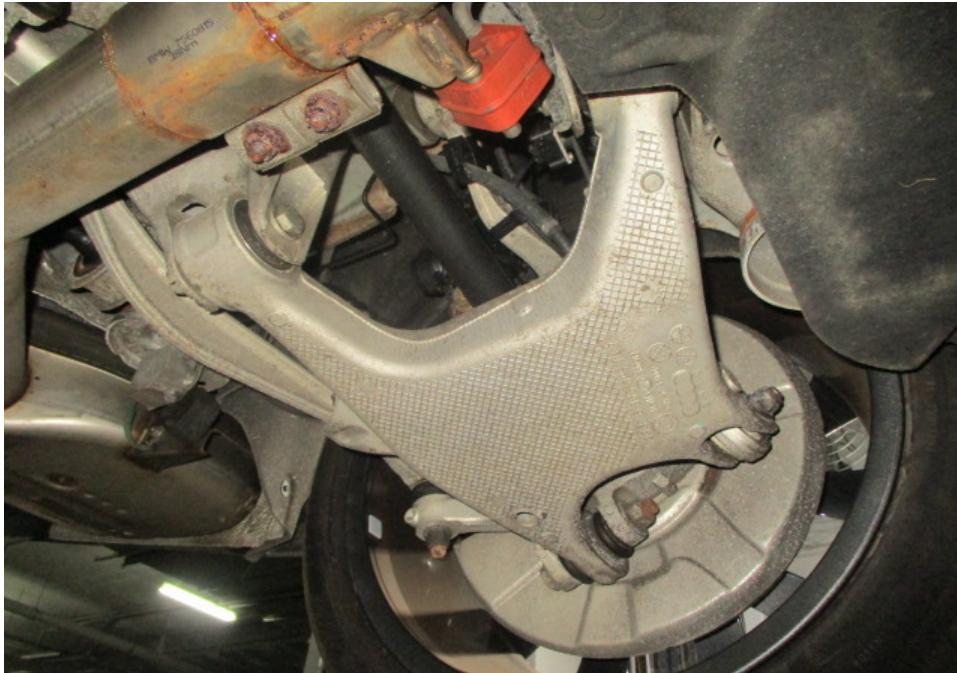
**Photo 20** shows a general view of the control arms and linkages at the rear left wheel of the Motor Car. I did not observe any fluid leak and/or fluid stain on the underside of the Motor Car. All of the Motor Car's undercarriage components were observed to be intact and secured in an appropriate manner.

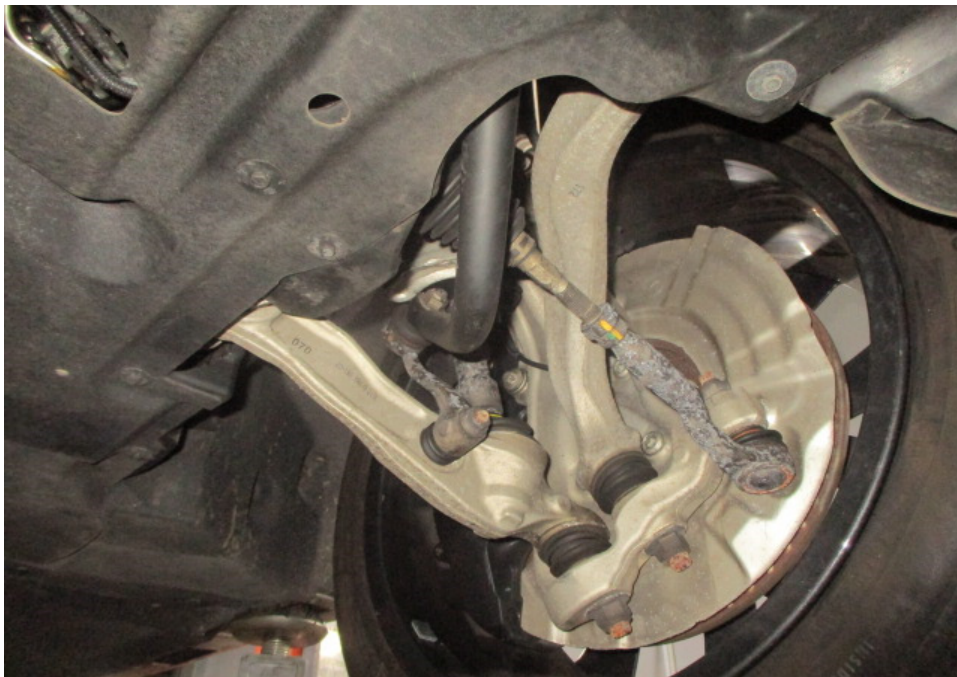
**Photo 21** shows the various undercarriage components at the front left wheel of the Motor Car. The mechanical components, control arms and linkages were all found to be intact and secured in an appropriate manner.

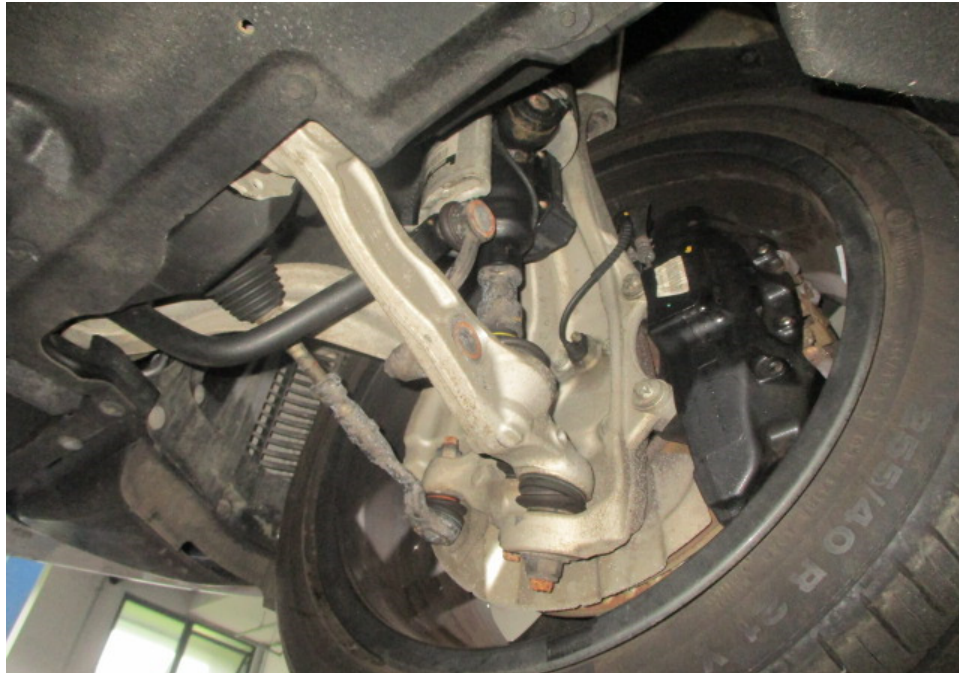
**Photo 22** shows the various undercarriage components at the front right wheel of the Motor Car. The mechanical components, control arms and linkages were all found to be intact and secured in an appropriate manner. I also did not observe any fluid leak and/or fluid stain on the underside of the Motor Car.

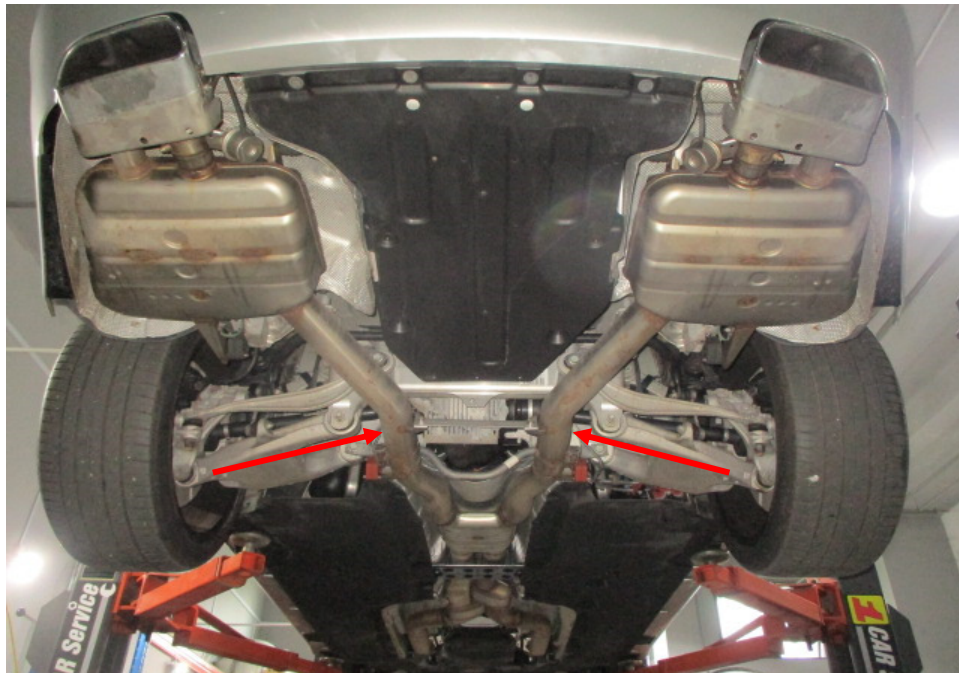
**Photo 23** shows the rear section of the Motor Car's exhaust system. My examination of the Motor Car's exhaust system revealed no sign(s) or indication(s) of any cut or weld marks along its exhaust pipes (arrowed), on its rear mufflers, on its centre resonator boxes and on its catalytic converters.

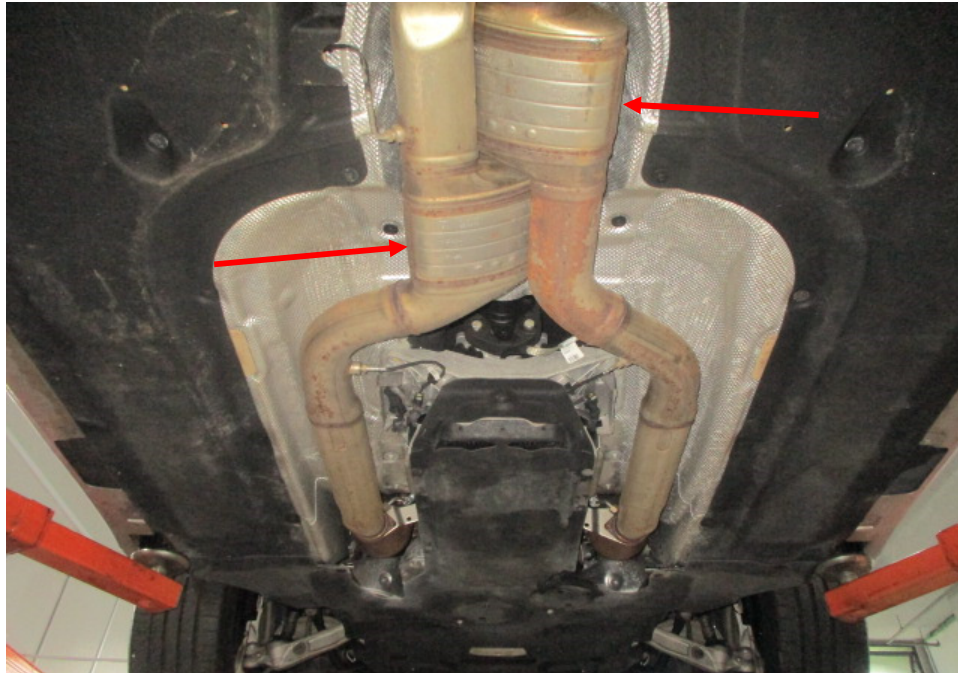
**Photo 24** shows the front section of the Motor Car's exhaust system. My examination of the Motor Car's exhaust system revealed no sign(s) or indication(s) of any cut or weld marks along its exhaust pipes, on its rear mufflers, on its centre resonator boxes (arrowed) and on its catalytic converters.

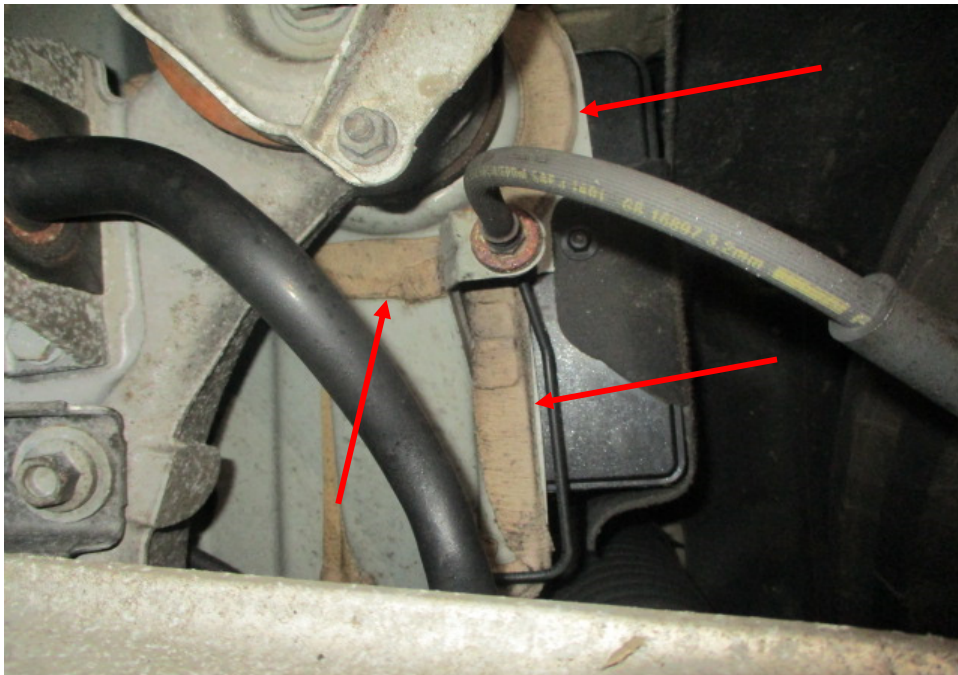
**Photo 25** shows the chassis/structural body at the underside rear right of the Motor Car. I did not find any weld marks other than original spot weld marks on the chassis/structural body of the Motor Car. The original factory sealant (arrowed) at the joints along the chassis/structural body was untouched, indicating no work was done on the chassis/structural body of the Motor Car and that the chassis/structural body was originally fitted.

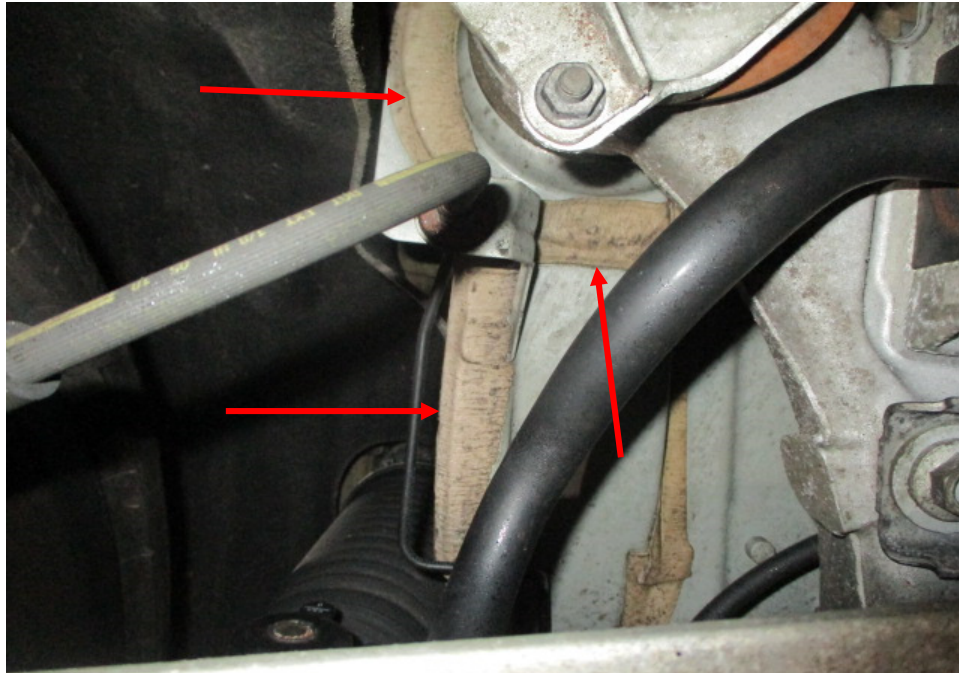
**Photo 26** shows the chassis/structural body at the underside rear left of the Motor Car. I did not find any weld marks other than original spot weld marks on the chassis/structural body of the Motor Car. The original factory sealant (arrowed) at the joints along the chassis/structural body was untouched, indicating no work was done on the chassis/structural body of the Motor Car and that the chassis/structural body was originally fitted.

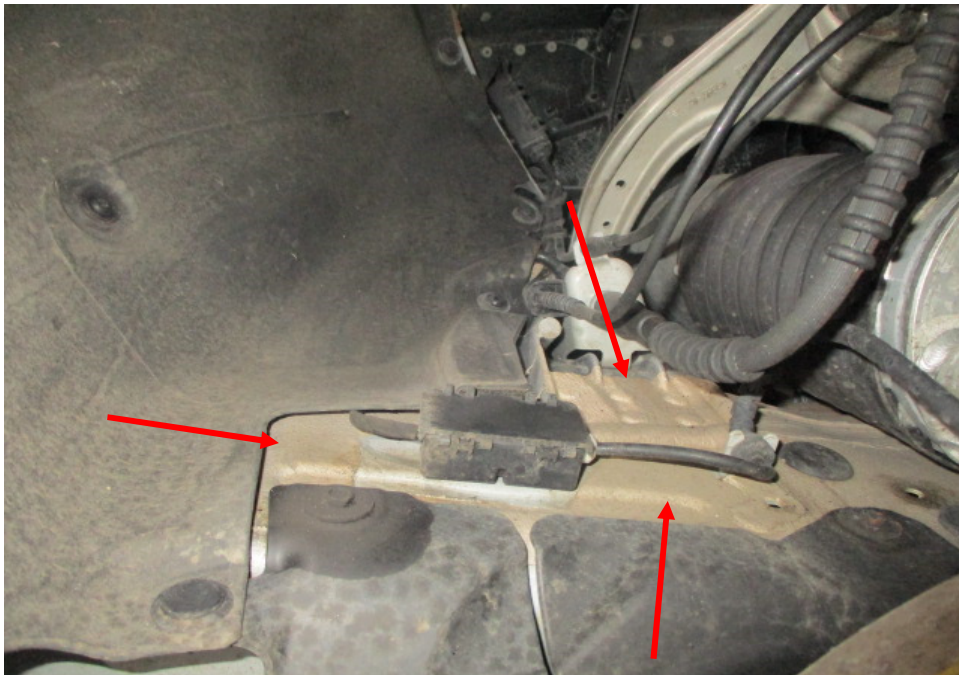
**Photo 27** shows the chassis/structural body at the underside front left of the Motor Car. The original factory sealant (arrowed) at the joints along the chassis/structural body was observed to be untouched. In general, I had found no work was carried out on the chassis/structural body of the Motor Car. The chassis/structural body of the Motor Car was originally fitted.

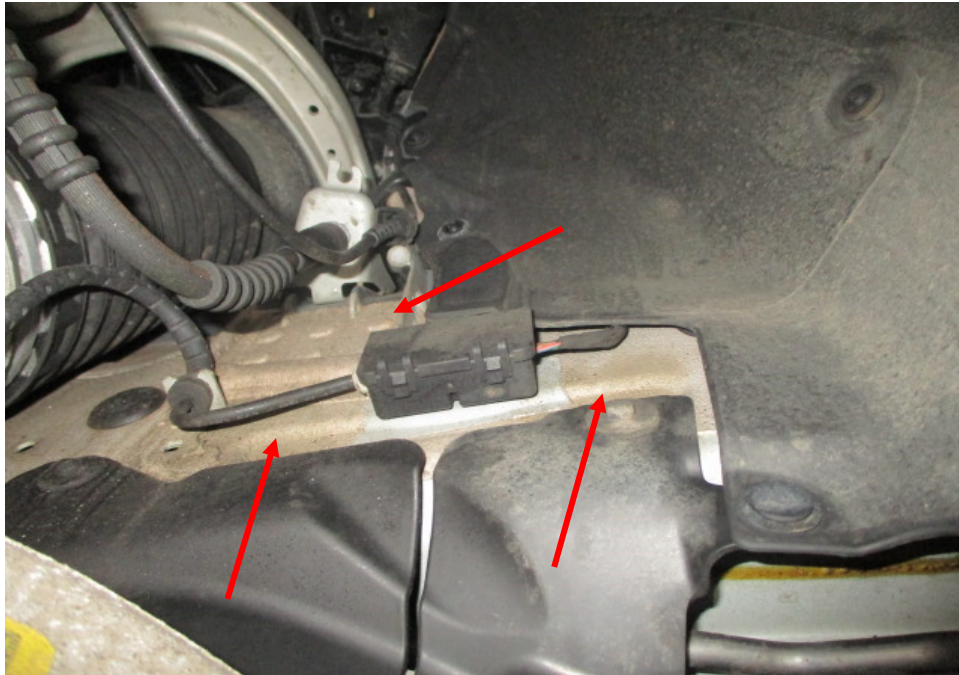
**Photo 28** shows the chassis/structural body at the underside front right of the Motor Car. I did not find any weld marks other than original spot weld marks on the chassis/structural body of the Motor Car. The original factory sealant (arrowed) at the joints along the chassis/structural body was untouched, indicating no work was done on the chassis/structural body of the Motor Car and that the chassis/structural body was originally fitted.

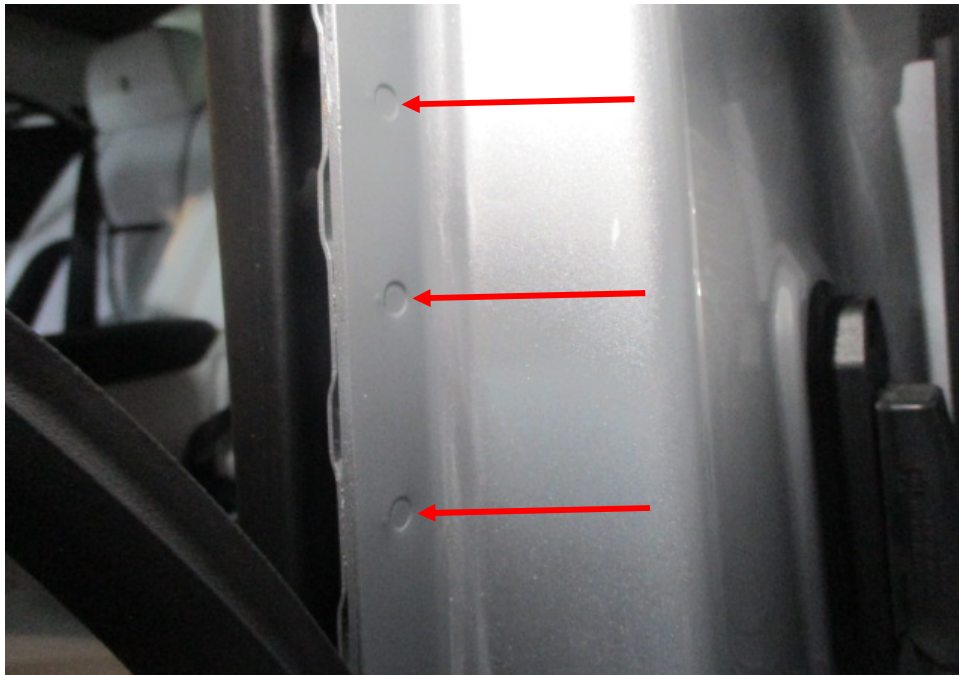
**Photo 29** shows the left side rear body panel of the Motor Car. I did not find any weld marks other than original spot weld marks (arrowed) on the left side rear body panel of the Motor Car, which indicates that there was no re-welding works carried out. In general, I had found all the non-detachable body panels of the Motor Car to be originally fitted at the time of my inspection.

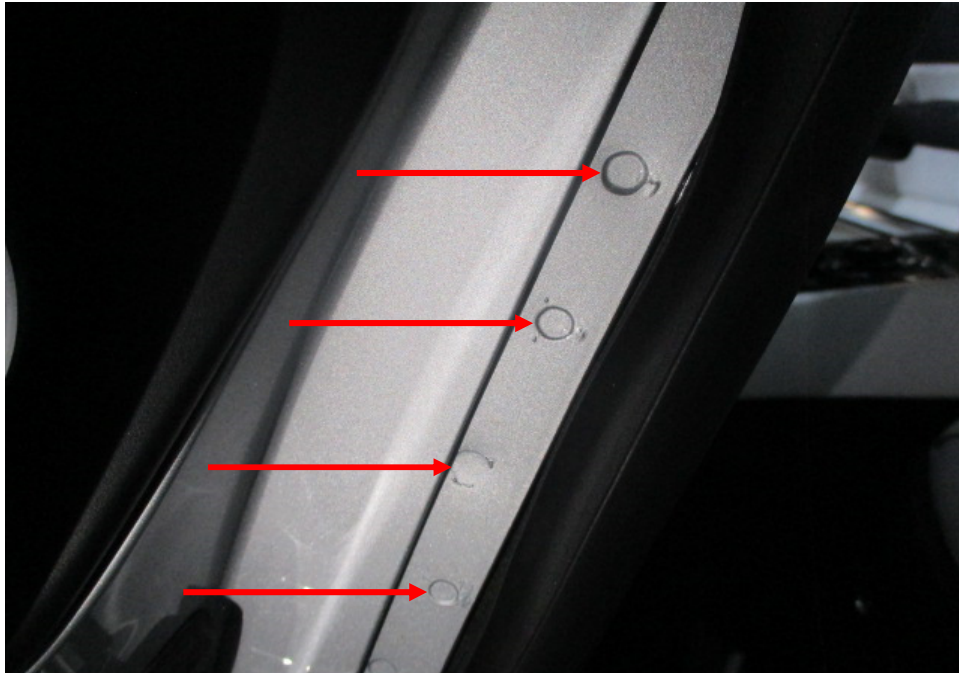
**Photo 30** shows the left side “A” pillar of the Motor Car. I did not find any weld marks other than original spot weld marks (arrowed) on the left side “A” pillar of the Motor Car, which indicates that there was no re-welding works carried out. In general, I had found all the non-detachable body panels of the Motor Car to be originally fitted at the time of my inspection.
