Your Ref: Rolls Royce Wraith  
(chassis number SCAXZ0200LUH25798)  
Our Ref : CI/TP22013016/D

**INSPECTION REPORT OF AN UNREGISTERED ROLLS ROYCE WRAITH  
MOTOR CAR WITH CHASSIS NUMBER SCAXZ0200LUH25798**

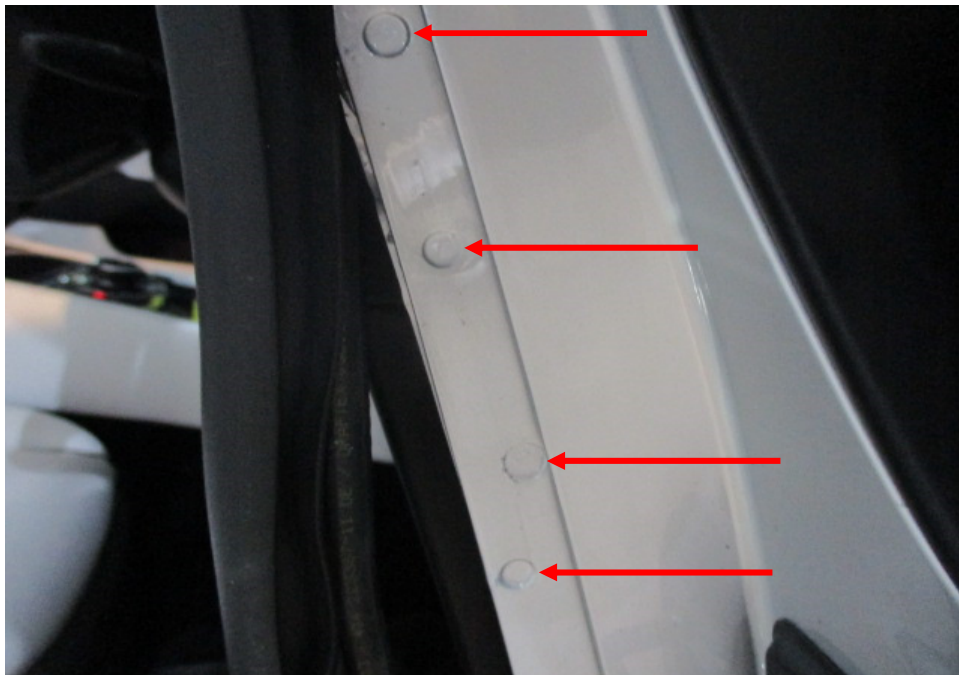
**Photo 31** shows the right side “A” pillar of the Motor Car. I did not find any weld marks other than original spot weld marks (arrowed) on the right side “A” pillar of the Motor Car, which indicates that there was no re-welding works carried out. In general, I had found all the non-detachable body panels of the Motor Car to be originally fitted at the time of my inspection.

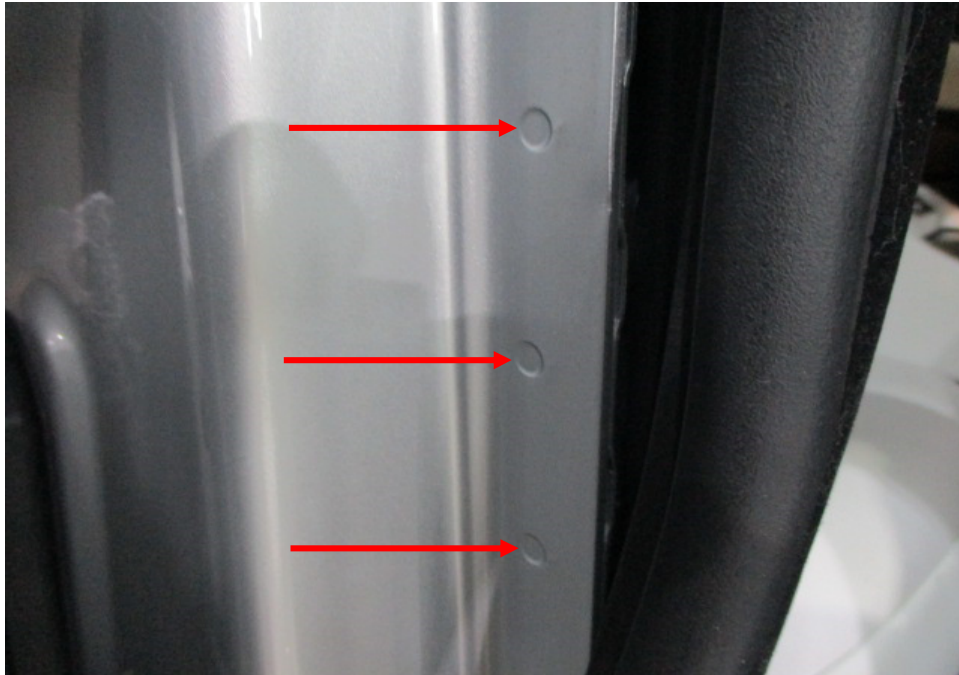
**Photo 32** shows the right side rear body panel of the Motor Car. I did not find any weld marks other than original spot weld marks (arrowed) on the right side rear body panel of the Motor Car, which indicates that there was no re-welding works carried out. In general, I had found all the non-detachable body panels of the Motor Car to be originally fitted at the time of my inspection.
