Your Ref: SNM22D209121  
Our Ref : CS4/CTI22013017/N

9 January 2023

**M/s China Taiping Insurance (Singapore) Pte. Ltd.**

**TECHNICAL INVESTIGATION REPORT OF FIRE INCIDENT INVOLVING THE INSURED VEHICLE SMW 3361M ON 18 DECEMBER 2022**

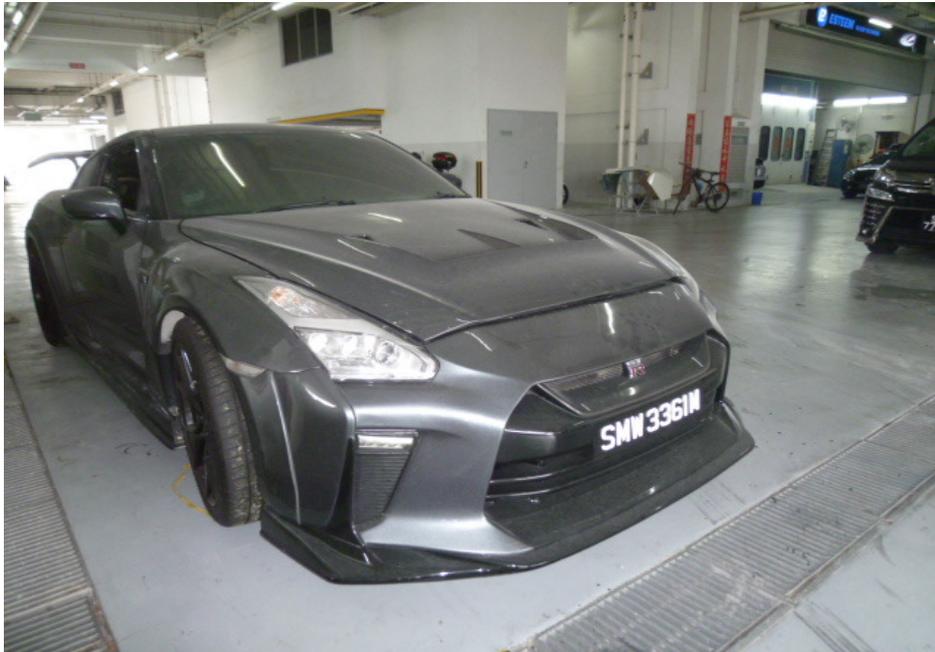
5. The Insured Vehicle was observed to have sustained severe fire damage to its interior compartment. Its top portion had also sustained minor fire damage that was mainly due to heat from the fire.
6. From the burn pattern, the fire appears to have been most intense at the rear portion of the Insured Vehicle. This follows the extent of burn damage being more severe within the interior compartment as compared to the burn damage at the top portion of the Insured Vehicle. See photos 1 – 6 below.

**Photo 1** shows a general view of the right side of the Insured Vehicle at the time of our inspection. From the burn pattern, the fire appears to have been most intense at the rear portion of the Insured Vehicle. This follows the severe fire damage that was observed within the interior compartment of the Insured Vehicle.

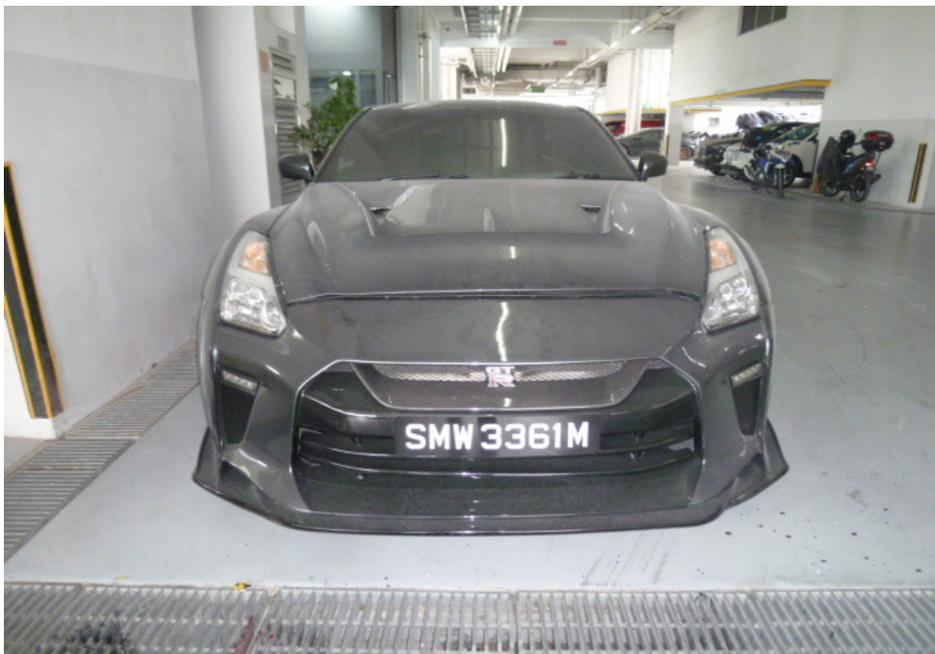
**Photo 2** shows a general view of the front portion of the Insured Vehicle at the time of our inspection. The Insured Vehicle was observed to have sustained severe fire damage at its right rear passenger portion. Its front portion was relatively unaffected by the fire.

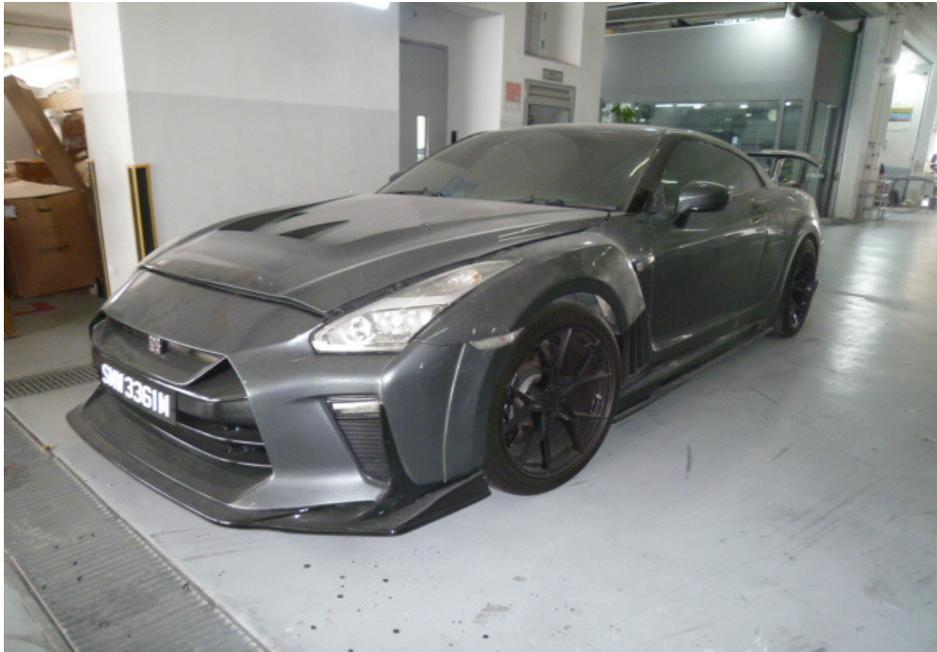
**Photo 3** shows a general view of the left portion of the Insured Vehicle at the time of our inspection. From the burn pattern, the fire appears to have been most intense at the right rear passenger portion of the Insured Vehicle. This follows the severe fire damage that was observed within the interior compartment of the Insured Vehicle.

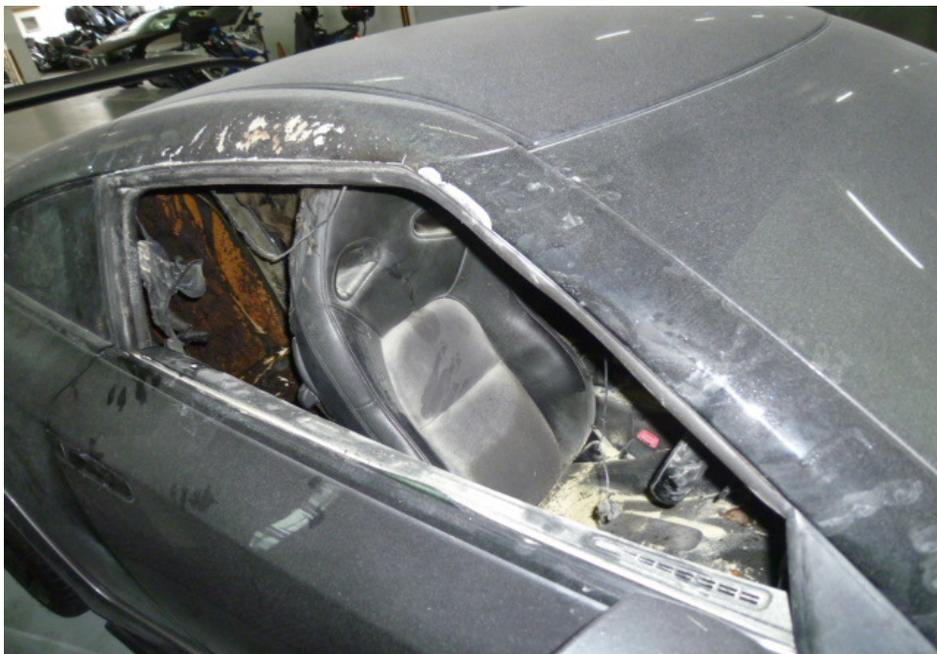
**Photo 4** shows a general view of the interior compartment of the Insured Vehicle, which was affected the most by the fire. Almost all the parts within the interior compartment were severely burnt and/or melted.

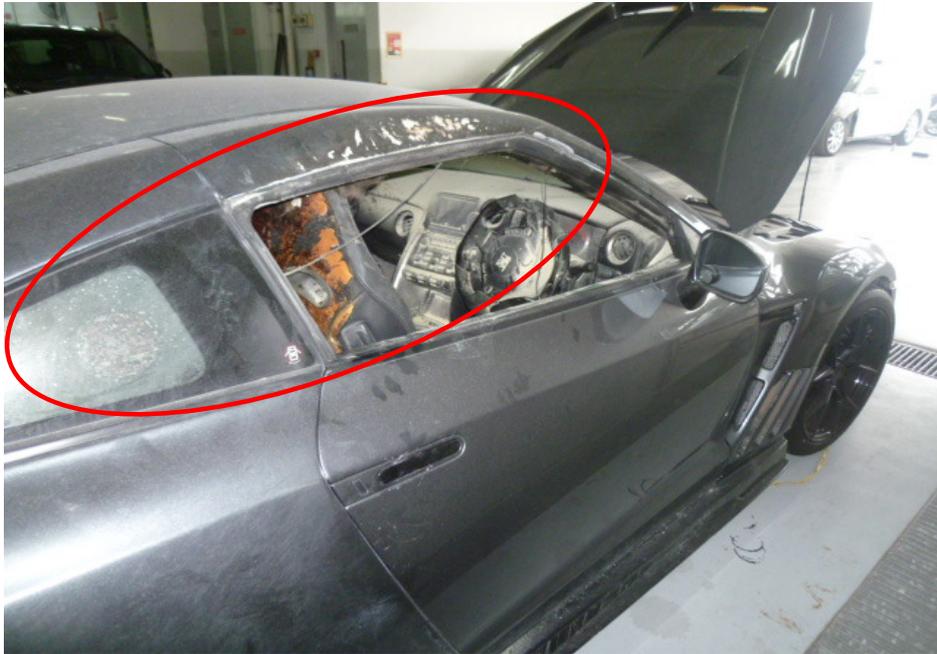
**Photo 5** shows a general view of the top portion of the Insured Vehicle. Its top portion had sustained minor fire damage that was mainly due to heat from the fire (circled).

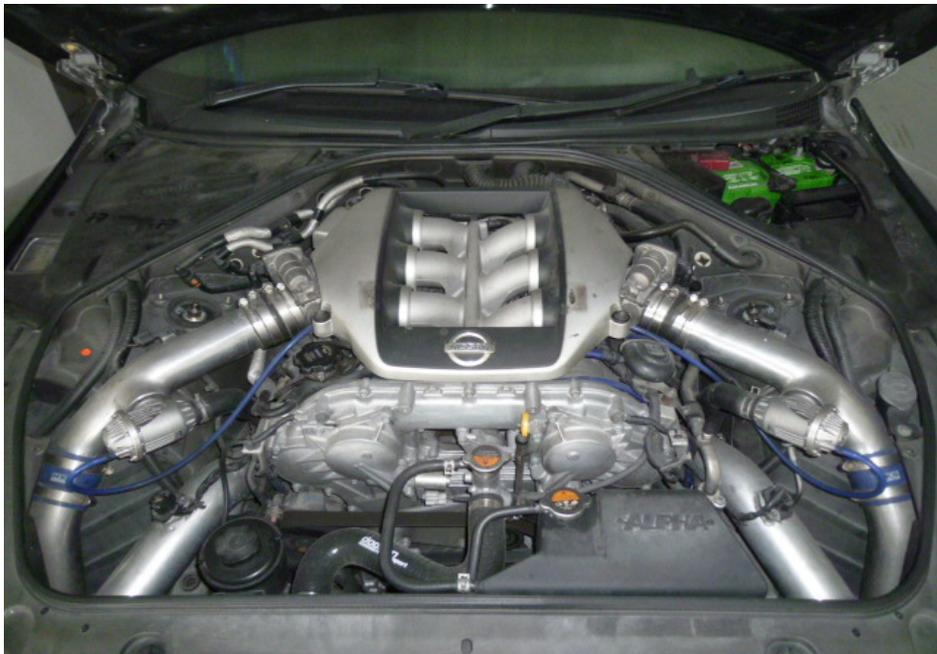
**Photo 6** shows a general view of the engine compartment of the Insured Vehicle. Its engine compartment was relatively unaffected by the fire.

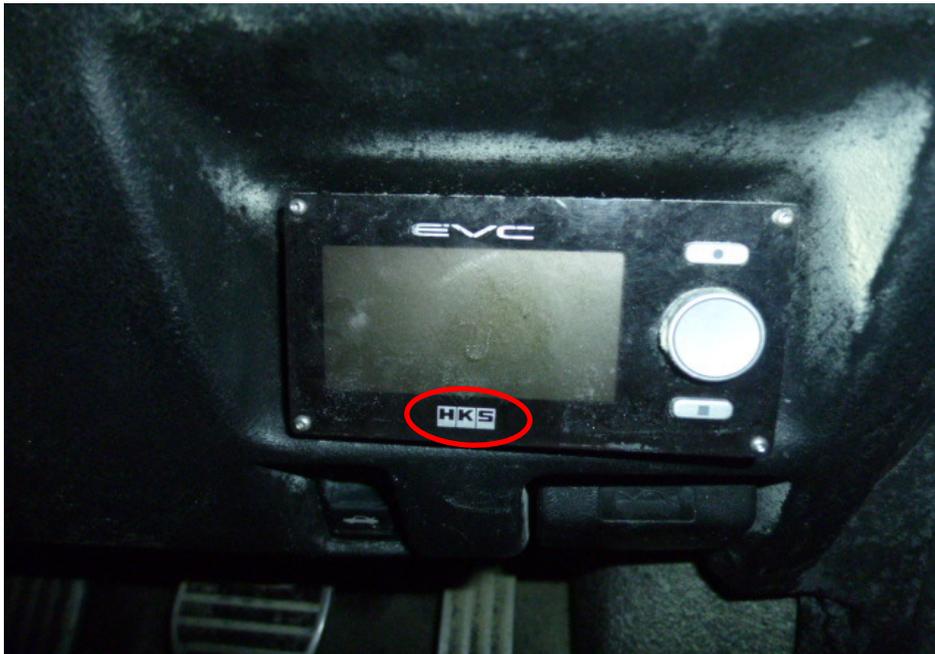
**Photo 7** shows the electronic boost controller additionally fitted onto the Insured Vehicle upon our inspection which had sustained minor fire damage. The brand of the controller was 'HKS' (circled).

29. We are further of the opinion that the additionally fitted electrical/electronic component found on the Insured Vehicle could have possibly caused overloading to the electrical system of the Insured Vehicle. However considering that the installation was carried out before the Insured Vehicle was purchased which was approximately more than a few years prior to the fire incident, the overloading was likely to be minimal.

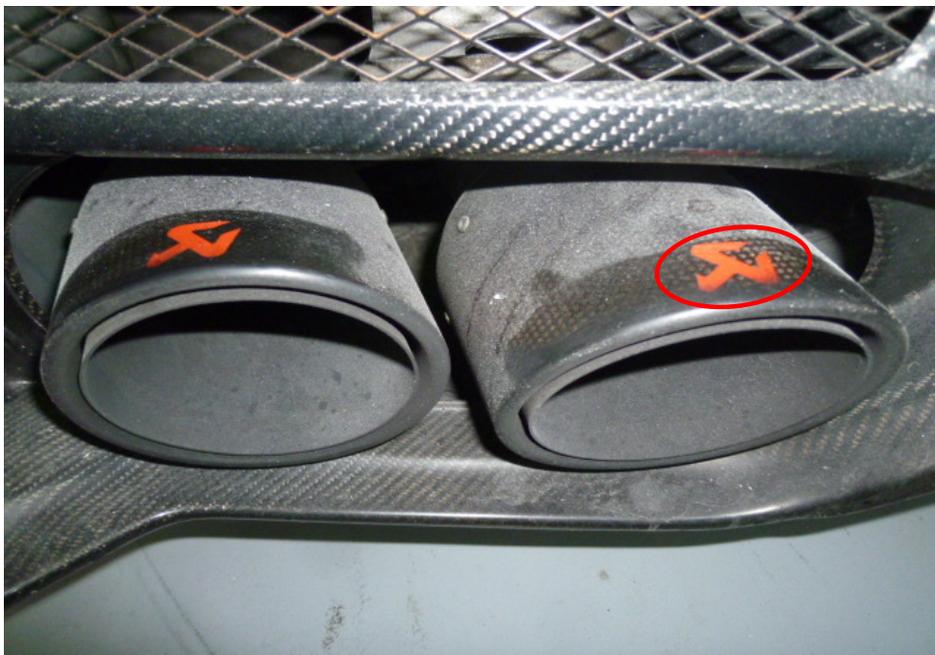
**Photo 9** shows a close up top view of the non-standard rear exhaust mufflers that were found to be fitted on the Insured Vehicle at the time of our inspection. The brand of the rear exhaust mufflers was 'AKRAPOVIC' (circled).

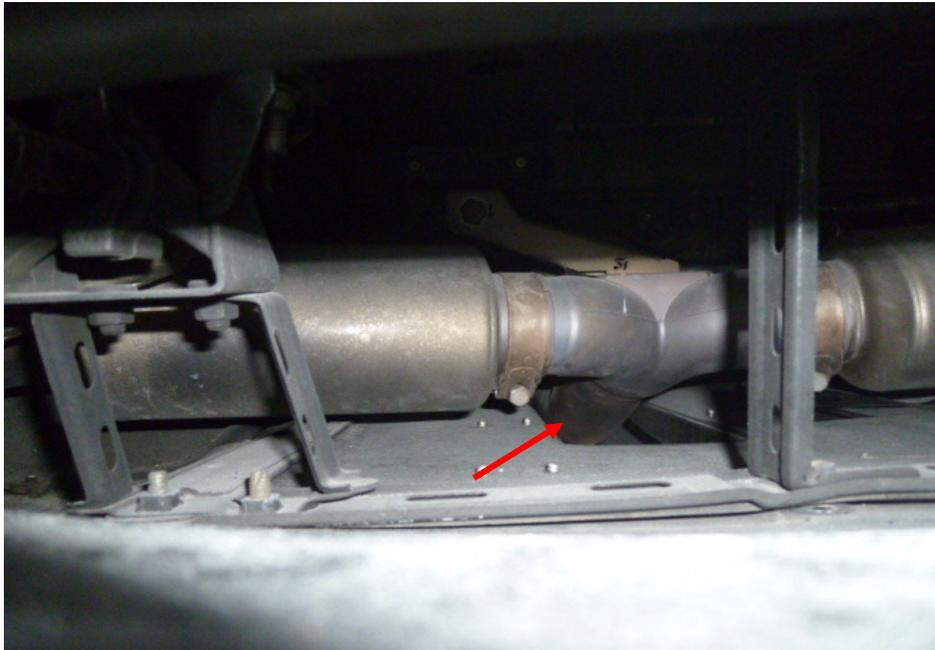
**Photo 10** shows a close up view of the non-standard mid pipe that was found to be fitted on the Insured Vehicle at the time of our inspection (arrowed). The brand of the rear exhaust mufflers was 'AKRAPOVIC'.

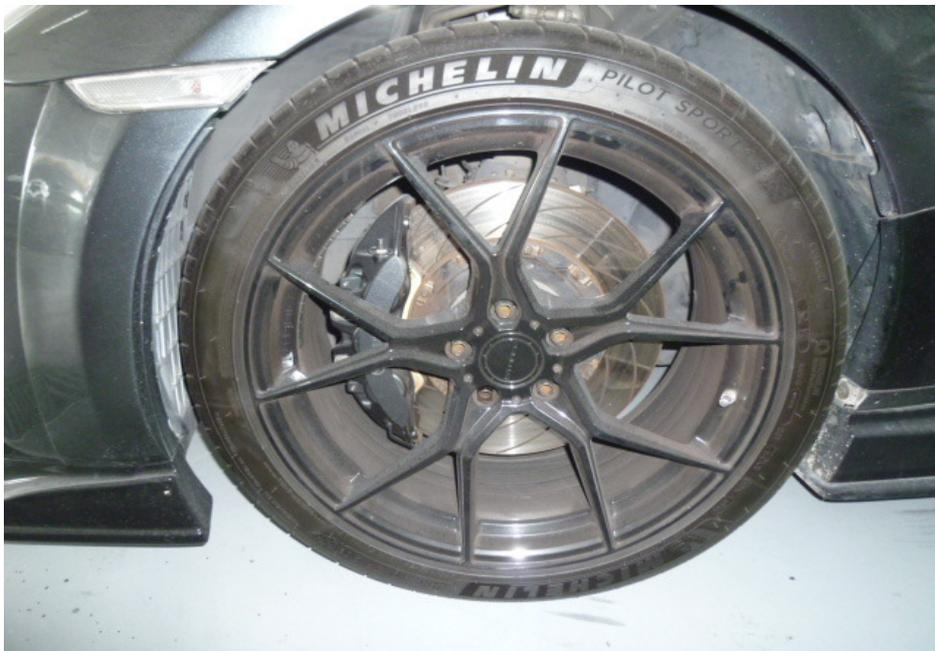
**Photo 11** shows the non-standard rim found to be fitted on the Insured Vehicle at the time of our inspection. The 20- inch alloy rims fitted on the Insured Vehicle were not the standard type for the Insured Vehicle.

30. Although the aftermarket alloy rims, mid pipe and rear exhaust mufflers fitted on the Insured Vehicle were not the standard type for the Insured Vehicle, we are of the view that these parts did not cause and/or contribute to the fire incident.

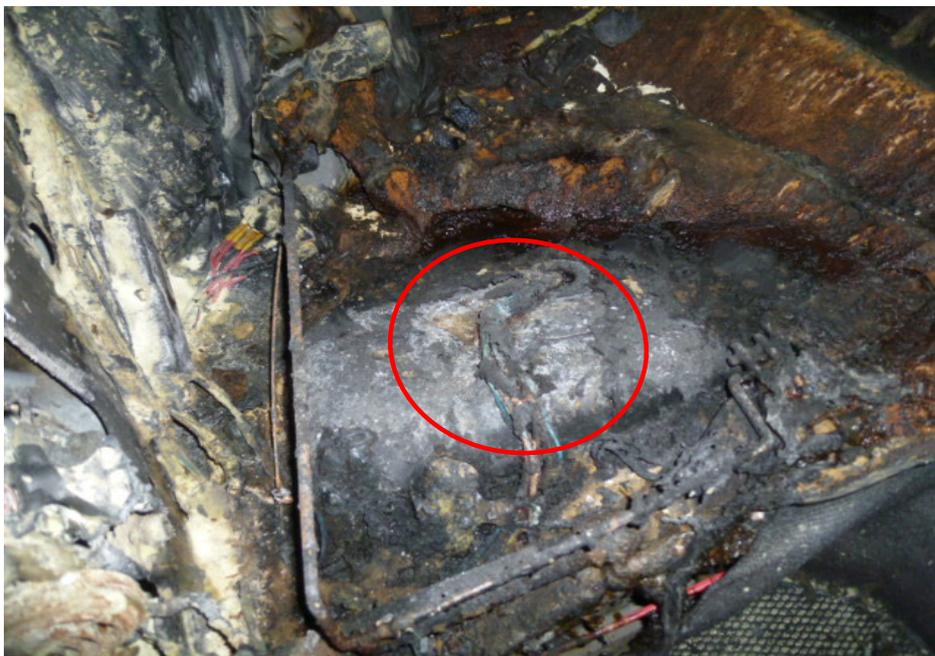
8. For this particular case, the fire appears to have originated within the interior compartment of the Insured Vehicle, somewhere under the right rear passenger seats which is where the petrol tank is located. This can be determined basing on the area where the extent of fire damage was most severe, the circumstances of the fires' origin at the material time of incident and also the high heat intensity burn marks (whitish burn marks) that were found on the exterior surface of the top portion of the petrol tank. These whitish burn marks are a result of exposure to prolonged heat intensity. Rust would normally start to develop around these areas soon after a fire as the prolonged exposure to high heat intensity usually causes the bare steel/metal material of the body parts to be exposed to natural environmental condition. The rust that had developed on the top portion of the petrol tank, in the immediate vicinity of where these whitish burn marks were found, would also support our findings of where the fire to the Insured Vehicle had originated. See photos 12 & 13 below.

**Photo 12** shows the burn pattern and whitish burn marks that were found on the exterior surface of the top portion of the petrol tank of the Insured Vehicle (circled). Such whitish burn marks are a result of exposure to prolonged heat intensity, which may indicate where the fire had started. Rust would also begin to develop on these areas soon after the fire.

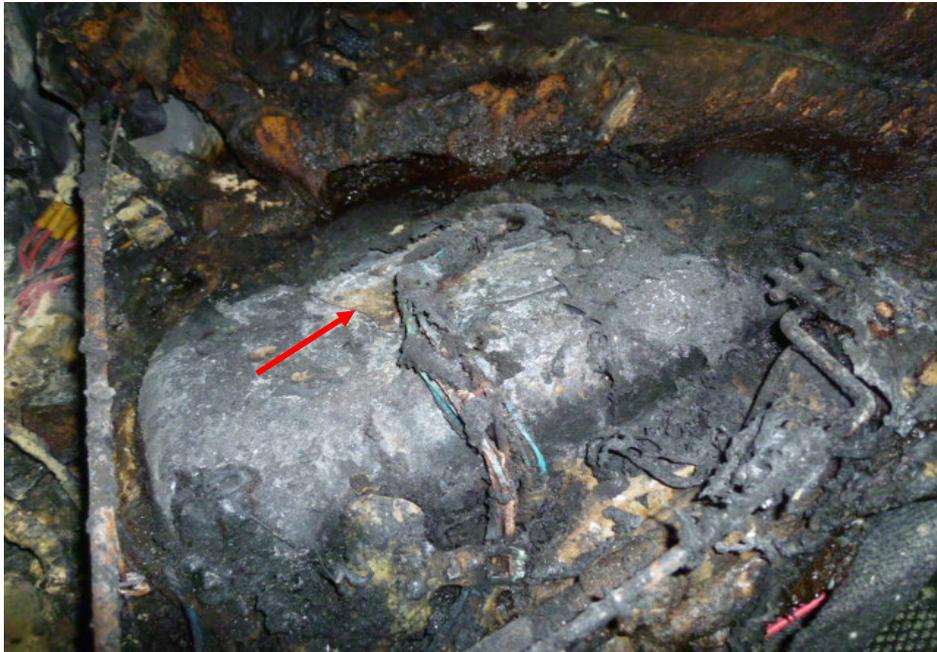
**Photo 13** shows a closer view of the rust that had developed on the exterior surface of the top portion of the petrol tank of the Insured Vehicle (arrowed). The development of rust is an indication that this area was subjected to prolonged exposure to high heat intensity, which had caused the steel/metal material of the front bonnet to be exposed to natural environmental condition. Hence the fire to the Insured Vehicle can be determined to have originated from the petrol tank.

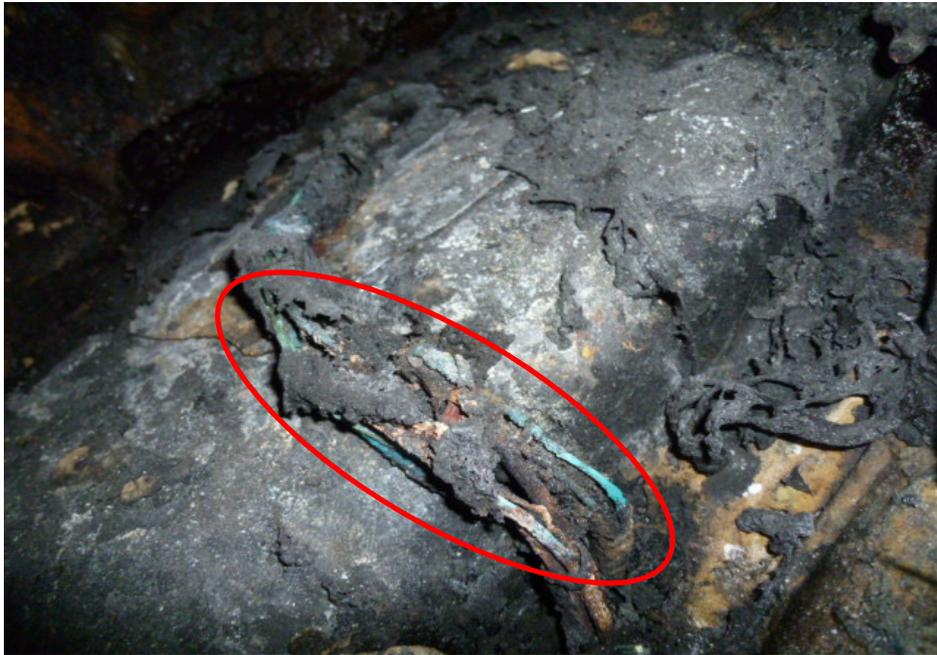
9. Upon closer examination of the petrol tank, which was where the fire to the Insured Vehicle had likely started, we had found traces of greenish residue on several stretches of burnt wirings. The presence of greenish residue indicates internal heating of copper wires, a sign of an electrical short circuit occurring. The greenish residue is normally left behind from oxidation as a result of chemical reaction involving the copper wires. This physical evidence would then appear to suggest that the cause of fire to the Insured Vehicle could have possibly been due to electrical in nature. See photos 14 - 17 below.

**Photo 14** shows the burnt wirings around the petrol tank which is in the immediate vicinity where the fire to the Insured Vehicle had likely started. Upon closer examination, we had found traces of greenish residue on several stretches of these burnt wirings (circled). The presence of greenish residue indicates internal heating of copper wires, a sign of an electrical short circuit occurring. The greenish residue is normally left behind from oxidation as a result of chemical reaction involving the copper wires.

26. Having investigated and technically analysed the damages of burnt nature to the Insured Vehicle, we are of the view that the cause of fire to the Insured Vehicle was of electrical in nature. For this particular case, the fire had originated along the wirings inside the petrol tank of the Insured Vehicle. The wirings were original factory wirings of the Insured Vehicle. The electrical fire had radiated to the surrounding components leading to fire within the interior compartment of the Insured Vehicle.

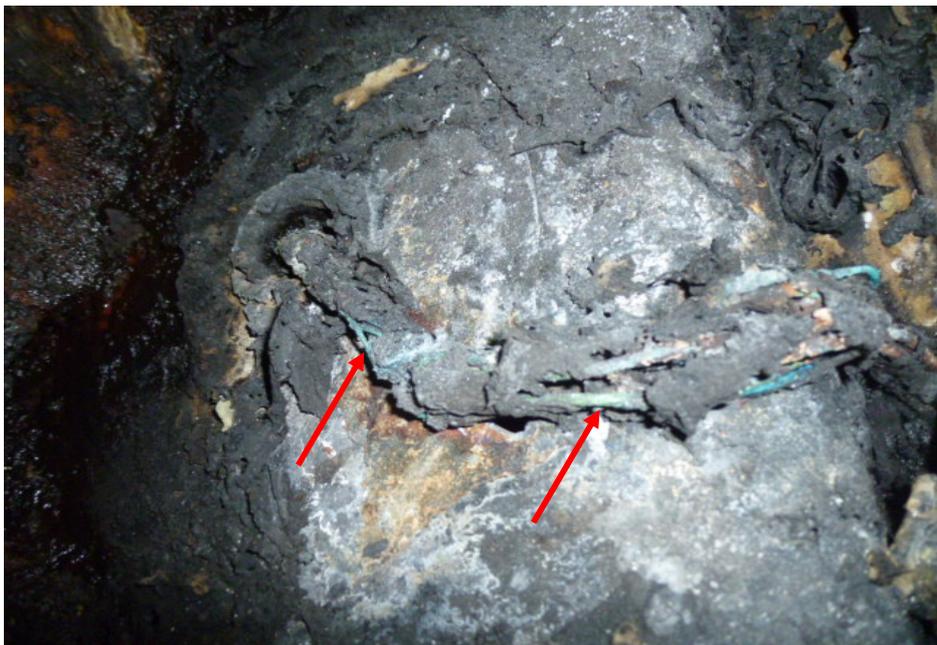
**Photo 15** shows a closer view of the greenish residue found on several stretches of burnt wirings (arrowed). The presence of such greenish residue suggests occurrence of an electrical short circuit.

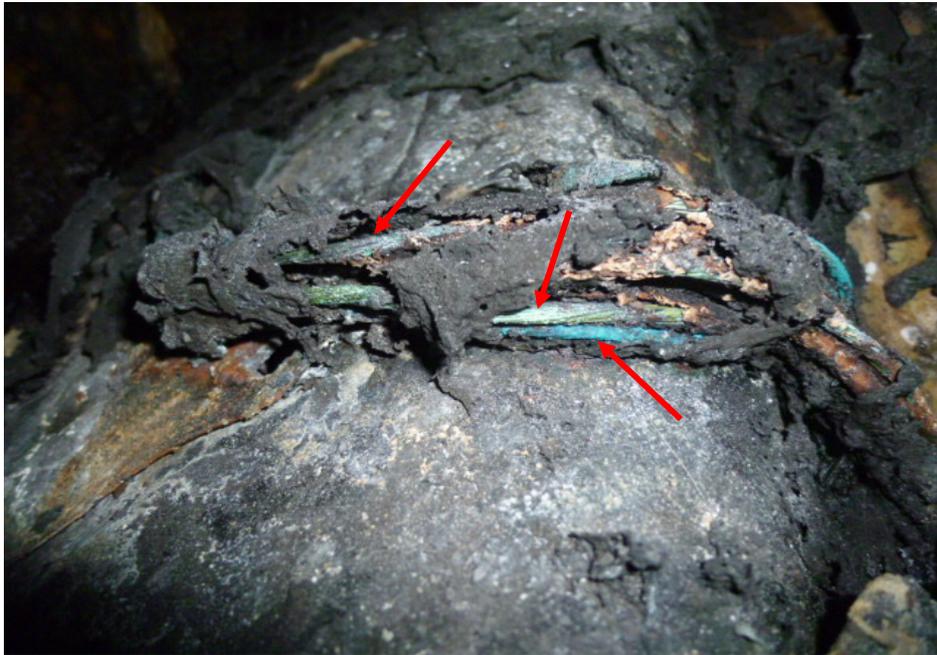
**Photo 16** shows a close up view of the greenish residue found on several stretches of burnt wirings (red arrows). The presence of such greenish residue suggests occurrence of an electrical short circuit.

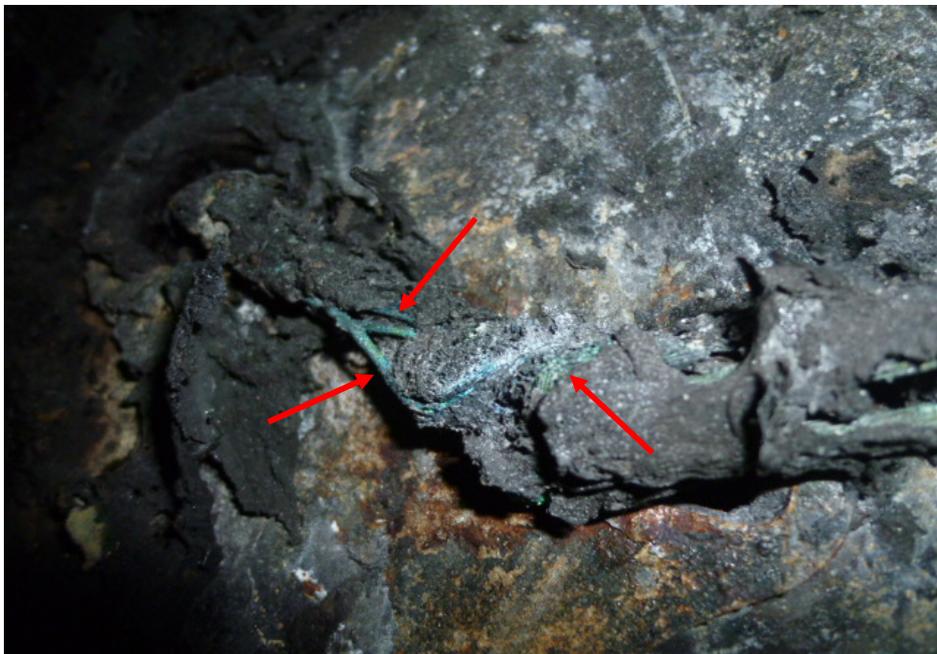
**Photo 17** shows a close up view of the greenish residue found on several stretches of burnt wirings (red arrows). The presence of such greenish residue suggests occurrence of an electrical short circuit.

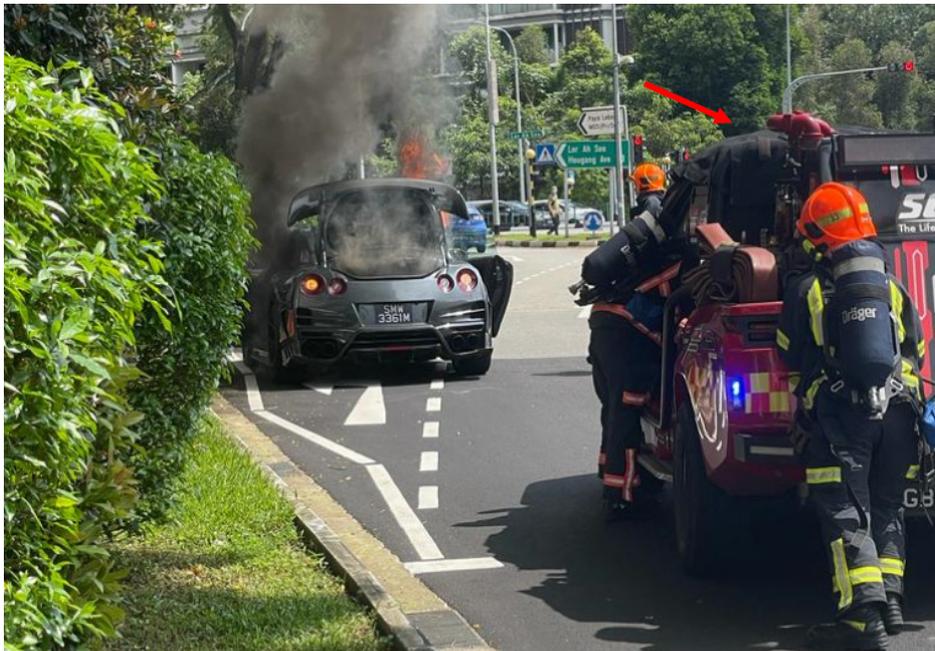
**Photo 21** shows the arrival of the SCDF not long after the Insured Vehicle caught fire. In general, the information that could be gathered from this photograph had corresponded to the events that were related to us by Mr Tan which is the SCDF responded to the incident (arrowed).

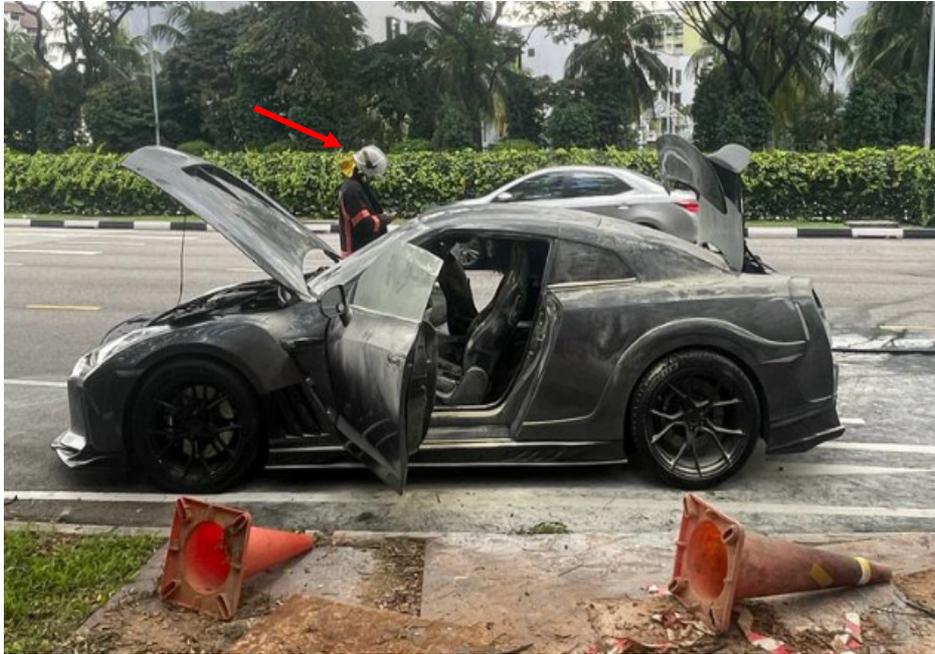
**Photo 22** shows the SCDF fire investigators performing preliminary investigations on the Insured Vehicle after the fire was extinguished (arrowed).

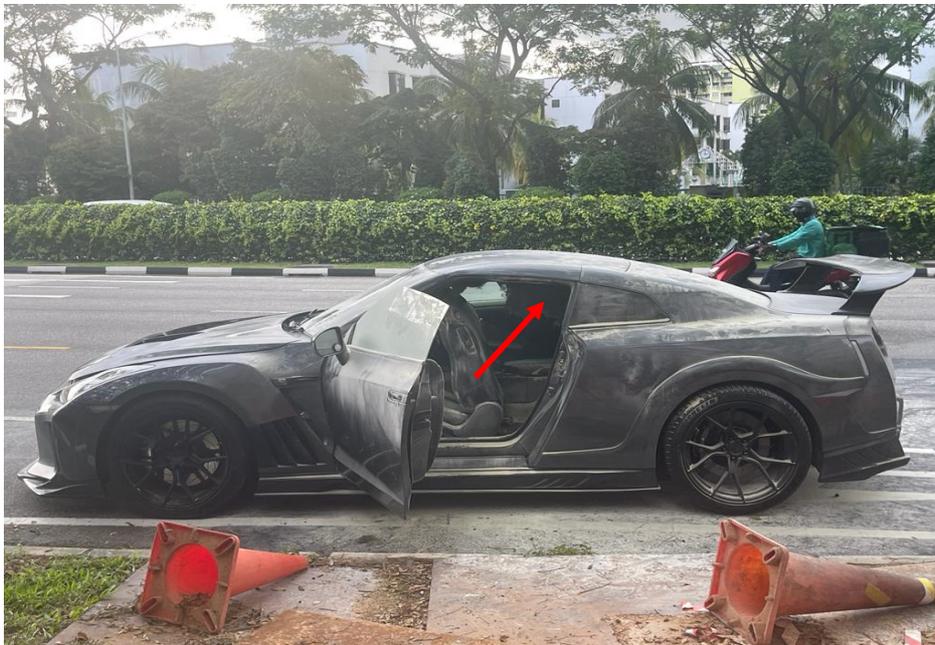
**Photo 23** shows the Insured Vehicle at the incident scene after the fire was extinguished. The severity of damage of the right rear passenger portion of the Insured Vehicle (arrowed) as compared to the left portion had corresponded to the events that were related to us by Mr Tan, which is the fire had started from the right rear passenger portion of the Insured Vehicle.
