You're Ref: TP/IP/33181/2022
Our Ref: CI/TPD22013018/P

30th December 2022

MECHANICAL INSPECTION REPORT OF MOTOR CAR SMQ 5937X

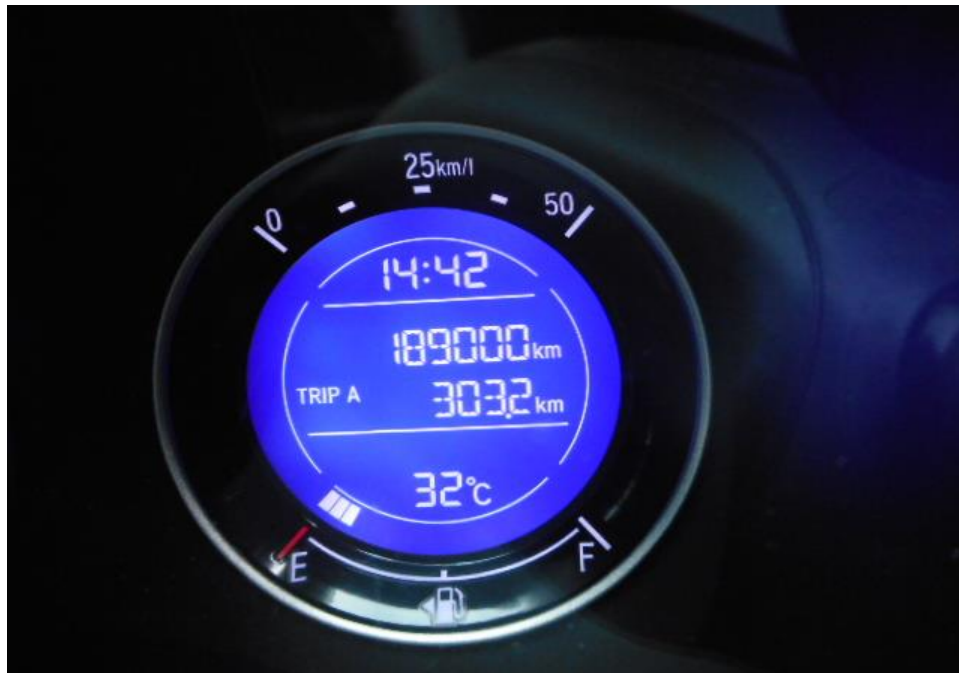
Photo 1 shows the mileage of the Motor Car at the time of my inspection. The mileage observed was 189,900km.

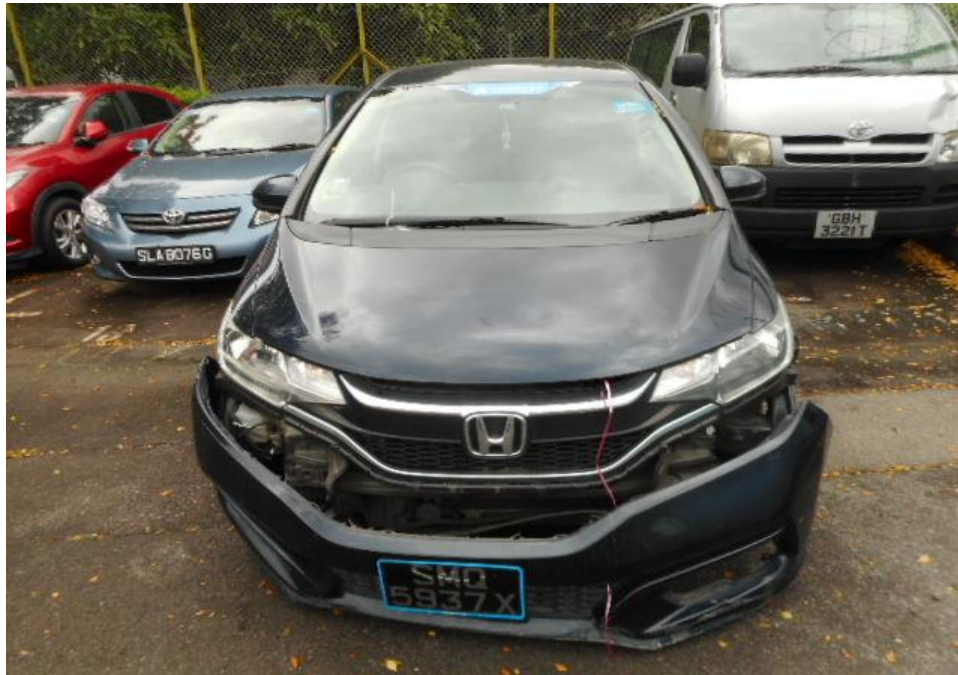
Photo 2 shows a general view of the Motor Car's front body at the time of my inspection. The front portion of the Motor Car was observed to have sustained damage. Its front bumper was the body part that were damaged as a result of the accident.

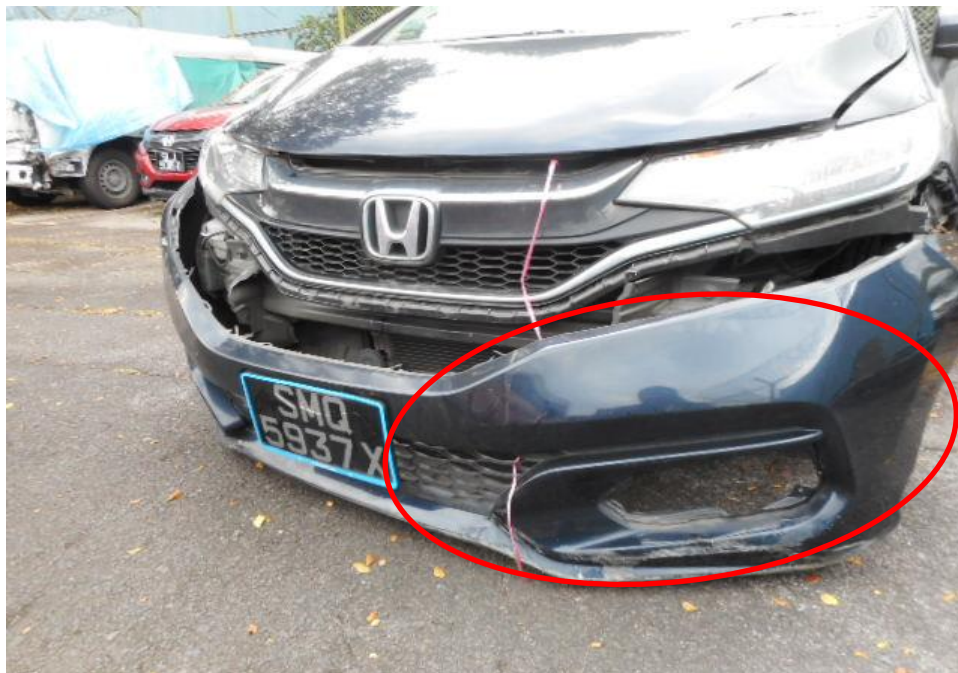
Photo 3 shows a close up view of the Motor Car's front body at the time of my inspection. The front portion of the Motor Car was observed to have sustained damage. Its front bumper (circled) was the body parts that were damaged as a result of the accident.

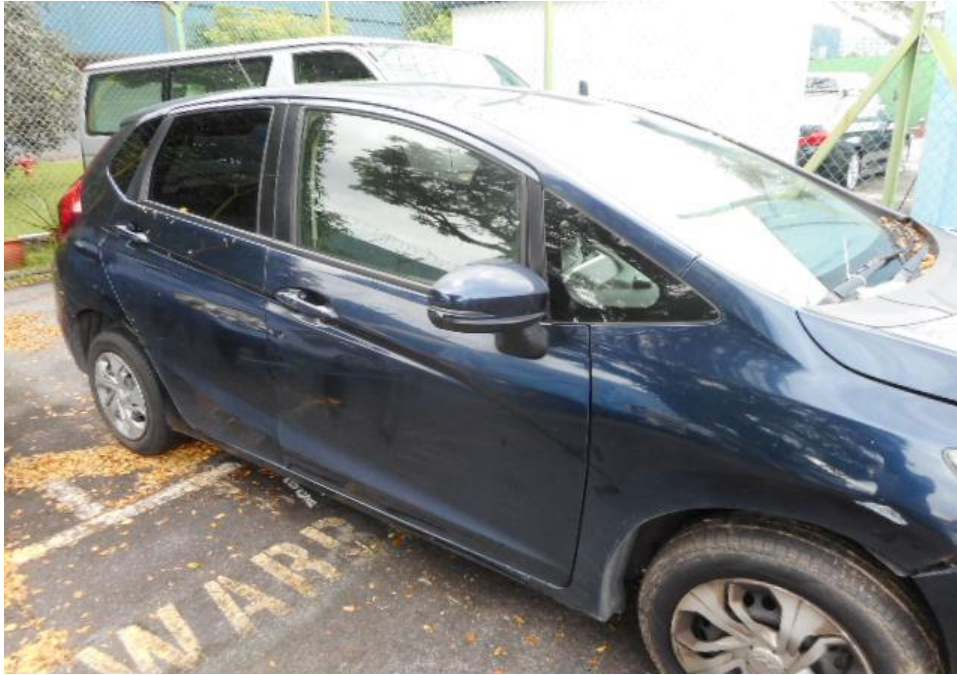
Photo 4 shows a general view of the Motor Car's right body at the time of my inspection. The right portion of the Motor Car was observed to have been unaffected by the accident.

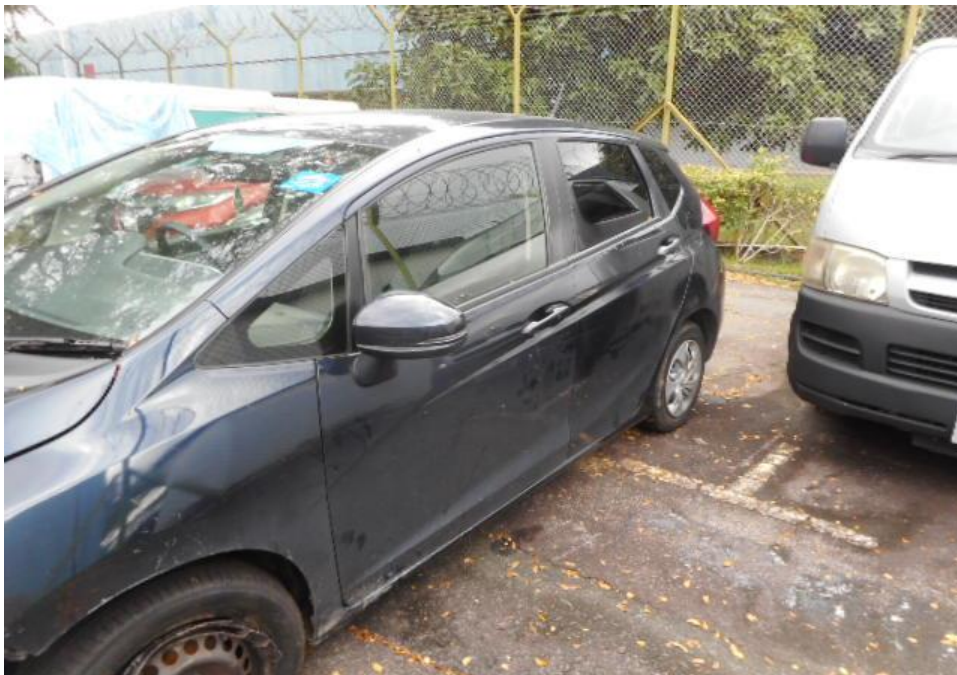
Photo 5 shows a general view of the Motor Car's left body at the time of my inspection. The left portion of the Motor Car was observed to have been unaffected by the accident.

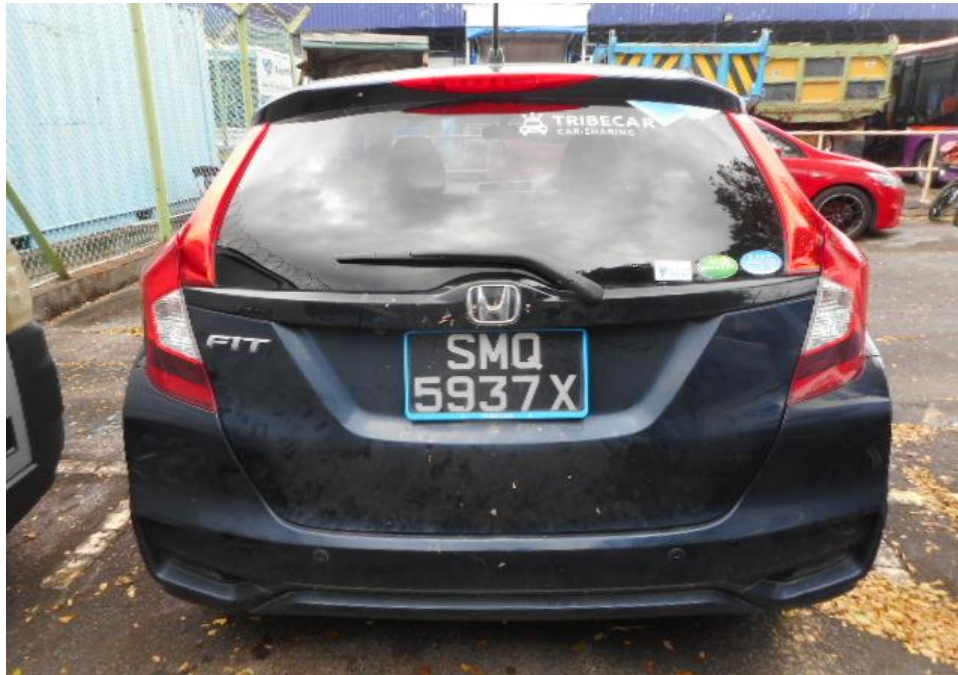
Photo 6 shows the general view of the Motor Car's rear body at the time of my inspection. The Motor Car rear was observed to be unaffected by the accident.

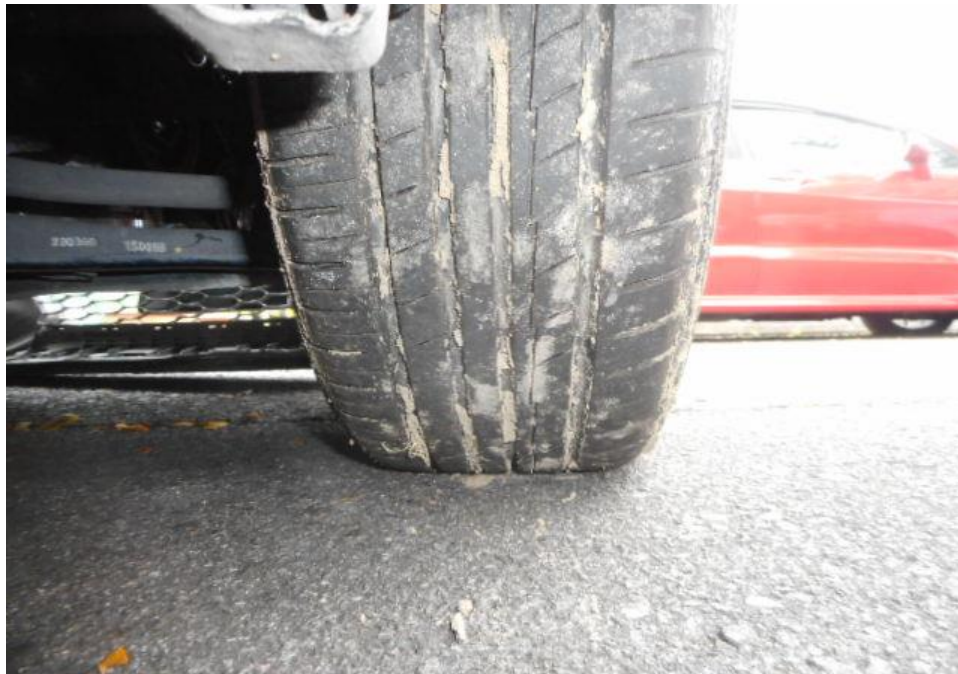
Photo 7 shows the condition of the front right tyre of the Motor Car, which was observed to be in serviceable condition with remaining tread depth of approximately 5.6mm. The tyre was sufficiently inflated for vehicular operation with no tear, cut or burst mark(s) on the outer and the inner sidewalls as well as across the tread. The 3 tyres of the Motor Car were wrapped around standard steel wheel rims without any damage.

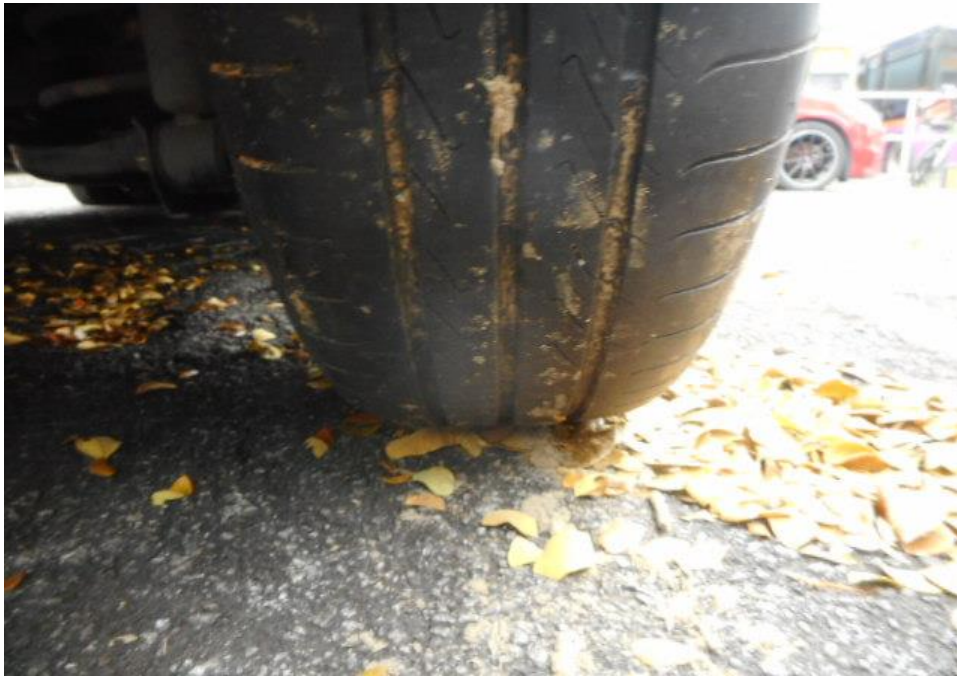
Photo 8 shows the condition of the rear right tyre of the Motor Car, which was observed to be in serviceable condition with remaining tread depth of approximately 4.6mm. The tyre was also observed to be sufficiently inflated for vehicular operation with no tear, cut or burst mark(s).

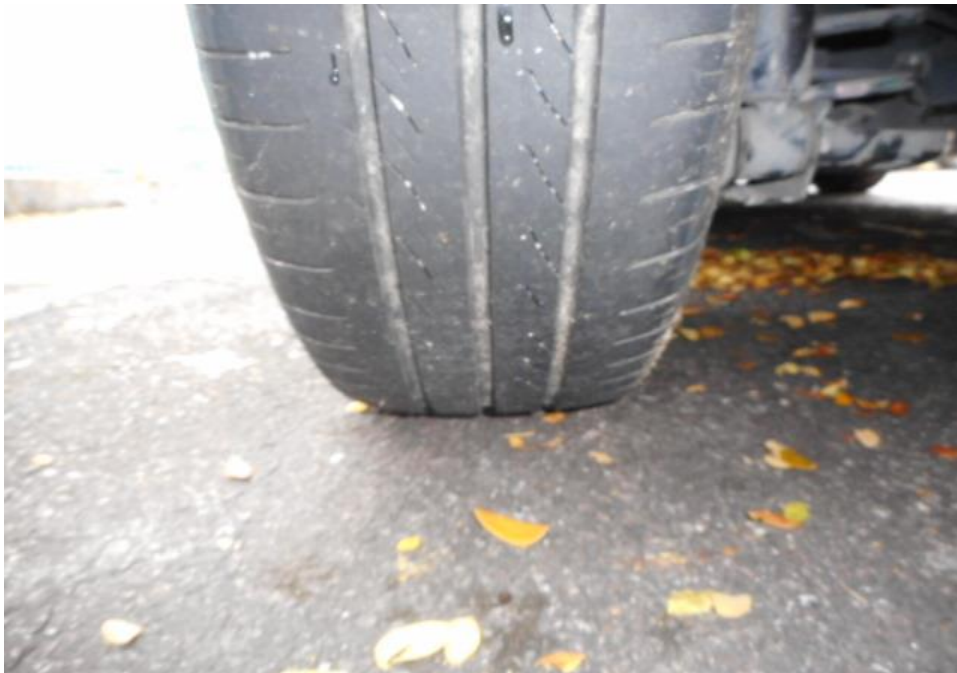
Photo 9 shows the condition of the rear left tyre of the Motor Car, which was observed to be in serviceable condition with remaining tread depth of approximately 4.1mm. The tyre, which was wrapped around steel wheel rim, was also observed to be sufficiently inflated for vehicular operation. The 3 tyres of the Motor Car were wrapped around standard steel wheel rims.

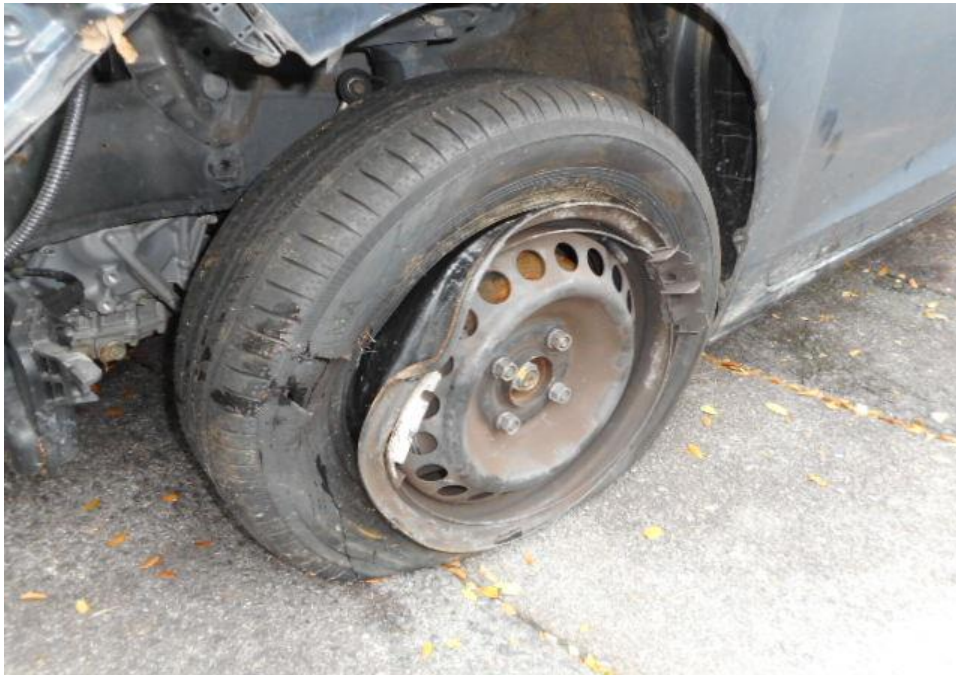
Photo 10 shows the general condition of the front left tyre of the Motor Car, which was observed to be in unserviceable condition with remaining tread depth of approximately 6mm. There was also cut mark(s) on the outer sidewalls of the Motor Car's tyre and the wheel rim was also damaged as a result of the accident.

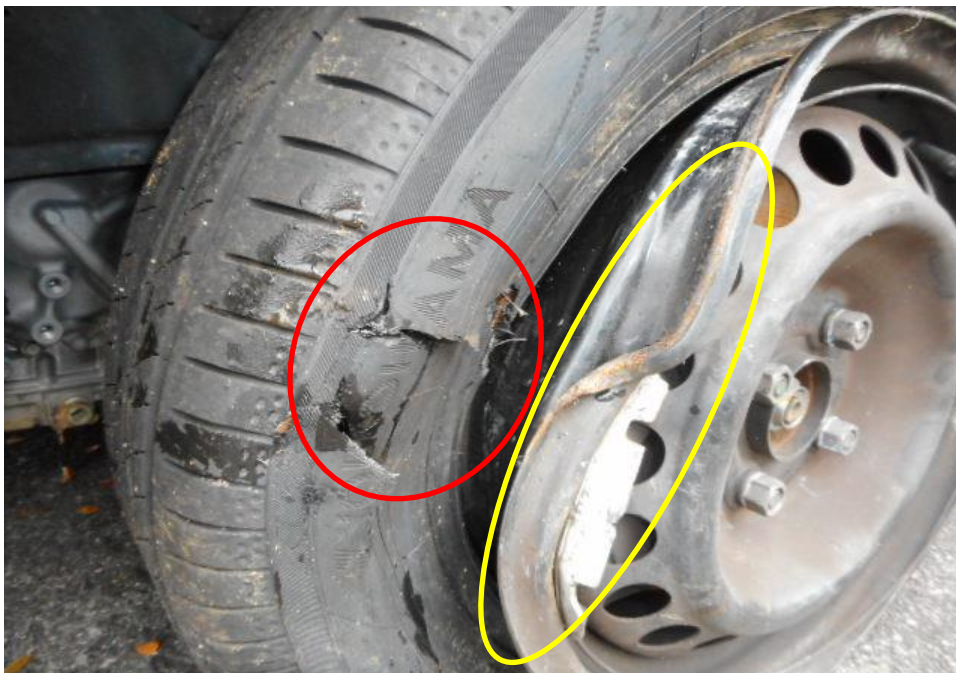
Photo 11 shows the close up condition of the front left tyre of the Motor Car, which was observed to be in unserviceable condition with remaining tread depth of approximately 6mm. There was also cut mark (red circle) on the outer sidewalls of the Motor Car's tyre and the wheel rim (yellow circle) was also damaged as a result of the accident.

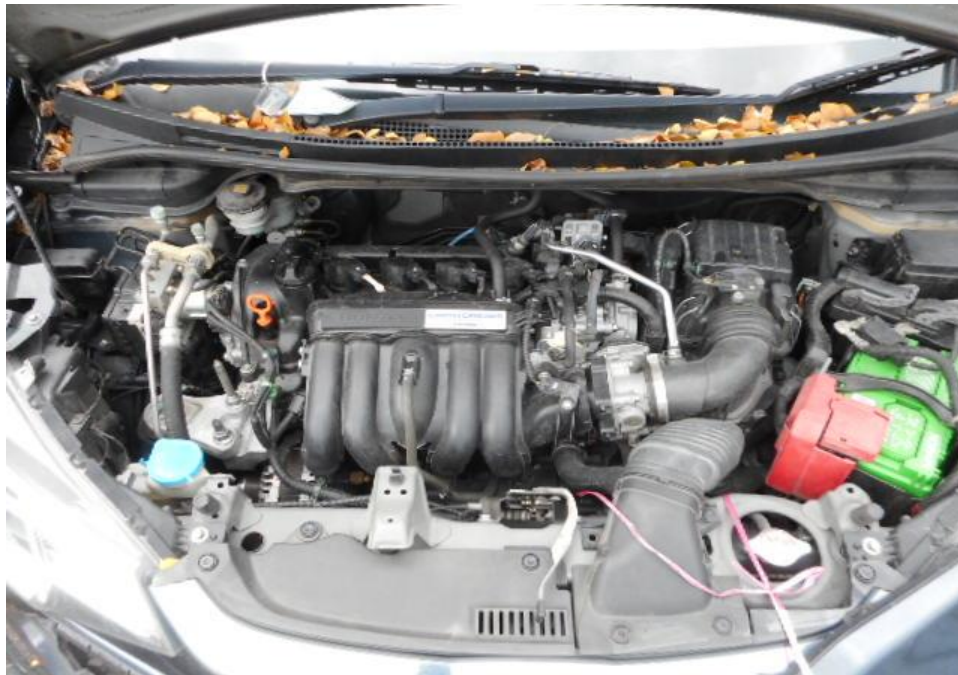
Photo 12 shows a general view of the Motor Car's engine compartment. The various parts and components inside the engine compartment were unaffected by the accident. There was also no sign(s) or indication(s) of fluid leakage and/or fluid stain within the engine compartment.

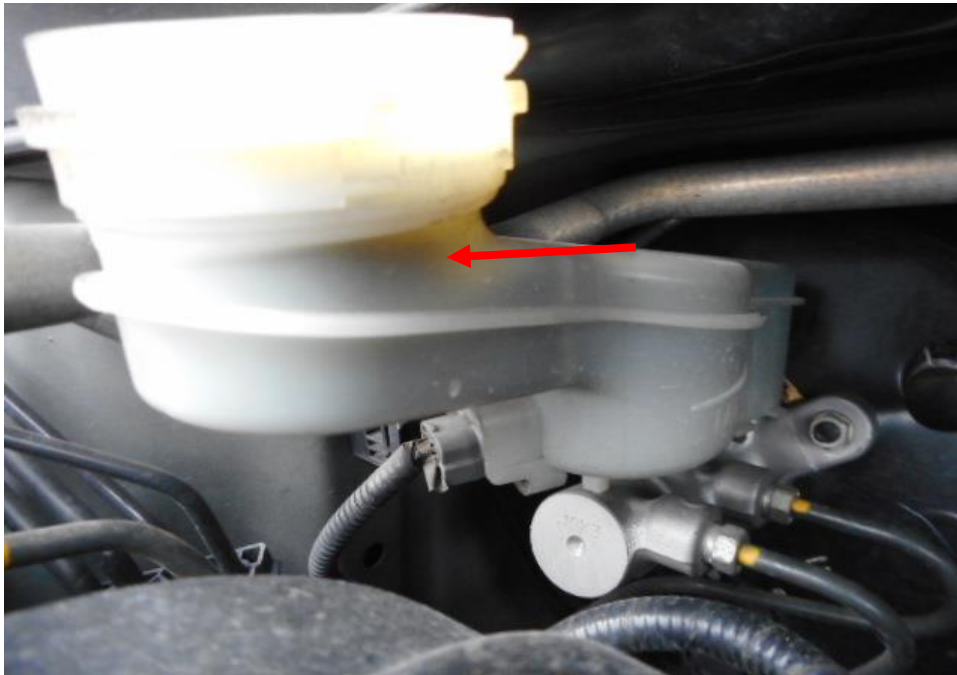
Photo 13 shows the brake fluid reservoir of the Motor Car at the time of my inspection. The brake fluid was observed to be of sufficient level (arrowed) and without any visible contamination.

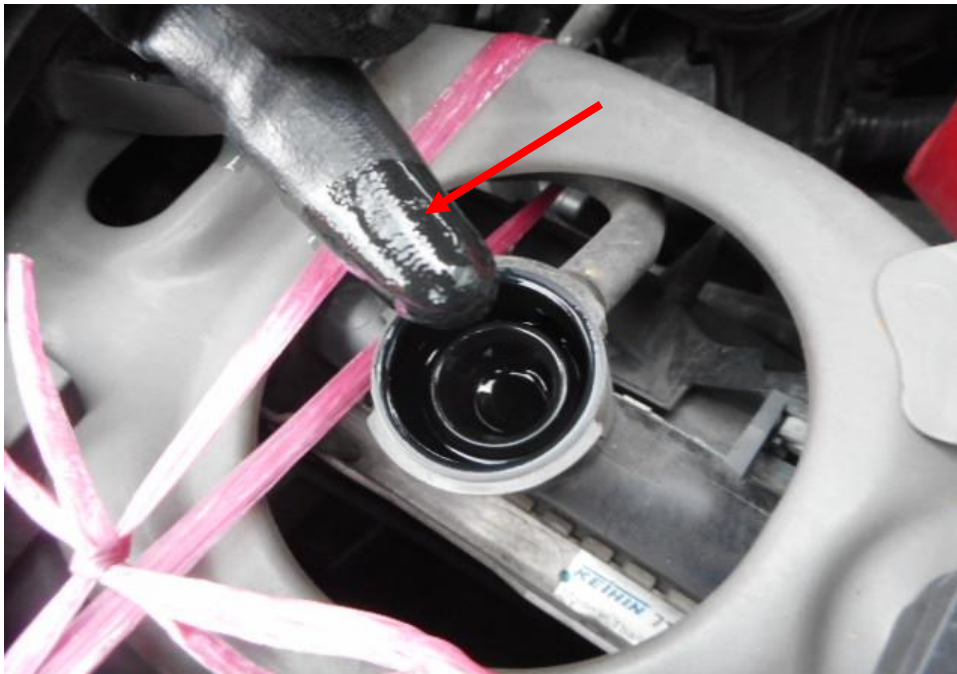
Photo 14 shows checks being carried out to the engine coolant of the Motor Car at the time of my inspection. The engine coolant was observed to be of sufficient level (arrowed) and without any visible contamination.

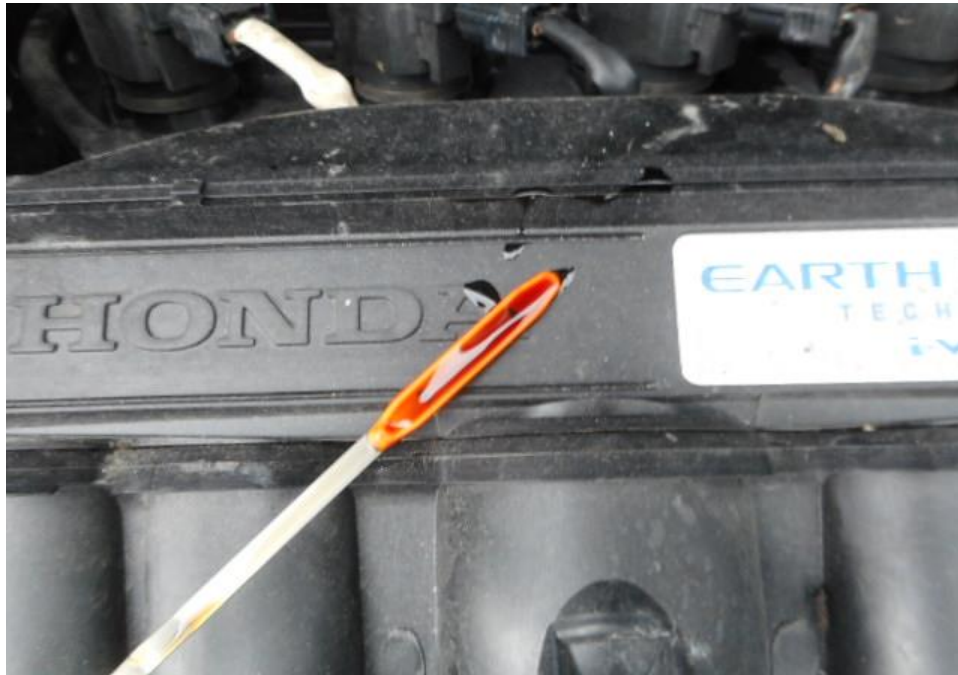
Photo 15 shows the engine oil dipstick of the Motor Car at the time of my inspection. The engine oil was observed to be of sufficient level and without any visible contamination.

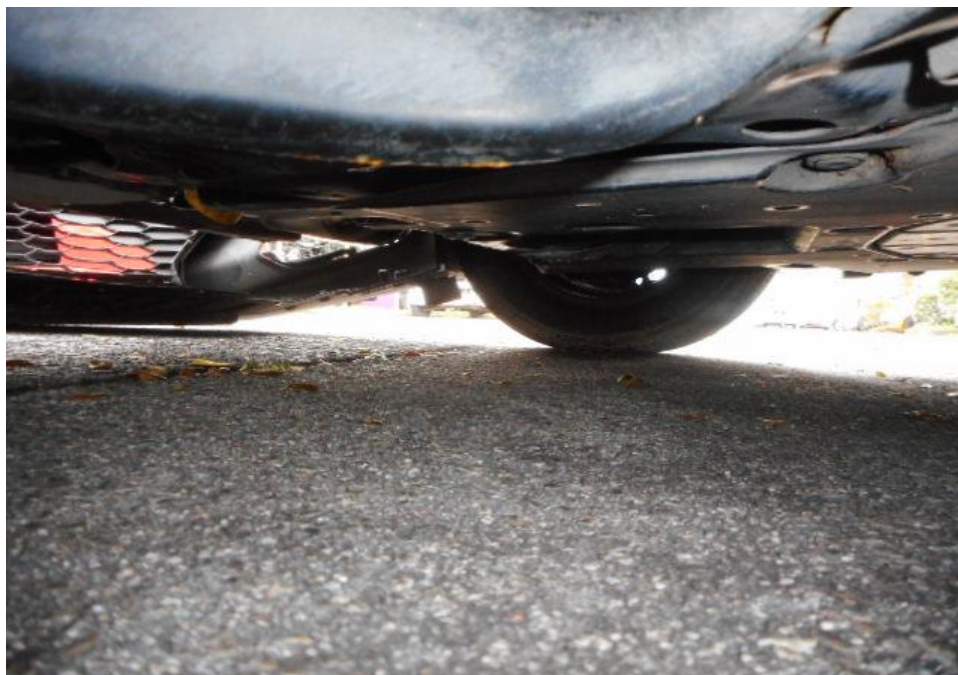
Photo 16 shows the undercarriage of the Motor Car, at the area where the engine housing and transmission housing are located. I did not find any sign(s) or indication(s) of fluid leak and/or fluid stain(s) on the underside of the Motor Car.

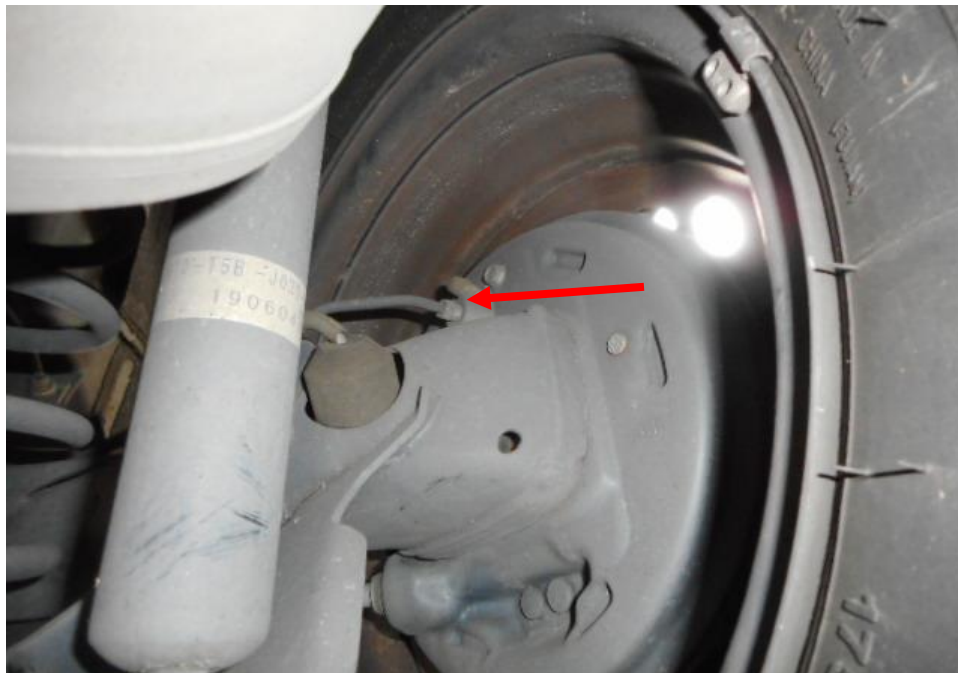
Photo 17 shows the brake hose/pipe (arrowed) at the rear right wheel of the Motor Car. No leakage of brake fluid was observed. Visual examination of the various components of the braking system like the drum brake, brake booster, brake pedal etc. had revealed all to be intact and without visible damage.

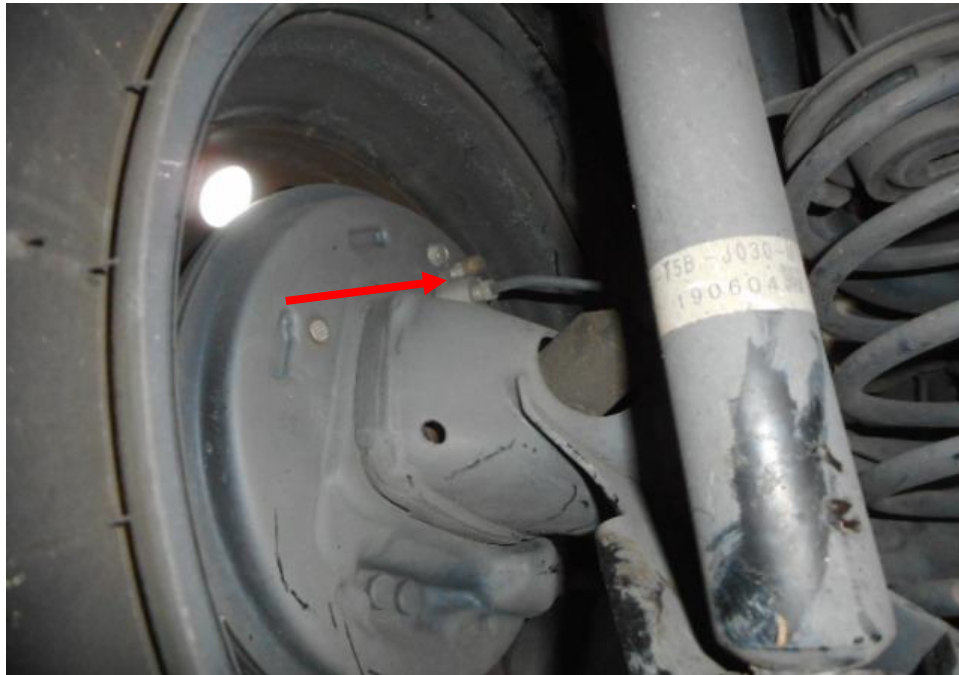
Photo 18 shows the brake hose/pipe (arrowed) at the rear left wheel of the Motor Car. I did not observe any leakage of brake fluid at the time of my inspection of the Motor Car. Static tests of the Motor Car's braking system had indicated that there was no internal leakage of pressure/vacuum. The undercarriage components of the Motor Car were also all found to be intact and without any visible damage.

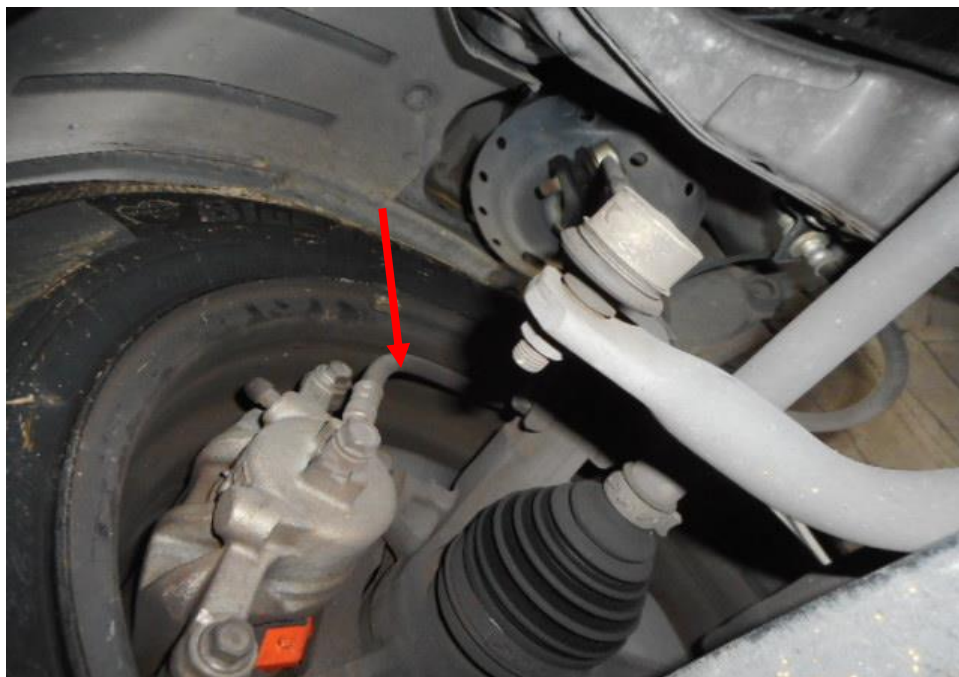
Photo 19 shows the brake hose/pipe (arrowed) at the front right wheel of the Motor Car. I did not observe any leakage of brake fluid at the time of my inspection of the Motor Car. Static tests of the Motor Car's braking system had indicated that there was no internal leakage of pressure/vacuum. The undercarriage components of the Motor Car were also all found to be intact and without any visible damage.

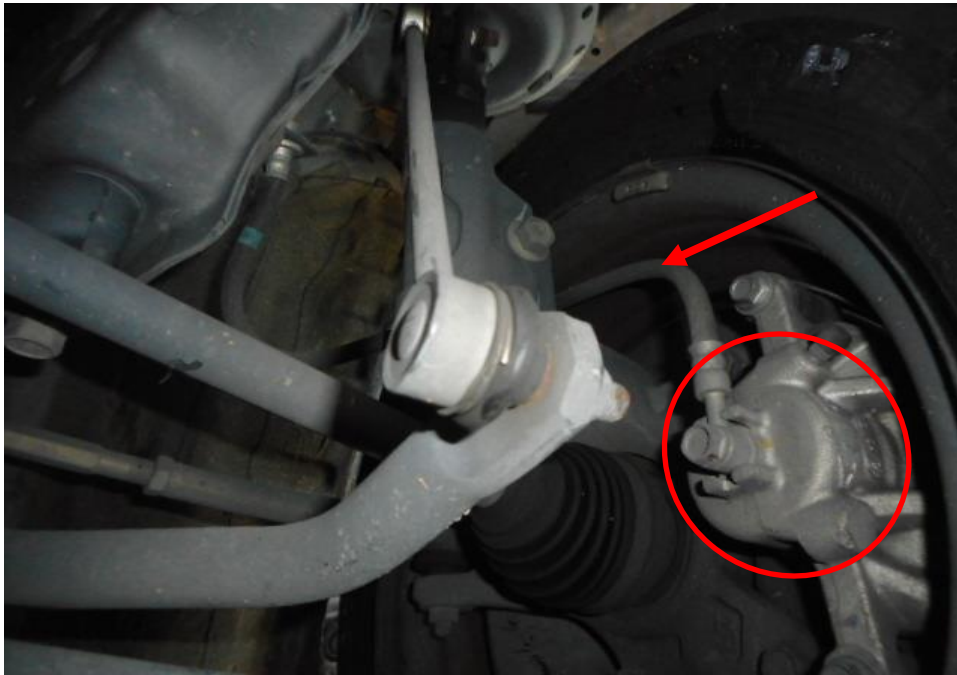
Photo 20 shows the brake hose/pipe (arrowed) at the front left wheel of the Motor Car. No leakage of brake fluid was observed. Visual examination of the various components of the braking system like the brake caliper (circled), brake booster, brake pedal etc had revealed all to be intact and without visible damage.

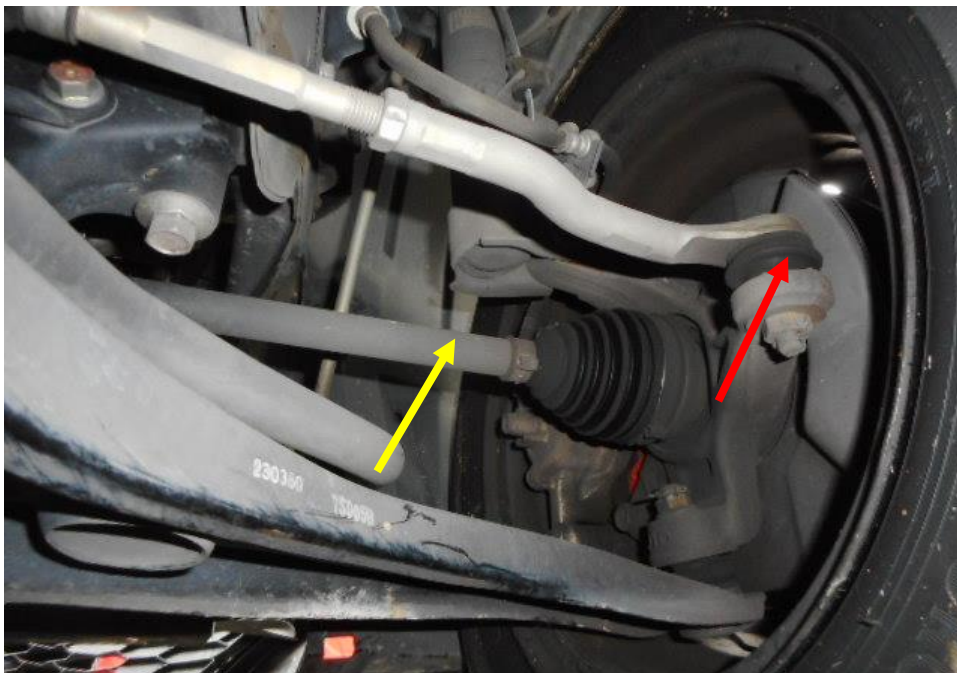
Photo 21 shows the various undercarriage components at the front right wheel of the Motor Car, in particular the steering tie rod (red arrow) and drive shaft (yellow arrow). The various steering components were all found to be intact and there was also no sign of fluid stain observed on the various undercarriage components at the front right wheel of the Motor Car.

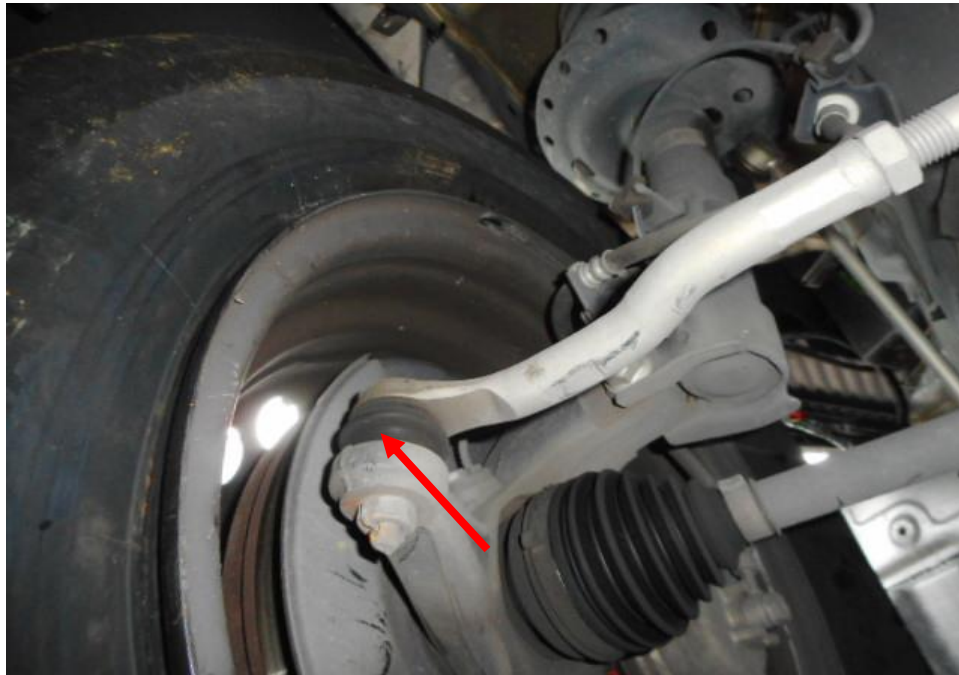
Photo 22 shows the various undercarriage components at the front left wheel of the Motor Car, which had included the steering tie rod (red arrow). The various undercarriage components of the Motor Car were all found to be intact without any visible damage.

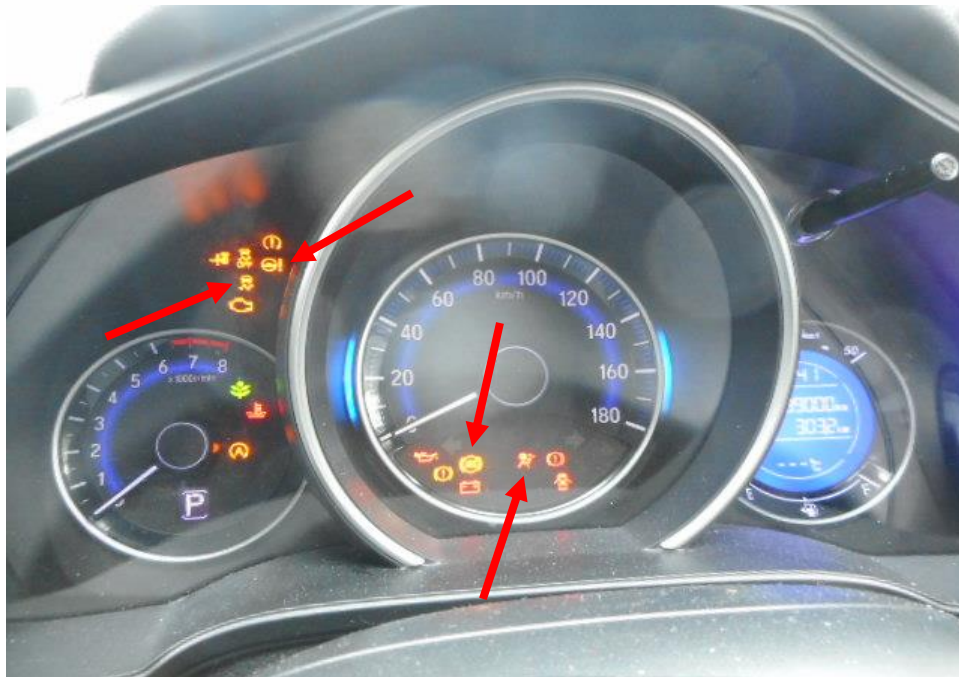
Photo 23 shows the warning light for Anti-Lock Brake System (ABS), Traction Control System (TCS), Electric Power Steering System (EPS) and Supplemental Restraint System (SRS) (arrowed) appearing on the instrument panel of the Motor Car during the self-test of its various electronic operating systems when its engine was cranked.

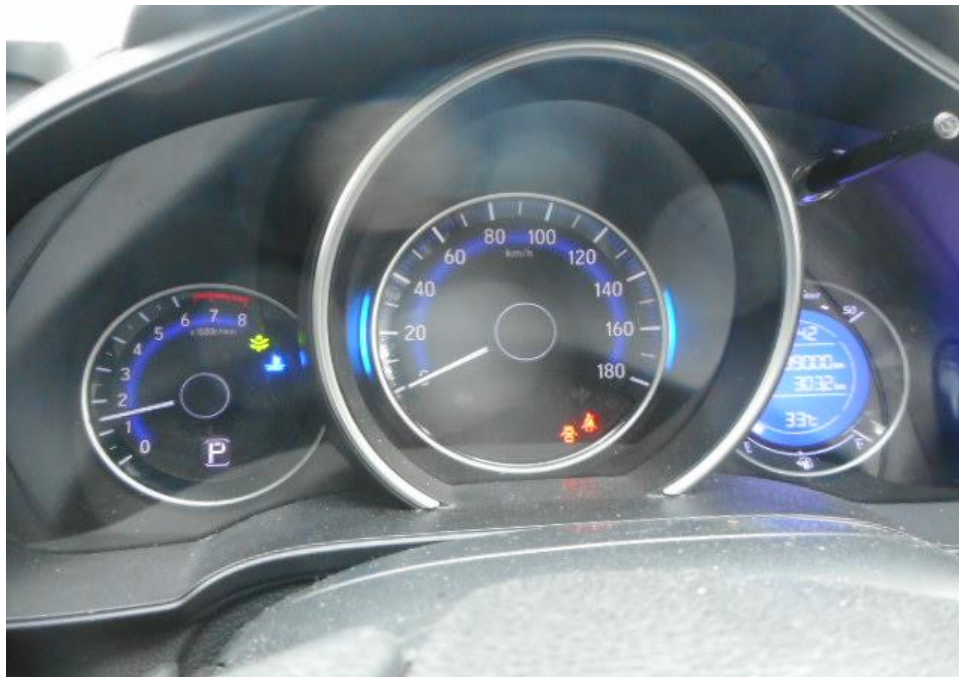
Photo 24 shows no warning lights illuminated on the instrument panel of the Motor Car after the engine was cranked. This would suggest that there was no abnormality to the electronic operating system of the Motor Car, like the ABS, EPS, TCS and SRS etc.
