Your Ref: TP/IP/33304/2022  
Our Ref : CI/TPD22013019/P

**Fatal Accident Investigation Team**

**MECHANICAL INSPECTION REPORT OF MOTOR VAN GBJ 653P**

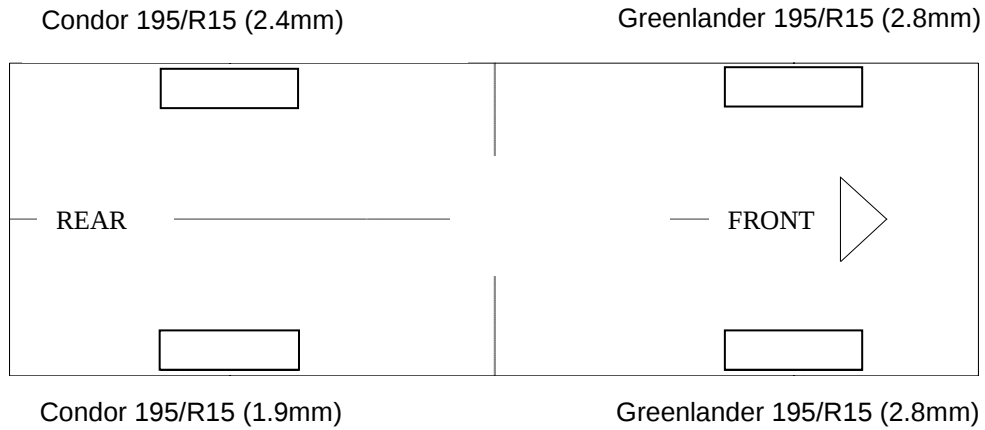
6. The 4 tyres of the Motor Van were observed to be in serviceable condition and sufficiently inflated for vehicular operation. I did not find any tear, cut or burst mark(s) on the outer and the inner sidewalls as well as across the tread of the 4 tyres. The tyre brand, tyre size and remaining tread depth of the 4 tyres of the Motor Van were recorded as follows:-

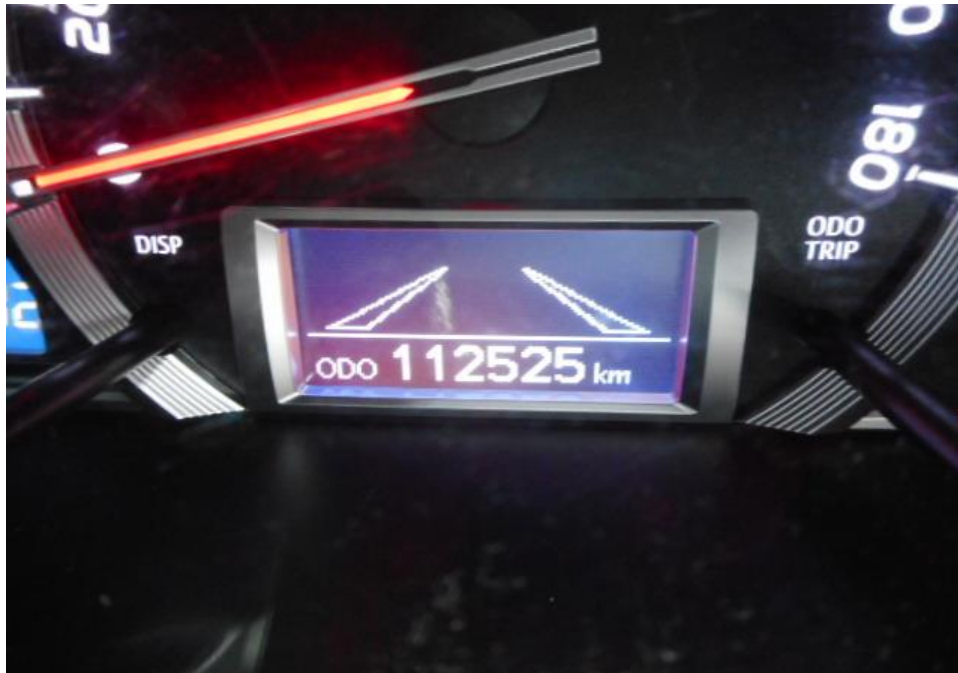
4. The mileage of the Motor Van at the time of my inspection was 112,525km.
5. The Motor Van appeared to have sustained damage at its rear portion. Its rear bumper and rear body panel was damaged at the time of my inspection.

**Photo 1** shows a general view of the instrument cluster of the Motor Van at the time of my inspection. The mileage of the Motor Van was 112,525km

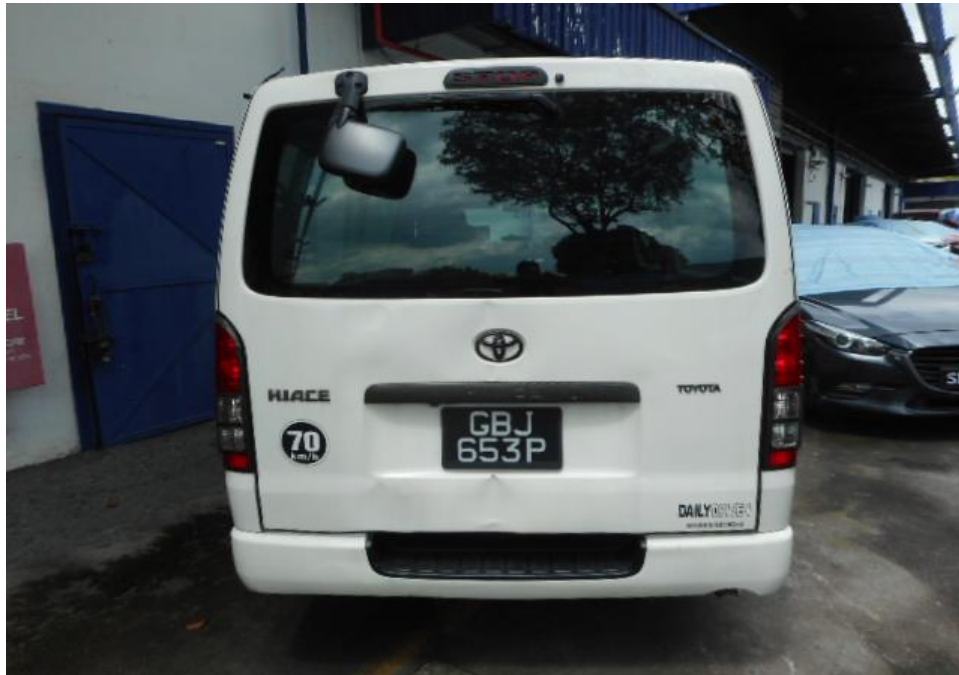
**Photo 2** shows a general view of the Motor Van's rear portion at the time of my inspection. It appeared to have sustained damage at its rear portion. Its rear bumper and rear body panel was damage at the time of my inspection.

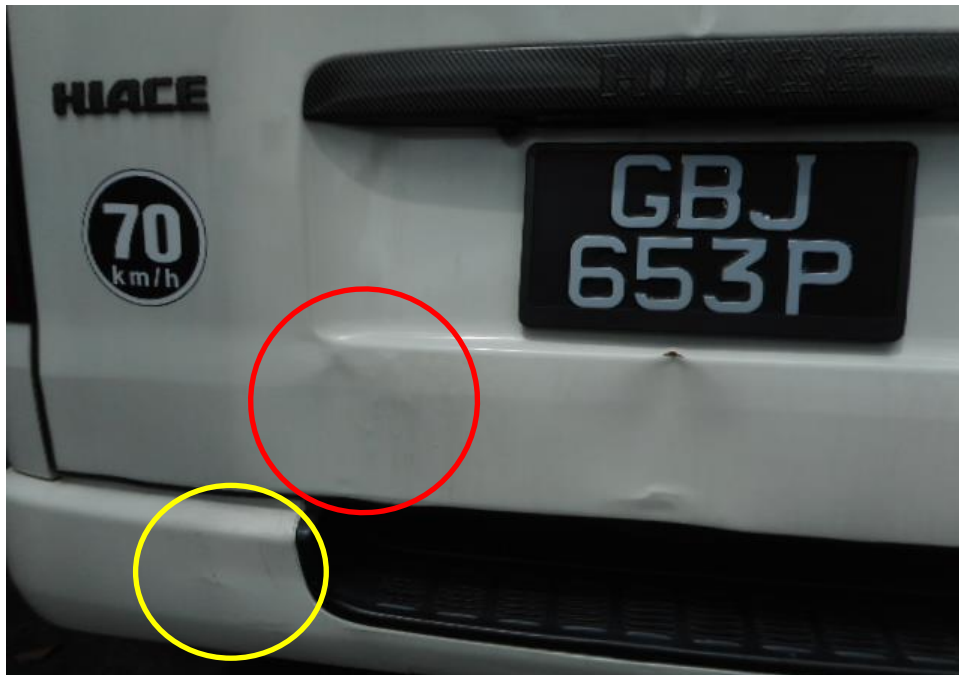
**Photo 3** shows a close up view of the Motor Van's rear portion at the time of my inspection. It appeared to have sustained damage at its rear portion. Its rear bumper (yellow circle) and rear body panel (red circle) was damage at the time of my inspection as a result of the accident.

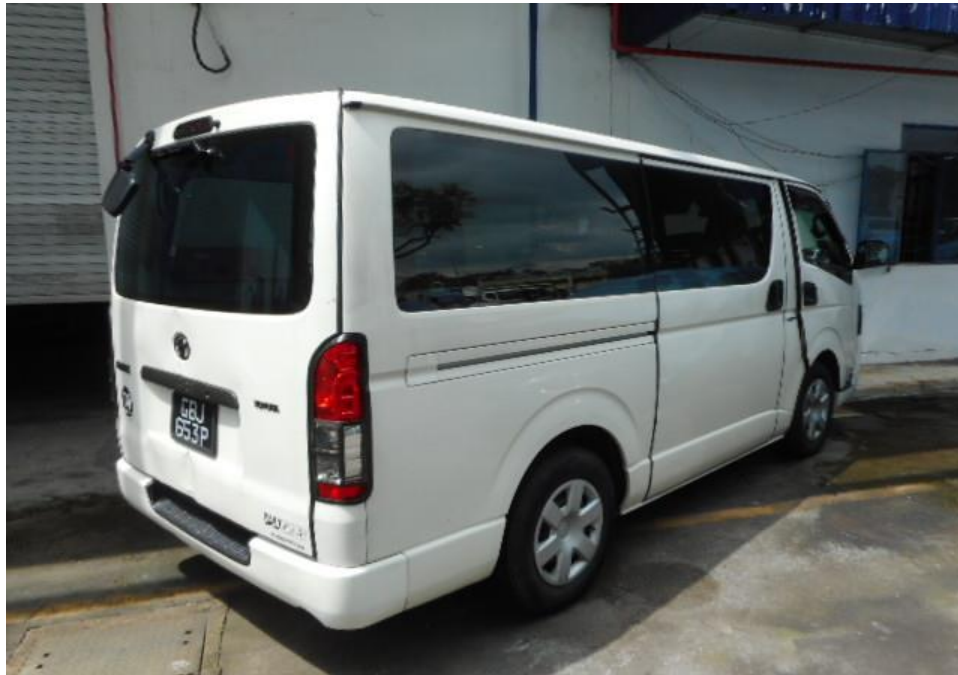
**Photo 4** shows a general view of the right body of the Motor Van at the time of my inspection. The Motor Van was observed to be intact and unaffected by the accident.

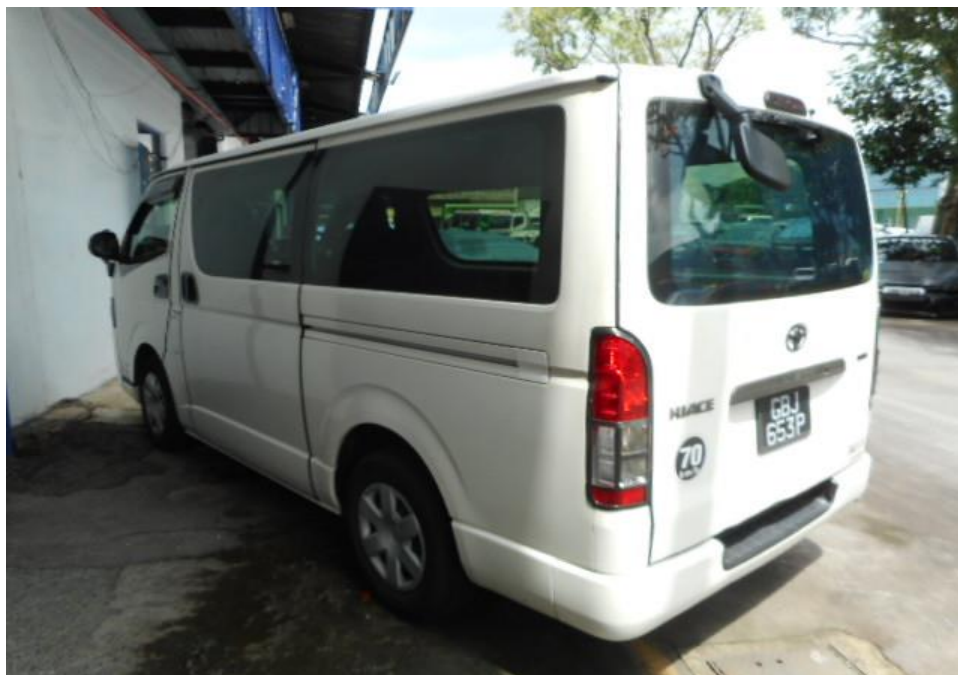
**Photo 5** shows a general view of the left body of the Motor Van at the time of my inspection. The Motor Van was observed to be intact and unaffected by the accident.

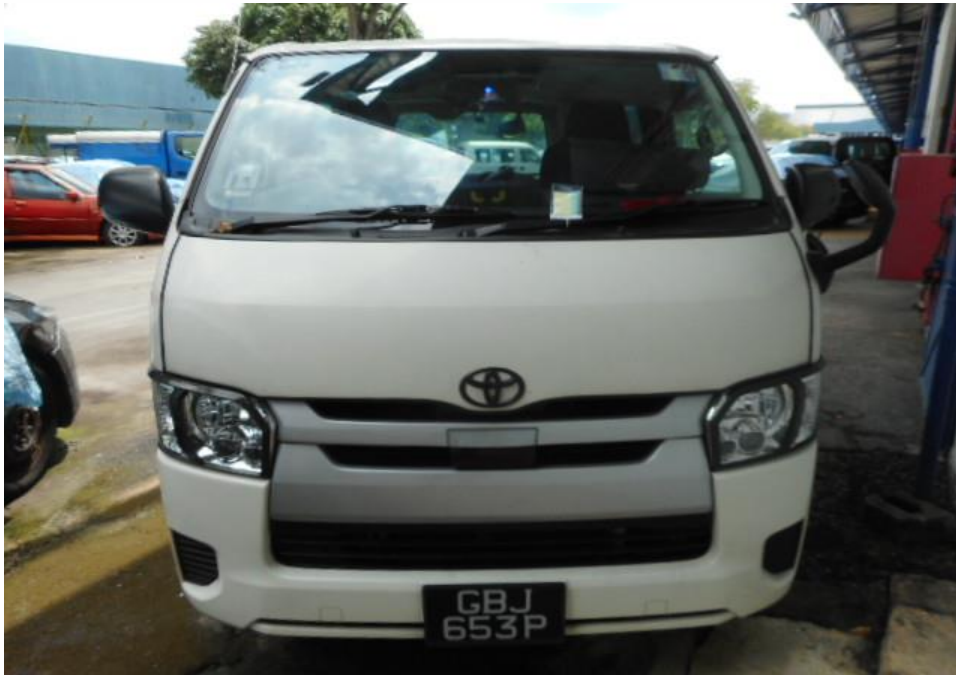
**Photo 6** shows a general view of the front body of the Motor Van at the time of my inspection. The Motor Van was observed to be intact and unaffected by the accident.

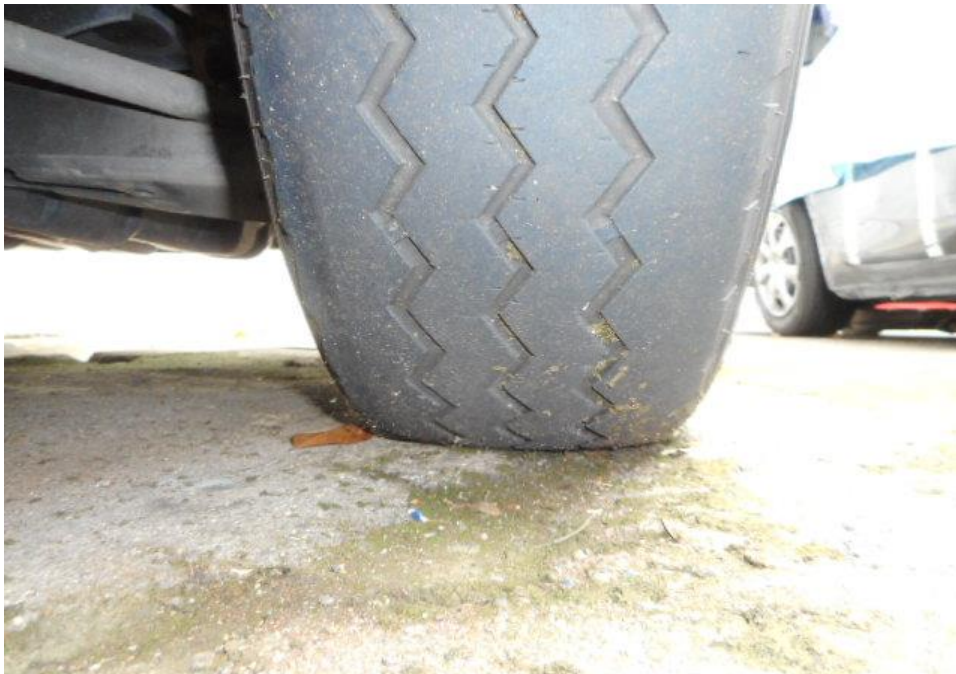
**Photo 7** shows the condition of the front right tyre of the Motor Van, which was observed to be in serviceable condition with remaining tread depth of approximately 2.8mm. The tyre, which was wrapped around standard steel wheel rim, was also observed to be sufficiently inflated for vehicular operation. There was no tear, cut or burst mark(s) on the outer and the inner sidewalls as well as across the tread of the 4 tyres that were fitted on the Motor Van.

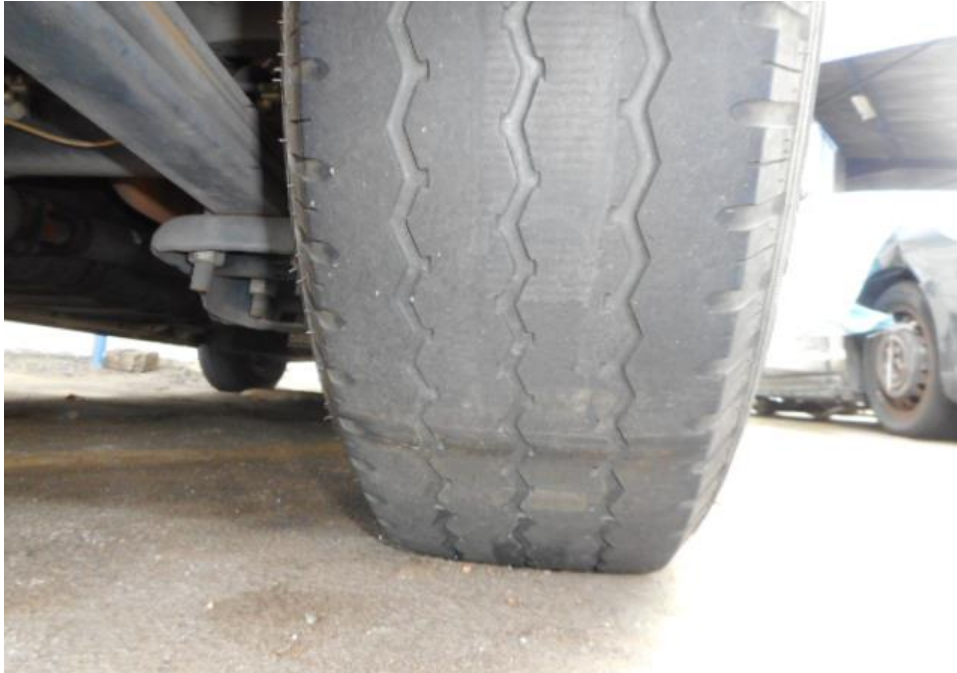
**Photo 8** shows the condition of the rear right tyre of the Motor Van, which was observed to be in serviceable condition with remaining tread depth of approximately 1.9mm. The tyre, which was wrapped around standard steel wheel rim, it was observed to be sufficiently inflated for vehicular operation.

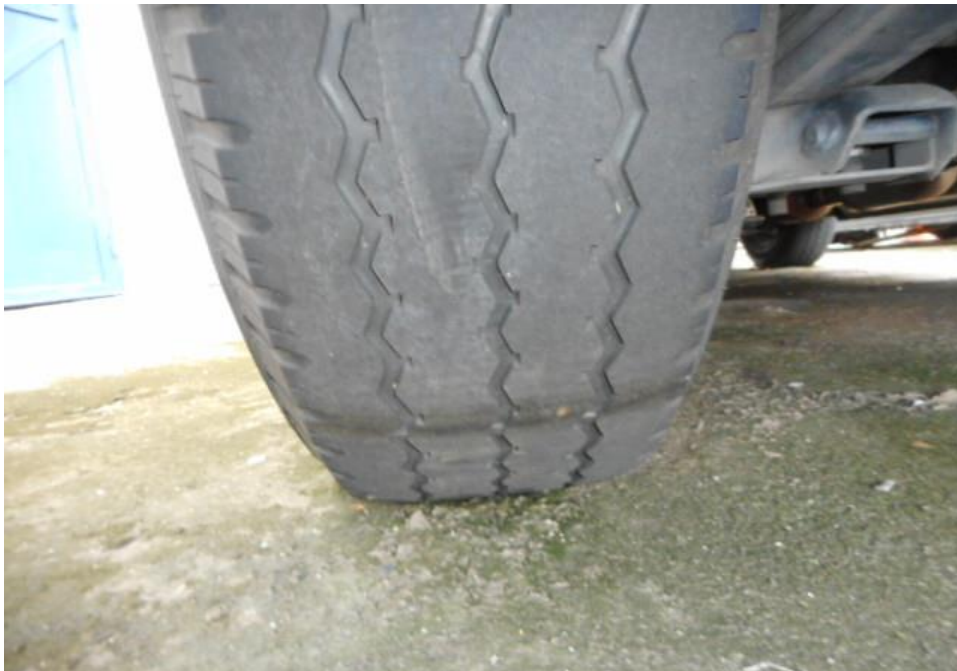
**Photo 9** shows the condition of the rear left tyres of the Motor Van, which was observed to be in serviceable condition with remaining tread depth of approximately 2.4mm. The tyres, which were wrapped around standard steel wheel rim, were also observed to be sufficiently inflated for vehicular operation. There was also no damage found on all 4 steel wheel rims of the Motor Van.

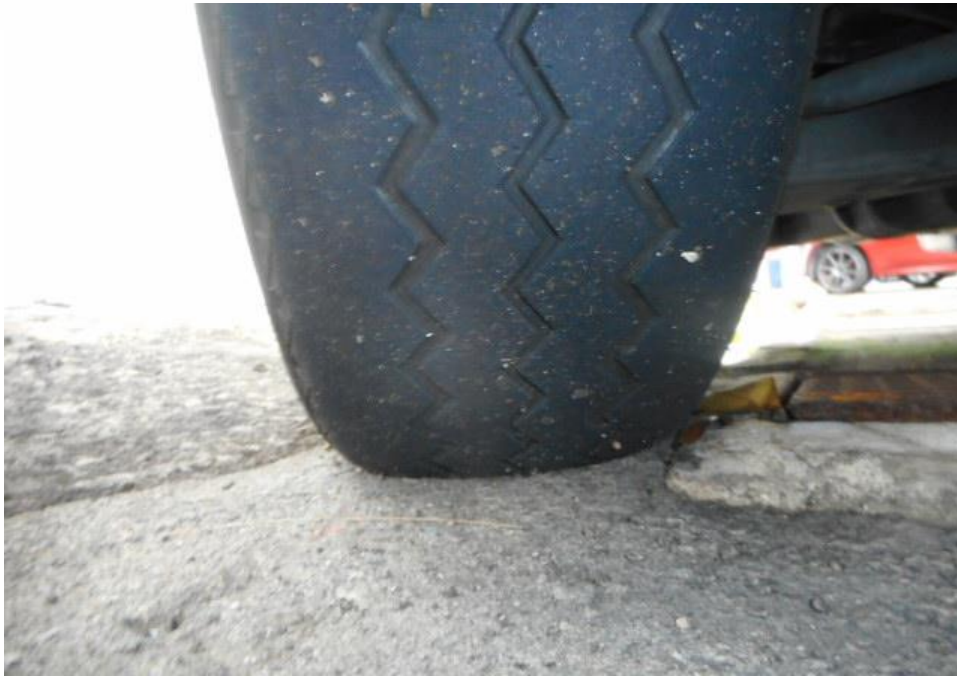
**Photo 10** shows the condition of the rear right tyres of the Motor Van, which were observed to be in serviceable condition with remaining, tread depth of approximately 2.8mm. There was also no tear, cut or burst mark(s) on the outer and the inner sidewalls as well as across the tread of the 4 tyres that were fitted on the Motor Van.

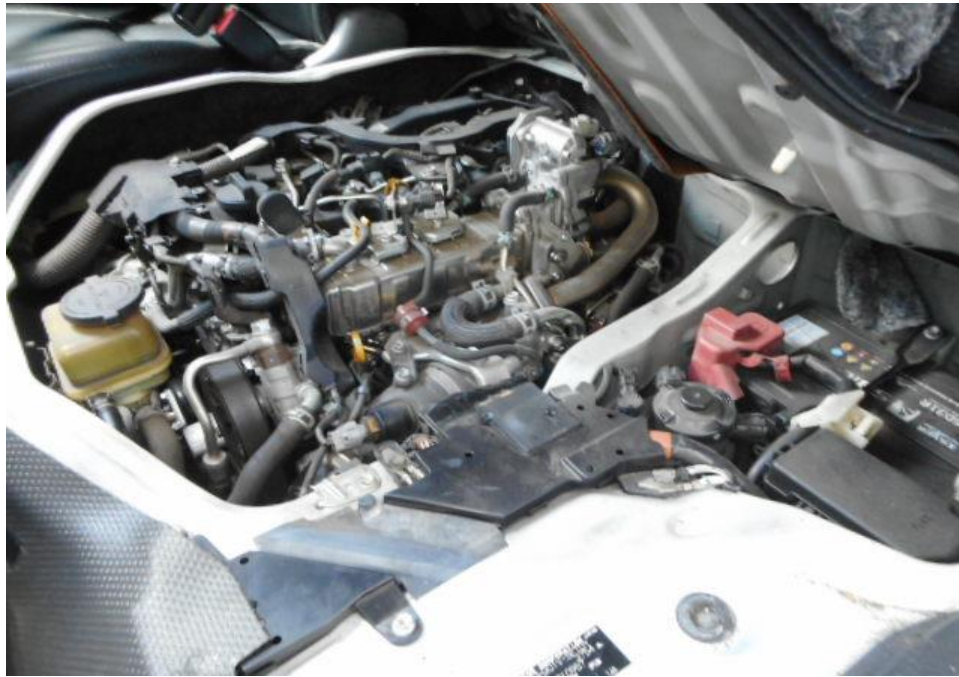
**Photo 11** shows a general view of the Motor Van's engine compartment, which was accessed by lifting the front cabin of the Motor Van. The various parts and components inside the engine compartment were unaffected by the accident. There was also no sign(s) or indication(s) of fresh fluid leakage and/or fluid stain within the engine compartment

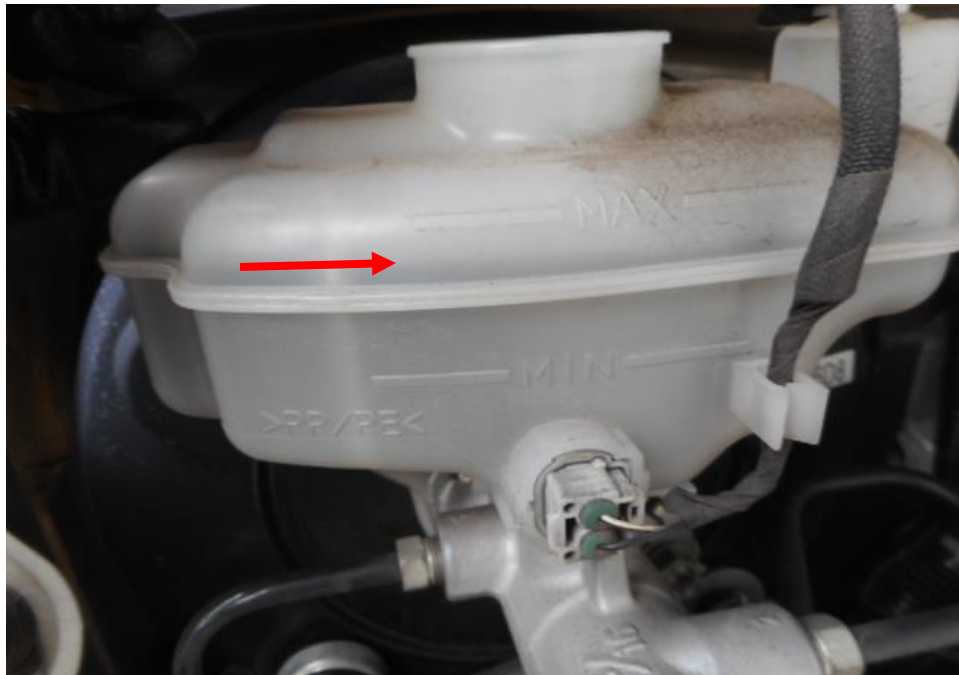
**Photo 12** shows the brake fluid reservoir of the Motor Van at the time of my inspection. The brake fluid was observed to be of sufficient level (arrowed) and without any visible contamination.

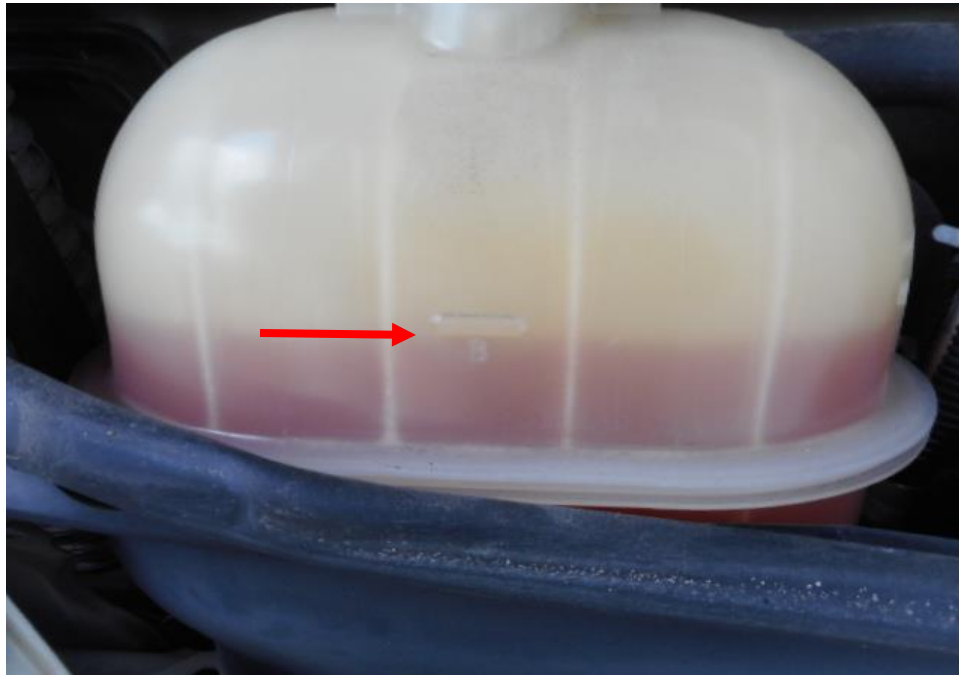
**Photo 13** shows the engine coolant of the Motor Van at the time of my inspection. The engine coolant (arrowed) was observed to be of sufficient level and without any visible contamination.

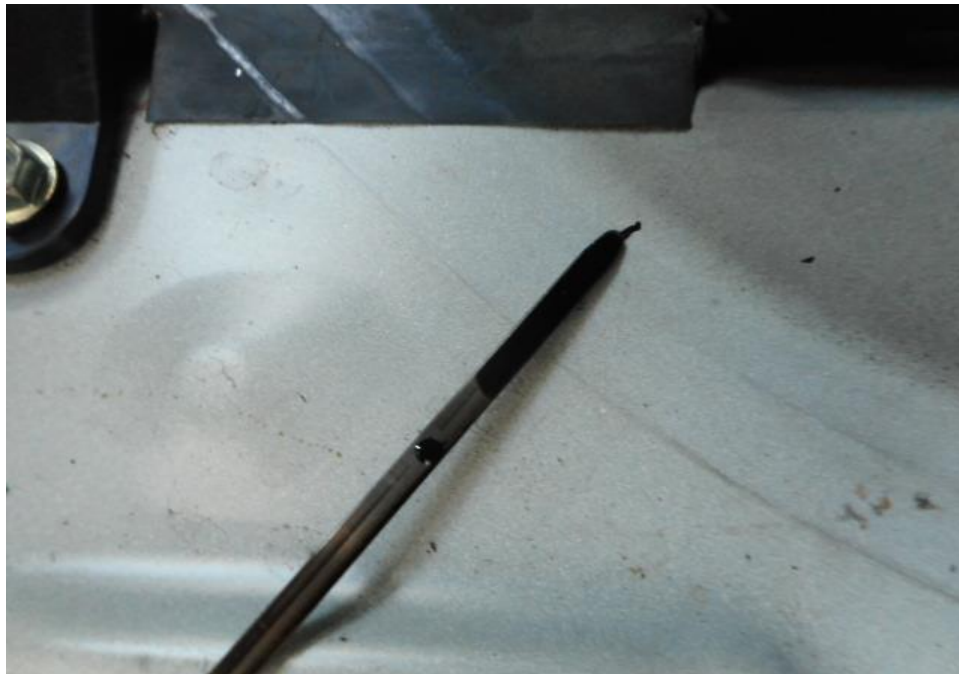
**Photo 14** shows the engine oil dip stick of the Motor Van at the time of my inspection. The engine oil was observed to be of sufficient level and without any visible contamination.

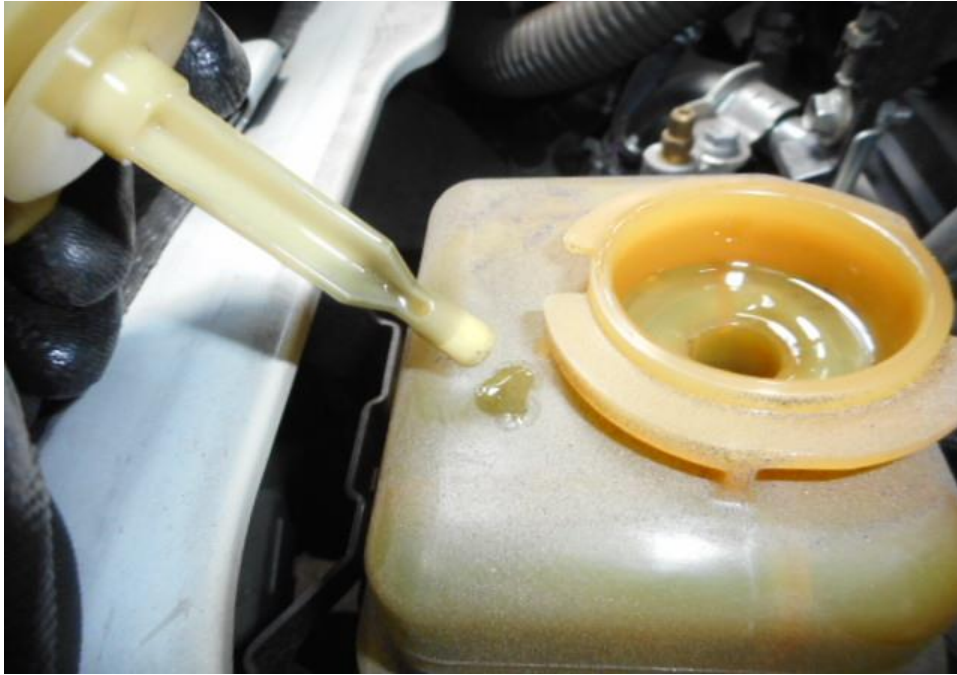
**Photo 15** shows the power steering fluid dip stick of the Motor Van at the time of my inspection. The steering fluid was observed to be of sufficient level and without any visible contamination.

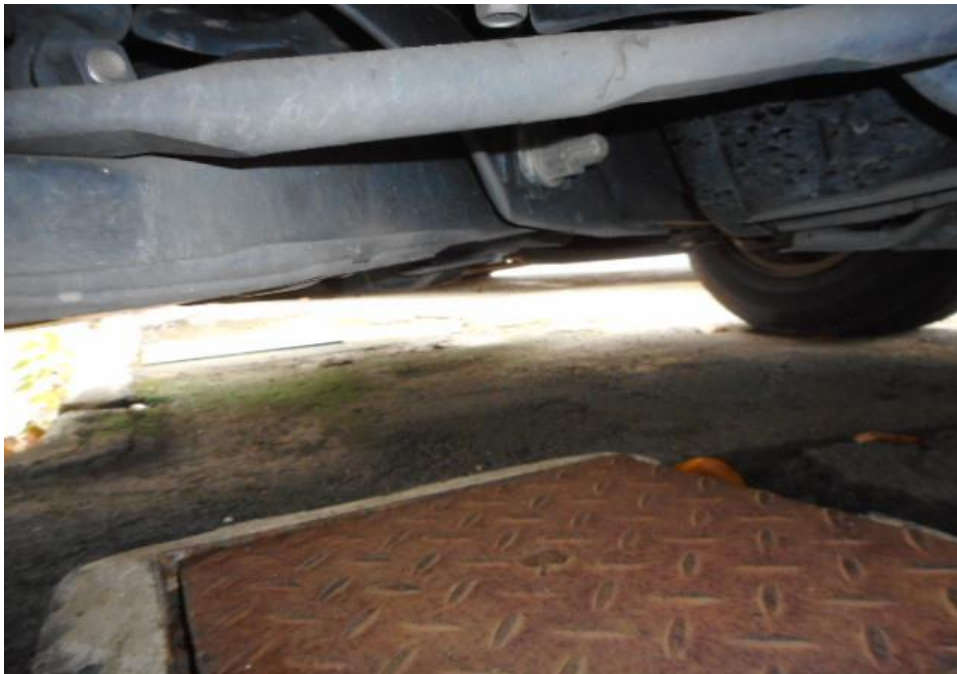
**Photo 16** shows the undercarriage of the Motor Van, at the area where the engine housing and transmission housing are located. . I did not find any sign(s) or indication(s) of fluid leak and/or fluid stain(s) on the underside of the Motor Van.

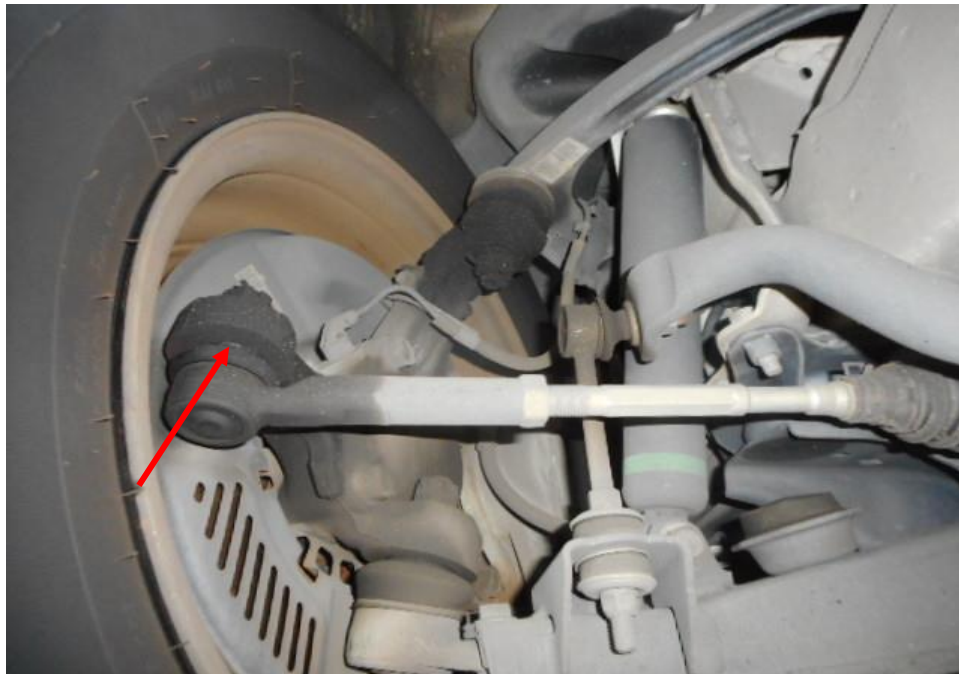
**Photo 17** shows the various undercarriage components at the front right wheel of the Motor Van, in particular the steering tie rod end (arrowed). The various steering components were all found to be intact, suggesting that the steering system of the Motor Van was likely to be in serviceable condition at the material time of accident. There was also no sign of fluid stain(s) observed on the various undercarriage components.

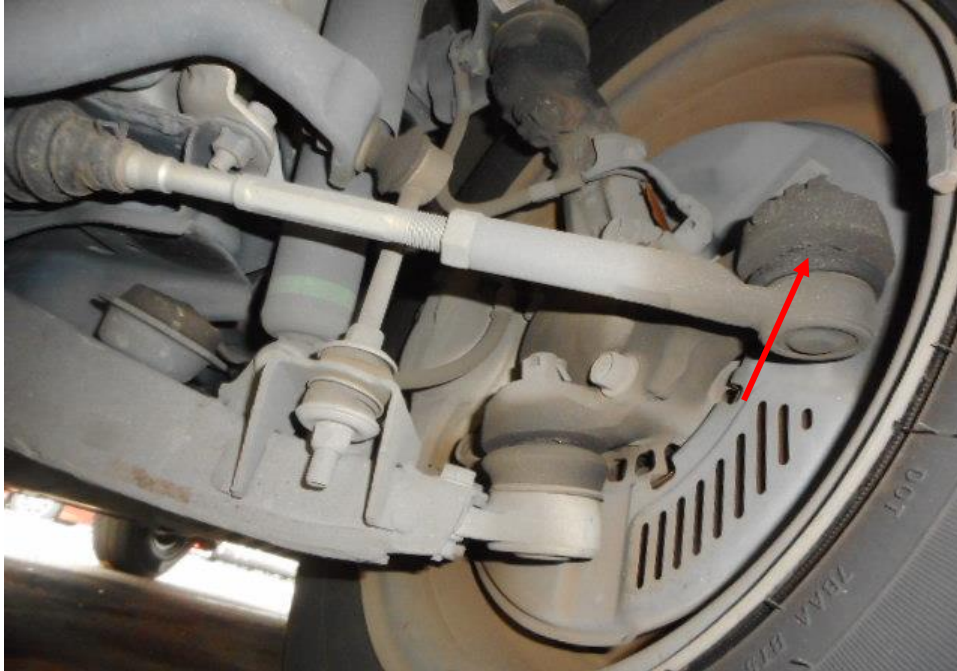
**Photo 18** shows the various undercarriage components at the front left wheel of the Motor Van, in particular the steering tie rod end (arrowed). The various undercarriage components of the Motor Van were all found to be intact without any visible damage. There was also no sign of fluid stain(s) observed on the various undercarriage components.

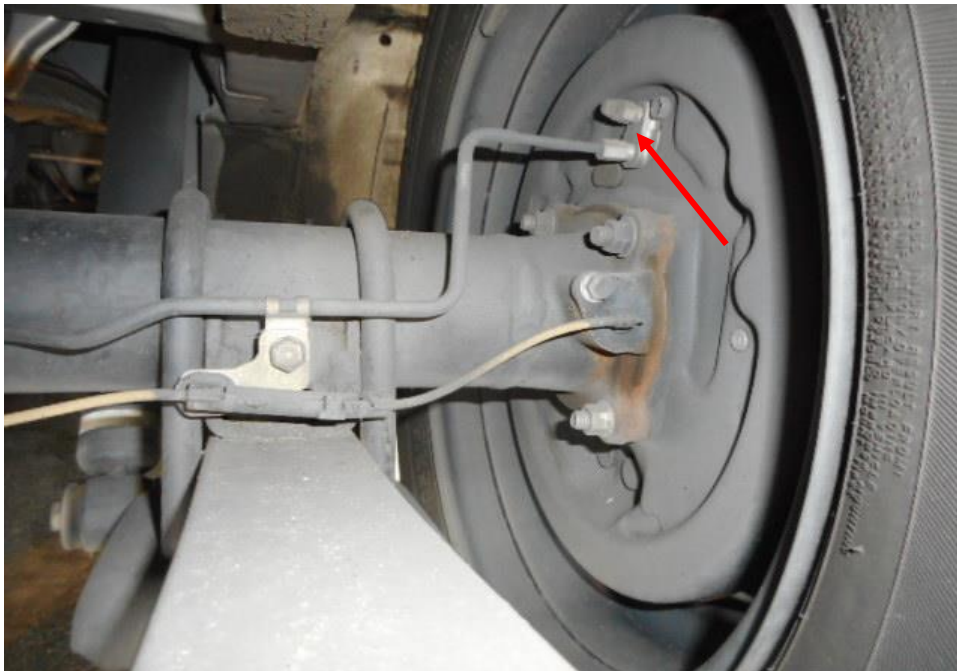
**Photo 19** shows the brake pipe (arrowed) at the rear right wheel of the Motor Van. I did not observe any leakage of brake fluid at the time of my inspection of the Motor Van. My static tests of the Motor Van's braking system, along with my visual examination of the various mechanical components in the braking system, had indicated that there was no internal leakage of pressure/vacuum. Hence the braking system of the Motor Van was likely to be in serviceable condition at the material time of accident.

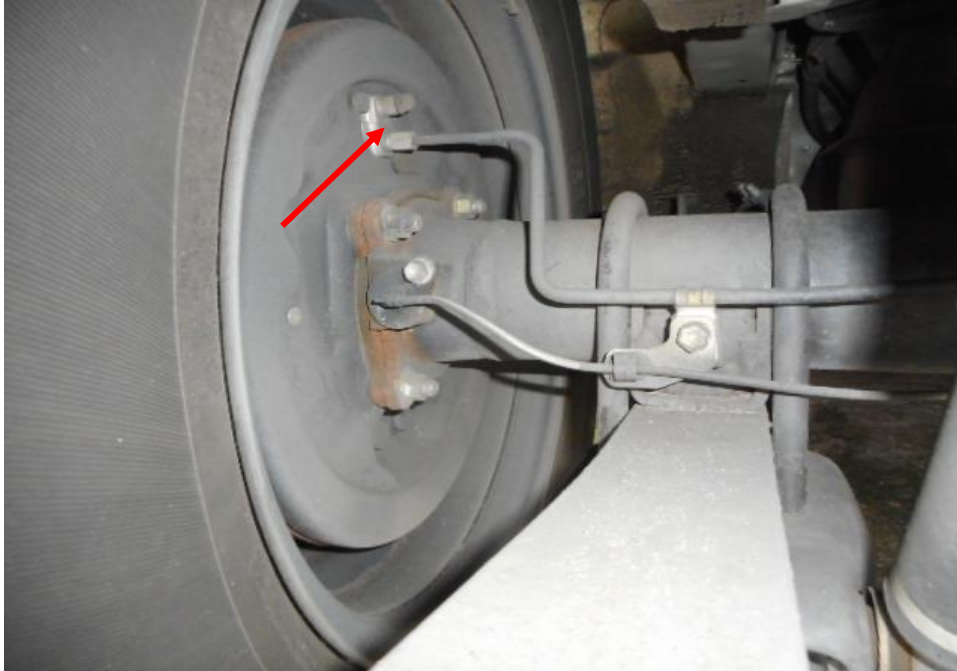
**Photo 20** shows the brake pipe (arrowed) at the rear left wheel of the Motor Van. I did not observe any leakage of brake fluid at the time of my inspection of the Motor Van. My static tests of the Motor Van's braking system, along with my visual examination of the various mechanical components in the braking system had indicated that there was no internal leakage of pressure/vacuum. Hence the braking system of the Motor Van was likely to be in serviceable condition at the material time of accident.

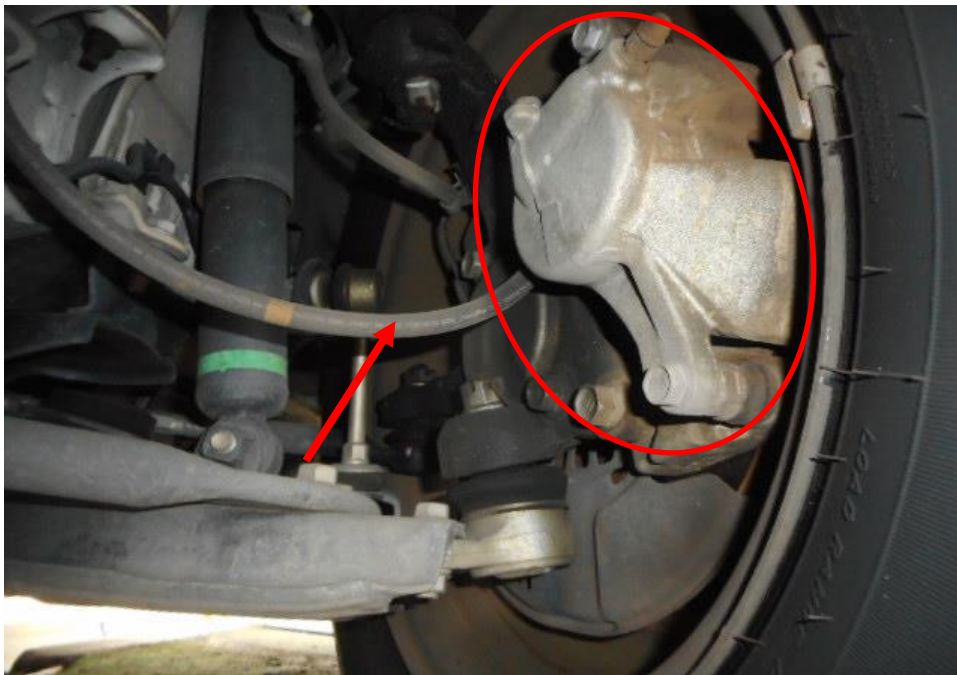
**Photo 21** shows the brake hose/pipe (arrowed) at the front right wheel of the Motor Van. No leakage of brake fluid was observed. Visual examination of the various components of the braking system like the brake caliper (circled), brake booster, brake pedal etc had revealed all to be intact and without visible damage at the time of accident. There was also no sign of fluid stain(s) observed on the various undercarriage components.

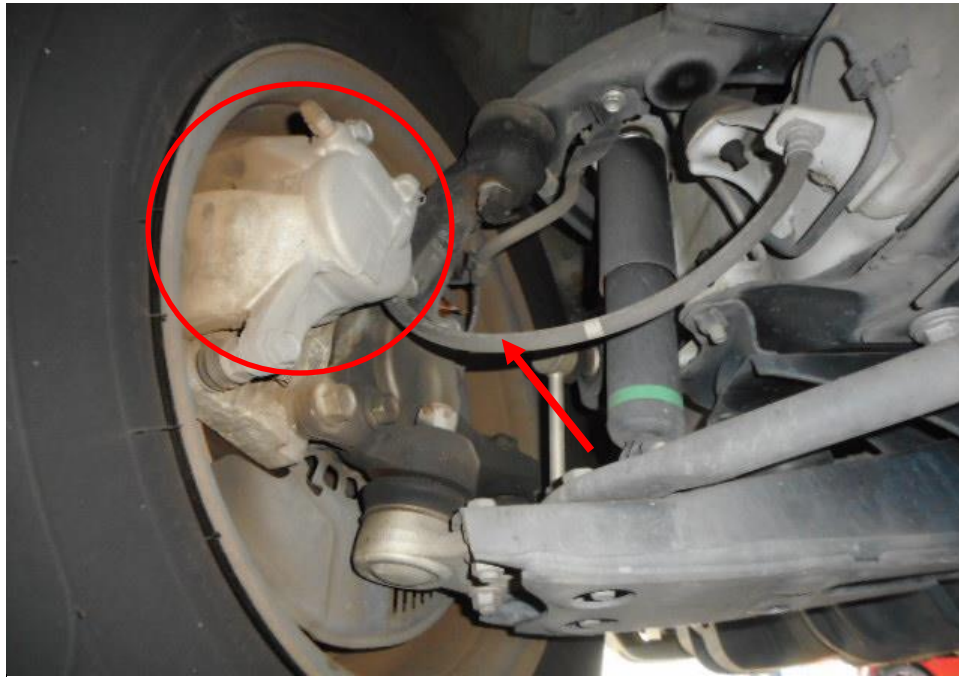
**Photo 22** shows the brake hose/pipe (arrowed) at the front left wheel of the Motor Van. No leakage of brake fluid was observed. Visual examination of the various components of the braking system like the brake caliper (circled), brake booster, brake pedal etc had revealed all to be intact and without visible damage at the time of accident. There was also no sign of fluid stain(s) observed on the various undercarriage components.

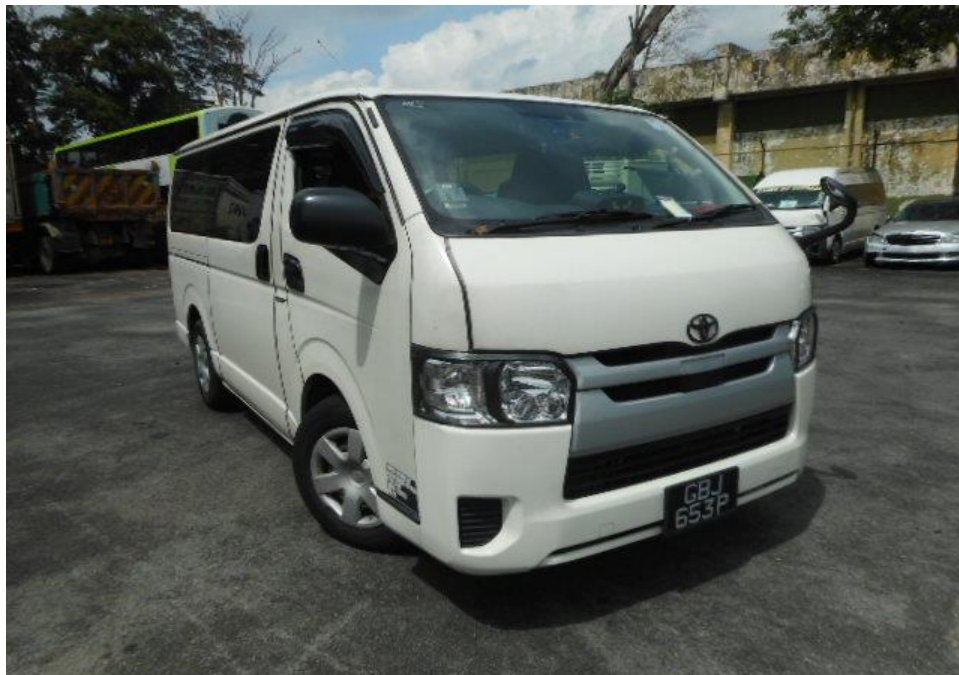
**Photo 23** shows the front right wheel of the Motor Van turned to its full left. During my steering system test, I did not experience any abnormal free play and/or resistance when I had turned the steering wheel towards full left and full right. This would suggest that the steering system of the Motor Van was likely to be in serviceable condition at the material time of accident.

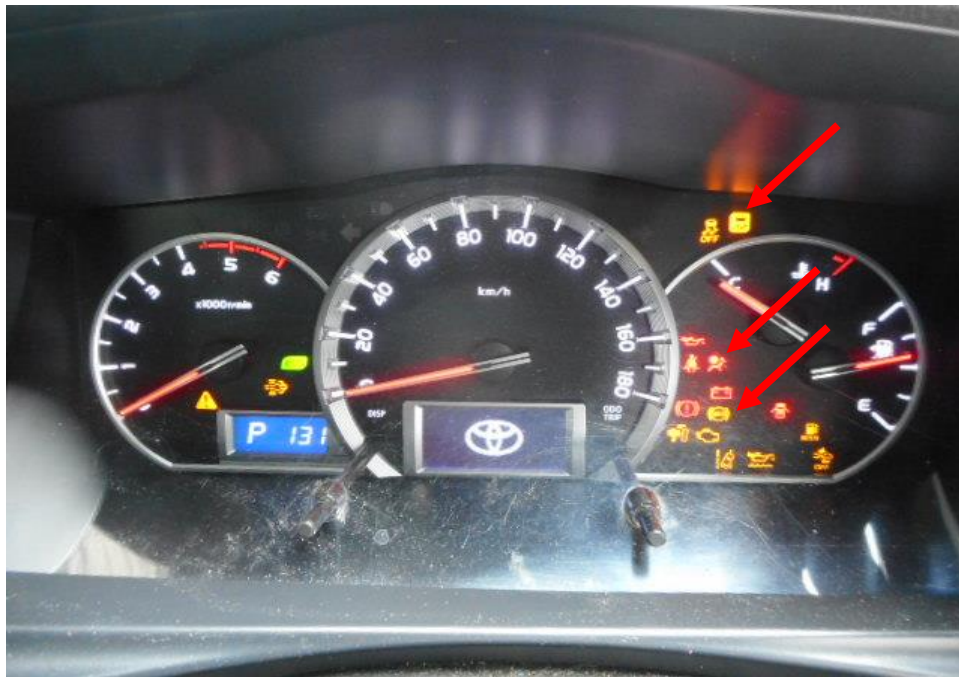
**Photo 24** shows the warning light for Anti-Lock Brake System (ABS), Traction Control System (TCS) and Supplemental Restraint System (SRS) (arrowed) appearing on the instrument panel of the Motor Van during the self-test of its various electronic operating systems when its engine was cranked.

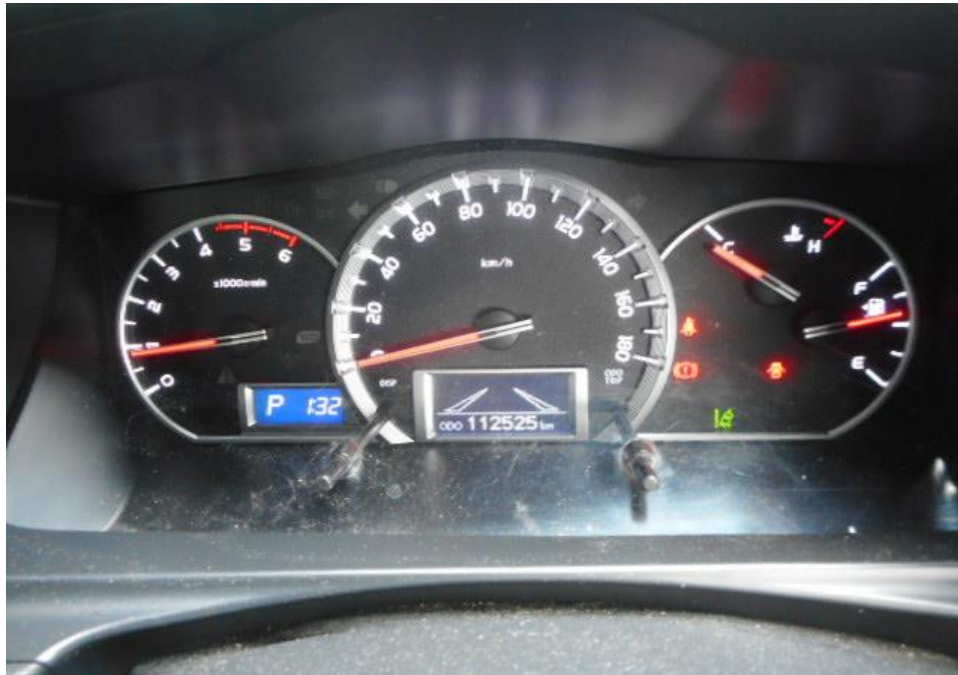
**Photo 25** shows no warning lights illuminated on the instrument panel of the Motor Van after the engine was cranked. This would suggest that there was no abnormality to the electronic operating system of the Motor Van, like the ABS, TCS, SRS and etc.
