You're Ref: TP/IP/32687/2022
Our Ref: CI/TPD22013020/P

30th December 2022

Fatal Accident Investigation Team

MECHANICAL INSPECTION REPORT OF MOTOR TAXI SHA 3417L

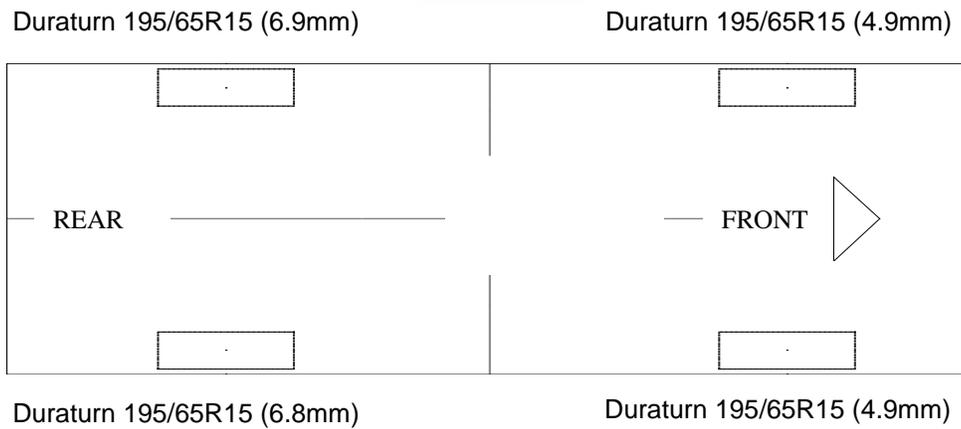
6. The condition of the Motor Taxi's 4 tyres was observed to be in serviceable condition. I did not find any tear, cut or burst mark(s) on the outer and the inner sidewalls as well as across the tread of the 4 tyres. The 4 tyres were also observed to be sufficiently inflated for vehicular operation. The tyre brand, tyre size and remaining tread depth of the 4 tyres were recorded as follows:-

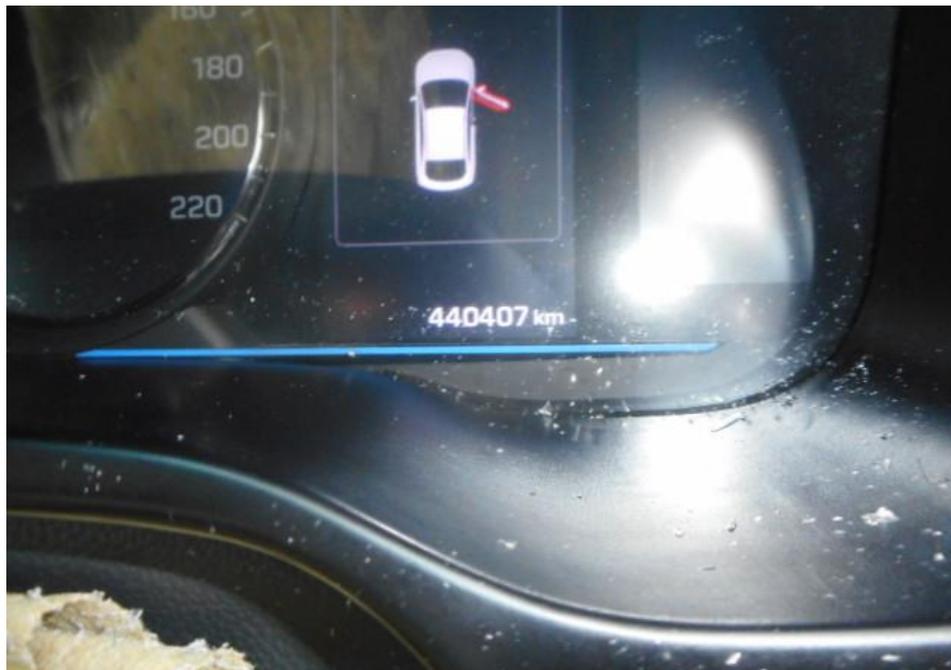
Photo 1 shows the mileage of the Motor Taxi at the time of my inspection. The mileage observed was 440,407km.

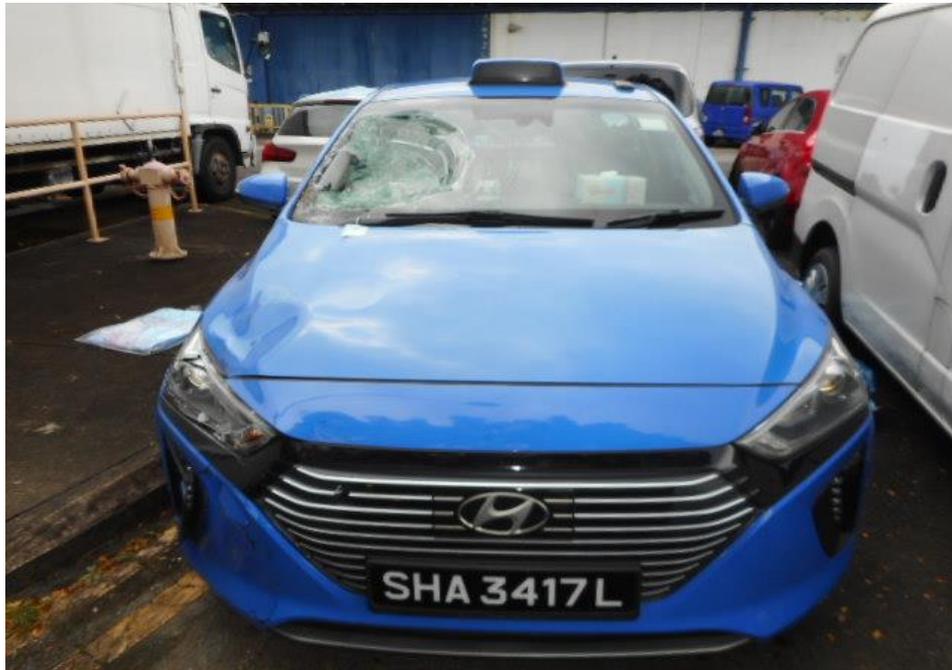
4. The mileage of the Motor Taxi at the time of my inspection was 440,407km.
5. The Motor Taxi was observed to have sustained damage at its front portion. Its front windscreen, front bonnet, front bumper and front right headlamp was amongst the body parts that were damaged as a result of the accident.

Photo 2 shows a general view of the Motor Taxi's front body at the time of my inspection. The front portion of the Motor Taxi was observed to have sustained damage. Its front windscreen, front bonnet, front bumper and front right headlamp was amongst the body parts that were damaged as a result of the accident.

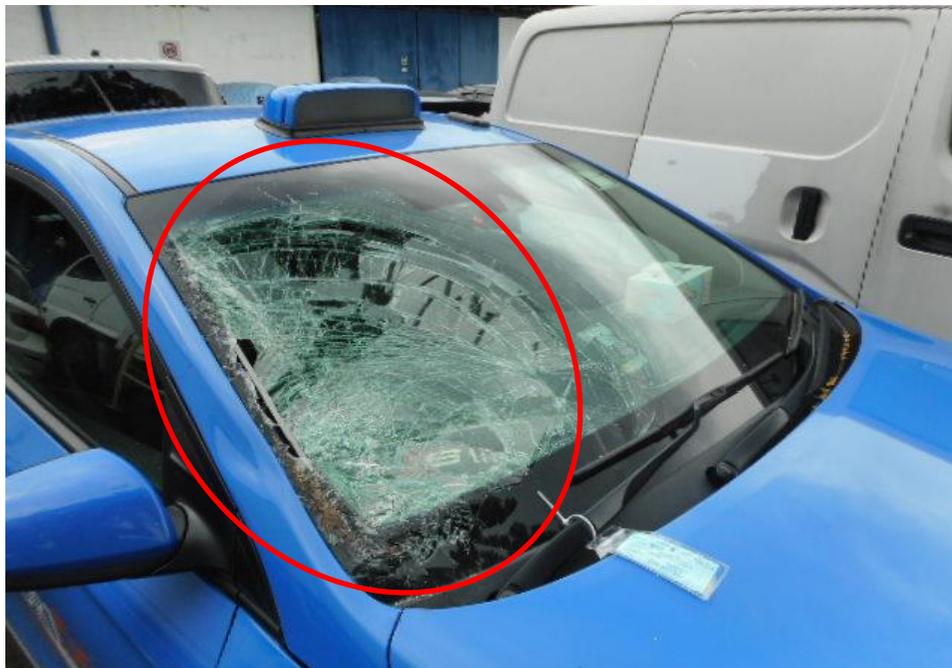
Photo 3 shows a close up view of the Motor Taxi's front body at the time of my inspection. The front portion of the Motor Taxi was observed to have sustained damage. Its front windscreen (circled) was the body parts that were damaged as a result of the accident.

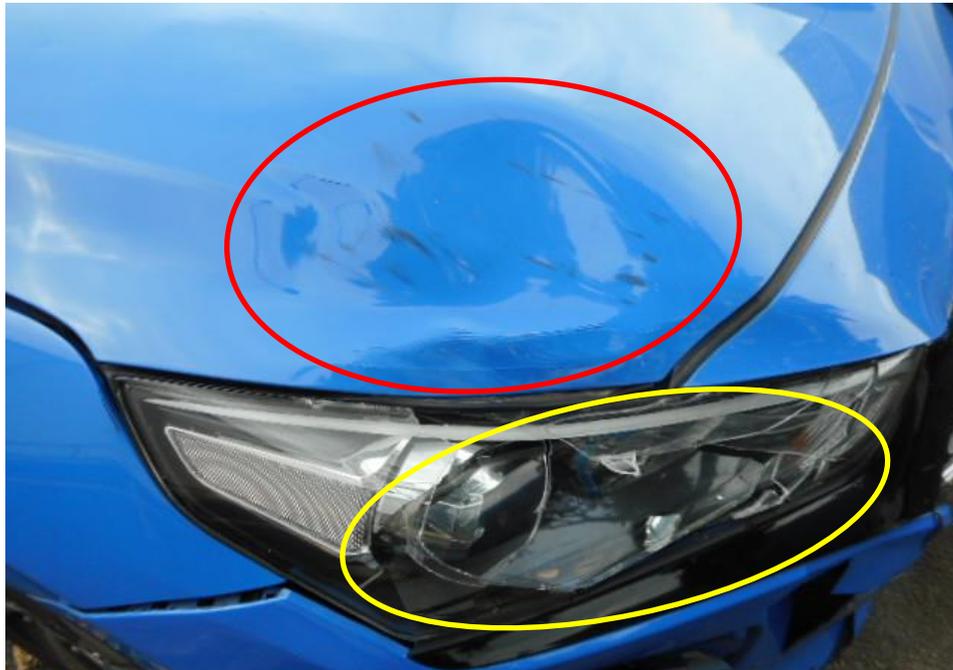
Photo 4 shows a close up view of the Motor Taxi's front body at the time of my inspection. The front portion of the Motor Taxi was observed to have sustained damage. Its front bonnet (red circle) and front right headlamp (yellow circle) was the body parts that were damaged as a result of the accident.

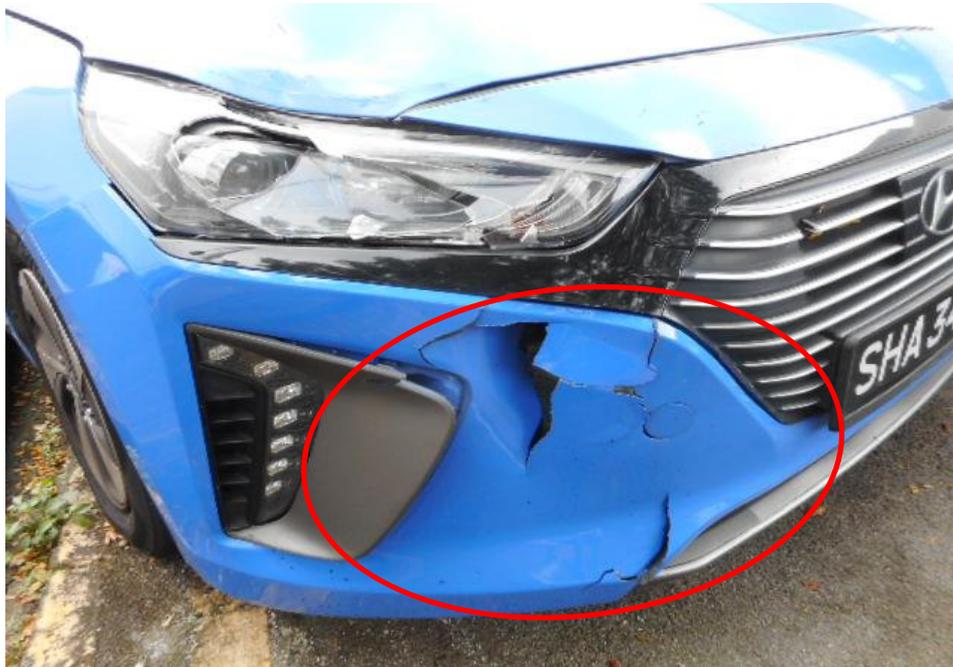
Photo 5 shows a close up view of the Motor Taxi's front body at the time of my inspection. The front portion of the Motor Taxi was observed to have sustained damage. Its front bumper (circled) was the body parts that were damaged as a result of the accident.

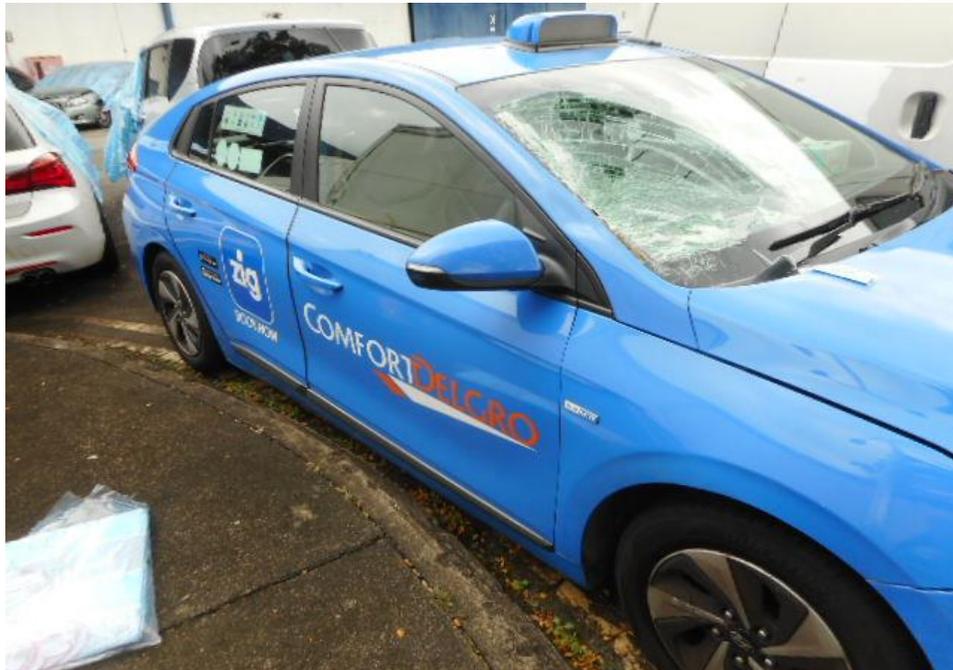
Photo 6 shows a general view of the Motor Taxi's right body at the time of my inspection. The right portion of the Motor Taxi was observed to have been unaffected by the accident.

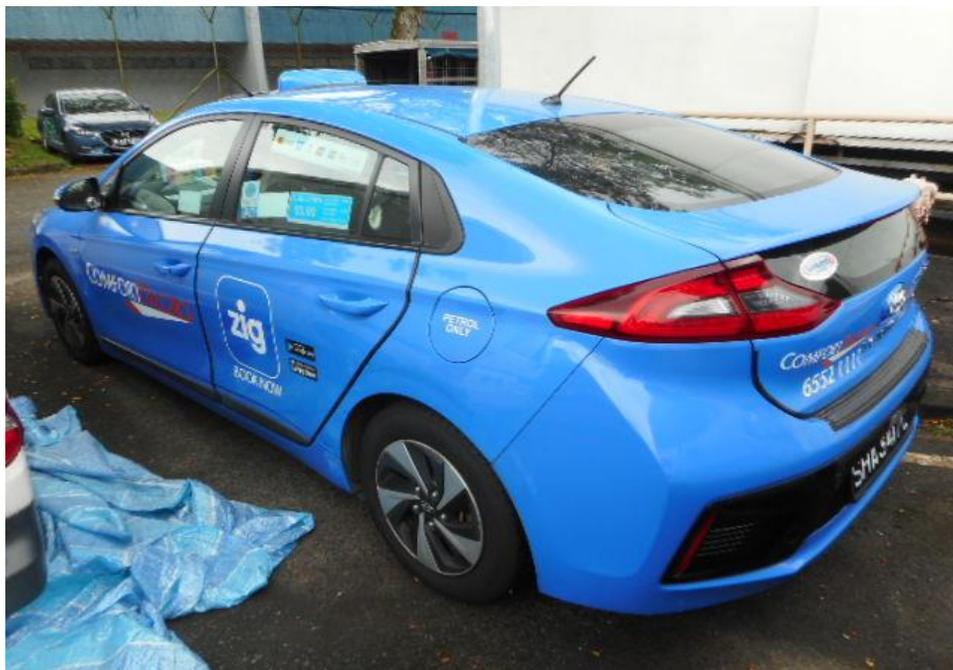
Photo 7 shows a general view of the Motor Taxi's left body at the time of my inspection. The left portion of the Motor Taxi was observed to have been unaffected by the accident.

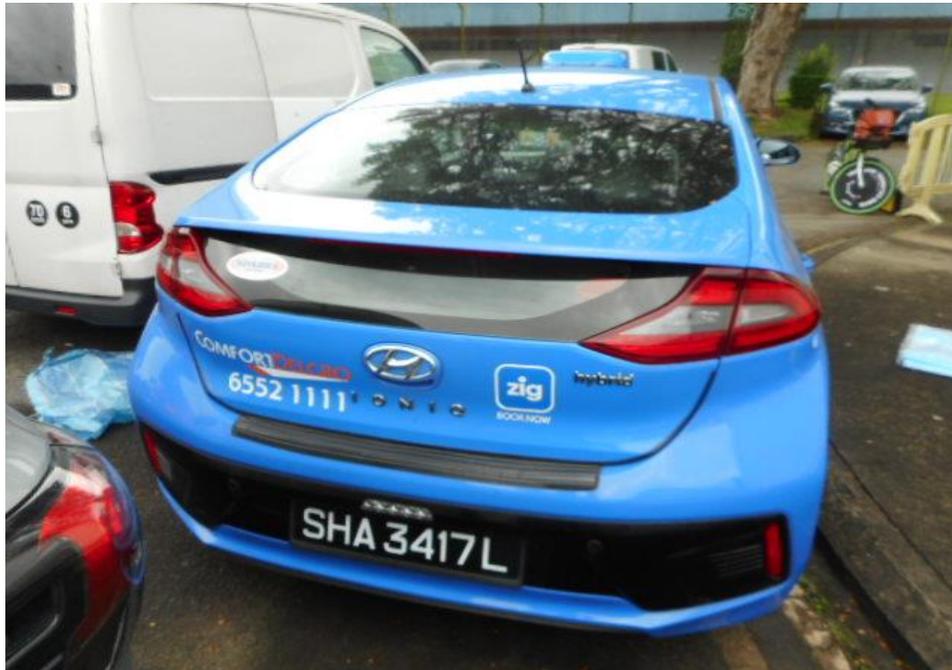
Photo 8 shows the general view of the Motor Taxi's rear body at the time of my inspection. The Motor Taxi rear was observed to be unaffected by the accident.

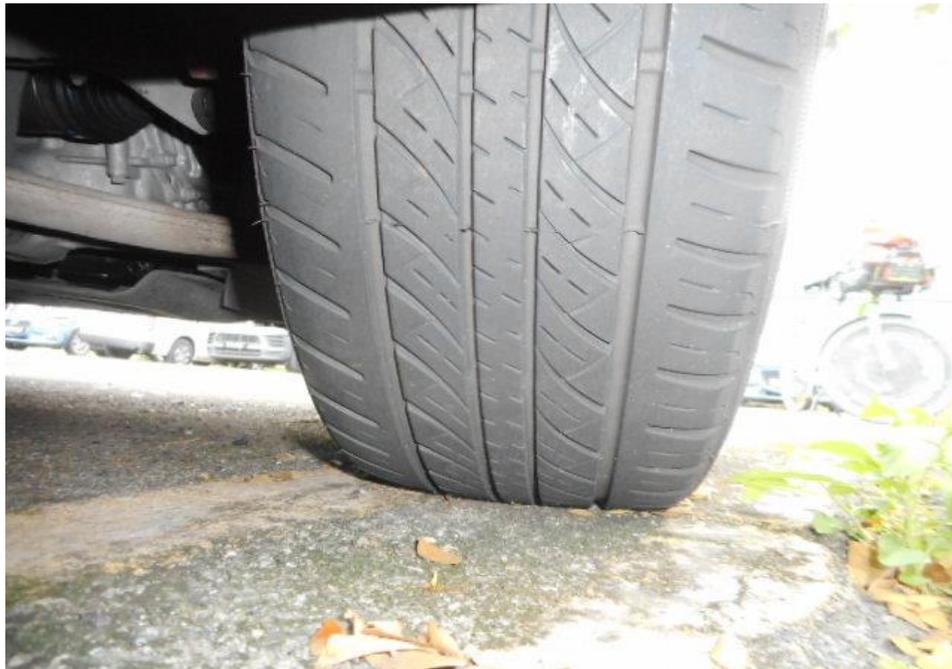
Photo 9 shows the condition of the front right tyre of the Motor Taxi, which was observed to be in serviceable condition with remaining tread depth of approximately 4.9mm. The tyre was sufficiently inflated for vehicular operation with no tear, cut or burst mark(s) on the outer and the inner sidewalls as well as across the tread. The 4 tyres of the Motor Taxi were wrapped around standard steel wheel rims without any damage.

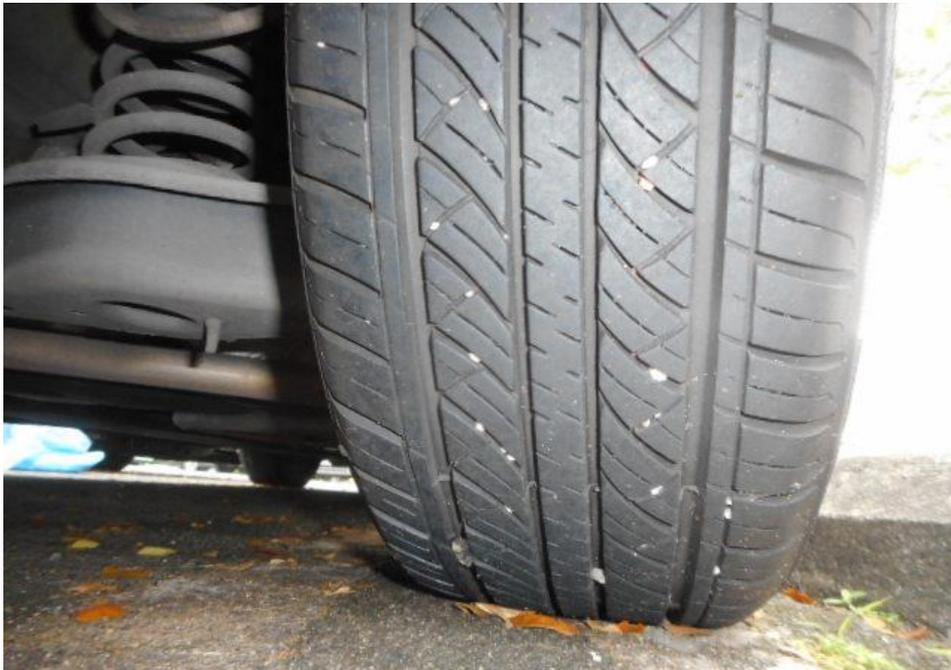
Photo 10 shows the condition of the rear right tyre of the Motor Taxi, which was observed to be in serviceable condition with remaining tread depth of approximately 6.8mm. The tyre was also observed to be sufficiently inflated for vehicular operation with no tear, cut or burst mark(s).

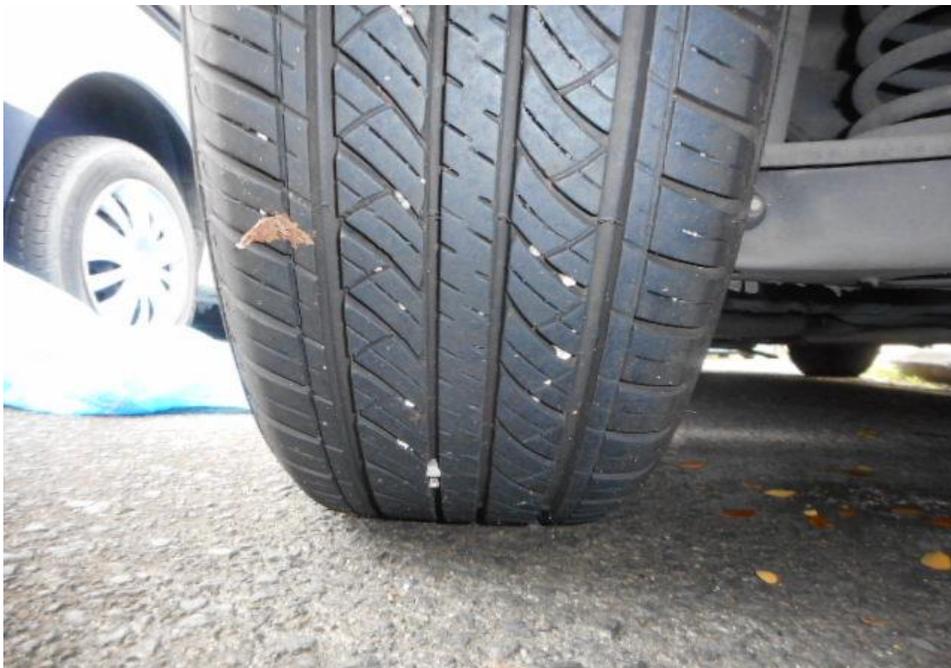
Photo 11 shows the condition of the rear left tyre of the Motor Taxi, which was observed to be in serviceable condition with remaining tread depth of approximately 6.9mm. The tyre, which was wrapped around steel wheel rim, was also observed to be sufficiently inflated for vehicular operation. The 4 tyres of the Motor Taxi were wrapped around standard steel wheel rims.

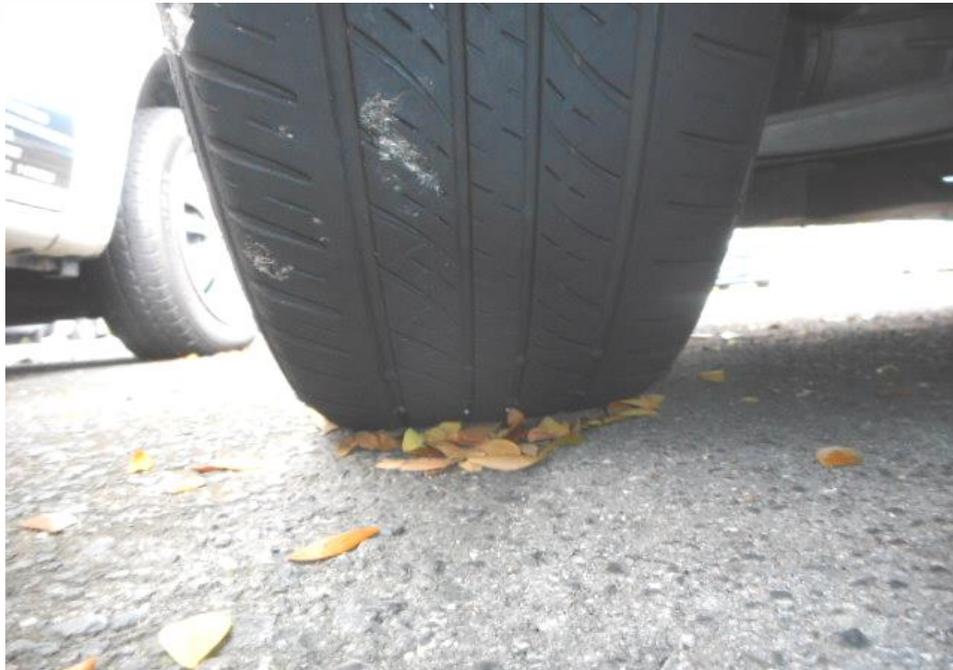
Photo 12 shows the condition of the front left tyre of the Motor Taxi, which was observed to be in serviceable condition with remaining tread depth of approximately 4.9mm. There was also no tear, cut or burst mark(s) on the outer and the inner sidewalls as well as across the tread of the Motor Taxi's 4 tyres.

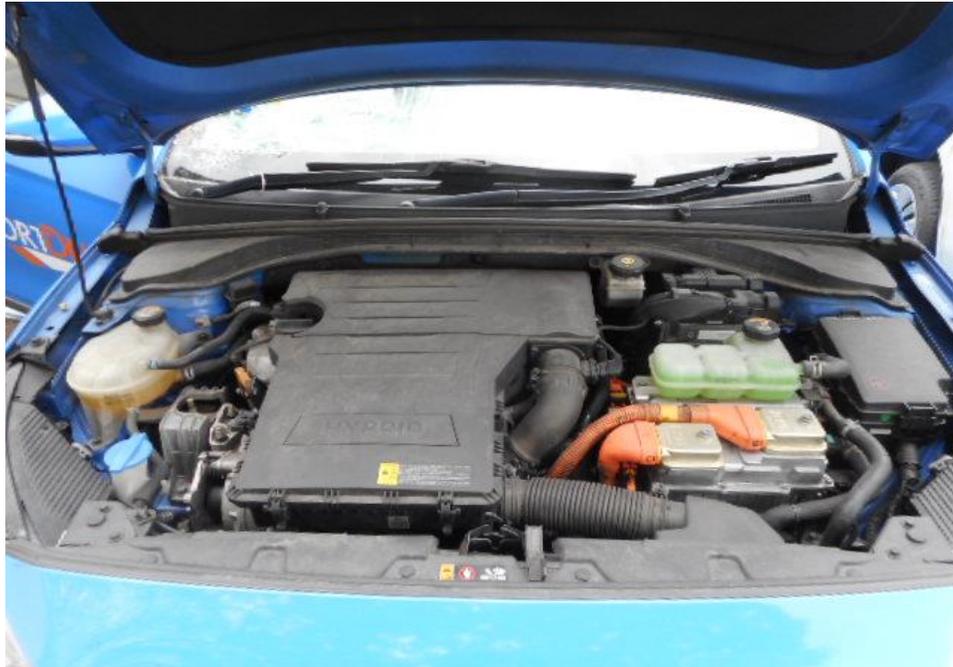
Photo 13 shows a general view of the Motor Taxi's engine compartment. The various parts and components inside the engine compartment were unaffected by the accident. There was also no sign(s) or indication(s) of fluid leakage and/or fluid stain within the engine compartment.

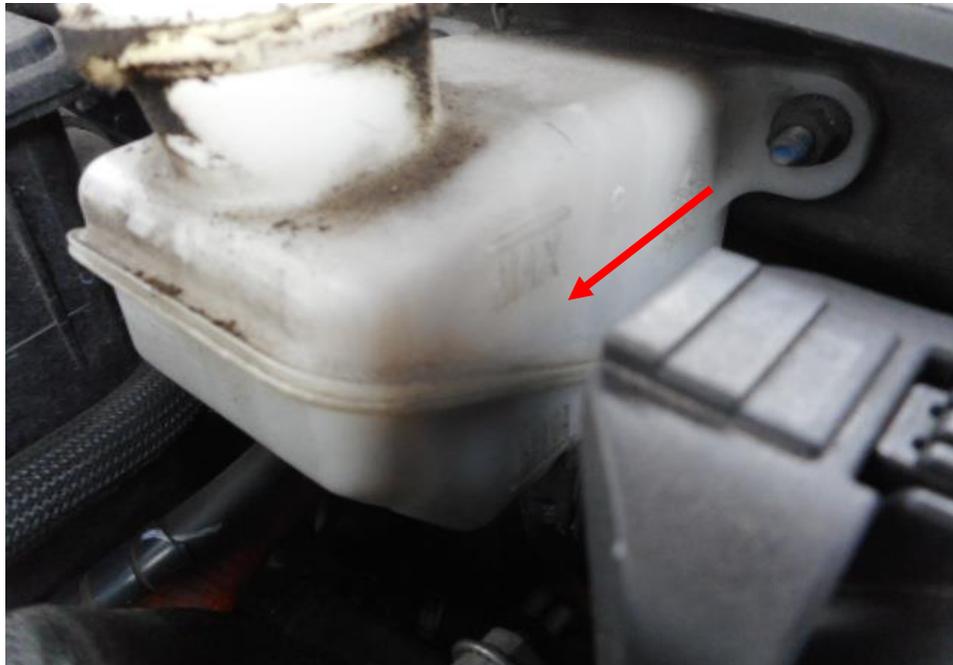
Photo 14 shows the brake fluid reservoir of the Motor Taxi at the time of my inspection. The brake fluid was observed to be of sufficient level (arrowed) and without any visible contamination.

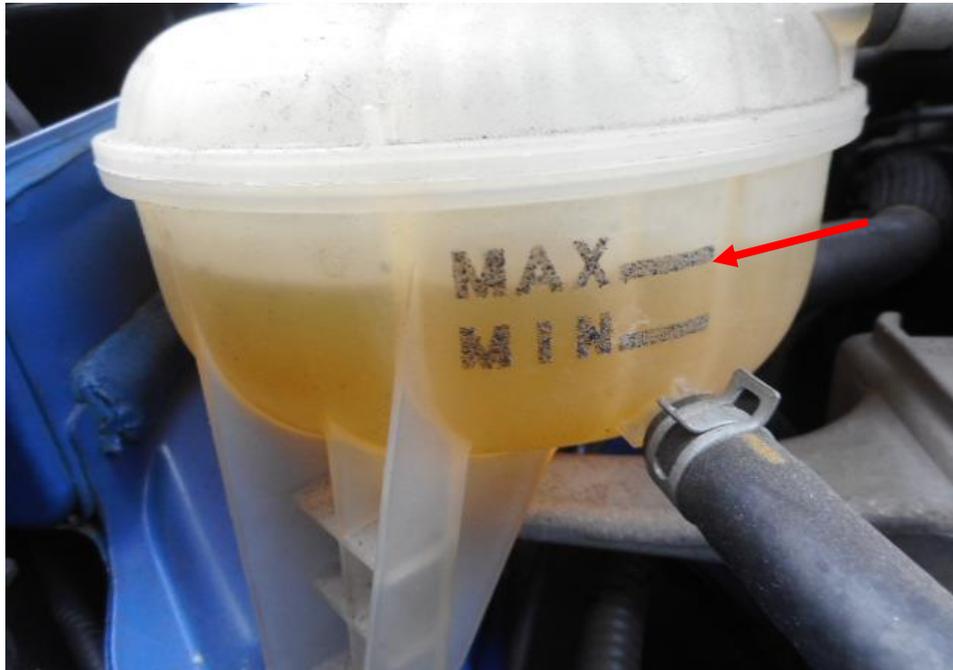
Photo 15 shows checks being carried out to the engine coolant of the Motor Taxi at the time of my inspection. The engine coolant was observed to be of sufficient level (arrowed) and without any visible contamination.

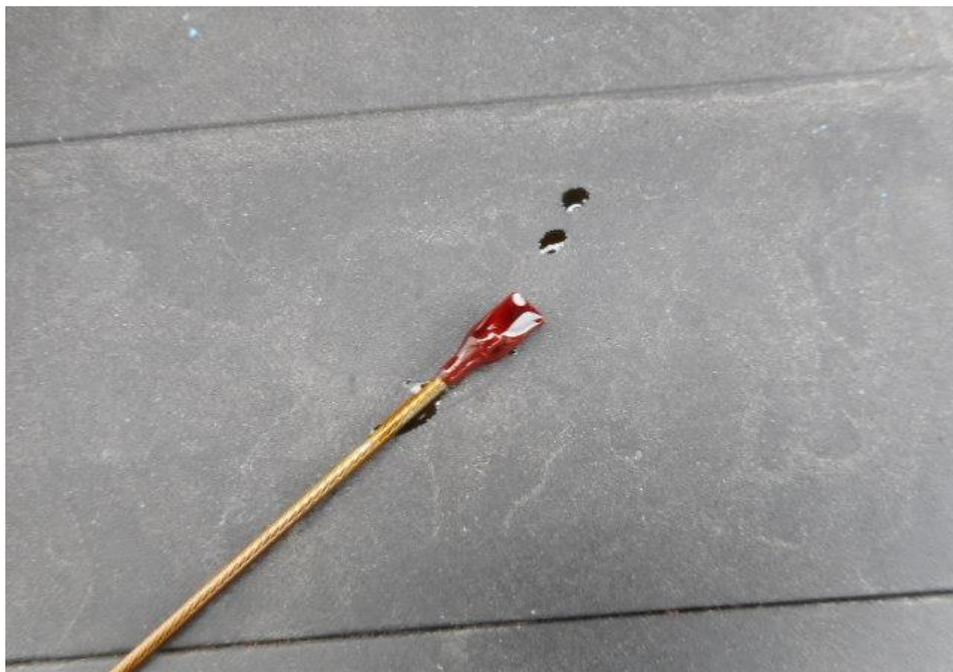
Photo 16 shows the engine oil dipstick of the Motor Taxi at the time of my inspection. The engine oil was observed to be of sufficient level and without any visible contamination.

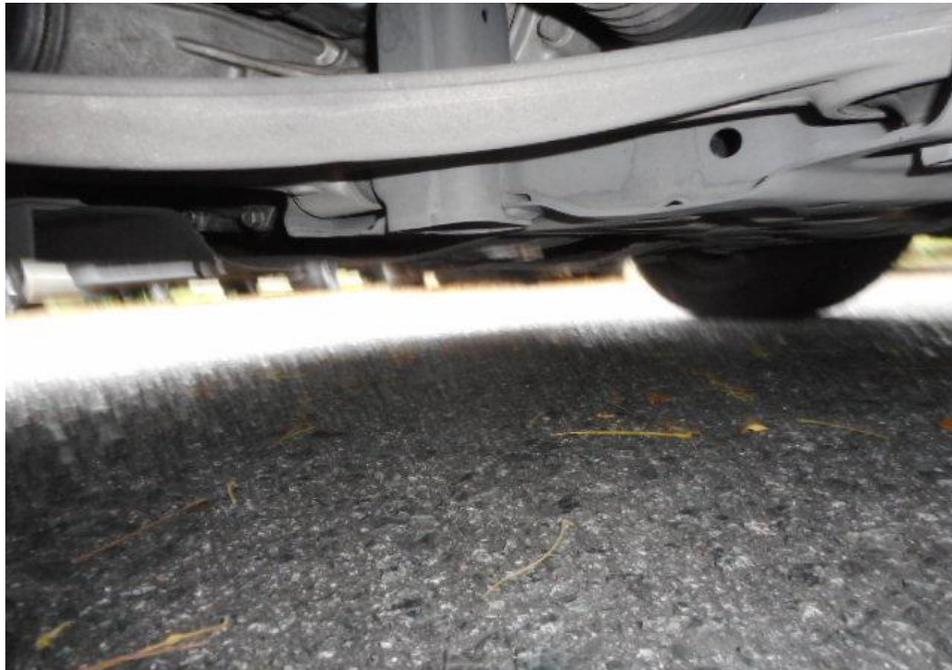
Photo 17 shows the undercarriage of the Motor Taxi, at the area where the engine housing and transmission housing are located. I did not find any sign(s) or indication(s) of fluid leak and/or fluid stain(s) on the underside of the Motor Taxi.

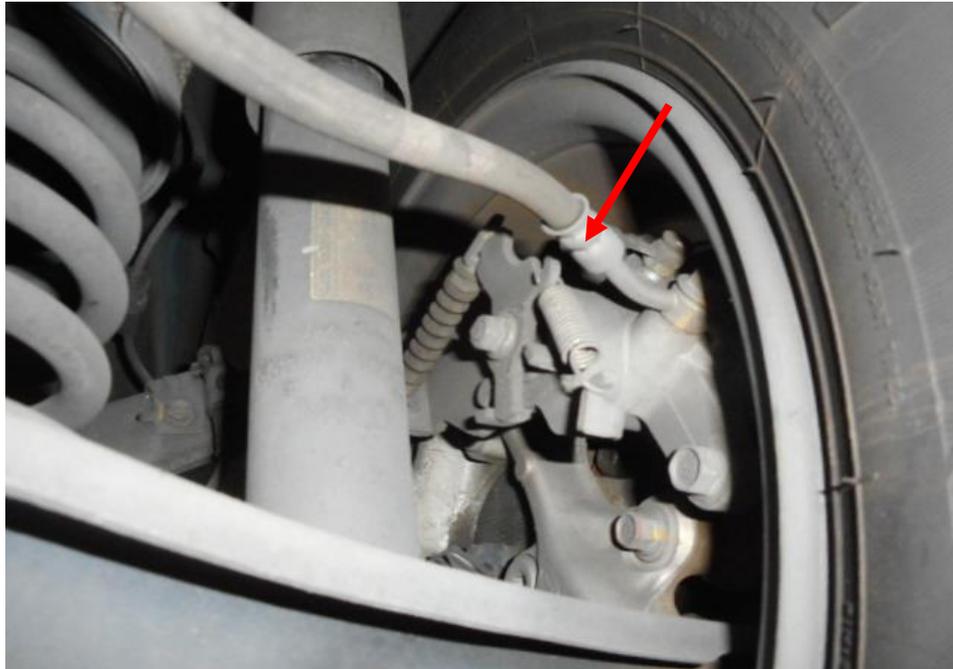
Photo 18 shows the brake hose/pipe (arrowed) at the rear right wheel of the Motor Taxi. No leakage of brake fluid was observed. Visual examination of the various components of the braking system like the drum brake, brake booster, brake pedal etc. had revealed all to be intact and without visible damage.

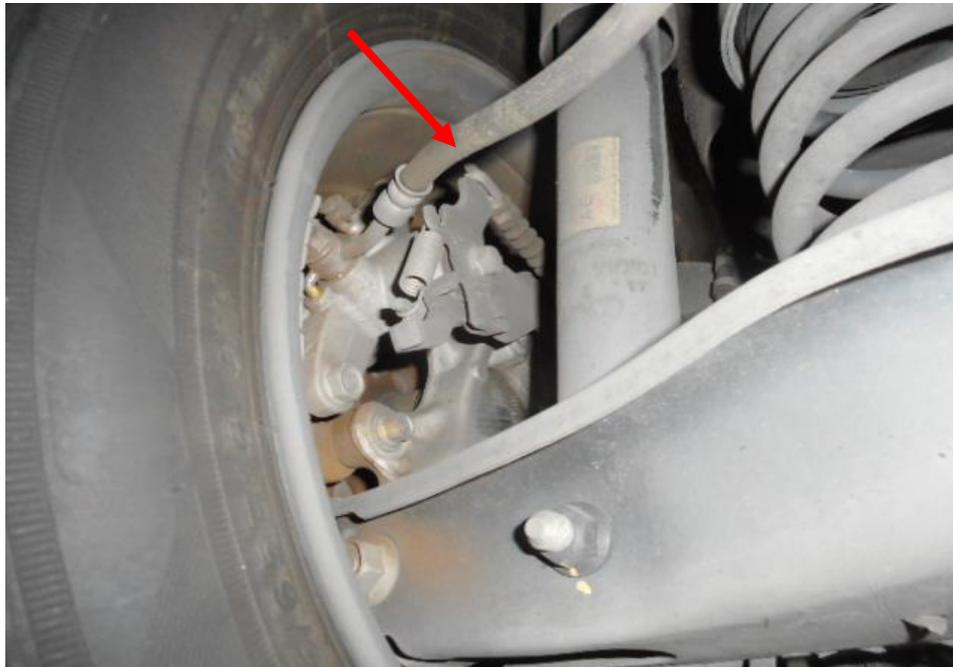
Photo 19 shows the brake hose/pipe (arrowed) at the rear left wheel of the Motor Taxi. I did not observe any leakage of brake fluid at the time of my inspection of the Motor Taxi. Static tests of the Motor Taxi's braking system had indicated that there was no internal leakage of pressure/vacuum. The undercarriage components of the Motor Taxi were also all found to be intact and without any visible damage.

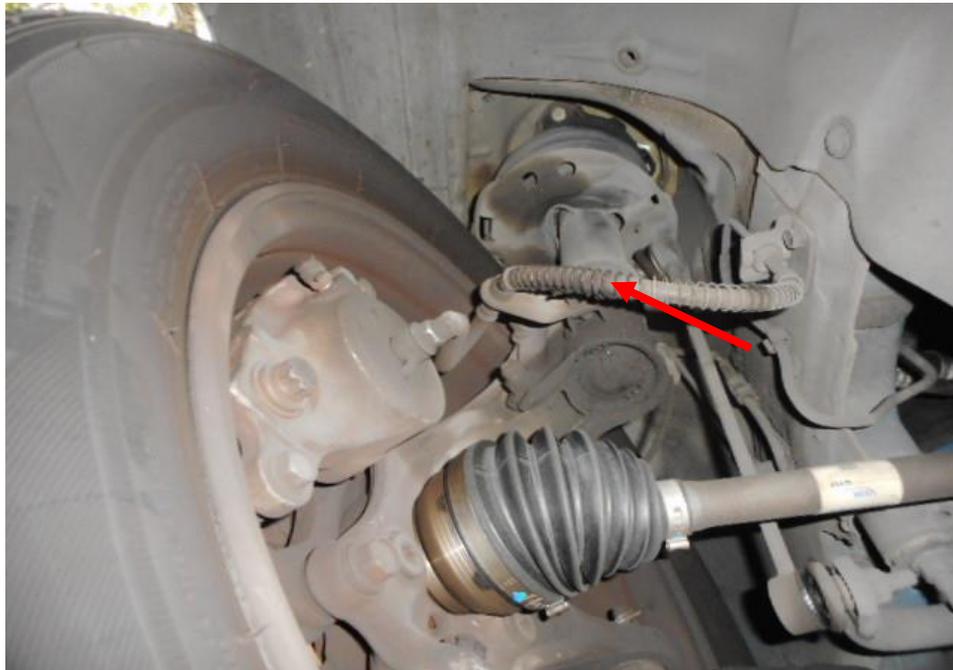
Photo 20 shows the brake hose/pipe (arrowed) at the front right wheel of the Motor Taxi. I did not observe any leakage of brake fluid at the time of my inspection of the Motor Taxi. Static tests of the Motor Taxi's braking system had indicated that there was no internal leakage of pressure/vacuum. The undercarriage components of the Motor Taxi were also all found to be intact and without any visible damage.

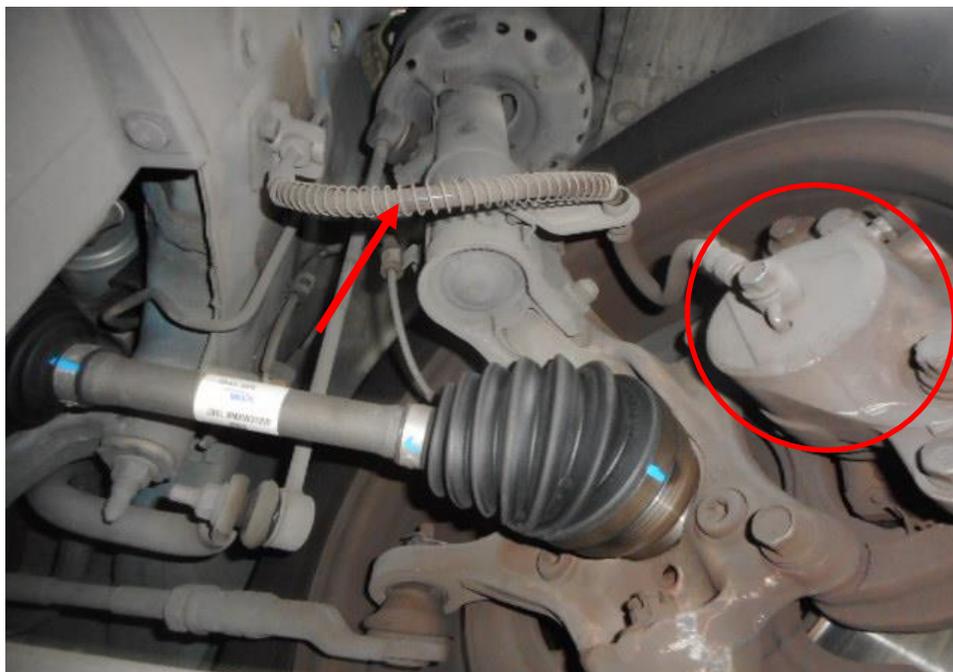
Photo 21 shows the brake hose/pipe (arrowed) at the front left wheel of the Motor Taxi. No leakage of brake fluid was observed. Visual examination of the various components of the braking system like the brake caliper (circled), brake booster, brake pedal etc had revealed all to be intact and without visible damage.

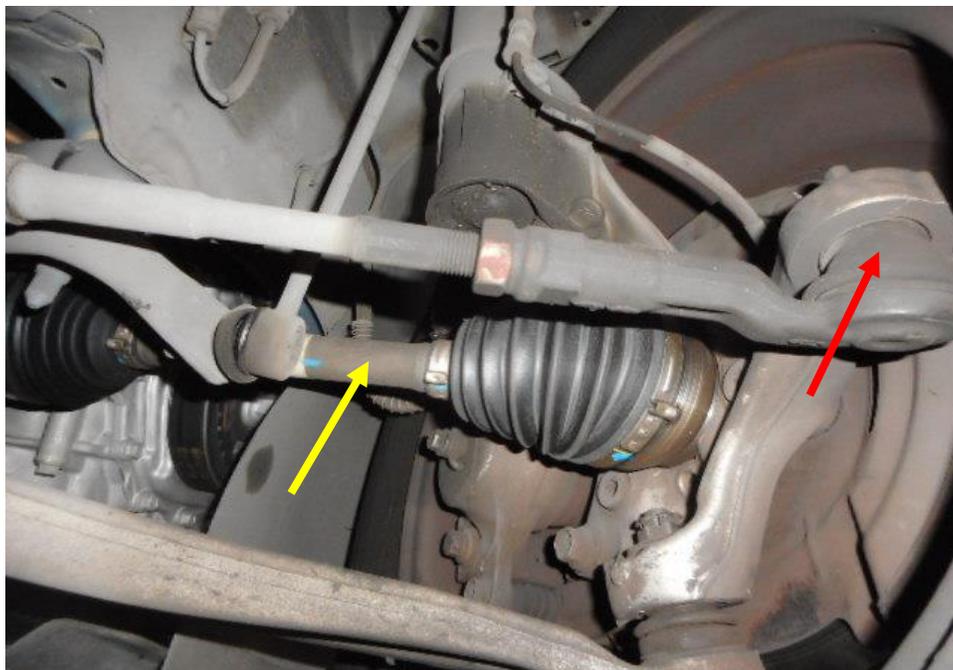
Photo 23 shows the various undercarriage components at the front right wheel of the Motor Taxi, in particular the steering tie rod (red arrow) and drive shaft (yellow arrow). The various steering components were all found to be intact, suggesting that the steering system of the Motor Taxi was likely to be in serviceable condition at the material time of accident. There was also no sign of fluid stain observed on the various undercarriage components at the front right wheel of the Motor Taxi.

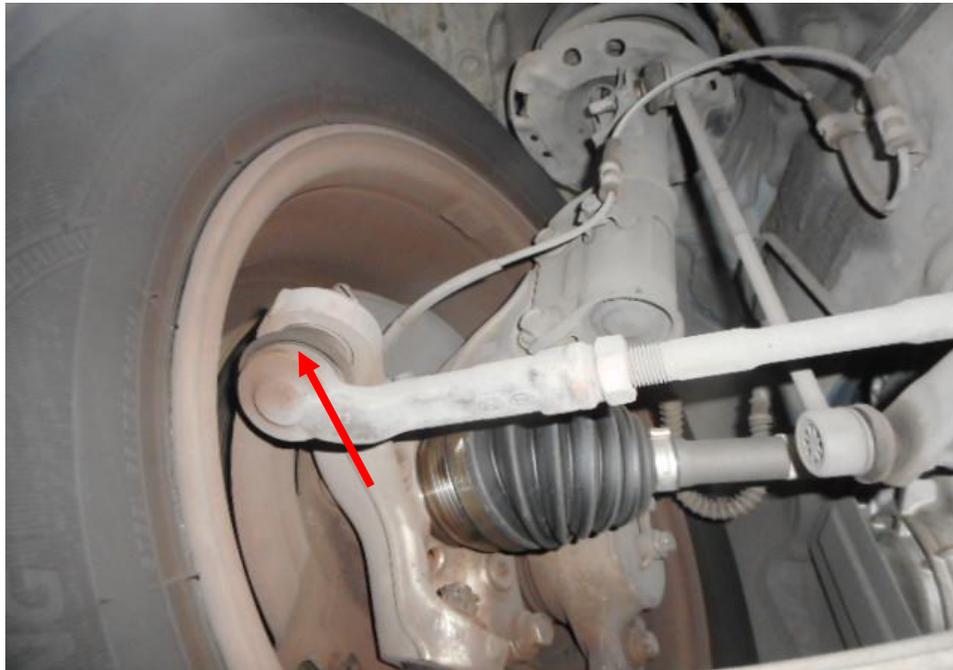
Photo 24 shows the various undercarriage components at the front left wheel of the Motor Taxi, which had included the steering tie rod (red arrow). The various undercarriage components of the Motor Taxi were all found to be intact without any visible damage.

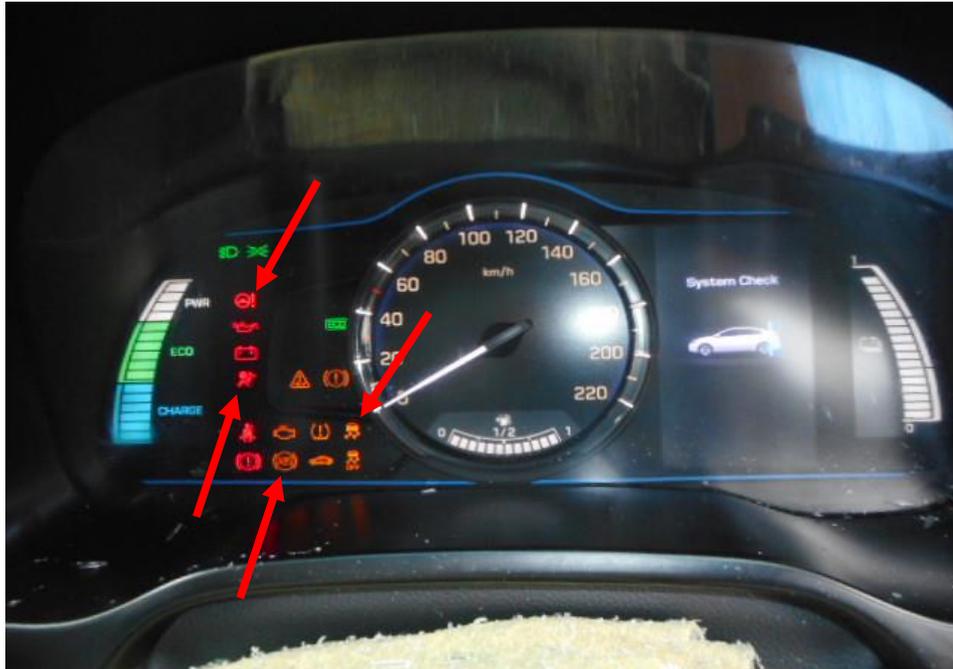
Photo 25 shows the warning light for Anti-Lock Brake System (ABS), Electric Power Steering System (EPS), Traction Control System (TCS) and Supplemental Restraint System (SRS) (arrowed) appearing on the instrument panel of the Motor Taxi during the self-test of its various electronic operating systems when its engine was cranked.

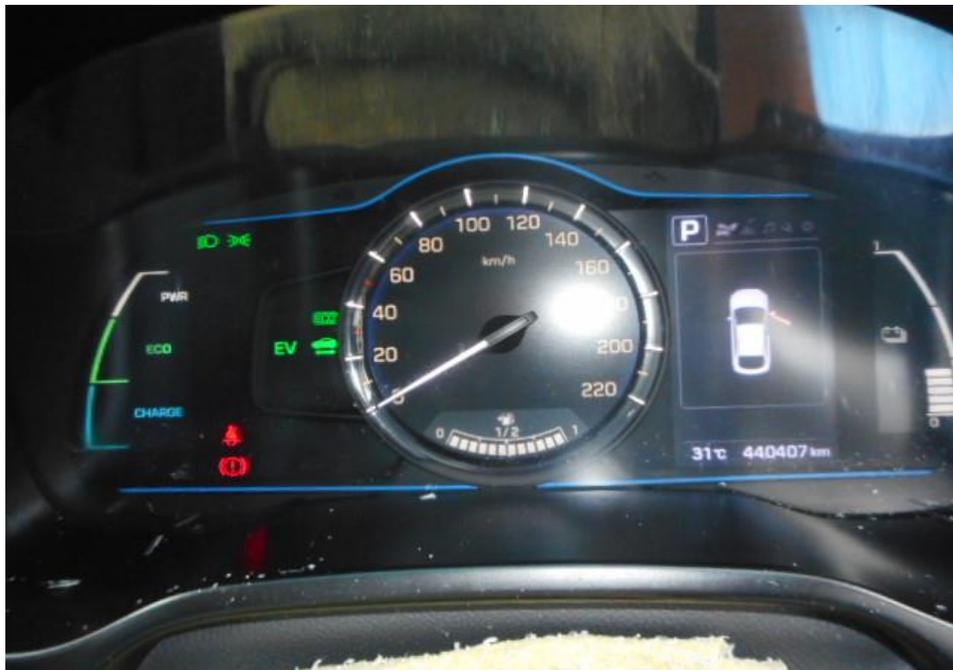
Photo 26 shows no warning lights illuminated on the instrument panel of the Motor Taxi after the engine was cranked. This would suggest that there was no abnormality to the electronic operating system of the Motor Taxi, like the ABS, EPS, TCS and SRS etc.
