You're Ref: TP/IP/32286/2022  
Our Ref: CI/TPD22013021/P

### **Fatal Accident Investigation Team**

### **MECHANICAL INSPECTION REPORT OF MOTOR CAR EW 14E**

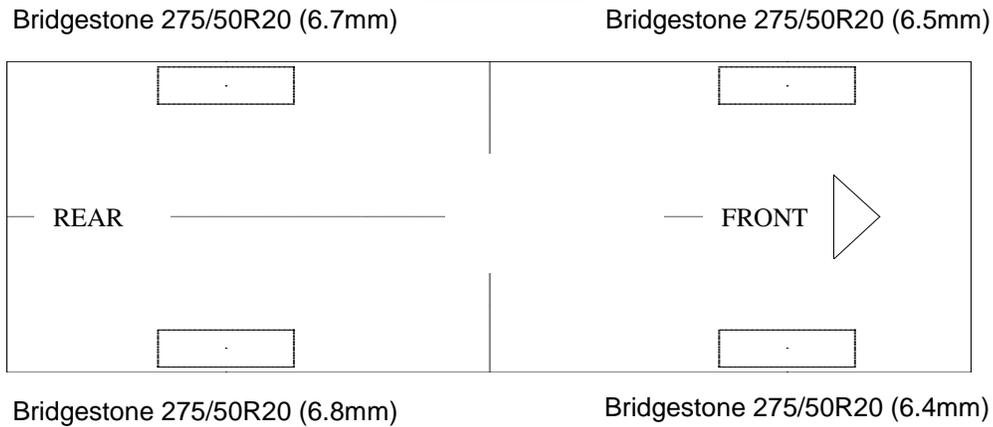
6. The condition of the Motor Car's 4 tyres was observed to be in serviceable condition. I did not find any tear, cut or burst mark(s) on the outer and the inner sidewalls as well as across the tread of the 4 tyres. The 4 tyres were also observed to be sufficiently inflated for vehicular operation. The tyre brand, tyre size and remaining tread depth of the 4 tyres were recorded as follows:-

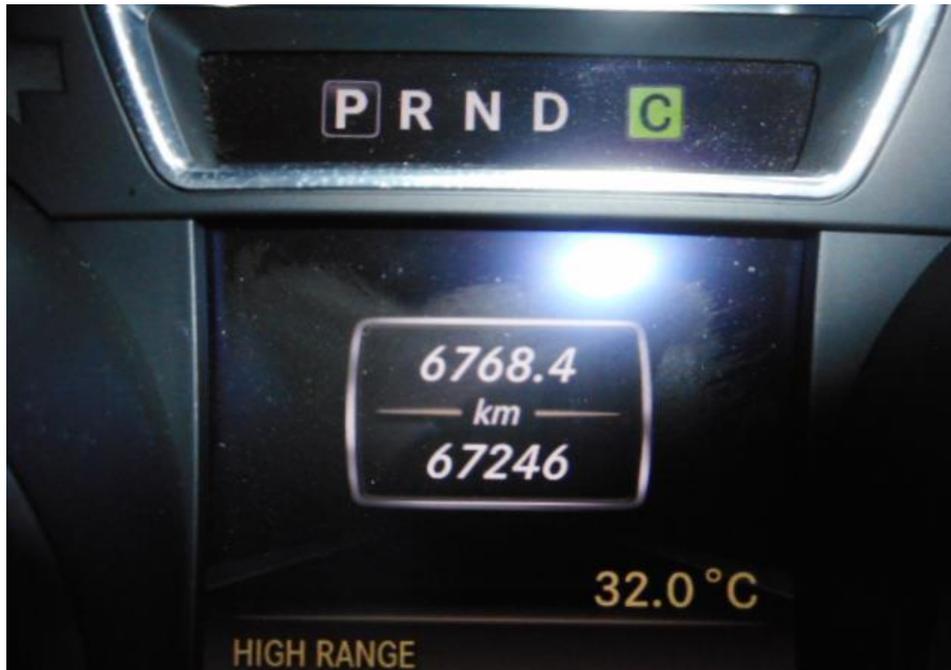
**Photo 1** shows the mileage of the Motor Car at the time of my inspection. The mileage observed was 67,246km.

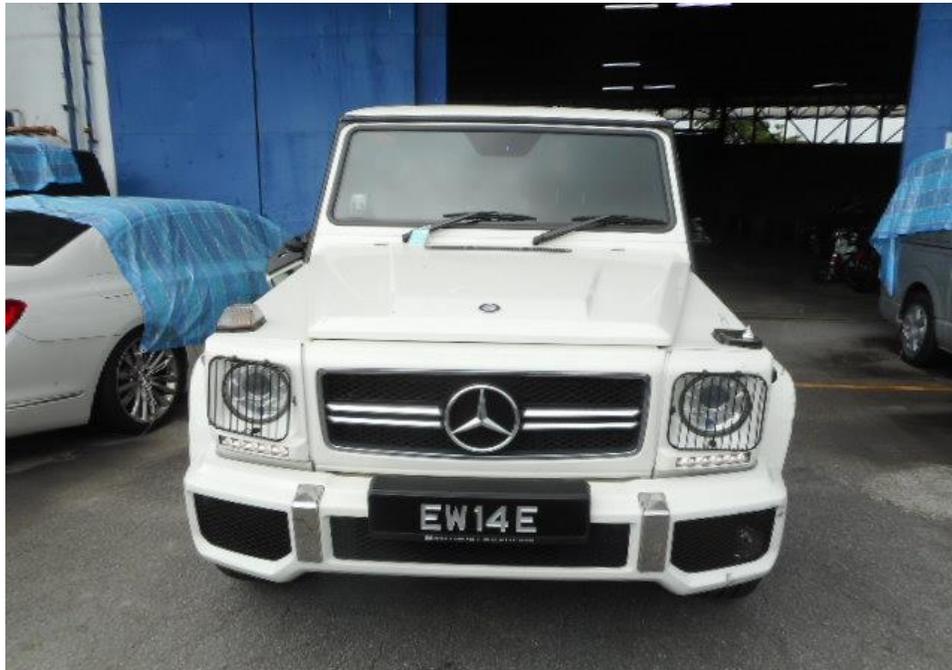
**Photo 2** shows the general view of the Motor Car's front body at the time of my inspection. The Motor Car was observed to have sustained damage at its front, right, left and rear portion. Its front bumper, front left headlamp cover, front left signal light, both right and left rear view mirror, rear bumper, right front and rear fender, left front and rear fender as well as engine radiator was amongst the body parts and engine component that were damaged as a result of the accident.

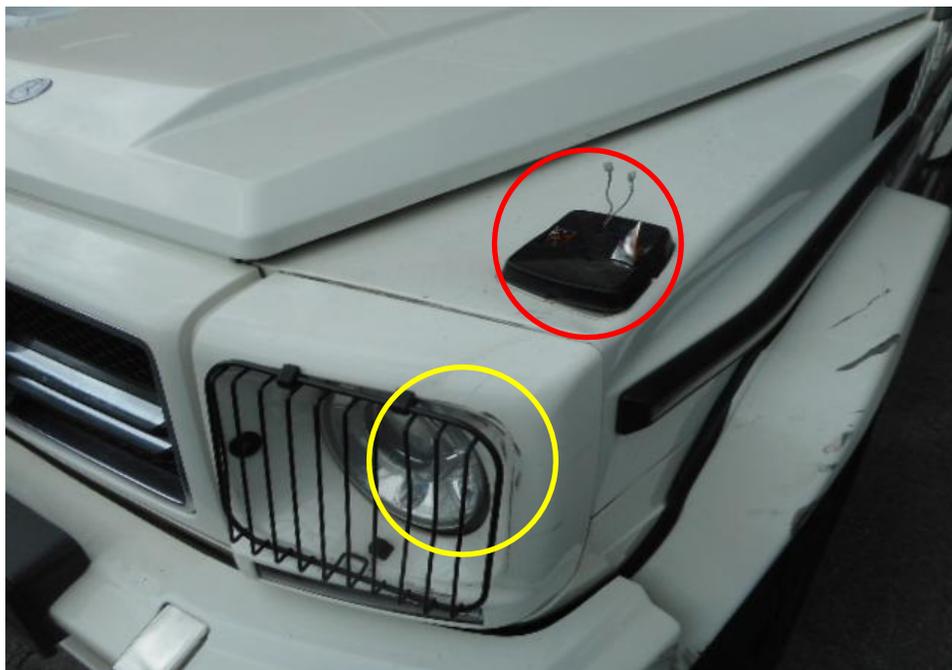
**Photo 3** shows a close up view of the Motor Car's front body at the time of my inspection. The Motor Car was observed to have sustained damage at its front portion. Its front left signal light (red circle) and front left headlamp cover (yellow circle) was amongst the body parts that were damaged as a result of the accident.

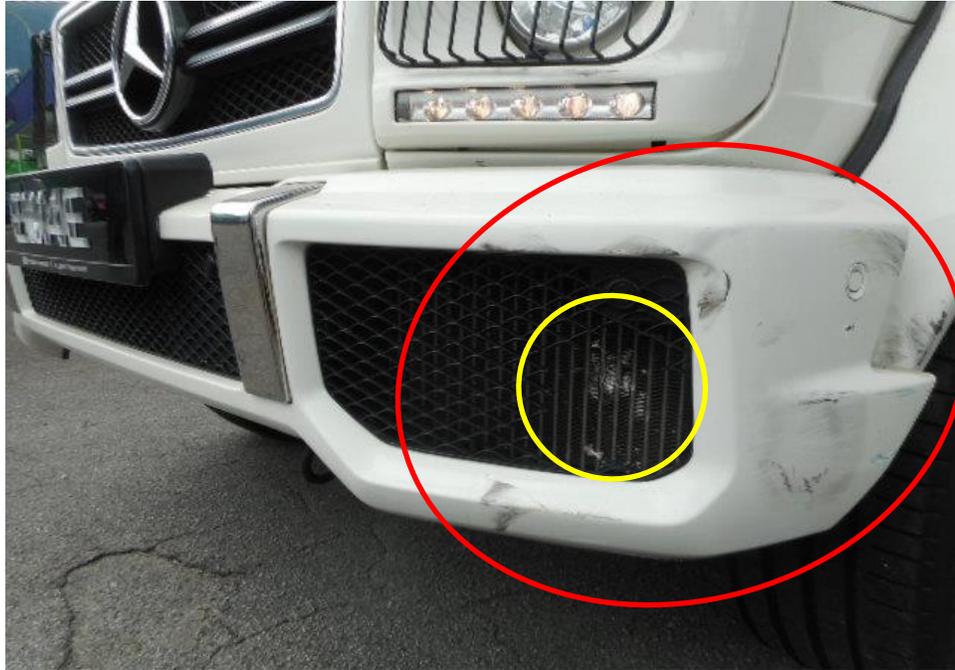
**Photo 4** shows a close up view of the Motor Car's front body at the time of my inspection. The Motor Car was observed to have sustained damage at its front portion. Its front bumper (red circle) and engine radiator (yellow circle) was amongst the body parts and engine radiator that were damaged as a result of the accident.

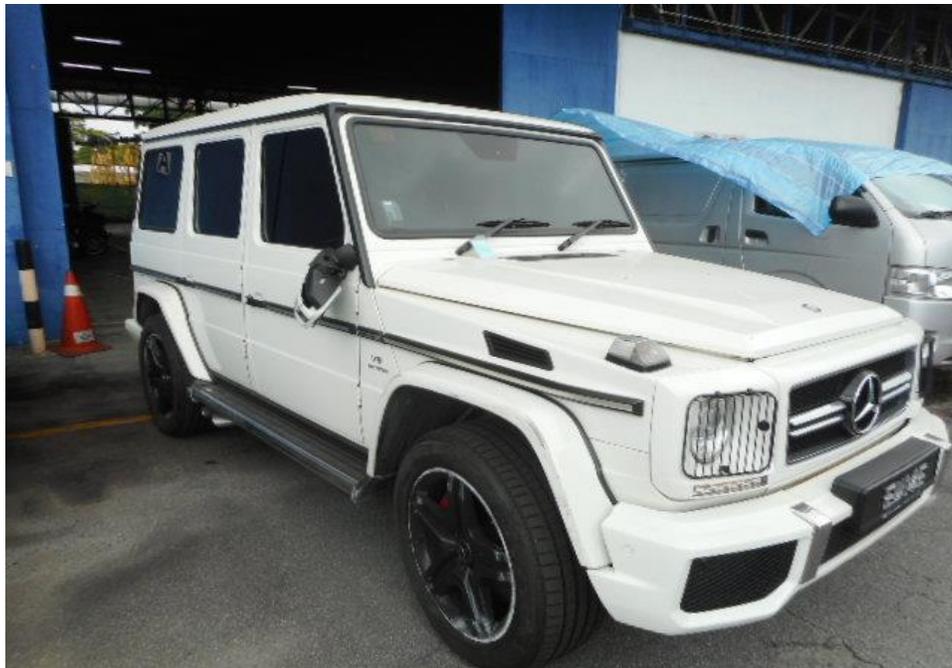
**Photo 5** shows the general view of the Motor Car's right body at the time of my inspection. The Motor Car was observed to have sustained damage at its right, portion. Its right rear view mirror, right front and rear fender was amongst the body parts that were damaged as a result of the accident.

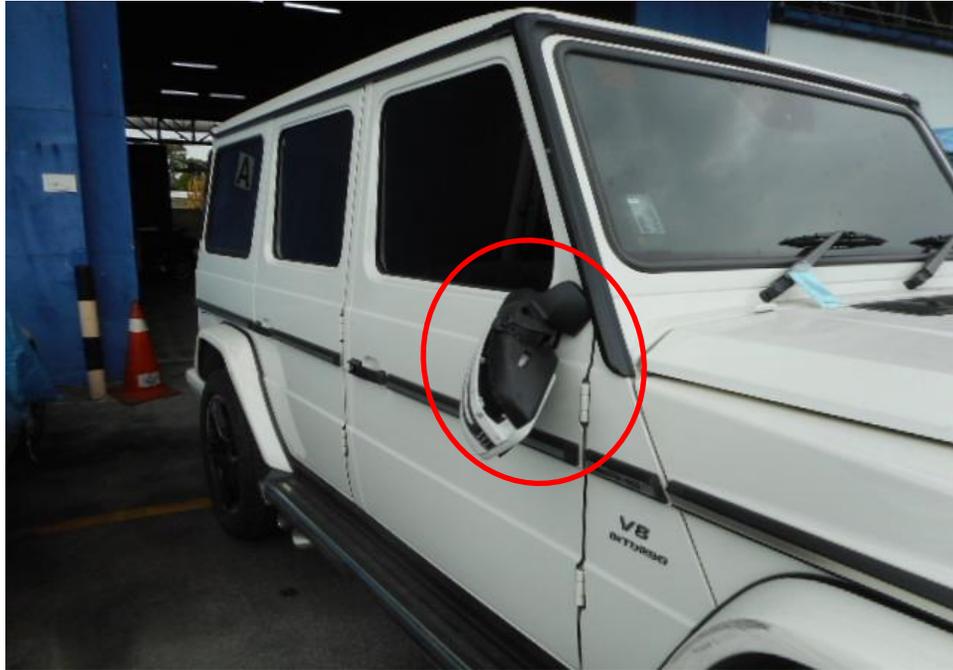
**Photo 6** shows a close up view of the Motor Car's right body at the time of my inspection. The Motor Car was observed to have sustained damage at its right, portion. Its right rear view mirror (circled) was amongst the body parts that were damaged as a result of the accident.

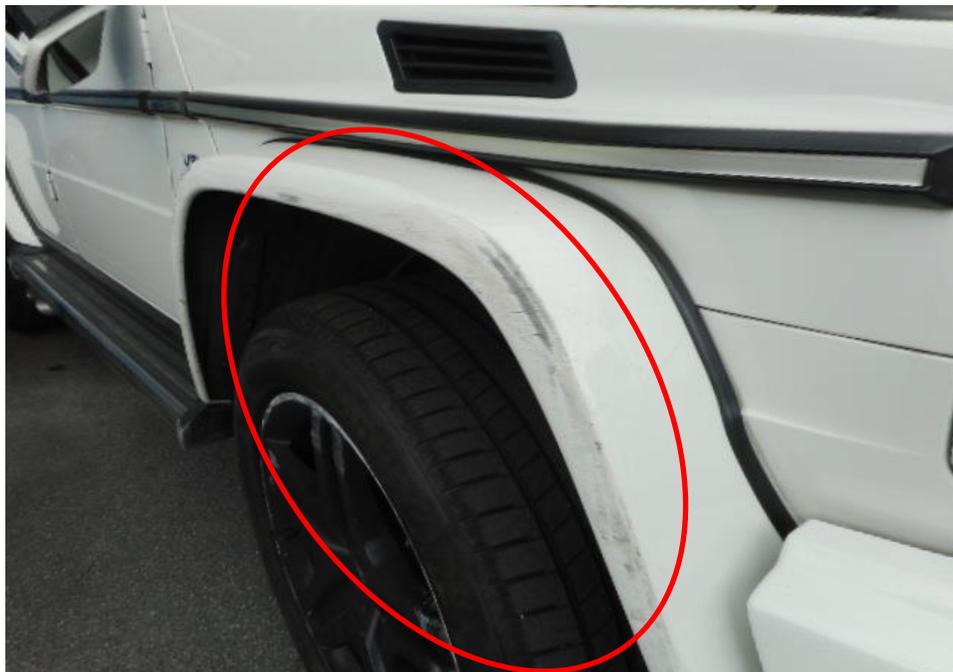
**Photo 7** shows a close up view of the Motor Car's right body at the time of my inspection. The Motor Car was observed to have sustained damage at its right, portion. Its right front fender was amongst the body parts that were damaged as a result of the accident.

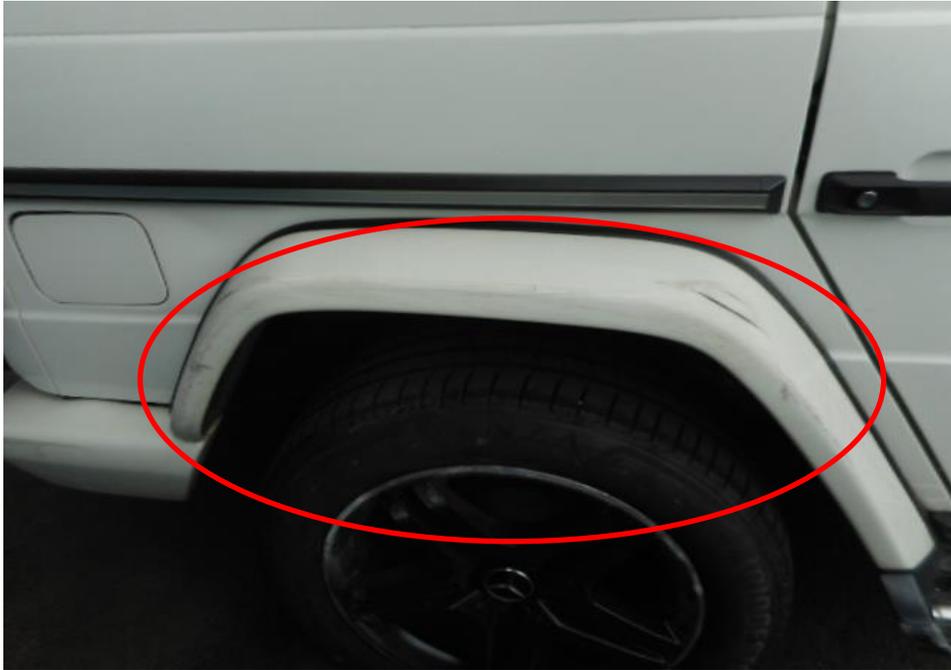
**Photo 8** shows a close up view of the Motor Car's right body at the time of my inspection. The Motor Car was observed to have sustained damage at its right, portion. Its right rear fender was amongst the body parts that were damaged as a result of the accident.

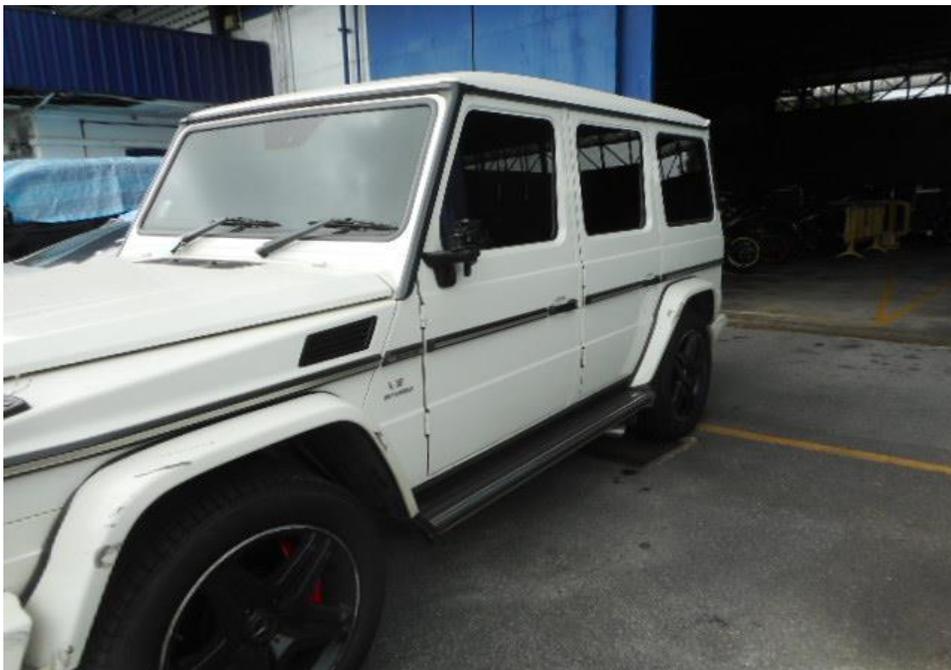
**Photo 9** shows the general view of the Motor Car's left body at the time of my inspection. The Motor Car was observed to have sustained damage at its right, portion. Its left rear view mirror, left front and rear fender was amongst the body parts that were damaged as a result of the accident.

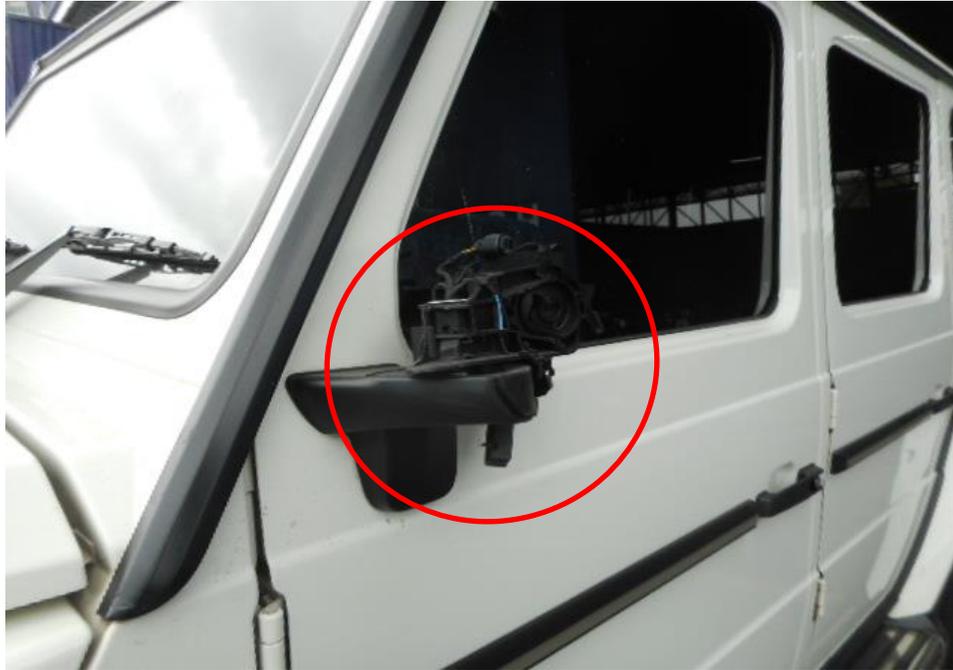
**Photo 10** shows a close up view of the Motor Car's left body at the time of my inspection. The Motor Car was observed to have sustained damage at its left, portion. Its left rear view mirror (circled) was amongst the body parts that were damaged as a result of the accident.

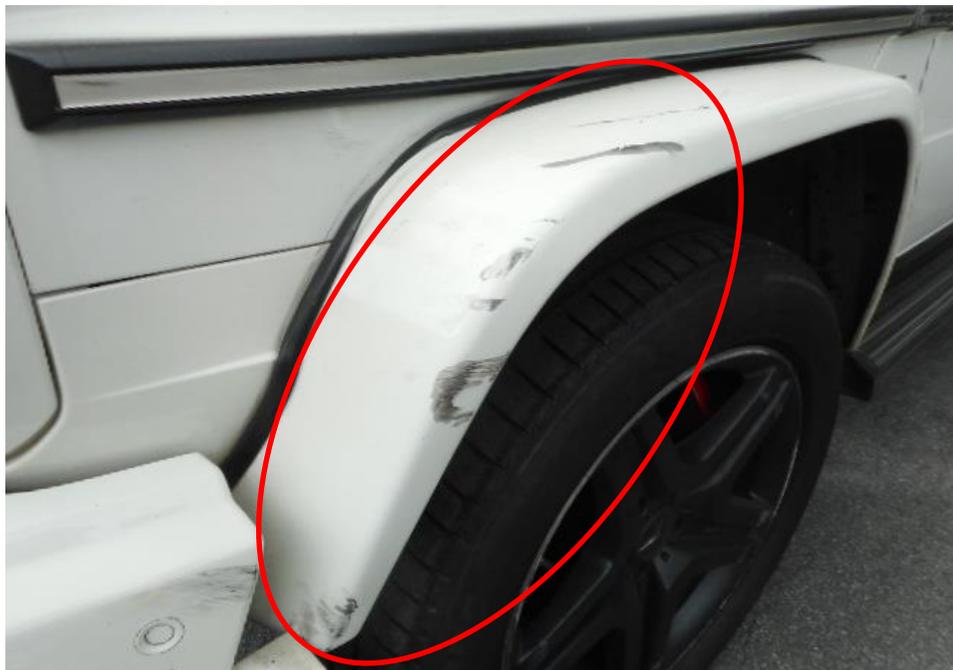
**Photo 11** shows a close up view of the Motor Car's left body at the time of my inspection. The Motor Car was observed to have sustained damage at its left, portion. Its left front fender was amongst the body parts that were damaged as a result of the accident.

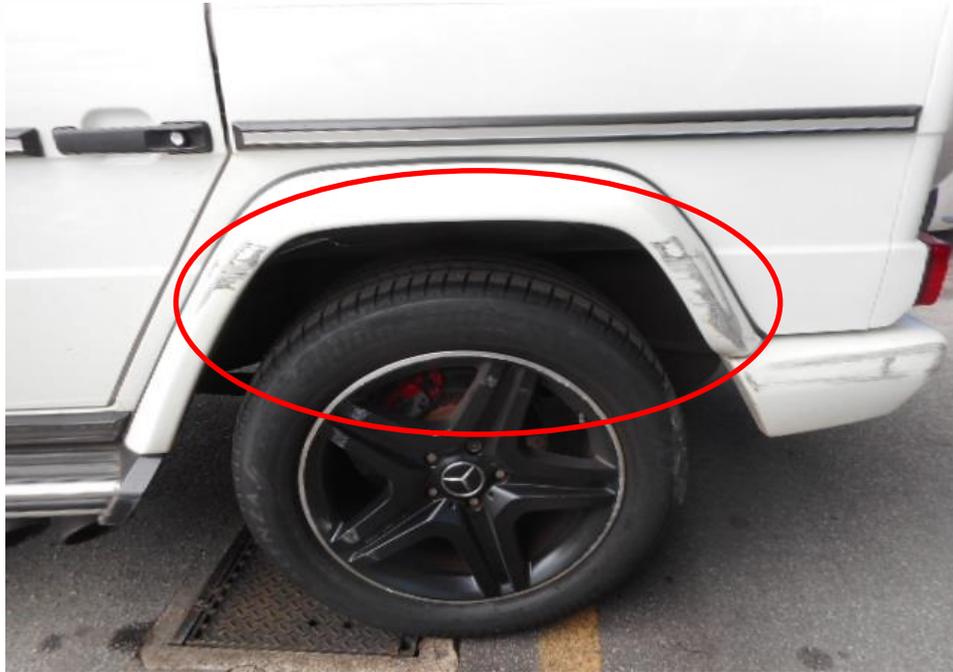
**Photo 12** shows a close up view of the Motor Car's left body at the time of my inspection. The Motor Car was observed to have sustained damage at its left, portion. Its left rear fender was amongst the body parts that were damaged as a result of the accident.

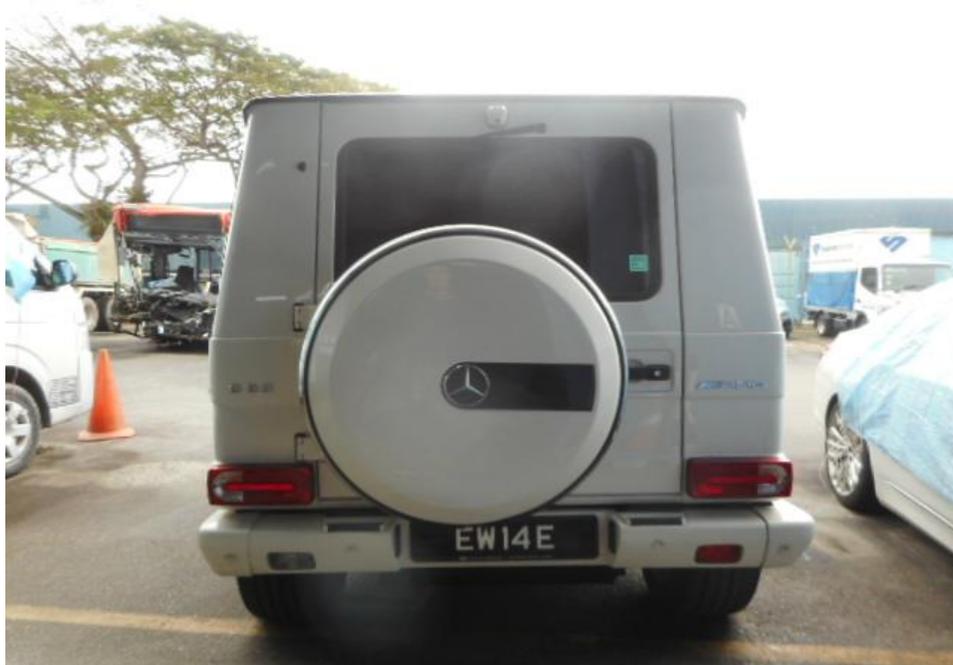
**Photo 13** shows the general view of the Motor Car's rear body at the time of my inspection. The Motor Car was observed to have sustained damage at its rear, portion. Its rear bumper was amongst the body parts that were damaged as a result of the accident.

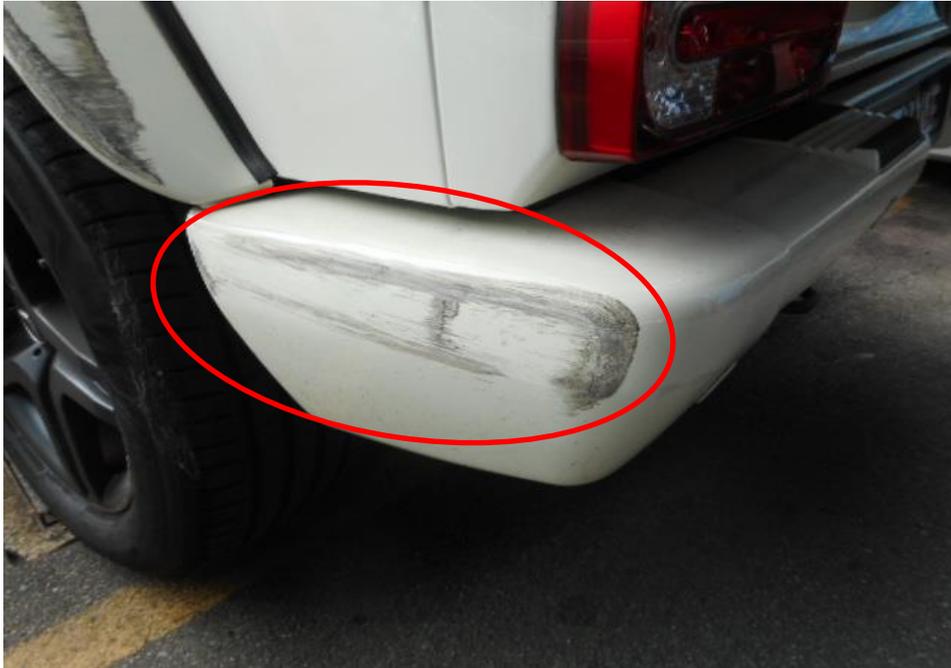
**Photo 14** shows a close up view of the Motor Car's rear body at the time of my inspection. The Motor Car was observed to have sustained damage at its rear, portion. Its rear bumper (circled) was amongst the body parts that were damaged as a result of the accident.

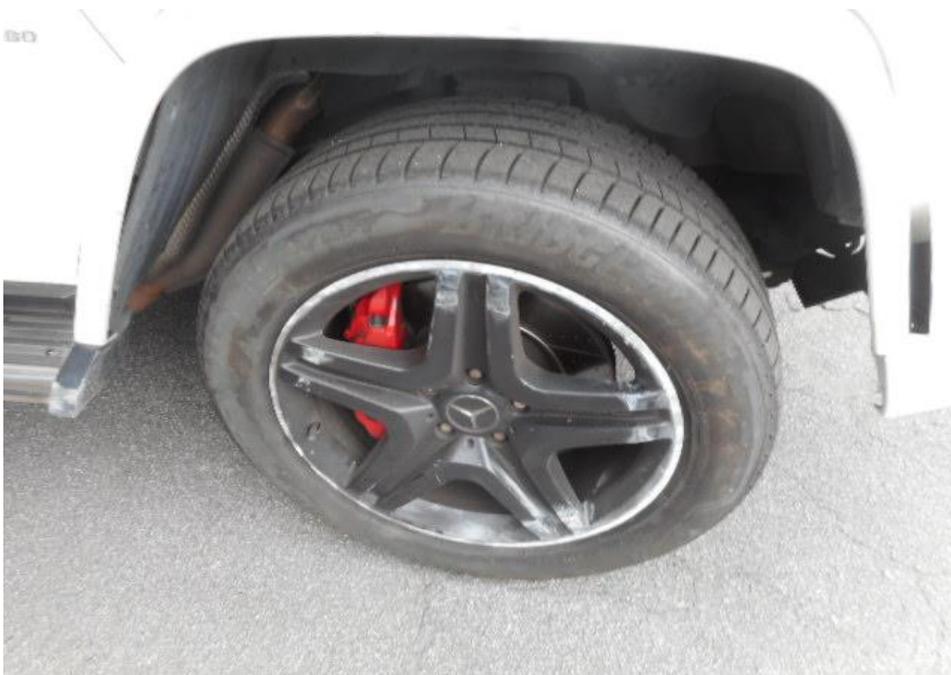
**Photo 15** shows the general view of the front right wheel rim of the Motor Car, which was observed to be damaged as a result of the accident.

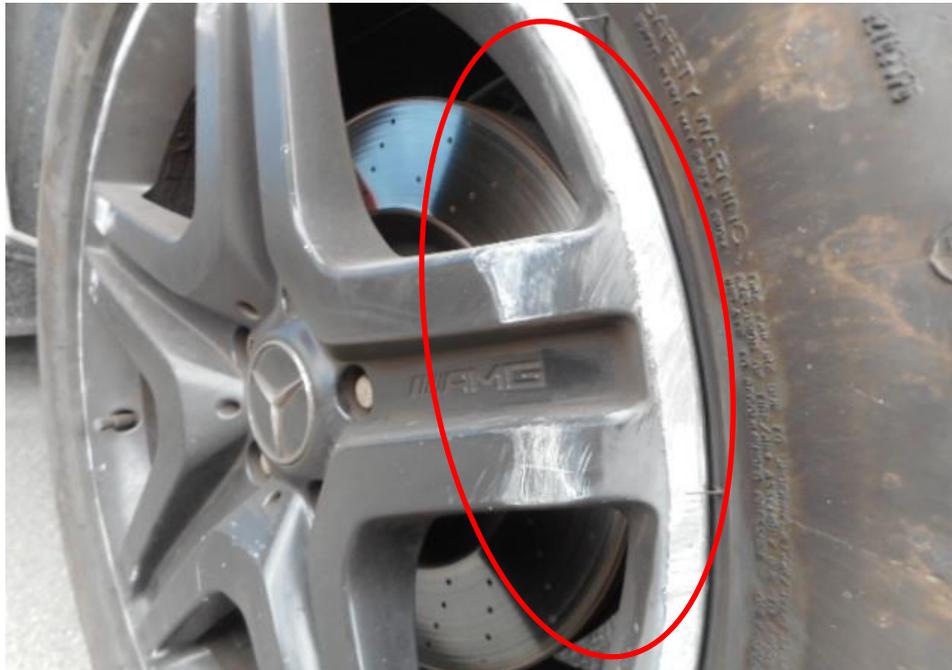
**Photo 16** shows the close up condition of the front right wheel rim (circled) of the Motor Car, which was observed to be damaged as a result of the accident.

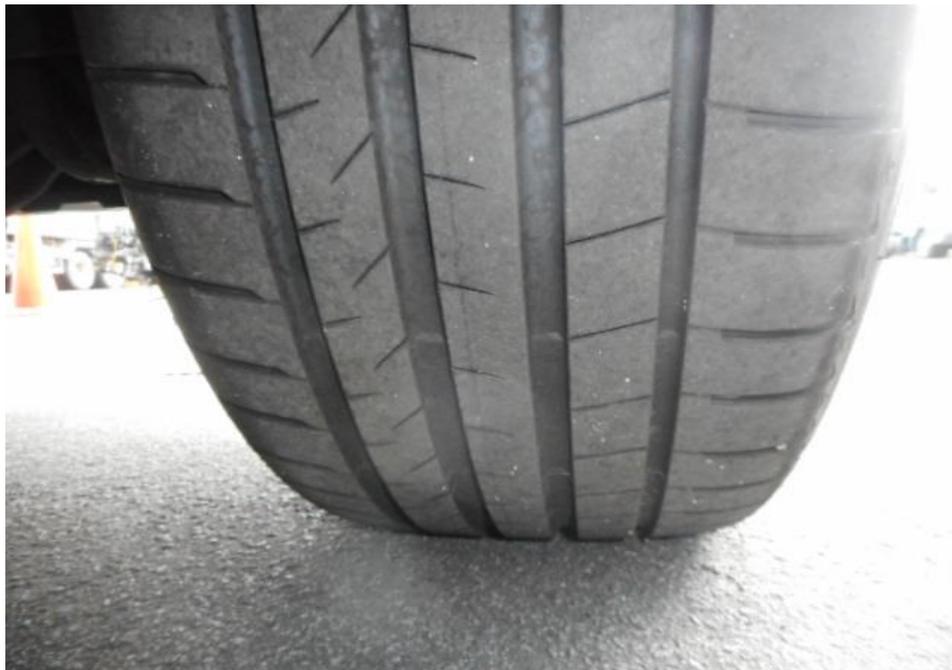
**Photo 17** shows the condition of the front right tyre of the Motor Car, which was observed to be in serviceable condition with remaining tread depth of approximately 6.4mm. The tyre was also observed to be sufficiently inflated for vehicular operation with no tear, cut or burst mark(s).

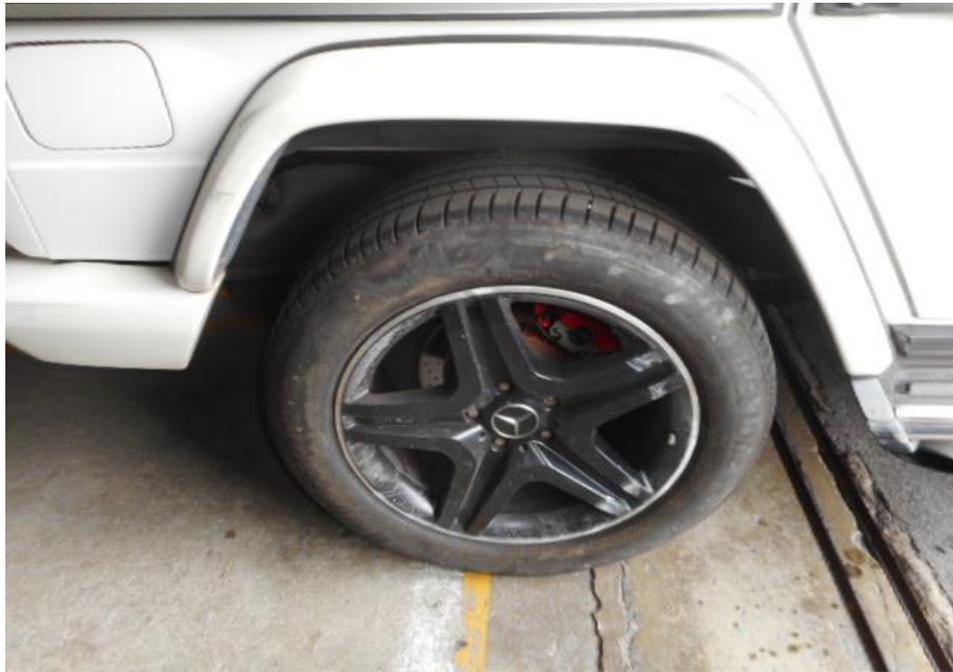
**Photo 18** shows the general view of the rear right wheel rim of the Motor Car, which was observed to be damaged as a result of the accident.

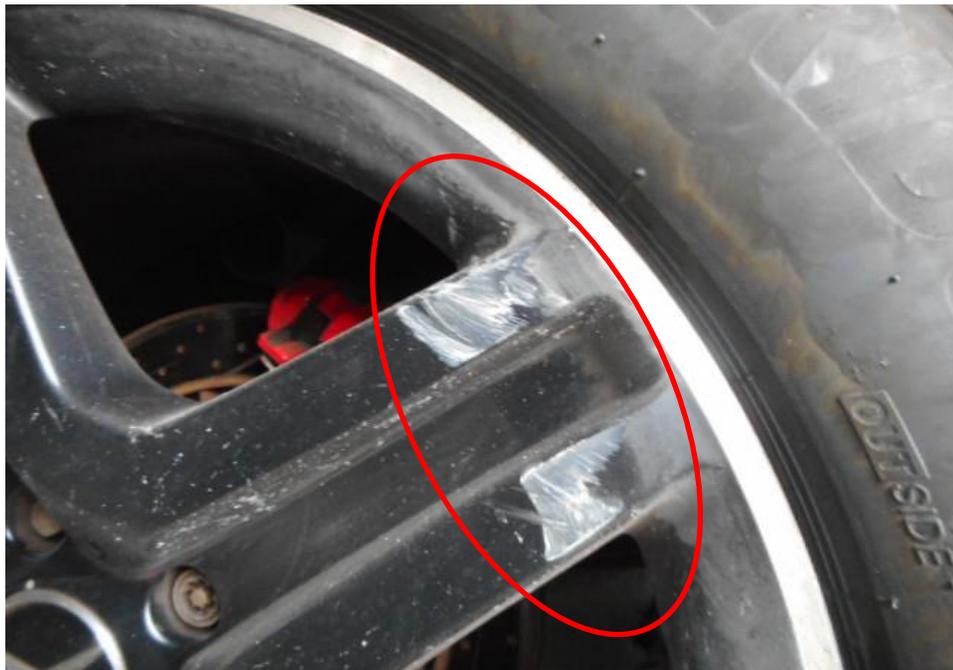
**Photo 19** shows the close up condition of the rear right wheel rim (circled) of the Motor Car, which was observed to be damaged as a result of the accident.

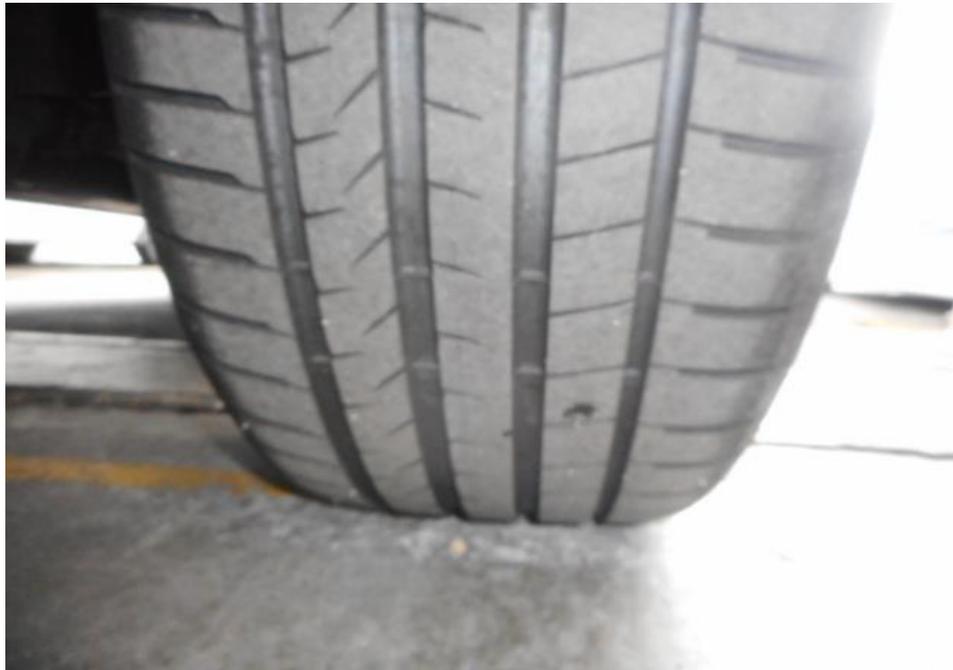
**Photo 20** shows the condition of the rear right tyre of the Motor Car, which was observed to be in serviceable condition with remaining tread depth of approximately 6.8mm. The tyre was also observed to be sufficiently inflated for vehicular operation with no tear, cut or burst mark(s).

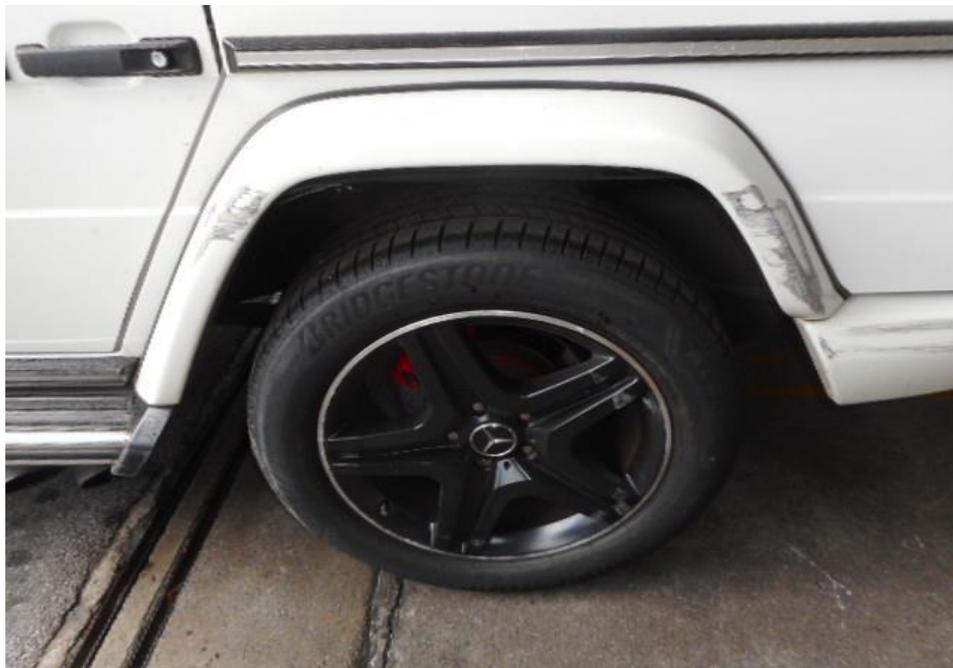
**Photo 21** shows the general view of the rear left wheel rim of the Motor Car, which was observed to be damaged as a result of the accident.

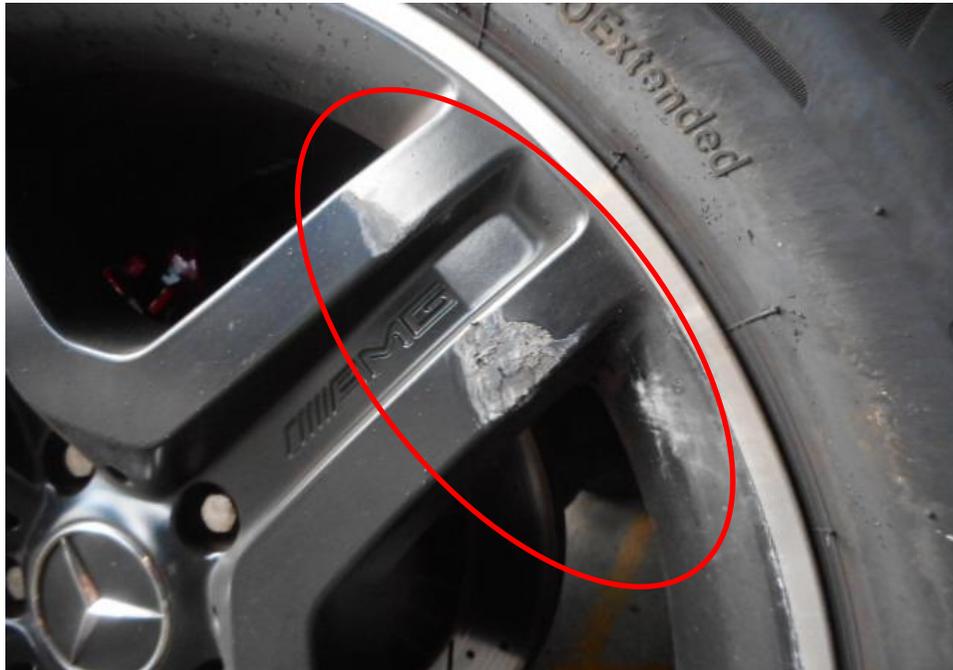
**Photo 22** shows the close up condition of the rear left wheel rim (circled) of the Motor Car, which was observed to be damaged as a result of the accident.

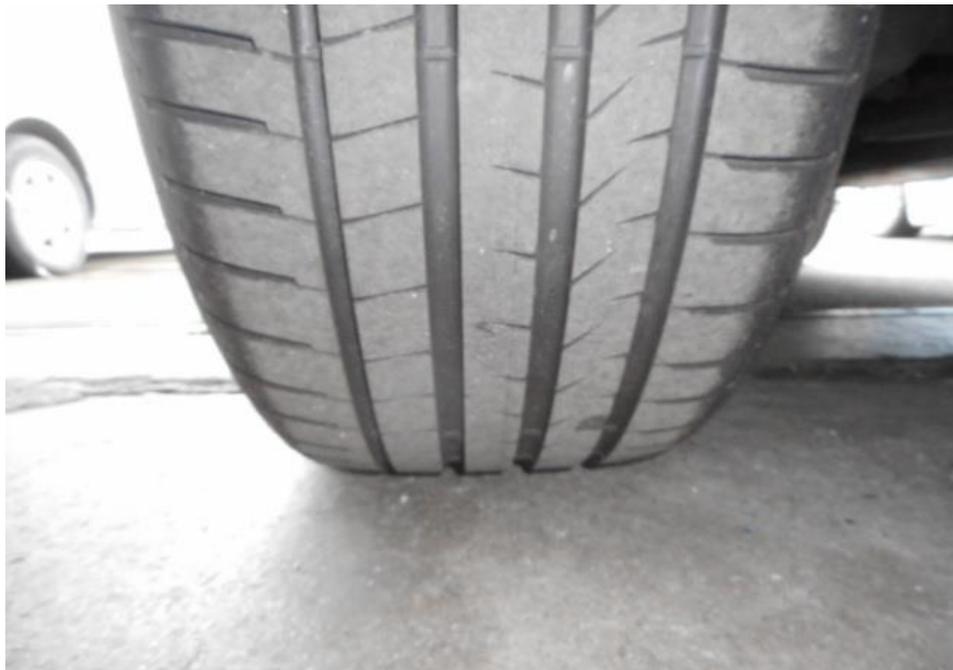
**Photo 23** shows the condition of the rear left tyre of the Motor Car, which was observed to be in serviceable condition with remaining tread depth of approximately 6.7mm. The tyre was also observed to be sufficiently inflated for vehicular operation with no tear, cut or burst mark(s).

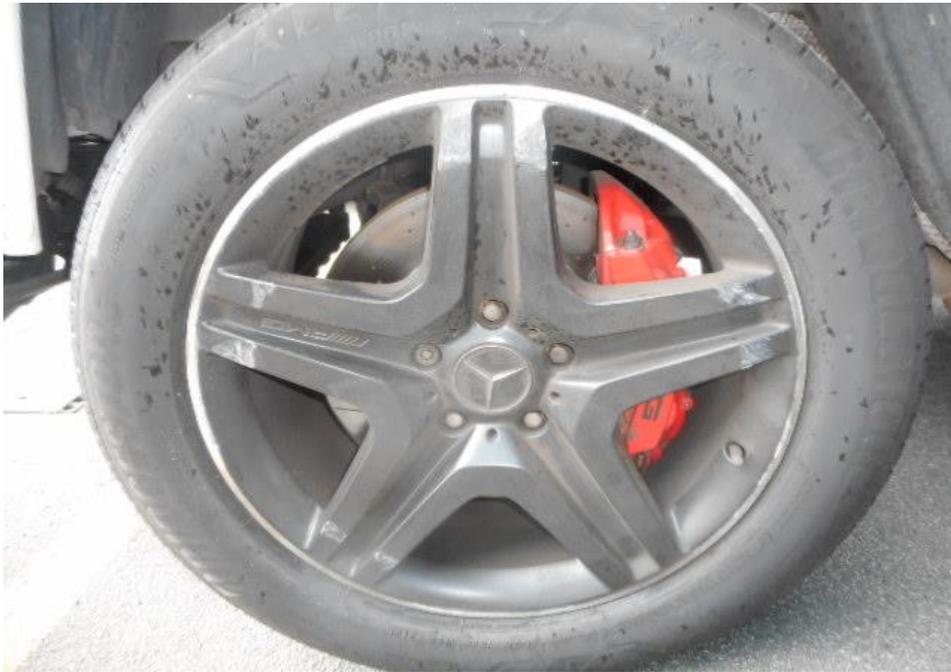
**Photo 24** shows the general view of the front left wheel rim of the Motor Car, which was observed to be damaged as a result of the accident.

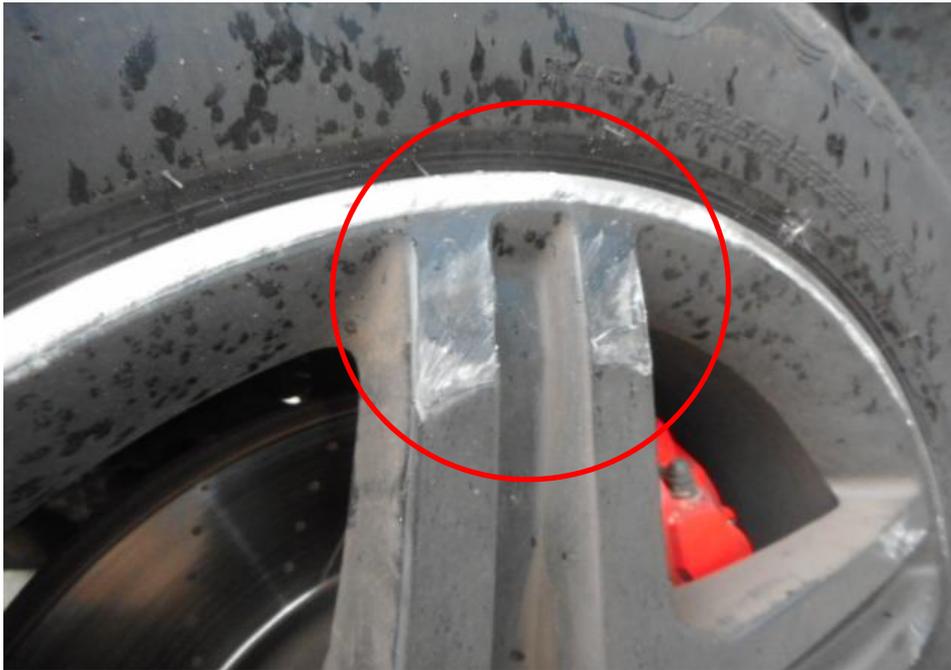
**Photo 25** shows the close up condition of the front left wheel rim (circled) of the Motor Car, which was observed to be damaged as a result of the accident.

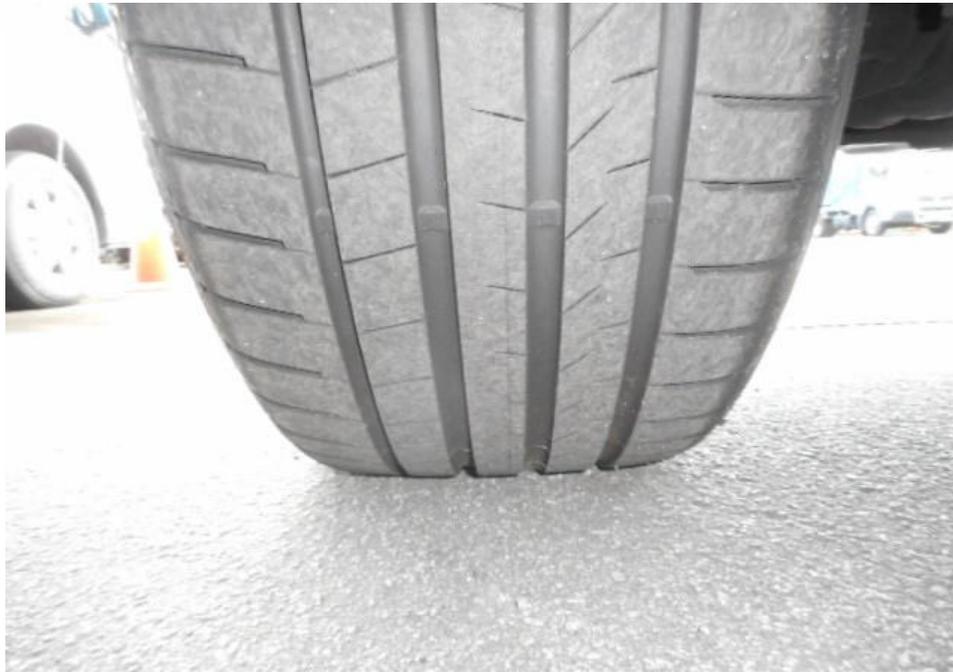
**Photo 26** shows the condition of the front left tyre of the Motor Car, which was observed to be in serviceable condition with remaining tread depth of approximately 6.5mm. The tyre was also observed to be sufficiently inflated for vehicular operation with no tear, cut or burst mark(s). The 4 tyres of the Motor Car were wrapped around standard alloy wheel rims.

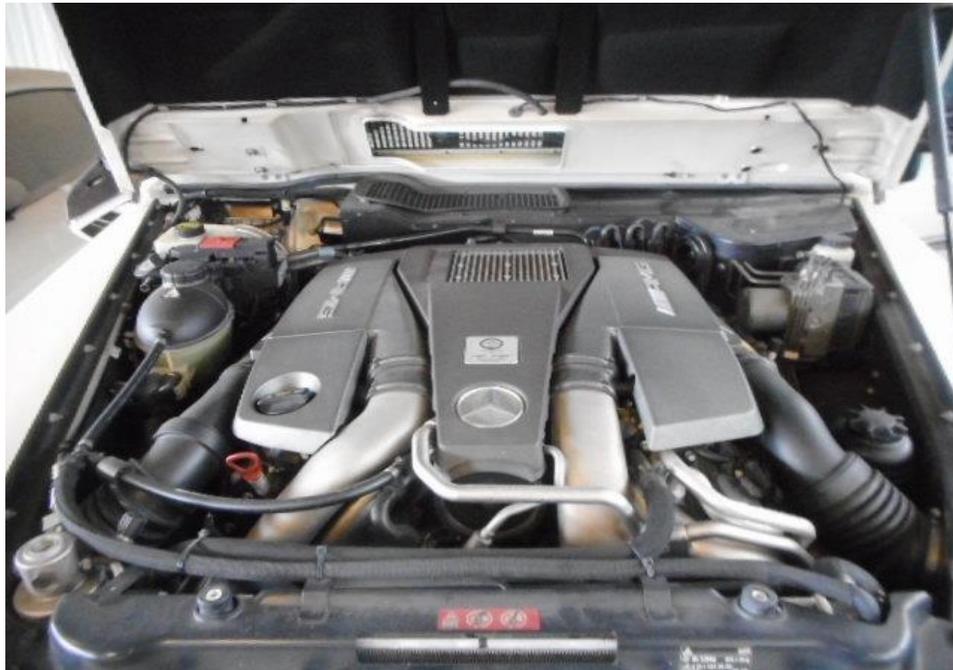
**Photo 27** shows a general view of the Motor Car's engine compartment. The various parts and components inside the engine compartment were unaffected by the accident. There was also no sign(s) or indication(s) of fluid leakage and/or fluid stain within the engine compartment.

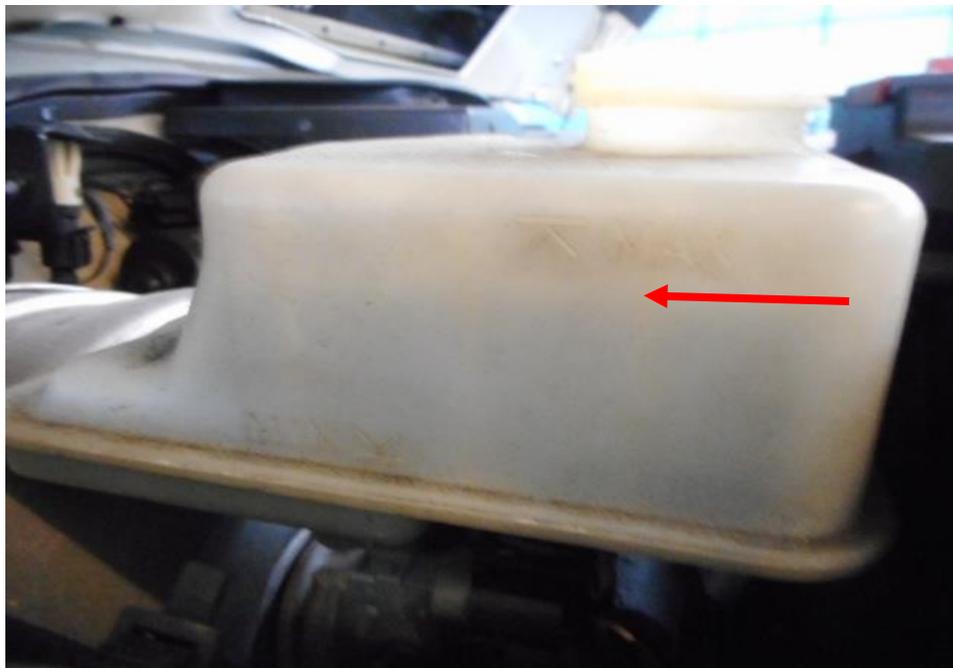
**Photo 28** shows the brake fluid reservoir of the Motor Car at the time of my inspection. The brake fluid was observed to be of sufficient level (arrowed) and without any visible contamination.

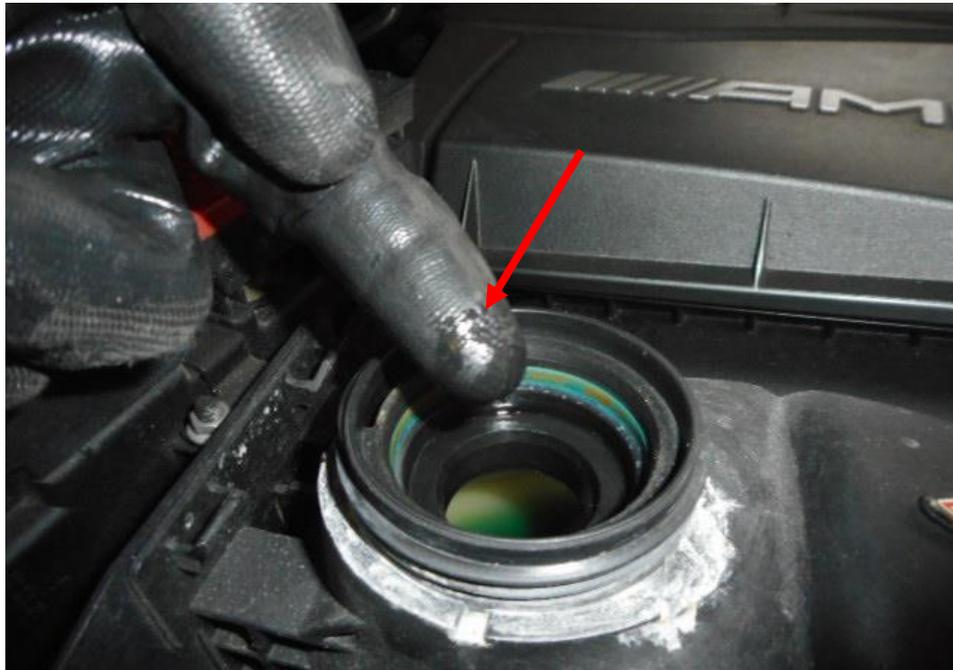
**Photo 29** shows checks being carried out to the engine coolant of the Motor Car at the time of my inspection. The engine coolant was observed to be of sufficient level (arrowed) and without any visible contamination.

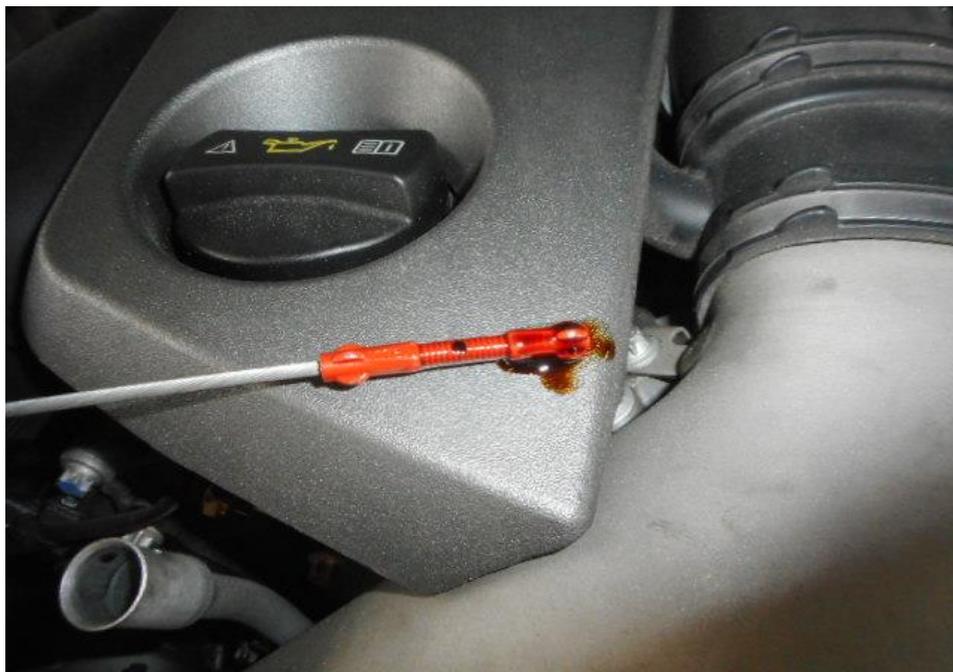
**Photo 30** shows the engine oil level dipstick of the Motor Car at the time of my inspection. The engine oil was observed to be of sufficient level and without any visible contamination.

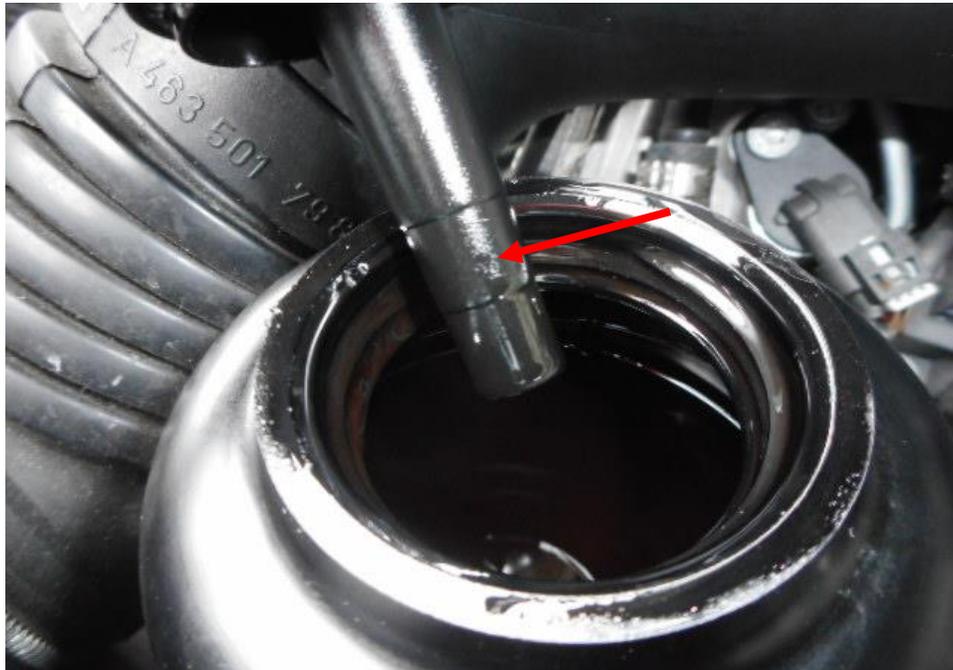
**Photo 31** shows the power steering fluid level dipstick of the Motor Car at the time of my inspection. The power steering fluid was observed to be of sufficient level and without any visible contamination.

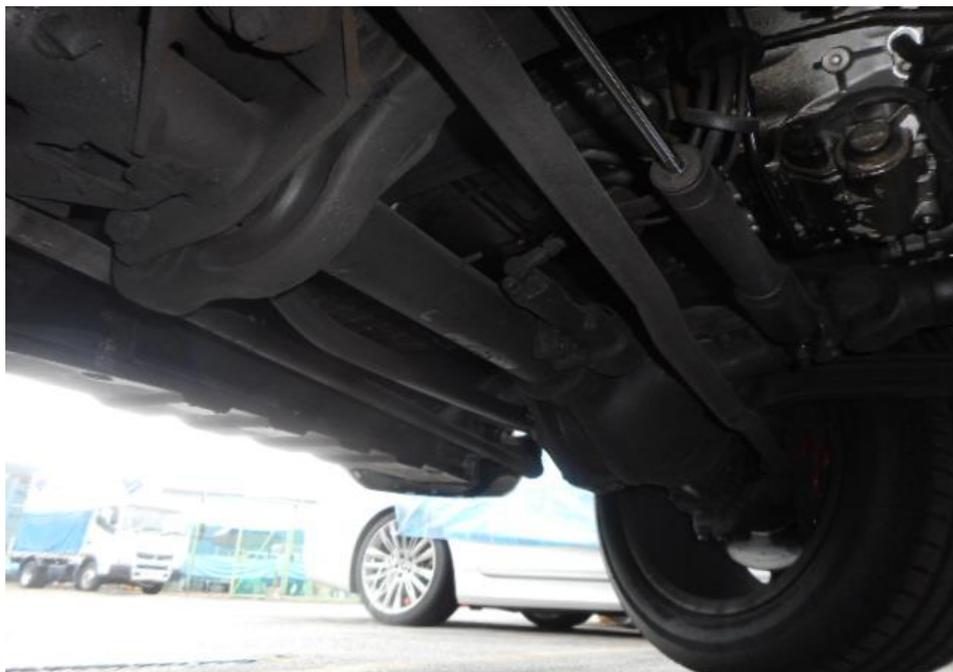
**Photo 32** shows the undercarriage of the Motor Car, at the area where the engine housing and transmission housing are located. I did not find any sign(s) or indication(s) of fluid leak and/or fluid stain(s) on the underside of the Motor Car.
