You're Ref: TP/IP/32286/2022  
Our Ref: CI/TPD22013021/P

### **Fatal Accident Investigation Team**

### **MECHANICAL INSPECTION REPORT OF MOTOR CAR EW 14E**

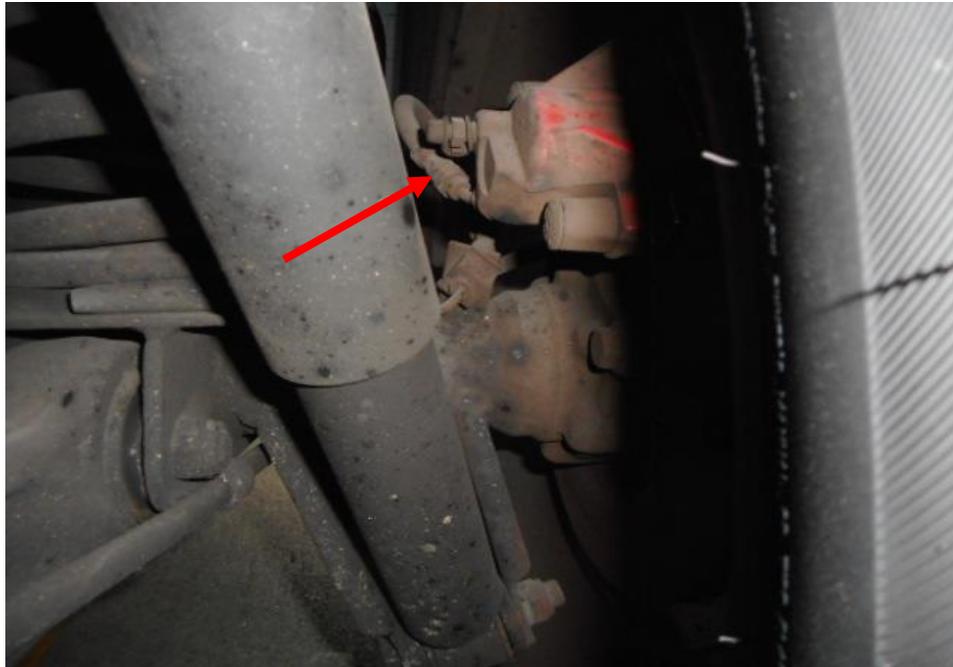
**Photo 33** shows the brake hose/pipe (arrowed) at the rear right wheel of the Motor Car. No leakage of brake fluid was observed. Visual examination of the various components of the braking system like the drum brake, brake booster, brake pedal etc. had revealed all to be intact and without visible damage.

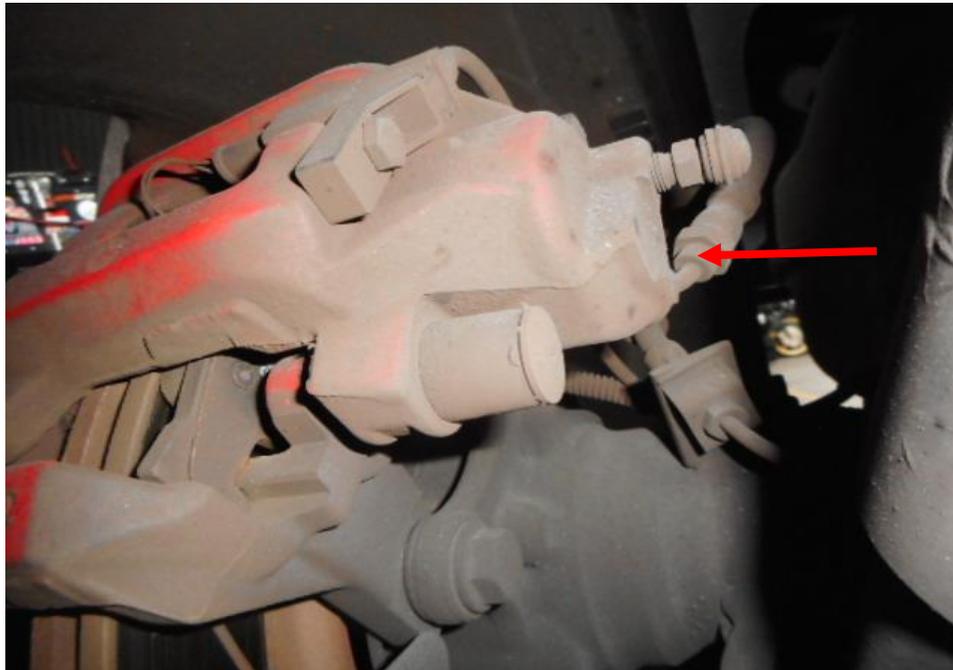
**Photo 34** shows the brake hose/pipe (arrowed) at the rear left wheel of the Motor Car. I did not observe any leakage of brake fluid at the time of my inspection of the Motor Car. Static tests of the Motor Car's braking system had indicated that there was no internal leakage of pressure/vacuum. The undercarriage components of the Motor Car were also all found to be intact and without any visible damage.

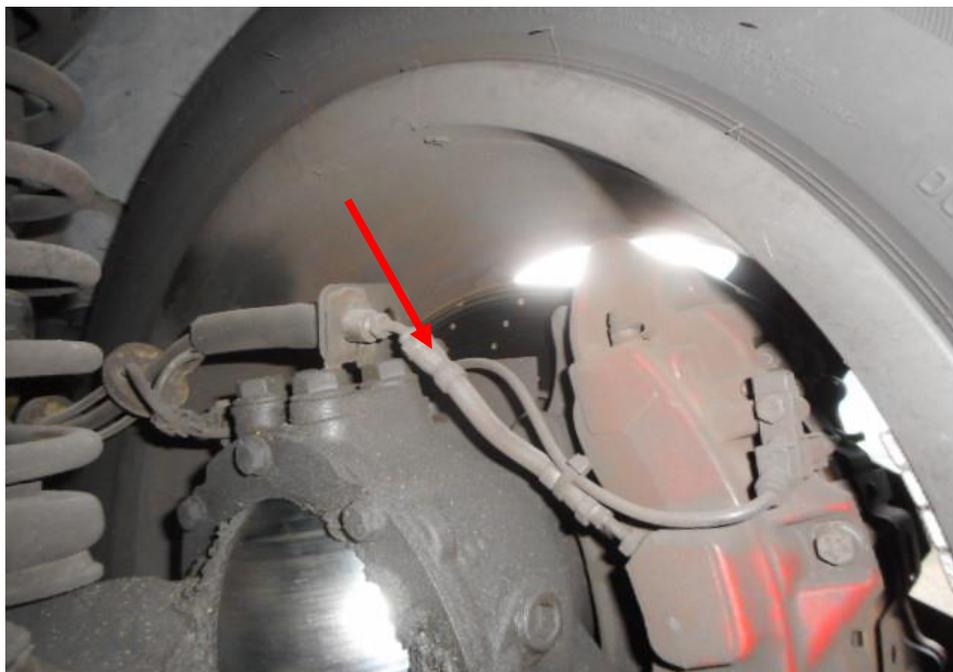
**Photo 35** shows the brake hose/pipe (arrowed) at the front right wheel of the Motor Car. I did not observe any leakage of brake fluid at the time of my inspection of the Motor Car. Static tests of the Motor Car's braking system had indicated that there was no internal leakage of pressure/vacuum.

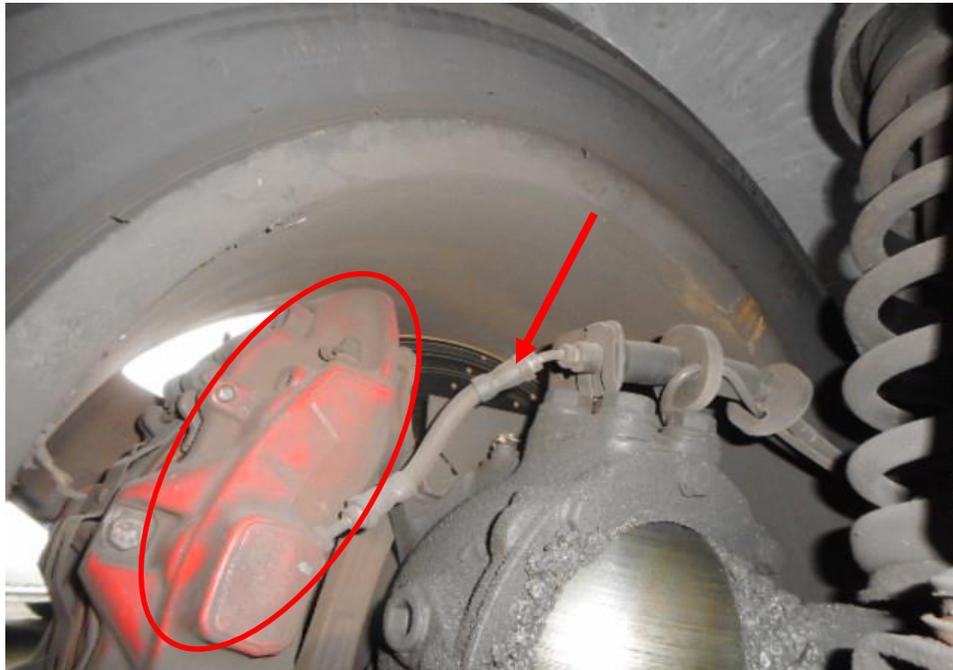
**Photo 36** shows the brake hose/pipe (arrowed) at the front left wheel of the Motor Car. No leakage of brake fluid was observed. Visual examination of the various components of the braking system like the brake caliper (circled), brake booster, brake pedal etc had revealed all to be intact and without visible damage.

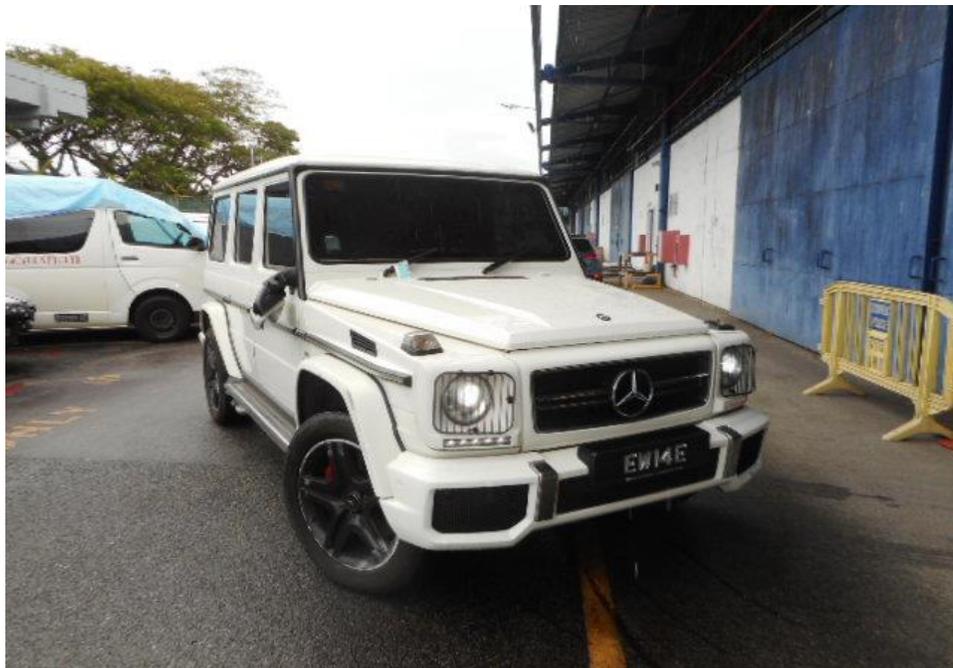
**Photo 37** shows the front right wheel of the Motor Car turned to its full left. During my steering system test, I did not experience any abnormal free play and/or resistance when I had turned the steering wheel towards the left and right. This would suggest that the steering system of the Motor Car was likely to be in serviceable condition at the material time of accident.

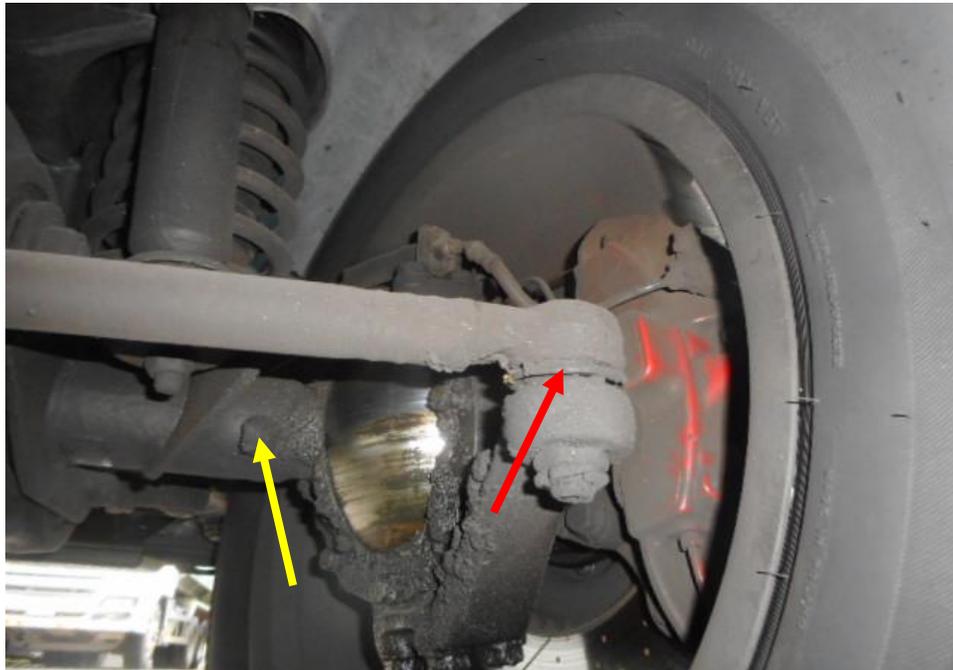
**Photo 38** shows the various undercarriage components at the front right wheel of the Motor Car, in particular the steering tie rod (red arrow) and in particular the drive shaft (yellow arrow). The various steering components were all found to be intact, suggesting that the steering system of the Motor Car was likely to be in serviceable condition at the material time of accident. There was also no sign of fluid stain observed on the various undercarriage components at the front right wheel of the Motor Car.

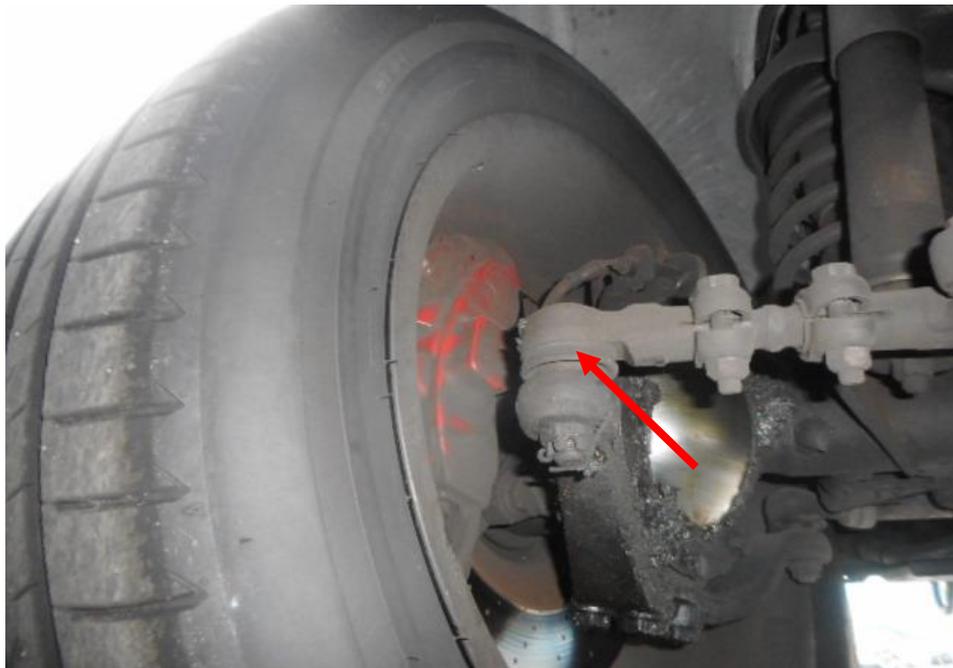
**Photo 39** shows the various undercarriage components at the front left wheel of the Motor Car, which had included the steering tie rod (arrowed). The various undercarriage components of the Motor Car were all found to be intact without any visible damage.

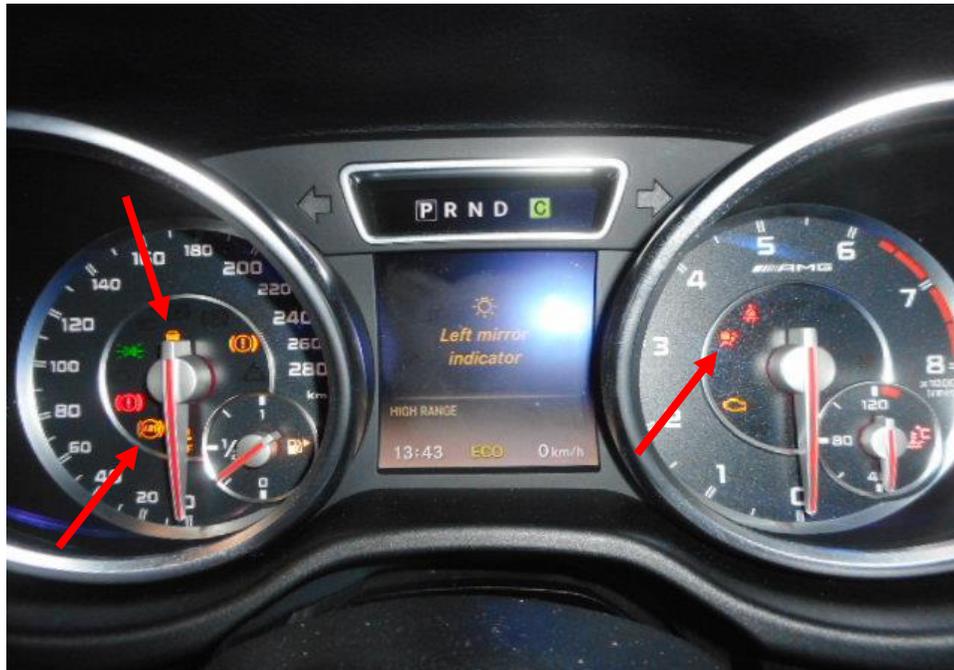
**Photo 40** shows the warning light for Anti-Lock Brake System (ABS), Traction Control System (TCS) and Supplemental Restraint System (SRS) (arrowed) appearing on the instrument panel of the Motor Car during the self-test of its various electronic operating systems when its engine was cranked.

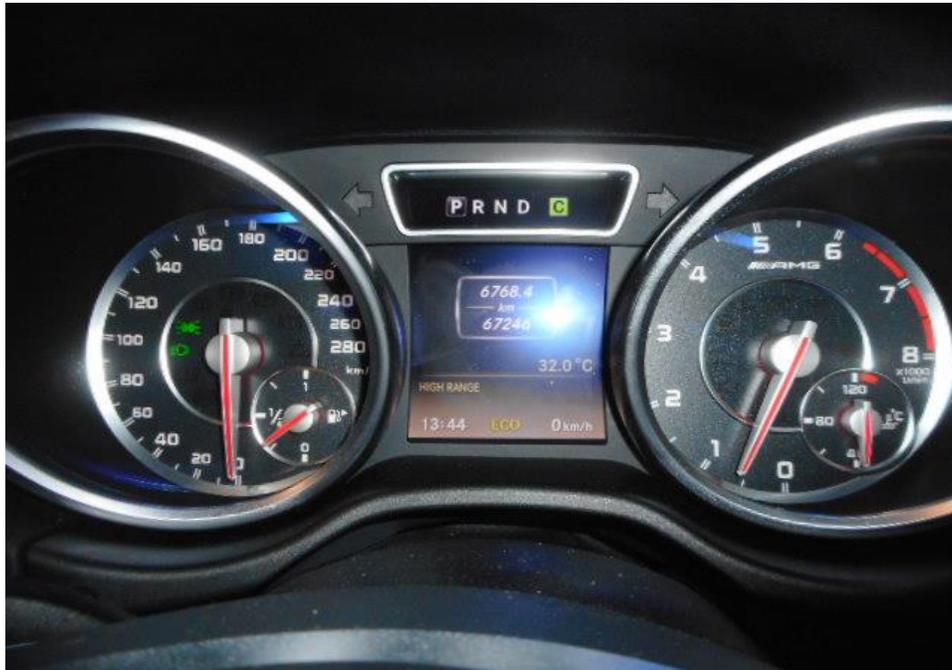
**Photo 41** shows no warning lights illuminated on the instrument panel of the Motor Car after the engine was cranked. This would suggest that there was no abnormality to the electronic operating system of the Motor Car, like the ABS, TCS and SRS etc.
