Your Ref: TP/IP/32680/2022
Our Ref : CI/TPD22013023/P

Fatal Accident Investigation Team

MECHANICAL INSPECTION REPORT OF MOTOR CAR SJK 1934Y

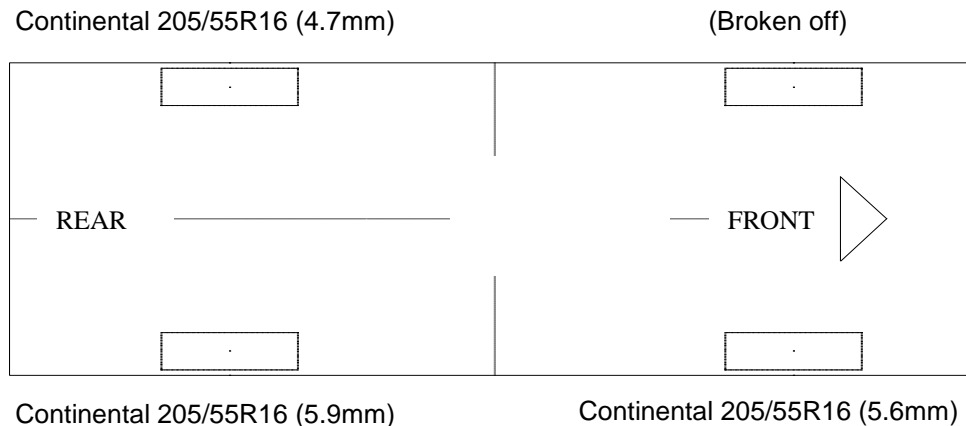
6. The Motor Car's front left wheel rim was observed to be broken off and the front left tyre was observed to be missing as a result of the accident. However, the front right, both rear left and right tyres and wheel rims was observed to be in serviceable condition. I did not find any tear, cut or burst mark(s) on the outer and the inner sidewalls as well as across the tread of the 3 tyres. The front and rear left tyres were observed to be sufficiently inflated for vehicular operation. The tyre brand, tyre size and remaining tread depth of the 3 tyres were recorded as follows:-

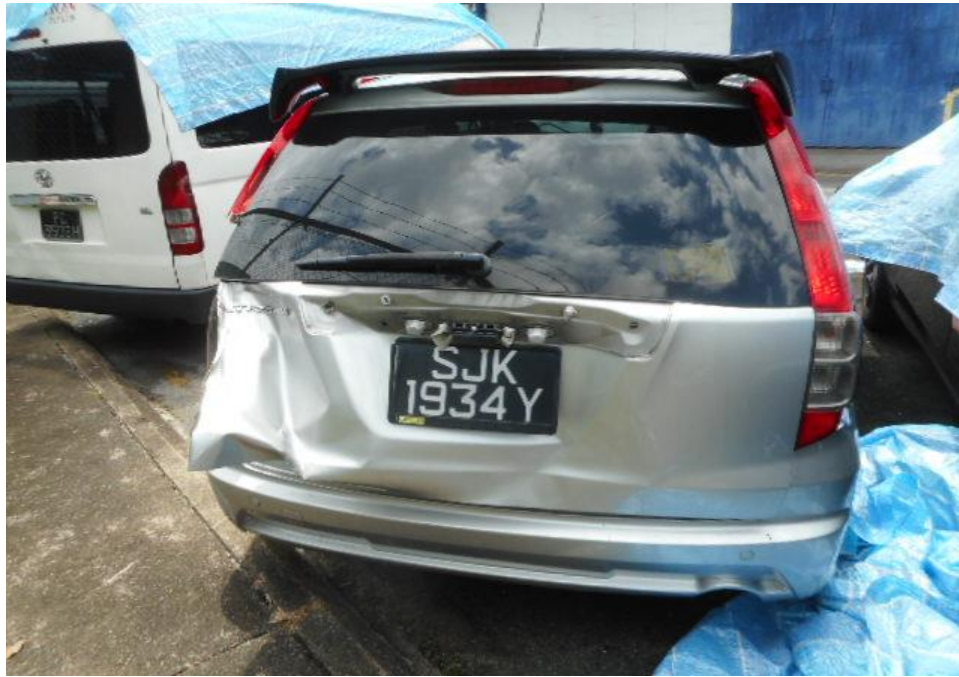
Photo 1 shows a general view of the Motor Car's rear body at the time of my inspection. The Motor car was observed to have sustained damage at its rear portion. Its rear boot and rear left brake lamp was the body parts that were damaged as a result of the accident.

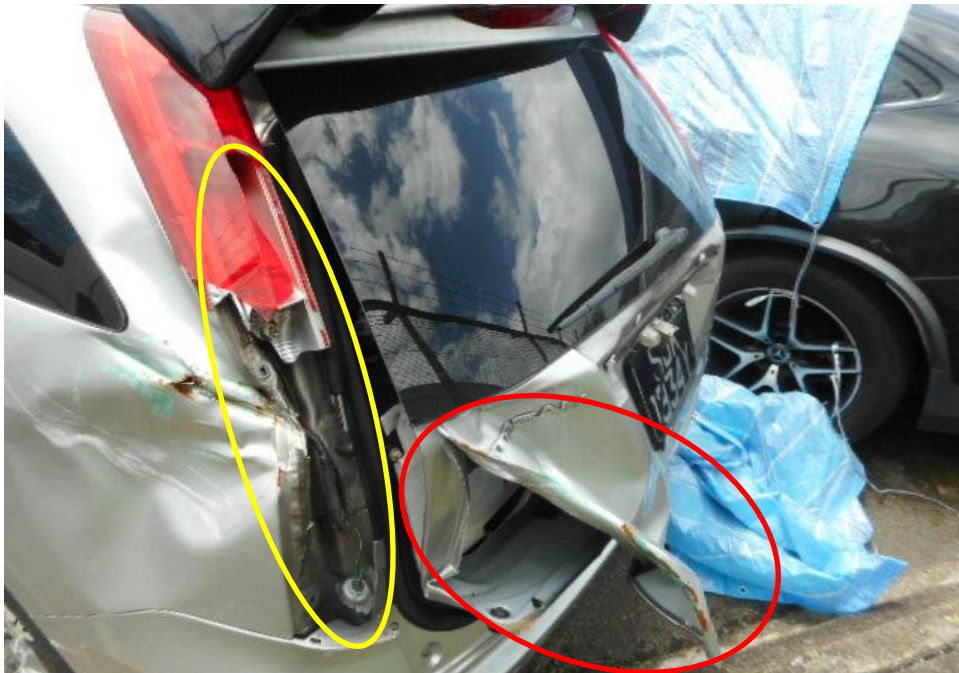
Photo 2 shows the close up view of the Motor Car's rear body at the time of my inspection. The Motor car was observed to have sustained damage at its rear portion. Its rear boot (red circle) and its rear left brake lamp (yellow circle) was damaged as a result of the accident.

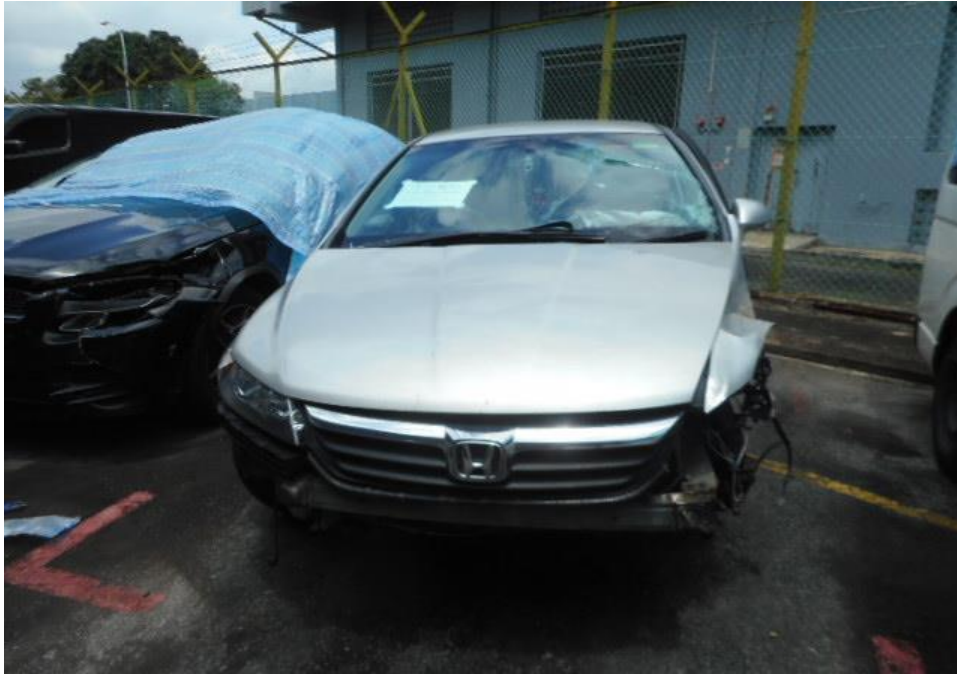
Photo 3 shows a general view of the Motor Car's front body at the time of my inspection. The Motor car was observed to have sustained damage at its front portion. Its front windscreen, front bumper, front left fender, front left headlamp was the body parts that were damaged as a result of the accident.

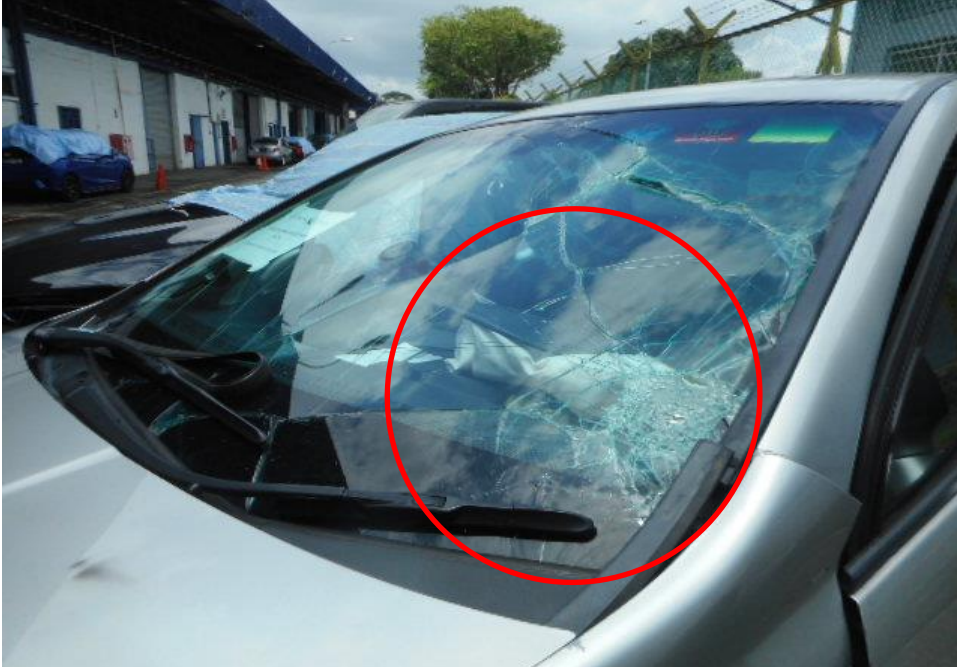
Photo 4 shows the close up view of the Motor Car's front body at the time of my inspection. The Motor car was observed to have sustained damage at its front portion. Its front windscreen (circled) was damaged as a result of the accident.

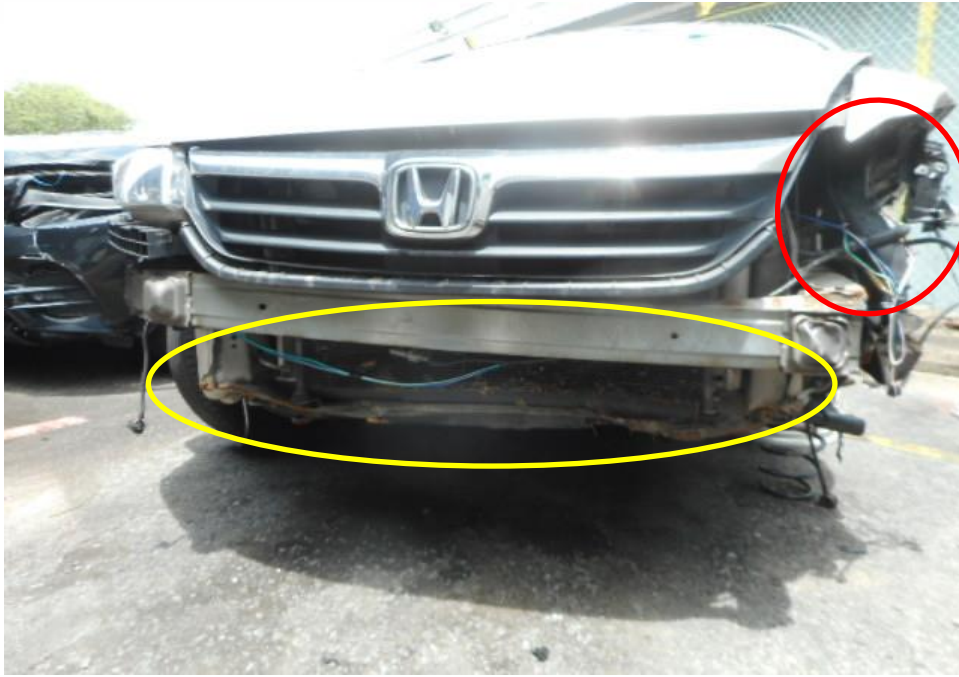
Photo 5 shows the close up view of the Motor Car's front body at the time of my inspection. The Motor car was observed to have sustained damage at its front portion. Its front bumper (yellow circle) and its front left headlamp (red circle) was damaged as a result of the accident.

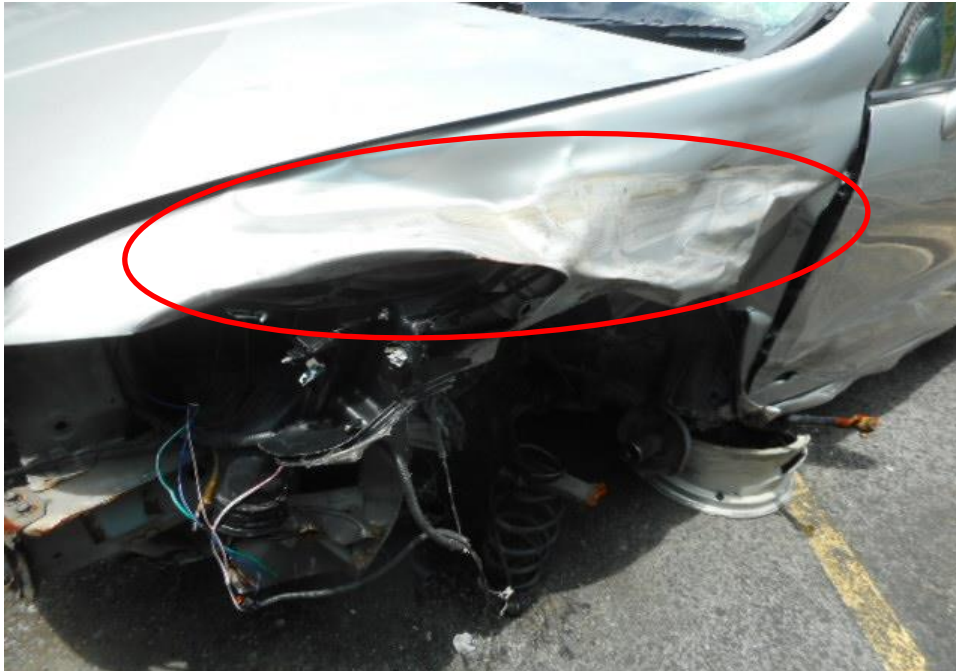
Photo 6 shows the close up view of the Motor Car's front body at the time of my inspection. The Motor car was observed to have sustained damage at its front portion. Its front left fender (red circle) was damaged as a result of the accident.

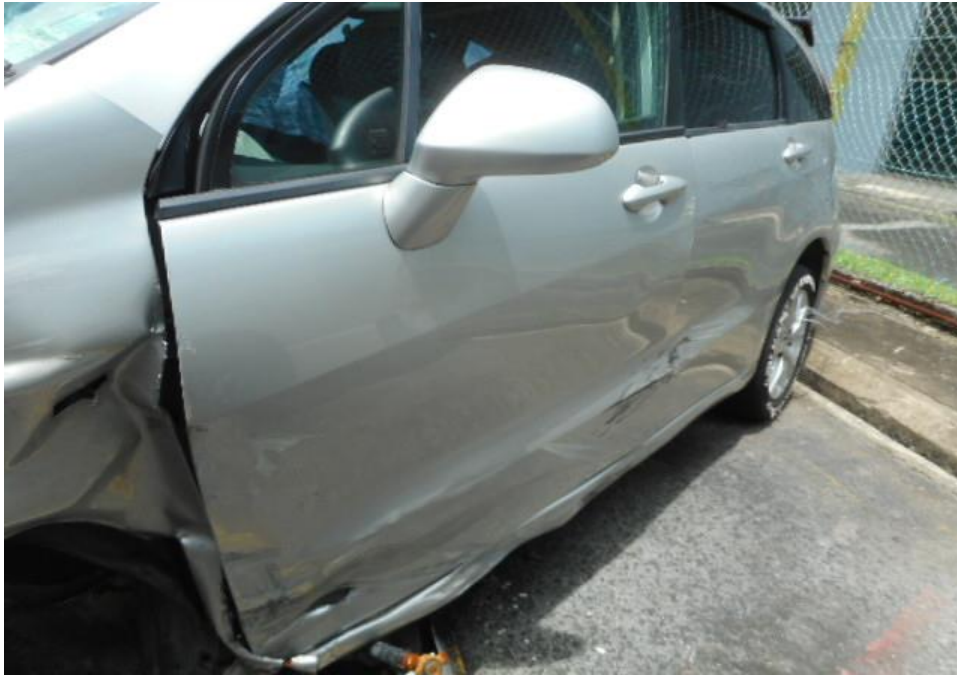
Photo 7 shows a general view of the Motor Car's left body at the time of my inspection. The Motor car was observed to have sustained damage at its left portion. Its left door and left body panel was damaged as a result of the accident.

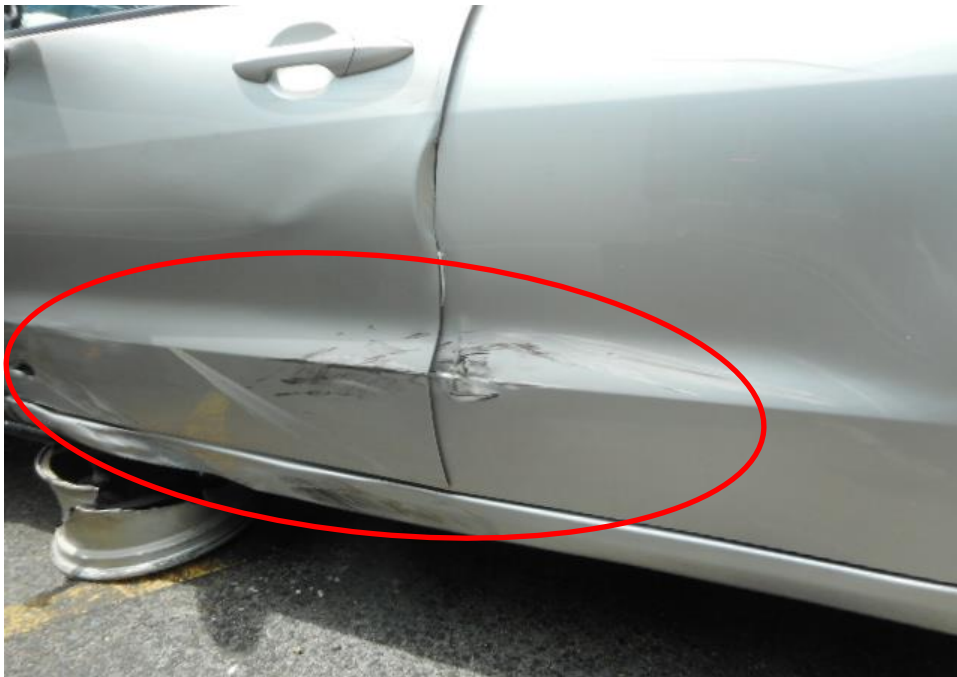
Photo 8 shows a close up view of the Motor Car's left body at the time of my inspection. The Motor car was observed to have sustained damage at its left portion. Its left door (circled) was damaged as a result of the accident.

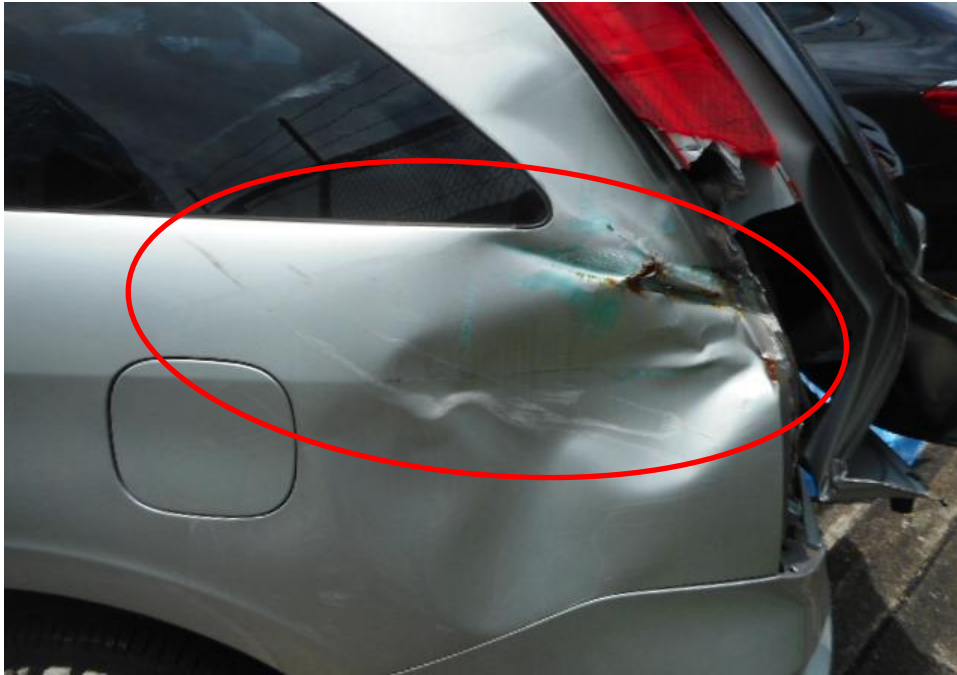
Photo 9 shows a close up view of the Motor Car's left body at the time of my inspection. The Motor car was observed to have sustained damage at its left portion. Its left body panel (circled) was damaged as a result of the accident.

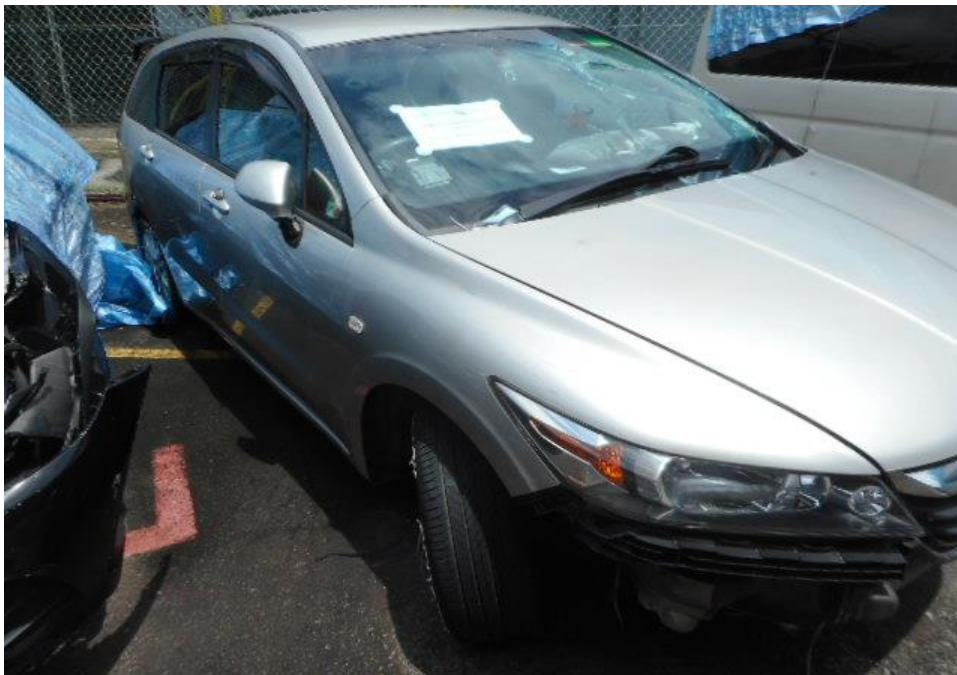
Photo 10 shows a general view of the Motor Car's right body at the time of my inspection. The right portion of the Motor Car was observed to have been undamaged by the accident.

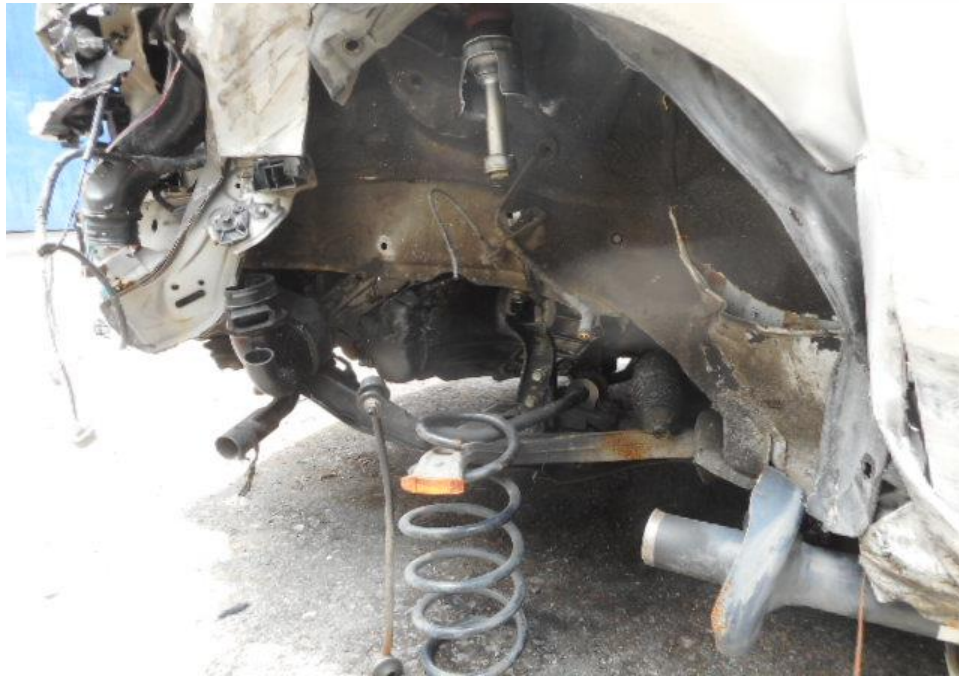
Photo 11 shows the location of where the front left tyre and wheel rim of the Motor Car should be, however observed that the wheel rim was broken off and tyre was missing as a result of the accident.

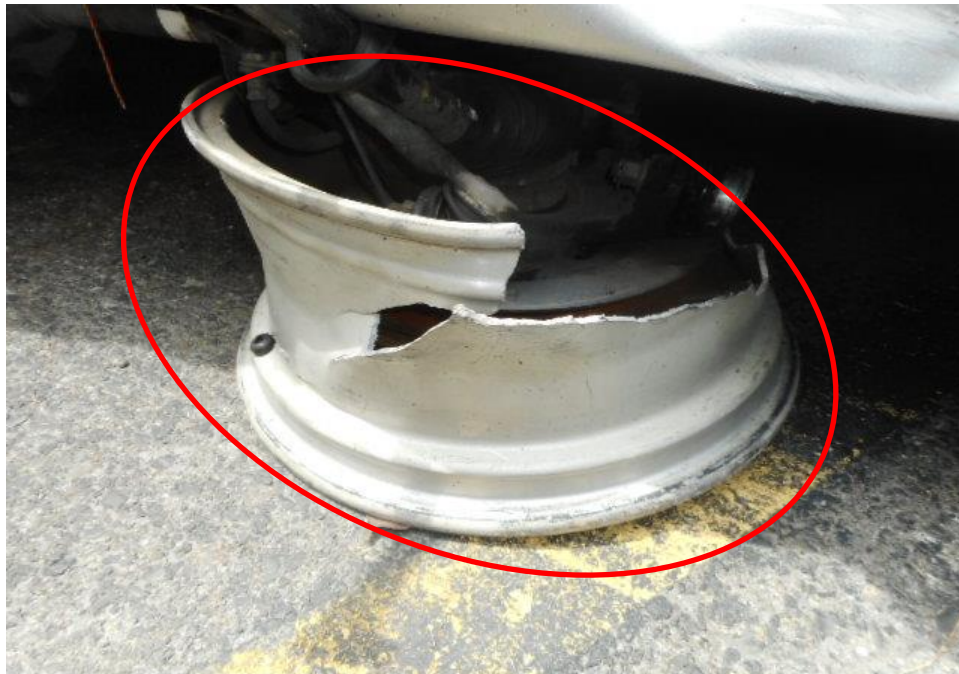
Photo 12 shows the front left wheel rim of the Motor Car observed that the wheel rim was broken off and damaged (circled) and the tyre was missing as a result of the accident.

18. The Motor Car's front left tyre was missing and wheel rim was observed to be broken off as a result of the accident. However, the front right and both rear tyres of the Motor Car were found to be in serviceable condition. The front right and both rear tyres were also observed to be sufficiently inflated for vehicular operation with remaining tread depth of approximately 4.7mm to 5.9mm.

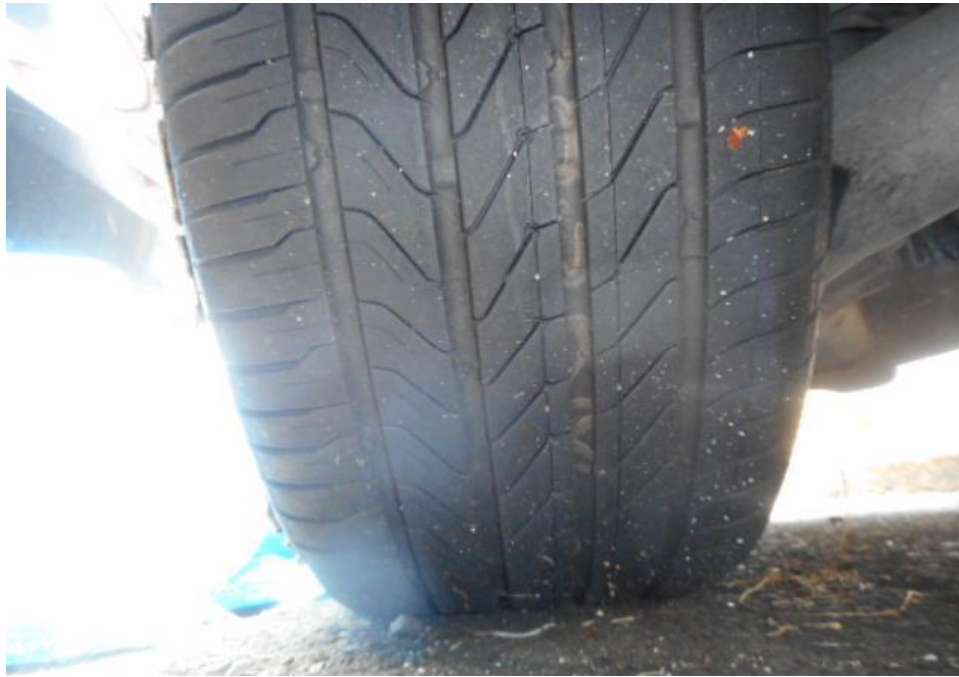
Photo 13 shows the general condition of the rear left tyre of the Motor Car, which was observed to be in serviceable condition with remaining tread depth of approximately 5.9mm. The tyre was also observed to be sufficiently inflated for vehicular operation with no tear, cut or burst mark(s).

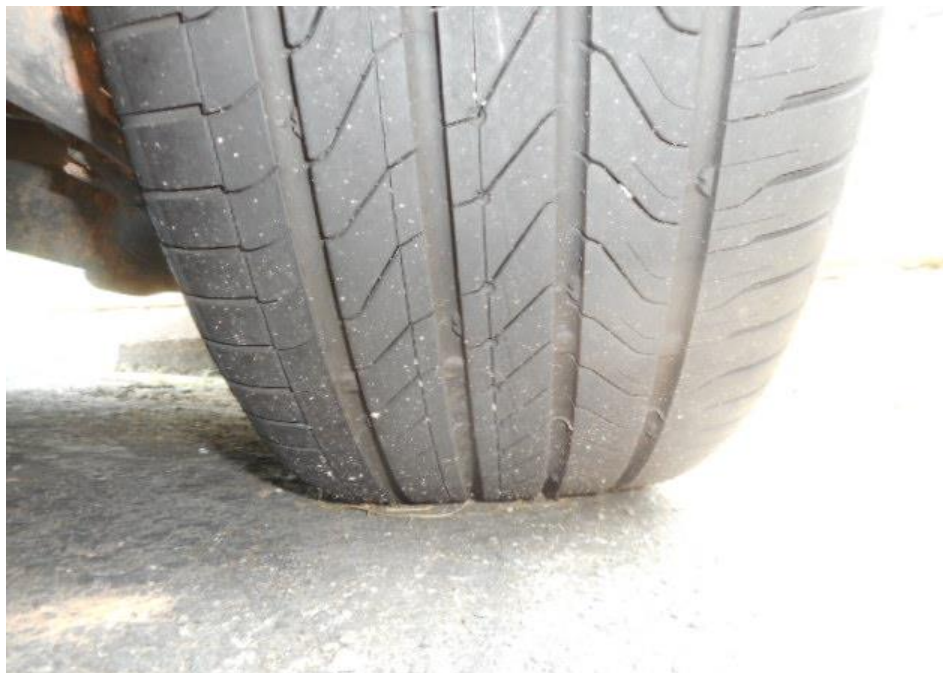
Photo 14 shows the condition of the rear right tyre of the Motor Car, which was observed to be in serviceable condition with remaining tread depth of approximately 4.7mm. The tyre was also observed to be sufficiently inflated for vehicular operation with no tear, cut or burst mark(s).

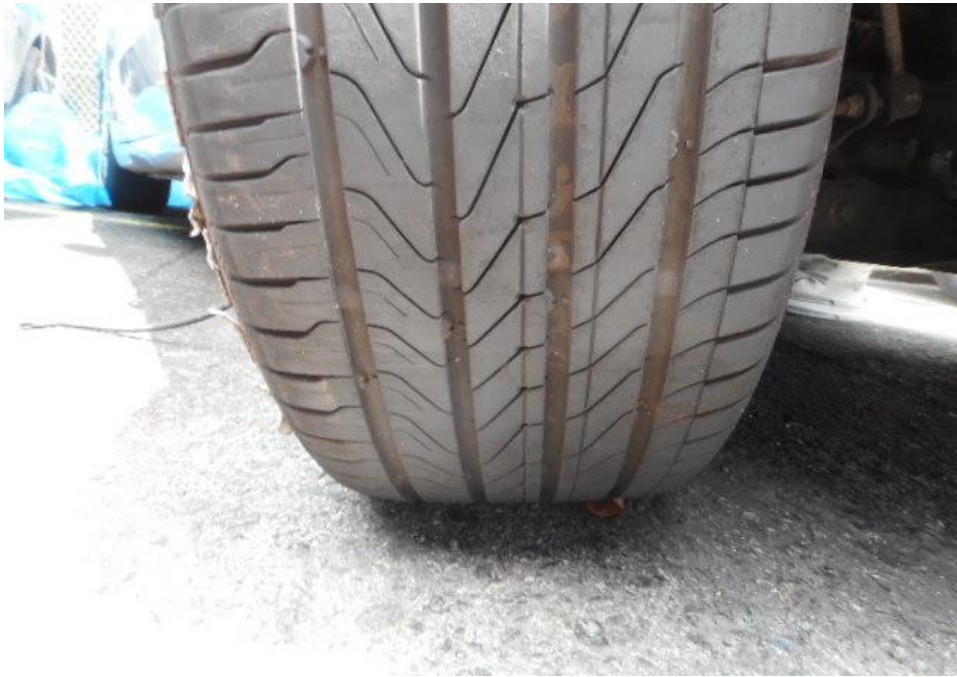
Photo 15 shows the condition of the front right tyre of the Motor Car, which was observed to be in serviceable condition with remaining tread depth of approximately 5.6mm. The tyre was also observed to be sufficiently inflated for vehicular operation with no tear, cut or burst mark(s).

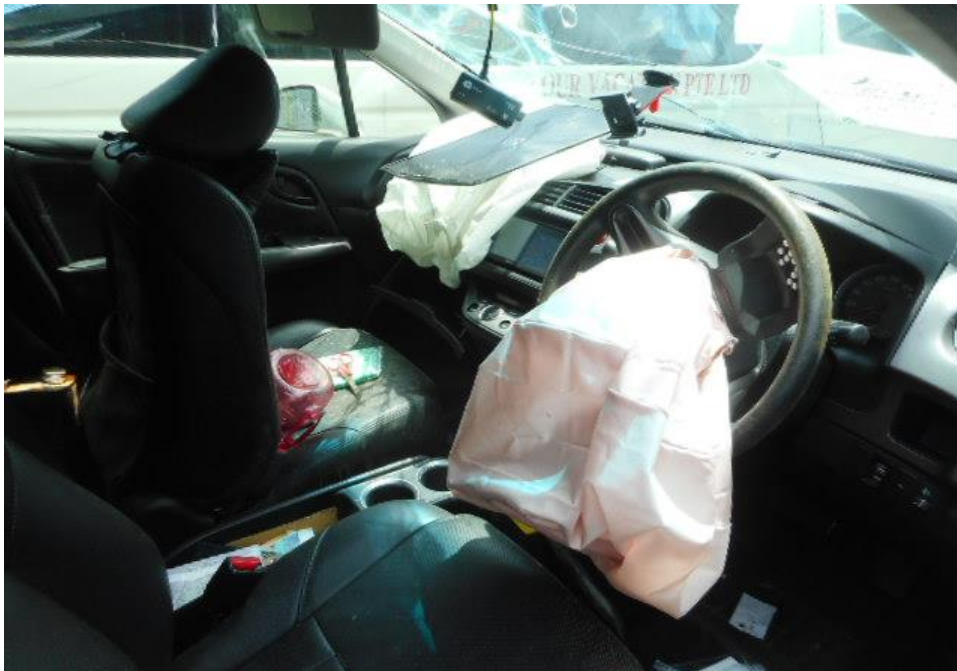
Photo 16 shows the deployment of the Supplemental Restraint System (SRS) airbag in the Motor Car as a result of the accident.

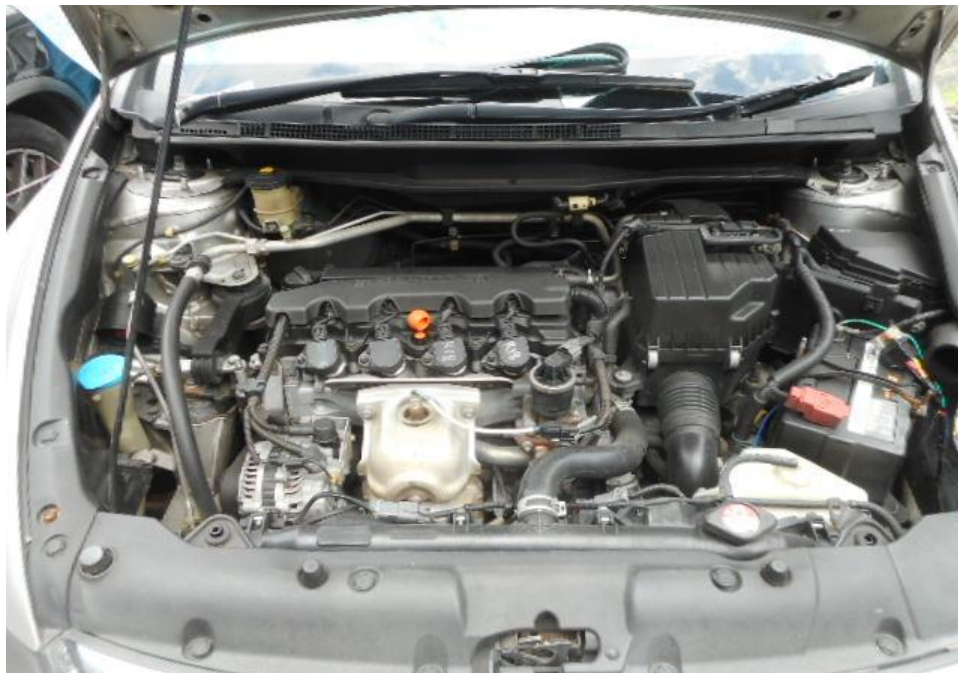
8. Upon examination of the engine compartment of the Motor Car, I had observed only brake fluid in the reservoir to be insufficient due to the missing brake caplier and broken brake hose at the front left wheel as a result of the accident. However, all the other parts and components inside the engine compartment was observed to be intact and unaffected by the accident. The engine coolant and engine oil were all found to be of sufficient level for operating purposes. Visually, there was also no contamination found to these fluids.

Photo 17 shows a general view of the Motor Car's engine compartment. Only the brake fluid in the reservoir was observed to be insufficient due to the missing brake caplier and broken brake hose at the front left wheel as a result of the accident. The other various parts and components inside the engine compartment were unaffected by the accident. There was also no sign(s) or indication(s) of fluid leakage and/or fluid stain within the engine compartment.

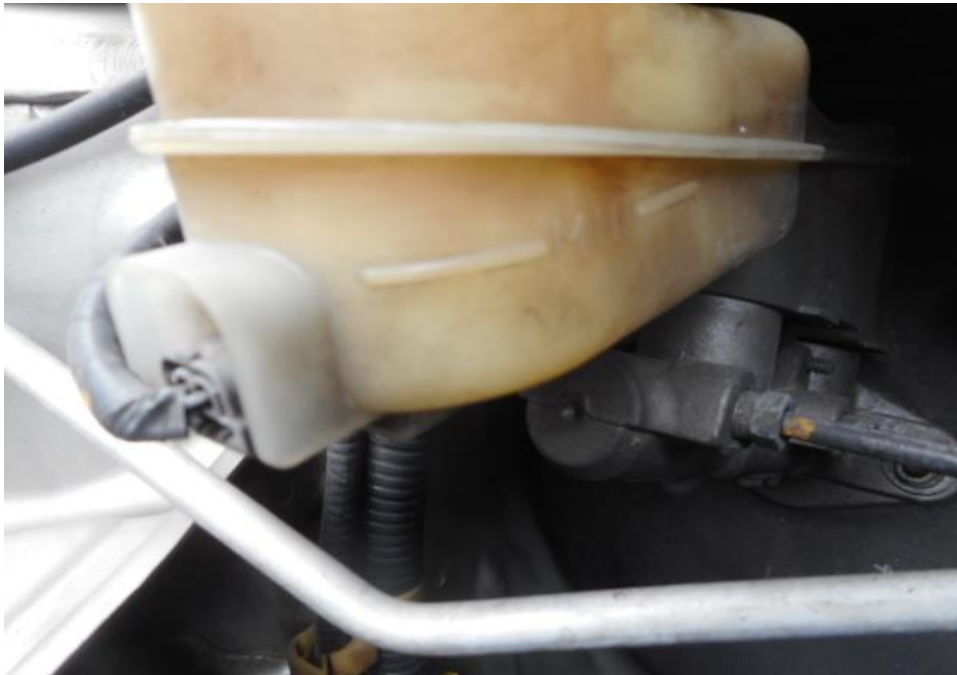
Photo 18 shows checks being carried out to the brake fluid reservoir of the Motor Car at the time of my inspection. The brake fluid was observed to be of insufficient due to the missing brake caplier and the broken brake hose at the front left wheel as a result of the accident.

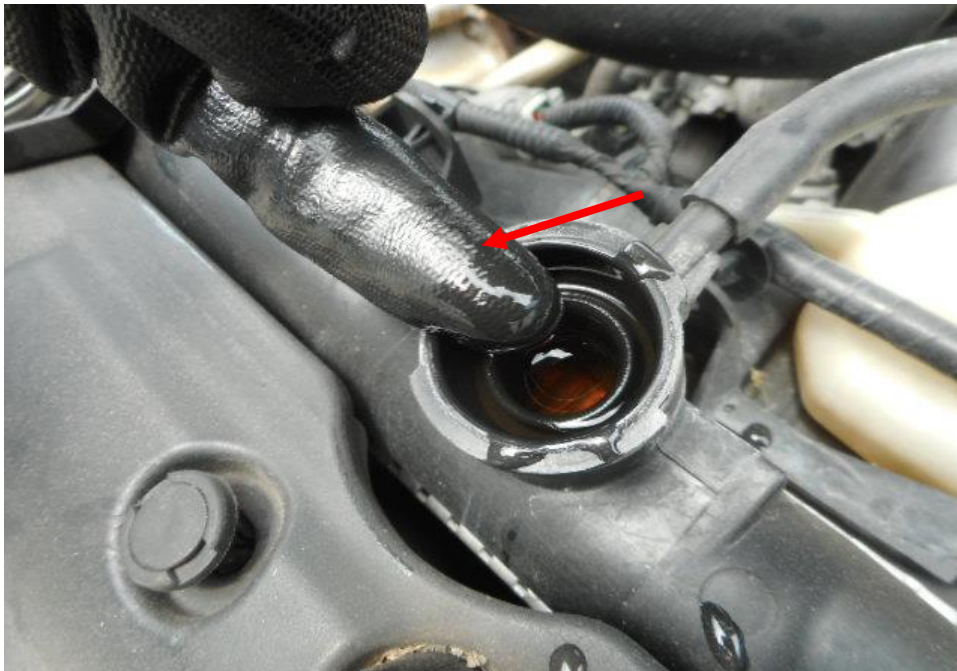
Photo 19 shows the engine coolant reservoir of the Motor Car at the time of my inspection. The coolant was observed to be of sufficient level (arrowed) and without any visible contamination.

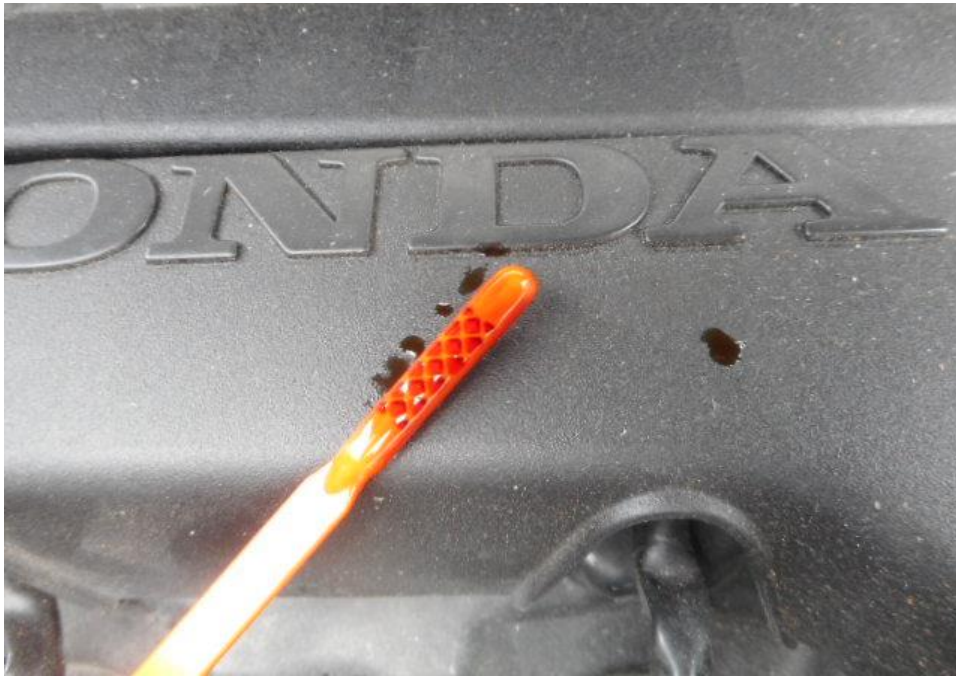
Photo 20 shows the engine oil level dipstick of the Motor Car at the time of my inspection. The engine oil was observed to be of sufficient level and without any visible contamination.

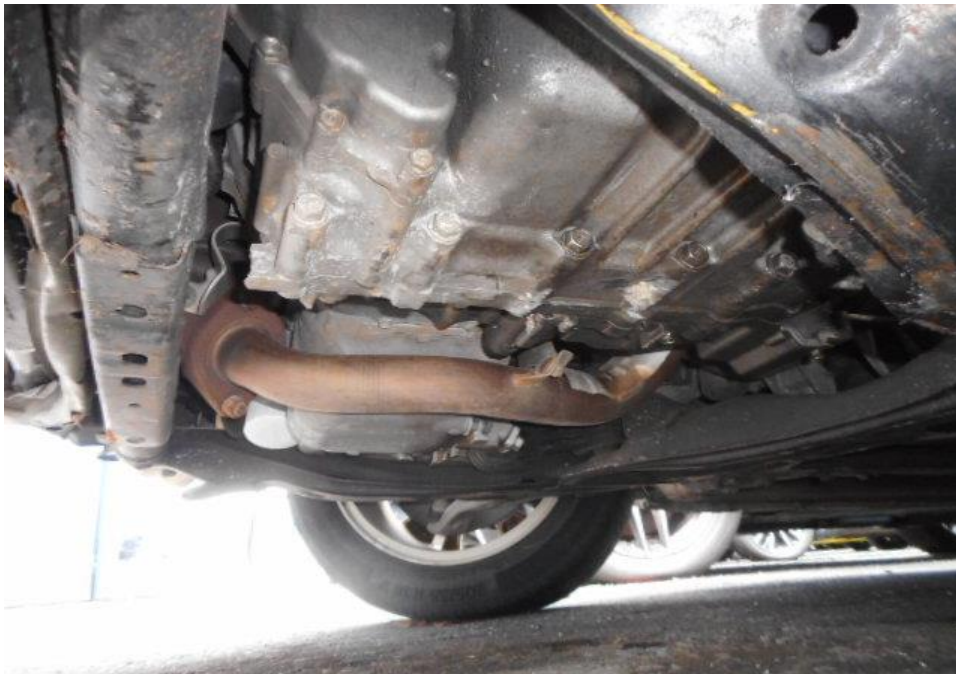
Photo 21 shows the undercarriage of the Motor Car, at the area where the engine housing and transmission housing are located. I did not find any sign(s) or indication(s) of fluid leak and/or fluid stain(s) on the underside of the Motor Car.

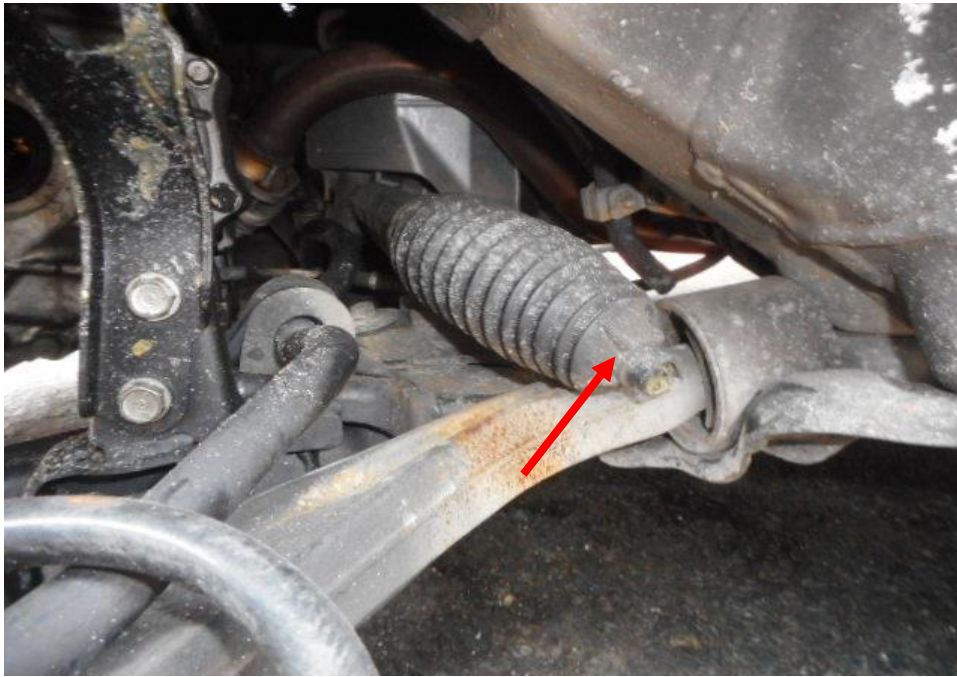
12. The visual examination of the various steering components had revealed that the front left steering tie rod and the front left driveshaft was missing of the front right wheel was damaged was a result of the accident. However, the other the other steering components of the other wheels were all generally intact.

Photo 22 shows the various undercarriage components at the front left wheel of the Motor Car, in particular the front left steering tie rod (arrowed) was observed to be missing as a result of the accident.

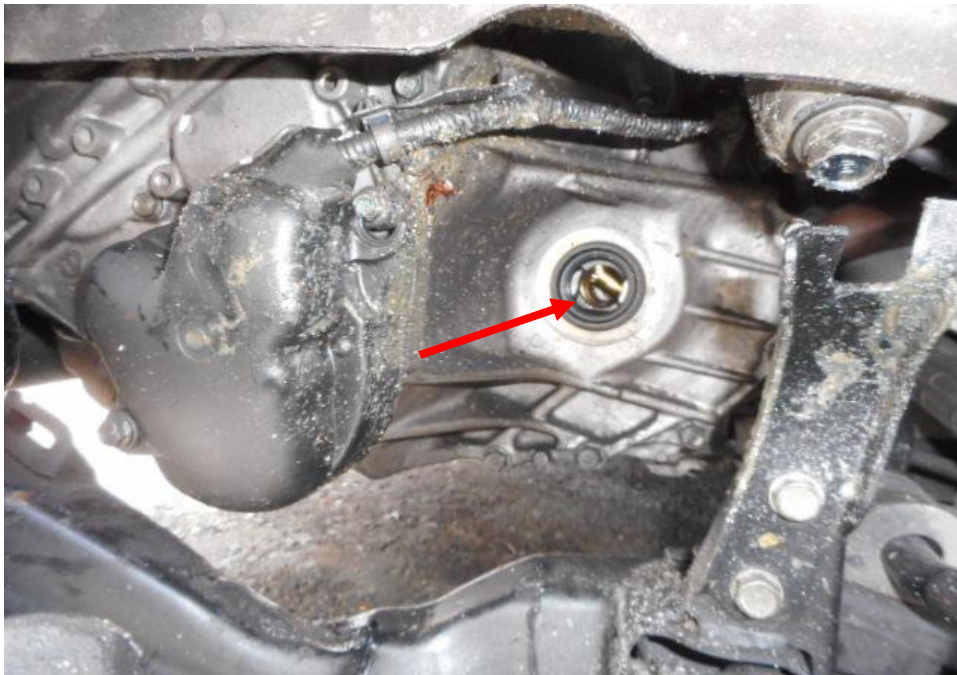
Photo 23 shows the various undercarriage components at the front left wheel of the Motor Car, in particular the front left driveshaft (arrowed) was observed to be missing as a result of the accident.

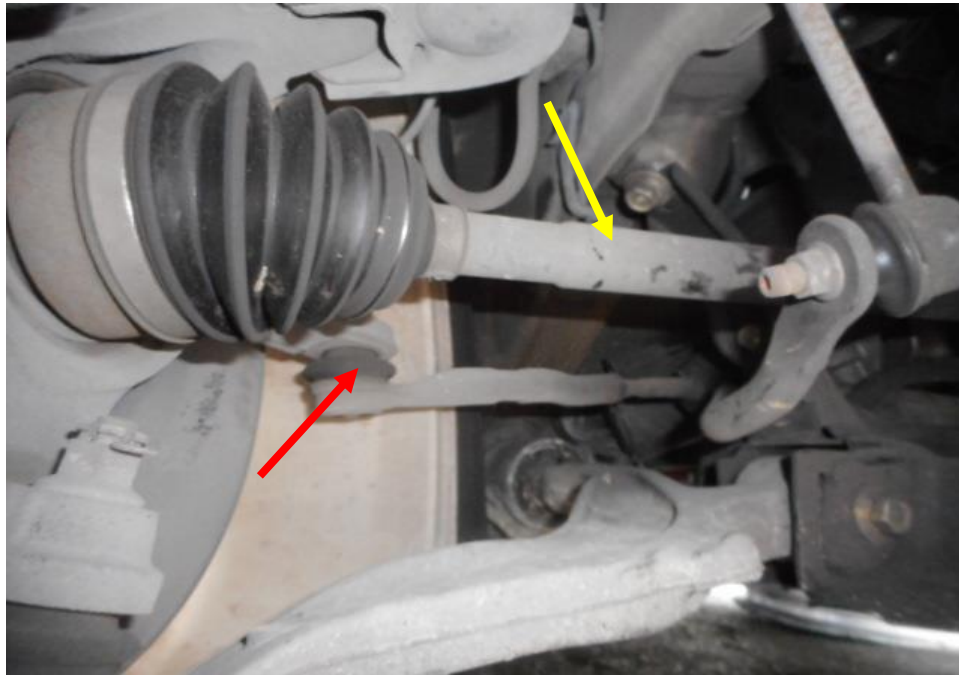
Photo 24 shows the various undercarriage components at the front left wheel of the Motor Car, in particular the steering tie rod (red arrow) and the driveshaft (yellow arrow) was observed to be intact.

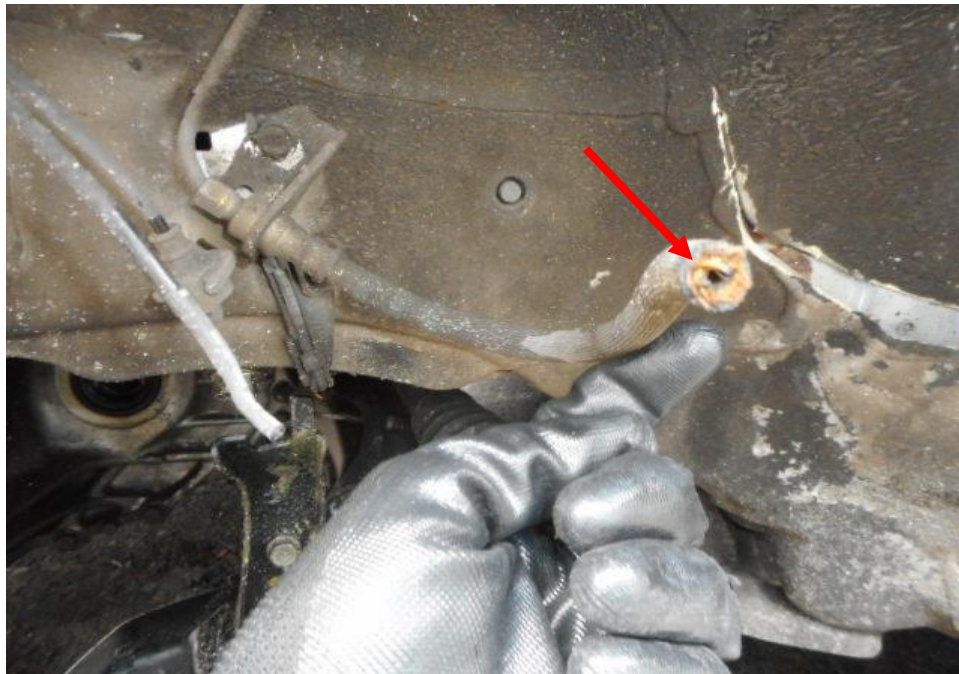
13. My visual examination of the various braking components had revealed that the front left brake caplier was missing and front left brake hose was damaged as a result of the accident. However, the other the other braking components of the other wheels were all generally intact. The brake fluid in the reservoir was of insufficient level, due to the missing brake caplier and broken brake hose which had caused a brake fluid leakage. See photo 22 - 28 below.

Photo 25 shows the brake hose/pipe (arrowed) at the front left wheel of the Motor Car. I did observed leakage of brake fluid from the broken brake hose due to the missing brake caplier which was caused by the result of the accident at the time of my inspection of the Motor Car.

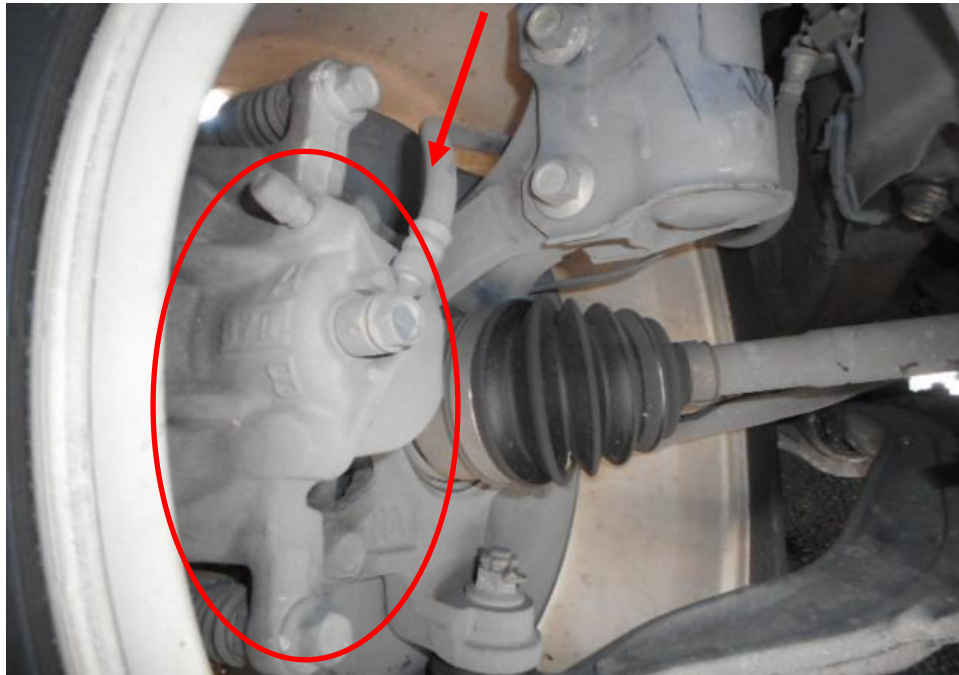
Photo 26 shows the brake hose/pipe (arrowed) at the front right wheel of the Motor Car. No leakage of brake fluid was observed. Visual examination of the various components of the braking system like the brake caliper (circled), brake booster, brake pedal etc had revealed all to be intact and without visible damage.

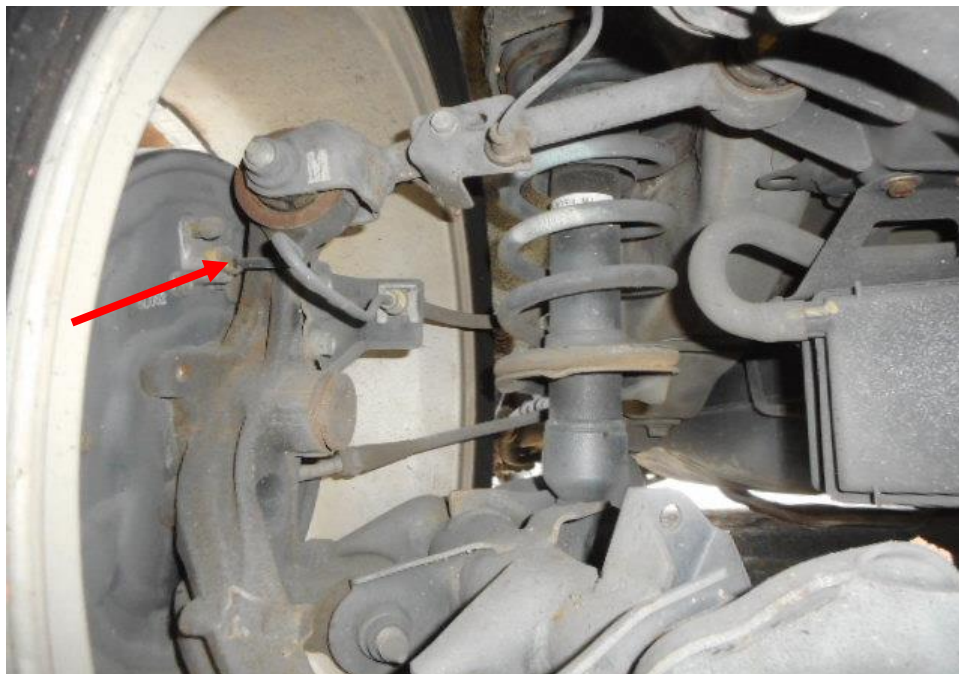
Photo 27 shows the brake hose/pipe (arrowed) at the rear left wheel of the Motor Car. No leakage of brake fluid was observed. Visual examination of the various components of the braking system like the drum brake, brake booster, brake pedal etc. had revealed all to be intact and without visible damage.

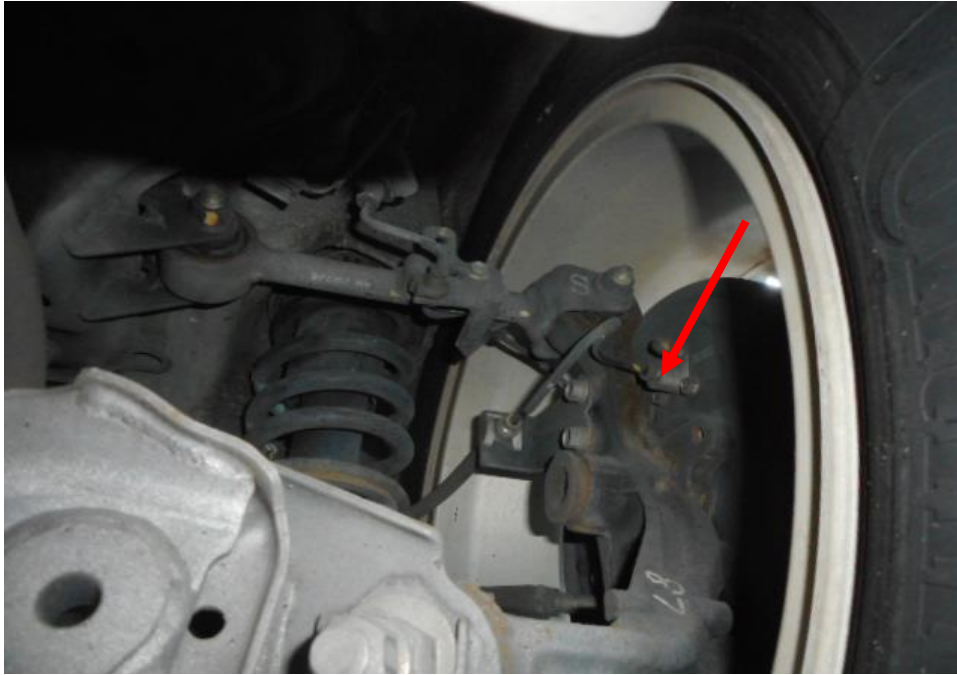
Photo 28 shows the brake hose/pipe (arrowed) at the rear right wheel of the Motor Car. No leakage of brake fluid was observed. Visual examination of the various components of the braking system like the drum brake, brake booster, brake pedal etc. had revealed all to be intact and without visible damage.

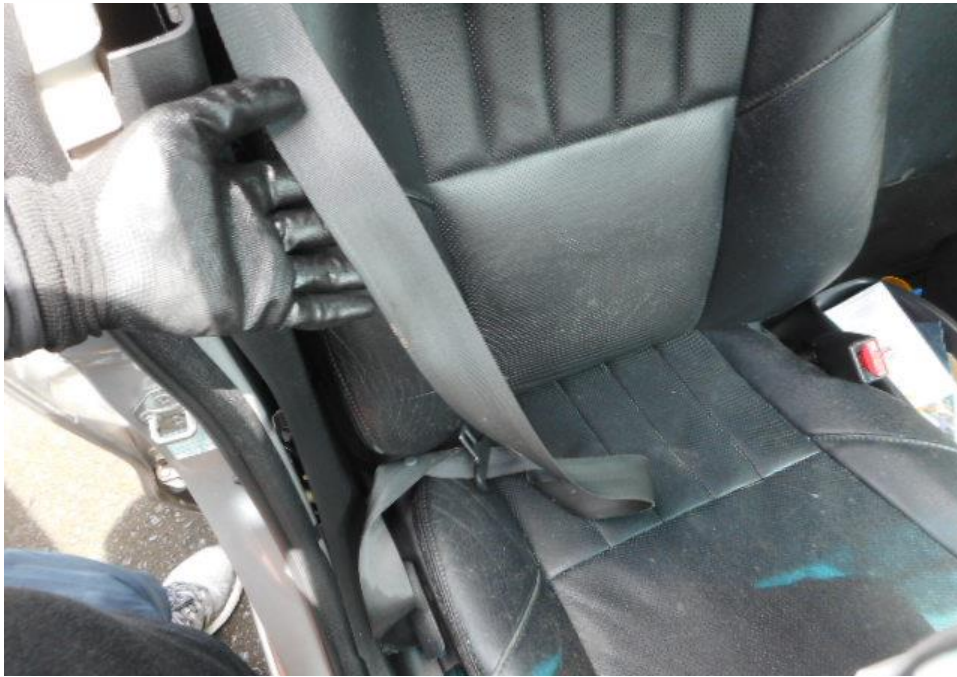
Photo 29 shows that the seat belt on the right seat was worn at the material time of accident as the safety pre-tensioners was activated at the moment of impact and caused the seat belt to be locked into the last position.

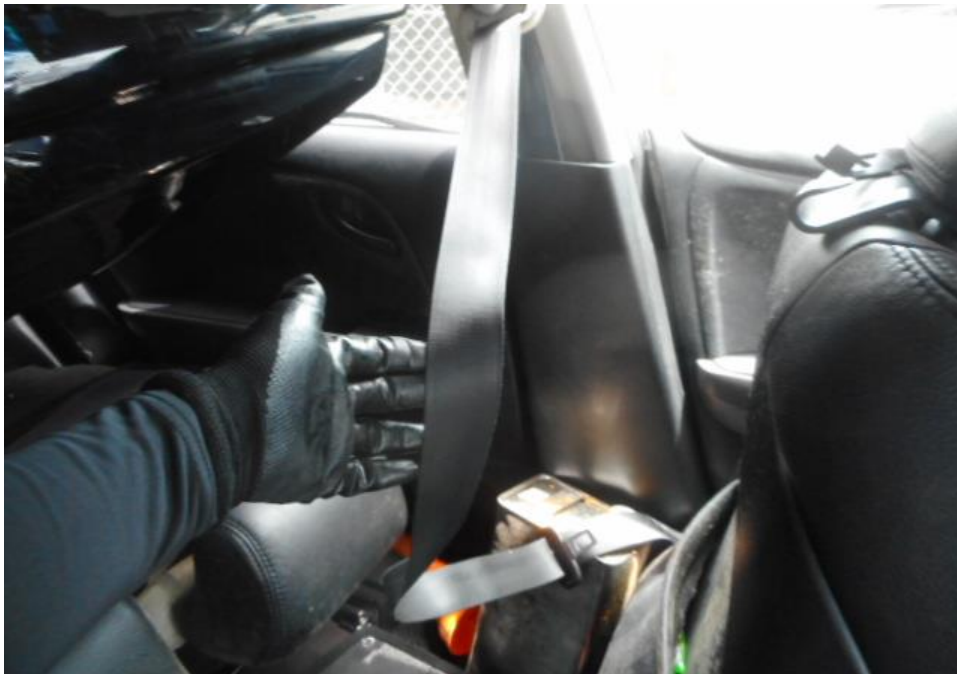
Photo 30 shows that the seat belt on the left seat was worn at the material time of accident as the safety pre-tensioners was activated at the moment of impact and caused the seat belt to be locked into the last position.
