Your Ref: BMW X6  
(chassis number WBSCY020809G93040)  
Our Ref : CI/TP22013027/D

30 December 2022

**GC International Import Pte Ltd**

**INSPECTION REPORT OF AN UNREGISTERED BMW X6 MOTOR CAR WITH  
CHASSIS NUMBER WBSCY020809G93040**

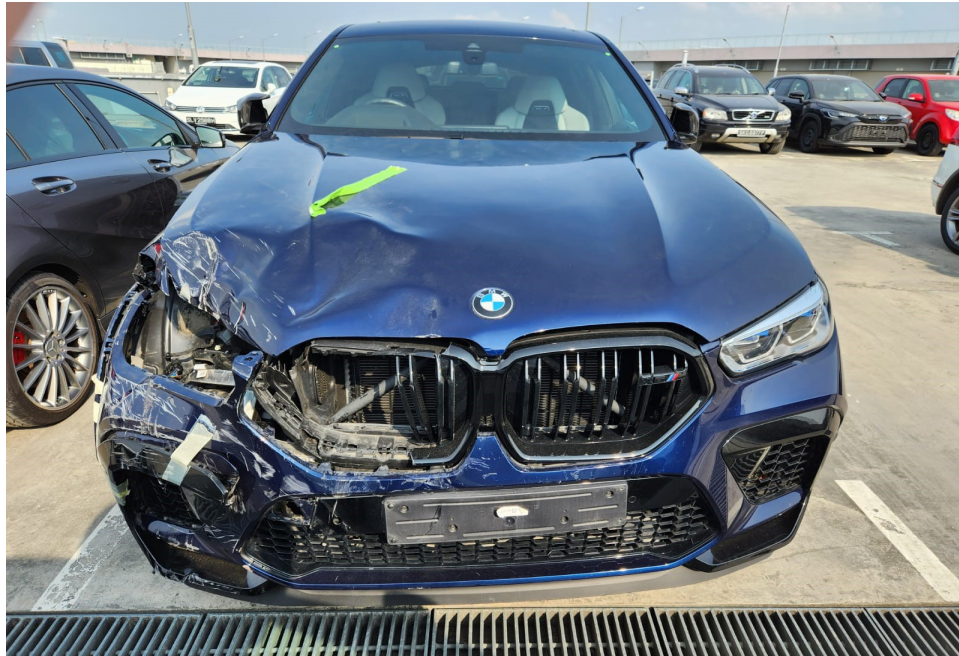
3. The photographs provided to me had showed damage to the front right portion of the Motor Car. Body parts damaged include the front bumper, front bumper lower lip, front bumper centre garnish, front bumper centre lower grille, front bumper right lower garnish, front bumper right lower grille, front bumper right reflector, front bumper right sensors, front number plate garnish, front right headlamp, front right fender, front right fender wheel arc garnish, radiator grilles and front bonnet amongst others.
4. Apart for the front right portion, there was no physical damage observed to other areas of the Motor Car. The airbag(s) of the Motor Car was not deployed as seen from the photographs that were provided to me. See photo 1 – 5 below.

**Photo 1** shows the frontal body of the Motor Car (photograph provided to me). The photographs provided to me had showed damage to the front right portion of the Motor Car. The front bumper, front bumper centre garnish, front bumper centre lower grille, front bumper right sensors, front number plate garnish, front right headlamp, radiator grilles and front bonnet were amongst the body parts that were observed to have been damaged.

22. The body parts at the front right portion of the Motor Car were visually examined and it was noted that the repair/restoration works carried out to the damaged area of the Motor Car (refer to photograph 1 & 2 above) were reasonably adequate and in order.

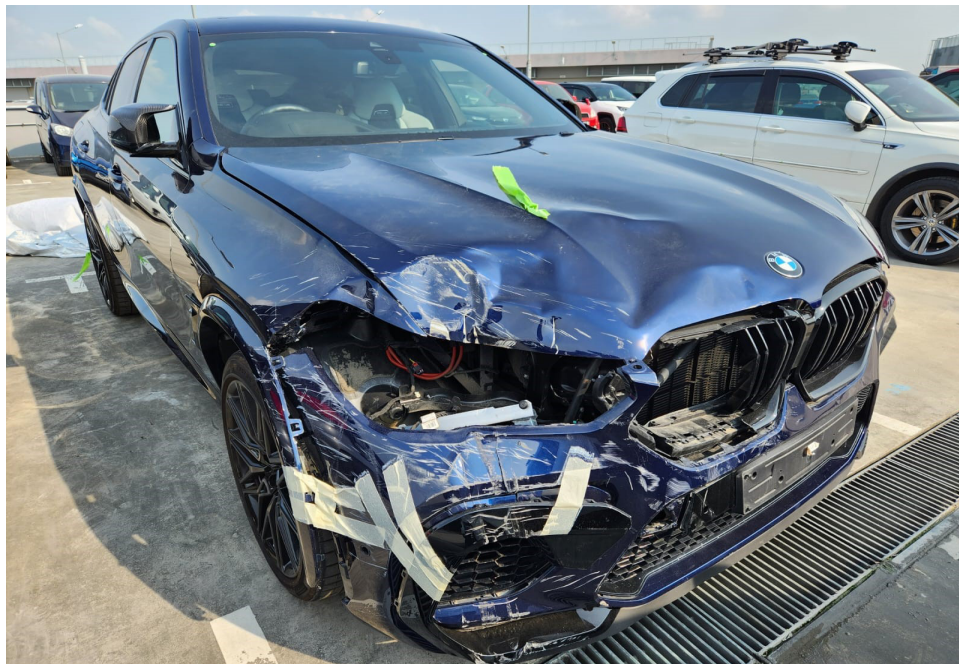
**Photo 2** shows the front right body of the Motor Car (photograph provided to me). The photographs provided to me had showed damage to the front right portion of the Motor Car. The front bumper, front bumper lower lip, front bumper right lower garnish, front bumper right lower grille, front bumper right reflector, front right headlamp, front right fender, front right fender wheel arc garnish and front bonnet were amongst the body parts that were observed to have been damaged.

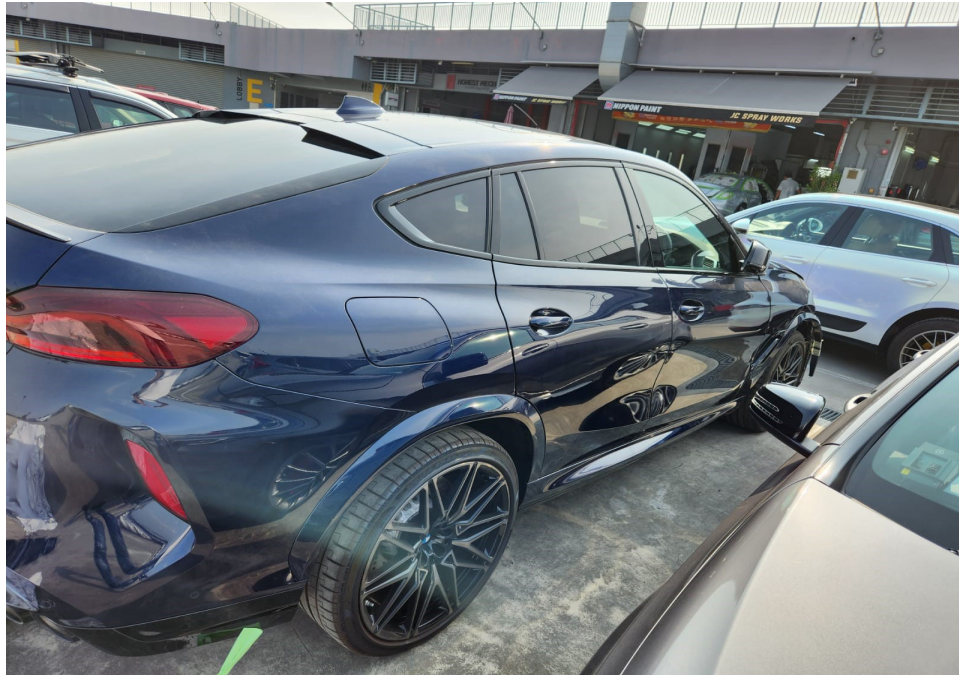
**Photo 3** shows the rear right body of the Motor Car (photograph provided to me). Apart for the front right portion, there was no physical damage observed to other areas of the Motor Car.

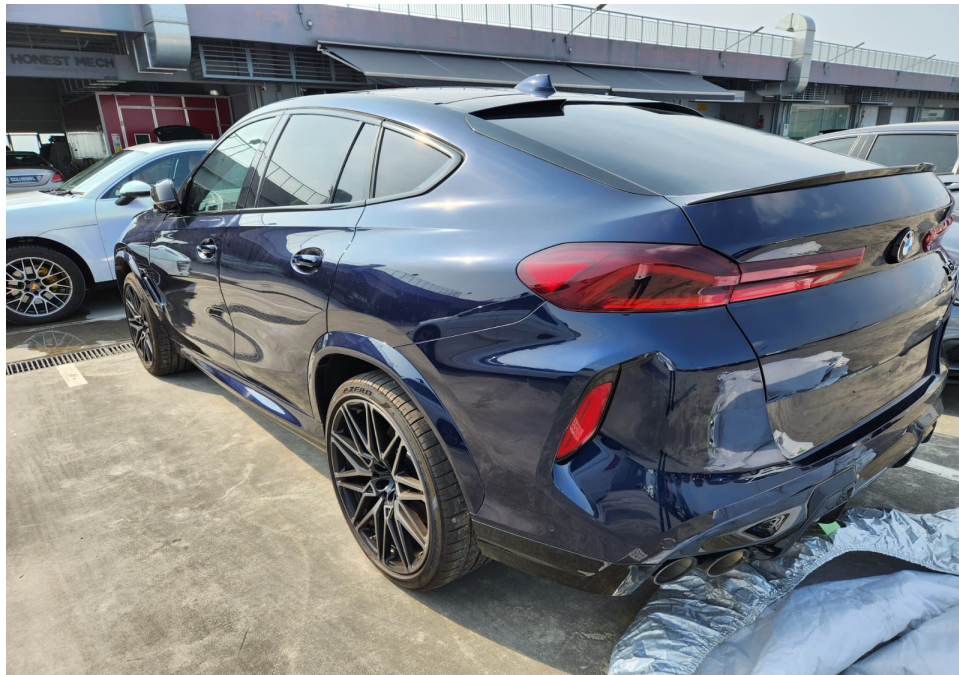
**Photo 4** shows the rear left body of the Motor Car (photograph provided to me). Apart for the front right portion, there was no physical damage observed to other areas of the Motor Car.

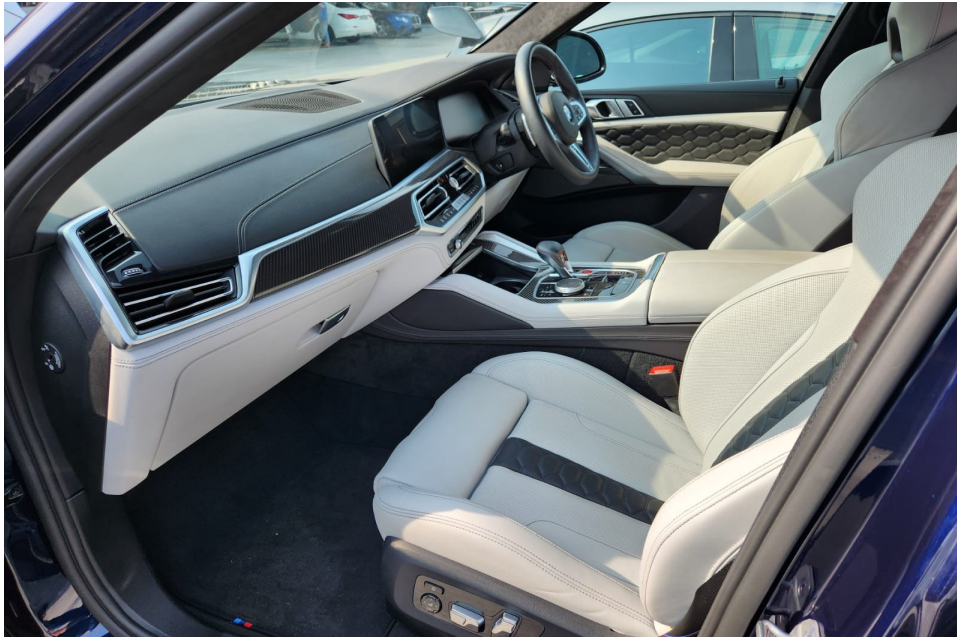
**Photo 5** shows the interior compartment of the Motor Car (photograph provided to me). The various parts and components within the interior compartment were all intact and unaffected. The airbag(s) was not deployed as seen from the photographs that were provided to me.

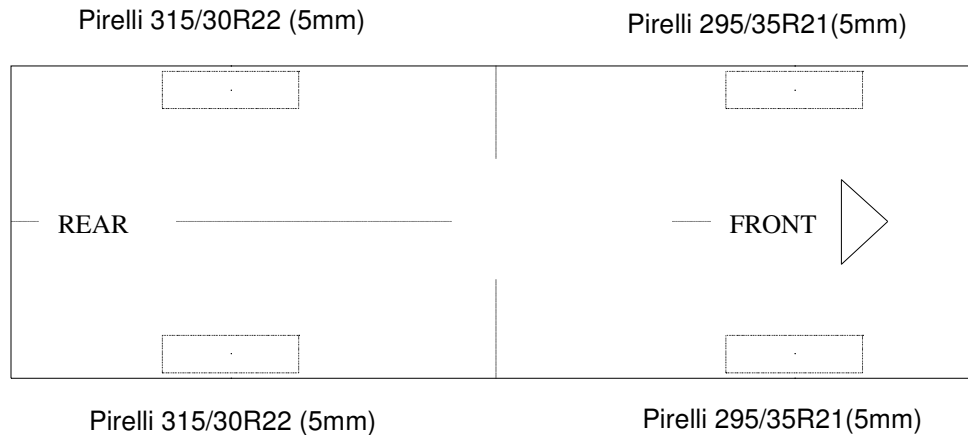
8. The Motor Car was fitted with 21inch (front) and 22inch (rear) sport wheel rims that were wrapped with tyres that were observed to be of serviceable condition. The tyres were also sufficiently inflated for vehicular operation. The tyre brand, tyre size and approximate remaining tread depth of the 4 tyres of the Motor Car were recorded as follows: -

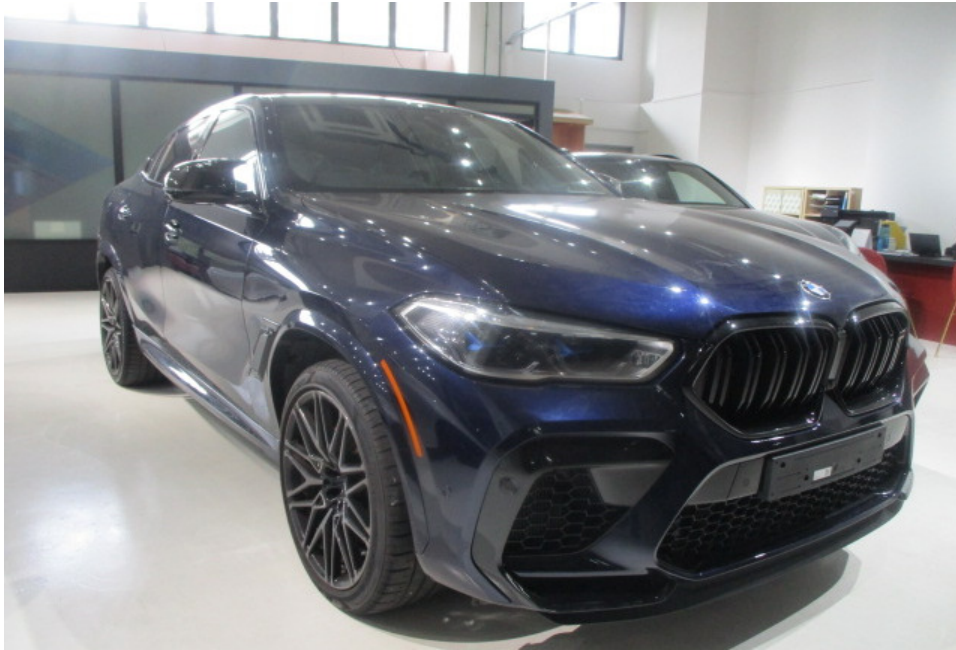
**Photo 6** shows a general view of the front right body of the Motor Car at the time of my inspection. The Motor Car was observed to be in a relatively good general condition with no loose exterior fittings observed. The body parts at the front right portion of the Motor Car were visually examined and it was observed that the repair/restoration works carried out to the damaged area of the Motor Car (refer to photograph 1 & 2 above) were reasonably adequate and in order.

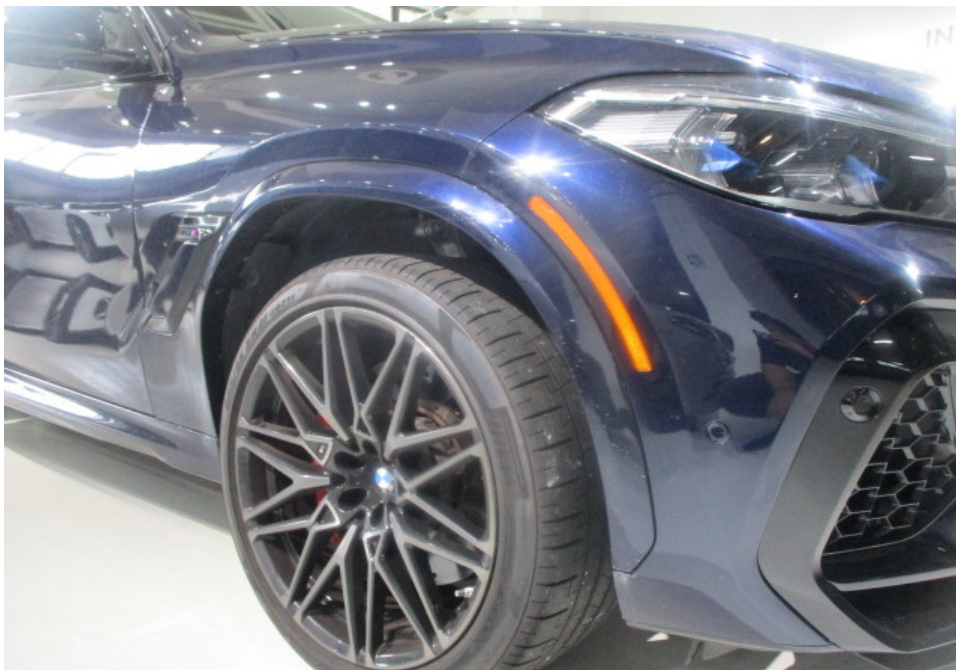
**Photo 7** shows a closer view of the Motor Car's front bumper, front bumper right reflector, front right fender, front right fender wheel arc garnish and front right wheel rim. The body parts at the front right portion of the Motor Car were visually examined and it was observed that the repair/restoration works carried out to the damaged area of the Motor Car (refer to photograph 1 & 2 above) were reasonably adequate and in order.

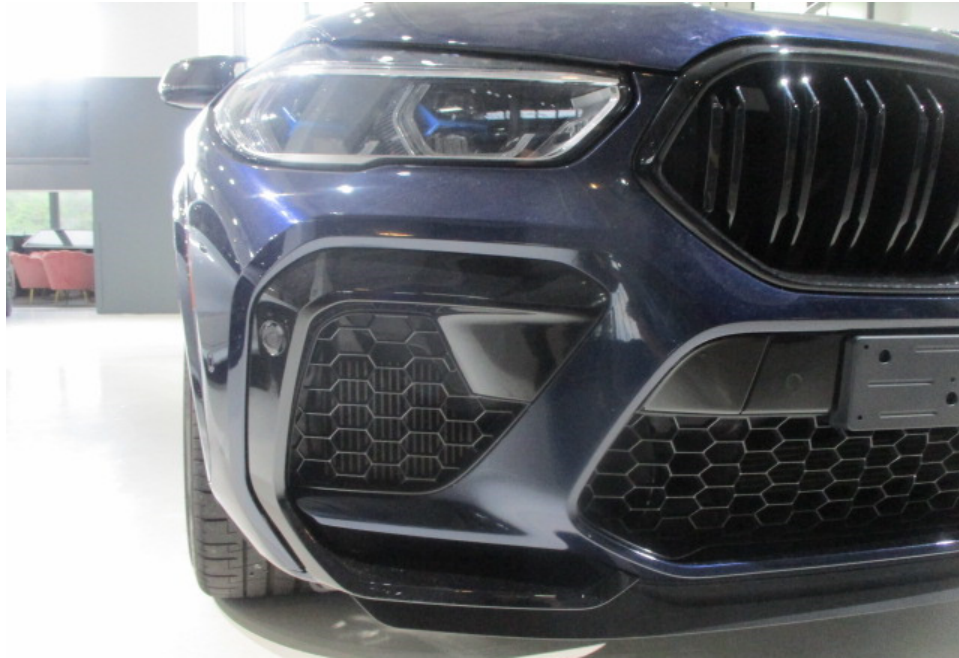
**Photo 8** shows a closer view of the Motor Car's front bumper, front bumper lower lip, front bumper right lower garnish, front bumper right lower grille and front right headlamp. The body parts at the front right portion of the Motor Car were visually examined and it was observed that the repair/restoration works carried out to the damaged area of the Motor Car (refer to photograph 1 & 2 above) were reasonably adequate and in order.

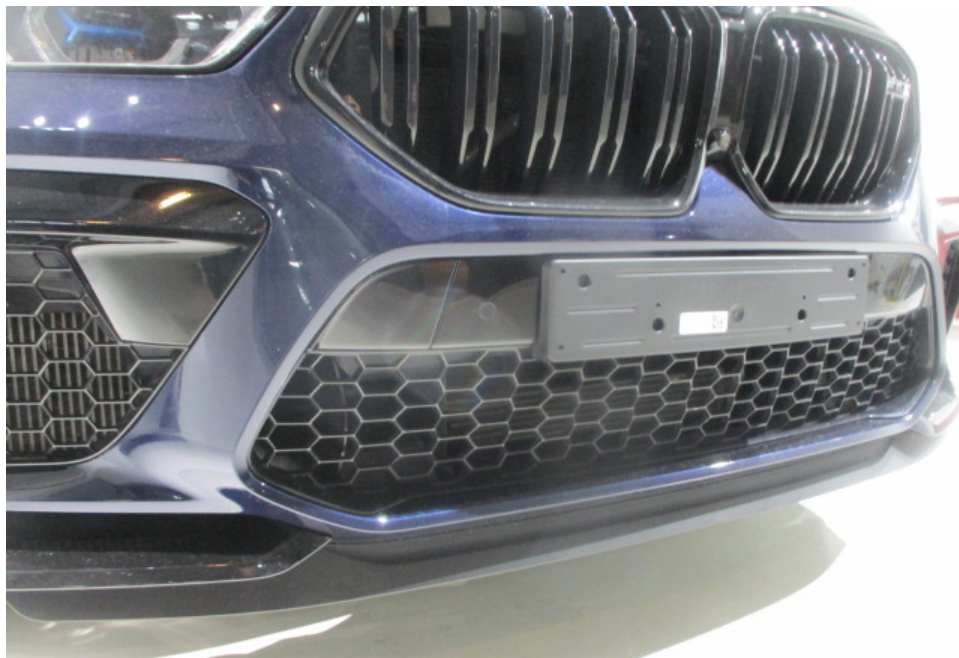
**Photo 9** shows a closer view of the Motor Car's front bumper centre garnish, front bumper centre lower grille, front bumper sensors, front number plate garnish and radiator grilles. The body parts at the front right portion of the Motor Car were visually examined and it was observed that the repair/restoration works carried out to the damaged area of the Motor Car (refer to photograph 1 & 2 above) were reasonably adequate and in order.

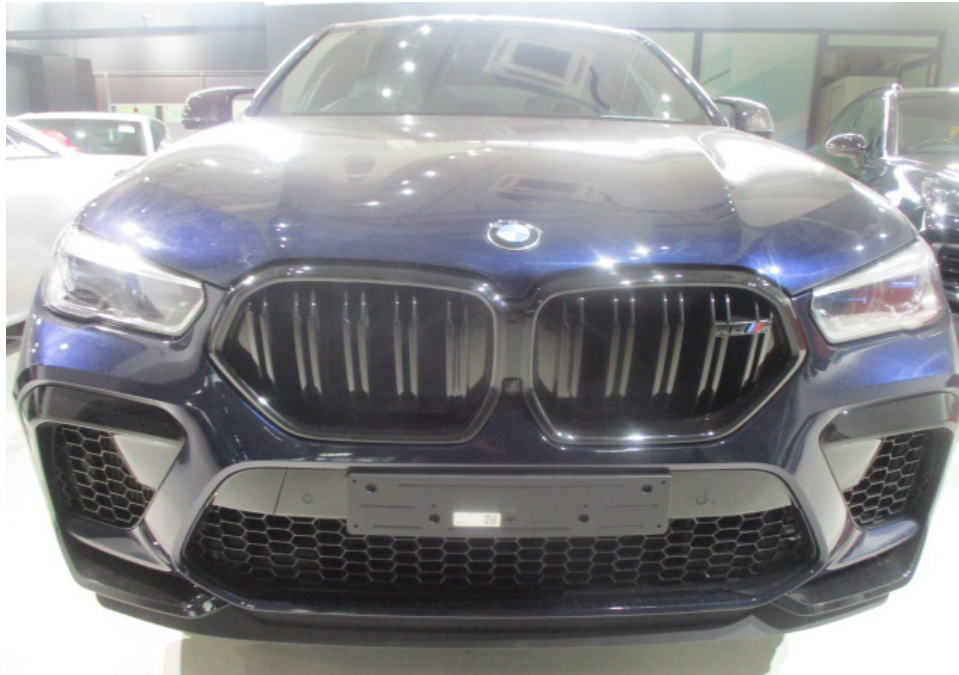
**Photo 10** shows a closer view of the Motor Car's frontal portion. The body parts at the front right portion of the Motor Car were visually examined and it was observed that the repair/restoration works carried out to the damaged area of the Motor Car (refer to photograph 1 & 2 above) were reasonably adequate and in order.

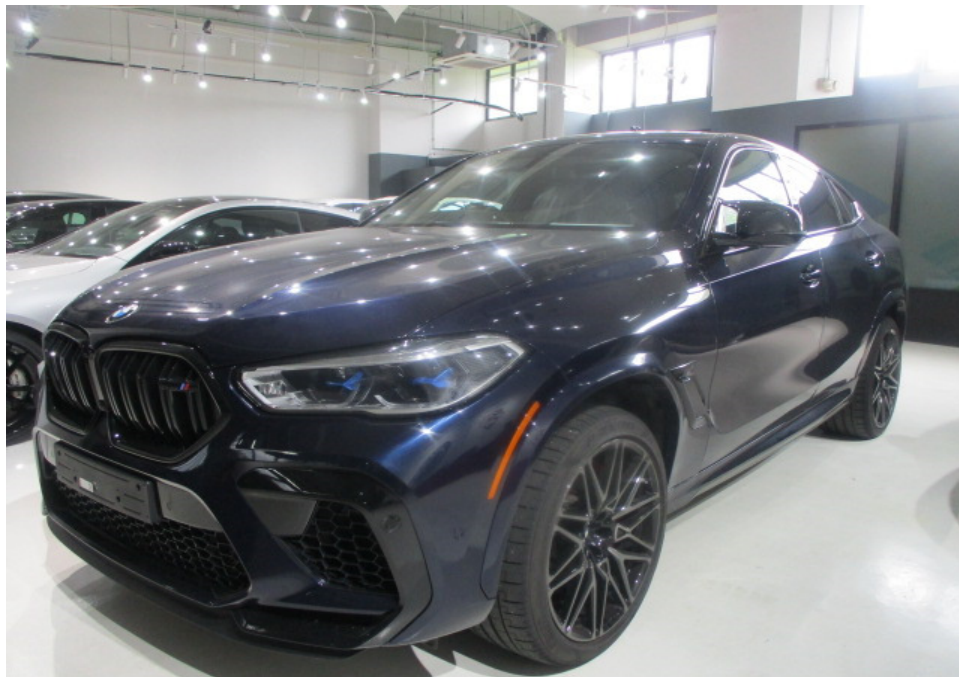
**Photo 11** shows a general view of the front left body of the Motor Car at the time of my inspection. The Motor Car was observed to be in a relatively good general condition with no loose exterior fittings observed. The body parts at the front right portion of the Motor Car were visually examined and it was observed that the repair/restoration works carried out to the damaged area of the Motor Car (refer to photograph 1 & 2 above) were reasonably adequate and in order.

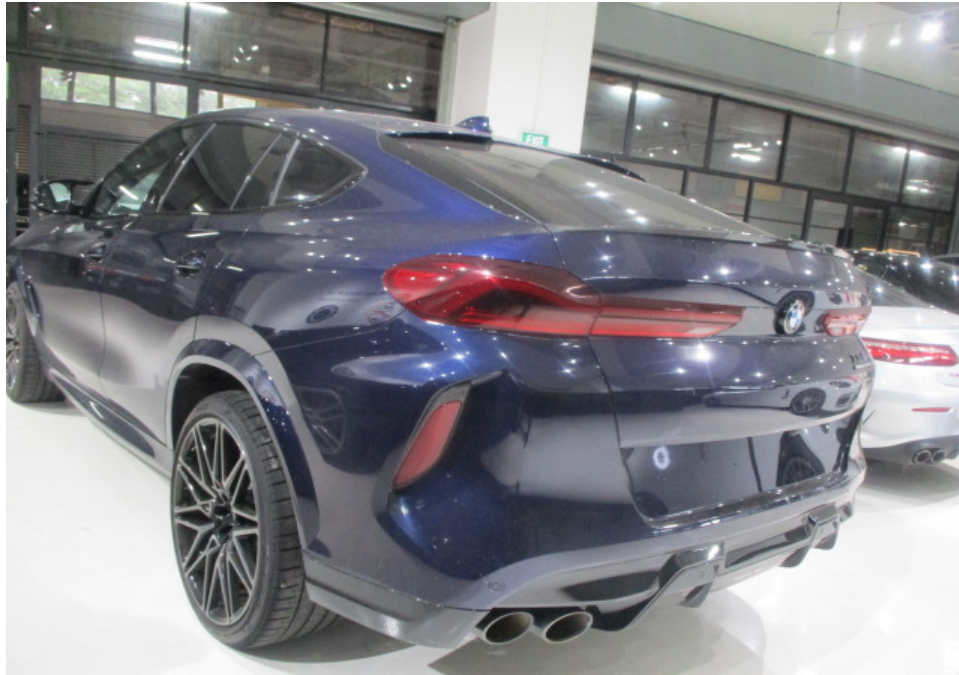
**Photo 12** shows a general view of the rear left body of the Motor Car at the time of my inspection. The Motor Car was observed to be in a relatively good general condition with no loose exterior fittings observed. The mileage of the Motor Car recorded at the time of my inspection was 17,950km.

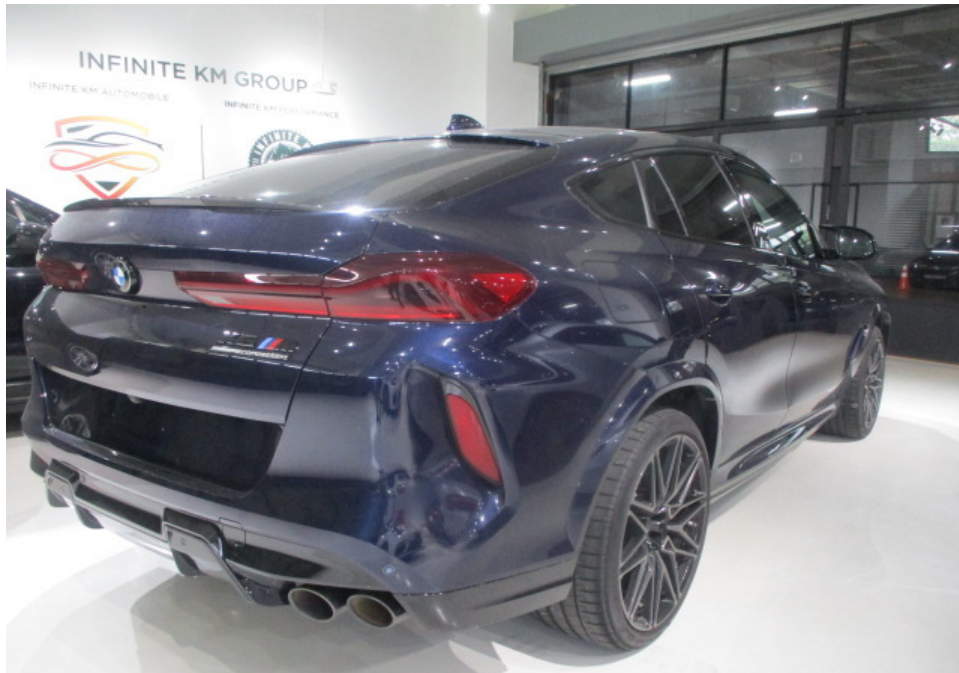
**Photo 13** shows a general view of the rear right body of the Motor Car at the time of my inspection. The Motor Car was observed to be in a relatively good general condition with no loose exterior fittings observed. The mileage of the Motor Car recorded at the time of my inspection was 17,950km.

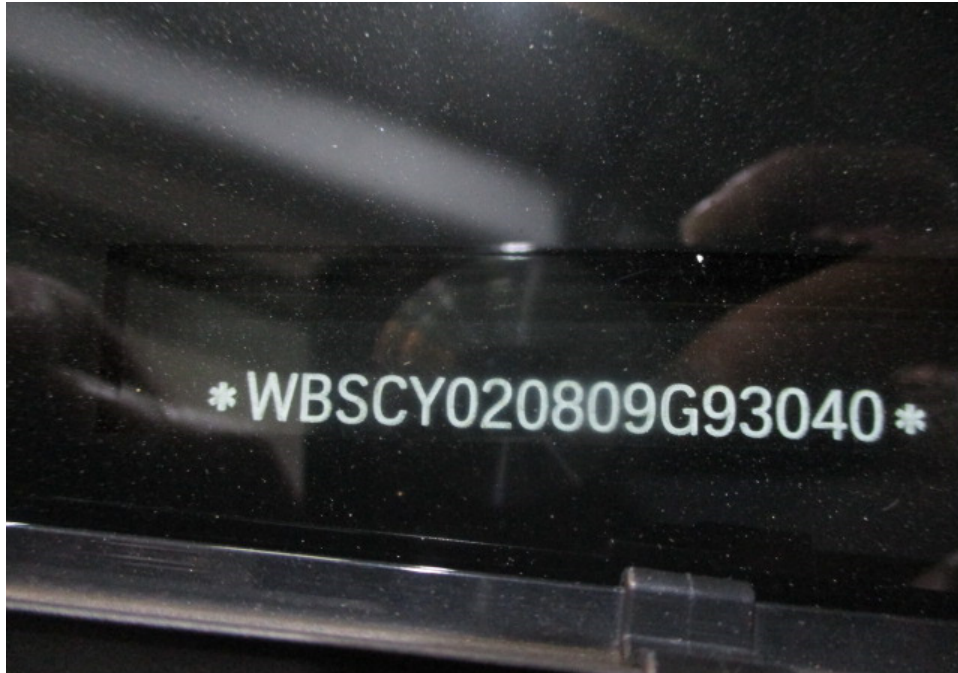
**Photo 14** shows the chassis number of the Motor Car. The chassis number recorded was WBSCY020809G93040.

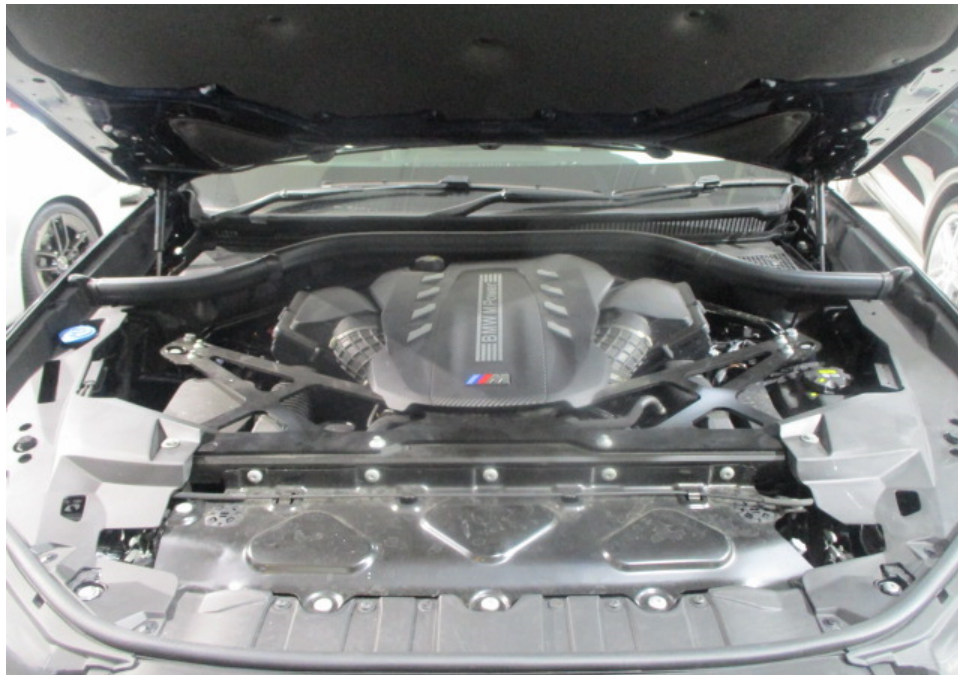
**Photo 15** shows a general view of the Motor Car's engine compartment at the time of my inspection. The various parts and components inside the engine compartment were all observed to be intact and properly fitted. There was also no sign(s) or indication(s) of fluid leak and/or fluid stain found inside the engine compartment.

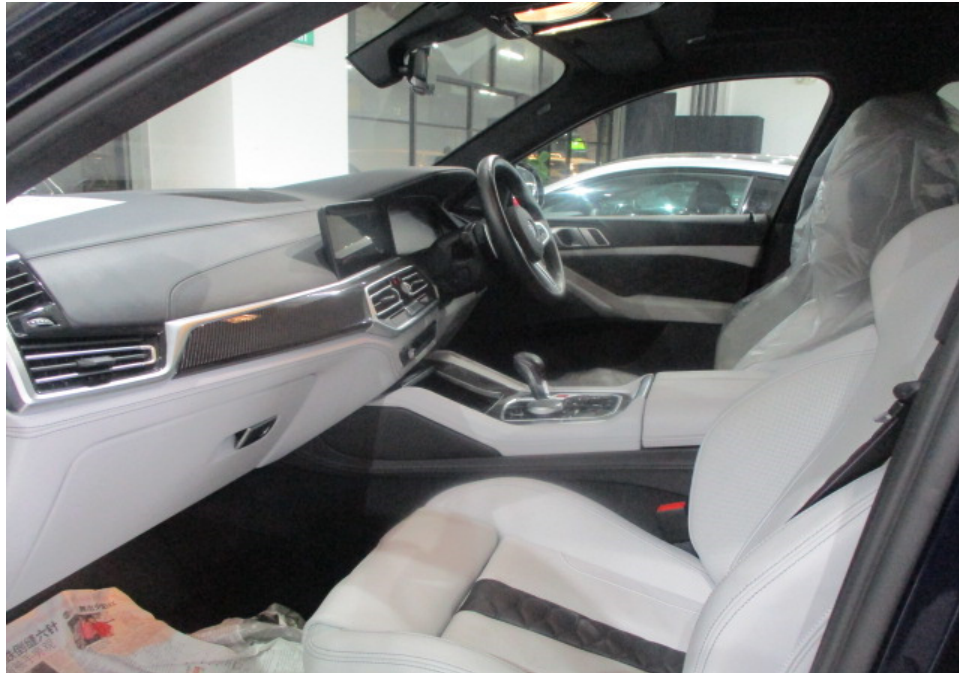
**Photo 16** shows the interior compartment of the Motor Car at the time of my inspection. The various parts and components, trims, carpet, and upholstery inside the interior compartment were all observed to be intact and properly fitted.

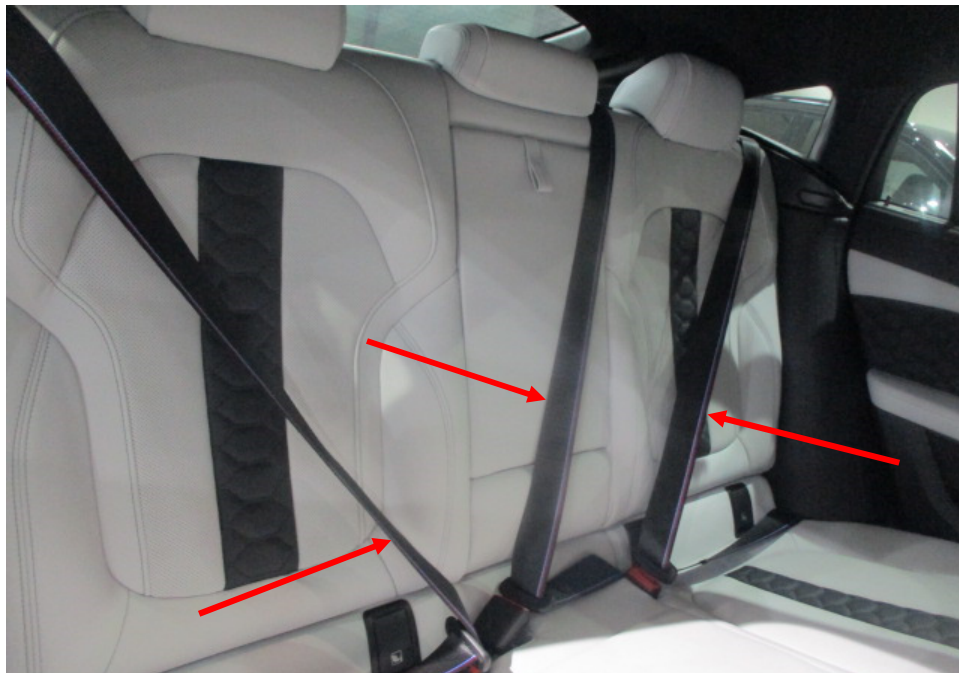
**Photo 17** shows the rear seats of the Motor Car. All the seats of the Motor Car were secured via seat rails to the floorboard. They were also fitted with a retractable seat belt reel and a pre-tensioner. The seat belts (arrowed) were tested and were able to be fastened into the respective pre-tensions that were fitted on the side of each individual seat.

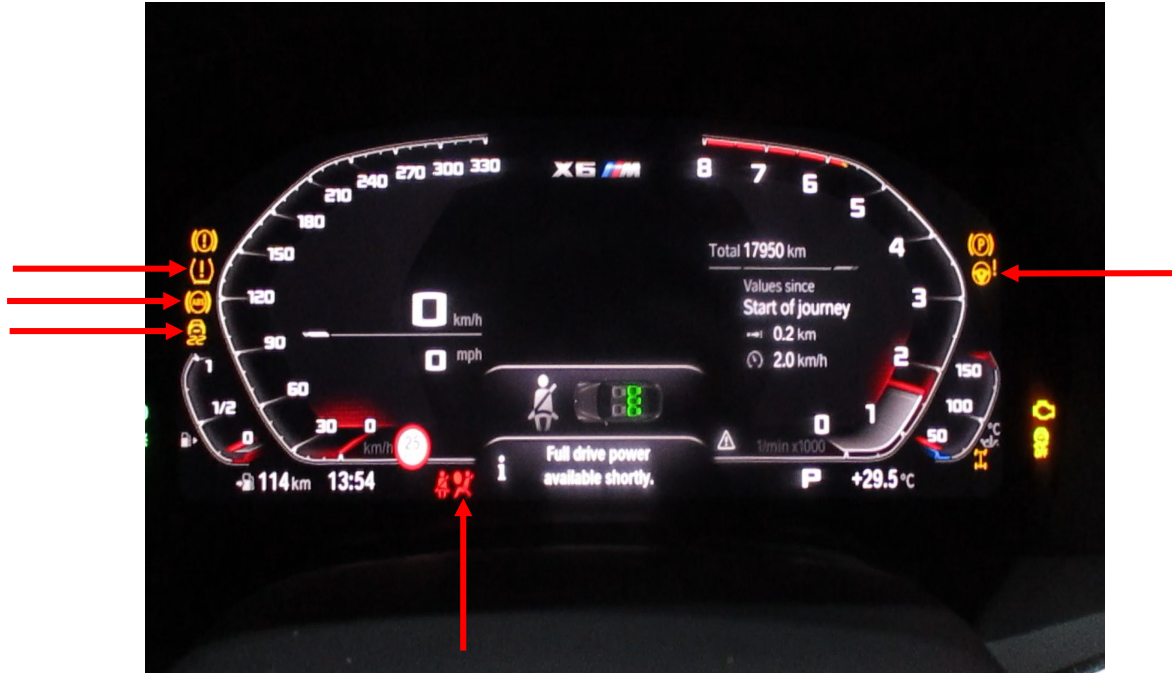
**Photo 18** shows the warning lights for the various electronic safety features appearing on the instrument panel of the Motor Car during its self-test when the engine is cranked, in particular the ABS, SRS, IAS, TPM and DSC lights (arrowed).

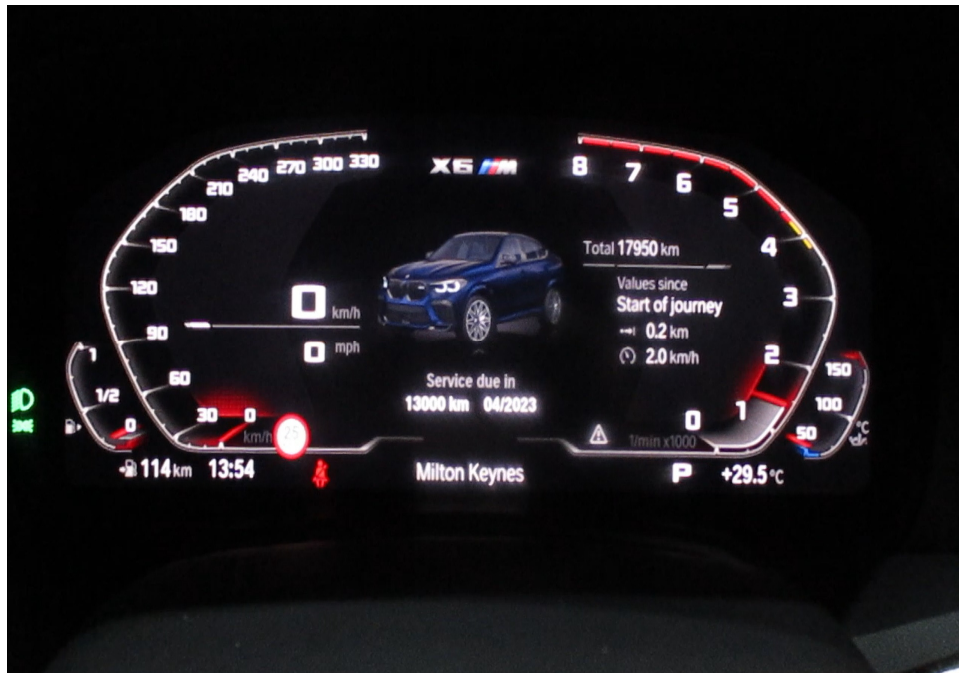
**Photo 19** shows the respective warning lights no longer illuminated, indicating that there is no fault detected to the ABS, SRS, IAS, TPM and DSC systems of the Motor Car during the self-test. These electronic systems were hence in working condition at the time of my inspection.

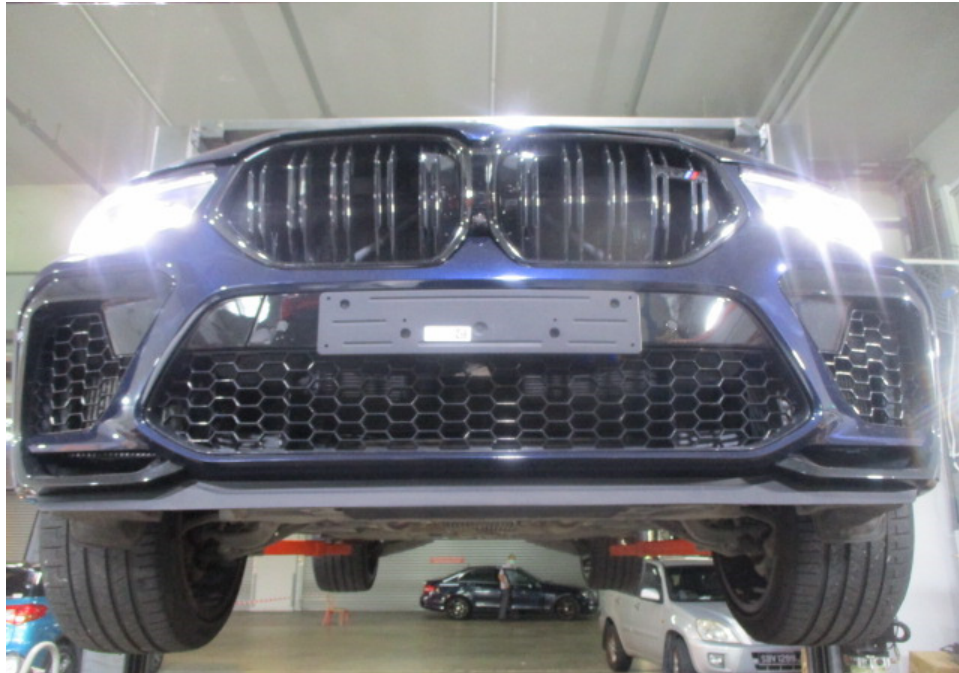
**Photo 20** shows the Motor Car hoisted up for checks on its undercarriage. There was no sign(s) or indication(s) of fluid leakage and/or fluid stain(s) on the underside of the Motor Car. The undercarriage components of the Motor Car were also all observed to be intact and secured in an appropriate manner.

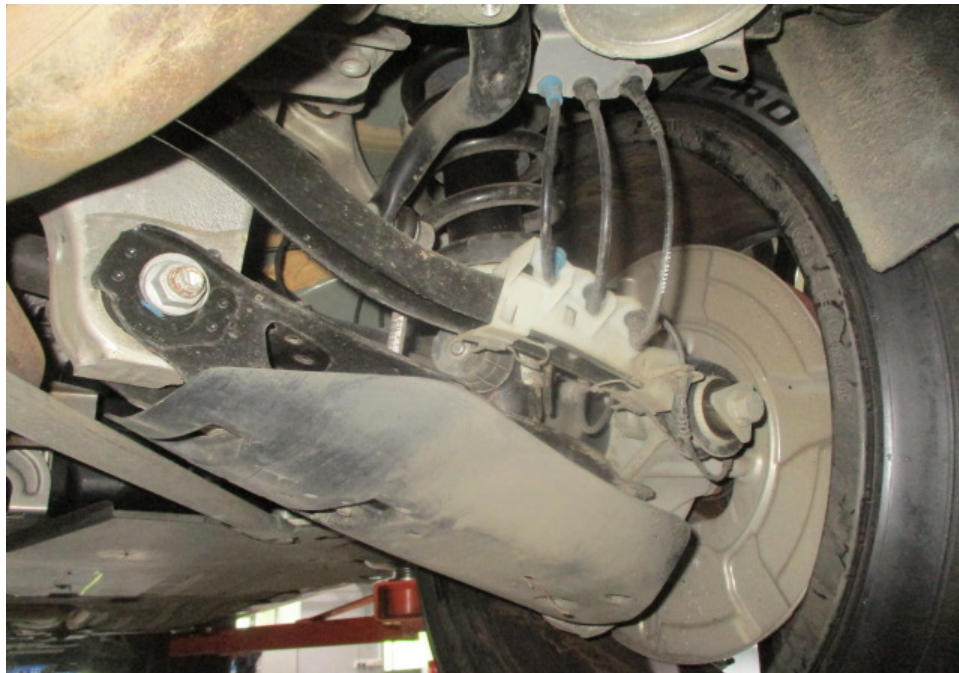
**Photo 21** shows a general view of the control arms and linkages at the rear right wheel of the Motor Car. I did not observe any fluid leak and/or fluid stain on the underside of the Motor Car. All of the Motor Car's undercarriage components were observed to be intact and secured in an appropriate manner.

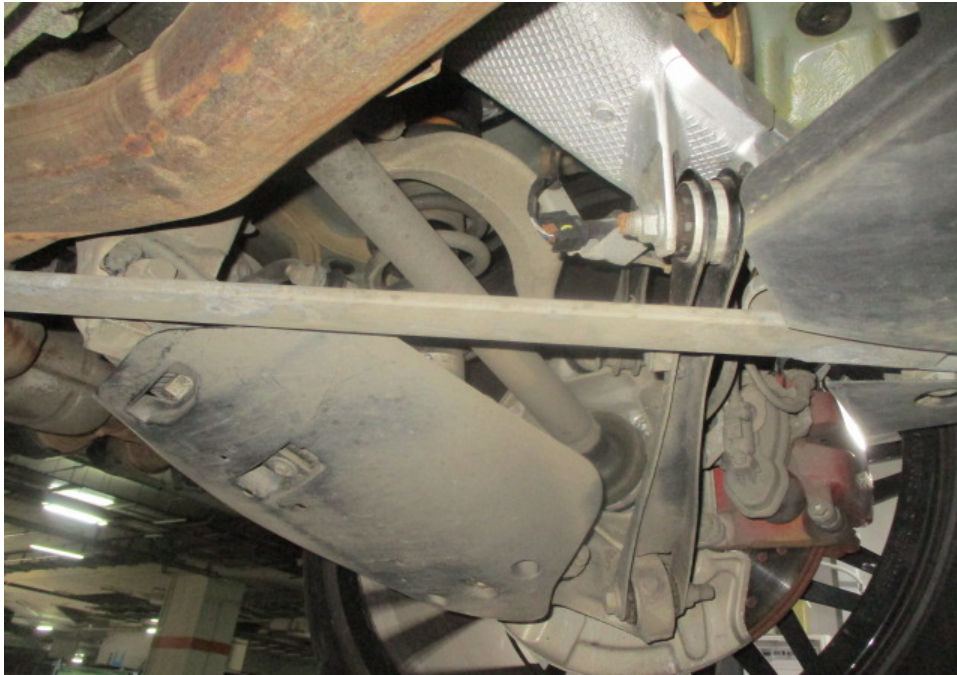
**Photo 22** shows a general view of the control arms and linkages at the rear left wheel of the Motor Car. I did not observe any fluid leak and/or fluid stain on the underside of the Motor Car. All of the Motor Car's undercarriage components were observed to be intact and secured in an appropriate manner.

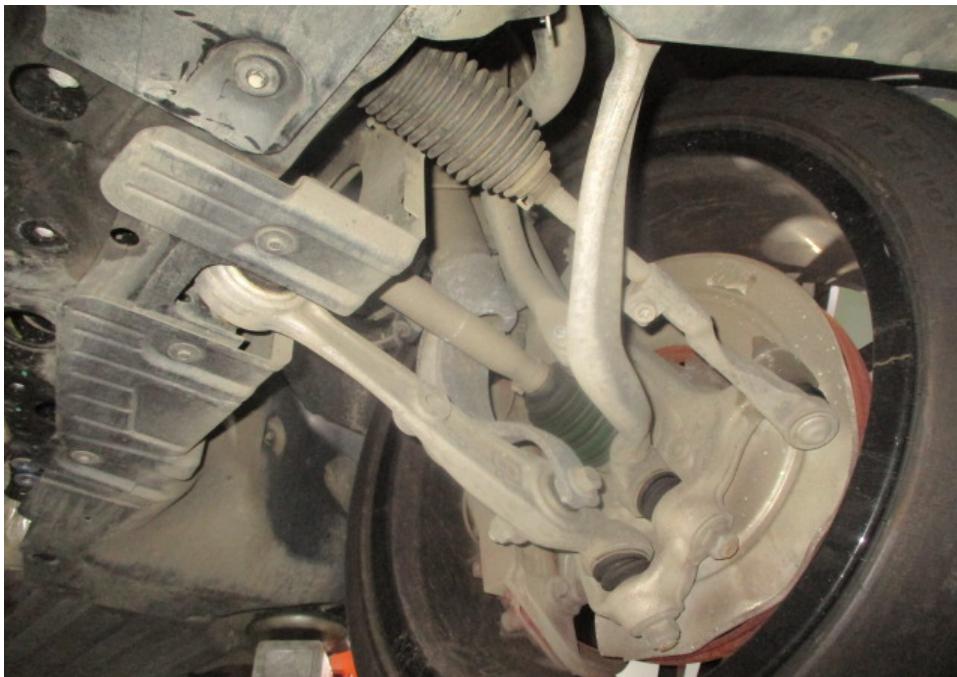
**Photo 23** shows the various undercarriage components at the front left wheel of the Motor Car. The mechanical components, control arms and linkages were all found to be intact and secured in an appropriate manner.

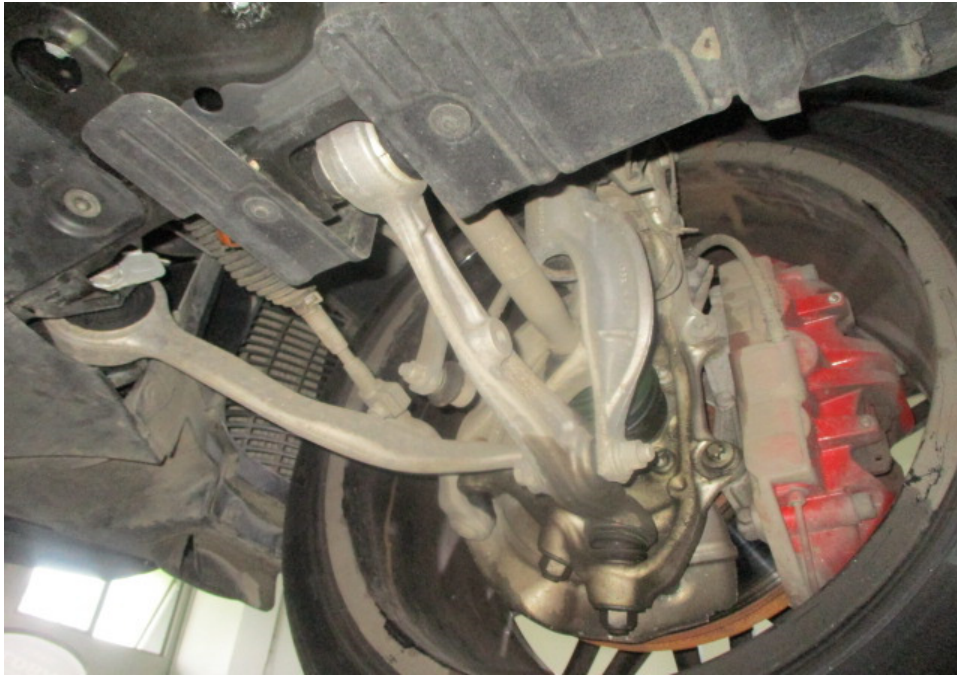
**Photo 24** shows the various undercarriage components at the front right wheel of the Motor Car. The mechanical components, control arms and linkages were all found to be intact and secured in an appropriate manner. I also did not observe any fluid leak and/or fluid stain on the underside of the Motor Car.

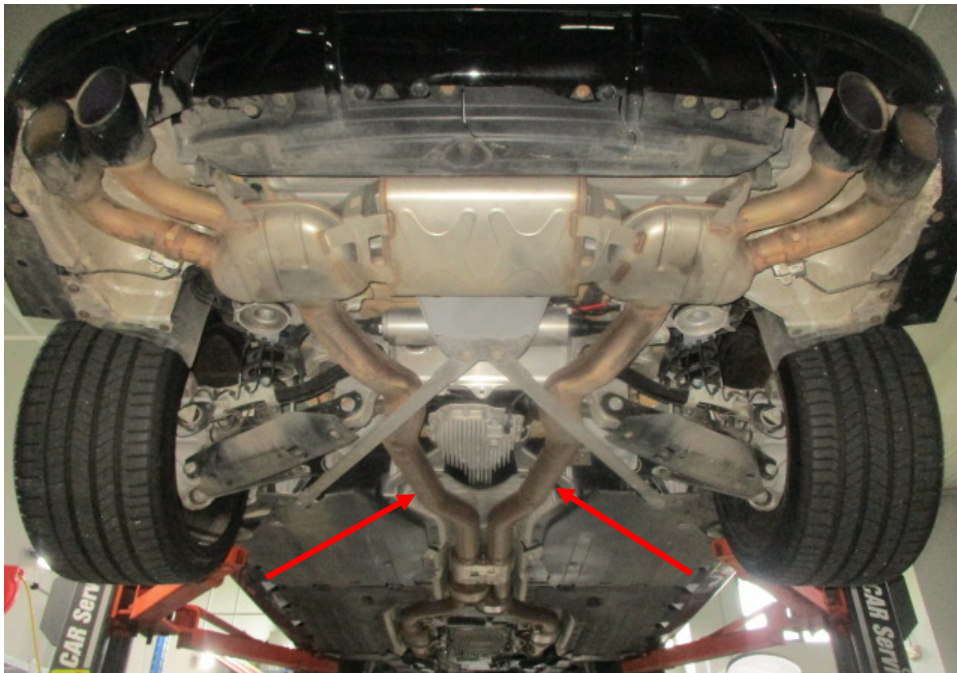
**Photo 25** shows the rear section of the Motor Car's exhaust system. My examination of the Motor Car's exhaust system revealed no sign(s) or indication(s) of any cut or weld marks along its exhaust pipes (arrowed), on its rear mufflers, on its centre resonator boxes and on its catalytic converters.

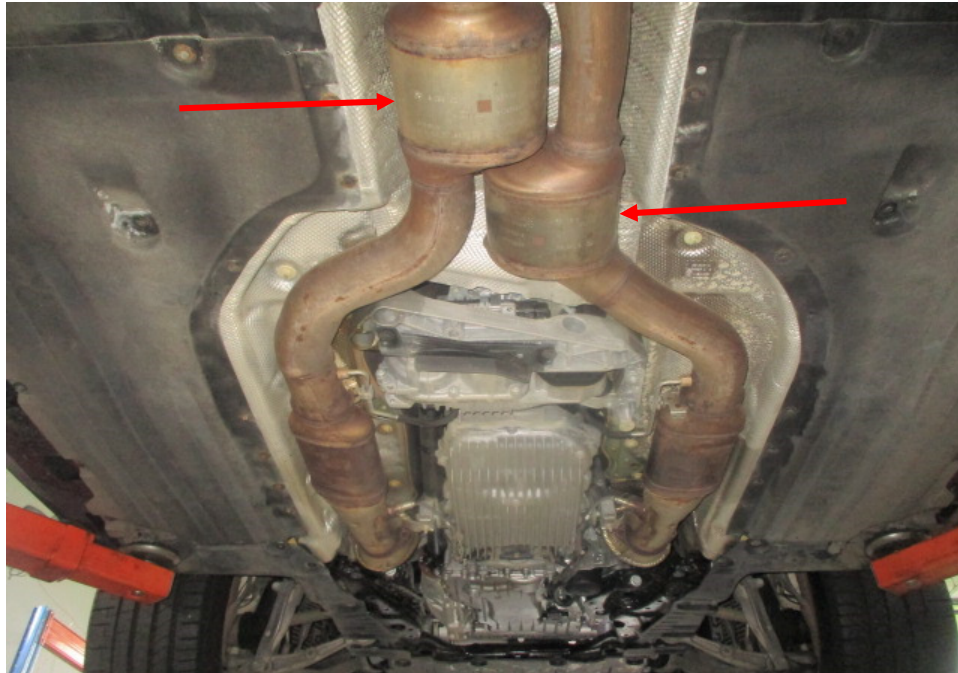
**Photo 26** shows the front section of the Motor Car's exhaust system. My examination of the Motor Car's exhaust system revealed no sign(s) or indication(s) of any cut or weld marks along its exhaust pipes, on its rear mufflers, on its centre resonator boxes (arrowed) and on its catalytic converters.

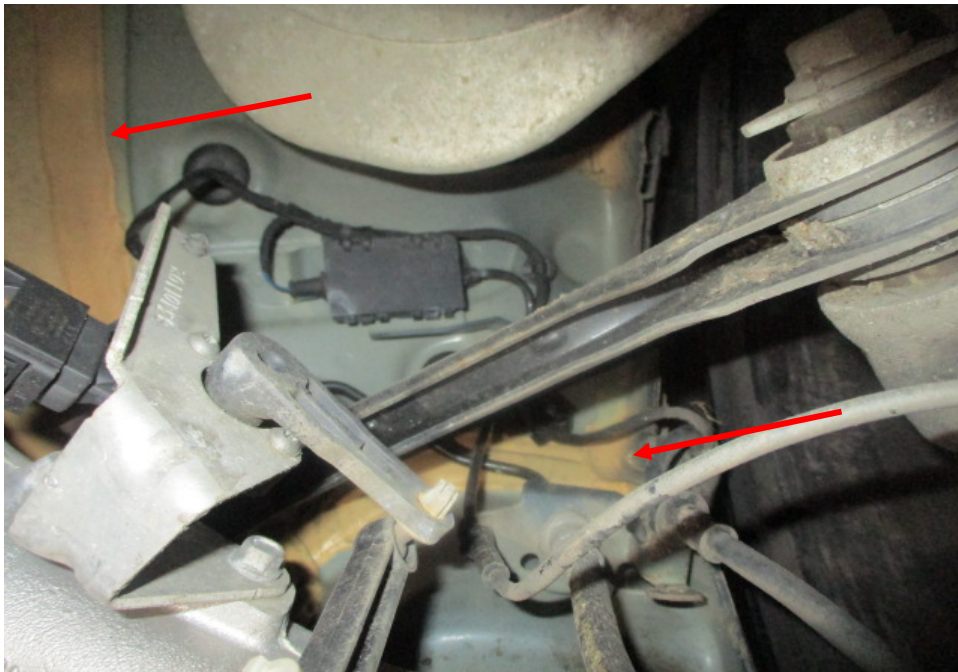
**Photo 27** shows the chassis/structural body at the underside rear right of the Motor Car. I did not find any weld marks other than original spot weld marks on the chassis/structural body of the Motor Car. The original factory sealant (arrowed) at the joints along the chassis/structural body was untouched, indicating no work was done on the chassis/structural body of the Motor Car and that the chassis/structural body was originally fitted.

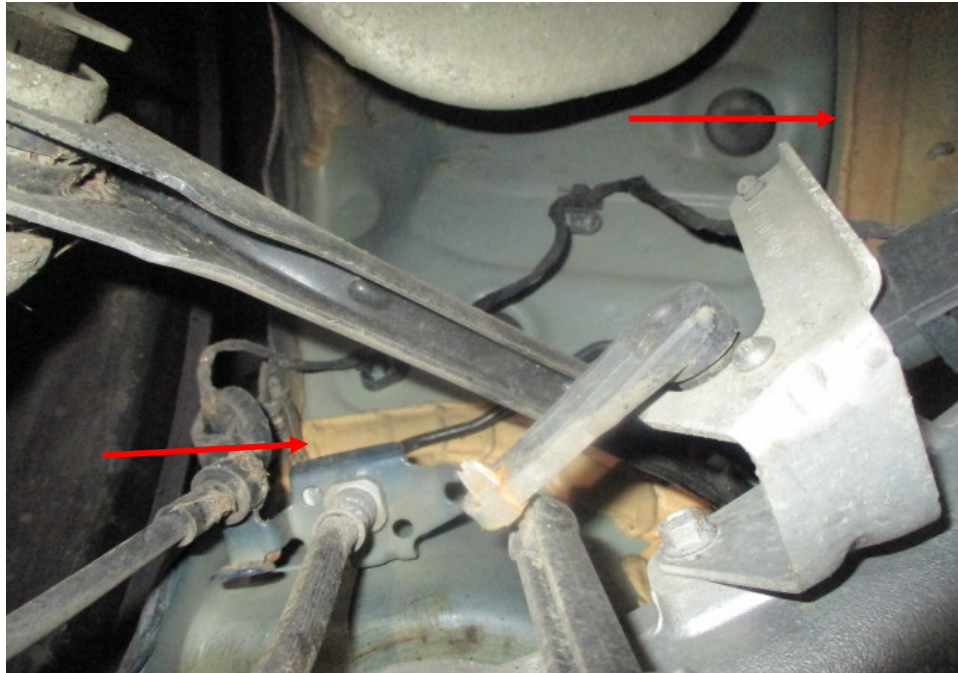
**Photo 28** shows the chassis/structural body at the underside rear left of the Motor Car. I did not find any weld marks other than original spot weld marks on the chassis/structural body of the Motor Car. The original factory sealant (arrowed) at the joints along the chassis/structural body was untouched, indicating no work was done on the chassis/structural body of the Motor Car and that the chassis/structural body was originally fitted.

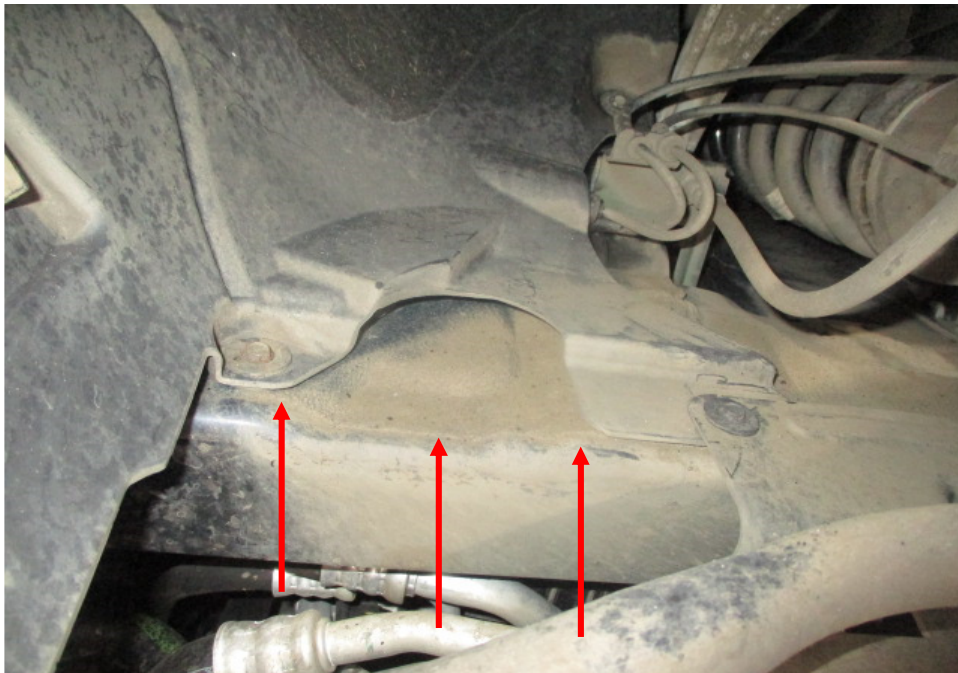
**Photo 29** shows the chassis/structural body at the underside front left of the Motor Car. The original factory sealant (arrowed) at the joints along the chassis/structural body was observed to be untouched. In general, I had found no work was carried out on the chassis/structural body of the Motor Car. The chassis/structural body of the Motor Car was originally fitted.

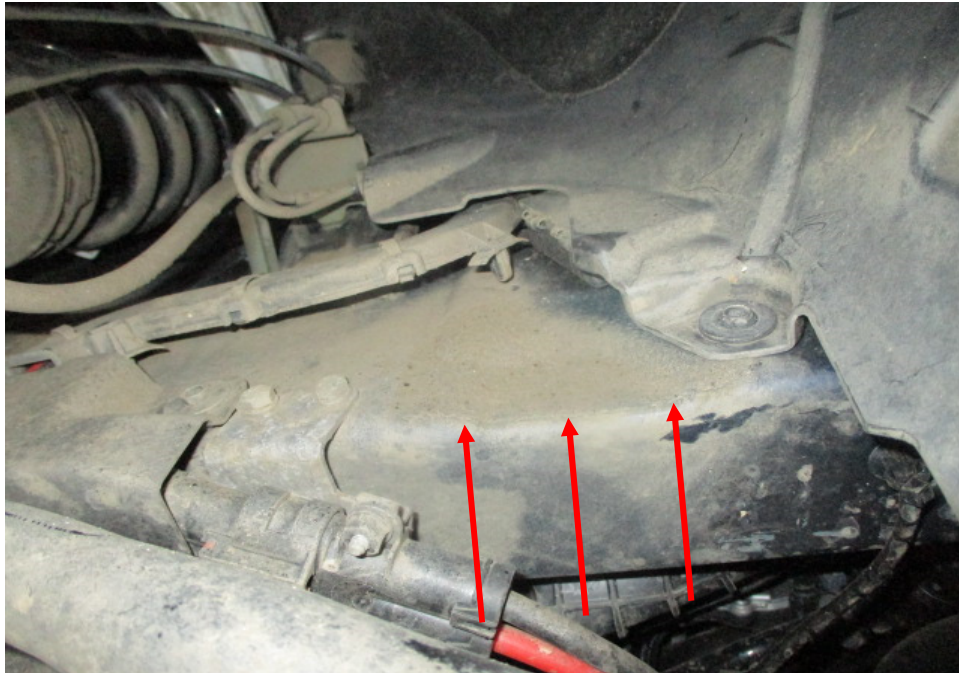
**Photo 30** shows the chassis/structural body at the underside front right of the Motor Car. I did not find any weld marks other than original spot weld marks on the chassis/structural body of the Motor Car. The original factory sealant (arrowed) at the joints along the chassis/structural body was untouched, indicating no work was done on the chassis/structural body of the Motor Car and that the chassis/structural body was originally fitted.
