Your Ref: BMW X6  
(chassis number WBSCY020809G93040)  
Our Ref : CI/TP22013027/D

30 December 2022

**GC International Import Pte Ltd**

**INSPECTION REPORT OF AN UNREGISTERED BMW X6 MOTOR CAR WITH  
CHASSIS NUMBER WBSCY020809G93040**

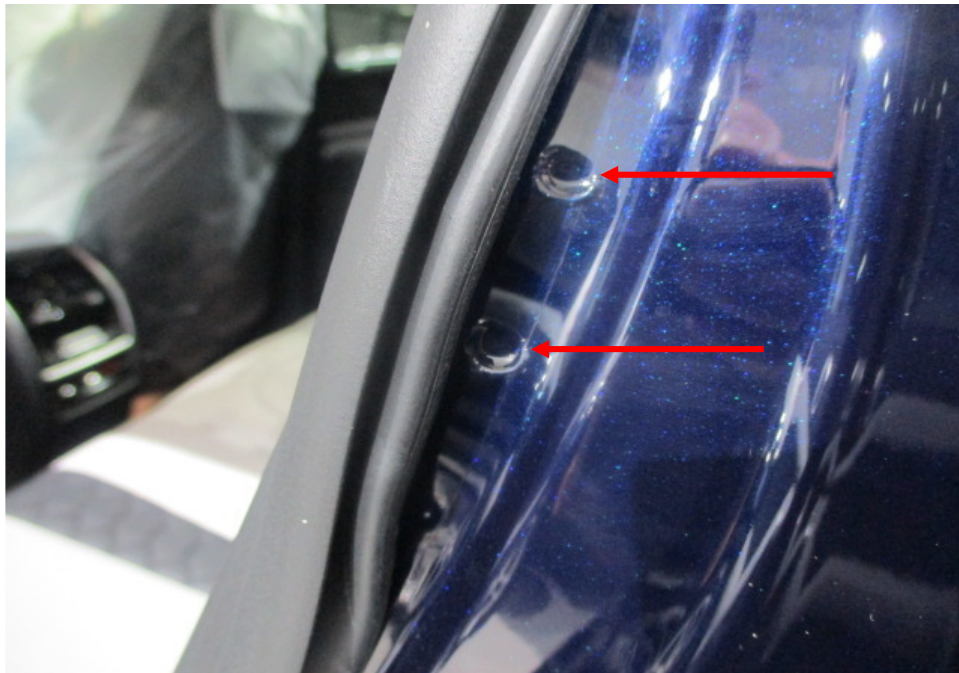
**Photo 31** shows the left side "C" pillar of the Motor Car. I did not find any weld marks other than original spot weld marks (arrowed) on the left side "C" pillar of the Motor Car, which indicates that there was no re-welding works carried out. In general, I had found all the non-detachable body panels of the Motor Car to be originally fitted at the time of my inspection.

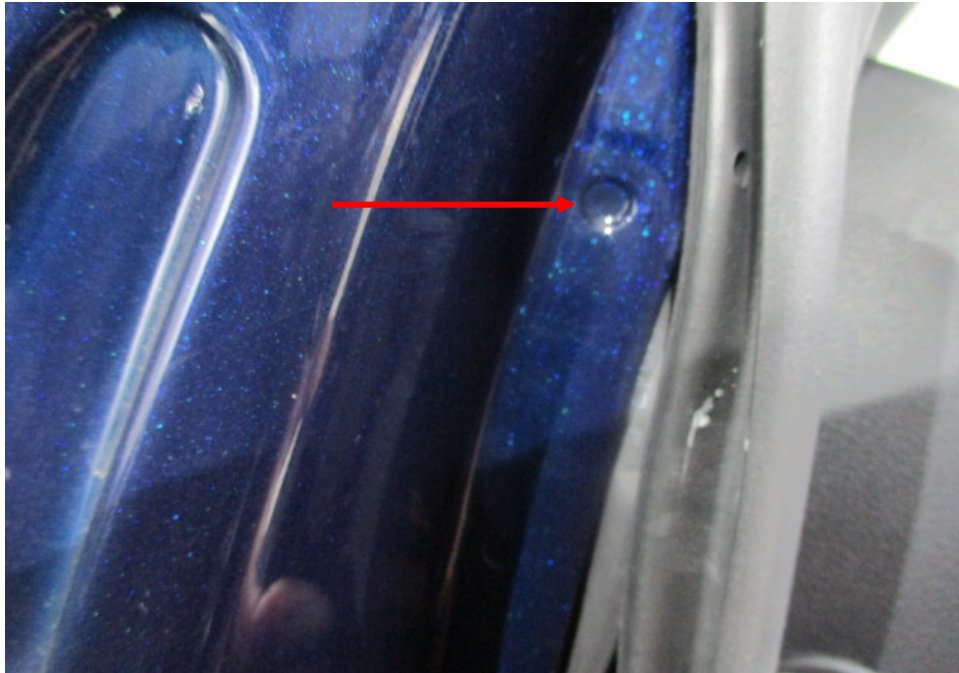
**Photo 32** shows the left side "A" pillar of the Motor Car. I did not find any weld marks other than original spot weld marks (arrowed) on the left side "A" pillar of the Motor Car, which indicates that there was no re-welding works carried out. In general, I had found all the non-detachable body panels of the Motor Car to be originally fitted at the time of my inspection.

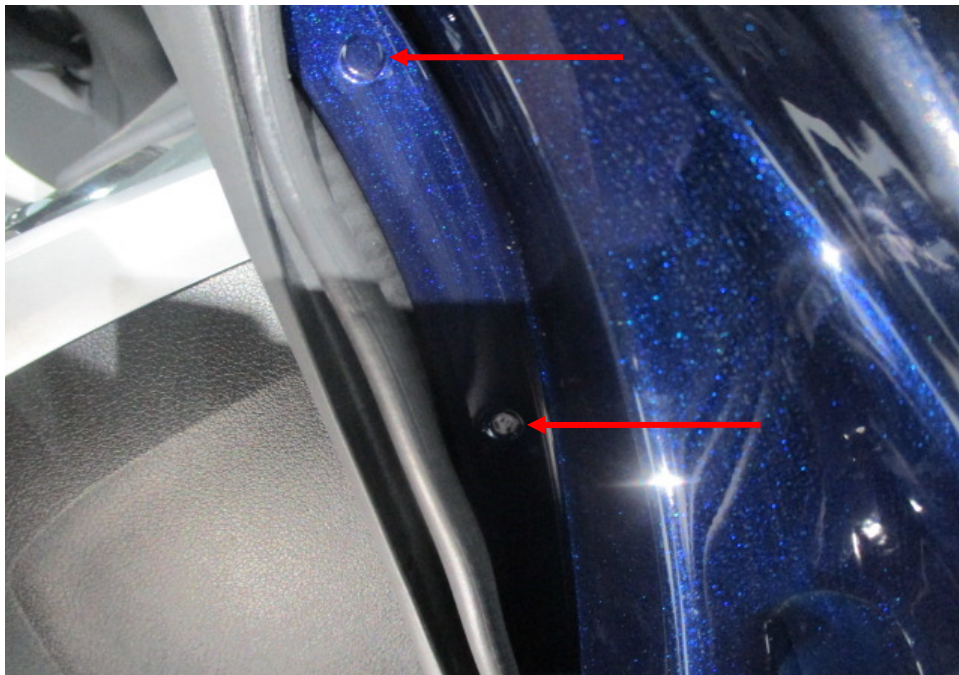
**Photo 33** shows the right side "A" pillar of the Motor Car. I did not find any weld marks other than original spot weld marks (arrowed) on the right side "A" pillar of the Motor Car, which indicates that there was no re-welding works carried out. In general, I had found all the non-detachable body panels of the Motor Car to be originally fitted at the time of my inspection.

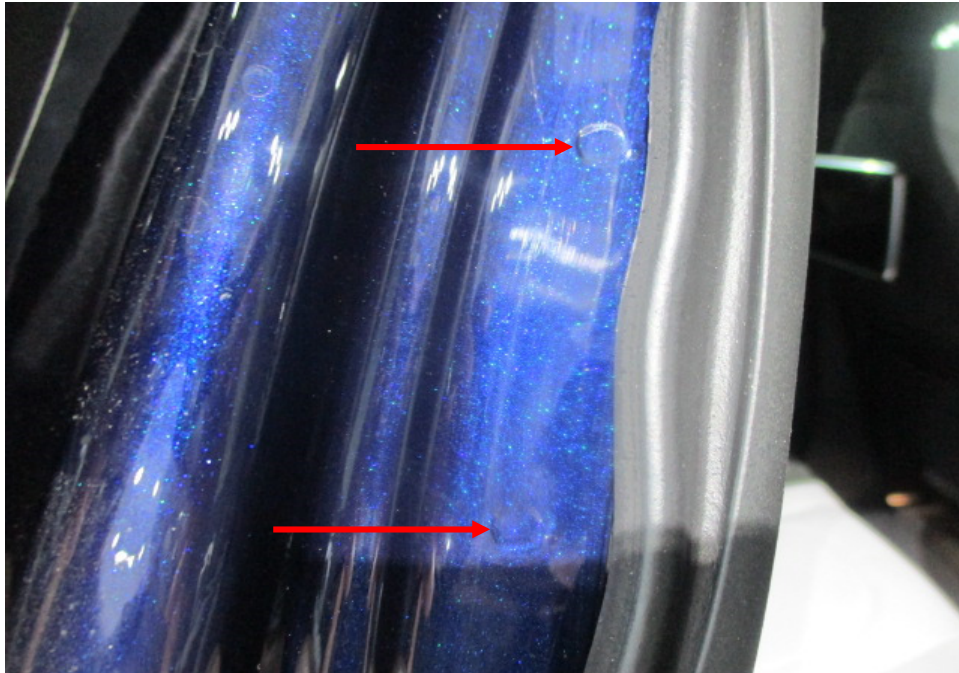
**Photo 34** shows the right side "C" pillar of the Motor Car. I did not find any weld marks other than original spot weld marks (arrowed) on the right side "C" pillar of the Motor Car, which indicates that there was no re-welding works carried out. In general, I had found all the non-detachable body panels of the Motor Car to be originally fitted at the time of my inspection.
