Your Ref: Mercedes Benz C63s Coupe  
(chassis number W1K2053872G006624)  
Our Ref : CI/TP23000002/D

**INSPECTION REPORT OF AN UNREGISTERED MERCEDES BENZ C63s  
COUPE MOTOR CAR WITH CHASSIS NUMBER W1K2053872G006624**

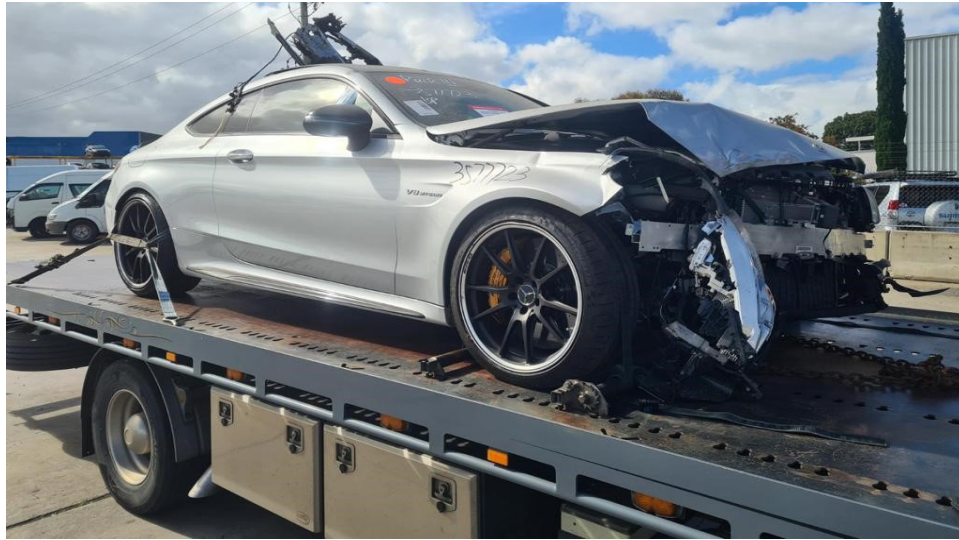
3. The photographs provided to me had showed damage to the frontal portion of the Motor Car. Body parts damaged include the front bumper reinforcement, front bonnet, front bonnet hinges, front bonnet lock, front right headlamp, front right fender, front right fender inner shield, front left headlamp, front left fender, front left fender inner shield, front left door and left side rocker panel garnish amongst others.

4. The Motor Car's front radiator grille, front emblem, front bumper and all its related parts and attachments like the front bumper centre lower garnish, front bumper centre lower grille, front bumper right lower grille, front bumper left lower grille, front bumper tow cover and front bumper sensors amongst others, were observed to be missing/dislodged/damaged.

**Photo 1** shows the front right body of the Motor Car (photograph provided to me). The photographs provided to me had showed damage to the frontal portion of the Motor Car. The front bumper reinforcement, front bonnet, front bonnet right hinge, front bonnet lock, front right headlamp, front right fender and front right fender inner shield were amongst the body parts that were observed to have been damaged. The Motor Car's front radiator grille, front emblem, front bumper and all its related parts and attachments like the front bumper centre lower garnish, front bumper centre lower grille, front bumper right lower grille and front bumper tow cover, amongst others were observed to be missing/dislodged/damaged.

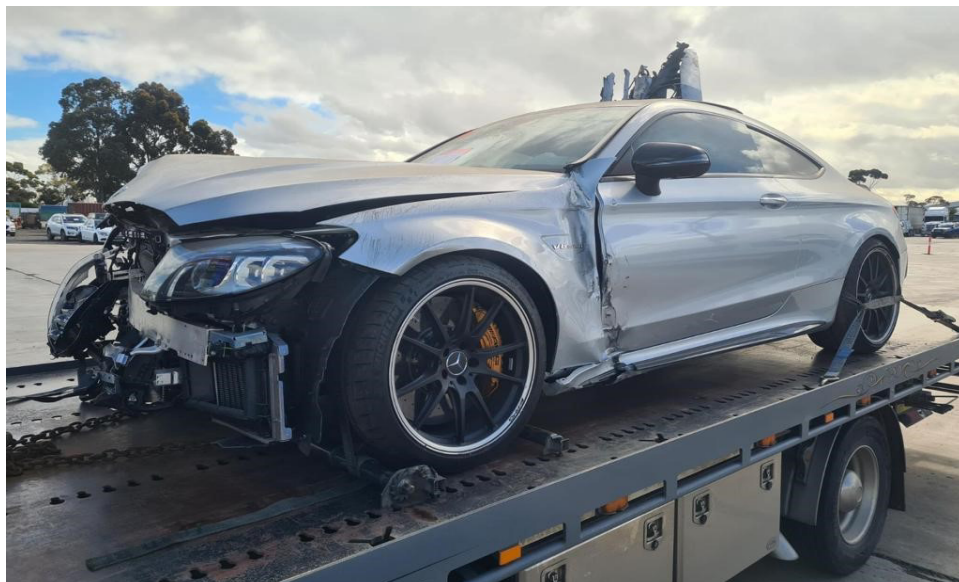
**Photo 2** shows the front left body of the Motor Car (photograph provided to me). The photographs provided to me had showed damage to the frontal portion of the Motor Car. The front bumper reinforcement, front bonnet, front left headlamp, front left fender, front left fender inner shield, front left door and left side rocker panel garnish were amongst the body parts that were observed to have been damaged. The Motor Car's front bumper and all its related parts and attachments like the front bumper centre lower garnish, front bumper centre lower grille, front bumper left lower grille and front bumper sensors amongst others, were observed to be missing/dislodged/damaged.

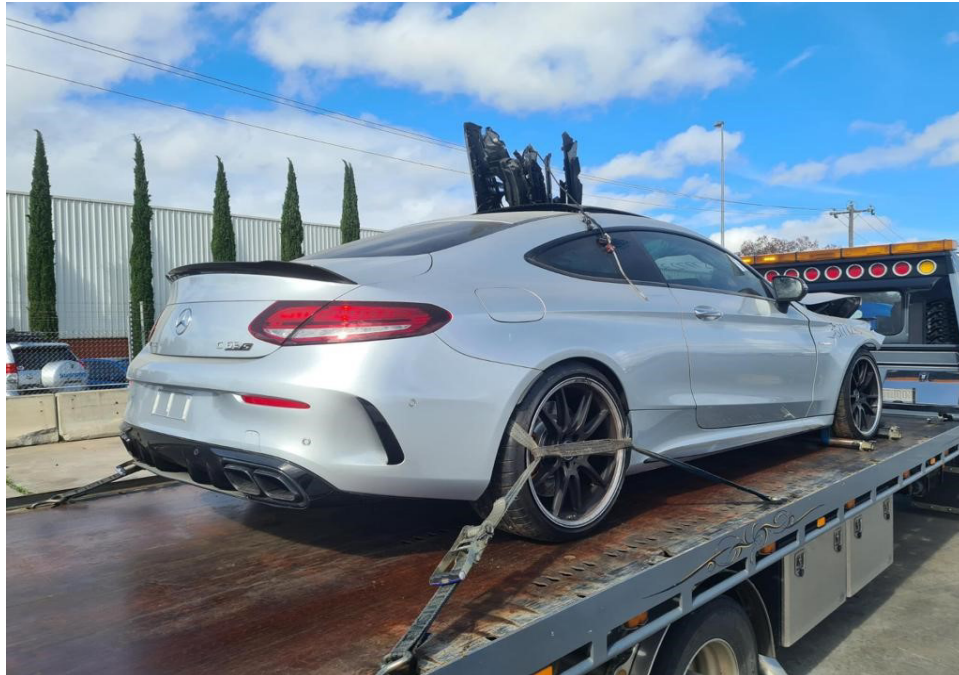
**Photo 3** shows the rear right body of the Motor Car (photograph provided to me). Apart for the frontal portion, there was no physical damage observed to other areas of the Motor Car.

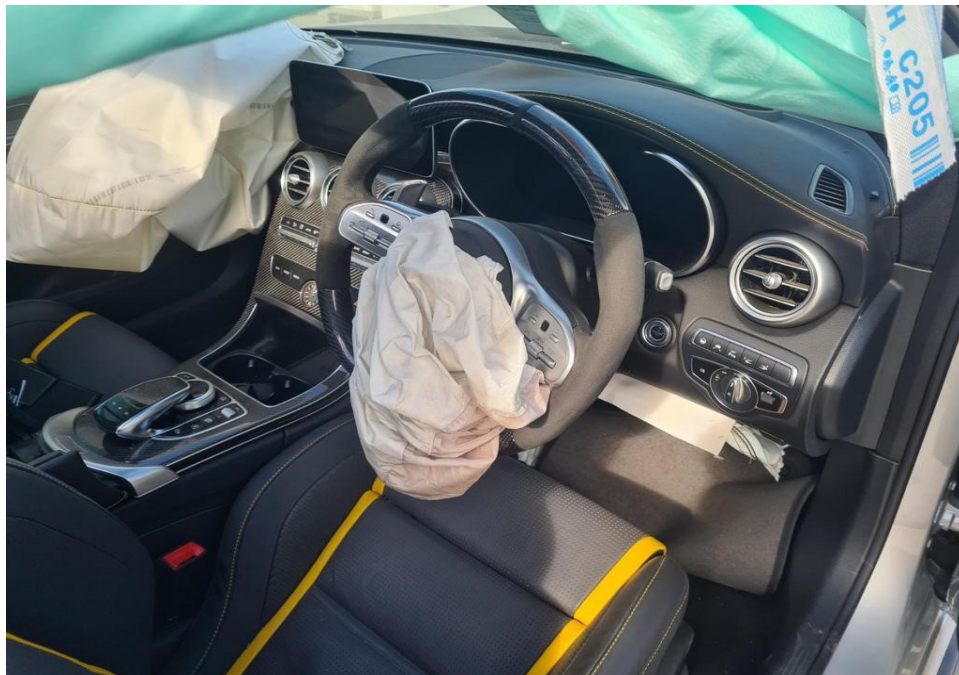
5. Apart for the frontal portion, there was no physical damage observed to other areas of the Motor Car. The driver's airbag, driver's knee airbag, front left passenger airbag and right curtain airbag were deployed. See photo 1 – 4 below.

**Photo 4** shows the interior compartment of the Motor Car (photograph provided to me). The driver's airbag, driver's knee airbag, front left passenger airbag and right curtain airbag were deployed.

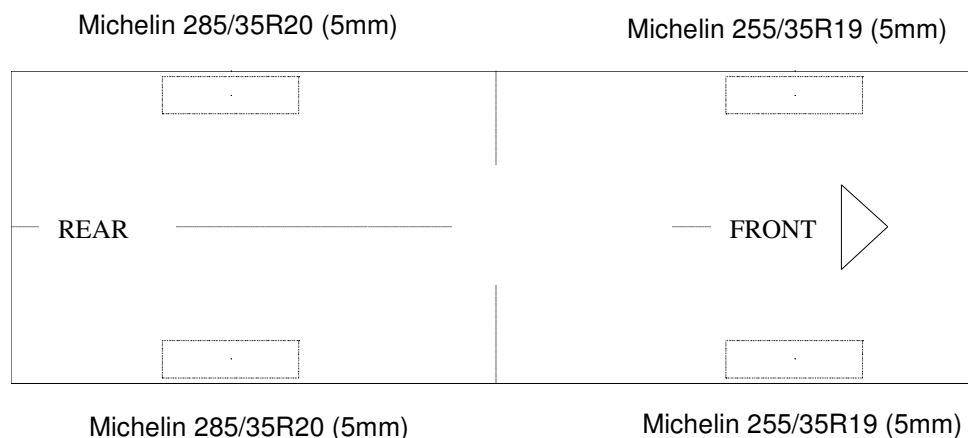
9. The Motor Car was fitted with 19inch (front) and 20inch (rear) sport wheel rims that were wrapped with tyres that were observed to be of serviceable condition. The tyres were also sufficiently inflated for vehicular operation. The tyre brand, tyre size and approximate remaining tread depth of the 4 tyres of the Motor Car were recorded as follows: -

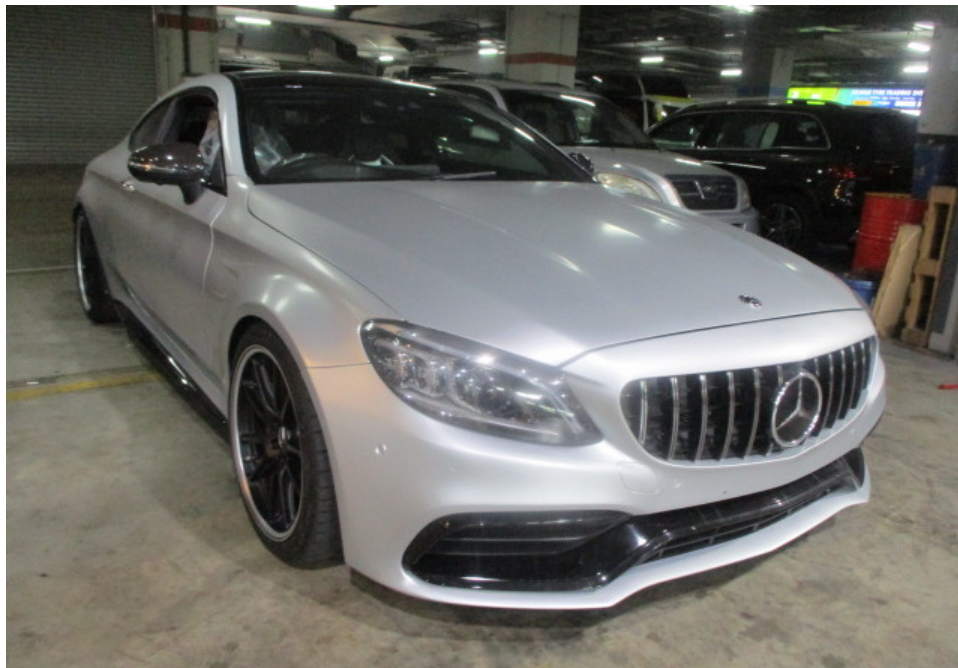
**Photo 5** shows a general view of the front right body of the Motor Car at the time of my inspection. The Motor Car was observed to be in a relatively good general condition with no loose exterior fittings observed. The body parts at the frontal portion of the Motor Car were visually examined and it was observed that the repair/restoration works carried out to the damaged area of the Motor Car (refer to photograph 1 & 2 above) were reasonably adequate and in order.

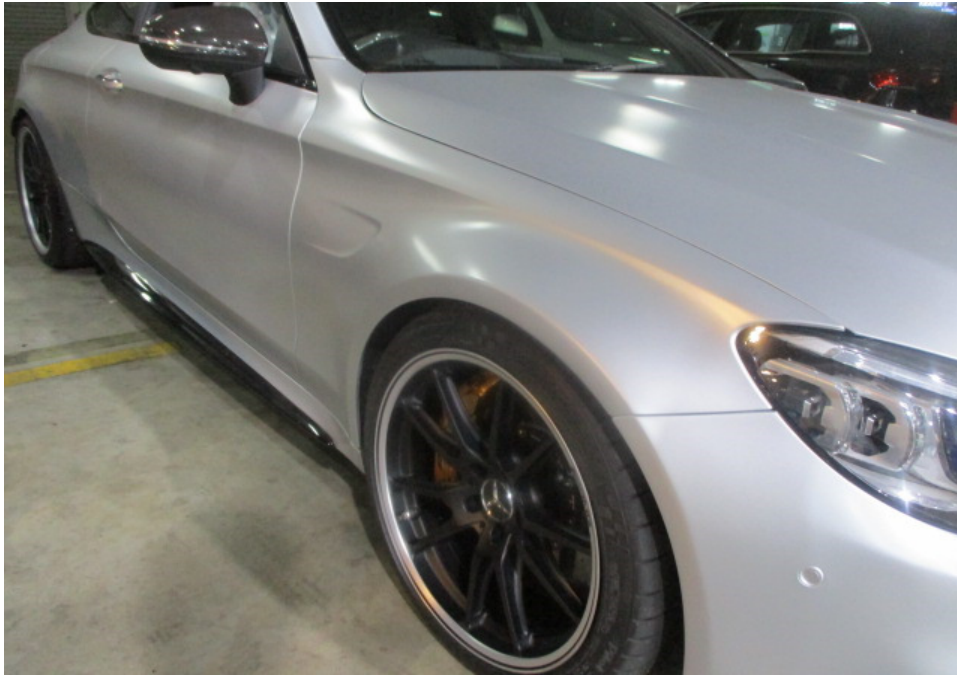
**Photo 6** shows a closer view of the Motor Car's front bonnet, front right headlamp, front right wheel rim and front right fender. The body parts at the frontal portion of the Motor Car were visually examined and it was observed that the repair/restoration works carried out to the damaged area of the Motor Car (refer to photograph 1 & 2 above) were reasonably adequate and in order.

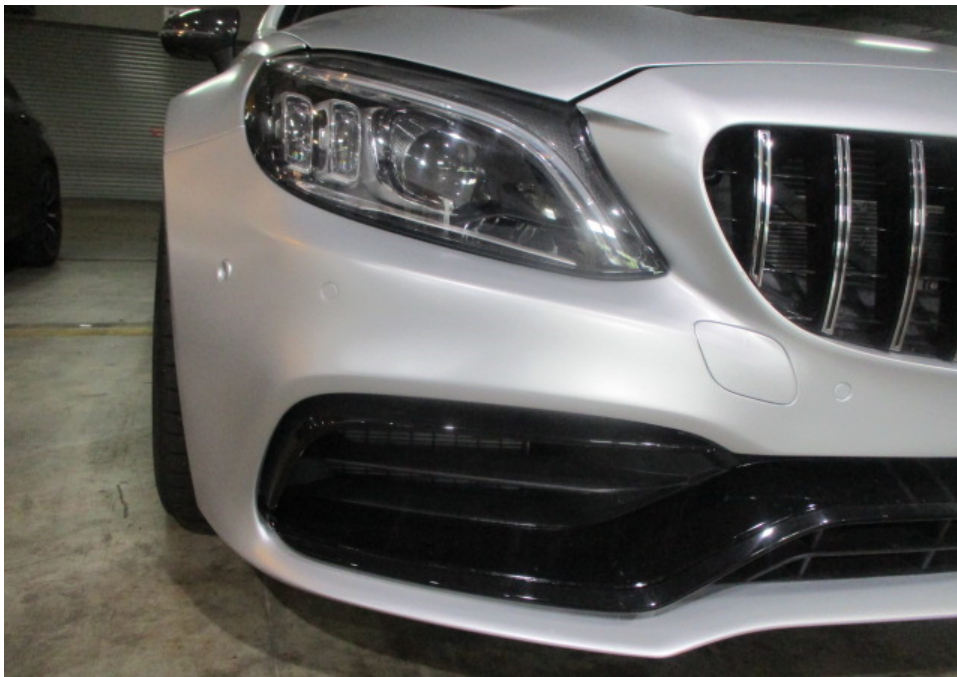
**Photo 7** shows a closer view of the Motor Car's front bumper, front bumper right lower grille, front bumper tow cover and front right headlamp. The body parts at the frontal portion of the Motor Car were visually examined and it was observed that the repair/restoration works carried out to the damaged area of the Motor Car (refer to photograph 1 & 2 above) were reasonably adequate and in order.

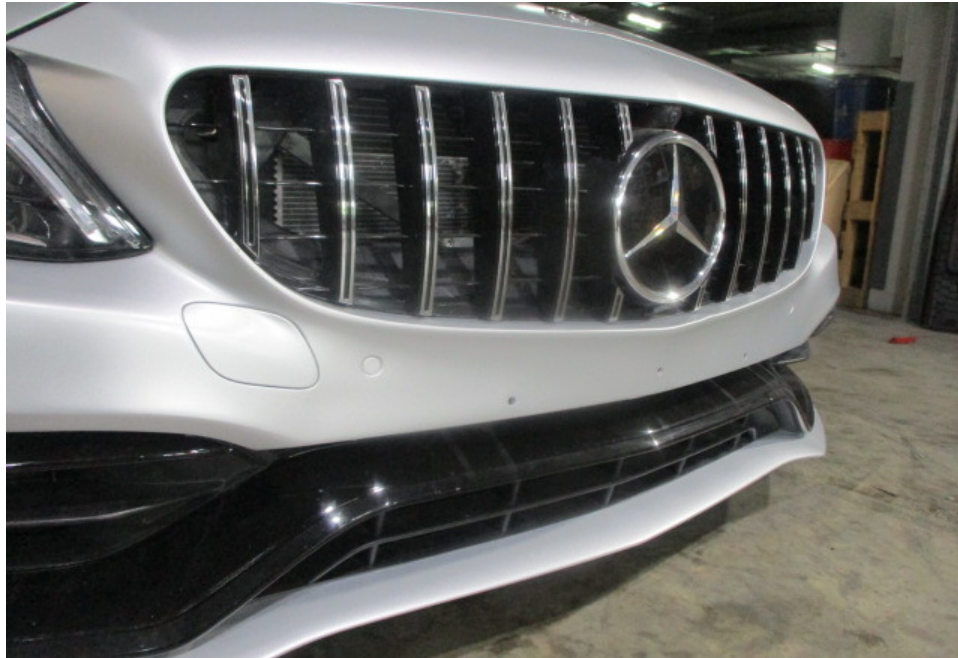
**Photo 8** shows a closer view of the Motor Car's front bumper, front bumper centre lower garnish, front bumper centre lower grille, front bumper sensors, front radiator grille and front emblem. The body parts at the frontal portion of the Motor Car were visually examined and it was observed that the repair/restoration works carried out to the damaged area of the Motor Car (refer to photograph 1 & 2 above) were reasonably adequate and in order.

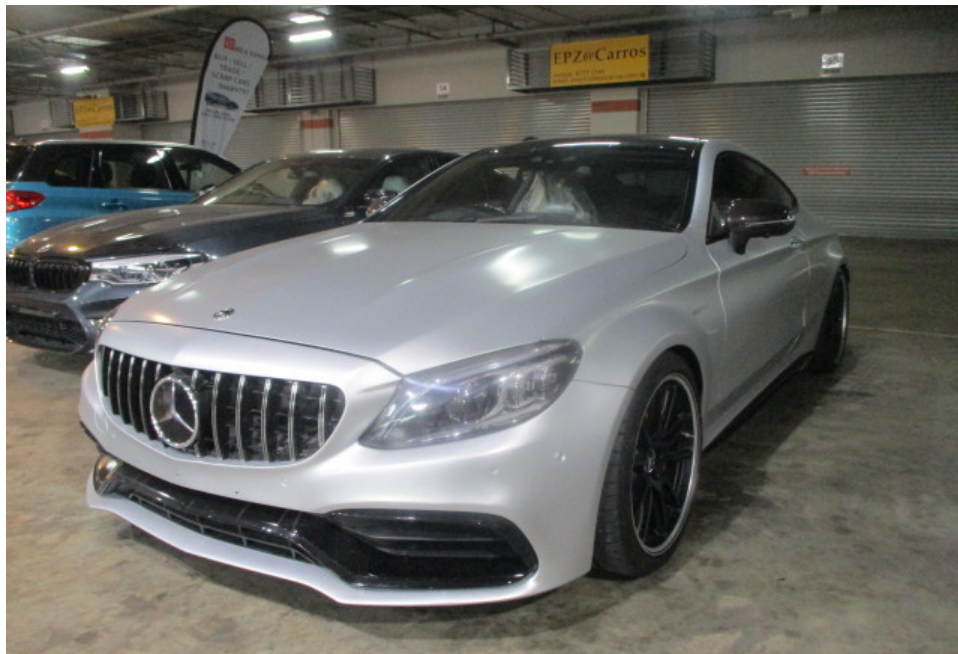
**Photo 9** shows a general view of the front left body of the Motor Car at the time of my inspection. The Motor Car was observed to be in a relatively good general condition with no loose exterior fittings observed. The body parts at the frontal portion of the Motor Car were visually examined and it was observed that the repair/restoration works carried out to the damaged area of the Motor Car (refer to photograph 1 & 2 above) were reasonably adequate and in order.

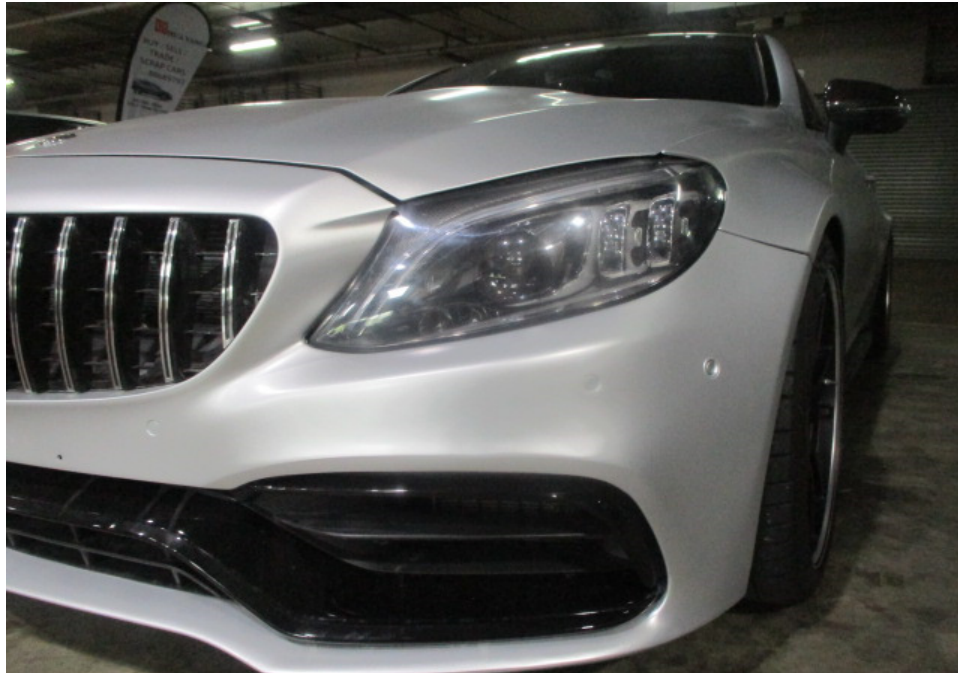
**Photo 10** shows a closer view of the Motor Car's front bumper, front bumper left lower grille, front bumper sensors and front left headlamp. The body parts at the frontal portion of the Motor Car were visually examined and it was observed that the repair/restoration works carried out to the damaged area of the Motor Car (refer to photograph 1 & 2 above) were reasonably adequate and in order.

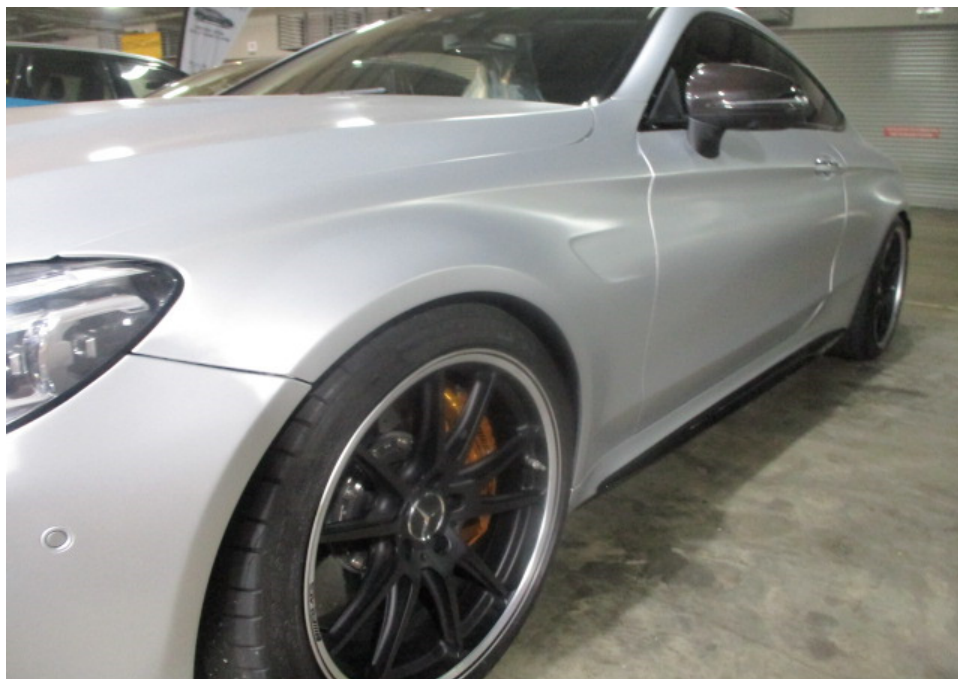
**Photo 11** shows a closer view of the Motor Car's front left headlamp, front left fender, front left wheel rim, front left door and left side rocker panel garnish. The body parts at the frontal portion of the Motor Car were visually examined and it was observed that the repair/restoration works carried out to the damaged area of the Motor Car (refer to photograph 1 & 2 above) were reasonably adequate and in order.

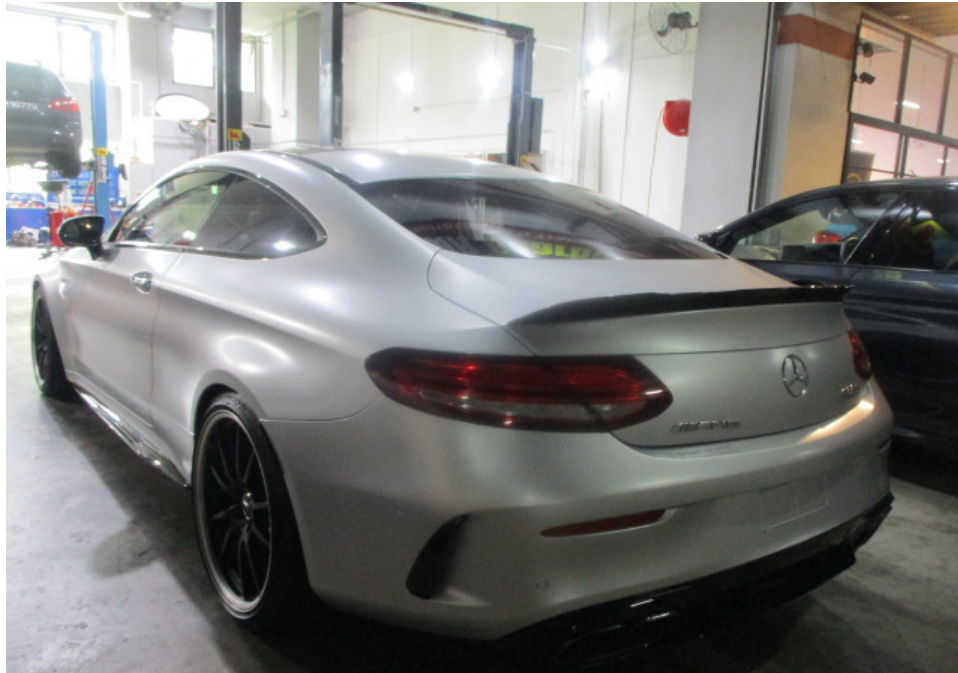
**Photo 12** shows a general view of the rear left body of the Motor Car at the time of my inspection. The Motor Car was observed to be in a relatively good general condition with no loose exterior fittings observed. The mileage of the Motor Car recorded at the time of my inspection was 7,138km.

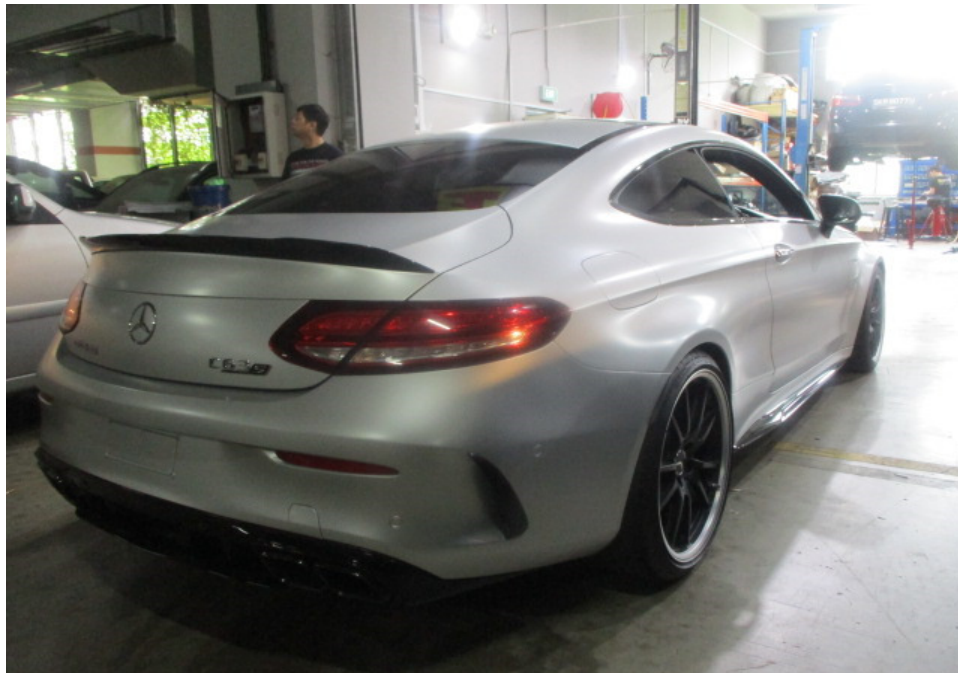
**Photo 13** shows a general view of the rear right body of the Motor Car at the time of my inspection. The Motor Car was observed to be in a relatively good general condition with no loose exterior fittings observed. The mileage of the Motor Car recorded at the time of my inspection was 7,138km.

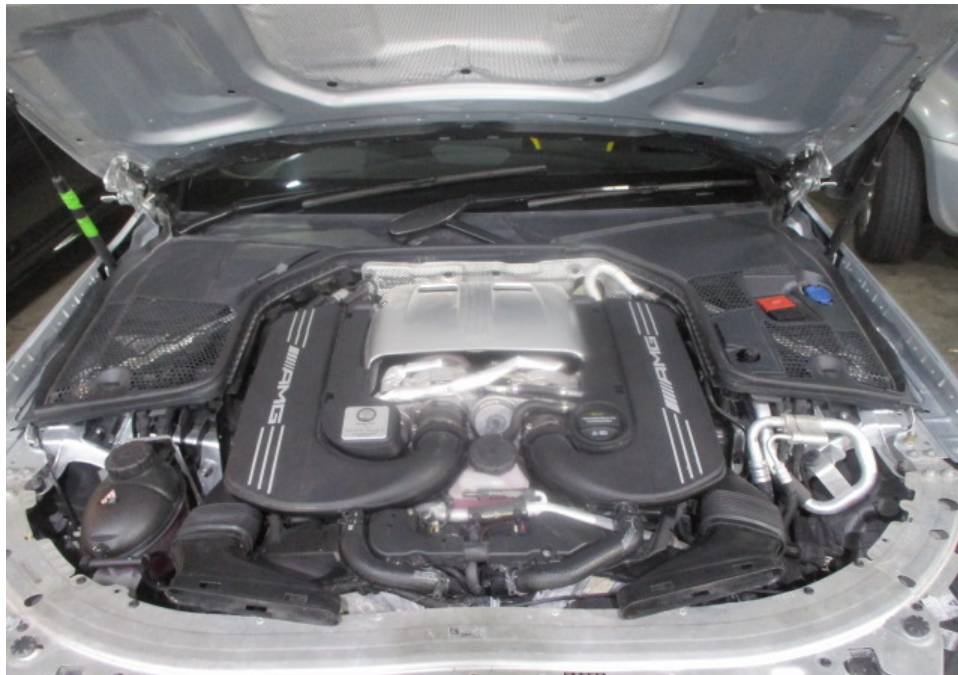
**Photo 15** shows a general view of the Motor Car's engine compartment at the time of my inspection. The various parts and components inside the engine compartment were all observed to be intact and properly fitted. There was also no sign(s) or indication(s) of fluid leak and/or fluid stain found inside the engine compartment.

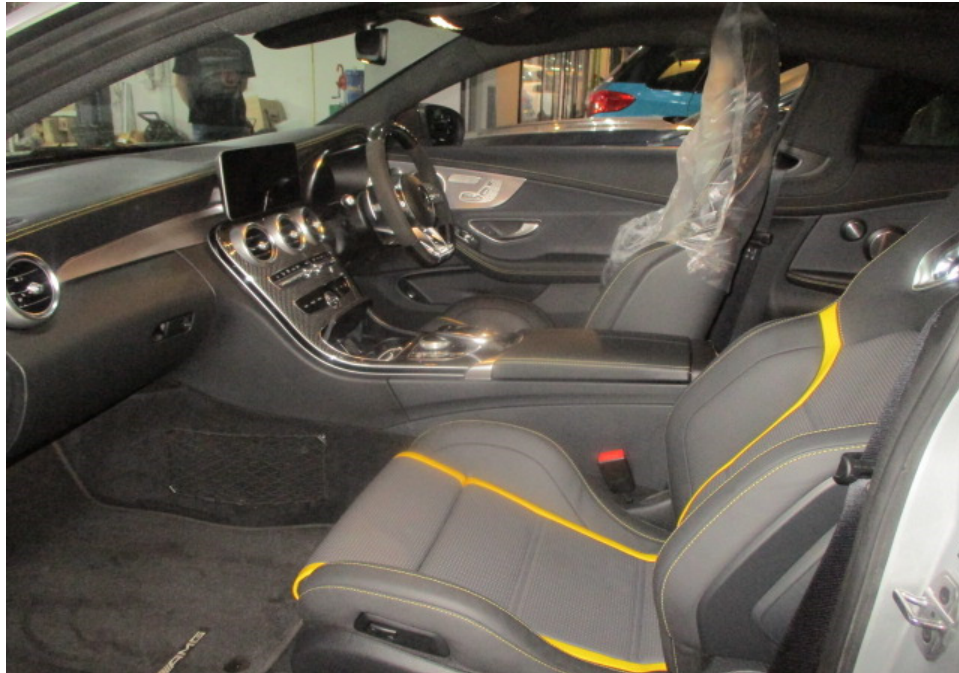
**Photo 16** shows the interior compartment of the Motor Car at the time of my inspection. The various parts and components, trims, carpet, and upholstery inside the interior compartment were all observed to be intact and properly fitted.

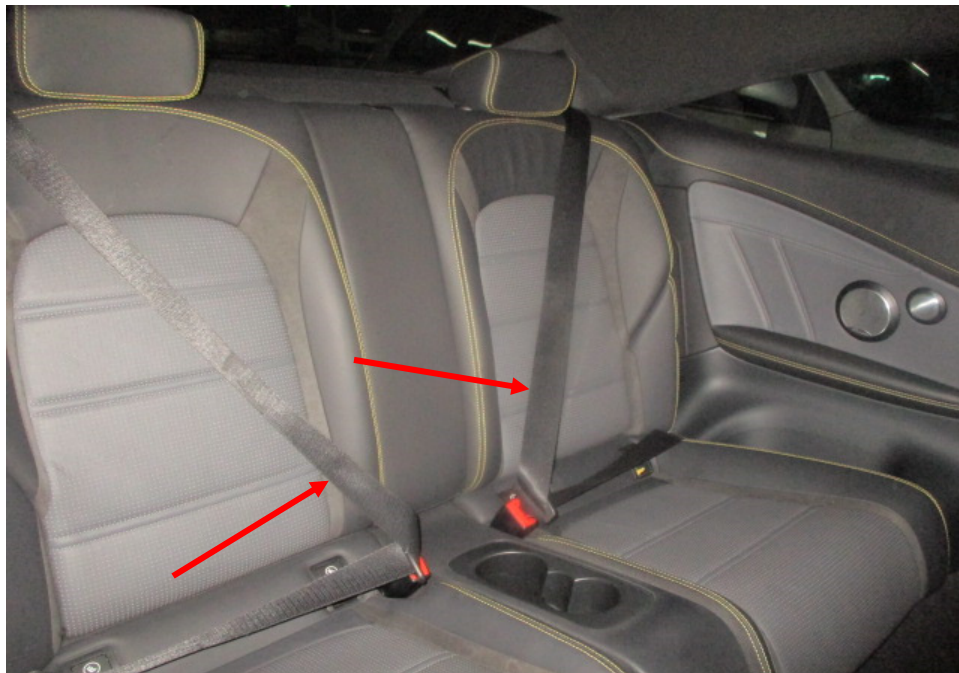
**Photo 17** shows the rear seats of the Motor Car. All the seats of the Motor Car were secured via seat rails to the floorboard. They were also fitted with a retractable seat belt reel and a pre-tensioner. The seat belts (arrowed) were tested and were able to be fastened into the respective pre-tensions that were fitted on the side of each individual seat.

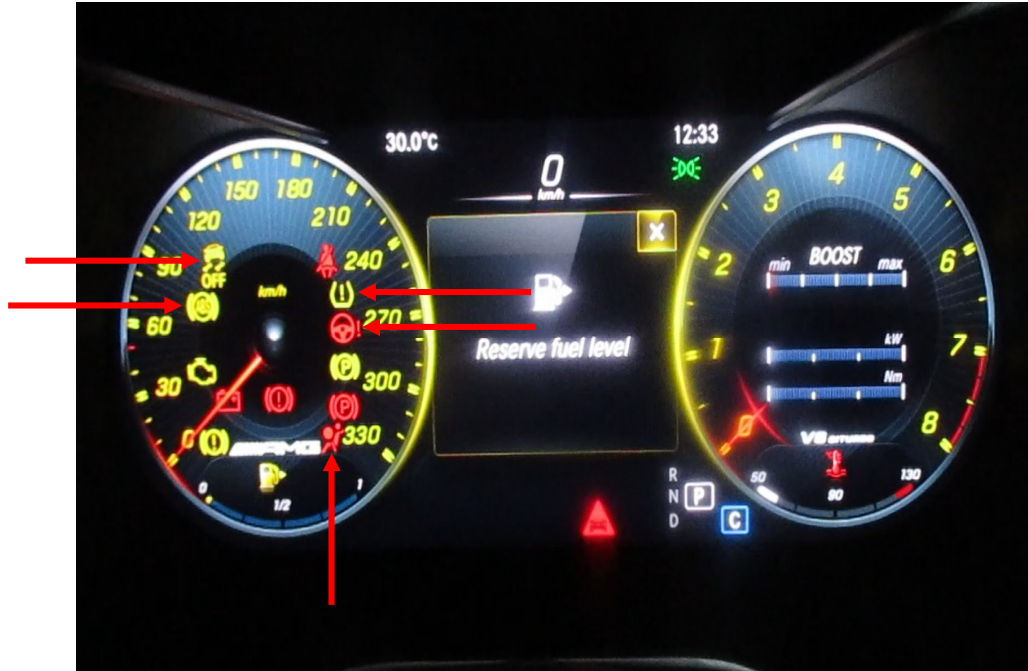
**Photo 18** shows the warning lights for the various electronic safety features appearing on the instrument panel of the Motor Car during its self-test when the engine is cranked, in particular the ABS, SRS, EPS, TPM and TCS lights (arrowed).

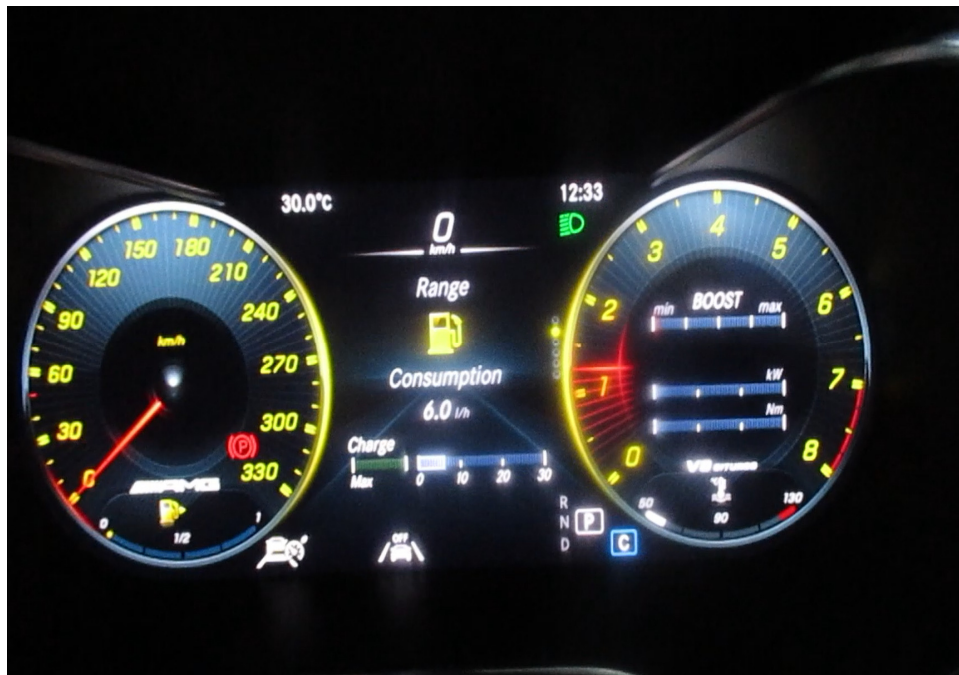
**Photo 19** shows the respective warning lights no longer illuminated, indicating that there is no fault detected to the ABS, SRS, EPS, TPM and TCS systems of the Motor Car during the self-test. These electronic systems were hence in working condition at the time of my inspection.

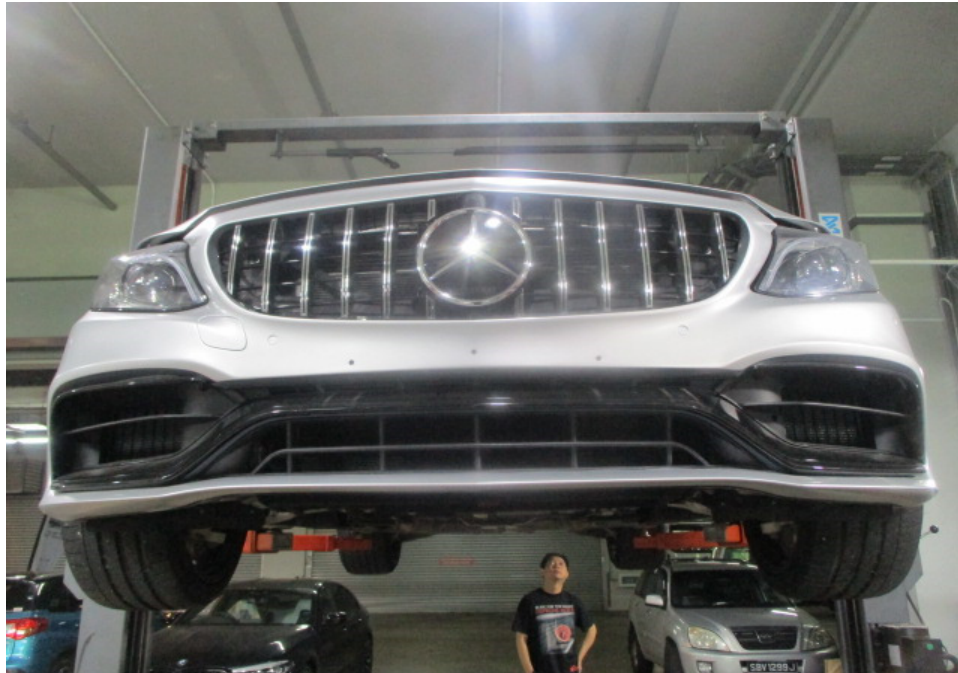
**Photo 20** shows the Motor Car hoisted up for checks on its undercarriage. There was no sign(s) or indication(s) of fluid leakage and/or fluid stain(s) on the underside of the Motor Car. The undercarriage components of the Motor Car were also all observed to be intact and secured in an appropriate manner.

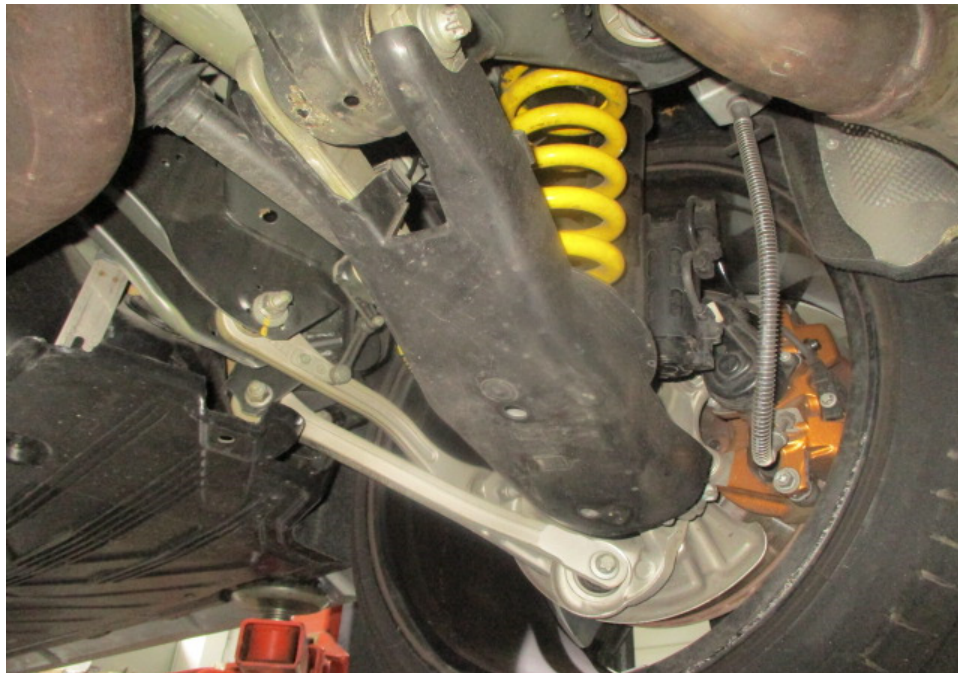
**Photo 21** shows a general view of the control arms and linkages at the rear right wheel of the Motor Car. I did not observe any fluid leak and/or fluid stain on the underside of the Motor Car. All of the Motor Car's undercarriage components were observed to be intact and secured in an appropriate manner.

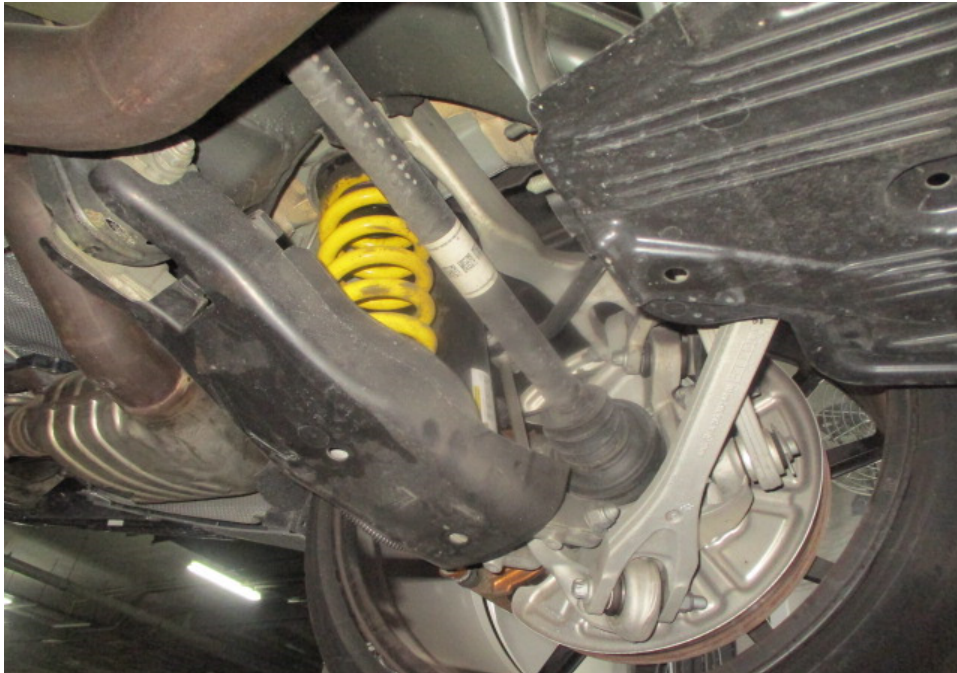
**Photo 22** shows a general view of the control arms and linkages at the rear left wheel of the Motor Car. I did not observe any fluid leak and/or fluid stain on the underside of the Motor Car. All of the Motor Car's undercarriage components were observed to be intact and secured in an appropriate manner.

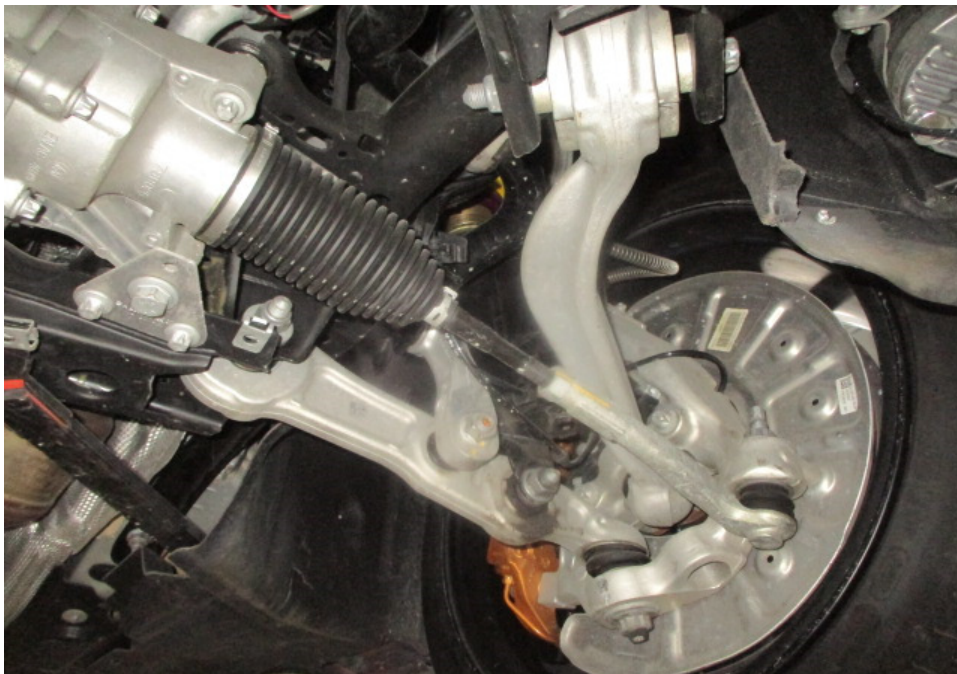
**Photo 23** shows the various undercarriage components at the front left wheel of the Motor Car. The mechanical components, control arms and linkages were all found to be intact and secured in an appropriate manner.

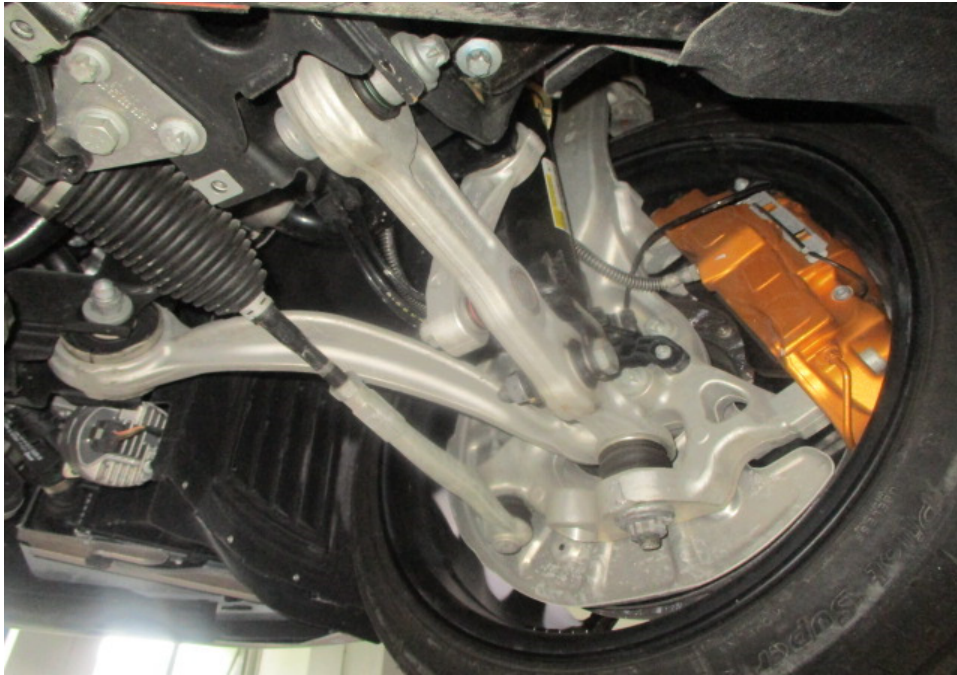
**Photo 24** shows the various undercarriage components at the front right wheel of the Motor Car. The mechanical components, control arms and linkages were all found to be intact and secured in an appropriate manner. I also did not observe any fluid leak and/or fluid stain on the underside of the Motor Car.

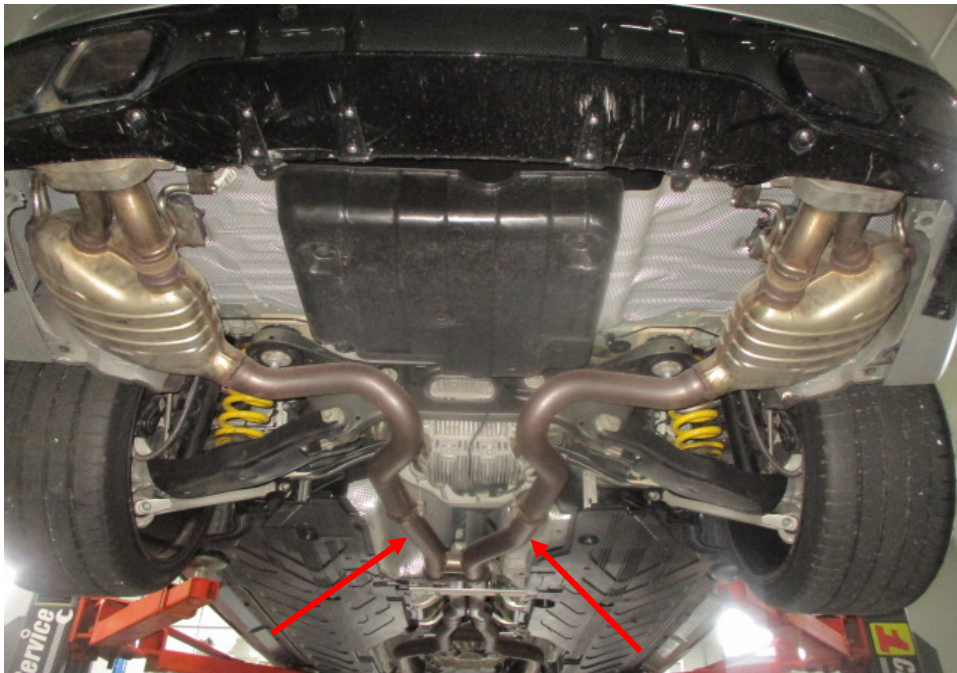
**Photo 25** shows the rear section of the Motor Car's exhaust system. My examination of the Motor Car's exhaust system revealed no sign(s) or indication(s) of any cut or weld marks along its exhaust pipes (arrowed), on its rear mufflers and on its catalytic converters.

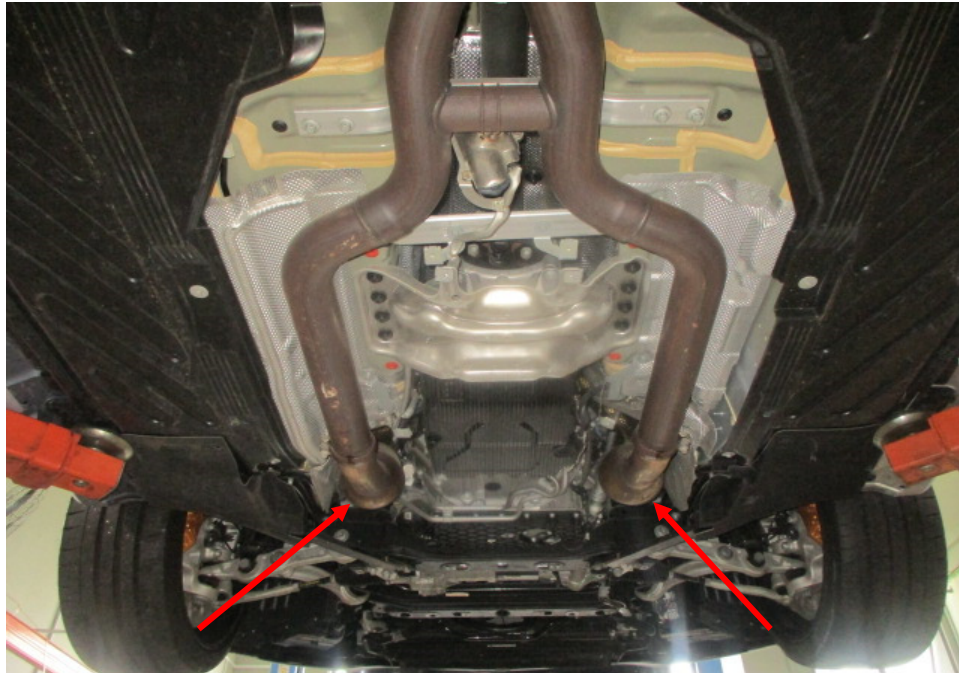
**Photo 26** shows the front section of the Motor Car's exhaust system. My examination of the Motor Car's exhaust system revealed no sign(s) or indication(s) of any cut or weld marks along its exhaust pipes, on its rear mufflers and on its catalytic converters (arrowed).

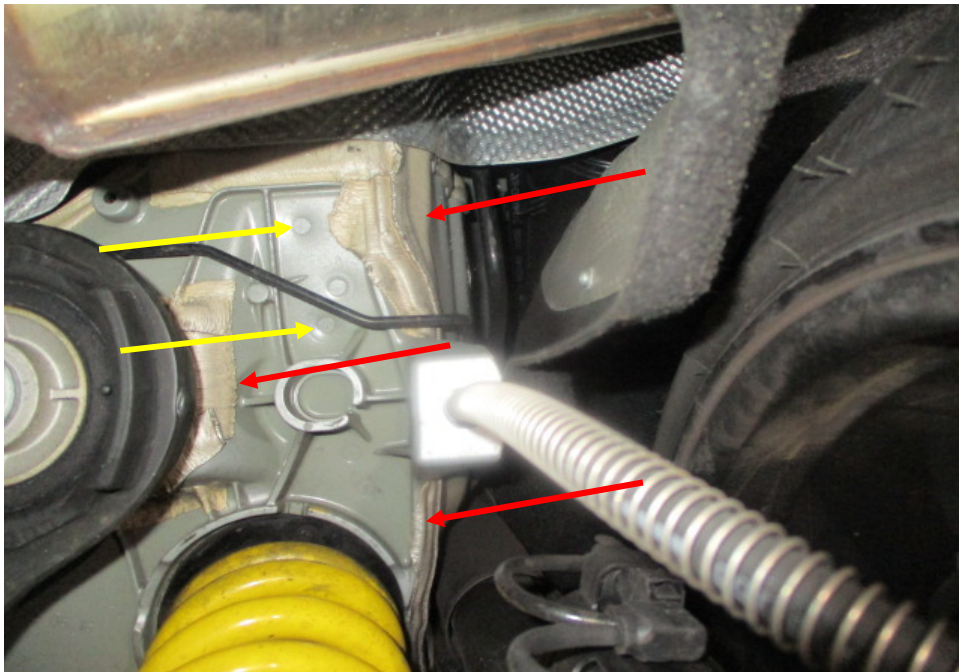
**Photo 27** shows the chassis/structural body at the underside rear right of the Motor Car. I did not find any weld marks other than original spot weld marks (yellow arrow) on the chassis/structural body of the Motor Car. The original factory sealant (red arrow) at the joints along the chassis/structural body was untouched, indicating no work was done on the chassis/structural body of the Motor Car and that the chassis/structural body was originally fitted.

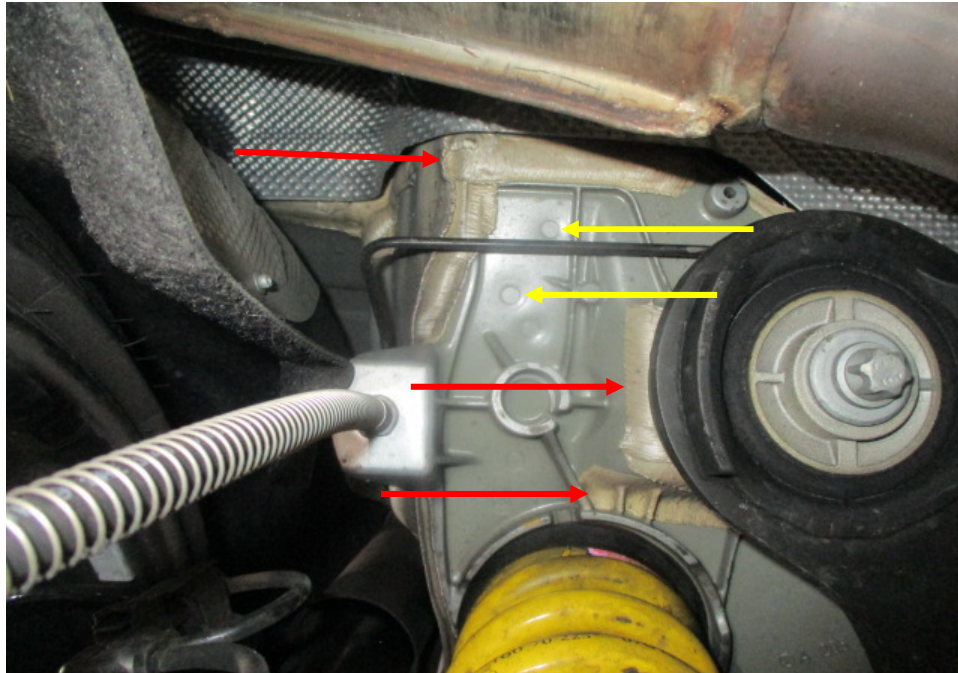
**Photo 28** shows the chassis/structural body at the underside rear left of the Motor Car. I did not find any weld marks other than original spot weld marks (yellow arrow) on the chassis/structural body of the Motor Car. The original factory sealant (red arrow) at the joints along the chassis/structural body was untouched, indicating no work was done on the chassis/structural body of the Motor Car and that the chassis/structural body was originally fitted.

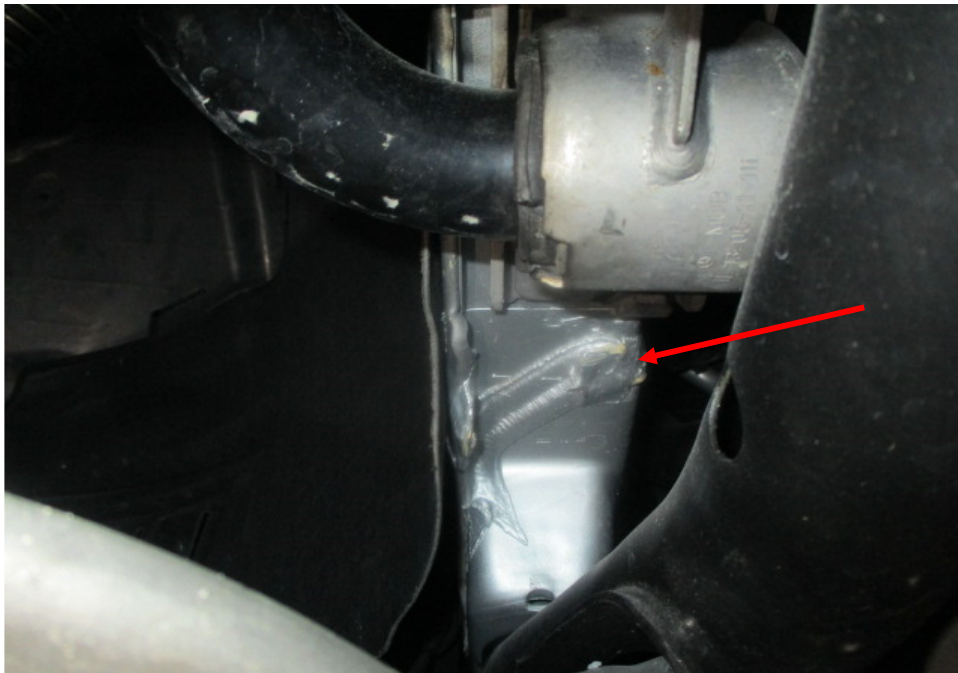
**Photo 29** shows the chassis/structural body at the underside front left of the Motor Car. The original factory sealant (arrowed) at the joints along the chassis/structural body was observed to be untouched. In general, I had found no work was carried out on the chassis/structural body of the Motor Car. The chassis/structural body of the Motor Car was originally fitted.

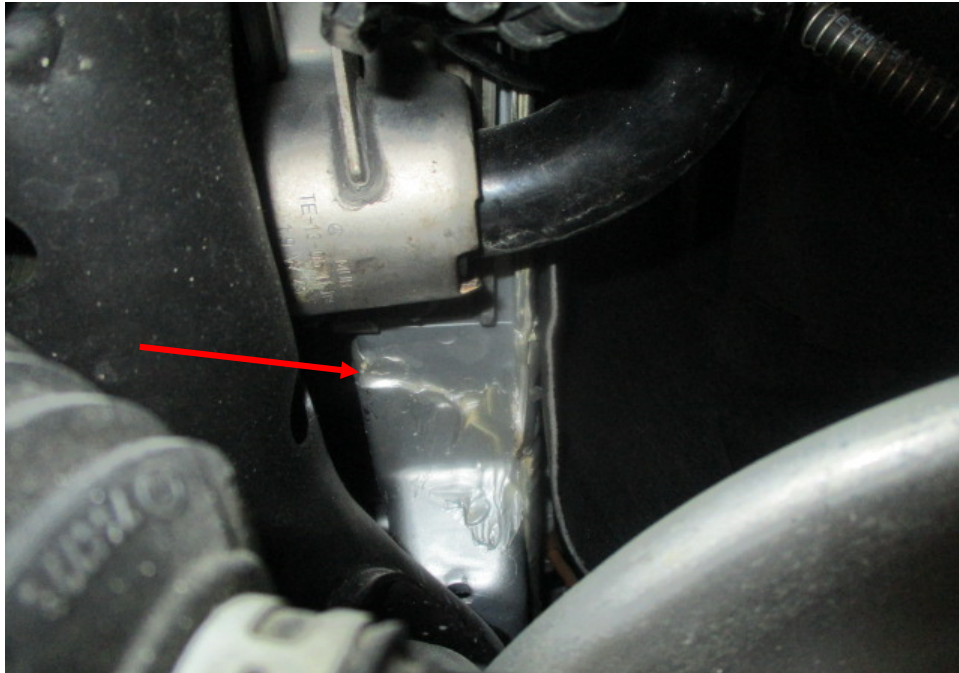
**Photo 30** shows the chassis/structural body at the underside front right of the Motor Car. I did not find any weld marks other than original spot weld marks on the chassis/structural body of the Motor Car. The original factory sealant (arrowed) at the joints along the chassis/structural body was untouched, indicating no work was done on the chassis/structural body of the Motor Car and that the chassis/structural body was originally fitted.
