Your Ref: Mercedes Benz C63s Coupe  
(chassis number W1K2053872G006624)  
Our Ref : CI/TP23000002/D

**INSPECTION REPORT OF AN UNREGISTERED MERCEDES BENZ C63s  
COUPE MOTOR CAR WITH CHASSIS NUMBER W1K2053872G006624**

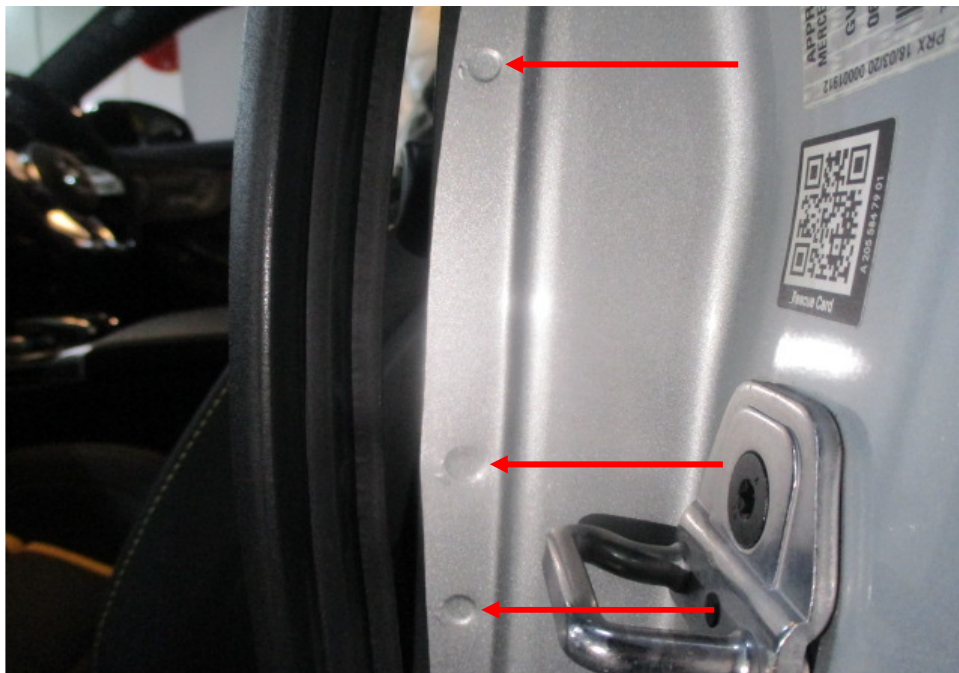
**Photo 31** shows the left side rear body panel of the Motor Car. I did not find any weld marks other than original spot weld marks (arrowed) on the left side rear body panel of the Motor Car, which indicates that there was no re-welding works carried out. In general, I had found all the non-detachable body panels of the Motor Car to be originally fitted at the time of my inspection.

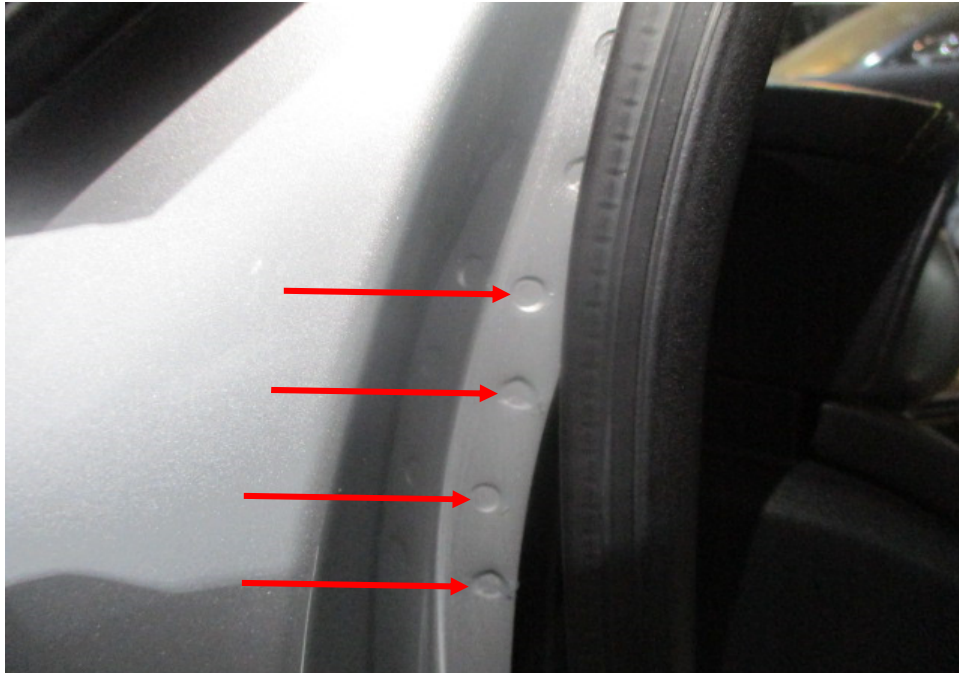
**Photo 32** shows the left side "A" pillar of the Motor Car. I did not find any weld marks other than original spot weld marks (arrowed) on the left side "A" pillar of the Motor Car, which indicates that there was no re-welding works carried out. In general, I had found all the non-detachable body panels of the Motor Car to be originally fitted at the time of my inspection.

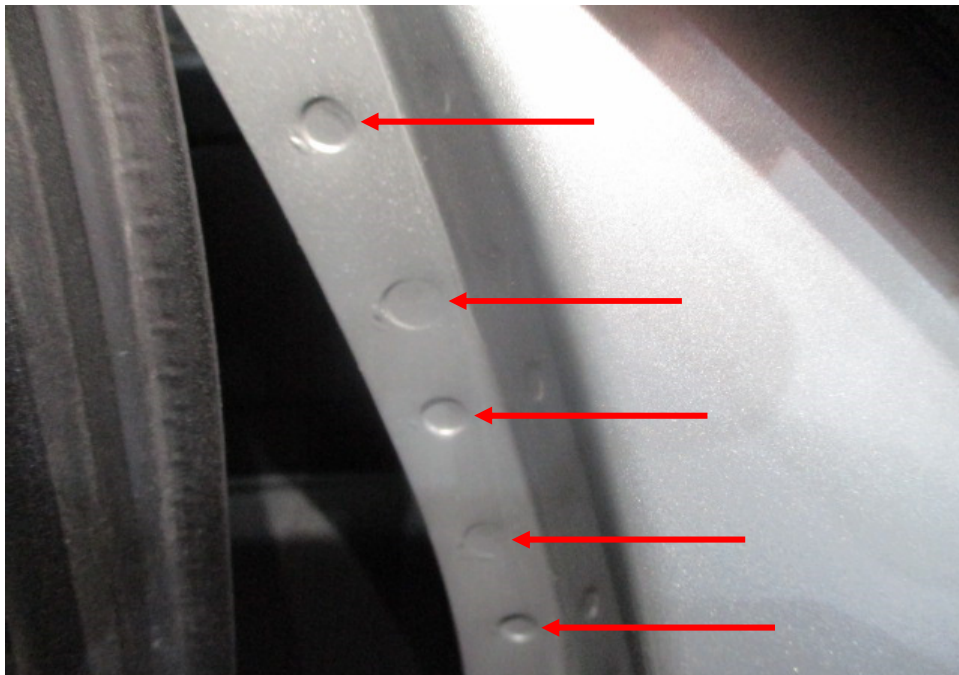
**Photo 33** shows the right side "A" pillar of the Motor Car. I did not find any weld marks other than original spot weld marks (arrowed) on the right side "A" pillar of the Motor Car, which indicates that there was no re-welding works carried out. In general, I had found all the non-detachable body panels of the Motor Car to be originally fitted at the time of my inspection.

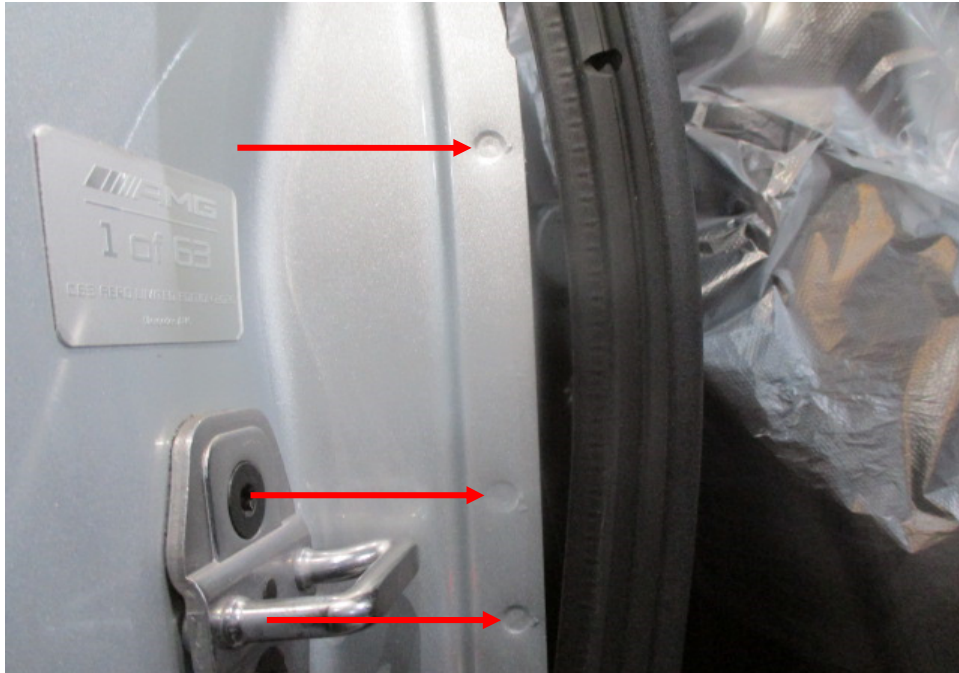
**Photo 34** shows the right side rear body panel of the Motor Car. I did not find any weld marks other than original spot weld marks (arrowed) on the right side rear body panel of the Motor Car, which indicates that there was no re-welding works carried out. In general, I had found all the non-detachable body panels of the Motor Car to be originally fitted at the time of my inspection.
