Your Ref: BMW M5
(chassis number WBSJF02020CE61792)
Our Ref : CI/TP23000003/D

03 January 2023

INSPECTION REPORT OF AN UNREGISTERED BMW M5 MOTOR CAR WITH CHASSIS NUMBER WBSJF02020CE61792

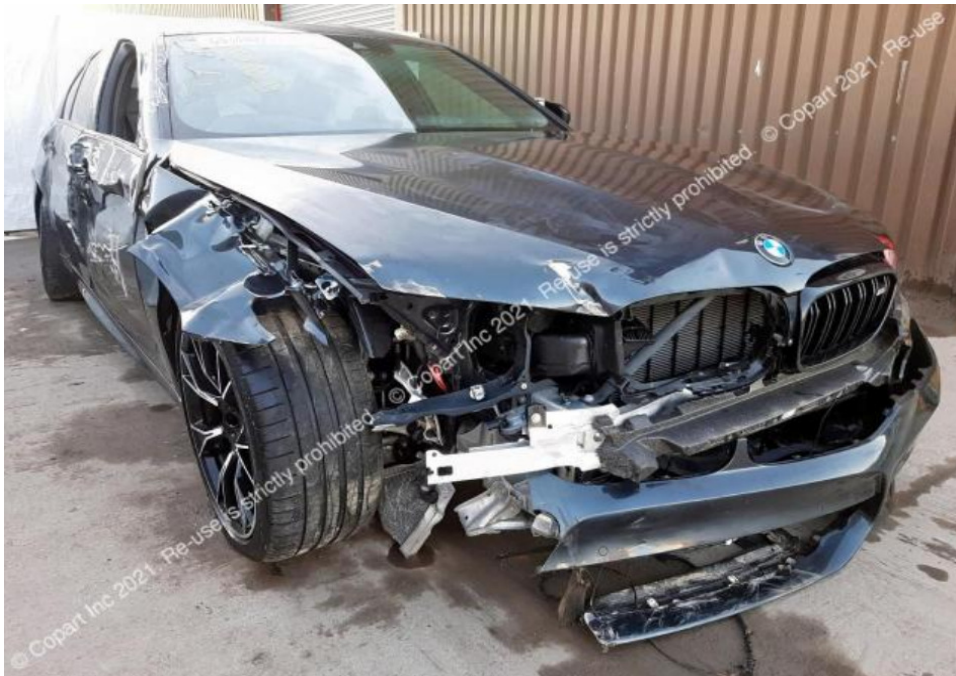
Photo 1 shows the front right body of the Motor Car (photograph provided to me). The photographs provided to me had showed damage to the front right portion and right side portion of the Motor Car. The front bumper, front bumper centre lower grille, front bumper right lower grille, front bumper right sensor, front bumper sponge, front bumper reinforcement, front bonnet, front right headlamp, front right headlamp bracket, front right radiator grille, front right fender, front right fender inner shield, front right door and right side wing mirror were amongst the body parts that were observed to have been damaged.

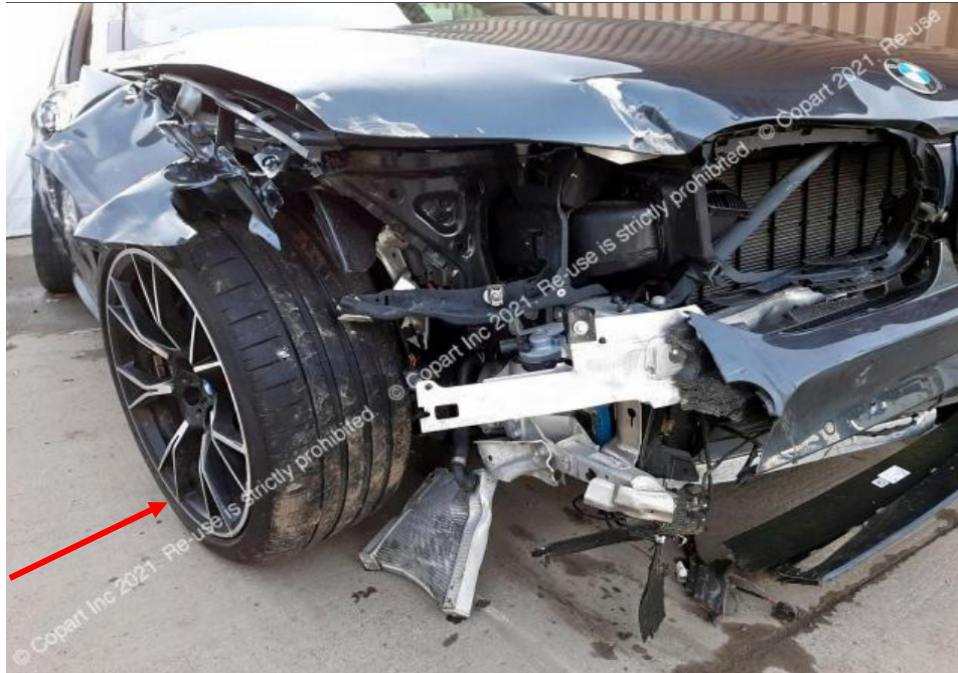
Photo 2 shows a closer view of the damaged front right portion of the Motor Car (photograph provided to me). The front bumper, front bumper centre lower grille, front bumper right lower grille, front bumper reinforcement, front bonnet, front right headlamp, front right headlamp bracket, front right fender and front right fender inner shield were amongst the body parts that were observed to have been damaged. The front right wheel (arrowed) was also observed to be shifted from normal position, suggesting damage to the Motor Car's front right undercarriage parts.

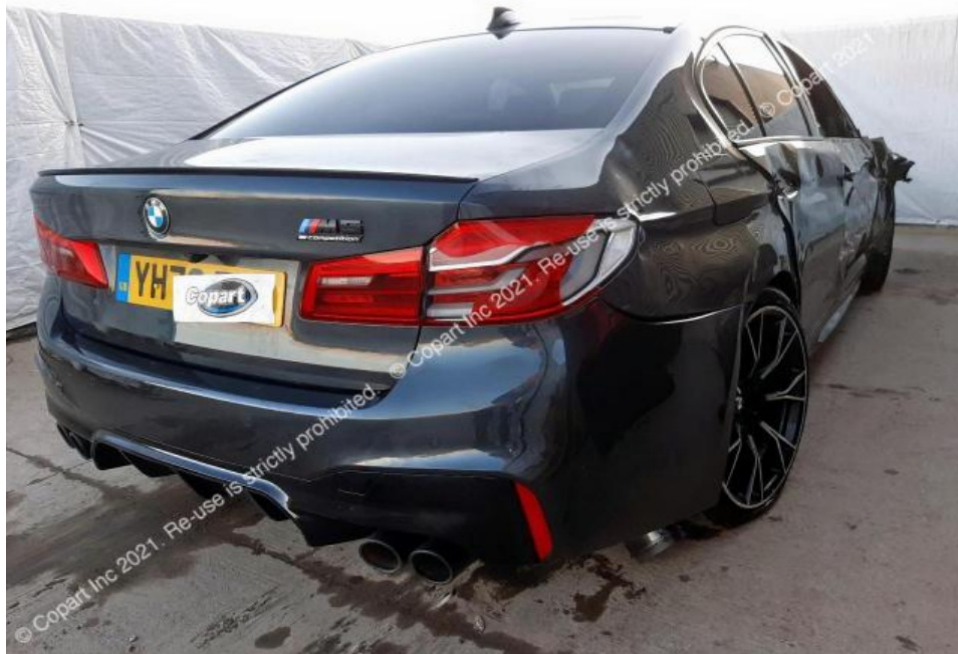
Photo 3 shows the rear right body of the Motor Car (photograph provided to me). The rear right taillamp, rear right fender, rear right door and rear right door handle were amongst the body parts that were observed to have been damaged.

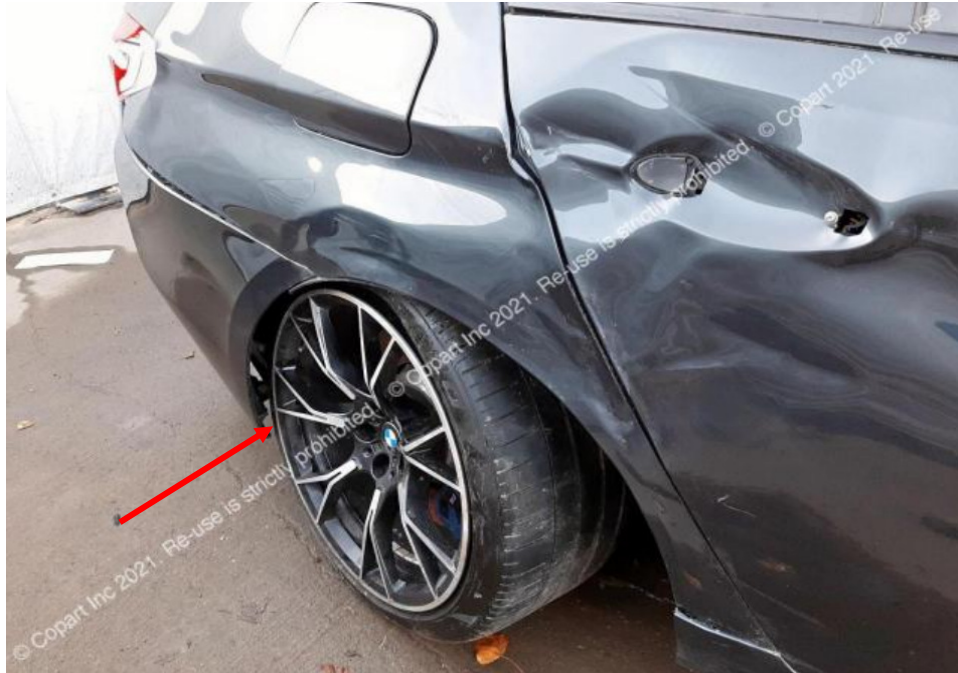
Photo 4 shows a closer view of the damaged right rear portion of the Motor Car (photograph provided to me). The rear right door, rear right door handle and rear right fender were amongst the body parts that were observed to have been damaged. The rear right wheel (arrowed) was also observed to be shifted from normal position, suggesting damage to the Motor Car's rear right undercarriage parts.

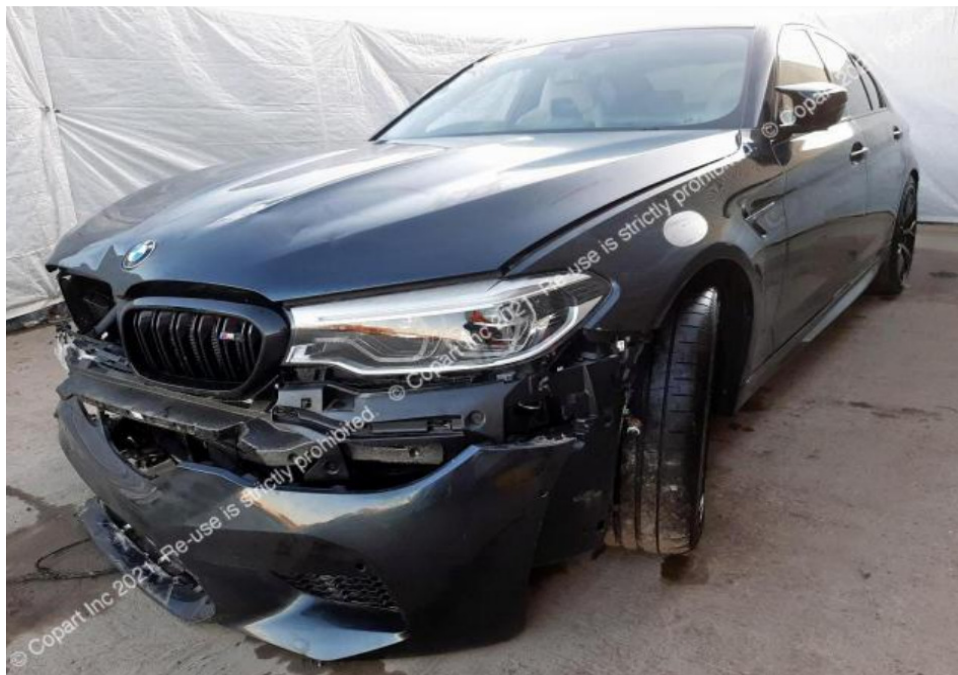
Photo 5 shows the front left body of the Motor Car (photograph provided to me). The left side of the Motor Car was undamaged as seen from the photographs that were provided to me.

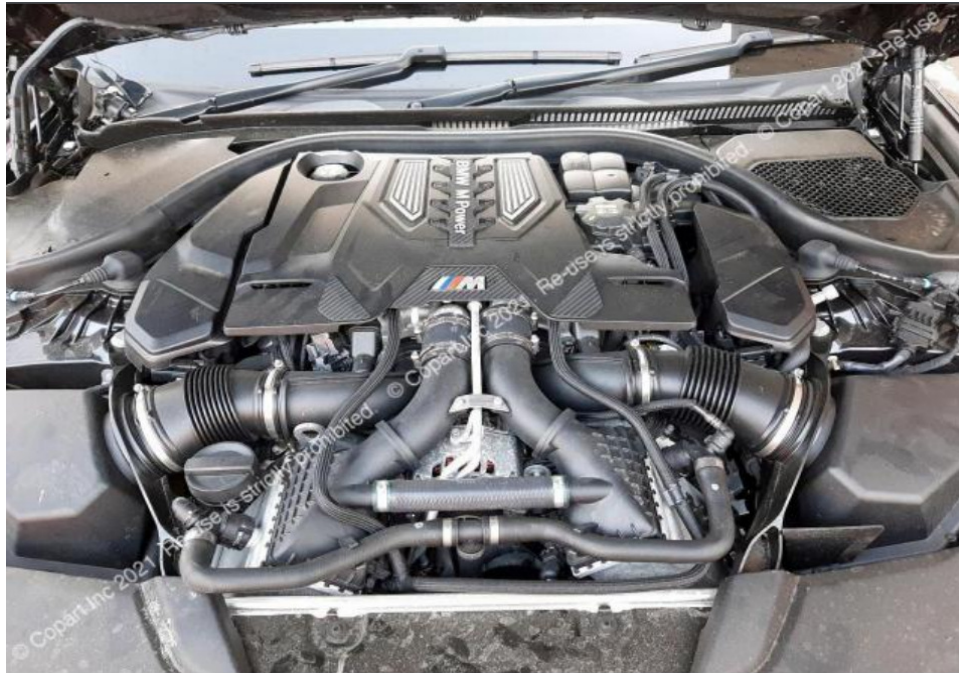
Photo 6 shows the engine compartment of the Motor Car (photograph provided to me). The various parts and components within the engine compartment were all intact and unaffected.

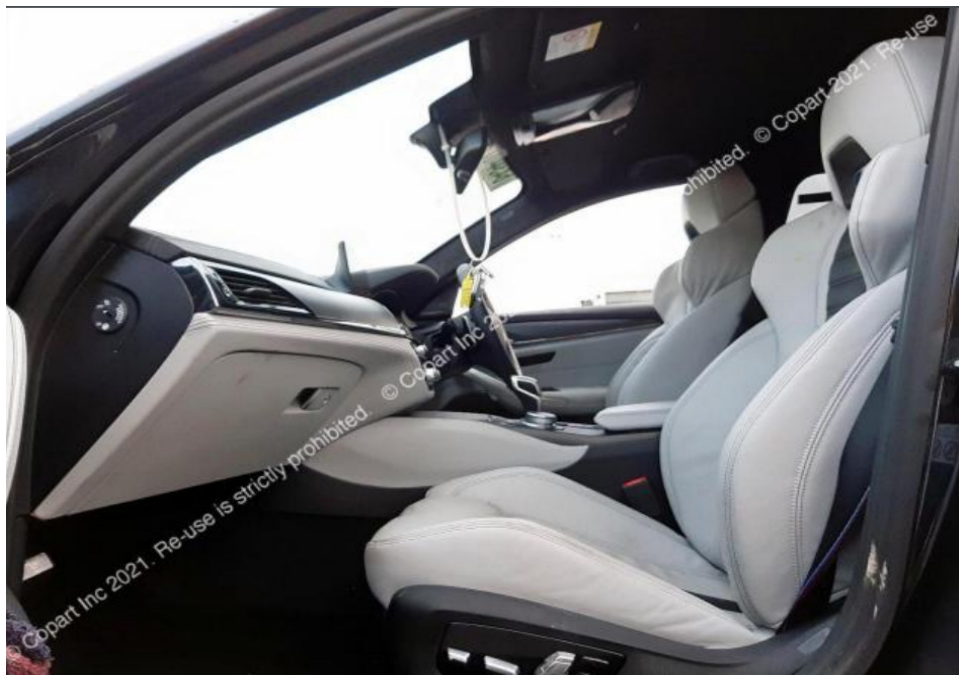
Photo 7 shows the interior compartment of the Motor Car (photograph provided to me). The various parts and components within the interior compartment were all intact and unaffected. The airbag(s) was not deployed.

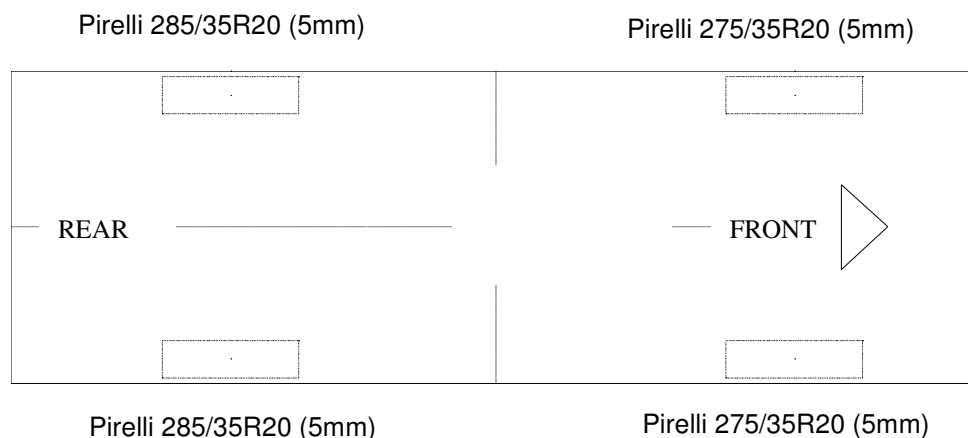
10. The Motor Car was fitted with 20inch sport wheel rims that were wrapped with tyres that were observed to be of serviceable condition. The tyres were also sufficiently inflated for vehicular operation. The tyre brand, tyre size and approximate remaining tread depth of the 4 tyres of the Motor Car were recorded as follows: -

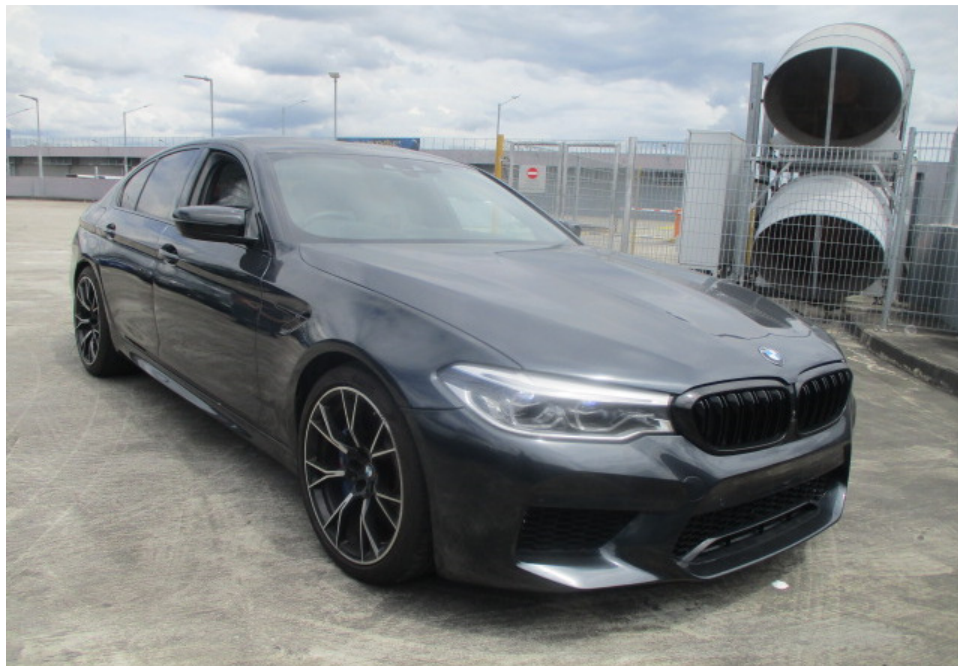
Photo 8 shows a general view of the front right body of the Motor Car at the time of my inspection. The Motor Car was observed to be in a relatively good general condition with no loose exterior fittings observed. The body parts at the front right portion of the Motor Car were visually examined and it was observed that the repair/restoration works carried out to the damaged area of the Motor Car (refer to photograph 1 & 2 above) were reasonably adequate and in order.

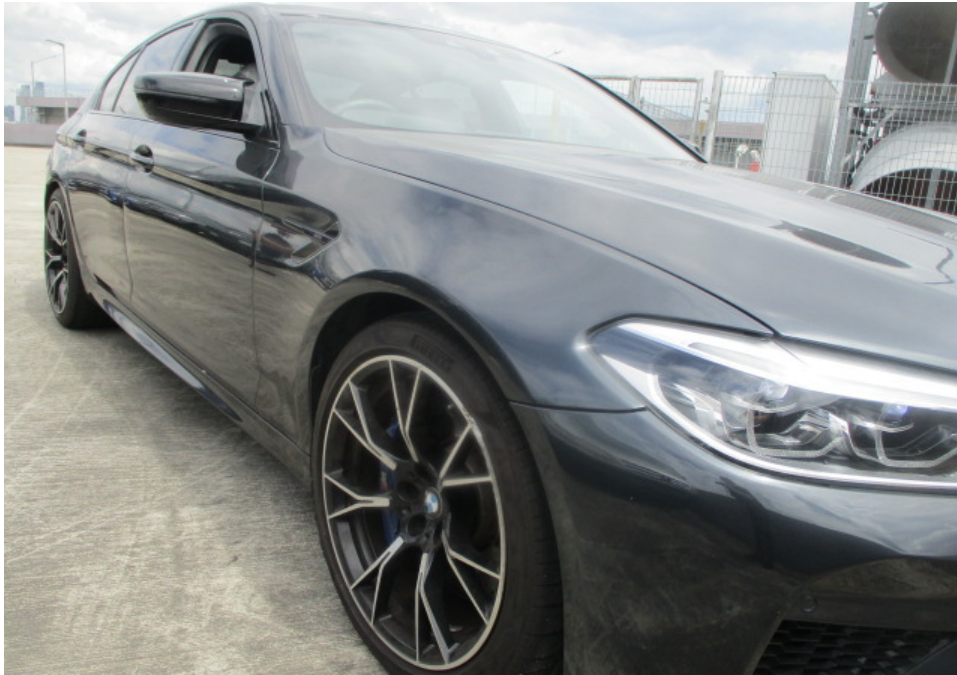
Photo 9 shows a closer view of the Motor Car's front right headlamp, front right wheel rim and front right fender. The body parts at the front right portion and right side front portion of the Motor Car were visually examined and it was observed that the repair/restoration works carried out to the damaged area of the Motor Car (refer to photograph 1 - 2 above) were reasonably adequate and in order.

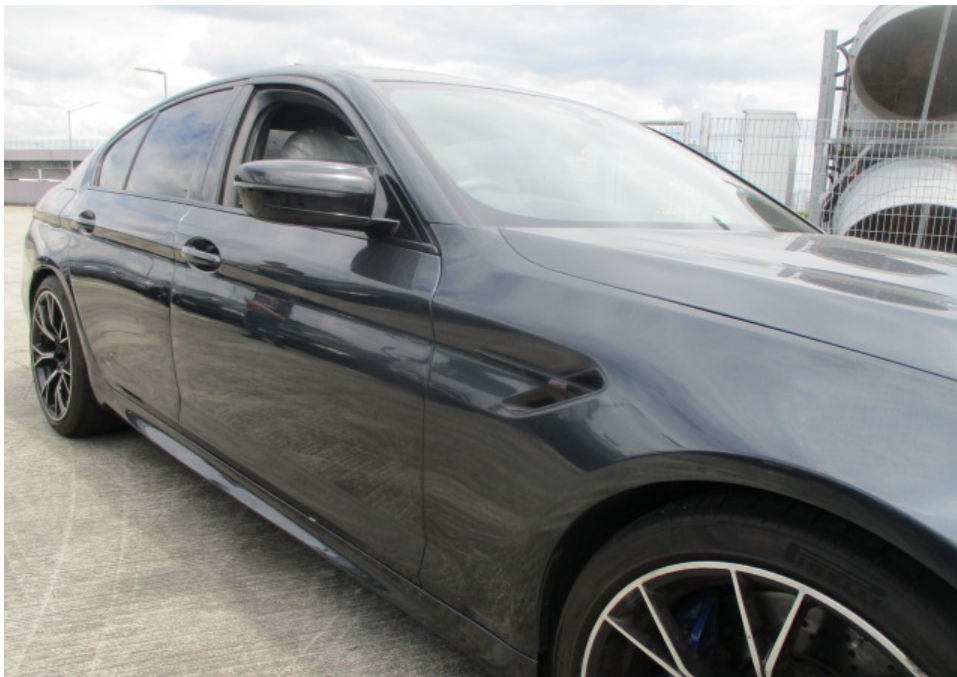
Photo 10 shows a closer view of the Motor Car's front right fender, front right door and right side wing mirror. The body parts at the right side front portion of the Motor Car were visually examined and it was observed that the repair/restoration works carried out to the damaged area of the Motor Car (refer to photograph 2 above) were reasonably adequate and in order.

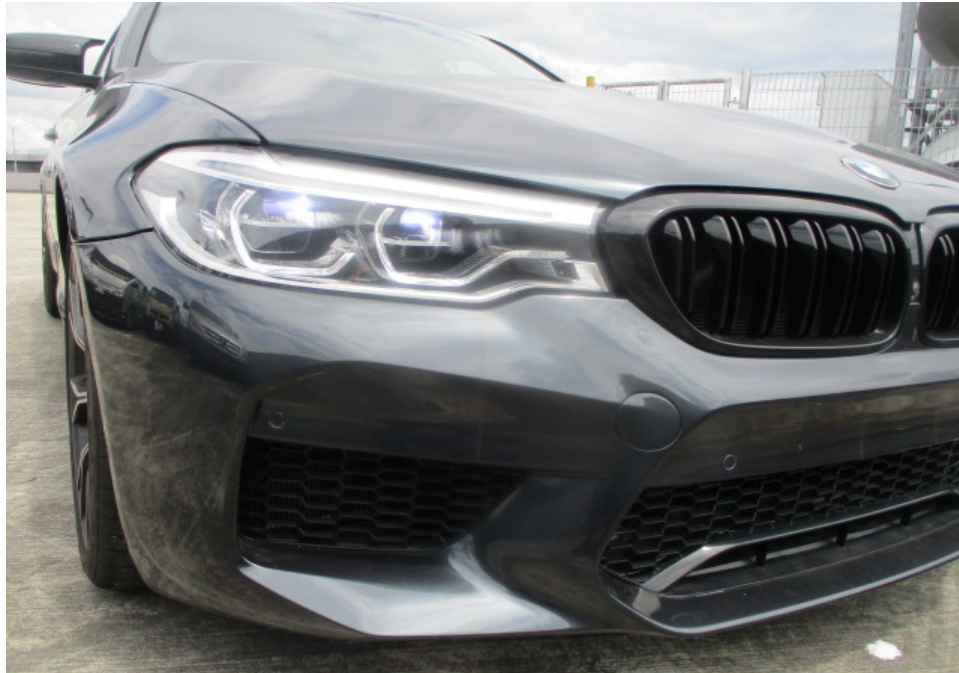
Photo 11 shows a closer view of the Motor Car's front bumper, front bumper right lower grille and front right headlamp. The body parts at the front right portion of the Motor Car were visually examined and it was observed that the repair/restoration works carried out to the damaged area of the Motor Car (refer to photograph 1 - 2 above) were reasonably adequate and in order.

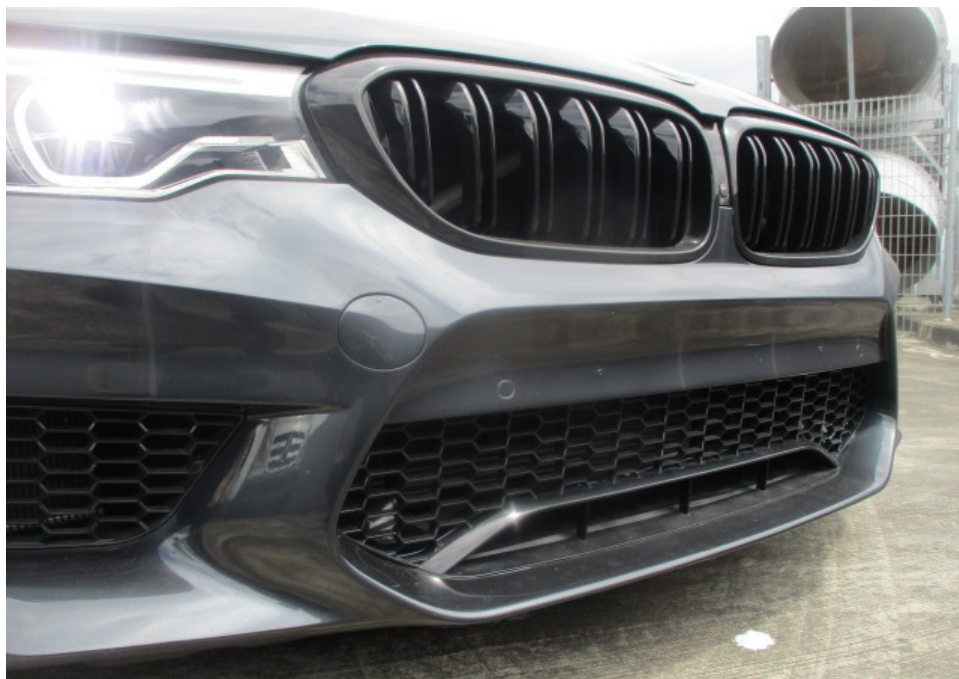
Photo 12 shows a closer view of the Motor Car's front bumper, front bumper centre lower grille, front bumper sensors, front bumper tow cover and front radiator grilles. The body parts at the front right portion of the Motor Car were visually examined and it was observed that the repair/restoration works carried out to the damaged area of the Motor Car (refer to photograph 1 - 2 above) were reasonably adequate and in order.

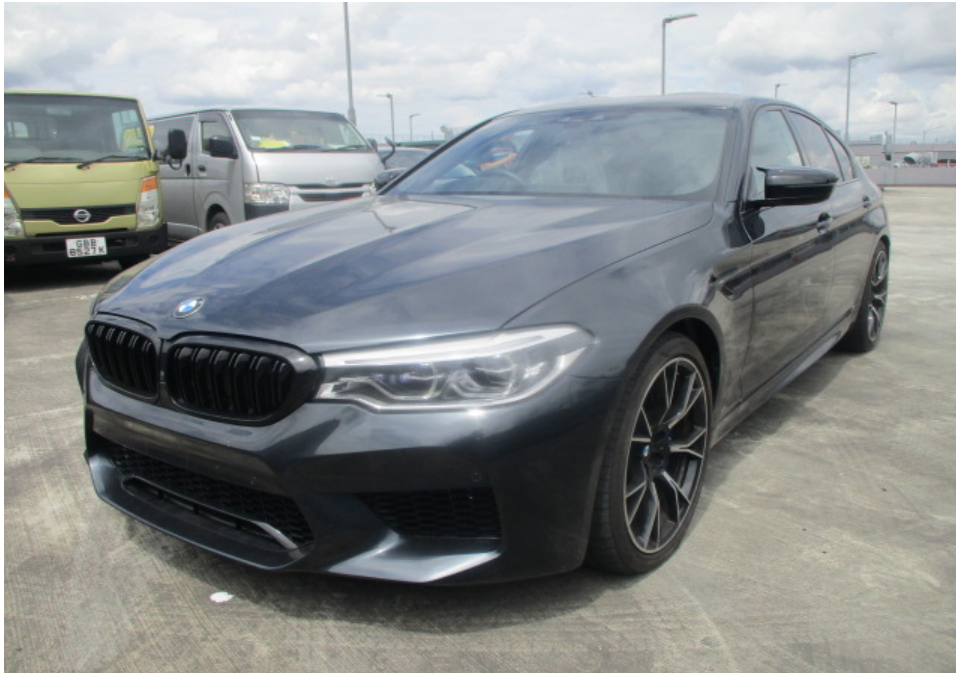
Photo 13 shows a general view of the front left body of the Motor Car at the time of my inspection. The Motor Car was observed to be in a relatively good general condition with no loose exterior fittings observed. The mileage of the Motor Car recorded at the time of my inspection was 10,672km.

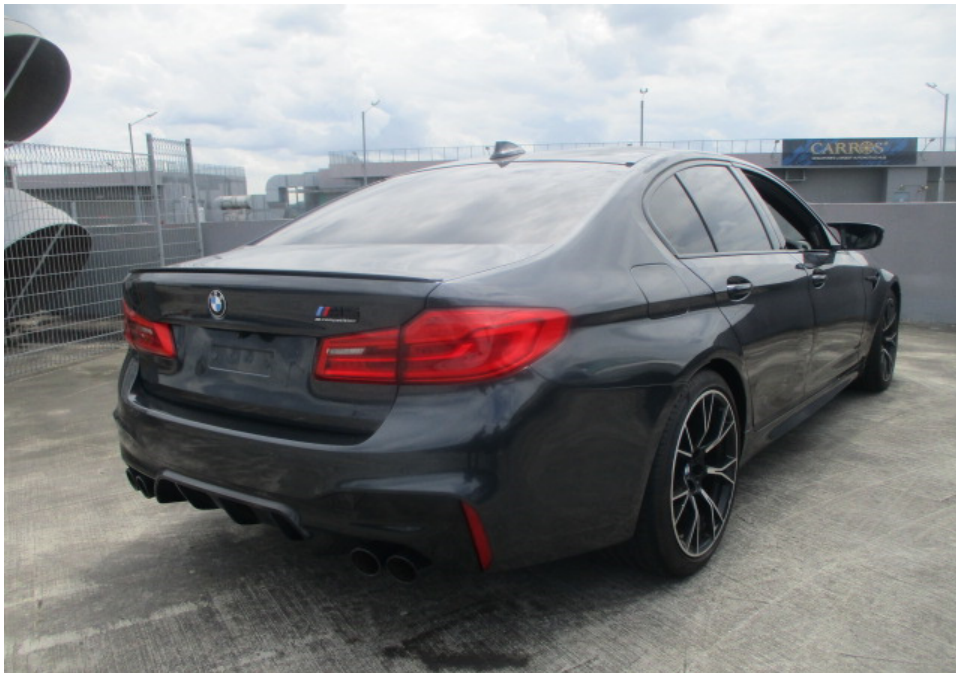
Photo 14 shows a general view of the rear right body of the Motor Car at the time of my inspection. The Motor Car was observed to be in a relatively good general condition with no loose exterior fittings observed. The body parts at the right side portion of the Motor Car were visually examined and it was observed that the repair/restoration works carried out to the damaged area of the Motor Car (refer to photograph 3 & 4 above) were reasonably adequate and in order.

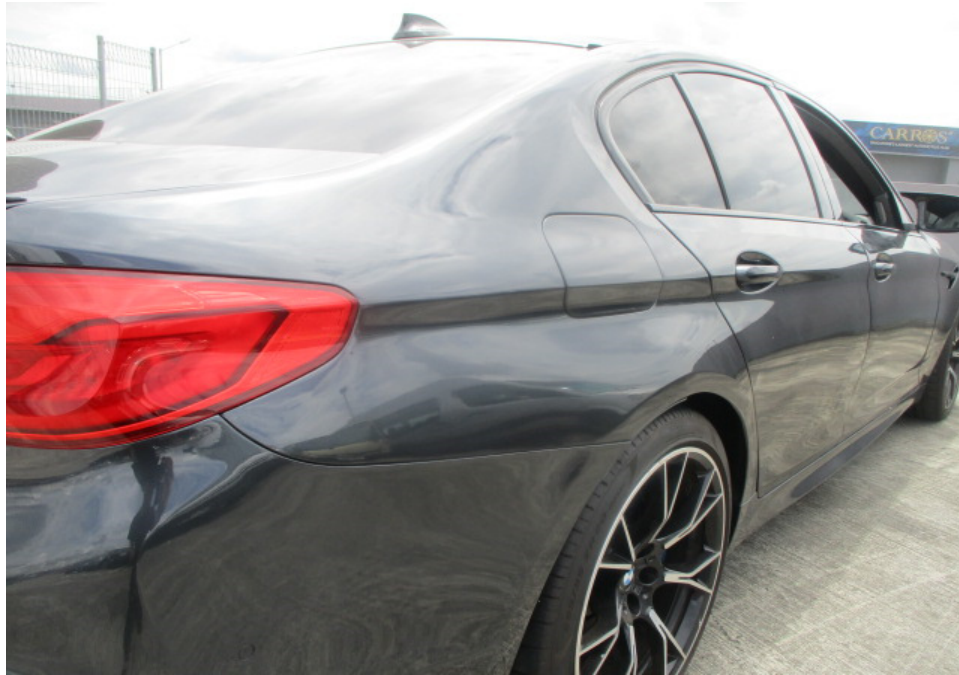
Photo 15 shows a closer view of the Motor Car's rear bumper, rear right taillamp and rear right fender. The body parts at the right side rear portion of the Motor Car were visually examined and it was observed that the repair/restoration works carried out to the damaged area of the Motor Car (refer to photograph 3 & 4 above) were reasonably adequate and in order.

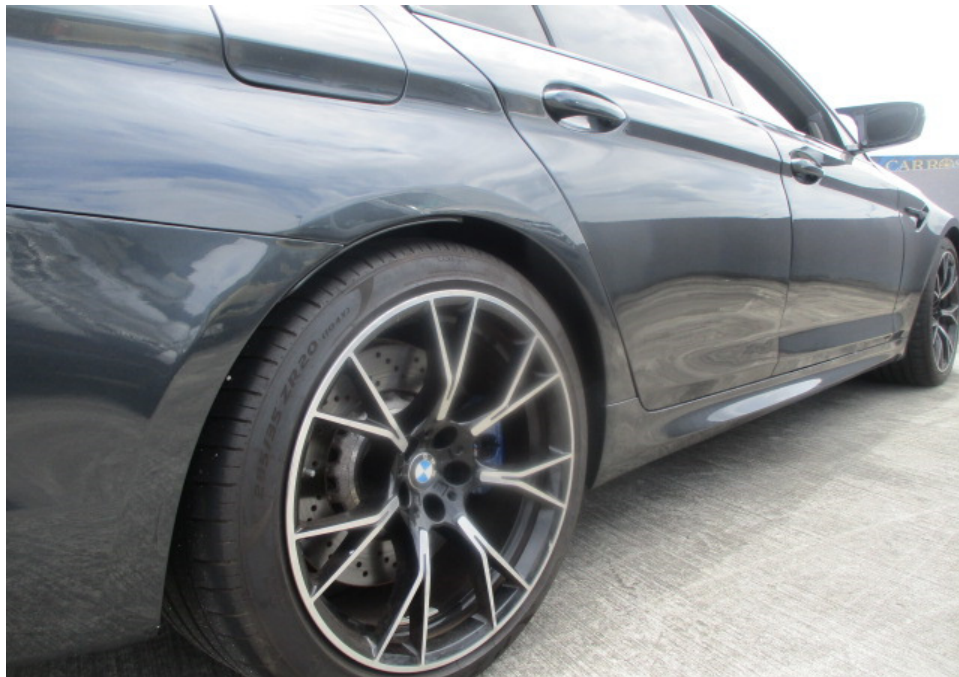
Photo 16 shows a closer view of the Motor Car's rear right wheel, rear right fender and rear right door. The body parts at the right side rear portion of the Motor Car were visually examined and it was observed that the repair/restoration works carried out to the damaged area of the Motor Car (refer to photograph 3 & 4 above) were reasonably adequate and in order.

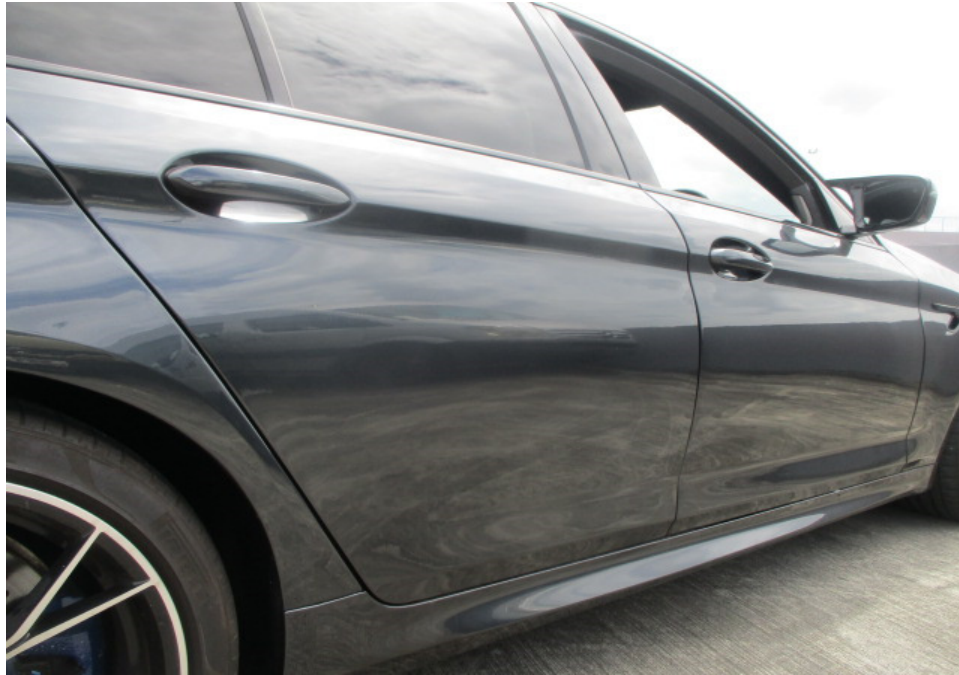
Photo 17 shows a closer view of the Motor Car's rear right door, rear right door handle, front right door, front right door handle and right side rocker panel garnish. The body parts at the right side centre portion of the Motor Car were visually examined and it was observed that the repair/restoration works carried out to the damaged area of the Motor Car (refer to photograph 2 & 4 above) were reasonably adequate and in order.

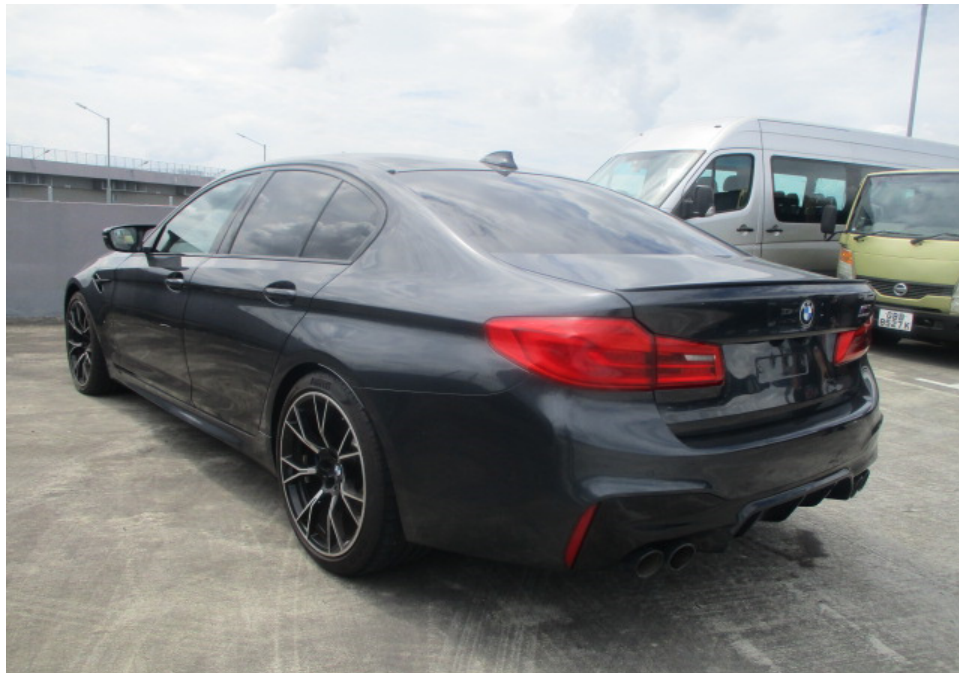
Photo 18 shows a general view of the rear left body of the Motor Car at the time of my inspection. The Motor Car was observed to be in a relatively good general condition with no loose exterior fittings observed. The mileage of the Motor Car recorded at the time of my inspection was 10,672km.

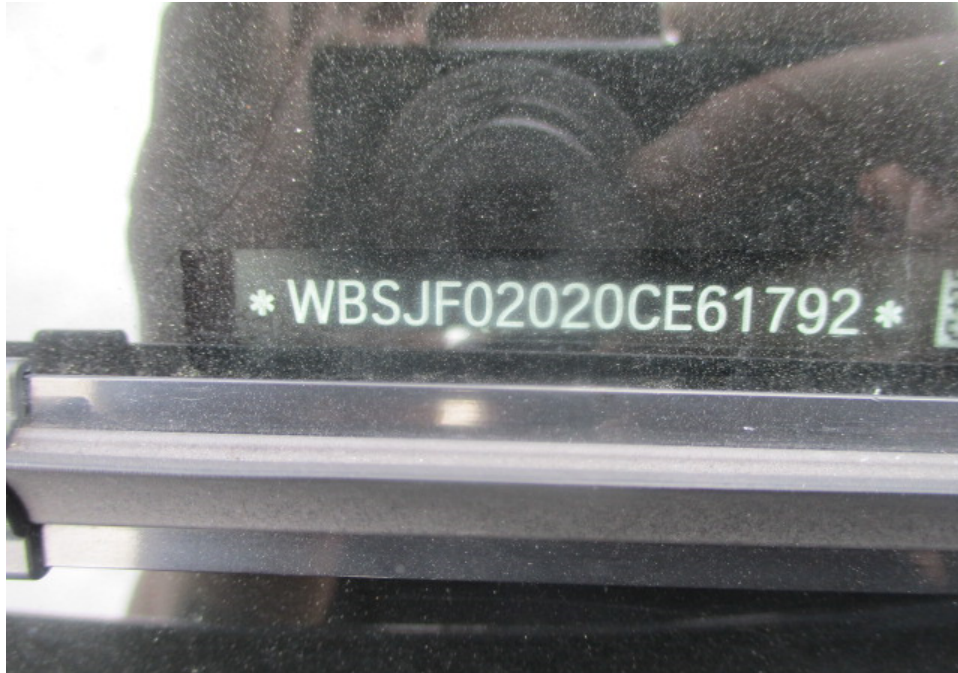
Photo 19 shows the chassis number of the Motor Car. The chassis number recorded was WBSJF02020CE61792.

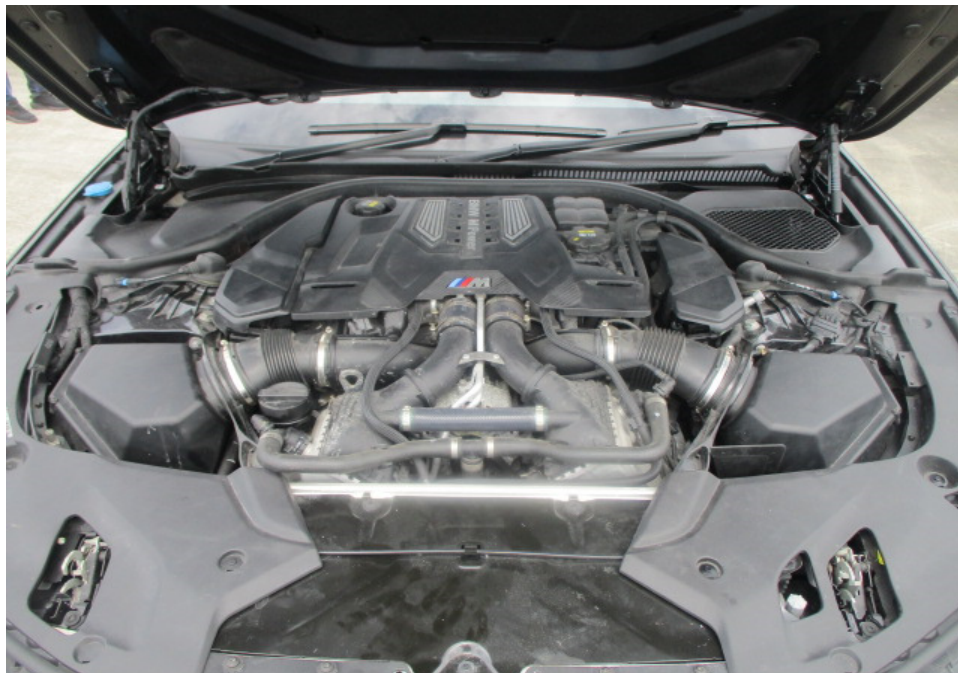
Photo 20 shows a general view of the Motor Car's engine compartment at the time of my inspection. The various parts and components inside the engine compartment were all observed to be intact and properly fitted. There was also no sign(s) or indication(s) of fluid leak and/or fluid stain found inside the engine compartment.

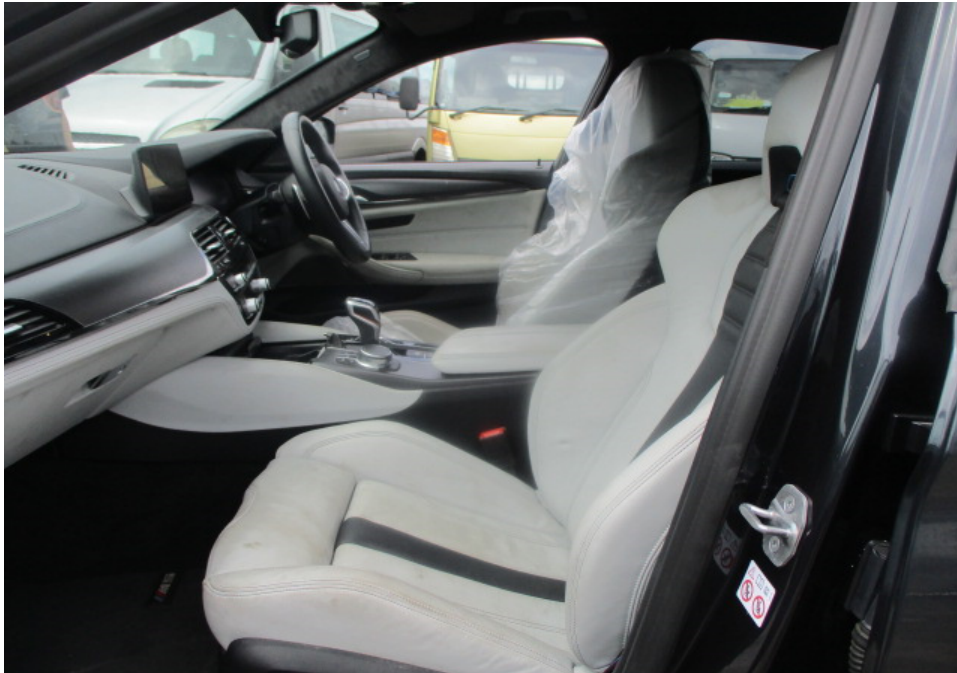
Photo 21 shows the interior compartment of the Motor Car at the time of my inspection. The various parts and components, trims, carpet, and upholstery inside the interior compartment were all observed to be intact and properly fitted.

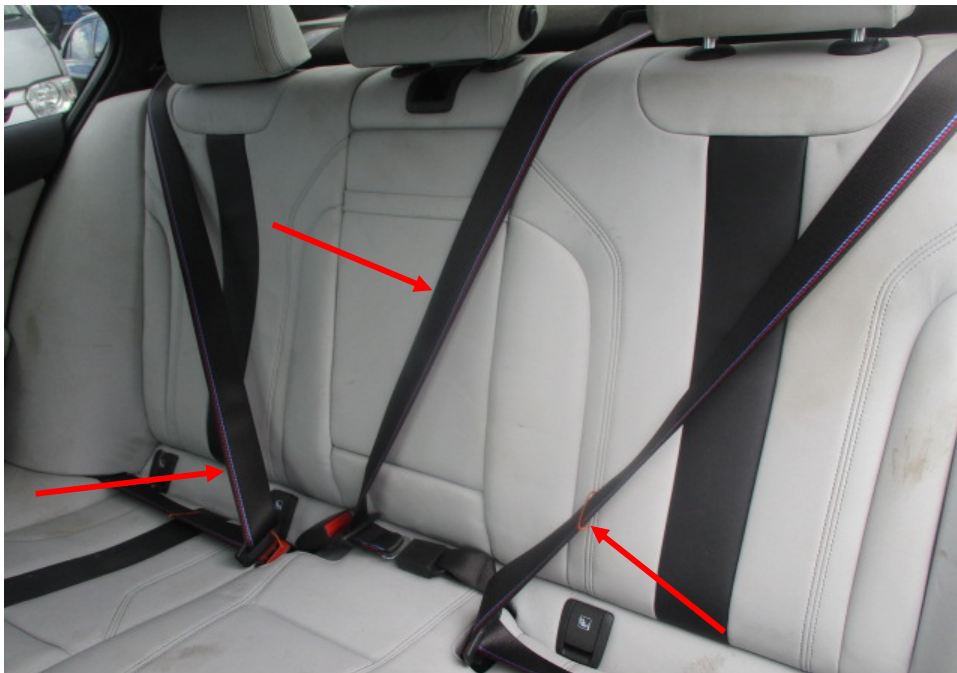
Photo 22 shows the rear seats of the Motor Car. All the seats of the Motor Car were secured via seat rails to the floorboard. They were also fitted with a retractable seat belt reel and a pre-tensioner. The seat belts (arrowed) were tested and were able to be fastened into the respective pre-tensions that were fitted on the side of each individual seat.

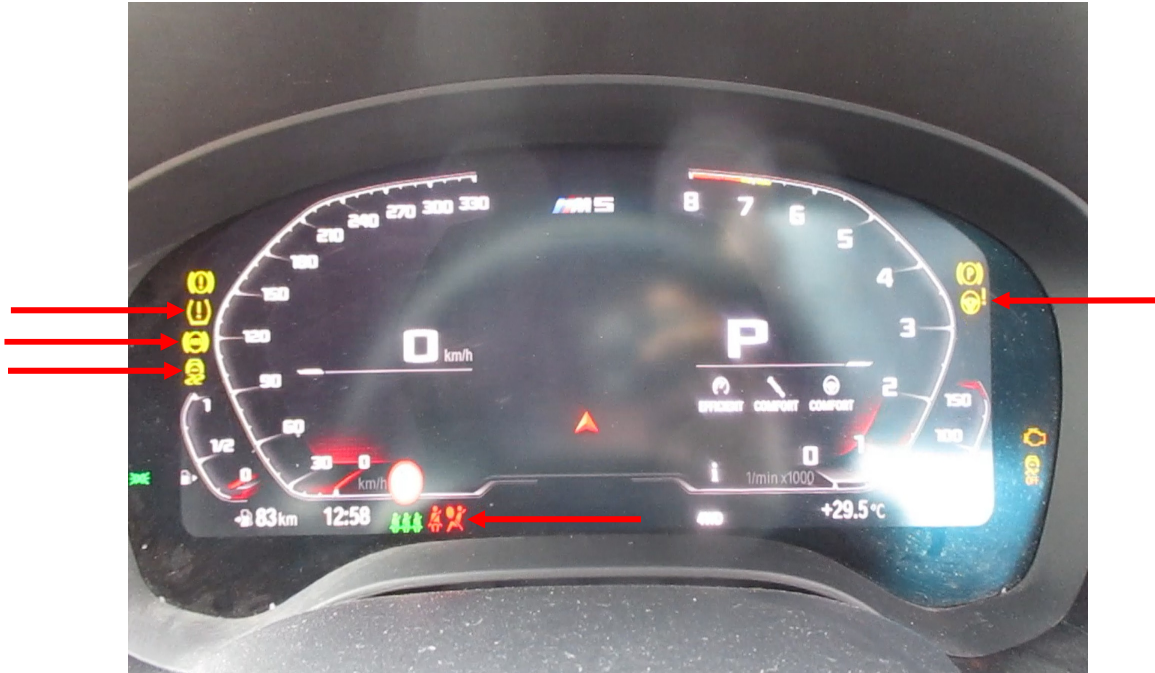
Photo 23 shows the warning lights for the various electronic safety features appearing on the instrument panel of the Motor Car during its self-test when the engine is cranked, in particular the ABS, SRS, IAS, TPM and DSC lights (arrowed).

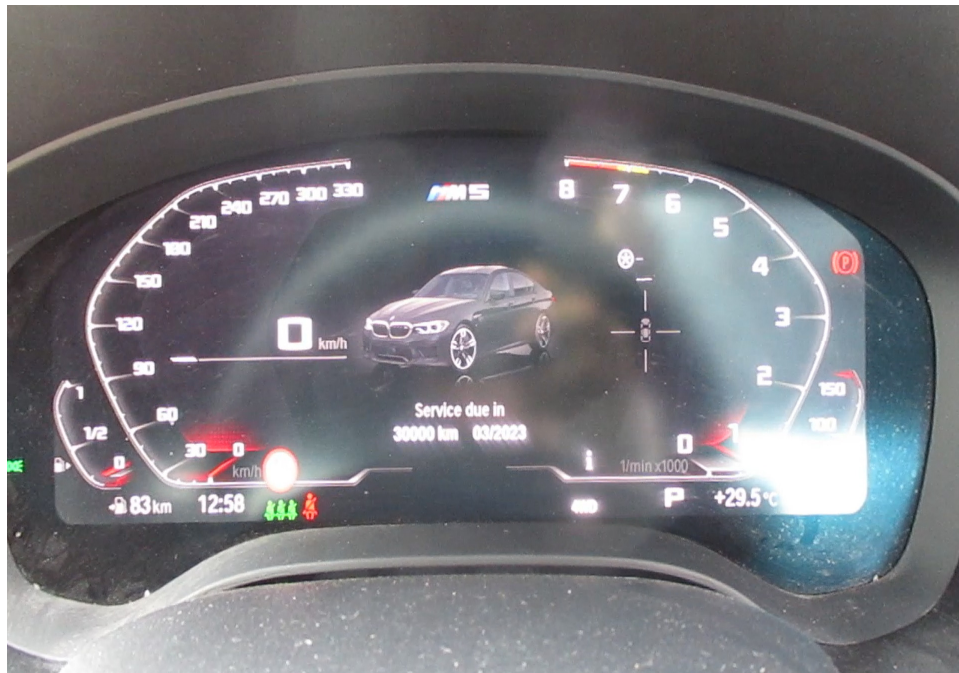
Photo 24 shows the respective warning lights no longer illuminated, indicating that there is no fault detected to the ABS, SRS, IAS, TPM and DSC systems of the Motor Car during the self-test. These electronic systems were hence in working condition at the time of my inspection.

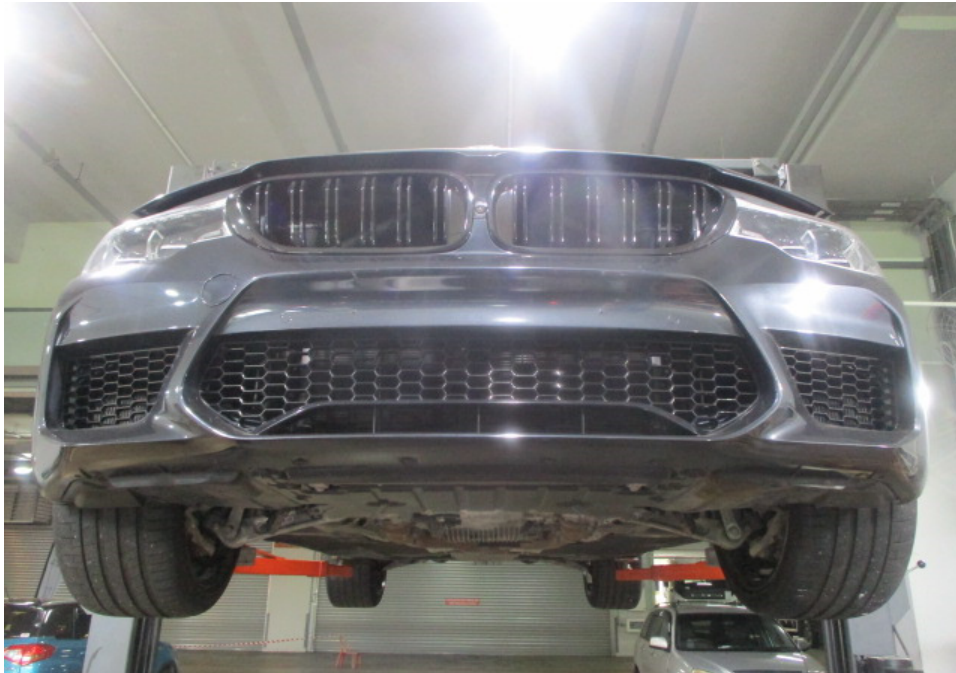
Photo 25 shows the Motor Car hoisted up for checks on its undercarriage. There was no sign(s) or indication(s) of fluid leakage and/or fluid stain(s) on the underside of the Motor Car. The undercarriage components of the Motor Car were also all observed to be intact and secured in an appropriate manner.

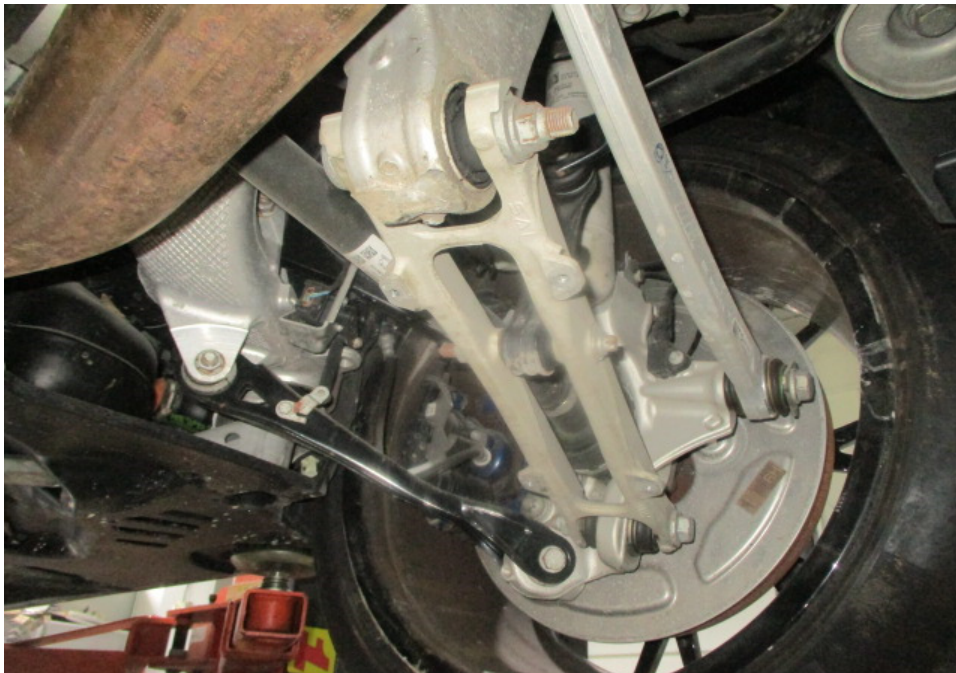
Photo 26 shows a general view of the control arms and linkages at the rear right wheel of the Motor Car. I did not observe any fluid leak and/or fluid stain on the underside of the Motor Car. All of the Motor Car's undercarriage components were observed to be intact and secured in an appropriate manner.

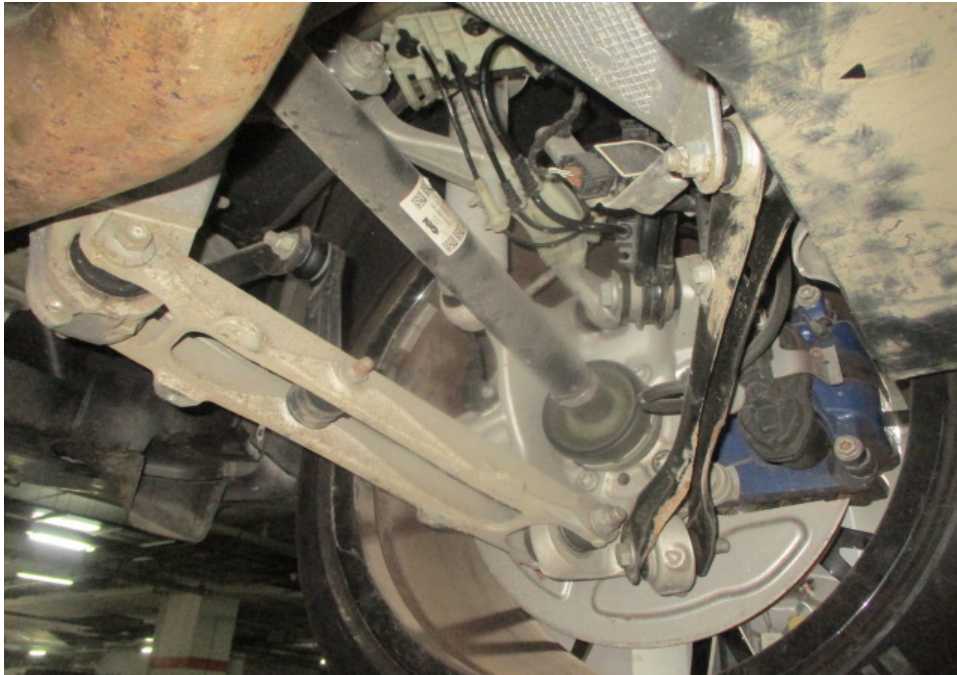
Photo 27 shows a general view of the control arms and linkages at the rear left wheel of the Motor Car. I did not observe any fluid leak and/or fluid stain on the underside of the Motor Car. All of the Motor Car's undercarriage components were observed to be intact and secured in an appropriate manner.

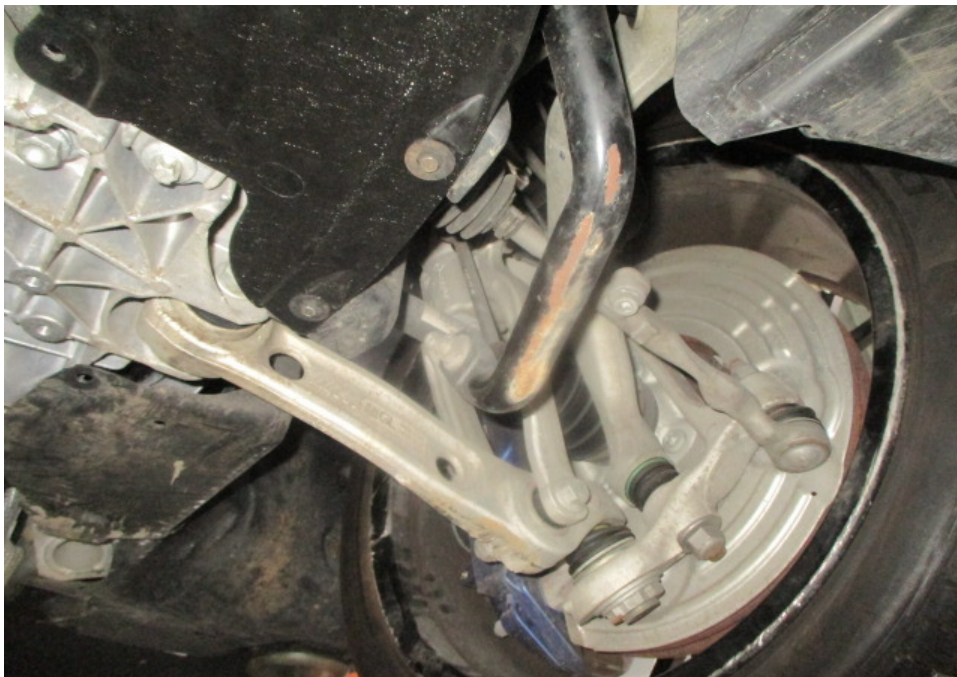
Photo 28 shows the various undercarriage components at the front left wheel of the Motor Car. The mechanical components, control arms and linkages were all found to be intact and secured in an appropriate manner.

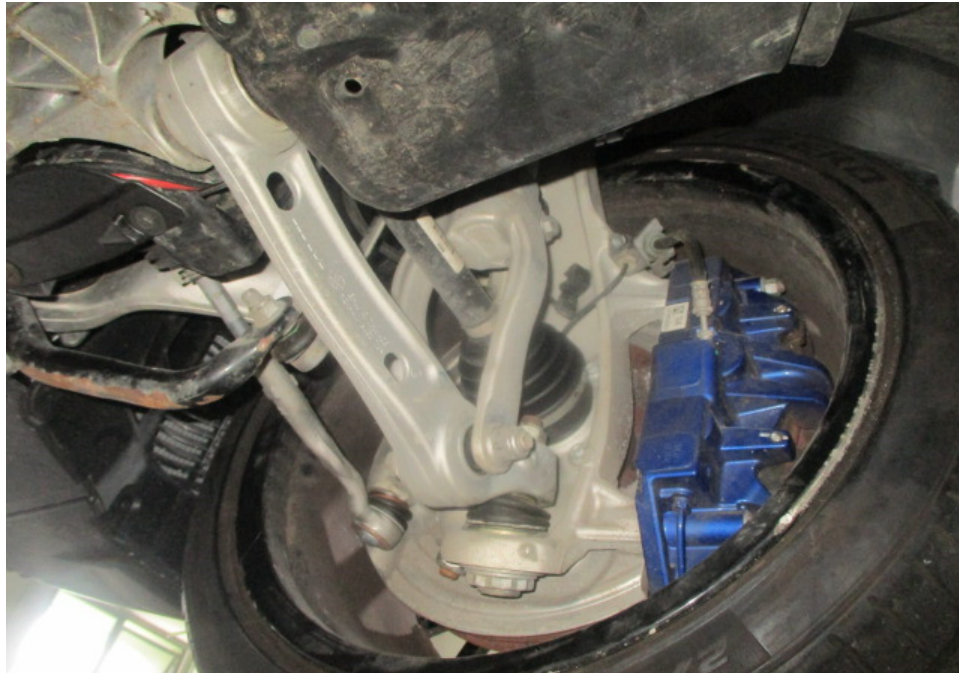
Photo 29 shows the various undercarriage components at the front right wheel of the Motor Car. The mechanical components, control arms and linkages were all found to be intact and secured in an appropriate manner. I also did not observe any fluid leak and/or fluid stain on the underside of the Motor Car.

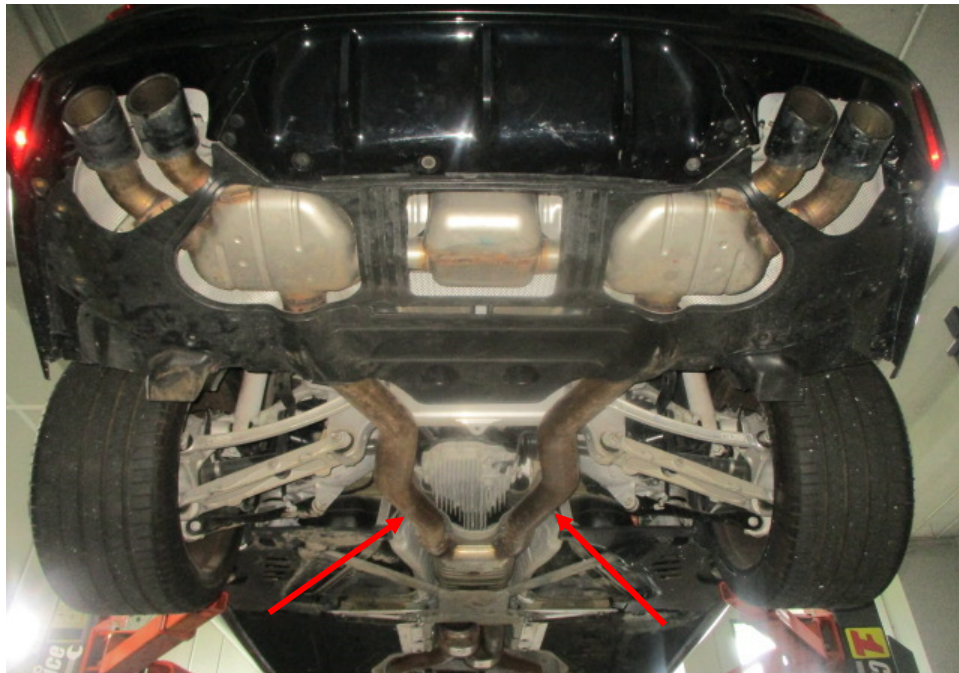
Photo 30 shows the rear section of the Motor Car's exhaust system. My examination of the Motor Car's exhaust system revealed no sign(s) or indication(s) of any cut or weld marks along its exhaust pipes (arrowed), on its rear mufflers, on its centre resonator boxes and on its catalytic converters.
