Your Ref: BMW M5
(chassis number WBSJF02020CE61792)
Our Ref : CI/TP23000003/D

03 January 2023

INSPECTION REPORT OF AN UNREGISTERED BMW M5 MOTOR CAR WITH CHASSIS NUMBER WBSJF02020CE61792

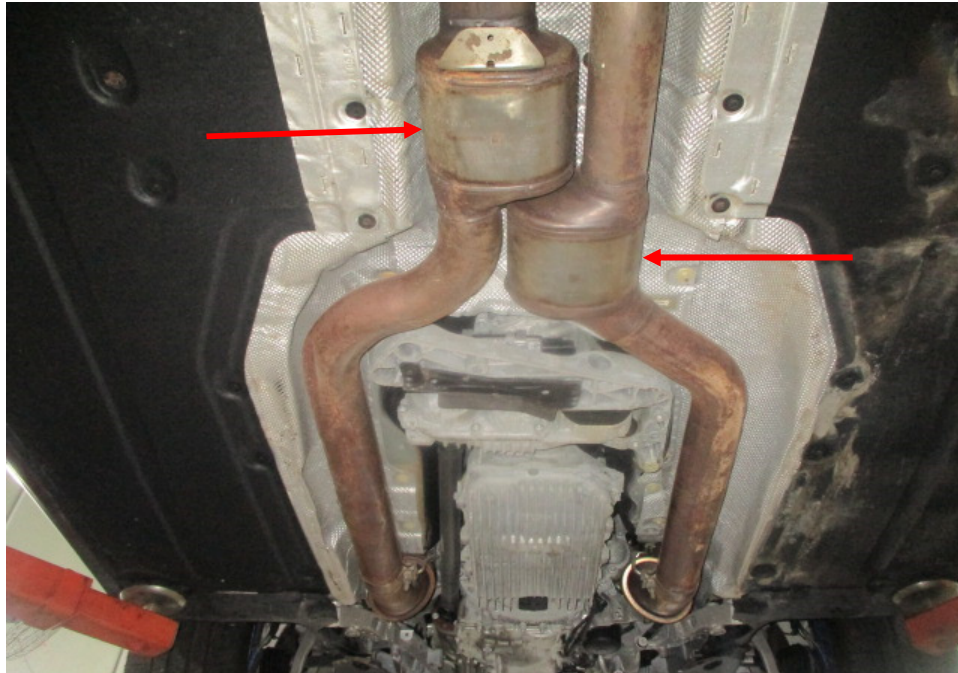
Photo 31 shows the front section of the Motor Car's exhaust system. My examination of the Motor Car's exhaust system revealed no sign(s) or indication(s) of any cut or weld marks along its exhaust pipes, on its rear mufflers, on its centre resonator boxes (arrowed) and on its catalytic converters.

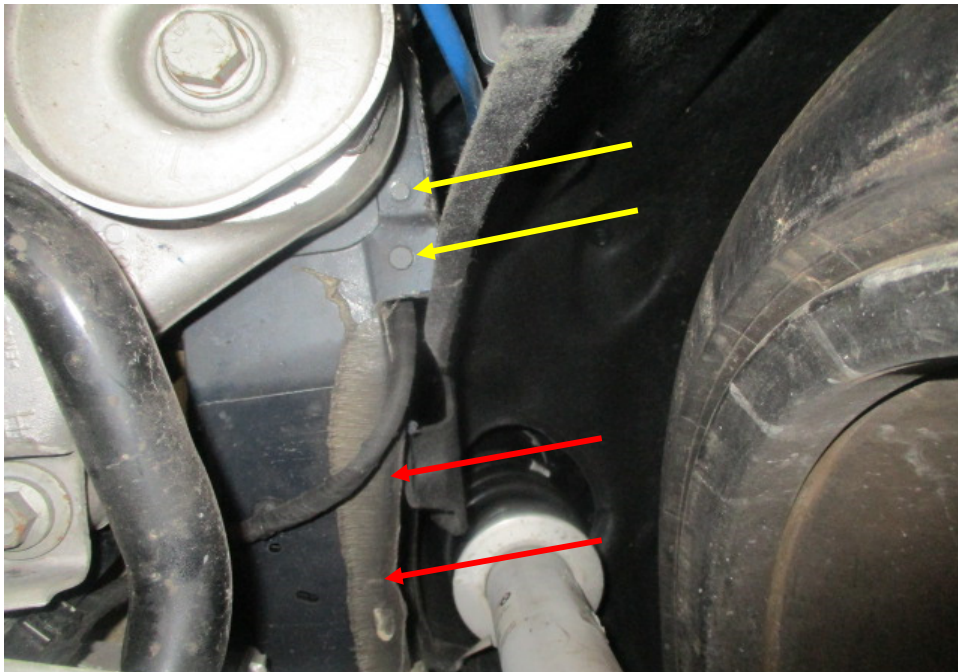
Photo 32 shows the chassis/structural body at the underside rear right of the Motor Car. I did not find any weld marks other than original spot weld marks (yellow arrow) on the chassis/structural body of the Motor Car. The original factory sealant (red arrow) at the joints along the chassis/structural body was untouched, indicating no work was done on the chassis/structural body of the Motor Car and that the chassis/structural body was originally fitted.

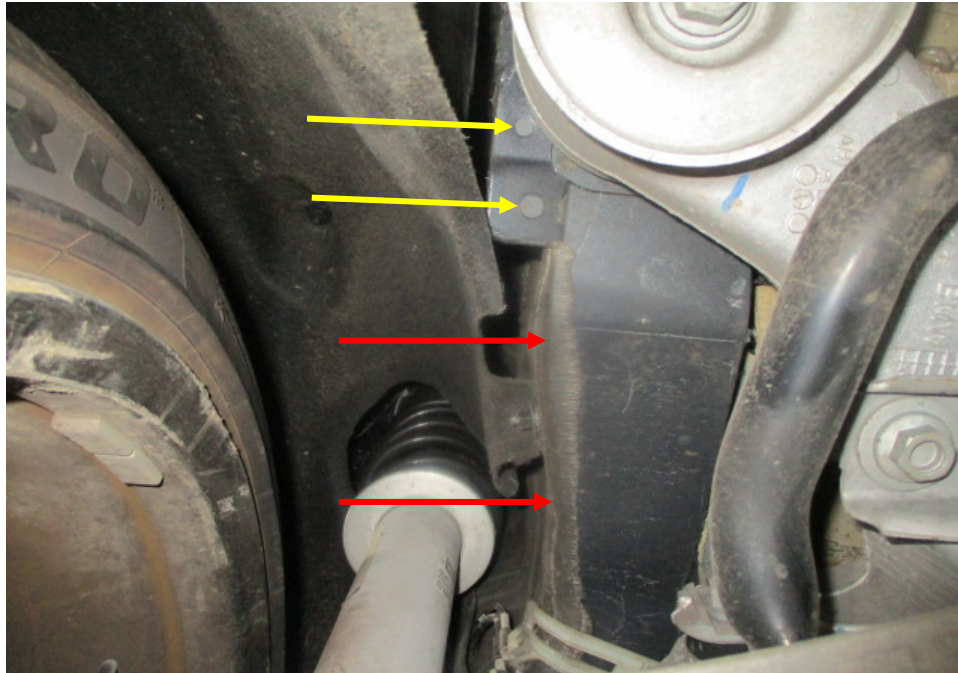
Photo 33 shows the chassis/structural body at the underside rear left of the Motor Car. I did not find any weld marks other than original spot weld marks (yellow arrow) on the chassis/structural body of the Motor Car. The original factory sealant (red arrow) at the joints along the chassis/structural body was untouched, indicating no work was done on the chassis/structural body of the Motor Car and that the chassis/structural body was originally fitted.

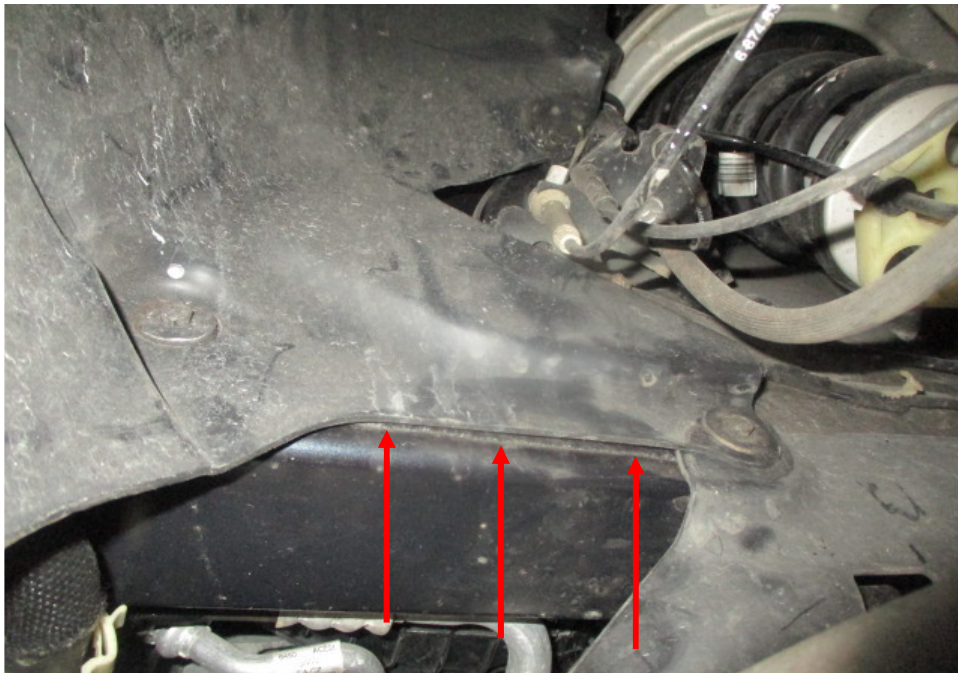
Photo 34 shows the chassis/structural body at the underside front left of the Motor Car. The original factory sealant (arrowed) at the joints along the chassis/structural body was observed to be untouched. In general, I had found no work was carried out on the chassis/structural body of the Motor Car. The chassis/structural body of the Motor Car was originally fitted.

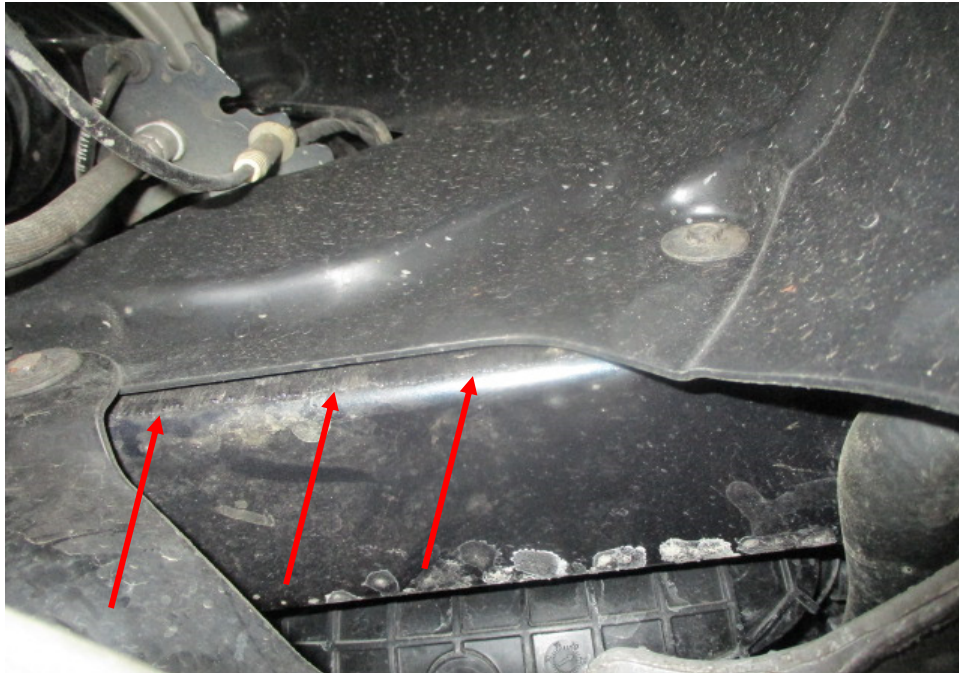
Photo 35 shows the chassis/structural body at the underside front right of the Motor Car. I did not find any weld marks other than original spot weld marks on the chassis/structural body of the Motor Car. The original factory sealant (arrowed) at the joints along the chassis/structural body was untouched, indicating no work was done on the chassis/structural body of the Motor Car and that the chassis/structural body was originally fitted.

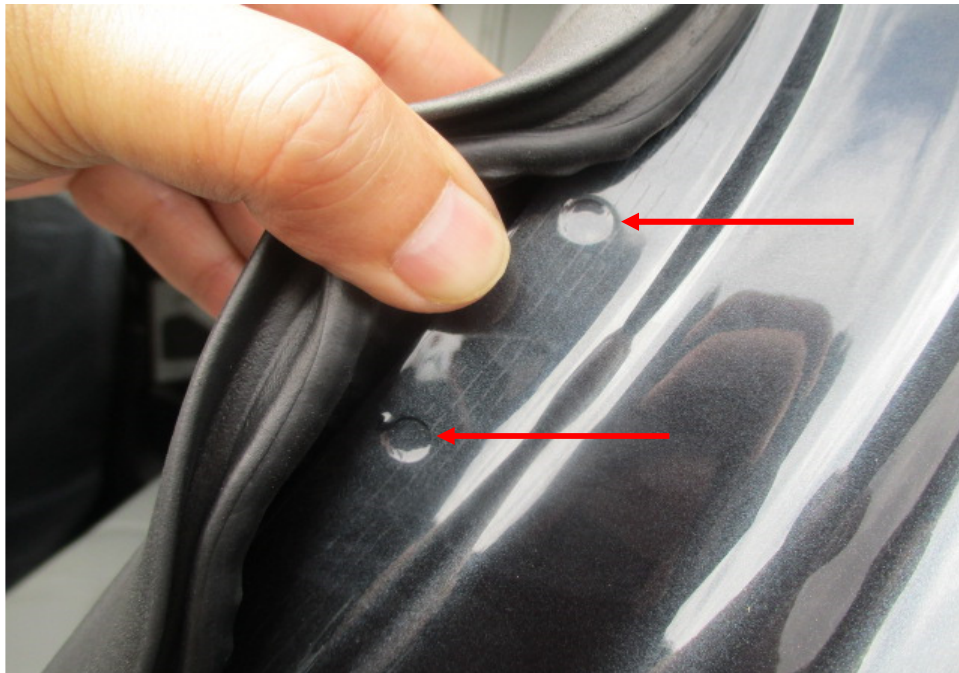
Photo 36 shows the left side "C" pillar of the Motor Car. I did not find any weld marks other than original spot weld marks (arrowed) on the left side "C" pillar of the Motor Car, which indicates that there was no re-welding works carried out. In general, I had found all the non-detachable body panels of the Motor Car to be originally fitted at the time of my inspection.

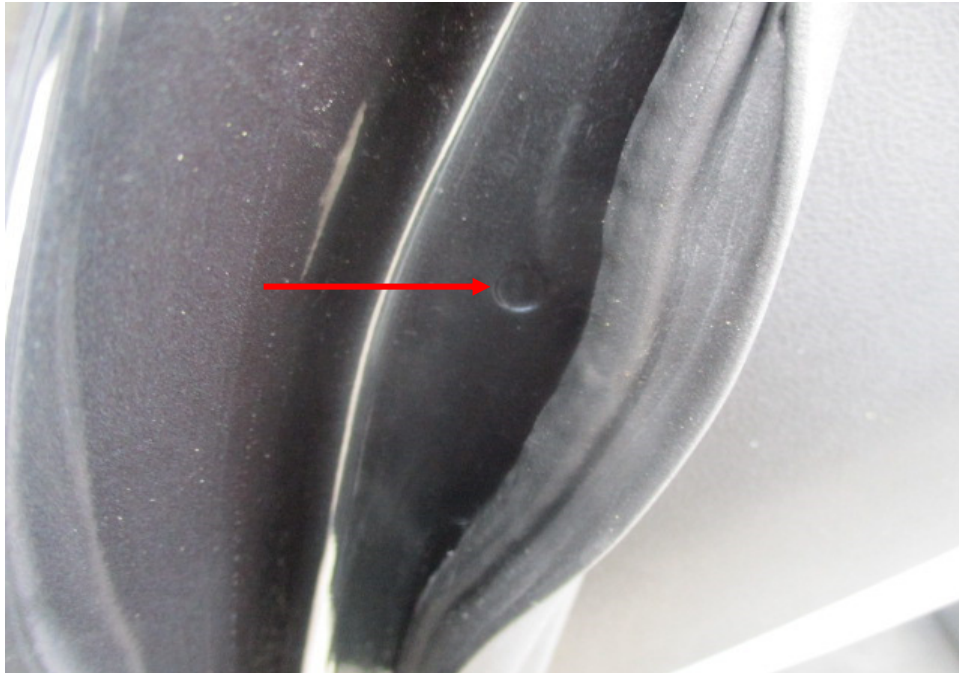
Photo 37 shows the left side "A" pillar of the Motor Car. I did not find any weld marks other than original spot weld marks (arrowed) on the left side "A" pillar of the Motor Car, which indicates that there was no re-welding works carried out. In general, I had found all the non-detachable body panels of the Motor Car to be originally fitted at the time of my inspection.

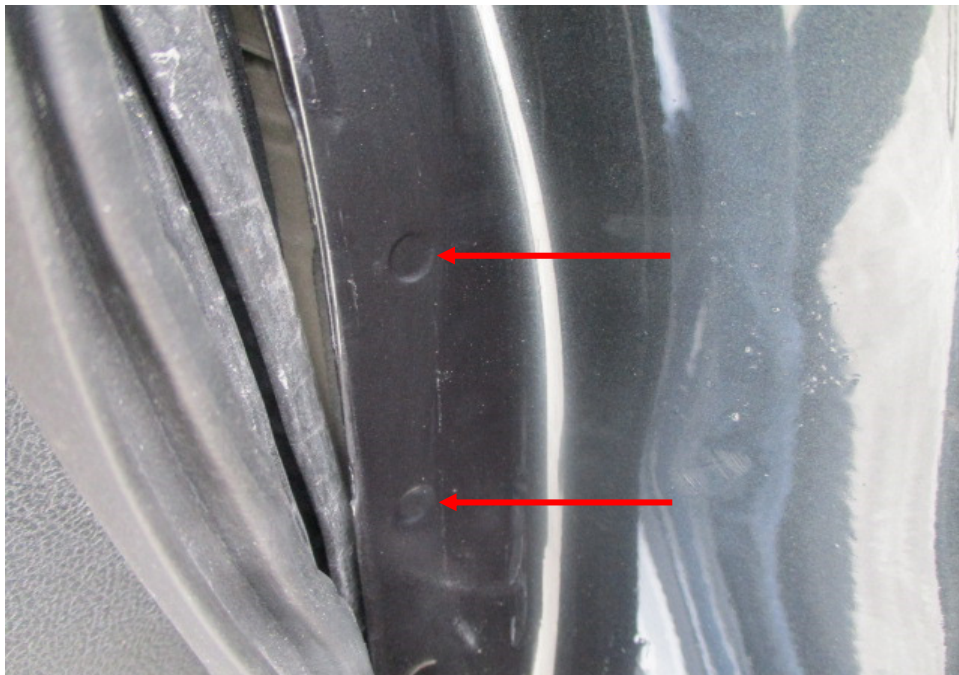
Photo 38 shows the right side "A" pillar of the Motor Car. I did not find any weld marks other than original spot weld marks (arrowed) on the right side "A" pillar of the Motor Car, which indicates that there was no re-welding works carried out. In general, I had found all the non-detachable body panels of the Motor Car to be originally fitted at the time of my inspection.

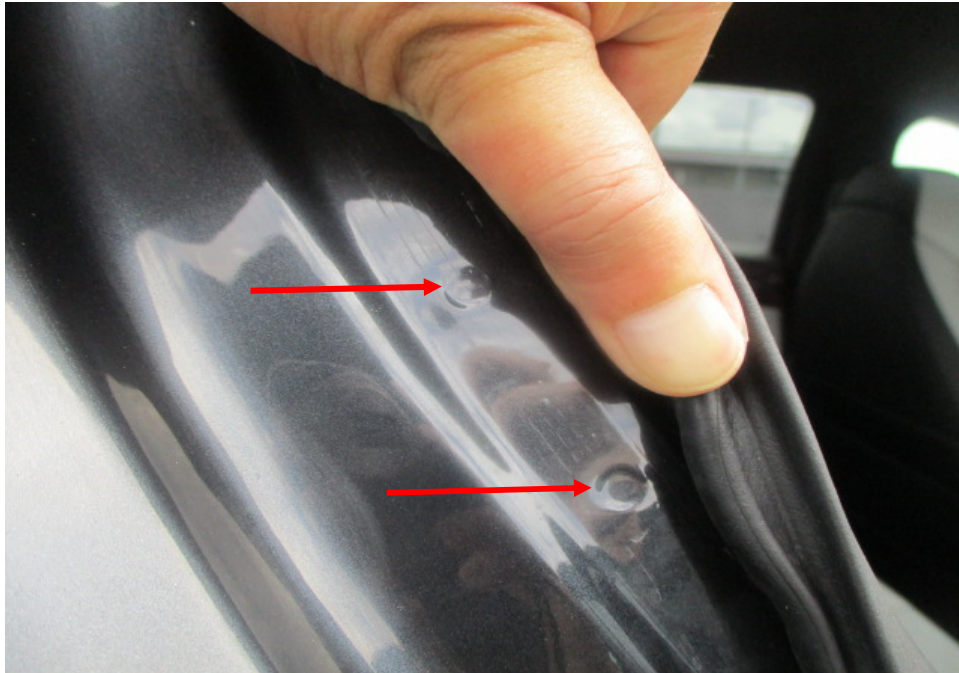
Photo 39 shows the right side "C" pillar of the Motor Car. I did not find any weld marks other than original spot weld marks (arrowed) on the right side "C" pillar of the Motor Car, which indicates that there was no re-welding works carried out. In general, I had found all the non-detachable body panels of the Motor Car to be originally fitted at the time of my inspection.
