Your Ref: BMW M4 Coupe  
(chassis number WBS32AZ030CG68319)  
Our Ref : CI/TP23000006/D

03 January 2023

### **INSPECTION REPORT OF AN UNREGISTERED BMW M4 COUPE MOTOR CAR WITH CHASSIS NUMBER WBS32AZ030CG68319**

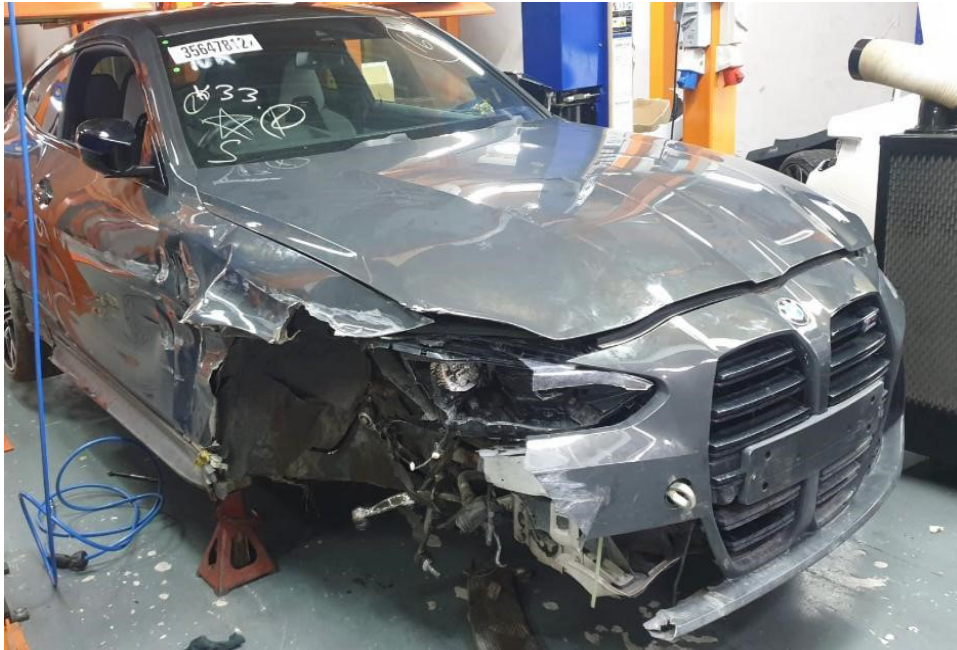
3. The photographs provided to me had showed damage to the front right portion and right side portion of the Motor Car. Body parts damaged at the front right portion include the front bumper, front bumper reinforcement, front bumper right lower grille, front bumper right sensor, front bumper right corner air guide, front bonnet, front right headlamp, front right headlamp bracket and front left headlamp amongst others.

4. As for the Motor Car's right side portion, I had observed damage to the front right fender, front right fender inner shield, front right door, rear right body panel and right side rocker panel garnish amongst others. The Motor Car's front right wheel rim and front right tyre were also observed to be detached from the Motor Car with damage seen to the front right knuckle arm, front right wheel bearing, front right shock absorber, front right lower arm and front right steering tie rod end amongst others.

**Photo 1** shows the front right body of the Motor Car (photograph provided to me). The Motor Car was observed to have sustained damage at its front right portion and right side portion. The front bumper, front bumper reinforcement, front bumper right lower grille, front bumper right sensor, front bumper right corner air guide, front bonnet, front right headlamp, front right headlamp bracket, front right fender, front right fender inner shield, front right door and right side rocker panel garnish were amongst the body parts that were observed to have been damaged. The Motor Car's front right wheel rim and front right tyre were also observed to be detached from the Motor Car with damage seen to the front right knuckle arm, front right wheel bearing, front right shock absorber, front right lower arm and front right steering tie rod end amongst others.

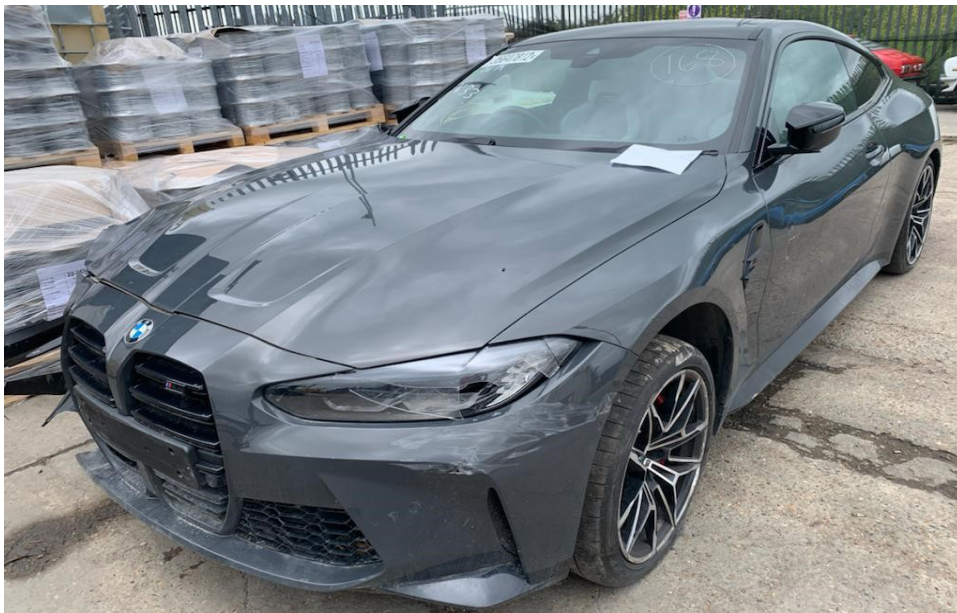
**Photo 2** shows the front left body of the Motor Car (photograph provided to me). The front left headlamp was observed to be damaged. Other than this, the left side portion of the Motor Car was observed to be without physical damage.

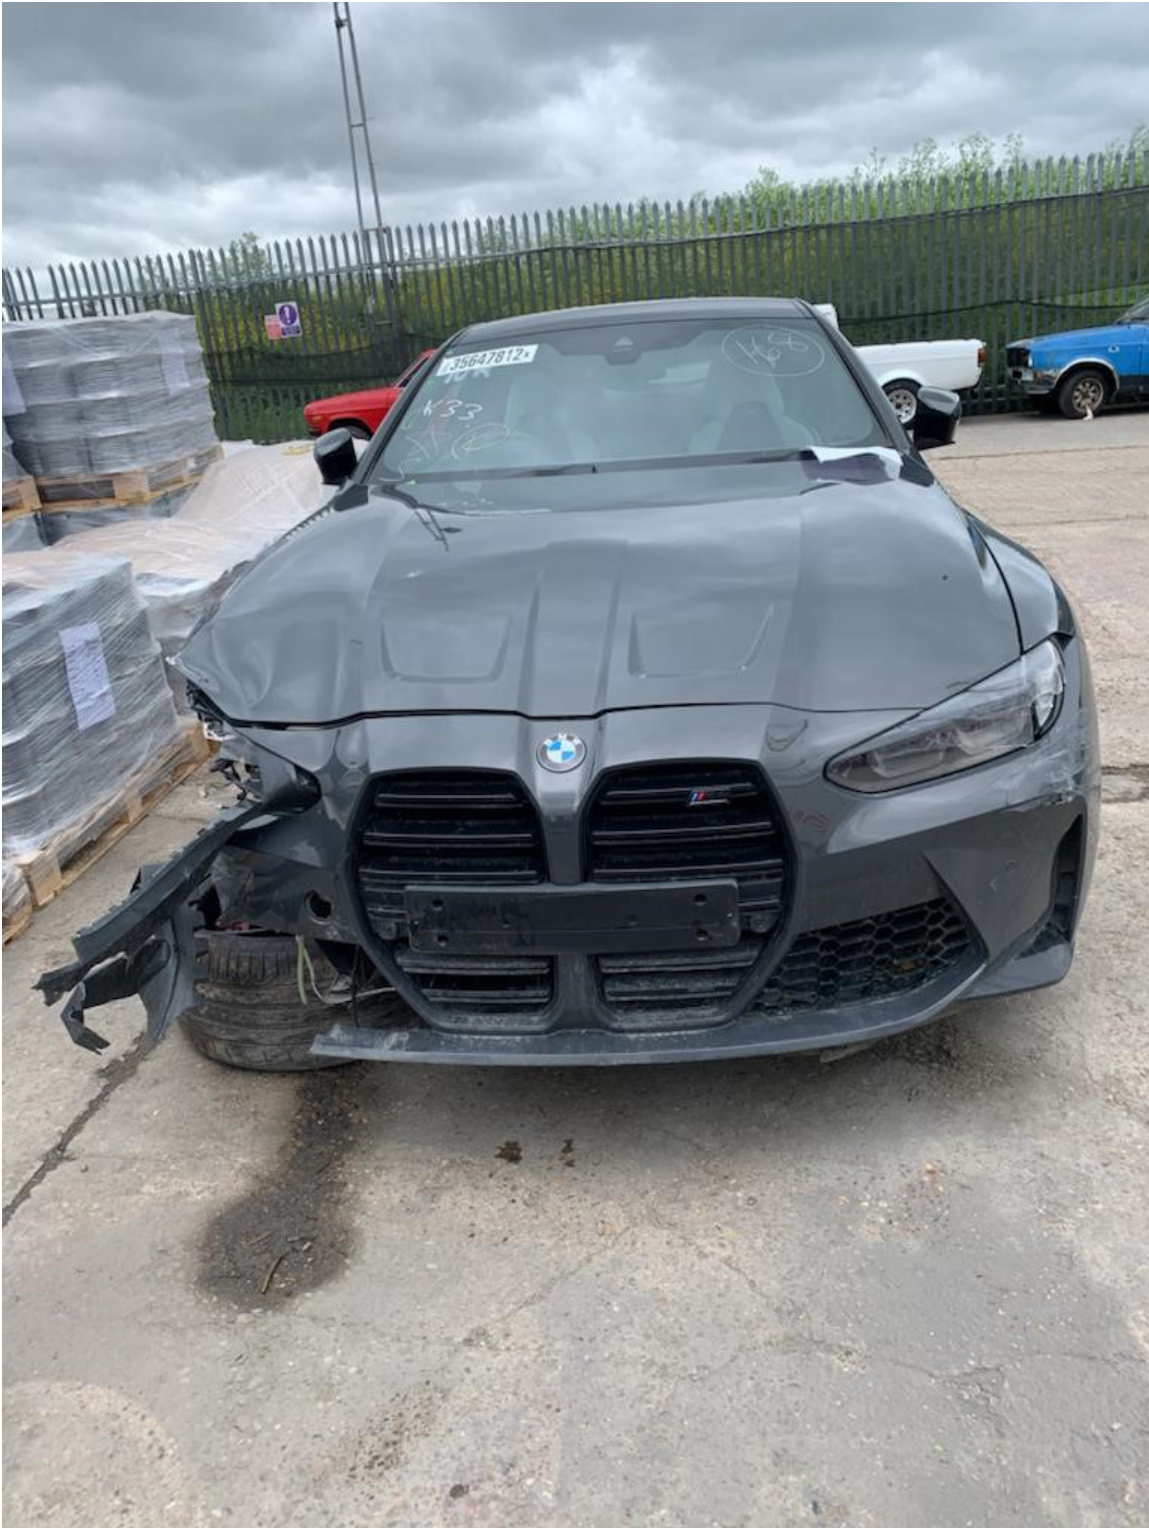
**Photo 3** shows the frontal body of the Motor Car (photograph provided to me). The Motor Car was observed to have sustained damage at its front right portion. The front bumper, front bumper right lower grille, front bumper right sensor, front bumper right corner air guide, front bonnet, front right headlamp and front left headlamp were amongst the body parts that were observed to have been damaged. The airbag(s) of the Motor Car was not deployed as seen from the photographs that were provided to me.

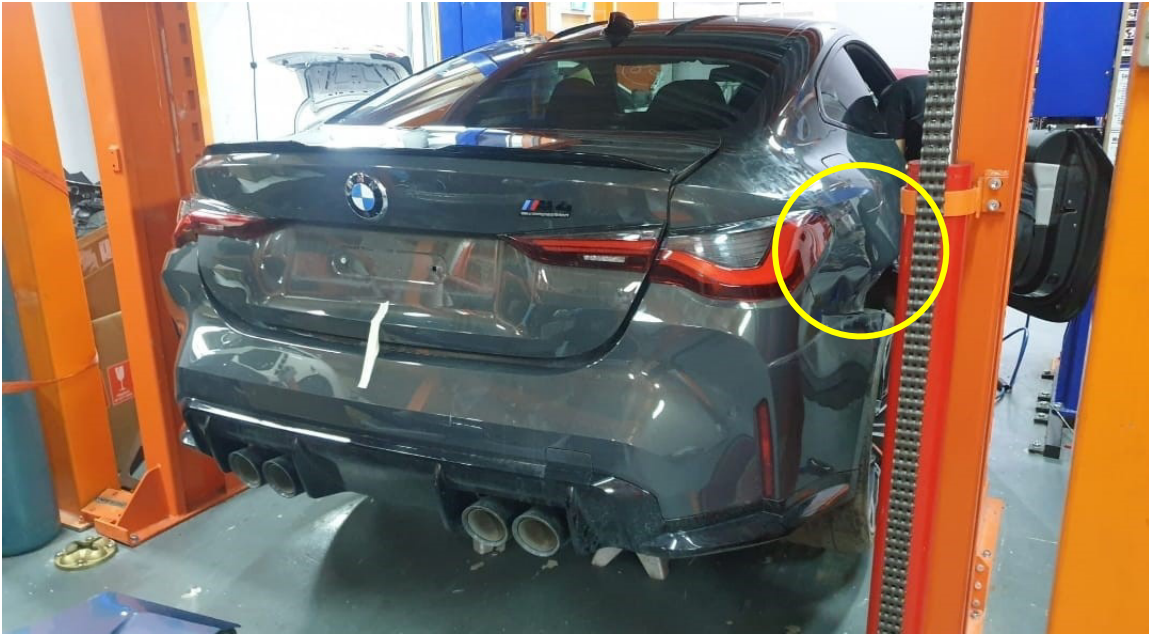
**Photo 4** shows the rear right body of the Motor Car (photograph provided to me). The rear right body panel was observed to be damaged (circled).

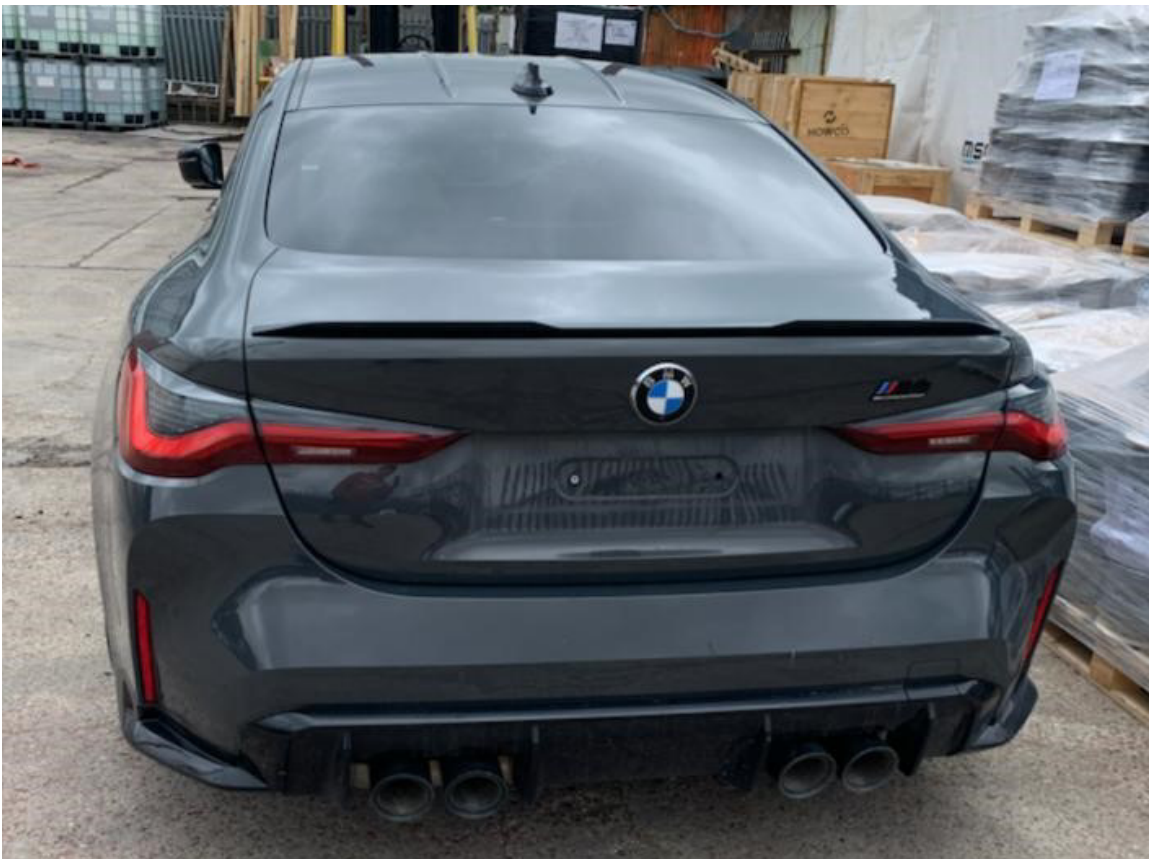
**Photo 5** shows the rear body of the Motor Car (photograph provided to me). No physical damage was observed to the rear portion of the Motor Car.

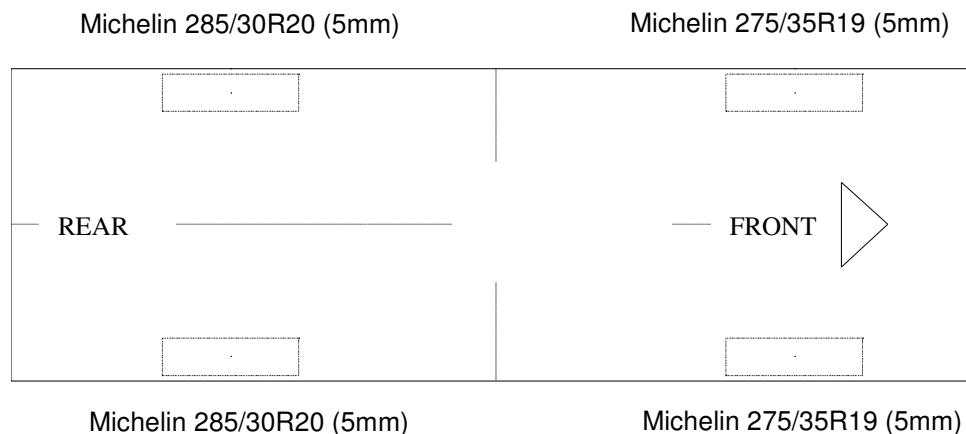
9. It was fitted with 19inch (front) and 20inch (rear) sport wheel rims that were wrapped with tyres that were observed to be of serviceable condition. The tyres were also sufficiently inflated for vehicular operation. The tyre brand, tyre size and approximate remaining tread depth of the 4 tyres of the Motor Car were recorded as follows: -

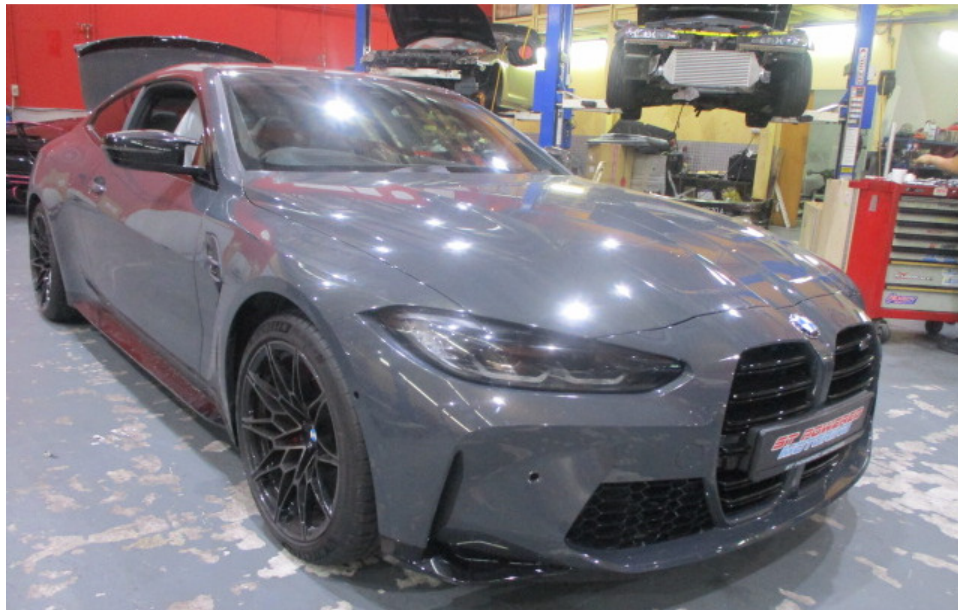
**Photo 6** shows a general view of the front right body of the Motor Car at the time of my inspection. The Motor Car was observed to be in a relatively good general condition with no loose exterior fittings observed. The body parts at the front right portion and right side portion of the Motor Car were visually examined and it was observed that the repair/restoration works carried out to the damaged area of the Motor Car (refer to photograph 1 & 3 above) were reasonably adequate and in order.

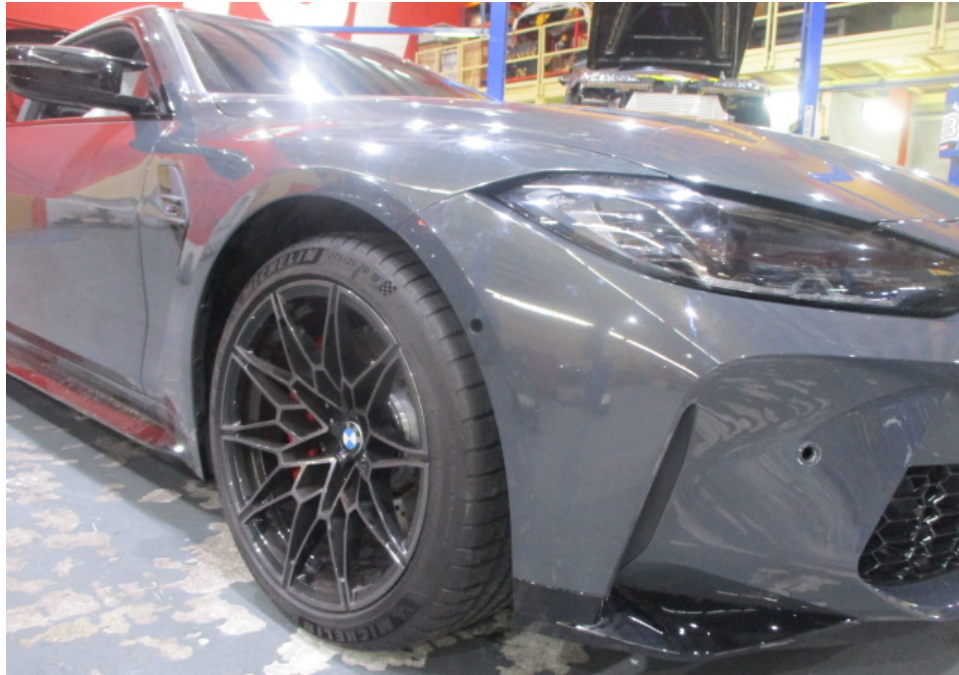
**Photo 7** shows a closer view of the Motor Car's front bumper, front right headlamp, front right fender, front right wheel rim and front right tyre. The body parts at the right side front portion of the Motor Car were visually examined and it was observed that the repair/restoration works carried out to the damaged area of the Motor Car (refer to photograph 1 above) were reasonably adequate and in order.

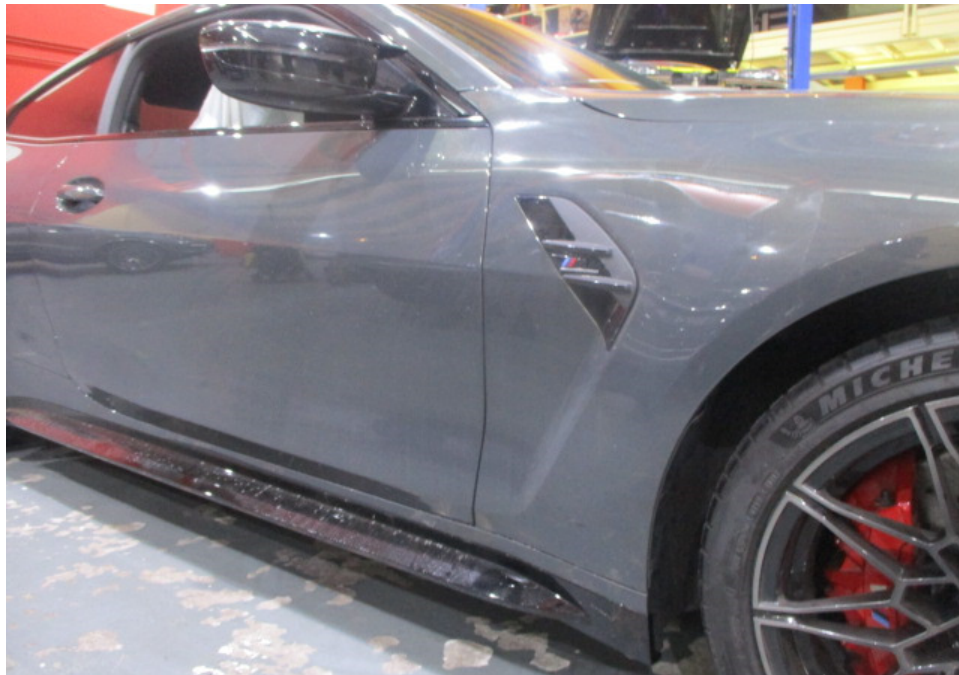
**Photo 8** shows a closer view of the Motor Car's front right fender, front right door, right side wing mirror and right side rocker panel garnish. The body parts at the right side portion of the Motor Car were visually examined and it was observed that the repair/restoration works carried out to the damaged area of the Motor Car (refer to photograph 1 above) were reasonably adequate and in order.

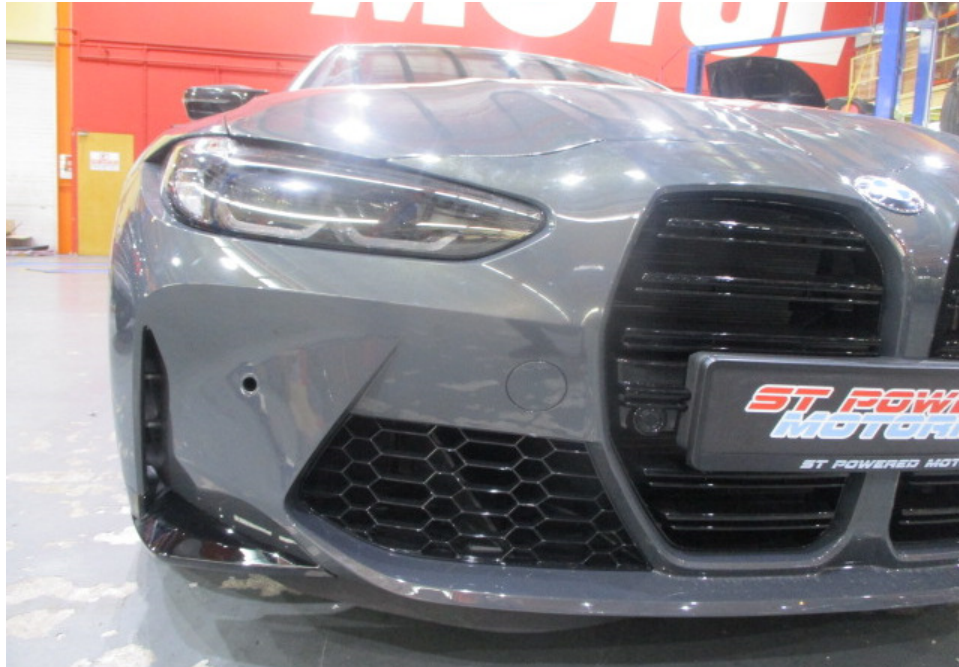
**Photo 9** shows a closer view of the Motor Car's front bumper, front bumper right lower grille, front bumper right corner air guide, front right headlamp, front right radiator grille and front bonnet. The body parts at the front right portion of the Motor Car were visually examined and it was observed that the repair/restoration works carried out to the damaged area of the Motor Car (refer to photograph 1 & 3 above) were reasonably adequate and in order.

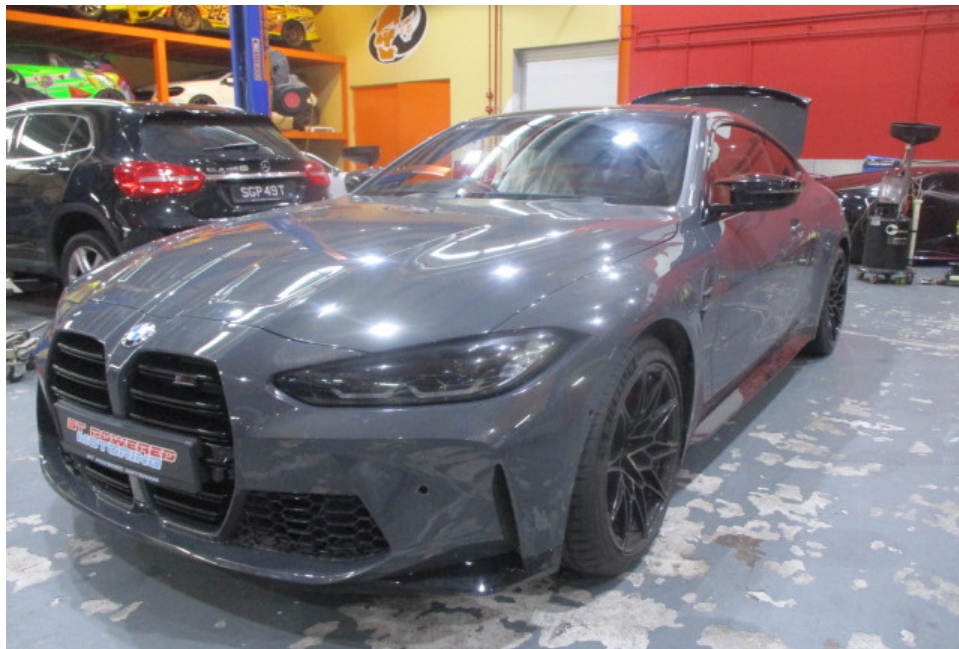
**Photo 10** shows a general view of the front left body of the Motor Car at the time of my inspection. The Motor Car was observed to be in a relatively good general condition with no loose exterior fittings observed. The body parts at the front left portion of the Motor Car were visually examined and it was observed that the repair/restoration works carried out to the damaged area of the Motor Car (refer to photograph 2 & 3 above) were reasonably adequate and in order.

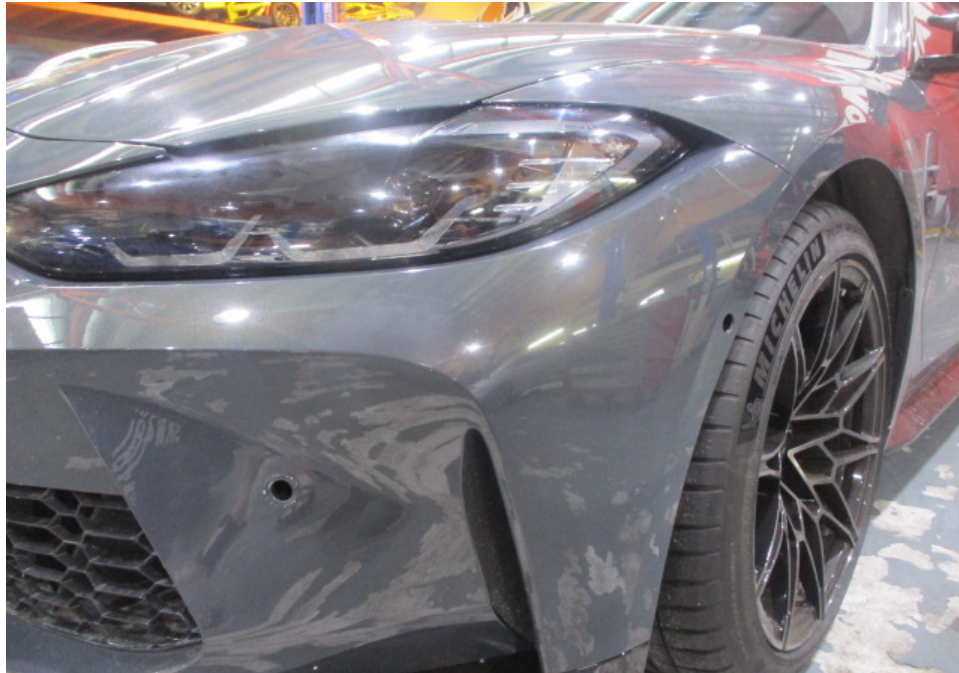
**Photo 11** shows a closer view of the Motor Car's front left headlamp, front left wheel rim and front left fender. The body parts at the front left portion of the Motor Car were visually examined and it was observed that the repair/restoration works carried out to the damaged area of the Motor Car (refer to photograph 2 & 3 above) were reasonably adequate and in order.

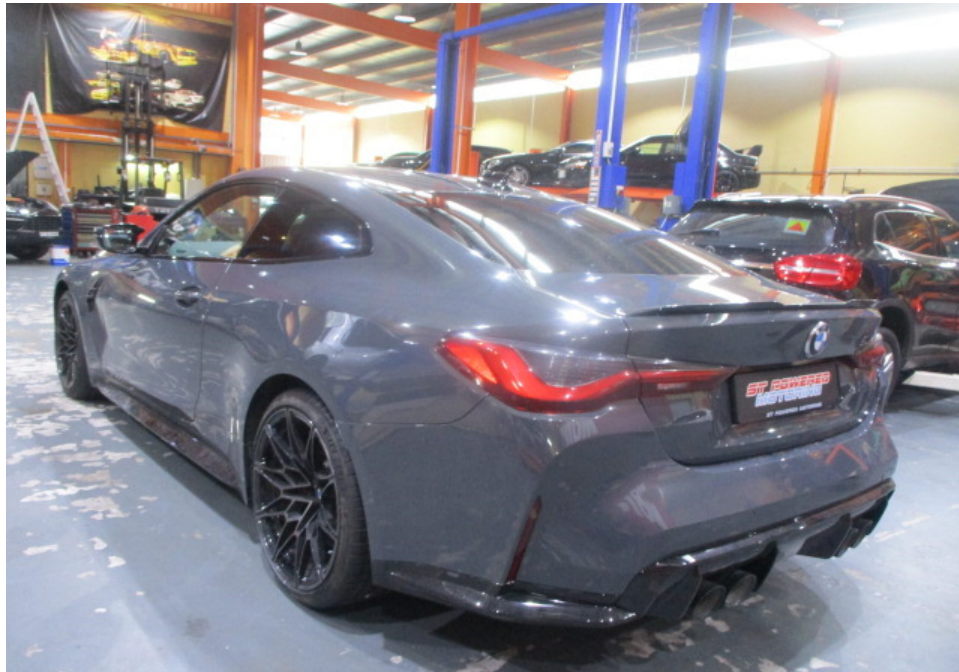
**Photo 12** shows a general view of the rear left body of the Motor Car at the time of my inspection. The Motor Car was observed to be in a relatively good general condition with no loose exterior fittings observed. The mileage of the Motor Car recorded at the time of my inspection was 18,097km.

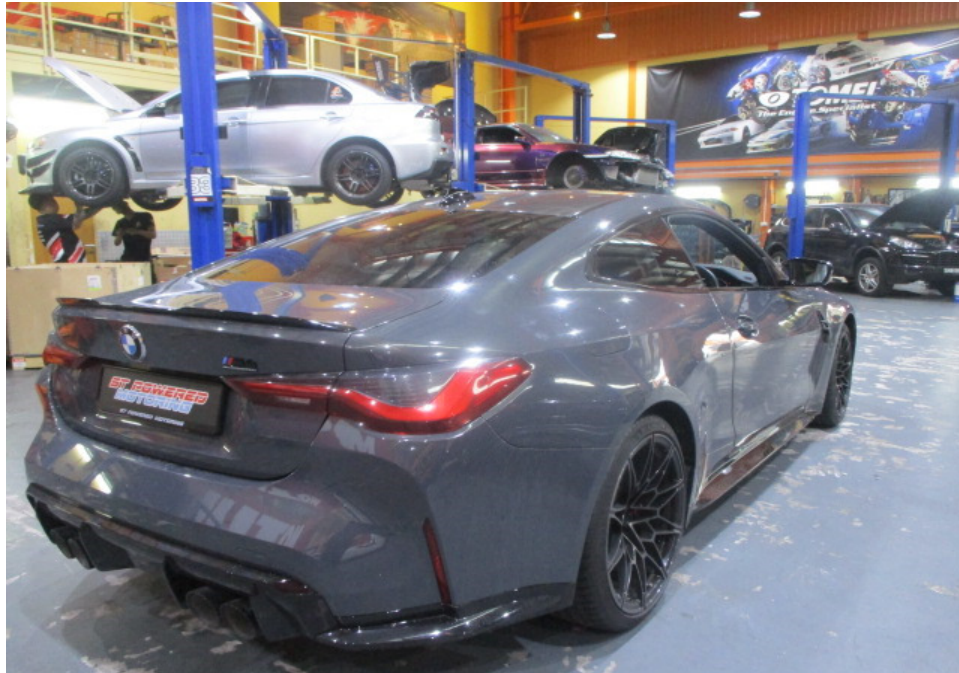
**Photo 13** shows a general view of the rear right body of the Motor Car at the time of my inspection. The Motor Car was observed to be in a relatively good general condition with no loose exterior fittings observed. The body parts at the rear right portion of the Motor Car were visually examined and it was observed that the repair/restoration works carried out to the damaged area of the Motor Car (refer to photograph 4 above) were reasonably adequate and in order.

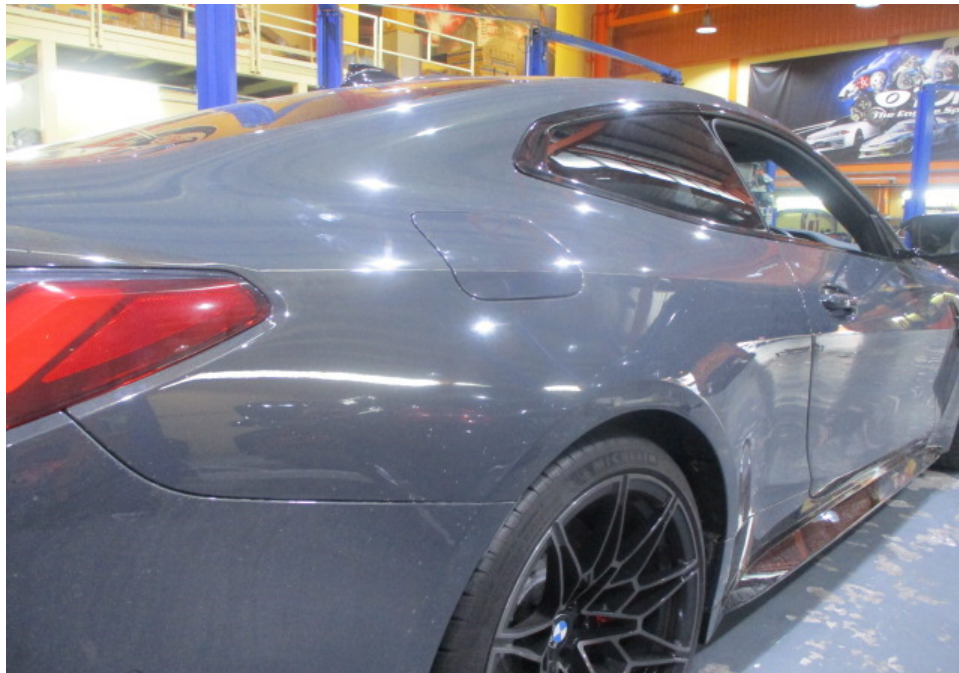
**Photo 14** shows a closer view of the Motor Car's rear bumper, rear right taillamp and rear right body panel. The body parts at the rear right portion of the Motor Car were visually examined and it was observed that the repair/restoration works carried out to the damaged area of the Motor Car (refer to photograph 4 above) were reasonably adequate and in order.

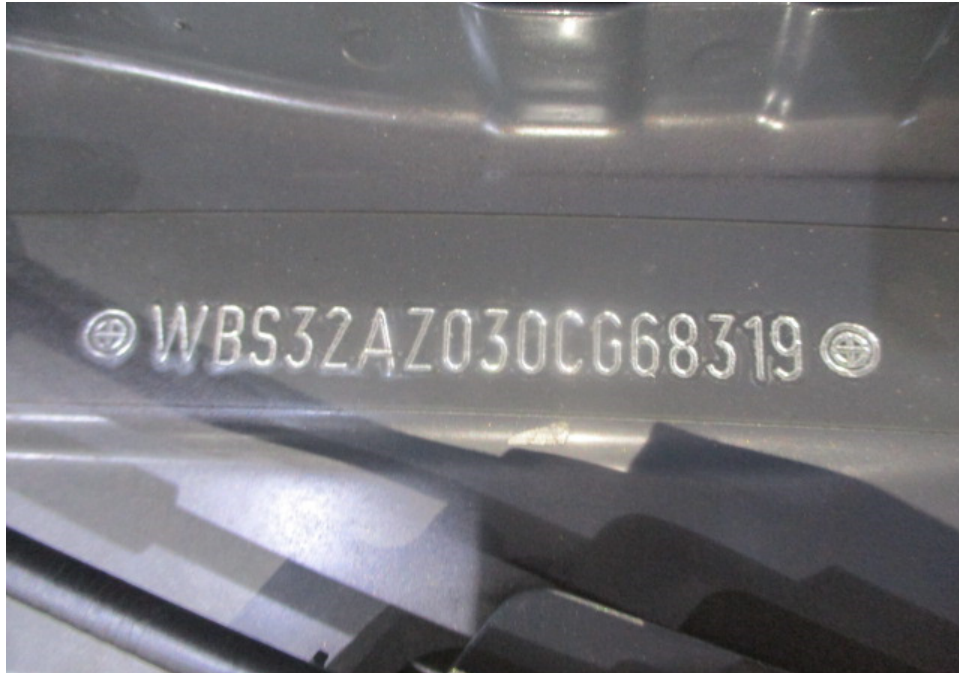
**Photo 15** shows the chassis number of the Motor Car. The chassis number recorded was WBS32AZ030CG68319.

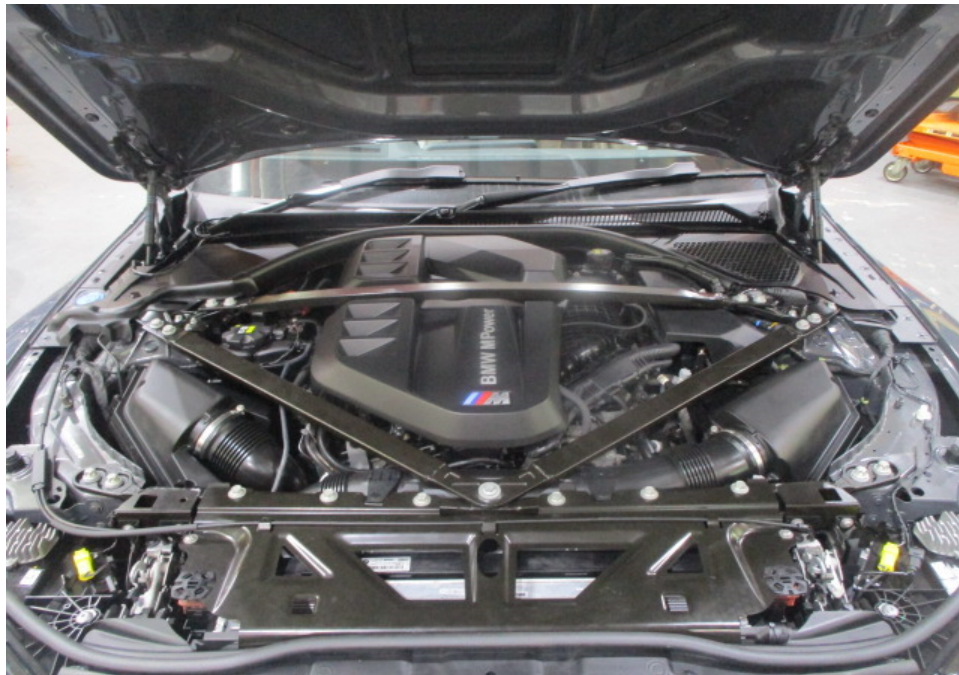
**Photo 16** shows a general view of the engine compartment of the Motor Car at the time of my inspection. The various parts and components inside the engine compartment were all observed to be intact and properly fitted. There was also no sign(s) or indication(s) of fluid leak and/or fluid stain found inside the engine compartment.

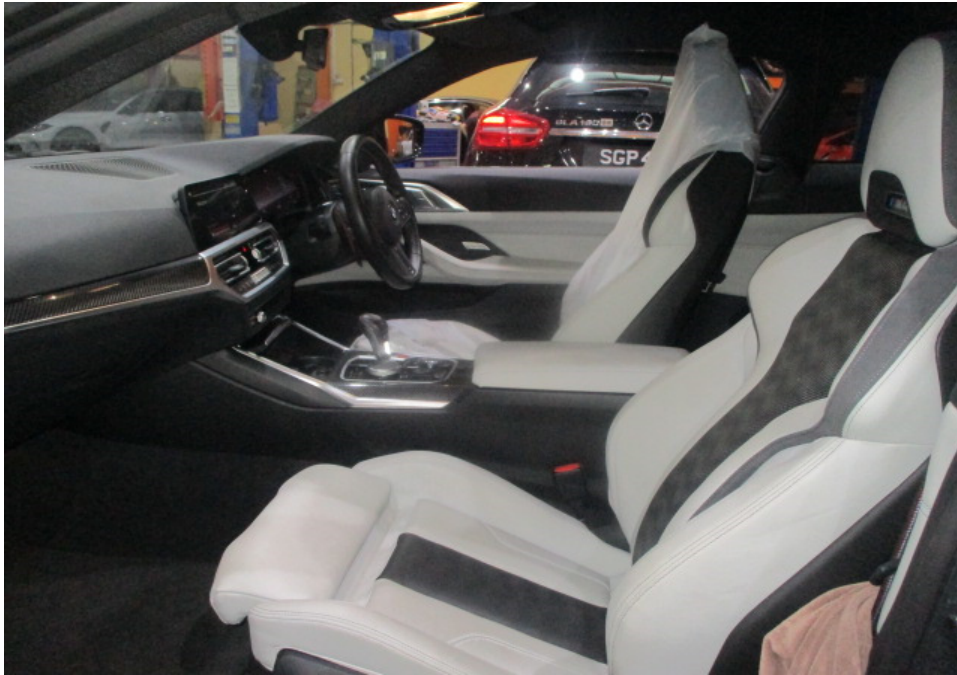
**Photo 17** shows the interior compartment of the Motor Car. The front dashboard, steering wheel, seats, upholstery and trims etc were all observed to be intact and properly fitted.

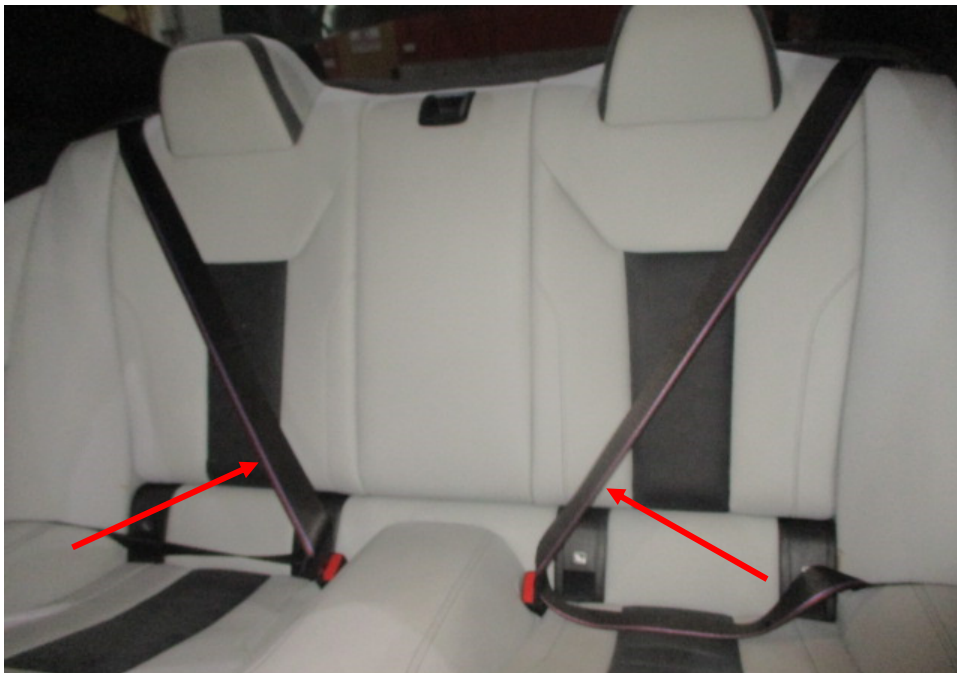
**Photo 18** shows the rear seats of the Motor Car. All the seats of the Motor Car were secured via seat rails to the floorboard. They were also fitted with a retractable seat belt reel and a pre-tensioner. The seat belts (arrowed) were tested and were able to be fastened into the respective pre-tensions that were fitted on the side of each individual seat.

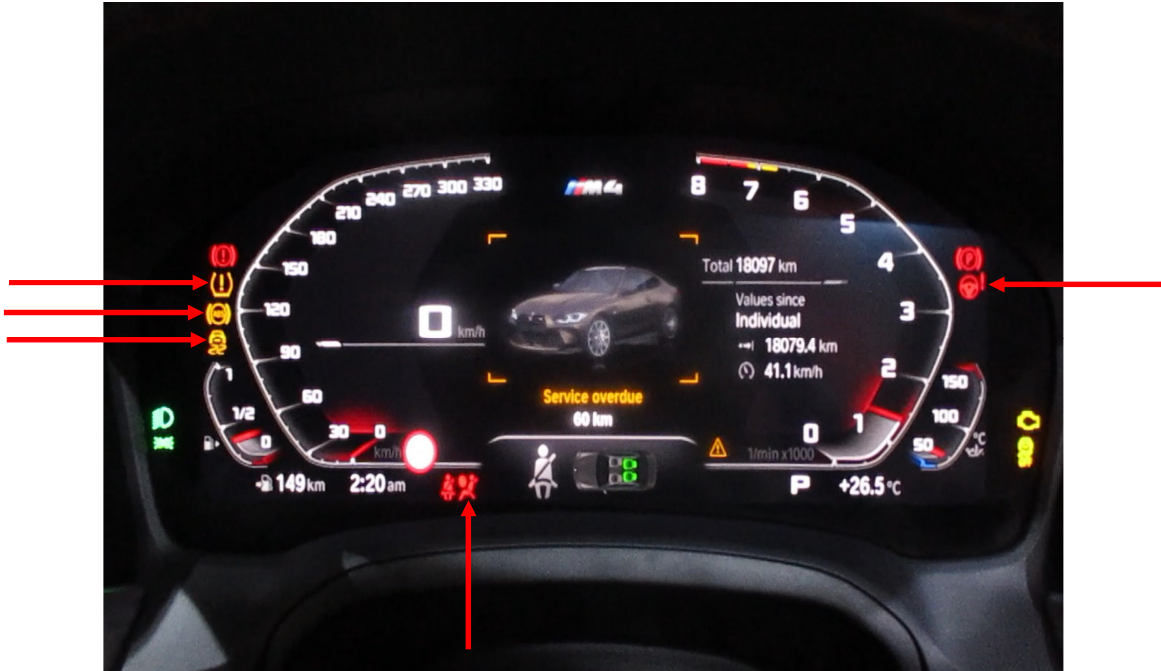
**Photo 19** shows the warning lights for the various electronic safety features appearing on the instrument panel of the Motor Car during its self-test when the engine is cranked, in particular the ABS, SRS, IAS, TPM and DSC lights (arrowed).

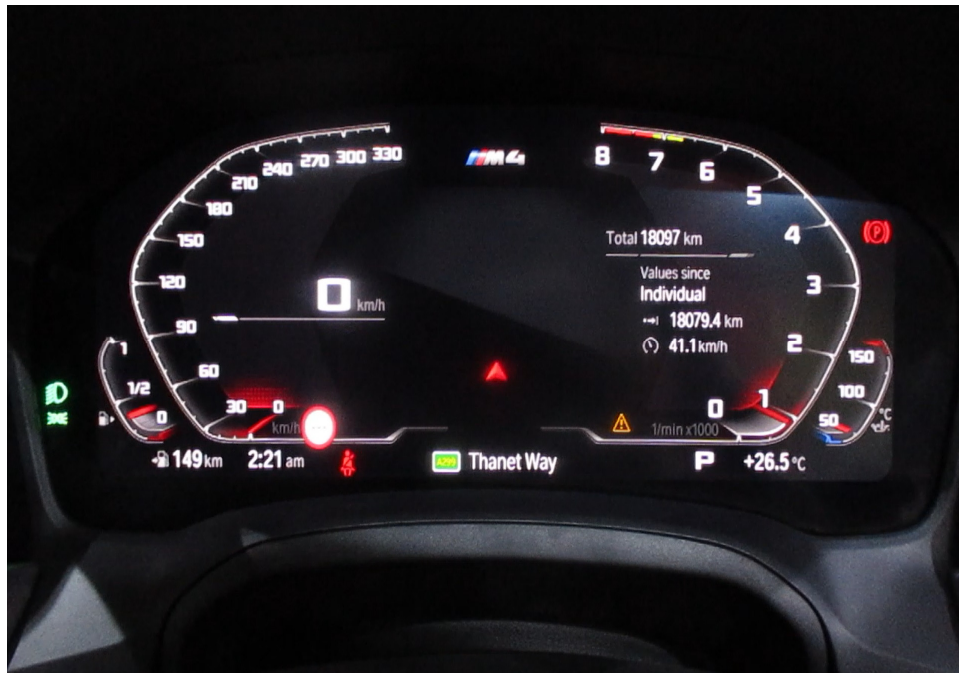
**Photo 20** shows the respective warning lights no longer illuminated, indicating that there is no fault detected to the ABS, SRS, IAS, TPM and DSC systems of the Motor Car during the self-test. These electronic systems were hence in working condition at the time of my inspection.

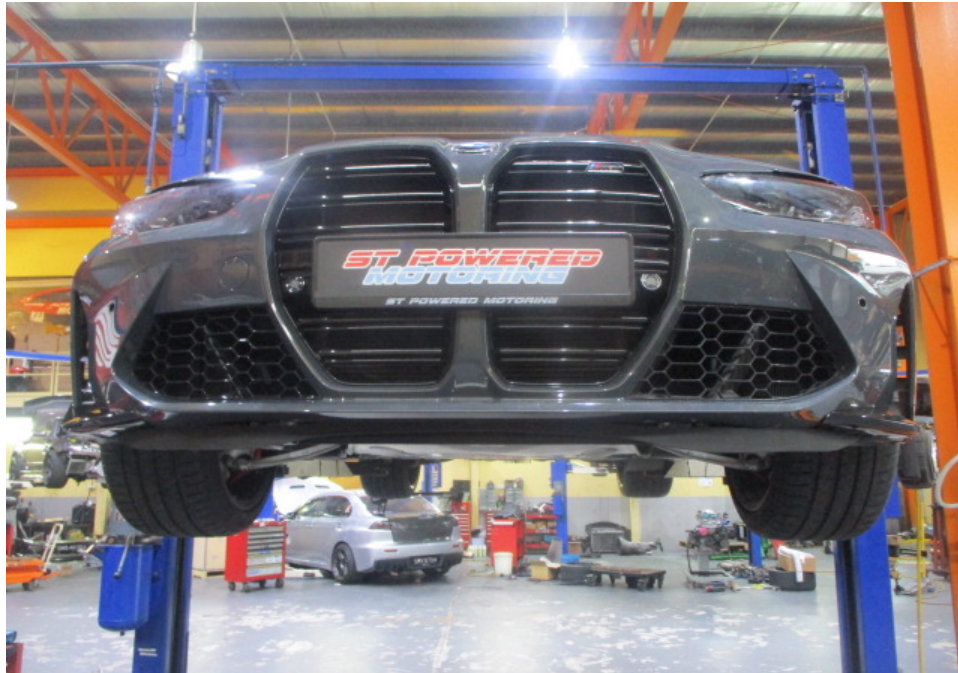
**Photo 21** shows the Motor Car hoisted up for checks on its undercarriage. There was no sign(s) or indication(s) of fluid leakage and/or fluid stain(s) on the underside of the Motor Car. The undercarriage components of the Motor Car were also all observed to be intact and secured in an appropriate manner.

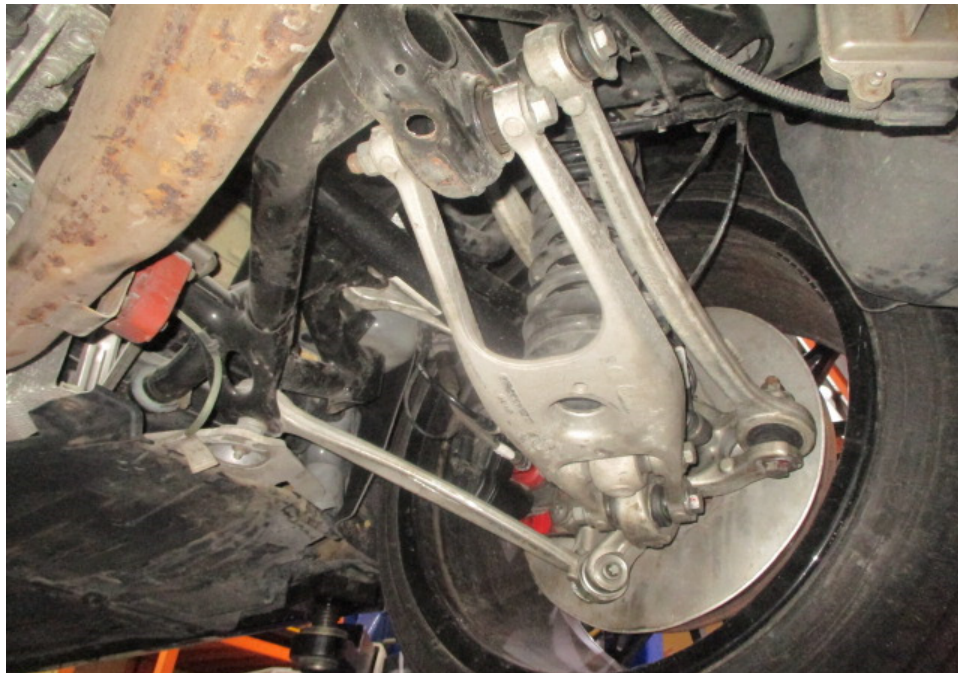
**Photo 22** shows a general view of the control arms and linkages at the rear right wheel of the Motor Car. I did not observe any fluid leak and/or fluid stain on the underside of the Motor Car. All of the Motor Car's undercarriage components were observed to be intact and secured in an appropriate manner.

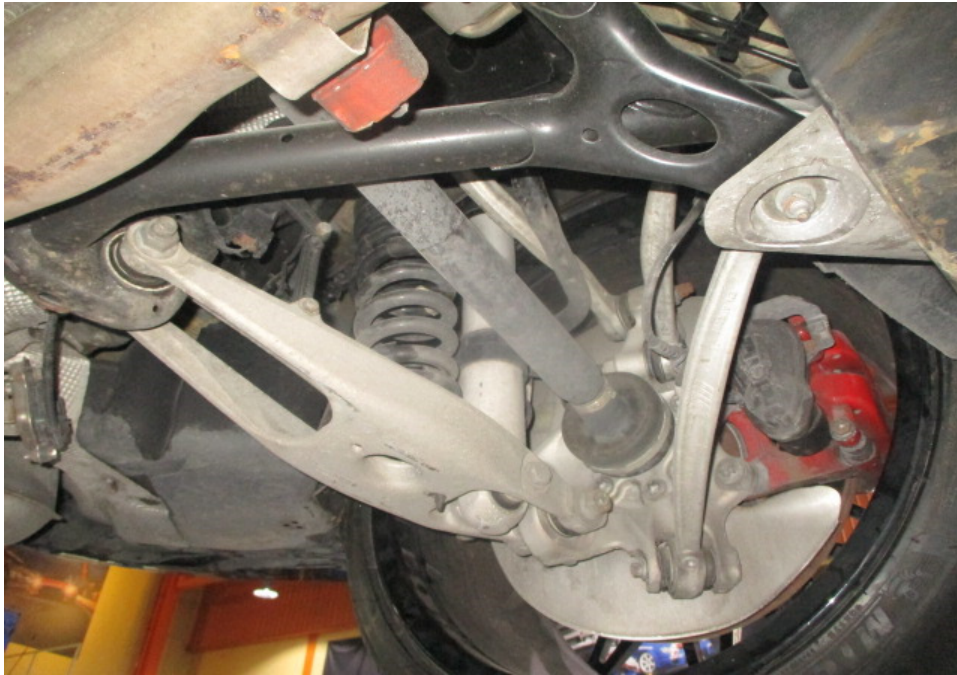
**Photo 23** shows a general view of the control arms and linkages at the rear left wheel of the Motor Car. I did not observe any fluid leak and/or fluid stain on the underside of the Motor Car. All of the Motor Car's undercarriage components were observed to be intact and secured in an appropriate manner.

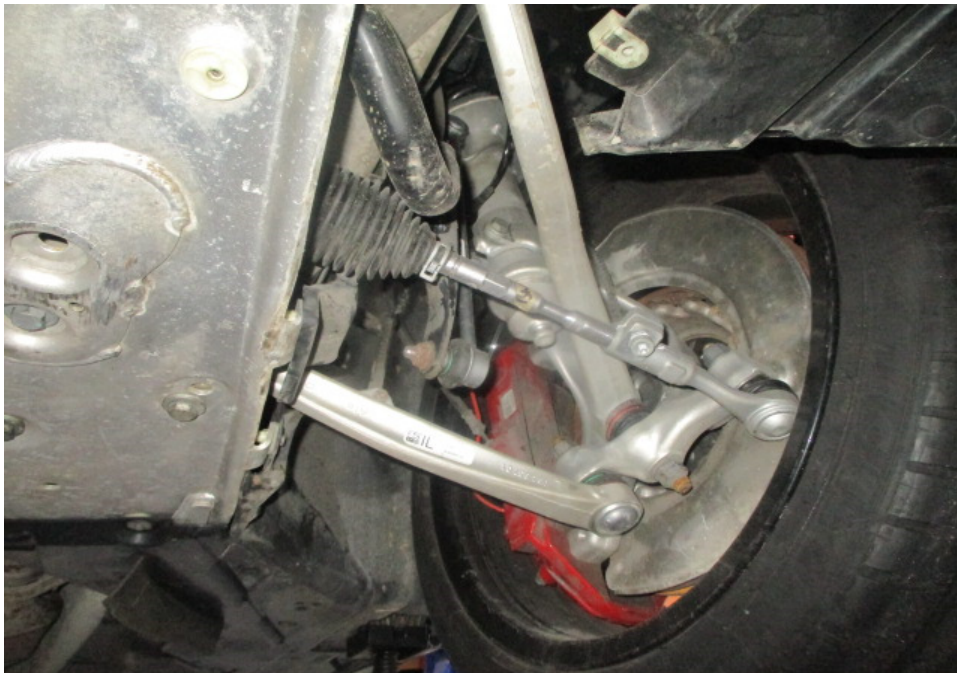
**Photo 24** shows a general view of the control arms and linkages at the front left wheel of the Motor Car. I did not observe any fluid leak and/or fluid stain on the underside of the Motor Car. All of the Motor Car's undercarriage components were observed to be intact and secured in an appropriate manner.

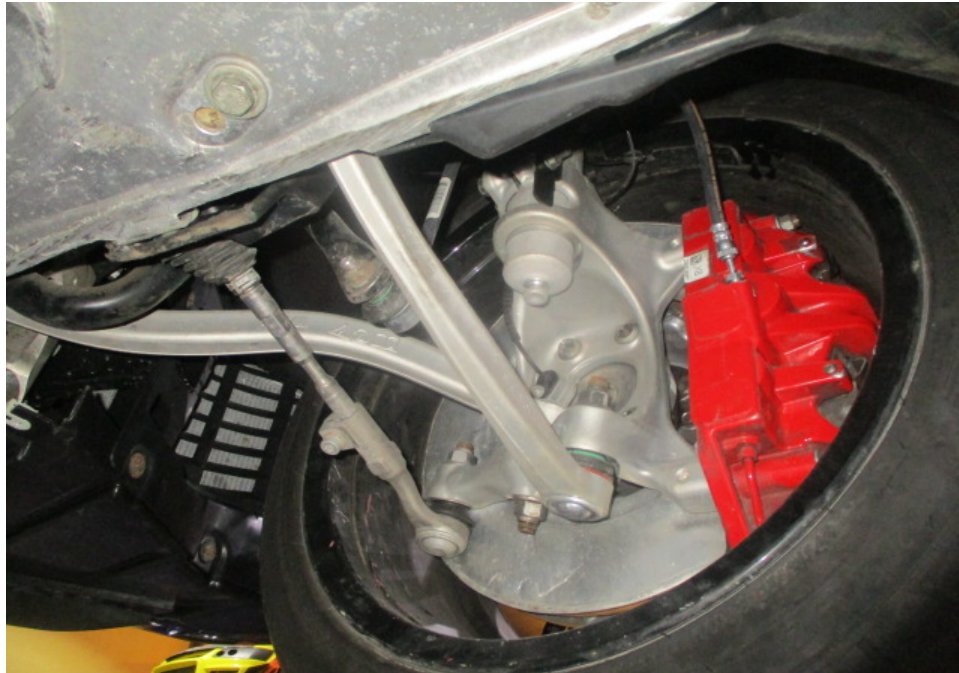
**Photo 25** shows the various undercarriage components at the front right wheel of the Motor Car. The mechanical components, control arms and linkages were all found to be intact and secured in an appropriate manner. I also did not observe any fluid leak and/or fluid stain on the underside of the Motor Car.

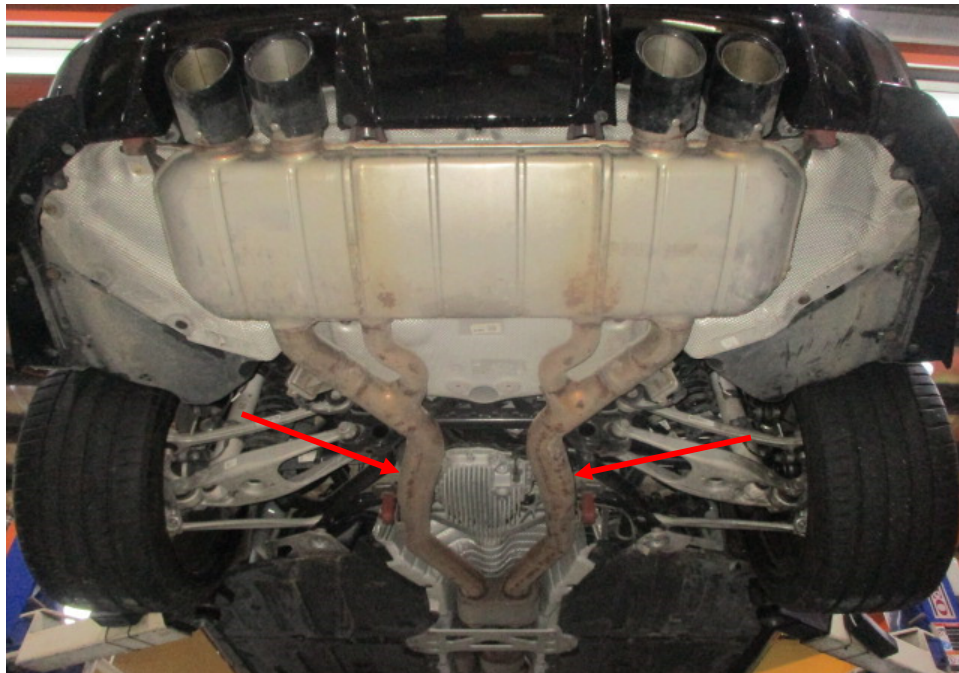
**Photo 26** shows the rear section of the Motor Car's exhaust system. My examination of the Motor Car's exhaust system revealed no sign(s) or indication(s) of any cut or weld marks along its exhaust pipes (arrowed), on its rear muffler, on its centre resonator boxes and on its catalytic converters.

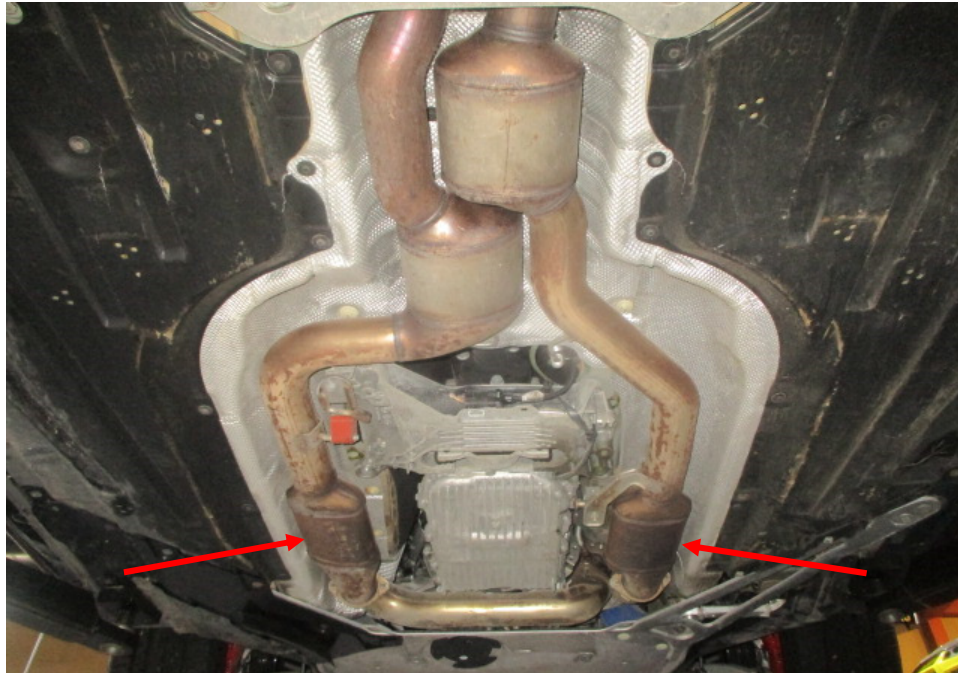
**Photo 27** shows the front section of the Motor Car's exhaust system. My examination of the Motor Car's exhaust system revealed no sign(s) or indication(s) of any cut or weld marks along its exhaust pipes, on its rear muffler, on its centre resonator boxes (arrowed) and on its catalytic converters.
