Your Ref: BMW M4 Coupe  
(chassis number WBS32AZ030CG68319)  
Our Ref : CI/TP23000006/D

03 January 2023

### **INSPECTION REPORT OF AN UNREGISTERED BMW M4 COUPE MOTOR CAR WITH CHASSIS NUMBER WBS32AZ030CG68319**

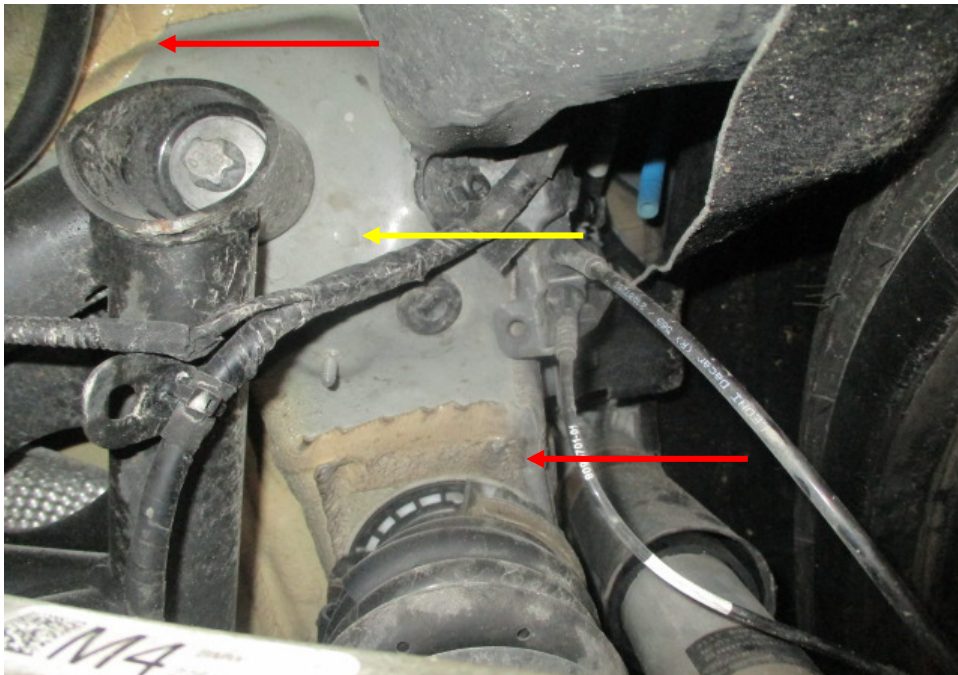
**Photo 28** shows the chassis/structural body at the underside rear right of the Motor Car. I did not find any weld marks other than original spot weld marks (yellow arrow) on the chassis/structural body of the Motor Car. The original factory sealant (red arrow) at the joints along the chassis/structural body was untouched, indicating no work was done on the chassis/structural body of the Motor Car and that the chassis/structural body was originally fitted.

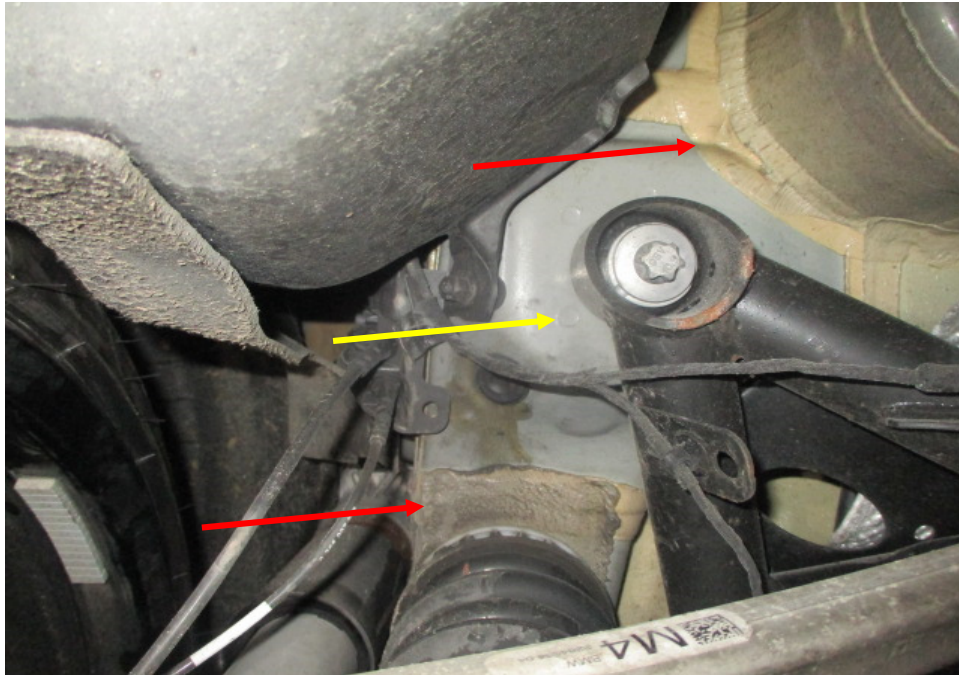
**Photo 29** shows the chassis/structural body at the underside rear left of the Motor Car. I did not find any weld marks other than original spot weld marks (yellow arrow) on the chassis/structural body of the Motor Car. The original factory sealant (red arrow) at the joints along the chassis/structural body was untouched, indicating no work was done on the chassis/structural body of the Motor Car and that the chassis/structural body was originally fitted.

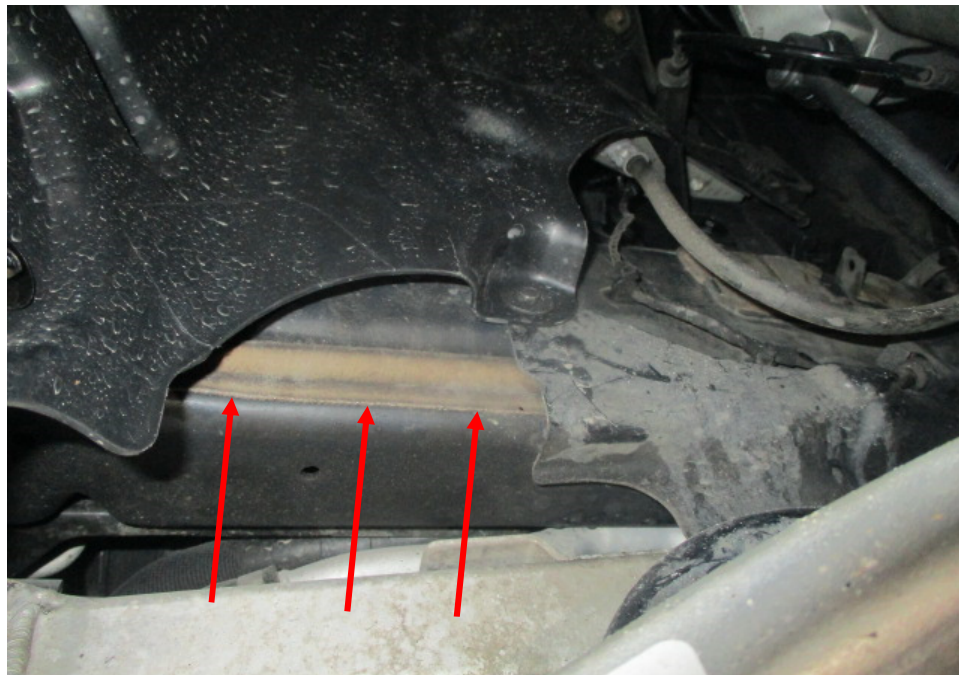
**Photo 30** shows the chassis/structural body at the underside front left of the Motor Car. The original factory sealant (arrowed) at the joints along the chassis/structural body was observed to be untouched. In general, I had found no work was carried out on the chassis/structural body of the Motor Car. The chassis/structural body of the Motor Car was originally fitted.

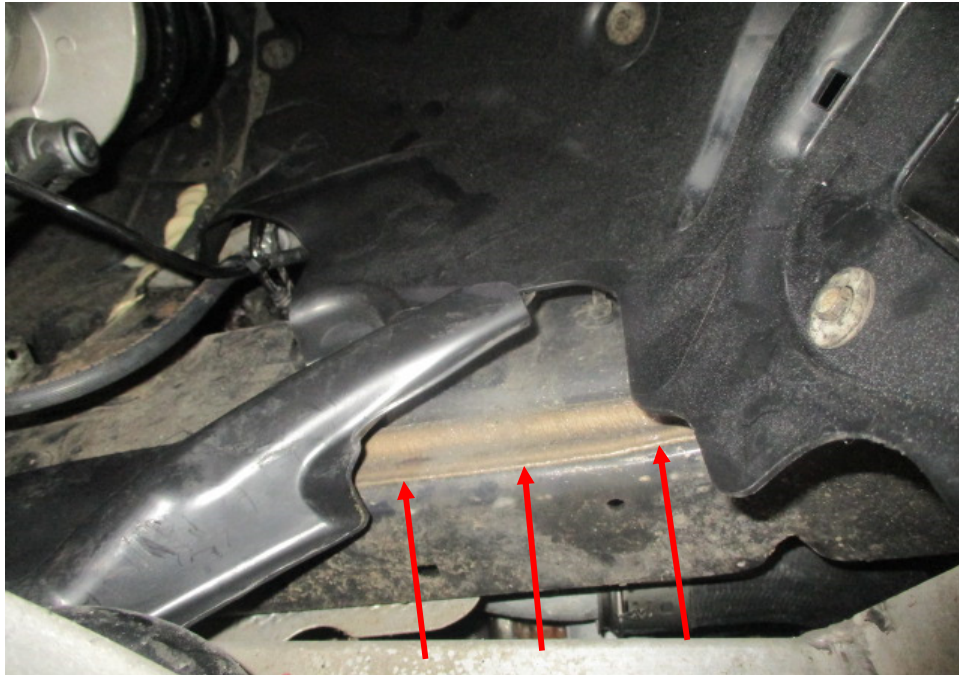
**Photo 31** shows the chassis/structural body at the underside front right of the Motor Car. The original factory sealant (arrowed) at the joints along the chassis/structural body was observed to be untouched. In general, I had found no work was carried out on the chassis/structural body of the Motor Car. The chassis/structural body of the Motor Car was originally fitted.

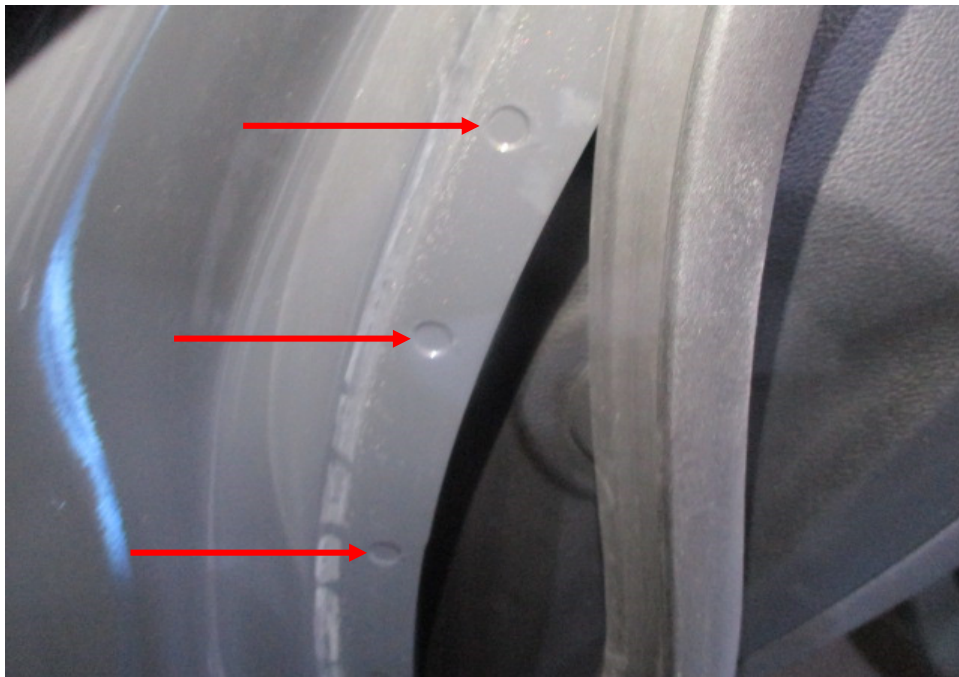
**Photo 32** shows the left side "A" pillar of the Motor Car. I did not find any weld marks other than original spot weld marks (arrowed) on the left side "A" pillar of the Motor Car, which indicates that there was no re-welding works carried out. In general, I had found all the non-detachable body panels of the Motor Car to be originally fitted at the time of my inspection.

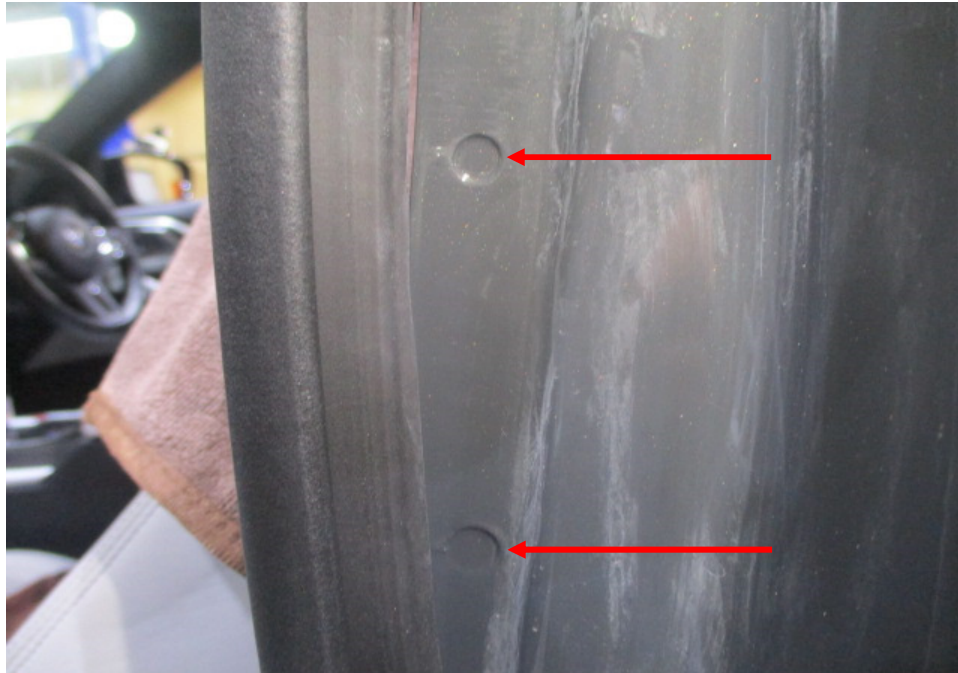
**Photo 33** shows the left side rear body panel of the Motor Car. I did not find any weld marks other than original spot weld marks (arrowed) on the left side rear body panel of the Motor Car, which indicates that there was no re-welding works carried out. In general, I had found all the non-detachable body panels of the Motor Car to be originally fitted at the time of my inspection.

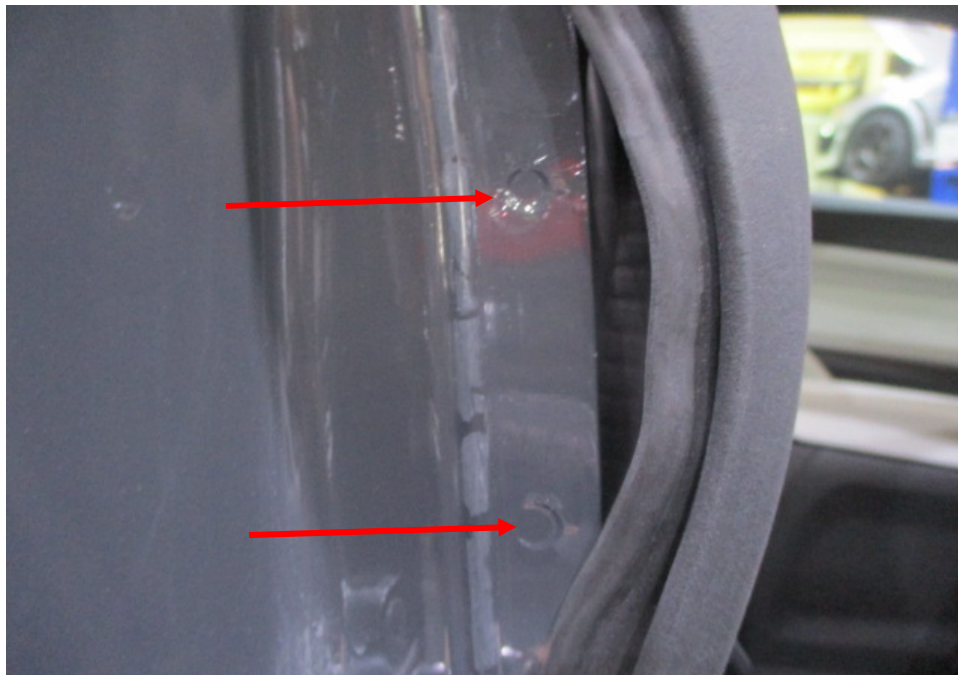
**Photo 34** shows the right side rear body panel of the Motor Car. I did not find any weld marks other than original spot weld marks (arrowed) on the right side rear body panel of the Motor Car, which indicates that there was no re-welding works carried out. In general, I had found all the non-detachable body panels of the Motor Car to be originally fitted at the time of my inspection.

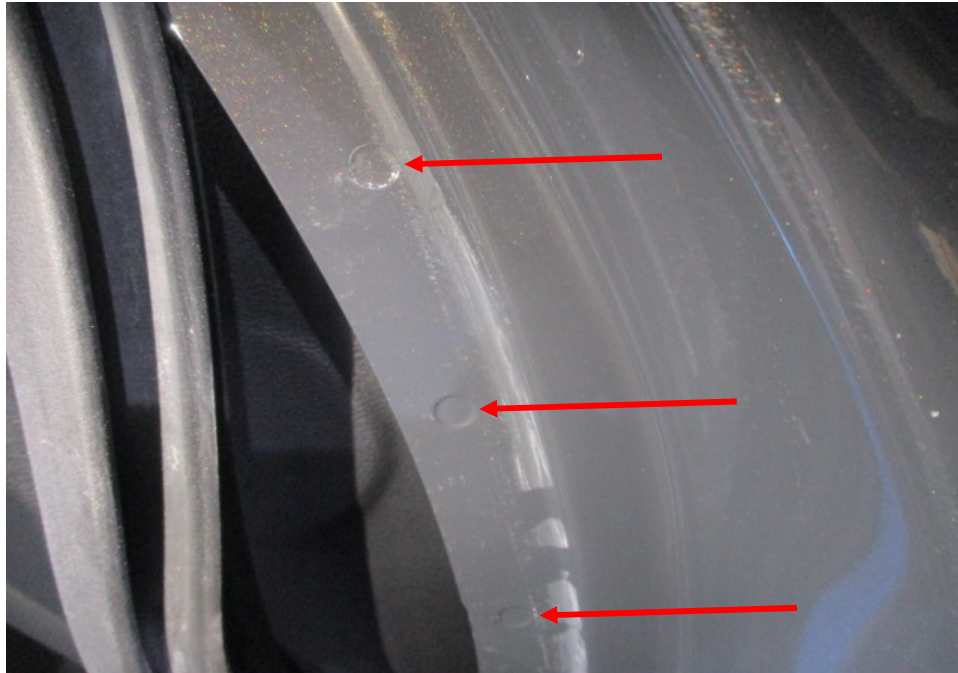
**Photo 35** shows the right side "A" pillar of the Motor Car. I did not find any weld marks other than original spot weld marks (arrowed) on the right side "A" pillar of the Motor Car, which indicates that there was no re-welding works carried out. In general, I had found all the non-detachable body panels of the Motor Car to be originally fitted at the time of my inspection.
