MECHANICAL INSPECTION REPORT OF MOTOR BUS, PD 511G

1. I refer to your request on 23rd December 2022 to conduct a physical inspection of a Motor Bus bearing registration number PD 511G (herein referred to as "**Motor Bus**"), which was involved in a road traffic accident on 16th November 2022.
2. The objective of this inspection is to determine if there was any possible mechanical failure to the Motor Bus that may have contributed to the accident.
3. Following the request, I had carried out a physical inspection of the Motor Bus on 30th December 2022 at the premises of Traffic Police vehicle pound, 517 Airport Road Singapore 539942. I now set out below my observations and comments with respect to this inspection.

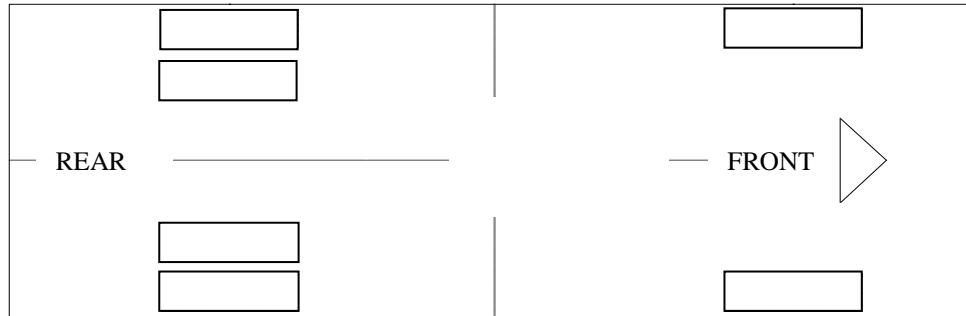
6. The 2 front tyres and 4 rear tyres of the Motor Bus were observed to be in serviceable condition and sufficiently inflated for vehicular operation. I did not find any tear, cut or burst mark(s) on the outer and the inner sidewalls as well as across the tread of the 6 tyres of the Motor Bus. The tyre brand, tyre size and remaining tread depth of the 6 tyres of the Motor Bus were recorded as follows:-

Motor Bus

Michelin 215/75R17.5 (11.2mm)

Michelin 215/75R17.5 (10.3mm)

Michelin 215/75R17.5 (11.1mm)

Michelin 215/75R17.5 (10.1mm)

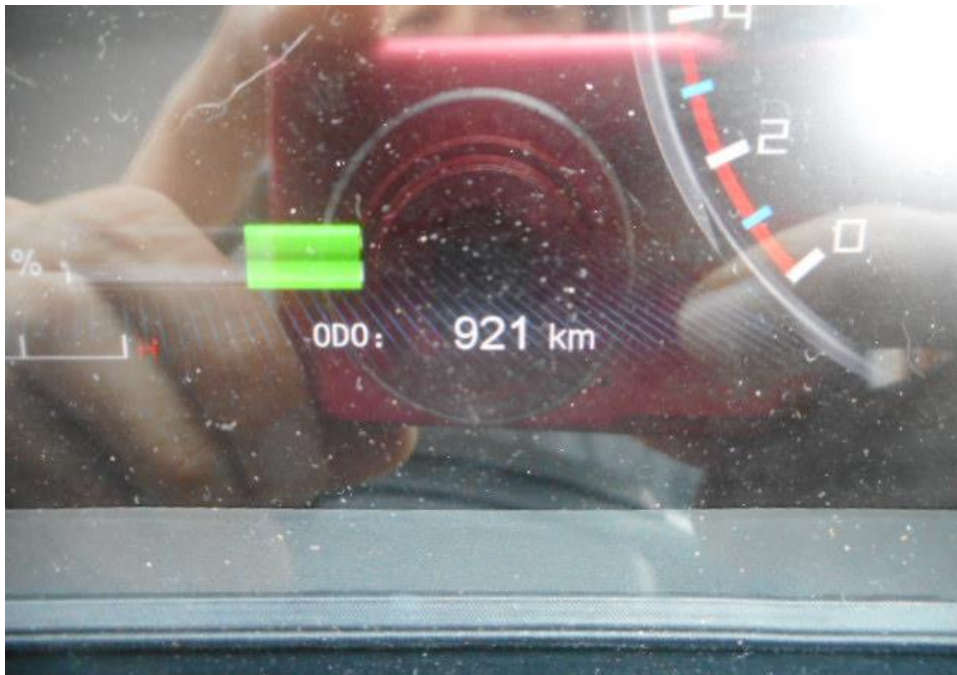
Photo 1 shows a general view of the instrument cluster of the Motor Bus at the time of my inspection. The mileage of the Motor Bus was 13,452km

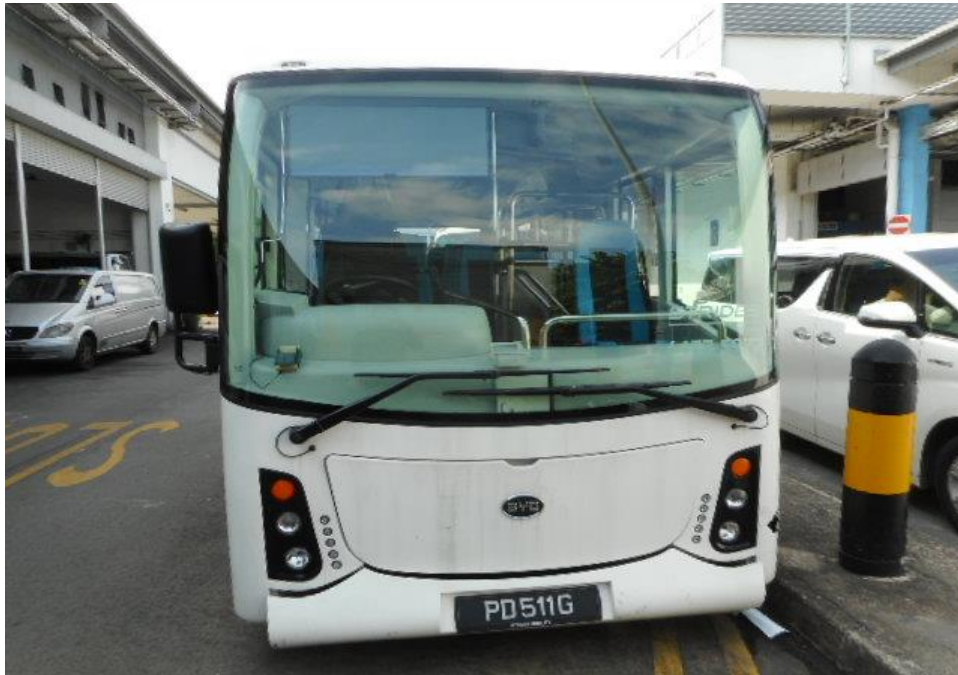
4. The mileage of the Motor Bus at the time of my inspection was 912km.
5. The Motor Bus was observed to have sustained damage at its front portion. Its front left body panel, front windscreen and left rear view mirror was amongst the body parts that were damaged as a result of the accident.

Photo 2 shows a general view of the front body of the Motor Bus at the time of my inspection. The front portion of the Motor Bus was observed to sustained damage at the time of inspection. Its front left body panel, front windscreen and left rear view mirror was amongst the body parts that were damaged as a result of the accident.

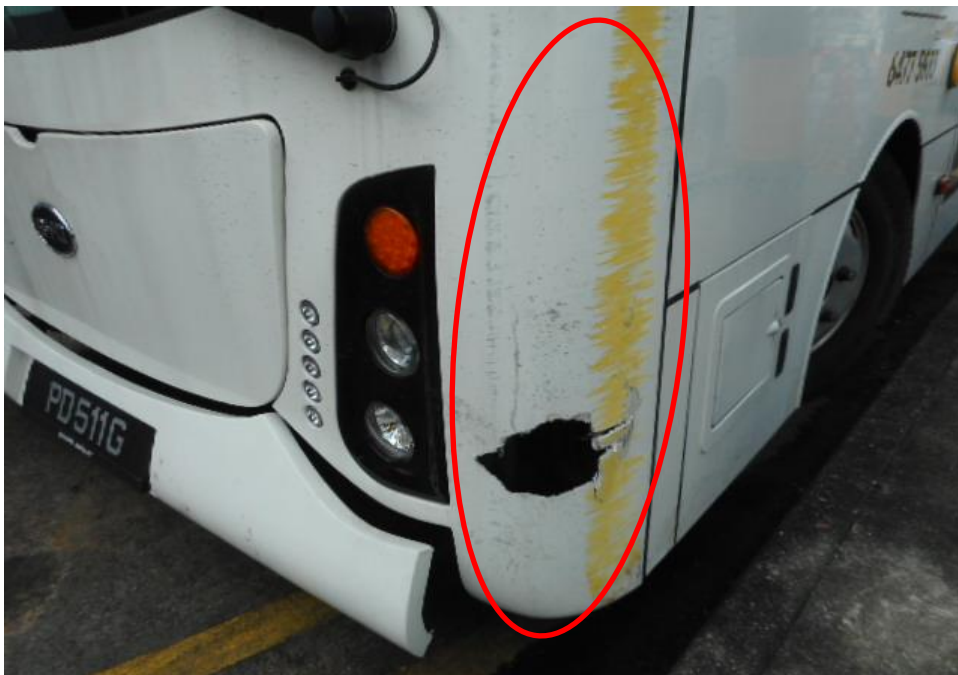
Photo 3 shows a close up view of the right body of the Motor Bus at the time of my inspection. The front portion of the Motor Bus was observed to sustained damage at the time of inspection. Its front left body panel (circled) was amongst the body parts that were damaged as a result of the accident.

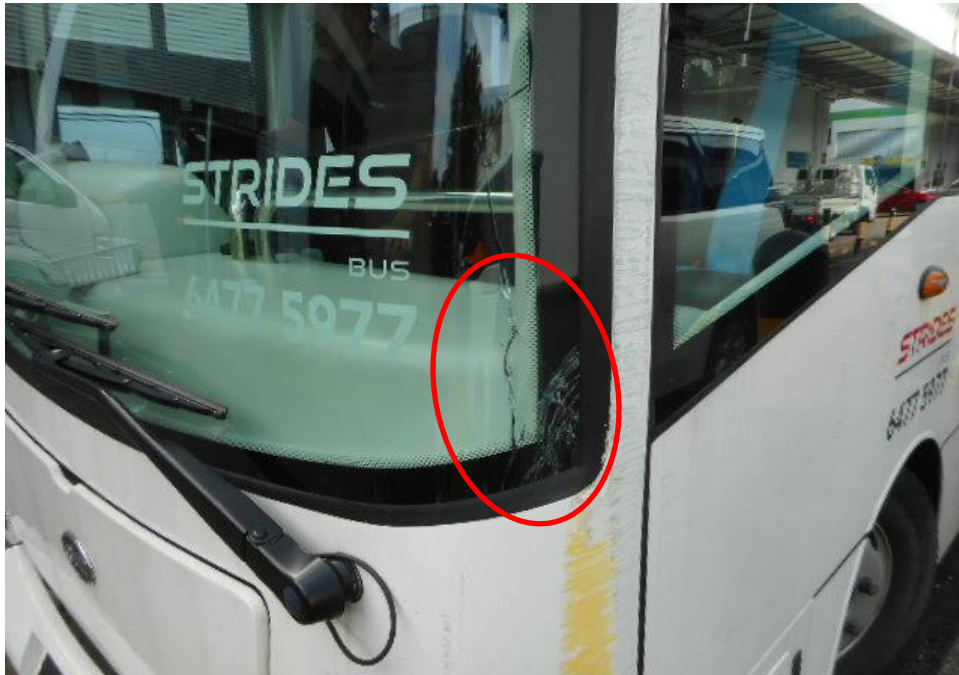
Photo 4 shows a close up view of the right body of the Motor Bus at the time of my inspection. The front portion of the Motor Bus was observed to sustained damage at the time of inspection. Its front windscreen (circled) was amongst the body parts that were damaged as a result of the accident.

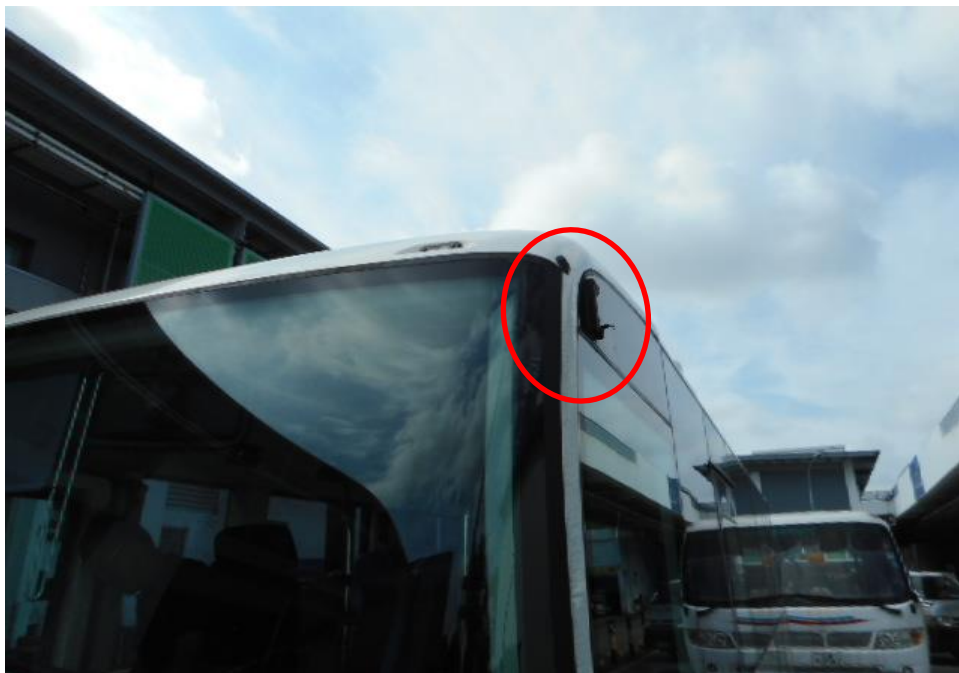
Photo 5 shows a close up view of the right body of the Motor Bus at the time of my inspection. The front portion of the Motor Bus was observed to sustained damage at the time of inspection. Its left rear view mirror (circled) was amongst the body parts that were damaged as a result of the accident.

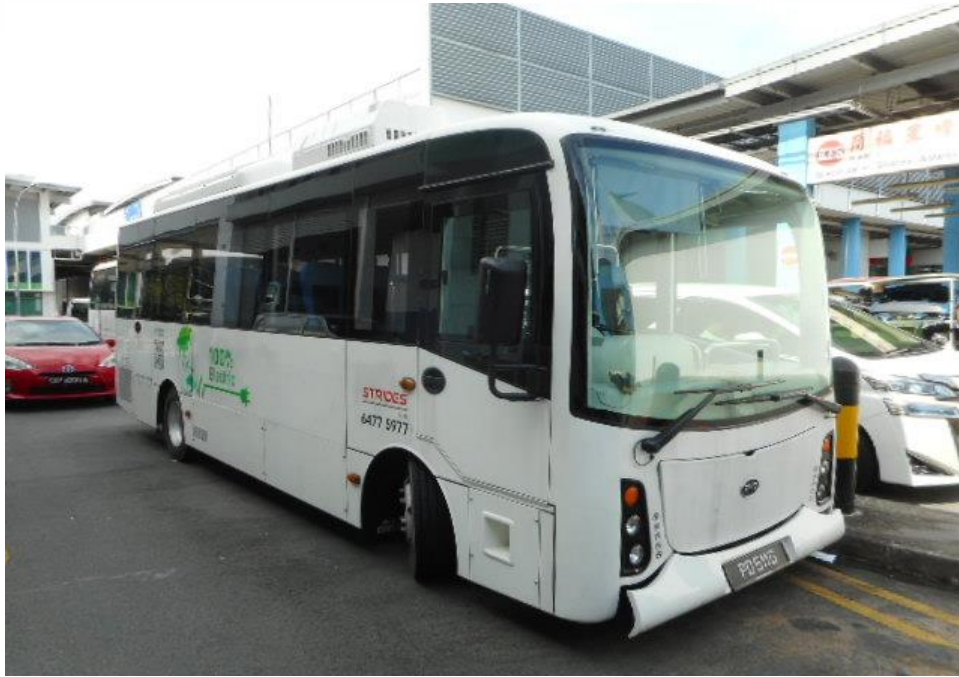
Photo 6 shows a general view of the right body of the Motor Bus at the time of my inspection. The right portion of the Motor Bus was observed to be intact and unaffected by the accident.

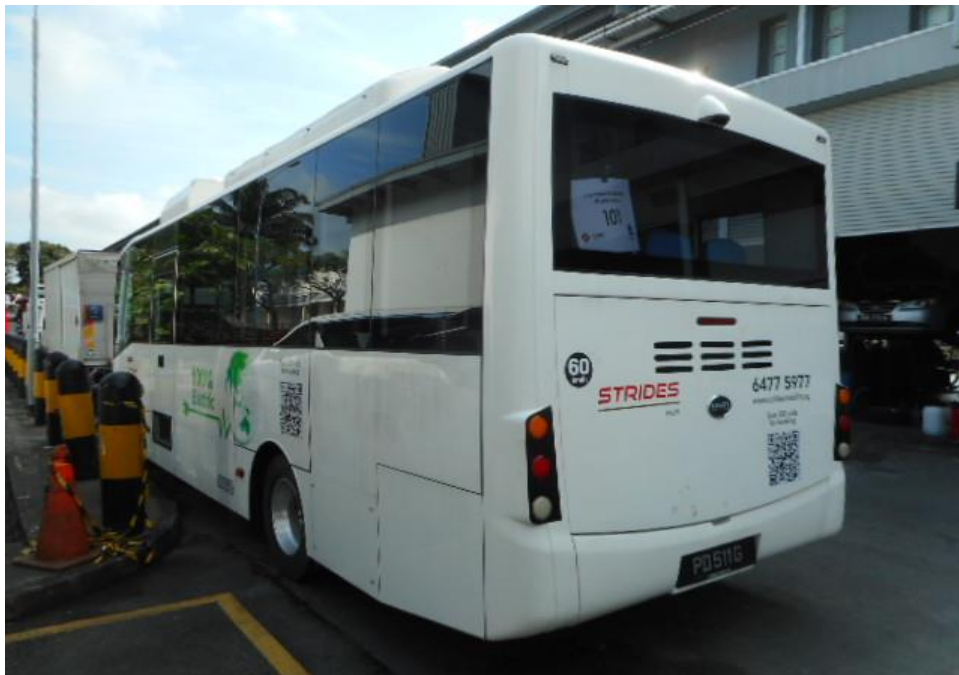
Photo 7 shows a general view of the left body of the Motor Bus at the time of my inspection. The left portion of the Motor Bus was observed to be intact and unaffected by the accident.

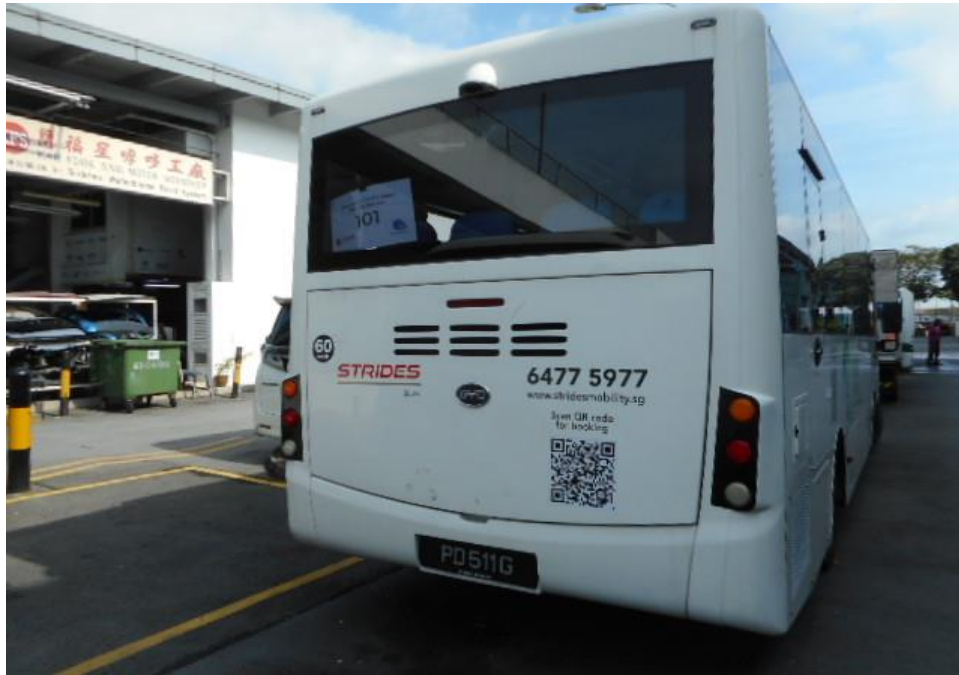
Photo 8 shows a general view of the Motor Bus's rear body at the time of my inspection. The rear of the Motor Bus was observed to be intact and unaffected by the accident.

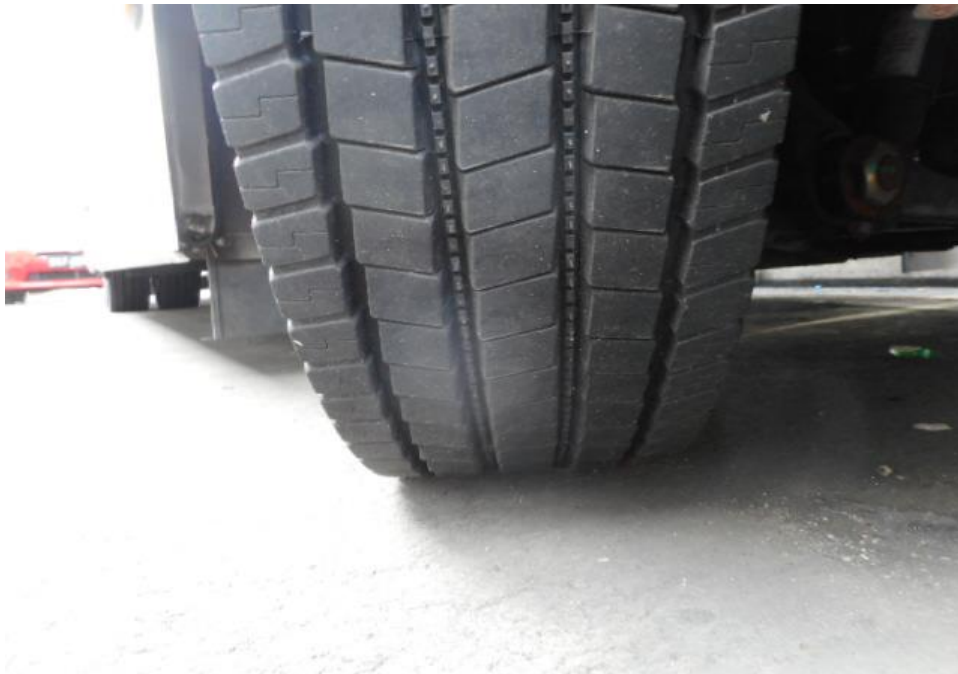
Photo 9 shows the condition of the front right tyre of the Motor Bus, which was observed to be in serviceable condition with remaining tread depth of approximately 10.1mm. The tyre, which was wrapped around standard steel wheel rim, was also observed to be sufficiently inflated for vehicular operation. There was no tear, cut or burst mark(s) on the outer and the inner sidewalls as well as across the tread of the 6 tyres that were fitted on the Motor Bus.

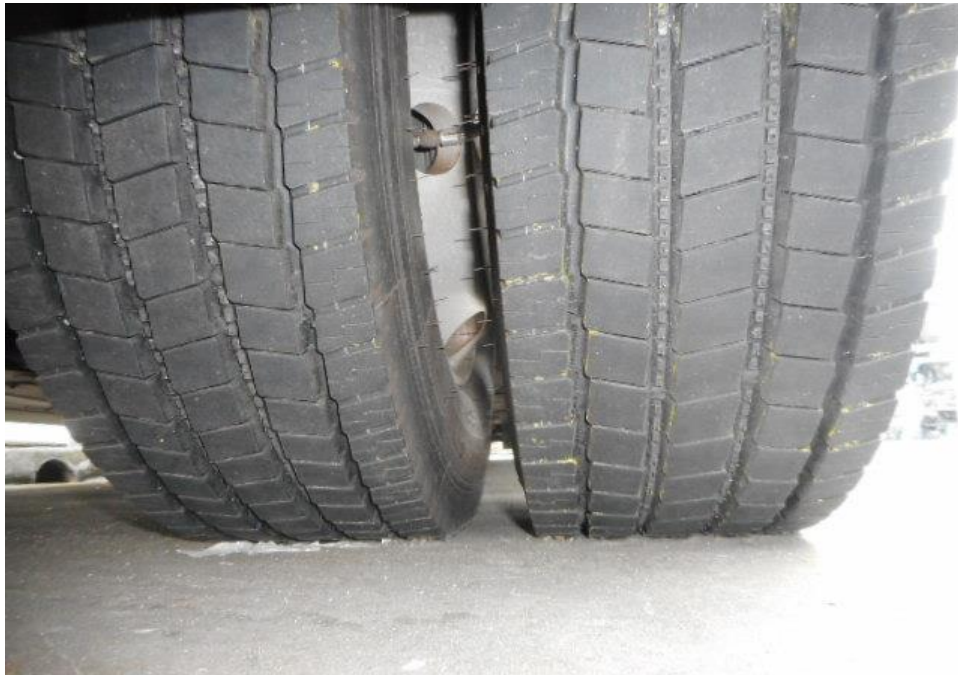
Photo 10 shows the condition of the rear right tyre of the Motor Bus, which was observed to be in serviceable condition with remaining tread depth of approximately 11.1mm. The tyre, which was wrapped around standard steel wheel rim, was also observed to be sufficiently inflated for vehicular operation.

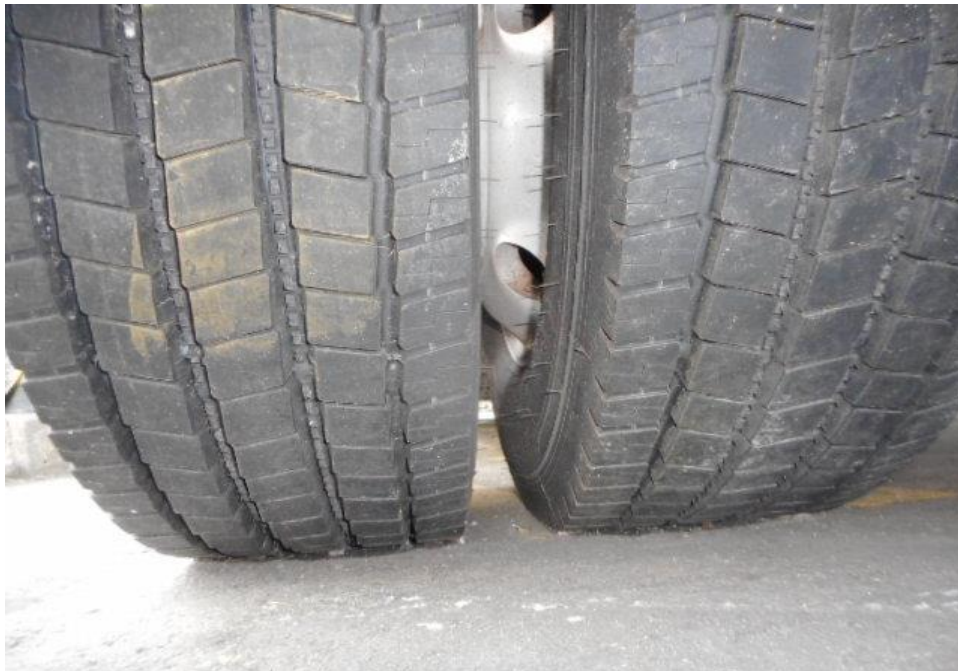
Photo 11 shows the condition of the rear left tyres of the Motor Bus, which was observed to be in serviceable condition with remaining tread depth of approximately 11.2mm. The tyres, which were wrapped around standard steel wheel rim, were also observed to be sufficiently inflated for vehicular operation. There was also no damage found on all 6 steel wheel rims of the Motor Bus.

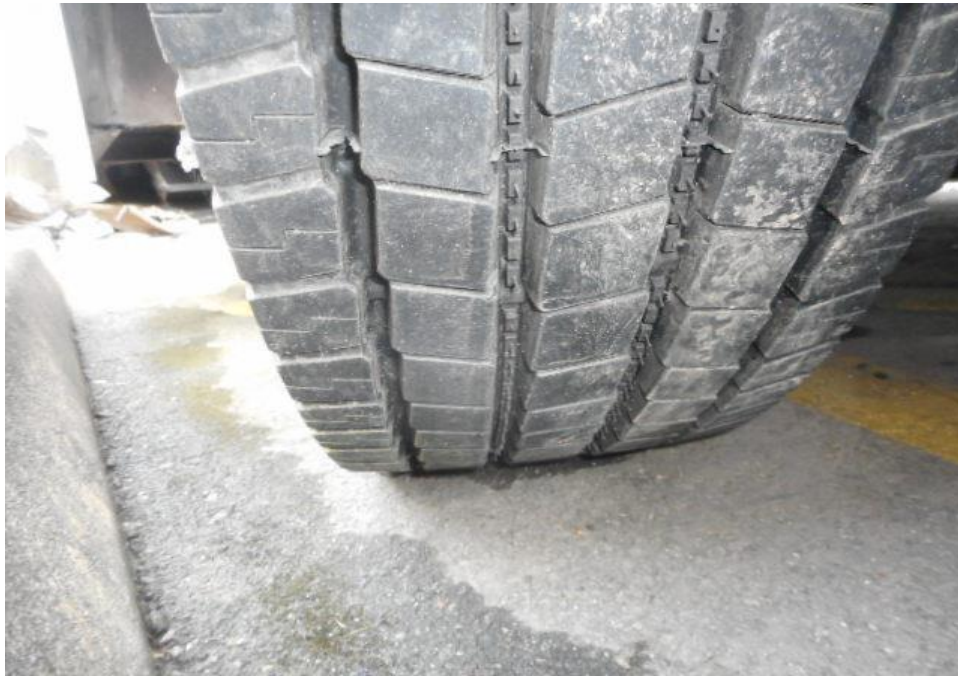
Photo 12 shows the condition of the front left tyres of the Motor Bus, which were observed to be in serviceable condition with remaining tread depth of approximately 10.3mm. There was also no tear, cut or burst mark(s) on the outer and the inner sidewalls as well as across the tread of the 6 tyres that were fitted on the Motor Bus.

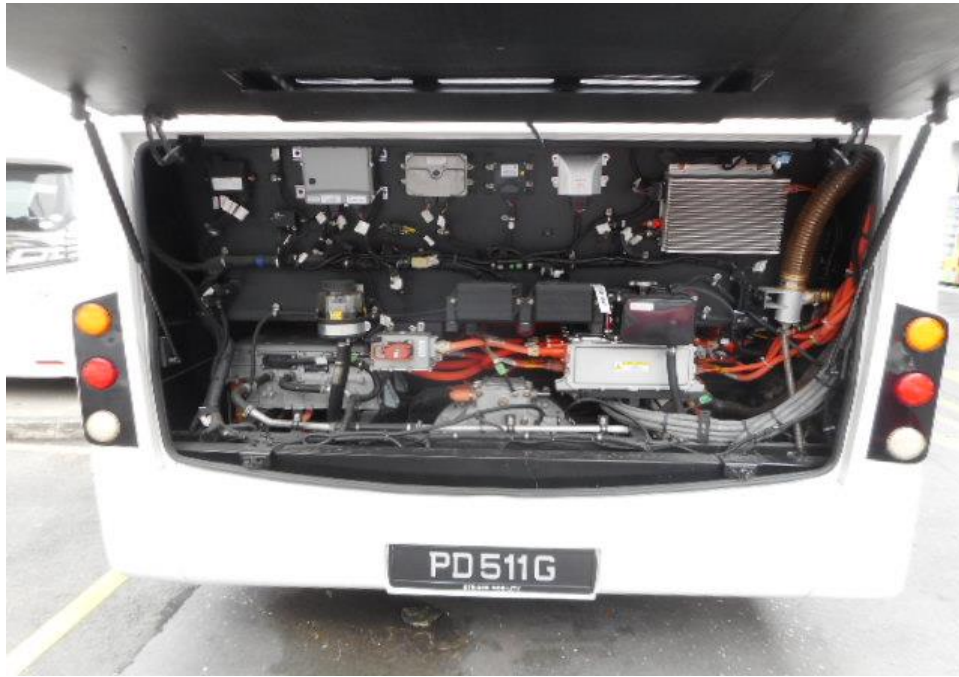
Photo 13 shows a general view of the Motor Bus's electric motor compartment, which was accessed by lifting the rear cabin of the Motor Bus. The various parts and components inside the electric motor compartment were unaffected by the accident. There was also no sign(s) or indication(s) of fresh fluid leakage and/or fluid stain within the electric motor compartment

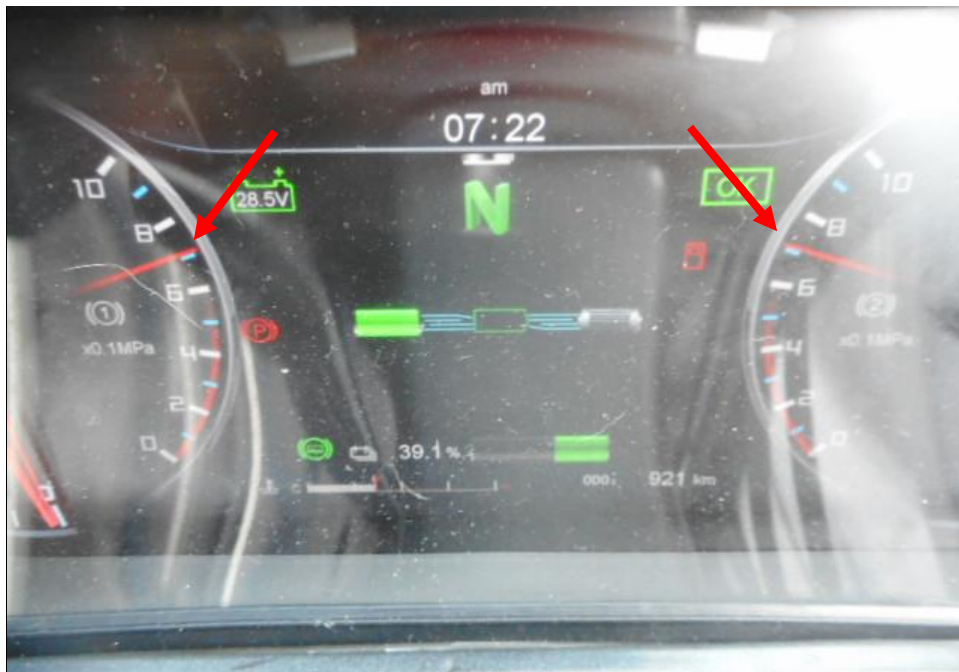
Photo 14 shows the air in the air brake cylinders of the Motor Bus at the time of my inspection. The air in the cylinder was observed to be of sufficient level (arrowed) & serviceable at the time of the accident.

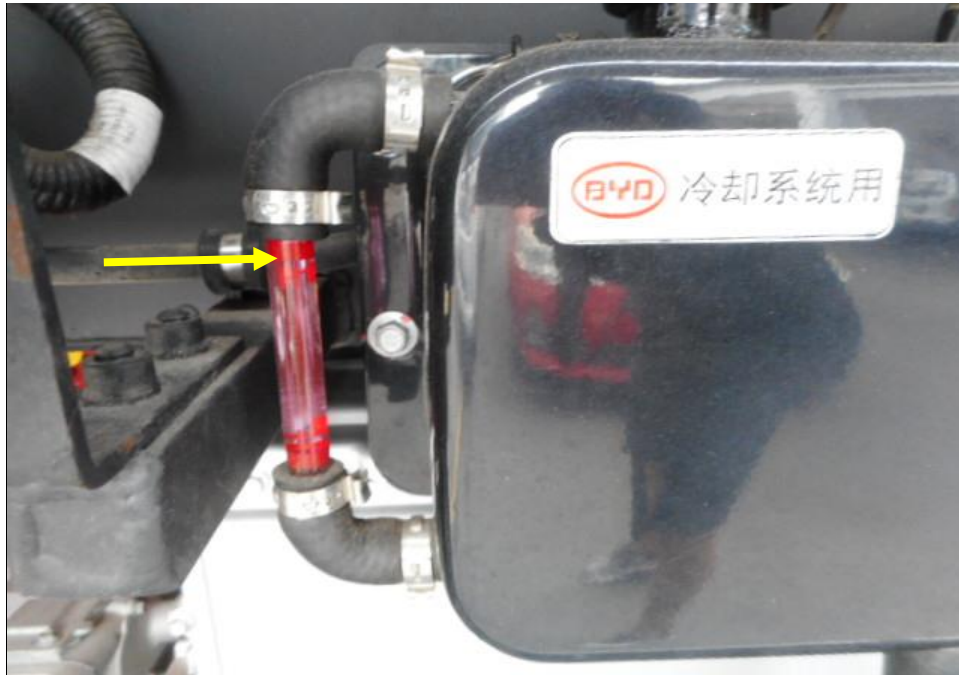
Photo 15 shows the electric motor coolant reservoir of the Motor Bus at the time of my inspection. The electric motor coolant was observed to be of sufficient level (arrowed) and without any visible contamination.

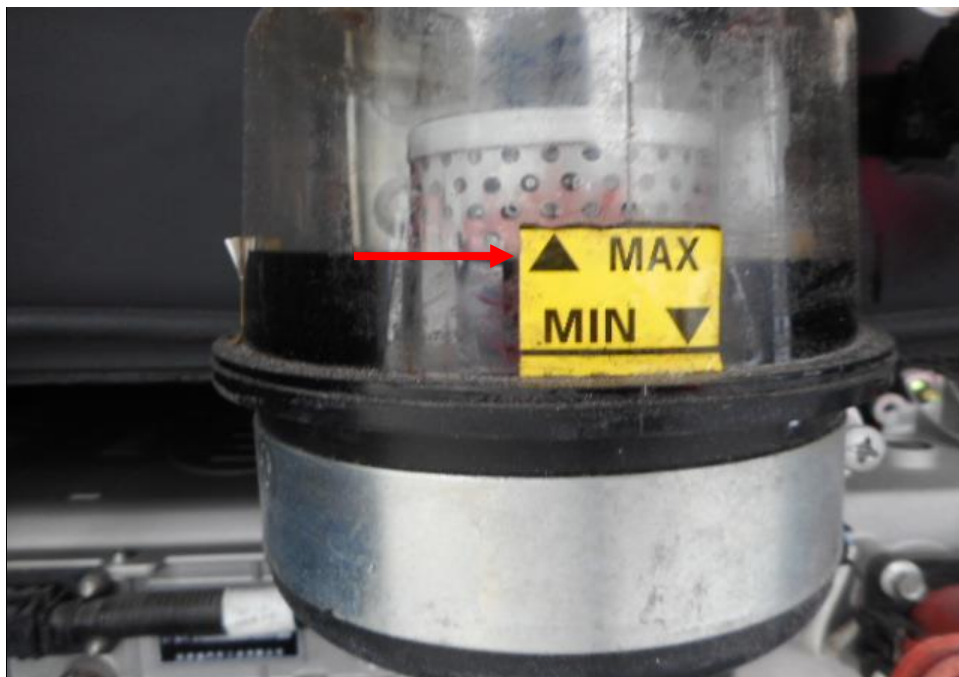
Photo 16 shows the power steering fluid reservoir of the Motor Bus at the time of my inspection. The power steering fluid was observed to be of sufficient level (arrowed) and without any visible contamination.

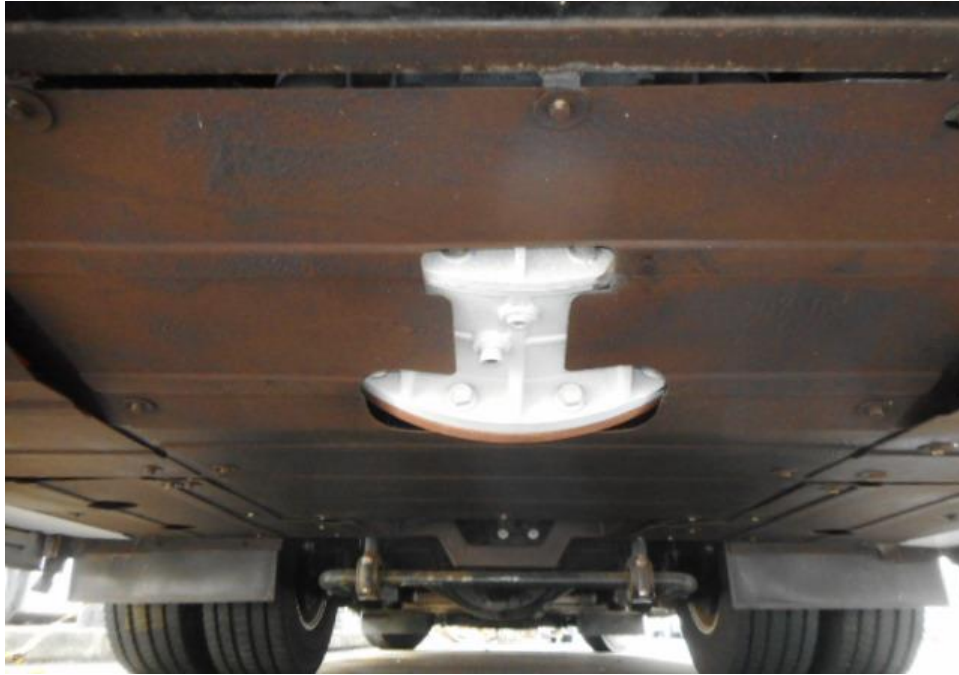
Photo 17 shows the undercarriage of the Motor Bus, at the area where the electric motor housing located. I did not find any sign(s) or indication(s) of fluid leak on the underside of the Motor Bus.

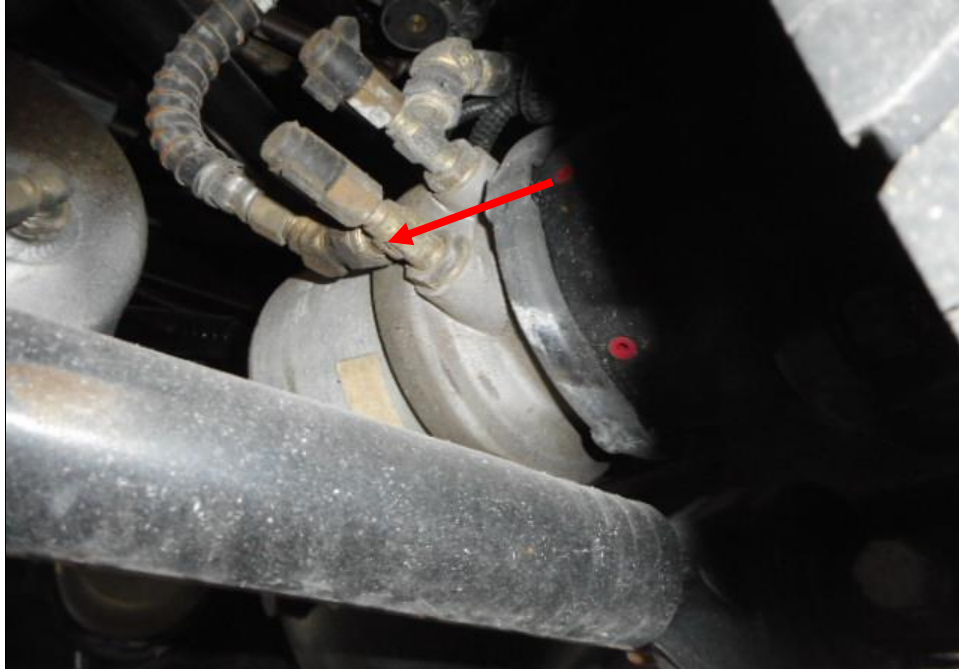
Photo 18 shows the brake pipe (arrowed) at the rear right wheel of the Motor Bus. I did not observe any leakage of brake fluid at the time of my inspection of the Motor Bus. My static tests of the Motor Bus's braking system, along with my visual examination of the various mechanical components in the braking system, had indicated that there was no internal leakage of pressure/vacuum. Hence the braking system of the Motor Bus was likely to be in serviceable condition at the material time of accident.

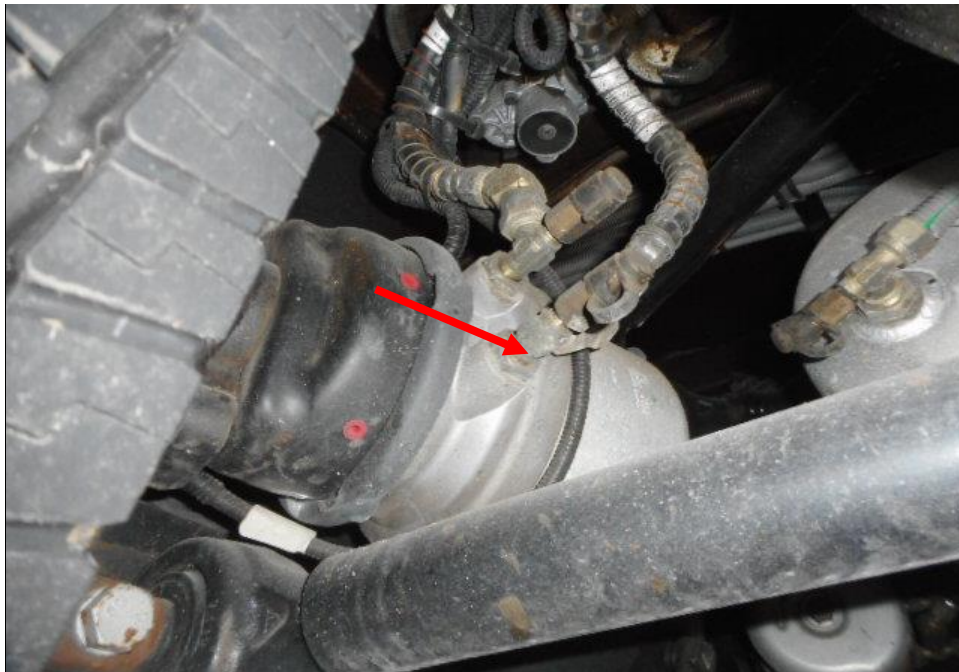
Photo 19 shows the brake pipe (arrowed) at the rear left wheel of the Motor Bus. I did not observe any leakage of brake fluid at the time of my inspection of the Motor Bus. My static tests of the Motor Bus's braking system, along with my visual examination of the various mechanical components in the braking system, had indicated that there was no internal leakage of pressure/vacuum. Hence the braking system of the Motor Bus was likely to be in serviceable condition at the material time of accident.

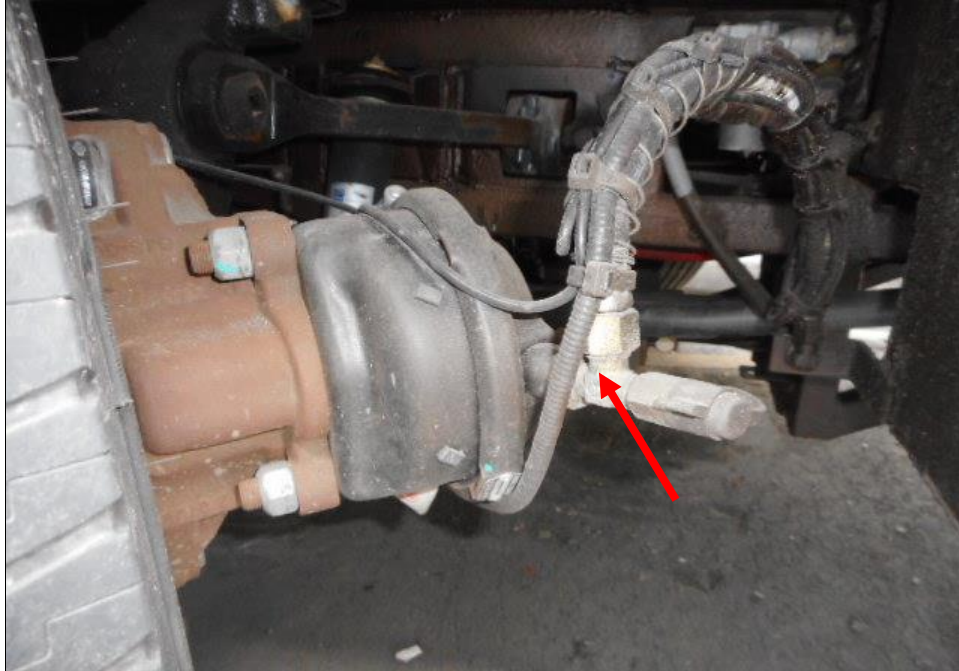
Photo 20 shows the brake pipe (arrowed) at the front right wheel of the Motor Bus. I did not observe any leakage of brake fluid at the time of my inspection of the Motor Bus. My static tests of the Motor Bus's braking system, along with my visual examination of the various mechanical components in the braking system, had indicated that there was no internal leakage of pressure/vacuum. Hence the braking system of the Motor Bus was likely to be in serviceable condition at the material time of accident.

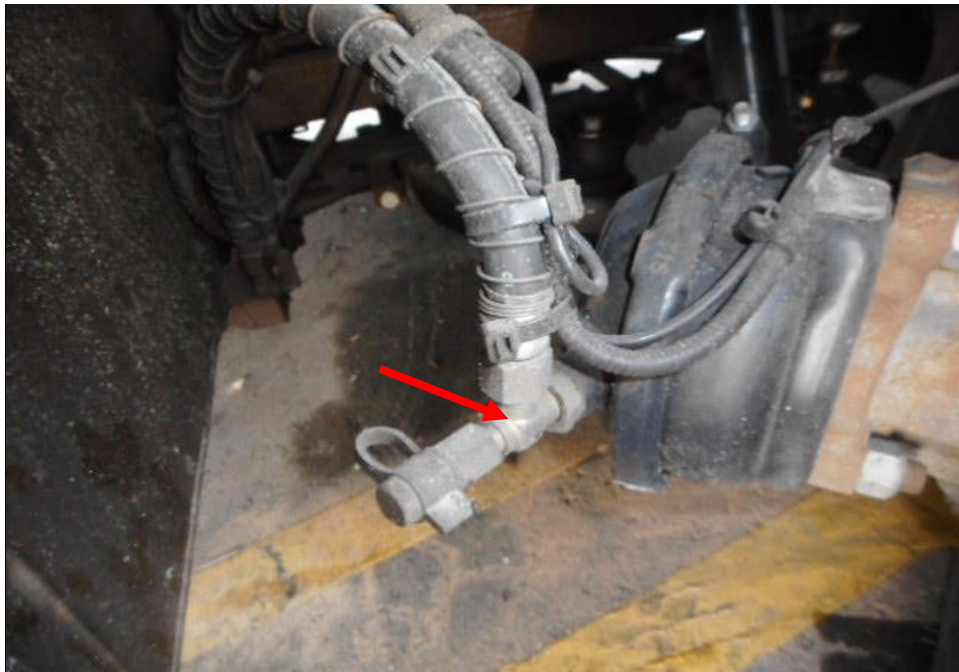
Photo 21 shows the brake pipe (arrowed) at the front left wheel of the Motor Bus. I did not observe any leakage of brake fluid at the time of my inspection of the Motor Bus. My static tests of the Motor Bus's braking system, along with my visual examination of the various mechanical components in the braking system had indicated that there was no internal leakage of pressure/vacuum. Hence the braking system of the Motor Bus was likely to be in serviceable condition at the material time of accident.

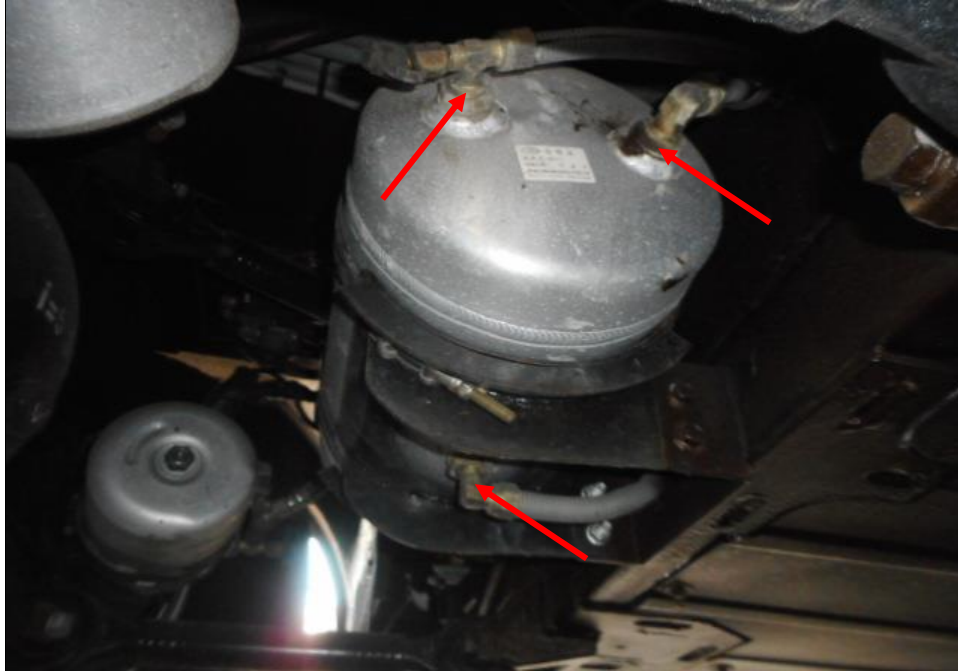
Photo 22 shows the air brake cylinders (arrowed) at the undercarriage of the Motor Bus. I did not observe any leakage of air brake fluid at the time of my inspection of the Motor Bus. My static tests of the Motor Bus's braking system, along with my visual examination of the various mechanical components in the braking system had indicated that there was no internal leakage of pressure/vacuum. Hence the braking system of the Motor Bus was likely to be in serviceable condition at the material time of accident.

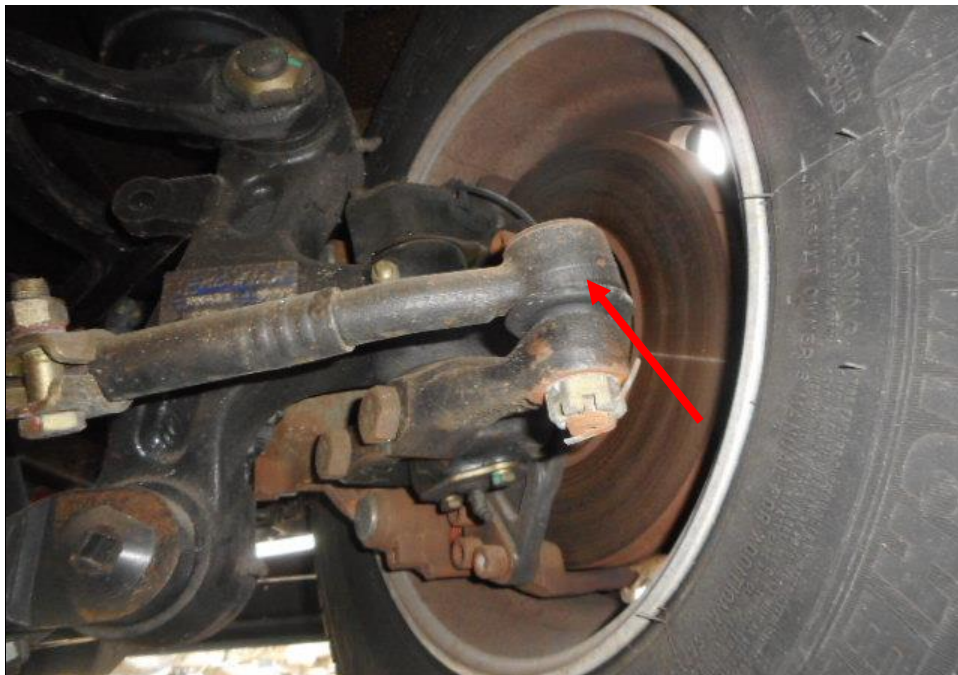
Photo 23 shows the various undercarriage components at the front right wheel of the Motor Bus, in particular the steering tie rod end (arrowed). The various steering components were all found to be intact, suggesting that the steering system of the Motor Bus was likely to be in serviceable condition at the material time of accident. There was also no sign of fluid stain(s) observed on the various undercarriage components.

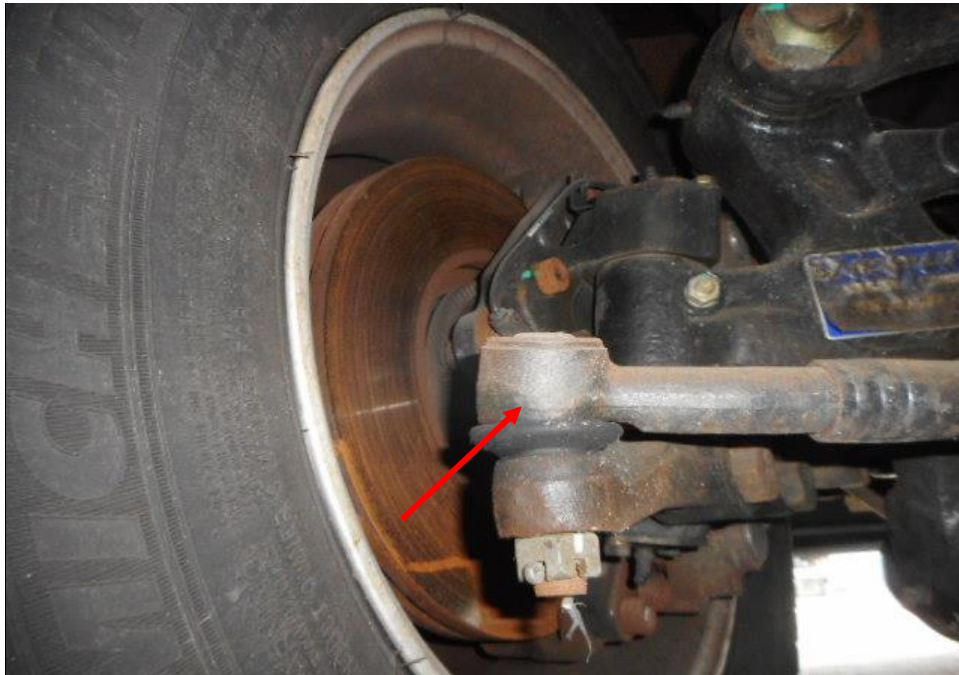
Photo 24 shows the various undercarriage components at the front left wheel of the Motor Bus, in particular the steering tie rod end (arrowed). The various undercarriage components of the Motor Bus were all found to be intact without any visible damage. There was also no sign of fluid stain(s) observed on the various undercarriage components.

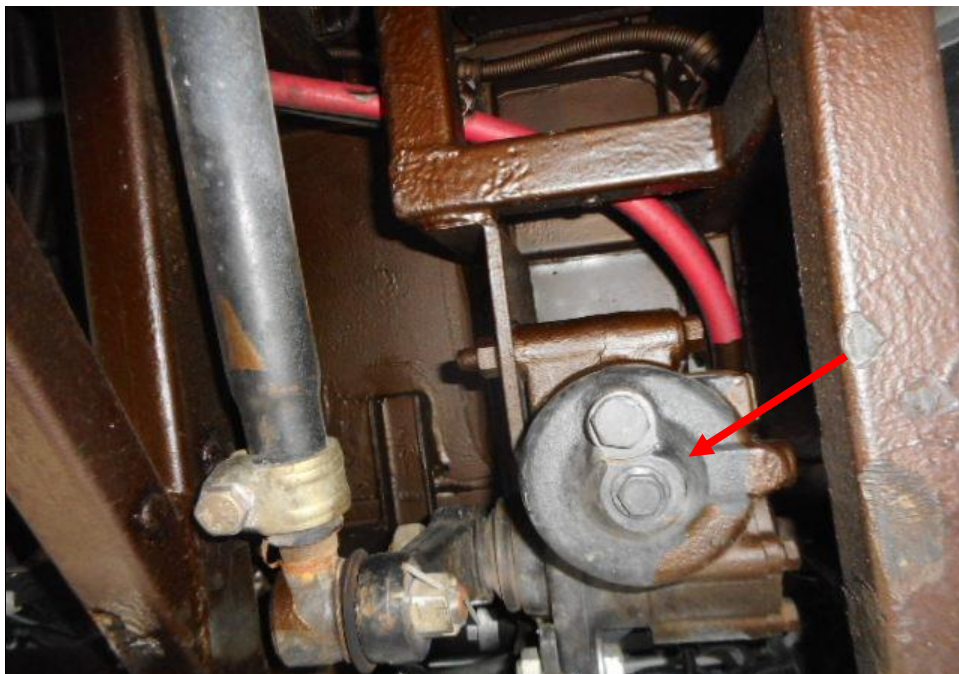
Photo 25 shows the steering box component (arrowed) at the undercarriage of the Motor Bus was found to be intact without any visible damage. There was also no sign of fluid stain(s) observed on the various undercarriage components.

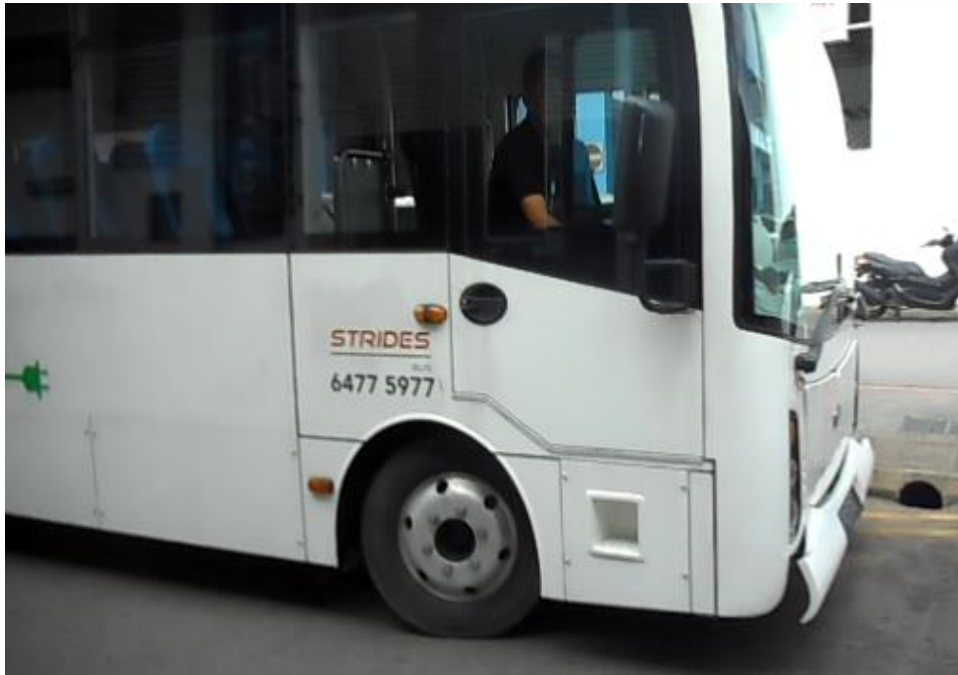
Photo 26 shows the front right wheel of the Motor Bus turned to its full left. During my steering system test, I did not experience any abnormal free play and/or resistance when I had turned the steering wheel towards full left and full right. This would suggest that the steering system of the Motor Bus was likely to be in serviceable condition at the material time of accident.

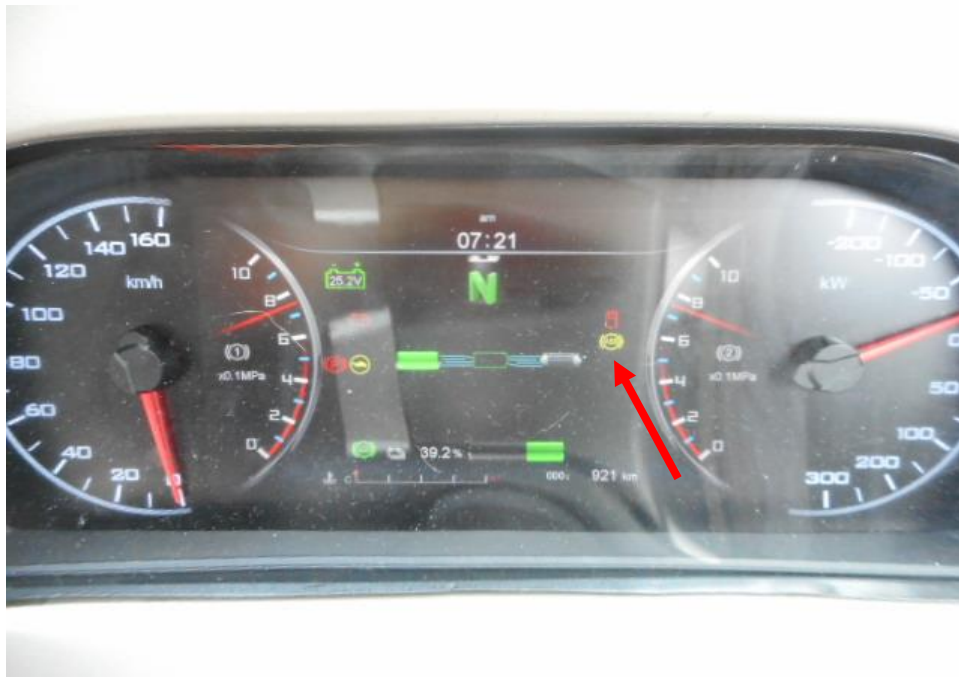
Photo 27 shows the warning light for Anti-Lock Brake System (ABS) (arrowed) appearing on the instrument panel of the Motor Bus during the self-test of its various electronic operating systems when its electric motor was cranked.

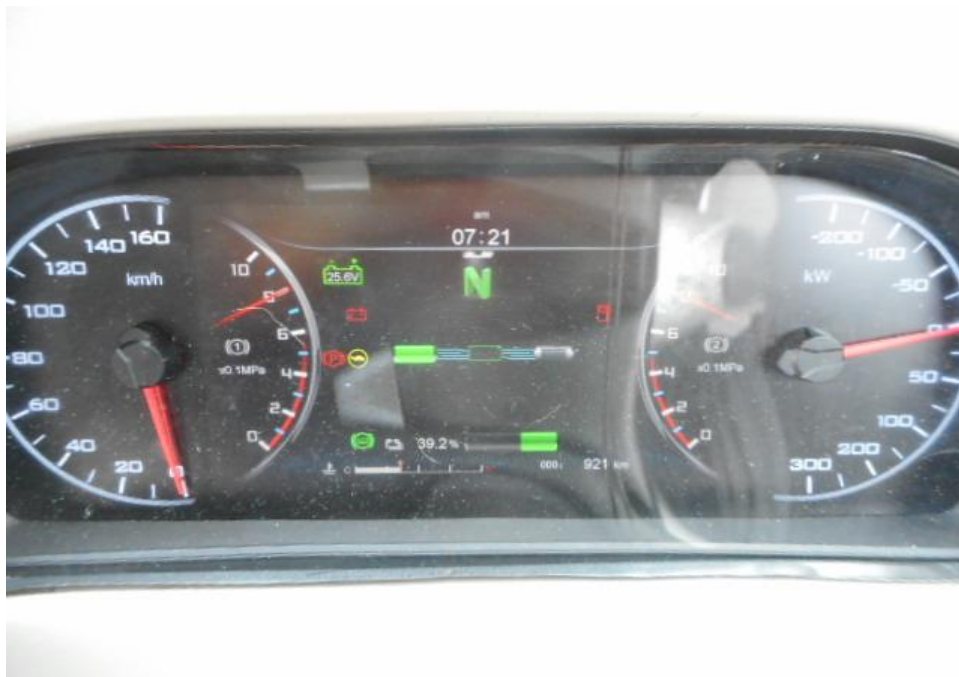
Photo 28 shows no warning lights illuminated on the instrument panel of the Motor Bus after the electric motor was cranked. This would suggest that there was no abnormality to the electronic operating system of the Motor Bus, like the ABS and etc.
