Your Ref: Porsche Cayenne  
(chassis number WP1ZZZ9YZMDA43144)  
Our Ref : CI/TP23000016/D

03 January 2023

**INSPECTION REPORT OF AN UNREGISTERED PORSCHE CAYENNE  
MOTOR CAR WITH CHASSIS NUMBER WP1ZZZ9YZMDA43144**

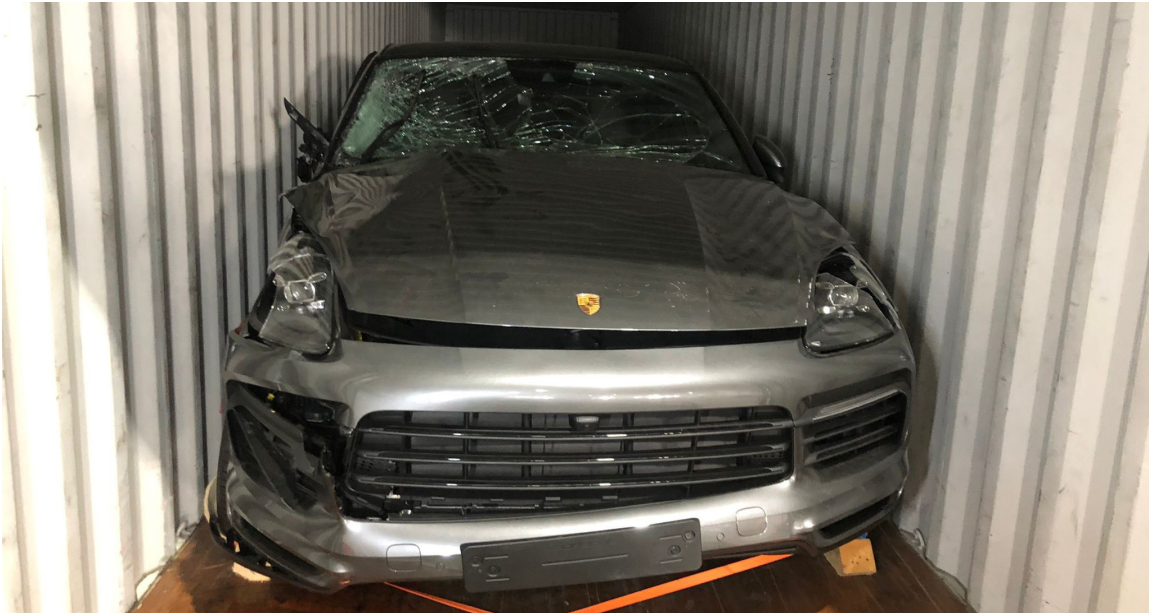
**Photo 1** shows the frontal body of the Motor Car (photograph provided to me). The Motor Car was observed to have sustained damage at its right side front portion and left side front portion. The front bumper, front bumper lower cover, front bumper right upper grille, front right day light, front right headlamp, front radiator grille, front bonnet and front windscreen were amongst the body parts that were observed to have been damaged at the right side front portion of the Motor Car.

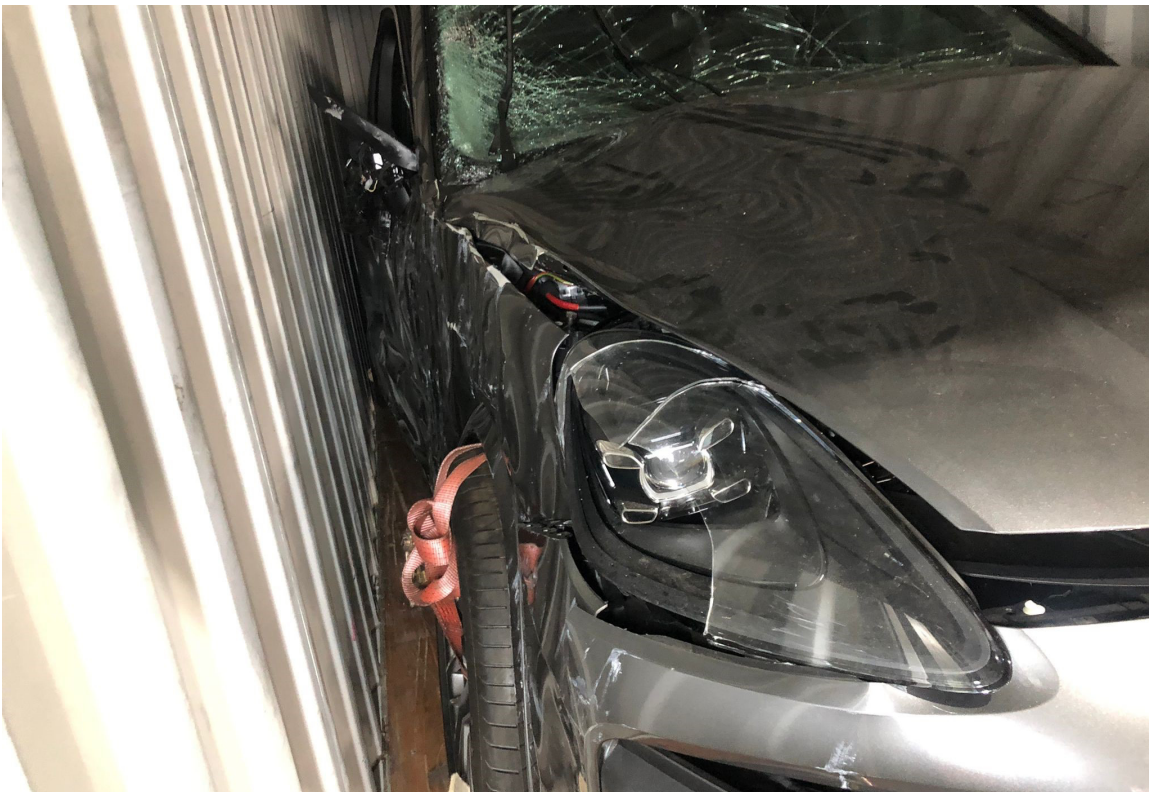
**Photo 2** shows the right side front body of the Motor Car (photograph provided to me). The front bonnet, front bumper, front right headlamp, front right fender, front right fender wheel arc garnish, front right door, front right door window and front windscreen were amongst the body parts that were observed to have been damaged.

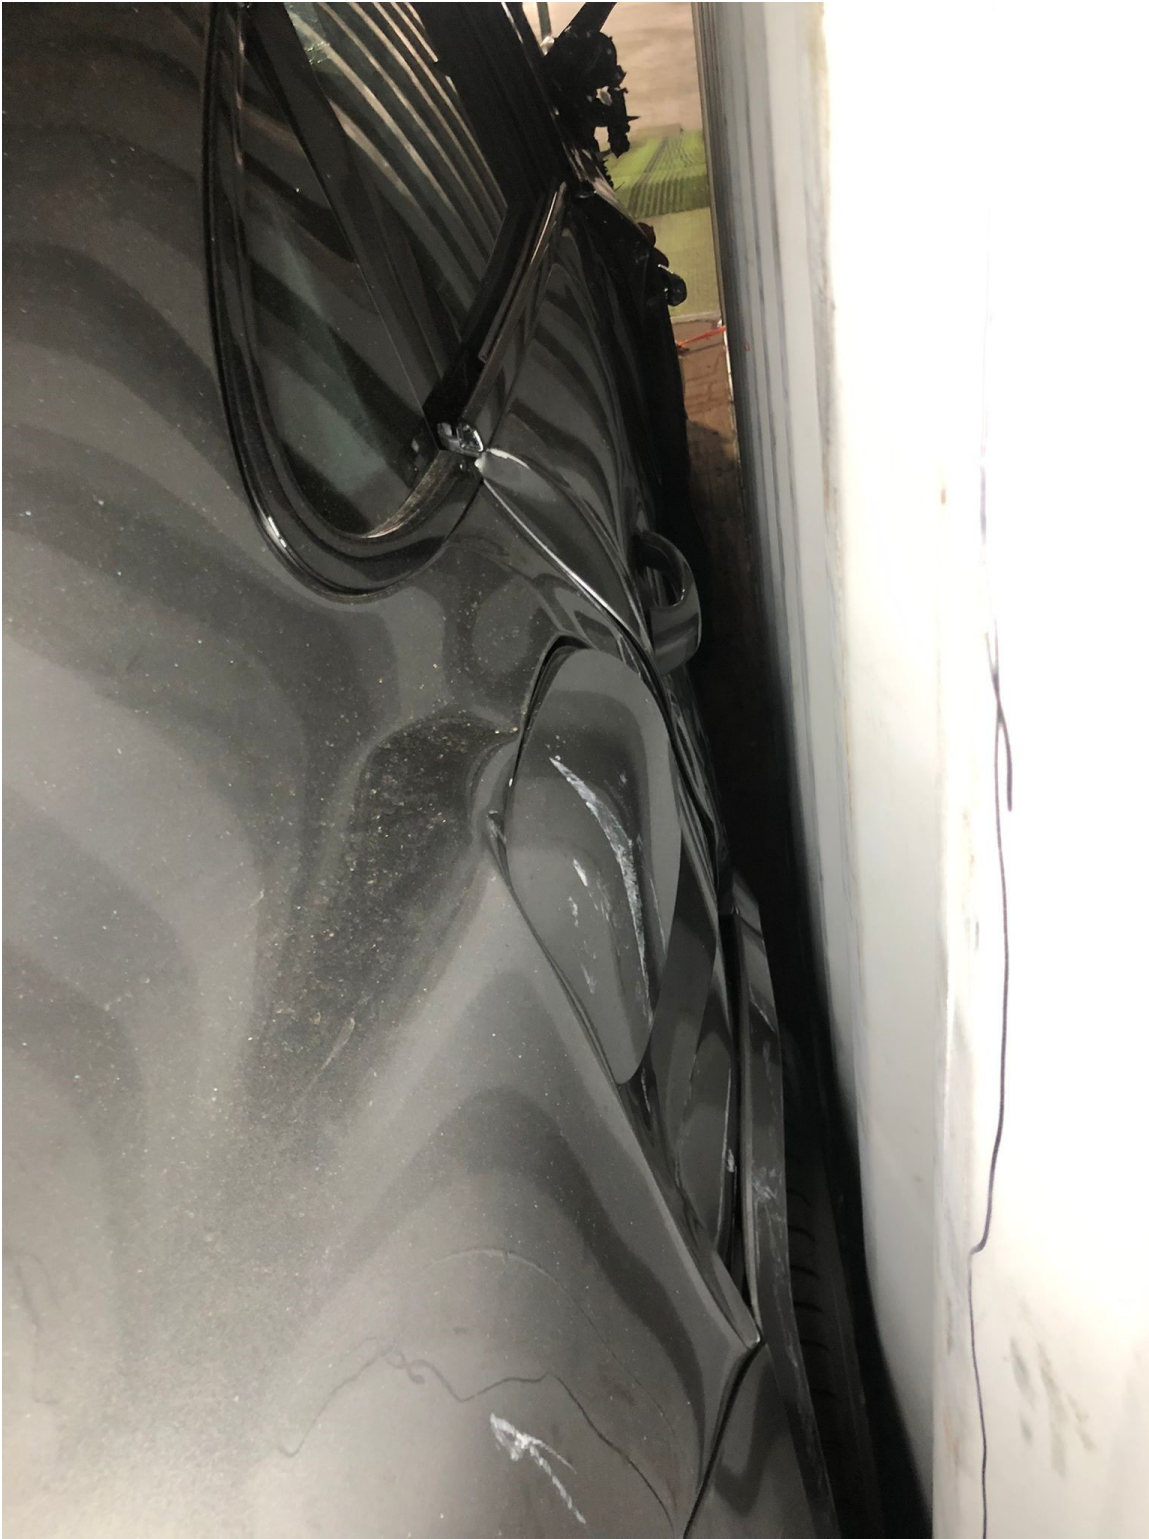
**Photo 3** shows the right side rear portion of the Motor Car (photograph provided to me). The Motor Car was observed to have sustained damage at its right side portion and left side front portion. Body parts damaged at the right side portion include the rear bumper, rear right fender, rear right fender wheel arc garnish, rear right door, fuel filler outer cover and right side wing mirror amongst others.

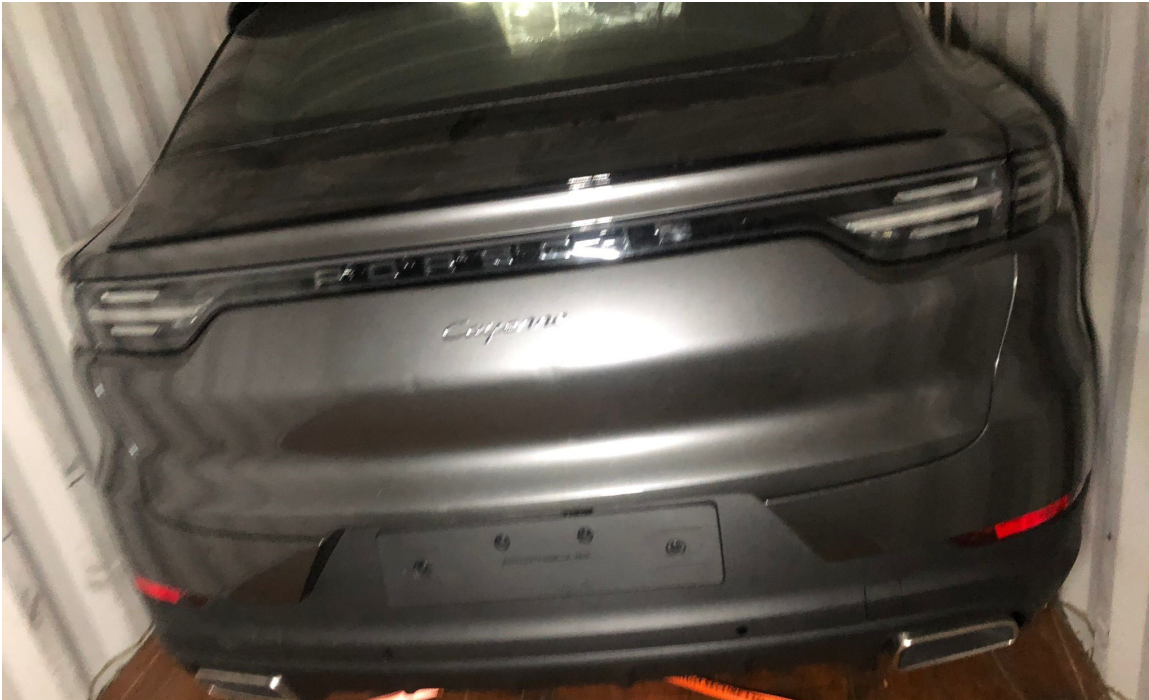
**Photo 4** shows the rear body of the Motor Car (photograph provided to me). The rear portion of the Motor Car was observed to be without any physical damage.

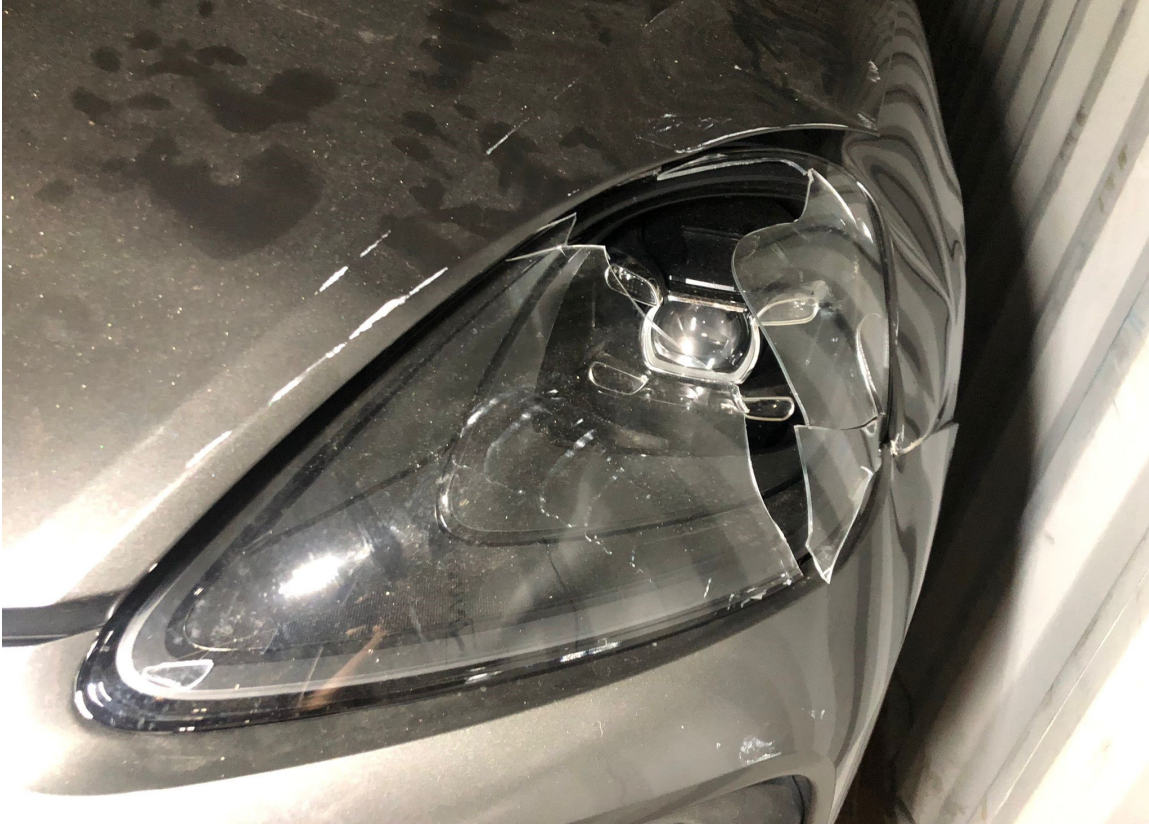
**Photo 5** shows the left side front body of the Motor Car (photograph provided to me). Apart for the right side portion, I had also observed damage at the left side front portion of the Motor Car. Body parts damaged include the front left headlamp and front left fender amongst others.

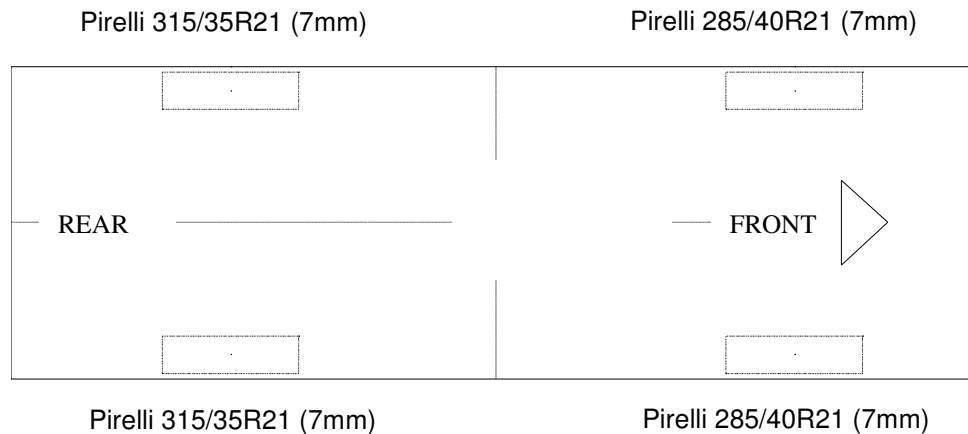
9. It was fitted with 21inch sport wheel rims that were wrapped with tyres that were observed to be of serviceable condition. The tyres were also sufficiently inflated for vehicular operation. The tyre brand, tyre size and approximate remaining tread depth of the 4 tyres of the Motor Car were recorded as follows: -

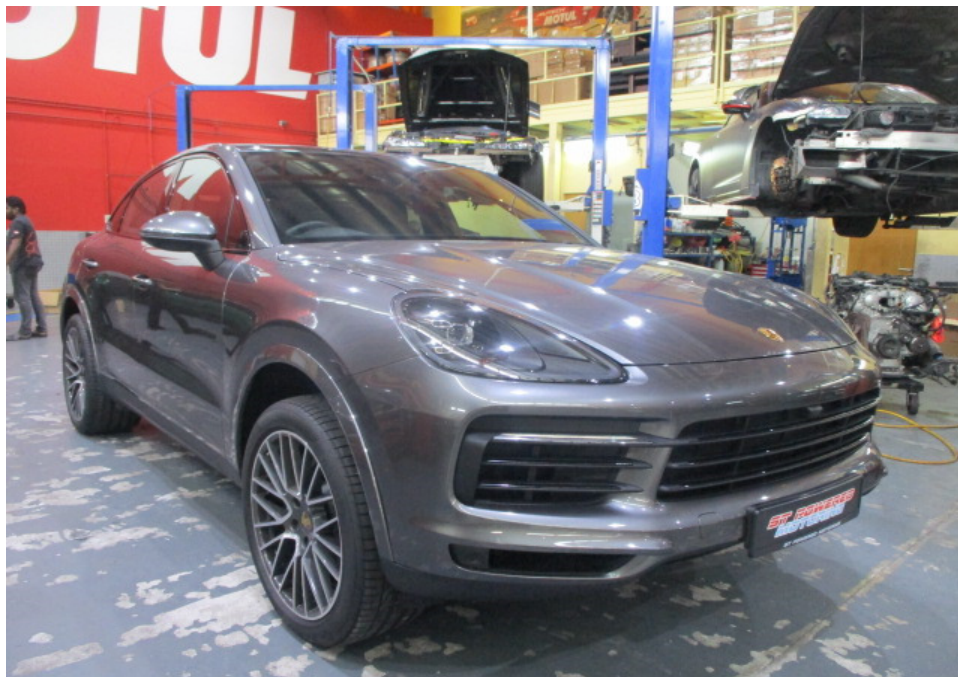
**Photo 6** shows a general view of the front right body of the Motor Car at the time of my inspection. The Motor Car was observed to be in a relatively good general condition with no loose exterior fittings observed. The body parts at the right side front portion of the Motor Car were visually examined and it was observed that the repair/restoration works carried out to the damaged area of the Motor Car (refer to photograph 1 & 2 above) were reasonably adequate and in order.

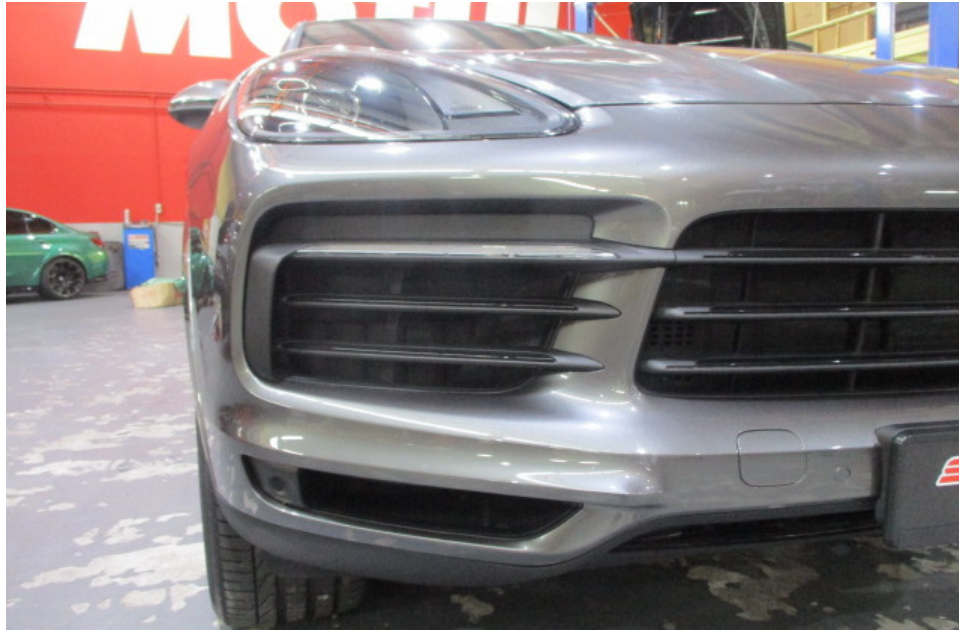
**Photo 7** shows a closer view of the Motor Car's front bumper, front bumper lower cover, front bumper right upper grille, front right day light, front right headlamp and front radiator grille. The body parts at the right side front portion of the Motor Car were visually examined and it was observed that the repair/restoration works carried out to the damaged area of the Motor Car (refer to photograph 1 & 2 above) were reasonably adequate and in order.

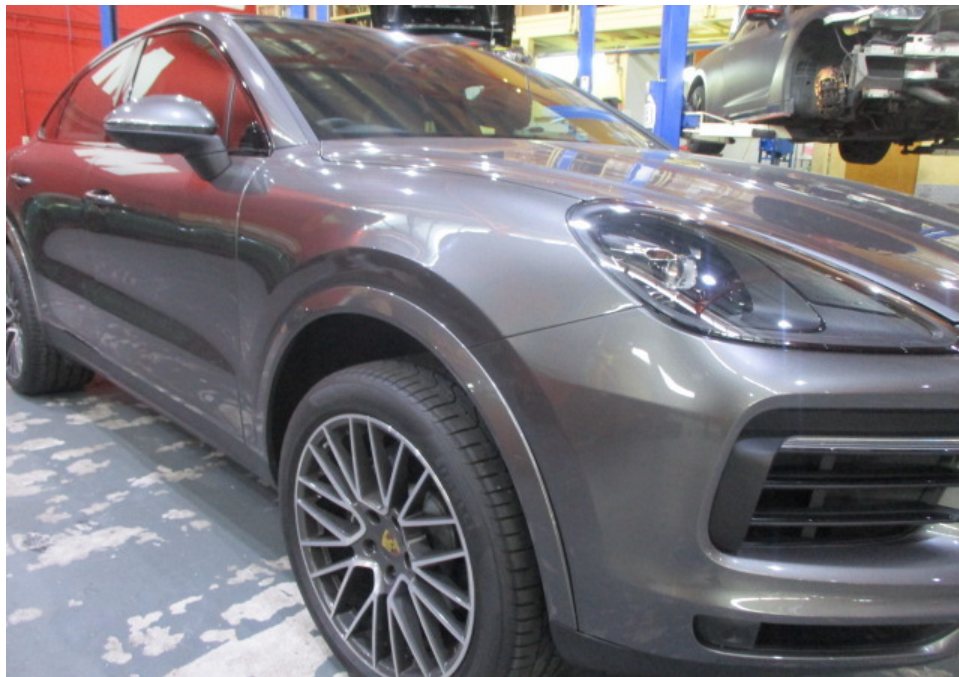
**Photo 8** shows a closer view of the Motor Car's front bonnet, front right headlamp, front right wheel rim, front right fender and front right fender wheel arc garnish. The body parts at the right side front portion of the Motor Car were visually examined and it was observed that the repair/restoration works carried out to the damaged area of the Motor Car (refer to photograph 2 above) were reasonably adequate and in order.

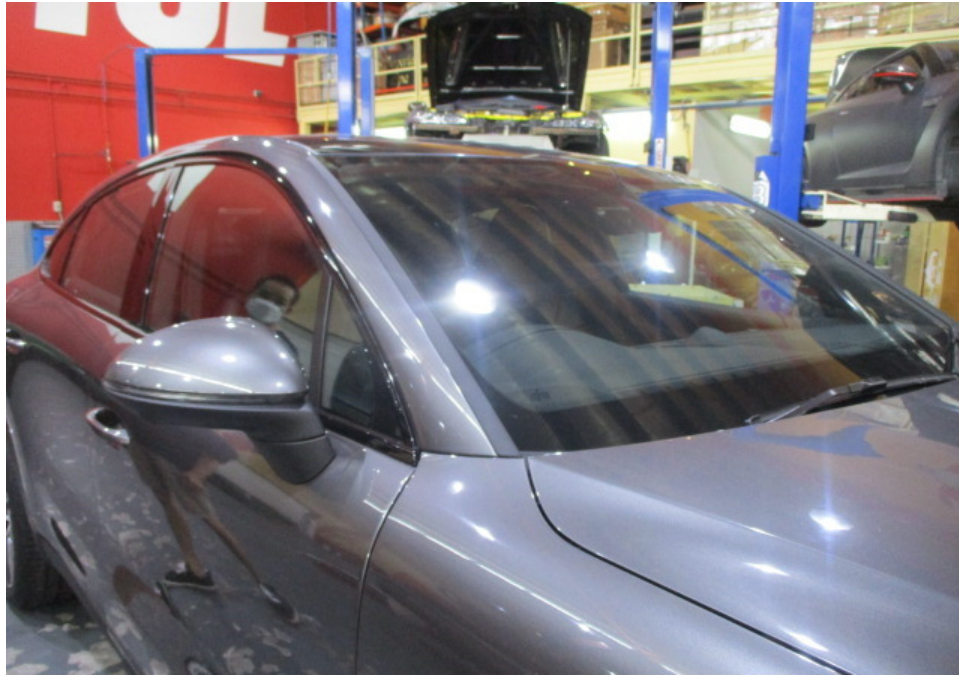
**Photo 9** shows a closer view of the Motor Car's front bonnet, front windscreen, front right outer "A" pillar and right side wing mirror. The body parts at the right side portion of the Motor Car were visually examined and it was observed that the repair/restoration works carried out to the damaged area of the Motor Car (refer to photograph 2 above) were reasonably adequate and in order.

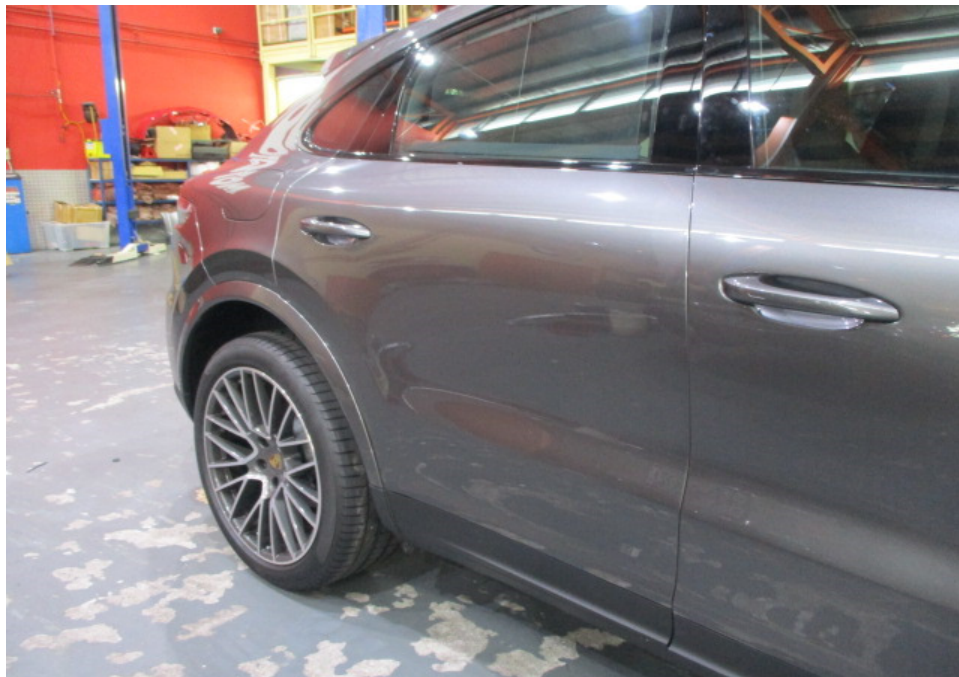
**Photo 10** shows a closer view of the Motor Car's front right door, rear right door and rear right fender wheel arc garnish. The body parts at the right side portion of the Motor Car were visually examined and it was observed that the repair/restoration works carried out to the damaged area of the Motor Car (refer to photograph 2 & 3 above) were reasonably adequate and in order.

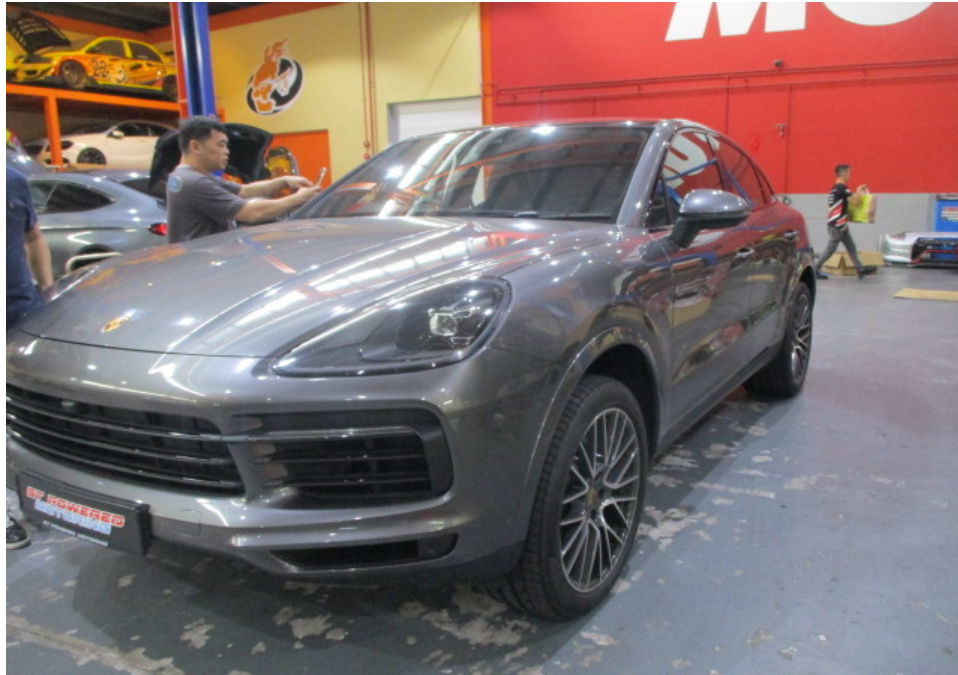
**Photo 11** shows a general view of the front left body of the Motor Car at the time of my inspection. The Motor Car was observed to be in a relatively good general condition with no loose exterior fittings observed. The body parts at the left side front portion of the Motor Car were visually examined and it was observed that the repair/restoration works carried out to the damaged area of the Motor Car (refer to photograph 5 above) were reasonably adequate and in order.

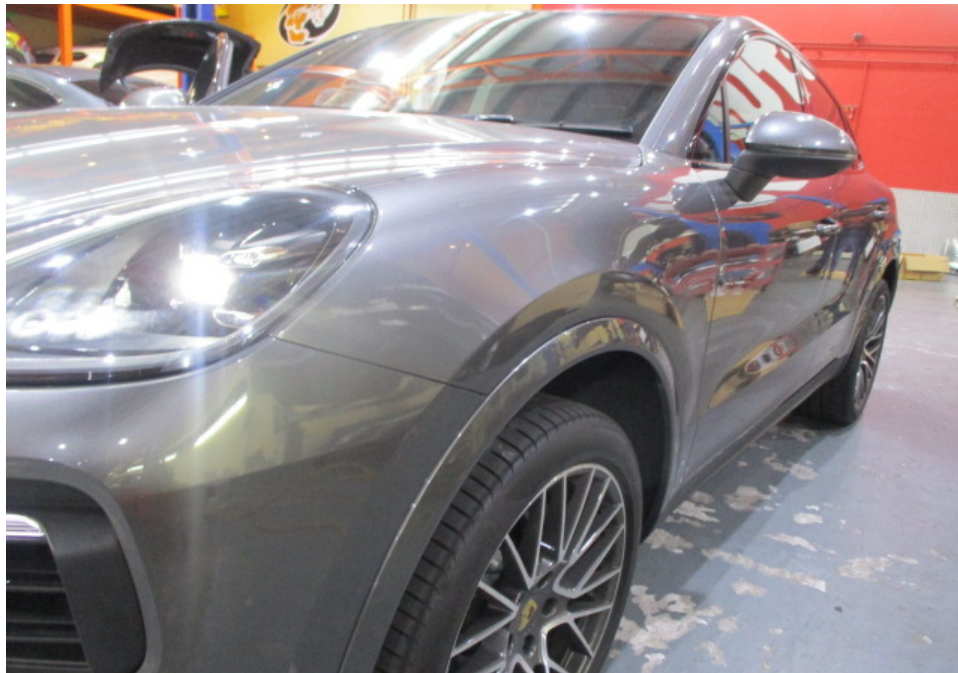
**Photo 12** shows a closer view of the Motor Car's front bonnet, front left headlamp, front left fender and front left fender wheel arc garnish. The body parts at the left side front portion of the Motor Car were visually examined and it was observed that the repair/restoration works carried out to the damaged area of the Motor Car (refer to photograph 5 above) were reasonably adequate and in order.

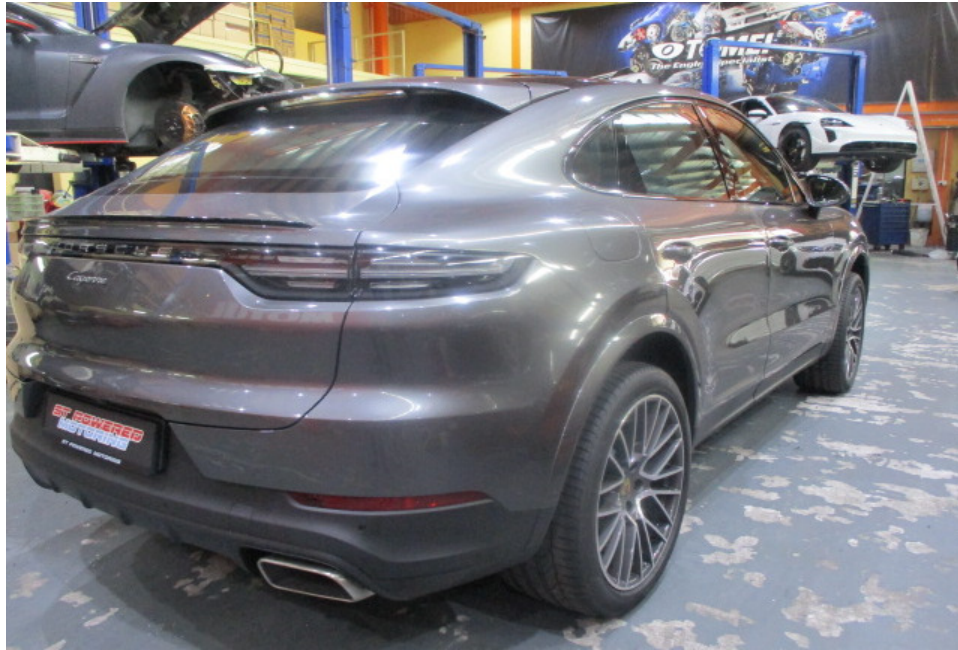
**Photo 13** shows a general view of the rear right body of the Motor Car at the time of my inspection. The Motor Car was observed to be in a relatively good general condition with no loose exterior fittings observed. The body parts at the right side rear portion of the Motor Car were visually examined and it was observed that the repair/restoration works carried out to the damaged area of the Motor Car (refer to photograph 3 above) were reasonably adequate and in order.

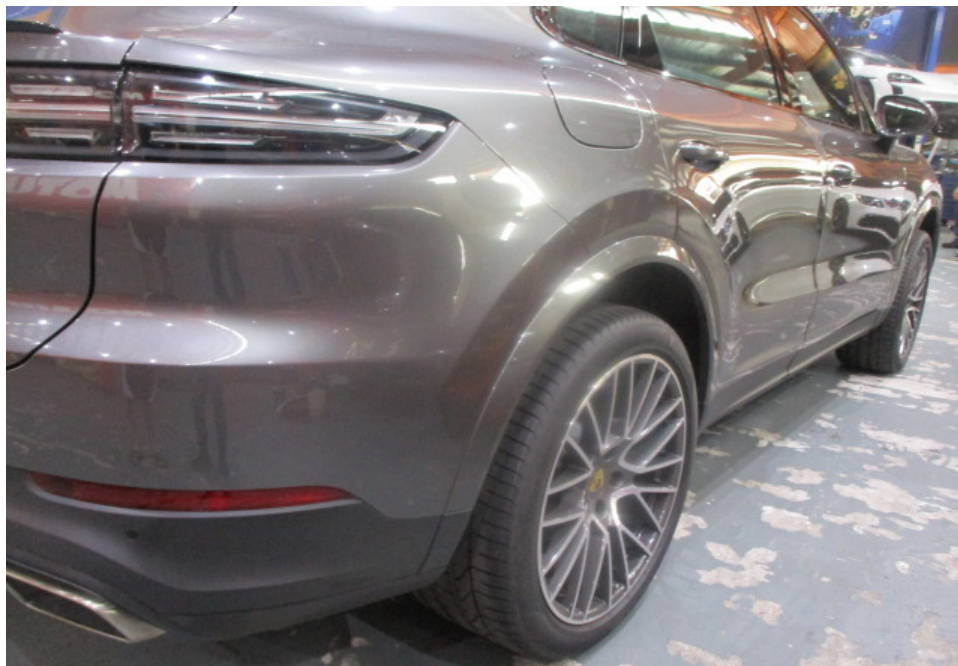
**Photo 14** shows a closer view of the Motor Car's rear bumper, rear bumper lower cover, rear right taillamp, rear right fender, rear right fender wheel arc garnish and rear right wheel rim. The body parts at the right side rear portion of the Motor Car were visually examined and it was observed that the repair/restoration works carried out to the damaged area of the Motor Car (refer to photograph 3 above) were reasonably adequate and in order.

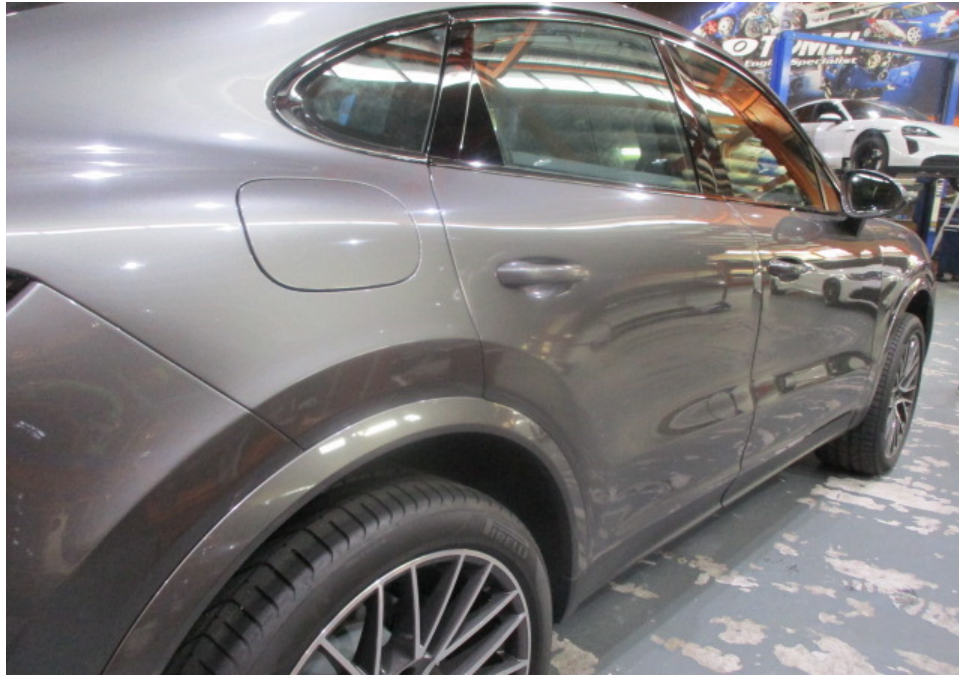
**Photo 15** shows a closer view of the Motor Car's rear bumper, rear right fender, rear right fender wheel arc garnish, rear right door and fuel filler outer cover. The body parts at the right side rear portion of the Motor Car were visually examined and it was observed that the repair/restoration works carried out to the damaged area of the Motor Car (refer to photograph 3 above) were reasonably adequate and in order.

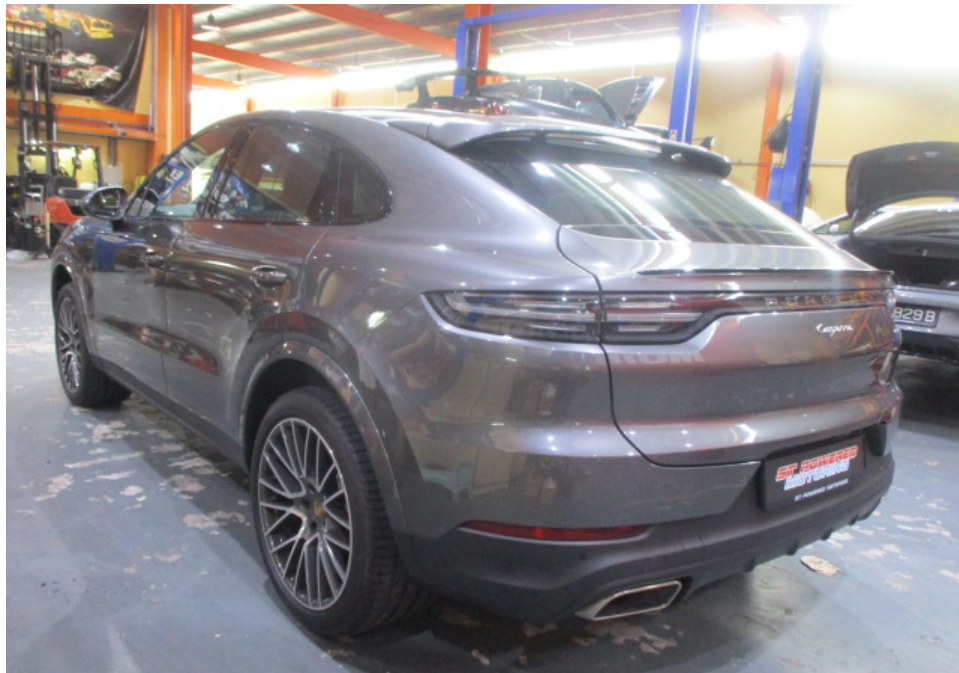
**Photo 16** shows a general view of the rear left body of the Motor Car at the time of my inspection. The Motor Car was observed to be in a relatively good general condition with no loose exterior fittings observed. The mileage of the Motor Car recorded at the time of my inspection was 78km.

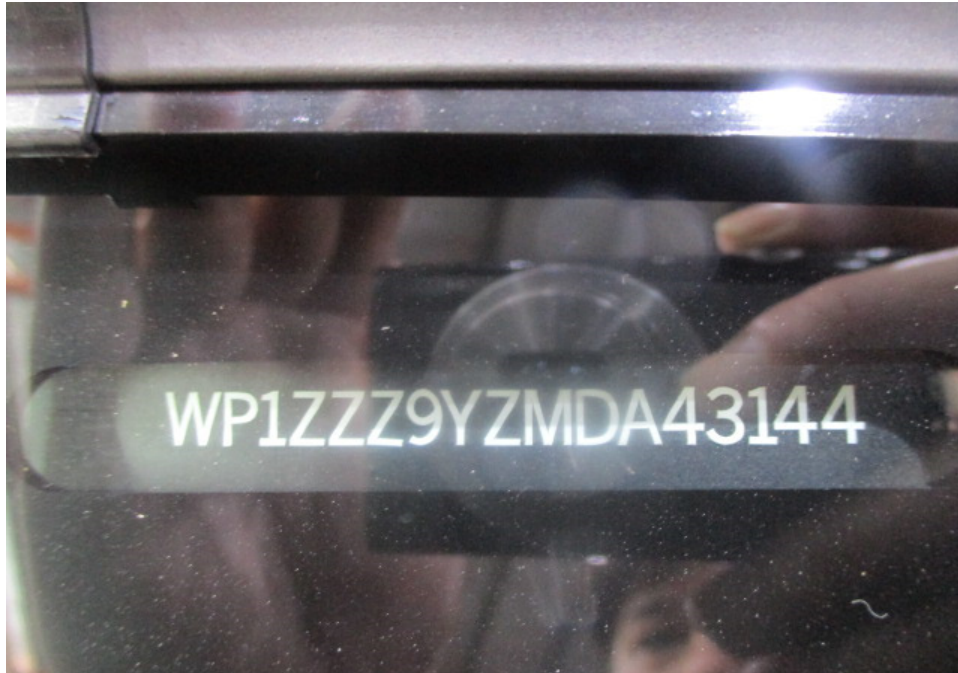
**Photo 17** shows the chassis number of the Motor Car. The chassis number recorded was WP1ZZZ9YZMDA43144.

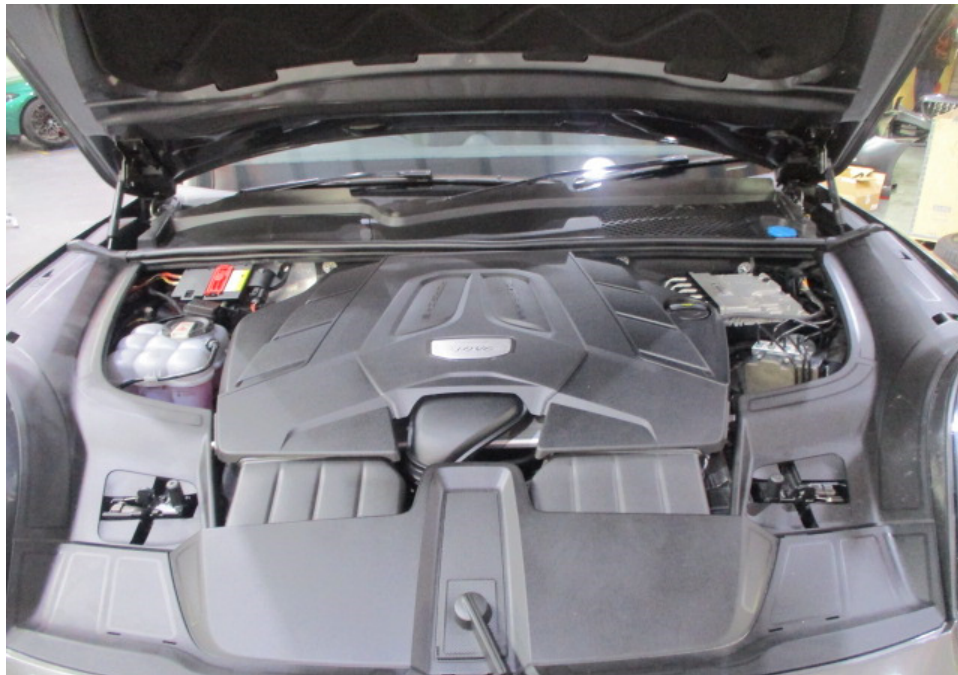
15. My examination of the engine compartment of the Motor Car revealed that the various parts and components inside the engine compartment were all intact and properly fitted. The engine oil, brake fluid and engine coolant were all found to be of sufficient level for operating purposes. Visually, there was also no contamination found to these fluids.

**Photo 18** shows a general view of the engine compartment of the Motor Car at the time of my inspection. The various parts and components inside the engine compartment were all observed to be intact and properly fitted. There was also no sign(s) or indication(s) of fluid leak and/or fluid stain found inside the engine compartment.

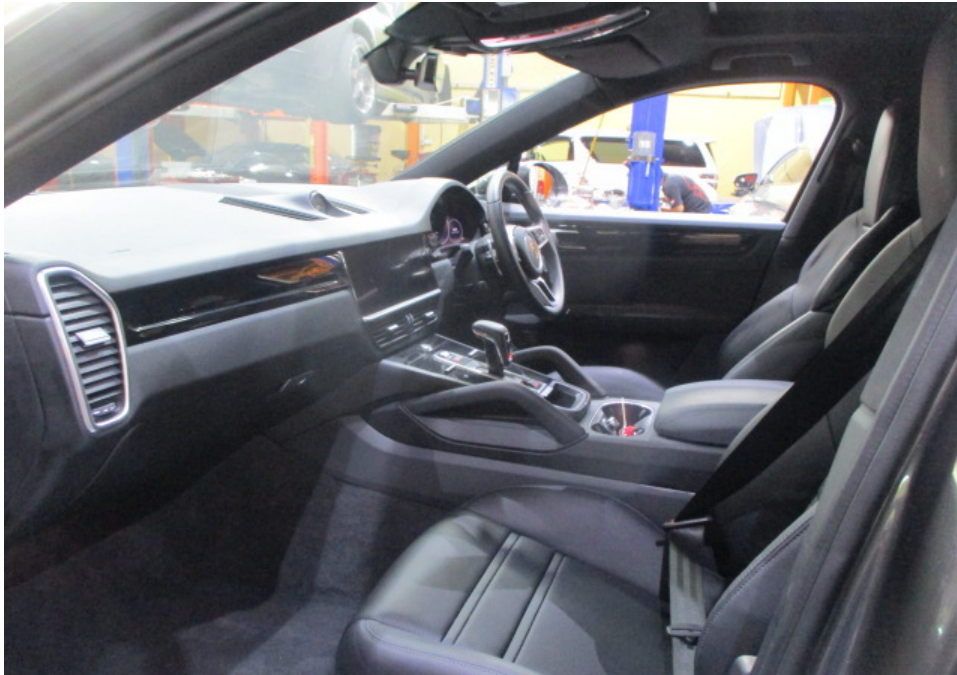
**Photo 19** shows the interior compartment of the Motor Car. The front dashboard, steering wheel, seats, upholstery and trims etc were all observed to be intact and properly fitted.

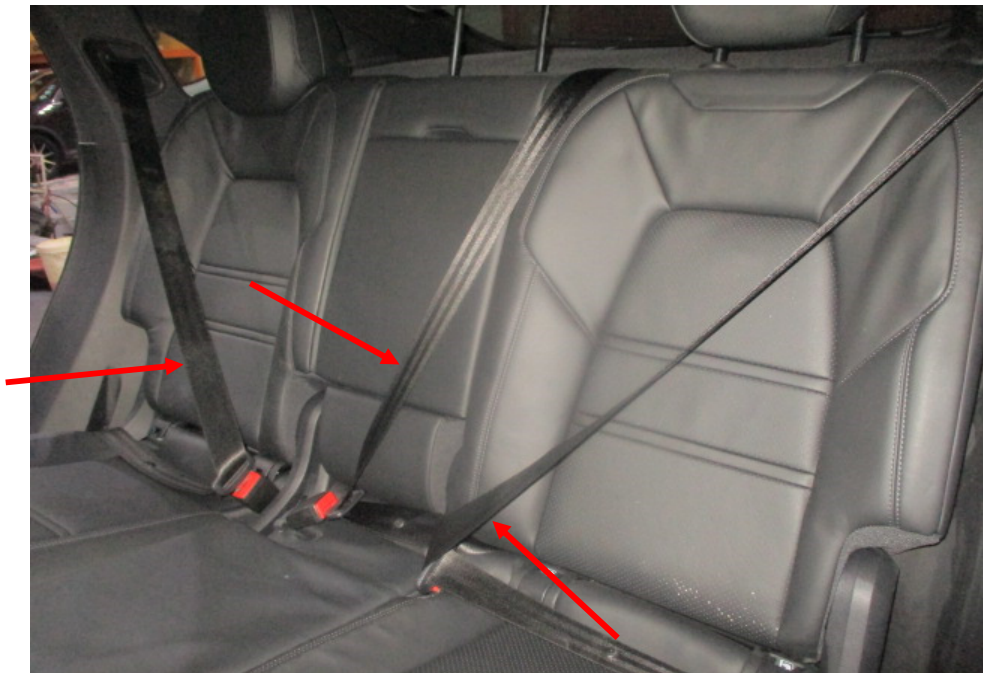
13. The seats of the Motor Car were found to be secured to the floorboard of the Motor Car via seat rails bolted onto the floorboard. Retractable seat belt reels and pre-tensioners were fitted on all seats of the Motor Car. The seat belts were tested and were able to be fastened securely into the respective pre-tensioners that were fixed to the side of all the seats.

**Photo 20** shows the rear seats of the Motor Car. All the seats of the Motor Car were secured via seat rails to the floorboard. They were also fitted with a retractable seat belt reel and a pre-tensioner. The seat belts (arrowed) were tested and were able to be fastened into the respective pre-tensions that were fitted on the side of each individual seat.

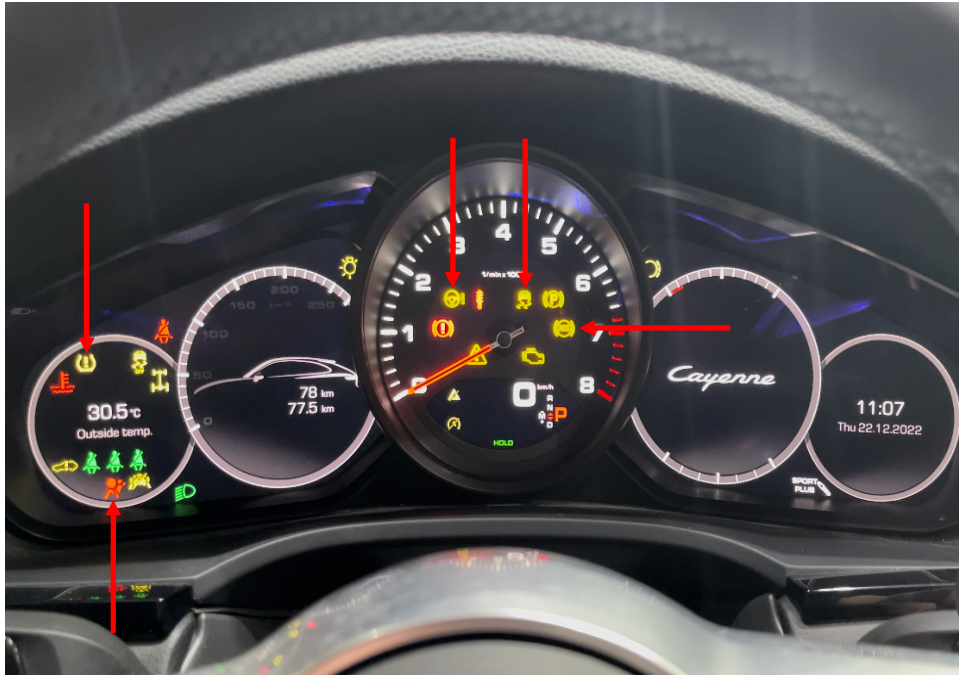
**Photo 21** shows the warning lights for the various electronic safety features appearing on the instrument panel of the Motor Car during its self-test when the engine is cranked, in particular the ABS, SRS, TPM, EPS and TCS lights (arrowed).

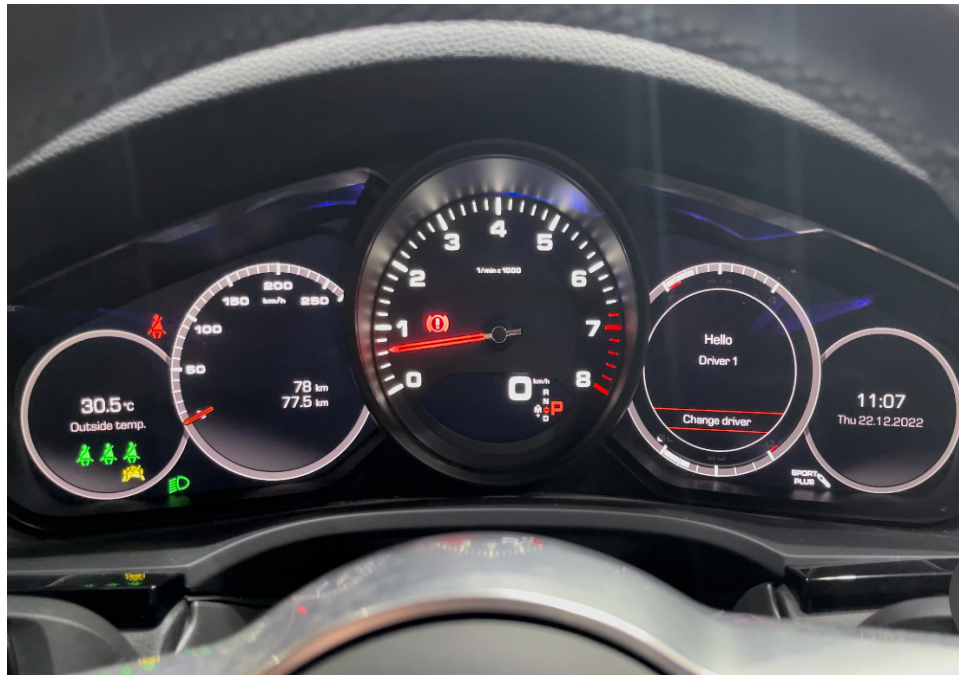
14. The Motor Car's automatic self-test of the functionality of its various electronic safety features like the Anti-Lock Brake System (ABS), Supplemental Restraint System (SRS), Tyre Pressure Monitor (TPM), Electric Power Steering (EPS) and Traction Control System (TCS) during cranking of the engine had indicated that these electronic systems were in working condition. This was determined from the respective warning lights disappearing from the instrument panel after the self-test.

**Photo 22** shows the respective warning lights no longer illuminated, indicating that there is no fault detected to the ABS, SRS, TPM, EPS and TCS systems of the Motor Car during the self-test. These electronic systems were hence in working condition at the time of my inspection.

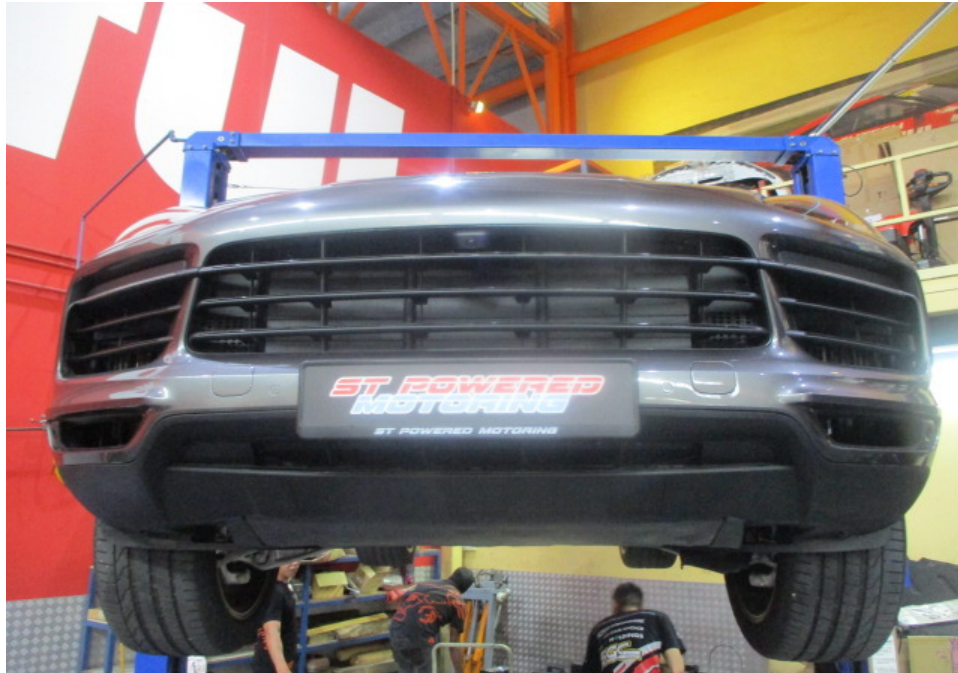
16. My checks on the underside of the Motor Car revealed no sign(s) or indication(s) of fluid leakage and/or fluid stain(s). The engine block and automatic transmission assembly were both secured properly. All the undercarriage components of the Motor Car were also observed to be intact and secured in an appropriate manner.

**Photo 23** shows the Motor Car hoisted up for checks on its undercarriage. There was no sign(s) or indication(s) of fluid leakage and/or fluid stain(s) on the underside of the Motor Car. The undercarriage components of the Motor Car were also all observed to be intact and secured in an appropriate manner.

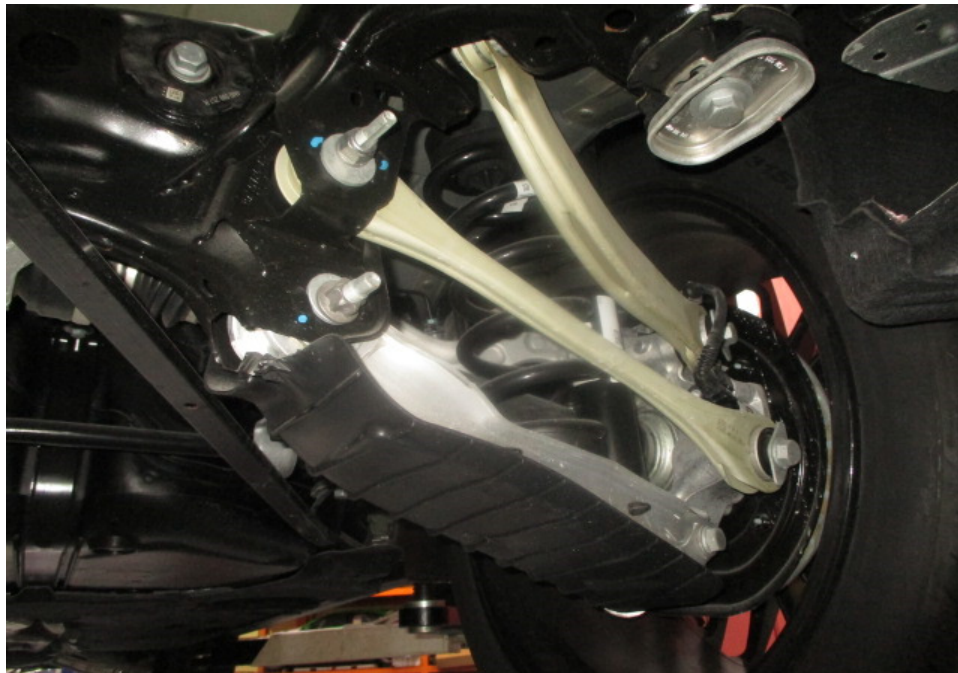
**Photo 24** shows a general view of the control arms and linkages at the rear right wheel of the Motor Car. I did not observe any fluid leak and/or fluid stain on the underside of the Motor Car. All of the Motor Car's undercarriage components were observed to be intact and secured in an appropriate manner.

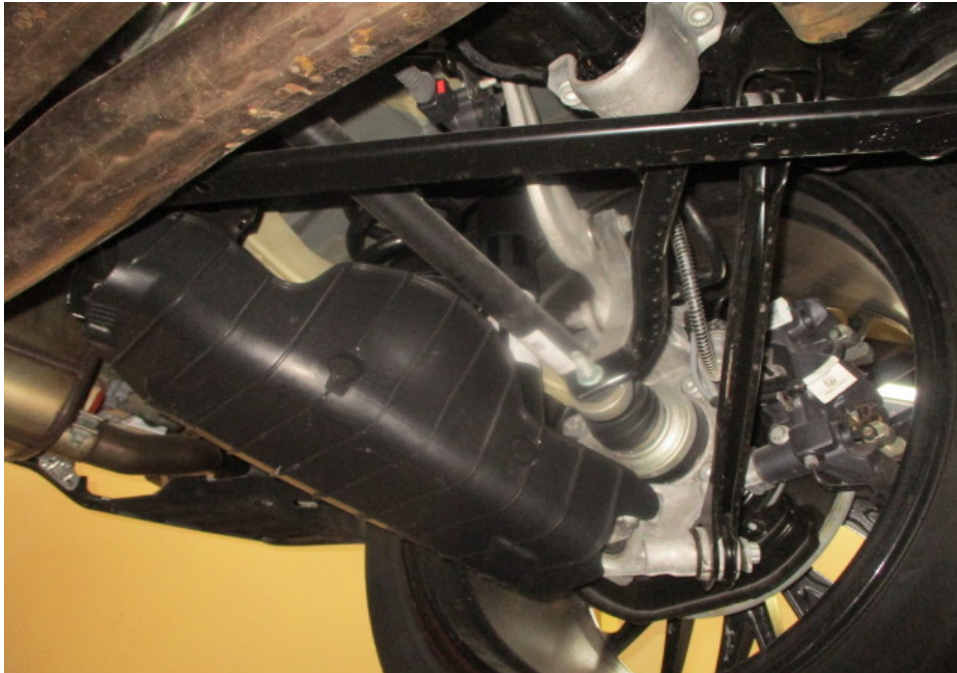
**Photo 25** shows a general view of the control arms and linkages at the rear left wheel of the Motor Car. I did not observe any fluid leak and/or fluid stain on the underside of the Motor Car. All of the Motor Car's undercarriage components were observed to be intact and secured in an appropriate manner.

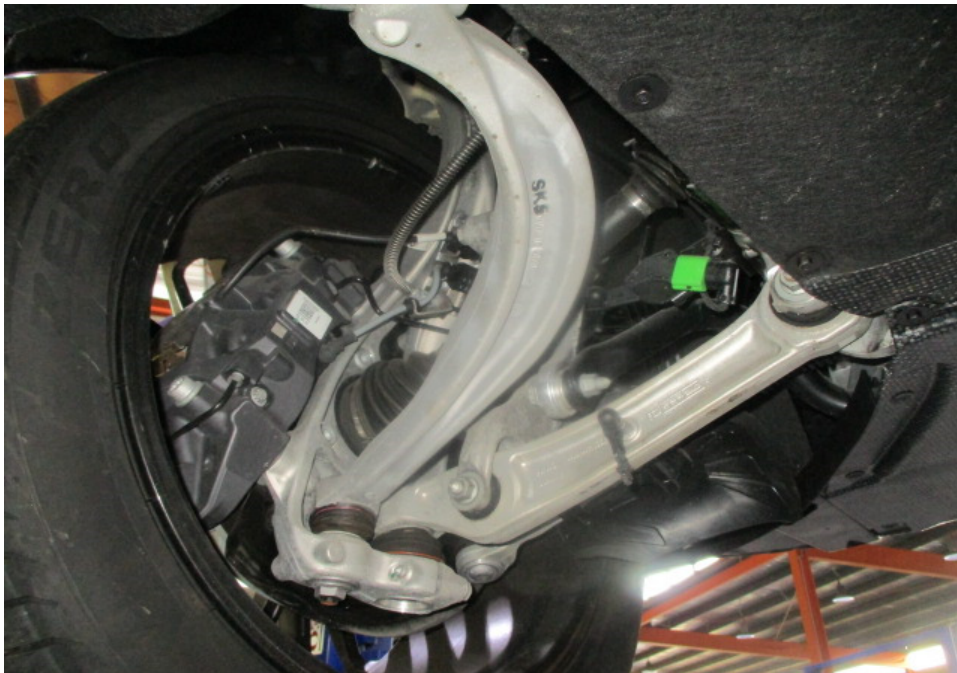
**Photo 26** shows a general view of the control arms and linkages at the front left wheel of the Motor Car. I did not observe any fluid leak and/or fluid stain on the underside of the Motor Car. All of the Motor Car's undercarriage components were observed to be intact and secured in an appropriate manner.

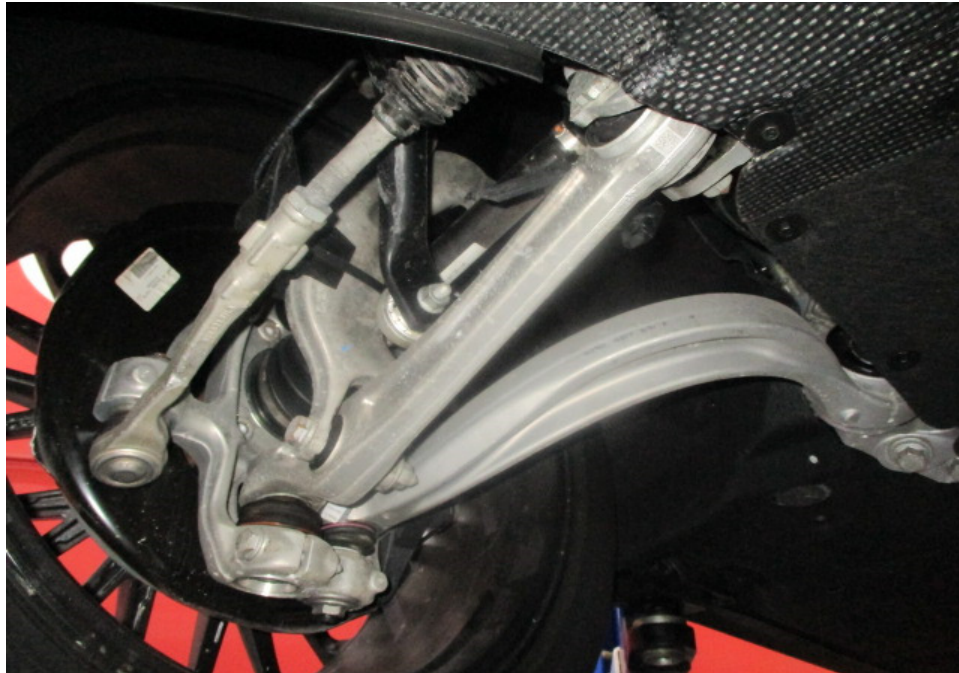
**Photo 27** shows the various undercarriage components at the front right wheel of the Motor Car. The mechanical components, control arms and linkages were all found to be intact and secured in an appropriate manner. I also did not observe any fluid leak and/or fluid stain on the underside of the Motor Car.
