Your Ref: Porsche Cayenne  
(chassis number WP1ZZZ9YZMDA43144)  
Our Ref : CI/TP23000016/D

03 January 2023

**INSPECTION REPORT OF AN UNREGISTERED PORSCHE CAYENNE  
MOTOR CAR WITH CHASSIS NUMBER WP1ZZZ9YZMDA43144**

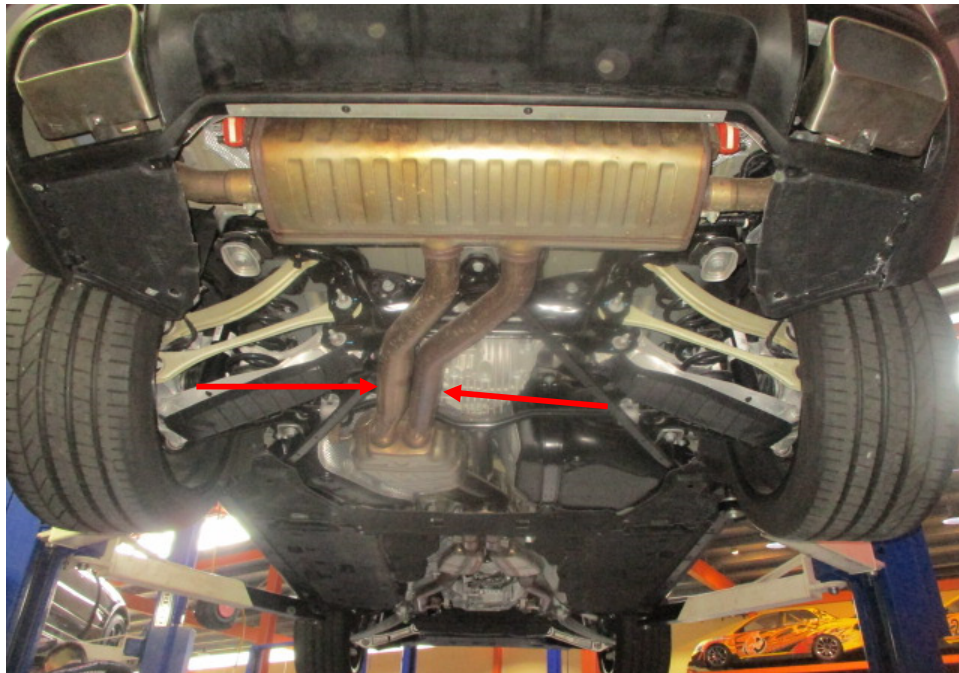
**Photo 28** shows the rear section of the Motor Car's exhaust system. My examination of the Motor Car's exhaust system revealed no sign(s) or indication(s) of any cut or weld marks along its exhaust pipes (arrowed), on its rear muffler, on its centre resonator boxes and on its catalytic converters.

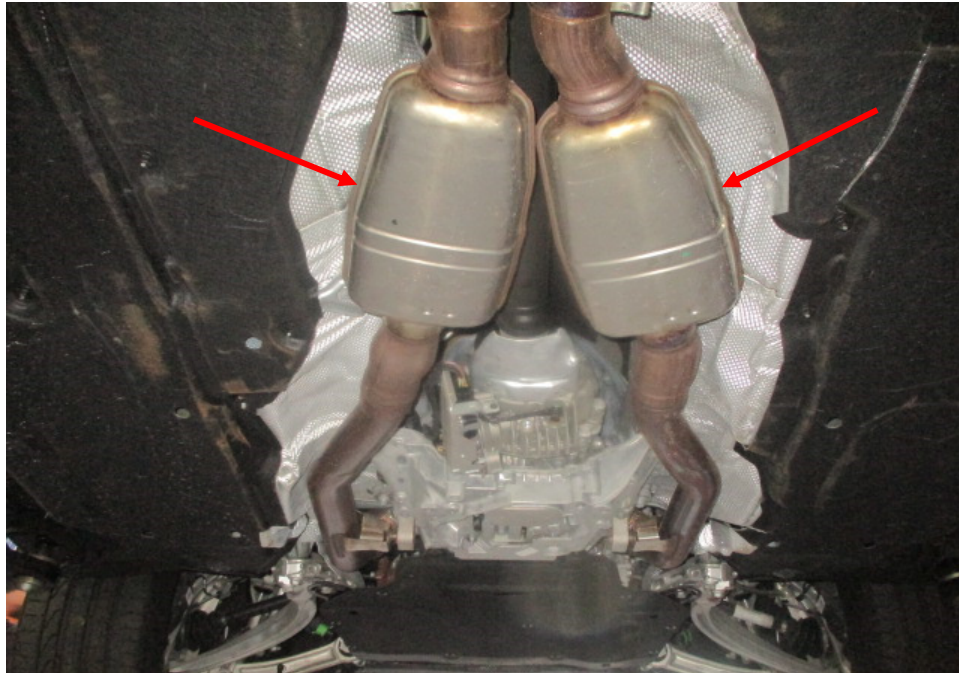
**Photo 29** shows the front section of the Motor Car's exhaust system. My examination of the Motor Car's exhaust system revealed no sign(s) or indication(s) of any cut or weld marks along its exhaust pipes, on its rear muffler, on its centre resonator boxes (arrowed) and on its catalytic converters.

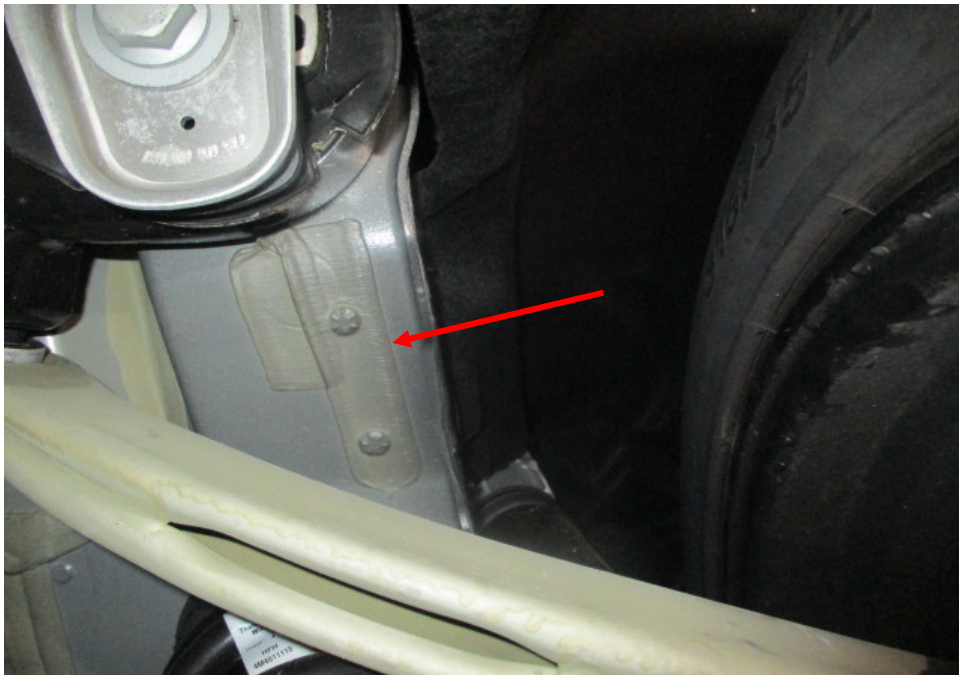
**Photo 30** shows the chassis/structural body at the underside rear right of the Motor Car. I did not find any weld marks other than original spot weld marks on the chassis/structural body of the Motor Car. The original factory sealant (arrowed) at the joints along the chassis/structural body was untouched, indicating no work was done on the chassis/structural body of the Motor Car and that the chassis/structural body was originally fitted.

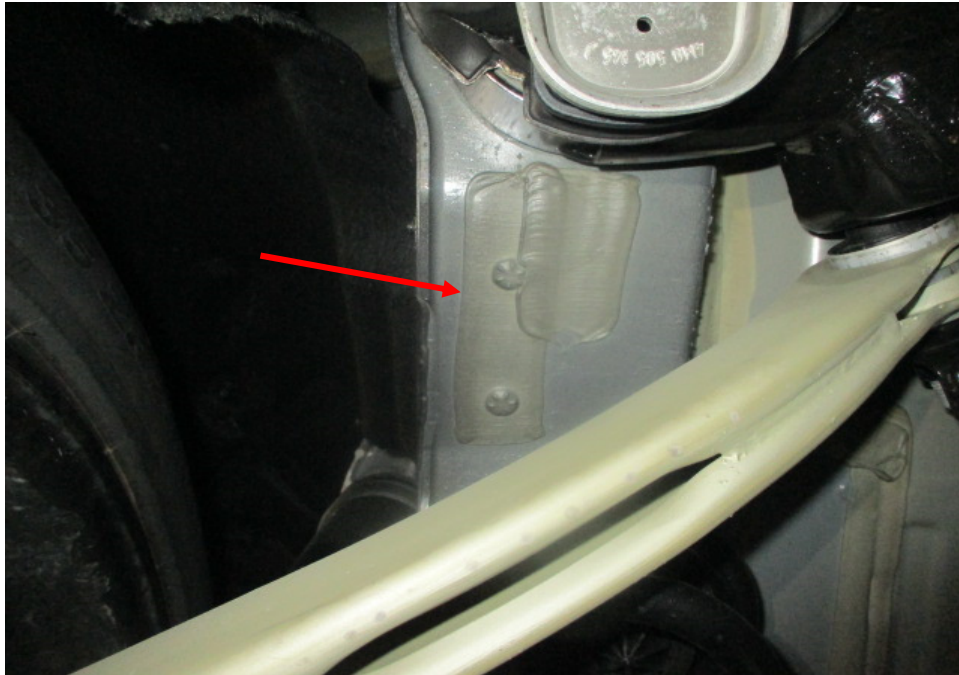
**Photo 31** shows the chassis/structural body at the underside rear left of the Motor Car. The original factory sealant (arrowed) at the joints along the chassis/structural body was observed to be untouched. In general, I had found no work was carried out on the chassis/structural body of the Motor Car. The chassis/structural body of the Motor Car was originally fitted.

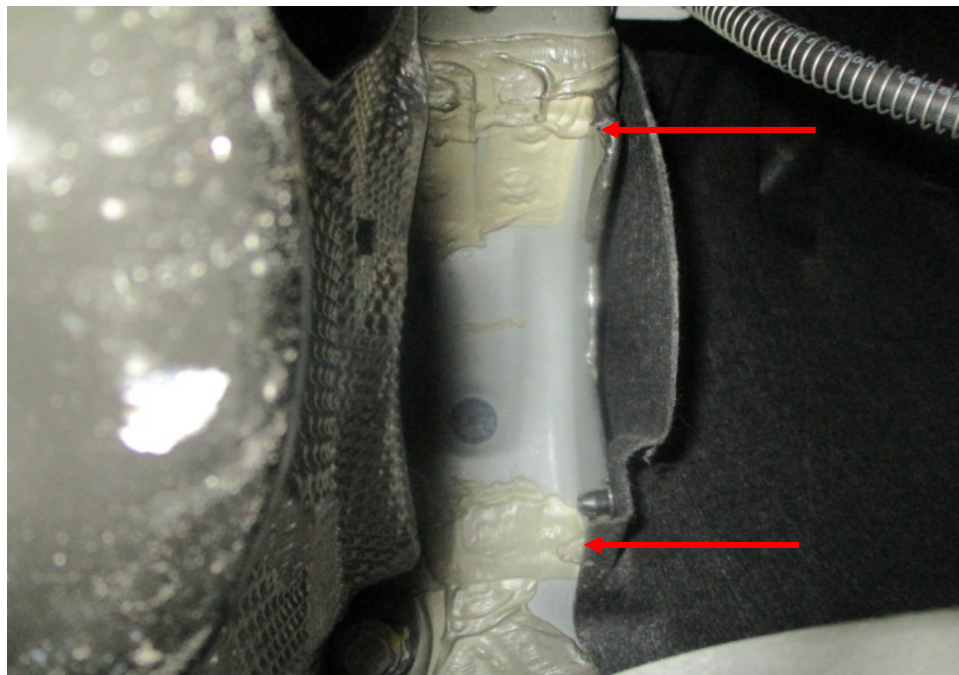
**Photo 32** shows the chassis/structural body at the underside front left of the Motor Car. I did not find any weld marks other than original spot weld marks on the chassis/structural body of the Motor Car. The original factory sealant (arrowed) at the joints along the chassis/structural body was untouched, indicating no work was done on the chassis/structural body of the Motor Car and that the chassis/structural body was originally fitted.

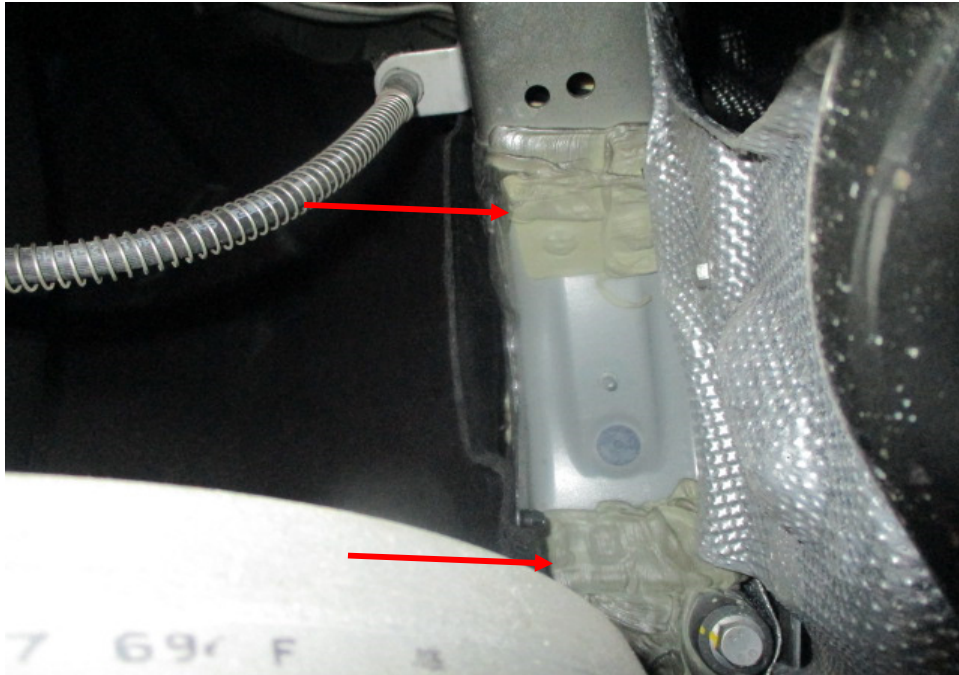
**Photo 33** shows the chassis/structural body at the underside front right of the Motor Car. The original factory sealant (arrowed) at the joints along the chassis/structural body was observed to be untouched. In general, I had found no work was carried out on the chassis/structural body of the Motor Car. The chassis/structural body of the Motor Car was originally fitted.
