Our Reference : KAAS/TA/6482/2756/TP/10.22
Date : 17 December 2022

VEHICLE APPRAISAL REPORT

Registration No.	: XD 2756J	Chassis Frame No.	: FP51JDA00616
Make / Model	: Mitsubishi FP51JDR4RDEA	Engine No. (Logcard)	: 6M70413455
Year of Manufacture/Reg	: 2008	Odometer Reading	: 230,721 KM
Colour	: Blue		
Class / Type	: Truck

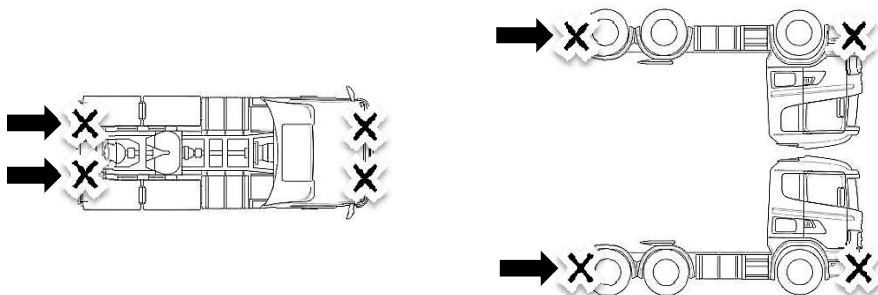
Damages sustained were consistent with the subject vehicle being involved in a collision with another vehicle and the impact was delivered

Squarely to the Rear

portion of the vehicle.

The general area of damages is at the
(Please refer to the parts list and photographs as attached for more information)

Front and Rear portion
