You're Ref: SJV 76Y
Our Ref: CI/TPD23000069/P

INSPECTION REPORT OF MOTOR CAR SJV 76Y

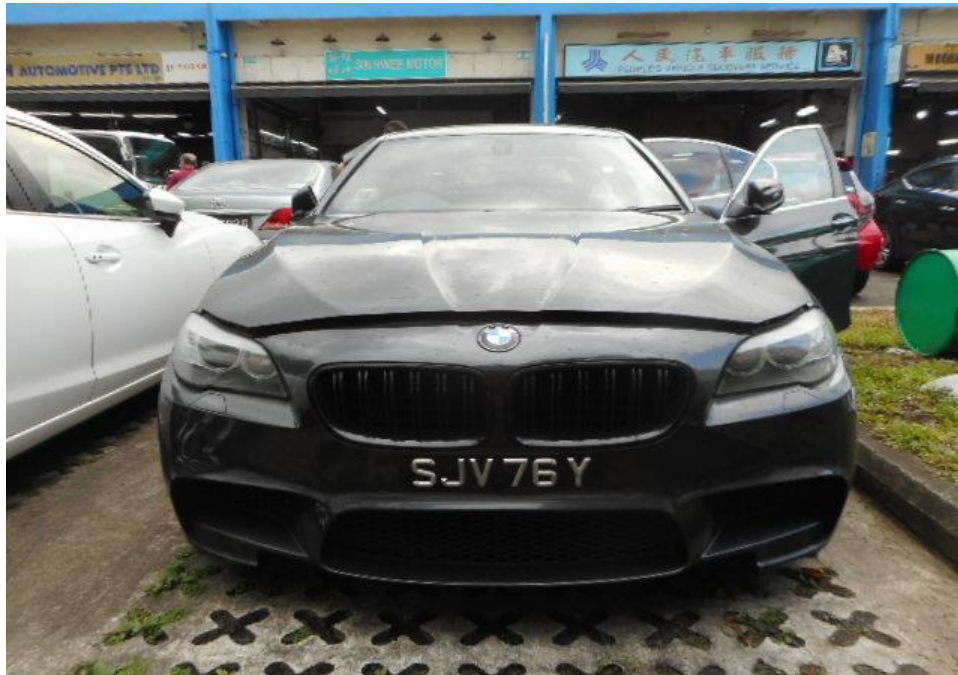
Photo 1 shows a general view of the Motor Car's exterior front body at the time of my inspection. The Motor Car front was observed to be unaffected by the incident.

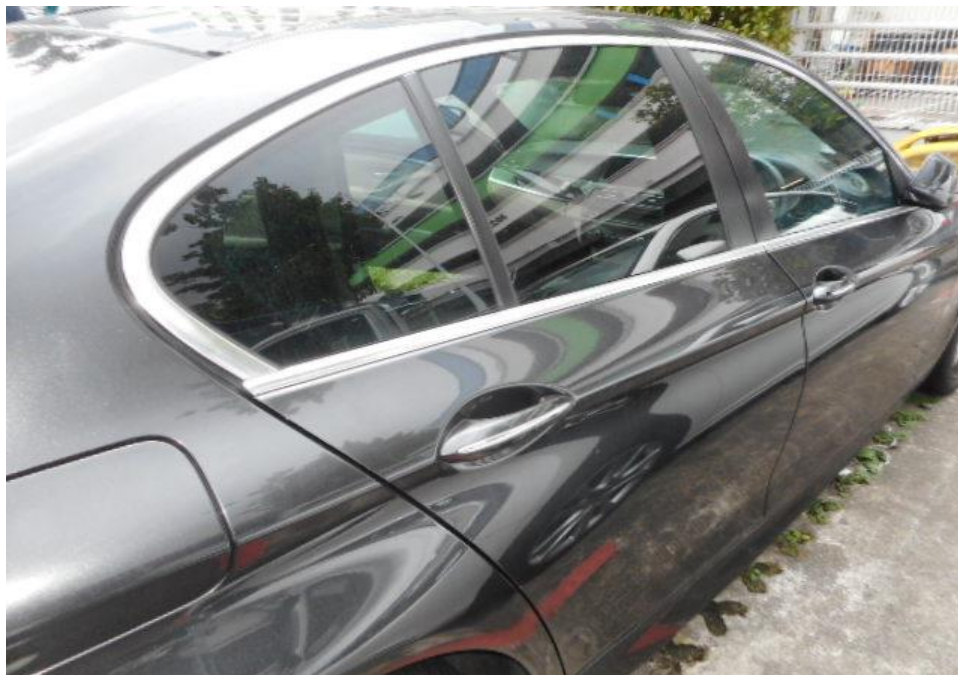
Photo 2 shows a general view of the Motor Car's exterior right body at the time of my inspection. The right portion of the Motor Car was observed to have been unaffected by the incident.

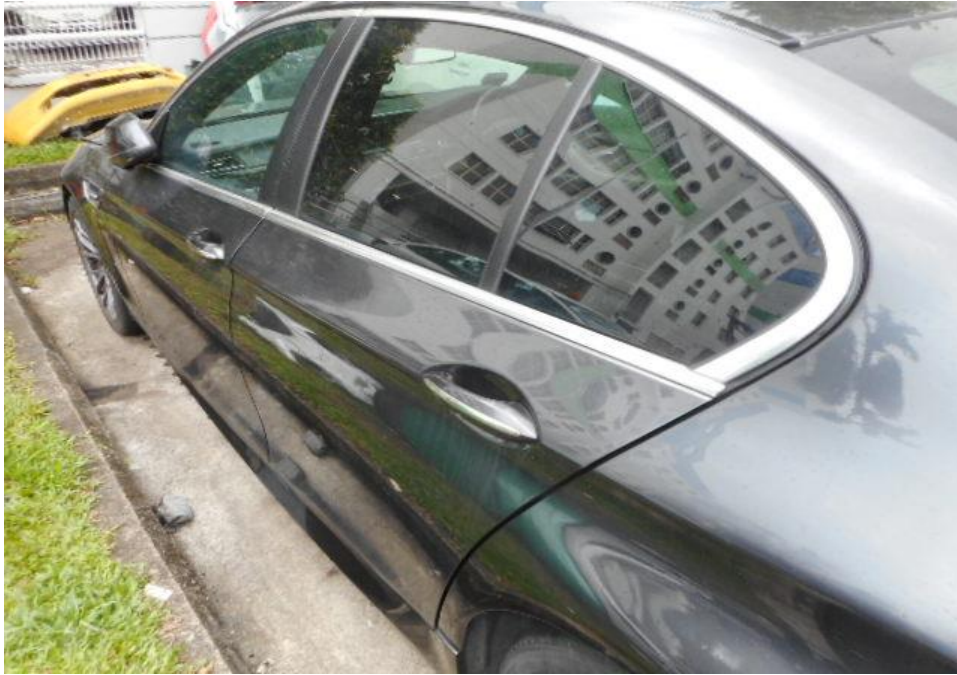
Photo 3 shows a general view of the Motor Car's exterior left body at the time of my inspection. The left portion of the Motor Car was observed to have been unaffected by the incident.

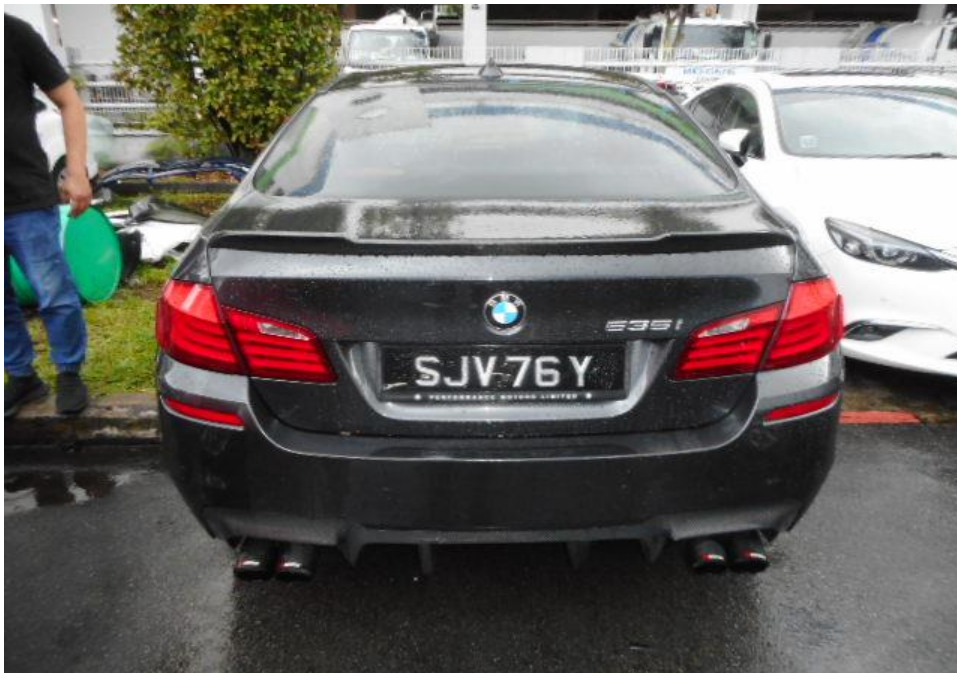
Photo 4 shows the general view of the Motor Car's exterior rear body at the time of my inspection. The Motor Car rear was observed to be unaffected by the incident.

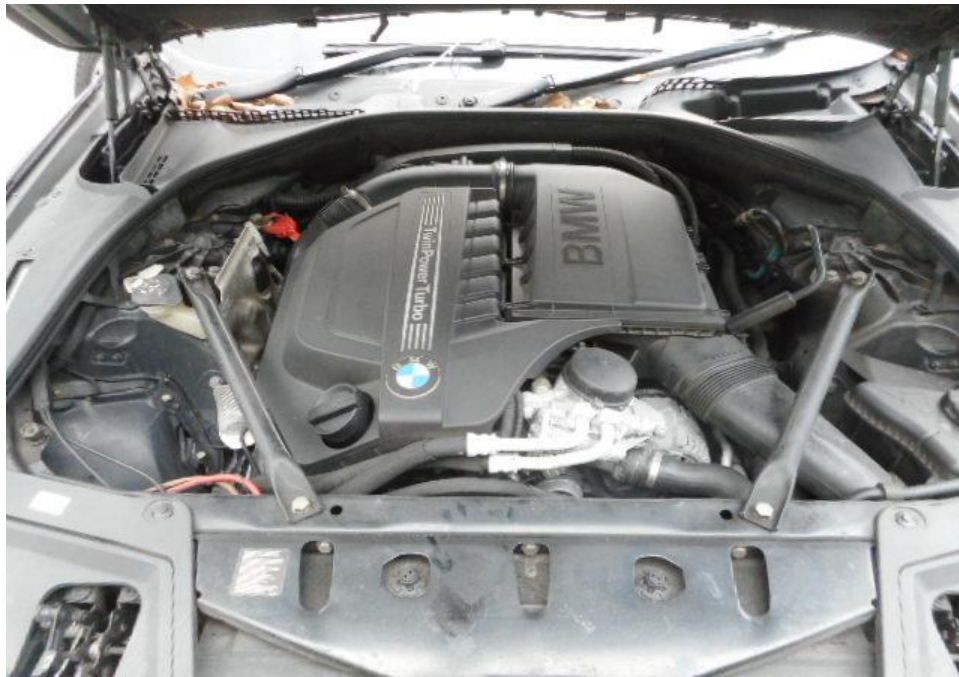
Photo 5 shows the general view of the Motor Car's engine compartment at the time of my inspection. The Motor Car engine was observed to be unaffected by the incident.

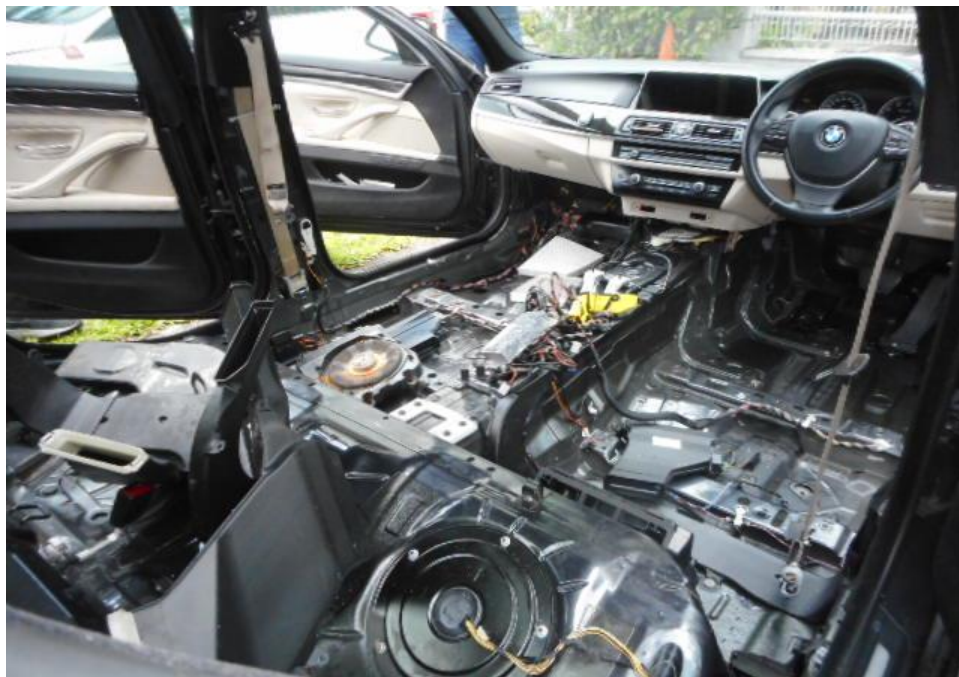
Photo 6 shows a general view of the Motor Car's interior portion at the time of our inspection. The Motor Car was observed to have sustained direct and indirect water intrusion damages in its interior cabin. At the time of our inspection shows that its front left and right seat, interior door handles, left seat rail mechanism and its electrical components were amongst the body parts that had sustained water intrusion damages.

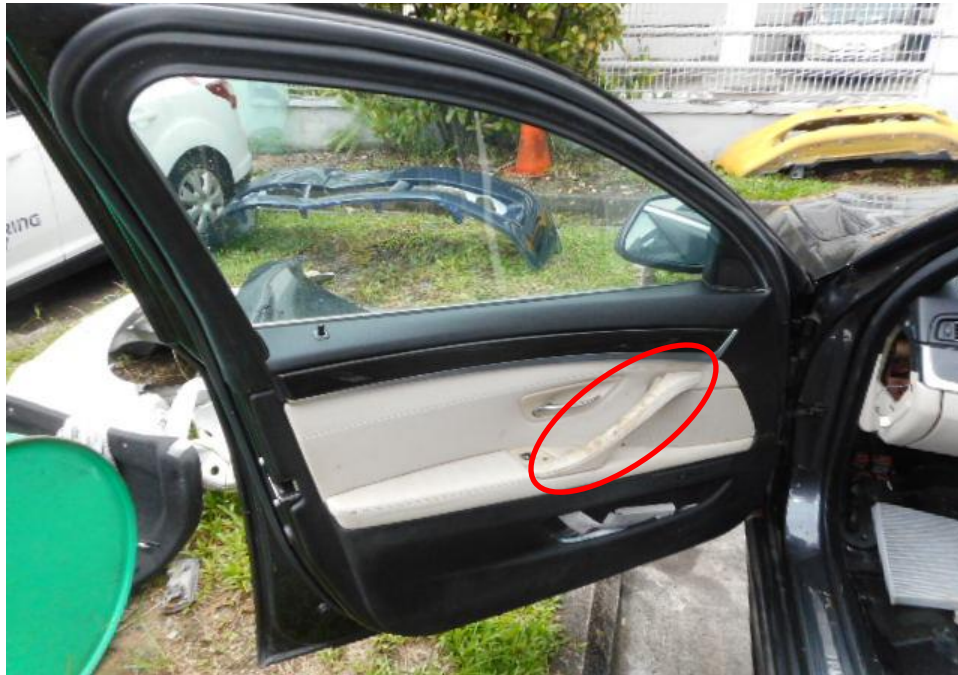
Photo 7 shows a general up view of the Motor Car's front left door handle. We have observed mouldy stains on its front left door handle (circled) due to indirect water intrusion into the interior cabin of the Motor Car.

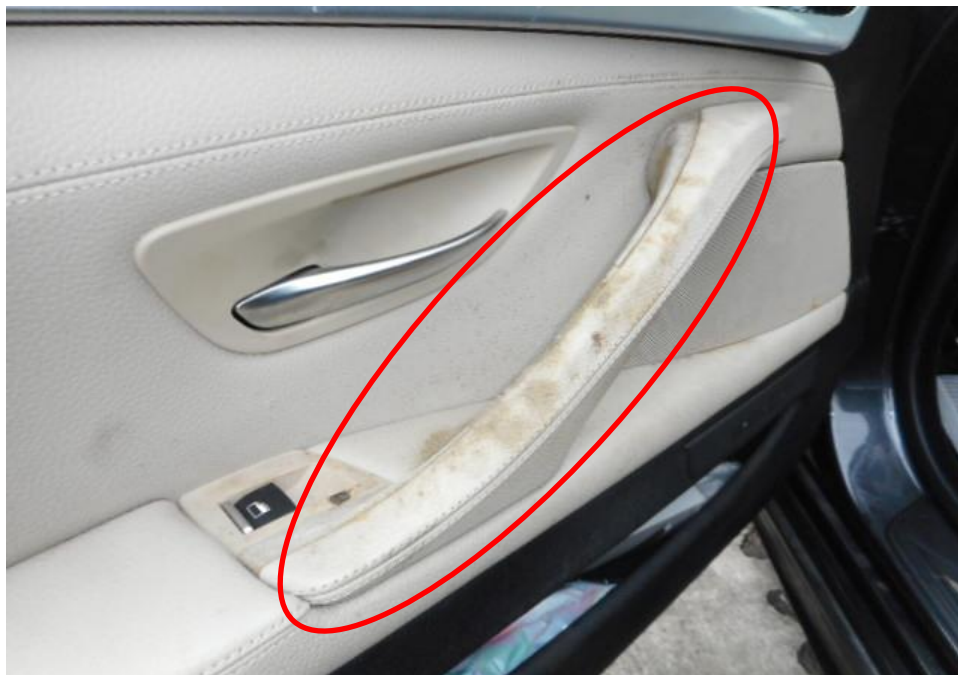
Photo 8 shows a close up view of the Motor Car's front left door handle. We have observed mouldy stains on its front left door handle (circled) due to indirect water intrusion into the interior cabin of the Motor Car.

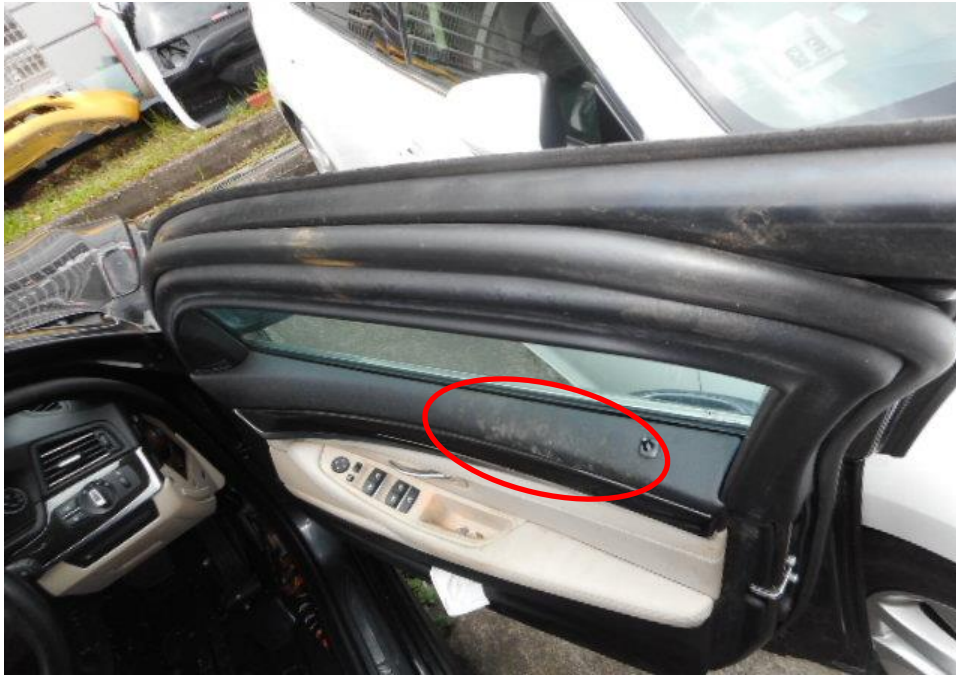
Photo 9 shows a general up view of the Motor Car's front right door panel. We have observed mouldy stains on its front right door panel (circled) due to indirect water intrusion into the interior cabin of the Motor Car.

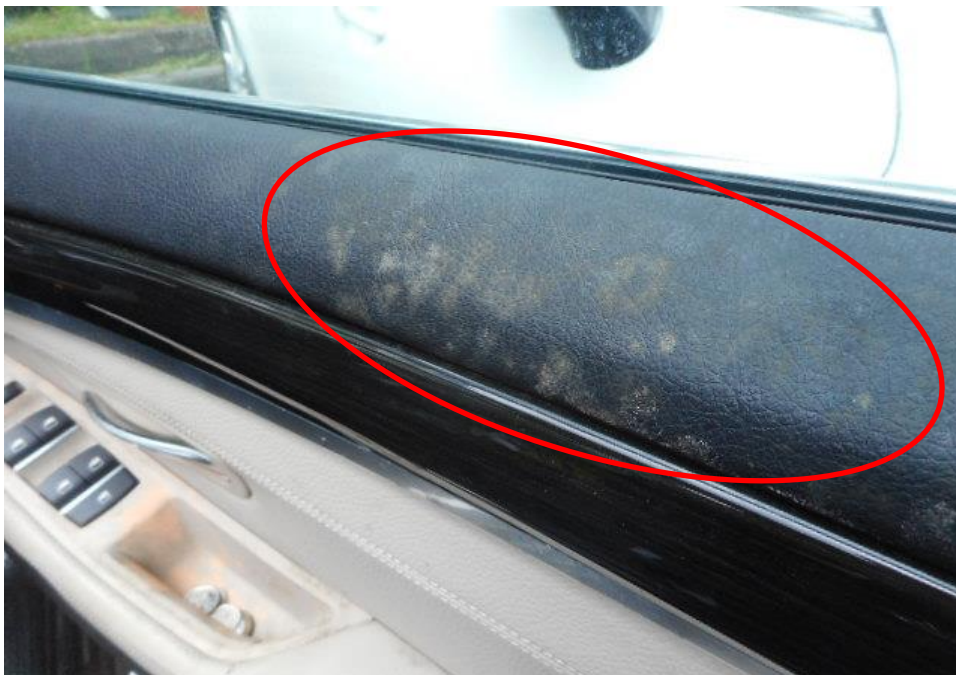
Photo 10 shows a close up view of the Motor Car's front right door panel. We have observed mouldy stains on its front right door panel (circled) due to indirect water intrusion into the interior cabin of the Motor Car.

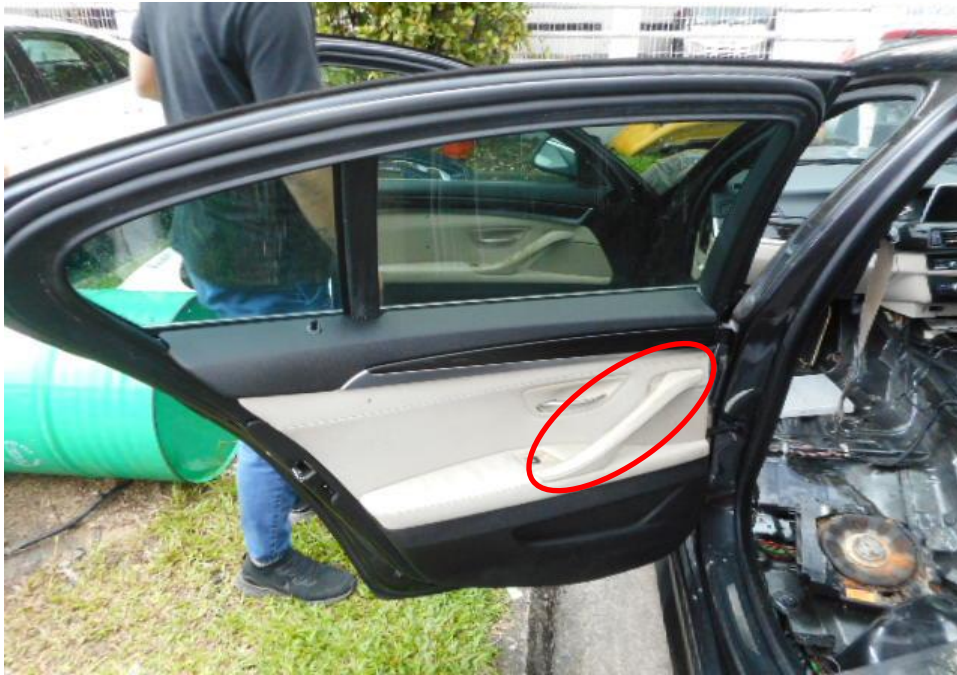
Photo 11 shows a general up view of the Motor Car's rear left door handle. We have observed mouldy stains on its rear left door handle (circled) due to indirect water intrusion into the interior cabin of the Motor Car.

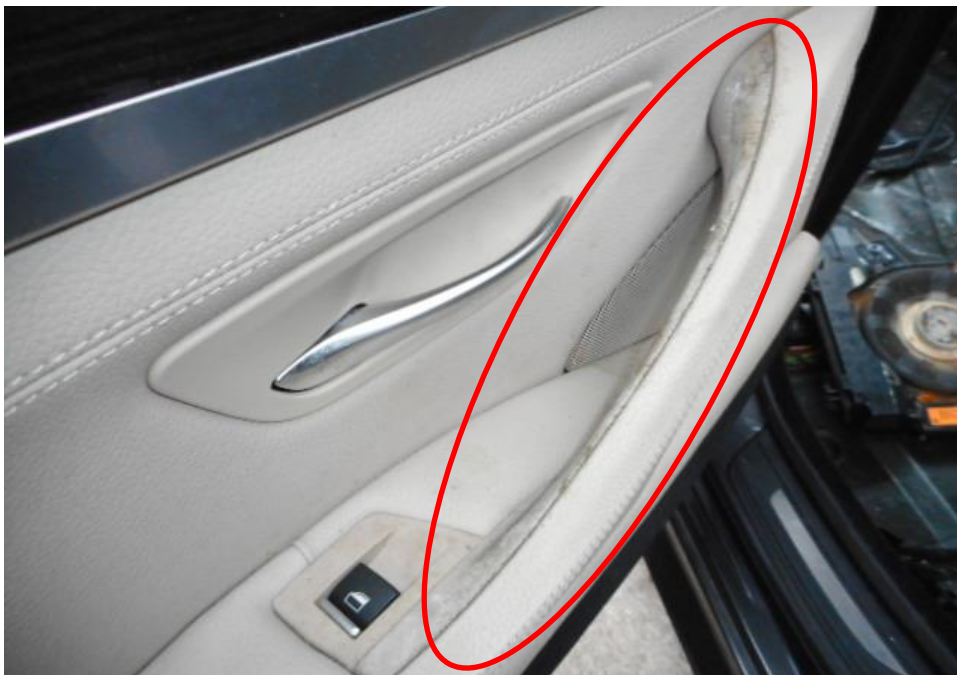
Photo 12 shows a close up view of the Motor Car's rear left door handle. We have observed mouldy stains on its rear left door handle (circled) due to indirect water intrusion into the interior cabin of the Motor Car.

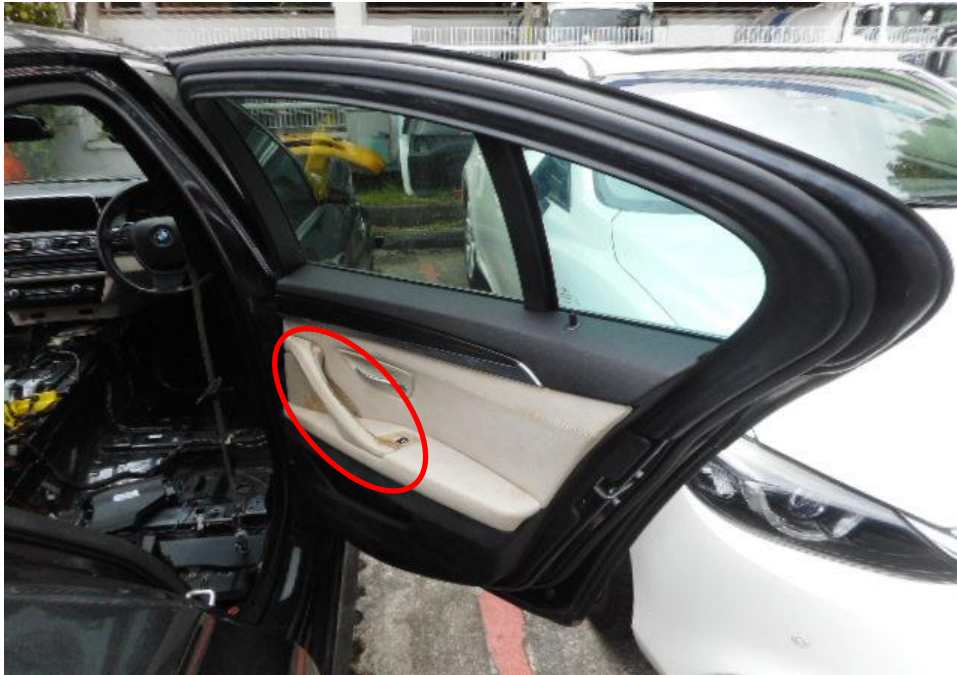
Photo 13 shows a general up view of the Motor Car's rear right door handle. We have observed mouldy stains on its rear right door handle (circled) due to indirect water intrusion into the interior cabin of the Motor Car.

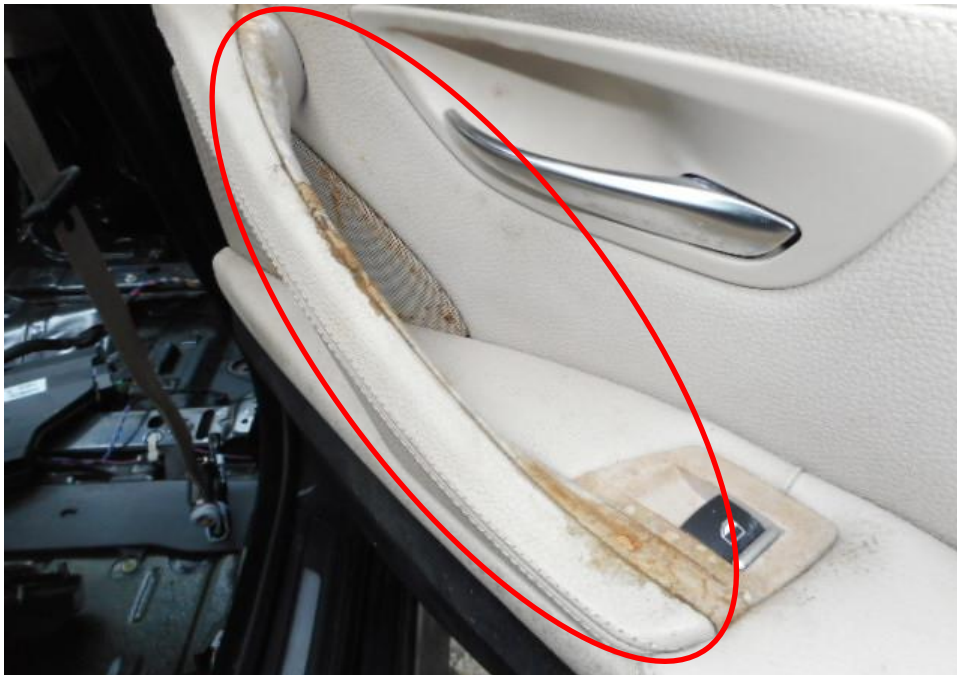
Photo 14 shows a close up view of the Motor Car's rear right door handle. We have observed mouldy stains on its rear right door handle (circled) due to indirect water intrusion into the interior cabin of the Motor Car.

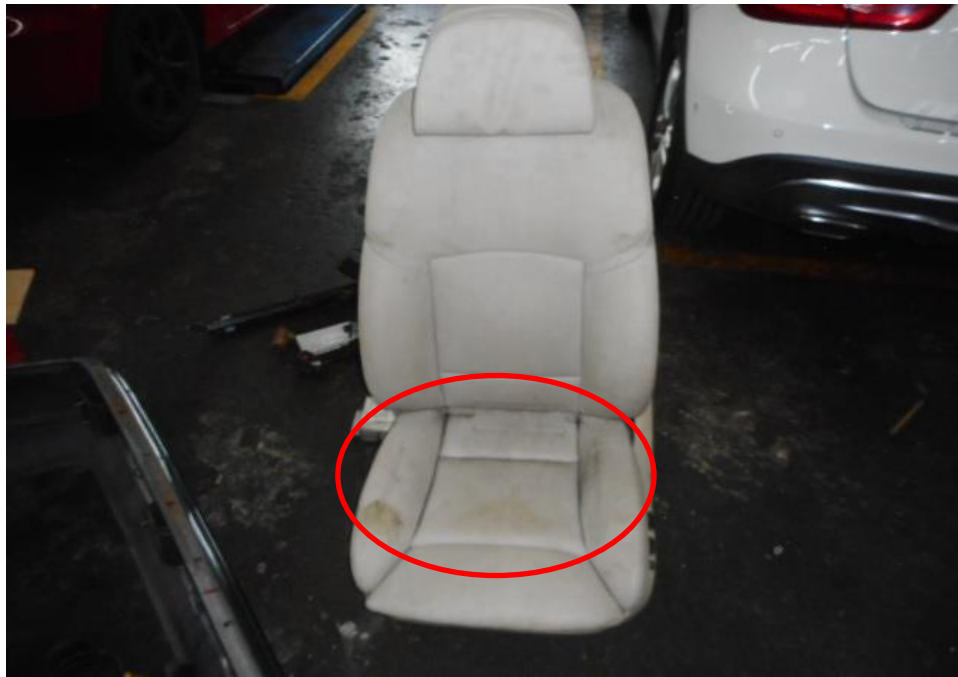
Photo 15 shows a general up view of the Motor Car's front left seat. We have observed mouldy stains on its front left seat (circled) due to indirect water intrusion into the interior cabin of the Motor Car.

9. For this particular case, plastic steering column cover and sound proofing cover to cover up the hole was on the left firewall. We observed that the water damages on the left seat rail mechanism and the electrical subwoofer that was below the left seat had sustained more water intrusion damages then to the right side. Refer to photos 15 – 28 above.

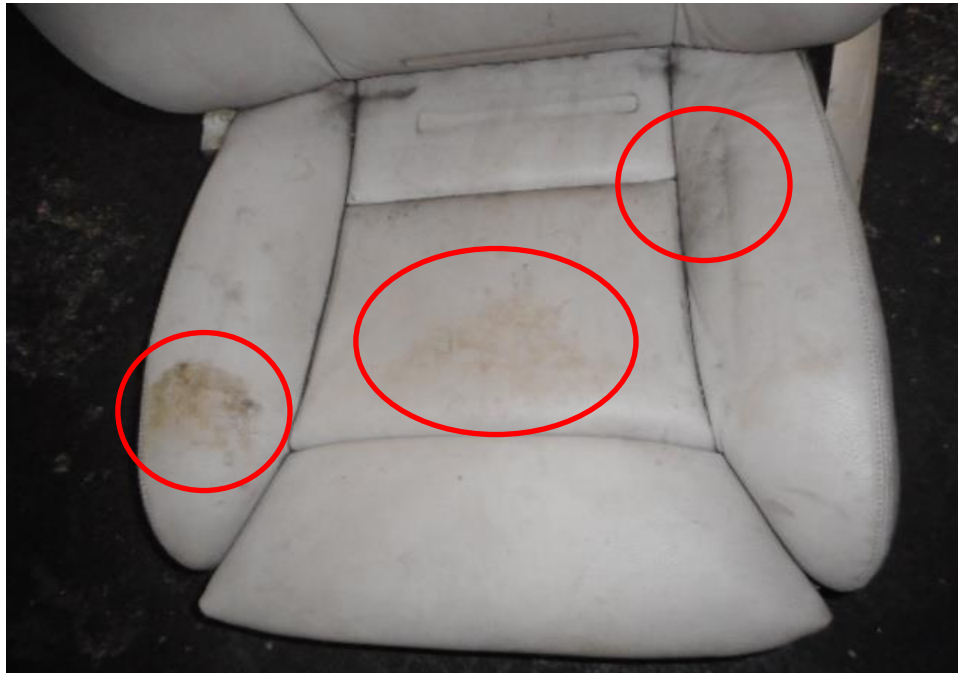
Photo 16 shows a close up view of the Motor Car's front left seat. We have observed mouldy stains on its front left seat (circled) due to indirect water intrusion into the interior cabin of the Motor Car.

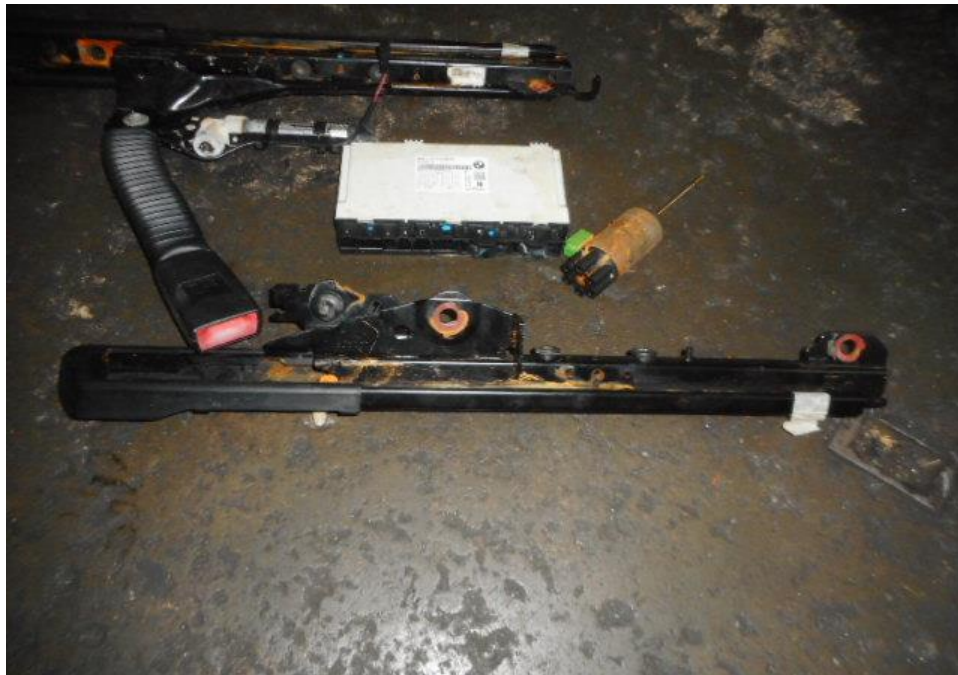
Photo 17 shows a general up view of the Motor Car's front left seat rail mechanism. We have observed rust built up on its front left seat mechanism due to damage by direct water intrusion into the interior cabin of the Motor Car.

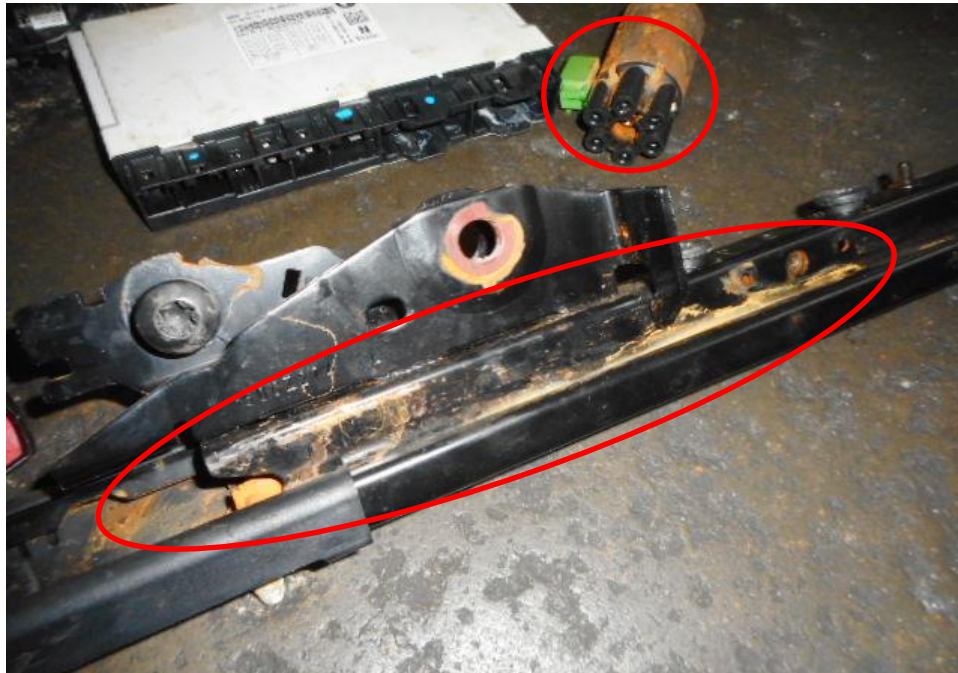
Photo 18 shows a close up view of the Motor Car's front left seat mechanism. We have observed rust built up on its front left seat mechanism due to damage by direct water intrusion into the interior cabin of the Motor Car.

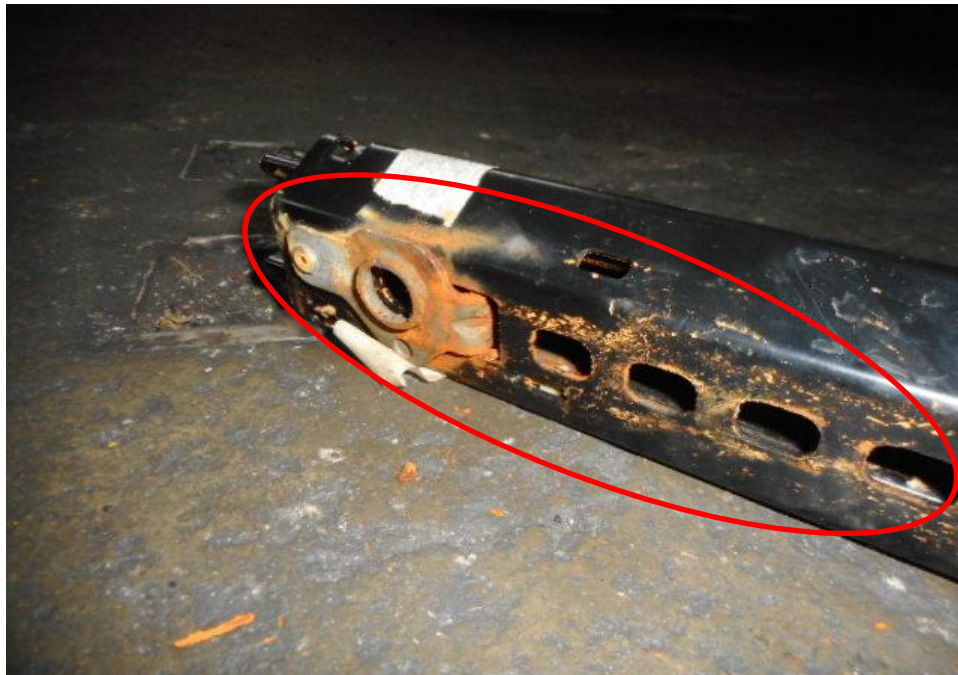
Photo 19 shows a close up view of the Motor Car's front left seat mechanism. We have observed rust built up on its front left seat mechanism due to damage by direct water intrusion into the interior cabin of the Motor Car.

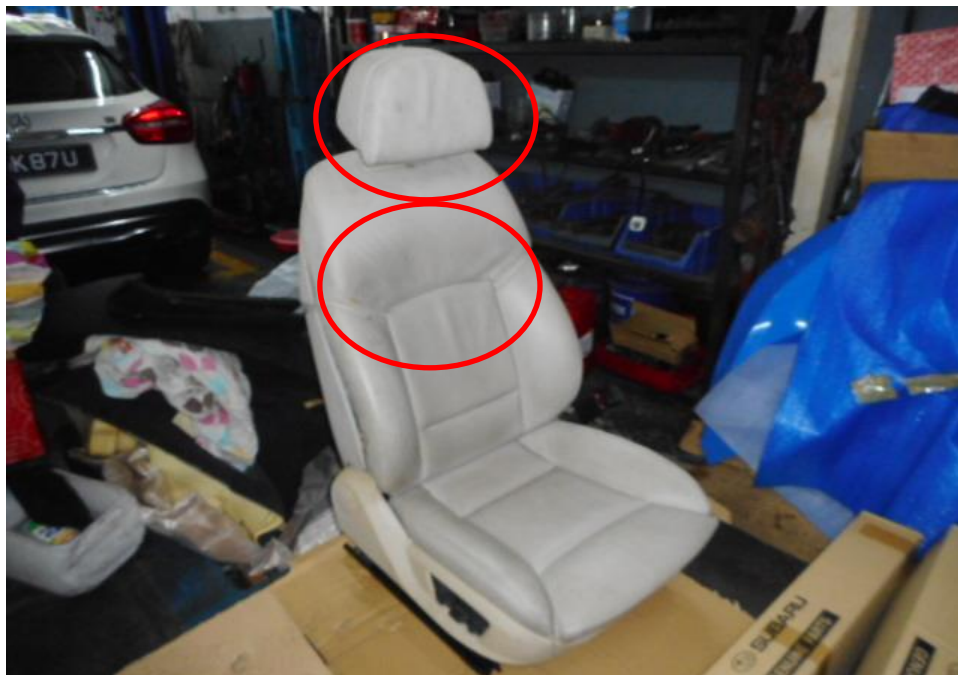
Photo 20 shows a general up view of the Motor Car's front right seat. We have observed mouldy stains on its front right seat (circled) due to indirect water intrusion into the interior cabin of the Motor Car.

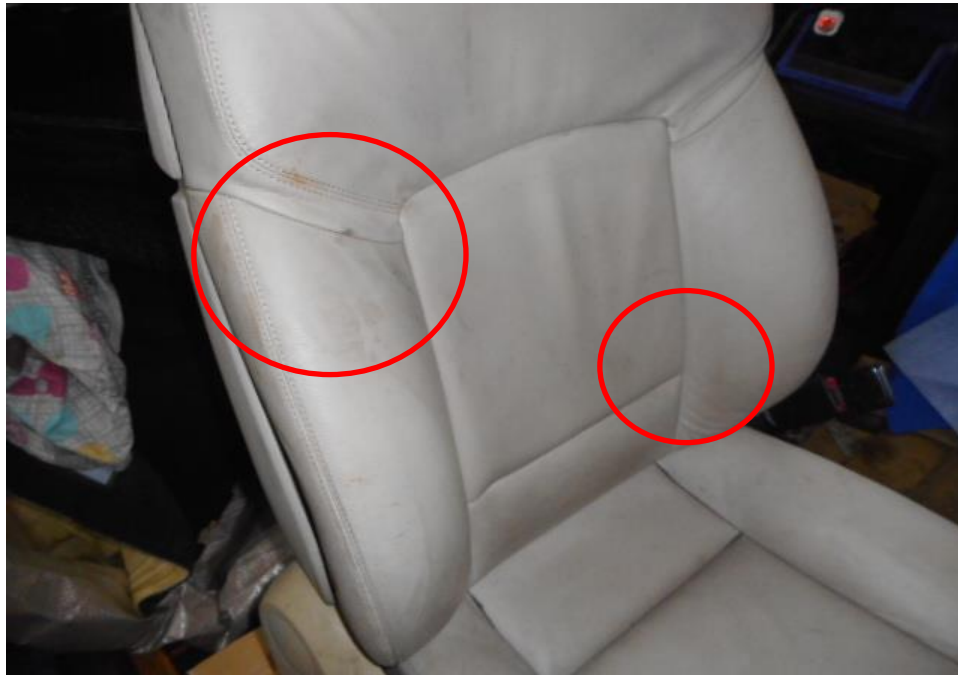
Photo 21 shows a close up view of the Motor Car's front right seat. We have observed mouldy stains on its front right seat (circled) due to indirect water intrusion into the interior cabin of the Motor Car.

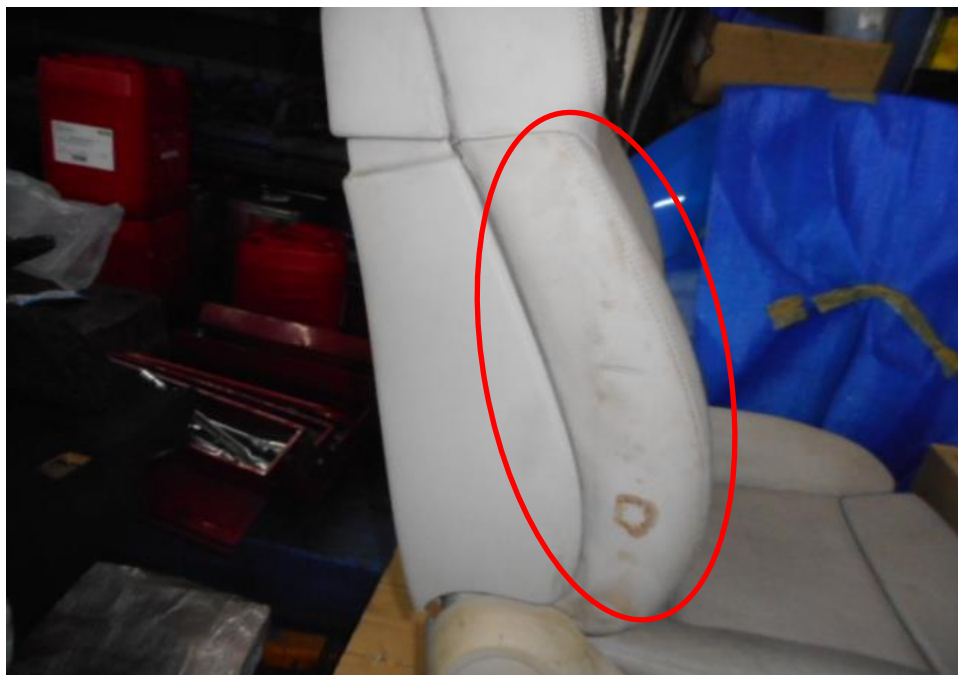
Photo 22 shows a close up view of the Motor Car's front right seat. We have observed mouldy stains on its front right seat (circled) due to indirect water intrusion into the interior cabin of the Motor Car.

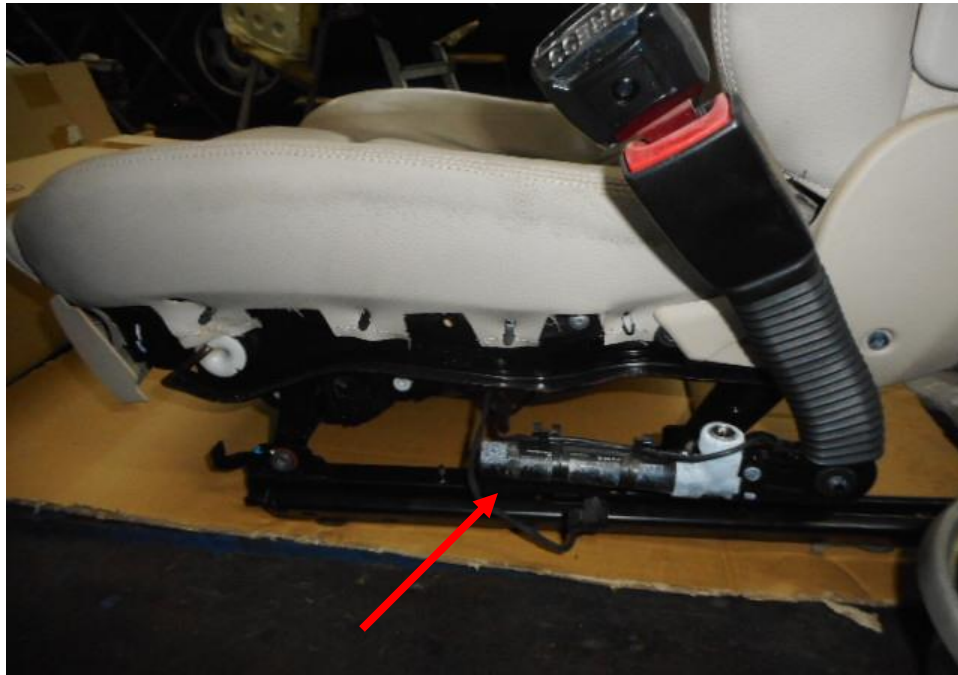
Photo 23 shows a general up view of the Motor Car's front right seat rail mechanism. We have observed that its front right seat mechanism (arrowed) did not sustain any damage by any water intrusion into the interior cabin of the Motor Car.

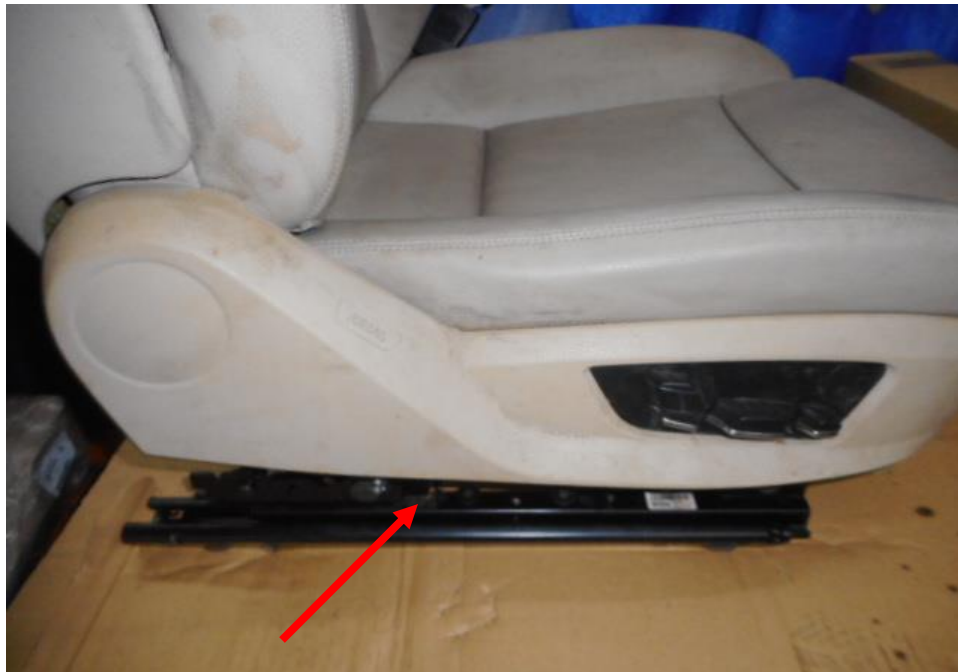
Photo 24 shows a general up view of the Motor Car's front right seat rail mechanism. We have observed that its front right seat mechanism did not sustain any damage by any water intrusion into the interior cabin of the Motor Car.

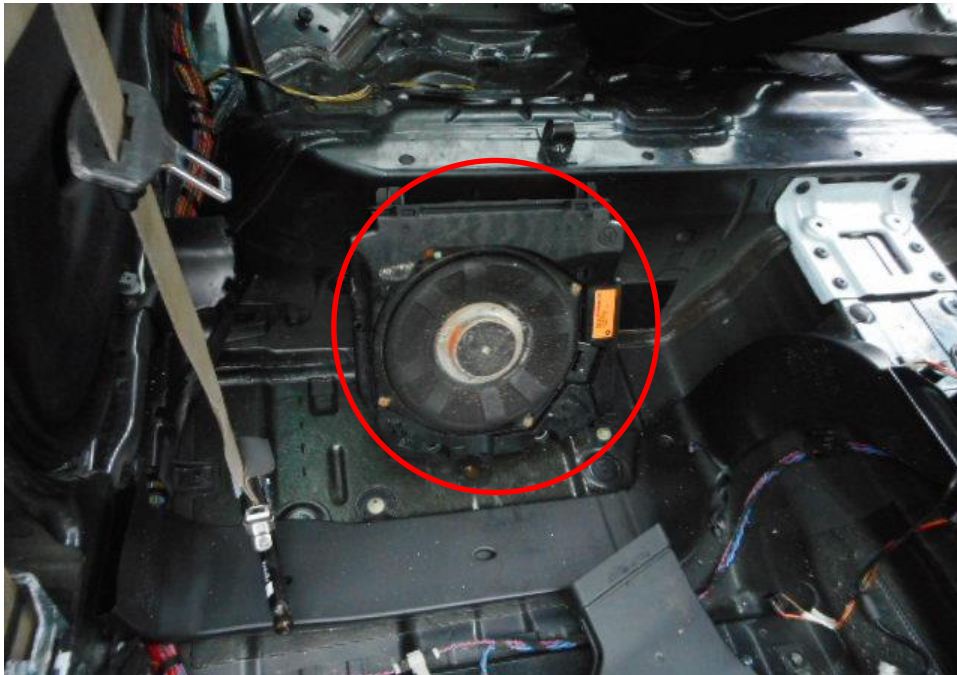
Photo 25 shows a general up view of the Motor Car's electrical audio subwoofer component (circled) located at the bottom of the front right seat. We have observed rust built up on its electrical component due to damage by direct water intrusion into the interior cabin of the Motor Car.

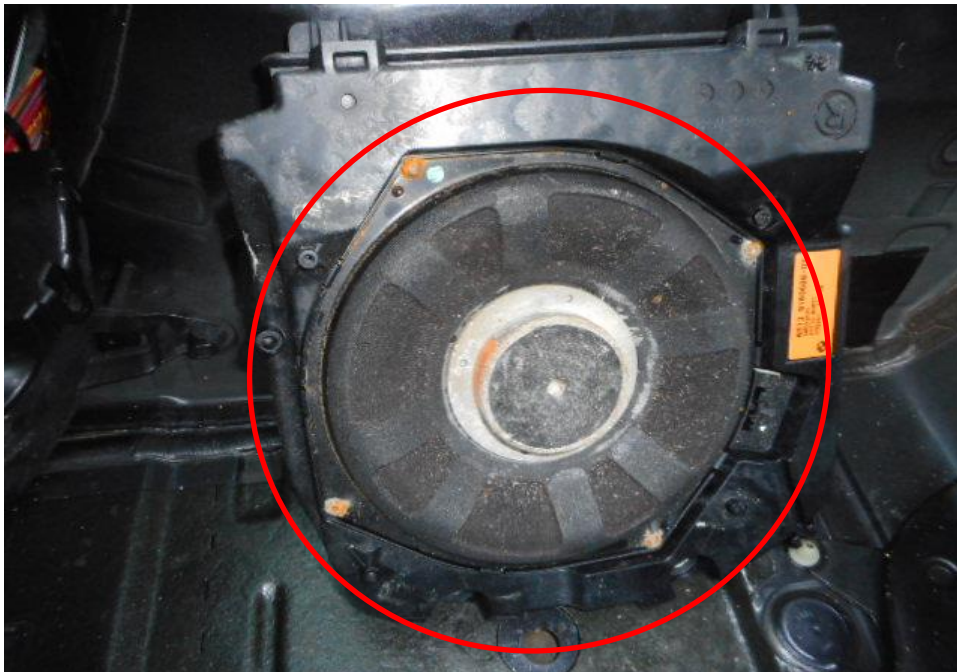
Photo 26 shows a close up view of the Motor Car's electrical audio subwoofer component (circled) located at the bottom of the front right seat. We have observed rust built up on its electrical component due to damage by direct water intrusion into the interior cabin of the Motor Car.

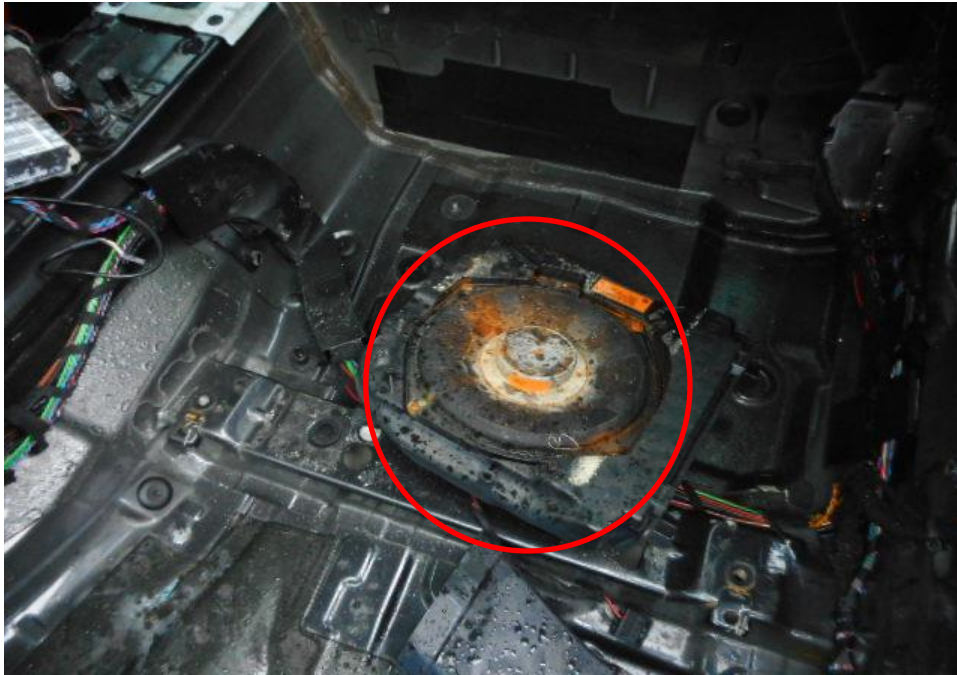
Photo 27 shows a general up view of the Motor Car's electrical audio subwoofer component (circled) located at the bottom of the front left seat. We have observed rust built up on its electrical component due to damage by direct water intrusion into the interior cabin of the Motor Car.

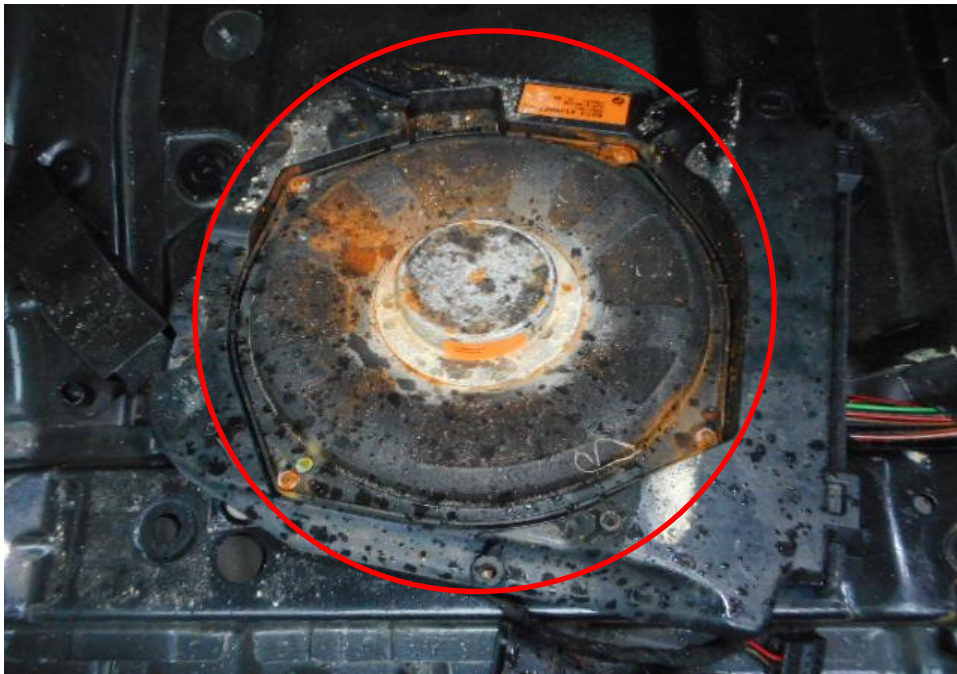
Photo 28 shows a close up view of the Motor Car's electrical audio subwoofer component (circled) located at the bottom of the front left seat. We have observed rust built up on its electrical component due to damage by direct water intrusion into the interior cabin of the Motor Car.

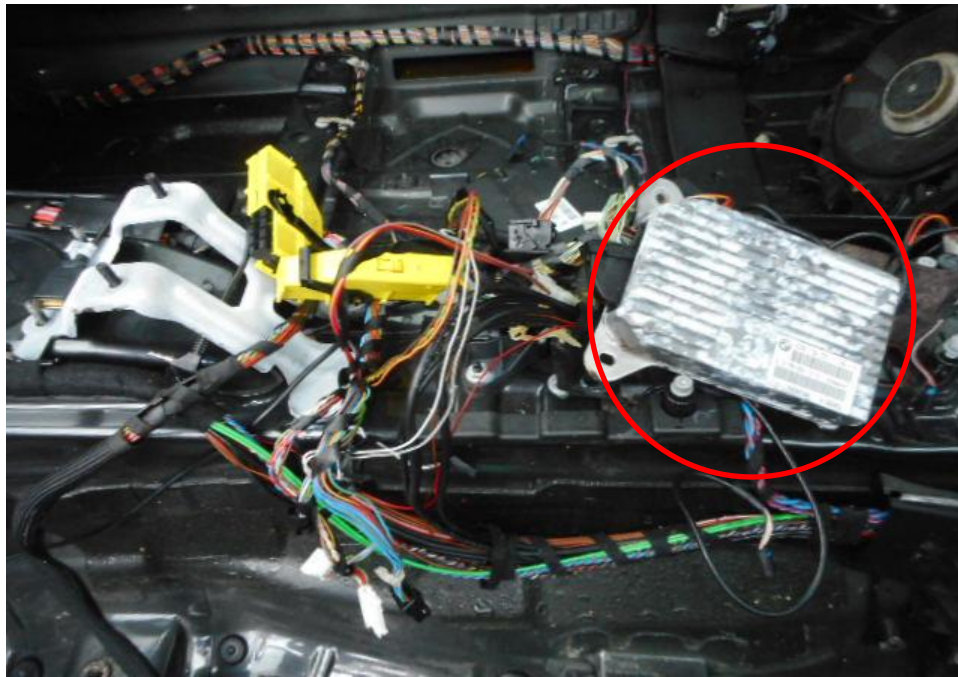
Photo 29 shows a general up view of the Motor Car's electrical Chassis control module component (circled) located at the bottom of the centre console. We have observed mould and rust built up on the electrical component due to damage by direct water intrusion into the interior cabin of the Motor Car.

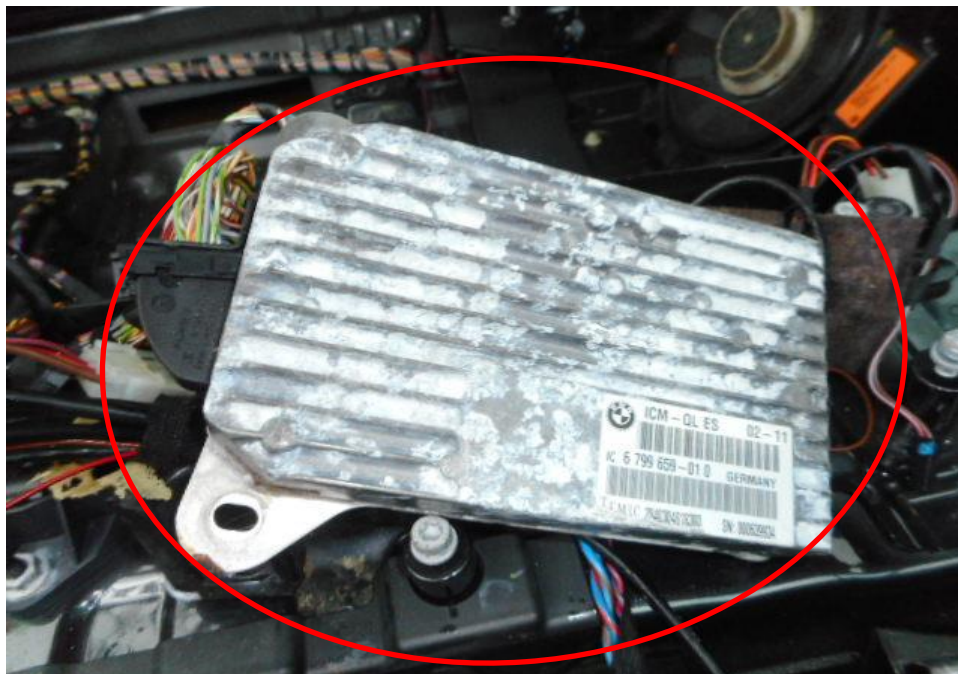
Photo 30 shows a close up view of the Motor Car's electrical Chassis control module component (circled) located at the bottom of the centre console. We have observed mould and rust built up on the electrical component due to damage by direct water intrusion into the interior cabin of the Motor Car.

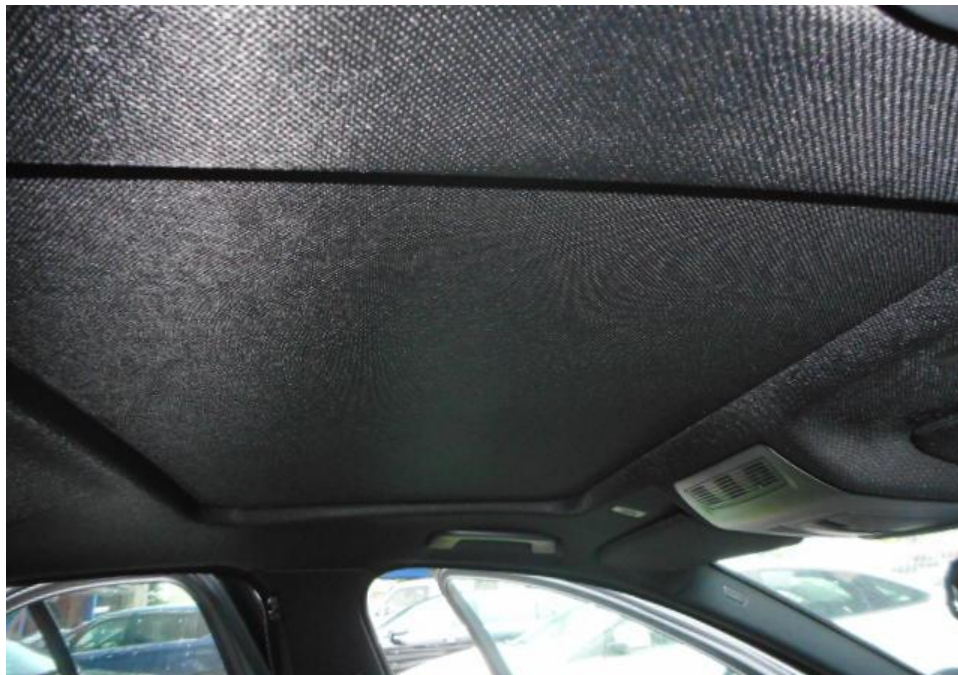
Photo 31 shows a general up view of the Motor Car's interior cabin roof material located at the top of the interior. We have observed no water intrusion damages to the interior cabin roof material of the Motor Car at the time of inspection and also after the water leak test.

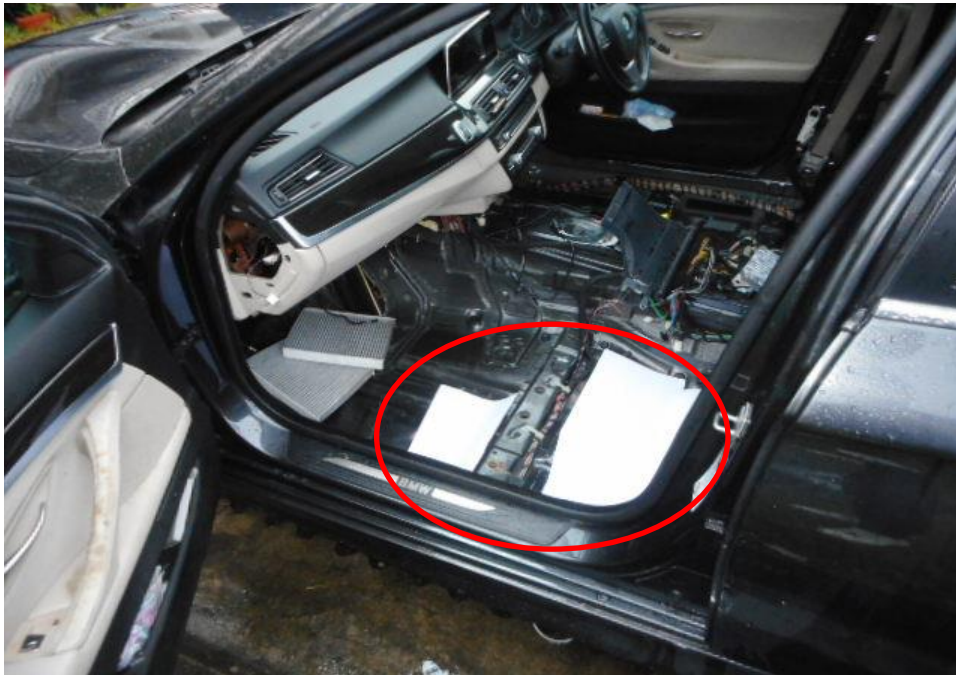
Photo 32 shows dry papers (red circle) that was placed into the floor of the interior cabin where the seats and electrical components was at and before water was poured onto the exterior door seals of the Motor Car to see if there was any water intrusion into the Motor Car
