You're Ref: SJV 76Y
Our Ref: CI/TPD23000069/P

INSPECTION REPORT OF MOTOR CAR SJV 76Y

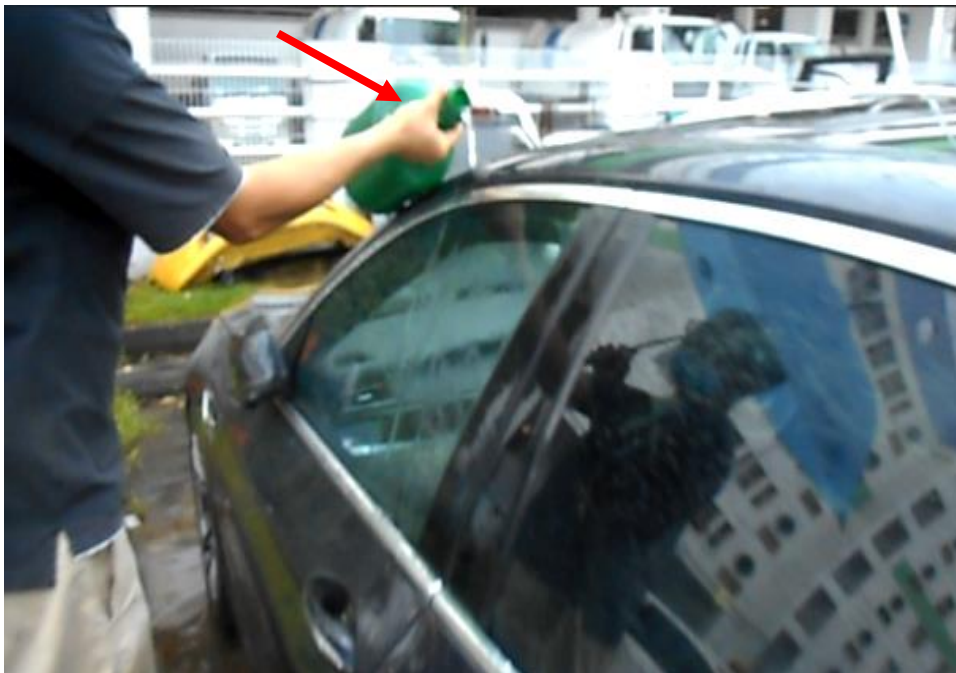
Photo 33 shows water leak test where (arrowed) water was poured onto the exterior door seals of the Motor Car to see if there was any water intrusion into the Motor Car

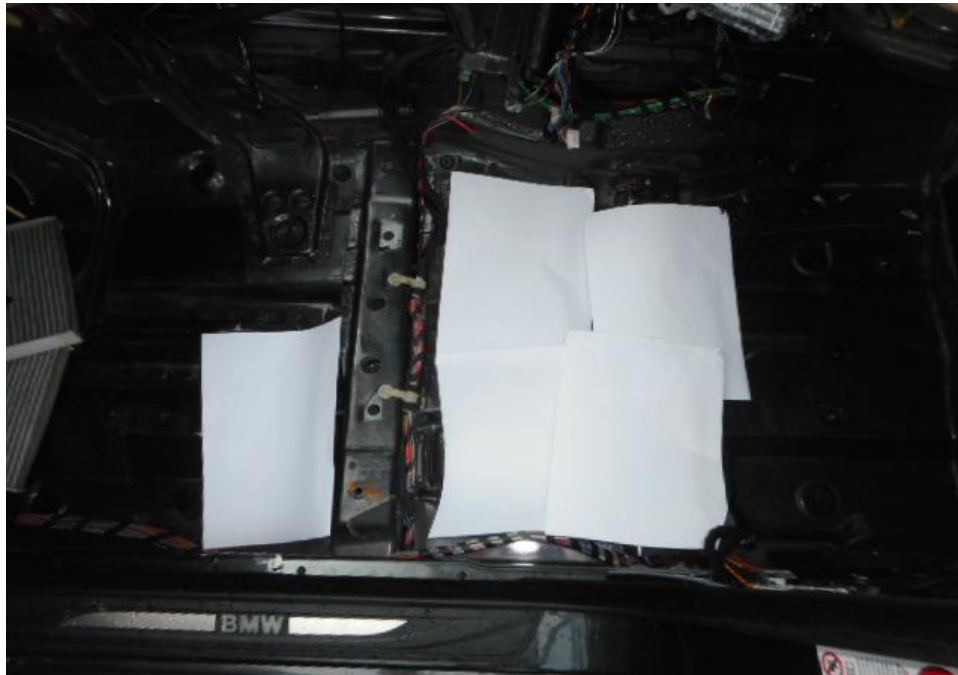
Photo 34 shows dry papers (red circle) that was placed into the floor of the interior cabin where the seats and electrical components was at and after water was poured onto the exterior door seals of the Motor Car and the papers remained dry and there was no water intrusion into the Motor Car

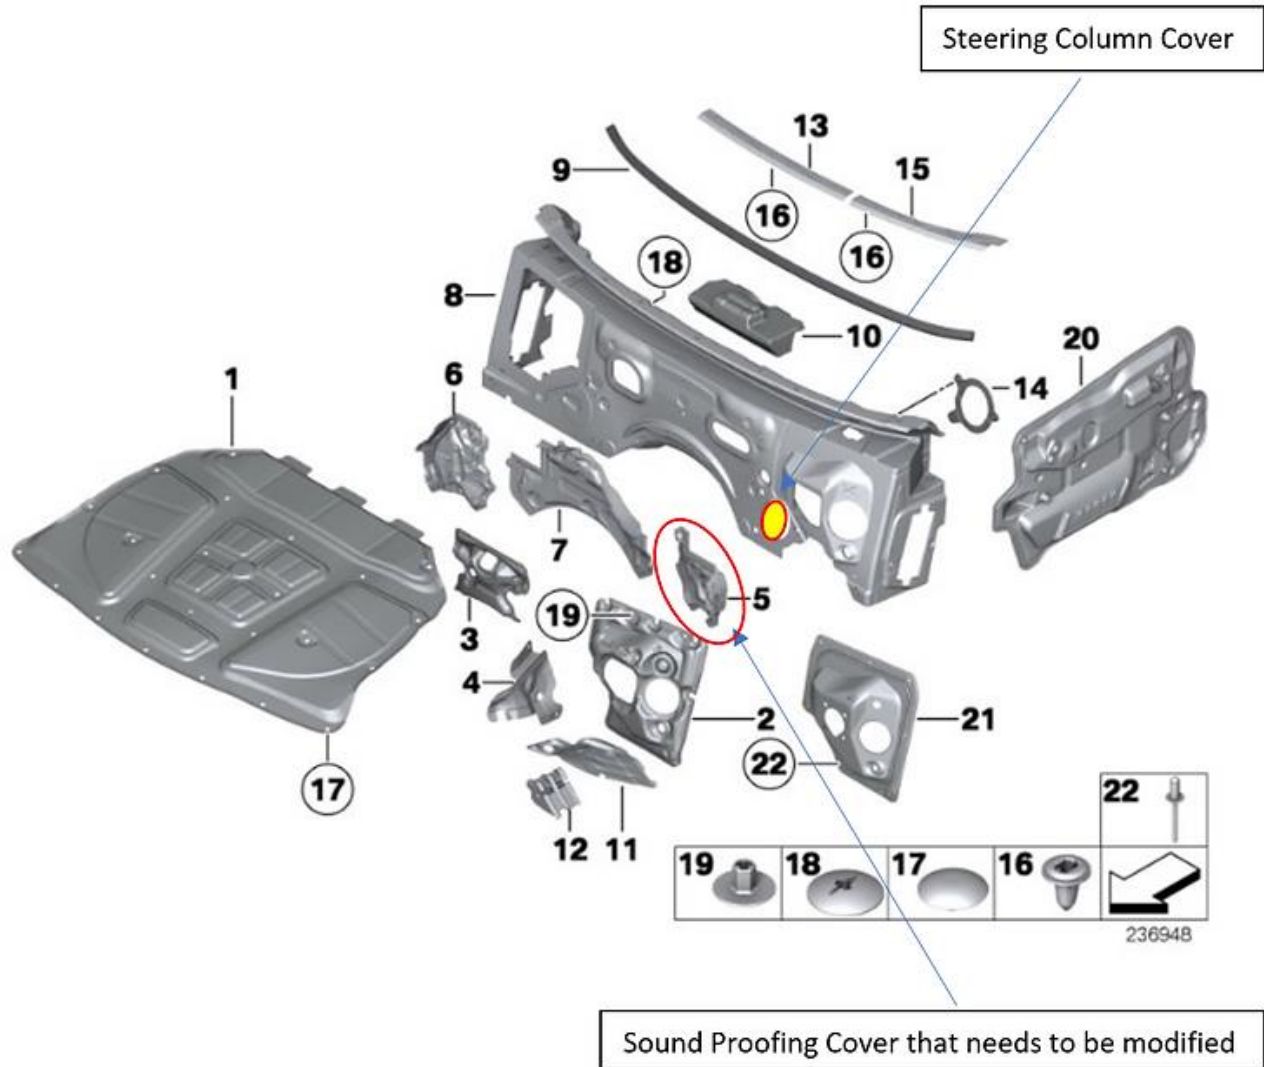
8. We have conducted our own research to this particular brand and model of the Motor Car and we noted that this Motor Car was offered in left- and right-hand drive for the steering column depending on country the Motor Car is imported to. The manufacture has built the Motor Car's chassis to allow the steering column to be placed either on the front left and right side firewall of the Motor Car. For this particular brand and model of the Motor Car the steering column is placed on the right-side firewall of the Motor Car. In this case to cover up the hole in the firewall where there is no steering column which was the left side, the manufacture had designed a plastic steering column cover and sound proofing cover to cover up the hole on the firewall to stop dirt and water from entering the interior cabin of the Motor Car these parts would fail overtime due to wear and tear thus allowing dirt and dust to enter the interior cabin from the firewall. See diagram 1 below.

Diagram 1 shows the diagram of the steering column cover (yellow circle) and sound proofing cover (red circle) is located at the left side firewall the Motor Car. We are in view the water intrusion to the Motor Car had entered from these components into the interior cabin of the Motor Car.

11. For this particular case, it was purely a case of wear and tear to the plastic material of the steering column cover and sound proofing cover that had fail overtime due to wear and tear which had allowed water to intrude into the interior cabin of the Motor Car through the left firewall resulting in the water damages to the various interior components of the Motor Car during the time when the Motor Car was impounded in the open in Traffic Police Vehicle Pound for investigations.
