## REFERENCES

| Third party vehicle | : YN4452H | Date of Accident | : 21/7/2022 |

## DAMAGED VEHICAL PARTICULARS

## DESCRIPTION OF DAMAGE

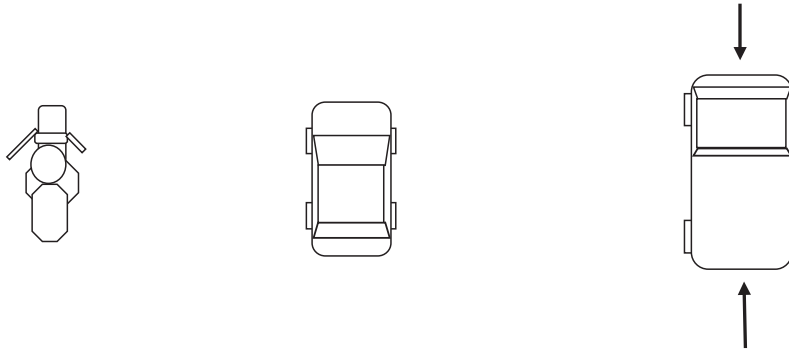
At the time of inspection, this vehicle sustained damages to the **Front and Rear Portion.**

Front bumper, front cross member dented, front grille base crack, rh headlamp holder, rh signal lamp broken, rear swing door dented rear end panel push in, rear safety bar bent etc.

We have not authorised repair. Under normal circumstances, estimated **8** working days are required to repair the vehicle.
