Your Ref: C10019456
Our Ref : CI/AGI23000407/N

**TECHNICAL INVESTIGATION REPORT OF INSURED VEHICLE SLZ 7027Z
INVOLVED IN AN ACCIDENT ON 23 DECEMBER 2022**

Registration Number : SLZ 7027Z
Make & Model : TOYOTA VIOS E AUTO
Year of Registration : December 2008
Chassis Number : MR053HY9305084687
Speedo Reading : 204,647km

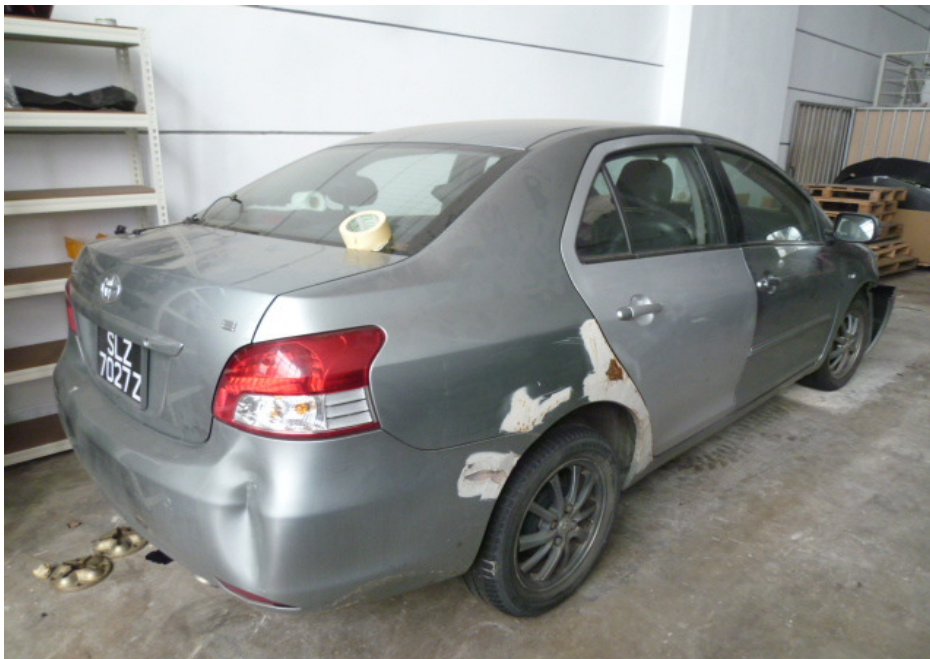
Photo 1 shows the general view of the left rear portion of the Insured Vehicle at the time of our inspection.

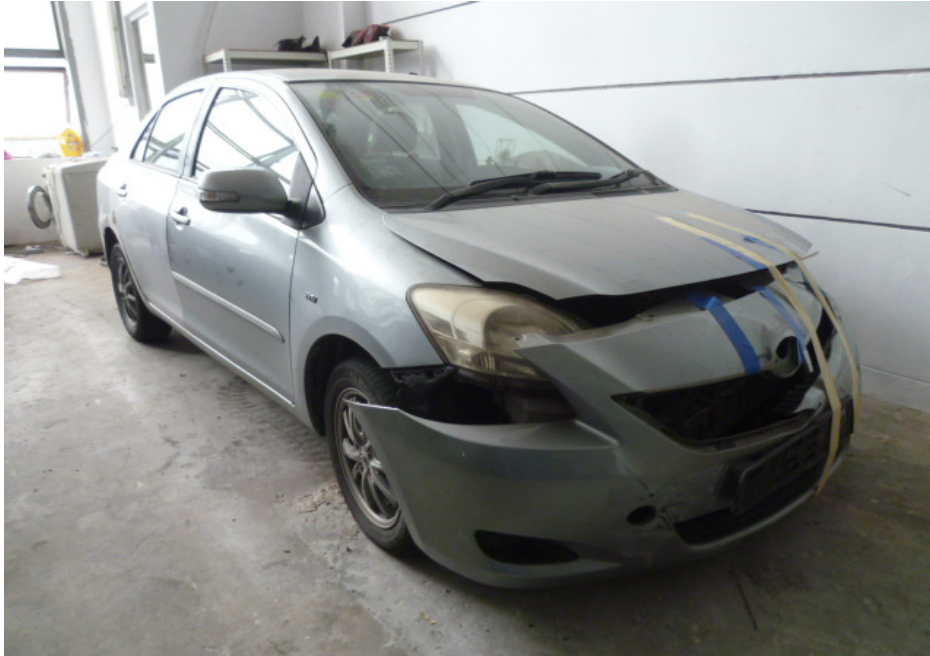
Photo 2 shows the general view of the right front portion of the Insured Vehicle at the time of our inspection.

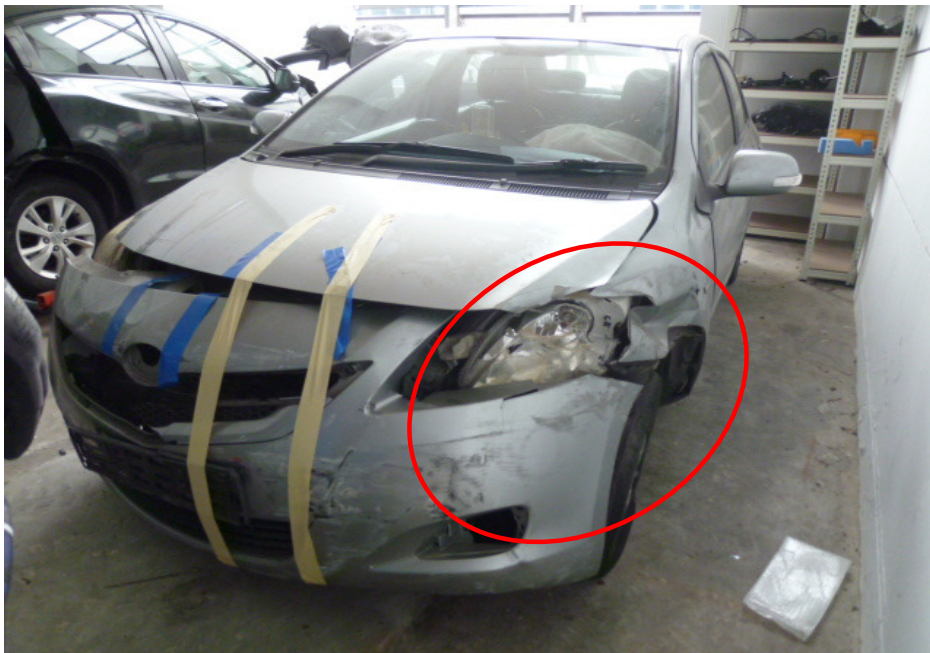
5. The Insured Vehicle was observed to have sustained impact damage that was confined to its left frontal portion. Its front bumper, front bonnet, front windscreen, left front fender, left headlamp, left front wheel rim and left front tyre were amongst the exterior body parts that were observed to have been damaged.

Photo 3 shows the general view of the left front portion of the Insured Vehicle at the time of our inspection. The Insured Vehicle was observed to have sustained impact damage that was confined to its left frontal portion. Its front bumper, front bonnet, front windscreen, left front fender, left headlamp, left front wheel rim and left front tyre were amongst the exterior body parts that were observed to have been damaged as a result of the accident.

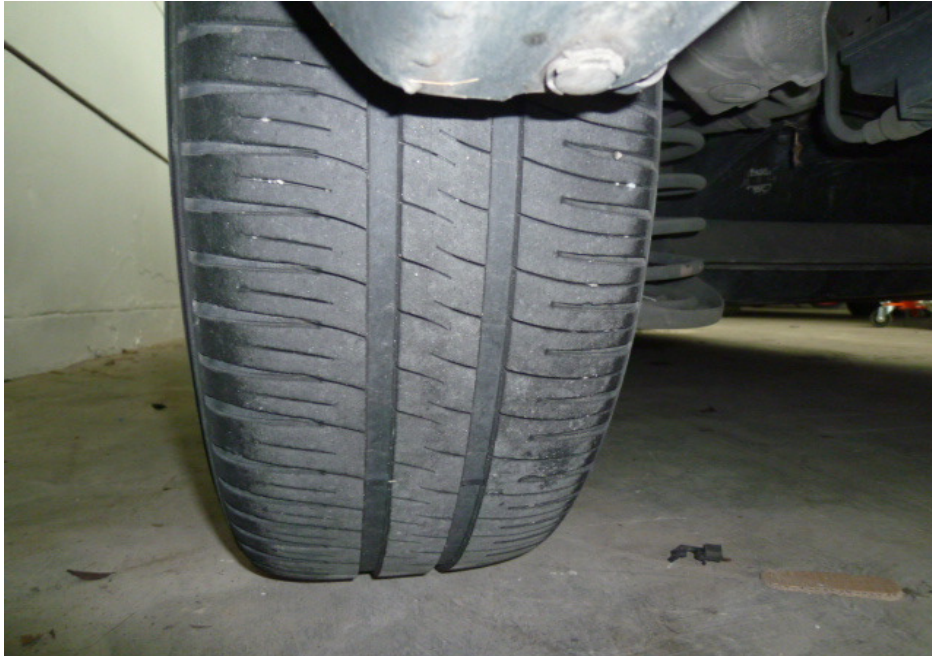
6. Examination carried out to the rear tyres that were fitted on the Insured Vehicle had revealed that both its rear tyres were in serviceable condition with remaining tread depth measured to be approximately 4mm. See photos 1 – 5 below.

Photo 4 shows the left rear tyre of the Insured Vehicle at the time of our inspection. The left rear tyre of the Insured Vehicle was observed to be in serviceable condition. The pattern of the tread was generally still visible. The remaining tread depth was measured to be approximately 4mm.

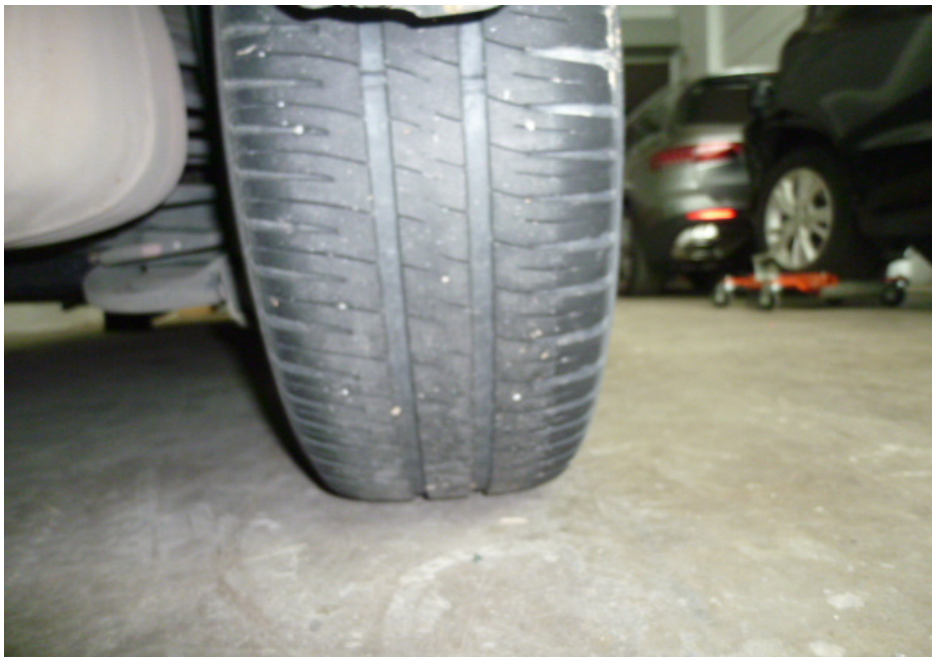
Photo 5 shows the right rear tyre of the Insured Vehicle at the time of our inspection. The right rear tyre of the Insured Vehicle was observed to be in serviceable condition. The pattern of the tread was generally still visible. The remaining tread depth was measured to be approximately 4mm.

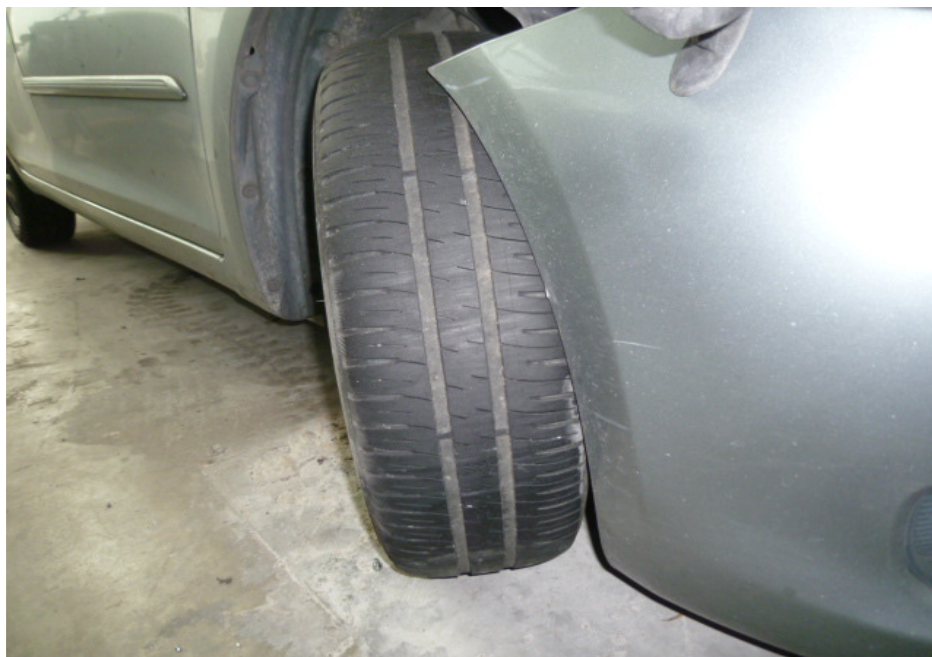
7. The right front tyre of the Insured Vehicle was also found to be in serviceable condition. The pattern of the tread was generally still visible. The tyre wear indicators, normally built into the groove of the tread pattern, were also observed to be not flushed with the tread pattern. The remaining depth of the tread was measured to be approximately 3mm.

Photo 6 shows the right front tyre of the Insured Vehicle at the time of our inspection. The right front tyre of the Insured Vehicle was observed to be in serviceable condition. The pattern of the tread was generally still visible. The remaining tread depth was measured to be approximately 3mm.

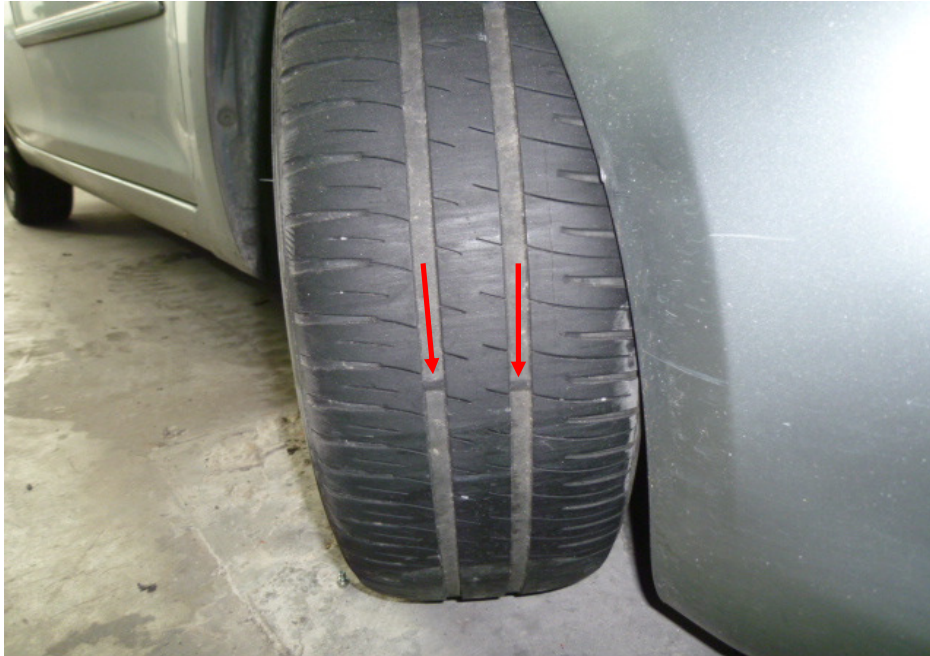
Photo 7 shows a closer view of the right front tyre of the Insured Vehicle at the time of our inspection. The pattern of the tread was generally still visible. The tyre wear indicators (arrowed), normally built into the groove of the tread pattern, were also observed to be not flushed with the tread pattern.

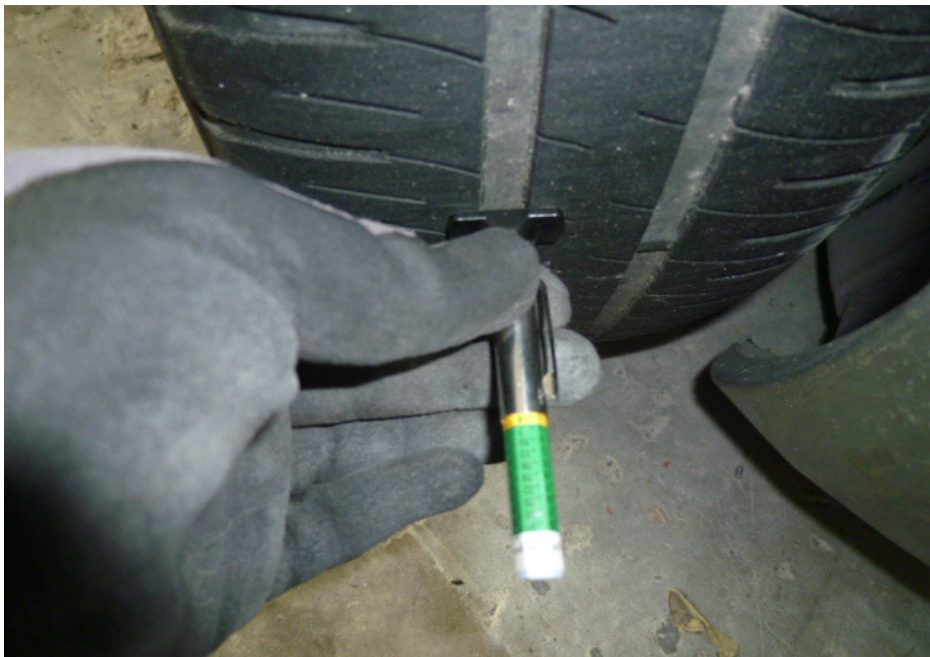
Photo 8 shows measurements being conducted on the remaining tread depth of the front right tyre of the Insured Vehicle. The remaining tread depth was measured to be approximately 3mm.

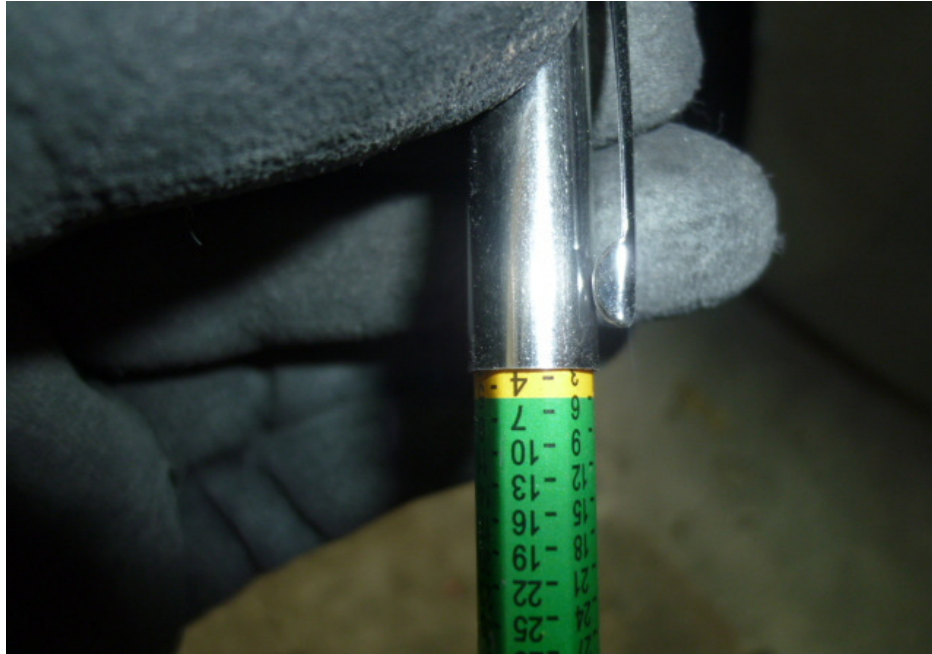
Photo 9 shows measurements being conducted on the remaining tread depth of the right front tyre of the Insured Vehicle. The remaining tread depth was measured to be approximately 3mm.

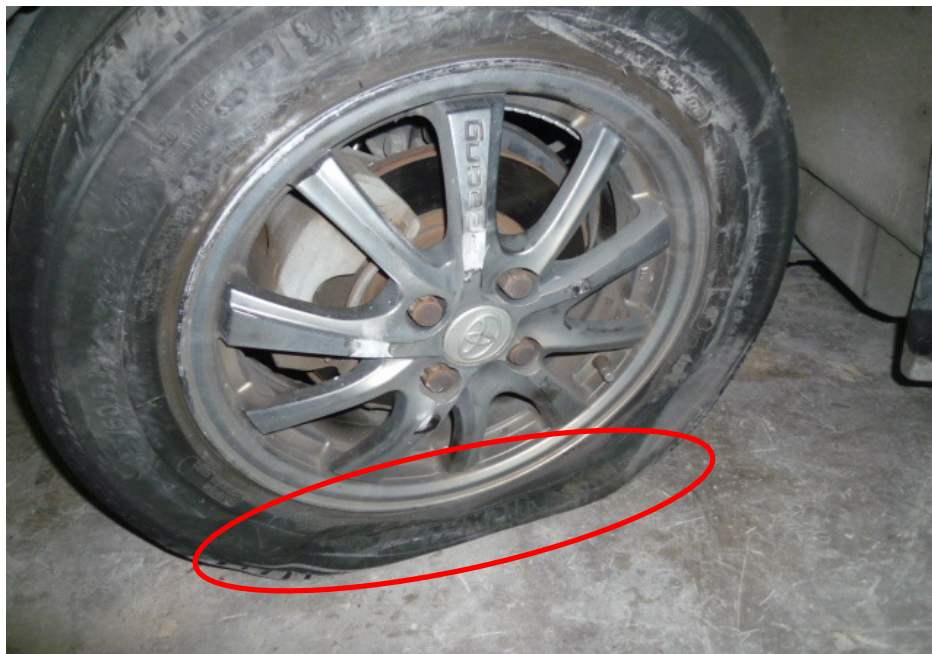
8. Upon examination of the left front tyre of the Insured Vehicle, we had observed that the left front tyre was deflated as a result of the accident. The rubber at the outer side of the tread was partially worn. The pattern at some areas at the outer side of the tread was vaguely visible due to worn rubber however the pattern of the tread was generally still visible. The reinforcing belts that are found within the tyre were not exposed at the time of our inspection. The tyre wear indicators, normally built into the groove of the tread pattern, were also observed to be not flushed with the tread pattern. The remaining tread depth of the left front tyre was measured to be approximately 2mm. See photos 6 - 14 below.

Photo 10 shows the left front tyre of the Insured Vehicle at the time of our inspection. We had observed that the left front tyre was deflated as a result of the accident (circled).

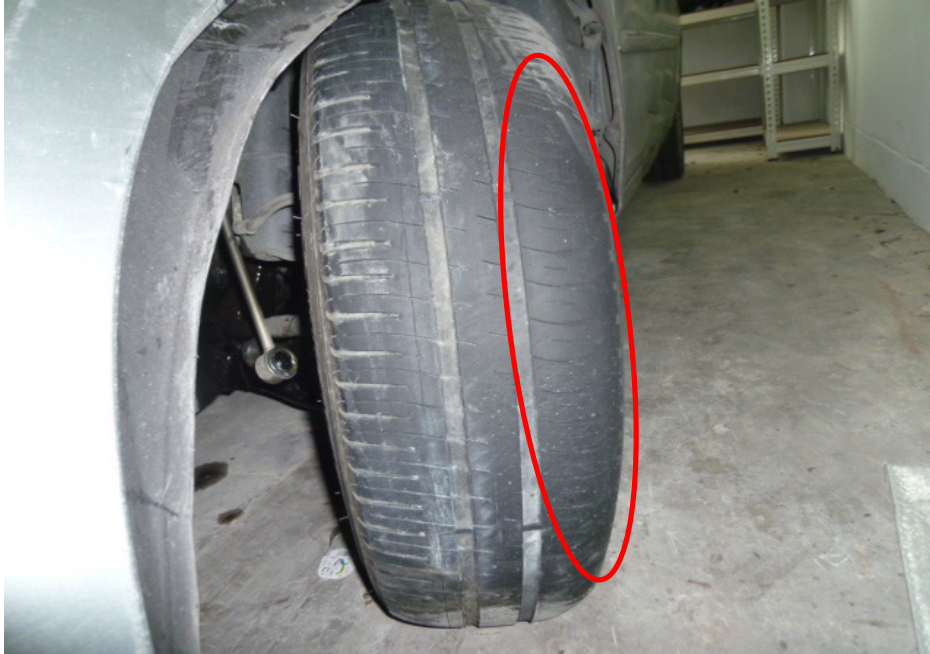
Photo 11 shows the left front tyre of the Insured Vehicle at the time of our inspection. The rubber at the outer side of the tread (circled) was partially worn. The pattern at some areas on the outer side of the tread was vaguely visible due to worn rubber however the reinforcing belts that are found within the tyre were not exposed at the time of our inspection.

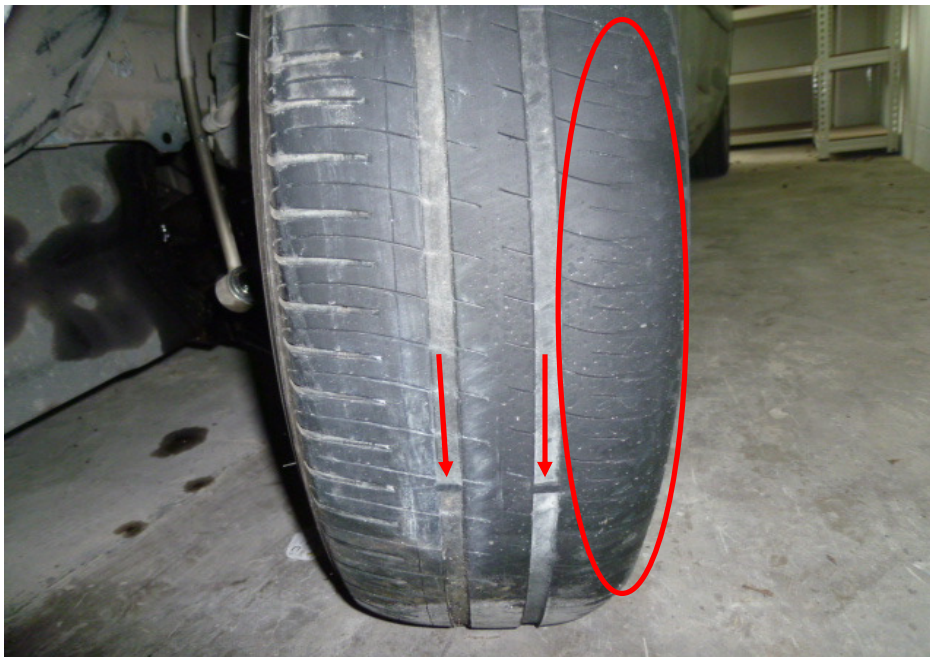
Photo 12 shows a closer view of the left front tyre of the Insured Vehicle at the time of our inspection. The rubber at the outer side of the tread (circled) was partially worn. However the pattern of the tread was generally still visible. The

tyre wear indicators (arrowed), normally built into the groove of the tread pattern, were also observed to be not flushed with the tread pattern (arrowed).

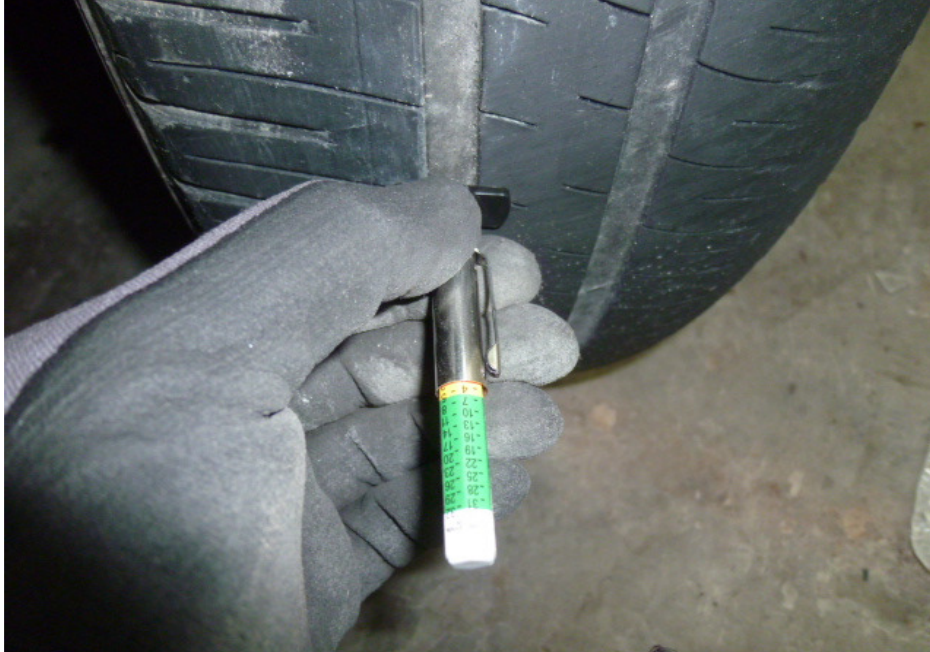
Photo 13 shows measurements being conducted on the remaining tread depth of the left front tyre of the Insured Vehicle. The remaining tread depth was measured to be approximately 2mm.

10. For this particular case, although the remaining tread depth of the left front tyre of the Insured Vehicle was measured to be approximately 2mm at some areas of the tread. This 2mm depth was not throughout at least 75% of the breadth of the tread and round the entire outer circumference of the tyre.

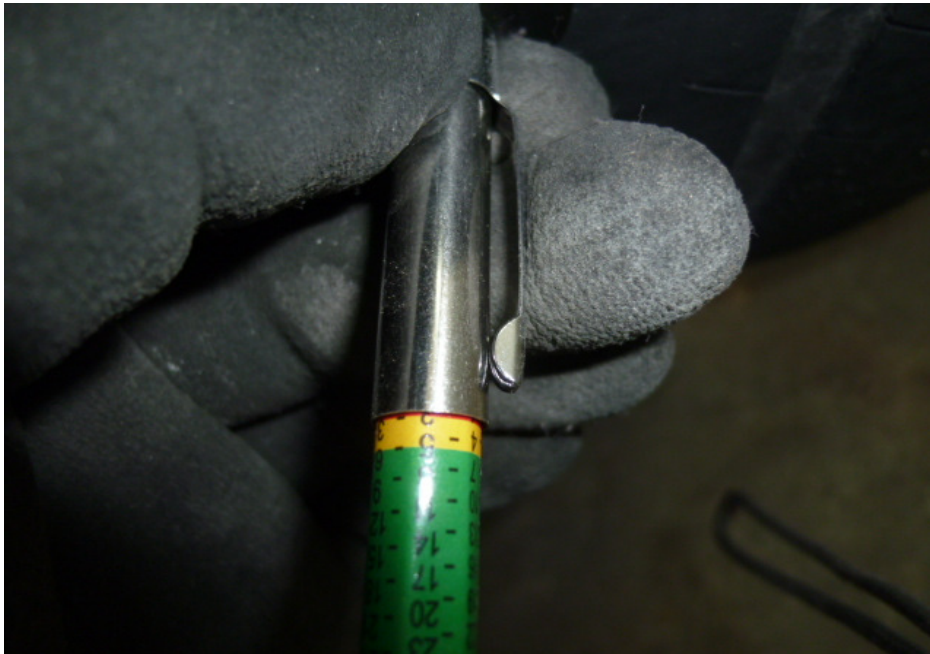
Photo 14 shows measurements being conducted on the remaining tread depth of the left front tyre of the Insured Vehicle. The remaining tread depth at the outer side of the left front tyre was measured to be approximately 2mm.

9. In general, having physically inspected the Insured Vehicle, we are of the view that the condition of the 4 tyres of the Insured Vehicle was still within the requirements of SECTION 109(f) CAP 276 of THE MOTOR VEHICLES (CONSTRUCTION AND USE) RULES, 1974, 1978 OF THE ROAD TRAFFIC ACT. Under this section it states that "no person shall use, or cause or permit to be used on a road any motor vehicle or trailer, a wheel of which is fitted with a pneumatic tyre, where the tyre is fitted to the wheel of any other motor vehicle or any trailer, the tread pattern (excluding any tie-bar) of the tyre does not have a depth of at least one millimetre throughout at least 75% of the breadth of the tread and round the entire outer circumference of the tyre.
