Your Ref: Rolls Royce Cullinan
(chassis number SCATF2209NU211273)
Our Ref : CI/TP23000411/D

**INSPECTION REPORT OF AN UNREGISTERED ROLLS ROYCE CULLINAN
MOTOR CAR WITH CHASSIS NUMBER SCATF2209NU211273**

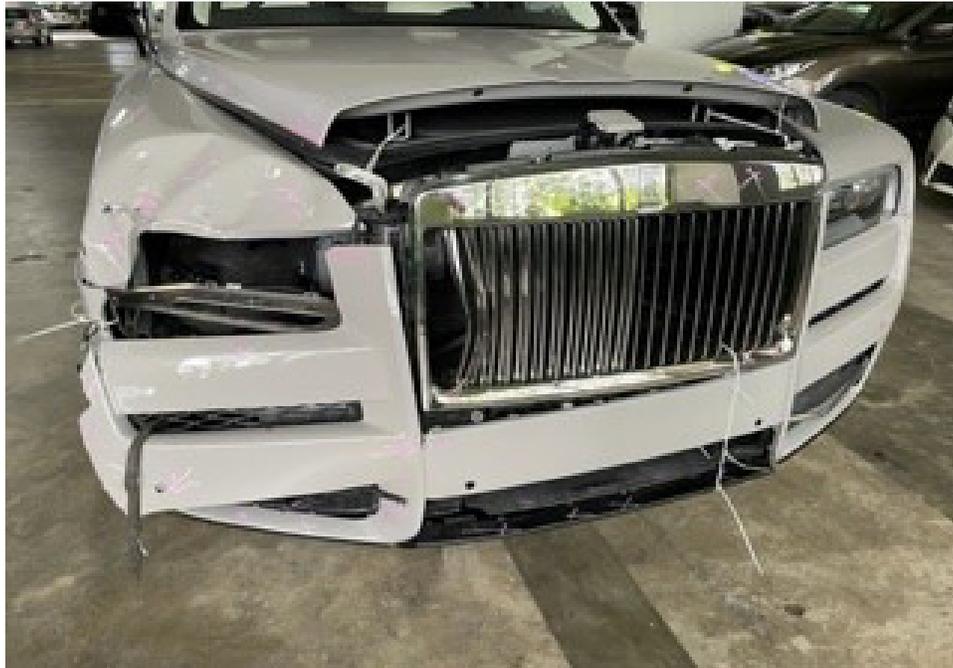
Photo 1 shows the front right body of the Motor Car (photograph provided to me). The photographs provided to me had showed damage to the front right portion of the Motor Car. The front bumper, front bumper lower cover, front bumper right lower grille, front bumper right lower grille garnish, front bumper sensors, front bumper top cover, front grille and front right headlamp were amongst the body parts that were observed to have been damaged.

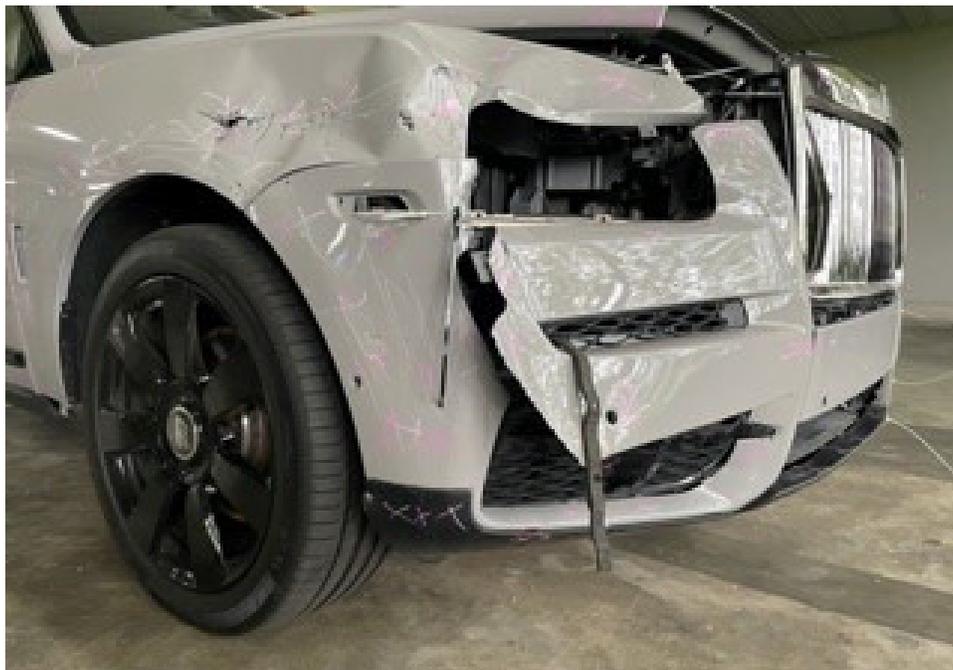
Photo 2 shows another view of the damage at the front right portion of the Motor Car (photograph provided to me). The front bumper, front bumper lower cover, front bumper right lower grille, front bumper right lower grille garnish, front bumper right signal lamp, front right headlamp and front right fender were amongst the body parts that were observed to have been damaged.

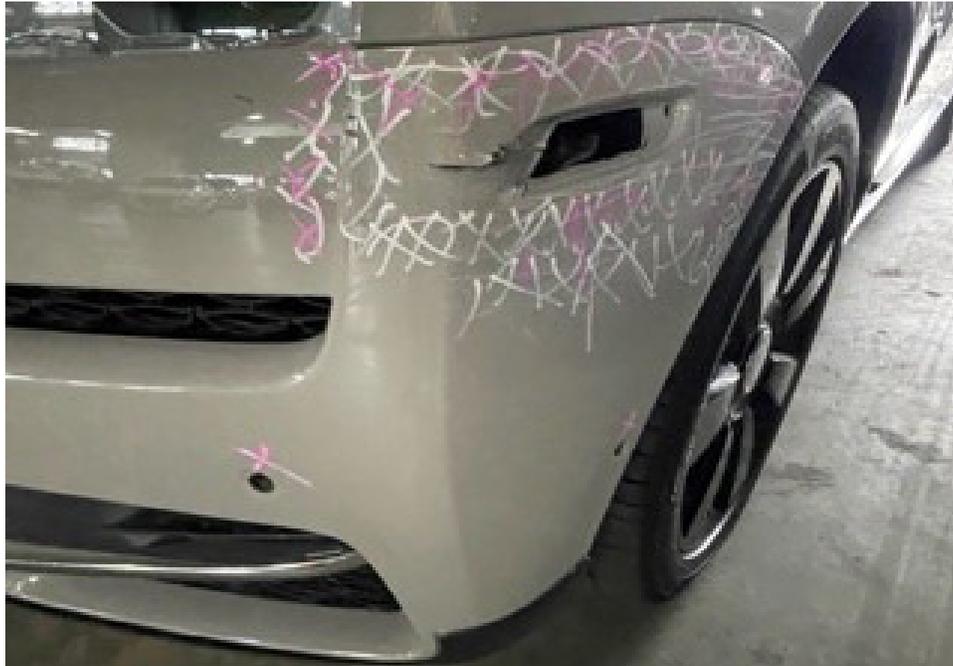
Photo 3 shows the Motor Car's damaged front bumper, front bumper left signal lamp and front bumper left sensor (photograph provided to me).

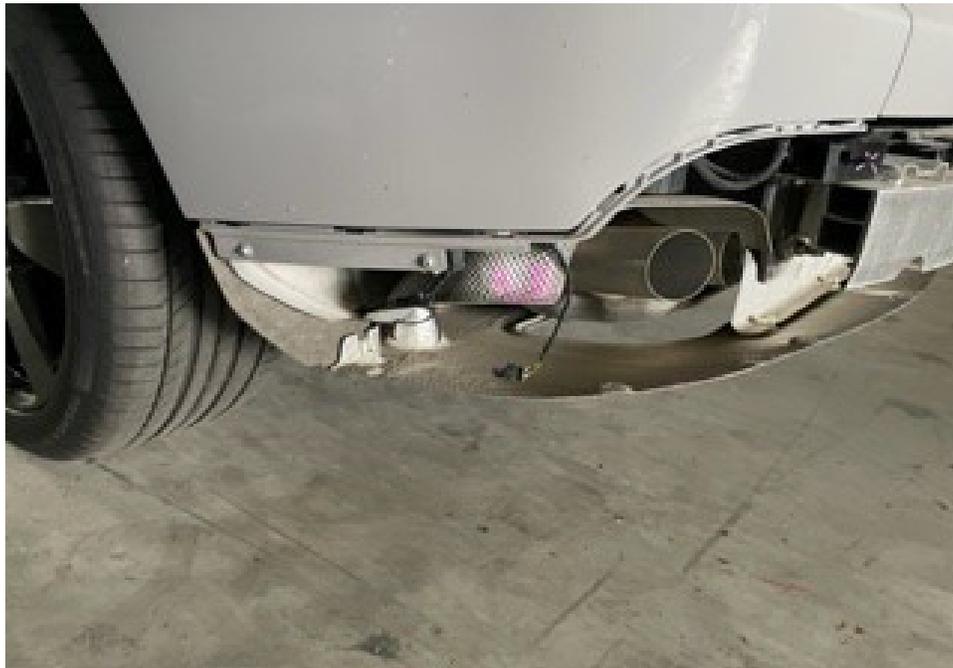
Photo 4 shows the Motor Car's rear bumper and all its related parts and attachments like the rear bumper sensors, rear left exhaust garnish and tow hook cover amongst others missing/dislodged/damaged (photograph provided to me).

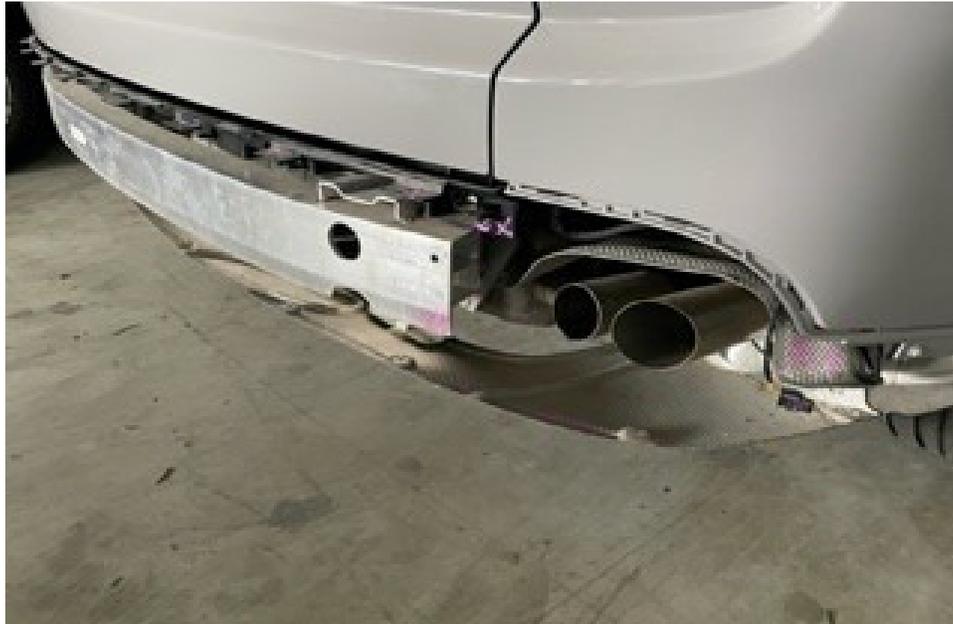
Photo 5 shows another view of the Motor Car's rear bumper and all its related parts and attachments like the rear bumper sensors, rear right exhaust garnish and tow hook cover amongst others missing/dislodged/damaged (photograph provided to me).

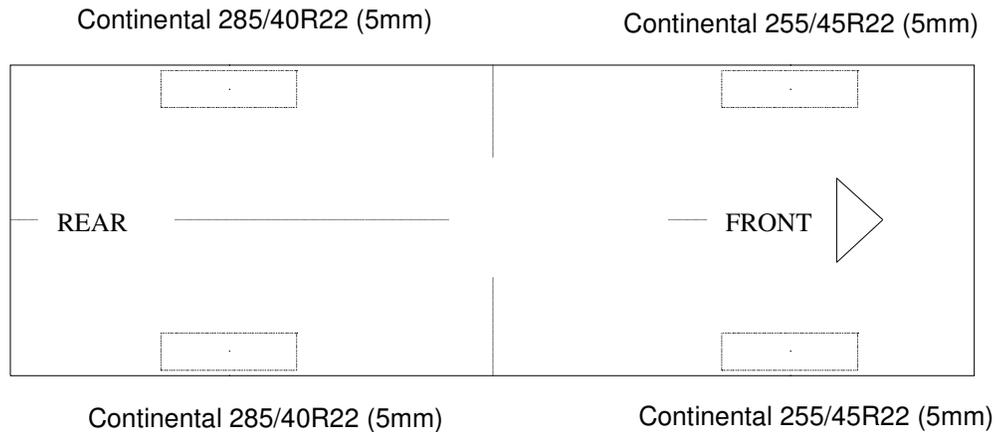
8. The Motor Car was fitted with 22inch sport wheel rims that were wrapped with tyres that were observed to be of serviceable condition. The tyres were also sufficiently inflated for vehicular operation. The tyre brand, tyre size and approximate remaining tread depth of the 4 tyres of the Motor Car were recorded as follows: -

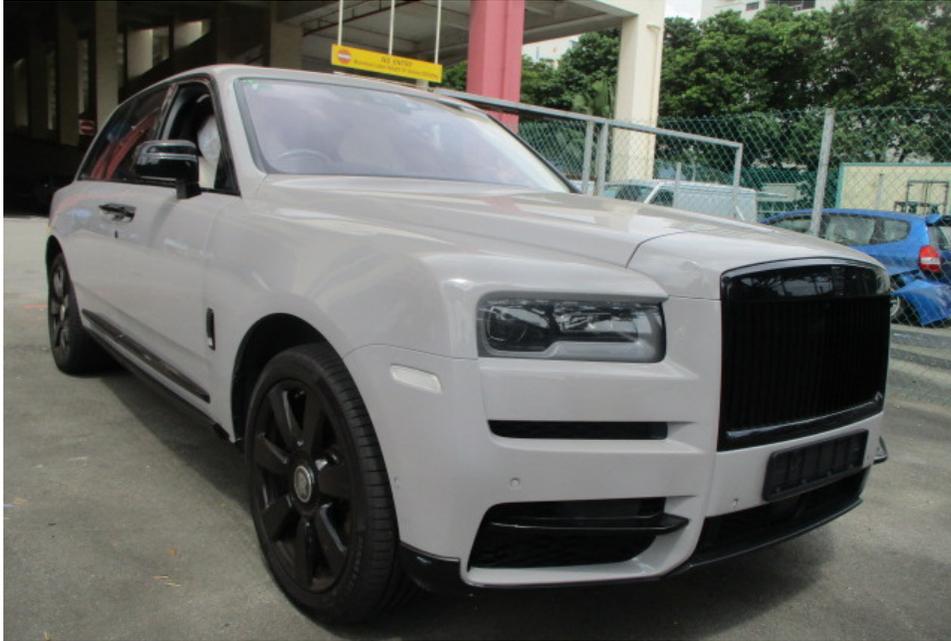
Photo 6 shows a general view of the front right body of the Motor Car at the time of my inspection. The Motor Car was observed to be in a relatively good general condition with no loose exterior fittings observed. The body parts at the front right portion of the Motor Car were visually examined and it was observed that the repair/restoration works carried out to the damaged area of the Motor Car (refer to photograph 1 & 2 above) were reasonably adequate and in order.

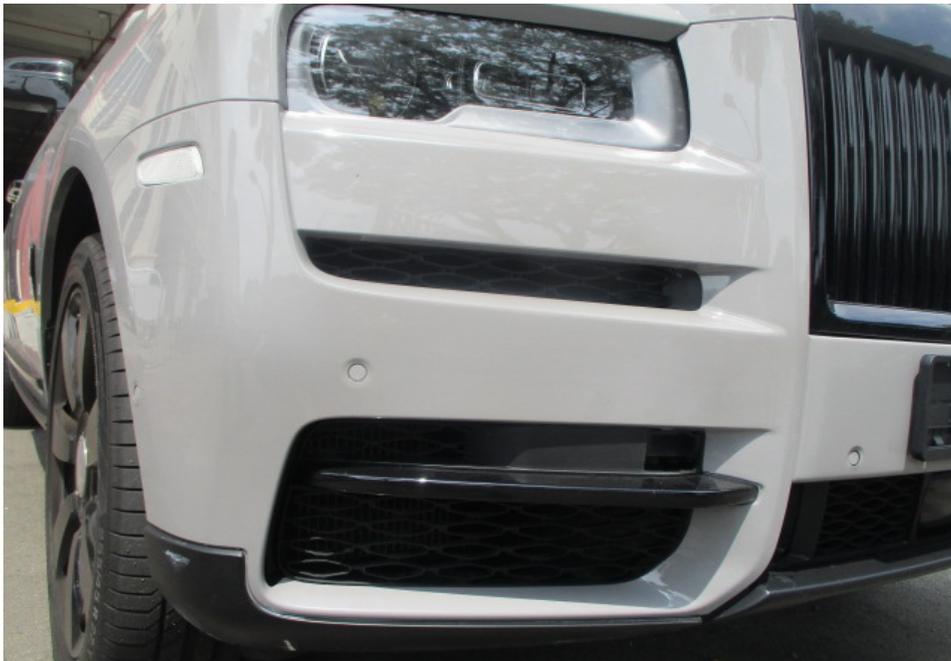
Photo 7 shows a closer view of the Motor Car's front bumper, front bumper lower cover, front bumper right lower grille, front bumper right lower grille garnish, front bumper sensors and front right headlamp. The body parts at the front right portion of the Motor Car were visually examined and it was observed that the repair/restoration works carried out to the damaged area of the Motor Car (refer to photograph 1 & 2 above) were reasonably adequate and in order.

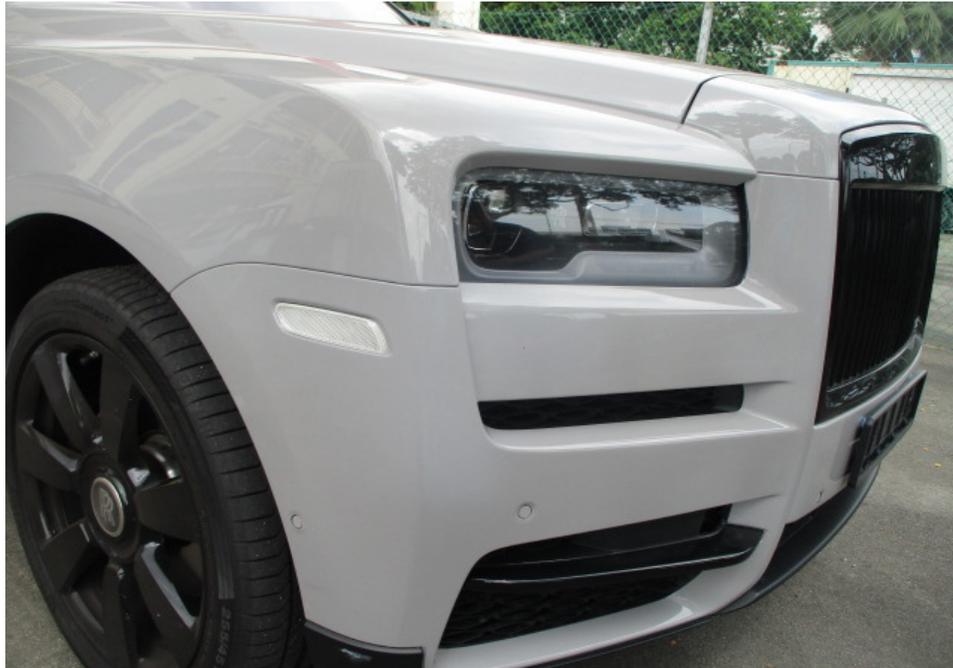
Photo 8 shows a closer view of the Motor Car's front bumper, front bumper right lower grille, front bumper right lower grille garnish, front bumper right signal lamp, front right headlamp and front right fender. The body parts at the front right portion of the Motor Car were visually examined and it was observed that the repair/restoration works carried out to the damaged area of the Motor Car (refer to photograph 1 & 2 above) were reasonably adequate and in order.

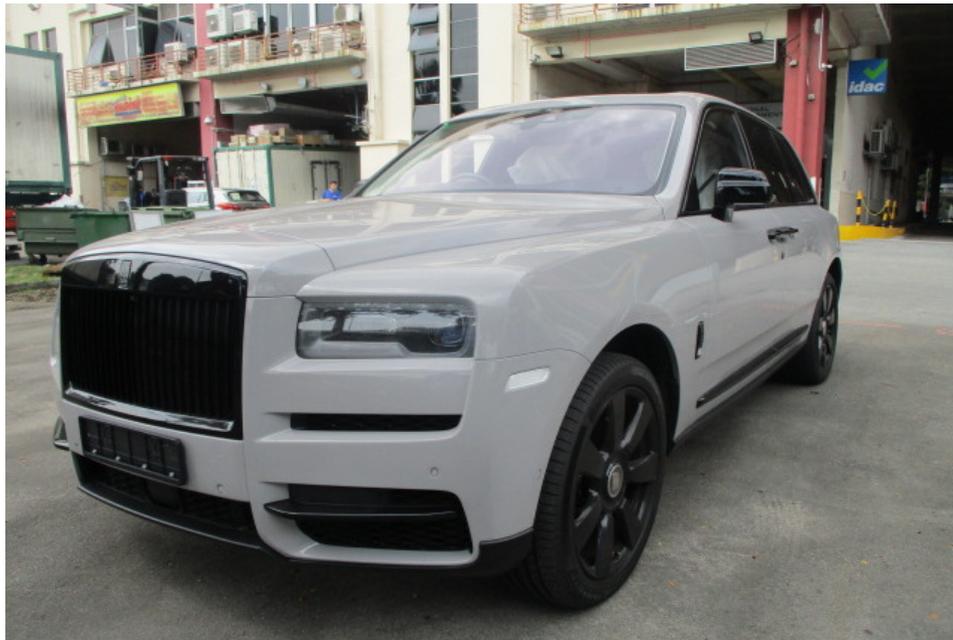
Photo 9 shows a general view of the front left body of the Motor Car at the time of my inspection. The Motor Car was observed to be in a relatively good general condition with no loose exterior fittings observed. The body parts at the front left portion of the Motor Car were visually examined and it was observed that the repair/restoration works carried out to the damaged area of the Motor Car (refer to photograph 3 above) were reasonably adequate and in order.

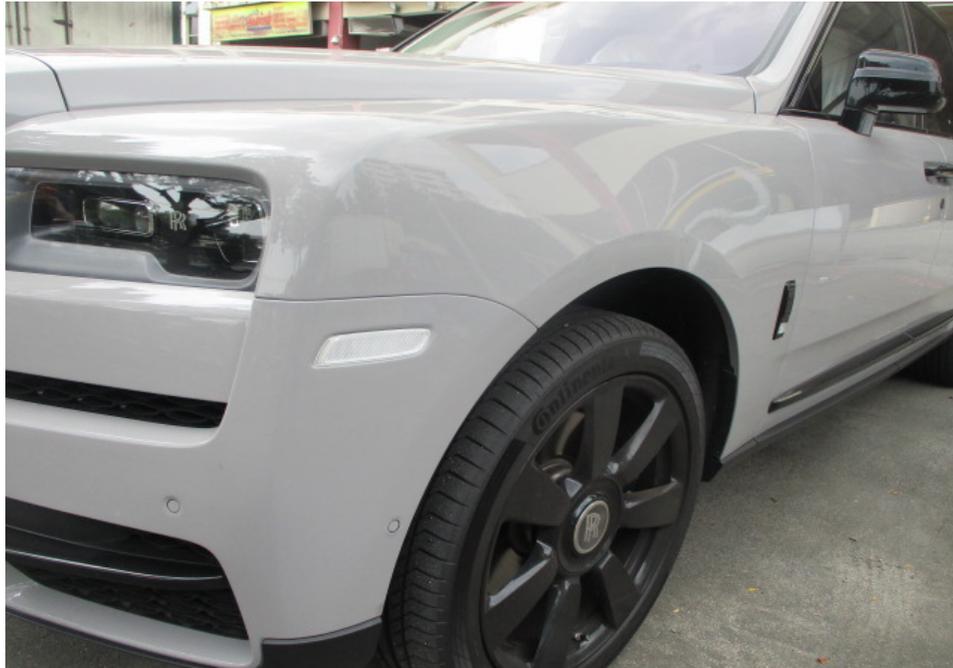
Photo 10 shows a closer view of the Motor Car's front bumper, front bumper left signal lamp, front bumper left sensor, front left headlamp and front left fender. The body parts at the front left portion of the Motor Car were visually examined and it was observed that the repair/restoration works carried out to the damaged area of the Motor Car (refer to photograph 3 above) were reasonably adequate and in order.

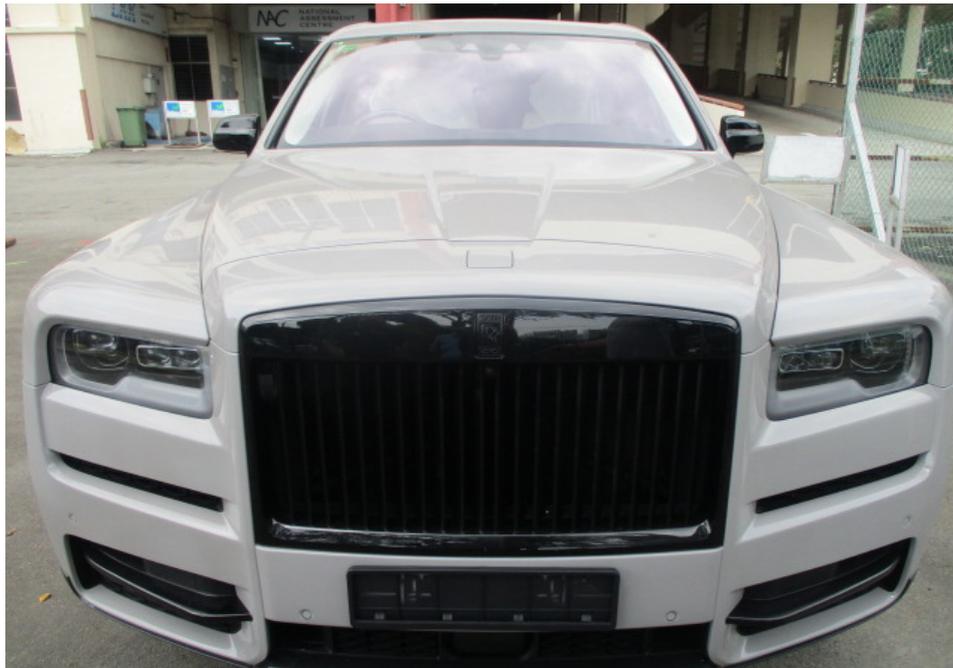
Photo 11 shows a closer view of the Motor Car's front bumper top cover and front grille. The body parts at the frontal portion of the Motor Car were visually examined and it was observed that the repair/restoration works carried out to the damaged area of the Motor Car (refer to photograph 1 - 3 above) were reasonably adequate and in order.

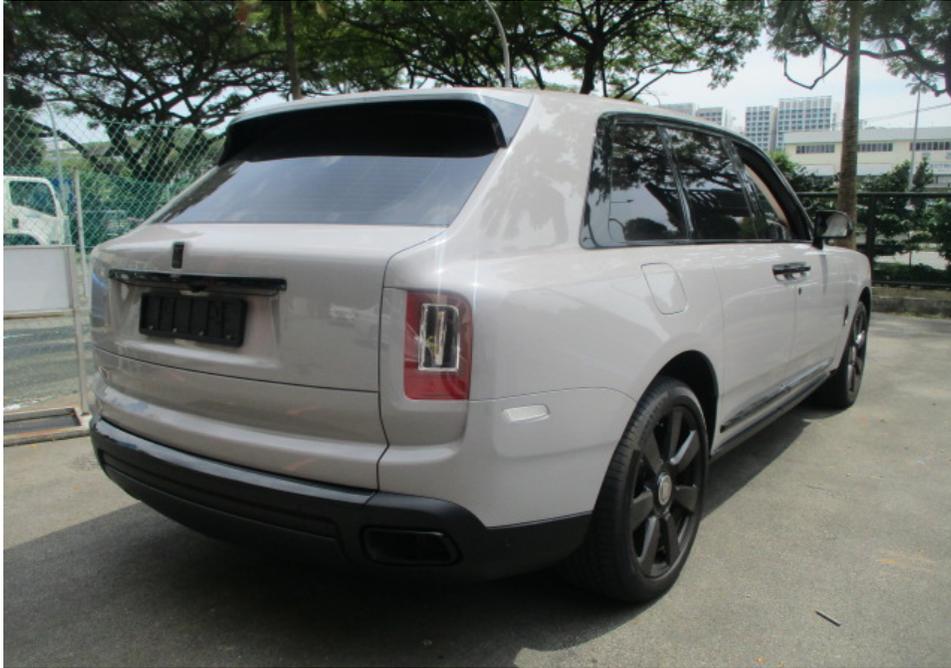
Photo 12 shows a general view of the rear right body of the Motor Car at the time of my inspection. The Motor Car was observed to be in a relatively good general condition with no loose exterior fittings observed. The body parts at the rear portion of the Motor Car were visually examined and it was observed that the repair/restoration works carried out to the damaged area of the Motor Car (refer to photograph 4 & 5 above) were reasonably adequate and in order.

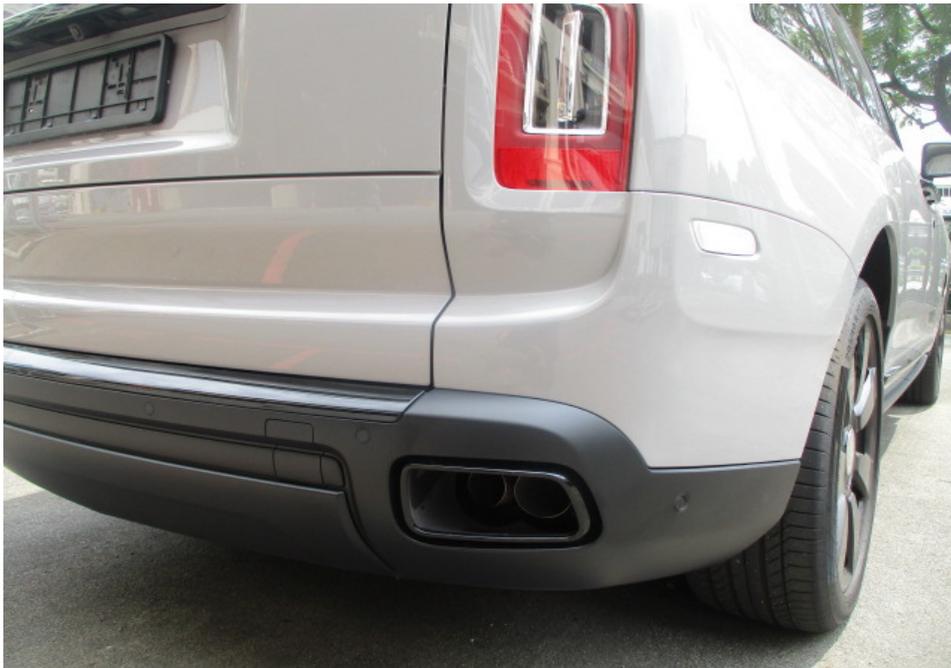
Photo 13 shows a closer view of the Motor Car's rear bumper, rear bumper sensors, rear right exhaust garnish and tow hook cover. The body parts at the rear portion of the Motor Car were visually examined and it was observed that the repair/restoration works carried out to the damaged area of the Motor Car (refer to photograph 4 & 5 above) were reasonably adequate and in order.

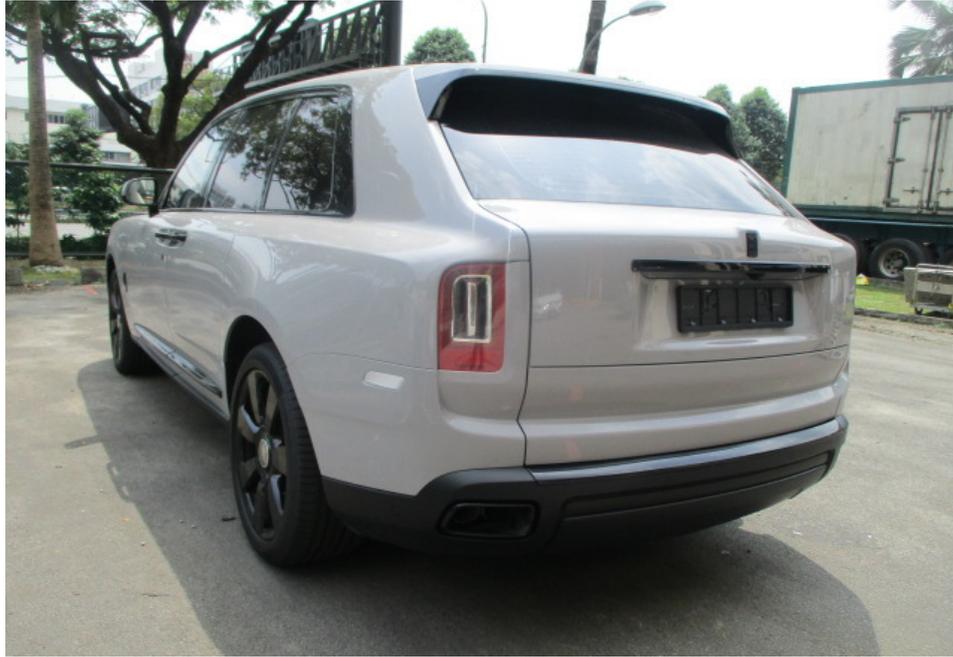
Photo 14 shows a general view of the rear left body of the Motor Car at the time of my inspection. The Motor Car was observed to be in a relatively good general condition with no loose exterior fittings observed. The body parts at the rear portion of the Motor Car were visually examined and it was observed that the repair/restoration works carried out to the damaged area of the Motor Car (refer to photograph 4 & 5 above) were reasonably adequate and in order.

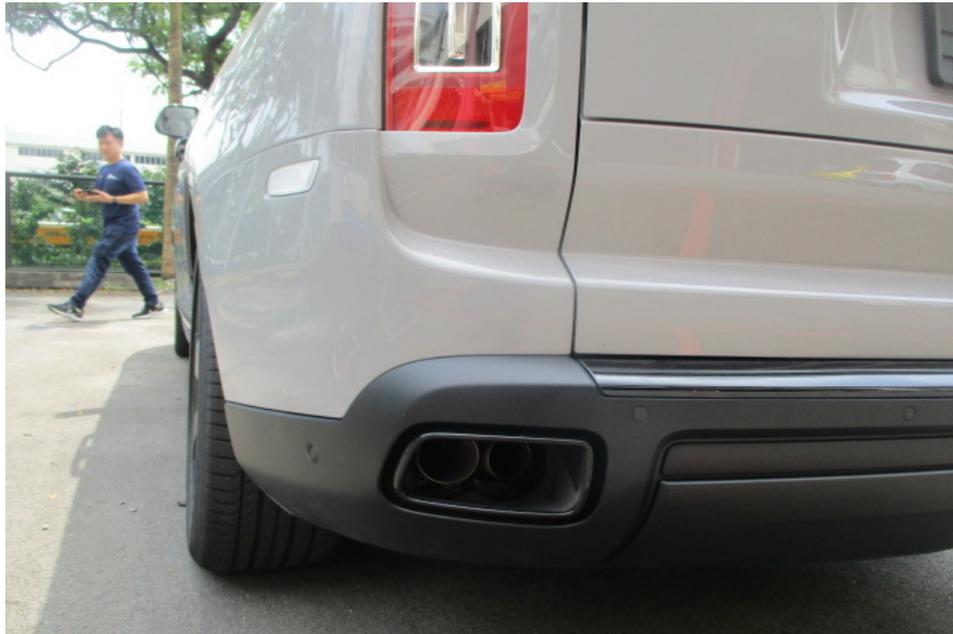
Photo 15 shows a closer view of the Motor Car's rear bumper, rear bumper sensors and rear left exhaust garnish. The body parts at the rear portion of the Motor Car were visually examined and it was observed that the repair/restoration works carried out to the damaged area of the Motor Car (refer to photograph 4 & 5 above) were reasonably adequate and in order.

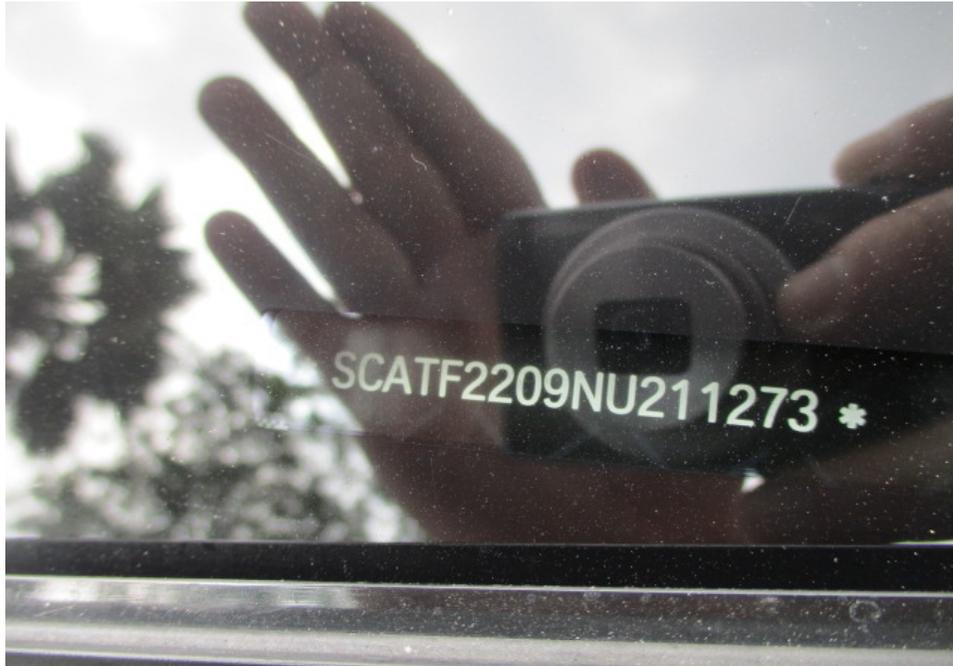
Photo 16 shows the chassis number of the Motor Car. The chassis number recorded was SCATF2209NU211273.

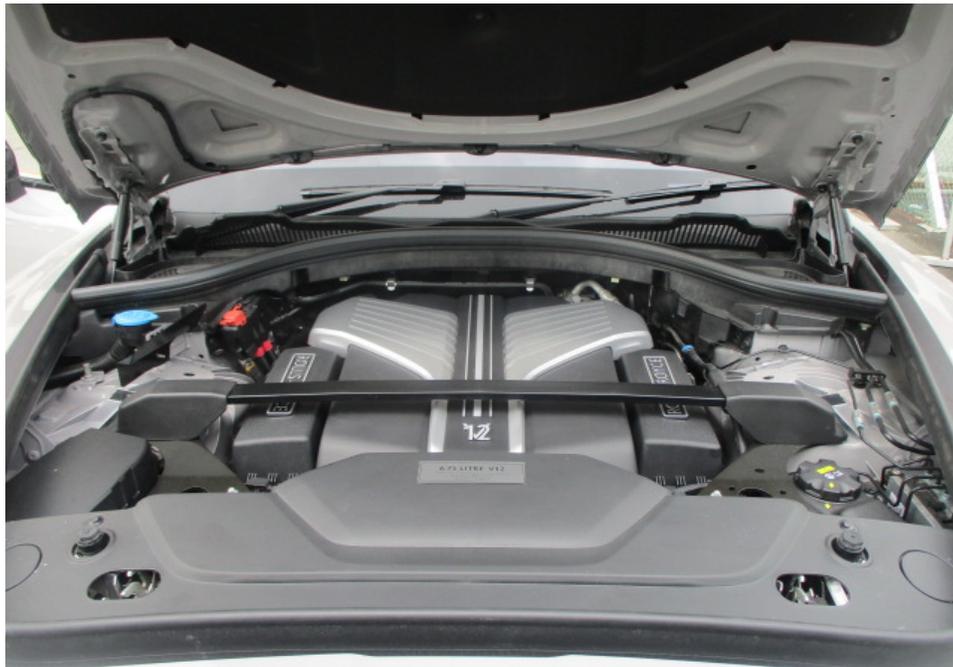
Photo 17 shows a general view of the Motor Car's engine compartment at the time of my inspection. The various parts and components inside the engine compartment were all observed to be intact and properly fitted. There was also no sign(s) or indication(s) of fluid leak and/or fluid stain found inside the engine compartment.

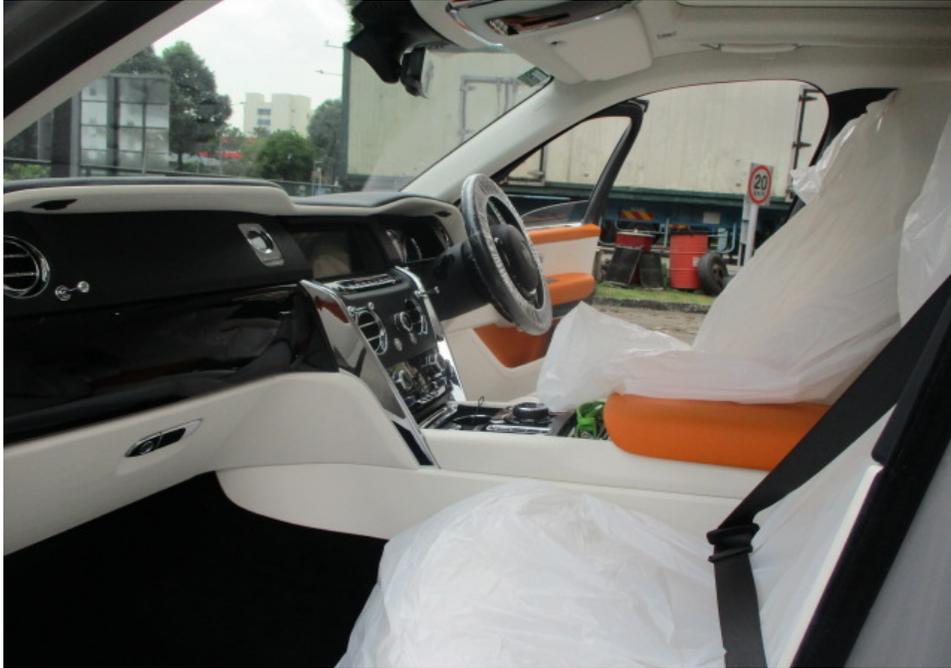
Photo 18 shows the interior compartment of the Motor Car at the time of my inspection. The various parts and components, trims, carpet, and upholstery inside the interior compartment were all observed to be intact and properly fitted.

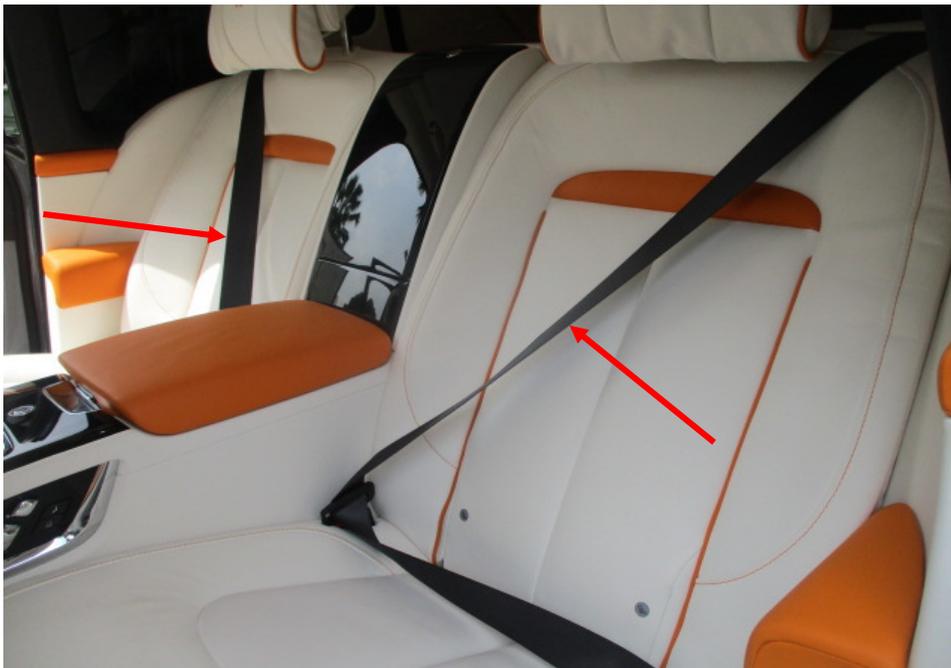
Photo 19 shows the rear seats of the Motor Car. All the seats of the Motor Car were secured via seat rails to the floorboard. They were also fitted with a retractable seat belt reel and a pre-tensioner. The seat belts (arrowed) were tested and were able to be fastened into the respective pre-tensions that were fitted on the side of each individual seat.

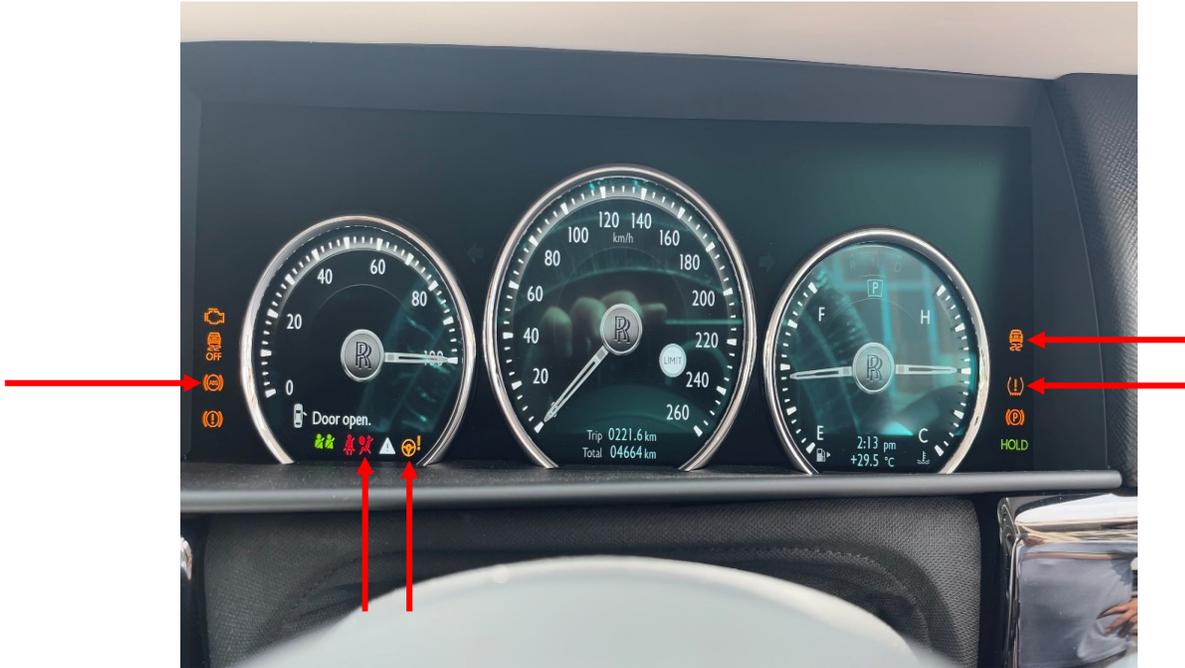
Photo 20 shows the warning lights for the various electronic safety features appearing on the instrument panel of the Motor Car during its self-test when the engine is cranked, in particular the ABS, SRS, EPS, TPM and TCS lights (arrowed).

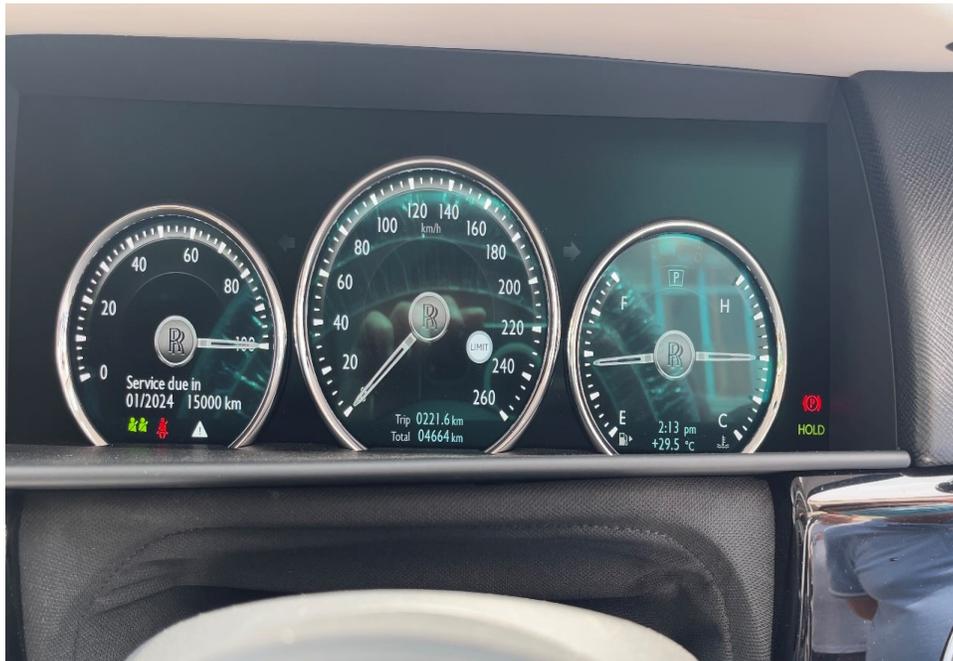
Photo 21 shows the respective warning lights no longer illuminated, indicating that there is no fault detected to the ABS, SRS, EPS, TPM and TCS systems of the Motor Car during the self-test. These electronic systems were hence in working condition at the time of my inspection.

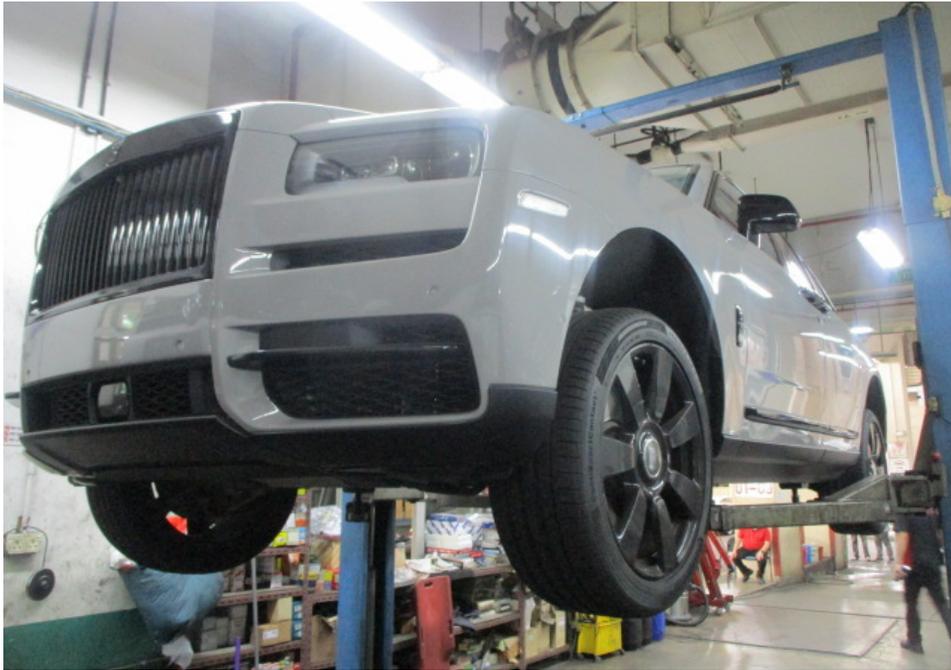
Photo 22 shows the Motor Car hoisted up for checks on its undercarriage. There was no sign(s) or indication(s) of fluid leakage and/or fluid stain(s) on the underside of the Motor Car. The undercarriage components of the Motor Car were also all observed to be intact and secured in an appropriate manner.

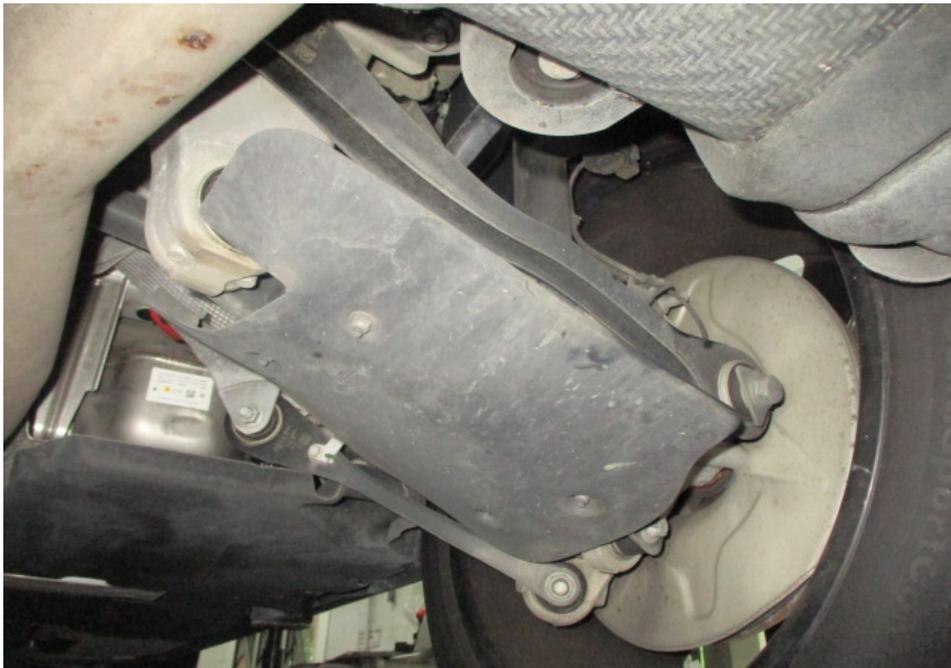
Photo 23 shows a general view of the control arms and linkages at the rear right wheel of the Motor Car. I did not observe any fluid leak and/or fluid stain on the underside of the Motor Car. All of the Motor Car's undercarriage components were observed to be intact and secured in an appropriate manner.

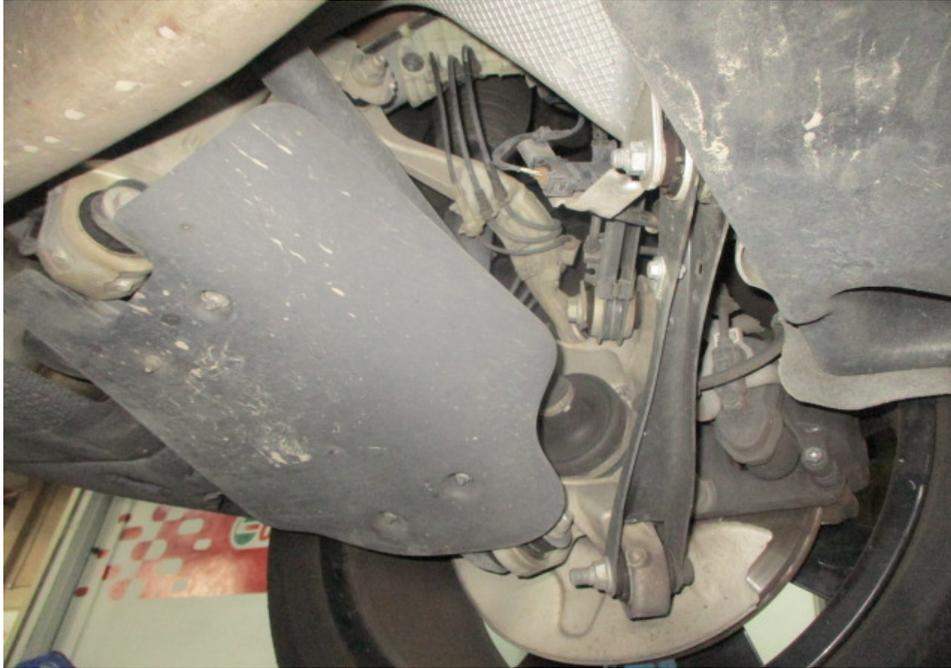
Photo 24 shows a general view of the control arms and linkages at the rear left wheel of the Motor Car. I did not observe any fluid leak and/or fluid stain on the underside of the Motor Car. All of the Motor Car's undercarriage components were observed to be intact and secured in an appropriate manner.

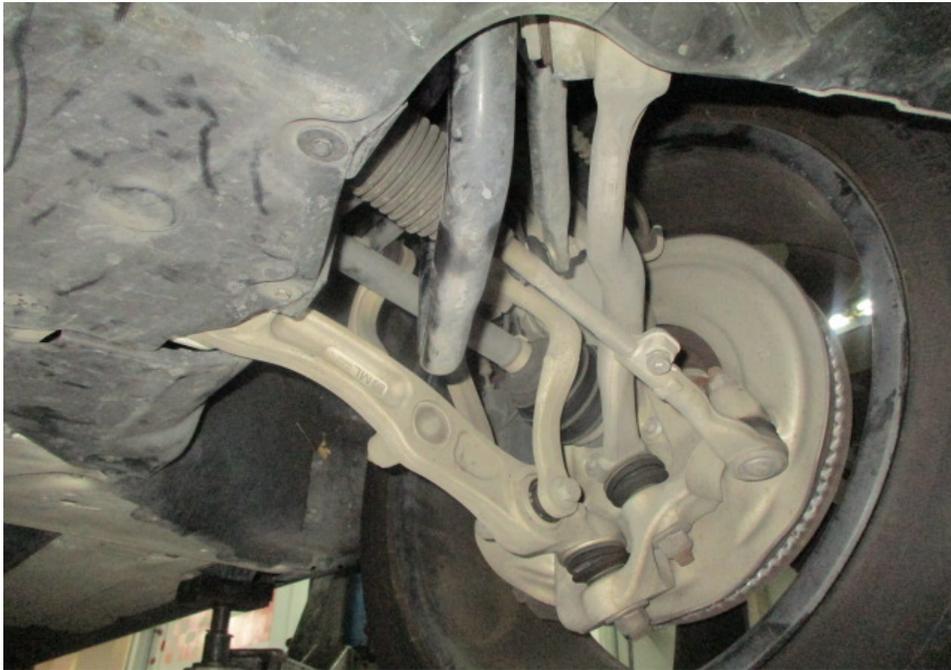
Photo 25 shows the various undercarriage components at the front left wheel of the Motor Car. The mechanical components, control arms and linkages were all found to be intact and secured in an appropriate manner.

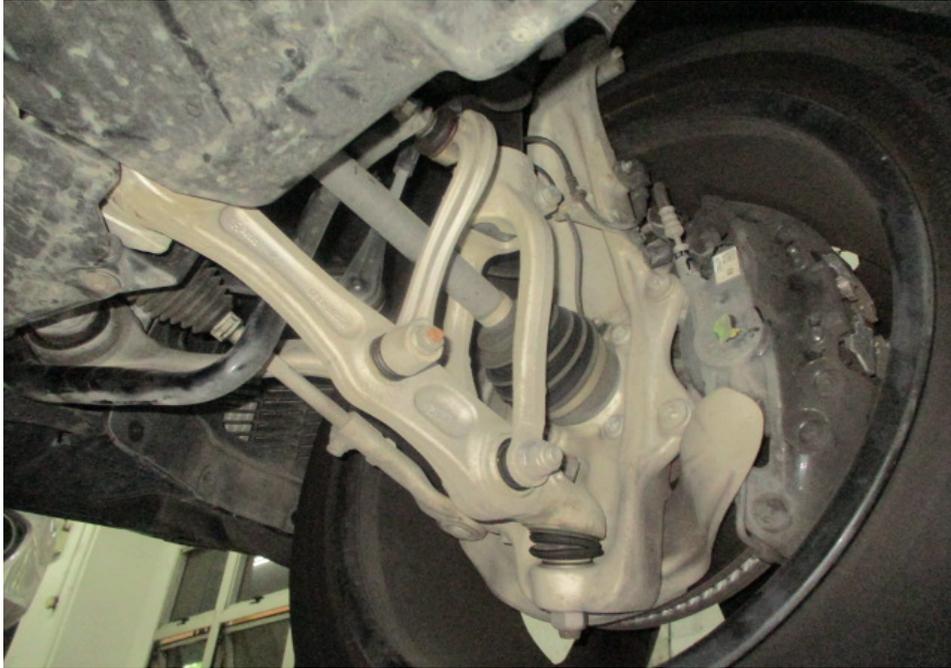
Photo 26 shows the various undercarriage components at the front right wheel of the Motor Car. The mechanical components, control arms and linkages were all found to be intact and secured in an appropriate manner. I also did not observe any fluid leak and/or fluid stain on the underside of the Motor Car.

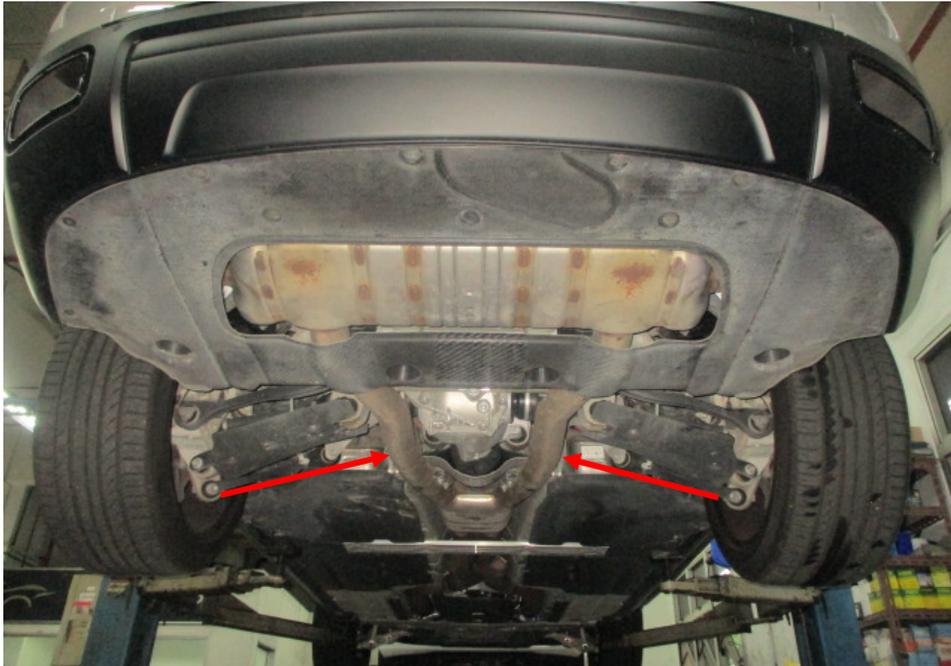
Photo 27 shows the rear section of the Motor Car's exhaust system. My examination of the Motor Car's exhaust system revealed no sign(s) or indication(s) of any cut or weld marks along its exhaust pipes (arrowed), on its rear muffler, on its centre resonator boxes and on its catalytic converters.

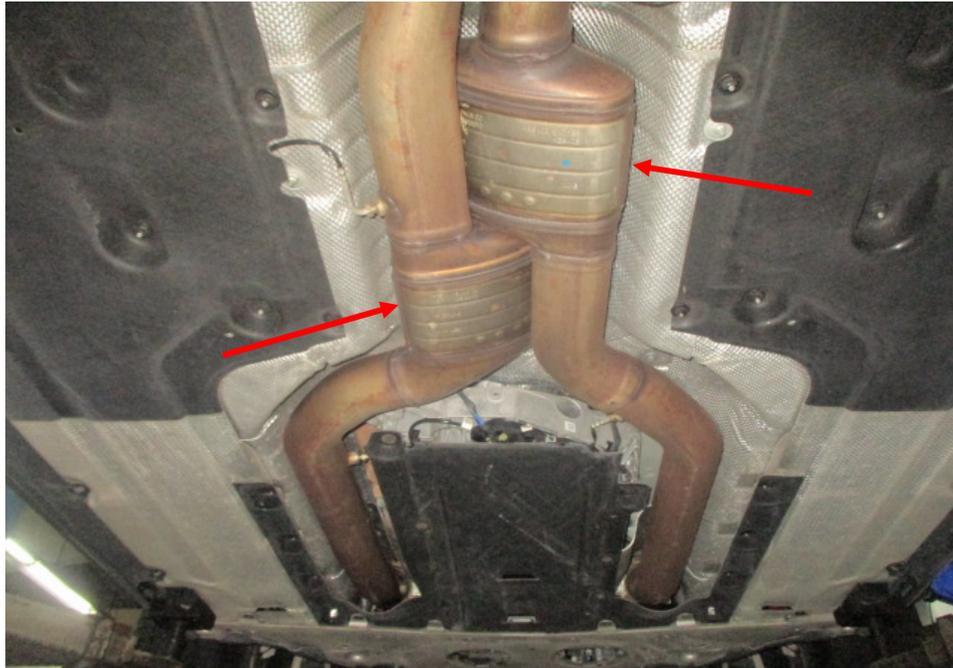
Photo 28 shows the front section of the Motor Car's exhaust system. My examination of the Motor Car's exhaust system revealed no sign(s) or indication(s) of any cut or weld marks along its exhaust pipes, on its rear muffler, on its centre resonator boxes (arrowed) and on its catalytic converters.

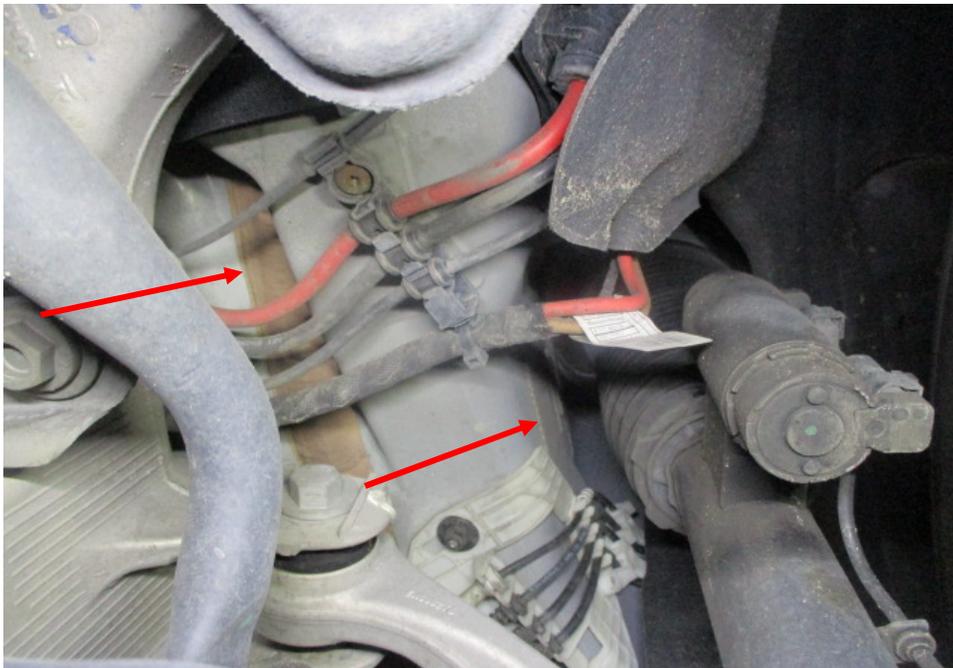
Photo 29 shows the chassis/structural body at the underside rear right of the Motor Car. I did not find any weld marks other than original spot weld marks on the chassis/structural body of the Motor Car. The original factory sealant (arrowed) at the joints along the chassis/structural body was untouched, indicating no work was done on the chassis/structural body of the Motor Car and that the chassis/structural body was originally fitted.

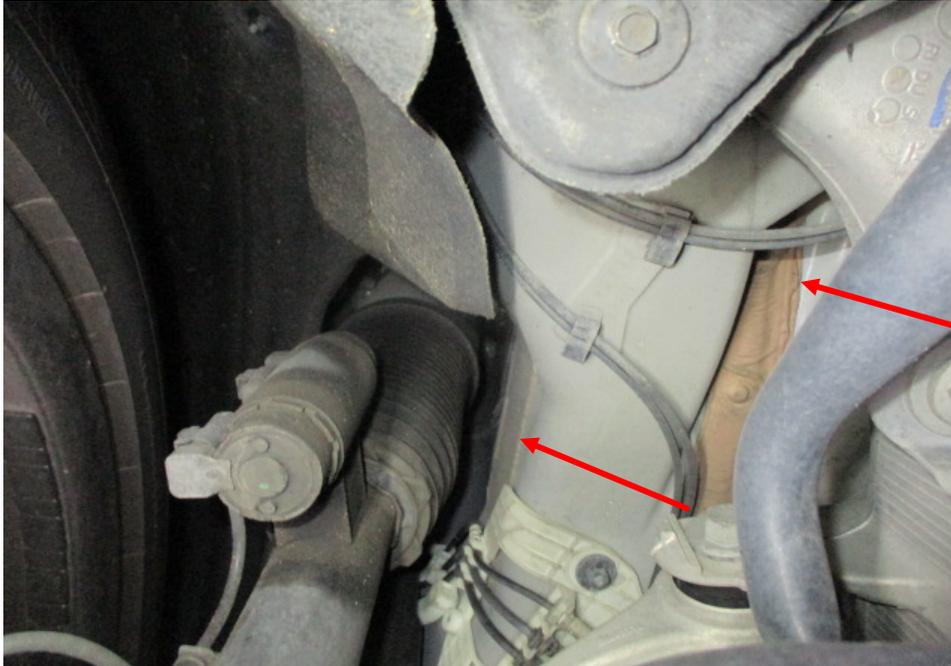
Photo 30 shows the chassis/structural body at the underside rear left of the Motor Car. I did not find any weld marks other than original spot weld marks on the chassis/structural body of the Motor Car. The original factory sealant (arrowed) at the joints along the chassis/structural body was untouched, indicating no work was done on the chassis/structural body of the Motor Car and that the chassis/structural body was originally fitted.
