Your Ref: Rolls Royce Cullinan
(chassis number SCATF2209NU211273)
Our Ref : CI/TP23000411/D

**INSPECTION REPORT OF AN UNREGISTERED ROLLS ROYCE CULLINAN
MOTOR CAR WITH CHASSIS NUMBER SCATF2209NU211273**

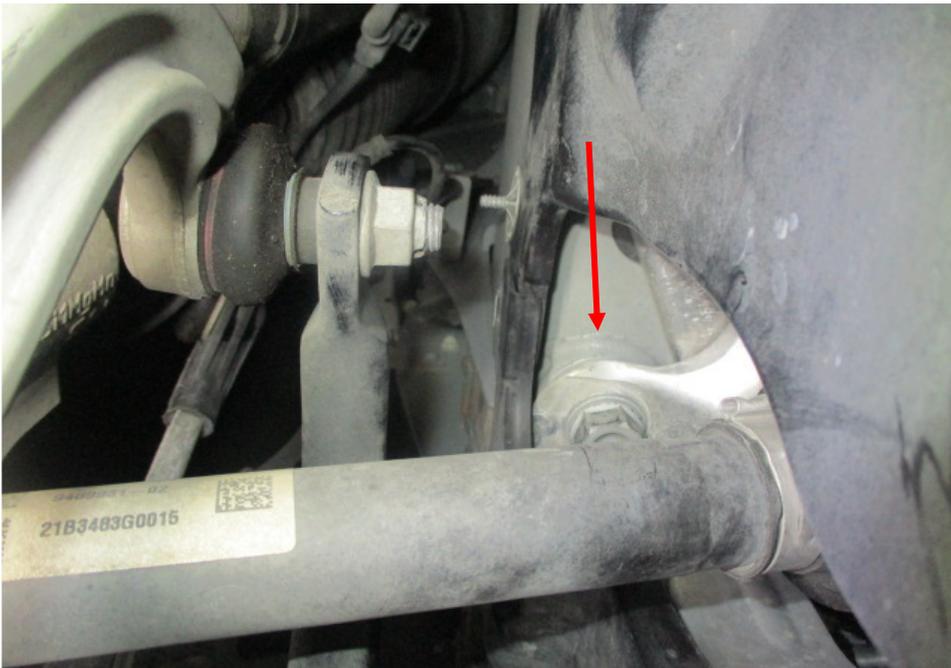
Photo 31 shows the chassis/structural body at the underside front left of the Motor Car. The original factory sealant (arrowed) at the joints along the chassis/structural body was observed to be untouched. In general, I had found no work was carried out on the chassis/structural body of the Motor Car. The chassis/structural body of the Motor Car was originally fitted.

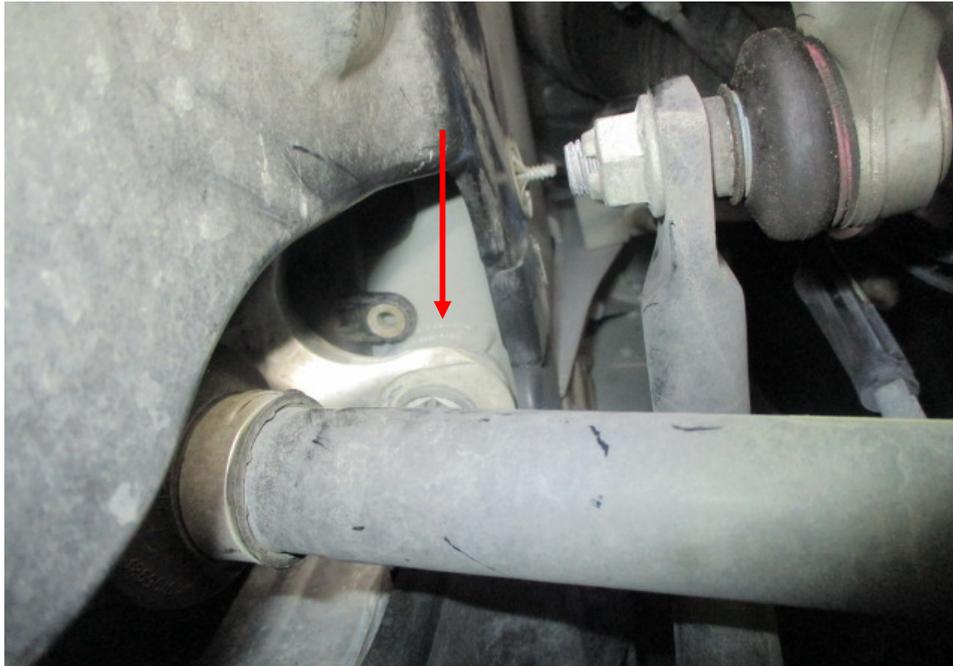
Photo 32 shows the chassis/structural body at the underside front right of the Motor Car. I did not find any weld marks other than original spot weld marks on the chassis/structural body of the Motor Car. The original factory sealant (arrowed) at the joints along the chassis/structural body was untouched, indicating no work was done on the chassis/structural body of the Motor Car and that the chassis/structural body was originally fitted.

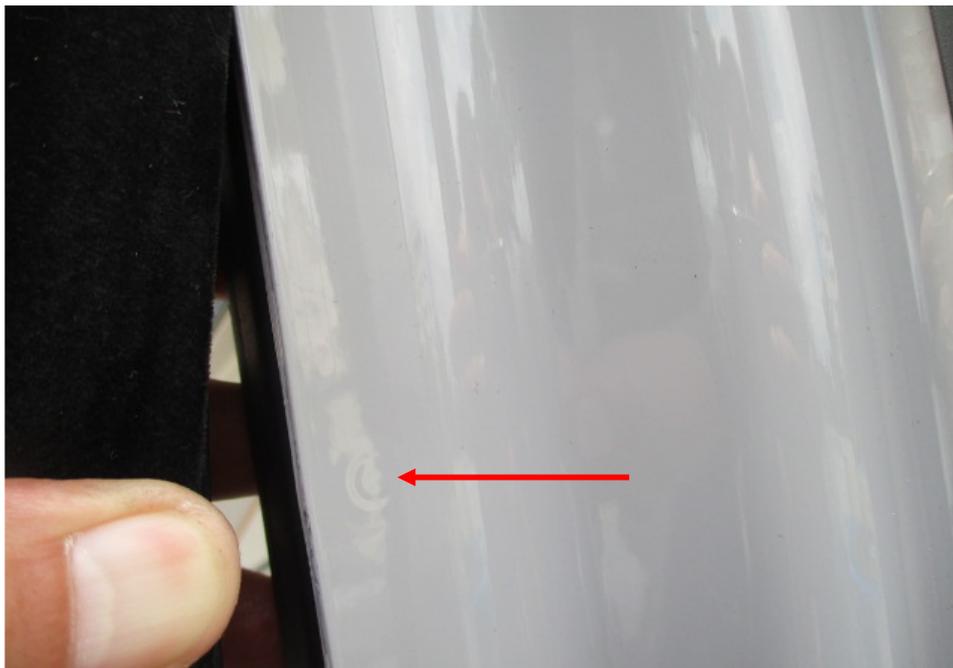
Photo 33 shows the left side rear body panel of the Motor Car. I did not find any weld marks other than original spot weld marks (arrowed) on the left side rear body panel of the Motor Car, which indicates that there was no re-welding works carried out. In general, I had found all the non-detachable body panels of the Motor Car to be originally fitted at the time of my inspection.

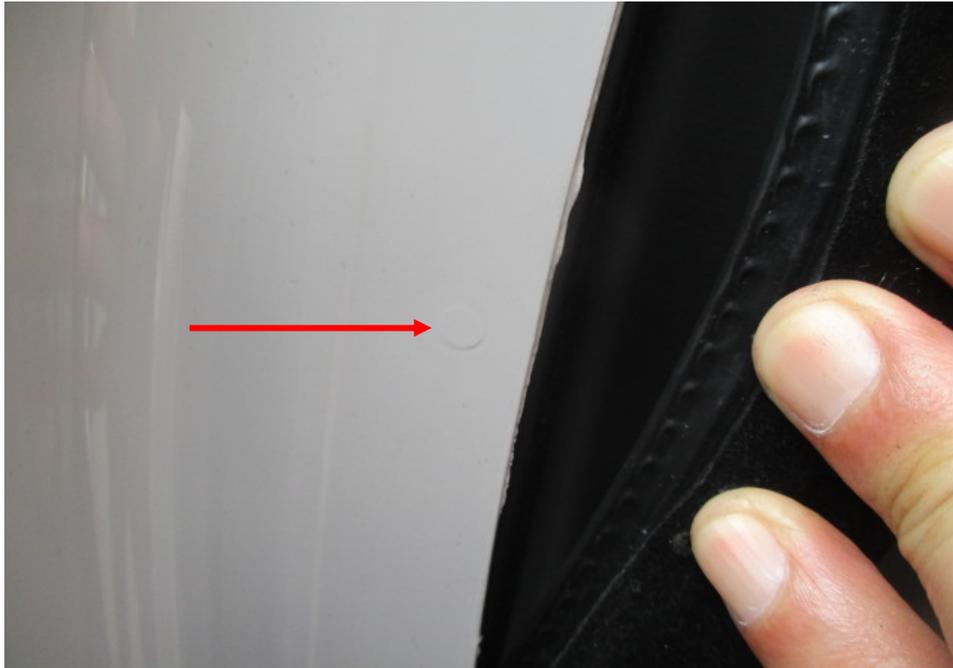
Photo 34 shows the left side "A" pillar of the Motor Car. I did not find any weld marks other than original spot weld marks (arrowed) on the left side "A" pillar of the Motor Car, which indicates that there was no re-welding works carried out. In general, I had found all the non-detachable body panels of the Motor Car to be originally fitted at the time of my inspection.

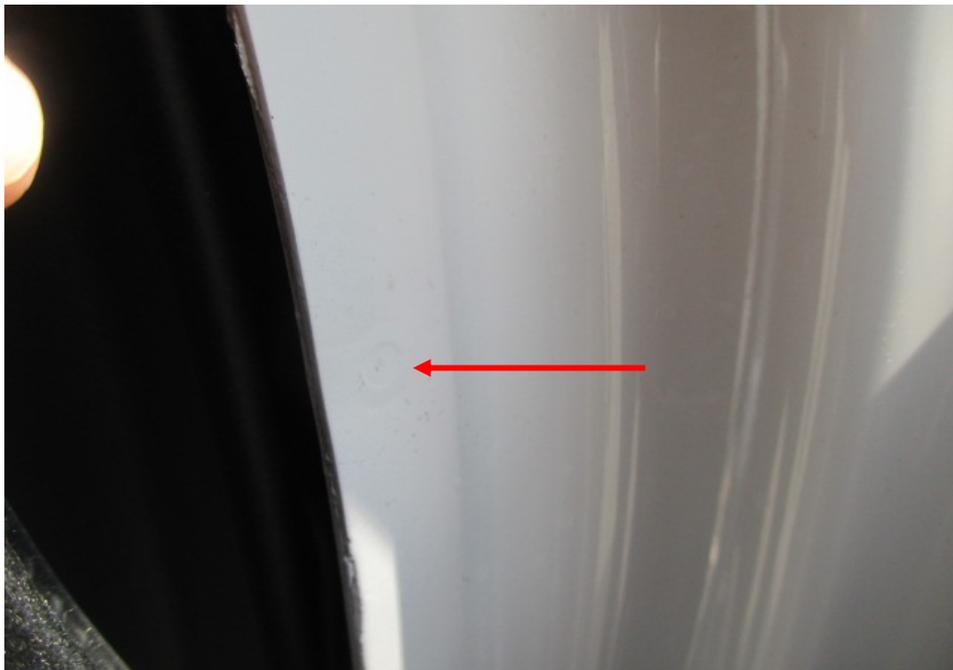
Photo 35 shows the right side "A" pillar of the Motor Car. I did not find any weld marks other than original spot weld marks (arrowed) on the right side "A" pillar of the Motor Car, which indicates that there was no re-welding works carried out. In general, I had found all the non-detachable body panels of the Motor Car to be originally fitted at the time of my inspection.

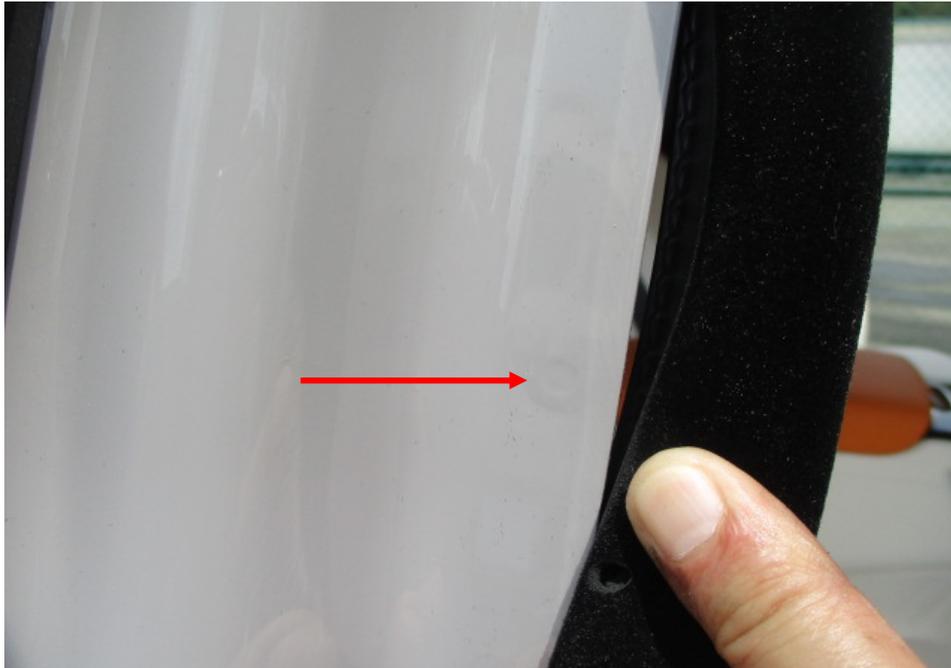
Photo 36 shows the right side rear body panel of the Motor Car. I did not find any weld marks other than original spot weld marks (arrowed) on the right side rear body panel of the Motor Car, which indicates that there was no re-welding works carried out. In general, I had found all the non-detachable body panels of the Motor Car to be originally fitted at the time of my inspection.
