Your Ref: Porsche Macan
(chassis number WP1ZZZ95ZNLB13408)
Our Ref : CI/TP23000466/D

14 January 2023

INSPECTION REPORT OF AN UNREGISTERED PORSCHE MACAN MOTOR CAR WITH CHASSIS NUMBER WP1ZZZ95ZNLB13408

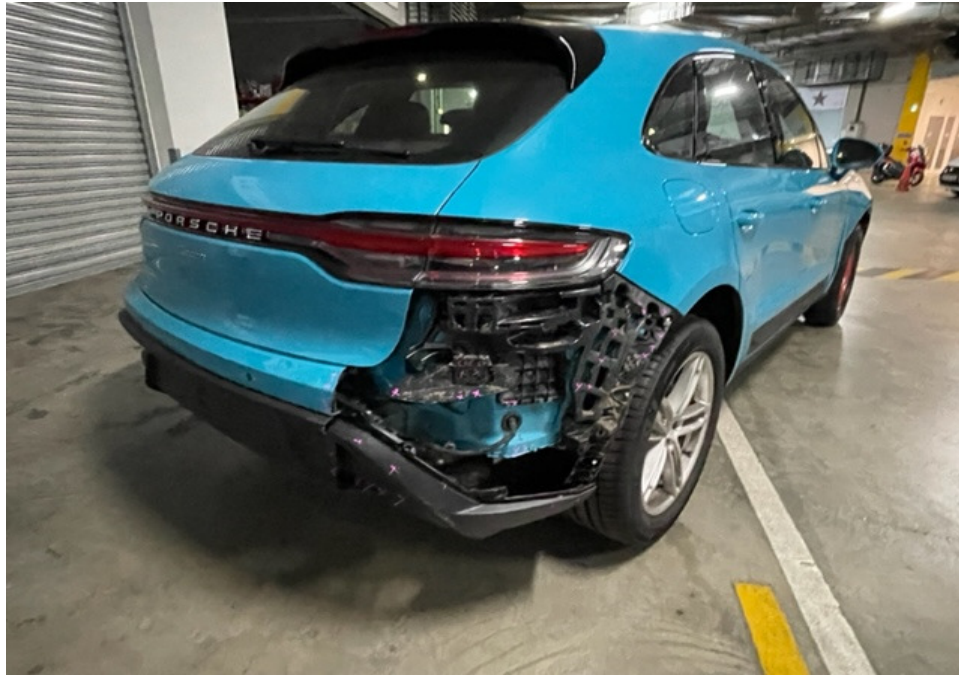
Photo 1 shows the rear right body of the Motor Car (photograph provided to me). The photographs provided to me had showed damage to the rear right portion of the Motor Car. The rear bumper, rear bumper lower cover, rear bumper right sensors, rear bumper right reflector and rear right exhaust tip were amongst the body parts that were observed to have been damaged.

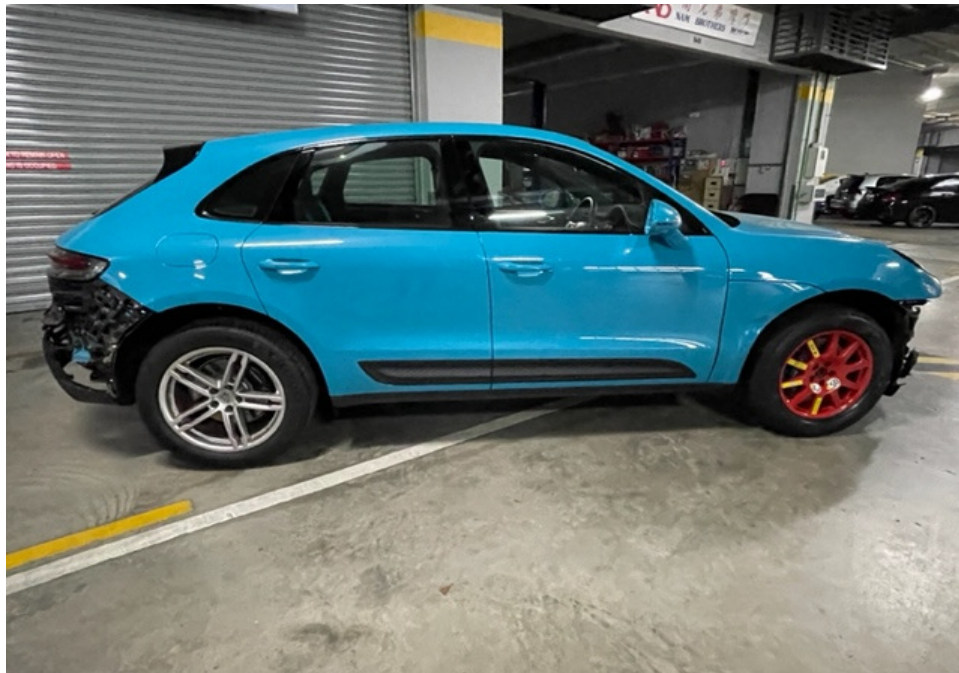
Photo 2 shows the right side body of the Motor Car (photograph provided to me). Apart for the damage at the rear right portion, I had also observed that the Motor Car's front right fender was damaged, and its front right wheel rim was not the original wheel rim. The Motor Car's airbag(s) was not deployed as seen from the photographs that were provided to me.

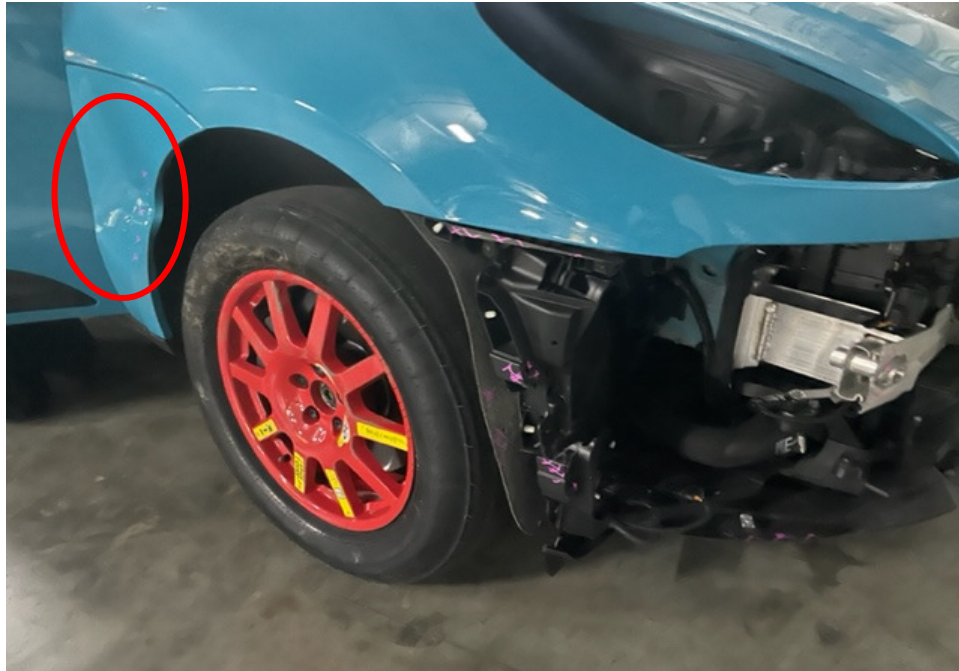
Photo 3 shows the Motor Car's damaged front right fender (circled). The Motor Car's front right wheel rim was observed to be not the original wheel rim (photograph provided to me).

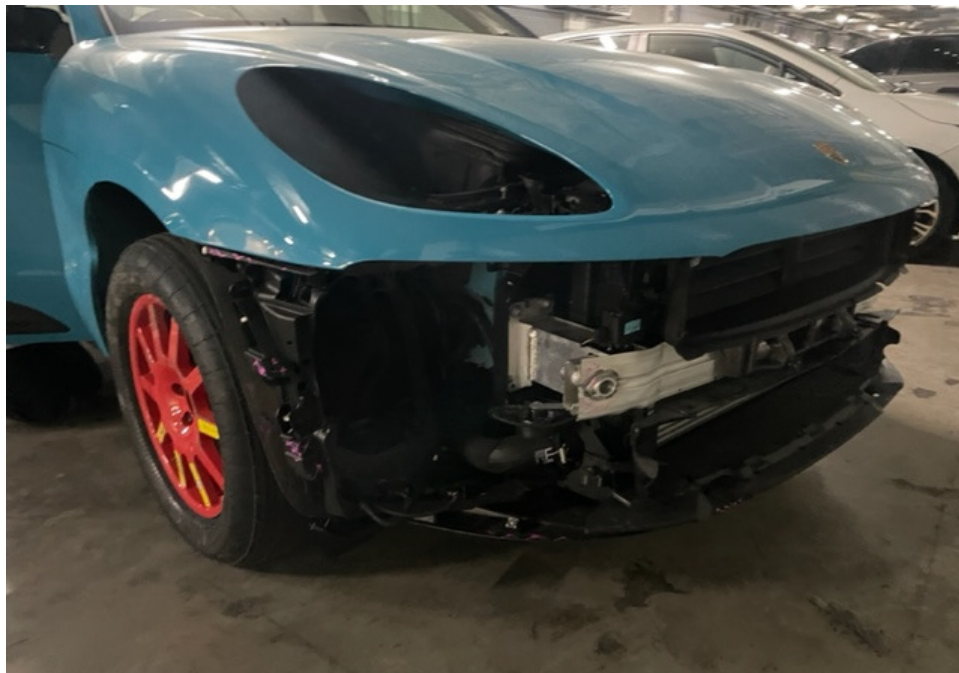
Photo 4 shows the front right body of the Motor Car (photograph provided to me). The Motor Car's front right headlamp, front grille, front bumper and all its related parts and attachments like the front bumper lower cover, front bumper right lower grille, front bumper sensors and front right day light amongst others, were observed to be missing/dislodged/damaged.

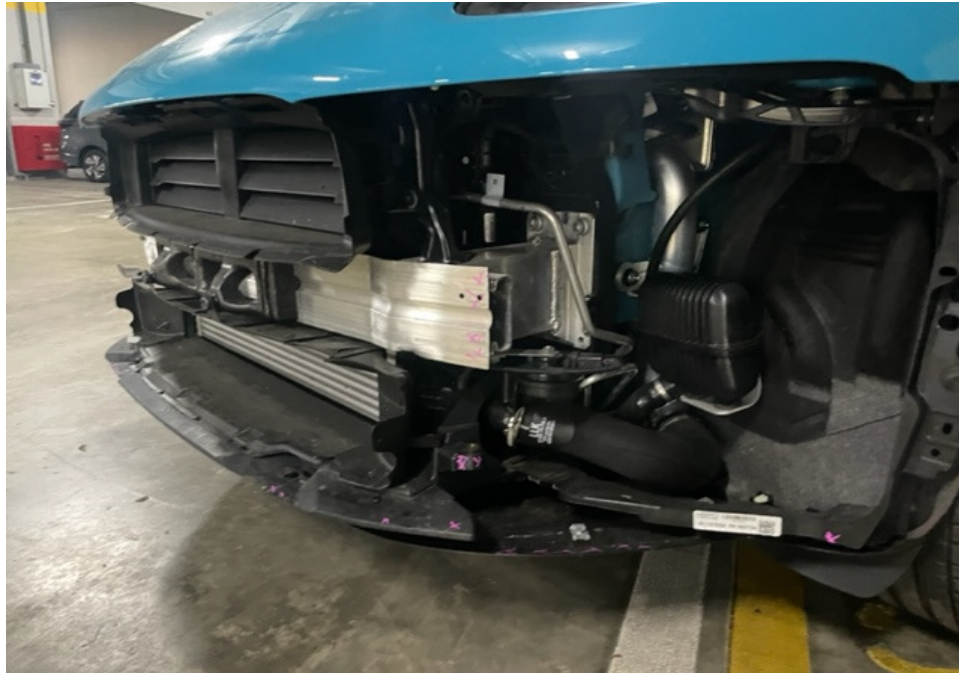
Photo 5 shows another view of the Motor Car's front bumper and all its related parts and attachments like the front bumper lower cover, front bumper left lower grille, front bumper sensors and front left day light amongst other, missing/dislodged/damaged. (photograph provided to me).

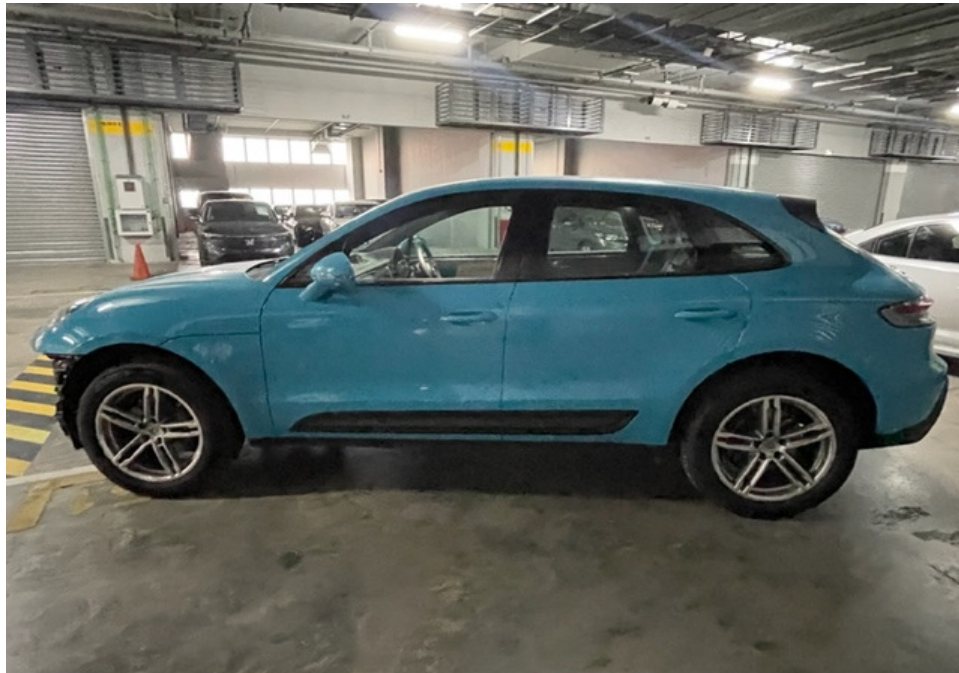
Photo 6 shows the left side body of the Motor Car (photograph provided to me). No physical damage was observed to the left side portion of the Motor Car. The Motor Car's airbag(s) was not deployed as seen from the photographs that were provided to me.

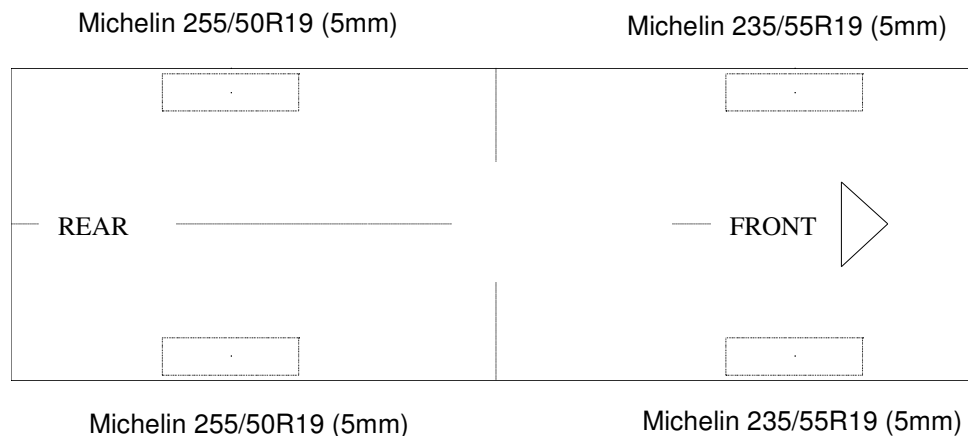
9. The Motor Car was fitted with 19inch sport wheel rims that were wrapped with tyres that were observed to be of serviceable condition. The tyres were also sufficiently inflated for vehicular operation. The tyre brand, tyre size and approximate remaining tread depth of the 4 tyres of the Motor Car were recorded as follows: -

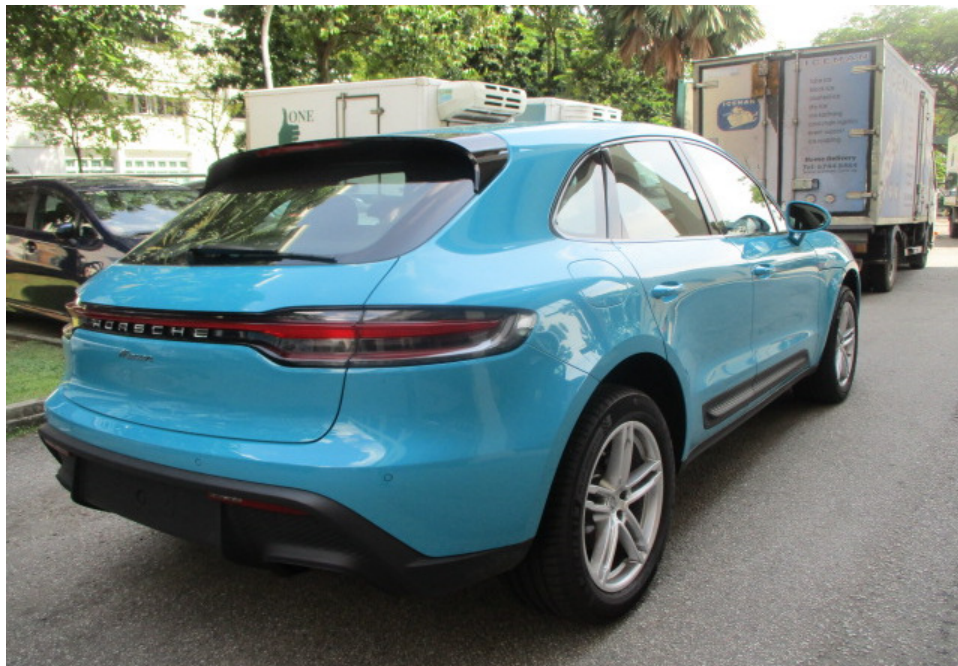
Photo 7 shows a general view of the rear right body of the Motor Car at the time of my inspection. The Motor Car was observed to be in a relatively good general condition with no loose exterior fittings observed. The body parts at the rear right portion of the Motor Car were visually examined and it was observed that the repair/restoration works carried out to the damaged area of the Motor Car (refer to photograph 1 & 2 above) were reasonably adequate and in order.

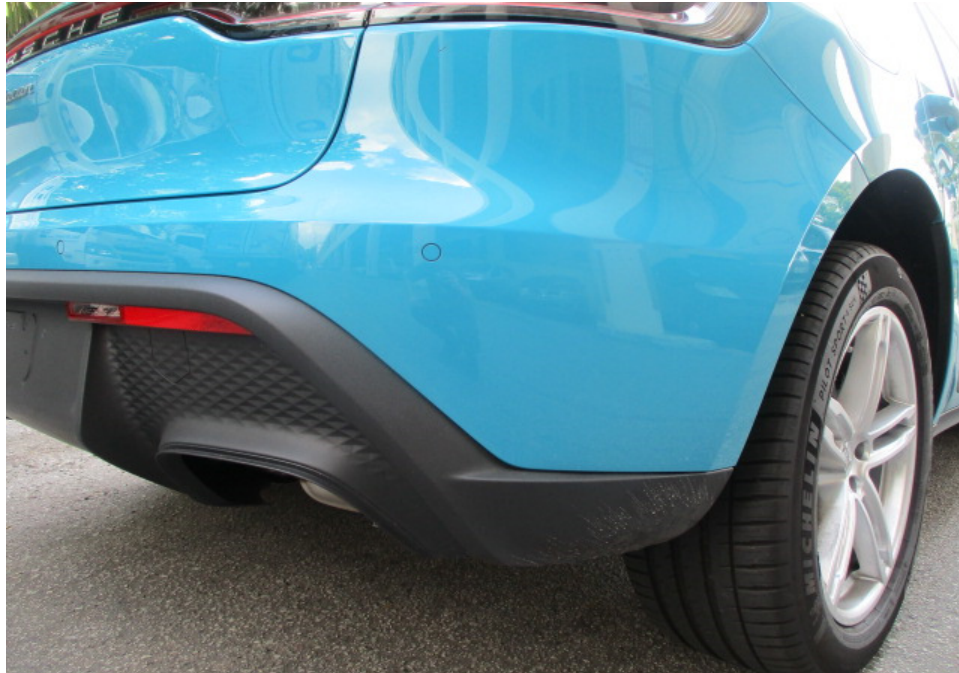
Photo 8 shows a closer view of the Motor Car's rear bumper, rear bumper lower cover, rear bumper sensors and front bumper right reflector. The body parts at the rear right portion of the Motor Car were visually examined and it was observed that the repair/restoration works carried out to the damaged area of the Motor Car (refer to photograph 1 & 2 above) were reasonably adequate and in order.

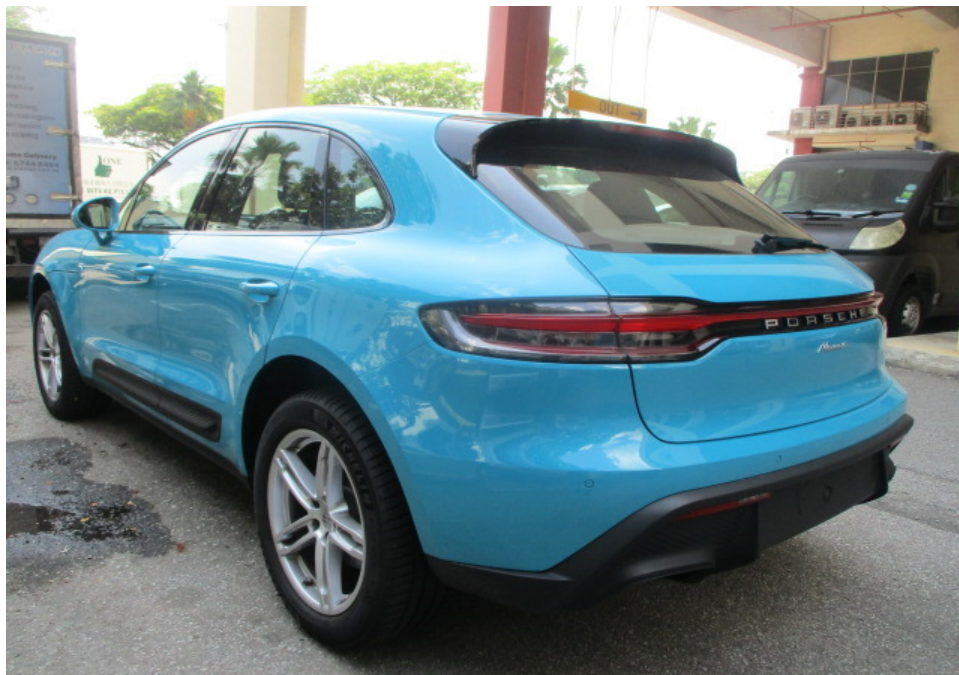
Photo 9 shows a general view of the rear left body of the Motor Car at the time of my inspection. The Motor Car was observed to be in a relatively good general condition with no loose exterior fittings observed. The mileage of the Motor Car recorded at the time of my inspection was 1,380km.

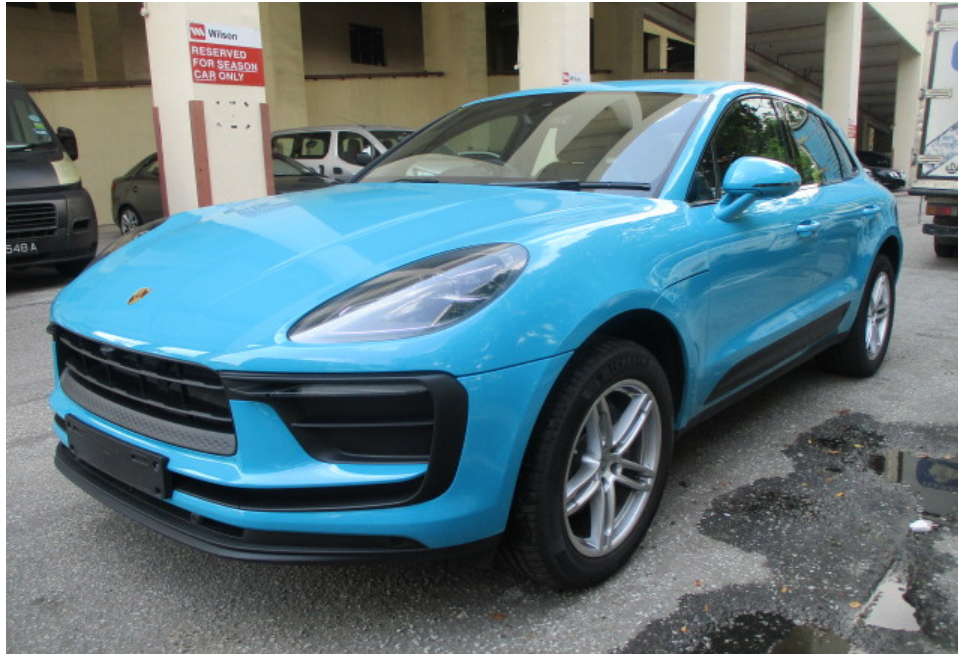
Photo 10 shows a general view of the front left body of the Motor Car at the time of my inspection. The Motor Car was observed to be in a relatively good general condition with no loose exterior fittings observed. The body parts at the frontal portion of the Motor Car were visually examined and it was observed that the repair/restoration works carried out to the damaged area of the Motor Car (refer to photograph 4 & 5 above) were reasonably adequate and in order.

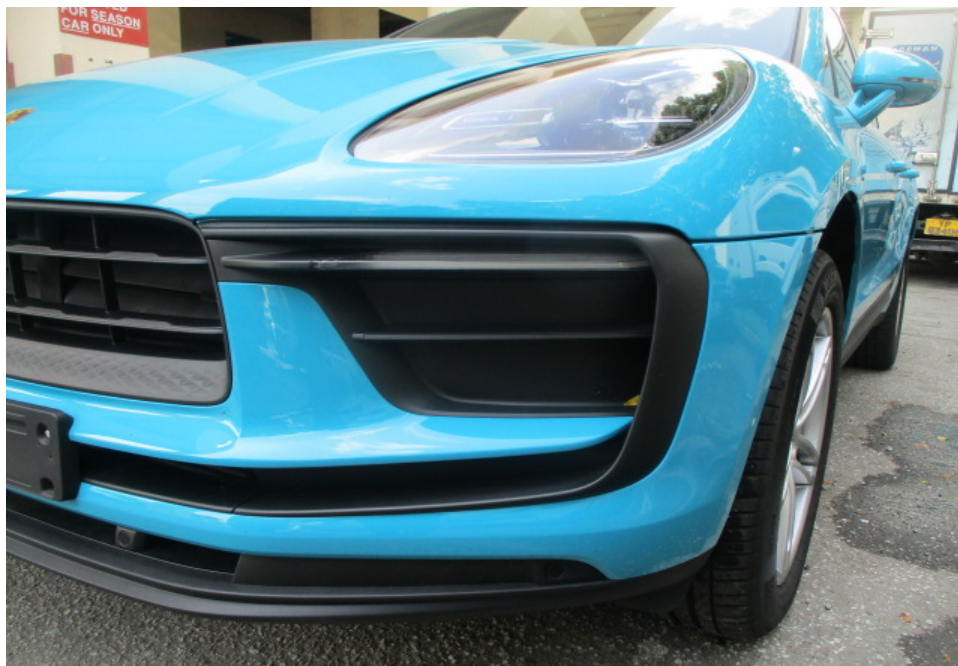
Photo 11 shows a closer view of the Motor Car's front bumper, front bumper lower cover, front bumper left lower grille, front left day light and front left headlamp. The body parts at the frontal portion of the Motor Car were visually examined and it was observed that the repair/restoration works carried out to the damaged area of the Motor Car (refer to photograph 4 & 5 above) were reasonably adequate and in order.

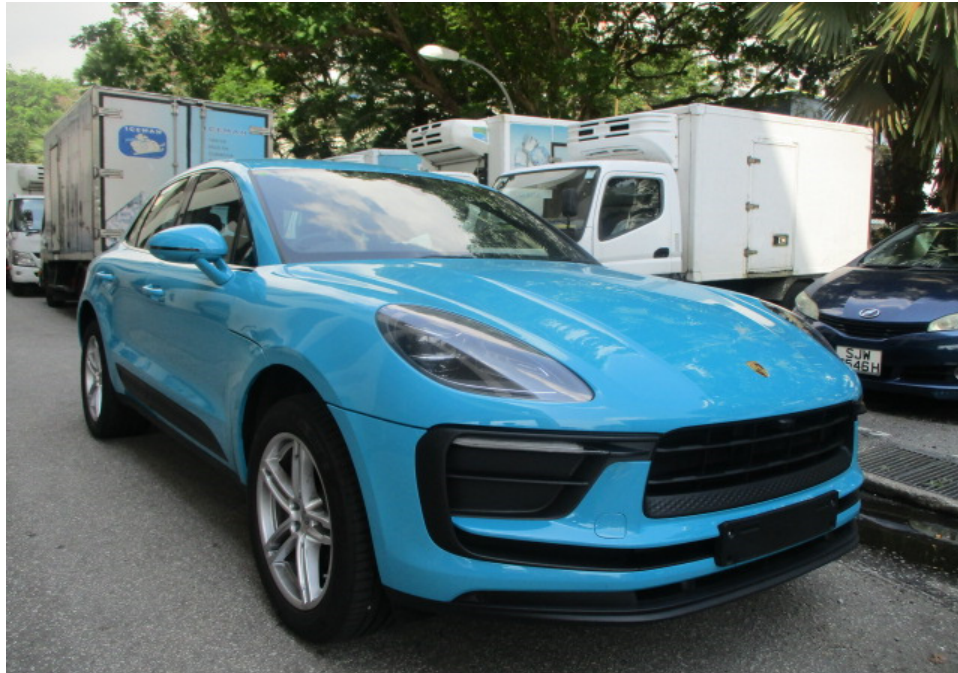
Photo 12 shows a general view of the front right body of the Motor Car at the time of my inspection. The Motor Car was observed to be in a relatively good general condition with no loose exterior fittings observed. The body parts at the frontal portion of the Motor Car were visually examined and it was observed that the repair/restoration works carried out to the damaged area of the Motor Car (refer to photograph 4 & 5 above) were reasonably adequate and in order.

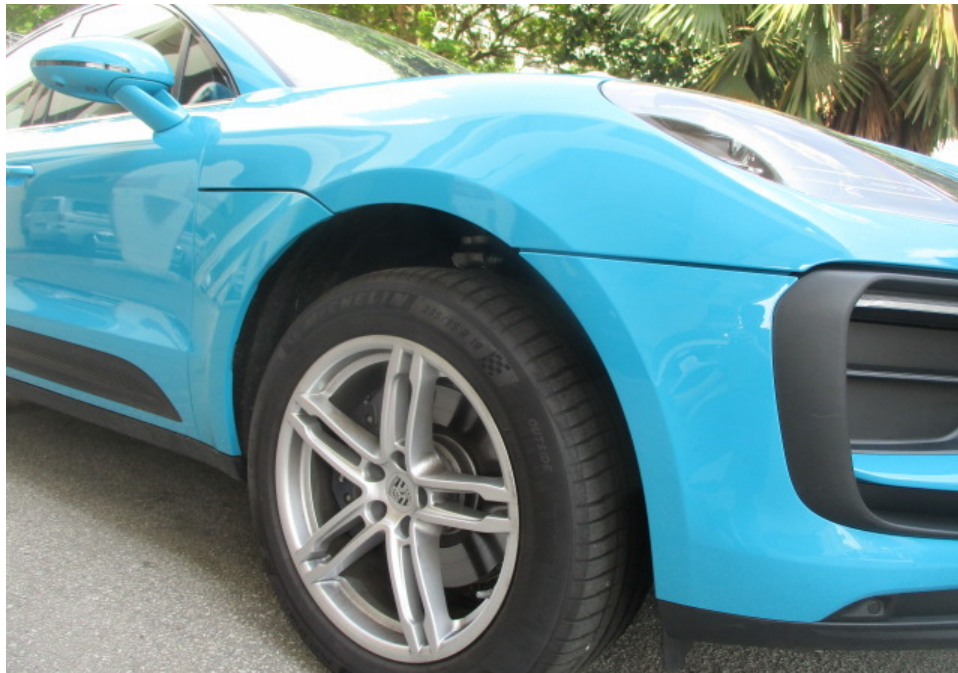
Photo 13 shows a closer view of the Motor Car's front right wheel rim, front right fender and front bonnet. The body parts at the frontal portion of the Motor Car were visually examined and it was observed that the repair/restoration works carried out to the damaged area of the Motor Car (refer to photograph 3 above) were reasonably adequate and in order.

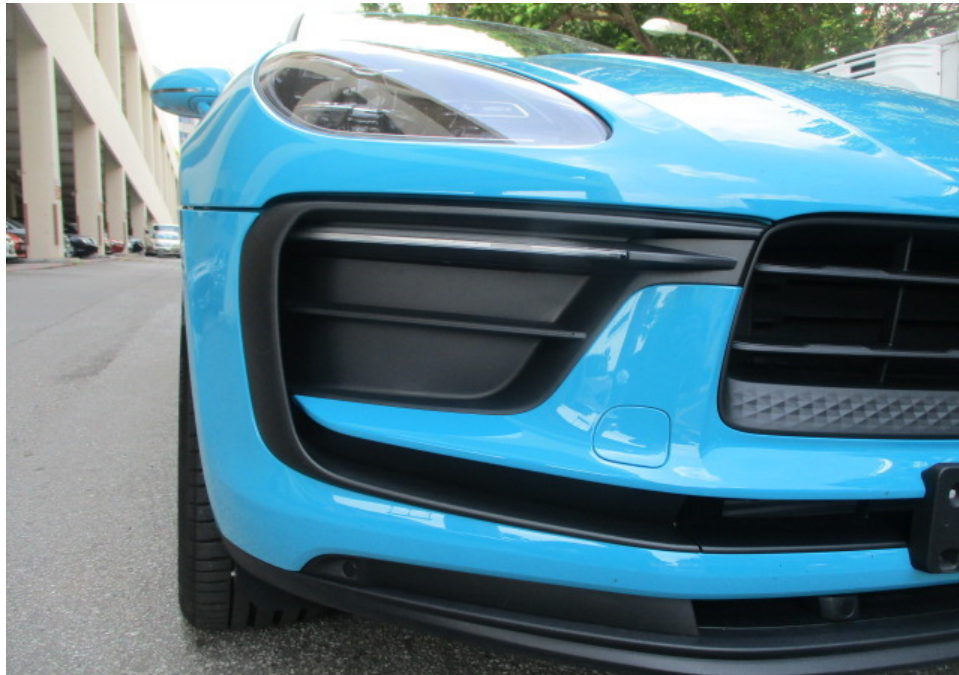
Photo 14 shows a closer view of the Motor Car's front bumper, front bumper lower cover, front bumper right lower grille, front right day light and front right headlamp. The body parts at the frontal portion of the Motor Car were visually examined and it was observed that the repair/restoration works carried out to the damaged area of the Motor Car (refer to photograph 4 & 5 above) were reasonably adequate and in order.

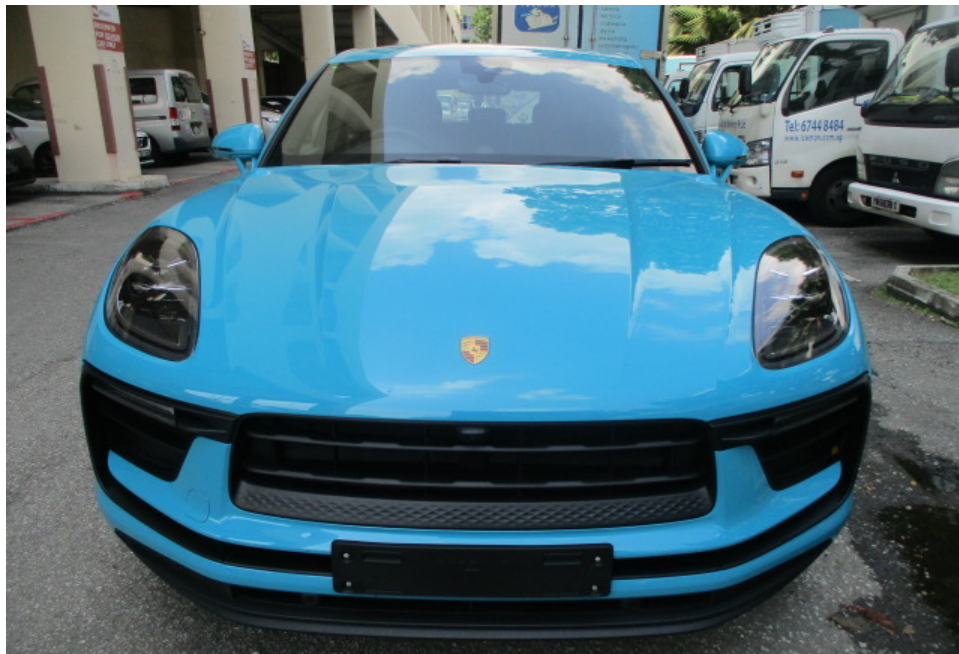
Photo 15 shows a general view of the frontal body of the Motor Car at the time of my inspection. The Motor Car was observed to be in a relatively good general condition with no loose exterior fittings observed. The body parts at the frontal portion of the Motor Car were visually examined and it was observed that the repair/restoration works carried out to the damaged area of the Motor Car (refer to photograph 4 & 5 above) were reasonably adequate and in order.

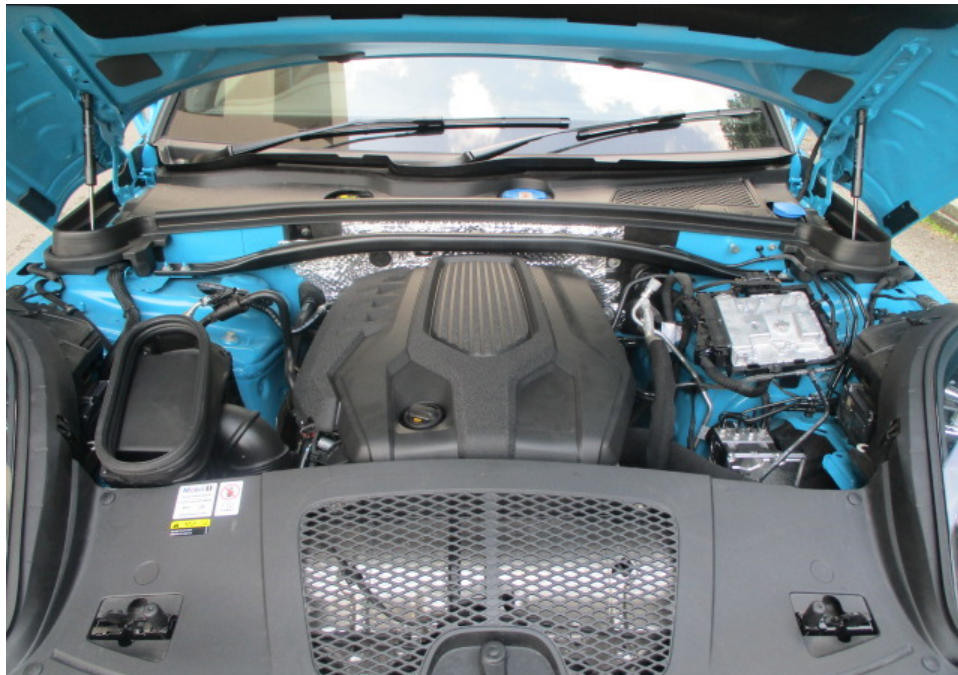
Photo 17 shows a general view of the Motor Car's engine compartment at the time of my inspection. The various parts and components inside the engine compartment were all observed to be intact and properly fitted. There was also no sign(s) or indication(s) of fluid leak and/or fluid stain found inside the engine compartment.

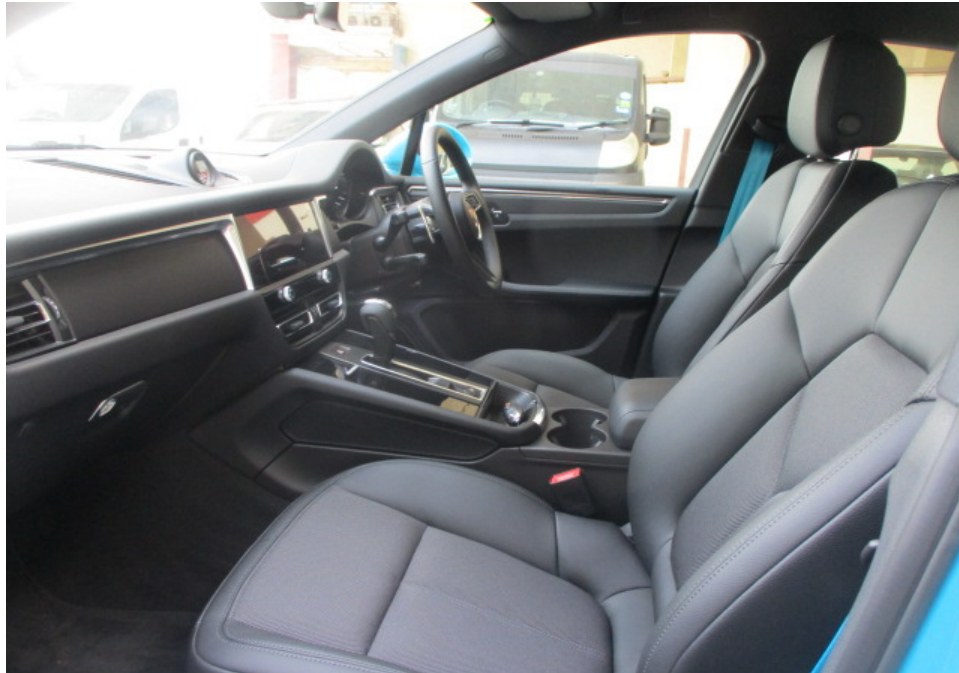
Photo 18 shows the interior compartment of the Motor Car at the time of my inspection. The various parts and components, trims, carpet, and upholstery inside the interior compartment were all observed to be intact and properly fitted.

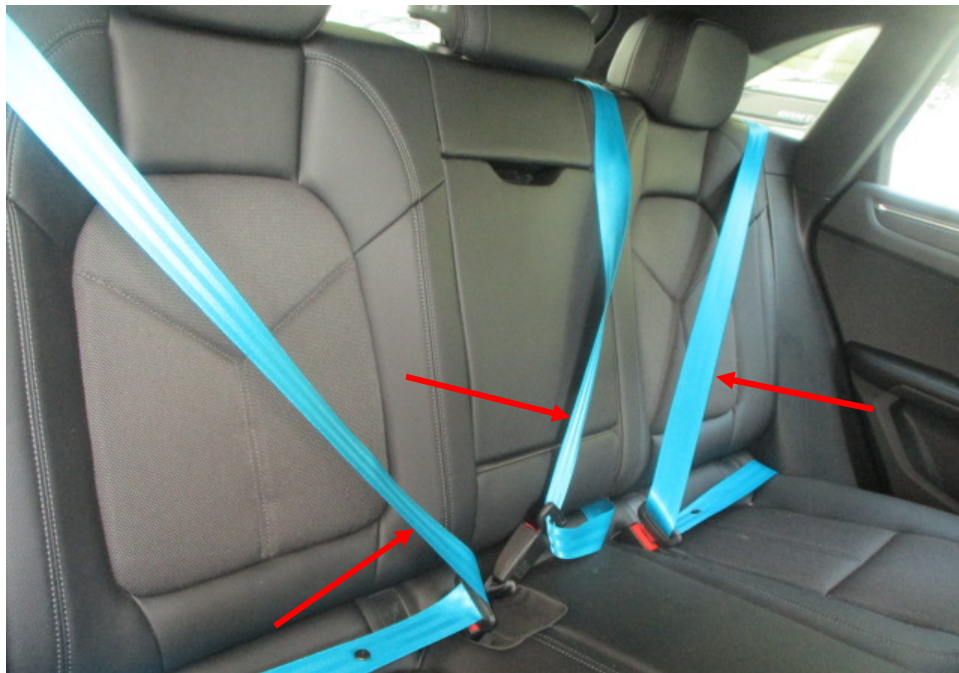
Photo 19 shows the rear seats of the Motor Car. All the seats of the Motor Car were secured via seat rails to the floorboard. They were also fitted with a retractable seat belt reel and a pre-tensioner. The seat belts (arrowed) were tested and were able to be fastened into the respective pre-tensions that were fitted on the side of each individual seat.

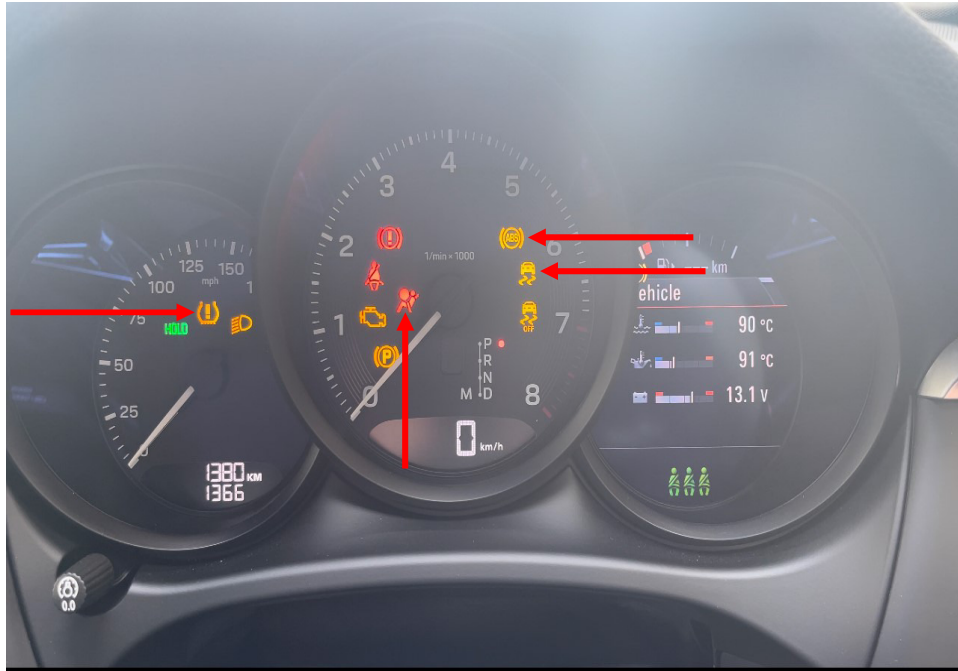
Photo 20 shows the warning lights for the various electronic safety features appearing on the instrument panel of the Motor Car during its self-test when the engine is cranked, in particular the ABS, SRS, TPM and TCS lights (arrowed).

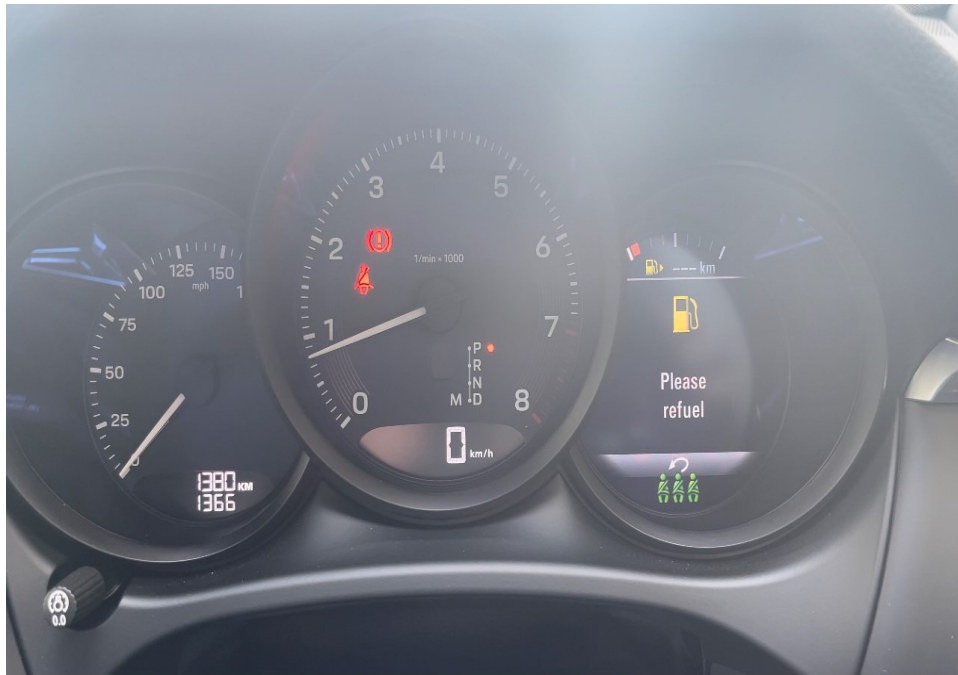
Photo 21 shows the respective warning lights no longer illuminated, indicating that there is no fault detected to the ABS, SRS, TPM and TCS systems of the Motor Car during the self-test. These electronic systems were hence in working condition at the time of my inspection.

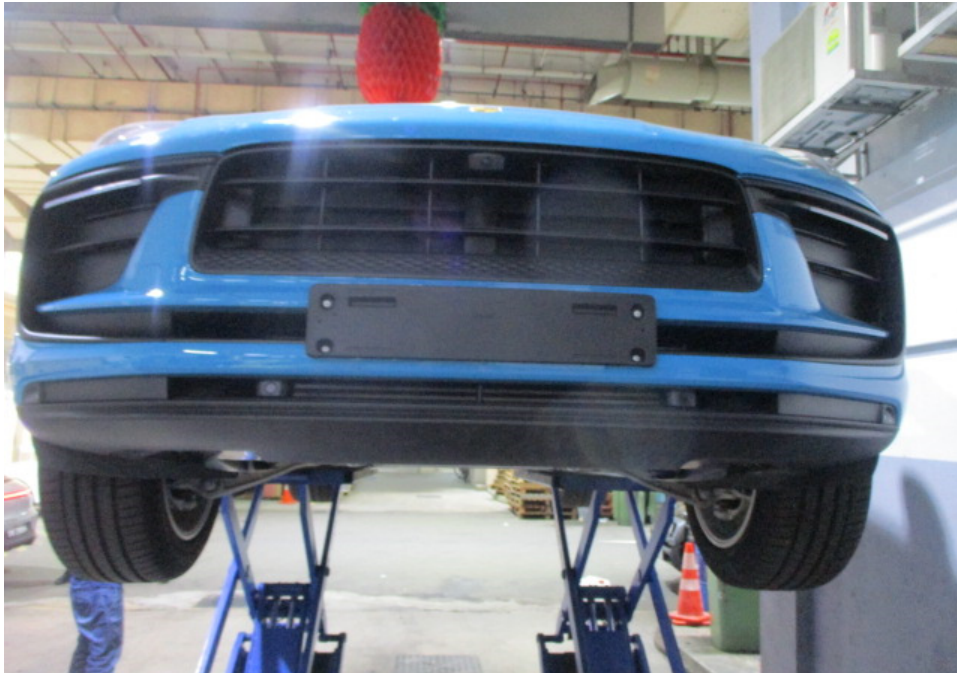
Photo 22 shows the Motor Car hoisted up for checks on its undercarriage. There was no sign(s) or indication(s) of fluid leakage and/or fluid stain(s) on the underside of the Motor Car. The undercarriage components of the Motor Car were also all observed to be intact and secured in an appropriate manner.

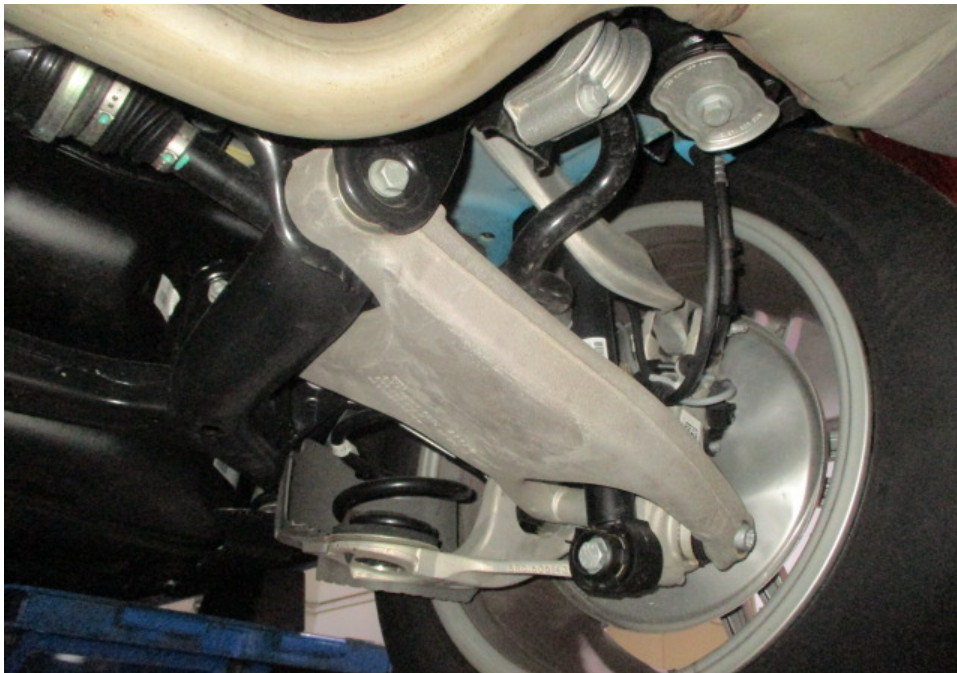
Photo 23 shows a general view of the control arms and linkages at the rear right wheel of the Motor Car. I did not observe any fluid leak and/or fluid stain on the underside of the Motor Car. All of the Motor Car's undercarriage components were observed to be intact and secured in an appropriate manner.

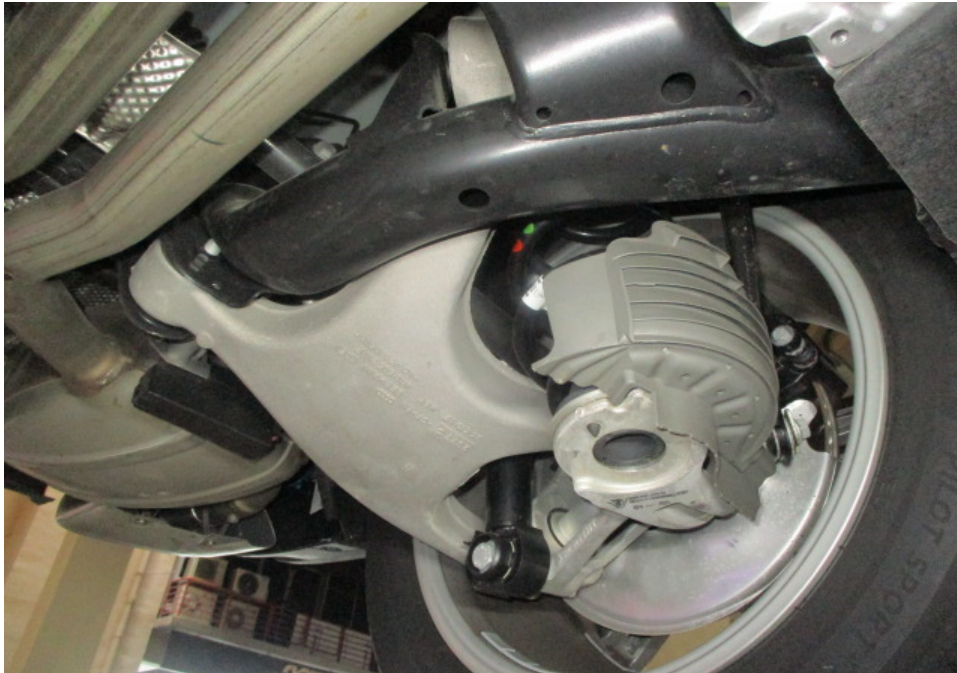
Photo 24 shows a general view of the control arms and linkages at the rear left wheel of the Motor Car. I did not observe any fluid leak and/or fluid stain on the underside of the Motor Car. All of the Motor Car's undercarriage components were observed to be intact and secured in an appropriate manner.

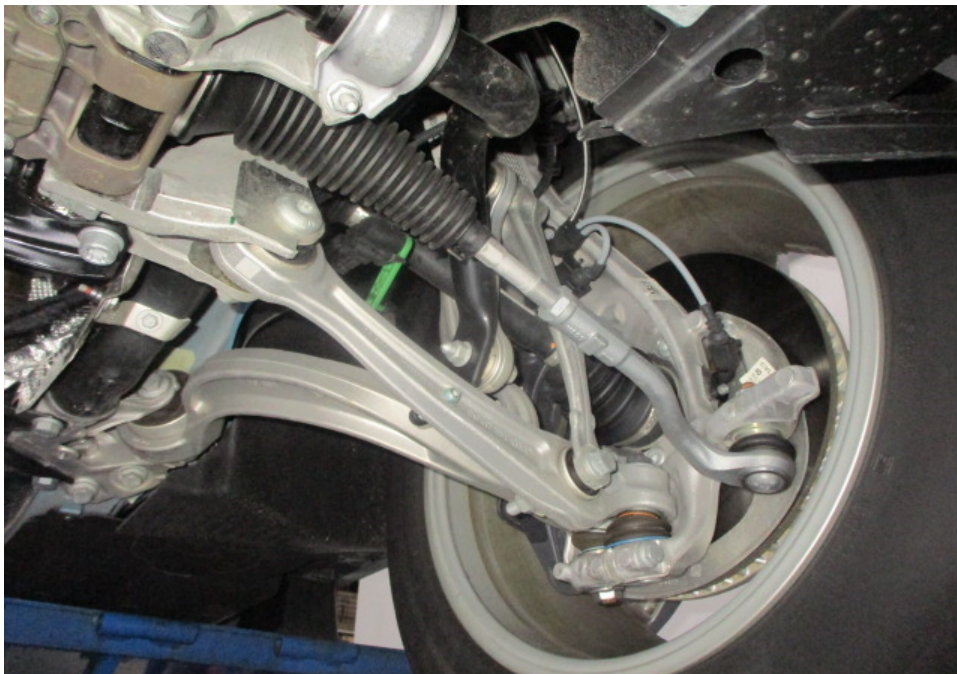
Photo 25 shows the various undercarriage components at the front left wheel of the Motor Car. The mechanical components, control arms and linkages were all found to be intact and secured in an appropriate manner.

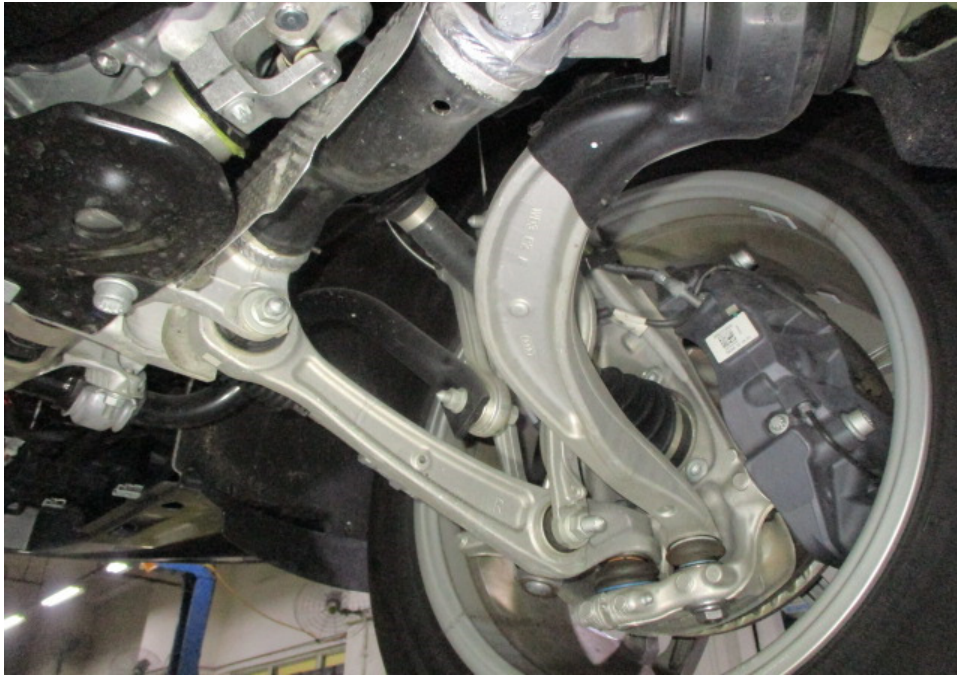
Photo 26 shows the various undercarriage components at the front right wheel of the Motor Car. The mechanical components, control arms and linkages were all found to be intact and secured in an appropriate manner. I also did not observe any fluid leak and/or fluid stain on the underside of the Motor Car.

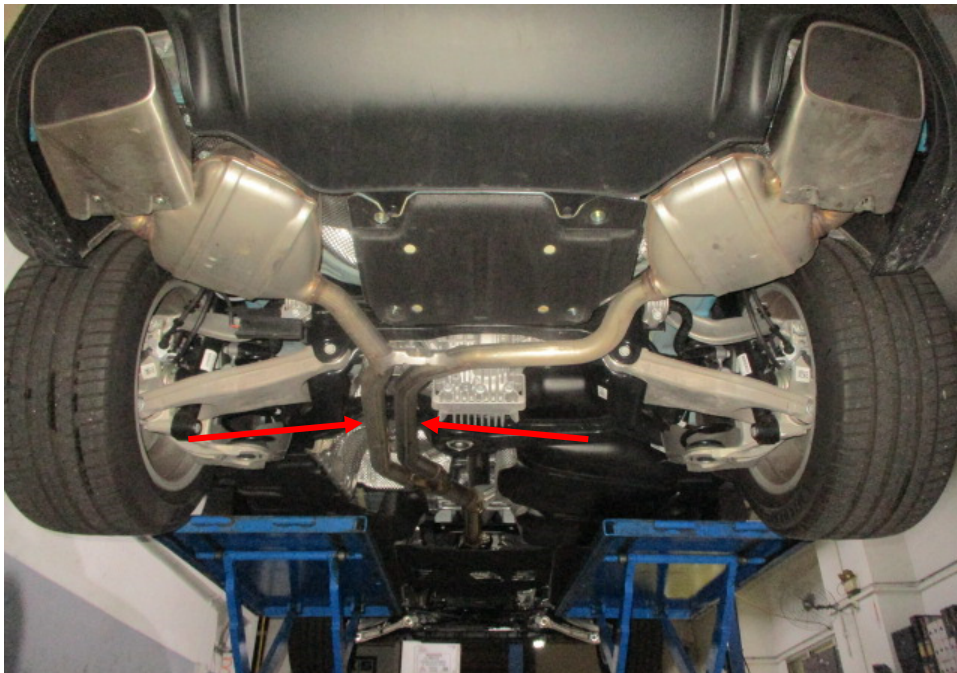
Photo 27 shows the rear section of the Motor Car's exhaust system. My examination of the Motor Car's exhaust system revealed no sign(s) or indication(s) of any cut or weld marks along its exhaust pipes (arrowed), on its rear mufflers and on its catalytic converter.

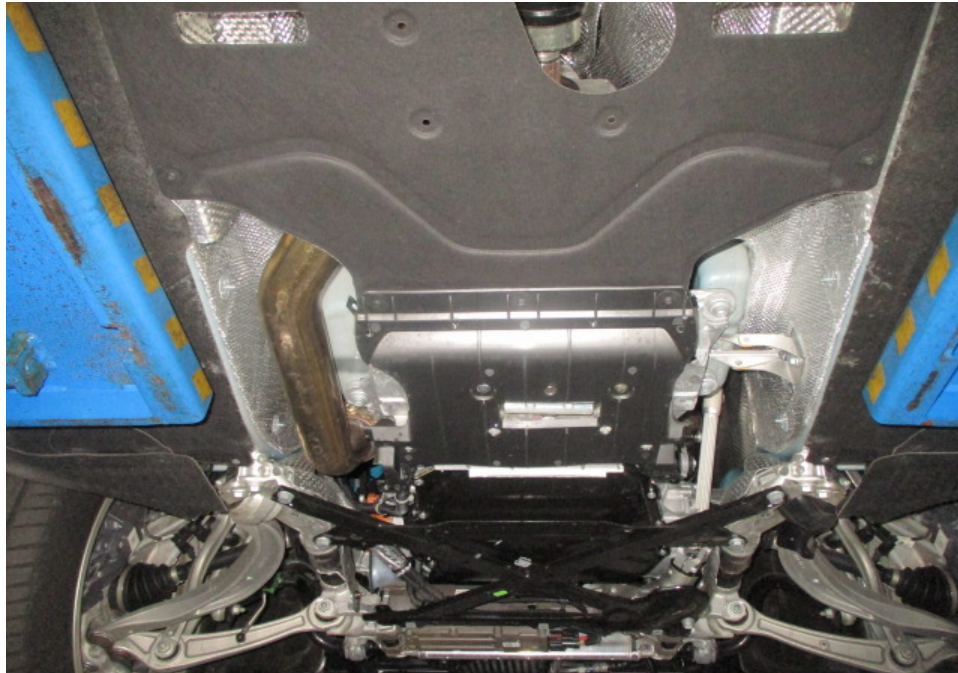
Photo 28 shows the front section of the Motor Car's exhaust system. My examination of the Motor Car's exhaust system revealed no sign(s) or indication(s) of any cut or weld marks along its exhaust pipes, on its rear mufflers, and on its catalytic converter.

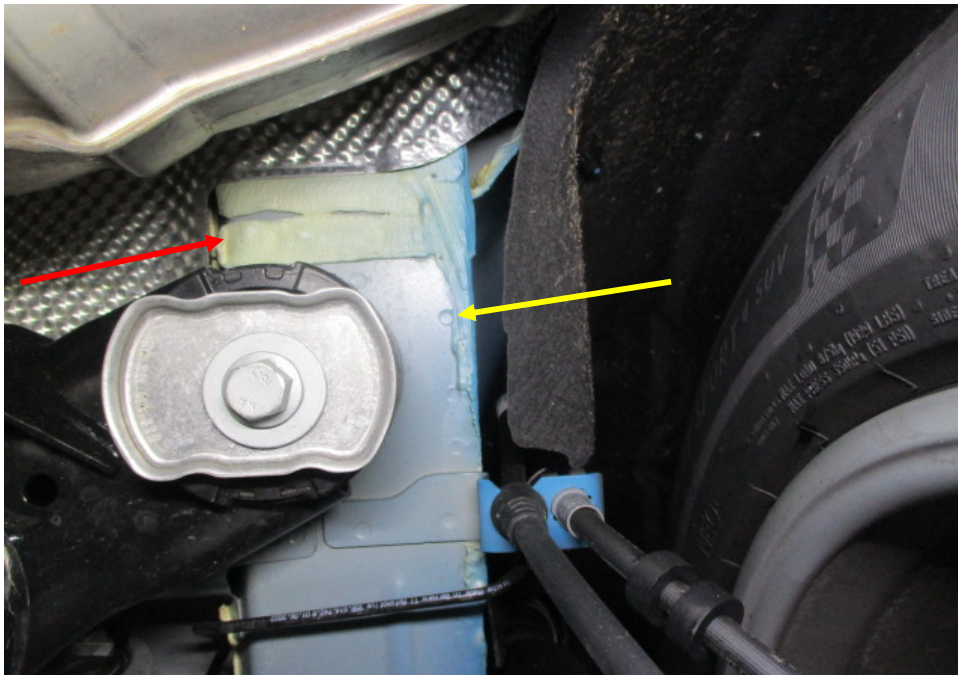
Photo 29 shows the chassis/structural body at the underside rear right of the Motor Car. I did not find any weld marks other than original spot weld marks (yellow arrow) on the chassis/structural body of the Motor Car. The original factory sealant (red arrow) at the joints along the chassis/structural body was untouched, indicating no work was done on the chassis/structural body of the Motor Car and that the chassis/structural body was originally fitted.

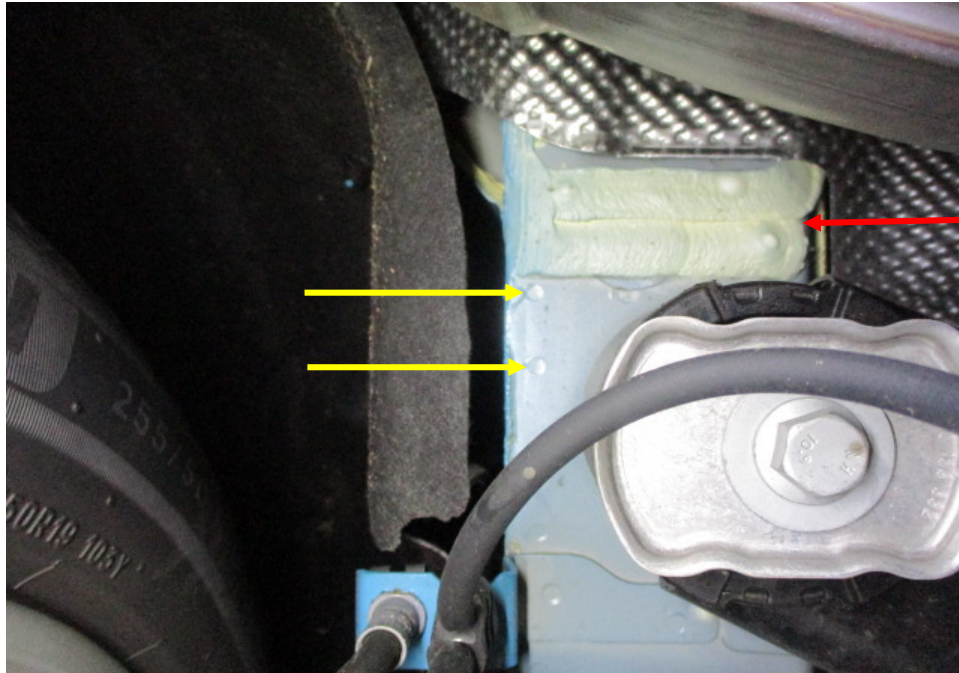
Photo 30 shows the chassis/structural body at the underside rear left of the Motor Car. I did not find any weld marks other than original spot weld marks (yellow arrow) on the chassis/structural body of the Motor Car. The original factory sealant (red arrow) at the joints along the chassis/structural body was untouched, indicating no work was done on the chassis/structural body of the Motor Car and that the chassis/structural body was originally fitted.

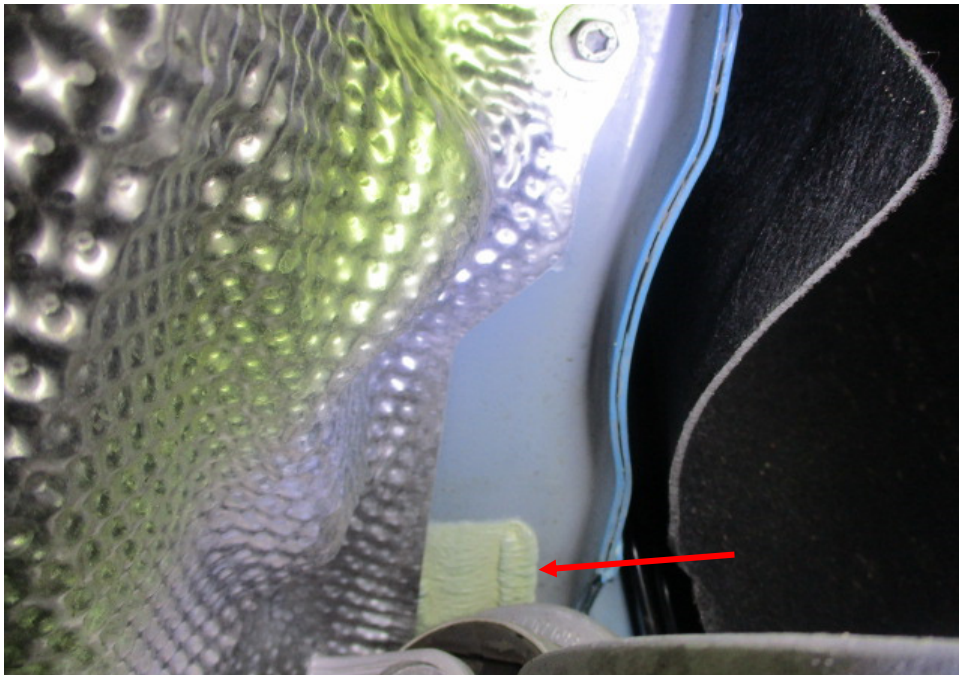
Photo 31 shows the chassis/structural body at the underside front left of the Motor Car. The original factory sealant (arrowed) at the joints along the chassis/structural body was observed to be untouched. In general, I had found no work was carried out on the chassis/structural body of the Motor Car. The chassis/structural body of the Motor Car was originally fitted.
