Your Ref: Porsche Macan
(chassis number WP1ZZZ95ZNLB13408)
Our Ref : CI/TP23000466/D

14 January 2023

INSPECTION REPORT OF AN UNREGISTERED PORSCHE MACAN MOTOR CAR WITH CHASSIS NUMBER WP1ZZZ95ZNLB13408

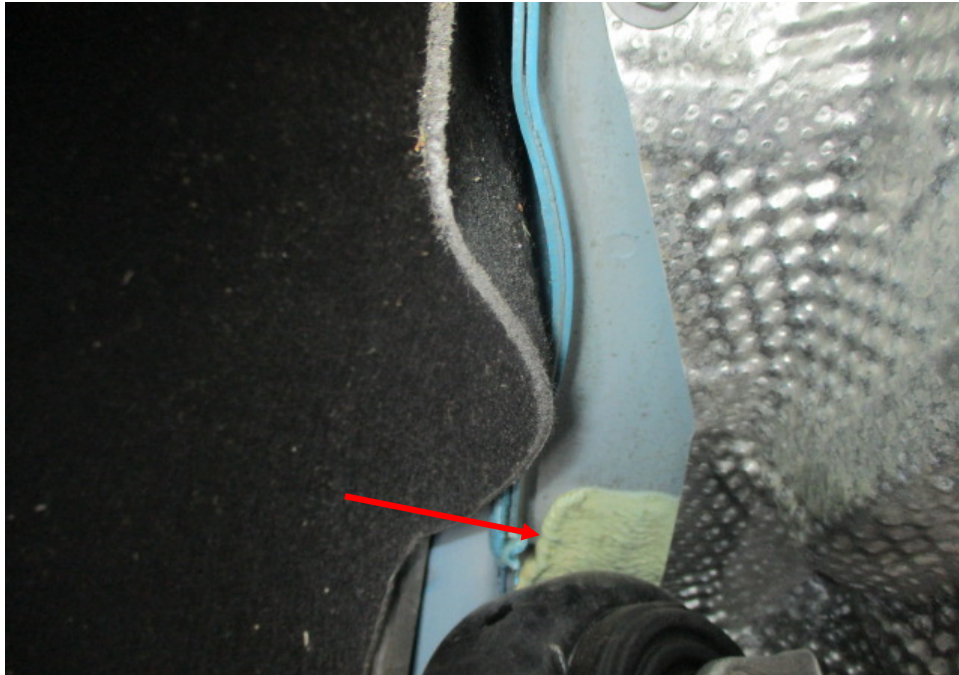
Photo 32 shows the chassis/structural body at the underside front right of the Motor Car. I did not find any weld marks other than original spot weld marks on the chassis/structural body of the Motor Car. The original factory sealant (arrowed) at the joints along the chassis/structural body was untouched, indicating no work was done on the chassis/structural body of the Motor Car and that the chassis/structural body was originally fitted.

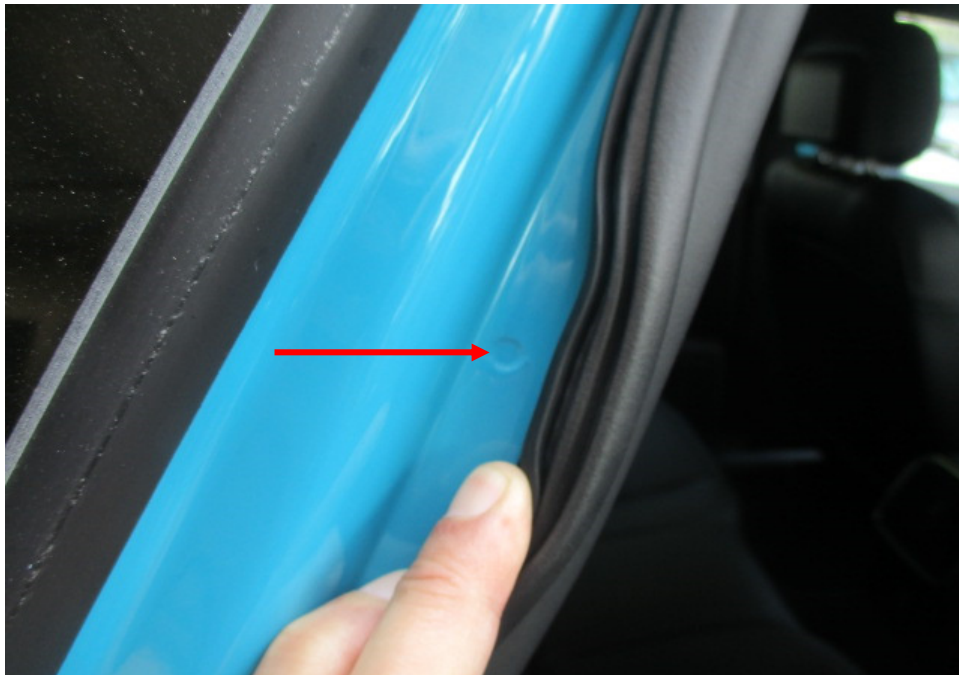
Photo 33 shows the right side "C" pillar of the Motor Car. I did not find any weld marks other than original spot weld marks (arrowed) on the right side "C" pillar of the Motor Car, which indicates that there was no re-welding works carried out. In general, I had found all the non-detachable body panels of the Motor Car to be originally fitted at the time of my inspection.

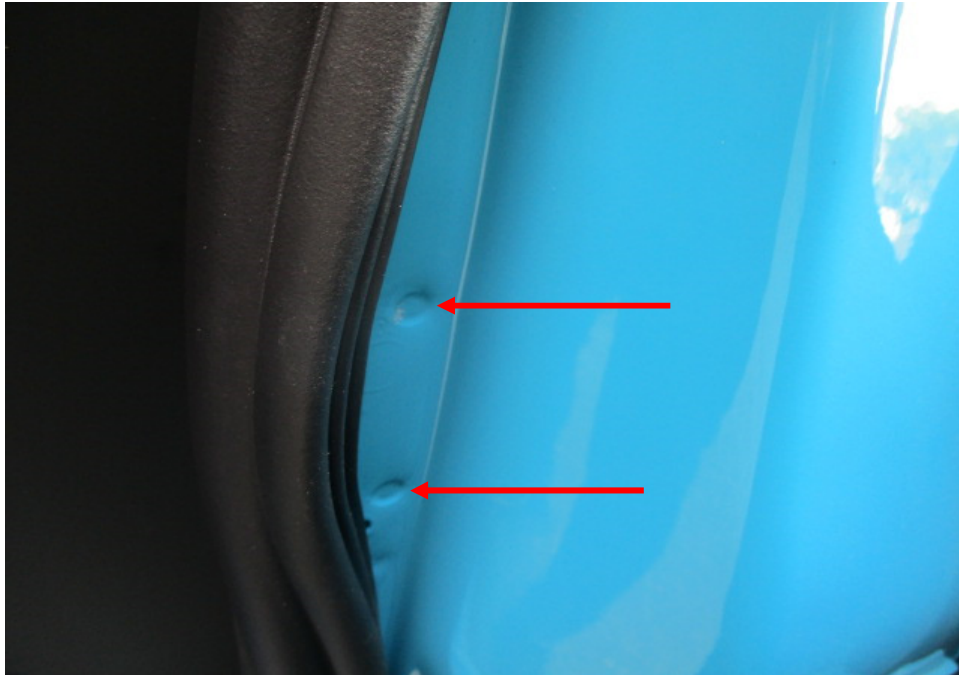
Photo 34 shows the right side "A" pillar of the Motor Car. I did not find any weld marks other than original spot weld marks (arrowed) on the right side "A" pillar of the Motor Car, which indicates that there was no re-welding works carried out. In general, I had found all the non-detachable body panels of the Motor Car to be originally fitted at the time of my inspection.

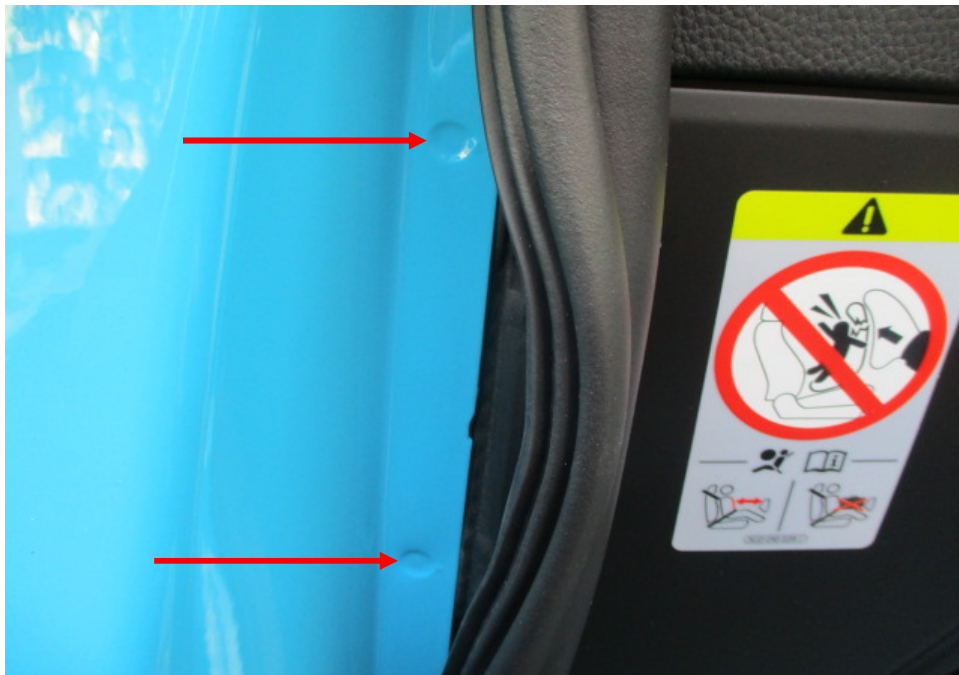
Photo 35 shows the left side "A" pillar of the Motor Car. I did not find any weld marks other than original spot weld marks (arrowed) on the left side "A" pillar of the Motor Car, which indicates that there was no re-welding works carried out. In general, I had found all the non-detachable body panels of the Motor Car to be originally fitted at the time of my inspection.

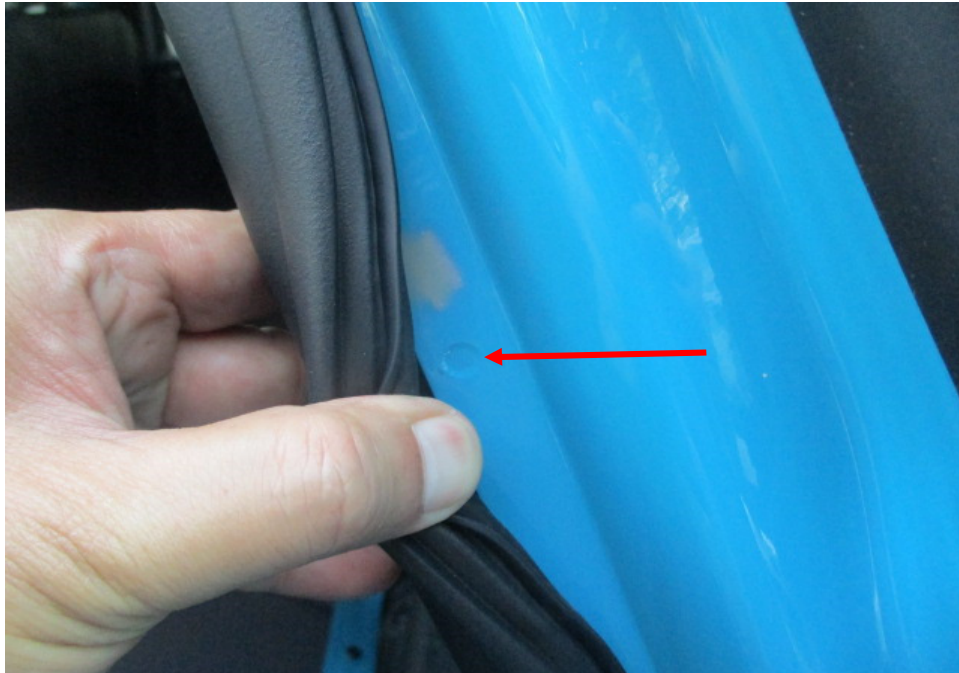
Photo 36 shows the left side “C” pillar of the Motor Car. I did not find any weld marks other than original spot weld marks (arrowed) on the left side “C” pillar of the Motor Car, which indicates that there was no re-welding works carried out. In general, I had found all the non-detachable body panels of the Motor Car to be originally fitted at the time of my inspection.
