Your Ref: Honda Engine

Our Ref: CI/TP23000502/D

INSPECTION REPORT OF A HONDA ENGINE WITH NUMBER L15A3676352

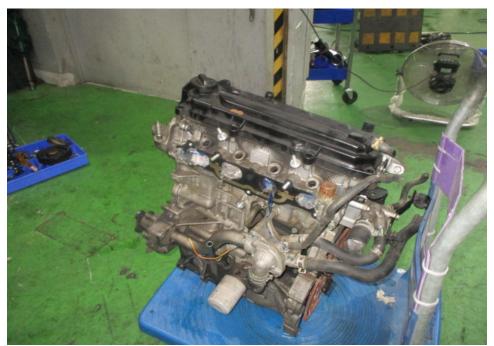
Photo 1 shows a general view of the Honda engine that I had inspected. The Honda engine was observed to be a used engine and was not fitted on any motor car. It was also observed to be a complete assembly with all mechanical parts still intact, within the engine housing.

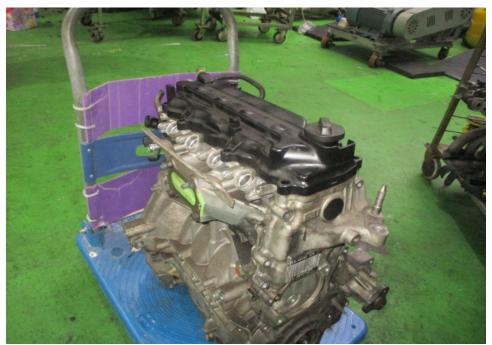
Photo 2 shows another view of the Honda engine that I had inspected. My visual examination of the engine housing revealed the housing to be of serviceable/satisfactory condition. There was no crack and/or hole observed on the engine housing.

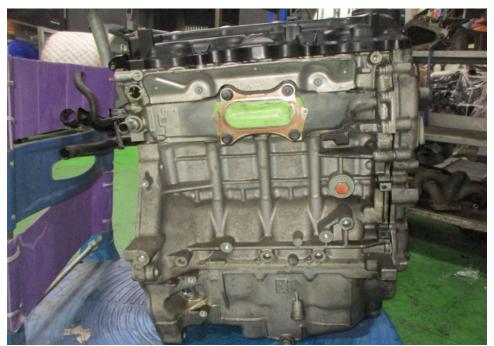
Photo 3 shows a closer view of the Honda engine that I had inspected. My visual examination of the engine housing revealed the housing to be of serviceable/satisfactory condition. There was no crack and/or hole observed on the engine housing.

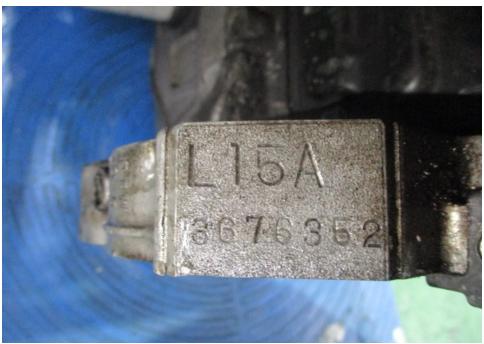
Photo 4 shows the engine number engraved on the housing of the Honda engine that I had inspected. The engine number was L15A3676352.

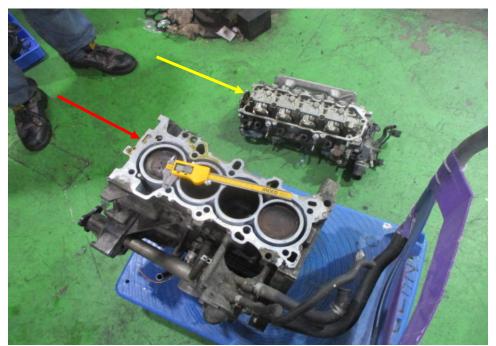
Photo 5 shows the top block (yellow arrow) of the Honda engine separated from its bottom block (red arrow). This was to enable me to carry out measurements of its cylinders, in particular the bore and stroke measurements of each cylinder, which typically can be used to determine the engine displacement or more commonly referred to as engine cc.

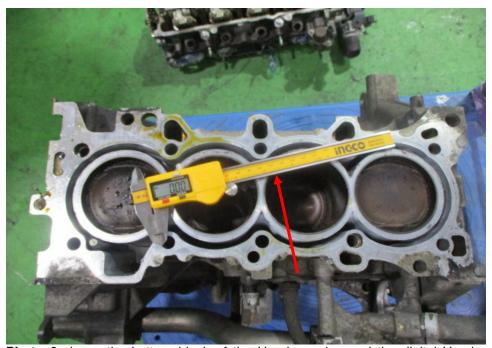
Photo 6 shows the bottom block of the Honda engine and the digital Vernier Caliper (arrowed) that was used to measure the bore and stroke measurements of each cylinder, which typically can be used to determine the engine displacement or more commonly referred to as engine cc. The digital Vernier Caliper was calibrated before the start of the measurements.

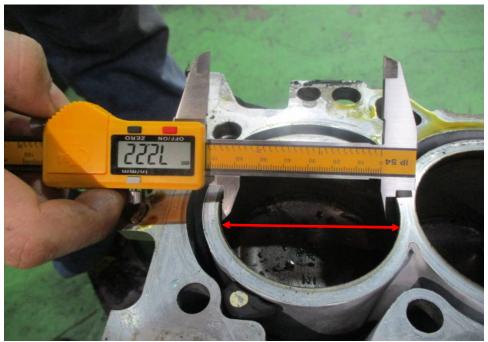
Photo 7 shows measurement being carried out to the bore (arrowed) of cylinder 1 of the Honda engine. The bore measurement of cylinder 1 was recorded to be 72.22mm.

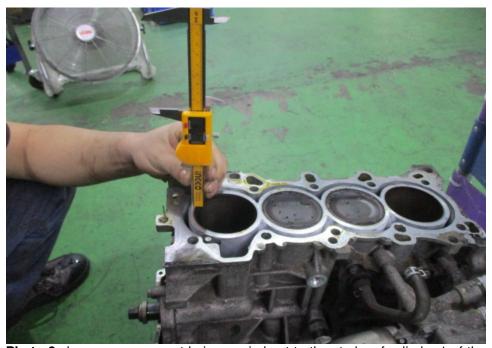
Photo 8 shows measurement being carried out to the stroke of cylinder 1 of the Honda engine. The bore and stroke measurements of the Honda engine were carried out using a digital Vernier Caliper that was calibrated before the start of the measurements.

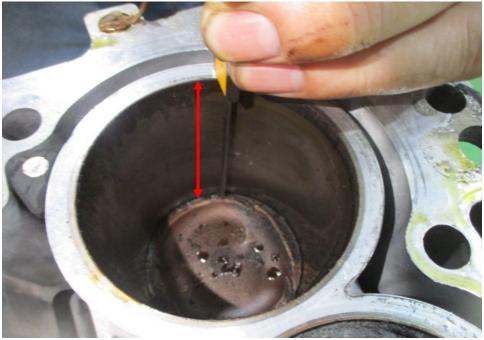
Photo 9 shows measurement being carried out to the stroke (arrowed) of cylinder 1 of the Honda engine. The bore and stroke measurements of the Honda engine were carried out using a digital Vernier Caliper that was calibrated before the start of the measurements.

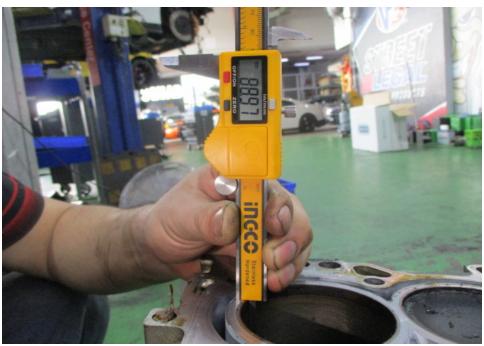
Photo 10 shows the stroke measurement of cylinder 1, which was recorded to be 88.97mm.

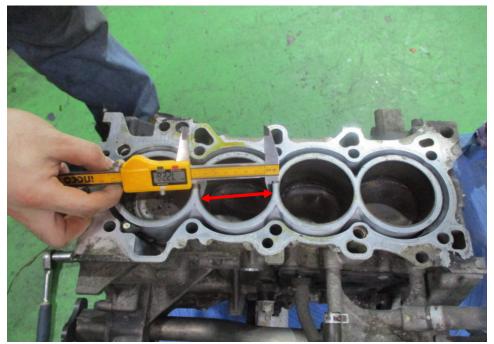
Photo 11 shows measurement being carried out to the bore (arrowed) of cylinder 2 of the Honda engine. The bore and stroke measurements of the Honda engine were carried out using a digital Vernier Caliper that was calibrated before the start of the measurements.

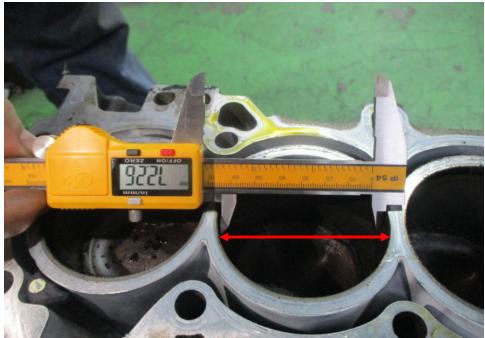
Photo 12 shows measurement being carried out to the bore (arrowed) of cylinder 2 of the Honda engine. The bore measurement of cylinder 2 was recorded to be 72.26mm.

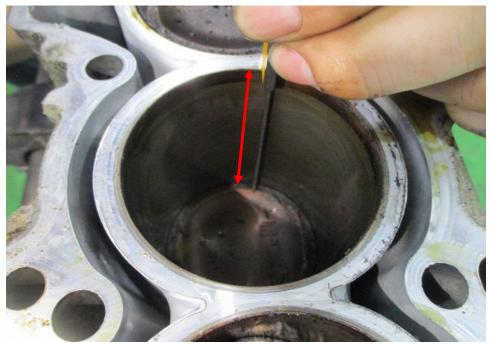
Photo 13 shows measurement being carried out to the stroke (arrowed) of cylinder 2 of the Honda engine. The bore and stroke measurements of the Honda engine were carried out using a digital Vernier Caliper that was calibrated before the start of the measurements.

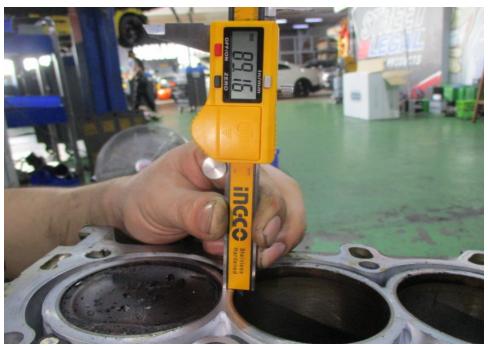
Photo 14 shows the stroke measurement of cylinder 2, which was recorded to be 89.16mm.

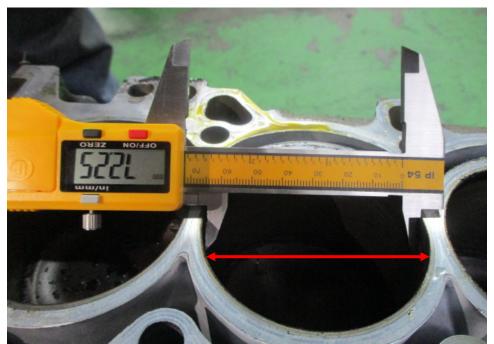
Photo 15 shows measurement being carried out to the bore (arrowed) of cylinder 3 of the Honda engine. The bore measurement of cylinder 3 was recorded to be 72.25mm.

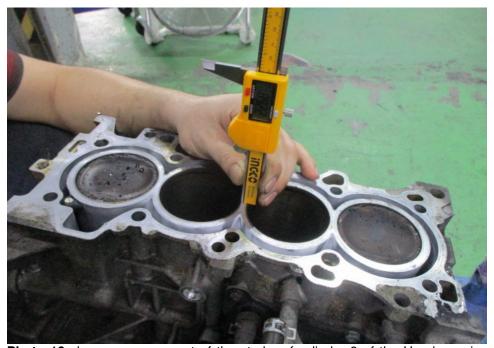
Photo 16 shows measurement of the stroke of cylinder 3 of the Honda engine that I had inspected. The bore and stroke measurements of the Honda engine were carried out using a digital Vernier Caliper that was calibrated before the start of measurements.

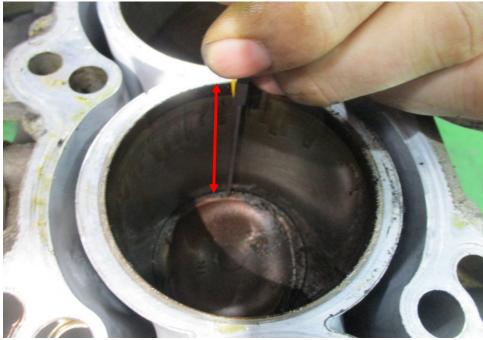
Photo 17 shows measurement being carried out to the stroke (arrowed) of cylinder 3 of the Honda engine. The bore and stroke measurements of the Honda engine were carried out using a digital Vernier Caliper that was calibrated before the start of the measurements.

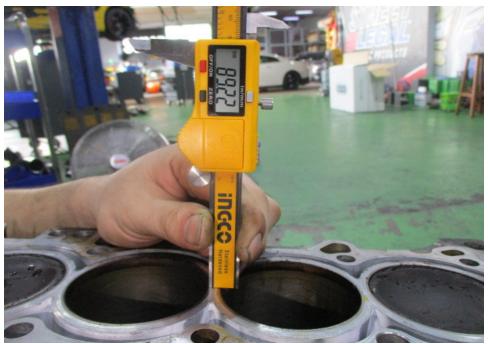
Photo 18 shows the stroke measurement of cylinder 3, which was recorded to be 89.22mm.

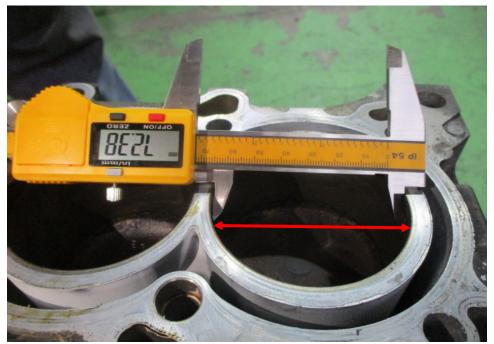
Photo 19 shows measurement being carried out to the bore (arrowed) of cylinder 4 of the Honda engine. The bore measurement of cylinder 4 was recorded to be 72.38mm.

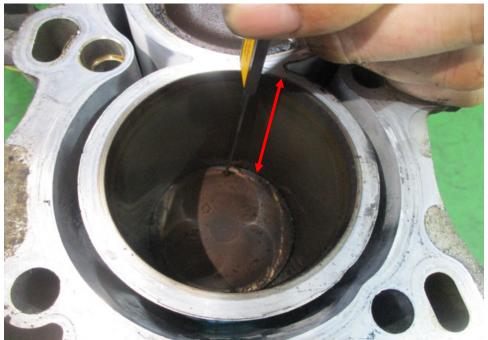
Photo 20 shows measurement being carried out to the stroke (arrowed) of cylinder 4 of the Honda engine. The bore and stroke measurements of the Honda engine were carried out using a digital Vernier Caliper that was calibrated prior to the start of measurements.

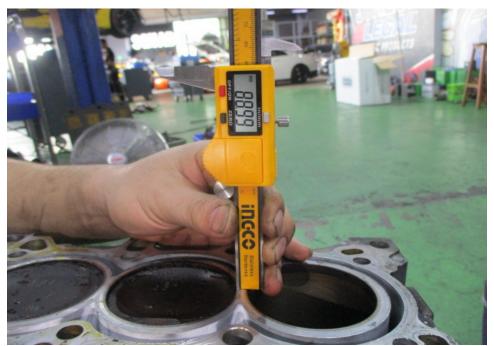
Photo 21 shows the stroke measurement of cylinder 4, which was recorded to be 88.99mm.
