Your Ref: BMW 840i  
(chassis number WBAGV220X0CE33235)  
Our Ref : CI/TP23000530/D

16 January 2023

**INSPECTION REPORT OF AN UNREGISTERED BMW 840i MOTOR CAR  
WITH CHASSIS NUMBER WBAGV220X0CE33235**

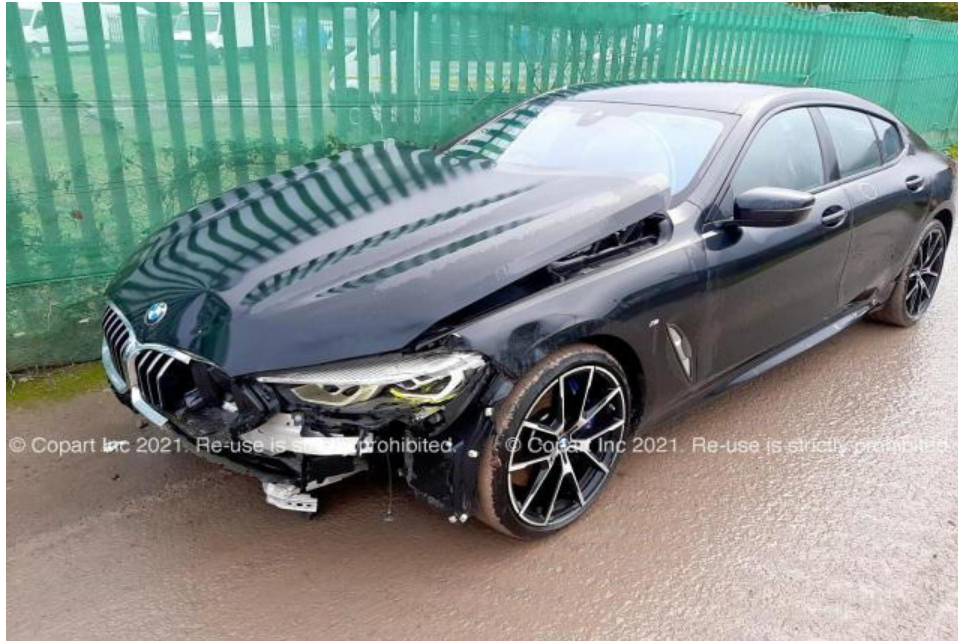
**Photo 1** shows the front left body of the Motor Car (photograph provided to me). The Motor Car was observed to have sustained damage at its frontal portion. The front bumper, front bumper brackets, front bumper centre lower grille, front bumper left lower grille, front bumper sensors, front bumper tow cover, front bumper sponge, front bumper reinforcement, front bumper lower reinforcement, front bumper under cover, front bonnet, front bonnet left hinge, front left radiator grille, front radiator air guide, front left headlamp and front left fender were amongst the body parts that were observed to have been damaged.

22. The body parts at the frontal portion of the Motor Car were visually examined and it was noted that the repair/restoration works carried out to the damaged area of the Motor Car (refer to photograph 1 - 3 above) were reasonably adequate and in order.

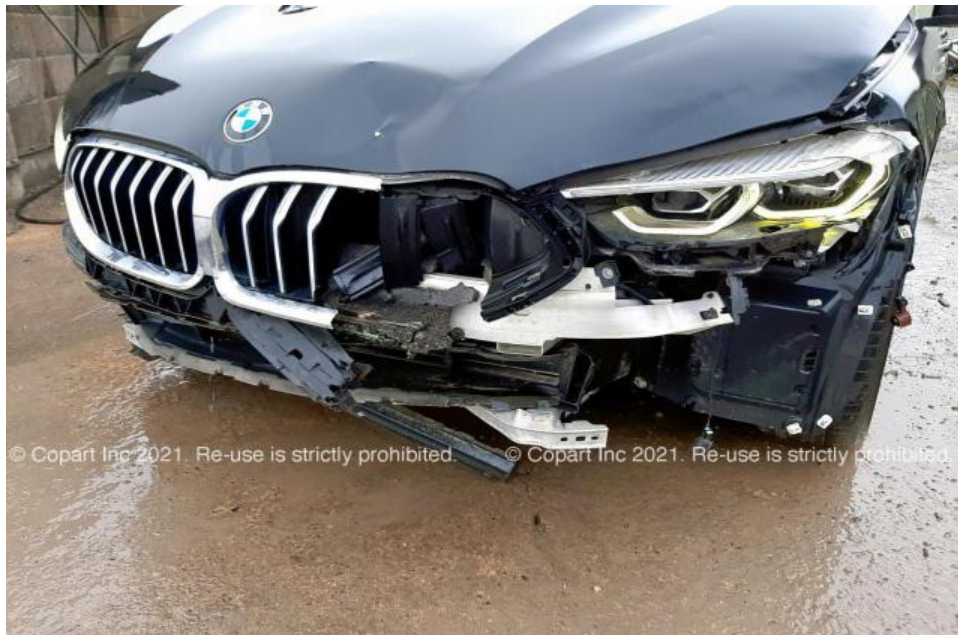
**Photo 2** shows a closer view of the damage at the frontal portion of the Motor Car (photograph provided to me). The front bumper, front bumper sponge, front bumper reinforcement, front bumper lower reinforcement, front bumper under cover, front left radiator grille, front radiator air guide and front left headlamp were amongst the body parts that were observed to have been damaged.

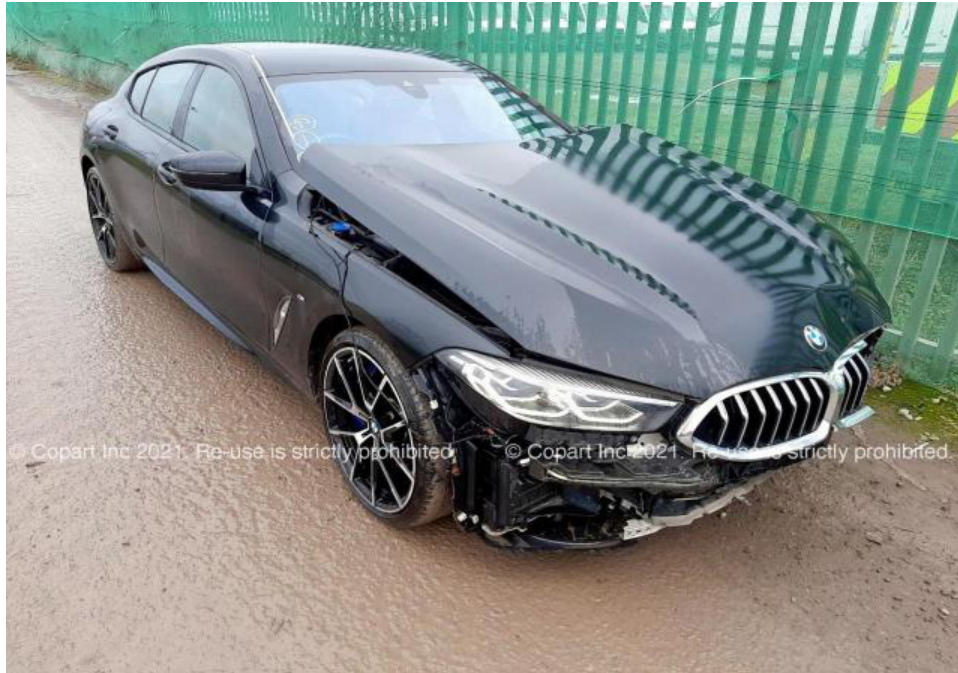
**Photo 3** shows the front right body of the Motor Car (photograph provided to me). The Motor Car was observed to have sustained damage at its frontal portion. The front bumper, front bumper brackets, front bumper sponge, front bumper lower reinforcement, front bumper centre lower grille, front bumper right lower grille, front bonnet and front bonnet right hinge were amongst the body parts that were observed to have been damaged.

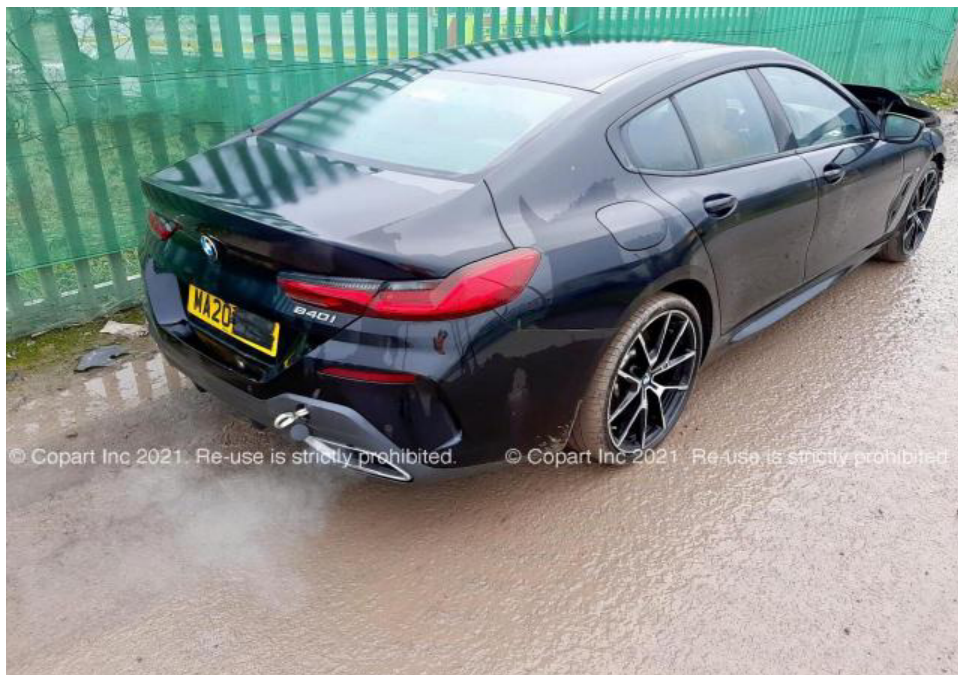
**Photo 4** shows the rear right body of the Motor Car (photograph provided to me). Apart for the frontal portion, there was no physical damage observed to other areas of the Motor Car.

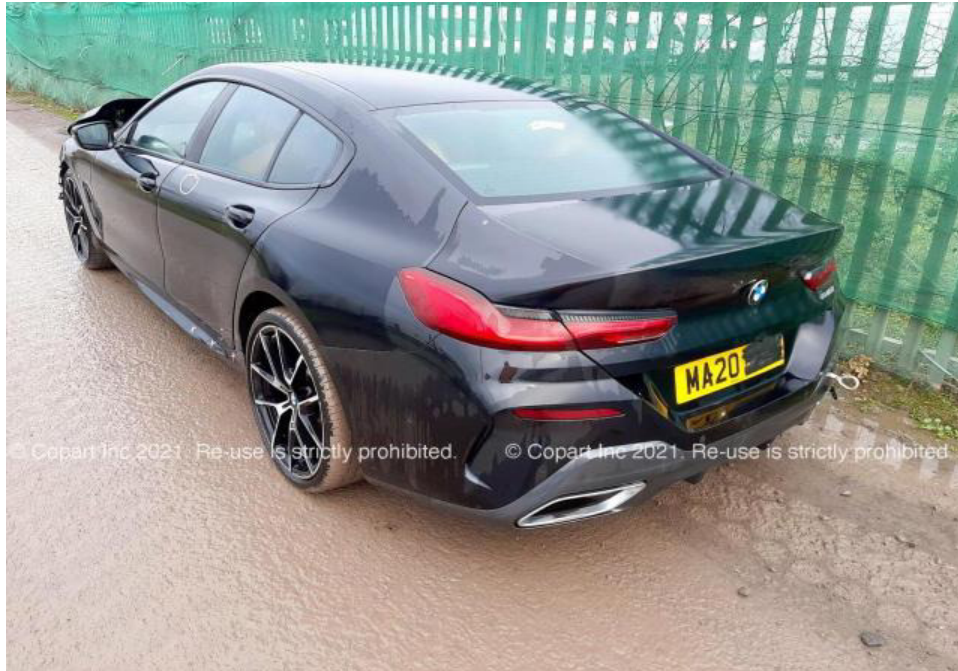
**Photo 5** shows the rear left body of the Motor Car (photograph provided to me). Apart for the frontal portion, there was no physical damage observed to other areas of the Motor Car.

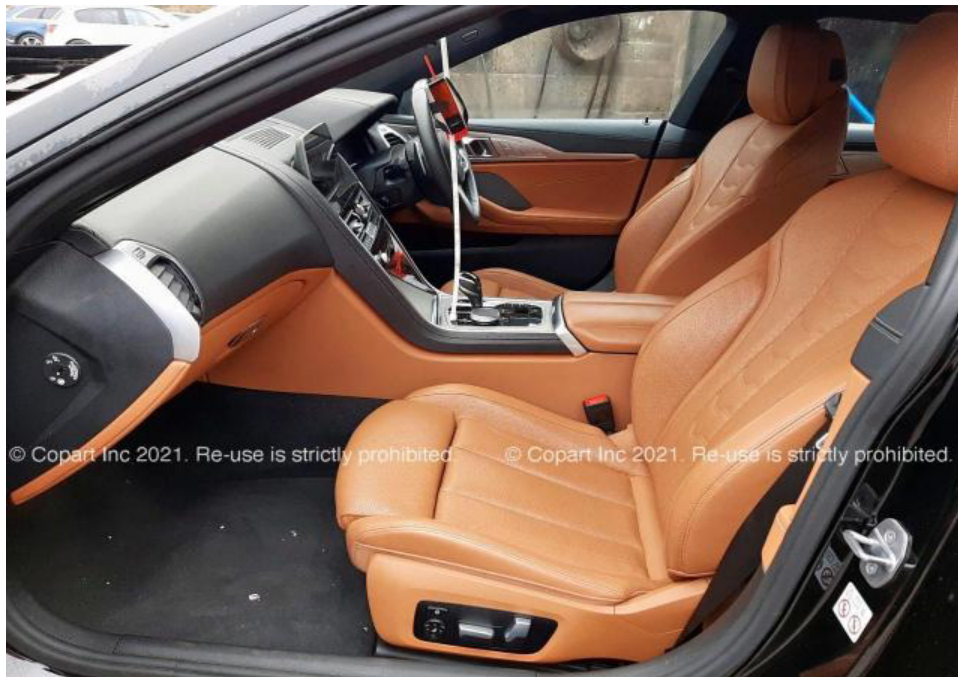
**Photo 6** shows the interior compartment of the Motor Car (photograph provided to me). The various parts and components within the interior compartment were all intact and unaffected. The Motor Car's airbag(s) was not deployed as seen from the photographs that were provided to me.

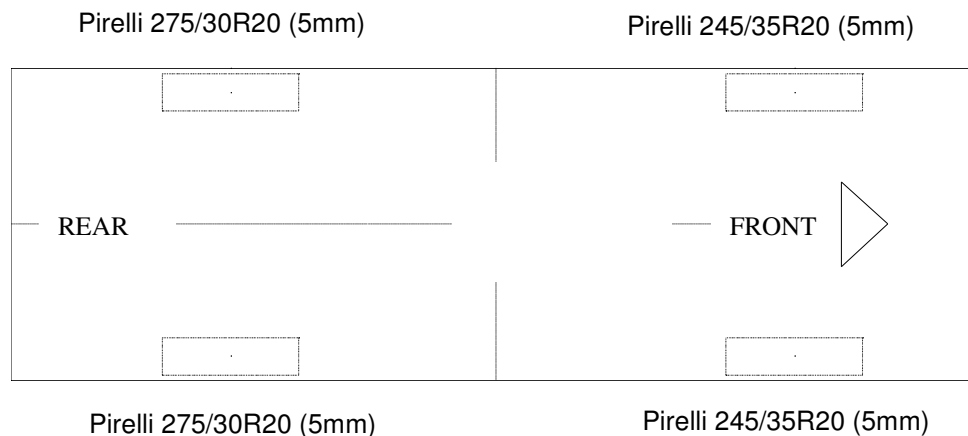
8. It was fitted with 20inch sport wheel rims that were wrapped with tyres that were observed to be of serviceable condition. The tyres were also sufficiently inflated for vehicular operation. The tyre brand, tyre size and approximate remaining tread depth of the 4 tyres of the Motor Car were recorded as follows: -

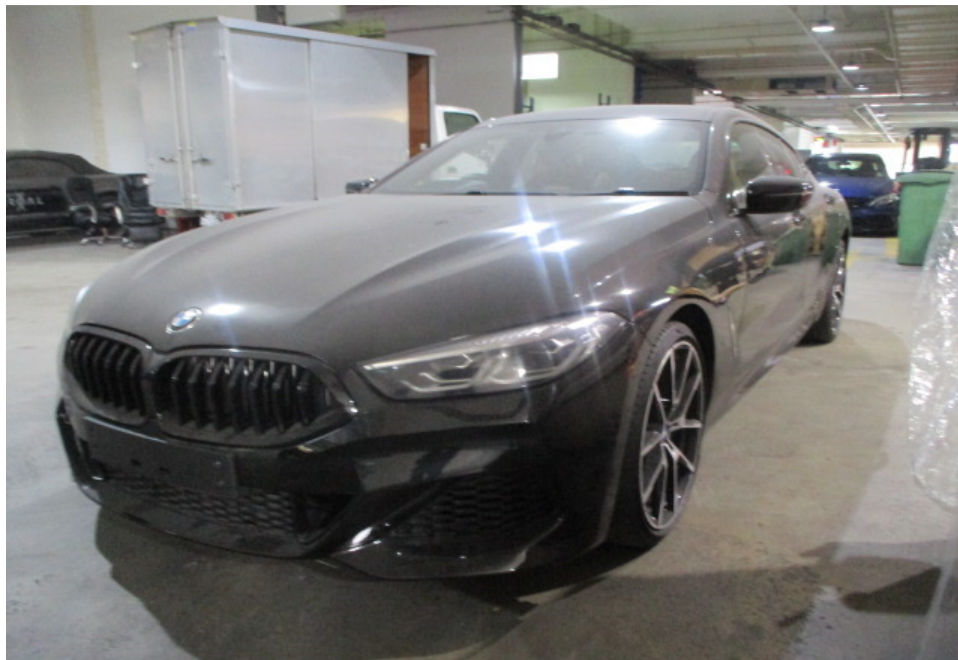
**Photo 7** shows a general view of the front left body of the Motor Car at the time of my inspection. The Motor Car was observed to be in a relatively good general condition with no loose exterior fittings observed. The body parts at the frontal portion of the Motor Car were visually examined and it was observed that the repair/restoration works carried out to the damaged area of the Motor Car (refer to photograph 1 - 3 above) were reasonably adequate and in order.

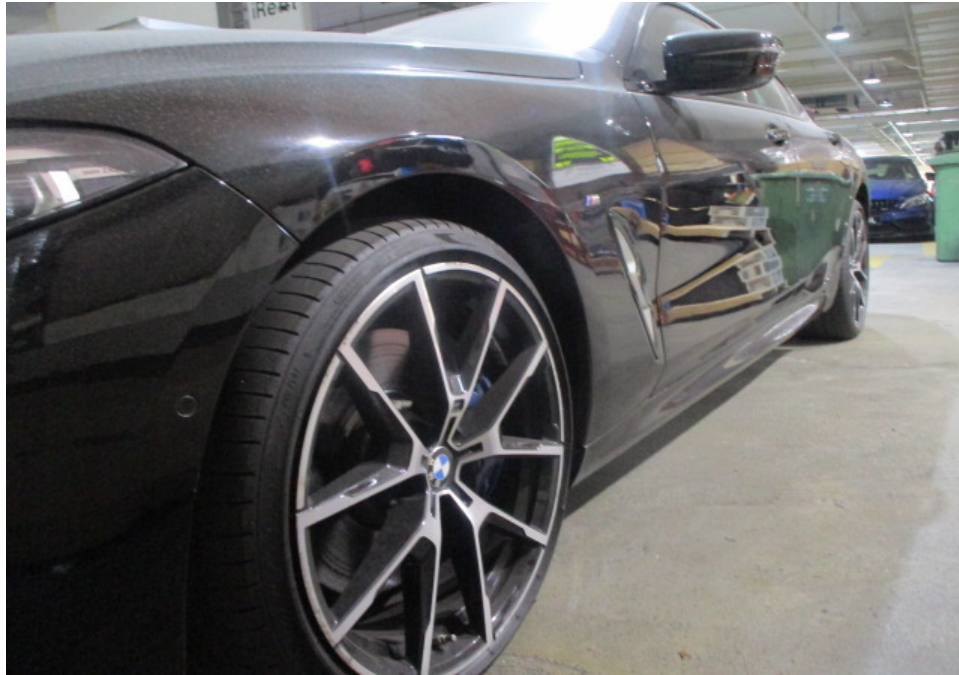
**Photo 8** shows a closer view of the Motor Car's front left wheel rim and front left fender at the time of my inspection. The body parts at the frontal portion of the Motor Car were visually examined and it was observed that the repair/restoration works carried out to the damaged area of the Motor Car (refer to photograph 1 - 3 above) were reasonably adequate and in order.

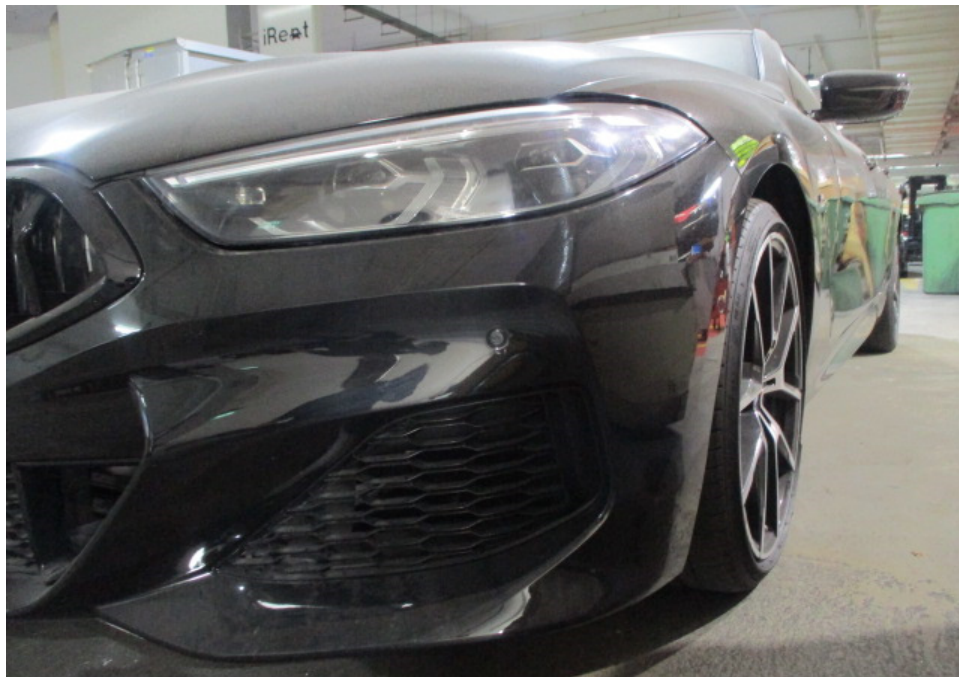
**Photo 9** shows a closer view of the Motor Car's front bumper, front bumper left lower grille, front bumper left sensor and front left headlamp. The body parts at the frontal portion of the Motor Car were visually examined and it was observed that the repair/restoration works carried out to the damaged area of the Motor Car (refer to photograph 1 - 3 above) were reasonably adequate and in order.

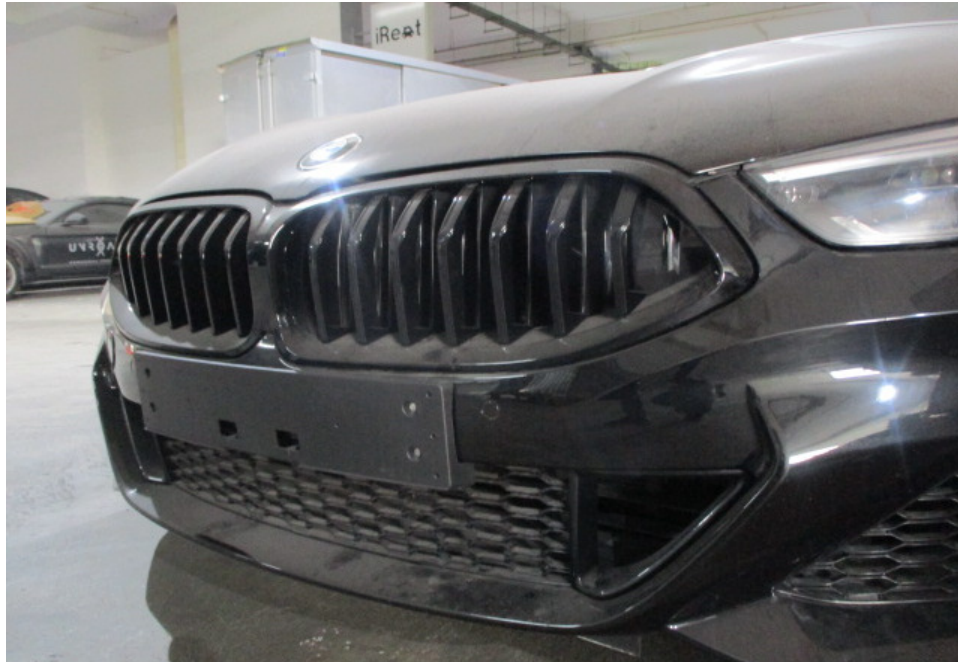
**Photo 10** shows a closer view of the Motor Car's front bumper, front bumper centre lower grille, front radiator grilles and front bonnet at the time of my inspection. The body parts at the frontal portion of the Motor Car were visually examined and it was observed that the repair/restoration works carried out to the damaged area of the Motor Car (refer to photograph 1 - 3 above) were reasonably adequate and in order.

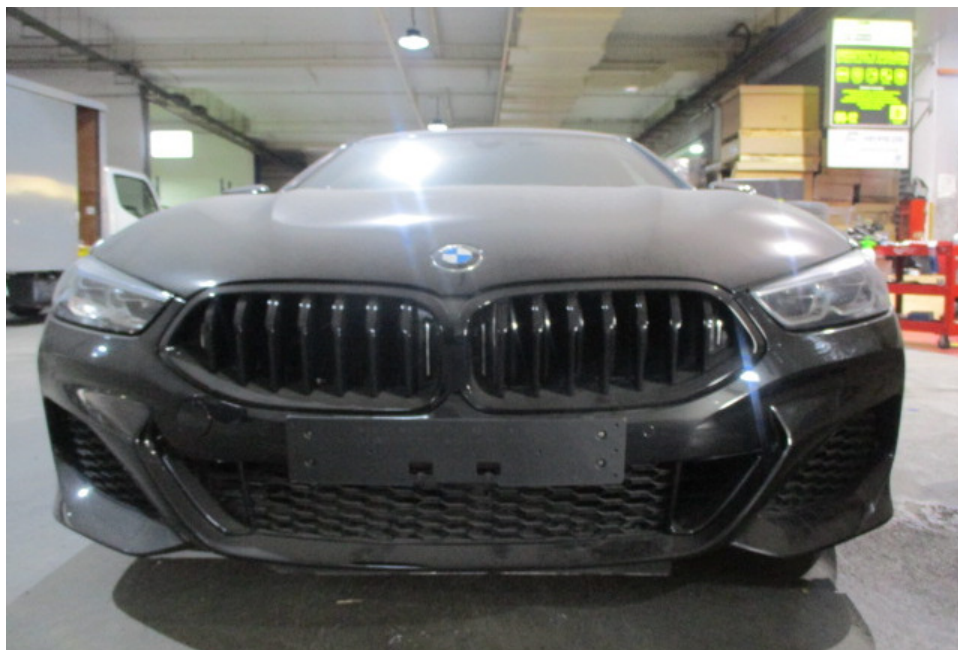
**Photo 11** shows a closer view of the Motor Car's frontal portion at the time of my inspection. The Motor Car was observed to be in a relatively good general condition with no loose exterior fittings observed. The body parts at the frontal portion of the Motor Car were visually examined and it was observed that the repair/restoration works carried out to the damaged area of the Motor Car (refer to photograph 1 - 3 above) were reasonably adequate and in order.

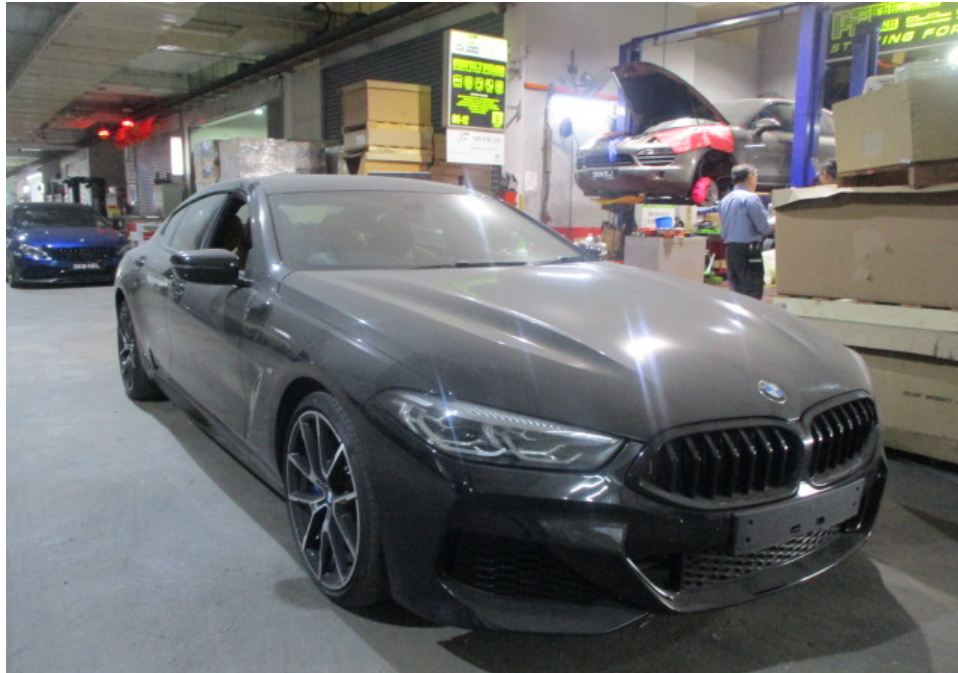
**Photo 12** shows a general view of the front right body of the Motor Car at the time of my inspection. The Motor Car was observed to be in a relatively good general condition with no loose exterior fittings observed. The body parts at the frontal portion of the Motor Car were visually examined and it was observed that the repair/restoration works carried out to the damaged area of the Motor Car (refer to photograph 1 - 3 above) were reasonably adequate and in order.

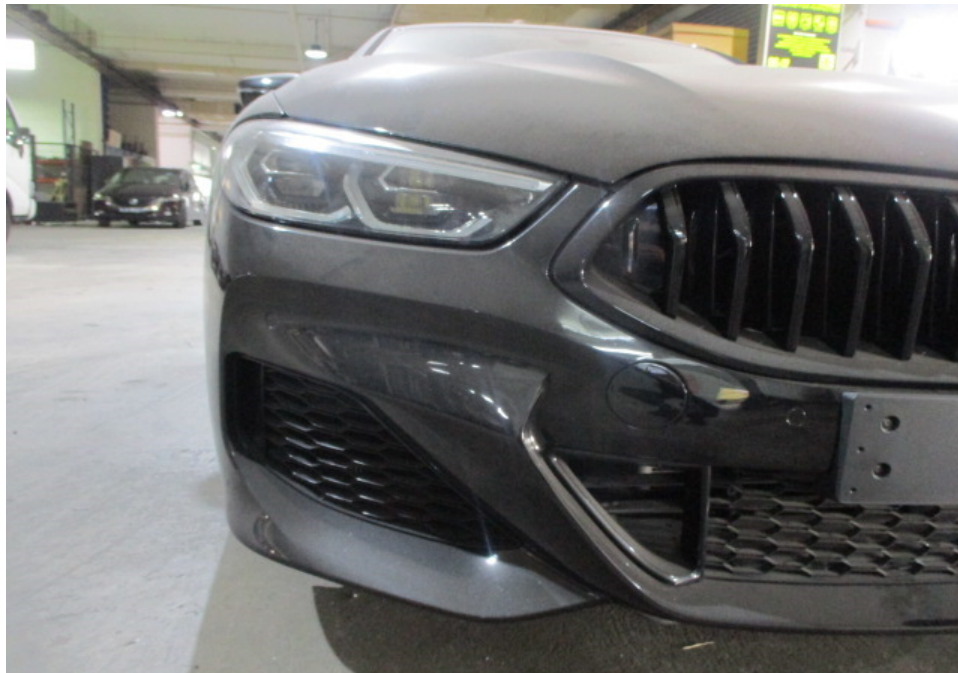
**Photo 13** shows a closer view of the Motor Car's front bumper, front bumper right lower grille and front right headlamp. The body parts at the frontal portion of the Motor Car were visually examined and it was observed that the repair/restoration works carried out to the damaged area of the Motor Car (refer to photograph 1 - 3 above) were reasonably adequate and in order.

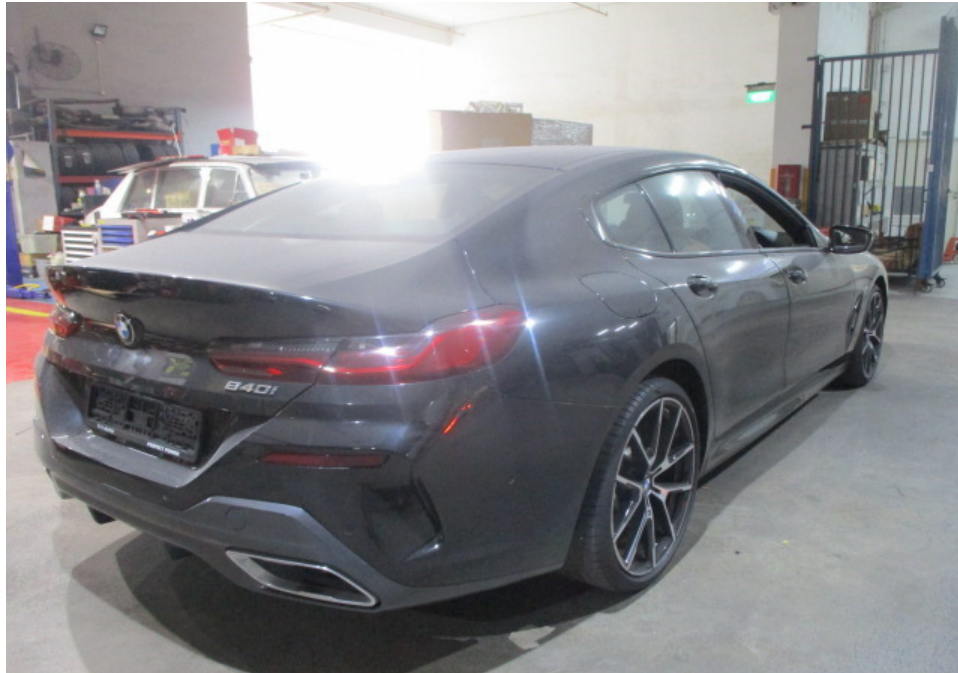
**Photo 14** shows a general view of the rear right body of the Motor Car at the time of my inspection. The Motor Car was observed to be in a relatively good general condition with no loose exterior fittings observed. The mileage of the Motor Car recorded at the time of my inspection was 23,078km.

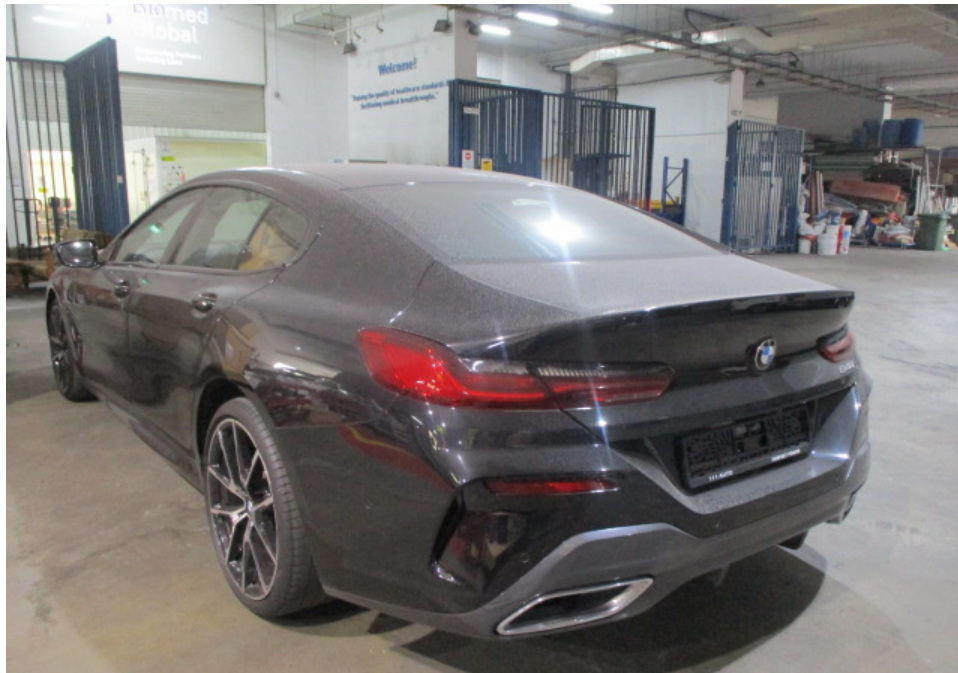
**Photo 15** shows a general view of the rear left body of the Motor Car at the time of my inspection. The Motor Car was observed to be in a relatively good general condition with no loose exterior fittings observed. The mileage of the Motor Car recorded at the time of my inspection was 23,078km.

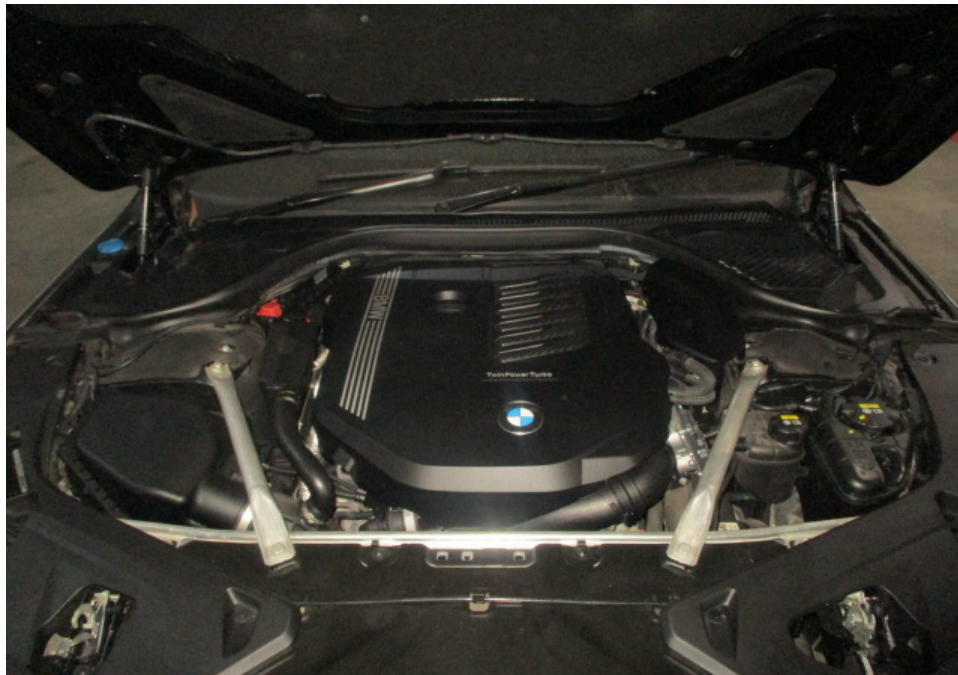
**Photo 17** shows a general view of the engine compartment of the Motor Car at the time of my inspection. The various parts and components inside the engine compartment were all observed to be intact and properly fitted. There was also no sign(s) or indication(s) of fluid leak and/or fluid stain found inside the engine compartment.

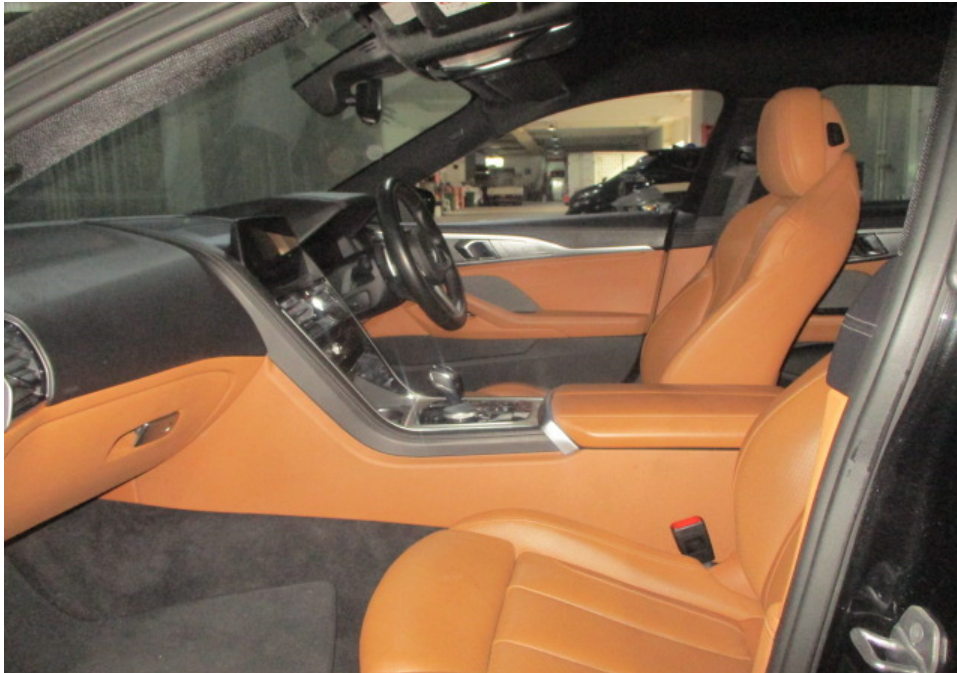
**Photo 18** shows the interior compartment of the Motor Car at the time of my inspection. The various parts and components, trims, carpet, and upholstery inside the interior compartment were all observed to be intact and properly fitted.

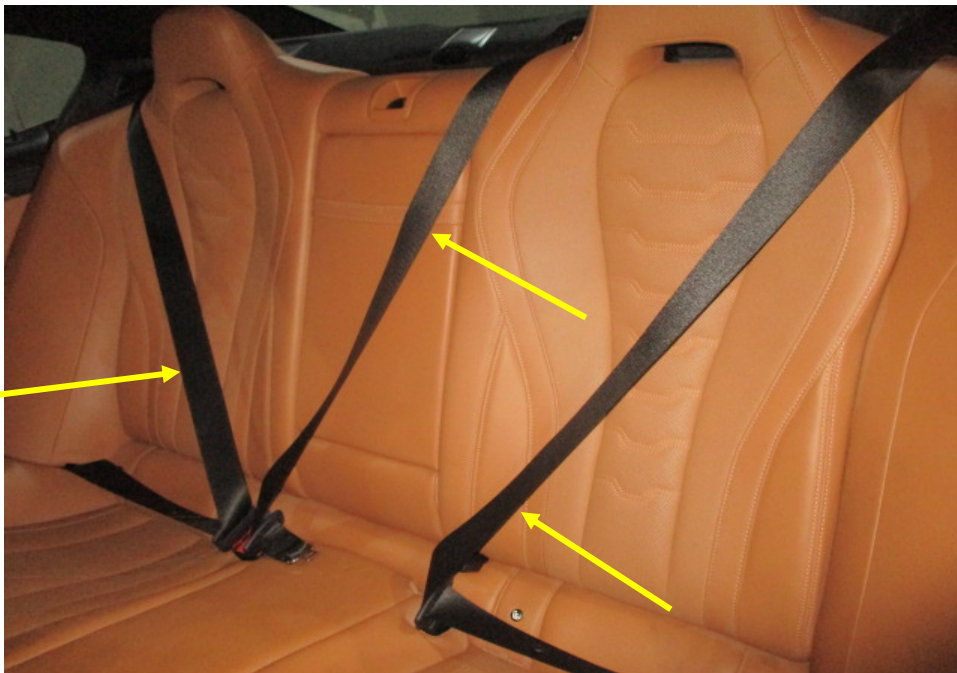
**Photo 19** shows the rear seats of the Motor Car. All the seats of the Motor Car were secured via seat rails to the floorboard. They were also fitted with a retractable seat belt reel and a pre-tensioner. The seat belts (arrowed) were tested and were able to be fastened into the respective pre-tensions that were fitted on the side of each individual seat.

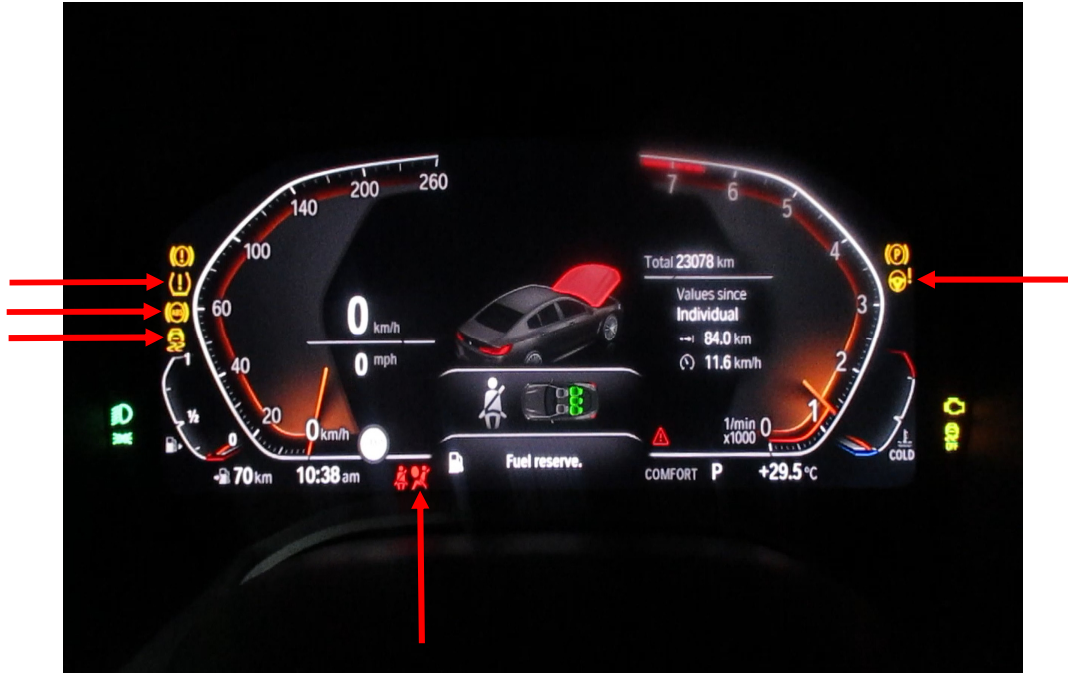
**Photo 20** shows the warning lights for the various electronic safety features appearing on the instrument panel of the Motor Car during its self-test when the engine is cranked, in particular the ABS, SRS, IAS, TPM and DSC lights (arrowed).

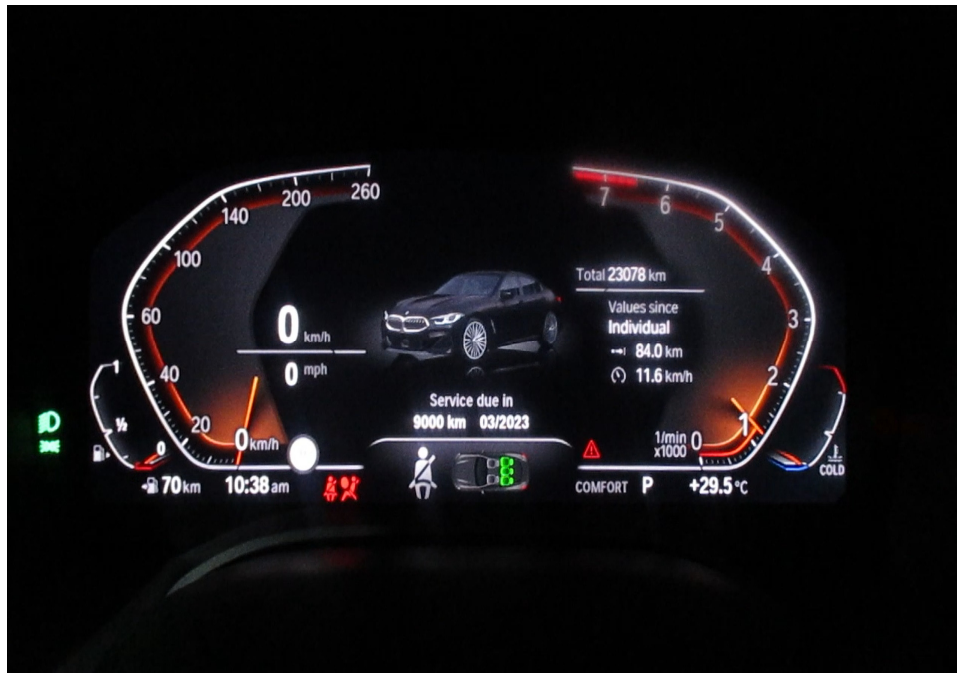
**Photo 21** shows the respective warning lights no longer illuminated, indicating that there is no fault detected to the ABS, SRS, IAS, TPM and DSC systems of the Motor Car during the self-test. These electronic systems were hence in working condition at the time of my inspection.

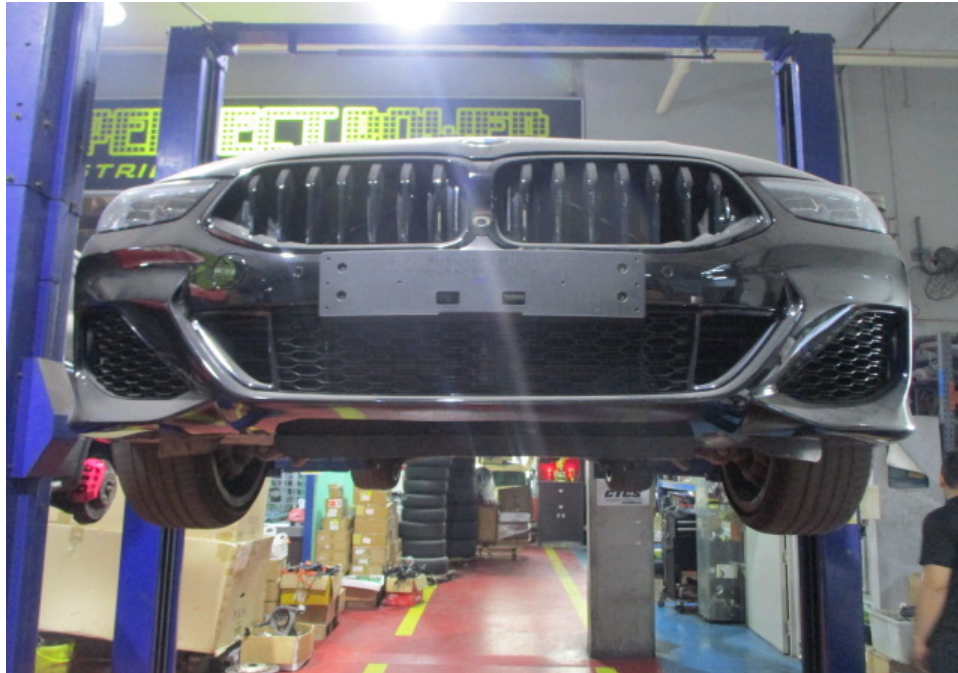
**Photo 22** shows the Motor Car hoisted up for checks on its undercarriage. There was no sign(s) or indication(s) of fluid leakage and/or fluid stain(s) on the underside of the Motor Car. The undercarriage components of the Motor Car were also all observed to be intact and secured in an appropriate manner.

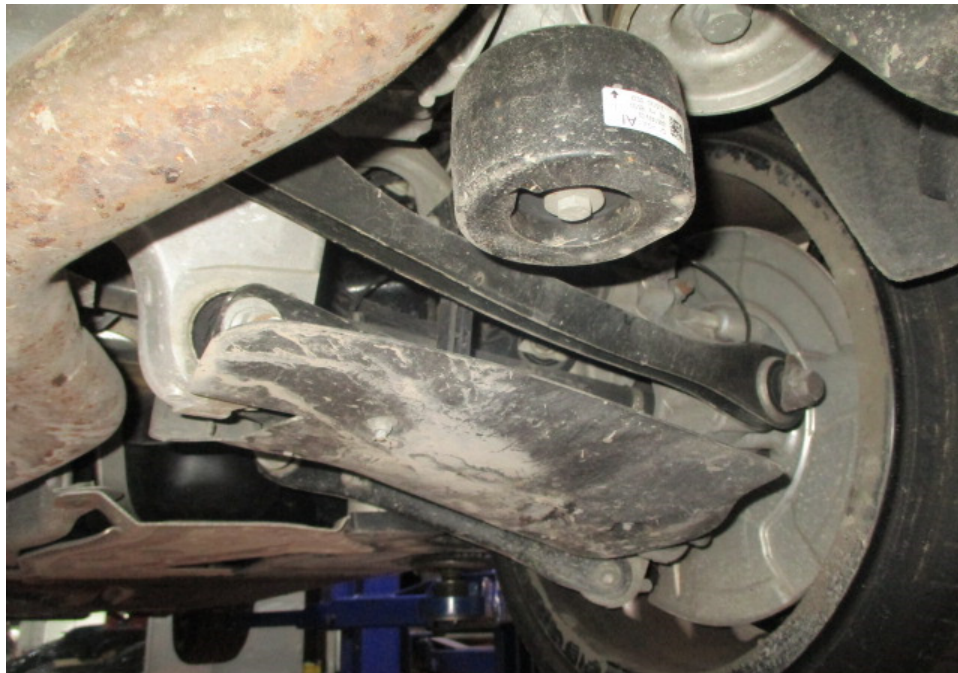
**Photo 23** shows a general view of the control arms and linkages at the rear right wheel of the Motor Car. I did not observe any fluid leak and/or fluid stain on the underside of the Motor Car. All of the Motor Car's undercarriage components were observed to be intact and secured in an appropriate manner.

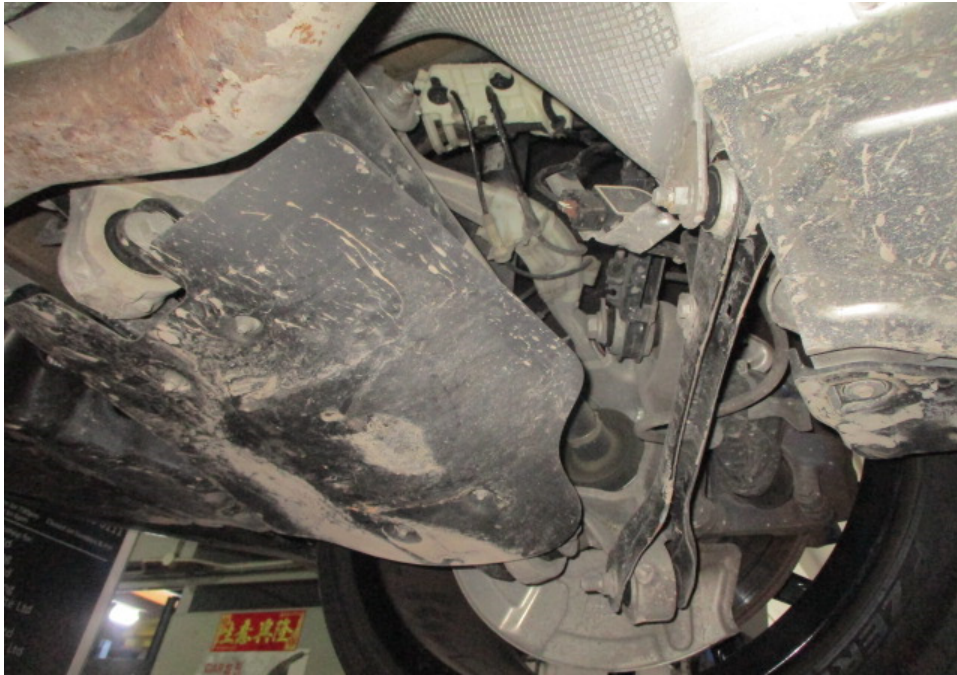
**Photo 24** shows a general view of the control arms and linkages at the rear left wheel of the Motor Car. I did not observe any fluid leak and/or fluid stain on the underside of the Motor Car. All of the Motor Car's undercarriage components were observed to be intact and secured in an appropriate manner.

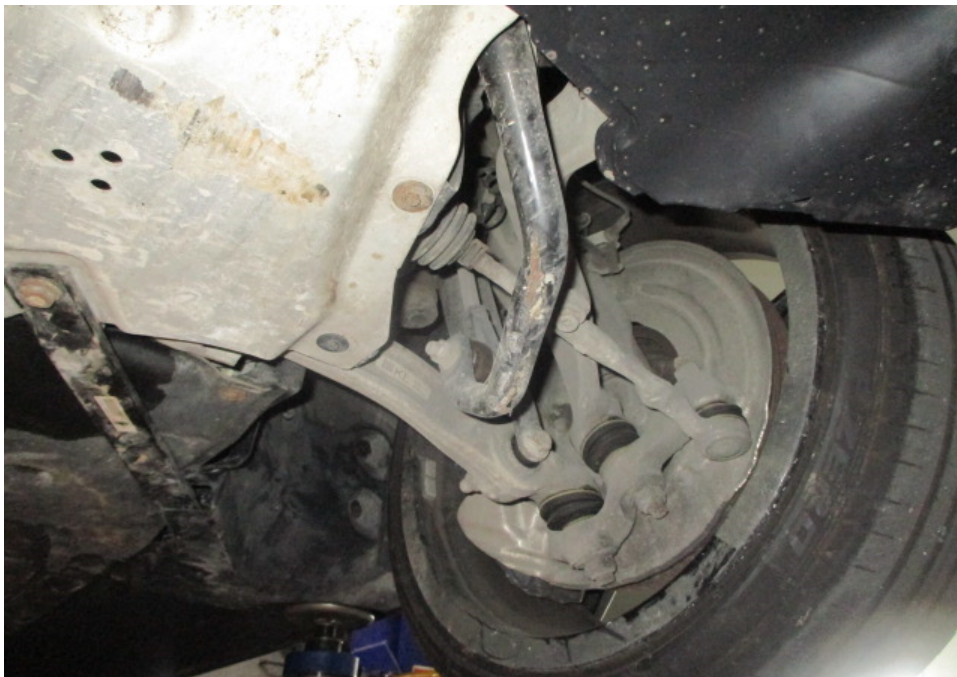
**Photo 25** shows the various undercarriage components at the front left wheel of the Motor Car. The mechanical components, control arms and linkages were all found to be intact and secured in an appropriate manner.

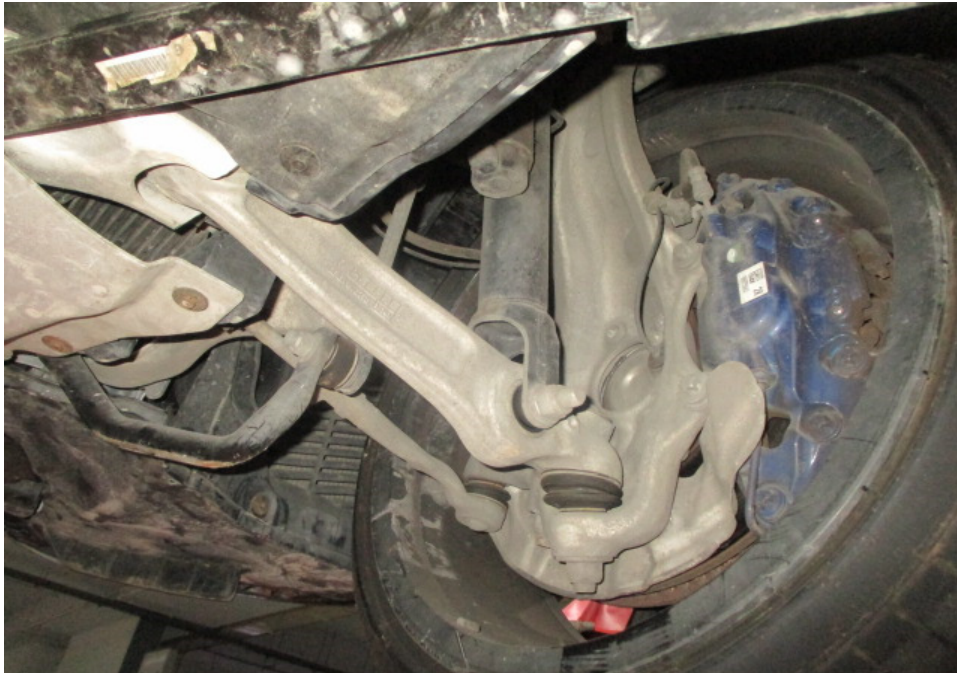
**Photo 26** shows the various undercarriage components at the front right wheel of the Motor Car. The mechanical components, control arms and linkages were all found to be intact and secured in an appropriate manner. I also did not observe any fluid leak and/or fluid stain on the underside of the Motor Car.

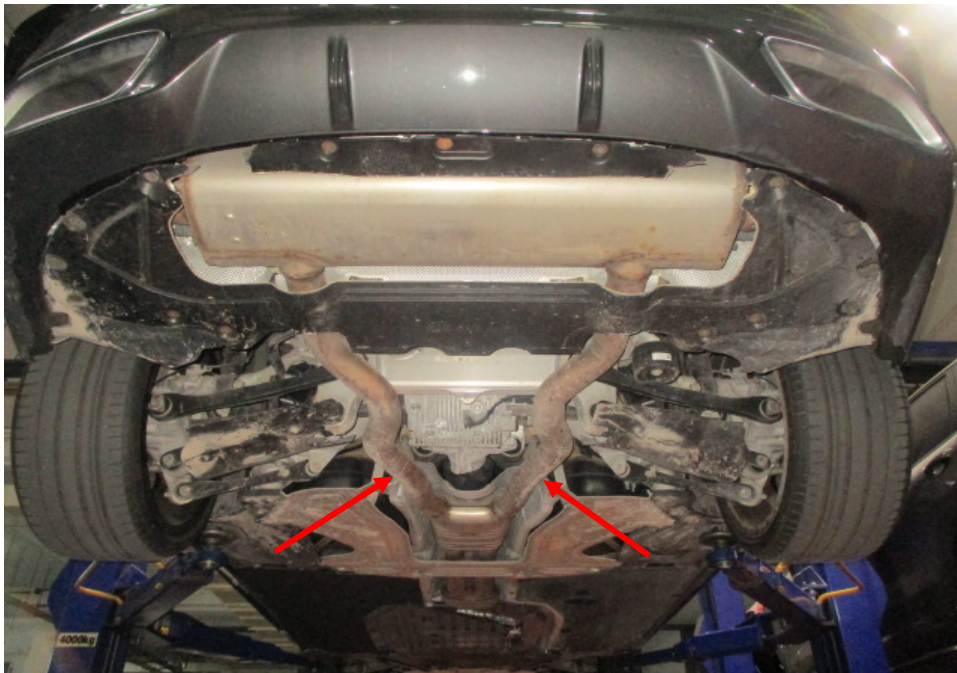
**Photo 27** shows the rear section of the Motor Car's exhaust system. My examination of the Motor Car's exhaust system revealed no sign(s) or indication(s) of any cut or weld marks along its exhaust pipes (arrowed), on its rear muffler, on its centre resonator boxes and on its catalytic converter.

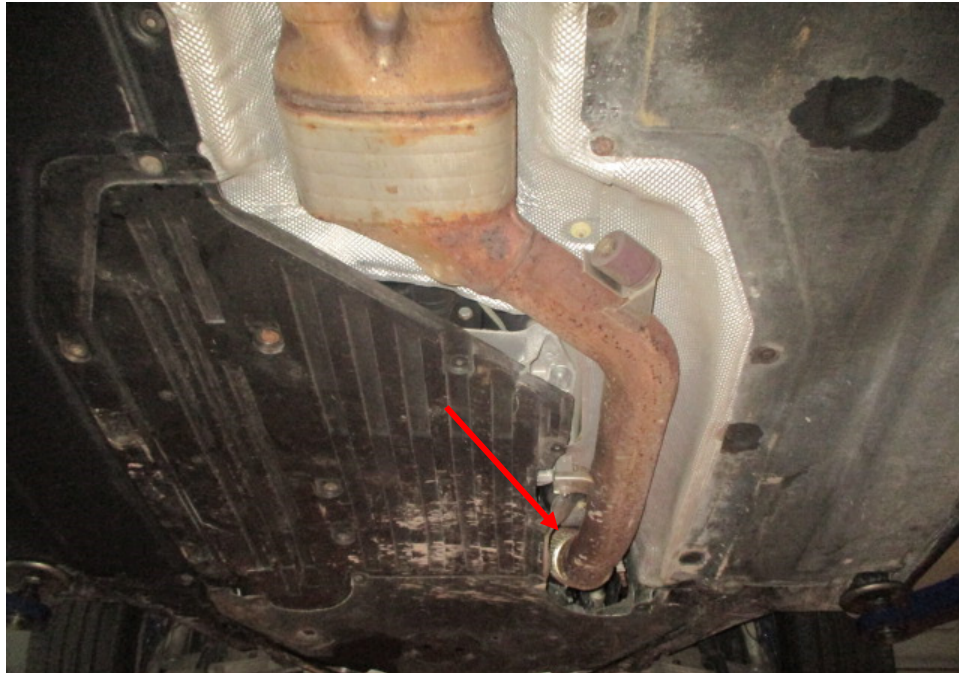
**Photo 28** shows the front section of the Motor Car's exhaust system. My examination of the Motor Car's exhaust system revealed no sign(s) or indication(s) of any cut or weld marks along its exhaust pipes, on its rear muffler, on its centre resonator boxes and on its catalytic converter (arrowed).

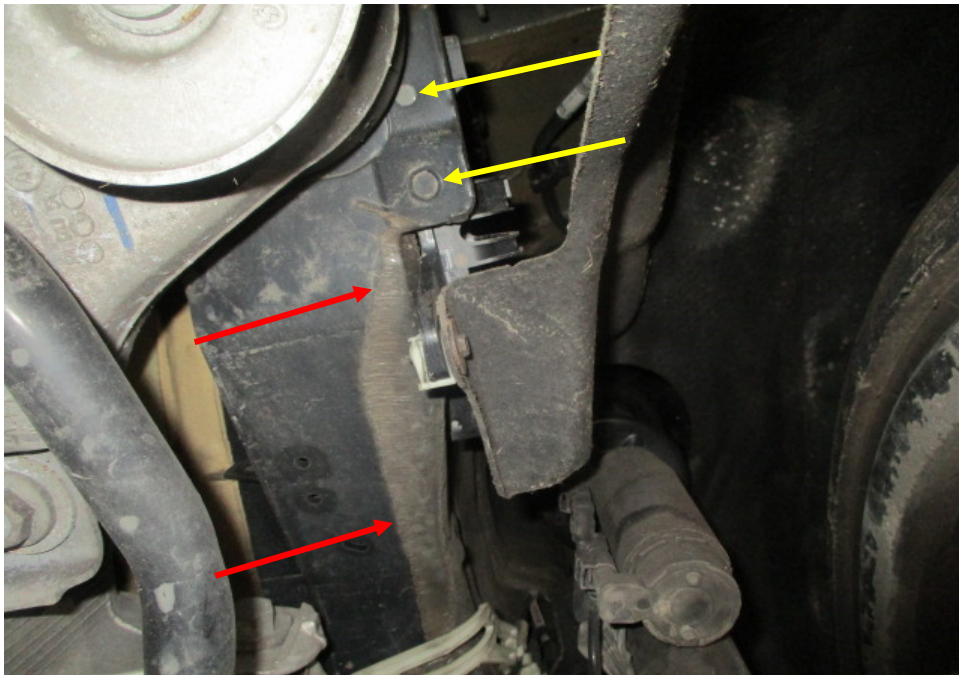
**Photo 29** shows the chassis/structural body at the underside rear right of the Motor Car. I did not find any weld marks other than original spot weld marks (yellow arrow) on the chassis/structural body of the Motor Car. The original factory sealant (red arrow) at the joints along the chassis/structural body was untouched, indicating no work was done on the chassis/structural body of the Motor Car and that the chassis/structural body was originally fitted.

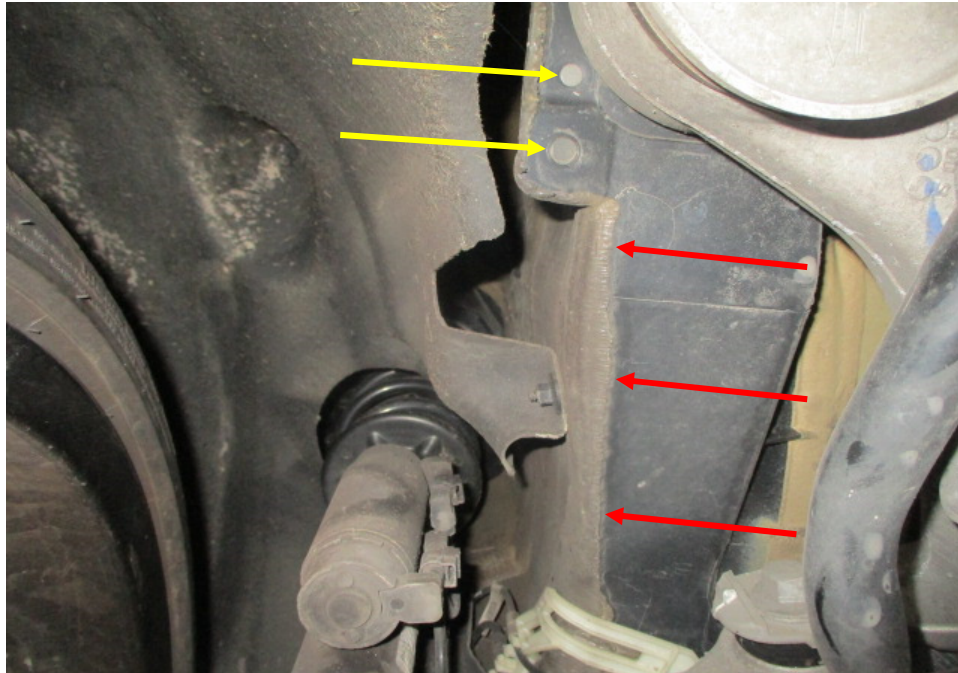
**Photo 30** shows the chassis/structural body at the underside rear left of the Motor Car. I did not find any weld marks other than original spot weld marks (yellow arrow) on the chassis/structural body of the Motor Car. The original factory sealant (red arrow) at the joints along the chassis/structural body was untouched, indicating no work was done on the chassis/structural body of the Motor Car and that the chassis/structural body was originally fitted.

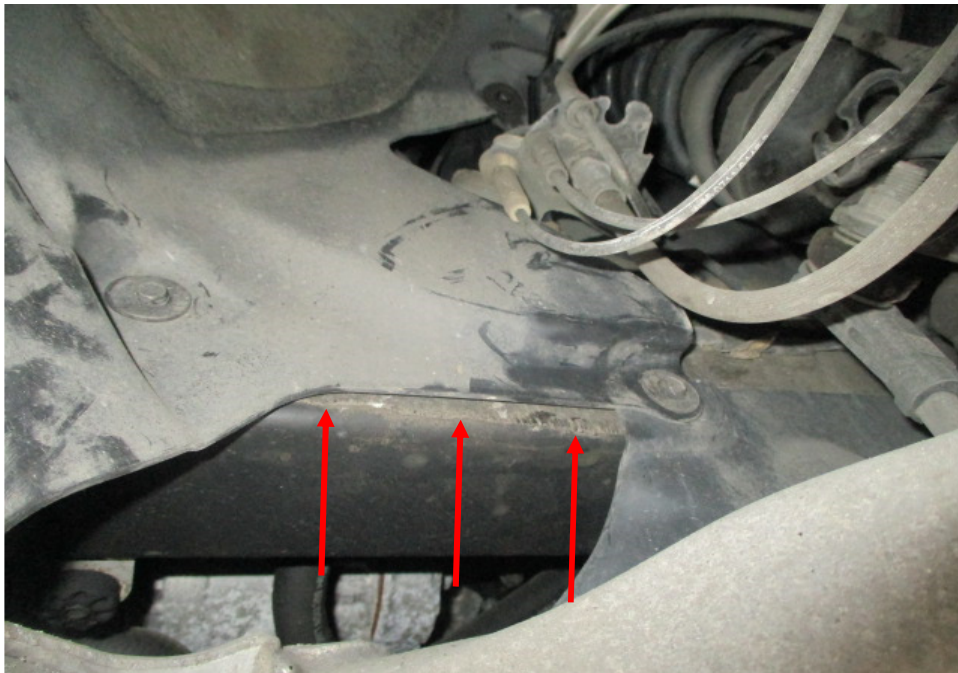
**Photo 31** shows the chassis/structural body at the underside front left of the Motor Car. The original factory sealant (arrowed) at the joints along the chassis/structural body was observed to be untouched. In general, I had found no work was carried out on the chassis/structural body of the Motor Car. The chassis/structural body of the Motor Car was originally fitted.
