Your Ref: BMW 840i  
(chassis number WBAGV220X0CE33235)  
Our Ref : CI/TP23000530/D

16 January 2023

**INSPECTION REPORT OF AN UNREGISTERED BMW 840i MOTOR CAR  
WITH CHASSIS NUMBER WBAGV220X0CE33235**

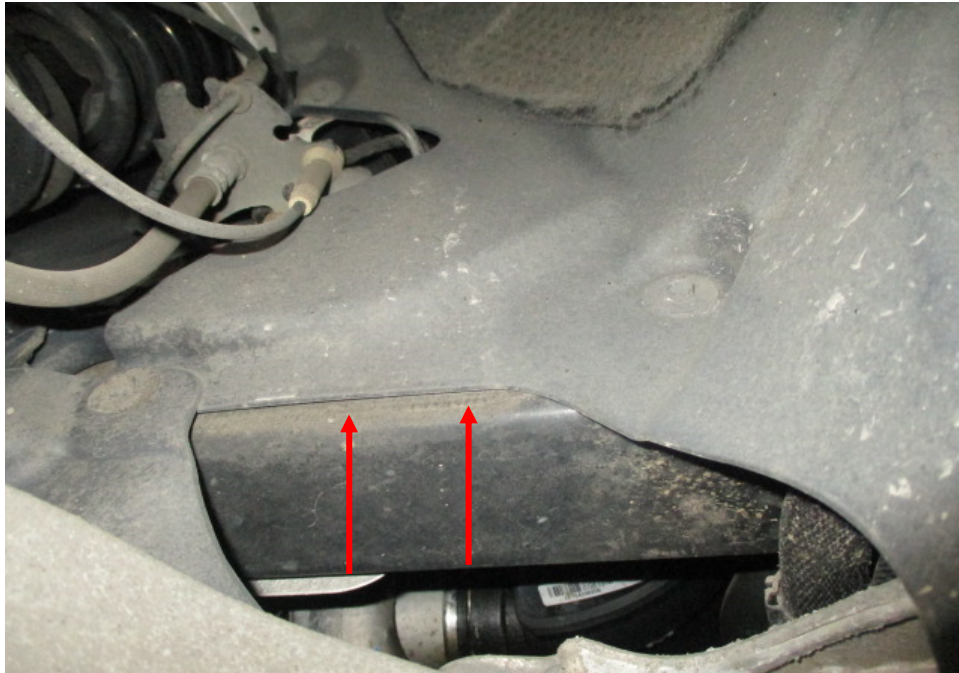
**Photo 32** shows the chassis/structural body at the underside front right of the Motor Car. The original factory sealant (arrowed) at the joints along the chassis/structural body was observed to be untouched. In general, I had found no work was carried out on the chassis/structural body of the Motor Car. The chassis/structural body of the Motor Car was originally fitted.

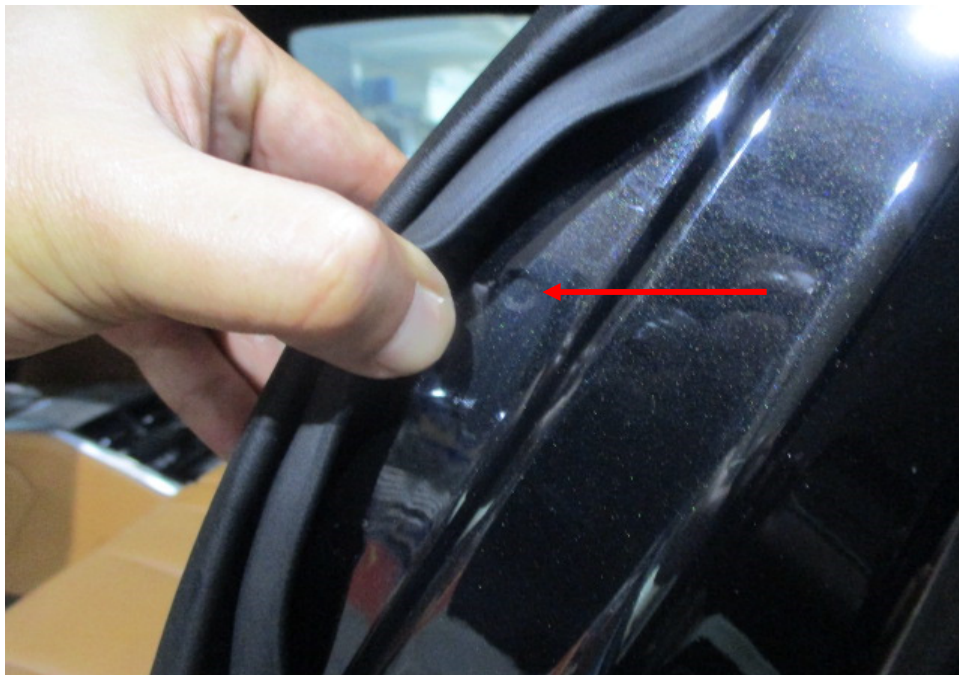
**Photo 33** shows the left side "C" pillar of the Motor Car. I did not find any weld marks other than original spot weld marks (arrowed) on the left side "C" pillar of the Motor Car, which indicates that there was no re-welding works carried out. In general, I had found all the non-detachable body panels of the Motor Car to be originally fitted at the time of my inspection.

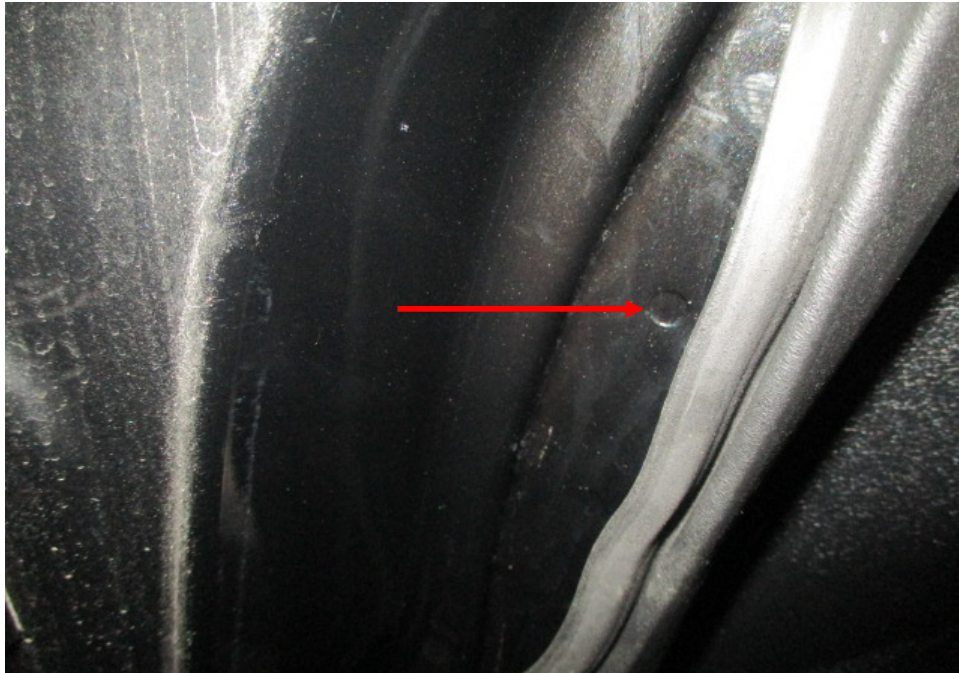
**Photo 34** shows the left side "A" pillar of the Motor Car. I did not find any weld marks other than original spot weld marks (arrowed) on the left side "A" pillar of the Motor Car, which indicates that there was no re-welding works carried out. In general, I had found all the non-detachable body panels of the Motor Car to be originally fitted at the time of my inspection.

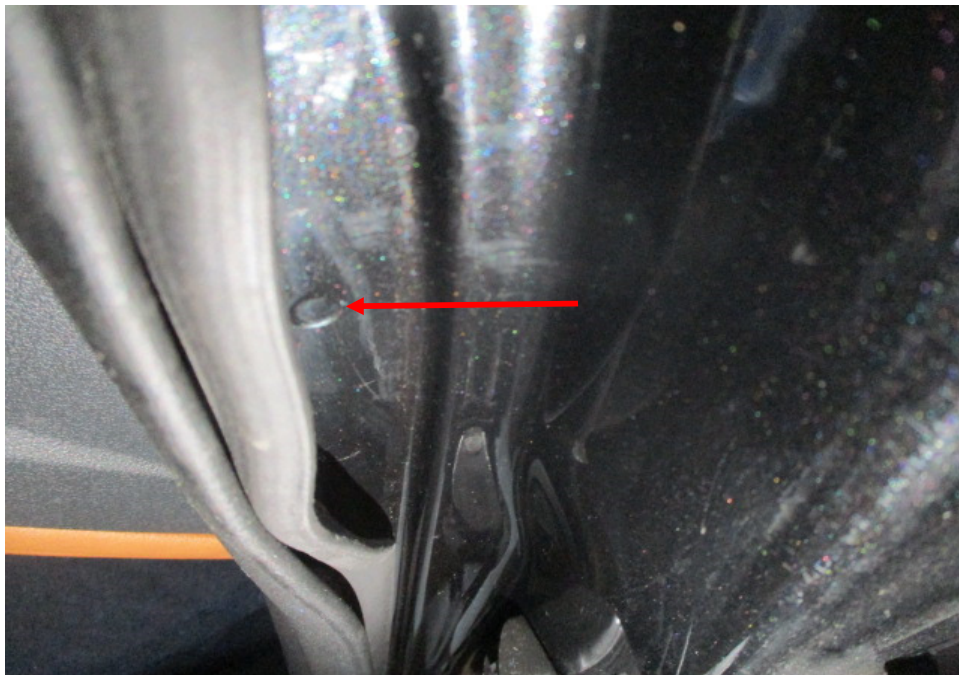
**Photo 35** shows the right side "A" pillar of the Motor Car. I did not find any weld marks other than original spot weld marks (arrowed) on the right side "A" pillar of the Motor Car, which indicates that there was no re-welding works carried out. In general, I had found all the non-detachable body panels of the Motor Car to be originally fitted at the time of my inspection.

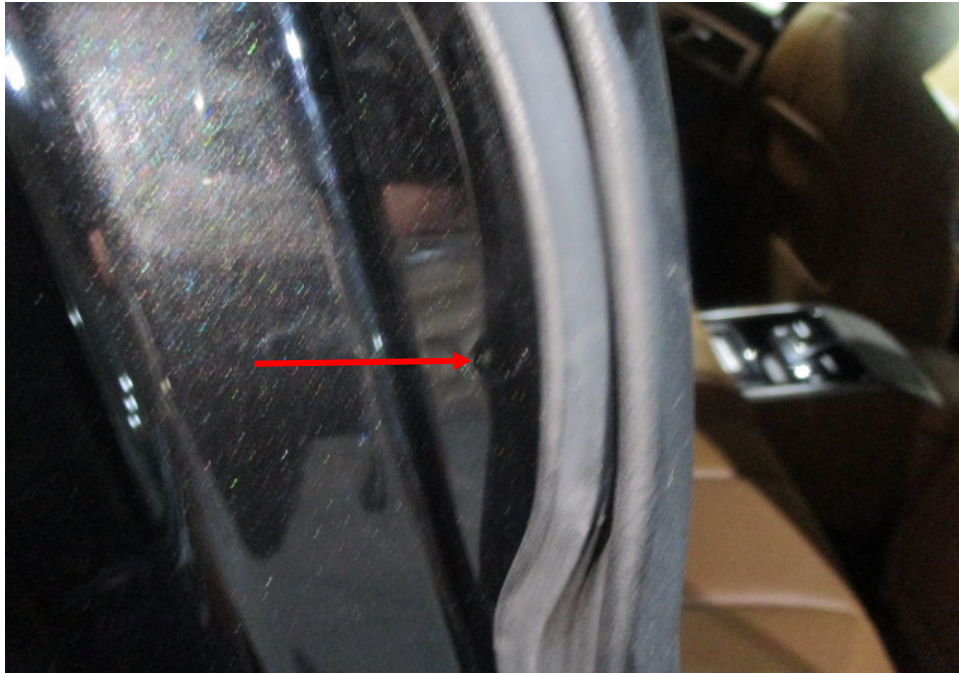
**Photo 36** shows the right side "C" pillar of the Motor Car. I did not find any weld marks other than original spot weld marks (arrowed) on the right side "C" pillar of the Motor Car, which indicates that there was no re-welding works carried out. In general, I had found all the non-detachable body panels of the Motor Car to be originally fitted at the time of my inspection.
