Your Ref: Honda Engine

(number L13A4068140)

Our Ref : CI/TP23000587/D

INSPECTION REPORT OF A HONDA ENGINE WITH NUMBER L13A4068140

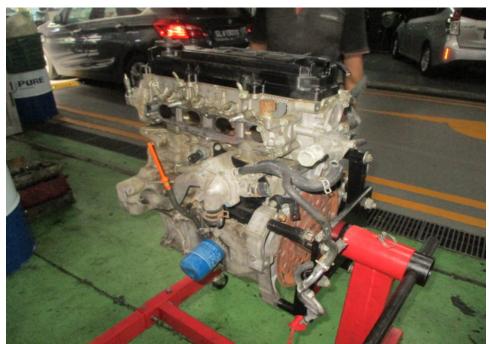
Photo 1 shows a general view of the Honda engine that I had inspected. The Honda engine was observed to be a used engine and was not fitted on any motor car. It was also observed to be a complete assembly with all mechanical parts still intact, within the engine housing.

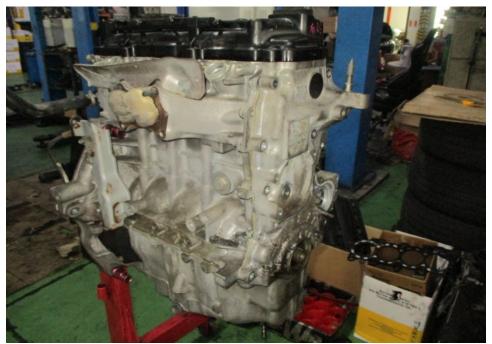
Photo 2 shows another view of the Honda engine that I had inspected. My visual examination of the engine housing revealed the housing to be of serviceable/satisfactory condition. There was no crack and/or hole observed on the engine housing.

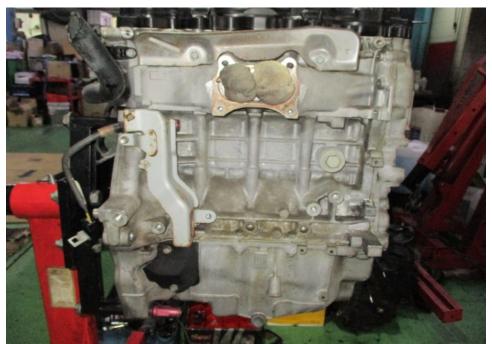
Photo 3 shows a closer view of the Honda engine that I had inspected. My visual examination of the engine housing revealed the housing to be of serviceable/satisfactory condition. There was no crack and/or hole observed on the engine housing.

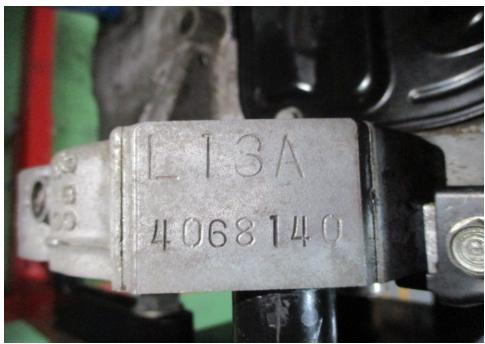
Photo 4 shows the engine number engraved on the housing of the Honda engine that I had inspected. The engine number was L13A4068140.

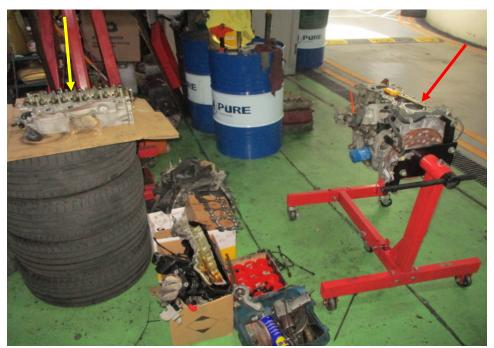
Photo 5 shows the top block (yellow arrow) of the Honda engine separated from its bottom block (red arrow). This was to enable me to carry out measurements of its cylinders, in particular the bore and stroke measurements of each cylinder, which typically can be used to determine the engine displacement or more commonly referred to as engine cc.

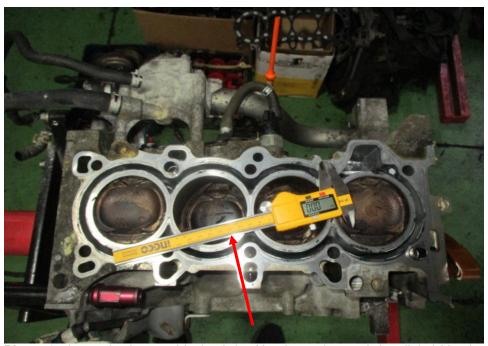
Photo 6 shows the bottom block of the Honda engine and the digital Vernier Caliper (arrowed) that was used to measure the bore and stroke measurements of each cylinder, which typically can be used to determine the engine displacement or more commonly referred to as engine cc. The digital Vernier Caliper was calibrated before the start of the measurements.

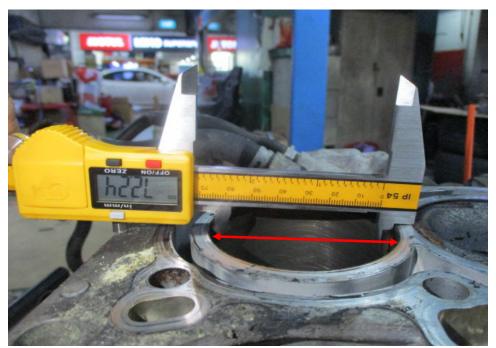
Photo 7 shows measurement being carried out to the bore (arrowed) of cylinder 1 of the Honda engine. The bore measurement of cylinder 1 was recorded to be 72.24mm.

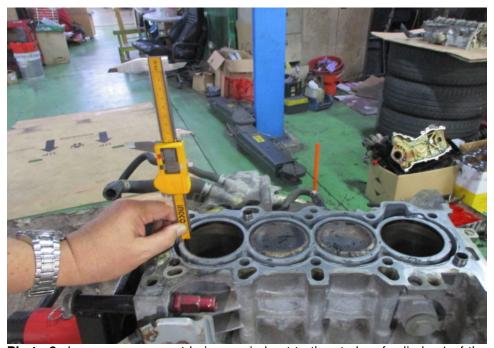
Photo 8 shows measurement being carried out to the stroke of cylinder 1 of the Honda engine. The bore and stroke measurements of the Honda engine were carried out using a digital Vernier Caliper that was calibrated before the start of the measurements.

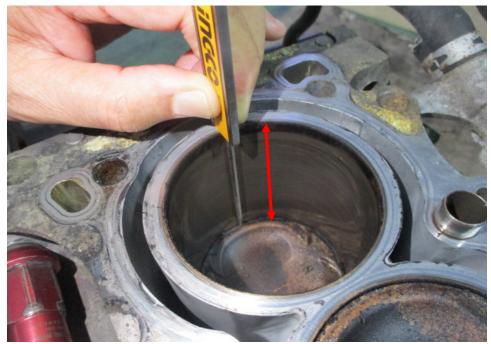
Photo 9 shows measurement being carried out to the stroke (arrowed) of cylinder 1 of the Honda engine. The bore and stroke measurements of the Honda engine were carried out using a digital Vernier Caliper that was calibrated before the start of the measurements.

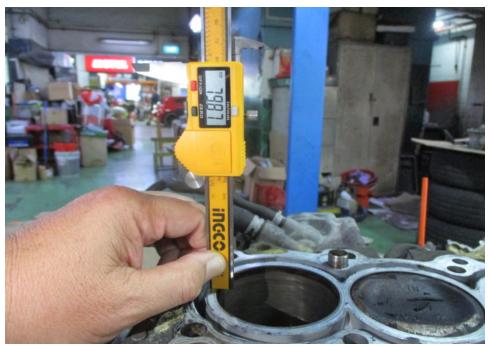
Photo 10 shows the stroke measurement of cylinder 1, which was recorded to be 79.87mm.

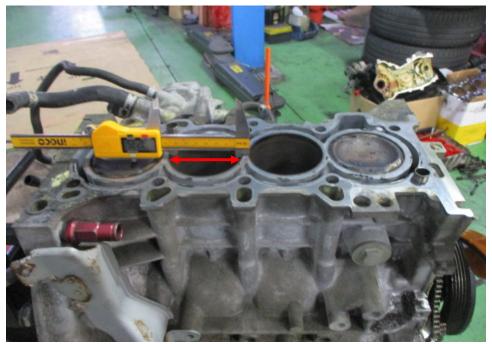
Photo 11 shows measurement being carried out to the bore (arrowed) of cylinder 2 of the Honda engine. The bore and stroke measurements of the Honda engine were carried out using a digital Vernier Caliper that was calibrated before the start of the measurements.

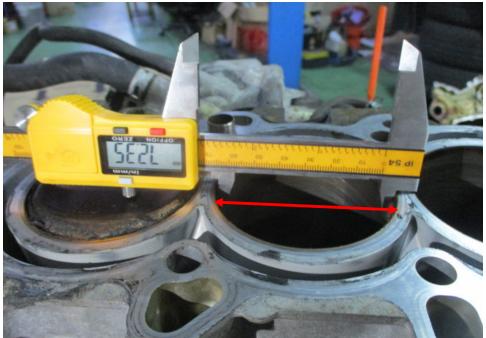
Photo 12 shows measurement being carried out to the bore (arrowed) of cylinder 2 of the Honda engine. The bore measurement of cylinder 2 was recorded to be 72.35mm.

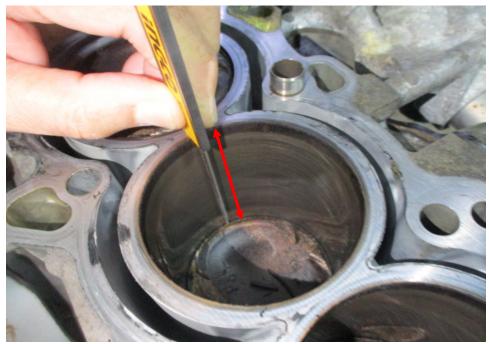
Photo 13 shows measurement being carried out to the stroke (arrowed) of cylinder 2 of the Honda engine. The bore and stroke measurements of the Honda engine were carried out using a digital Vernier Caliper that was calibrated before the start of the measurements.

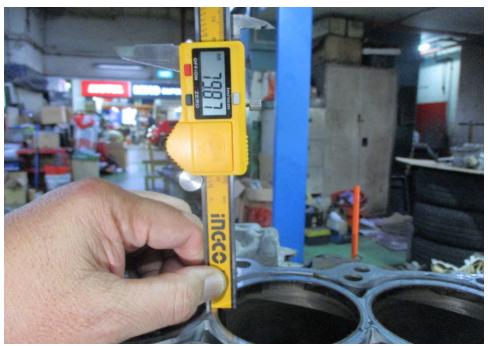
Photo 14 shows the stroke measurement of cylinder 2, which was recorded to be 79.87mm.

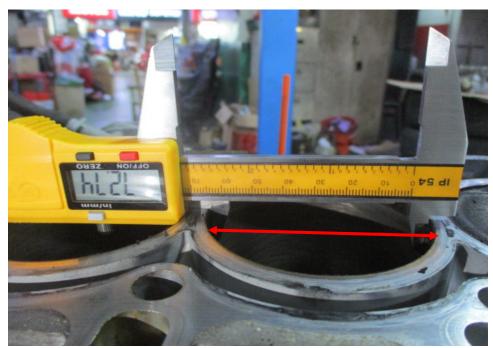
Photo 15 shows measurement being carried out to the bore (arrowed) of cylinder 3 of the Honda engine. The bore measurement of cylinder 3 was recorded to be 72.74mm.

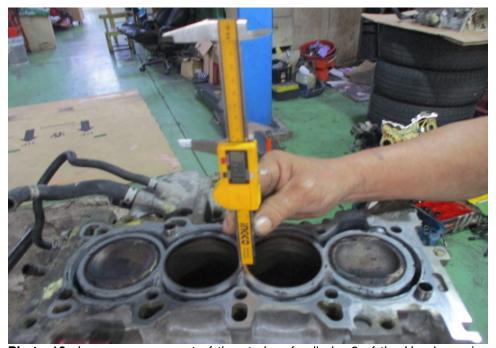
Photo 16 shows measurement of the stroke of cylinder 3 of the Honda engine that I had inspected. The bore and stroke measurements of the Honda engine were carried out using a digital Vernier Caliper that was calibrated before the start of measurements.

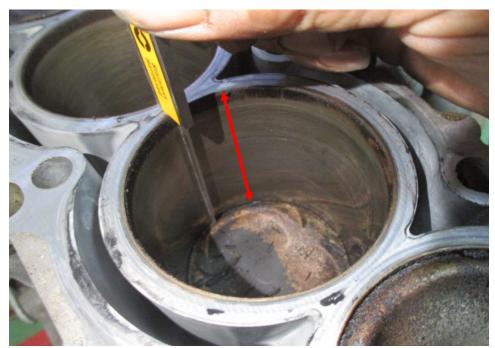
Photo 17 shows measurement being carried out to the stroke (arrowed) of cylinder 3 of the Honda engine. The bore and stroke measurements of the Honda engine were carried out using a digital Vernier Caliper that was calibrated before the start of the measurements.

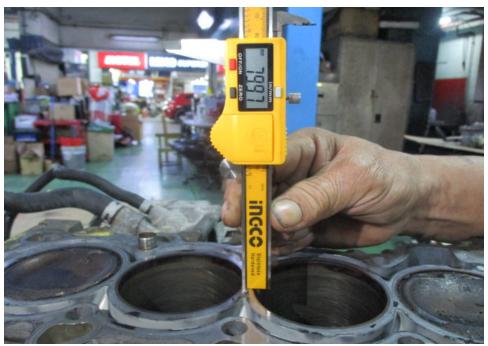
Photo 18 shows the stroke measurement of cylinder 3, which was recorded to be 79.97mm.

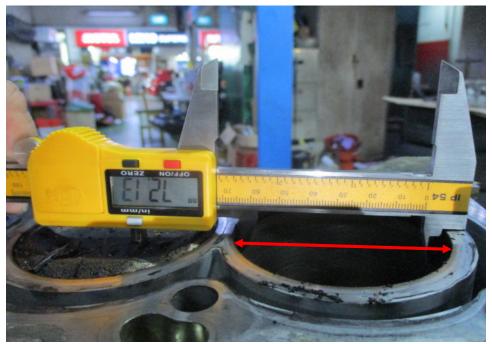
Photo 19 shows measurement being carried out to the bore (arrowed) of cylinder 4 of the Honda engine. The bore measurement of cylinder 4 was recorded to be 72.13mm.

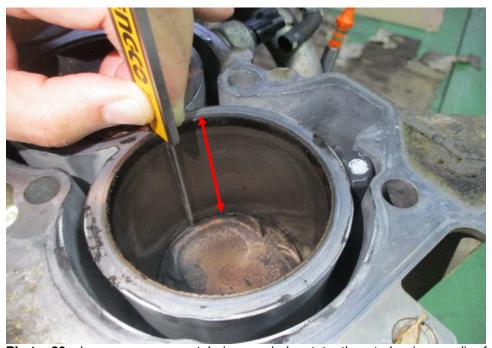
Photo 20 shows measurement being carried out to the stroke (arrowed) of cylinder 4 of the Honda engine. The bore and stroke measurements of the Honda engine were carried out using a digital Vernier Caliper that was calibrated prior to the start of measurements.

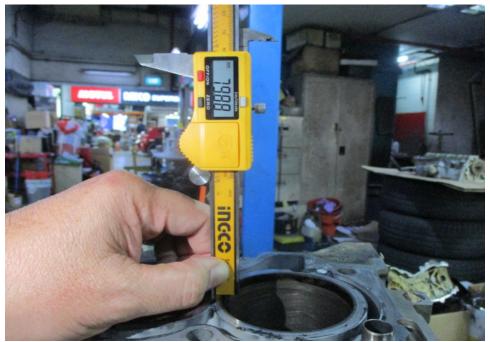
Photo 21 shows the stroke measurement of cylinder 4, which was recorded to be 79.88mm.
