Your Ref: McLaren GT  
(chassis number SBM22GCCXNW001704)  
Our Ref : CI/TP23000593/D

**INSPECTION REPORT OF AN UNREGISTERED MCLAREN GT MOTOR CAR  
WITH CHASSIS NUMBER SBM22GCCXNW001704**

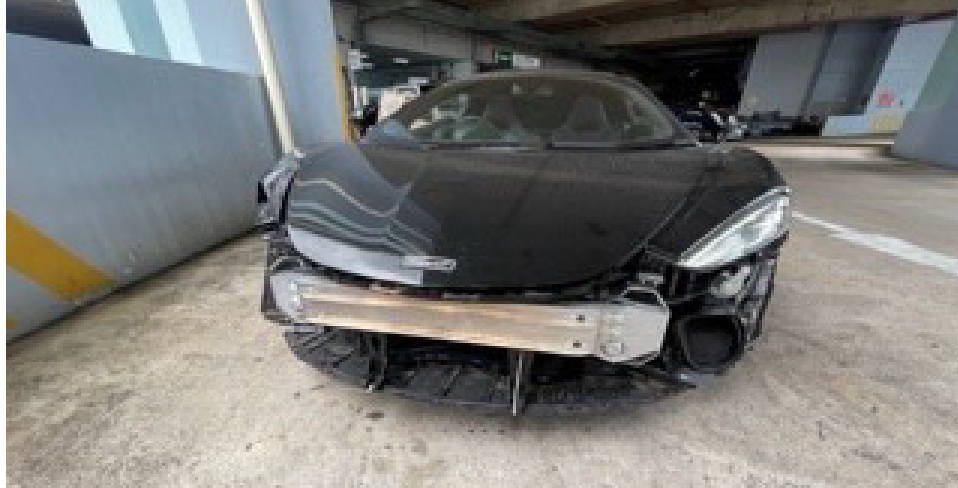
**Photo 1** shows the frontal body of the Motor Car (photograph provided to me). The photographs provided to me had showed damage to the frontal portion of the Motor Car. The front bumper reinforcement, front right headlamp and front right fender were amongst the body parts that were observed to have been damaged. The Motor Car's front bumper and all its related parts and attachments like the front bumper lower cover, front bumper sensors, front bumper tow cover, front bumper right air duct and front bumper left reflector amongst others, were also observed to be missing/dislodged/damaged.

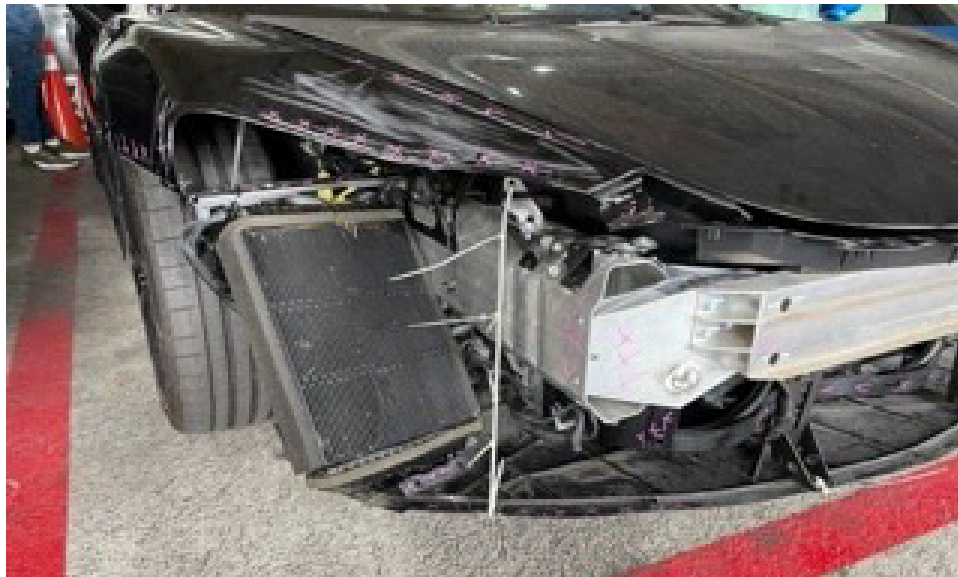
**Photo 2** shows the front right body of the Motor Car (photograph provided to me). The photographs provided to me had showed damage to the frontal portion of the Motor Car. The front bumper reinforcement, front right headlamp and front right fender were amongst the body parts that were observed to have been damaged. The Motor Car's front right fender inner shield, front bumper and all its related parts and attachments like the front bumper lower cover, front bumper sensors, front bumper right air duct and front bumper right reflector amongst others, were also observed to be missing/dislodged/damaged.

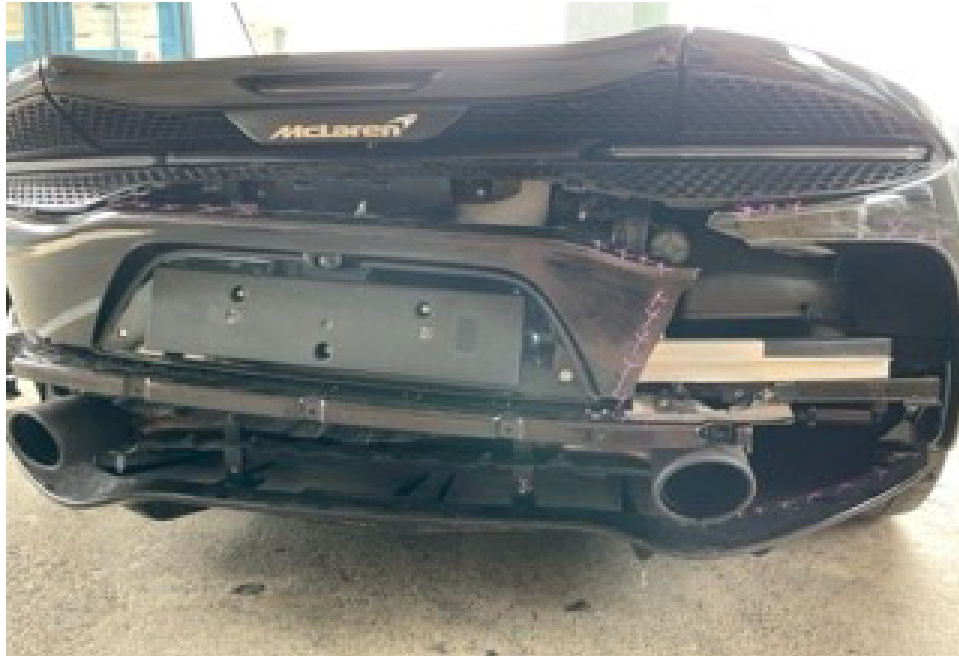
**Photo 3** shows the rear body of the Motor Car (photograph provided to me). Apart for the frontal portion, I had also observed damage to the rear portion of the Motor Car. Body parts damage at the rear portion include the rear bumper amongst others. The rear bumper lower cover, rear bumper lower diffuser, rear bumper sensors, rear bumper right grille and rear bumper right reflector amongst others, were also observed to be missing/dislodged/damaged.

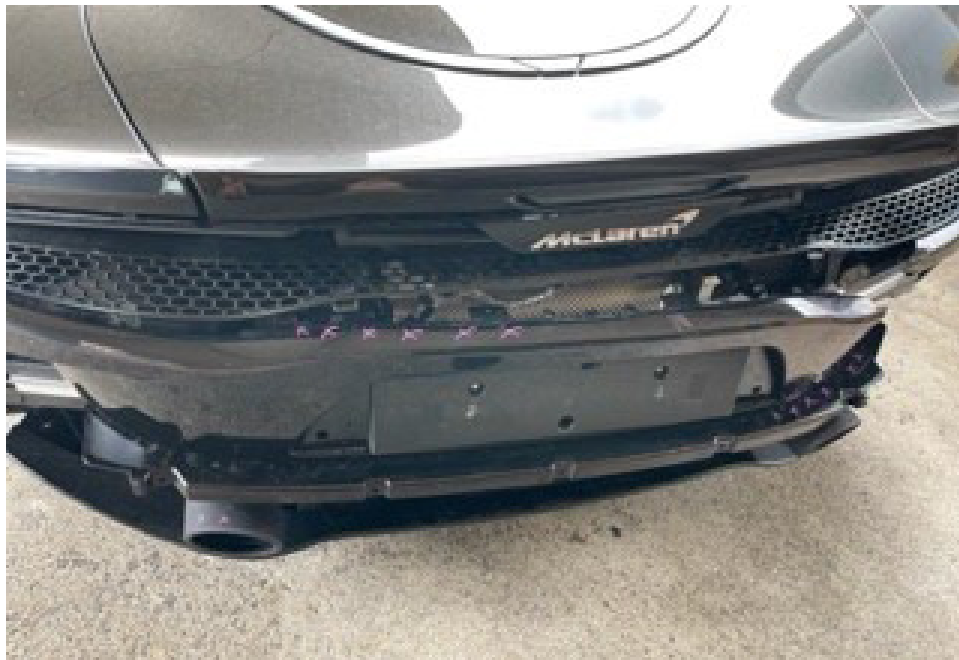
**Photo 4** shows another view of the Motor Car's rear body (photograph provided to me). Apart for the frontal portion, I had also observed damage to the rear portion of the Motor Car. Body parts damage at the rear portion include the rear bumper amongst others. The rear bumper lower cover, rear bumper lower diffuser, rear bumper sensors, rear bumper left grille and rear bumper left reflector amongst others, were also observed to be missing/dislodged/damaged.

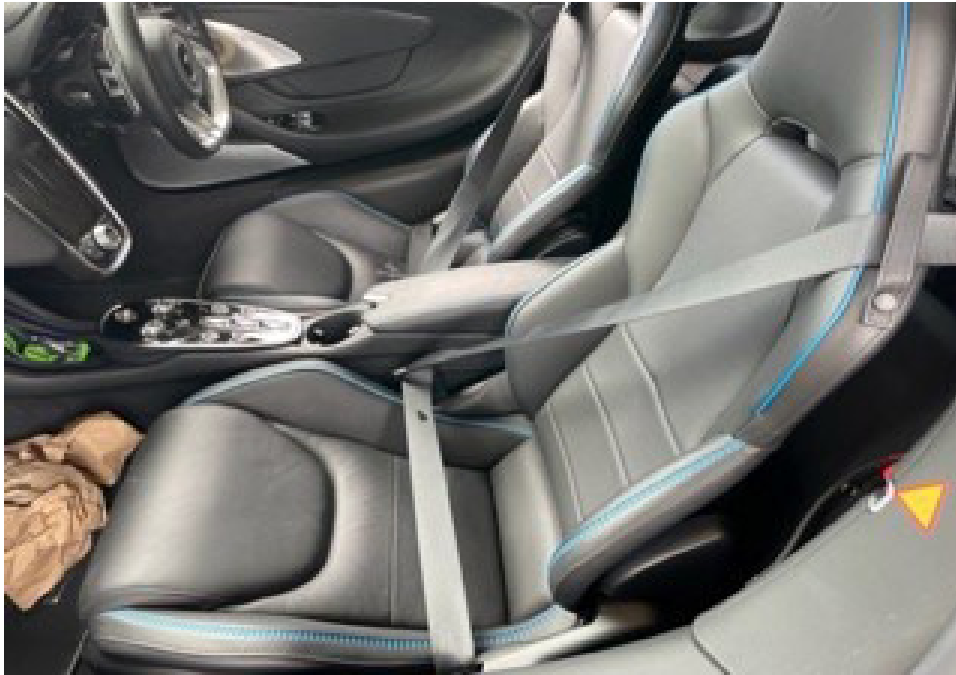
**Photo 5** shows the interior compartment of the Motor Car (photograph provided to me). The various parts and components within the interior compartment were all intact and unaffected. The Motor Car's airbag(s) was not deployed as seen from the photographs that were provided to me.

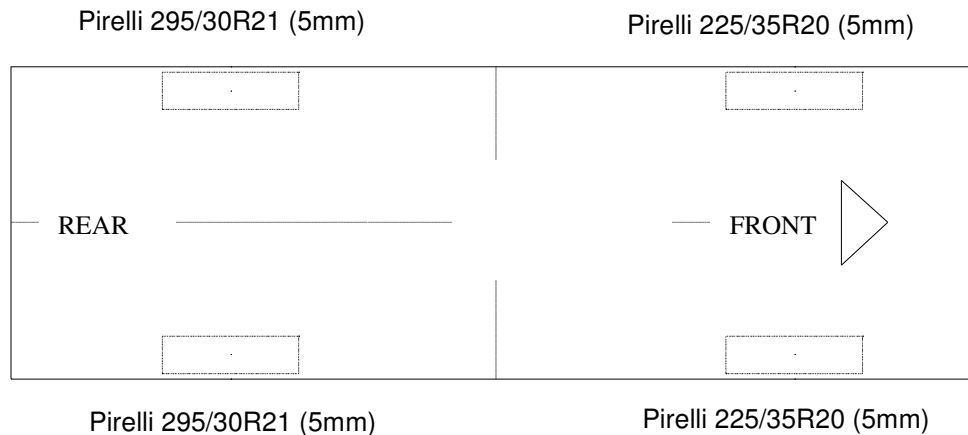
9. It was fitted with 20inch (front) and 21inch (rear) sport wheel rims that were wrapped with tyres that were observed to be of serviceable condition. The tyres were also sufficiently inflated for vehicular operation. The tyre brand, tyre size and approximate remaining tread depth of the 4 tyres of the Motor Car were recorded as follows: -

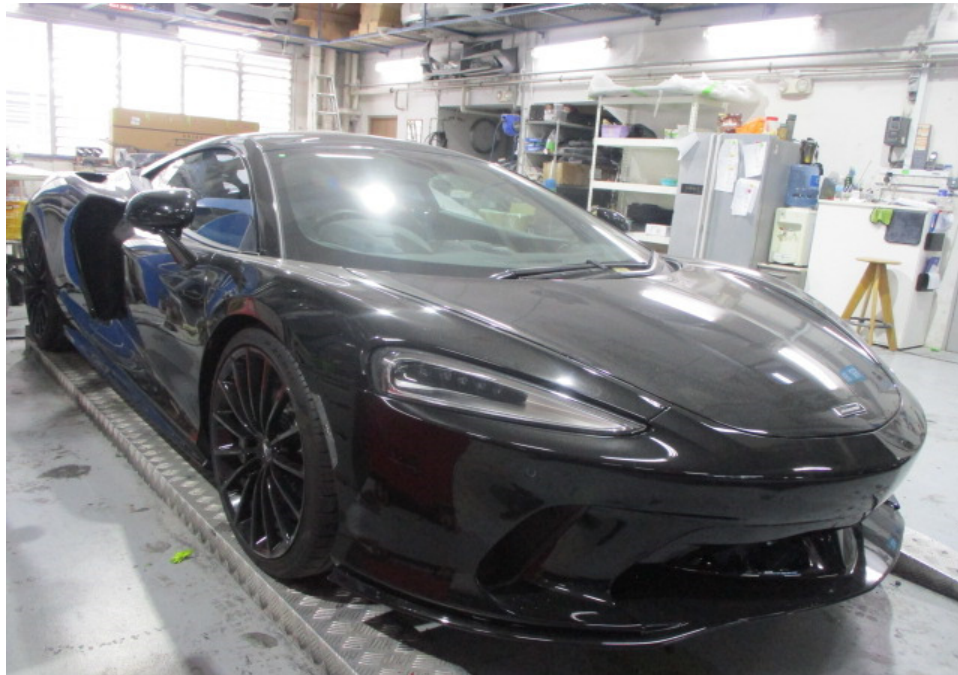
**Photo 6** shows a general view of the front right body of the Motor Car at the time of my inspection. The Motor Car was observed to be in a relatively good general condition with no loose exterior fittings observed. The body parts at the frontal portion of the Motor Car were visually examined and it was observed that the repair/restoration works carried out to the damaged area of the Motor Car (refer to photograph 1 & 2 above) were reasonably adequate and in order.

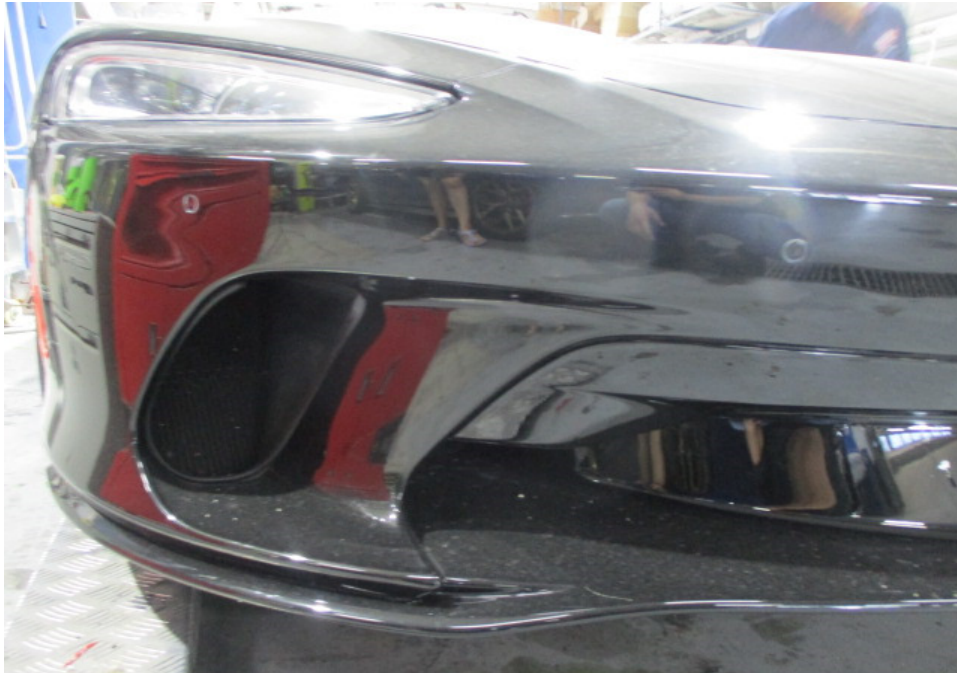
**Photo 7** shows a closer view of the Motor Car's front bumper, front bumper lower cover, front bumper sensors, front bumper right air duct and front right headlamp at the time of my inspection. The body parts at the frontal portion of the Motor Car were visually examined and it was observed that the repair/restoration works carried out to the damaged area of the Motor Car (refer to photograph 1 & 2 above) were reasonably adequate and in order.

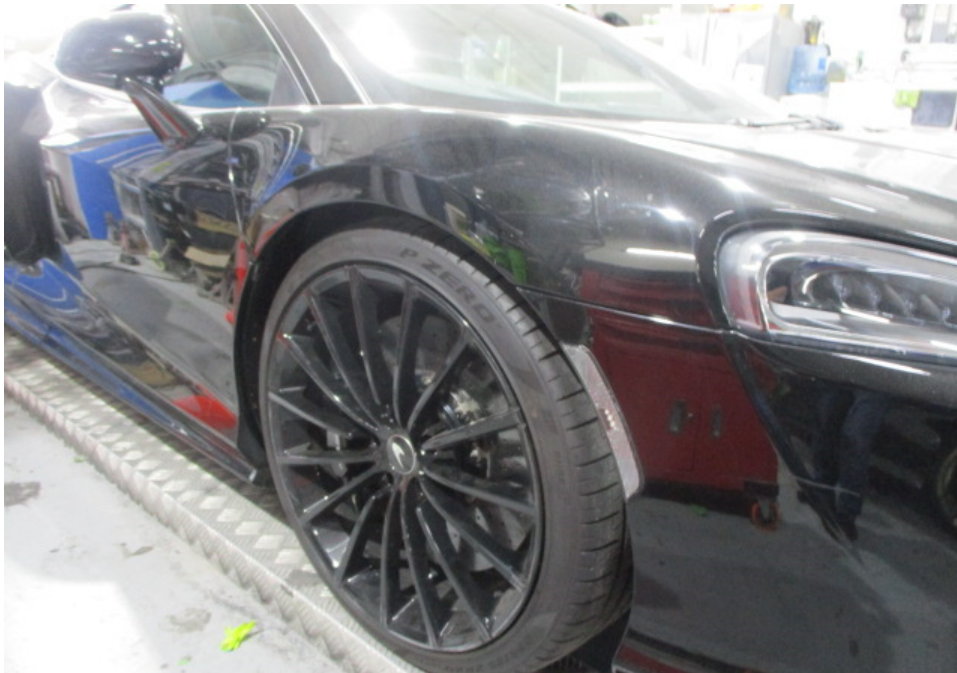
**Photo 8** shows a closer view of the Motor Car's front bumper right reflector, front right fender and front right wheel rim. The body parts at the frontal portion of the Motor Car were visually examined and it was observed that the repair/restoration works carried out to the damaged area of the Motor Car (refer to photograph 1 & 2 above) were reasonably adequate and in order.

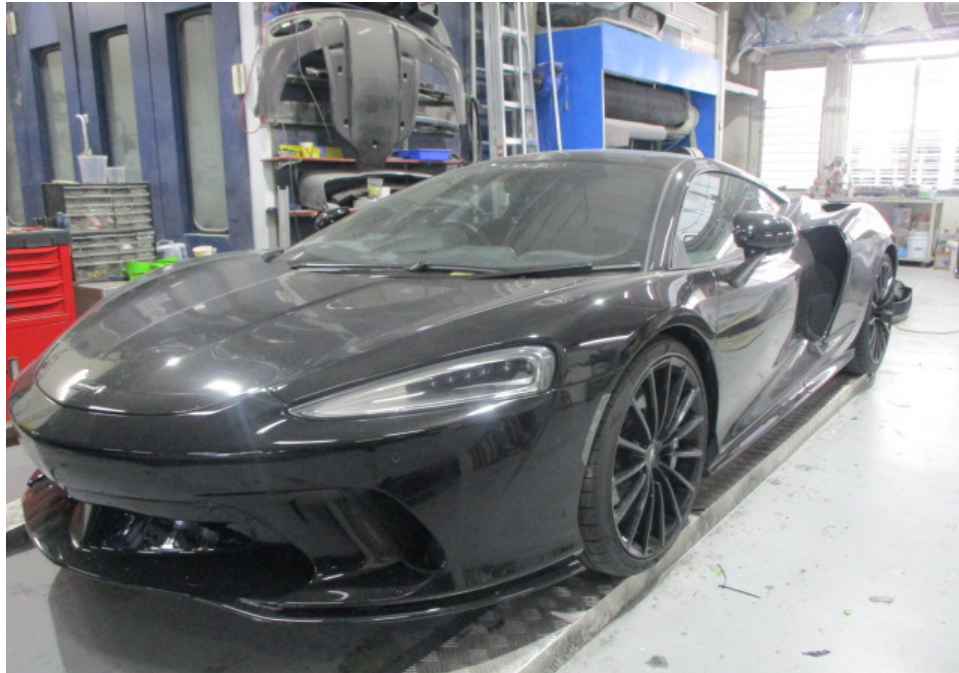
**Photo 9** shows a general view of the front left body of the Motor Car at the time of my inspection. The Motor Car was observed to be in a relatively good general condition with no loose exterior fittings observed. The body parts at the frontal portion of the Motor Car were visually examined and it was observed that the repair/restoration works carried out to the damaged area of the Motor Car (refer to photograph 1 & 2 above) were reasonably adequate and in order.

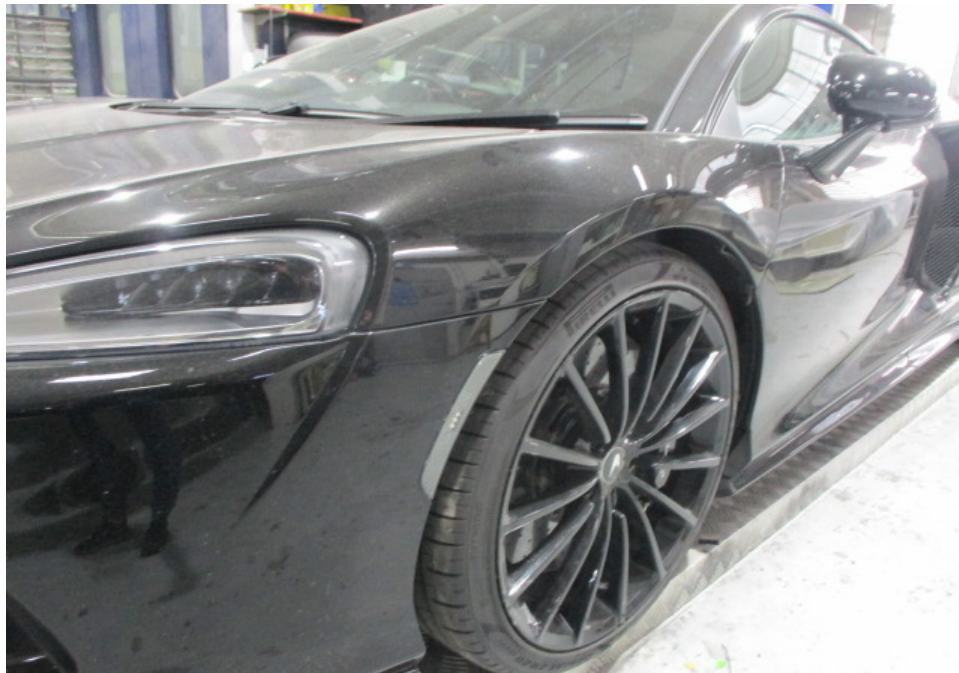
**Photo 10** shows a closer view of the Motor Car's front bumper left reflector, front left headlamp, front left fender and front left wheel rim. The body parts at the frontal portion of the Motor Car were visually examined and it was observed that the repair/restoration works carried out to the damaged area of the Motor Car (refer to photograph 1 & 2 above) were reasonably adequate and in order.

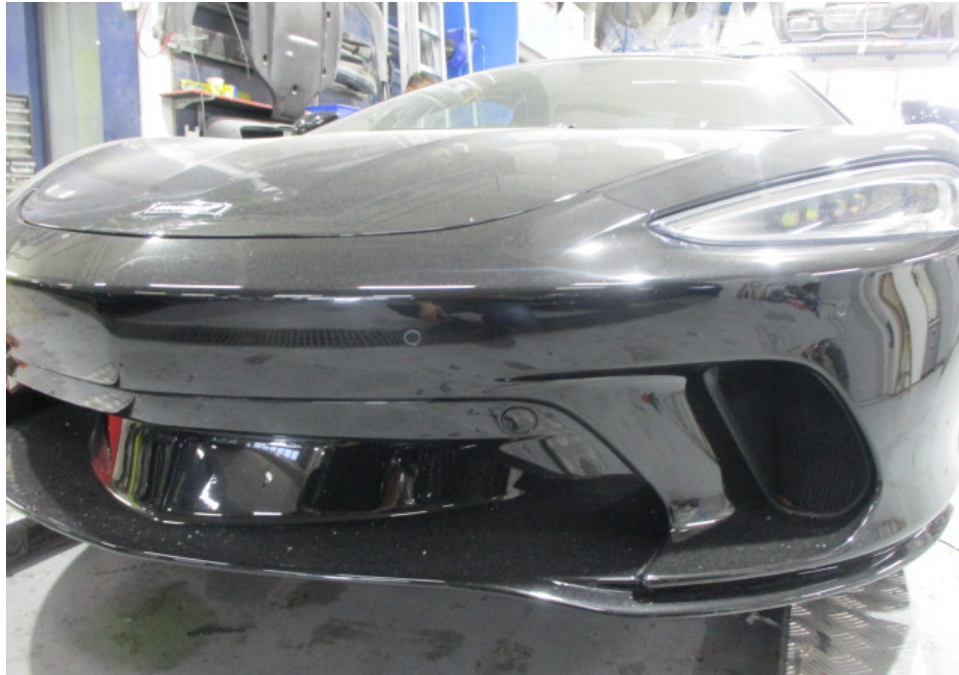
**Photo 11** shows a closer view of the Motor Car's front bumper, front bumper lower cover, front bumper sensors, front bonnet and front left headlamp. The body parts at the frontal portion of the Motor Car were visually examined and it was observed that the repair/restoration works carried out to the damaged area of the Motor Car (refer to photograph 1 & 2 above) were reasonably adequate and in order.

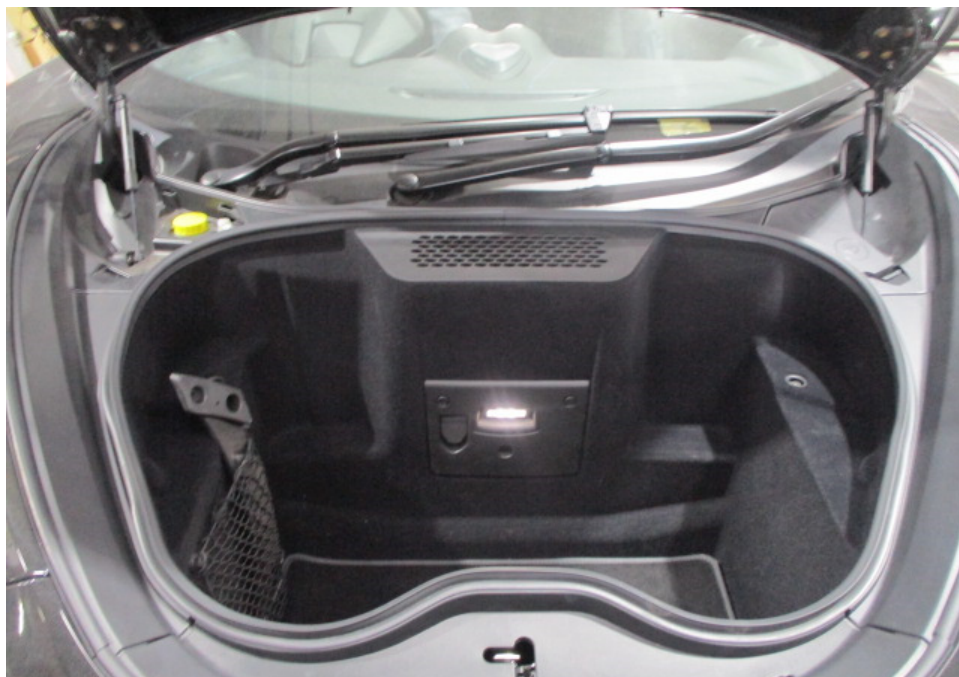
**Photo 12** shows a general view of the Motor Car's front bonnet compartment at the time of my inspection. All inner trims, garnishes and upholstery etc were observed to be intact and properly fitted.

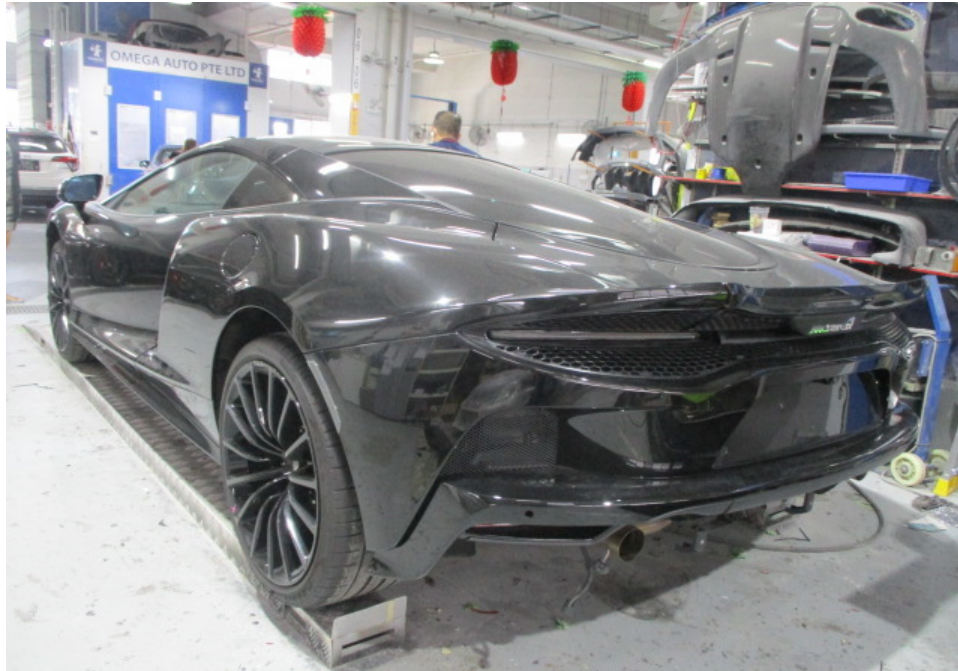
**Photo 13** shows a general view of the rear left body of the Motor Car at the time of my inspection, with its rear bumper lower cover and rear bumper lower diffuser removed to facilitate checks of its engine compartment and exhaust system. Overall, the Motor Car was observed to be in a relatively good general condition with no loose exterior fittings observed. The repair/restoration works carried out to the damaged area at the Motor Car's rear portion (refer to photograph 3 & 4 above) were reasonably adequate and in order.

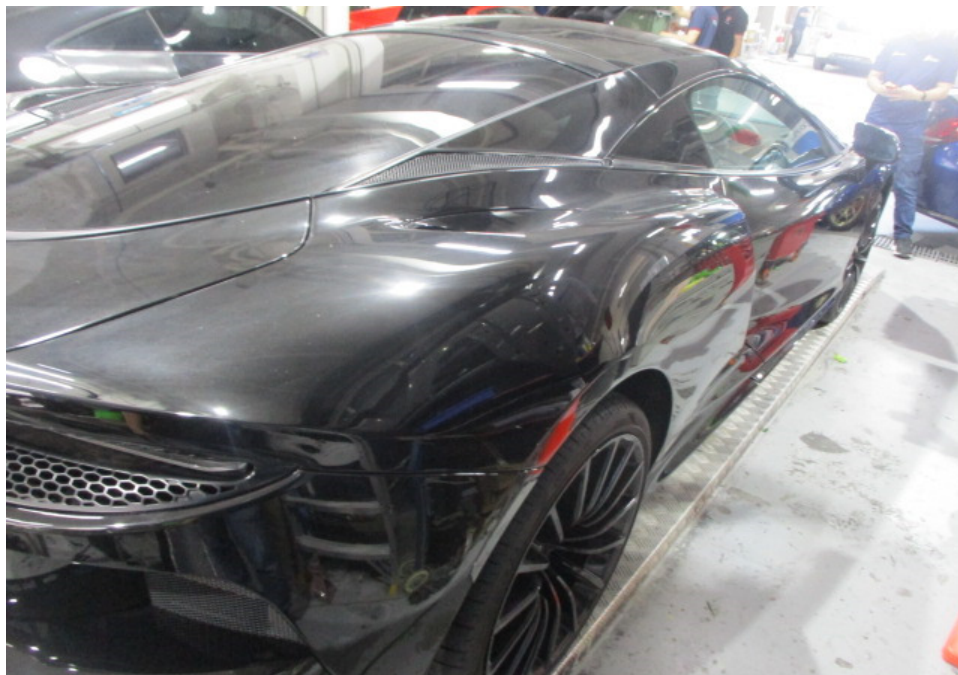
**Photo 14** shows a general view of the rear right body of the Motor Car at the time of my inspection, The Motor Car was observed to be in a relatively good general condition with no loose exterior fittings observed. The mileage of the Motor Car recorded at the time of my inspection was 4,853km.

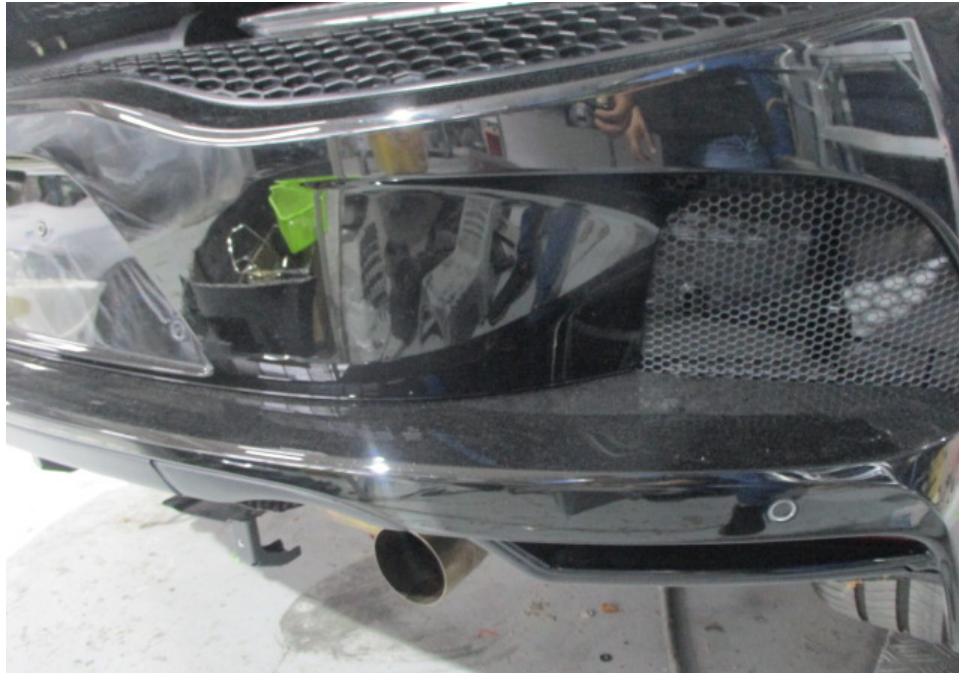
**Photo 15** shows a closer view of the Motor Car's rear bumper, rear bumper right grille and rear bumper right sensor. The body parts at the rear portion of the Motor Car were visually examined and it was observed that the repair/restoration works carried out to the damaged area of the Motor Car (refer to photograph 3 & 4 above) were reasonably adequate and in order.

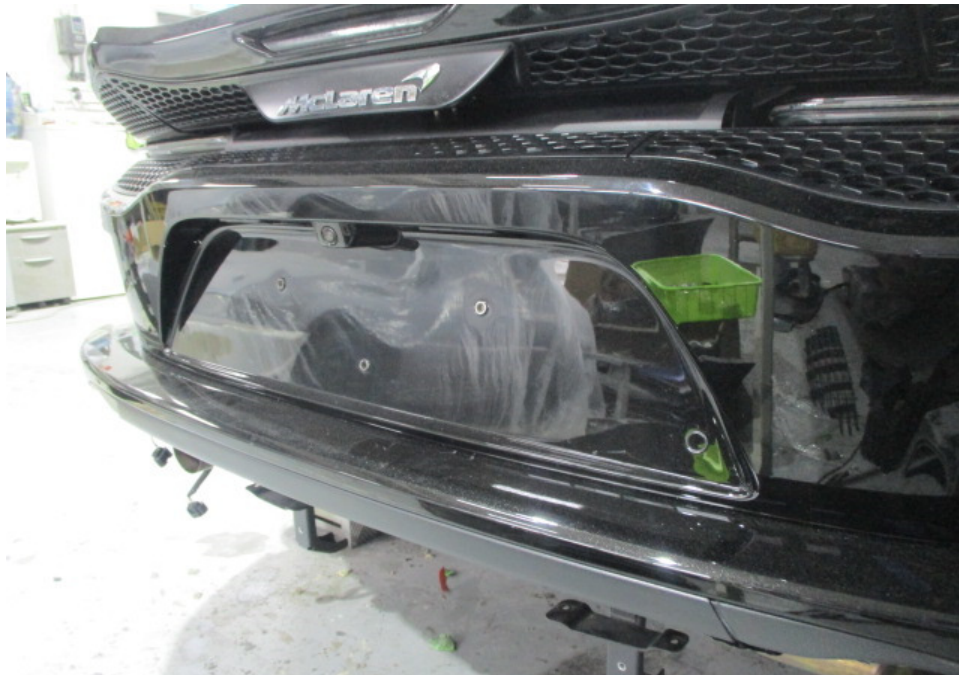
**Photo 16** shows a closer view of the Motor Car's rear bumper and rear bumper top centre grille. The body parts at the rear portion of the Motor Car were visually examined and it was observed that the repair/restoration works carried out to the damaged area of the Motor Car (refer to photograph 3 & 4 above) were reasonably adequate and in order.

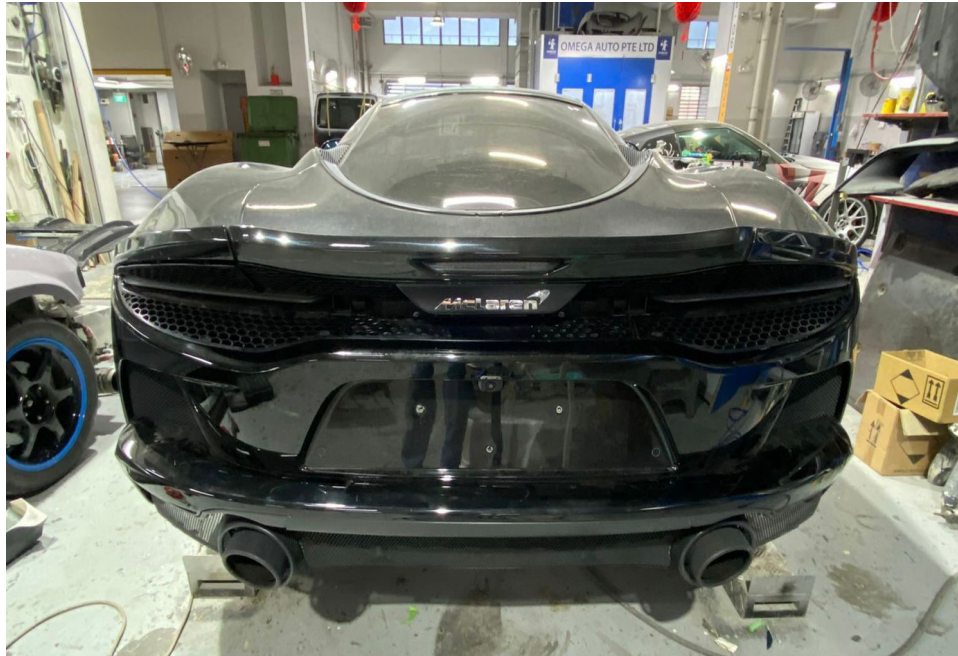
**Photo 17** shows a general view of the rear body of the Motor Car at the time of my inspection, with its rear bumper lower diffuser re-fitted. Overall, the Motor Car was observed to be in a relatively good general condition with no loose exterior fittings observed. The repair/restoration works carried out to the damaged area at the Motor Car's rear portion (refer to photograph 3 & 4 above) were reasonably adequate and in order.

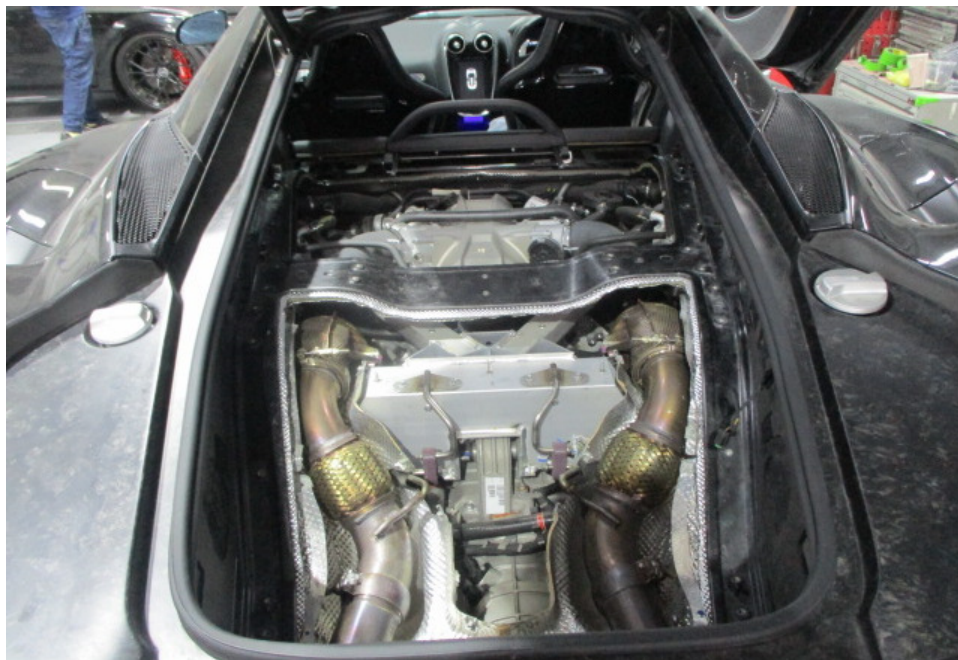
**Photo 18** shows a general of the Motor Car's engine compartment at the time of my inspection. I had found the various parts and components inside the engine compartment to be intact and properly fitted. There was also no sign(s) or indication(s) of fluid leak and/or fluid stain found inside the engine compartment. Refer to photograph 30 & 31 below, showing the engine compartment as viewed from the rear underside of the Motor Car.

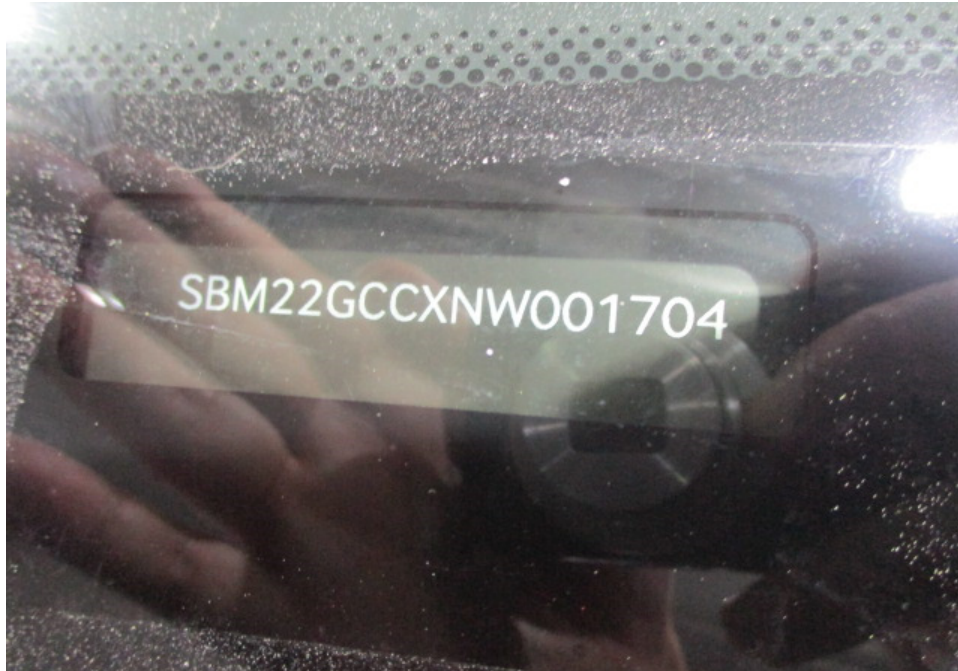
**Photo 19** shows the chassis number of the Motor Car. The chassis number recorded was SBM22GCCXNW001704.

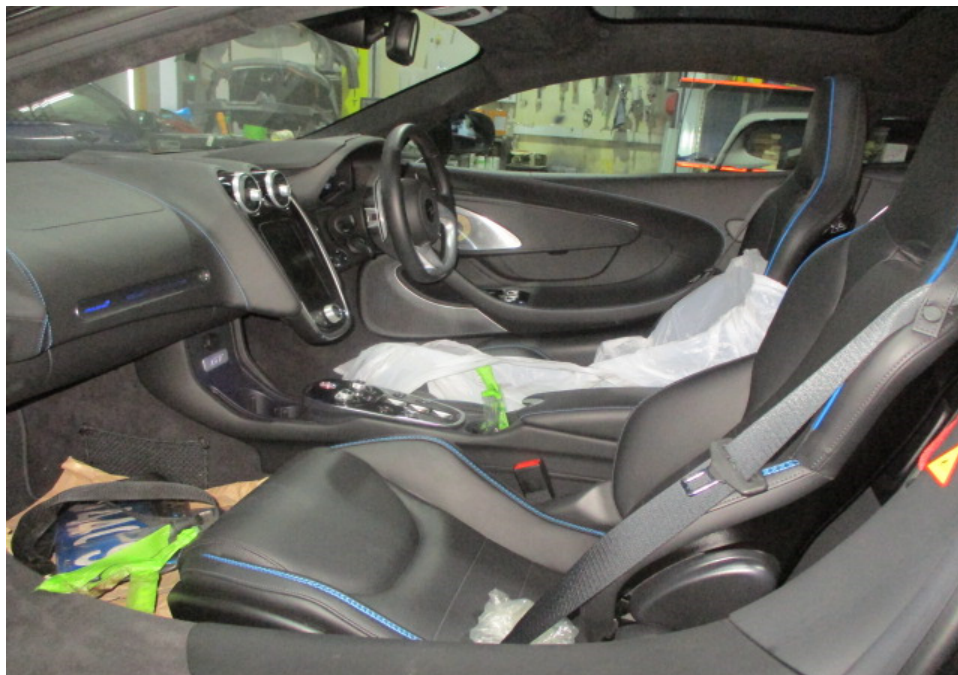
**Photo 20** shows the interior compartment of the Motor Car at the time of my inspection. The various parts and components, trims, carpet, and upholstery inside the interior compartment were all observed to be intact and properly fitted.

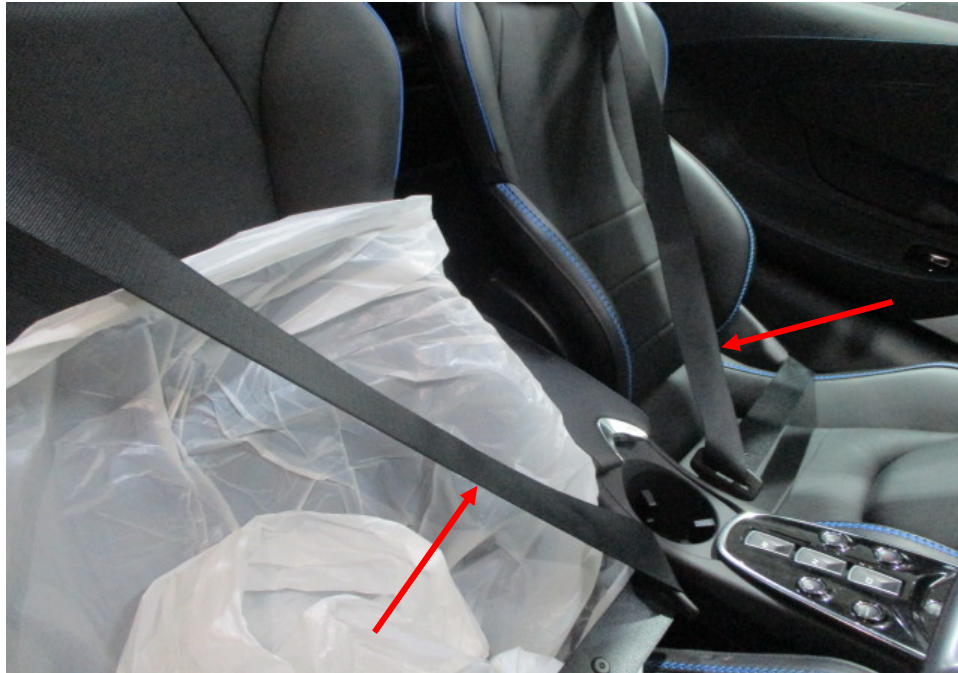
**Photo 21** shows the seats of the Motor Car. All the seats of the Motor Car were secured via seat rails to the floorboard. They were also fitted with a retractable seat belt reel and a pre-tensioner. The seat belts (arrowed) were tested and were able to be fastened into the respective pre-tensions that were fitted on the side of each individual seat.

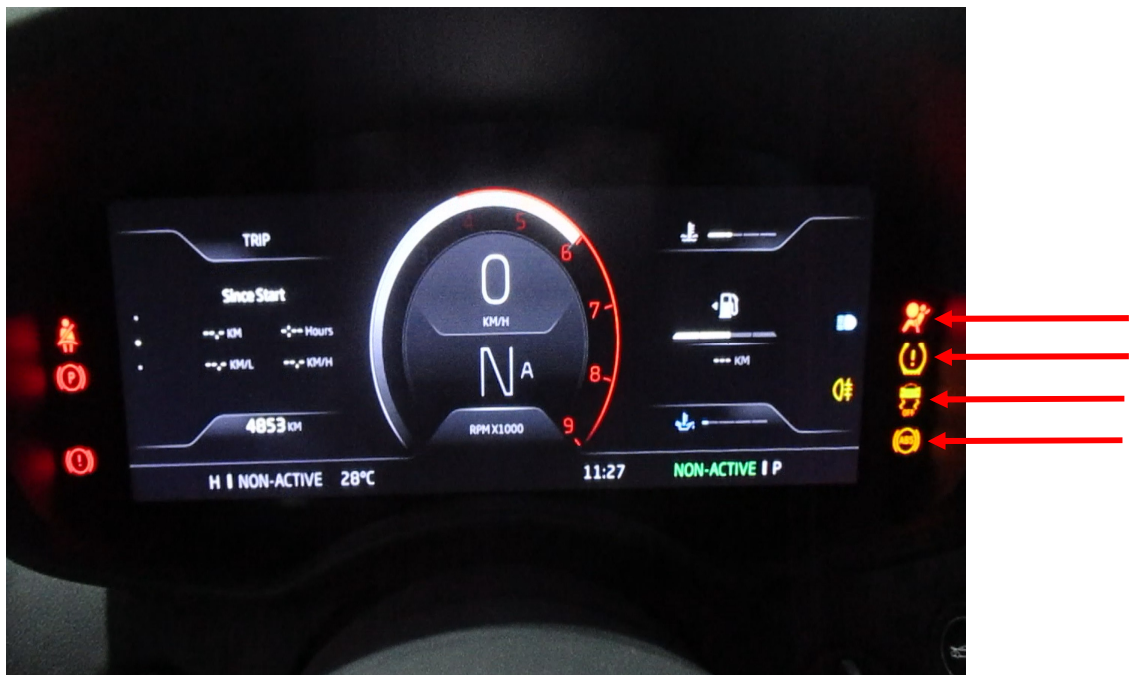
**Photo 22** shows the warning lights for the various electronic safety features appearing on the instrument panel of the Motor Car during its self-test when the engine is cranked, in particular the ABS, SRS, TPM and TCS lights (arrowed).

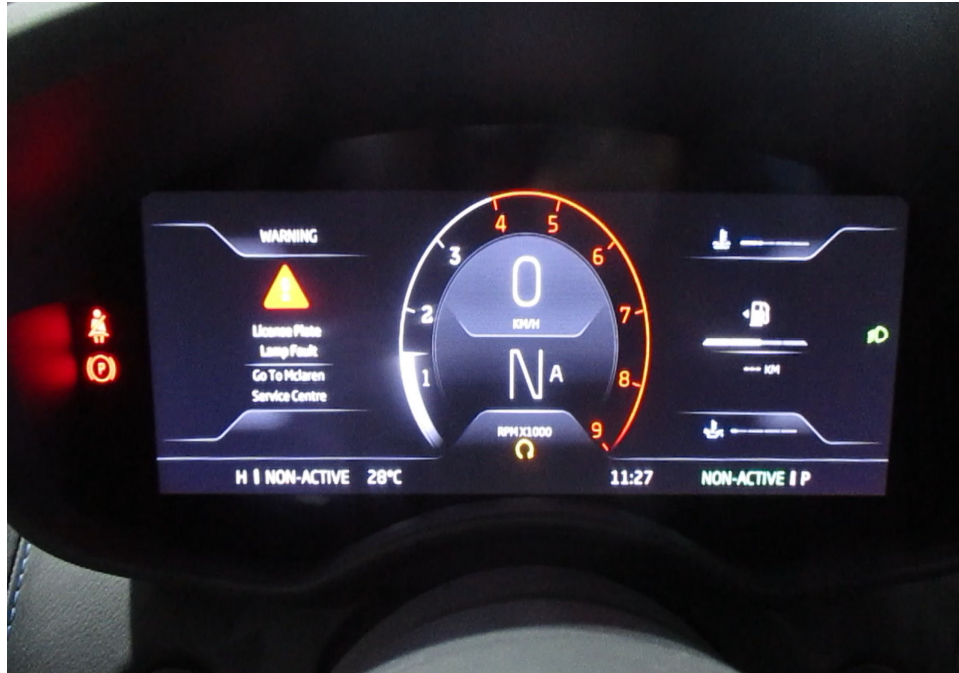
**Photo 23** shows the respective warning lights no longer illuminated, indicating that there is no fault detected to the ABS, SRS, TPM and TCS systems of the Motor Car during the self-test. These electronic systems were hence in working condition at the time of my inspection.

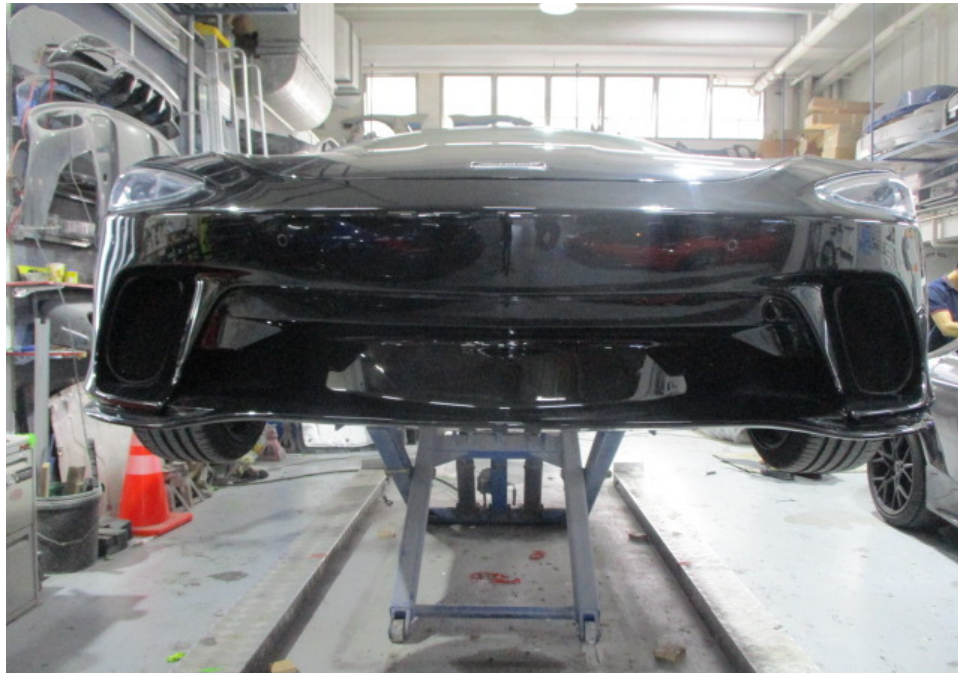
**Photo 24** shows the Motor Car hoisted up for checks on its undercarriage. There was no sign(s) or indication(s) of fluid leakage and/or fluid stain(s) on the underside of the Motor Car. The undercarriage components of the Motor Car were also all observed to be intact and secured in an appropriate manner.

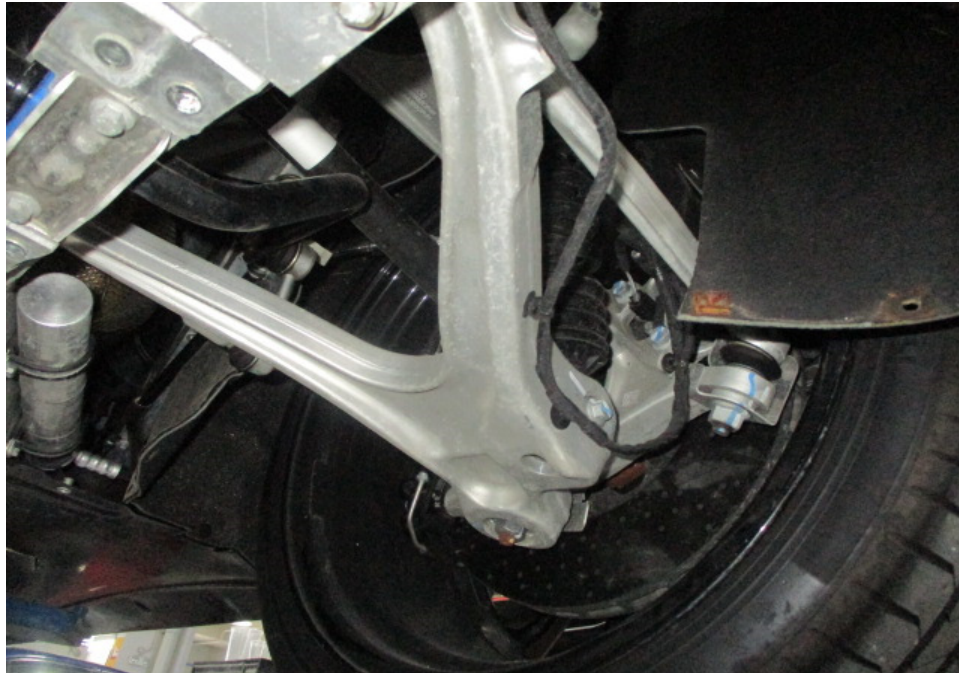
**Photo 25** shows a general view of the control arms and linkages at the rear right wheel of the Motor Car. I did not observe any fluid leak and/or fluid stain on the underside of the Motor Car. All of the Motor Car's undercarriage components were observed to be intact and secured in an appropriate manner.

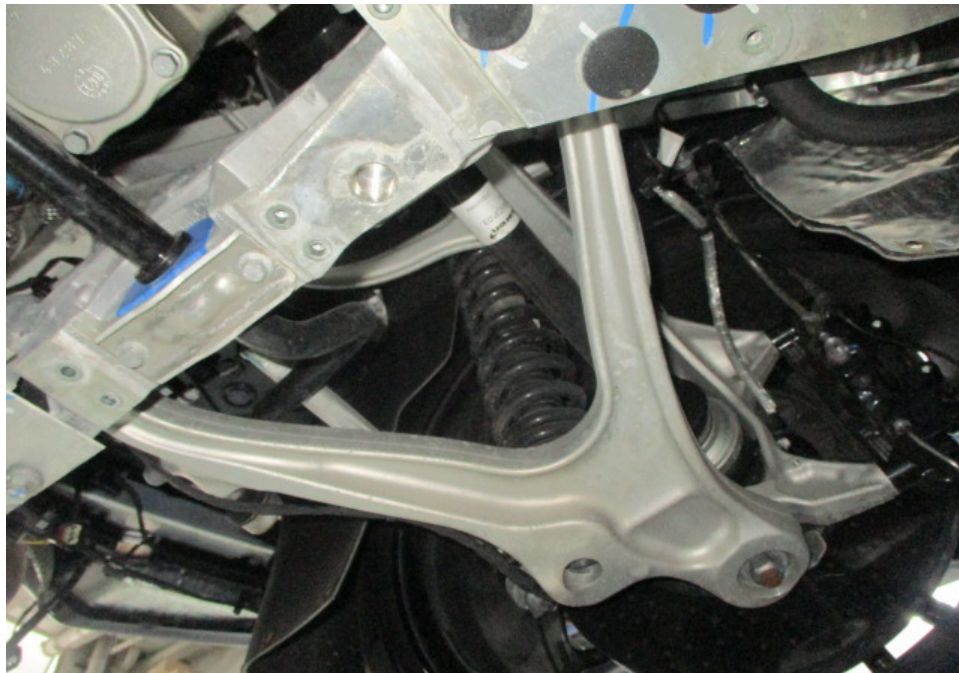
**Photo 26** shows a general view of the control arms and linkages at the rear left wheel of the Motor Car. I did not observe any fluid leak and/or fluid stain on the underside of the Motor Car. All of the Motor Car's undercarriage components were observed to be intact and secured in an appropriate manner.

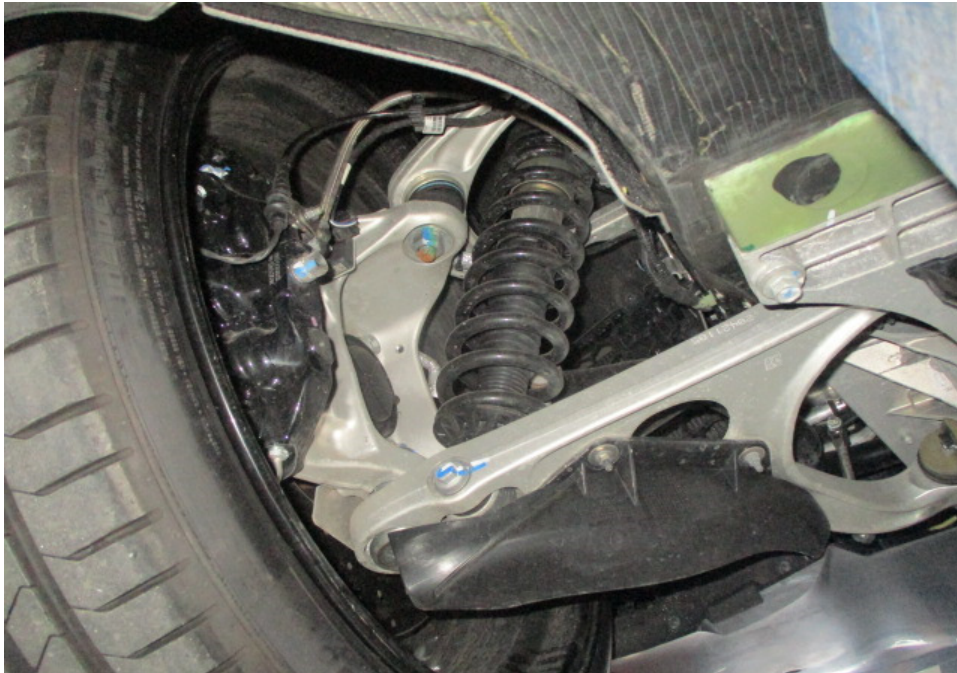
**Photo 27** shows the various undercarriage components at the front left wheel of the Motor Car. The mechanical components, control arms and linkages were all found to be intact and secured in an appropriate manner.

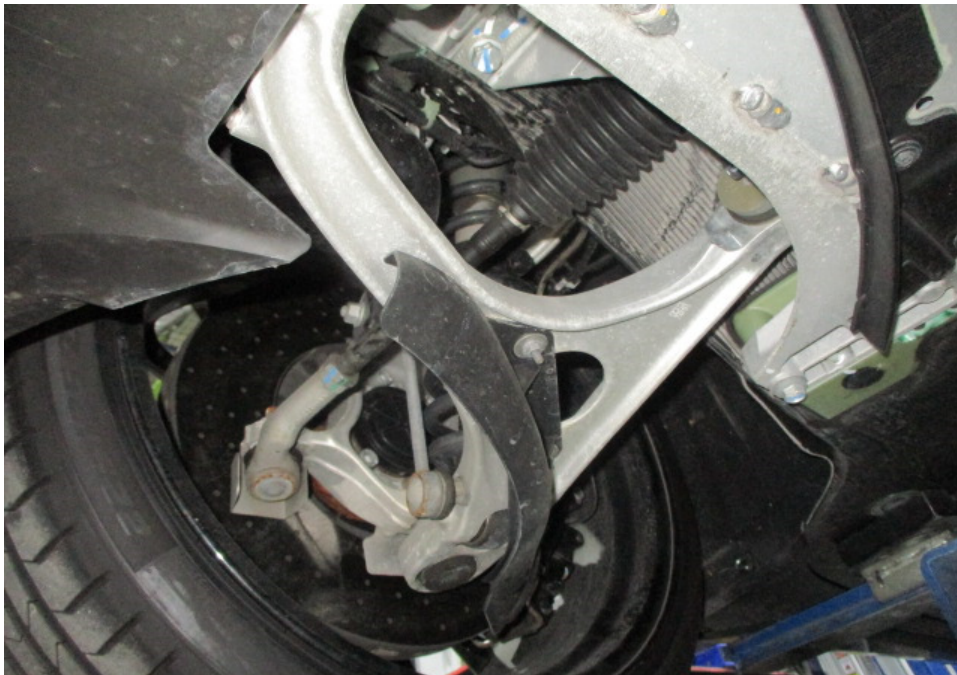
**Photo 28** shows the various undercarriage components at the front right wheel of the Motor Car. The mechanical components, control arms and linkages were all found to be intact and secured in an appropriate manner. I also did not observe any fluid leak and/or fluid stain on the underside of the Motor Car.

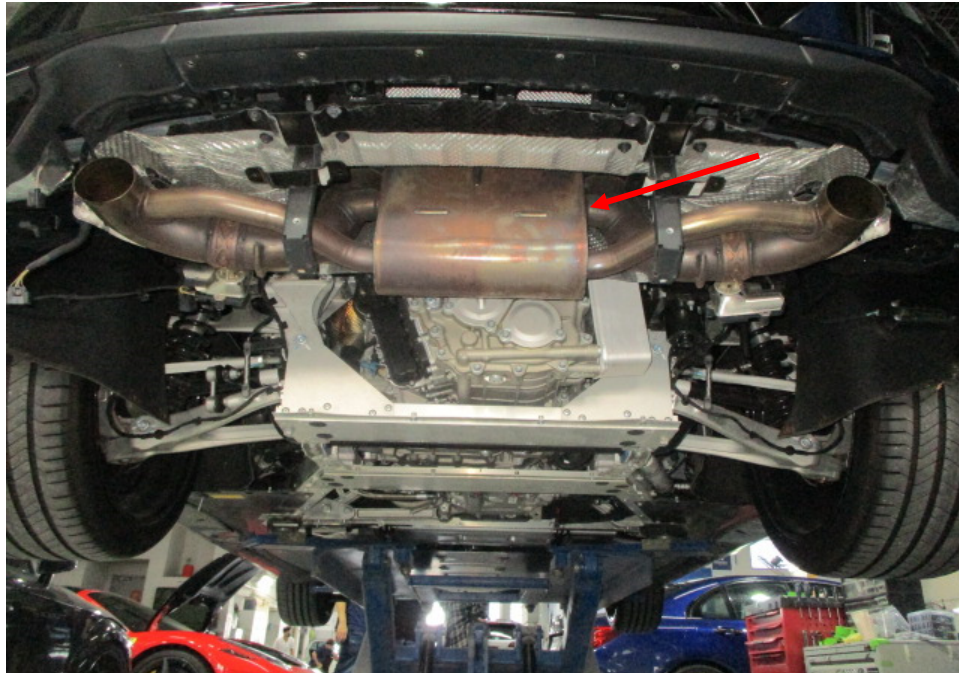
**Photo 29** shows the Motor Car's exhaust system. In general, my examination of the Motor Car's exhaust system revealed no sign(s) or indication(s) of any cut or weld marks along its exhaust pipes, on its catalytic converters and on its rear muffler (arrowed).

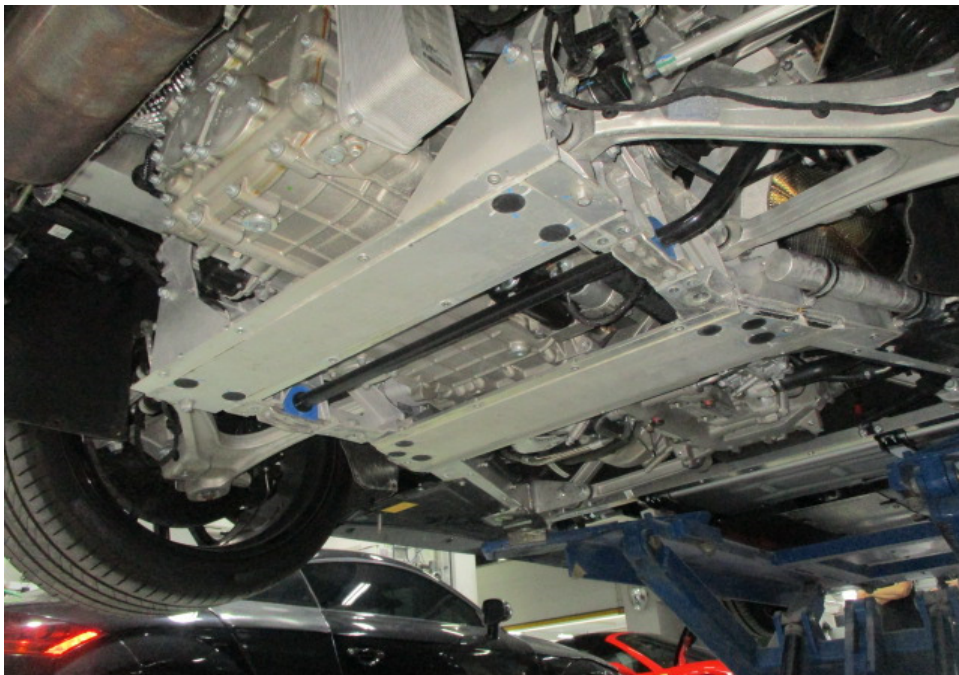
**Photo 30** shows the Motor Car's engine compartment as viewed from the rear underside of the Motor Car. The various parts and components inside the engine compartment were all observed to be intact and properly fitted. There was also no sign(s) or indication(s) of fluid leak and/or fluid stain found inside the engine compartment.
