Your Ref: McLaren GT  
(chassis number SBM22GCCXNW001704)  
Our Ref : CI/TP23000593/D

**INSPECTION REPORT OF AN UNREGISTERED MCLAREN GT MOTOR CAR  
WITH CHASSIS NUMBER SBM22GCCXNW001704**

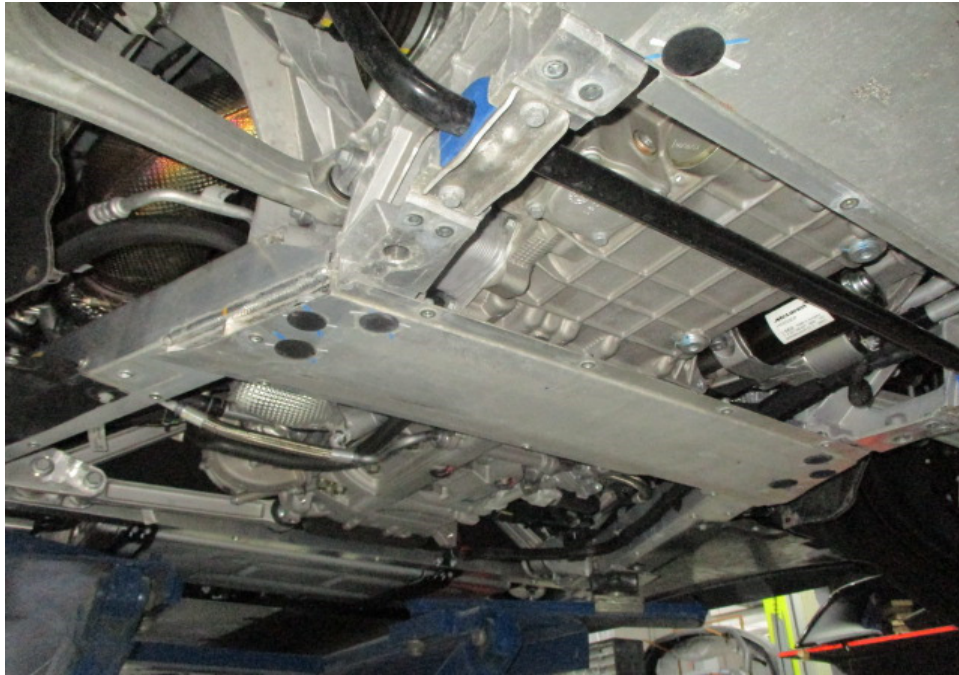
**Photo 31** shows another view of the Motor Car's engine compartment as viewed from the rear underside of the Motor Car. The various parts and components inside the engine compartment were all observed to be intact and properly fitted. There was also no sign(s) or indication(s) of fluid leak and/or fluid stain found inside the engine compartment.

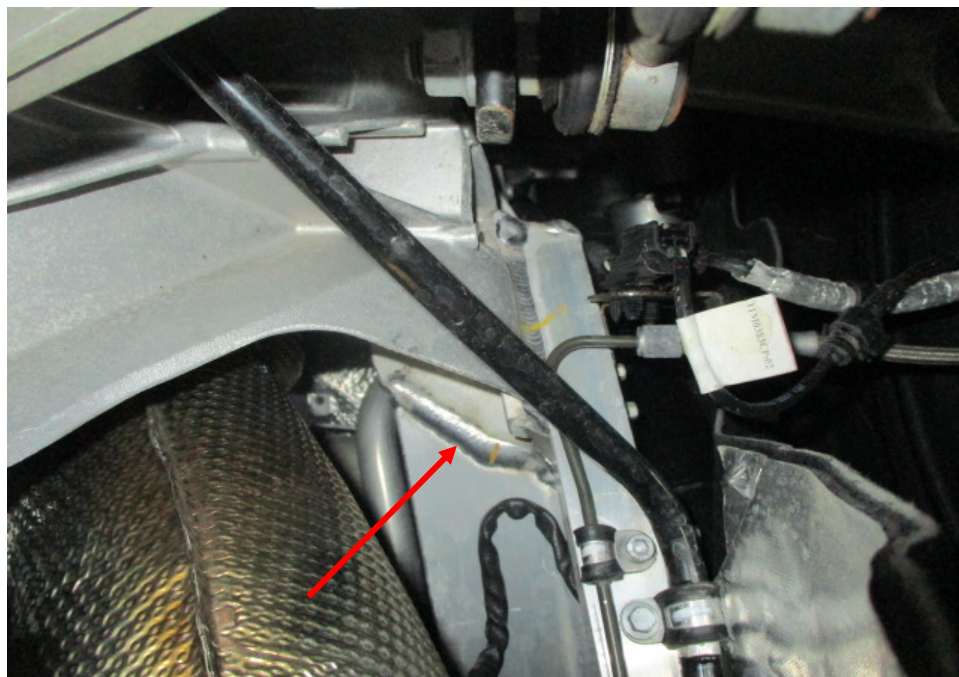
**Photo 32** shows the aluminium chassis/structural body at the underside rear right of the Motor Car. I did not find any weld marks other than original weld marks on the chassis/structural body of the Motor Car. The original factory sealant (arrowed) at the joints along the chassis/structural body was untouched, indicating no work was done on the chassis/structural body of the Motor Car and that the chassis/structural body was originally fitted.

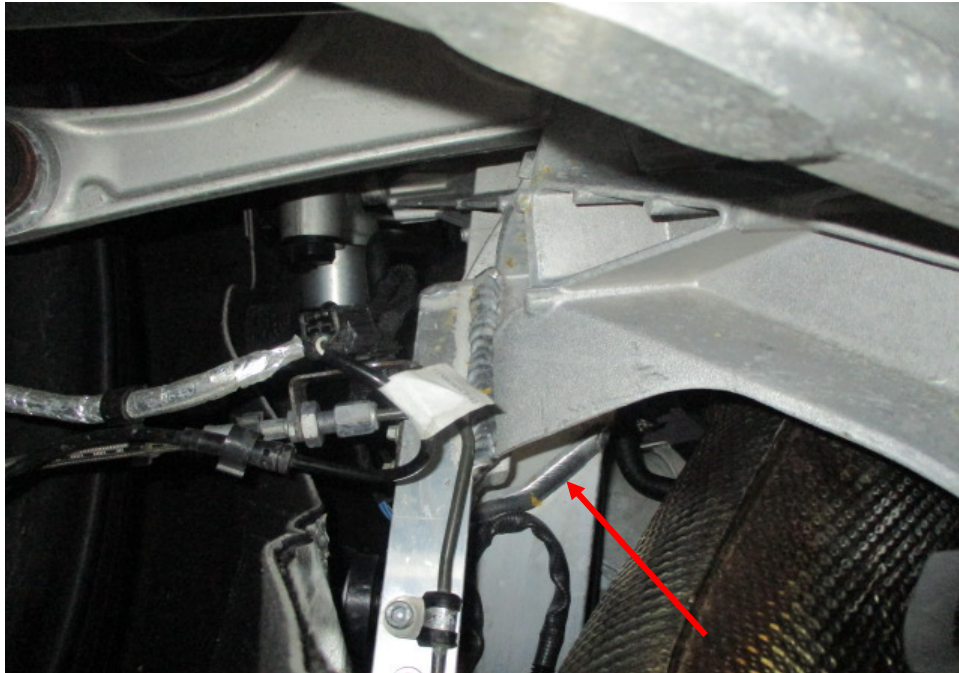
**Photo 33** shows the aluminium chassis/structural body at the underside rear left of the Motor Car. I did not find any weld marks other than original weld marks on the chassis/structural body of the Motor Car. The original factory sealant (arrowed) at the joints along the chassis/structural body was untouched, indicating no work was done on the chassis/structural body of the Motor Car and that the chassis/structural body was originally fitted.

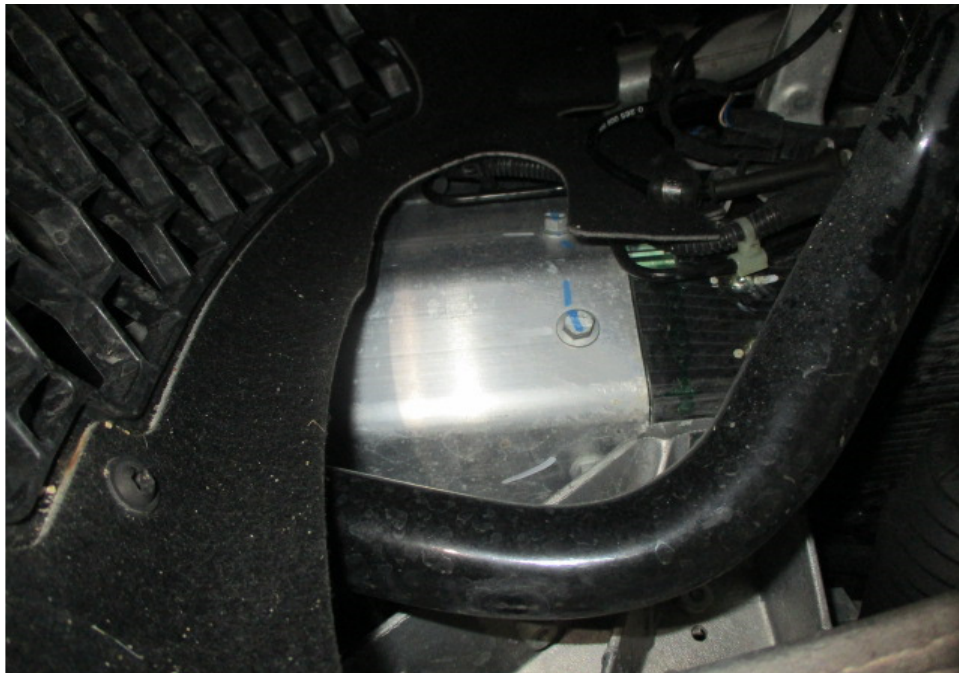
**Photo 34** shows the aluminium chassis/structural body at the underside front left of the Motor Car. The original factory sealant at the joints along the chassis/structural body was observed to be untouched. In general, I had found no work was carried out on the chassis/structural body of the Motor Car. The aluminium chassis/structural body of the Motor Car was originally fitted.

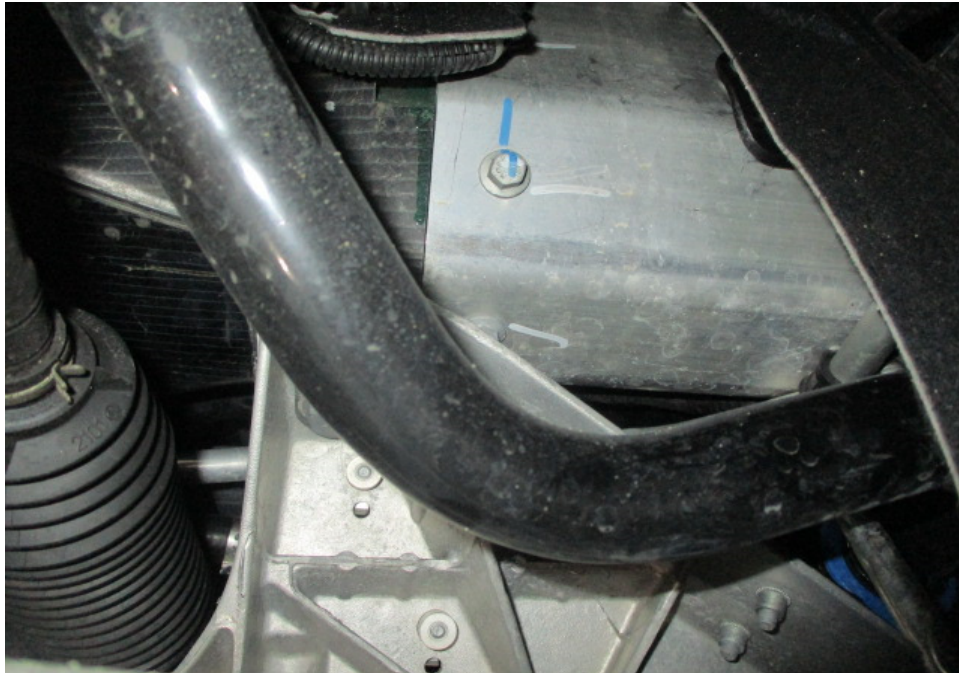
**Photo 35** shows the aluminium chassis/structural body at the underside front right of the Motor Car. I did not find any weld marks other than original weld marks on the chassis/structural body of the Motor Car. The original factory sealant at the joints along the chassis/structural body was untouched, indicating no work was done on the chassis/structural body of the Motor Car and that the chassis/structural body was originally fitted.

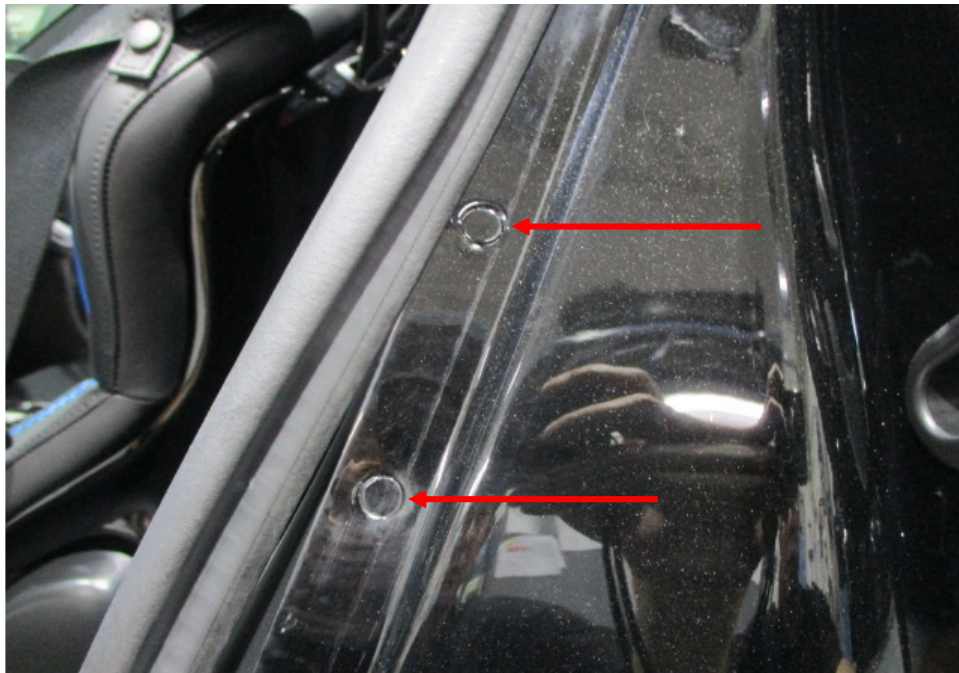
**Photo 36** shows the left side rear body panel of the Motor Car. I did not find any weld marks other than original spot weld marks (arrowed) on the left side rear body panel of the Motor Car, which indicates that there was no re-welding works carried out. In general, I had found all the non-detachable body panels of the Motor Car to be originally fitted at the time of my inspection.

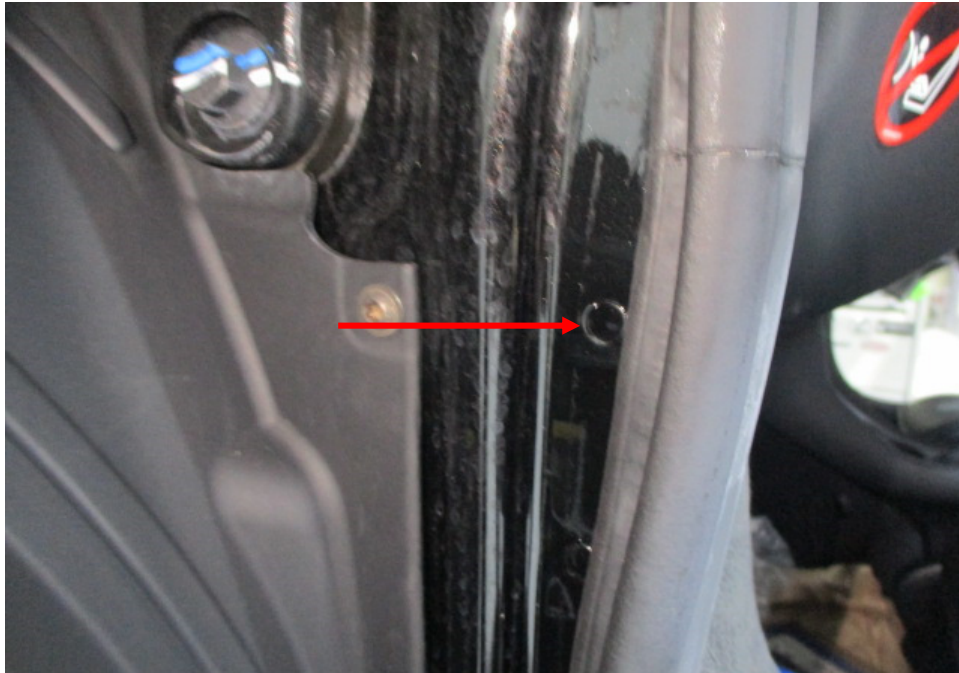
**Photo 37** shows the left side "A" pillar of the Motor Car. I did not find any weld marks other than original spot weld marks (arrowed) on the left side "A" pillar of the Motor Car, which indicates that there was no re-welding works carried out. In general, I had found all the non-detachable body panels of the Motor Car to be originally fitted at the time of my inspection.

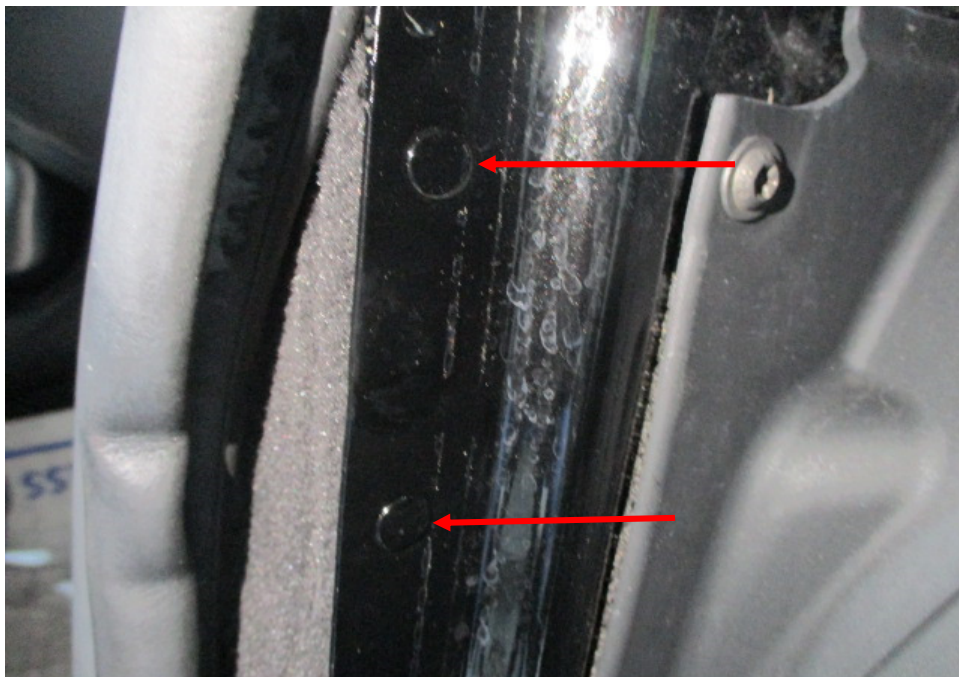
**Photo 38** shows the right side "A" pillar of the Motor Car. I did not find any weld marks other than original spot weld marks (arrowed) on the right side "A" pillar of the Motor Car, which indicates that there was no re-welding works carried out. In general, I had found all the non-detachable body panels of the Motor Car to be originally fitted at the time of my inspection.

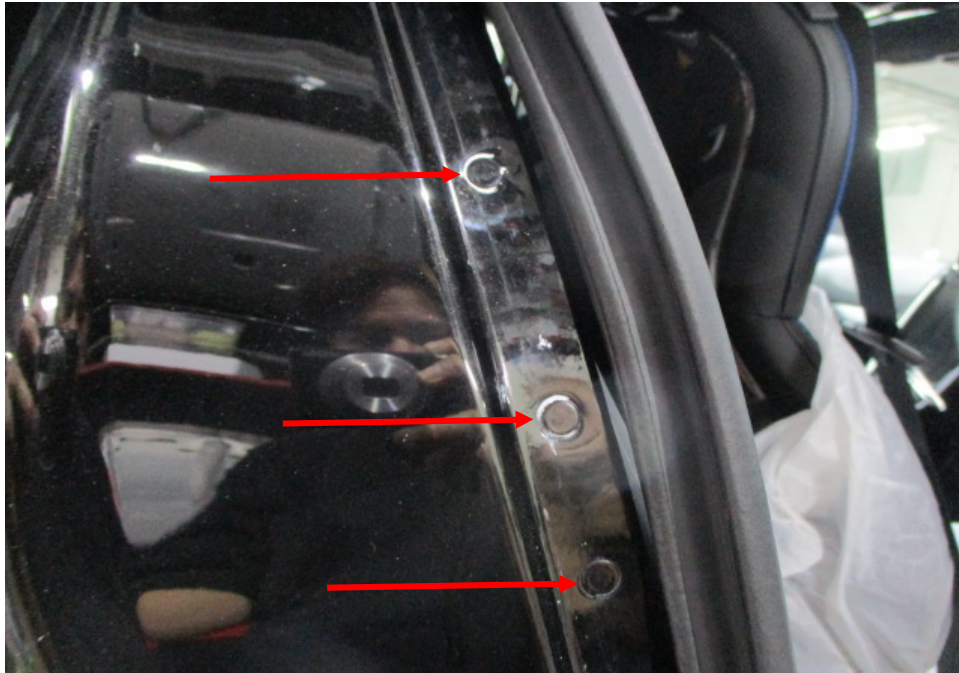
**Photo 39** shows the right side rear body panel of the Motor Car. I did not find any weld marks other than original spot weld marks (arrowed) on the right side rear body panel of the Motor Car, which indicates that there was no re-welding works carried out. In general, I had found all the non-detachable body panels of the Motor Car to be originally fitted at the time of my inspection.
