VEHICLE DAMAGE INSPECTION REPORT

Our Ref : PA/FBT6677/0822/tpw

Claim Type	: Third Party	Date of Accident	: 23 August 2022
Vehicle No	: FBT 6677 D	Date of Assignment	: 31 August 2022
Make	: CFMOTO	Date of Inspection	: 31 August 2022
Model	: 400GT	Date of Re-inspection	: 23 September 2022
Registration Date	: 28 April 2022	COE Expiry	: 27 April 2032
Color	: Blue	Chassis No	: LCEPESL53N6000159
Odometer	: 3,615km	Engine No	: Blocked

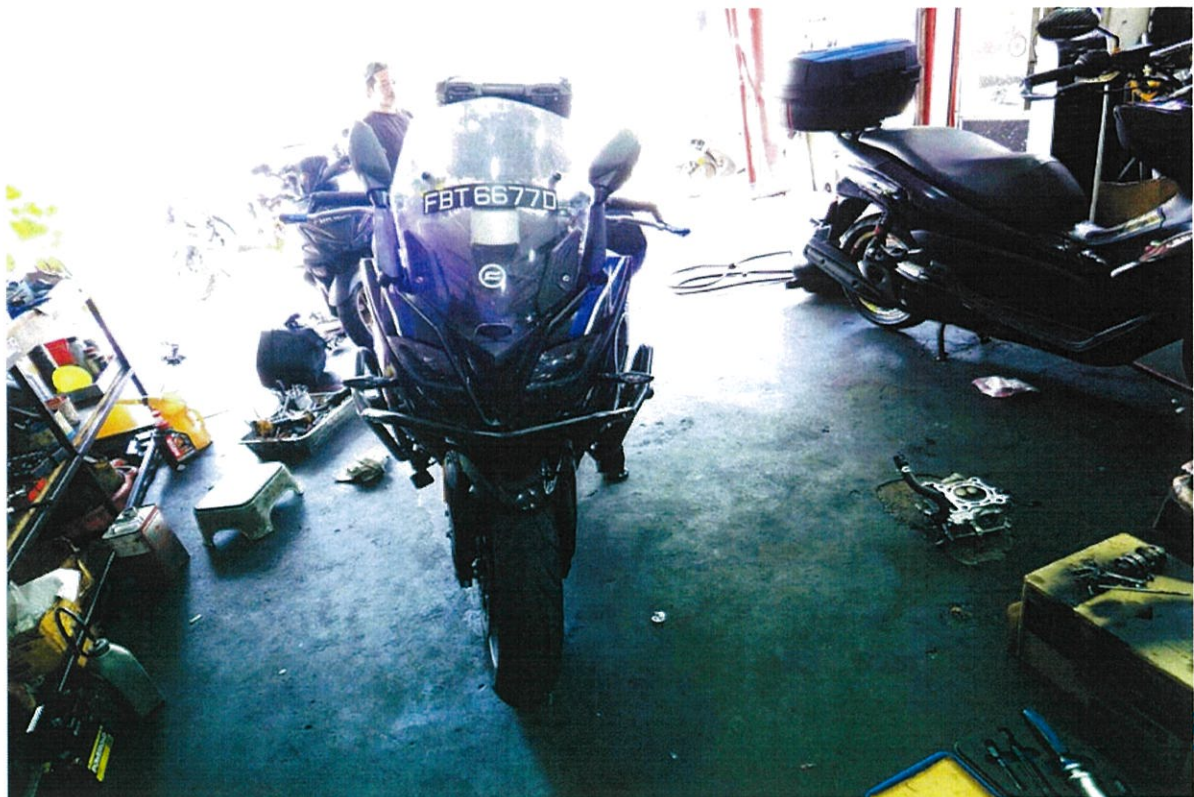
Re-Survey
After Repair

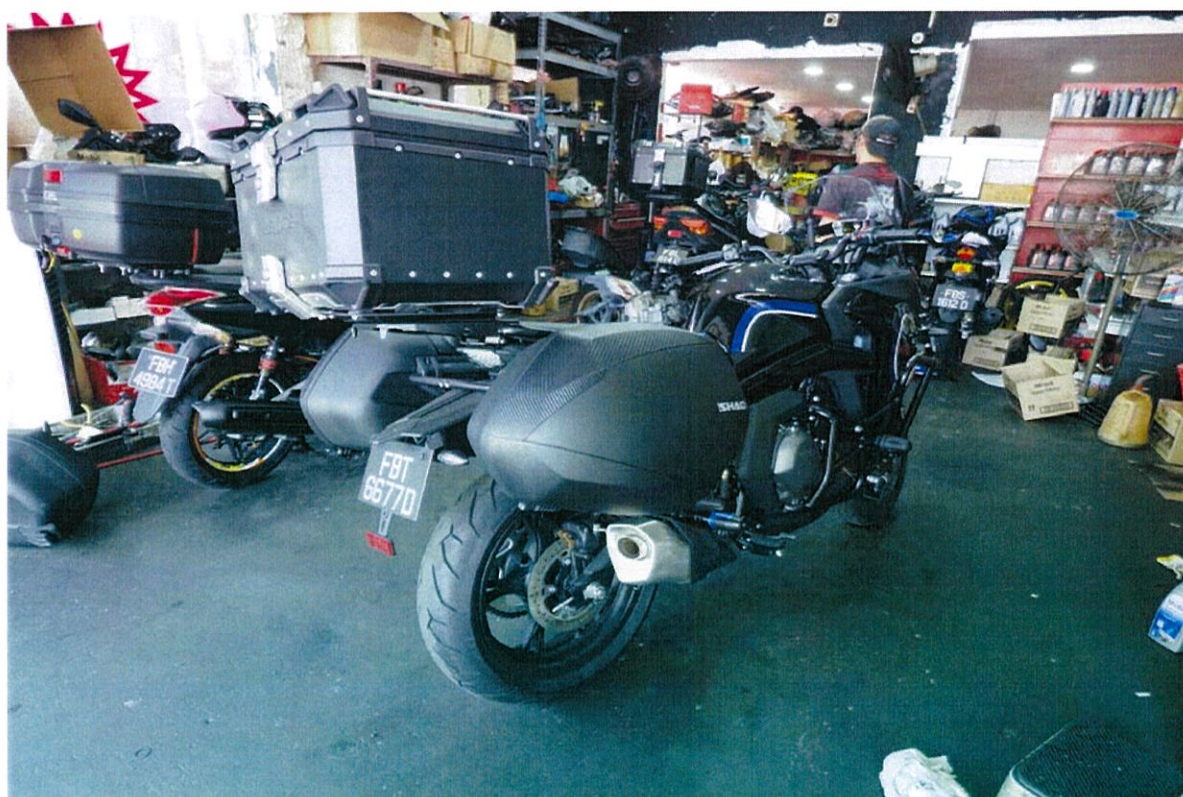
Re-Survey
After Repair

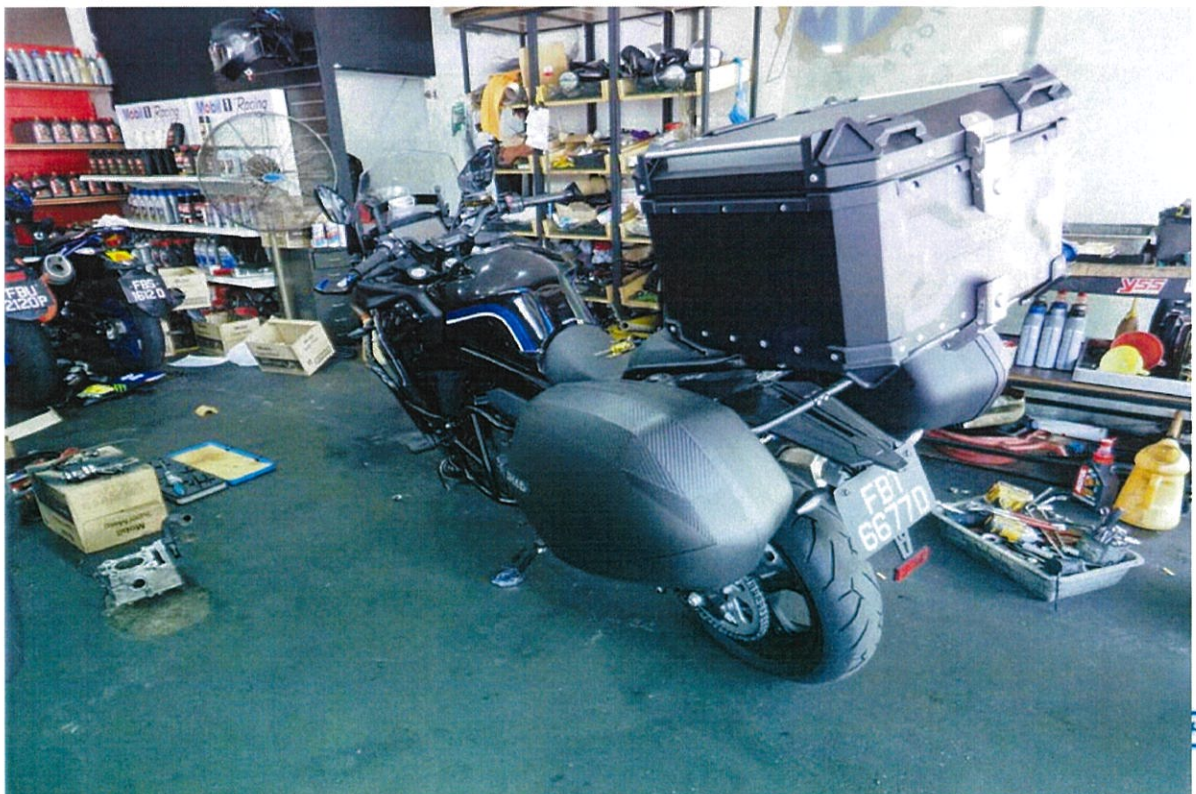
Re-Survey
After Repair

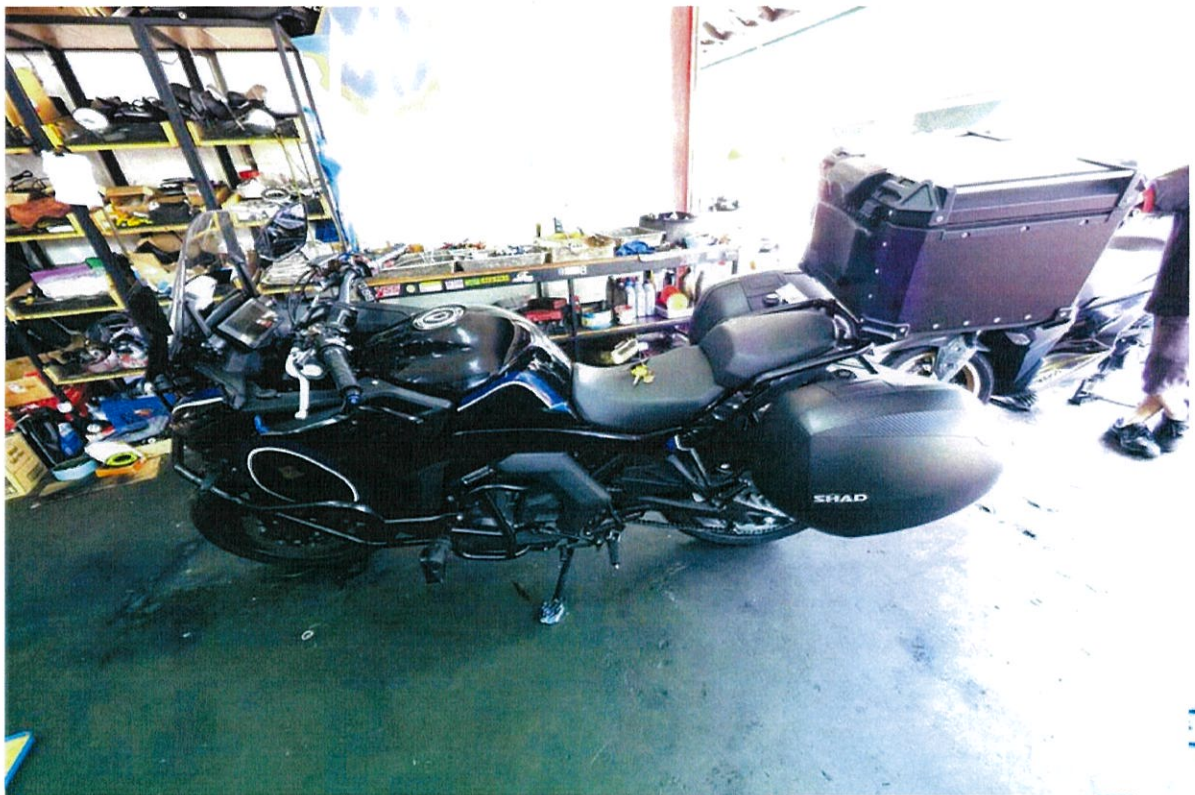
Re-Survey After Repair

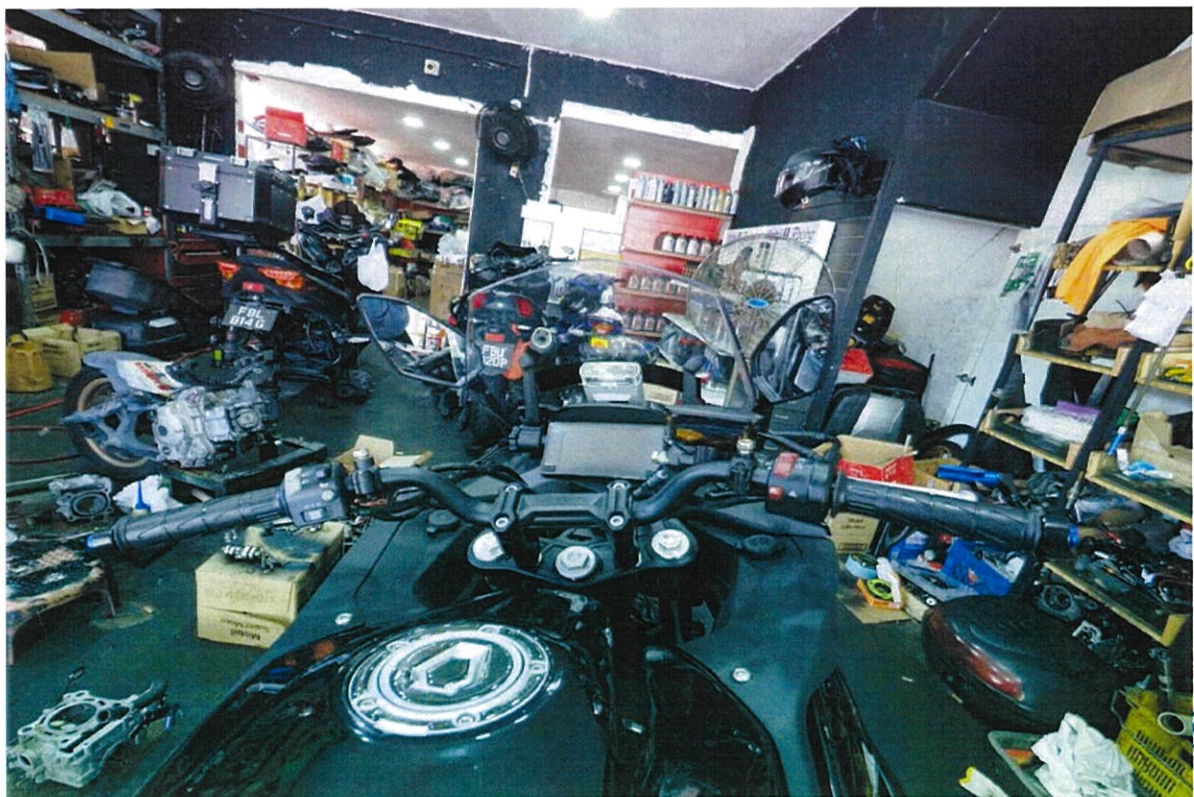
Re-Survey
After Repair
