Your Ref: Porsche 911 Carrera Coupe
(chassis number WP0ZZZ99ZNS201258)
Our Ref : CI/TP23000638/D

19 January 2023

**INSPECTION REPORT OF AN UNREGISTERED PORSCHE 911 CARRERA
COUPE MOTOR CAR WITH CHASSIS NUMBER WP0ZZZ99ZNS201258**

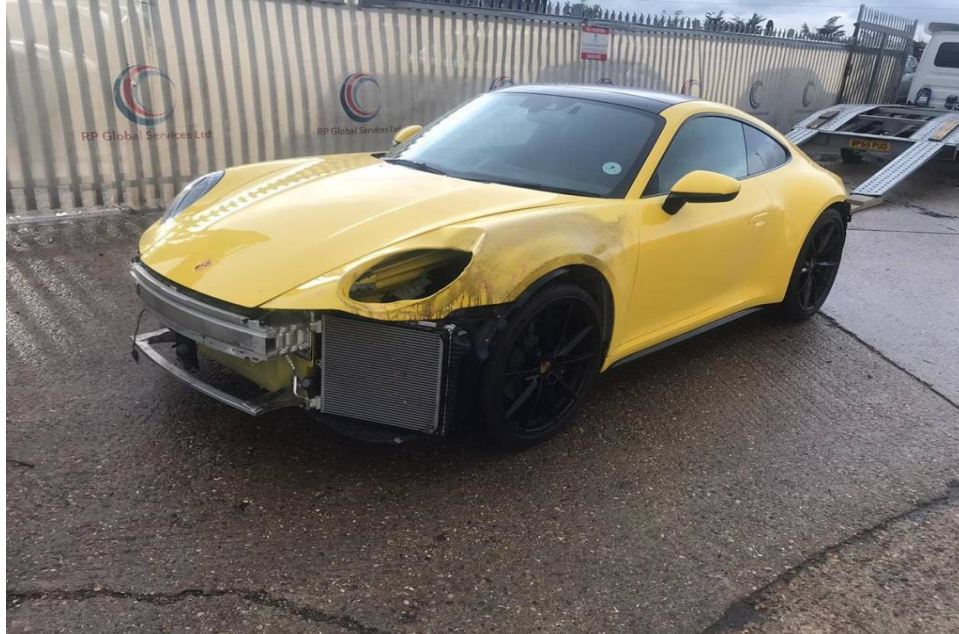
3. The Motor Car was observed to have sustained damage at its left side front portion. Body parts damaged include the front left fender amongst others.

Photo 1 shows a general view of the front left body of the Motor Car (photograph provided to me). The Motor Car was observed to have sustained damage at its left side front portion. The front left fender amongst others was observed to have been damaged. The Motor Car's front left headlamp, front bumper and all its related parts and attachments were missing/dislodged/damaged.

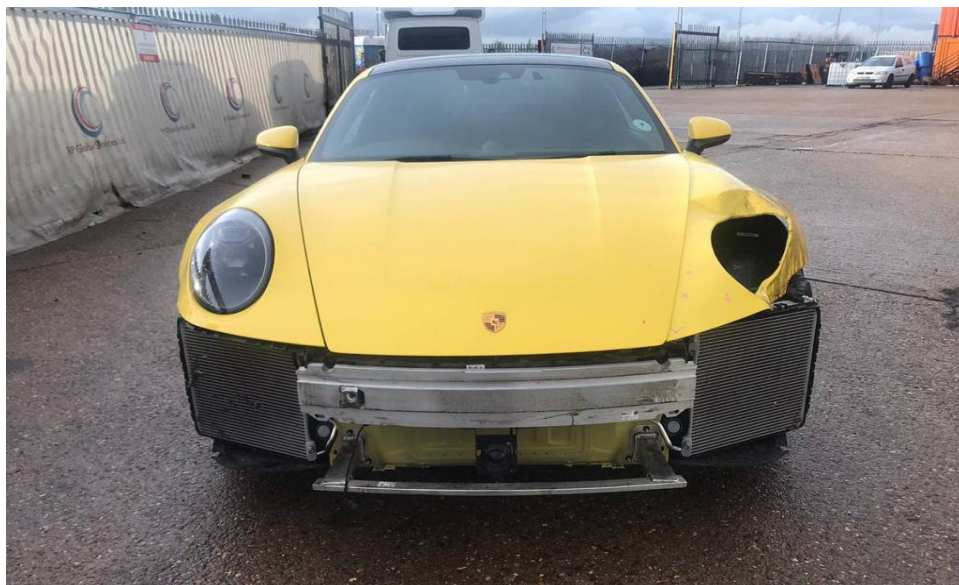
4. The photographs provided to me had also showed the Motor Car's front left headlamp, front bumper and all its related parts and attachments like the front bumper lower lip, front bumper right lower grille, front bumper left lower grille, front bumper centre air guide, front bumper sensors, front bumper tow cover, front left day light, front right day light, front left signal lamp and front right signal lamp amongst others, missing/dislodged/damaged.

Photo 2 shows the frontal body of the Motor Car (photograph provided to me). The Motor Car's front left headlamp, front bumper and all its related parts and attachments like the front bumper lower lip, front bumper right lower grille, front bumper left lower grille, front bumper centre air guide, front bumper sensors, front bumper tow cover, front left day light, front right day light, front left signal lamp and front right signal lamp amongst others, were missing/dislodged/damaged.

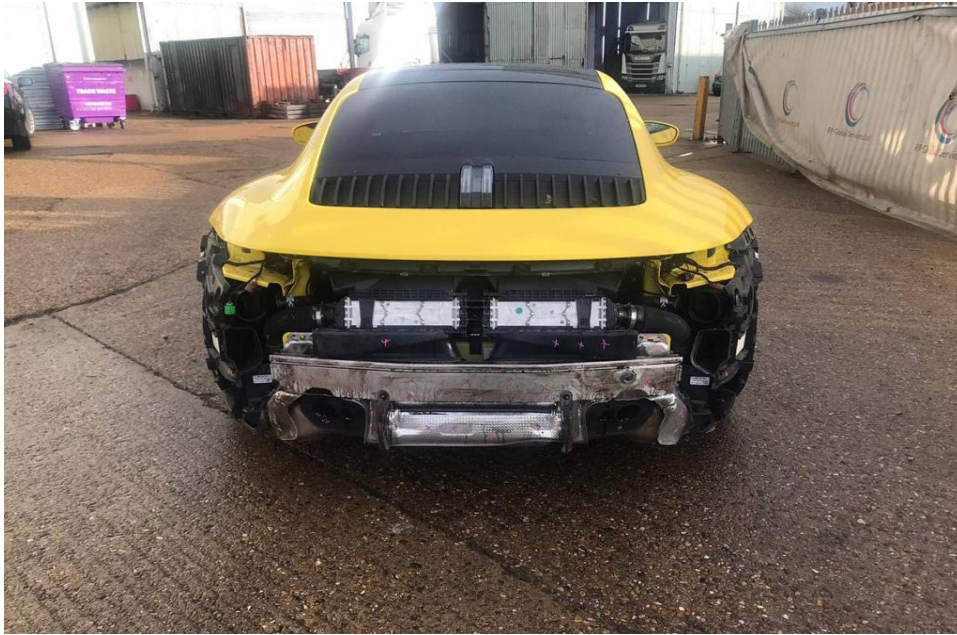
5. Several body parts at the rear portion of the Motor Car were also observed to be missing/dislodged/damaged. This had included the Motor Car's rear left taillamp, rear right taillamp, rear centre lamp, rear bumper and all its related parts and attachments like the rear bumper lower cover, rear bumper left reflector, rear bumper right reflector, rear bumper sensors, rear bumper tow cover, rear left exhaust garnish and rear right exhaust garnish amongst others.

Photo 3 shows a general view of the rear body of the Motor Car (photograph provided to me). The Motor Car's rear left taillamp, rear right taillamp, rear centre lamp, rear bumper and all its related parts and attachments like the rear bumper lower cover, rear bumper left reflector, rear bumper right reflector, rear bumper sensors, rear bumper tow cover, rear left exhaust garnish and rear right exhaust garnish amongst others, were missing/dislodged/damaged.

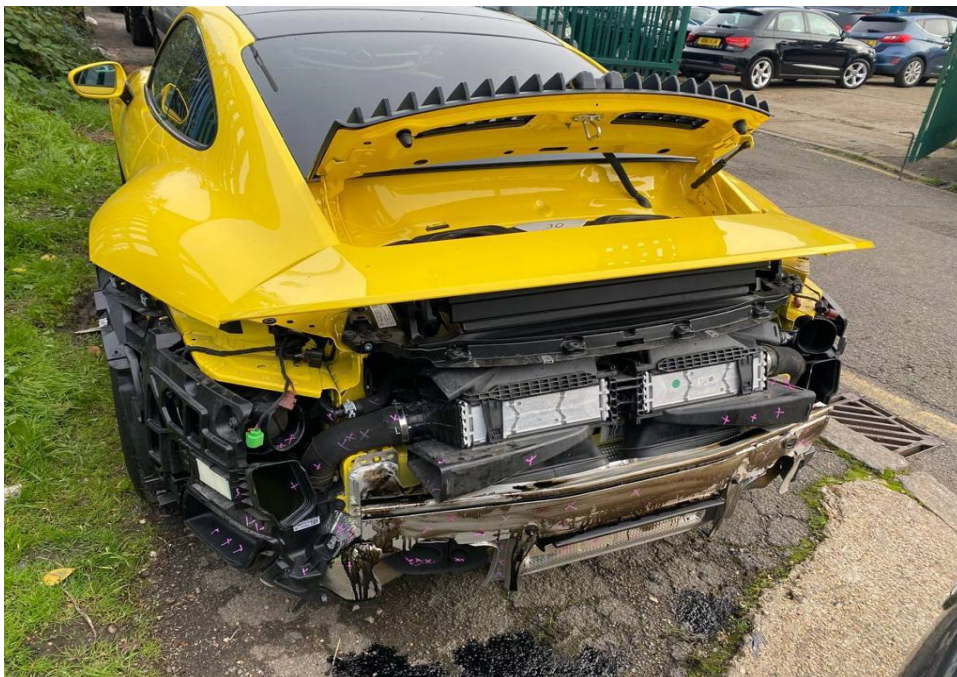
Photo 4 shows another view of the Motor Car's rear body (photograph provided to me). The Motor Car's rear left taillamp, rear right taillamp, rear centre lamp, rear bumper and all its related parts and attachments like the rear bumper lower cover, rear bumper left reflector, rear bumper right reflector, rear bumper sensors, rear bumper tow cover, rear left exhaust garnish and rear right exhaust garnish amongst others, were missing/dislodged/damaged.

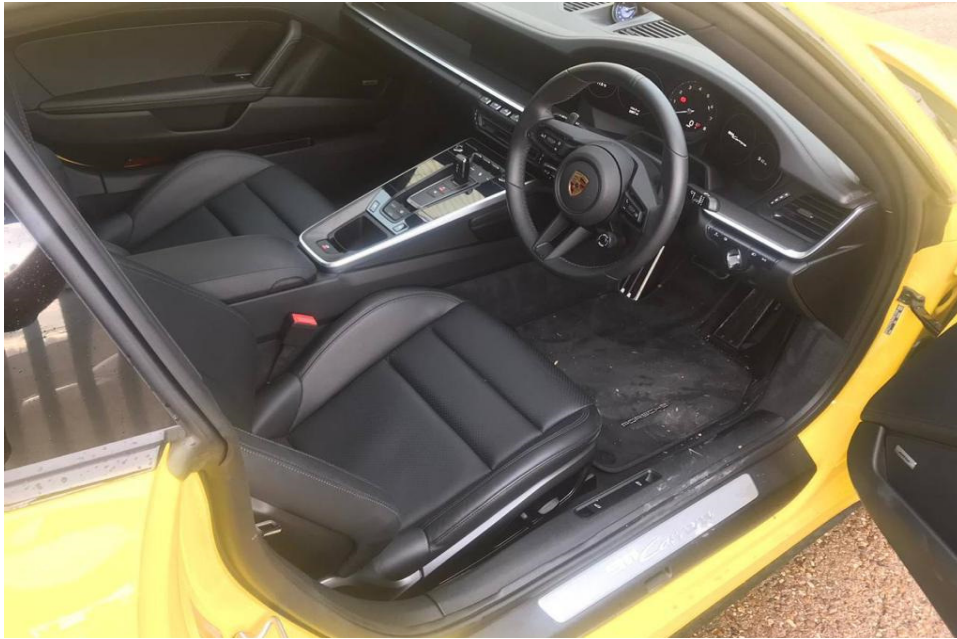
6. The airbag(s) of the Motor Car was not deployed as seen from the photographs that were provided to me. See photo 1 – 5 below.

Photo 5 shows the interior compartment of the Motor Car (photograph provided to me). The various parts and components within the interior compartment were all intact and unaffected. The Motor Car's airbag(s) was not deployed as seen from the photographs that were provided to me.

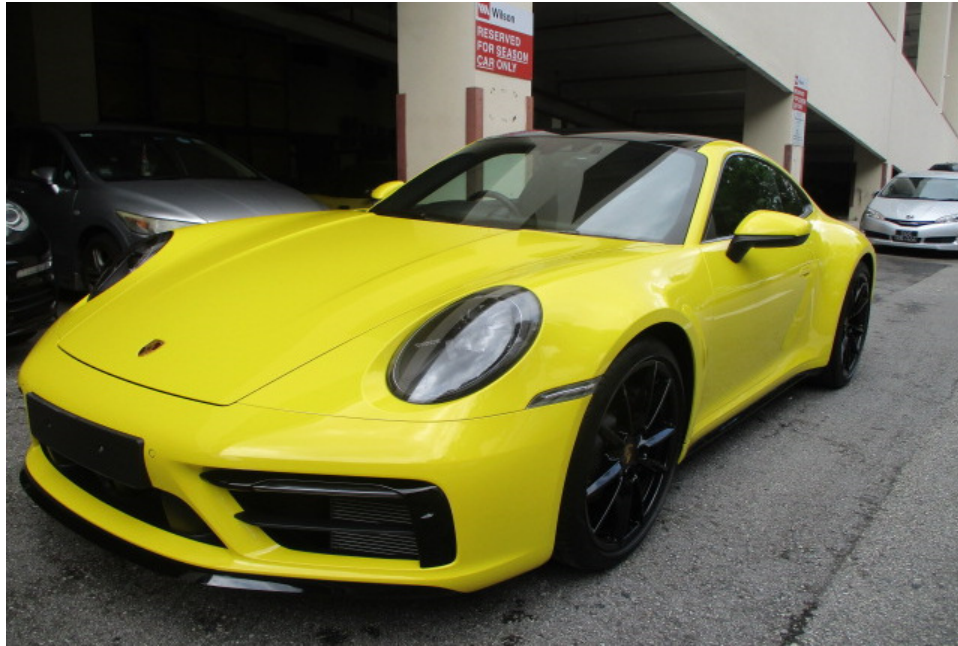
Photo 6 shows a general view of the front left body of the Motor Car at the time of my inspection. The Motor Car was observed to be in a relatively good general condition with no loose exterior fittings observed. The body parts at the frontal portion and left side front portion of the Motor Car were visually examined and it was observed that the repair/restoration works carried out to the damaged area of the Motor Car (refer to photograph 1 & 2 above) were reasonably adequate and in order.

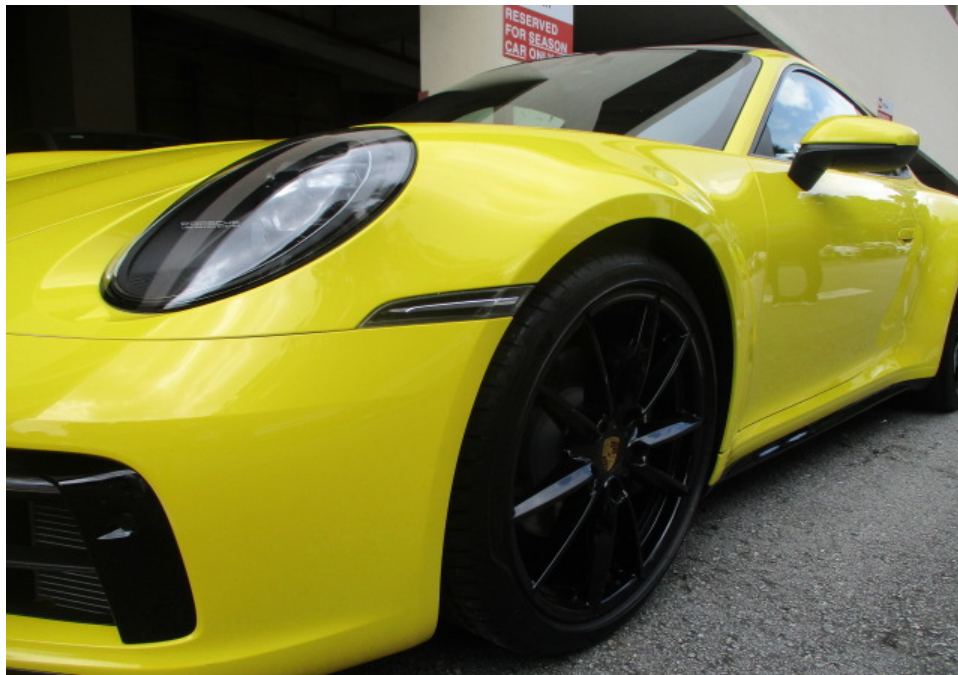
Photo 7 shows a closer view of the Motor Car's front left headlamp, front left signal lamp, front left fender and front left wheel rim. The body parts at the left side front portion of the Motor Car were visually examined and it was observed that the repair/restoration works carried out to the damaged area of the Motor Car (refer to photograph 1 above) were reasonably adequate and in order.

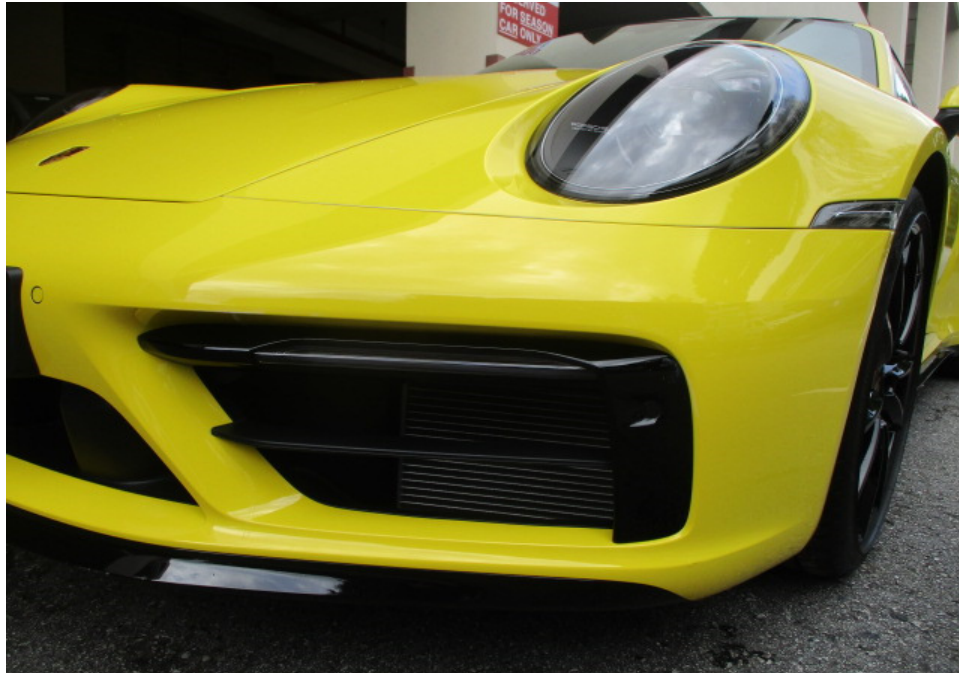
Photo 8 shows a closer view of the Motor Car's front bumper, front bumper lower lip, front bumper left lower grille, front left day light and front left headlamp. The body parts at the frontal portion of the Motor Car were visually examined and it was observed that the repair/restoration works carried out to the damaged area of the Motor Car (refer to photograph 1 & 2 above) were reasonably adequate and in order.

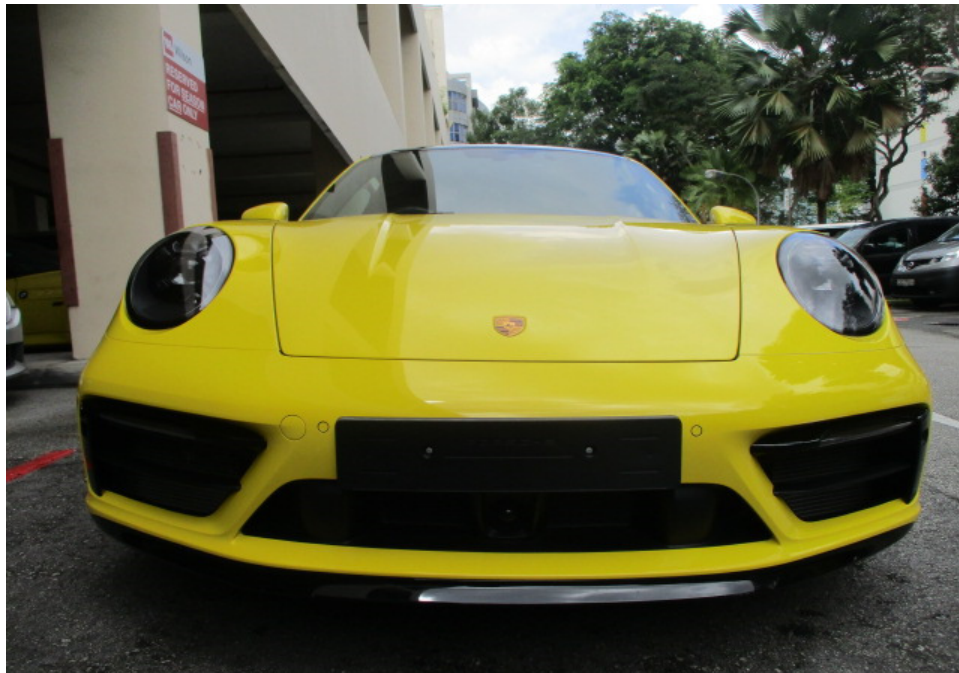
Photo 9 shows a closer view of the Motor Car's frontal portion at the time of my inspection. The body parts at the frontal portion of the Motor Car were visually examined and it was observed that the repair/restoration works carried out to the damaged area of the Motor Car (refer to photograph 2 above) were reasonably adequate and in order.

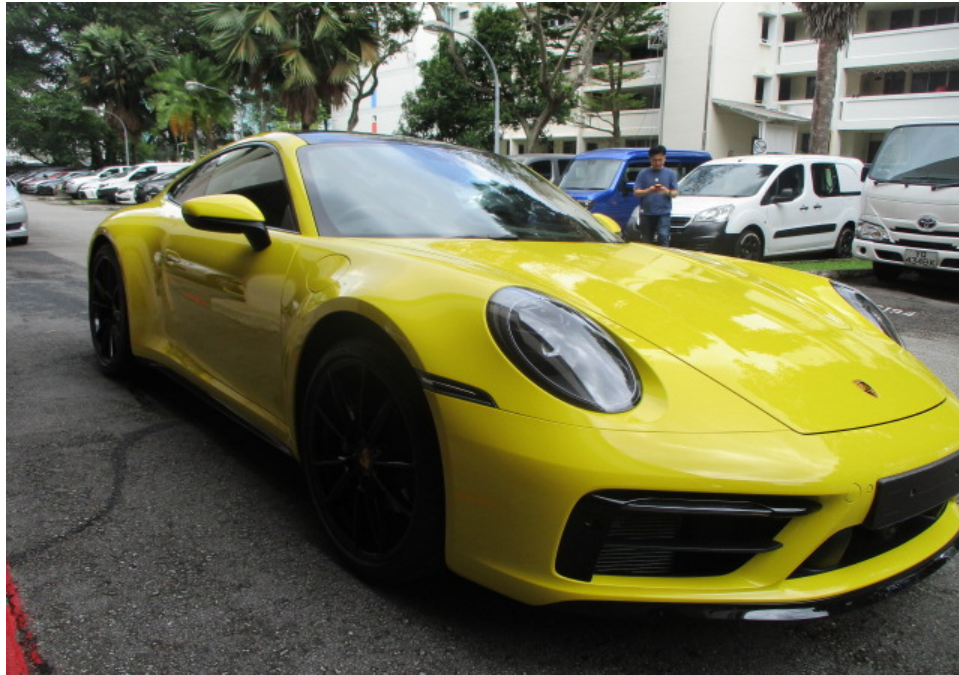
Photo 10 shows a general view of the front right body of the Motor Car at the time of my inspection. The Motor Car was observed to be in a relatively good general condition with no loose exterior fittings observed. The body parts at the frontal portion of the Motor Car were visually examined and it was observed that the repair/restoration works carried out to the damaged area of the Motor Car (refer to photograph 2 above) were reasonably adequate and in order.

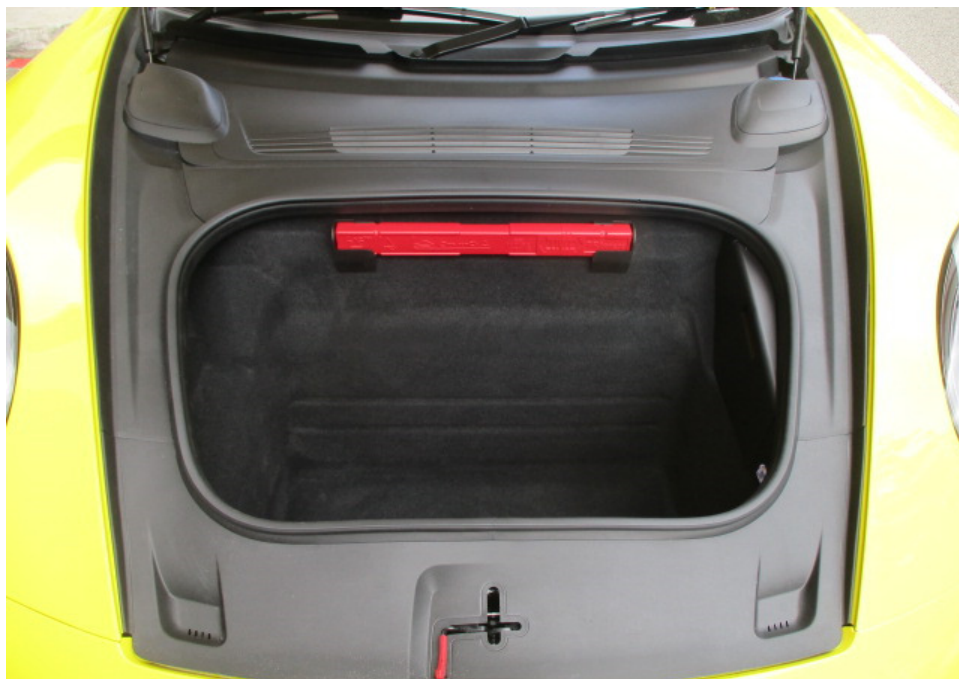
Photo 11 shows a general view of the Motor Car's front bonnet compartment at the time of my inspection. All inner trims, garnishes and upholstery etc were observed to be properly fitted.

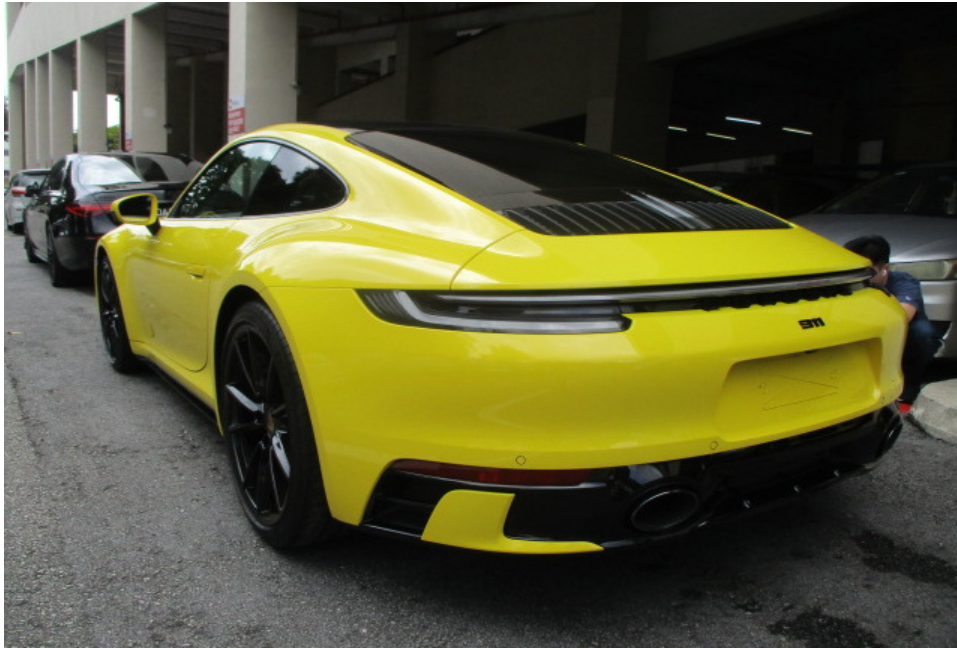
Photo 12 shows a general view of the rear left body of the Motor Car at the time of my inspection. The Motor Car was observed to be in a relatively good general condition with no loose exterior fittings observed. The body parts at the rear portion of the Motor Car were visually examined and it was observed that the repair/restoration works carried out to the damaged area of the Motor Car (refer to photograph 3 & 4 above) were reasonably adequate and in order.

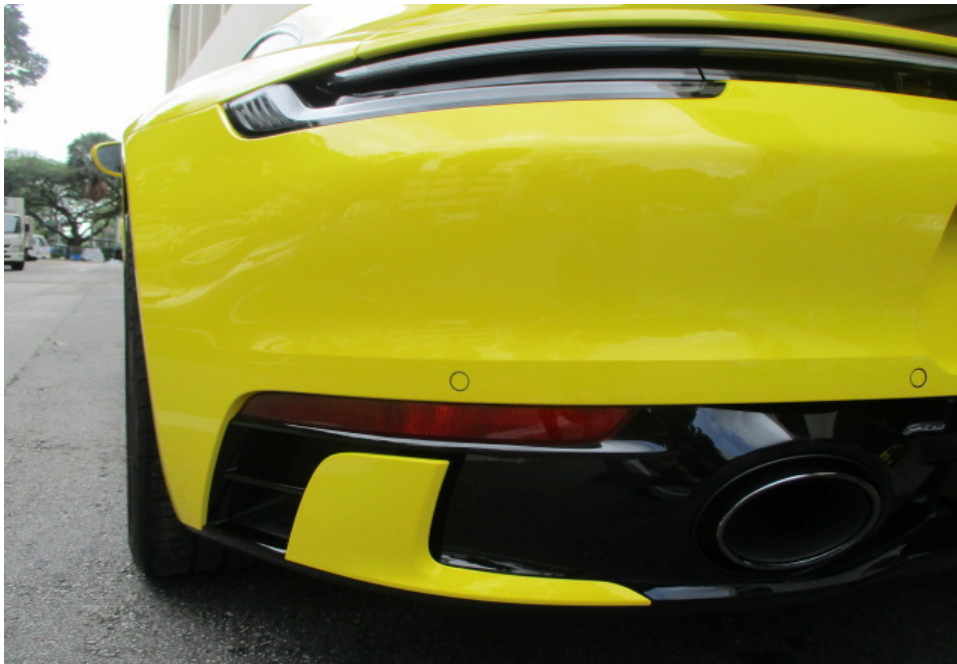
Photo 13 shows a closer view of the Motor Car's rear bumper, rear bumper lower cover, rear bumper left reflector, rear bumper sensors, rear left exhaust garnish and rear left taillamp. The body parts at the rear portion of the Motor Car were visually examined and it was observed that the repair/restoration works carried out to the damaged area of the Motor Car (refer to photograph 3 & 4 above) were reasonably adequate and in order.

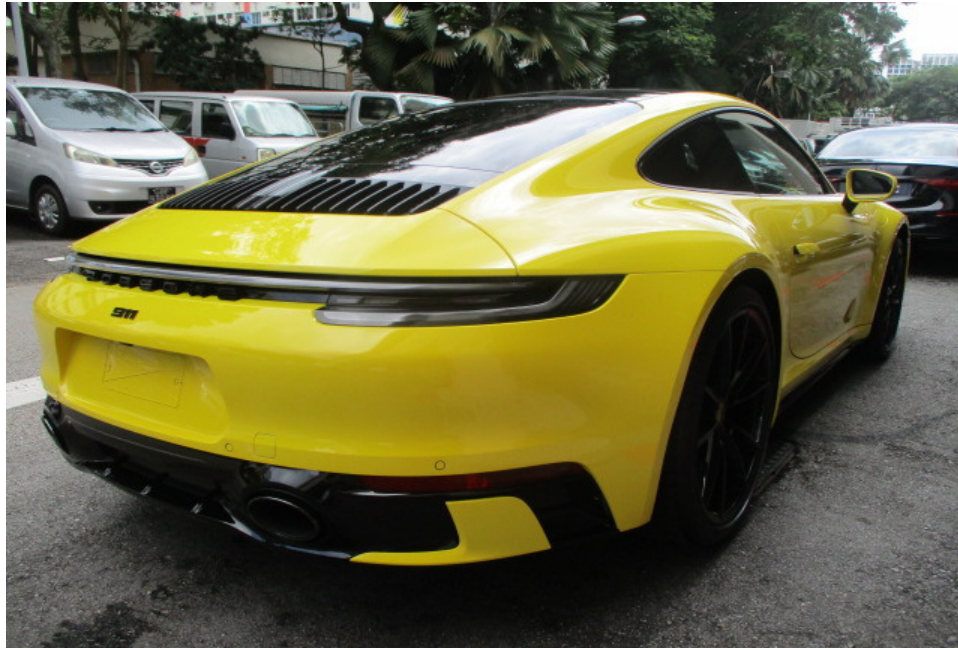
Photo 14 shows a general view of the rear right body of the Motor Car at the time of my inspection. The Motor Car was observed to be in a relatively good general condition with no loose exterior fittings observed. The body parts at the rear portion of the Motor Car were visually examined and it was observed that the repair/restoration works carried out to the damaged area of the Motor Car (refer to photograph 3 & 4 above) were reasonably adequate and in order.

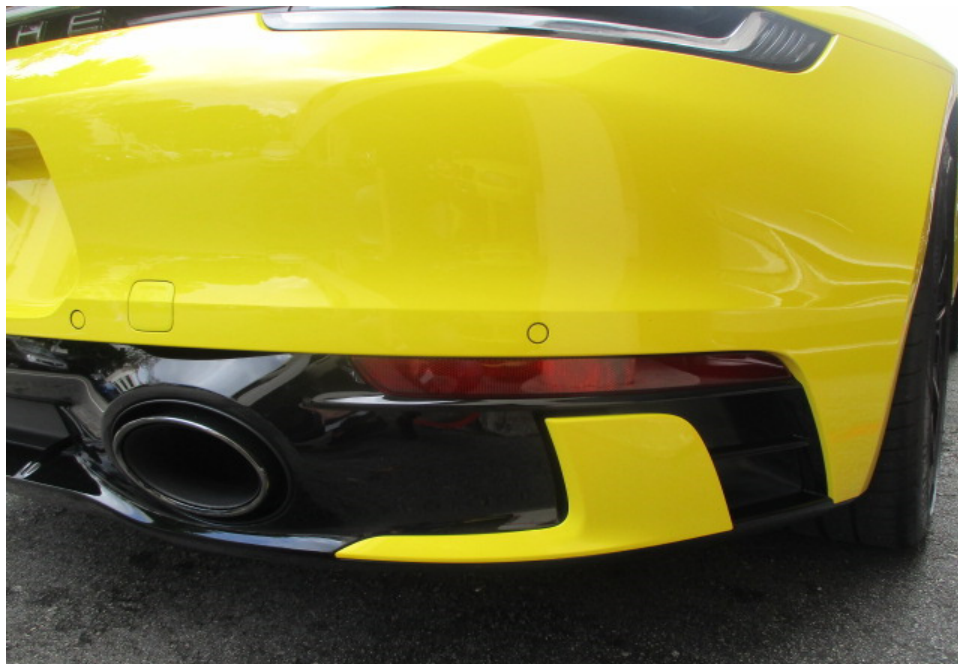
Photo 15 shows a closer view of the Motor Car's rear bumper, rear bumper lower cover, rear bumper right reflector, rear bumper sensors, rear bumper tow cover and rear right exhaust garnish. The body parts at the rear portion of the Motor Car were visually examined and it was observed that the repair/restoration works carried out to the damaged area of the Motor Car (refer to photograph 3 & 4 above) were reasonably adequate and in order.

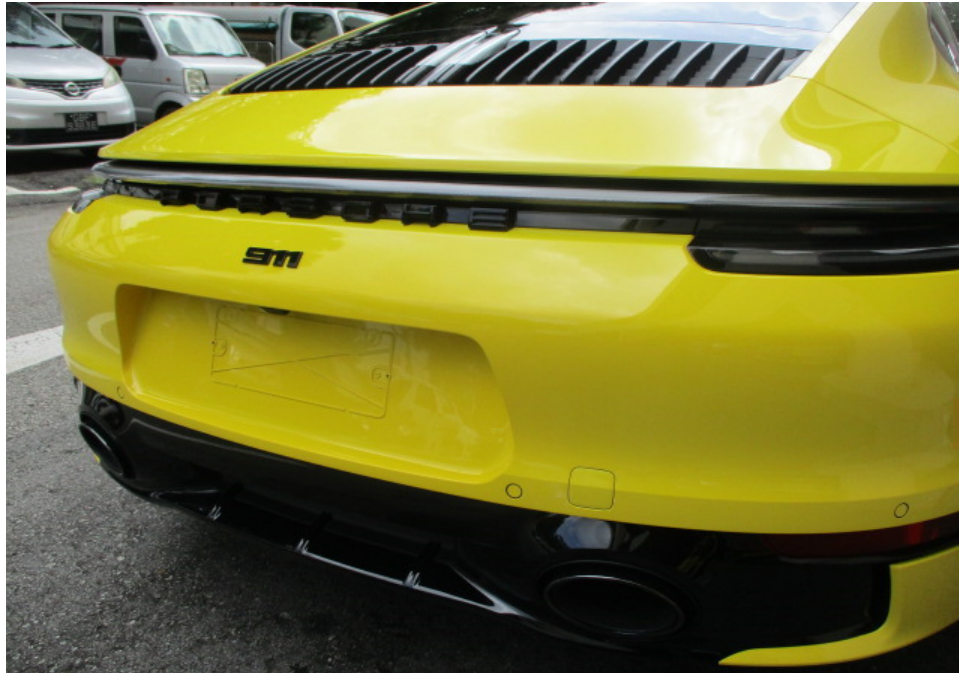
Photo 16 shows a closer view of the Motor Car's rear bumper, rear bumper lower cover, rear right taillamp and rear centre lamp. The body parts at the rear portion of the Motor Car were visually examined and it was observed that the repair/restoration works carried out to the damaged area of the Motor Car (refer to photograph 3 & 4 above) were reasonably adequate and in order.

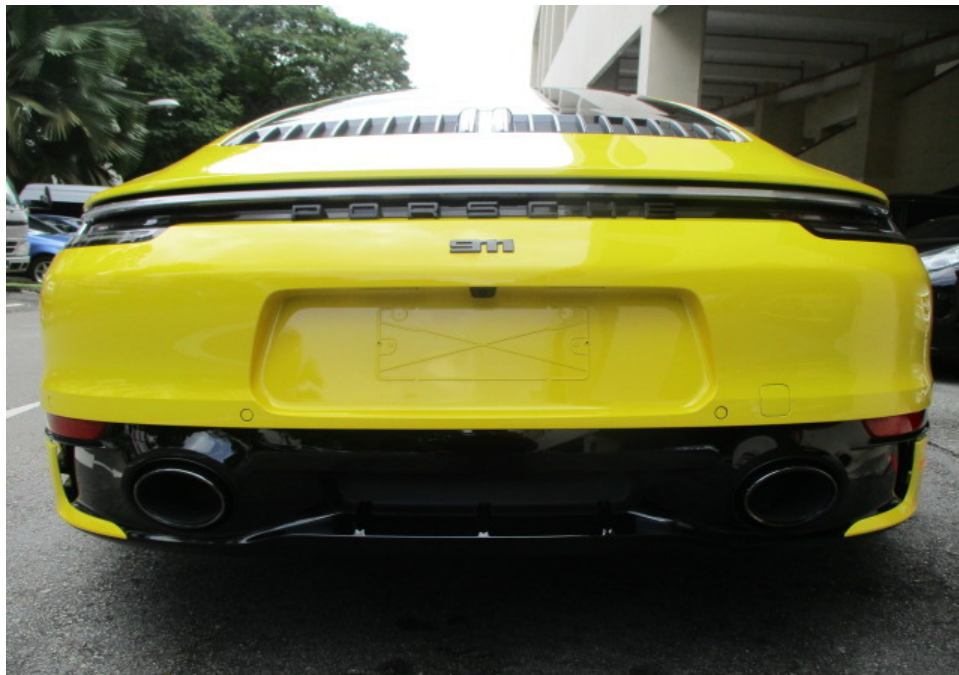
Photo 17 shows a closer view of the Motor Car's rear portion at the time of my inspection. The body parts at the rear portion of the Motor Car were visually examined and it was observed that the repair/restoration works carried out to the damaged area of the Motor Car (refer to photograph 3 & 4 above) were reasonably adequate and in order.

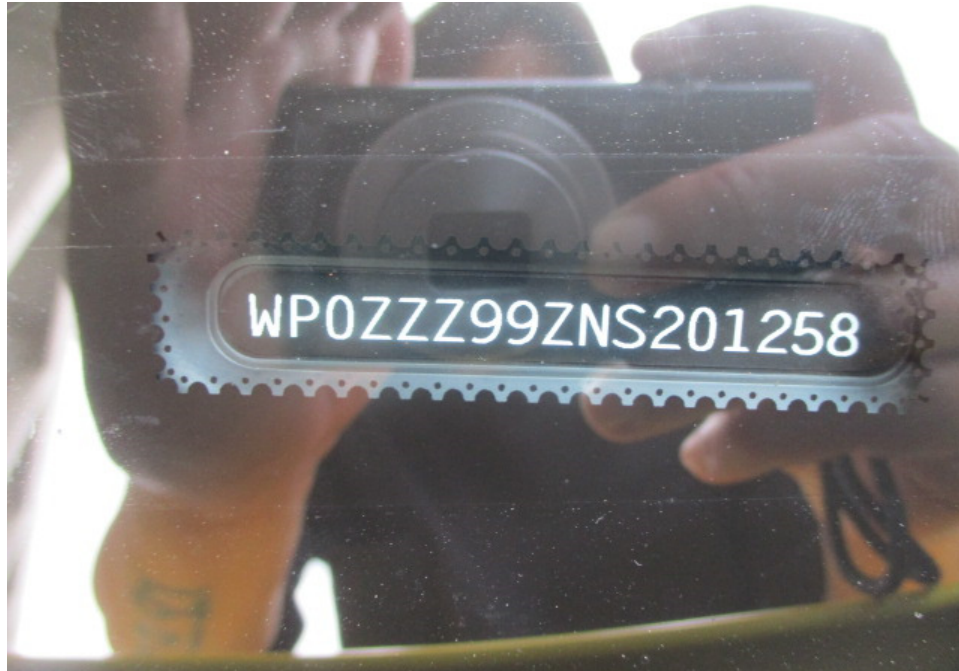
Photo 18 shows the chassis number of the Motor Car. The chassis number recorded was WP0ZZZ99ZNS201258.

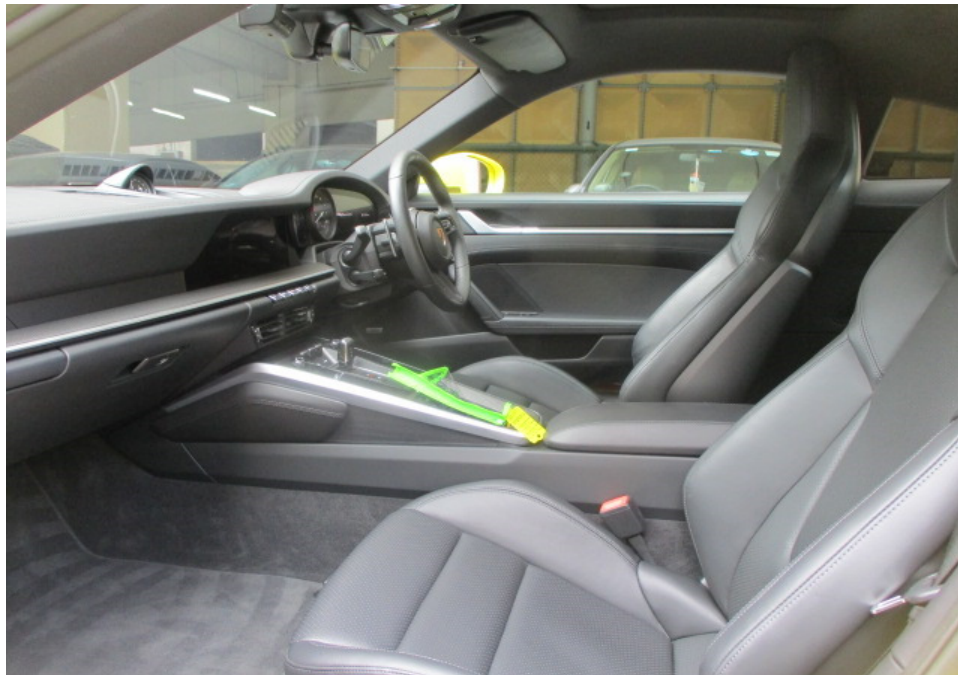
Photo 19 shows the interior compartment of the Motor Car at the time of my inspection. The various parts and components, trims, carpet, and upholstery inside the interior compartment were all observed to be intact and properly fitted.

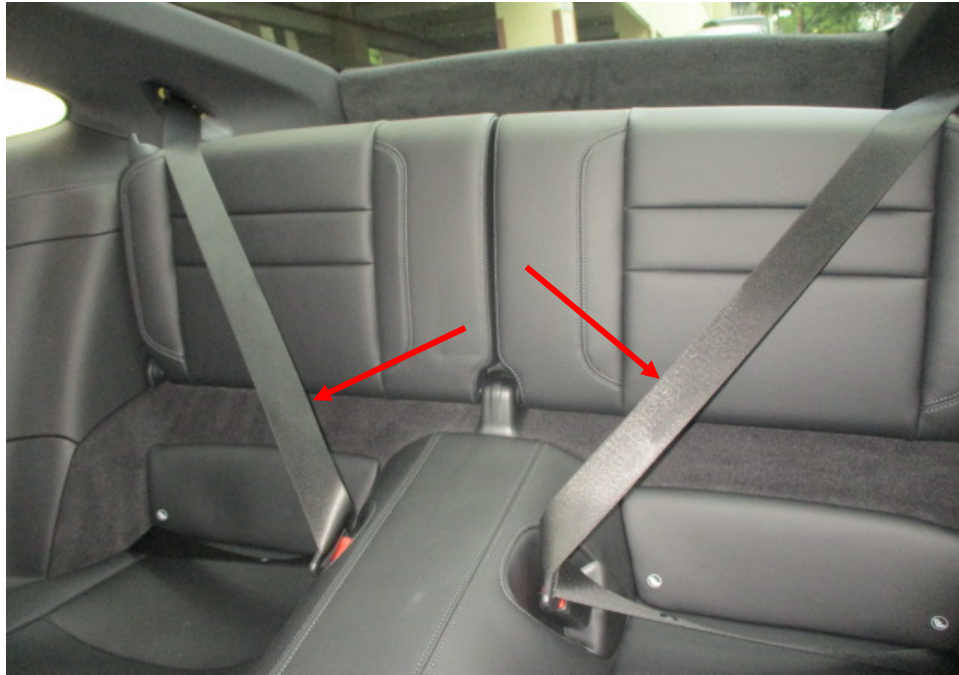
14. The seats of the Motor Car were found to be secured to the floorboard of the Motor Car via seat rails bolted onto the floorboard. Retractable seat belt reels and pre-tensioners were fitted on all seats of the Motor Car. The seat belts were tested and were able to be fastened securely into the respective pre-tensioners that were fixed to the side of all the seats.

Photo 20 shows the rear seats of the Motor Car. All the seats of the Motor Car were secured via seat rails to the floorboard. They were also fitted with a retractable seat belt reel and a pre-tensioner. The seat belts (arrowed) were tested and were able to be fastened into the respective pre-tensions that were fitted on the side of each individual seat.

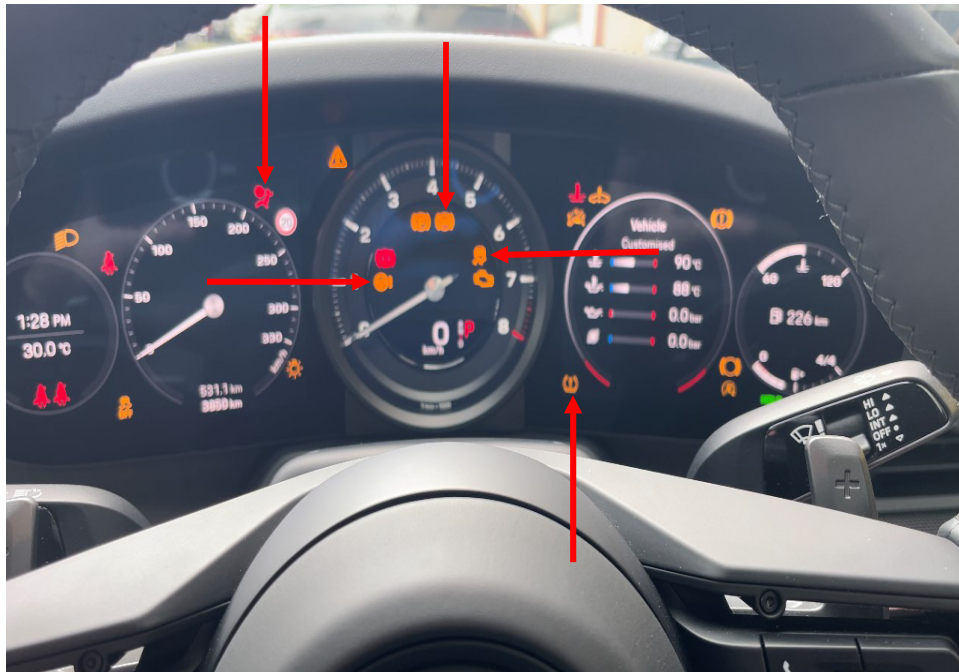
Photo 21 shows the warning lights for the various electronic safety features appearing on the instrument panel of the Motor Car during its self-test when the engine is cranked, in particular the ABS, SRS, EPS, TPM and TCS lights (arrowed).

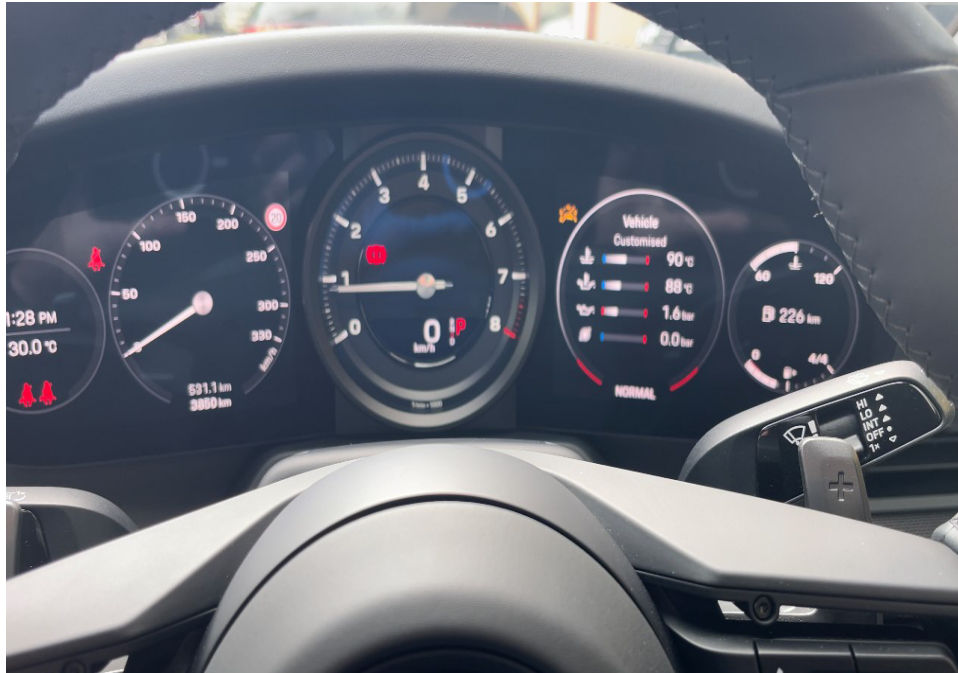
15. The Motor Car's automatic self-test of the functionality of its various electronic safety features like the Anti-Lock Brake System (ABS), Supplemental Restraint System (SRS), Electric Power Steering (EPS), Tyre Pressure Monitor (TPM) and Traction Control System (TCS) during cranking of the engine had indicated that these electronic systems were in working condition. This was determined from the respective warning lights disappearing from the instrument panel after the self-test.

Photo 22 shows the respective warning lights no longer illuminated, indicating that there is no fault detected to the ABS, SRS, EPS, TPM and TCS systems of the Motor Car during the self-test. These electronic systems were hence in working condition at the time of my inspection.

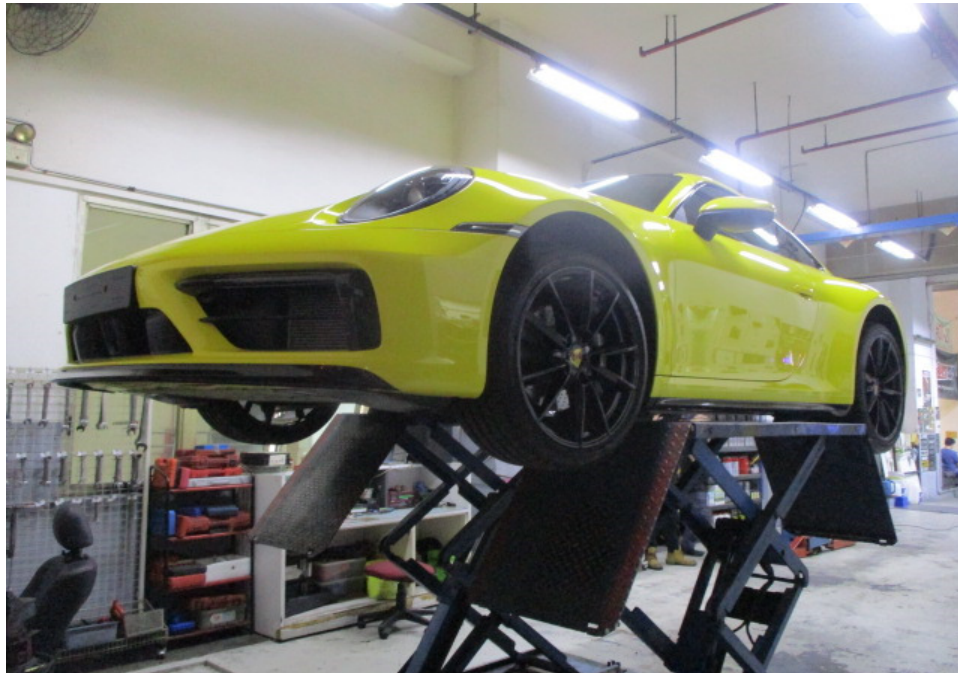
17. My checks on the underside of the Motor Car revealed no sign(s) or indication(s) of fluid leakage and/or fluid stain(s). The engine block and automatic transmission assembly were both secured properly. All undercarriage components of the Motor Car were also observed to be intact and secured in an appropriate manner.

Photo 23 shows the Motor Car hoisted up for checks on its undercarriage. There was no sign(s) or indication(s) of fluid leakage and/or fluid stain(s) on the underside of the Motor Car. The undercarriage components of the Motor Car were also all observed to be intact and secured in an appropriate manner.

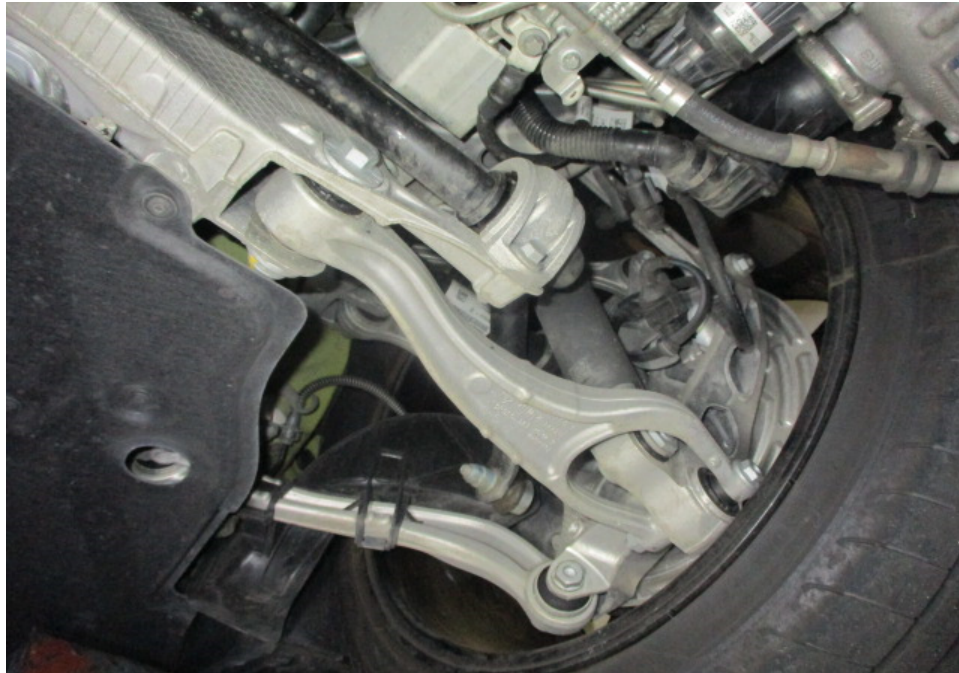
Photo 24 shows a general view of the control arms and linkages at the rear right wheel of the Motor Car. I did not observe any fluid leak and/or fluid stain on the underside of the Motor Car. All of the Motor Car's undercarriage components were observed to be intact and secured in an appropriate manner.

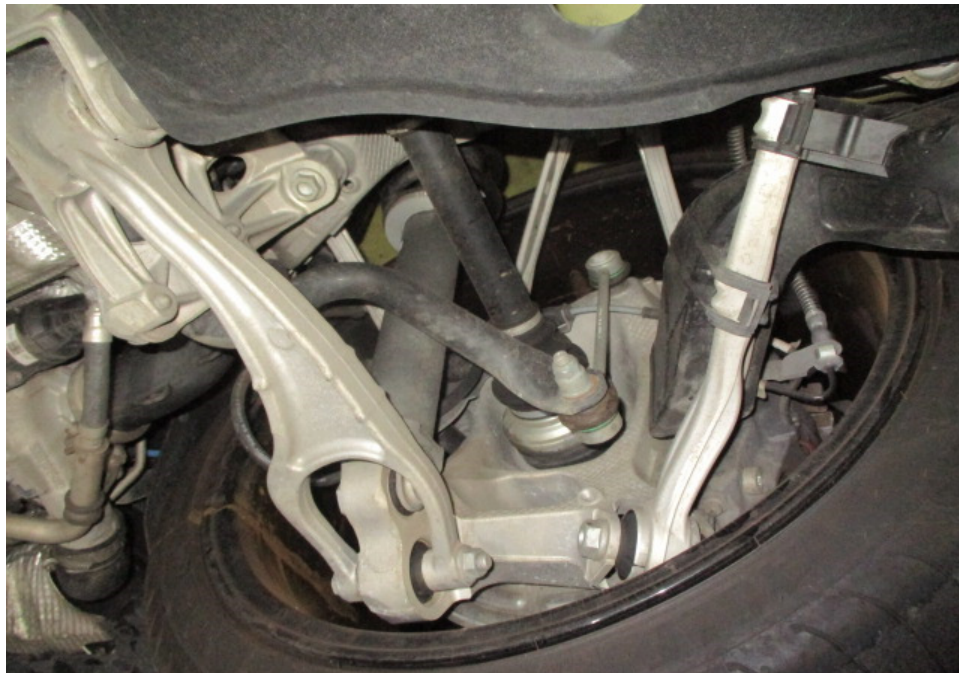
Photo 25 shows a general view of the control arms and linkages at the rear left wheel of the Motor Car. I did not observe any fluid leak and/or fluid stain on the underside of the Motor Car. All of the Motor Car's undercarriage components were observed to be intact and secured in an appropriate manner.

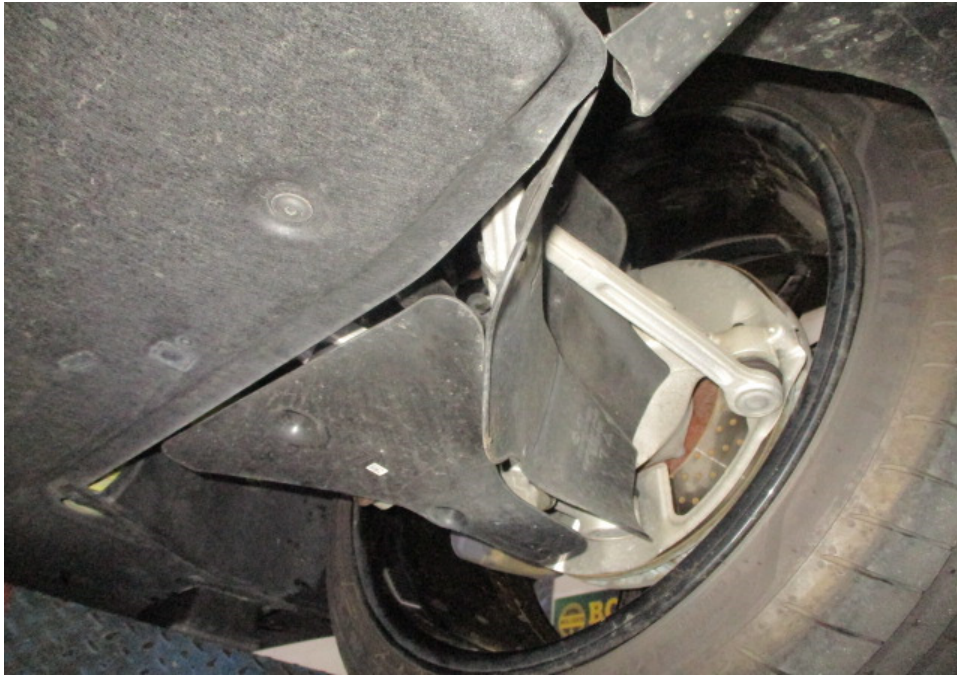
Photo 26 shows the various undercarriage components at the front left wheel of the Motor Car. The mechanical components, control arms and linkages were all found to be intact and secured in an appropriate manner.

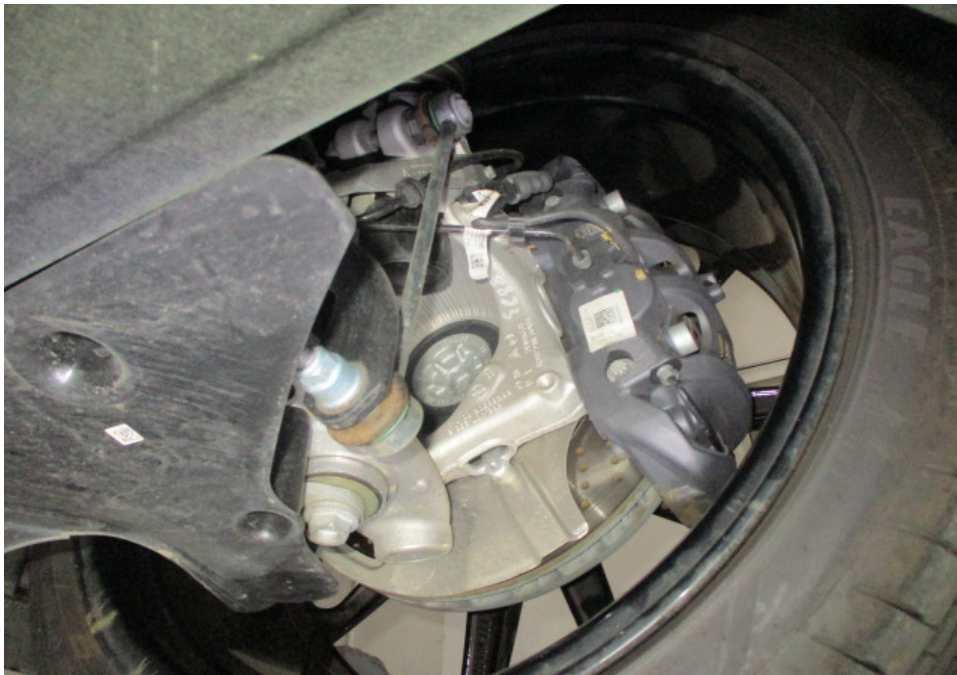
Photo 27 shows the various undercarriage components at the front right wheel of the Motor Car. The mechanical components, control arms and linkages were all found to be intact and secured in an appropriate manner. I also did not observe any fluid leak and/or fluid stain on the underside of the Motor Car.

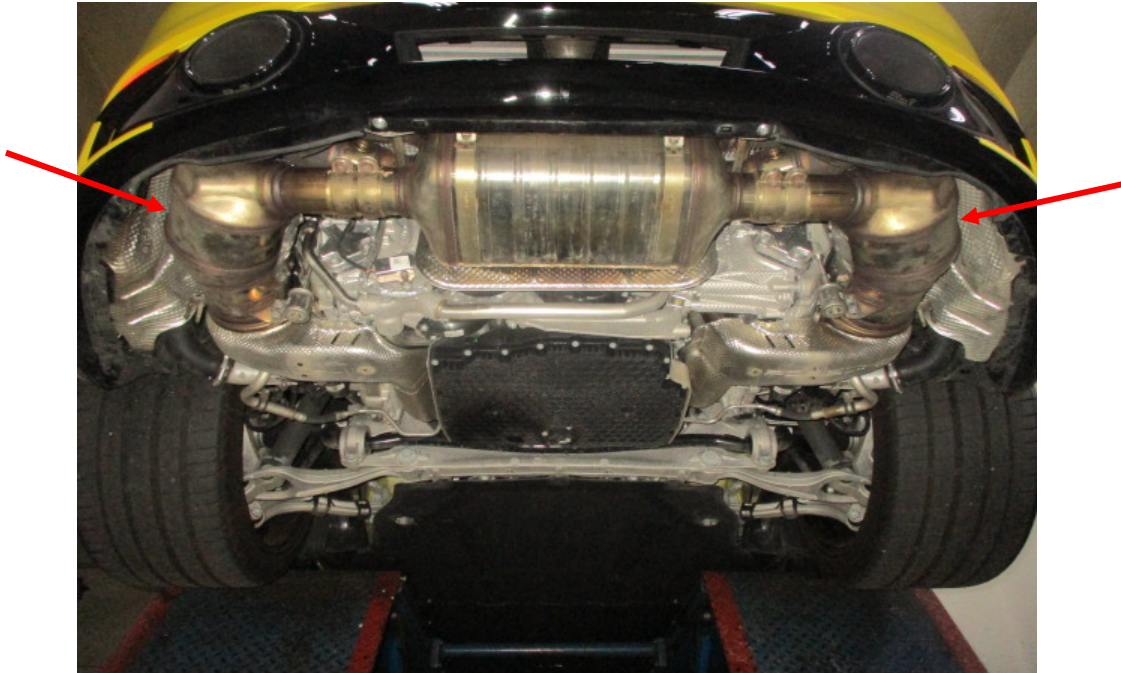
Photo 28 shows the Motor Car's exhaust system. My examination of the Motor Car's exhaust system revealed no sign(s) or indication(s) of any cut or weld marks along its exhaust pipes, on its catalytic converters (arrowed) and on its rear muffler.

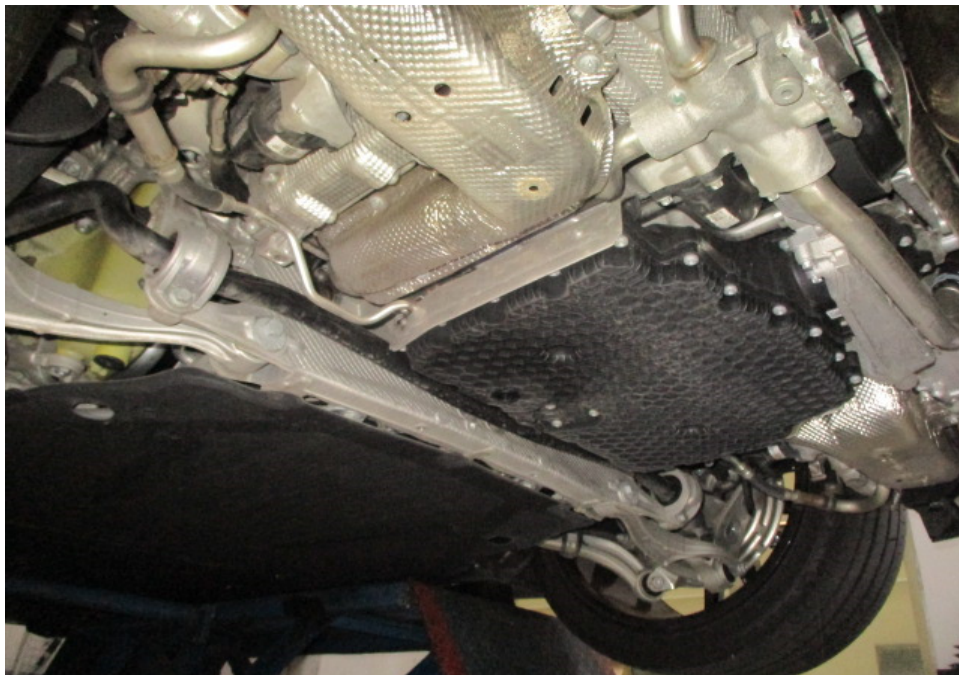
16. My examination of the Motor Car's engine compartment revealed that the various parts and components within the engine compartment were all intact and properly fitted. The engine oil, brake fluid and engine coolant were all found to be of sufficient level for operating purposes. Visually, there was also no contamination found to these fluids.

Photo 29 shows a general view of the Motor Car's engine compartment. The engine compartment was at the rear underside of the Motor Car. The various parts and components within the engine compartment were all observed to be intact and properly fitted. There was also no sign(s) or indication(s) of fluid leak and/or fluid stain found inside the engine compartment.

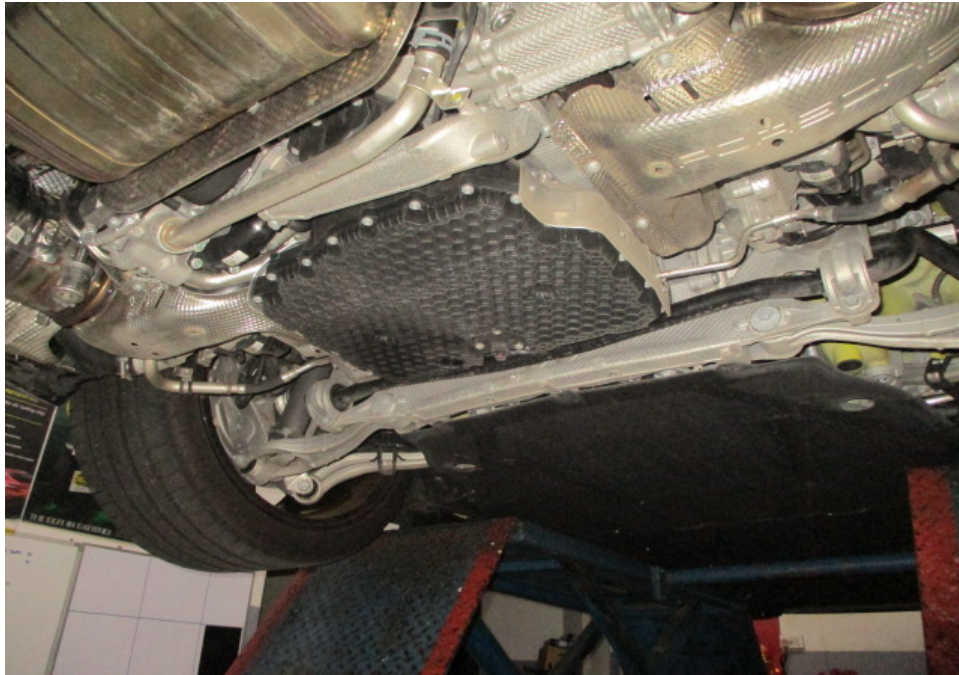
Photo 30 shows another view of the Motor Car's engine compartment. The engine compartment was at the rear underside of the Motor Car. The various parts and components within the engine compartment were all observed to be intact and properly fitted. There was also no sign(s) or indication(s) of fluid leak and/or fluid stain found inside the engine compartment.
