Your Ref: Porsche 911 Carrera Coupe
(chassis number WP0ZZZ99ZNS201258)
Our Ref : CI/TP23000638/D

19 January 2023

**INSPECTION REPORT OF AN UNREGISTERED PORSCHE 911 CARRERA
COUPE MOTOR CAR WITH CHASSIS NUMBER WP0ZZZ99ZNS201258**

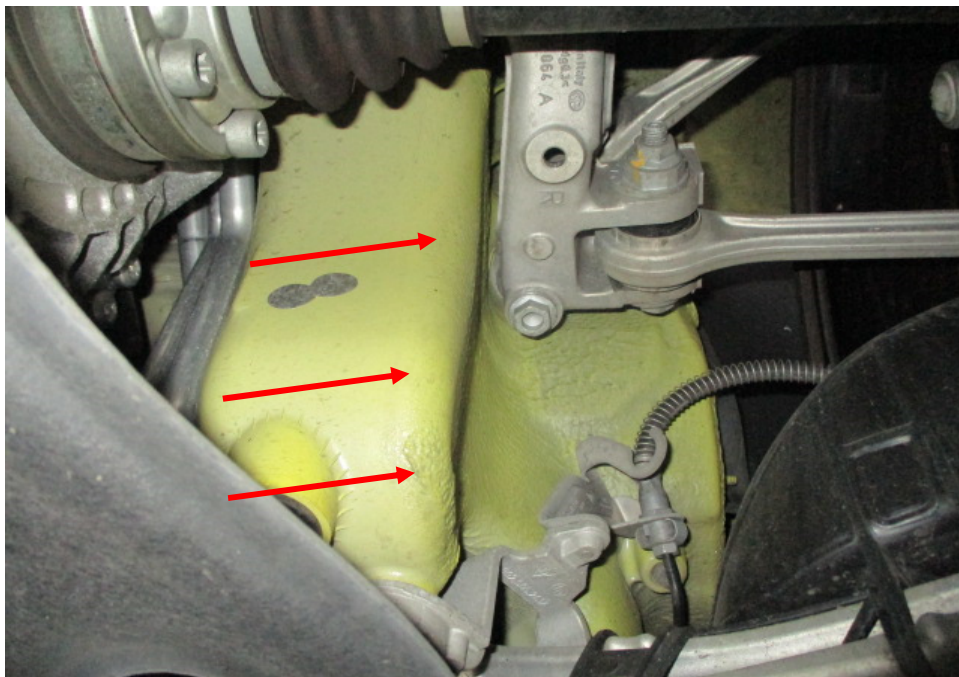
13. Visually, I did not find any weld marks, other than the original spot weld marks, on the chassis/structural body of the Motor Car. The original factory sealant at the joints along the chassis/structural body was also untouched, again indicating that no replacement of the chassis/structural body was carried out; and that the chassis/structural body was originally fitted.

Photo 31 shows the chassis/structural body at the underside rear right of the Motor Car. I did not find any weld marks other than original spot weld marks on the chassis/structural body of the Motor Car. The original factory sealant (arrowed) at the joints along the chassis/structural body was untouched, indicating no work was done on the chassis/structural body of the Motor Car and that the chassis/structural body was originally fitted.

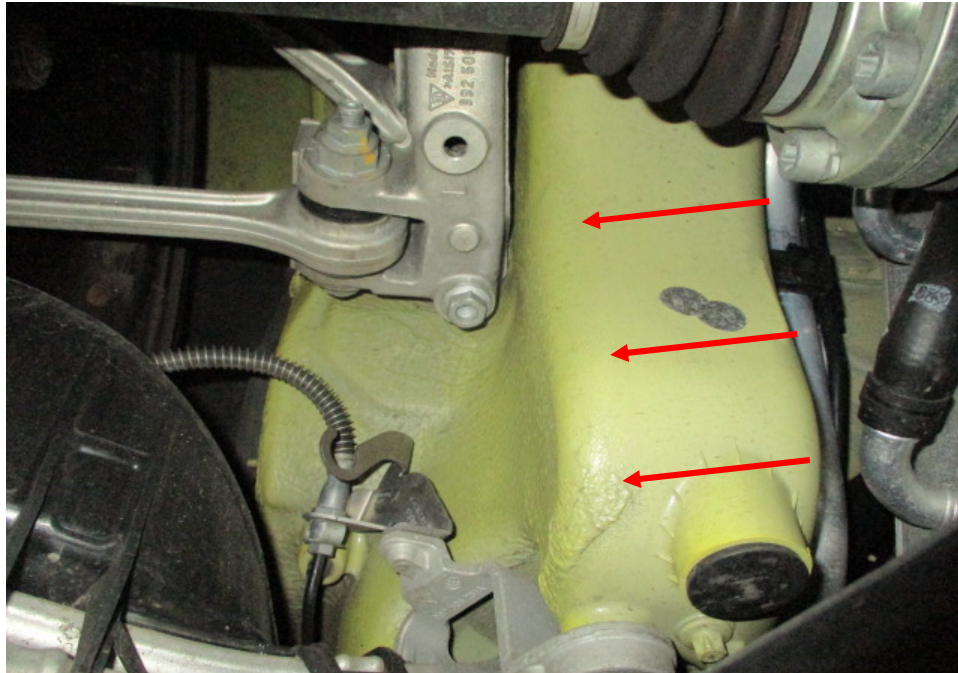
Photo 32 shows the chassis/structural body at the underside rear left of the Motor Car. The original factory sealant (arrowed) at the joints along the chassis/structural body was observed to be untouched. In general, I had found no work was carried out on the chassis/structural body of the Motor Car. The chassis/structural body of the Motor Car was originally fitted.

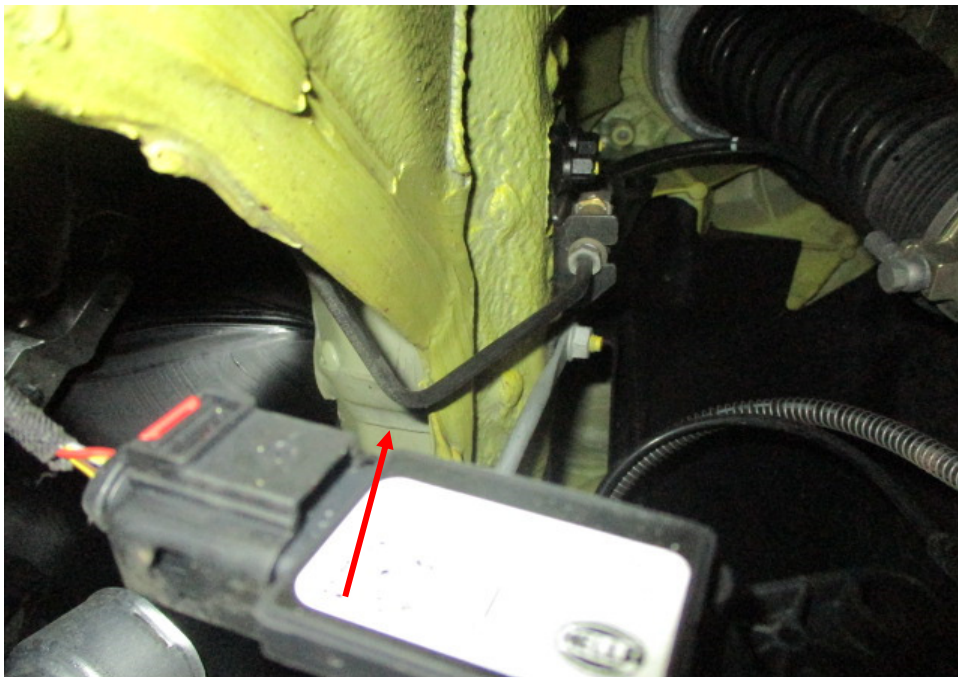
Photo 33 shows the chassis/structural body at the underside front left of the Motor Car. I did not find any weld marks other than original spot weld marks on the chassis/structural body of the Motor Car. The original factory sealant (arrowed) at the joints along the chassis/structural body was untouched, indicating no work was done on the chassis/structural body of the Motor Car and that the chassis/structural body was originally fitted.

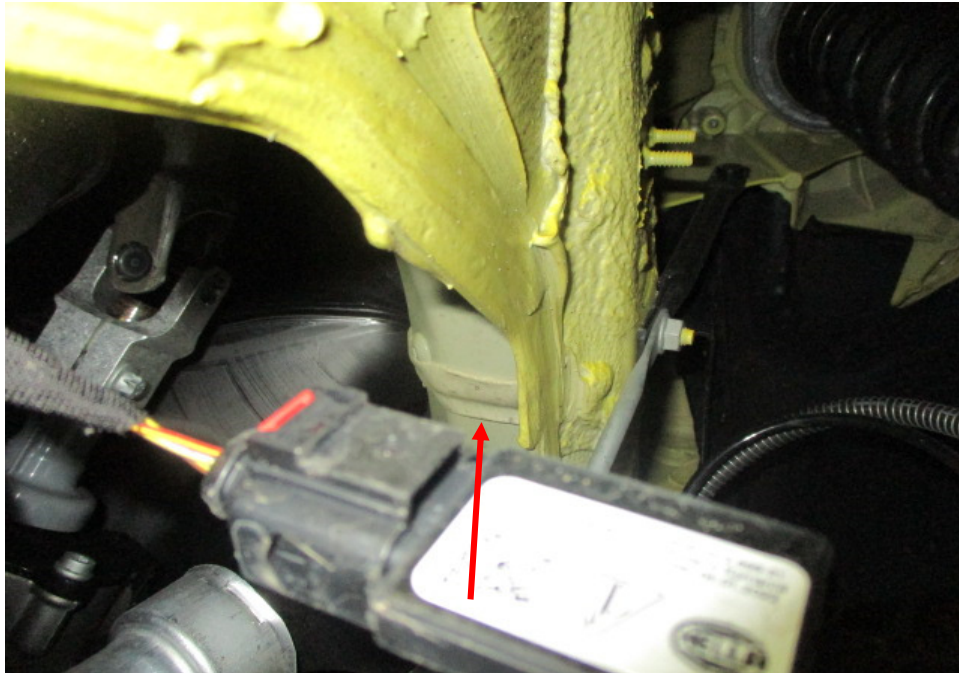
Photo 34 shows the chassis/structural body at the underside front right of the Motor Car. The original factory sealant (arrowed) at the joints along the chassis/structural body was observed to be untouched. In general, I had found no work was carried out on the chassis/structural body of the Motor Car. The chassis/structural body of the Motor Car was originally fitted.
