Your Ref: McLaren GT
(chassis number SBM22GCC5MW001172)
Our Ref : CI/TP23000664/D

19 January 2023

INSPECTION REPORT OF AN UNREGISTERED MCLAREN GT MOTOR CAR WITH CHASSIS NUMBER SBM22GCC5MW001172

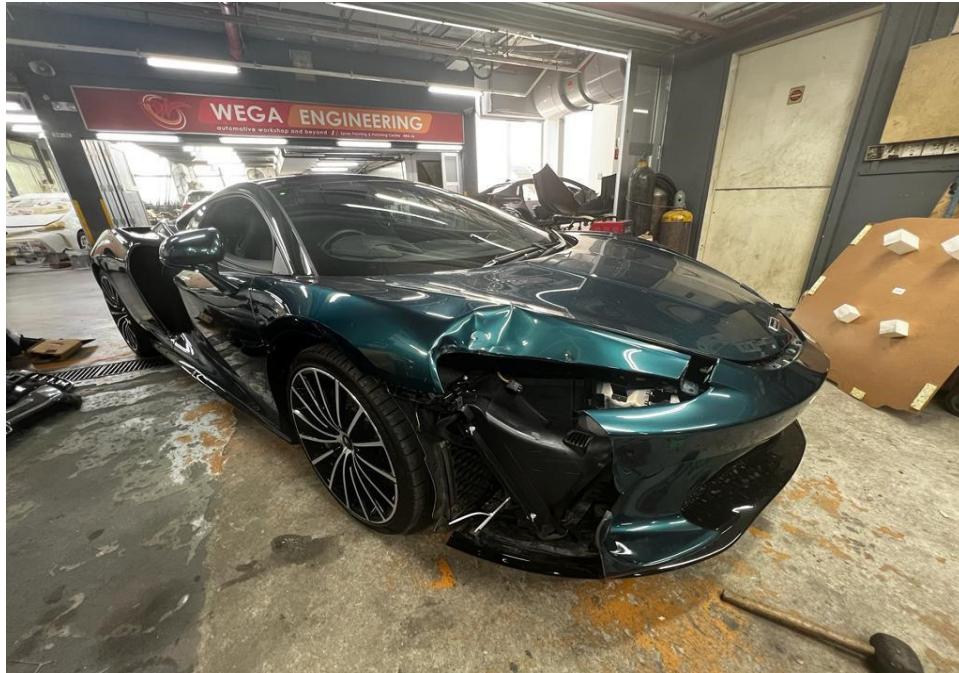
3. The photographs provided to me had showed damage to the front right portion of the Motor Car. Body parts damaged include the front bumper, front bumper right air duct, front bumper right bracket, front bumper right sensor, front right signal lamp, front right fender and front bonnet amongst others. The front right headlamp was also observed to be dislodged/missing/damaged.
4. Apart for the front right portion, there was no physical damage observed to other areas of the Motor Car. The airbag(s) was not deployed as seen from the photographs that were provided to me. See photo 1 – 5 below.

Photo 1 shows the front right body of the Motor Car (photograph provided to me). The photographs provided to me had showed damage to the front right portion of the Motor Car. The front bumper, front bumper right air duct, front bumper right bracket, front bumper right sensor, front right signal lamp, front right fender and front bonnet were amongst the body parts that were observed to have been damaged. The front right headlamp was dislodged/missing/damaged.

22. The body parts at the front right portion of the Motor Car were visually examined and it was noted that the repair/restoration works carried out to the damaged area of the Motor Car (refer to photograph 1 above) were reasonably adequate and in order.

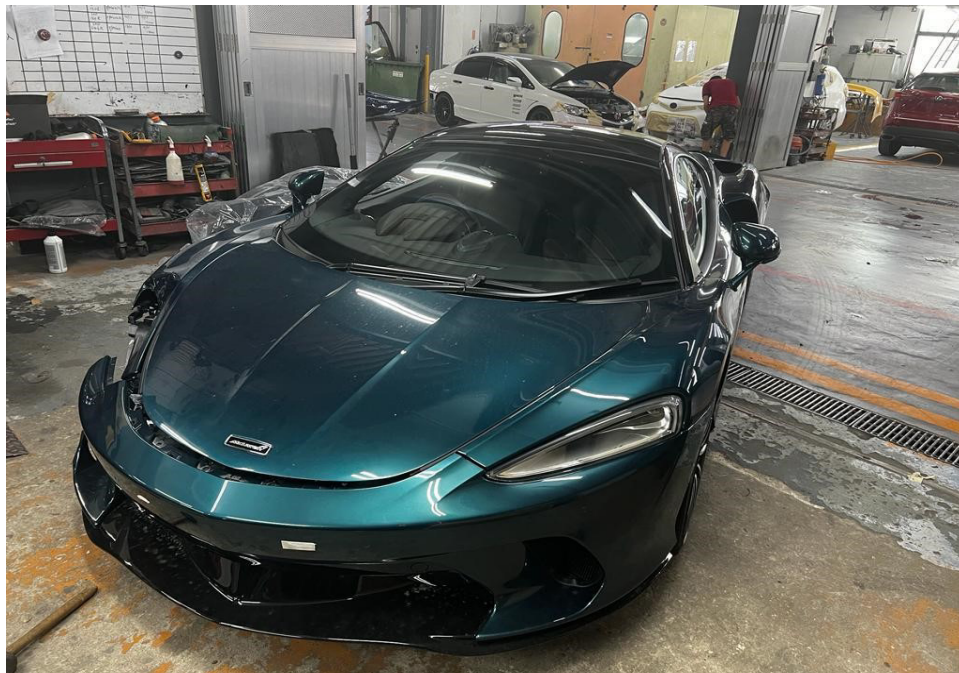
Photo 2 shows the front left body of the Motor Car (photograph provided to me). Apart for the front right portion, there was no physical damage observed to other areas of the Motor Car. The airbag(s) of the Motor Car was not deployed as seen from the photographs that were provided to me.

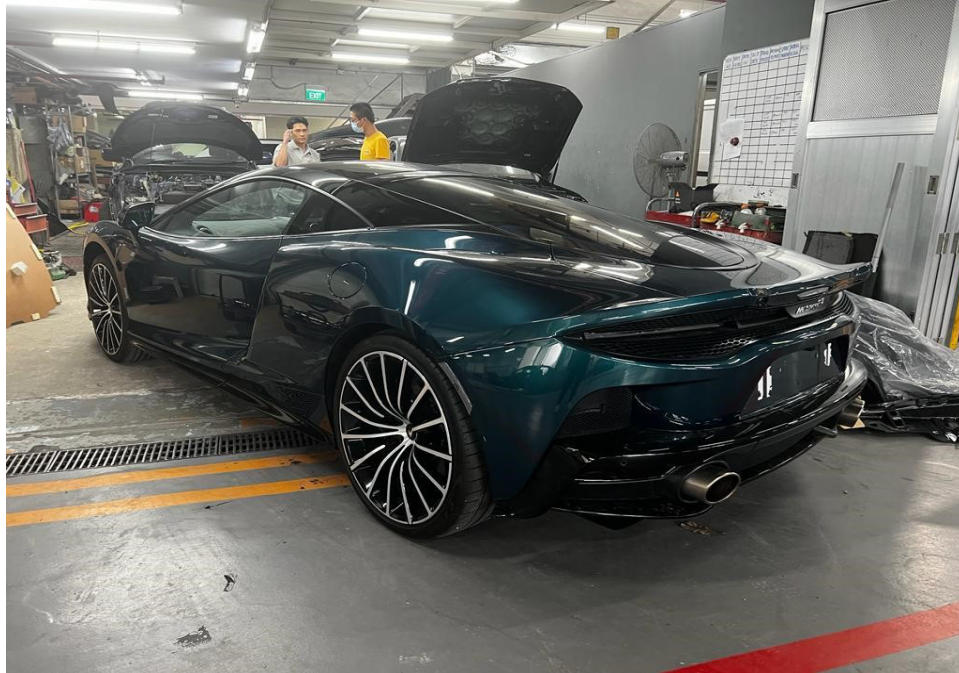
Photo 3 shows the rear left body of the Motor Car (photograph provided to me). Apart for the front right portion, there was no physical damage observed to other areas of the Motor Car. The airbag(s) of the Motor Car was not deployed as seen from the photographs that were provided to me.

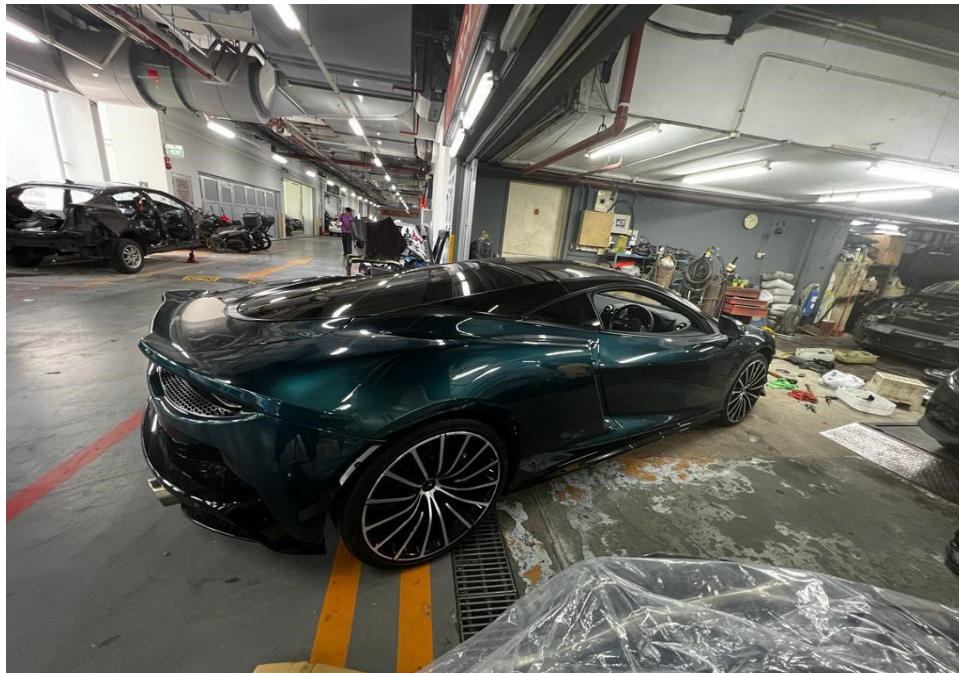
Photo 4 shows the rear right body of the Motor Car (photograph provided to me). Apart for the front right portion, there was no physical damage observed to other areas of the Motor Car. The airbag(s) of the Motor Car was not deployed as seen from the photographs that were provided to me.

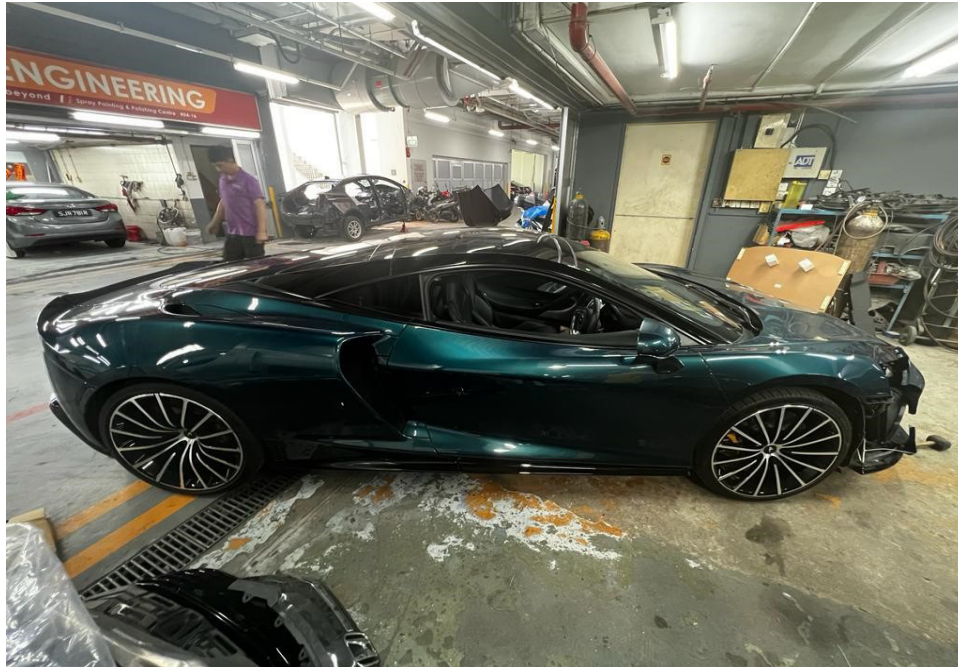
Photo 5 shows the right side body of the Motor Car (photograph provided to me). Apart for the front right portion, there was no physical damage observed to other areas of the Motor Car.

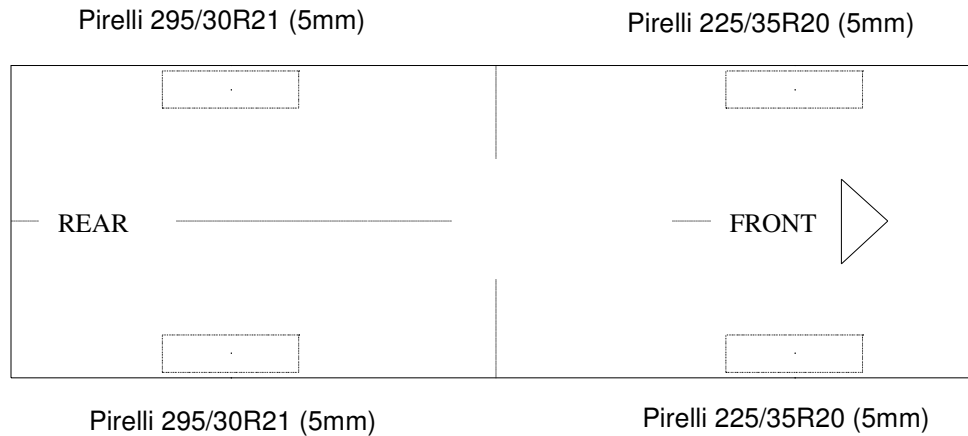
8. It was fitted with 20inch (front) and 21inch (rear) sport wheel rims that were wrapped with tyres that were observed to be of serviceable condition. The tyres were also sufficiently inflated for vehicular operation. The tyre brand, tyre size and approximate remaining tread depth of the 4 tyres of the Motor Car were recorded as follows: -

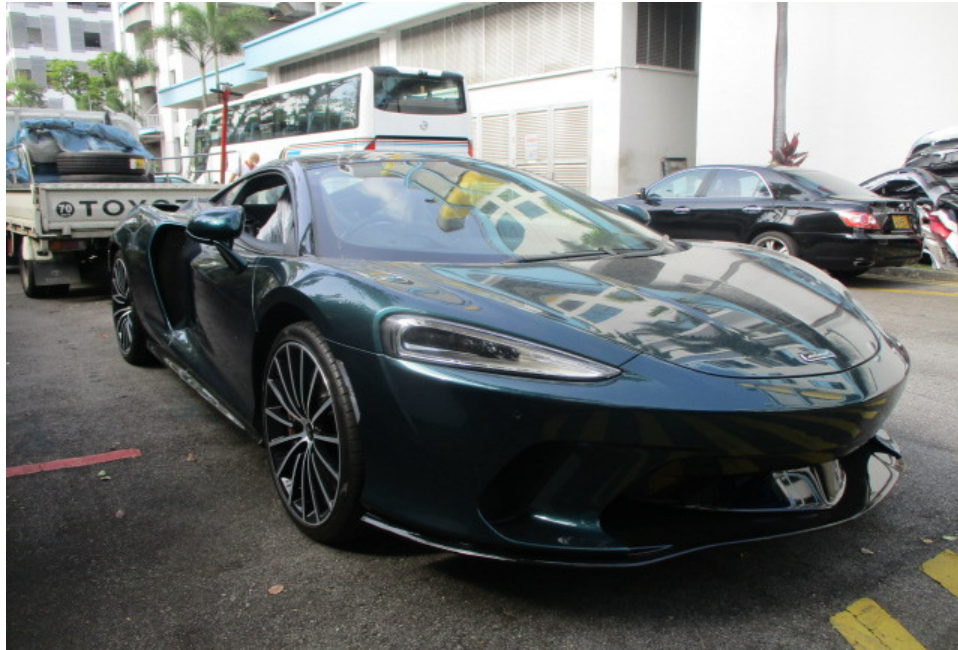
Photo 6 shows a general view of the front right body of the Motor Car at the time of my inspection. The Motor Car was observed to be in a relatively good general condition with no loose exterior fittings observed. The body parts at the front right portion of the Motor Car were visually examined and it was observed that the repair/restoration works carried out to the damaged area of the Motor Car (refer to photograph 1 above) were reasonably adequate and in order.

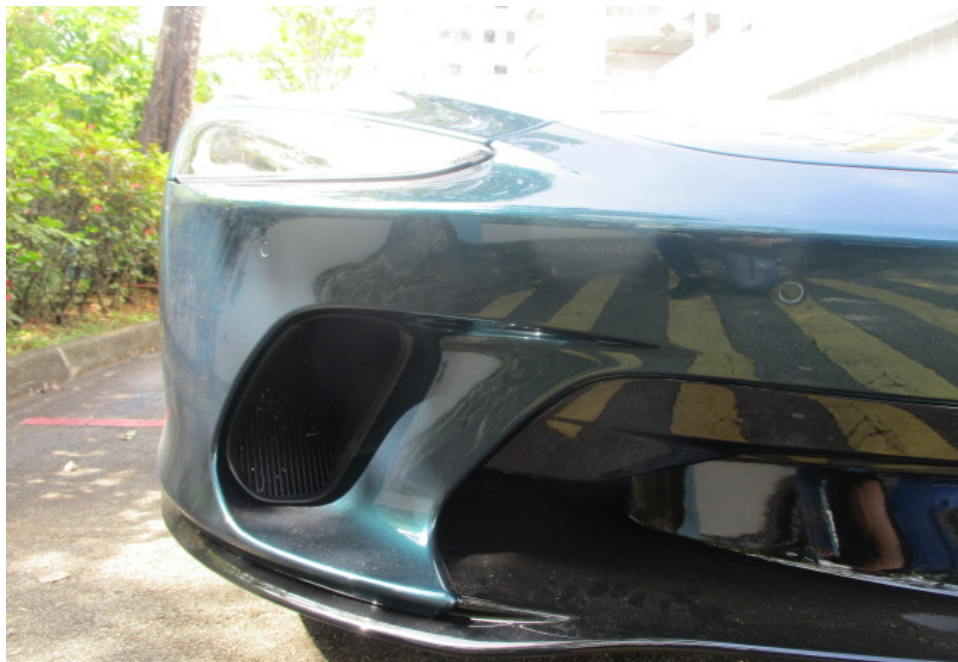
Photo 7 shows a closer view of the Motor Car's front bumper, front bumper lower lip, front bumper right air duct, front bumper right sensors and front right headlamp. The body parts at the front right portion of the Motor Car were visually examined and it was observed that the repair/restoration works carried out to the damaged area of the Motor Car (refer to photograph 1 above) were reasonably adequate and in order.

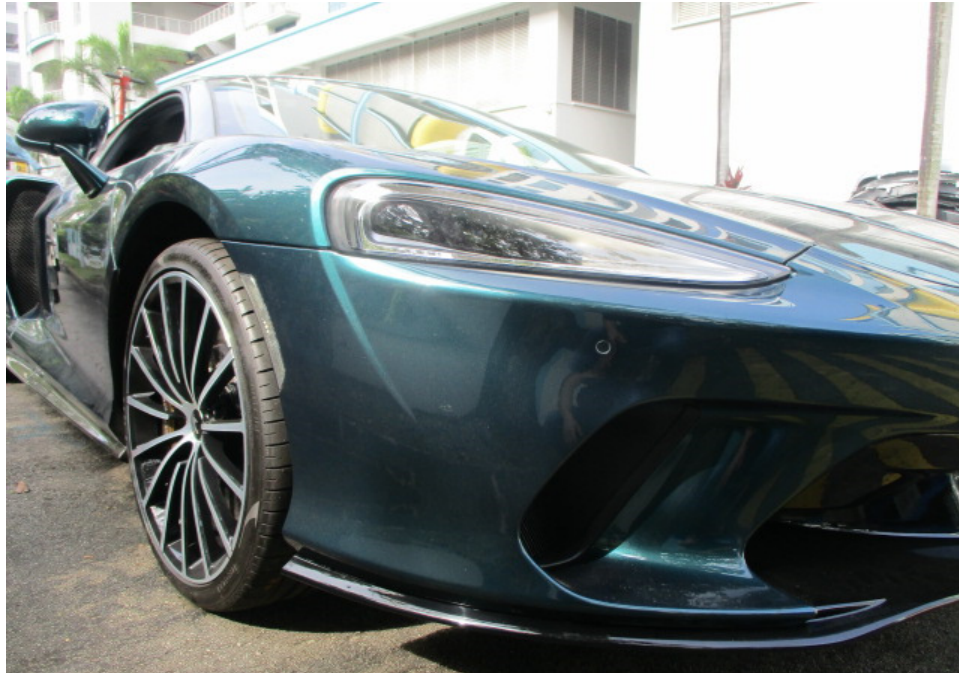
Photo 8 shows a closer view of the Motor Car's front bumper, front bumper lower lip, front right headlamp, front right signal lamp and front right fender at the time of my inspection. The body parts at the front right portion of the Motor Car were visually examined and it was observed that the repair/restoration works carried out to the damaged area of the Motor Car (refer to photograph 1 above) were reasonably adequate and in order.

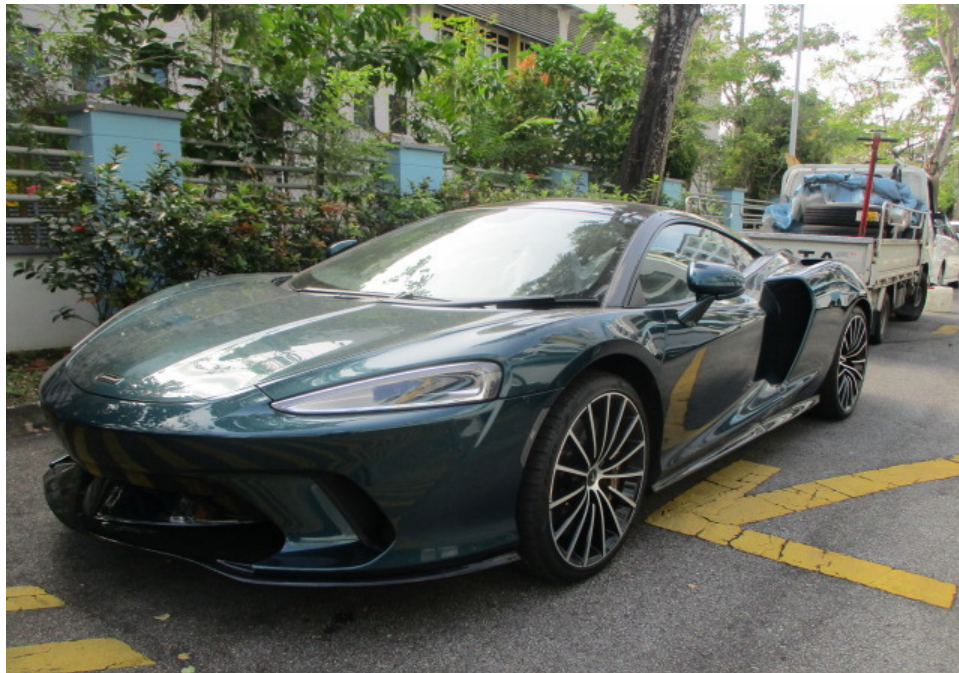
Photo 9 shows a general view of the front left body of the Motor Car at the time of my inspection. The Motor Car was observed to be in a relatively good general condition with no loose exterior fittings observed. The mileage of the Motor Car recorded at the time of my inspection was 2,095km.

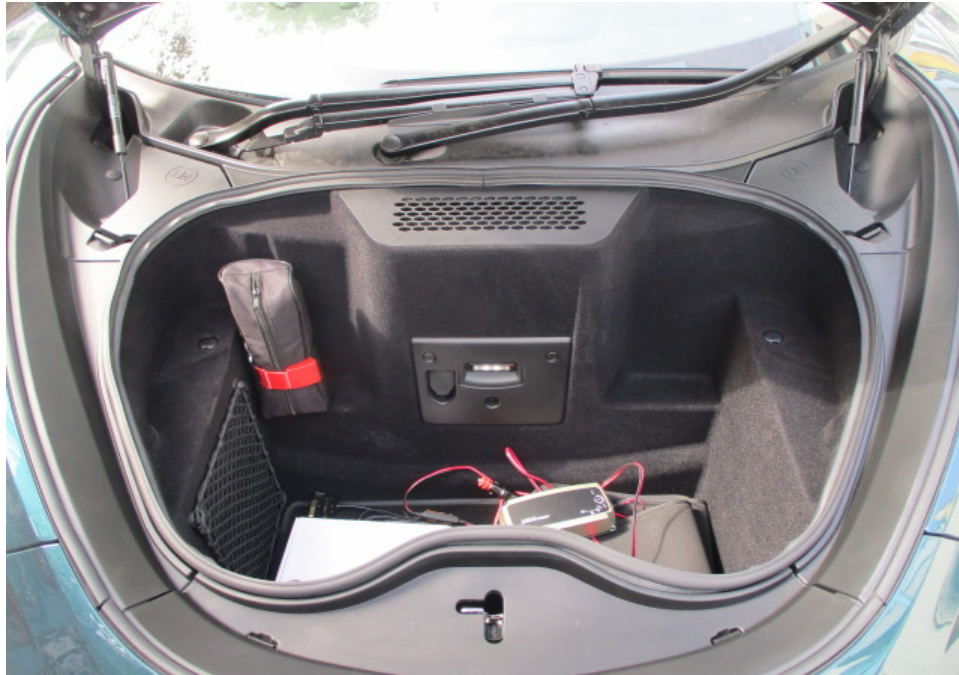
Photo 10 shows a general of the Motor Car's front bonnet compartment at the time of my inspection. All inner trims, garnishes and upholstery etc were observed to be intact and properly fitted.

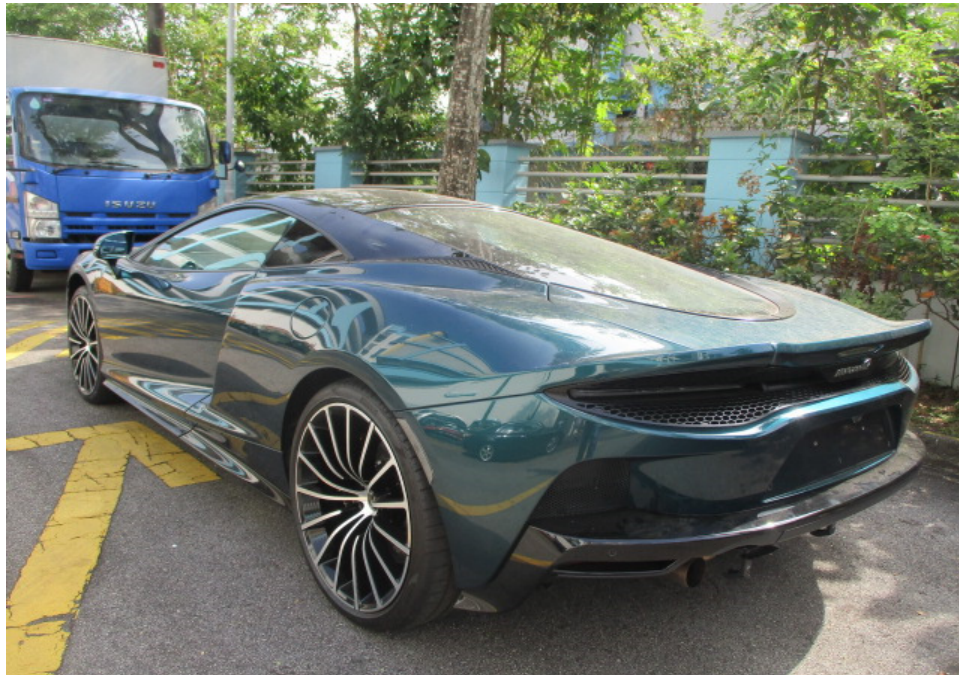
Photo 11 shows a general view of the rear left body of the Motor Car at the time of my inspection. The Motor Car was observed to be in a relatively good general condition with no loose exterior fittings observed. The mileage of the Motor Car recorded at the time of my inspection was 2,095km.

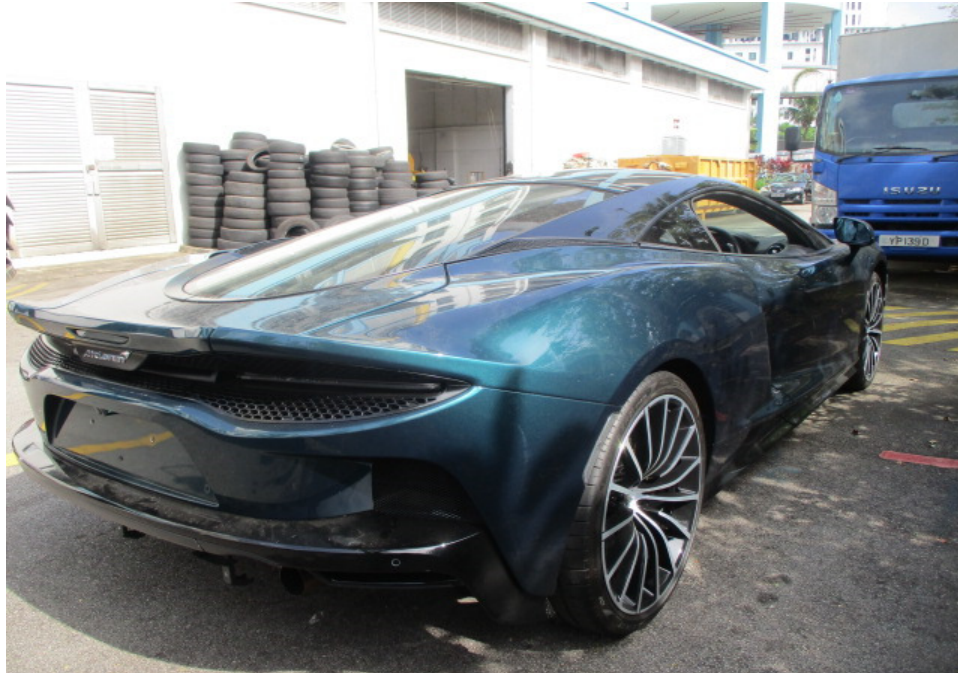
Photo 12 shows a general view of the rear right body of the Motor Car at the time of my inspection. The Motor Car was observed to be in a relatively good general condition with no loose exterior fittings observed. The mileage of the Motor Car recorded at the time of my inspection was 2,095km.

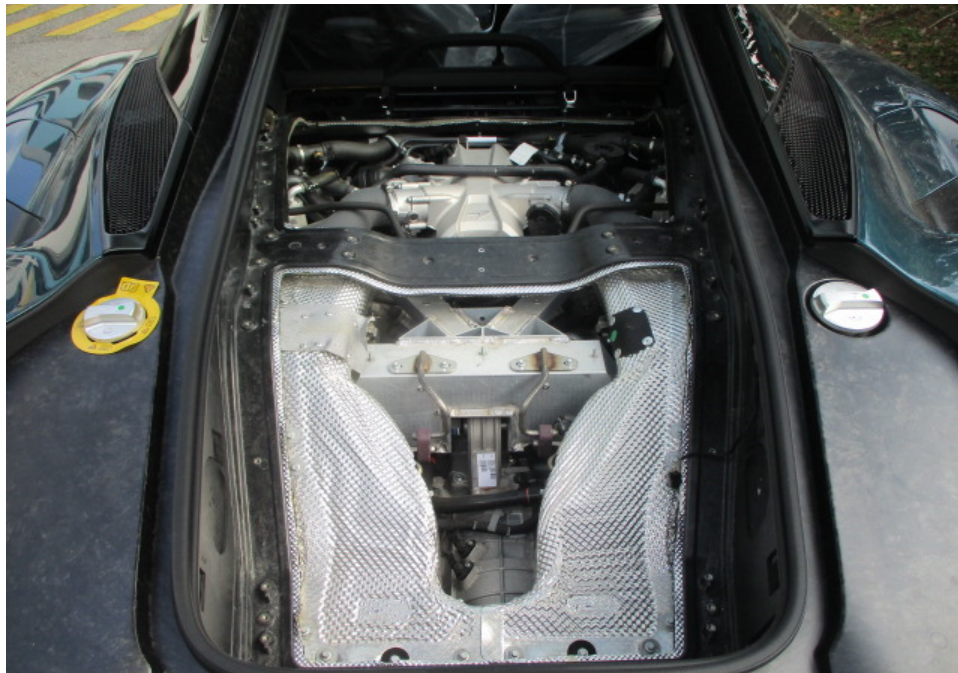
Photo 13 shows a general of the Motor Car's engine compartment at the time of my inspection. I had found the various parts and components inside the engine compartment to be intact and properly fitted. There was also no sign(s) or indication(s) of fluid leak and/or fluid stain found inside the engine compartment. Refer to photograph 25 & 26 below, showing the engine compartment as viewed from the rear underside of the Motor Car.

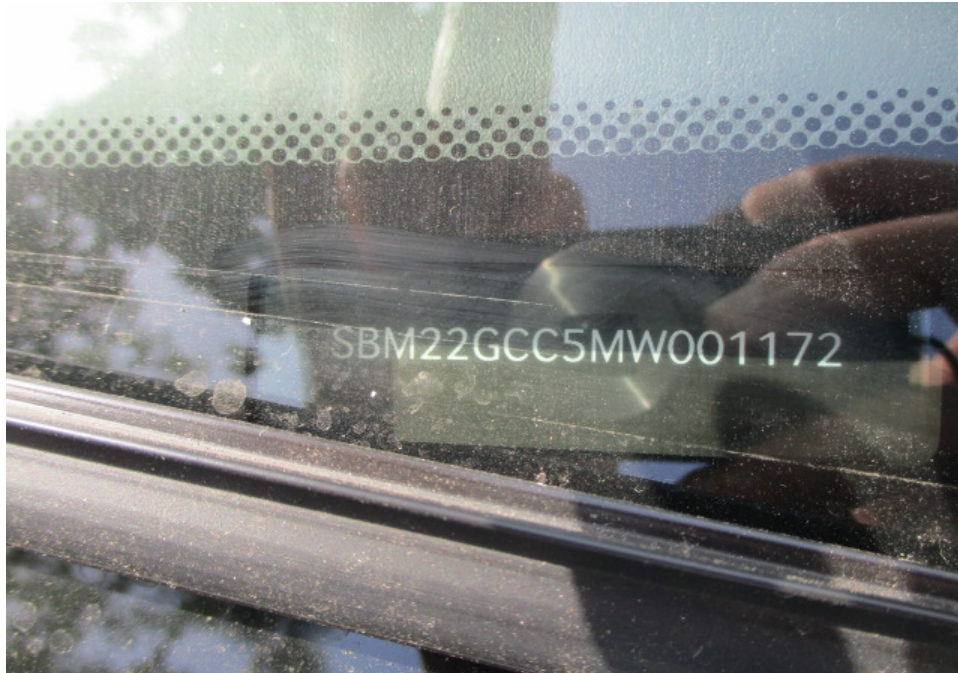
Photo 14 shows the chassis number of the Motor Car. The chassis number recorded was SBM22GCC5MW001172.

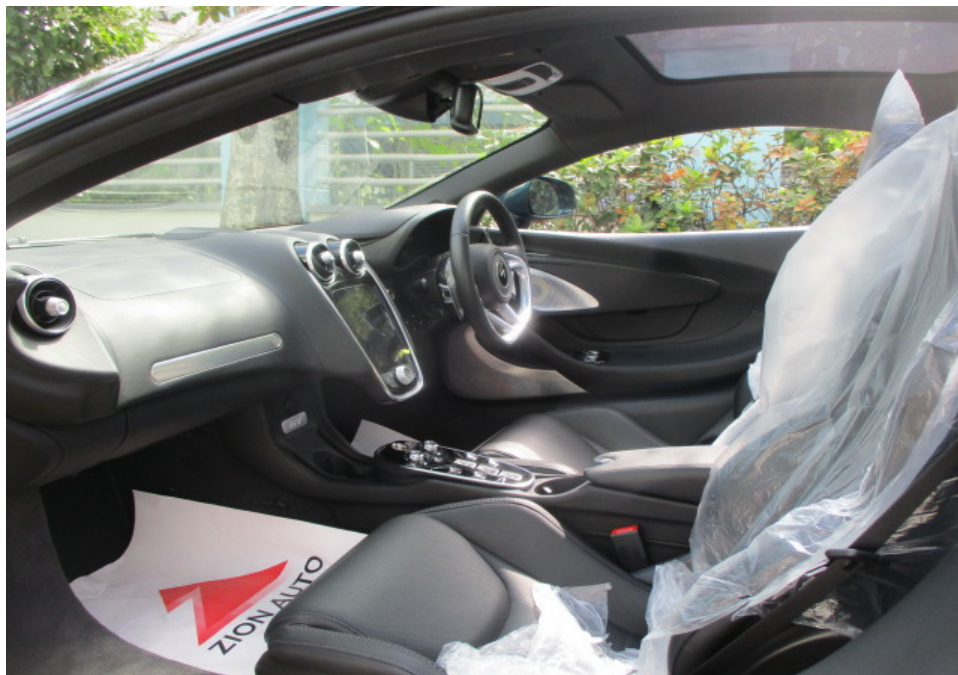
Photo 15 shows the interior compartment of the Motor Car at the time of my inspection. The various parts and components, trims, carpet, and upholstery inside the interior compartment were all observed to be intact and properly fitted.

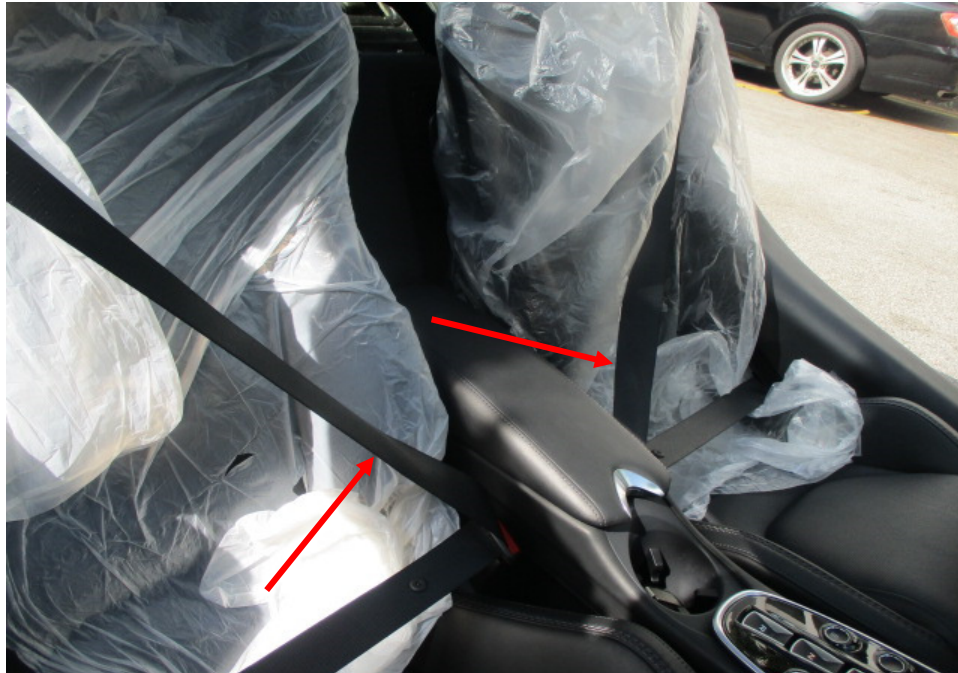
Photo 16 shows the seats of the Motor Car. All the seats of the Motor Car were secured via seat rails to the floorboard. They were also fitted with a retractable seat belt reel and a pre-tensioner. The seat belts (arrowed) were tested and were able to be fastened into the respective pre-tensions that were fitted on the side of each individual seat.

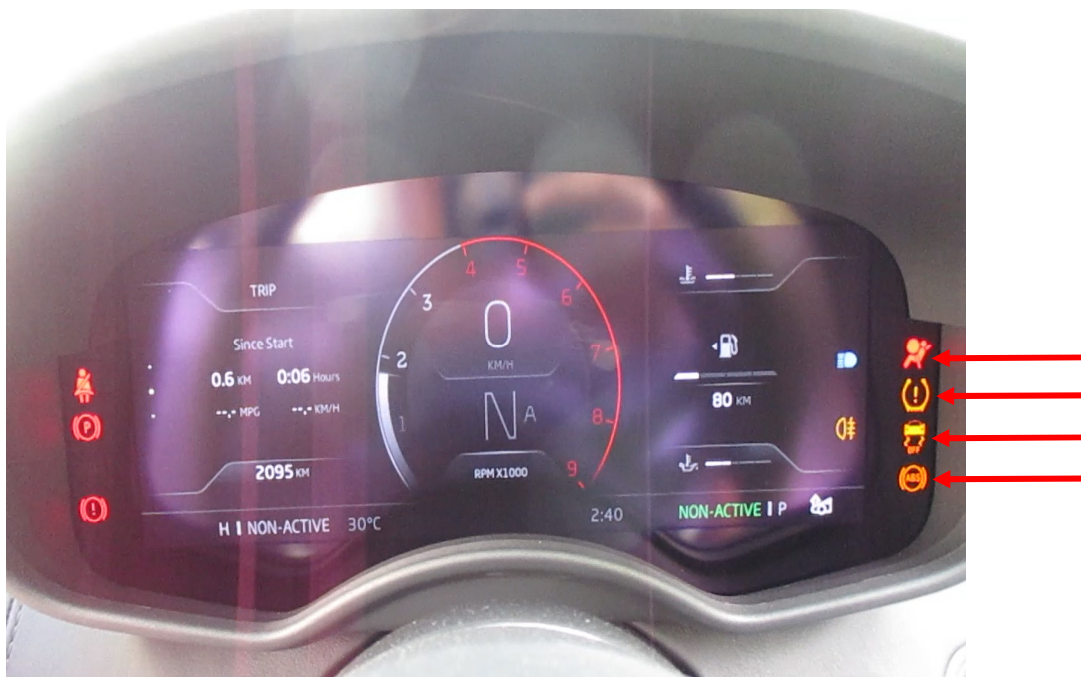
Photo 17 shows the warning lights for the various electronic safety features appearing on the instrument panel of the Motor Car during its self-test when the engine is cranked, in particular the ABS, SRS, TPM and TCS lights (arrowed).

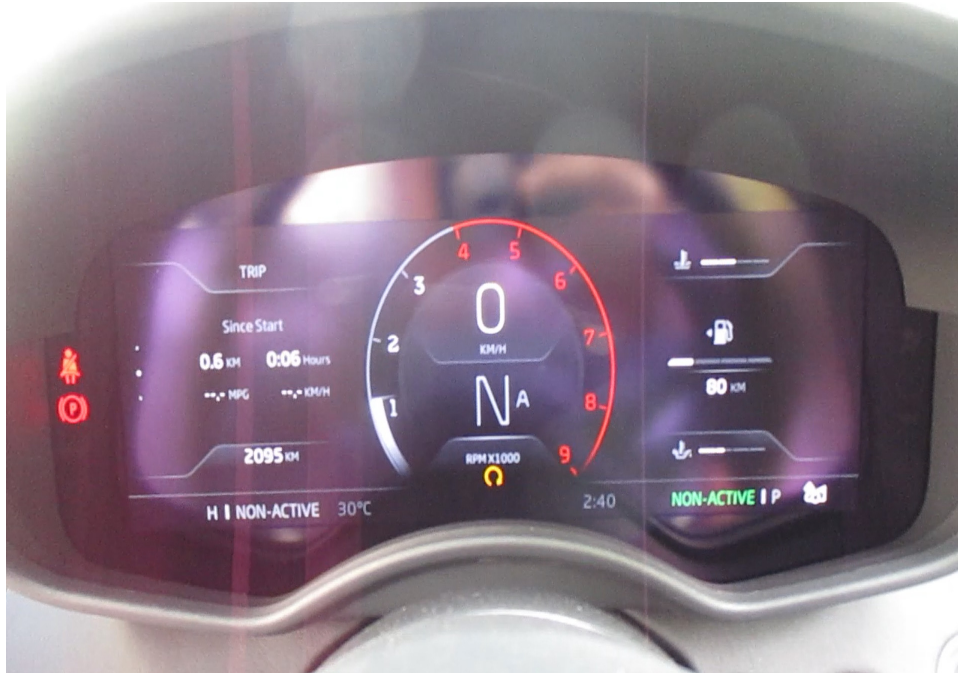
Photo 18 shows the respective warning lights no longer illuminated, indicating that there is no fault detected to the ABS, SRS, TPM and TCS systems of the Motor Car during the self-test. These electronic systems were hence in working condition at the time of my inspection.

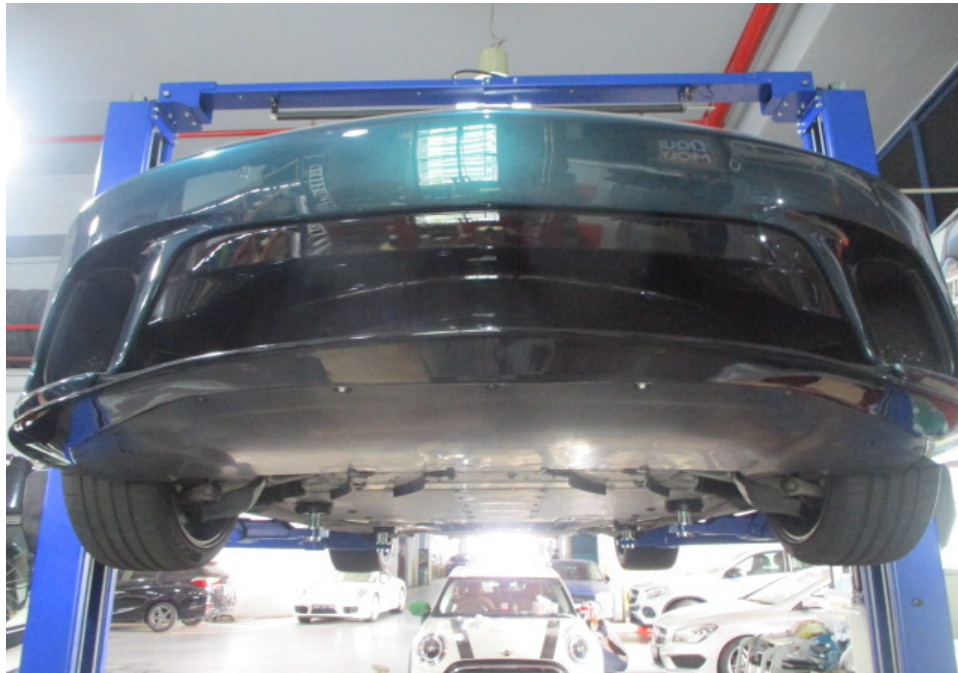
Photo 19 shows the Motor Car hoisted up for checks on its undercarriage. There was no sign(s) or indication(s) of fluid leakage and/or fluid stain(s) on the underside of the Motor Car. The undercarriage components of the Motor Car were also all observed to be intact and secured in an appropriate manner.

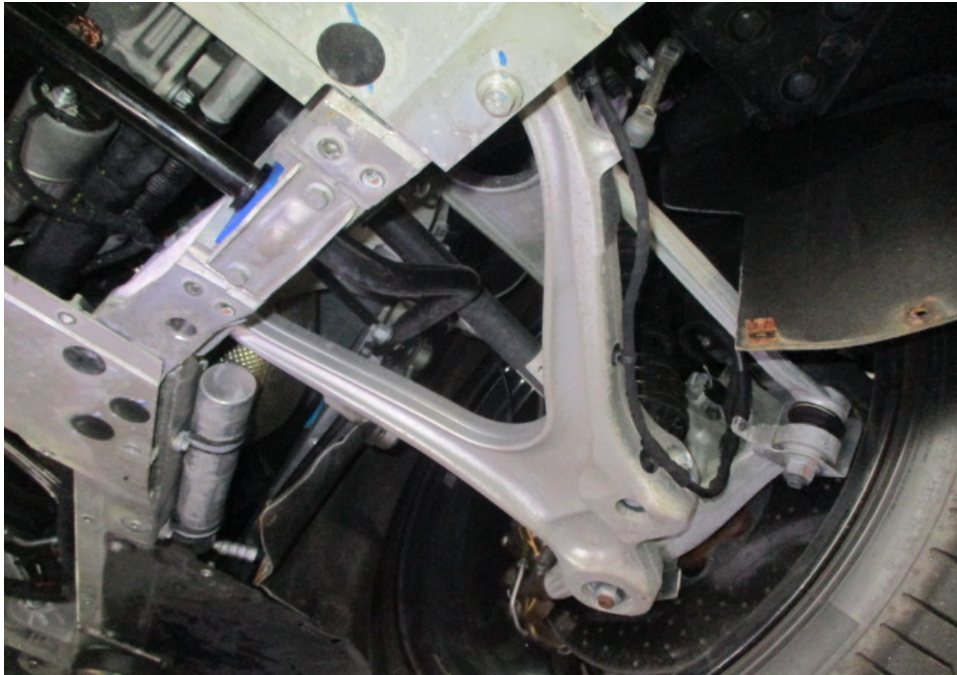
Photo 20 shows a general view of the control arms and linkages at the rear right wheel of the Motor Car. I did not observe any fluid leak and/or fluid stain on the underside of the Motor Car. All of the Motor Car's undercarriage components were observed to be intact and secured in an appropriate manner.

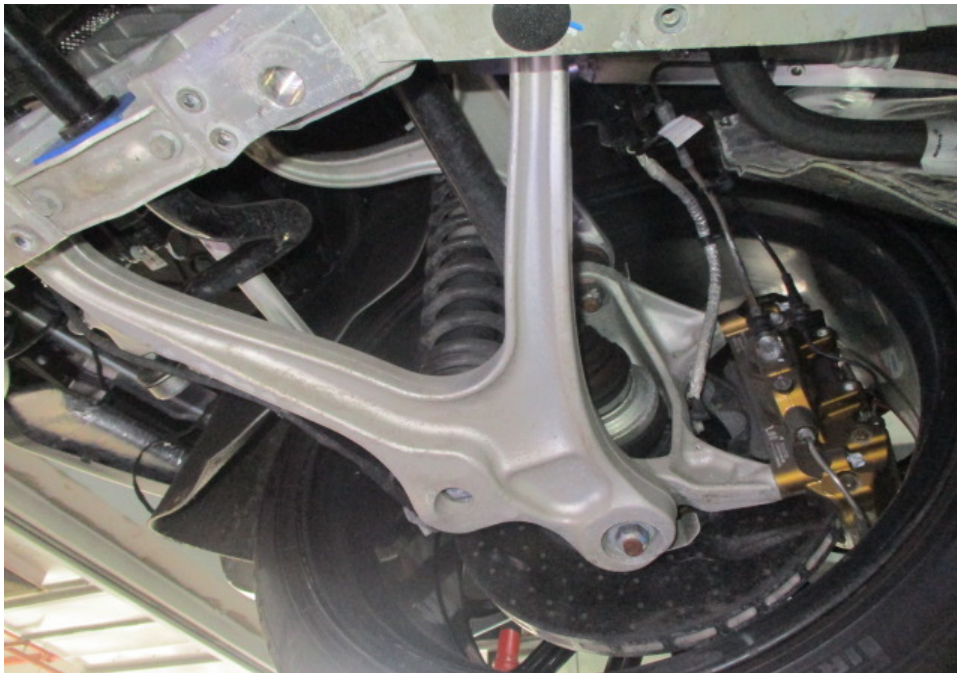
Photo 21 shows a general view of the control arms and linkages at the rear left wheel of the Motor Car. I did not observe any fluid leak and/or fluid stain on the underside of the Motor Car. All of the Motor Car's undercarriage components were observed to be intact and secured in an appropriate manner.

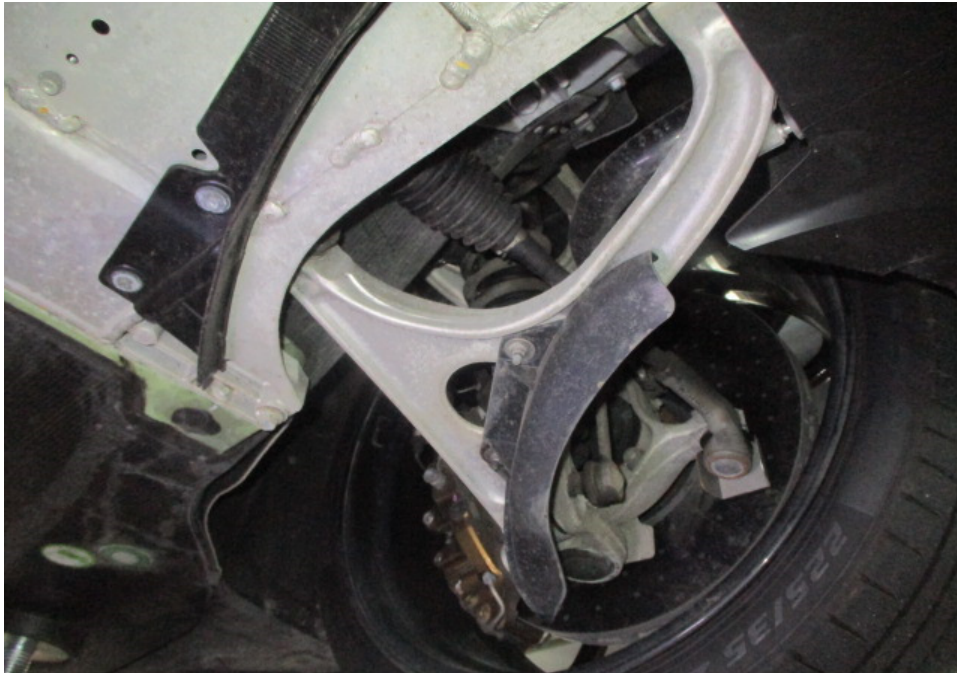
Photo 22 shows the various undercarriage components at the front left wheel of the Motor Car. The mechanical components, control arms and linkages were all found to be intact and secured in an appropriate manner.

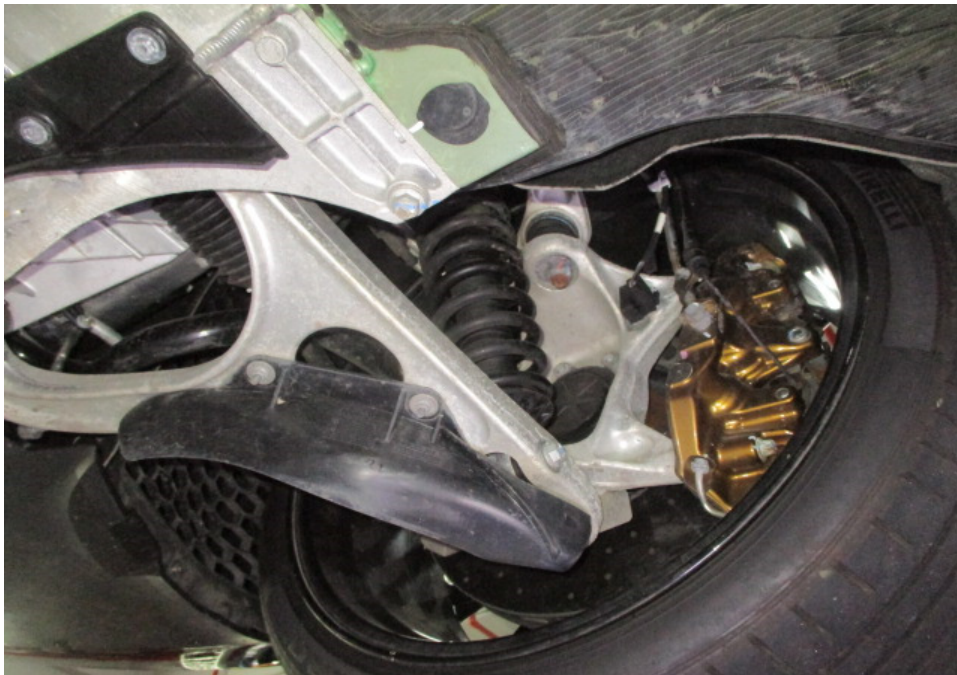
Photo 23 shows the various undercarriage components at the front right wheel of the Motor Car. The mechanical components, control arms and linkages were all found to be intact and secured in an appropriate manner. I also did not observe any fluid leak and/or fluid stain on the underside of the Motor Car.

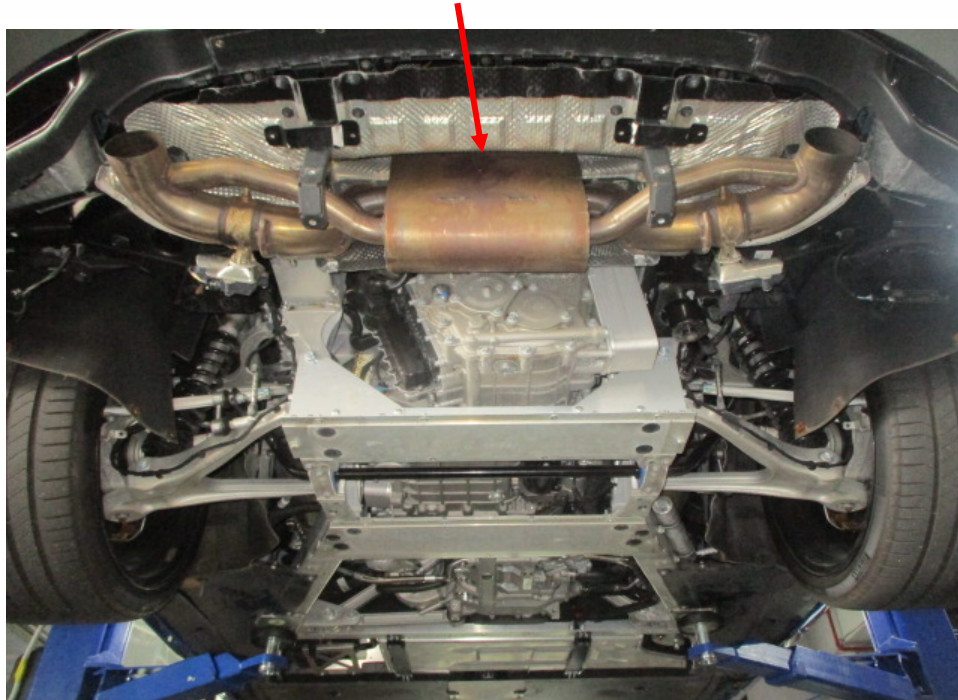
Photo 24 shows the Motor Car's exhaust system after dismantling of the rear undercovers. My examination of the Motor Car's exhaust system revealed no sign(s) or indication(s) of any cut or weld marks along its exhaust pipes, on its catalytic converters and on its rear muffler (arrowed).

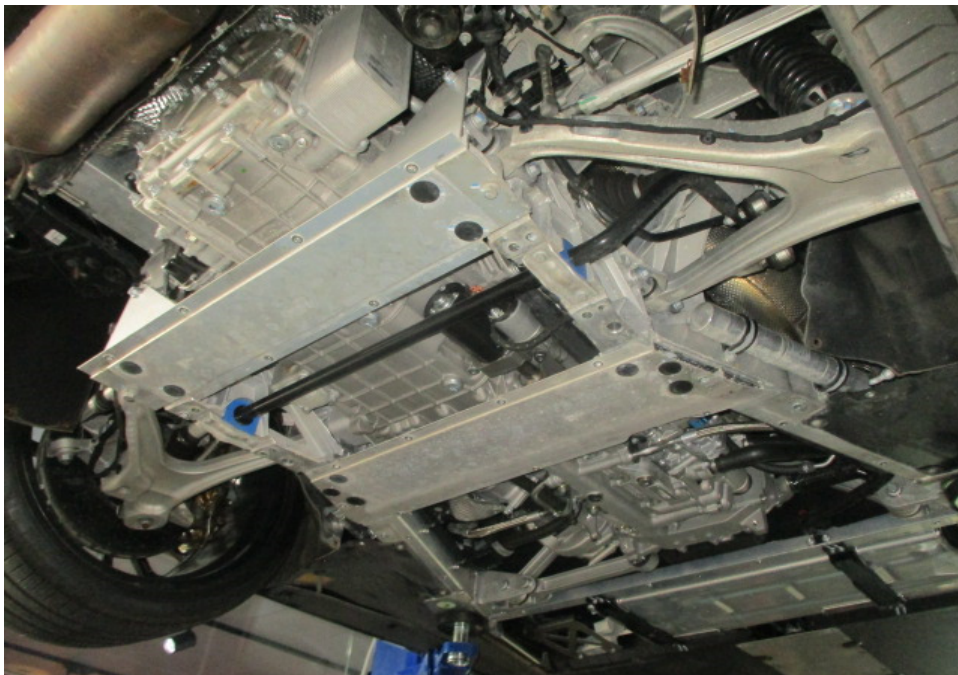
Photo 25 shows the Motor Car's engine compartment as viewed from the rear underside of the Motor Car, after dismantling of the rear undercovers. The various parts and components inside the engine compartment were all observed to be intact and properly fitted. There was also no sign(s) or indication(s) of fluid leak and/or fluid stain found inside the engine compartment.

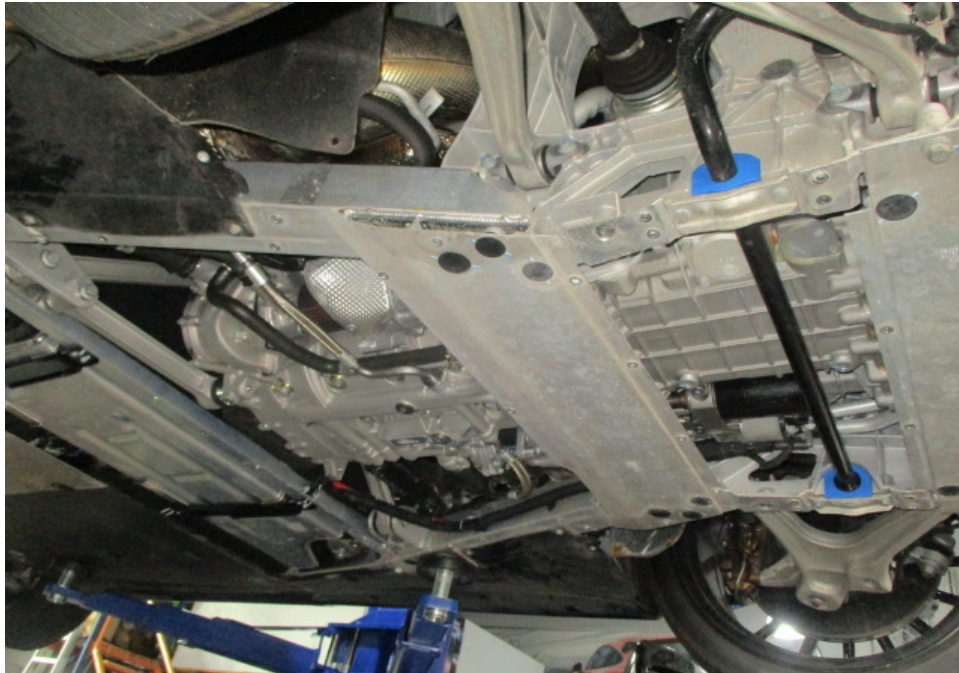
Photo 26 shows another view of the Motor Car's engine compartment as viewed from the rear underside of the Motor Car, after dismantling of the rear undercovers. The various parts and components inside the engine compartment were all observed to be intact and properly fitted. There was also no sign(s) or indication(s) of fluid leak and/or fluid stain found inside the engine compartment.

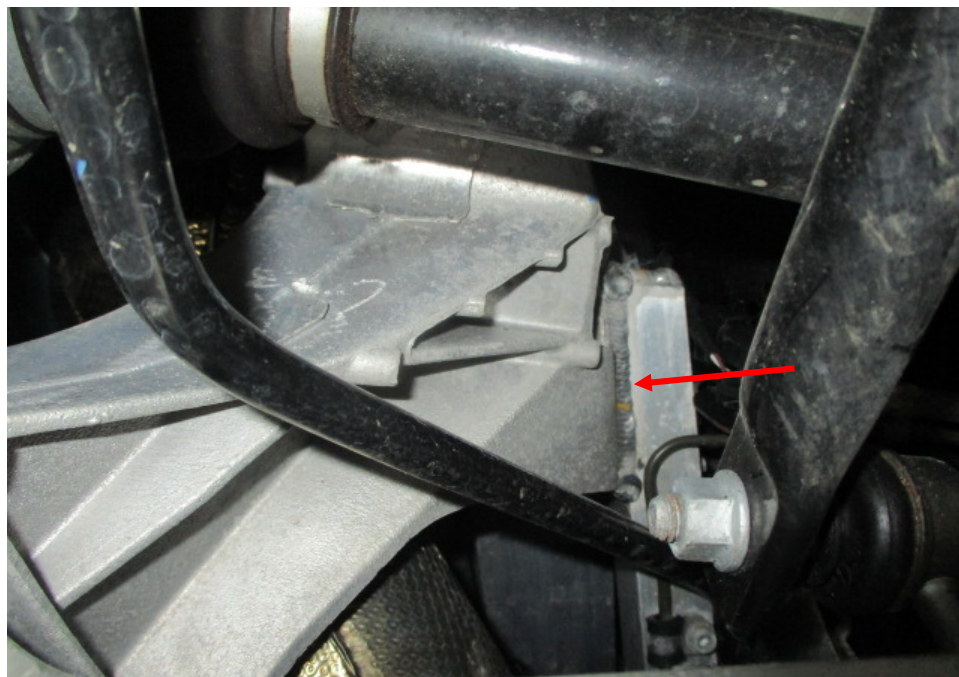
Photo 27 shows the aluminium chassis/structural body at the underside rear right of the Motor Car. I did not find any weld marks other than original weld marks on the chassis/structural body of the Motor Car. The original factory sealant (arrowed) at the joints along the chassis/structural body was untouched, indicating no work was done on the chassis/structural body of the Motor Car and that the chassis/structural body was originally fitted.

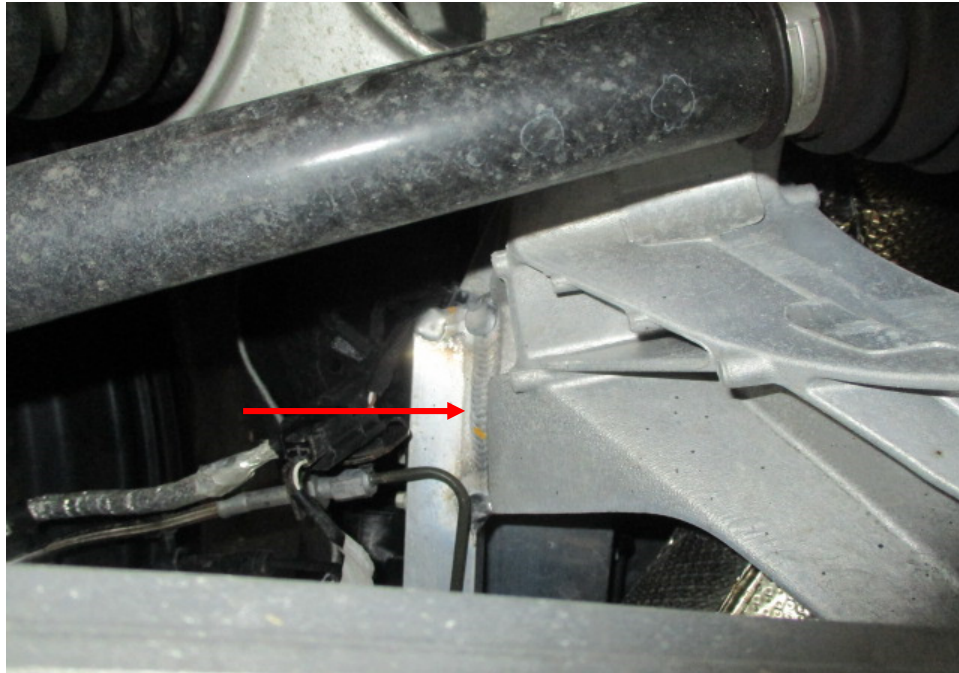
Photo 28 shows the aluminium chassis/structural body at the underside rear left of the Motor Car. I did not find any weld marks other than original weld marks on the chassis/structural body of the Motor Car. The original factory sealant (arrowed) at the joints along the chassis/structural body was untouched, indicating no work was done on the chassis/structural body of the Motor Car and that the chassis/structural body was originally fitted.

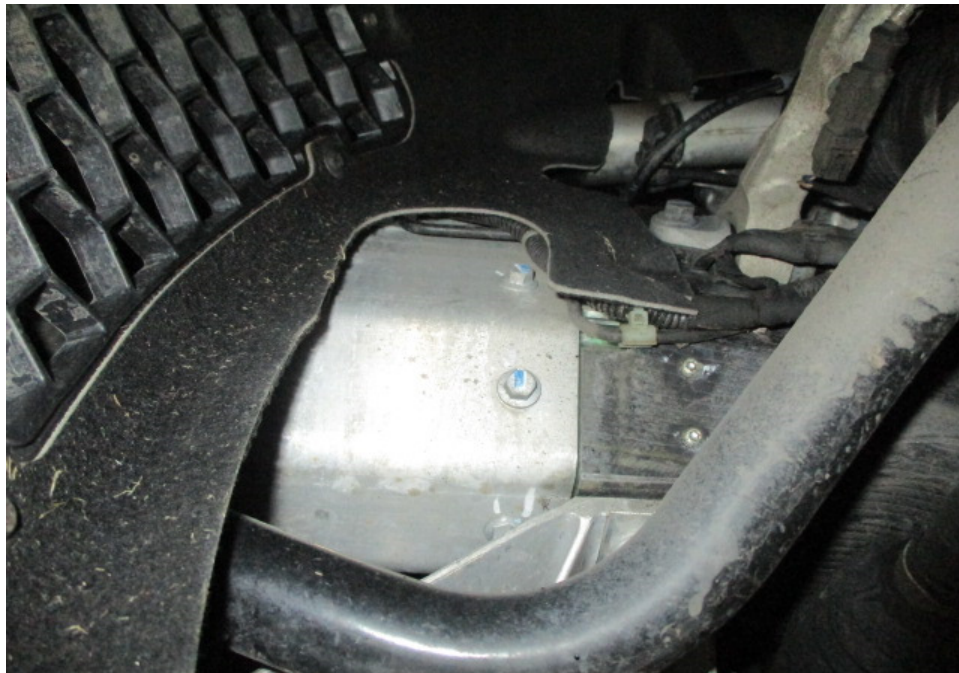
Photo 29 shows the aluminium chassis/structural body at the underside front left of the Motor Car. The original factory sealant at the joints along the chassis/structural body was observed to be untouched. In general, I had found no work was carried out on the chassis/structural body of the Motor Car. The aluminium chassis/structural body of the Motor Car was originally fitted.

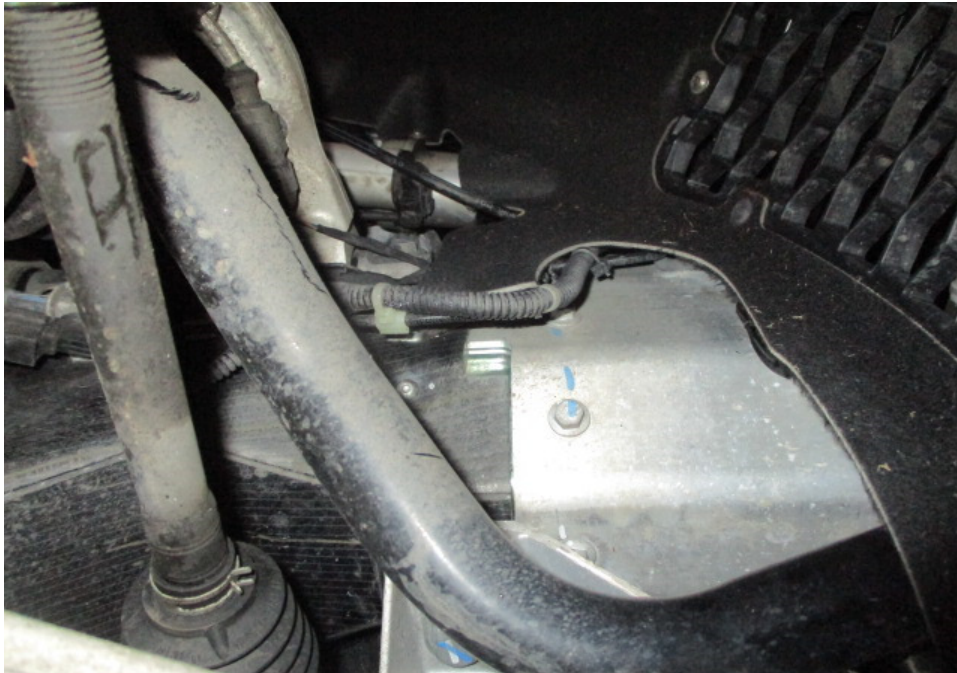
Photo 30 shows the aluminium chassis/structural body at the underside front right of the Motor Car. The original factory sealant at the joints along the chassis/structural body was observed to be untouched. In general, I had found no work was carried out on the chassis/structural body of the Motor Car. The aluminium chassis/structural body of the Motor Car was originally fitted.
