Your Ref: McLaren GT
(chassis number SBM22GCC5MW001172)
Our Ref : CI/TP23000664/D

19 January 2023

INSPECTION REPORT OF AN UNREGISTERED MCLAREN GT MOTOR CAR WITH CHASSIS NUMBER SBM22GCC5MW001172

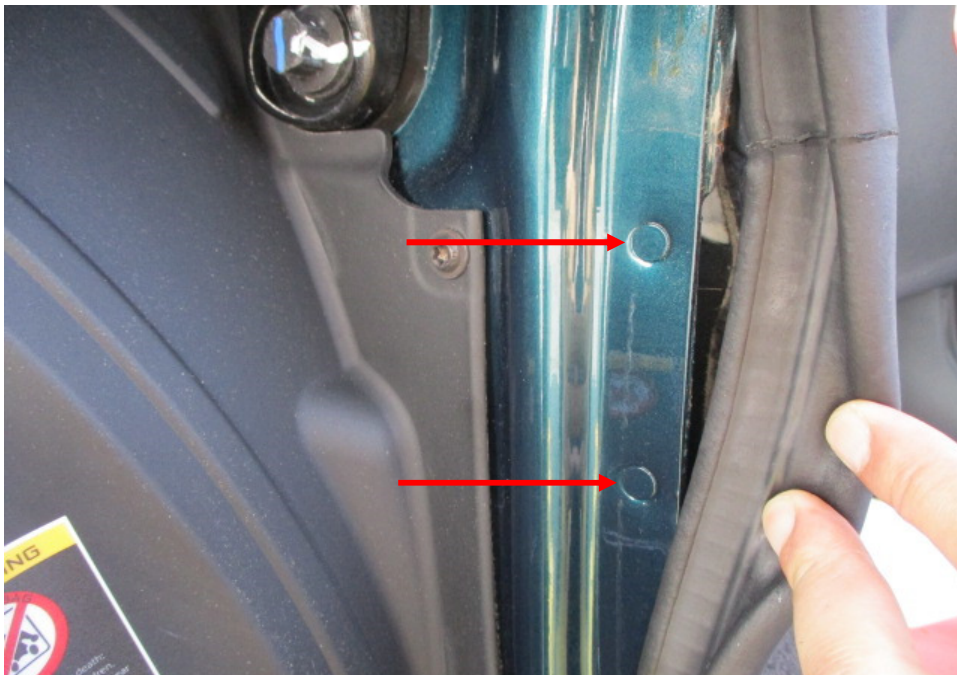
Photo 31 shows the left side "A" pillar of the Motor Car. I did not find any weld marks other than original spot weld marks (arrowed) on the left side "A" pillar of the Motor Car which, indicates that there was no re-welding works carried out. In general, I had found all the non-detachable body panels of the Motor Car to be originally fitted at the time of my inspection.

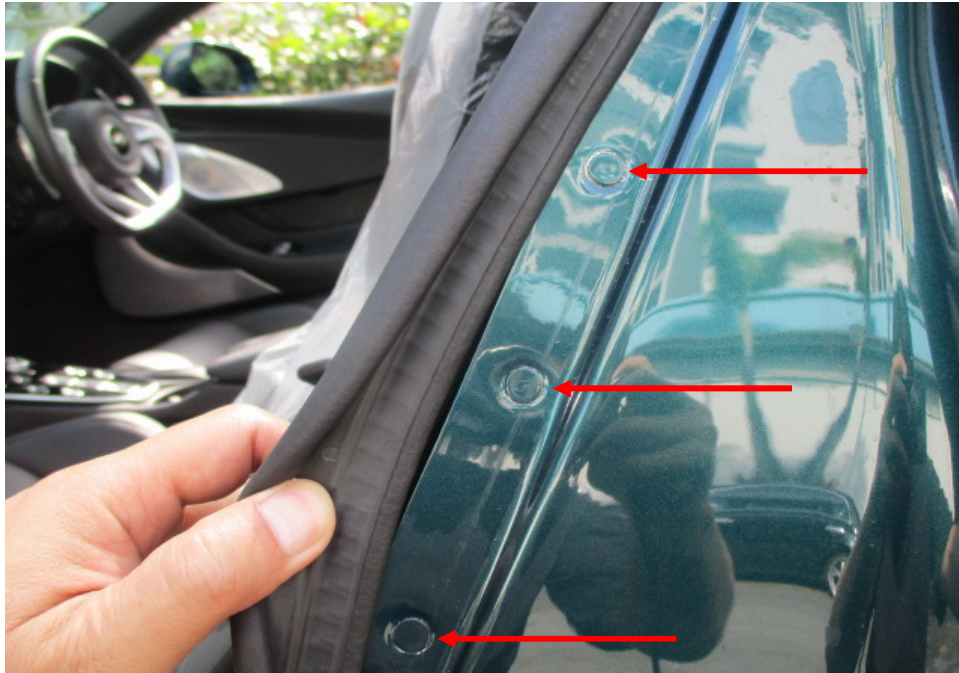
Photo 32 shows the left side rear body panel of the Motor Car. I did not find any weld marks other than original spot weld marks (arrowed) on the left side rear body panel of the Motor Car which, indicates that there was no re-welding works carried out. In general, I had found all the non-detachable body panels of the Motor Car to be originally fitted at the time of my inspection.

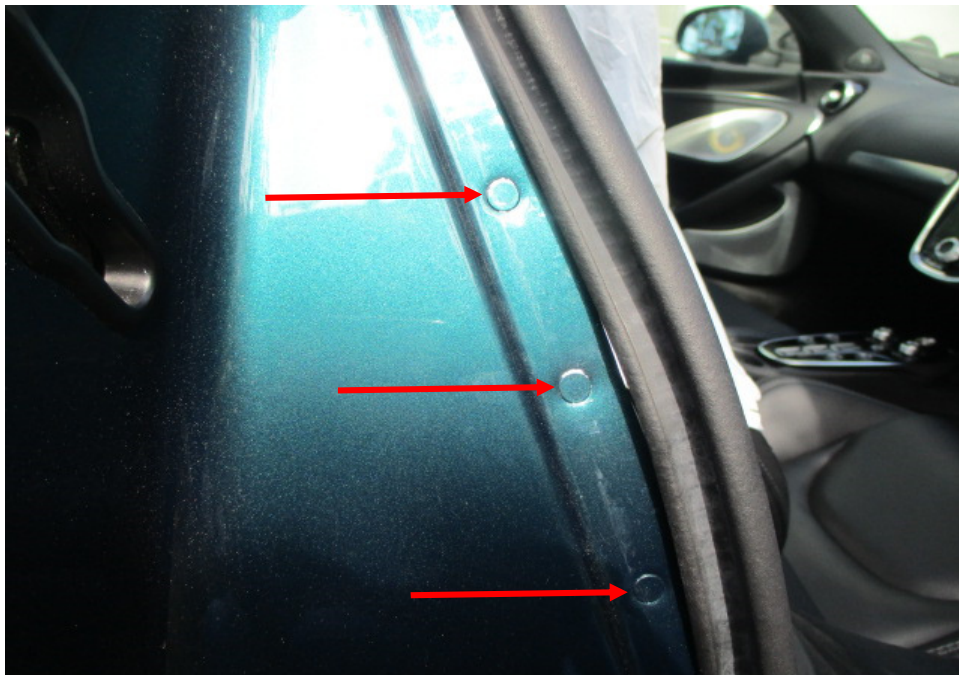
Photo 33 shows the right side rear body panel of the Motor Car. I did not find any weld marks other than original spot weld marks (arrowed) on the right side rear body panel pillar of the Motor Car which, indicates that there was no re-welding works carried out. In general, I had found all the non-detachable body panels of the Motor Car to be originally fitted at the time of my inspection.

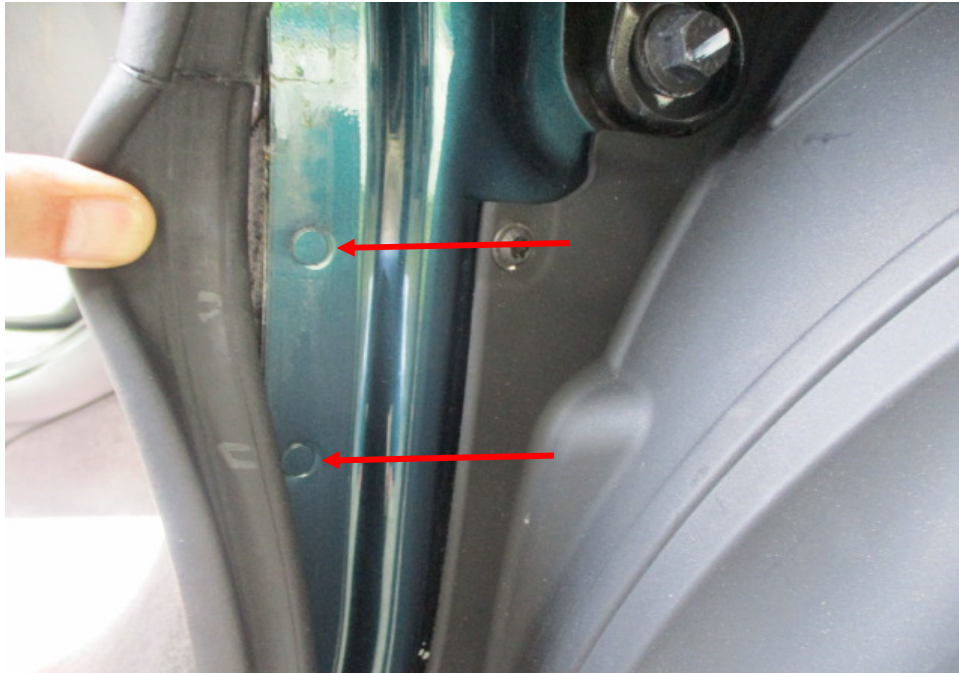
Photo 34 shows the right side "A" pillar of the Motor Car. I did not find any weld marks other than original spot weld marks (arrowed) on the right side "A" pillar of the Motor Car which, indicates that there was no re-welding works carried out. In general, I had found all the non-detachable body panels of the Motor Car to be originally fitted at the time of my inspection.
