## LKK Auto Consultants Pte Ltd

| Affiliated to Federation Internationale Des Experts En Automobile | | | | |
|---|---|---|---|--|
| LONPAC INSURANCE BHD<br>300 BEACH ROAD<br>#17-04/07 THE CONCOURSESINGAPORE 199555 | | | Ref: CC4/LPC23001037/Kpa3q2<br>Date: 09/05/2023<br>Code: LPC2 | |
| Insured Veh. | SJQ 9746P | Veh. Inspected | SBR 8008H | |

## ADJUSTMENT ON REPAIR COST FOR VEHICLE NO. SBR 8008H

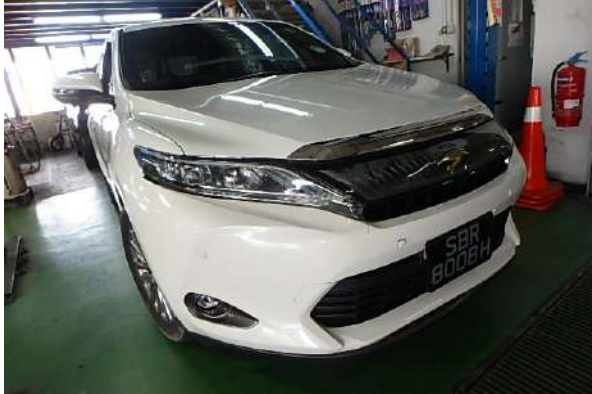
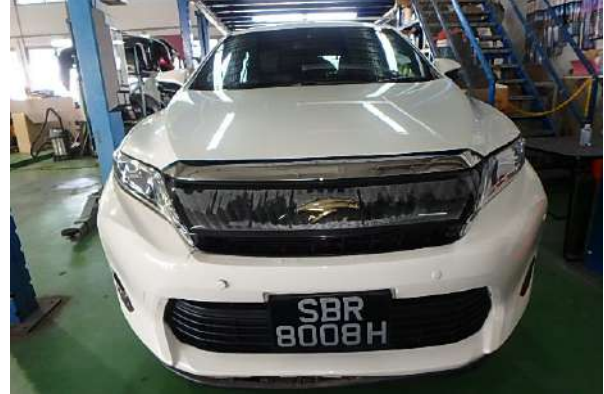
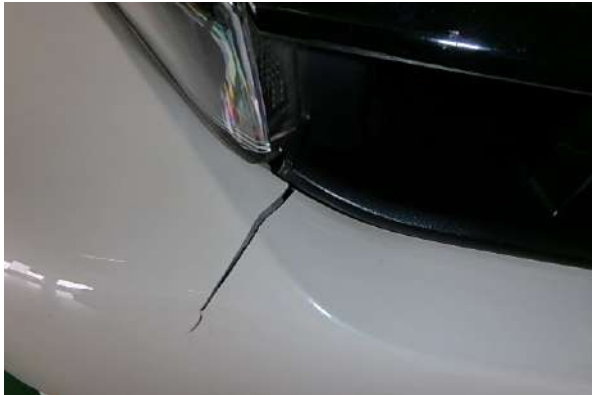
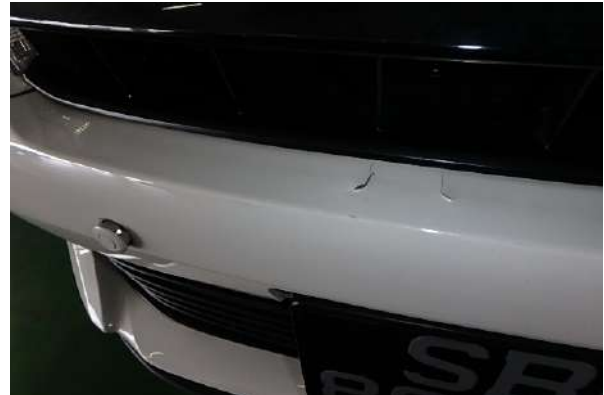
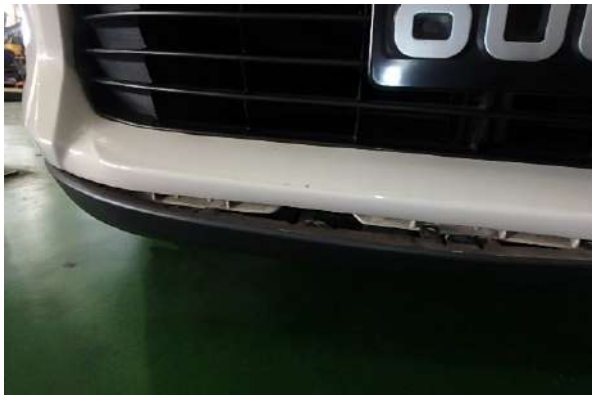
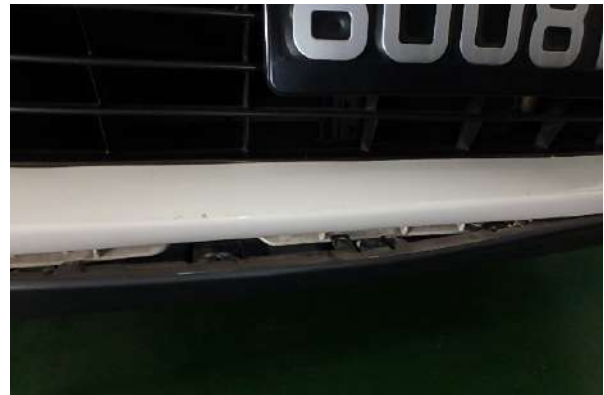
### INSPECTION

| Affiliated to Federation Internationale Des Experts En Automobile | | | | |
|---|---|---|---|--|
| THE VEHICLE SUSTAINED DAMAGES AT THE FRONT PORTION.<br>DAMAGES SEE DETAILS. | | | | |
