**AUTOMOBILE INSPECTION REPORT OF INSURED VEHICLE GBL 7324H**

Vehicle Registration No.	: GBL 7324H
Make / Model	: TOYOTA HIACE DX 2.8 AUTO
Chassis No	: GDH2011066392
Year of Registration	: March 2022
Mileage	: 38,258km

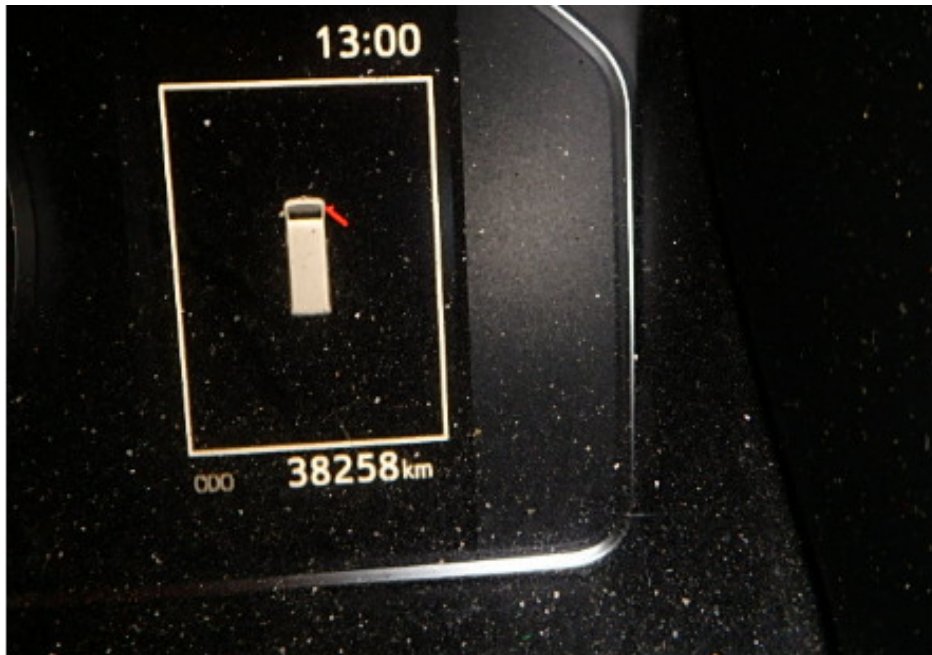
**Photo 1** shows the mileage of the Insured Vehicle at the time of our inspection. The mileage observed was 38,258km.

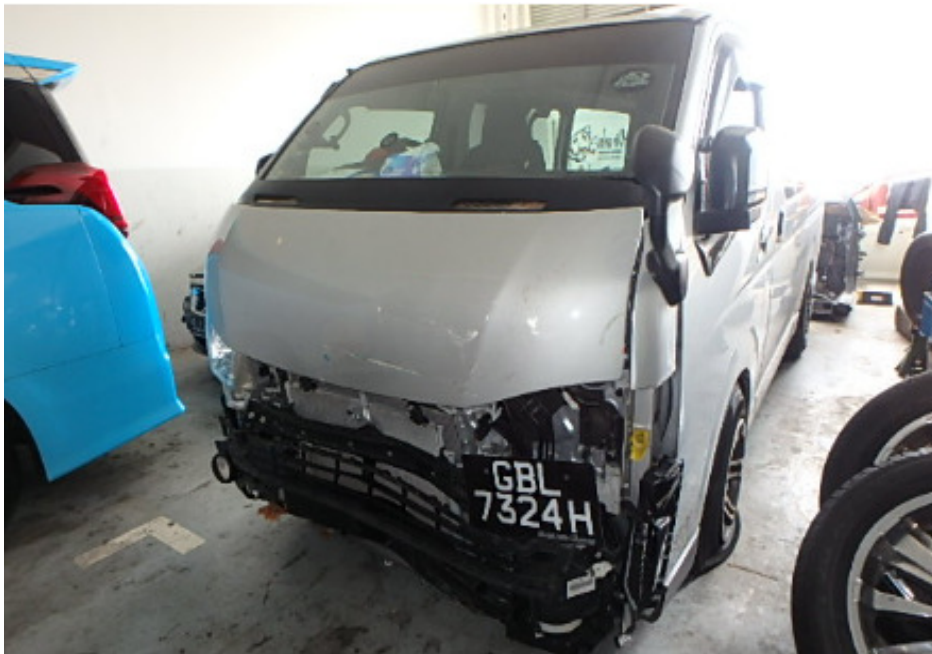
**Photo 2** shows a general view of the Insured Vehicle's left frontal portion at the time of our inspection.

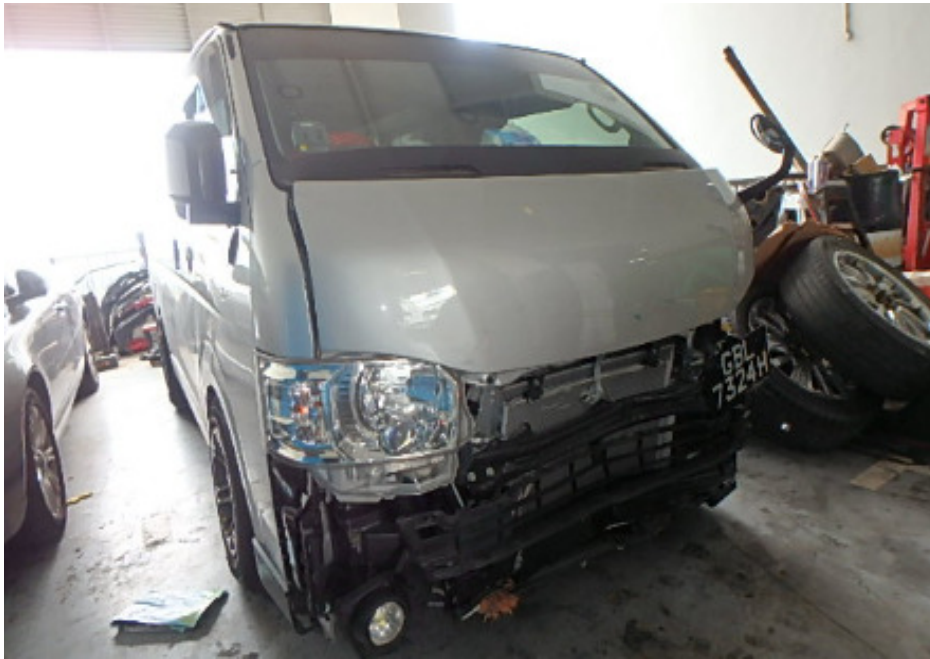
**Photo 3** shows a general view of the Insured Vehicle's right frontal portion at the time of our inspection.

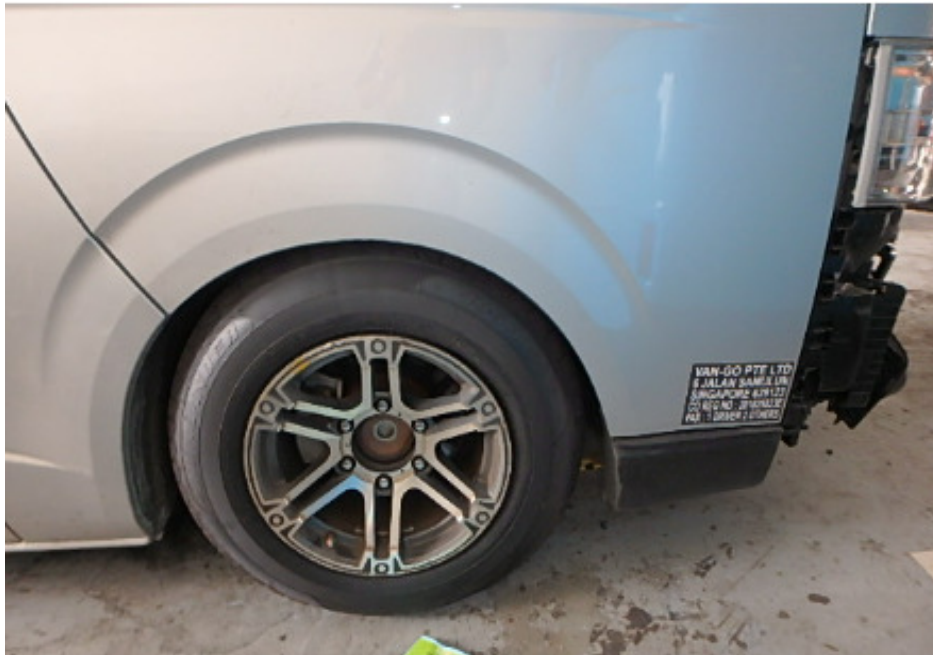
**Photo 4** shows the non-standard rim found to be fitted on the Insured Vehicle at the time of our inspection. The 15- inch alloy rims fitted on the Insured Vehicle were not the standard type for the Insured Vehicle.

15. Having carried out a detailed inspection of the Insured Vehicle, the Insured Vehicle does not come originally fitted with alloy/sport rims. As per the modification guidelines stipulated by Land Transport Authority (LTA), alloy/sport rims are only allowed for motor cars. For commercial vehicles such as the Insured Vehicle, it will be unable to pass the mandatory yearly LTA inspection unless it comes factory- fitted with alloy/sport rims.
16. Furthermore, the tyres fitted around the aftermarket 15- inch alloy rims are found to have protruded out of the body of the Insured Vehicle, which is also not allowed under the modification guidelines stipulated by Land Transport Authority (LTA).

17. Although the aftermarket alloy rims and protruding tyres fitted on the Insured Vehicle were not the standard type for the Insured Vehicle, we are of the view that these parts did not cause and/or contribute to the accident. The accident was purely due to human factor and not any issue related to the Insured Vehicle.

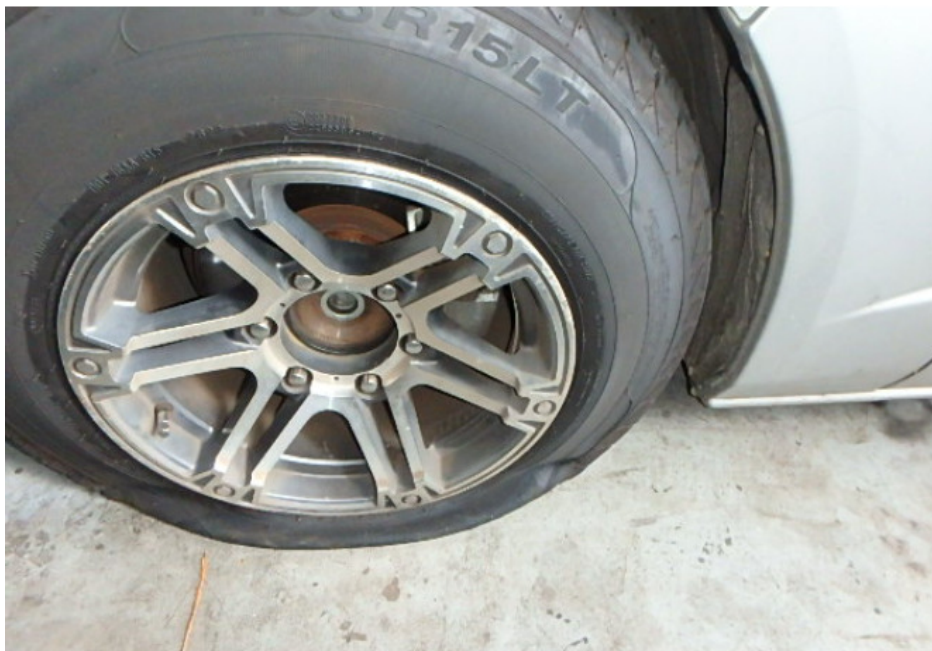
**Photo 5** shows a closer view of the non-standard rim found to be fitted on the Insured Vehicle at the time of our inspection. The 15- inch alloy rims fitted on the Insured Vehicle were not the standard type for the Insured Vehicle.

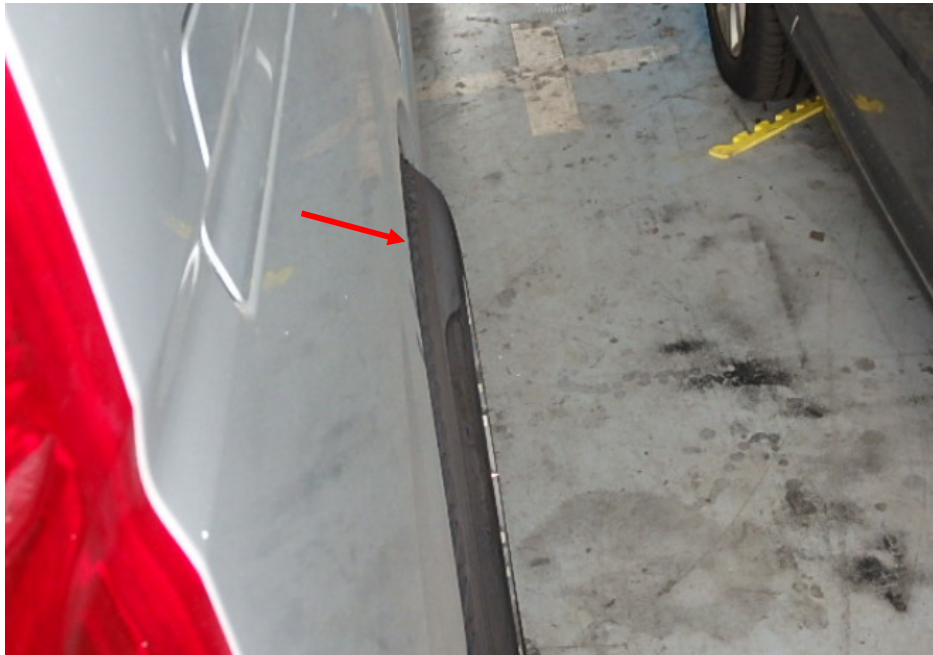
**Photo 6** shows the right rear tyre protruding out of the body of the Insured Vehicle at the time of our inspection (arrowed).

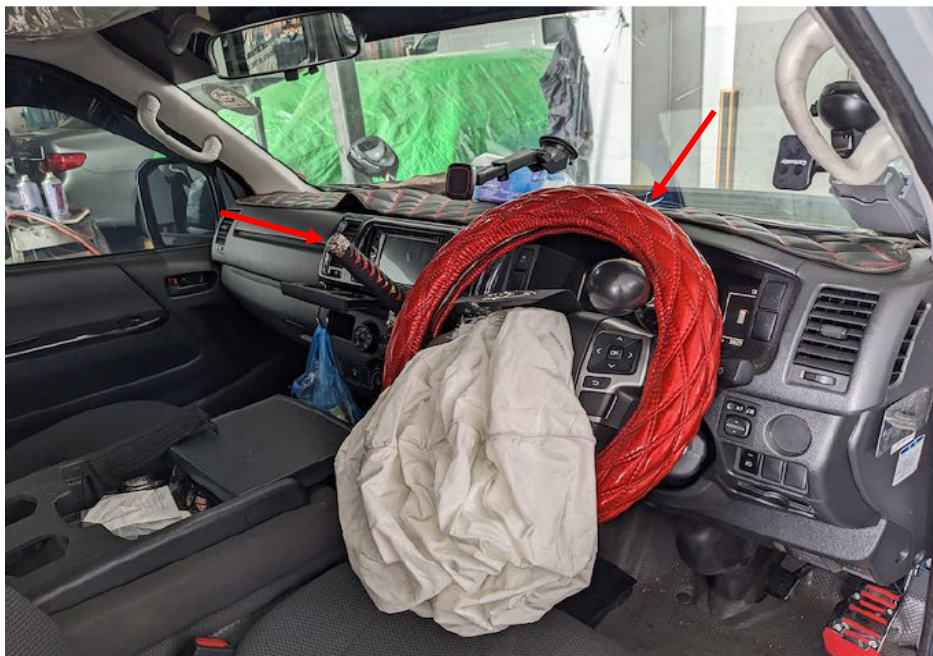
**Photo 7** shows a closer view of the aftermarket steering wheel cover and gear shift knob found to be fitted on the Insured Vehicle at the time of our inspection (arrowed). The steering wheel cover and gear shift knob found fitted on the Insured Vehicle were not the standard type for the Insured Vehicle.
