Your Ref: SNM23D200505  
Our Ref : CS/CTI23001075/N

**AUTOMOBILE INSPECTION REPORT OF INSURED VEHICLE GBL 7324H**

Vehicle Registration No.	: GBL 7324H
Make / Model	: TOYOTA HIACE DX 2.8 AUTO
Chassis No	: GDH2011066392
Year of Registration	: March 2022
Mileage	: 38,258km

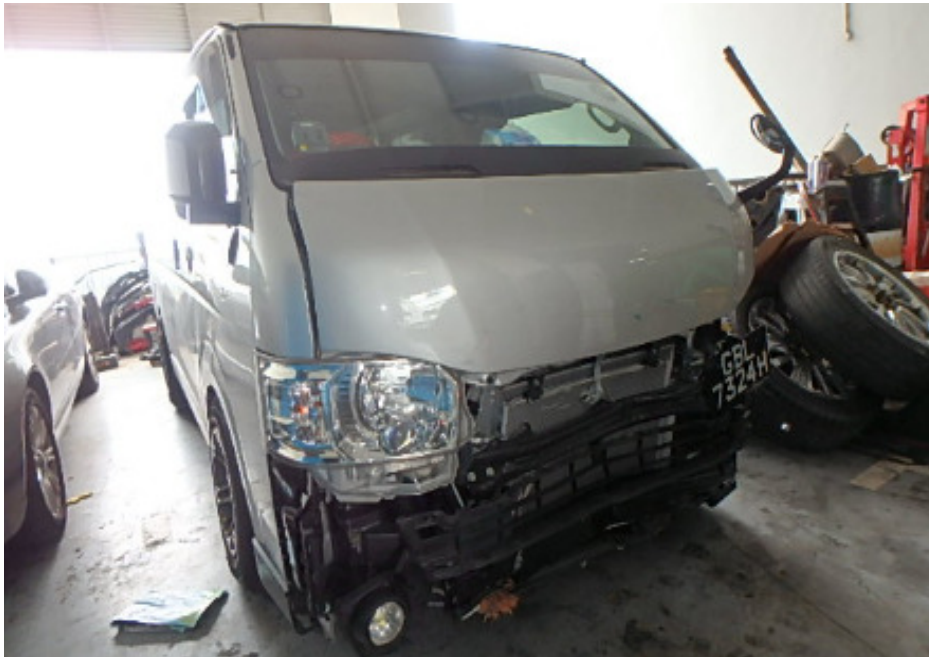
**Photo 3** shows a general view of the Insured Vehicle's right frontal portion at the time of our inspection.

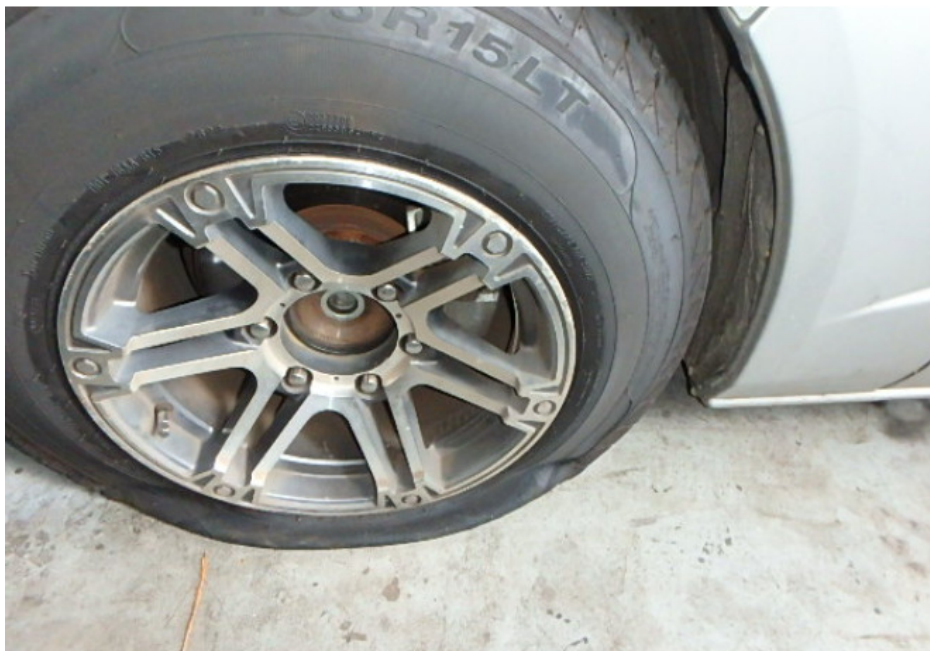
**Photo 5** shows a closer view of the non-standard rim found to be fitted on the Insured Vehicle at the time of our inspection. The 15- inch alloy rims fitted on the Insured Vehicle were not the standard type for the Insured Vehicle.

15. Having carried out a detailed inspection of the Insured Vehicle, the Insured Vehicle does not come originally fitted with alloy/sport rims. As per the modification guidelines stipulated by Land Transport Authority (LTA), alloy/sport rims are only allowed for motor cars. For commercial vehicles such as the Insured Vehicle, it will be unable to pass the mandatory yearly LTA inspection unless it comes factory- fitted with alloy/sport rims.
16. Furthermore, the tyres fitted around the aftermarket 15- inch alloy rims are found to have protruded out of the body of the Insured Vehicle, which is also not allowed under the modification guidelines stipulated by Land Transport Authority (LTA).

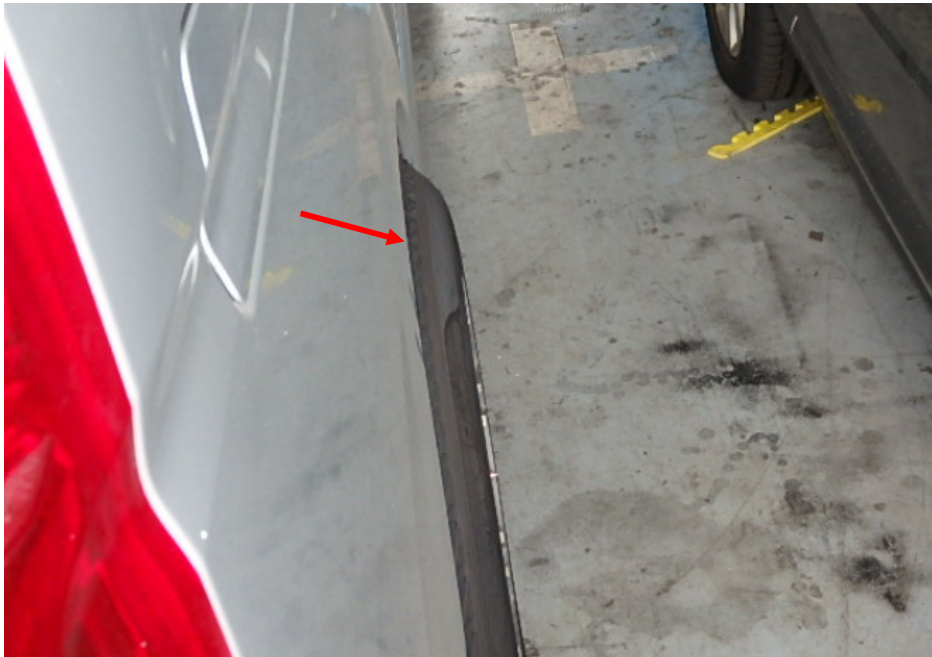
**Photo 6** shows the right rear tyre protruding out of the body of the Insured Vehicle at the time of our inspection (arrowed).

17. Although the aftermarket alloy rims and protruding tyres fitted on the Insured Vehicle were not the standard type for the Insured Vehicle, we are of the view that these parts did not cause and/or contribute to the accident. The accident was purely due to human factor and not any issue related to the Insured Vehicle.

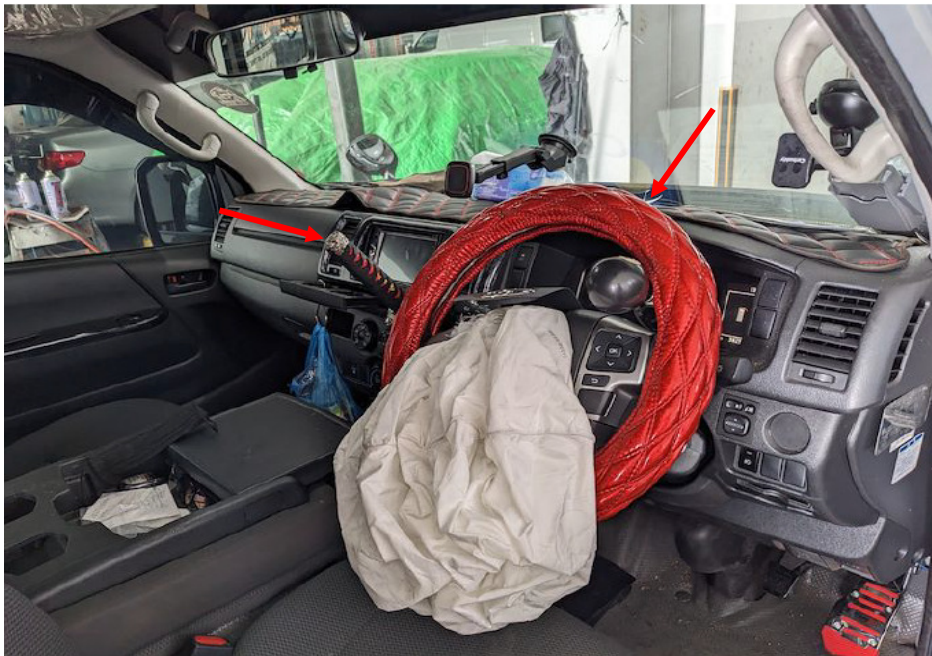
**Photo 7** shows a closer view of the aftermarket steering wheel cover and gear shift knob found to be fitted on the Insured Vehicle at the time of our inspection (arrowed). The steering wheel cover and gear shift knob found fitted on the Insured Vehicle were not the standard type for the Insured Vehicle.
